46–56 Gloucester Street, The Rocks

SHR No. 01609

Conservation Management Plan

Report prepared for NSW Land and Housing Corporation

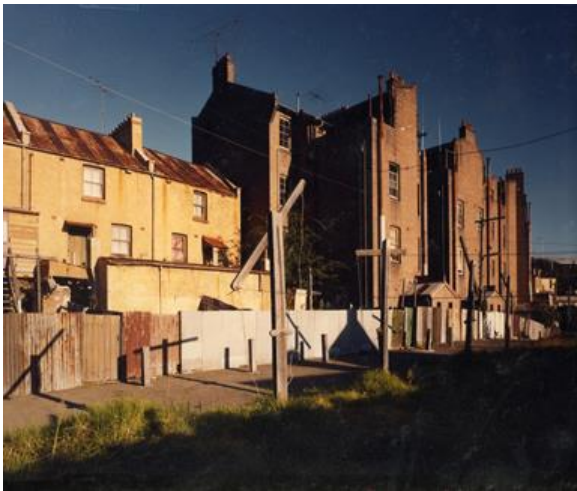
The same report noted that externally the building was 'almost entirely original but for the removal of shutters and recent modifications to the eastern façade that necessitated the removal of balconies' (referring to balustrades across the openings of rear porches, which can be seen in Figure 2.10). Lean-to additions and 'iron fences' were also noted as detracting from the eastern façade. The condition of the eastern façade at this time was noted as being in 'an advanced state of decay, in need

of major upgrading' and 'substantial repair' (Figure 2.9). It was noted that the western façade had recently undergone repainting. The only apparent deterioration noted was on the external access way on the first floor. The walkway was described as a 'concrete slab walkway on steel support beams spanning between brickwork buttresses'. The report noted that the internal condition of the dwellings appeared good, with no evidence of 'damp, spongy floors, unsound staircases or sagging ceilings' in the flats inspected.¹⁹

Figure 2.9 Building condition prior to renovation in the 1980s. (Source: SHFA [Sydney Cove Redevelopment Authority Archive] 40329 SCRA 162)

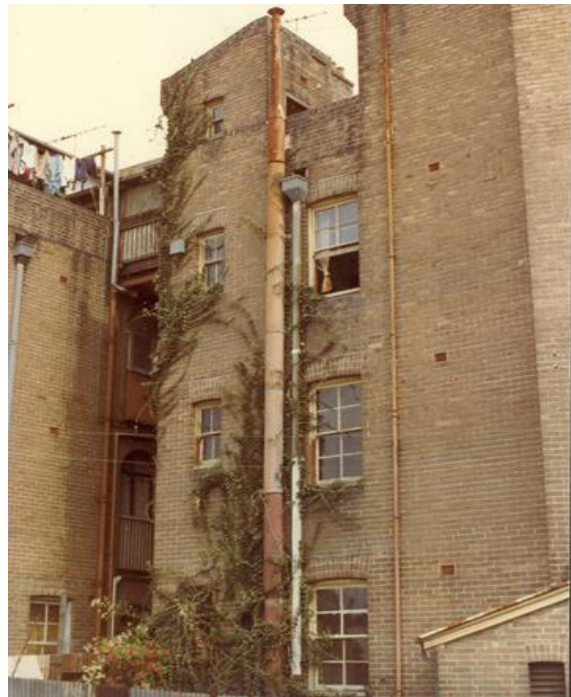
Figure 2.10 Rear (eastern) elevation (Flats 50 and 50A) showing the balustrade across the opening of rear porches, the garbage chute and building's condition in 1984. (Source: SHFA, Image 49763 CEM 31)

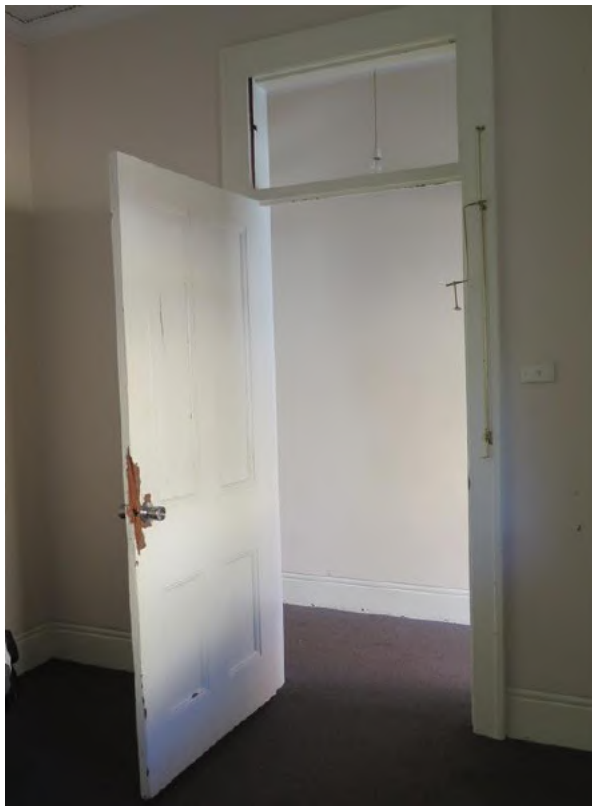
Figure 4.31 Damaged four-panel internal door with later door hardware (first floor level, Flat 54A). (Source: GML 2016)

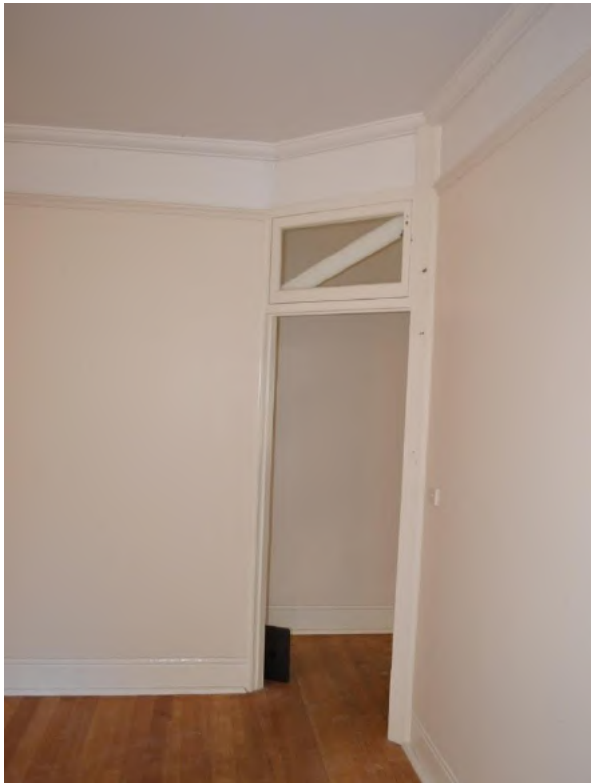
Figure 1.24 Living room (space G.3) showing the original doorway with fanlight (door is missing) to entry hall (space G.1)—46 / 46–56 Gloucester Street. (Source: GML Heritage, July 2016)

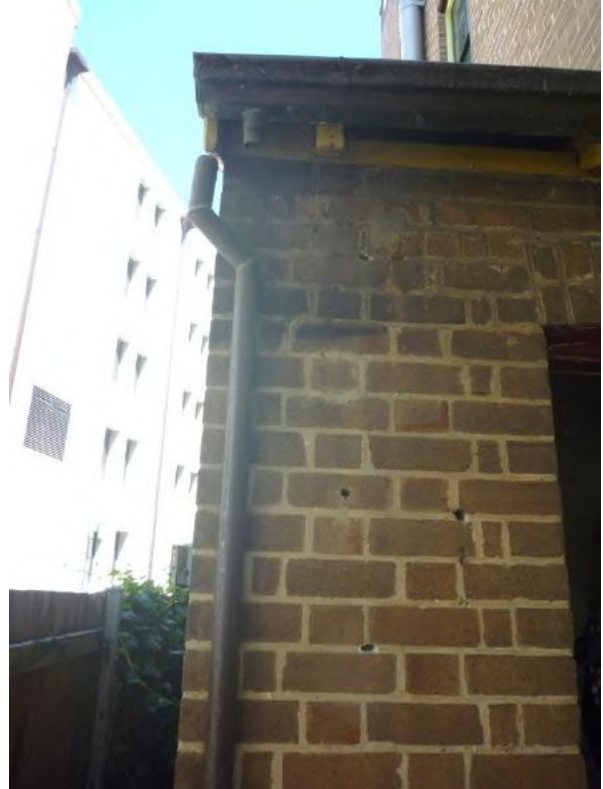
Figure 1.55 Failed guttering and down pipe to the roof of the external store (space E.3)—46/46–56 Gloucester Street. (Source: GML Heritage, July 2016)

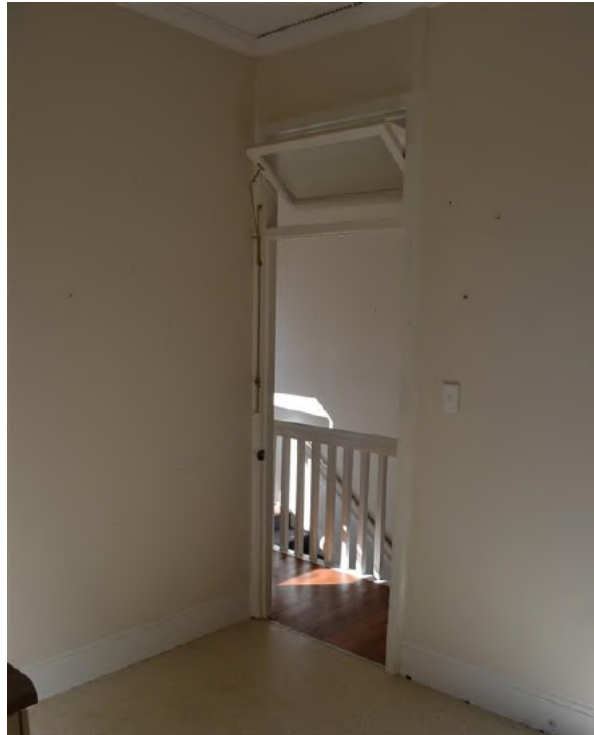
Figure 2.46 Fanlight with intact mechanism above the kitchen doorway (space 2.4) (Door is missing)—46A/46–56 Gloucester Street. (Source: GML Heritage, July 2016)

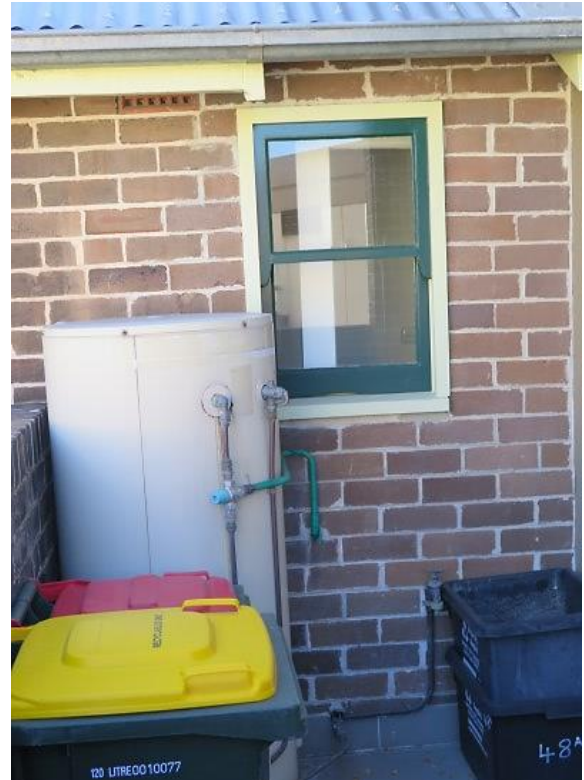
Figure 4.11 Rear wall of terrace (space E.2) showing modern spiral balance timber sash window and repaired brickwork to laundry—48A / 46–56 Gloucester Street. (Source: GML Heritage, May 2016)

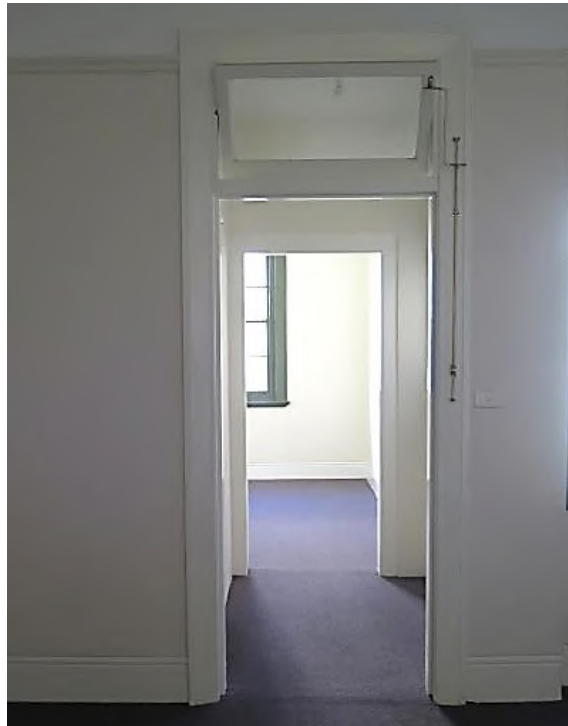
Figure 4.33 Doorway with original transom light above and reproduction mechanism between the living room (space 1.3) and the former rear porch (space 1.4)—48A / 46–56 Gloucester Street. Note original door is missing. (Source: GML Heritage, May 2016).

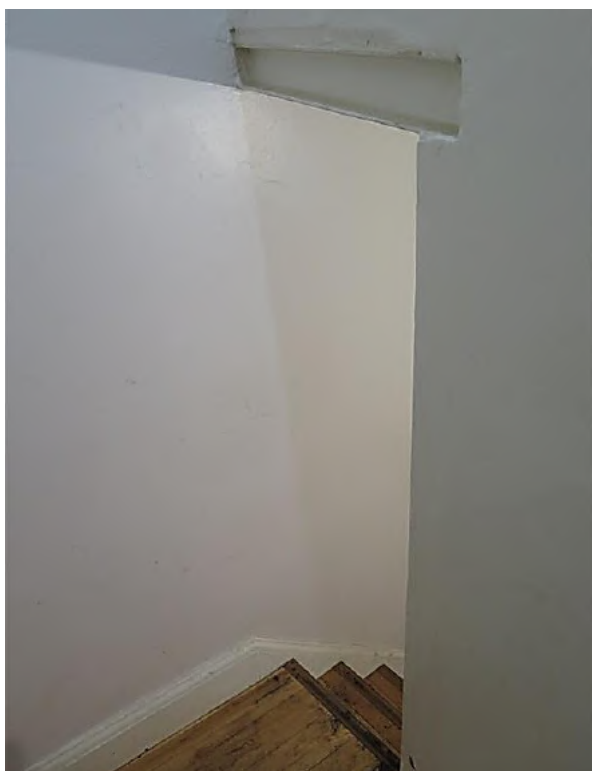
Figure 7.24 Repaired original stairs, original cement rendered and plastered brick walls, and original steel beam over the stair—52 / 46–56 Gloucester Street. (Source: GML Heritage, June 2016)

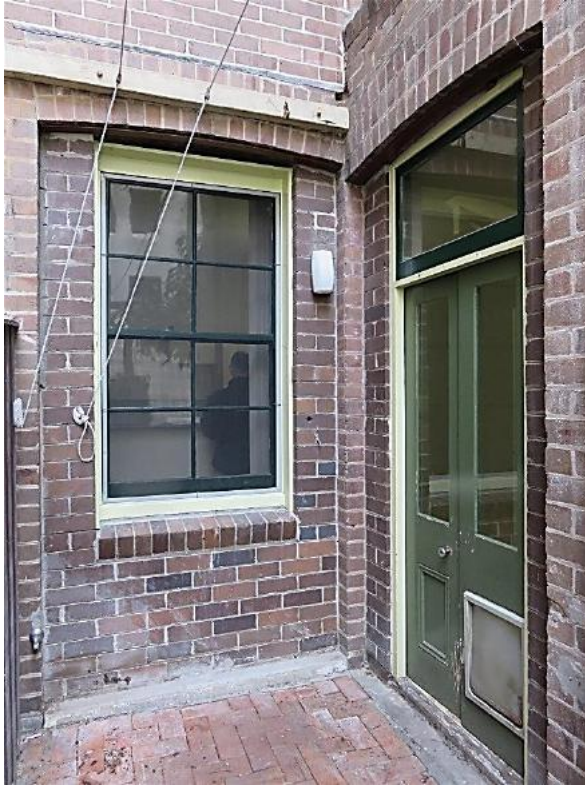
Figure 7.38 Original opening to rear elevation (Kitchen) with modern brick infill and replacement sash window—52/46–56 Gloucester Street (Source: GML Heritage, June 2016)

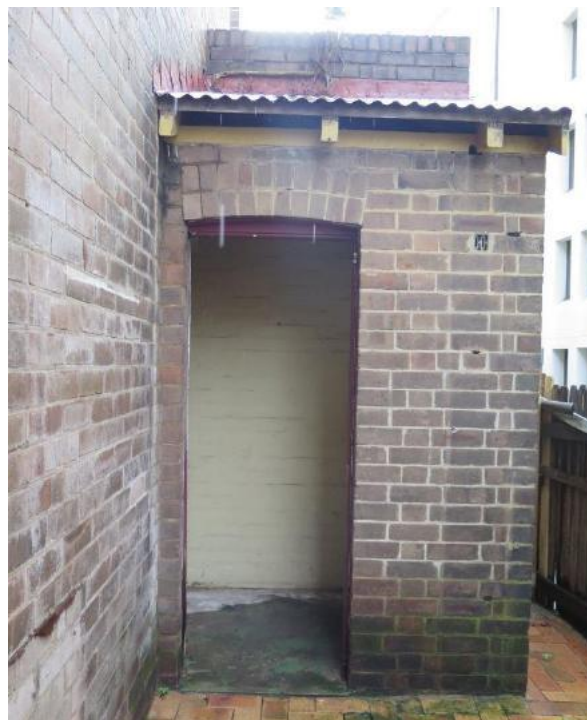
Figure 11.39 External WC (space E.3) with skillion roof, brick parapet. Boarded timber door is missing—54B / 46–56 Gloucester Street. (Source: GML Heritage, July 2016)

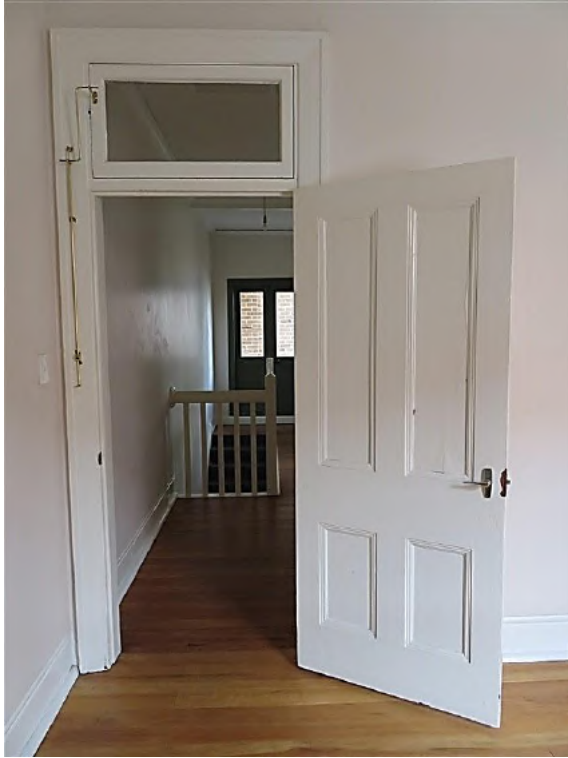
Figure 12.46 Front room on the second floor (space 2.4) showing the original four panel timber door with fanlight above with fanlight opener. The door furniture has been replaced—54C / 46–56 Gloucester Street. (Source: GML Heritage, July 2016)

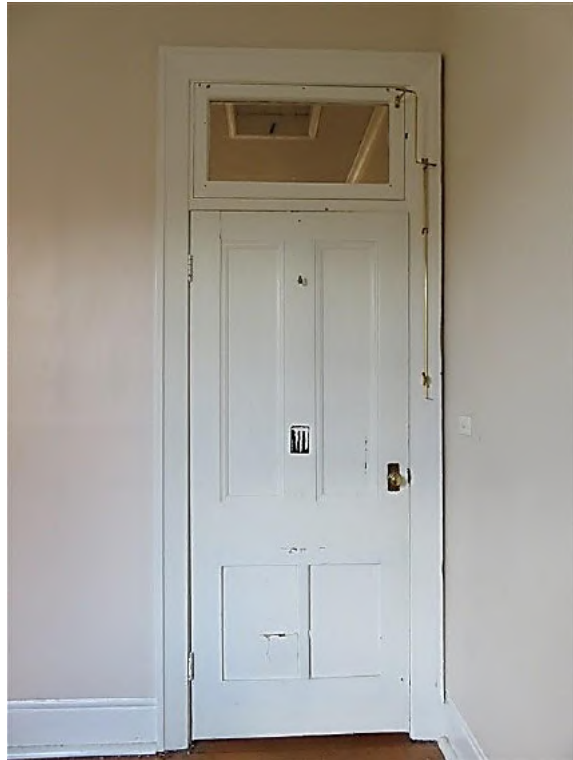
Figure 14.46 Four panel door and fanlight to space 2.4, showing bottom panels replaced and original architrave. Original cement run skirting with timber quad mould—56A / 46–56 Gloucester Street. (Source: GML Heritage, July 2016)
