CONSERVATION MANAGEMENT PLAN

Argyle Terraces, Nos. 13-15 Playfair Street The Rocks

Prepared for Sydney Harbour Foreshore Authority
December 2006

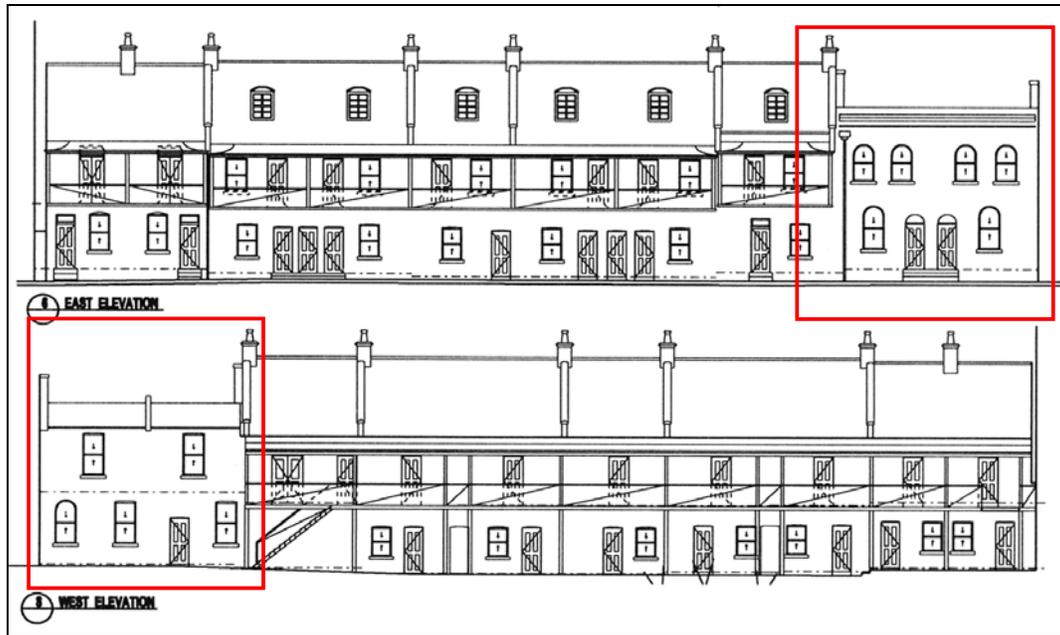
Figure 1.5 The Playfair (east) and rear (west) elevations of the building in the context of other highly significant Victorian development in Playfair Street. (Source: The Foreshore Authority)

“Argyle Terrace”, Nos. 13-15 Playfair Street, is a pair of two storey bald face terraces with parapet which conceals the gabled roof from Playfair Street. The external masonry walls are finished in stucco and painted and feature Italianate details including a central string course, moulded brackets to sills, arched window heads and deep cornice across the parapet. The north and western facades face an open courtyard which is bounded by a rock face below Foundation Park and Gloucester Walk to the west.

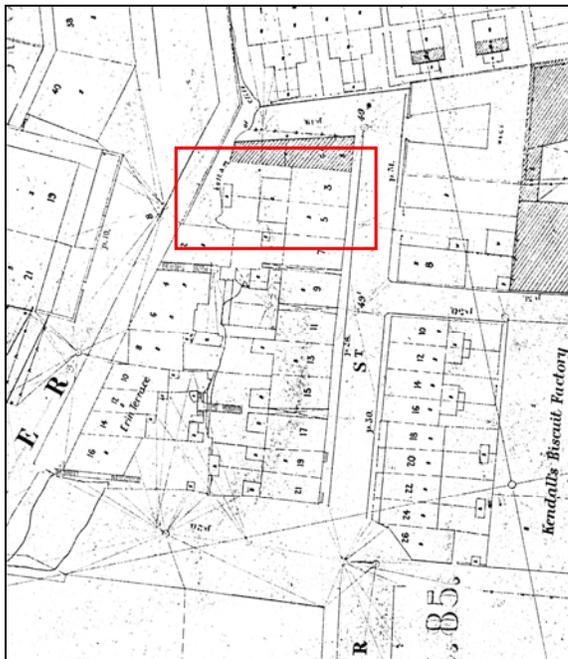
Figure 2.7 Plan dated 1887, amended in 1895 with no changes to the buildings.

A Sydney Water Plan dated 1887 (**Figure 2.7**)⁵⁴ illustrates the footprint and configuration of the buildings. Amended in 1895, there was no change indicated on the subject site, however, it would appear that a building was constructed to the north of the buildings (shown hatched) in the time between. The earlier street numbering is clear and the rear "wings" or annexes visible. A detached structure is also shown at the western end of the site, abutting the rock face.

2. Any new development should be carried out within the existing building envelopes, or original footprint of the Argyle Terrace Nos. 13-15 Playfair Street, The Rocks (refer to 1970s plans in **Figures 2.7 & 2.15**).
3. Period detailing should only be used for elements for which there is clear evidence of the original detail (either remaining in the fabric or in documents).
4. Where there is no evidence of the original detail, it is not necessary/appropriate to invent a period detail (unless the original character of the space is to be recreated and the new element is required to blend in).
5. Careful detailing will ensure minimal damage to the significant fabric and will allow for reversibility.
6. Where a function is being re-established, new fittings and fixtures may be adopted to complement the existing architectural character.

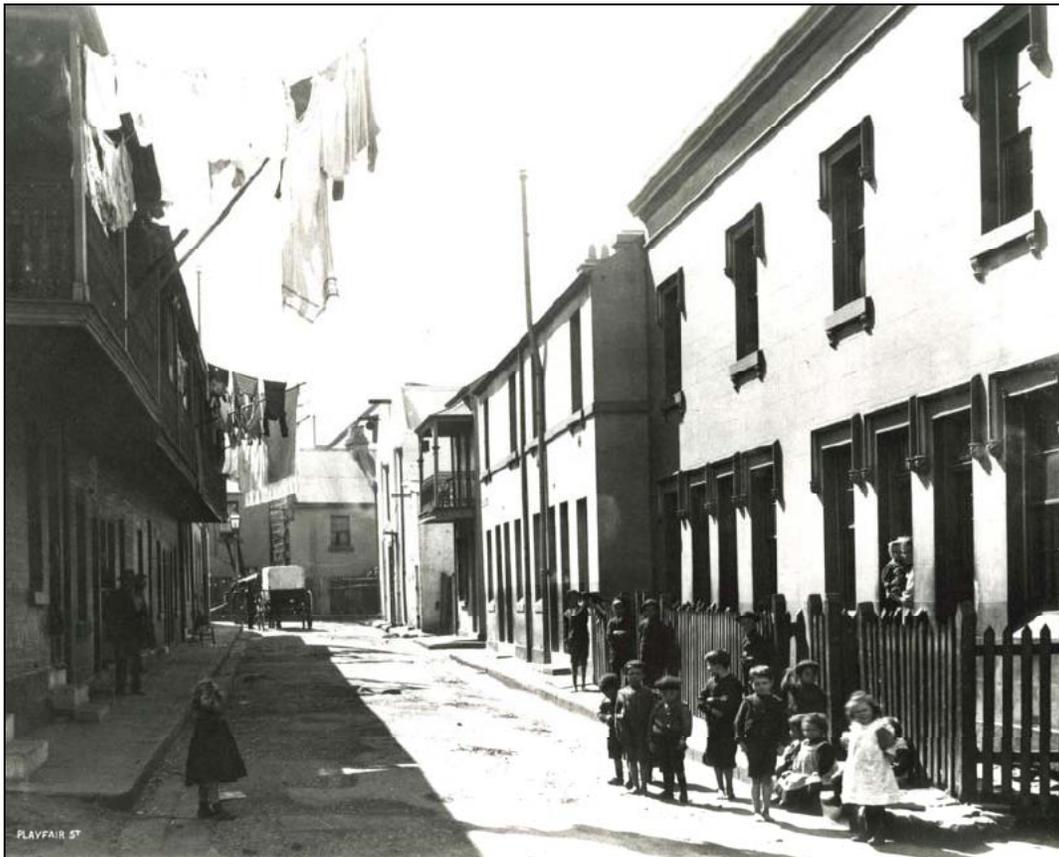
Figure 2.8 Photograph dated c. 1901 looking north along Playfair Street. The subject buildings are on the far left. Playfair Street is at this time a relatively narrow street flanked by residential development on each side. (Source: Foreshore Authority Archives PS 05)

A photograph dated c. 1901 (**Figure 2.8**) shows the context of the buildings and their frontage to Playfair Street. This section of Playfair Street is noticeably narrow with two storey dwellings also located on the eastern side of the street. Another photograph dated 1910 (**Figure 2.9**) also shows the front facades of the terrace.

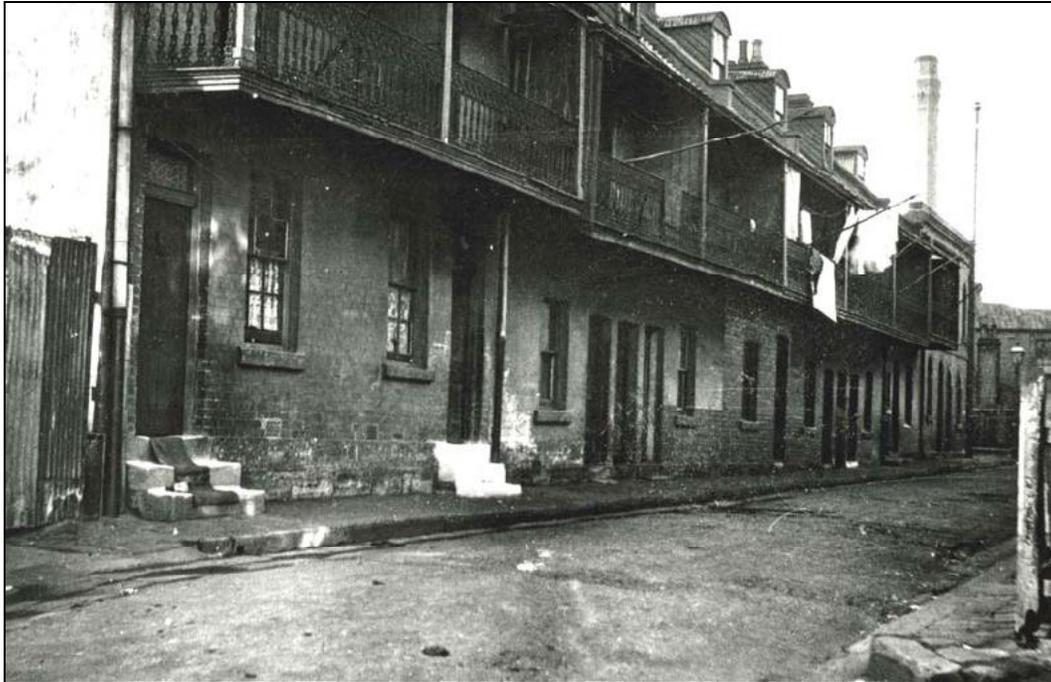
Figure 2.9 Photograph dated 15 October 1910 looking north along Playfair Street. The subject buildings (just visible at far right) are located at the northern end of a grouping of similarly scaled two storey terraces. (Source: Foreshore Authority Archives PS 06)

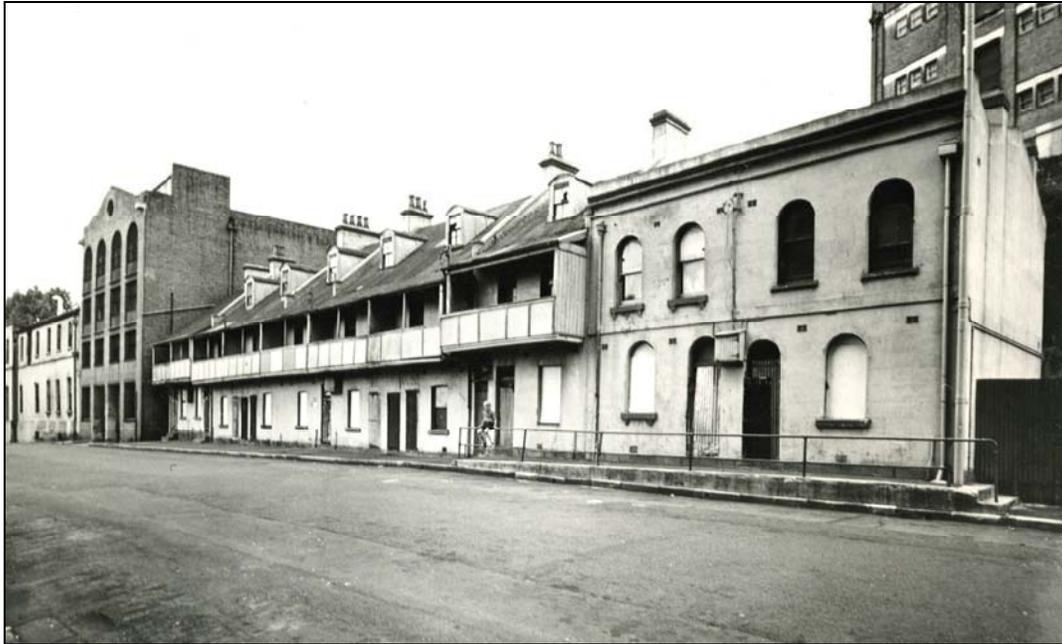
Figure 2.13 The buildings c.1970s prior to the restoration works. (Source: Foreshore Authority Archives PS 01)

Another photograph (**Figure 2.13**), also dating from the c. 1970s shows no great changes to the front façade of the building, although a meter box and associated cabling has been fixed to the wall plane. The ground floor openings also appear to be crudely boarded up. A narrow footpath with sandstone kerbing continues to run across the front of the terraces along this section of the street. The northern end falls and a handrail also runs across the front of Nos. 13-15. The photographs also highlight other changes in the area, such as the demolition of the earlier residential buildings on the eastern side of Playfair Street and the widening of the road.

The Playfair Street, eastern elevation appears to have retained its original form and details. The face sandstone plinth, rendered mouldings and arched openings are all assumed to be original. Elements such as the rainwater heads and downpipes, windows and doors and two bottom sandstone steps at the entry doors have been repaired and replaced as part of the 1970s or 1990s works to the building. It is interesting to note that the two door openings are not identical. The fanlight over the southern door, to No. 15 is deeper and springing point of the arch is set higher than the adjacent opening to No. 13. It is not clear if this is original, however, this detail is visible in a photograph of the building taken prior to the 1970s works (**Figure 2.13**).

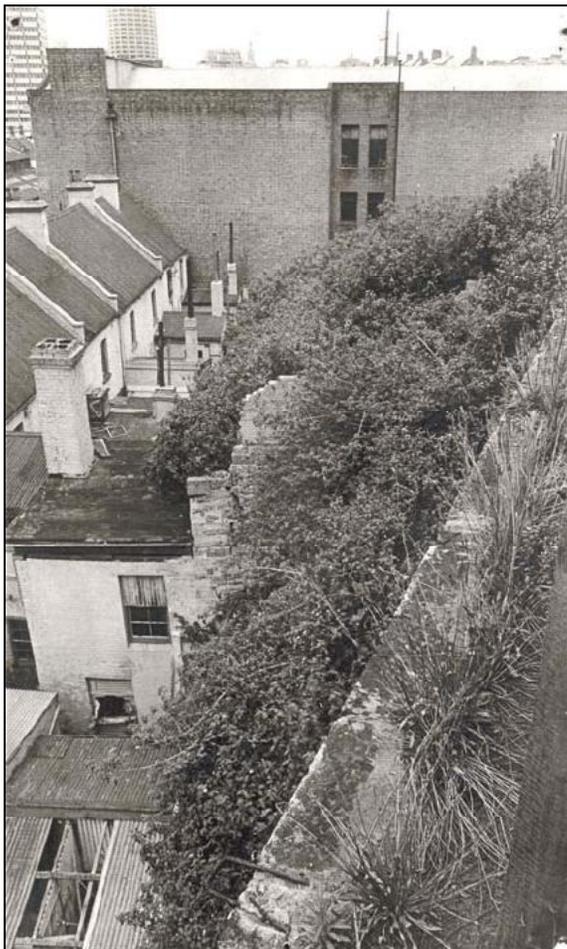
Figure 2.14 The rear of the buildings in early 1970s. The later addition to Nos. 13 and 15 is evident at bottom left. It would also appear that a two storey building had been constructed at the rear of No. 17.

A photograph of the rear of the buildings also assumed to date from this time (**Figure 2.14**) just shows the rear annexe of the building. The poor condition of the building is clear, part of the roof cladding is missing. The annexes appear to extend to the rock face to the west which is overgrown at this time. A two storey building occupies the rear yard of the neighbouring building, No. 17.

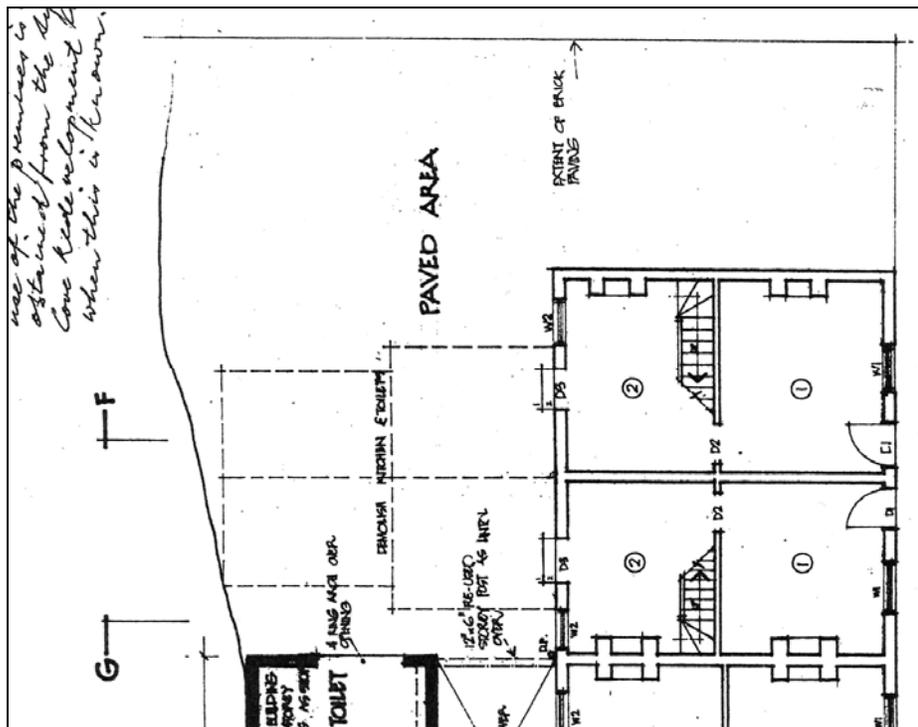
Figure 2.15 1971 Ground Floor Plan prepared by Fisher Jackson Hudson Architects showing the earlier configuration of the building. The outline of the rear wings and annexes are shown dotted. (Source: City Archives 1383/71)

The Fisher Jackson Hudson drawings show the proposed works, noted as “restoration” and adaptation works. The ground floor plan (**Figure 2.15**) shows the configuration and planning of the buildings including the location of internal stairs and walls. More importantly the outline of the early rear wings and annexes, which contained kitchen and bathroom spaces, is also indicated. The line of the rock face and brick paving to the north of the terraces is also shown. Apart from the demolition of the rear wing, the plans, dated 18 October 1971, indicate no changes to the internal layout of the terraces or existing openings. It was proposed to open up the individual small yards behind the buildings and adjoining terraces and create a single, paved courtyard

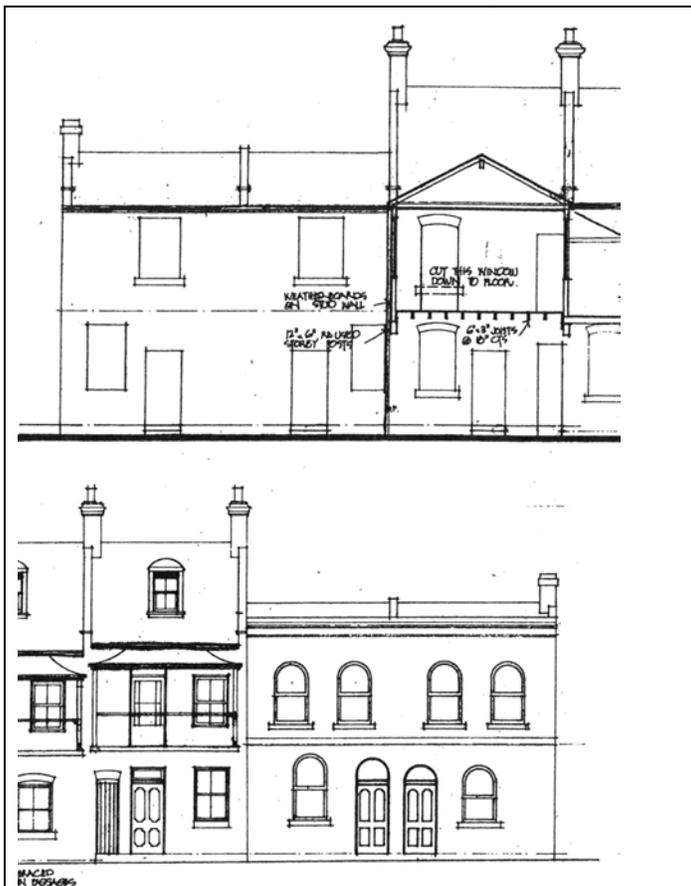
Figure 2.16 Elevations prepared by Fisher Jackson Hudson Architects indicating 1972 works. (Source: City Archives 1383/71)

The sections indicate some proposed new footings and structural works to the flooring of the ground floor. The 1993 Conservation Plan notes that the sub floor space (about 450mm) was actually excavated at this time and floor space filled to prevent rat infestation. The floor structure was removed and new timber structure was built on brick piers. It also noted that all hardwood floor boarding and floor structure to the ground floor was removed as part of the 1972 works. New flooring also had access panels cut in the eastern rooms. Access panels to the western rooms were carried out as part of the 1993 works. Plasterboard ceilings also added below the early or original lathe and plaster and the plaster finish from the internal walls was removed and walls were bagged and painted as part of these works.⁶²

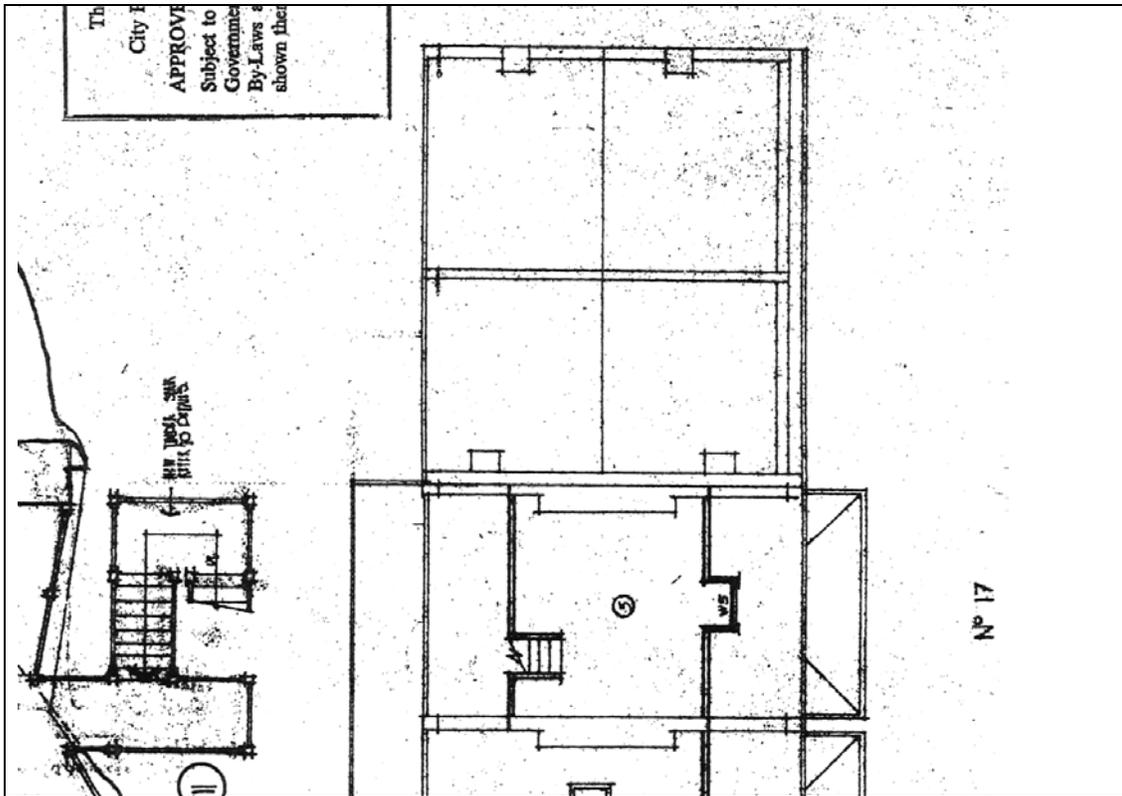
Figure 2.19 Roof plan prepared by Fisher Jackson Hudson Architects. (Source: City Archives 1383/71)

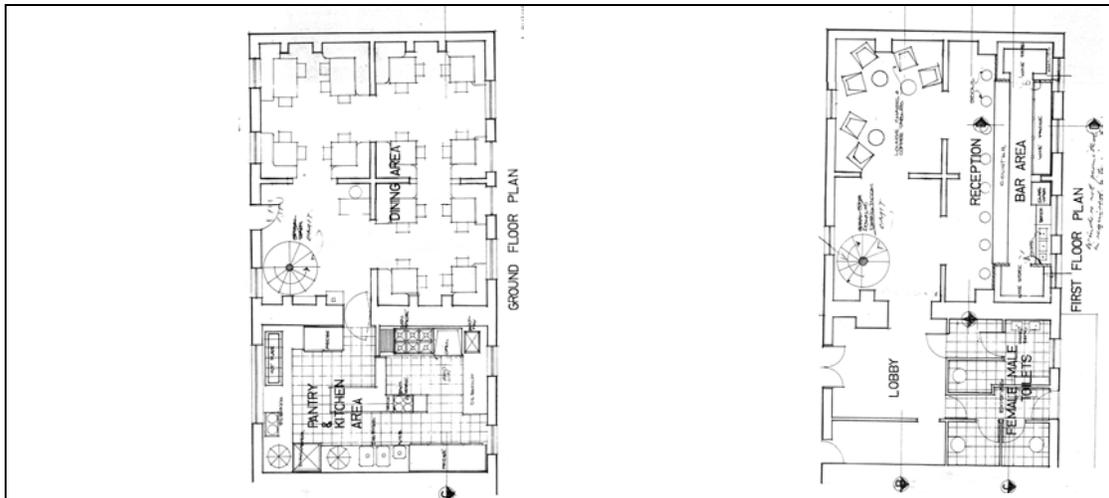
Figure 2.20 Plans for proposed restaurant in Nos. 13-17 approved in September 1973. (Source: City Archives)

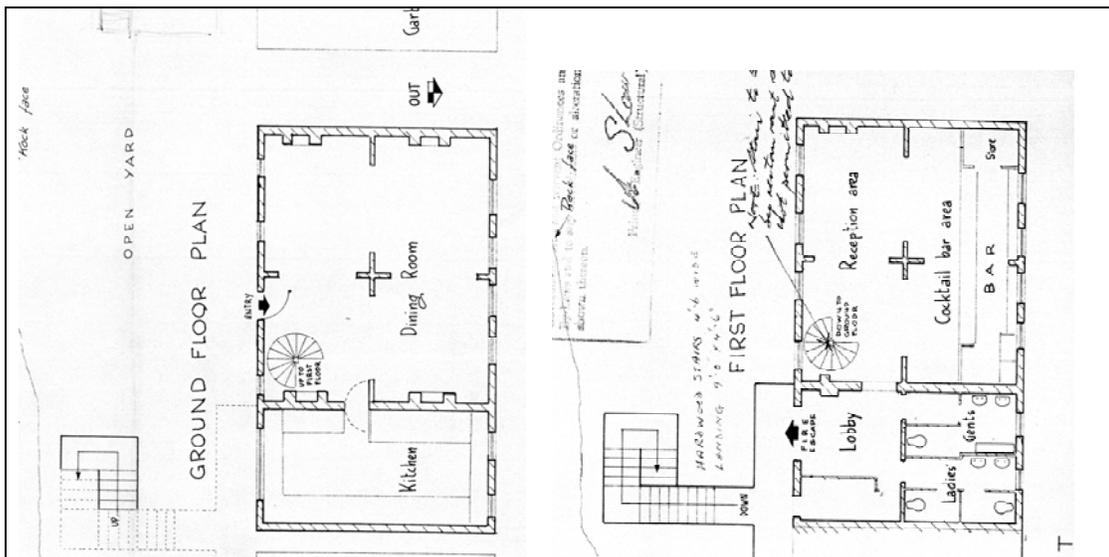
Figure 2.21 Plans dated June 1974 of the restaurant occupying Nos. 13-17 Playfair Street. (Source: City Archives)

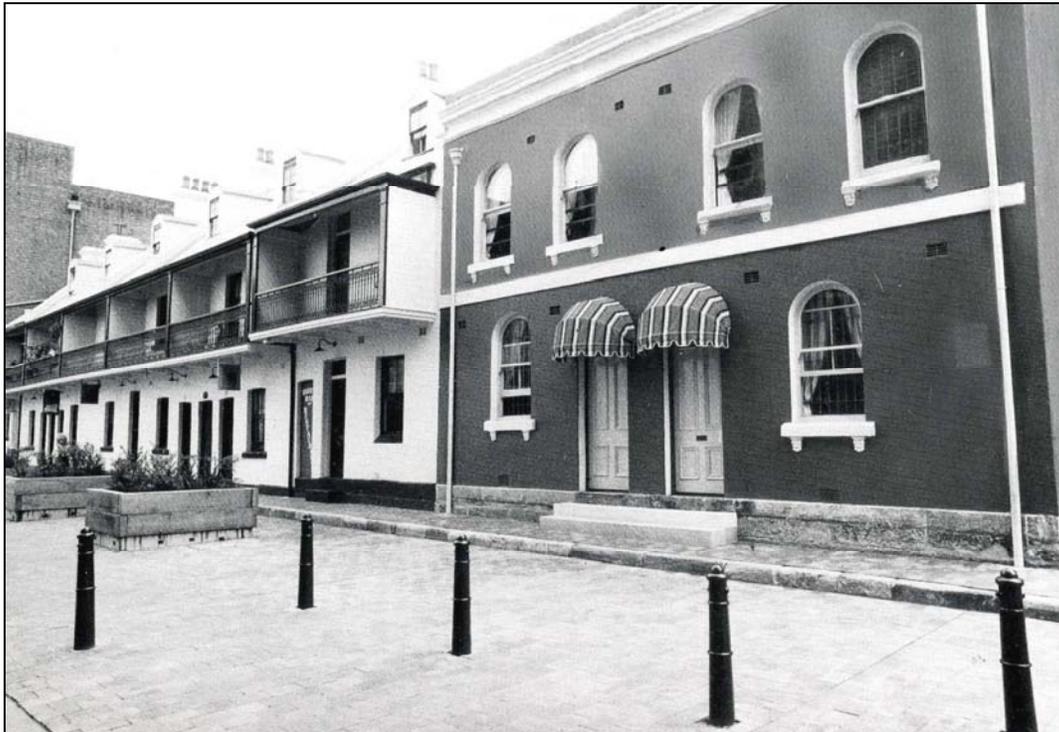
Figure 2.22 The buildings c.1980s after restoration works. (Source: Foreshore Authority Archives PS 07)

A photograph dating from c. 1980s (**Figure 2.22**), shows the newly painted and restored buildings and paving and landscaping to Playfair Street. Nos. 13-15 are painted in a contrasting, darker finish and small canopies over the two front entries. The rendered details, arched windows and mouldings are highlighted in a lighter colour. The face sandstone plinth course has been retained.

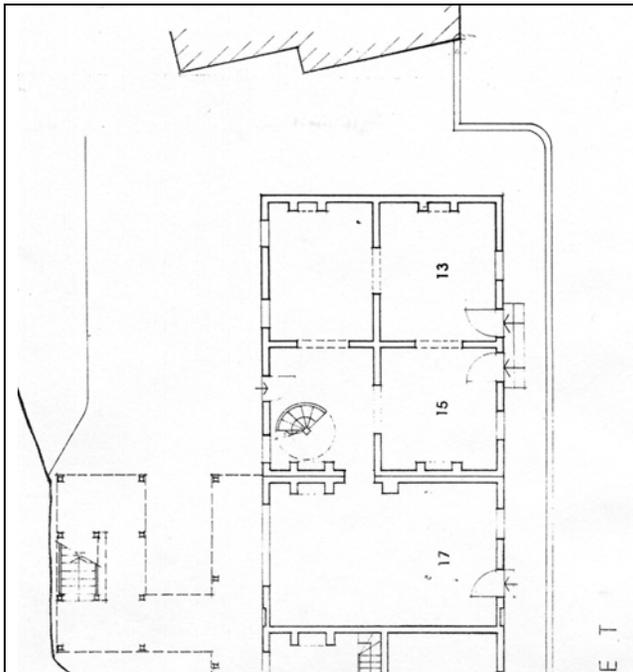
Figure 2.26 The 1993 measured ground floor plan prepared by Tropman & Tropman Architects.

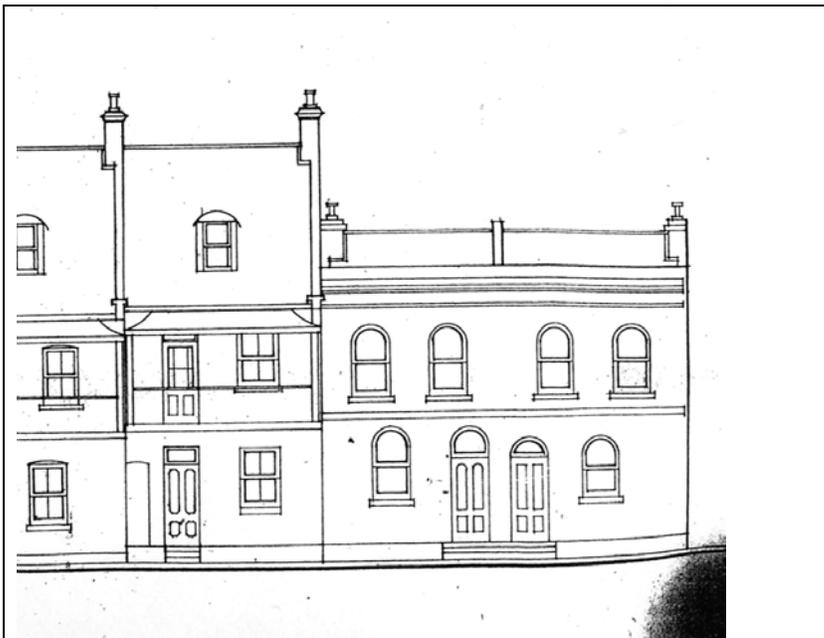
Figure 2.28 The east elevation prepared by Tropman & Tropman Architects. (Source: Foreshore Authority Archives RE 1199.01.01)

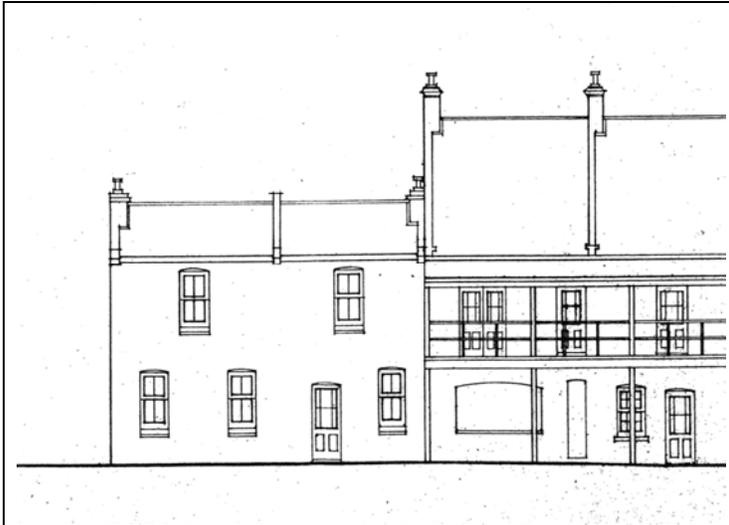
Figure 2.29 The west elevation prepared by Tropman & Tropman Architects. (Source: Foreshore Authority Archives RE 1199.01.01)

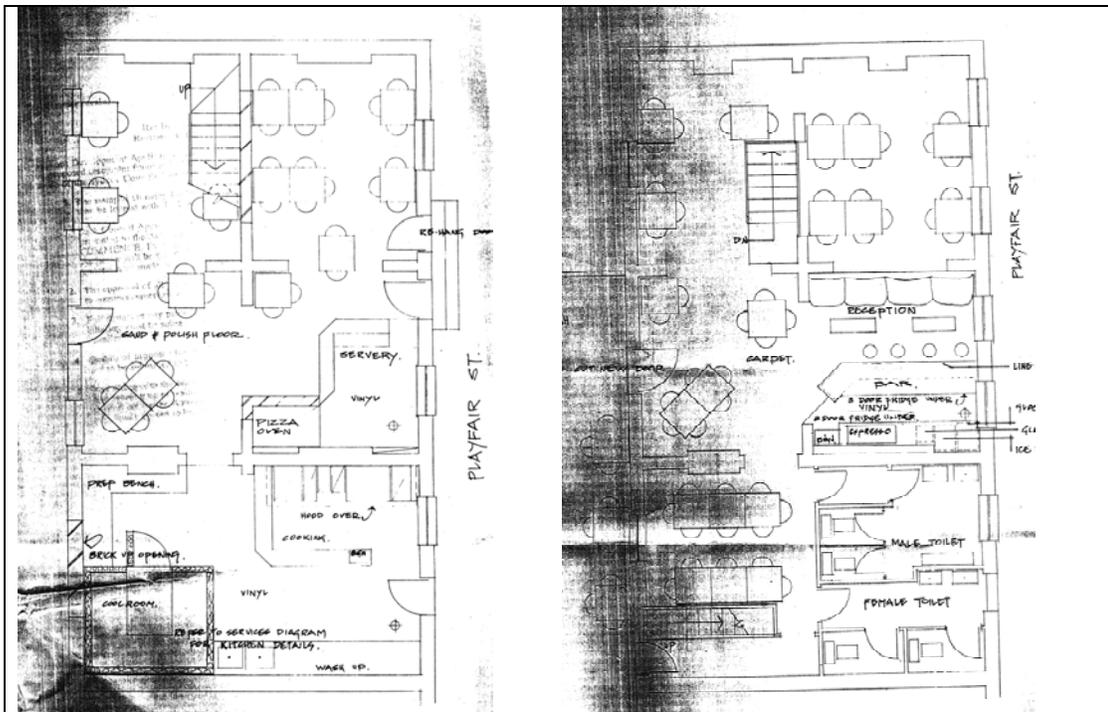
Figure 2.30 The plans for the Caminetto Restaurant in Nos. 13-17. (Source: Foreshore Authority Archives RE 1199.01.01)

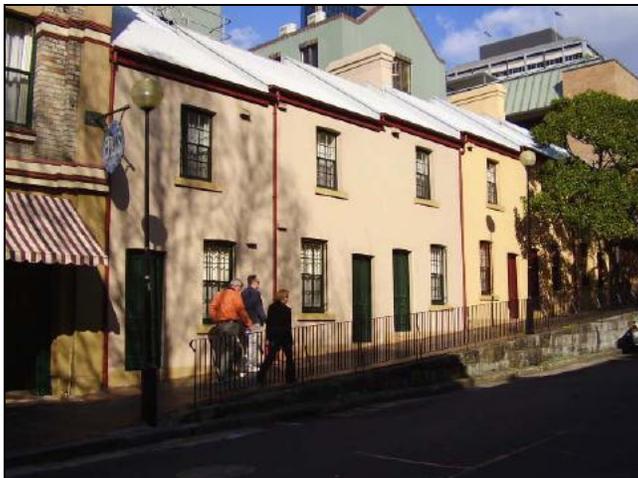
Figure 2.33 Nos. 42-52 Harrington Street are two storey, bald face terraces which date from a similar period from the subject terraces and feature similar scale and characteristics to Nos. 17-27 such as the simple nature of the facades and pitched roof, but also differ in that they do not have exposed party walls or balconies.

The terraces located in the northern end of Harrington Street, closer to the intersection with Argyle Street including Nos. 55-71 and more specifically Nos. 42-52 (**Figure 2.33**) on the eastern side of the street are two storey, bald face terraces with gable roofs and

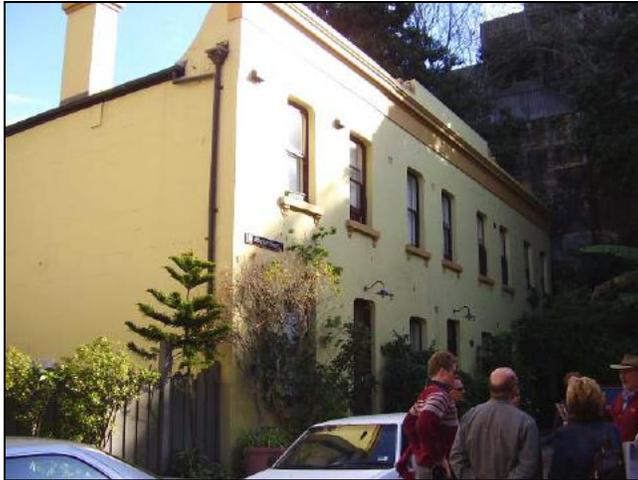
Figure 2.34 Playfair's Terrace at Nos. 1-7 Atherden Street.

Playfair's Terrace (**Figure 2.34**), located on the south western side of the street is a row of four, two storey Victorian terraces each of two bays constructed of stuccoed brick. Constructed in 1880, they are comparable with Nos. 13-15 Playfair Street with their simple parapet with profiled, projecting cornice. Like Nos. 13-15, there is no division between the houses on the front façade, and Playfair's Terrace also feature regular shaped openings and hipped roof behind the parapet. Unlike the subject buildings, these also retain the rear wings and service areas. Avery Terrace (**Figure 2.35**), located opposite, on the north western side of the street is a pair of two storey Victorian terraces also constructed with stuccoed brick with simple pitched roof between projecting party walls. Constructed in 1881, the buildings feature similar scale and some characteristics of the subject buildings.

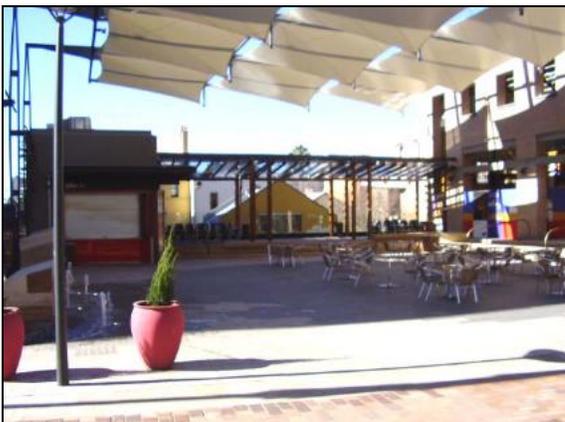
Figure 3.9 View of The Rocks Square looking east which features various masonry paving, a structural steel frame supporting the canvas shade cloth and modern street furniture and lighting. A number of food and beverage outlets surround the space.

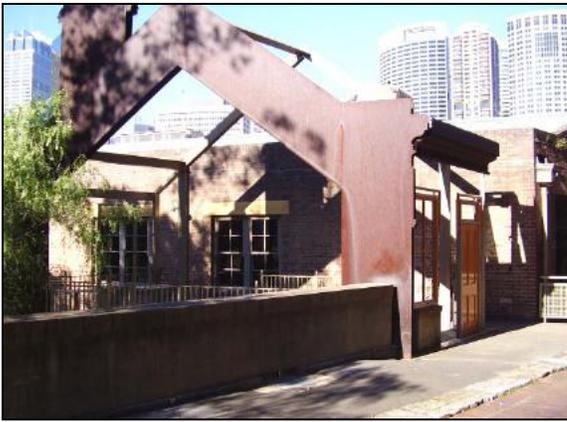
Figure 3.17 Sculptures at the south western corner of the Park interpret the former terrace and dwelling that occupied this area. The "tower" element incorporates a stairwell and platforms below that provide a pedestrian link to Playfair Street but also interpret the various levels of the earlier dwelling.

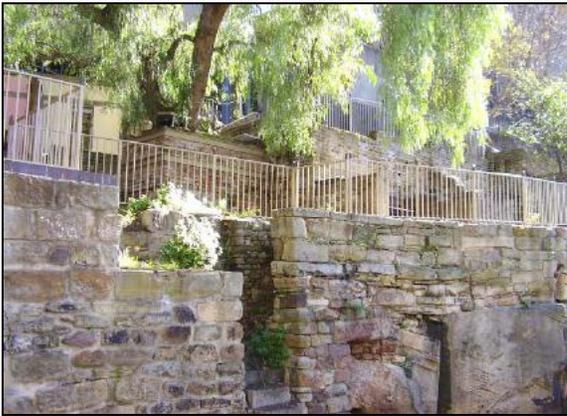
Figure 3.20 View of some of the earlier walls and terraced area conserved and “restored” as part of the 1990s works.

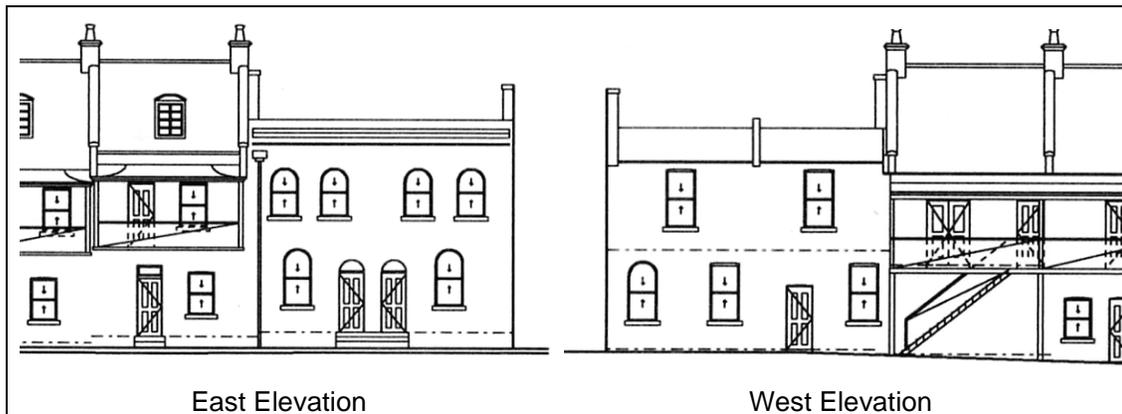
Figure 2.23 Building elevations (Source: Foreshore Authority, 2003).

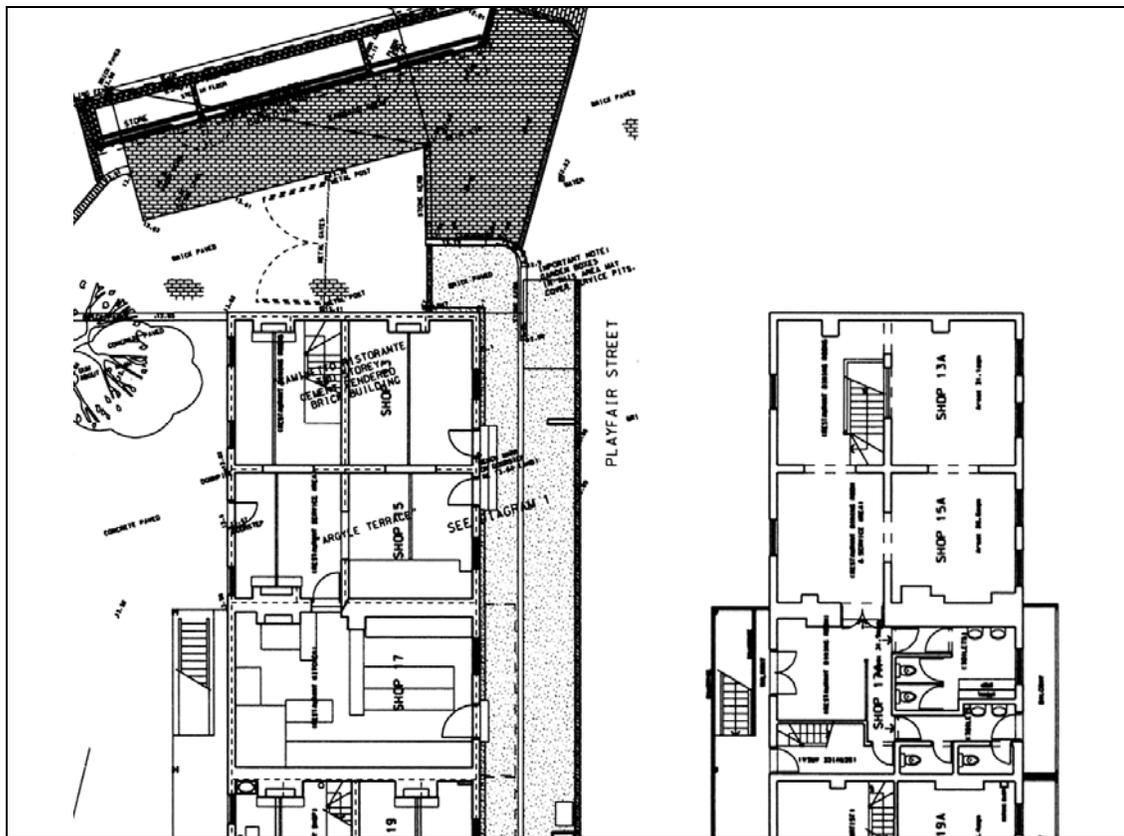
Figure 2.24 Ground and First Floor Plans Nos. 13-17 Playfair Street (Source: Foreshore Authority, 2003).

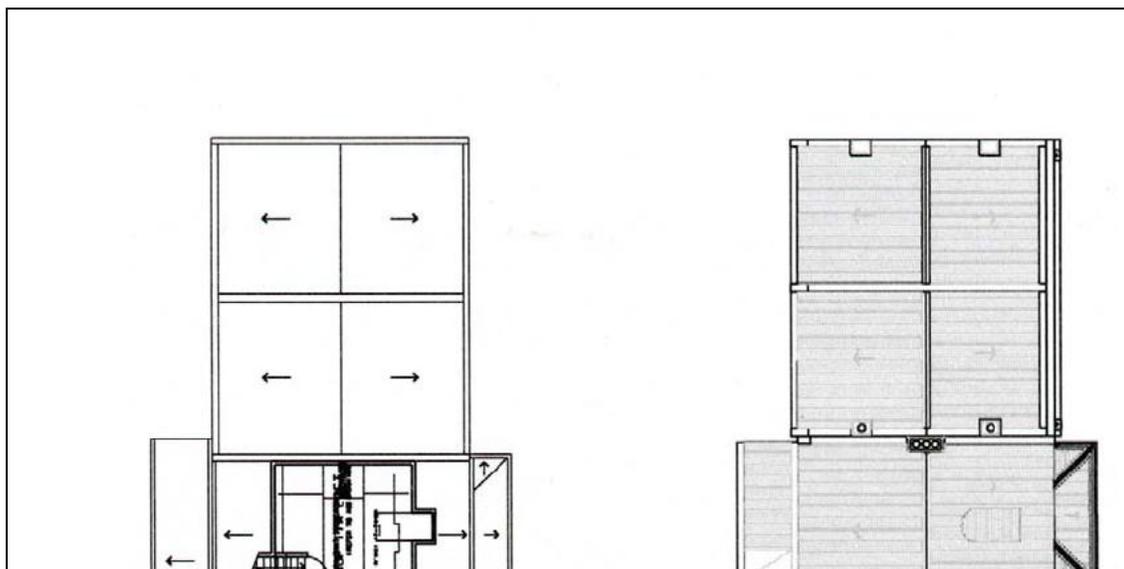
Figure 2.25 Roof Plan (Source: Foreshore Authority, 2003).

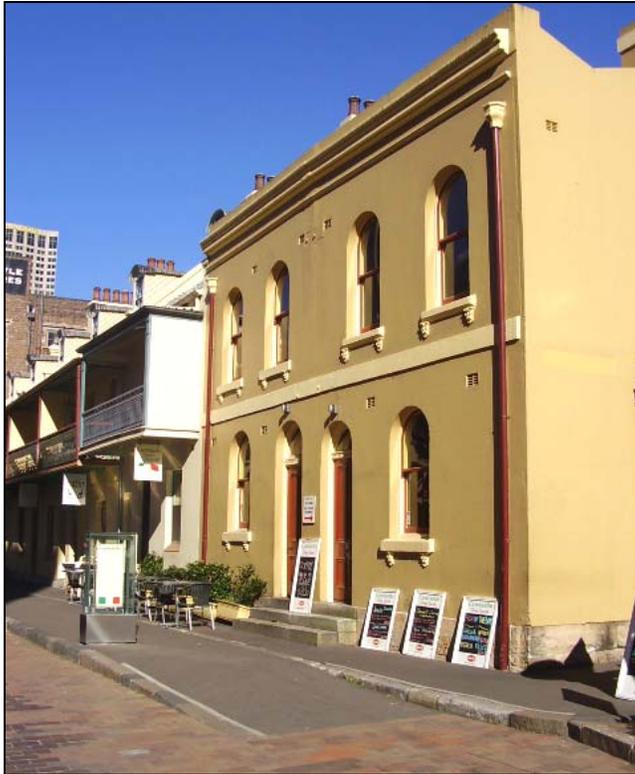
Figure 3.27 No. 13-15 Playfair Street is located at the northern end of a continuous row of mid to late 19th century terraces.

The rendered building sits on the original face stone plinth and also features original rendered mouldings and window sills. It is assumed that elements such as the entry doors and bottom two steps, rainwater heads and downpipes have been replaced.

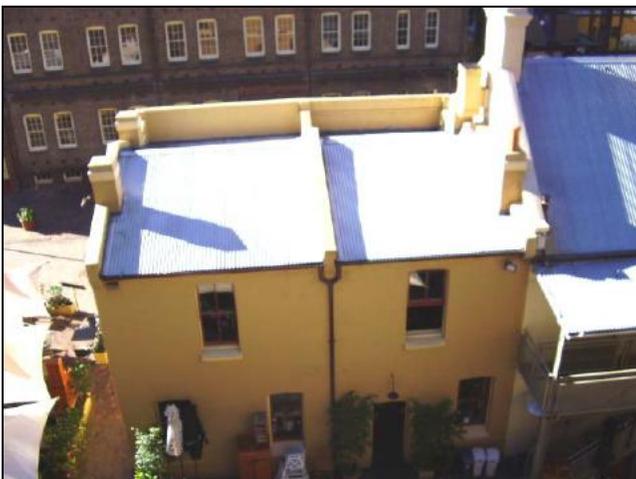
Figure 3.32 Nos. 13-15 features simple gable roof with central and end exposed party walls. The end walls each feature simple square chimneys. The roof, walls and chimneys appear to be in very good condition.

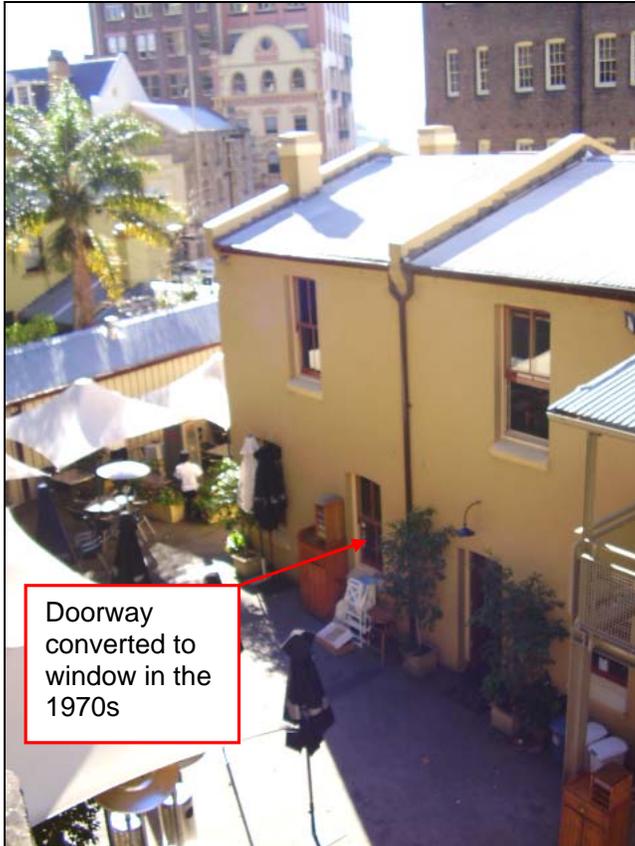
Figure 3.33 The rear facade of Nos. 13-15 is simply finished with simple window and door openings. The rear wings and outbuildings were removed and rear yards combined with the rear yards of Nos. 17-31 as part of the 1970s works.

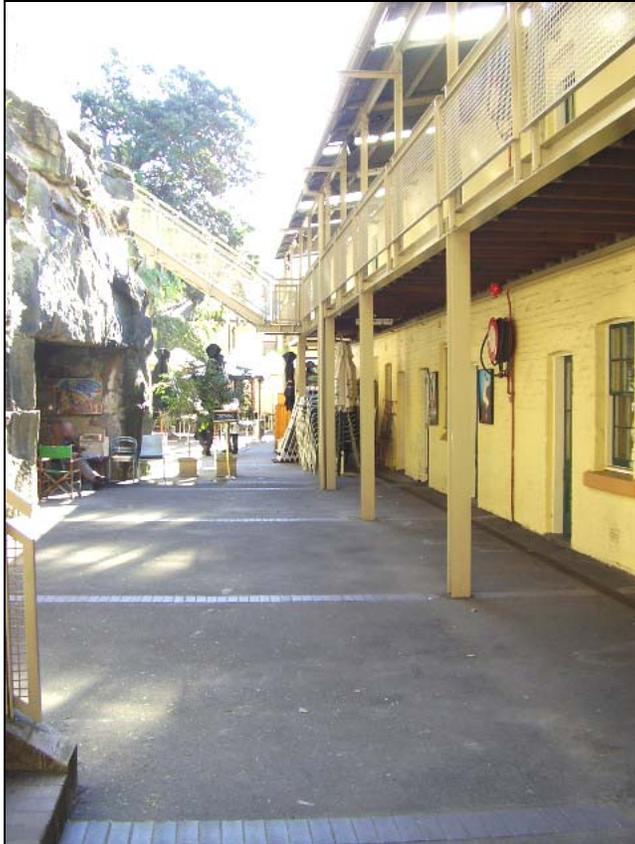
Figure 3.34 View of the open courtyard at the rear of the row of terraces on the western side of Playfair Street. The courtyard was opened up and formed as part of the 1970s works. The former boundary and fence lines are interpreted by brick paving.

The linking stair with Foundation Park and Gloucester Walk and steel framed deck were added in the 1990s.

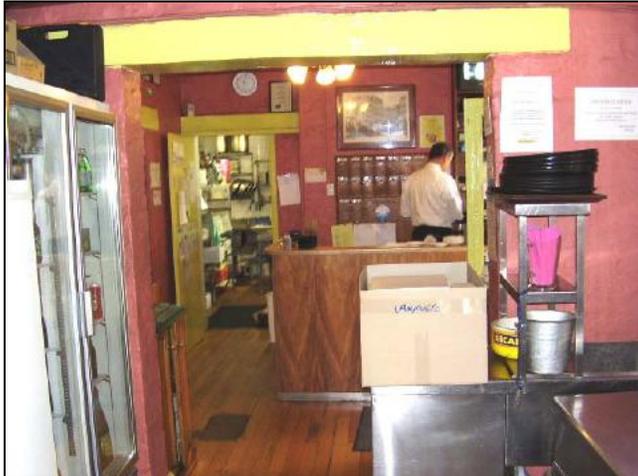
Figure 3.35 View of the “reception” area and entry in the western room of No. 15, looking south from western room of No. 13. The large opening was formed and lintel added as part of the 1970s works. The space features timber floors with bagged walls and simple ceilings. Modern fixtures and furniture have been added. The counter is located in an area that was fitted with a spiral stair in the 1970s which was removed as part of the 1990s works.

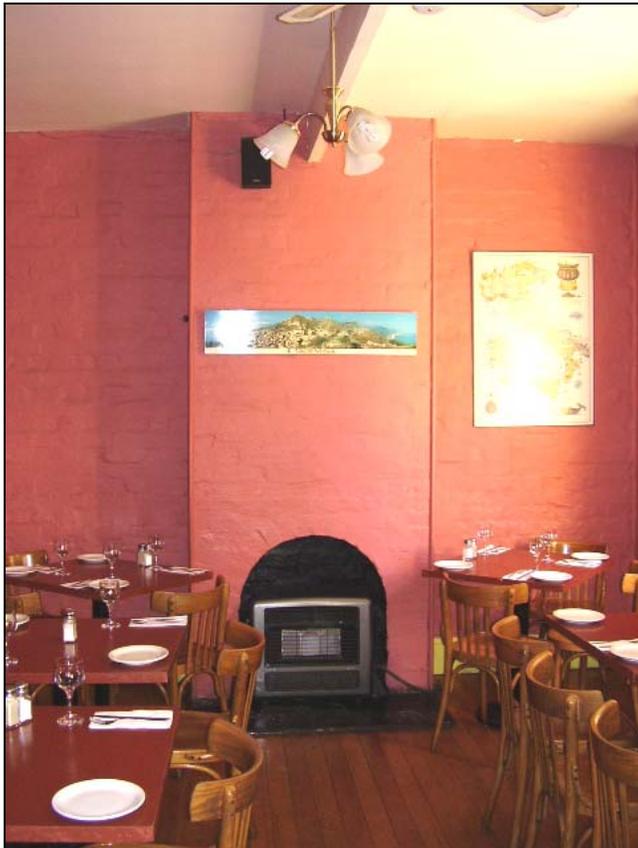
Figure 3.36 The northern wall of the front, eastern room of No. 13 retains its original dimension and features such as the original chimney breast with arched fireplace opening. A cement screed and step has been added to the hearth. The space features timber floors, which appear in sound and good condition, painted and bagged brick walls and simple plasterboard ceiling. An exposed beam runs across the centre of the ceilings. Modern lighting and ceiling fans and services have also been added to the ceiling all assumed to date from the 1990s works.

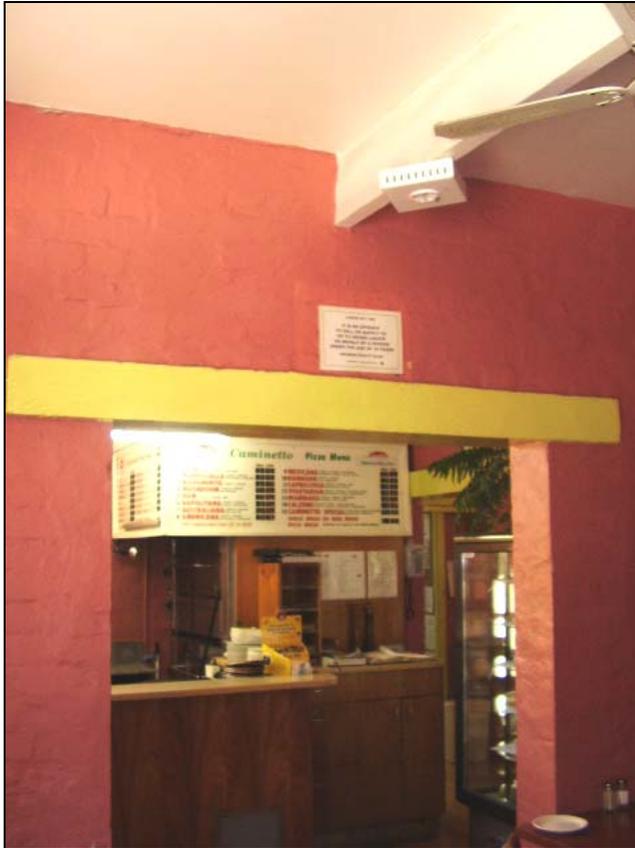
Figure 3.37 View looking south to the front, eastern room of No. 15 which is similarly finished and features brick encased pizza oven and modern bar and joinery added as part of the 1990s fitout. The opening was enlarged and beam added as part of the 1970s works.

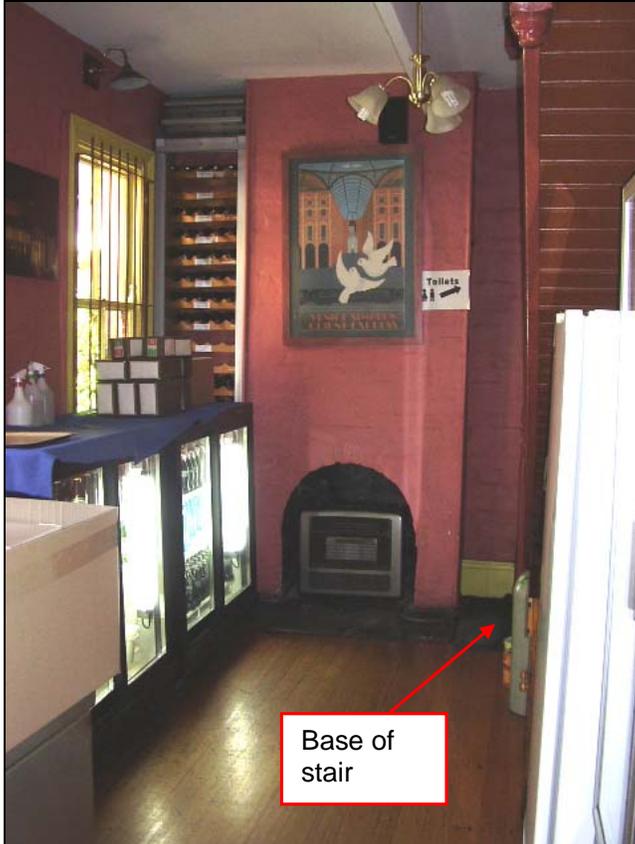
Figure 3.38 View of the western room of No. 13 looking north. The northern wall also features original chimney breast with arched opening and cemented hearth. A carpeted timber stair, which extends up the western face of the centre wall, was reinstated as part of the 1990s works.

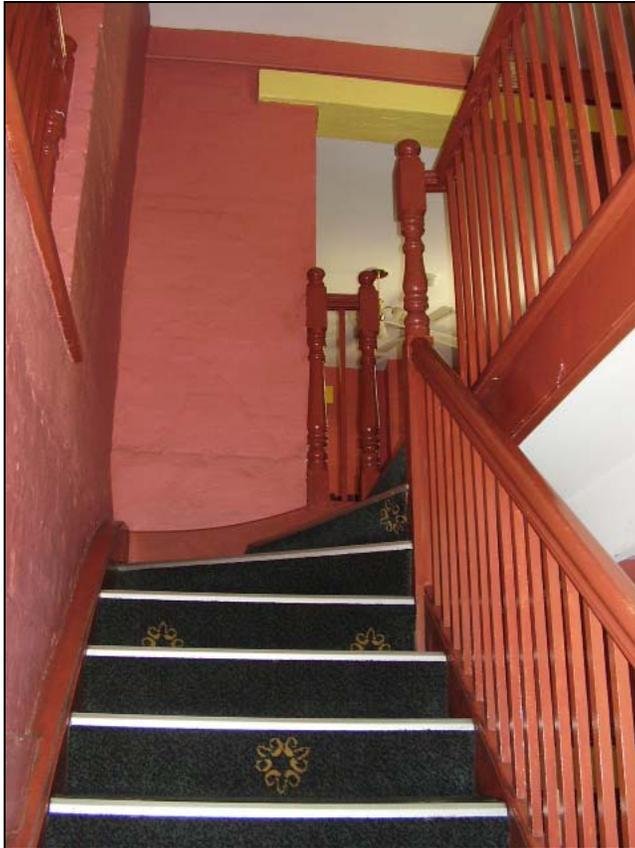
Figure 3.39 The timber stair in No. 13 reinstated as part of the 1990s works.

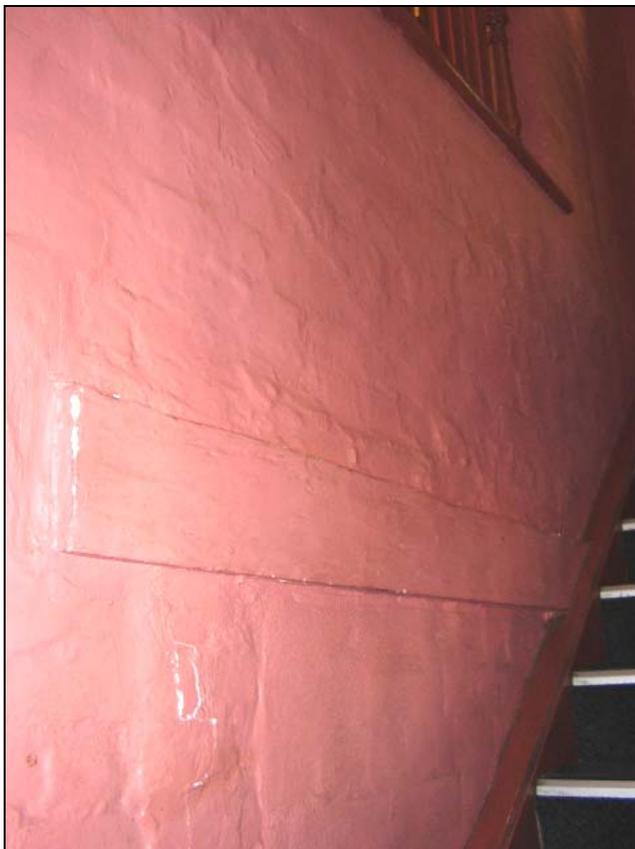
Figure 3.40 The cross wall in No. 13 retains evidence of an opening formed as part of the 1970s works. The opening was infilled when the stair was reinstated as part of the 1990s works.

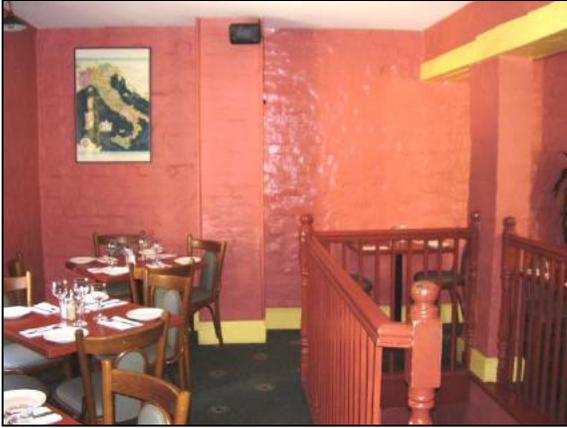
Figure 3.41 The upper, western room of No. 13 looking north. The chimney breast is evident on the northern wall.

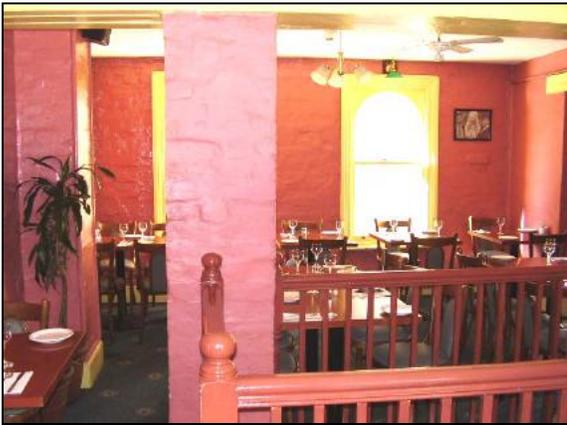
Figure 3.42 The upper, front, eastern room of No. 13 features double hung windows with arched heads overlooking Playfair Street.
