CONSERVATION MANAGEMENT PLAN

Argyle Terraces, Nos. 13-15 Playfair Street The Rocks

Prepared for Sydney Harbour Foreshore Authority
December 2006

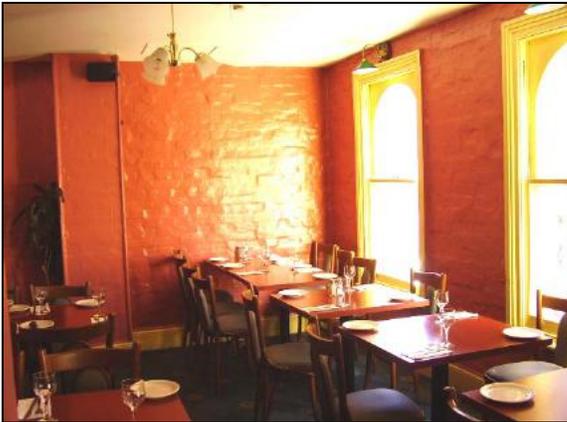
Figure 3.43 The front, eastern room of No. 13 looking north. The northern wall also retains the chimney breast. The upper level is similarly finished with carpeted timber floors, timber skirtings and simple ceilings.

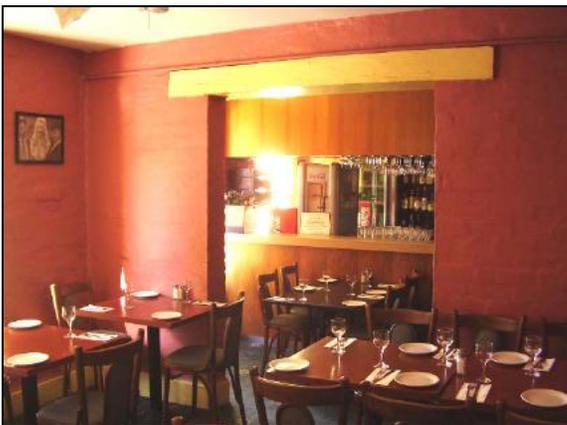
Figure 3.44 View of the front eastern room of No. 15 which features modern bar and joinery. The opening was formed as part of the 1970s works.

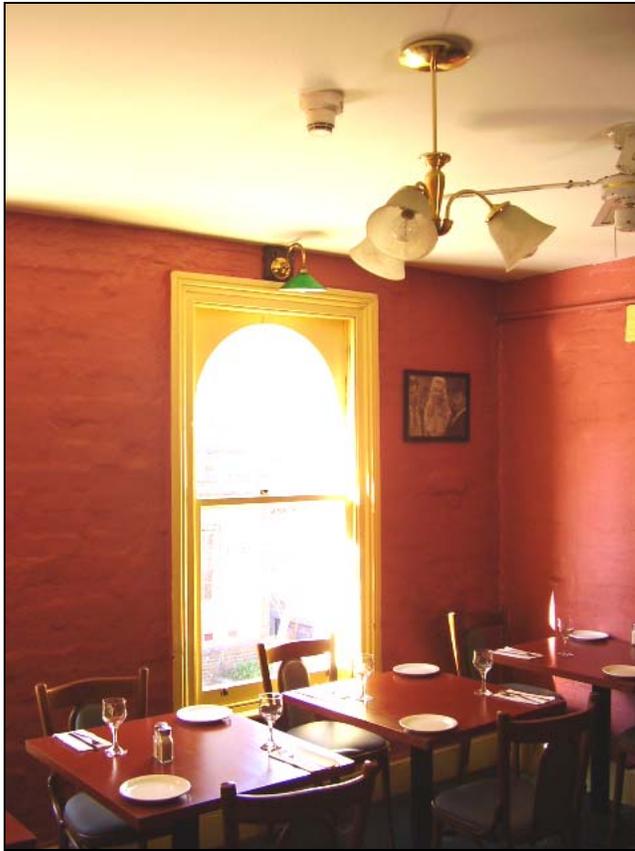
Figure 3.45 Detail of the window. Note the modern services and fixtures fixed to the ceilings.

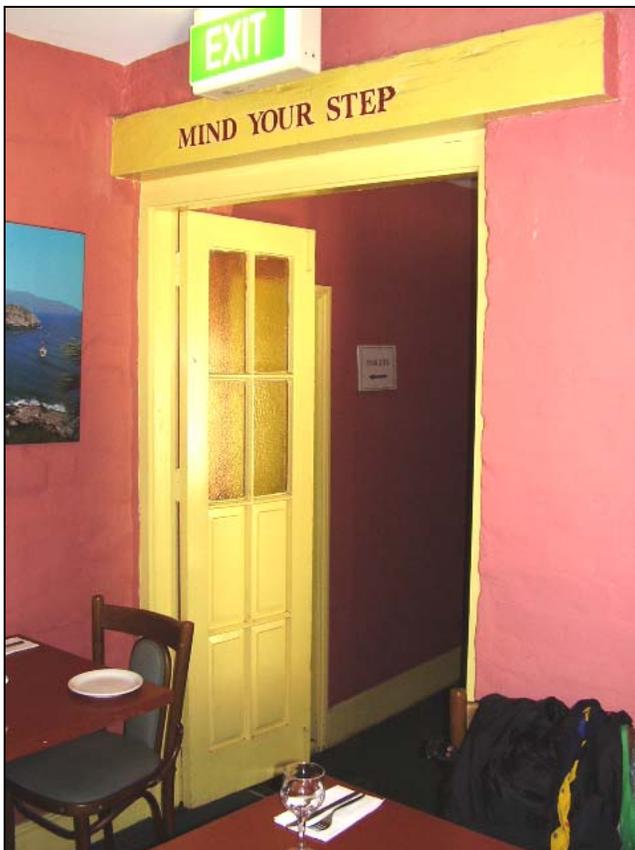
Figure 3.46 View of enlarged opening and doorway leading to the rear, western room of No. 17. The transition between the two buildings is evident with a change in floor level and "step".

The restaurant kitchen, public amenities and staff area and store room are located within No. 17 Playfair Street. Openings were formed in the walls between No. 15 and No. 17 as part of the 1970s works. Several restaurants have continued to occupy the combined areas since that time.

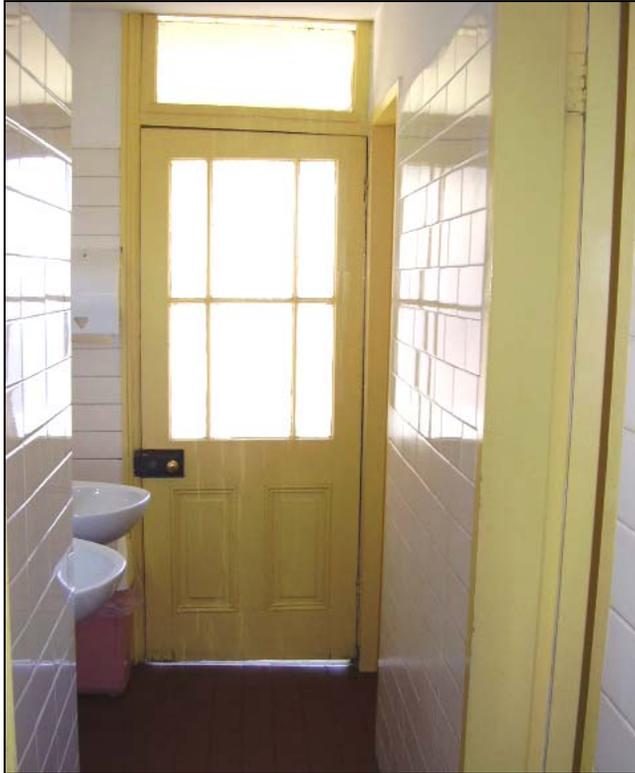
Figure 3.47 View of the female WCs added to the front, eastern room of No. 17 as part of the 1970s works. The bathrooms, which feature lightweight stud walls and ceramic tile finishes to floors and walls have been upgraded with modern fixtures and features appear to be in good condition.

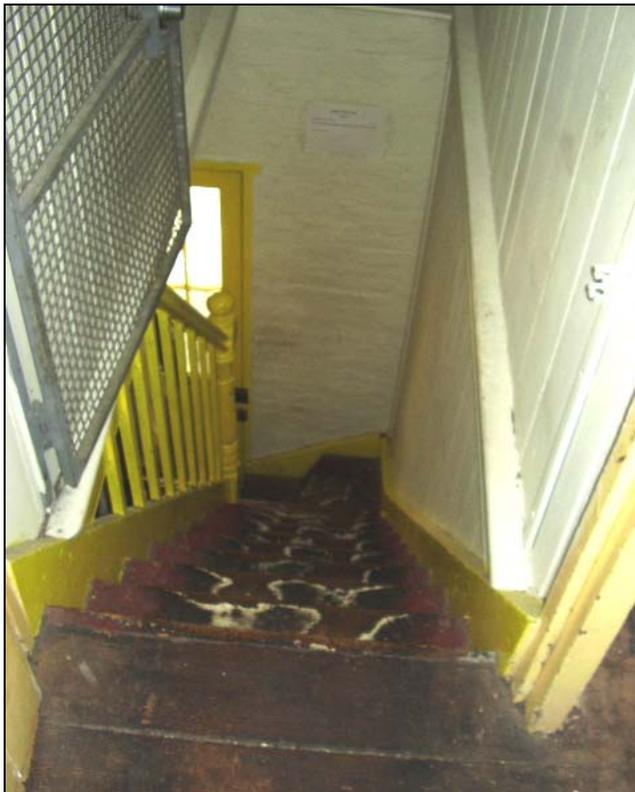
Figure 3.48 Narrow, timber stair access to the attic over No. 17. The stair, which features simple turned timber newell post and simple square balustrade is located in the rear, western room of No. 17. The stairwell is also partially enclosed by timber boarded partition. The stairwell and associated elements appear to be in good condition. The stair treads are slightly worn and retain evidence of several coats of paint and finishes.

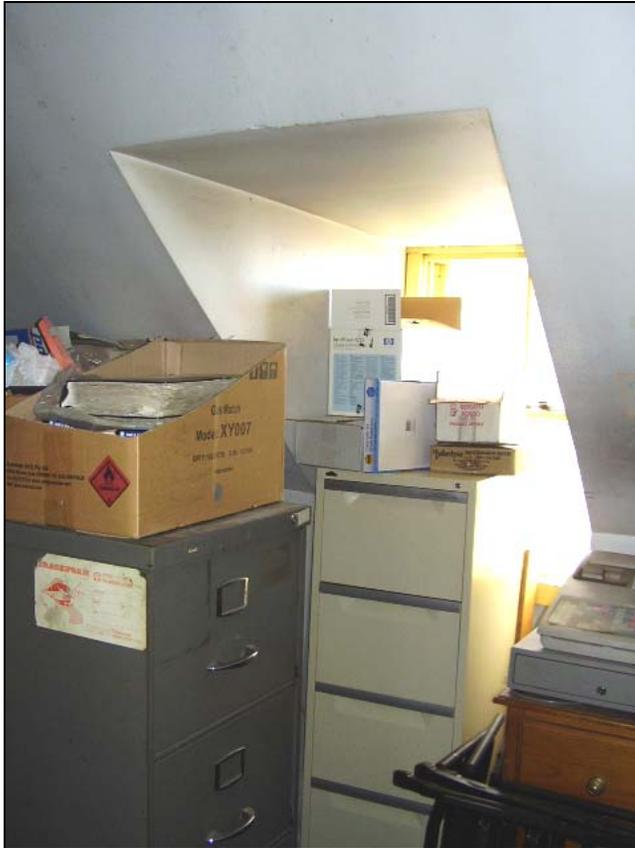
Figure 3.49 View of the attic and dormer window on the eastern roof slope of No. 17 Playfair Street.

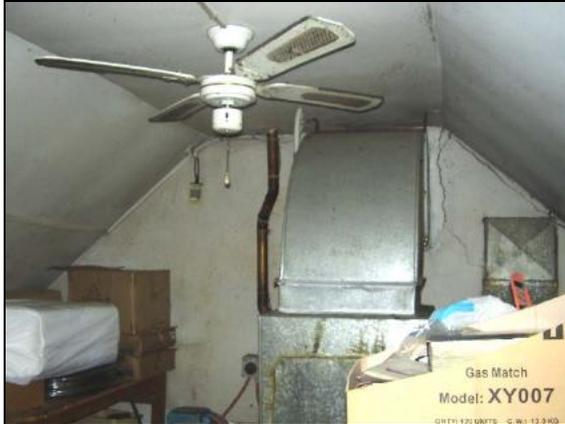
Figure 3.50 View of the northern wall and attic space which is simply finished with timber floors, plaster walls and raked ceiling which are in fair condition. A crack is visible to the right of the exhaust duct.

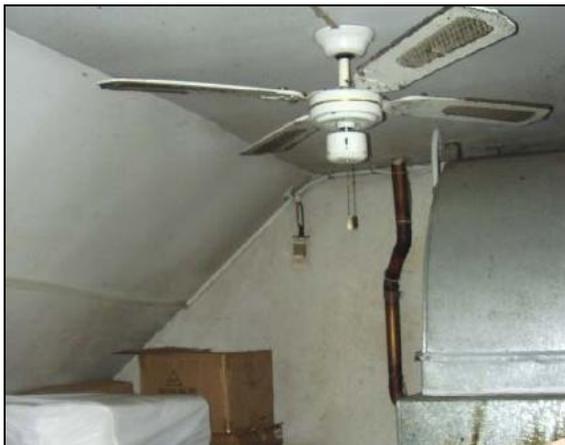
Figure 3.51 A fan and services have been added to the attic space. The space requires additional ventilation as the mechanical equipment generates some heat in the confined area.

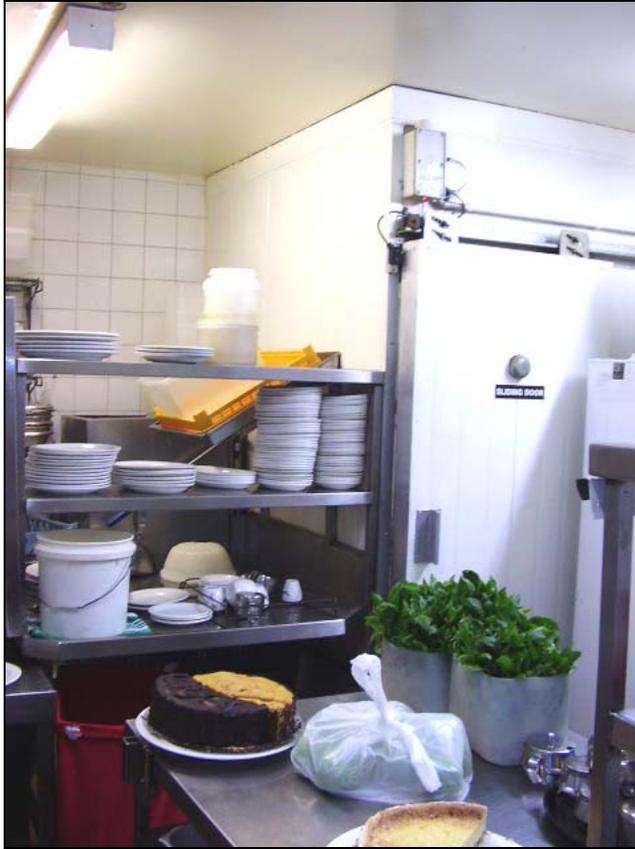
Figure 3.52 View of the kitchen in the ground floor of No. 17. The south western corner features a cool room added as part of the 1990 restaurant fitout/refurbishment.

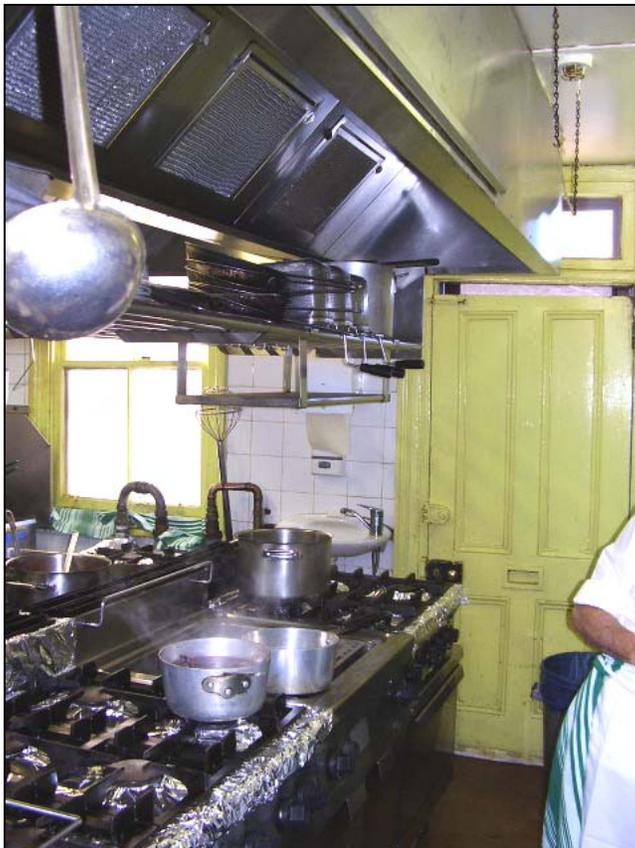
Figure 3.53 View of the ground floor kitchen looking east to the Playfair Street façade. The space features vinyl floor finish on concrete floor slab, ceramic tiles to the walls and modern stainless steel fixtures and fittings. The kitchen was originally created as part of the 1970s works to the building. The space now incorporates the open passage that existed between Nos. 17 and 19.

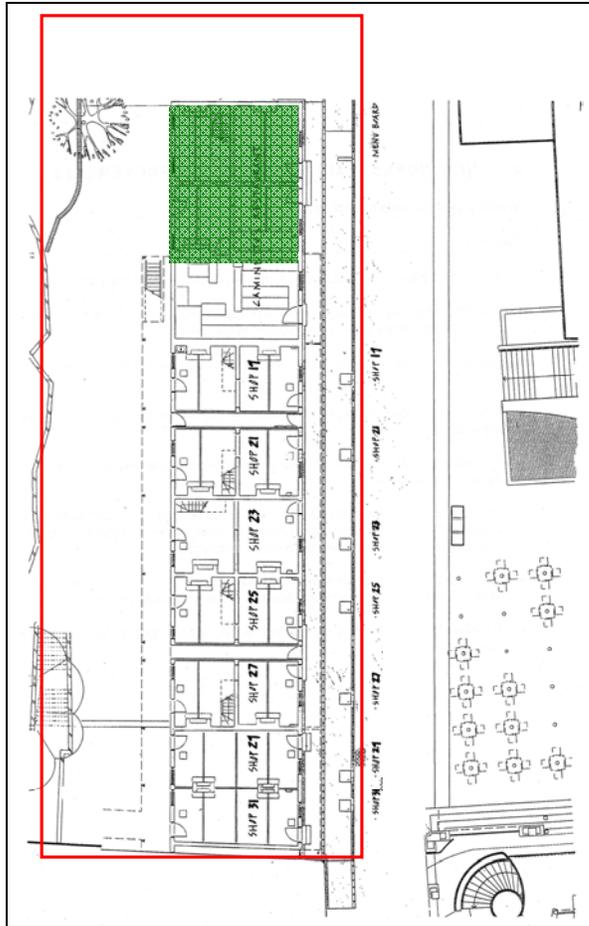
Figure 4.2 The recommended curtilage of the buildings follows the line of the rock face to the west, incorporates the open area to the north of the terrace grouping and also includes the original footpath in front of the buildings.

The expanded curtilage includes the open space around the terraces including Foundation Park, Playfair Street and The Rocks Square (at right).

The recommended curtilage of the Terraces can be defined by the line of the rock face to the west of the buildings, the rear boundaries of Nos. 1-7 Atherden Street to the north and the adjacent footpaths along the Playfair Street frontage. This curtilage also includes Nos. 17-31 which share a close relationship with the buildings interns of physical connection and period of construction. The curtilage represents the original site proportions and remaining "residential" character and development in Playfair Street.
