# Conservation Management Plan

Cleland Bond Store

33 Playfair Street, The Rocks

Clive Lucas, Stapleton & Partners Pty Ltd

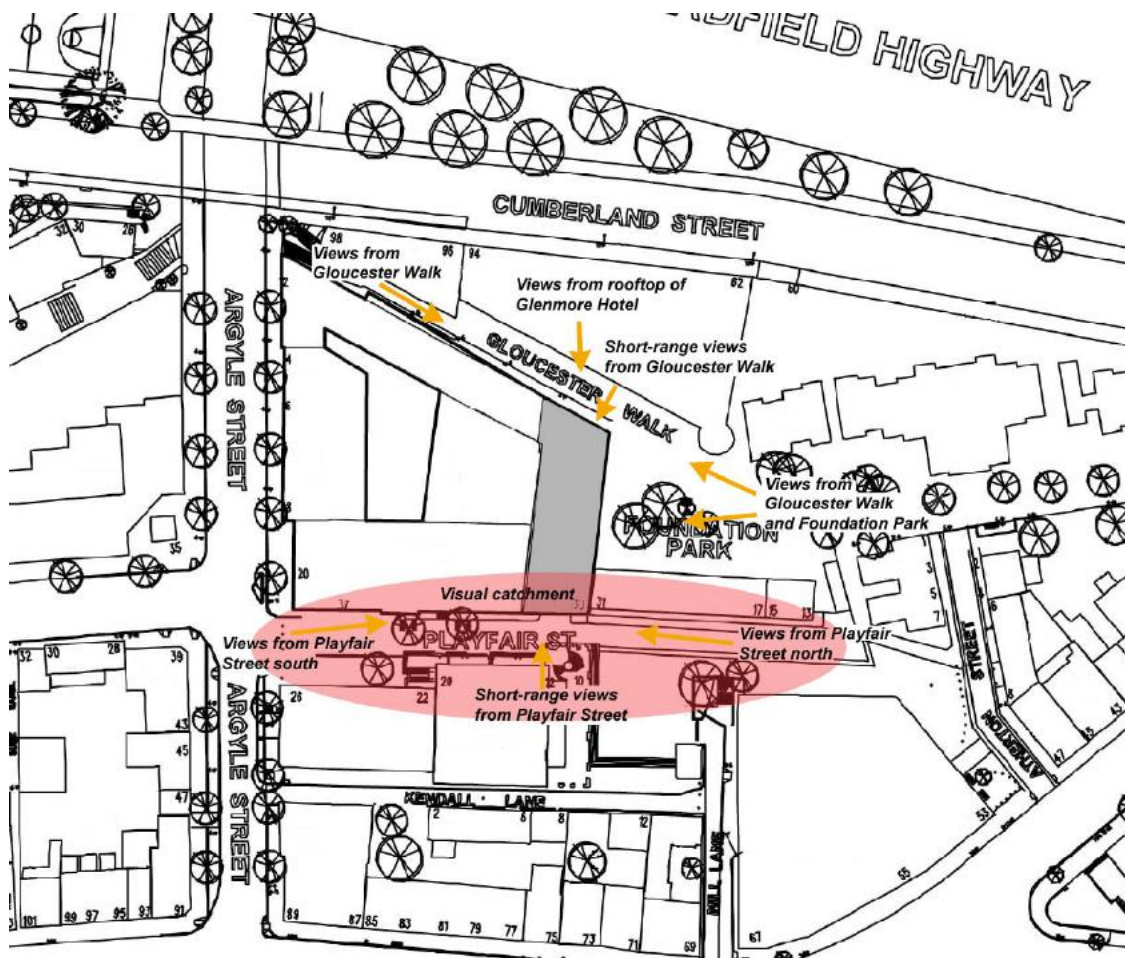
Figure 15: Diagram showing views and visual catchments of the Cleland Bond Store.

Views to the Cleland Bond Store are primarily afforded from various vantage points along Playfair Street, Gloucester Walk and Foundation Park. The view of the front (east) elevation presents a tall gabled parapet façade with a symmetrical fenestration pattern making a strong element in the streetscape (see Figures 11 and 12).

The Cleland Bond Store south elevation and roof can also be seen from Cumberland Street and the rooftop terrace of the adjacent Glenmore Hotel, 96 Cumberland Street (see Figure 16). See Figure 15 for a summary diagram of the views and visual catchments of the Cleland Bond Store.

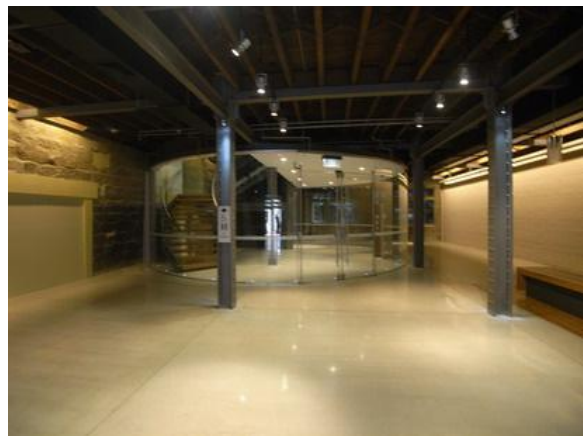
**Figure 35: Ground floor, glazed enclosure to caged steel frame lift and stair**

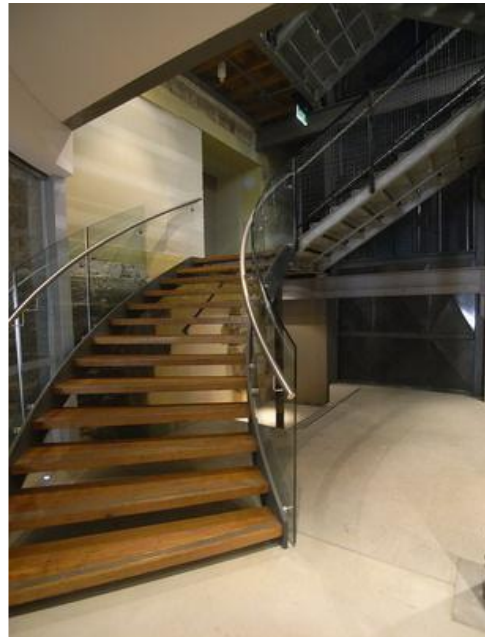
**Figure 37: Curved steel closed string stair with hardwood treads**

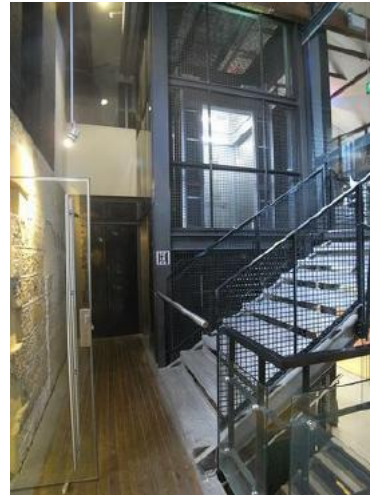
**Figure 45: Steel frame stair and caged lift between second and third floors**

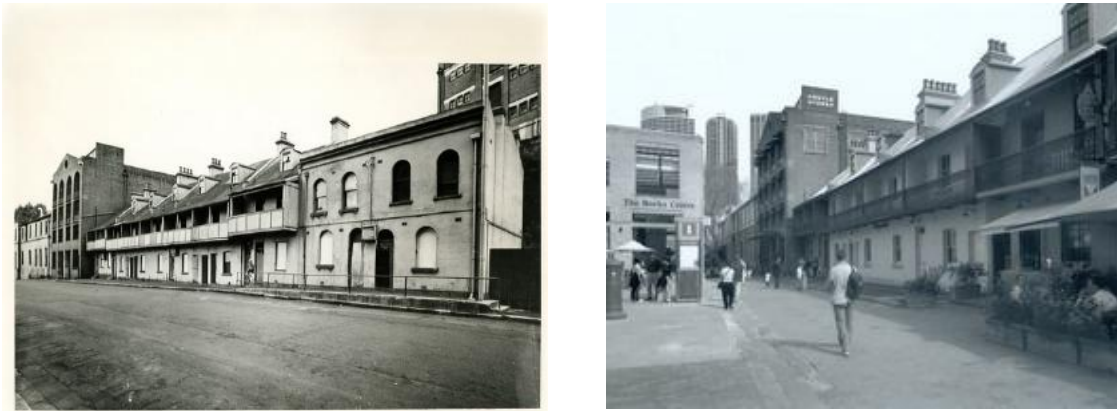
**Figure 50: View of Cleland Bond Store from Playfair Street north: c.1970s (left) and 2001 (right). (Source: c.1970s photograph – Foreshore Authority, 35188/PS/01; 2001 photograph – Foreshore Authority, 259635/13-31A)**

In the 1990s exterior blinds were added to the east elevation ground, first, second and third floor windows and a bracketed awning over the ground floor main entrance doors. These additions were removed during the 2006-2007 refurbishment works.

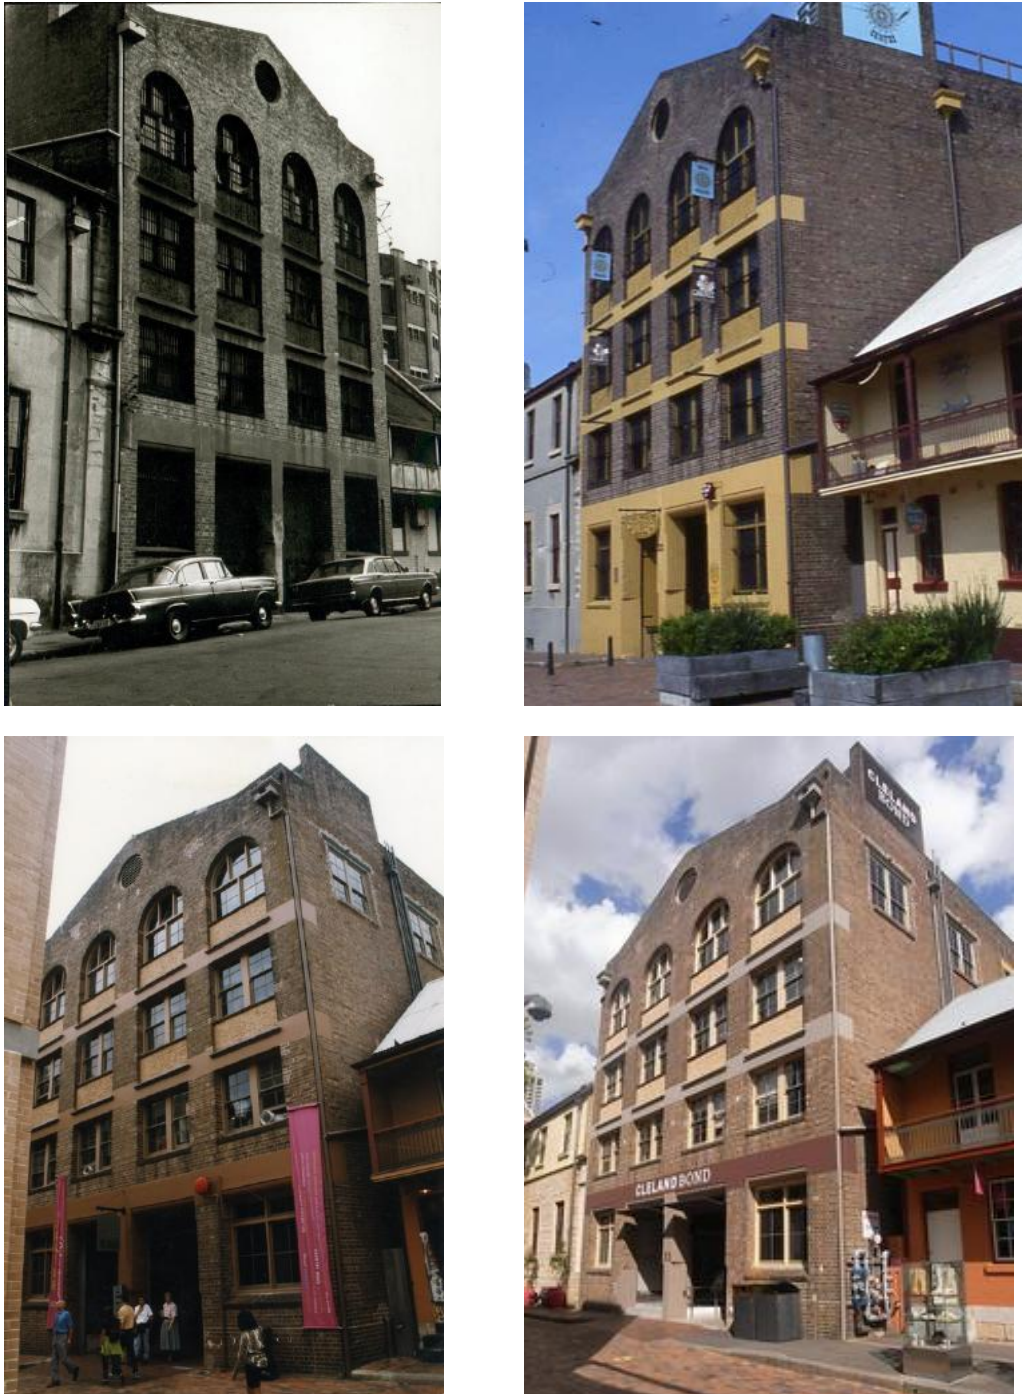
**Figure 52: Cleland Bond Store east elevation: 1970 (top left), 1987 (top right), 1997 (bottom left) and 2008 (bottom right). (Source: c1970 photograph – CLSP, Playfair Street historic photos; 1997 photograph – Foreshore Authority, 160710; 1987 photograph – Foreshore Authority, 157459/PS/197)**

Bars were removed from the east elevation windows as part of the 1971-1972 conservation works. By 1987, the ground floor was painted. In the 1990s new window openings were added to the north façade at the third floor and the 1980s paintwork was removed from the ground floor east elevation. By 2008, the bracketed sign and fire bell were removed and a painted sign with the words 'Cleland Bond' was added to the front facade.

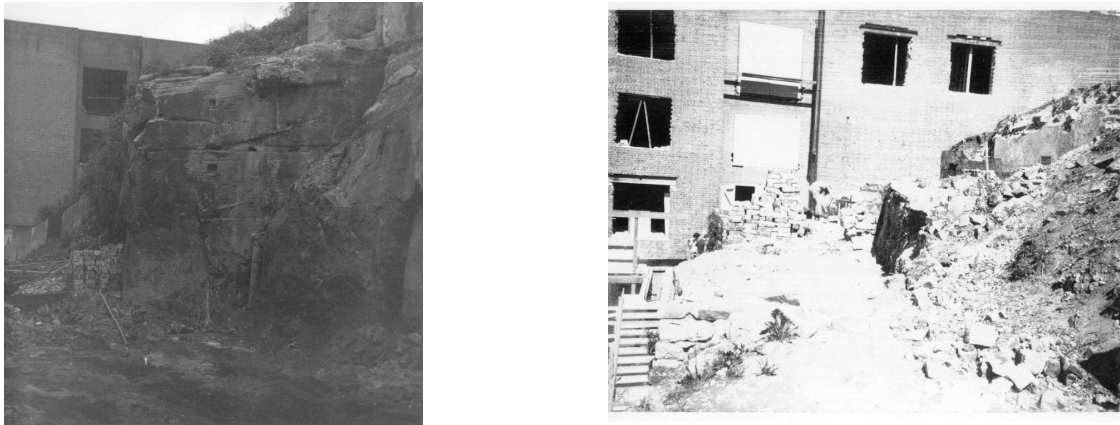
**Figure 53: Detail of Cleland Bond north elevation: before 1971-1972 conservation works (left), during 1971-1972 conservation works (right). (Source: Clive Lucas, Stapleton and Partners)**

New window openings on the first, second and third levels were added to the northern façade as part of the 1971-1972 conservation works.

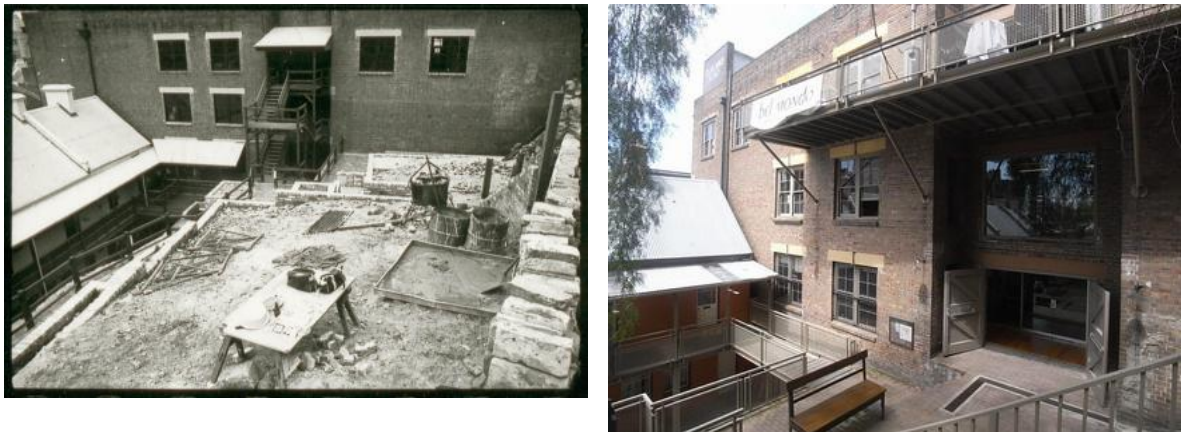
**Figure 54: Cleland Bond north elevation: c.1974 (left) shortly after 1971-1972 conservation works and 2008 (right). (Source: Clive Lucas, Stapleton and Partners)**

An exterior timber stair was added to the north façade providing access to the second and third floor as part of the 1971-1972 conservation works. This has since been removed and replaced with a bracketed balcony to the third floor door opening. There is currently no access to the second floor from the north elevation.

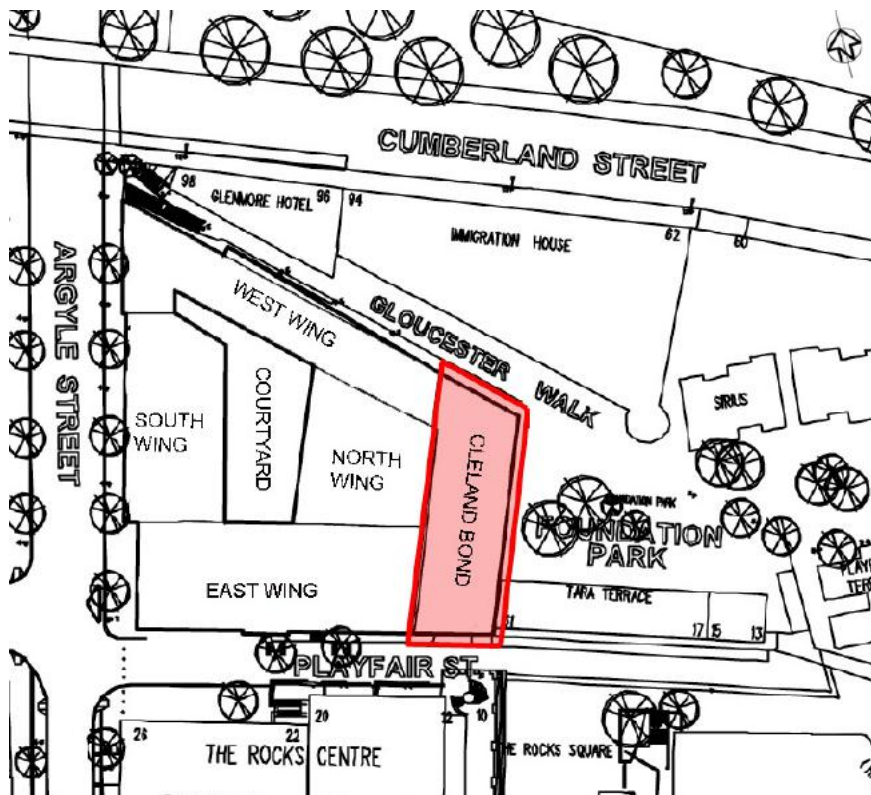
Figure 61: Minimum heritage curtilage

The study area boundaries define the minimum heritage curtilage applicable to Cleland Bond. This area is bounded by Playfair Street to the east, Gloucester Walk to the west and the Playfair Street terraces and Foundation Park to the north (see Figure 61).

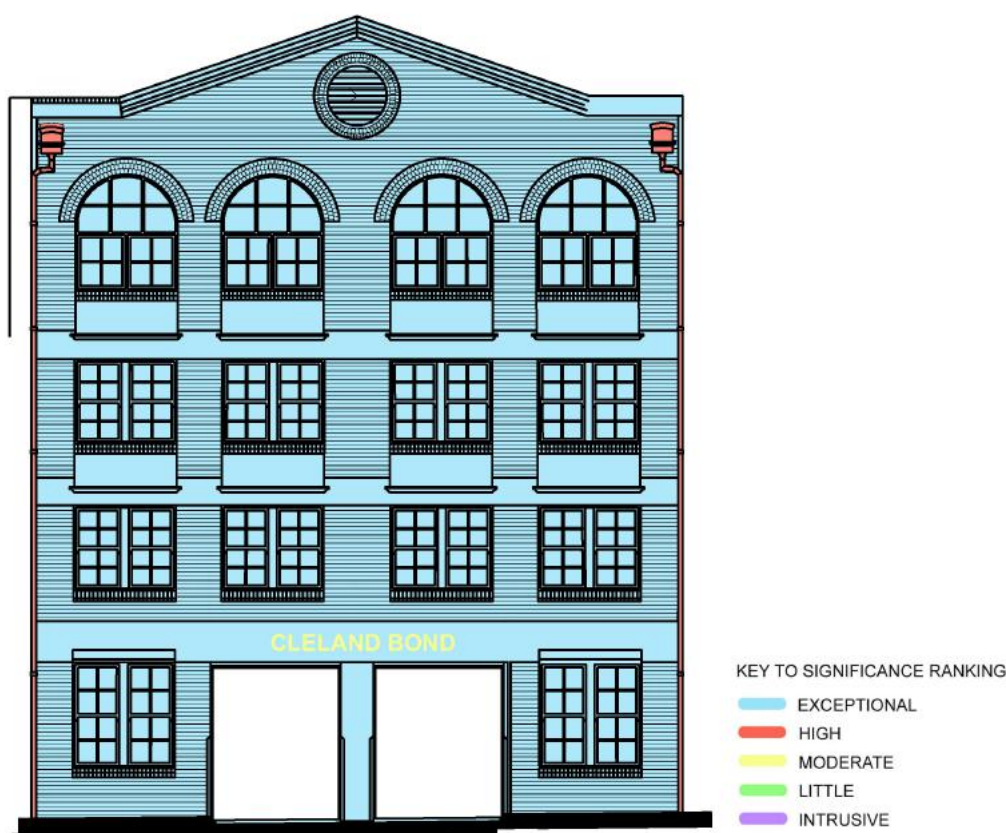
Figure 62: Ranking of significance, east elevation

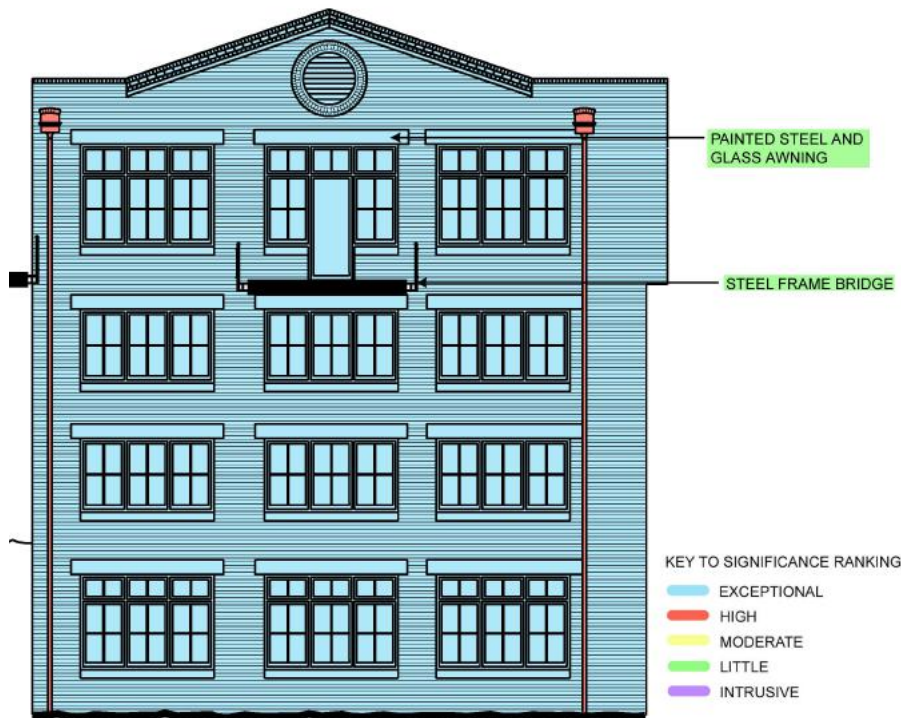
Figure 63: Ranking of significance, west elevation

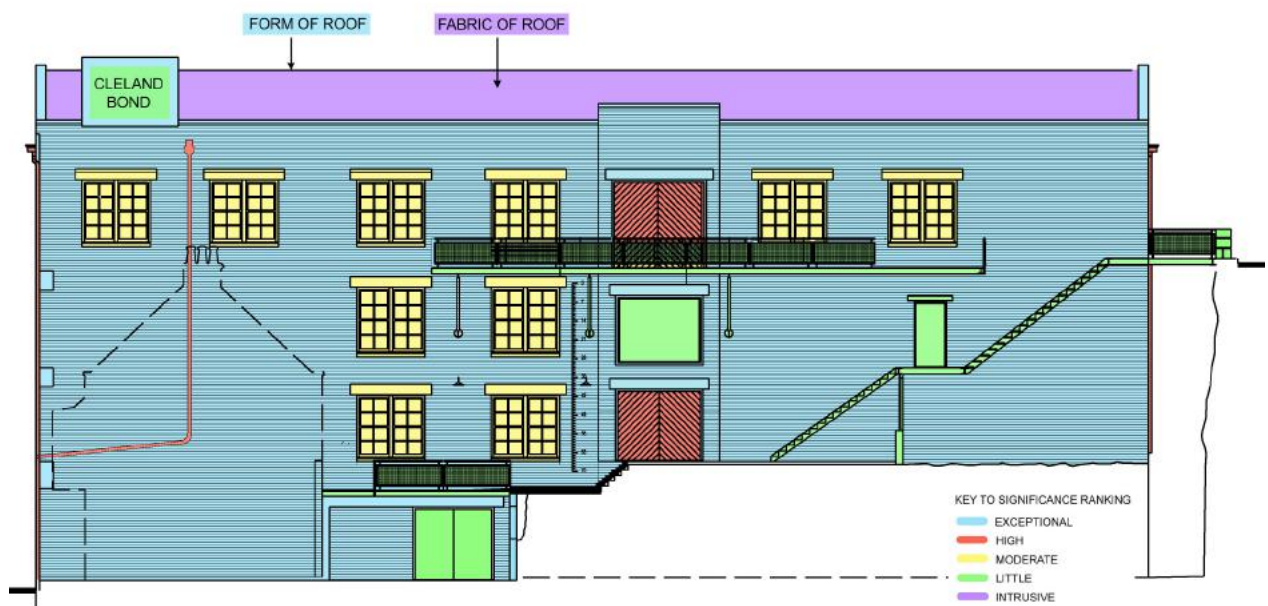
Figure 64: Ranking of significance, north elevation

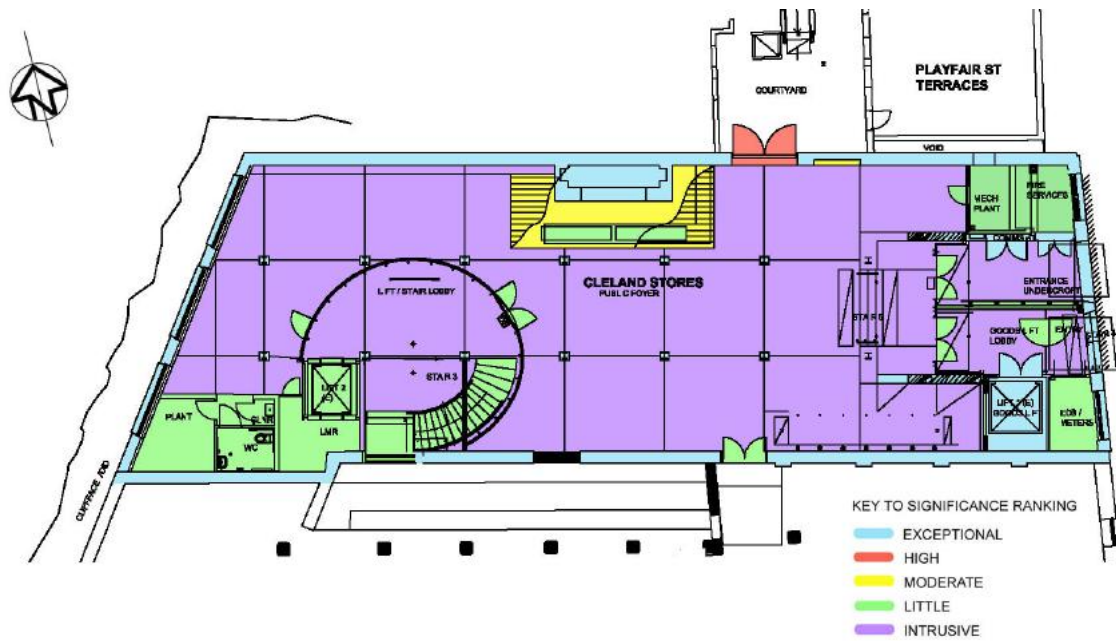
Figure 65: Ranking of significance, ground floor plan

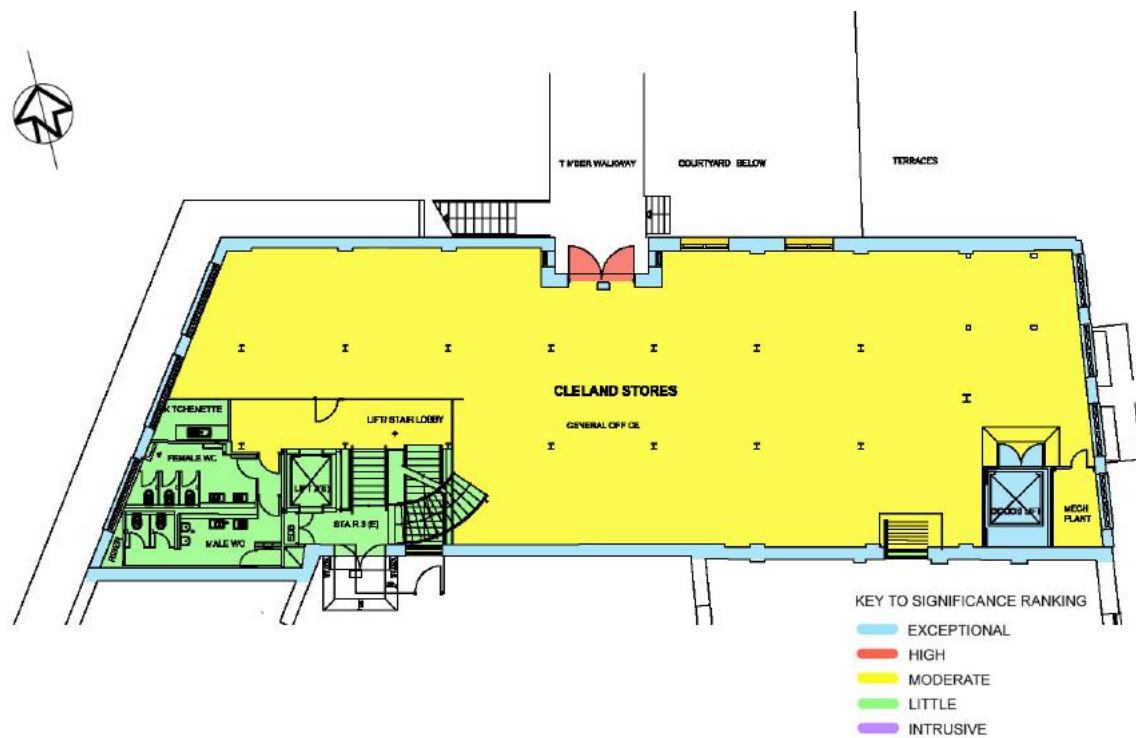
Figure 66: Ranking of significance, first floor plan

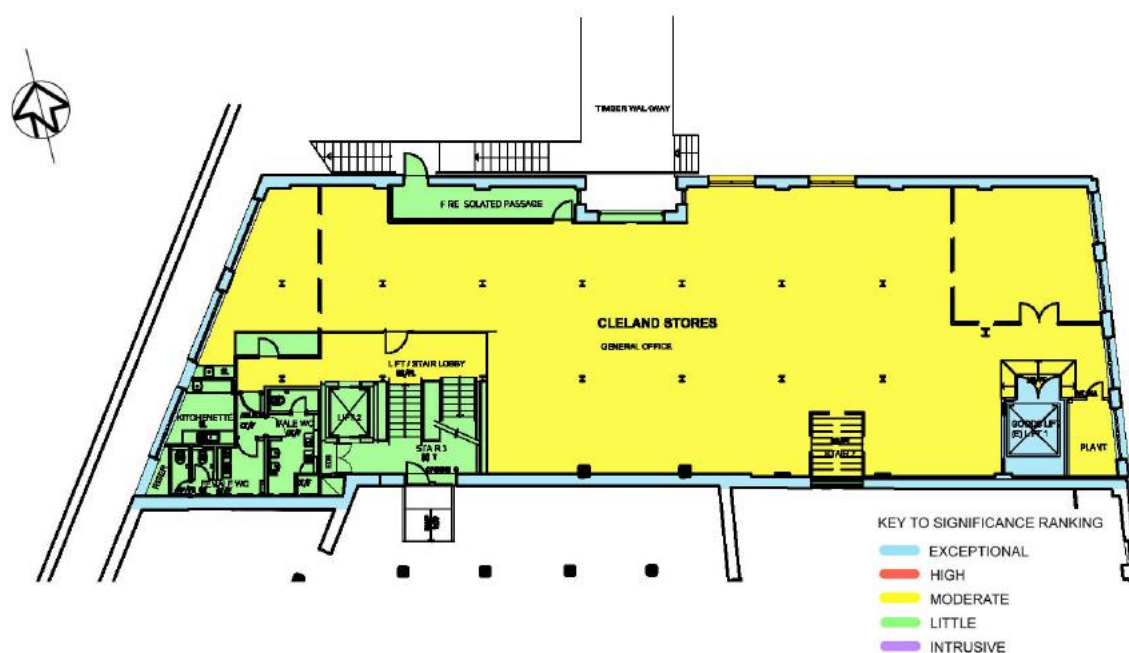
Figure 67: Ranking of significance, second floor plan

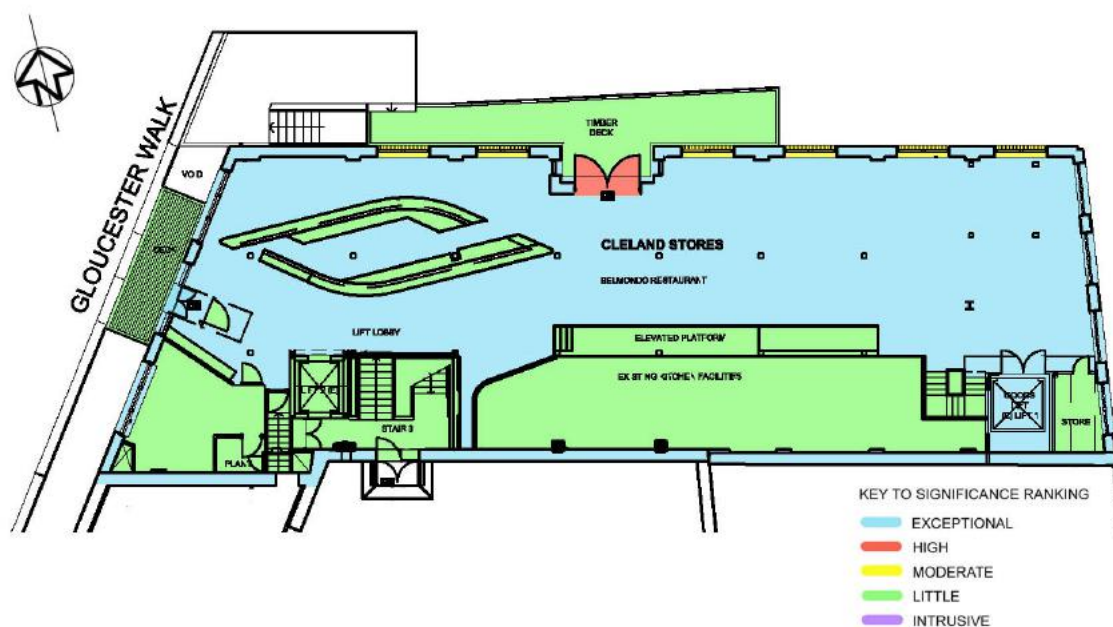
Figure 68: Ranking of significance, third floor plan

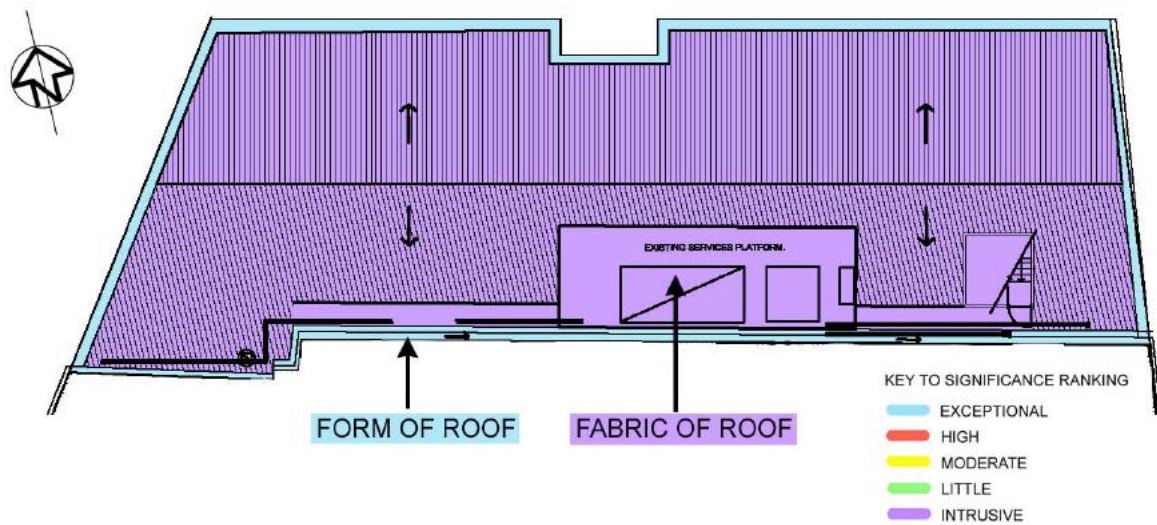
Figure 69: Ranking of significance, roof plan
