JOHNSONS CORNER

229-235 GEORGE STREET, THE ROCKS

CONSERVATION MANAGEMENT PLAN

June 2012

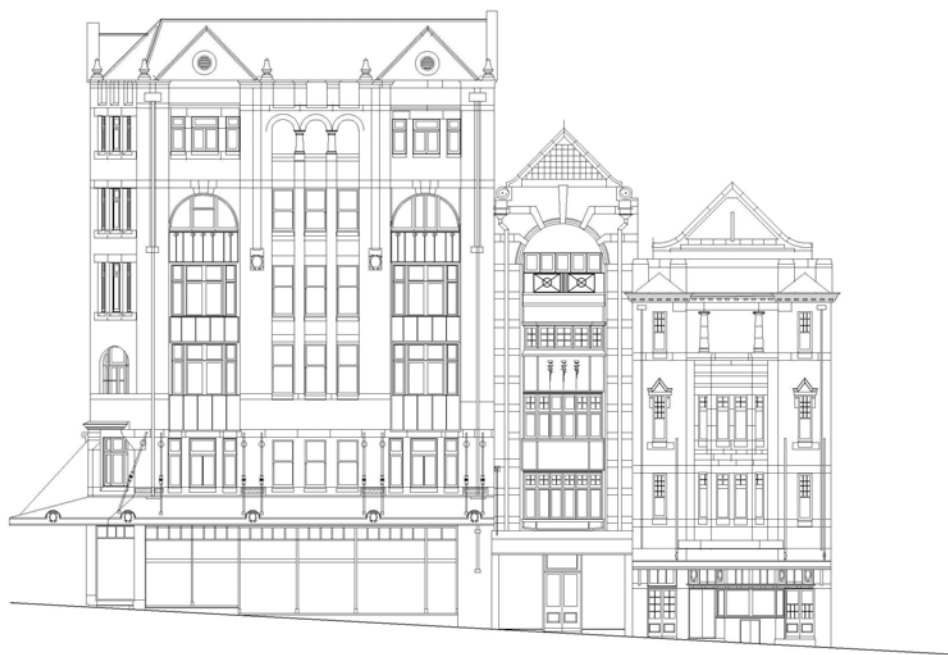
Figure 5 – Principal/ East Elevation of the Johnson's Building Group showing (from left to right) the Johnson's Building (233-235), the Commercial Building (231) and the former Brooklyn Hotel (229).

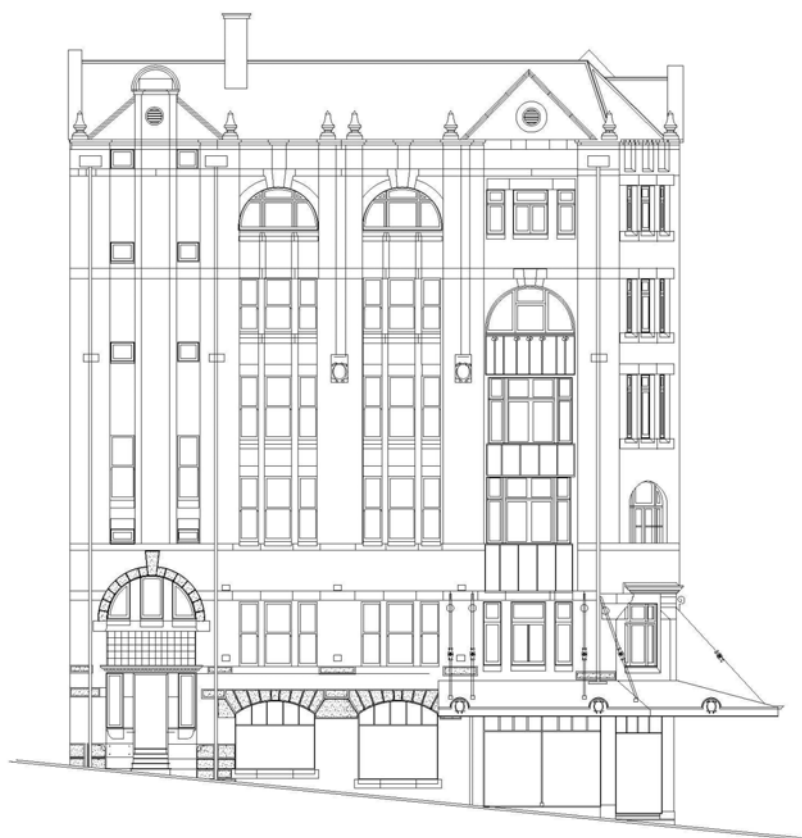
Figure 6: The southern Grosvenor Street façade

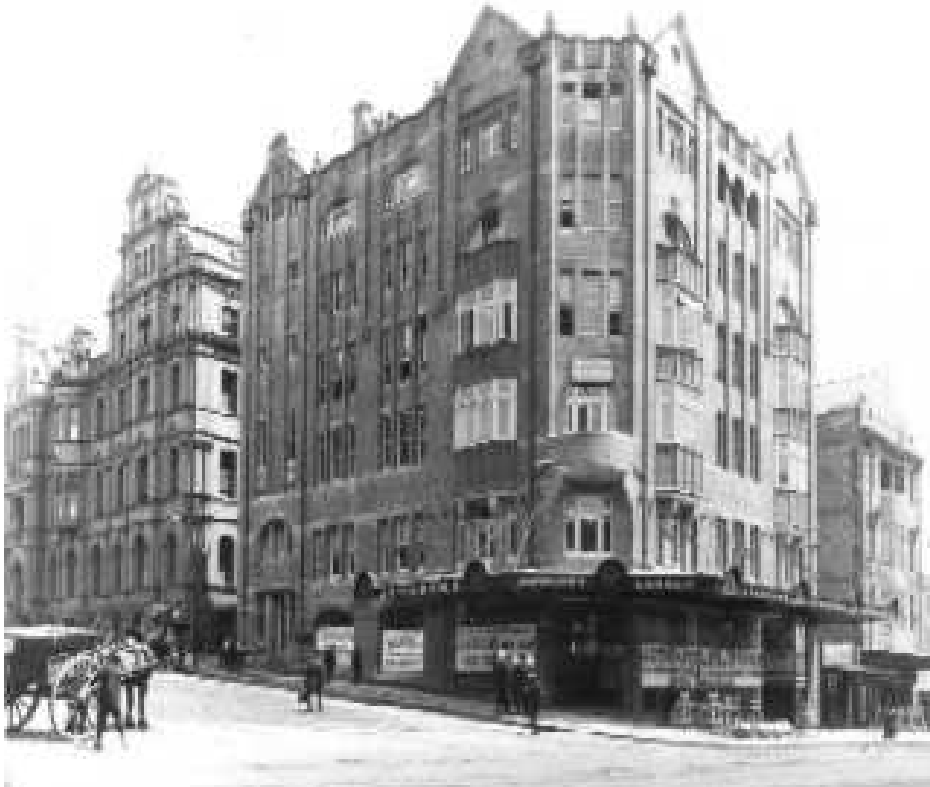
Figure 31 – 1912 view of the newly constructed Chamber of Commerce Building on the corner of George Street and Grosvenor Street and Brooklyn Hotel (at right). The single-storey temporary bar is also shown on the site of the Commercial building.

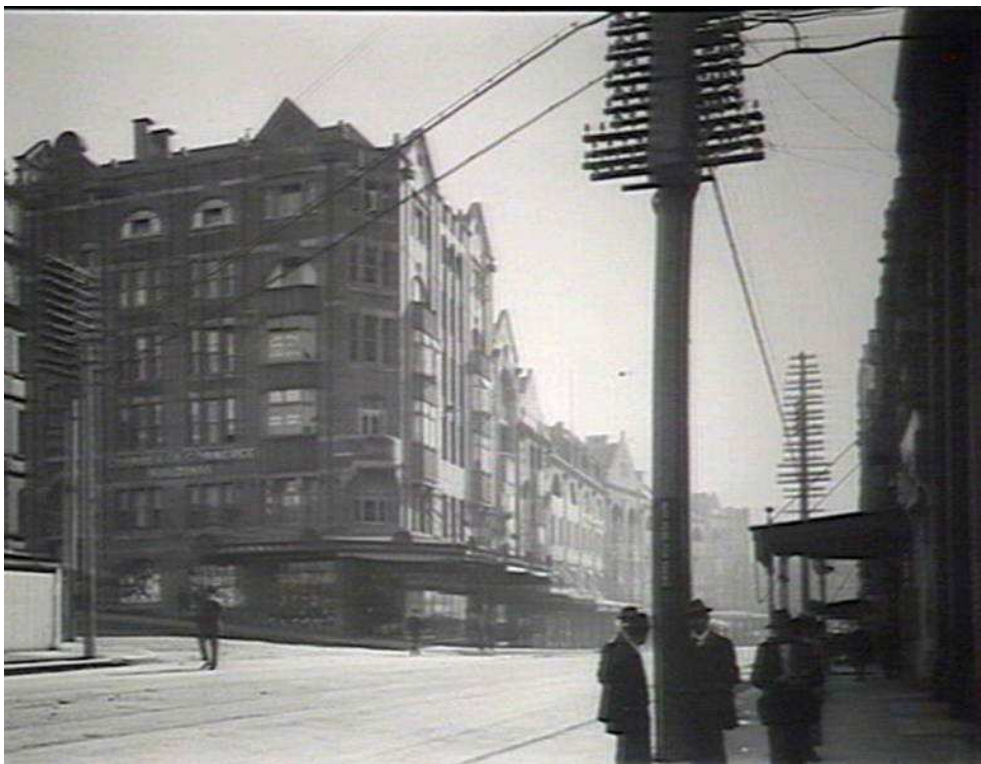
Figure 32 – The building group – June 1914 showing the completed Commercial Building

The Commercial Building was designed in the Government Architects Office and although a specific designer has not been identified, the building responds to adjoining development and may have been designed by W.L Vernon prior to leaving the office, or by his successor George McRae. McRae was Vernon's principal Assistant Architect from 1897 and the two shared a common architectural style. The first government tenants were listed in the Sands Directory from 1915 suggesting a construction date of circa 1914, which is consistent with historical photographs of the period (refer figure 32). Although built as a "shop for Mr Smith" it does not appear to have been occupied by him.

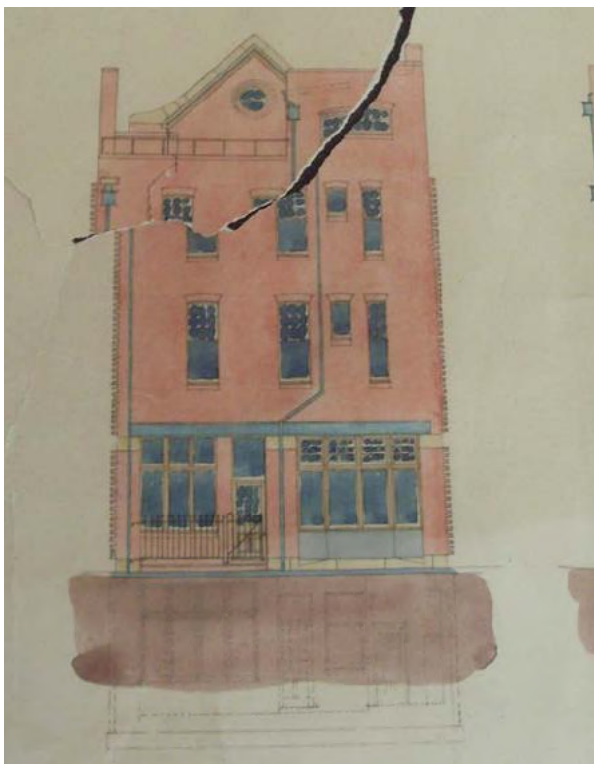
Figure 36 – Rear elevation to lane

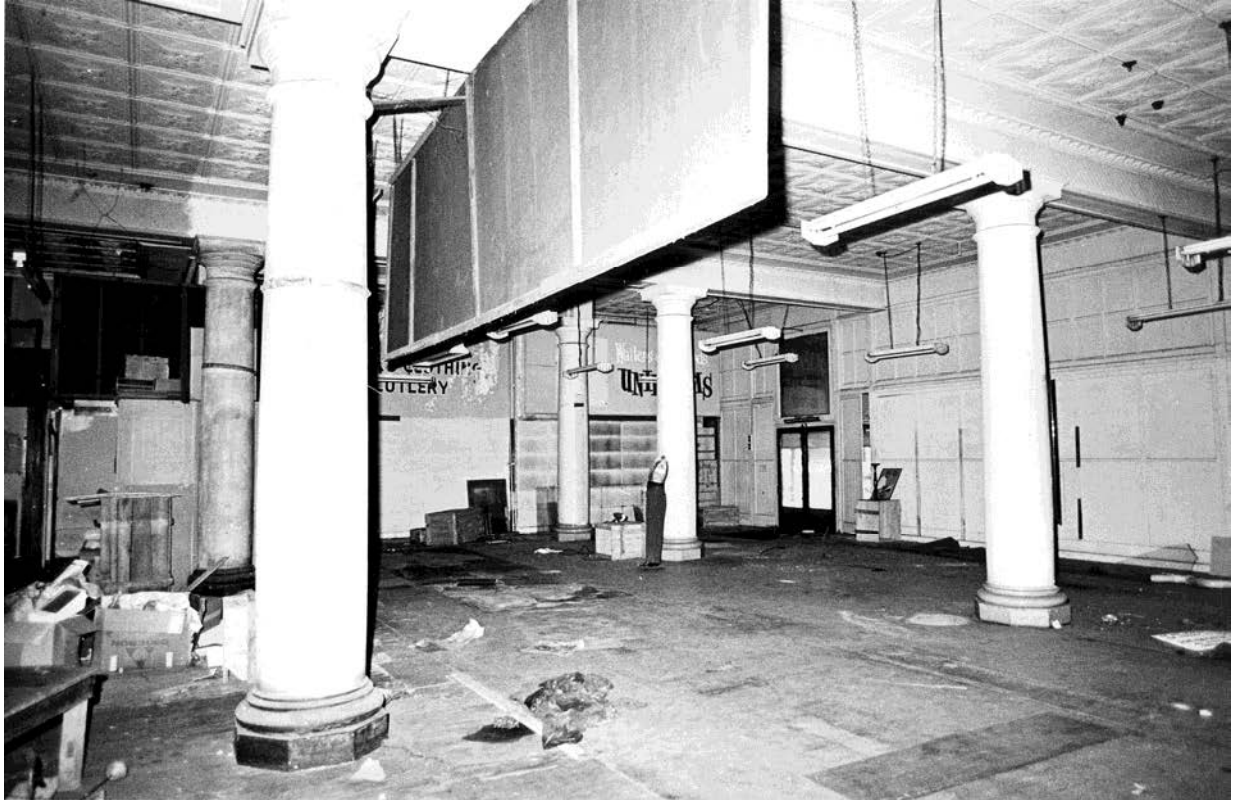
Figure 67 – The former ground floor interior of the Johnsons building, shown vacant. The original second entry to George Street is shown, along with original internal finishes.

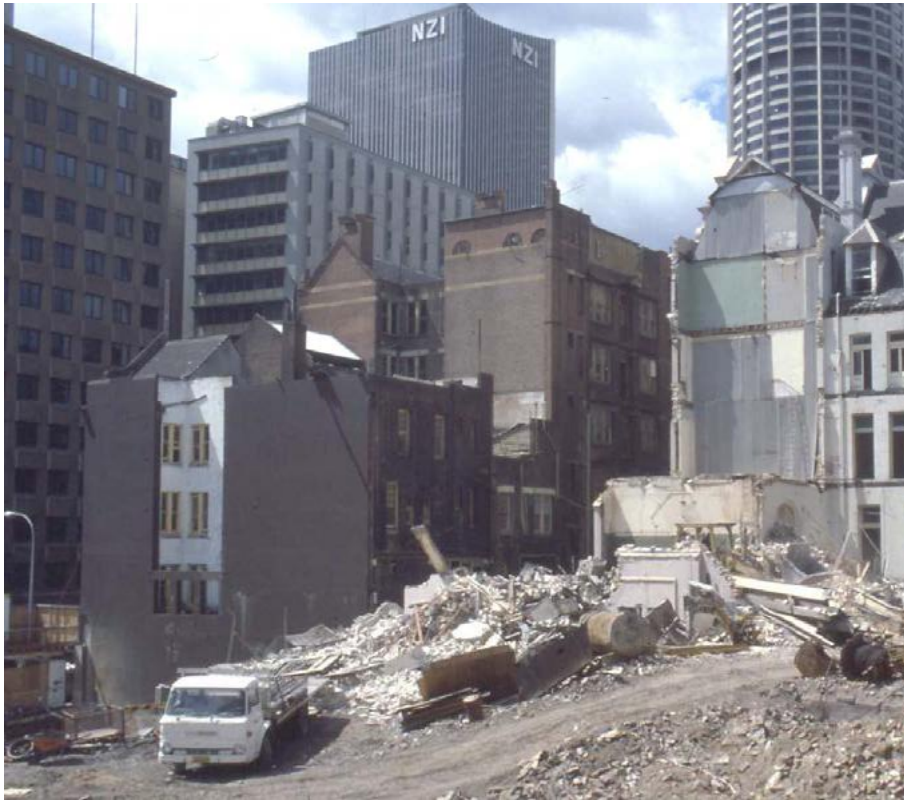
Figure 70 – The rear of the Johnsons group, with the Brooklyn Hotel shown at left and partially demolished Royal Naval House at right. (1983)

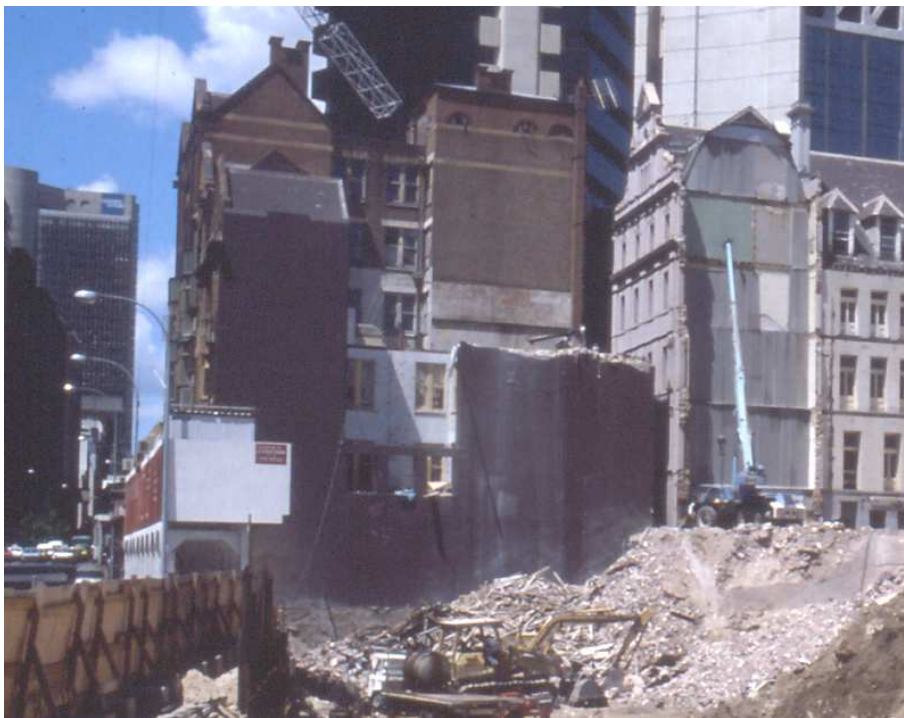
Figure 71 – View south to the building group showing the Brooklyn Hotel partially demolished (1983).

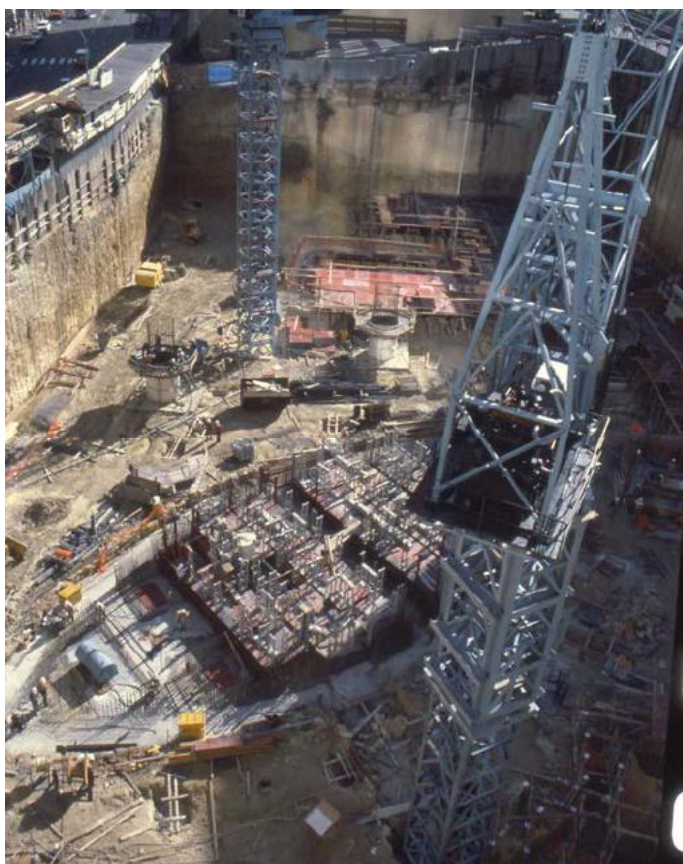
Figure 73 – Foundations of the Grosvenor Tower -view north- the subject site is not shown. (c.1984)

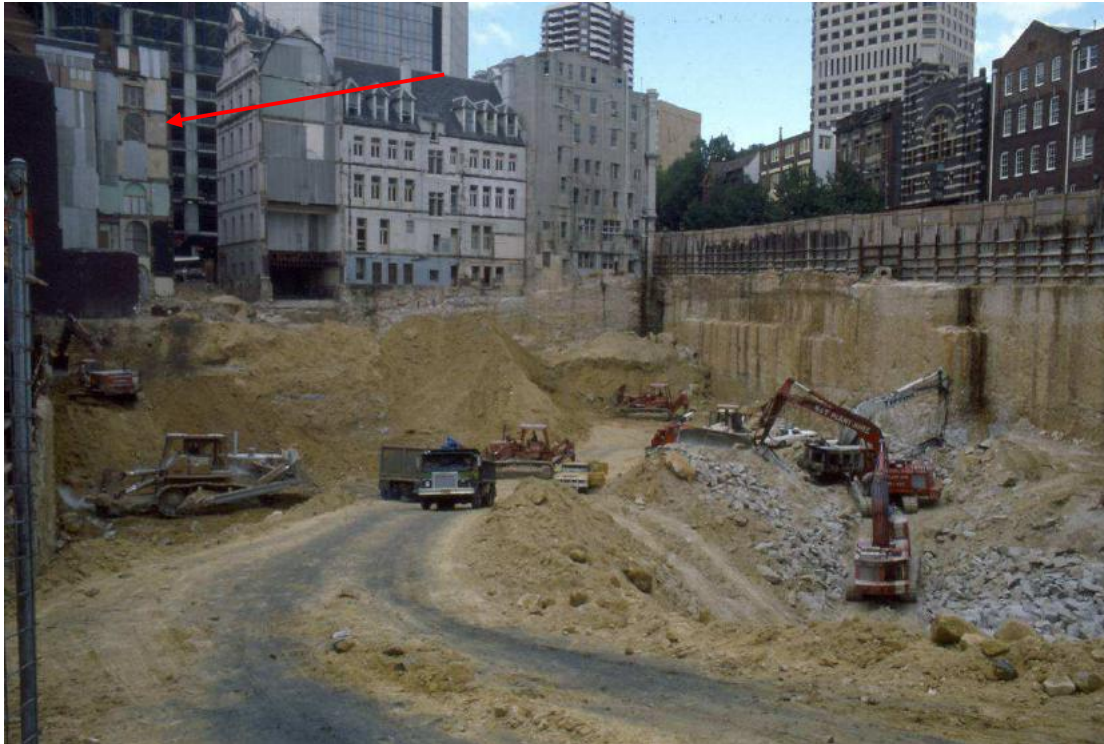
Figure 74 – The rear of the Johnson’s Building during the demolition and excavation (1984). The rear wings of The Brooklyn Hotel and the Commercial Building have been demolished, along with part of the Johnson’s Building (indicated). The form of the arched openings are retained in the stair well (refer views of the existing stair shown in section 3.4), though they have been infilled.

The Johnson's Building was extended to accommodate a substation and other services for the complex. The previous lift-well was used for ventilation, and a new lift-well and vertical services shaft added to the western side of the building (the extent of the demolition is shown in figure 74 above). The new extension was a sympathetic addition rather than a false reconstruction (refer figure 7).

View from the vestibule to the first floor (level 2 stair) landing. The stair was originally the main entrance to the commercial floors and the arched recess has been infilled and the stair is now utilised as a fire stair. In figure 74 the building is shown from the rear as partially demolished and these arches are clearly visible.

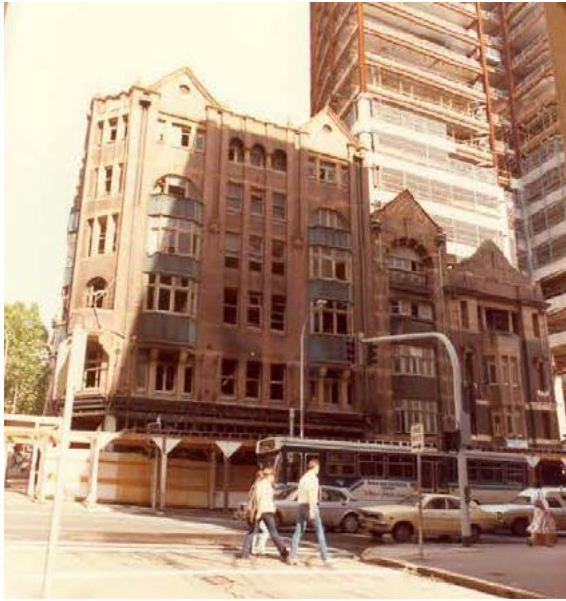
Figure 75 – The fire damaged Johnson's group as viewed from Dalley Street.

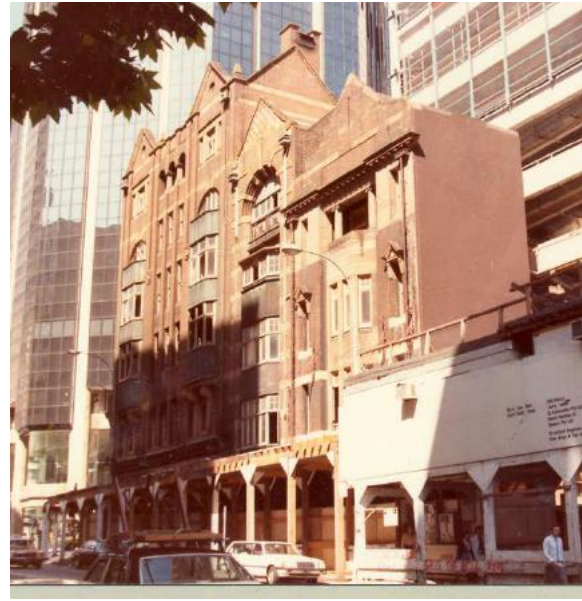
Figure 76 –The fire damaged Johnson's group as viewed from George Street (north)

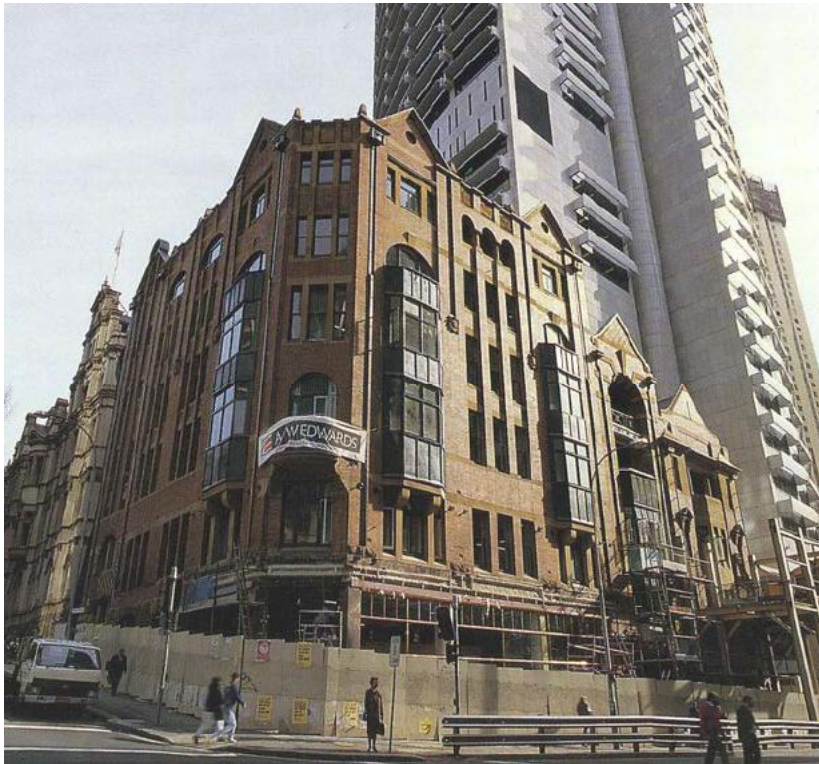
Figure 77 – Restoration of the Edwardian building facades. Note the scaffolding erected in front of the Commercial and Brooklyn Hotel buildings. The awning has also been removed.

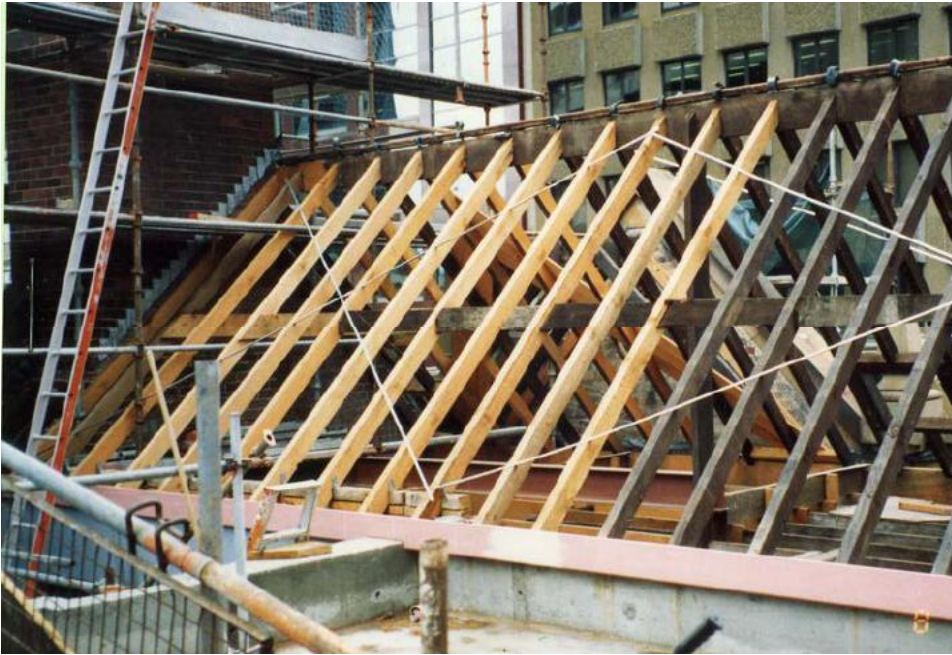
Figure 80 – Rebuilding of the roof to the George Street frontage of the Johnson’s building

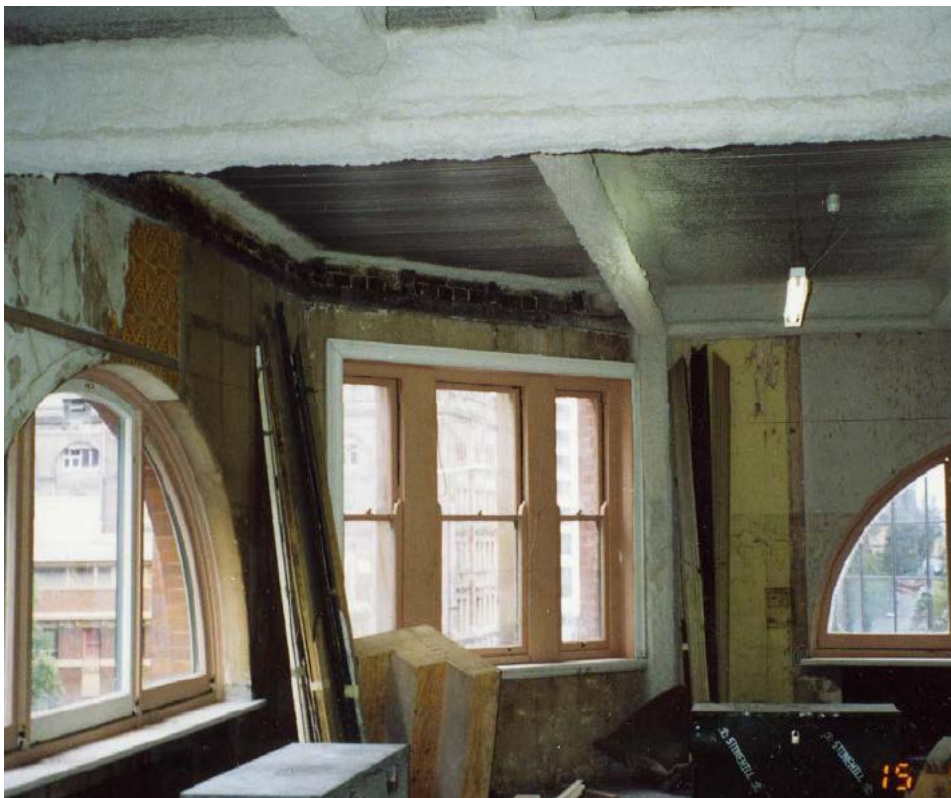
Figure 81 – View of internal works including fire rating- probably on the fifth floor of the Johnson’s Building.

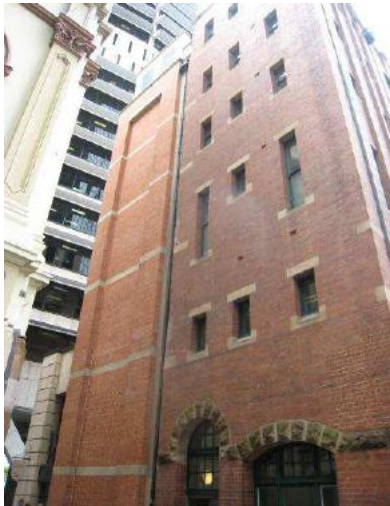
Figure 90 – Rear/ western elevation, showing the original and new sections, delineated by the differing brickwork

The rear of the hotel was demolished and rebuilt as part of the 1991 restorative works and the facade is comparatively plain compared to the original principal Edwardian facade. With the exception of the ground floor entry to the Hotel, the facade is plain bonded brick, with no openings and minimal detailing. The rear Hotel entry forms part of a single storey element that projects beneath the Grosvenor Tower. Repair of the northern gable was also undertaken as part of the restorative works and there is evidence of this in the brickwork.

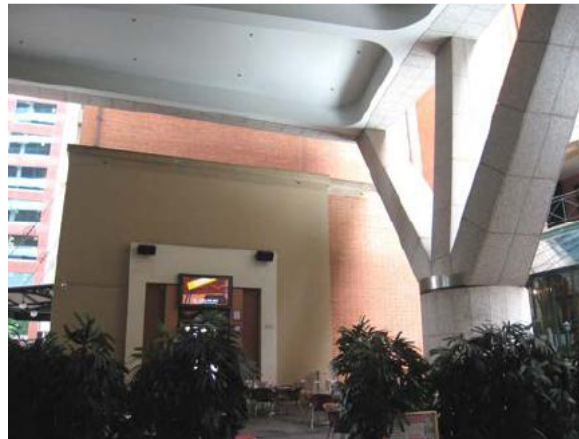
Figure 91 –Rear of the Brooklyn Hotel and part of structural system supporting the Grosvenor Tower.

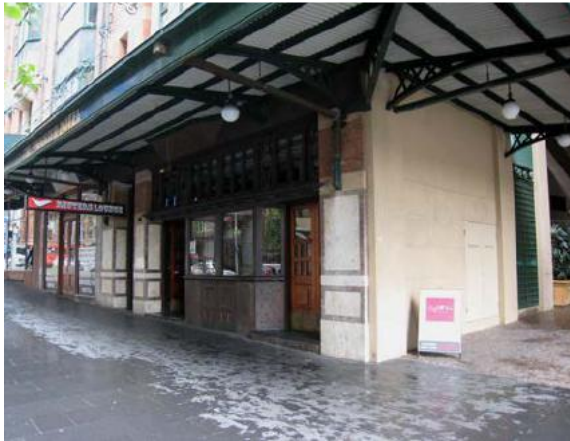
Figure 92 – The Brooklyn Hotel shopfront.

The George Street shopfronts across all three sites have been refurbished, with the Brooklyn Hotel being the most intact. Accounts of the fire damage suggest that damage to the facade of The Brooklyn Hotel was minimal and the shopfront appears to be intact with some general repair and refurbishment. The shopfront of the Commercial building was rebuilt and modified as part of the 1991 DA works and does not reflect the original façade arrangement. The cantilevered awning across the group was restored based on the original design, although measured drawings were not available. On the whole, these elements remain sympathetic to the Edwardian character and period of the building.

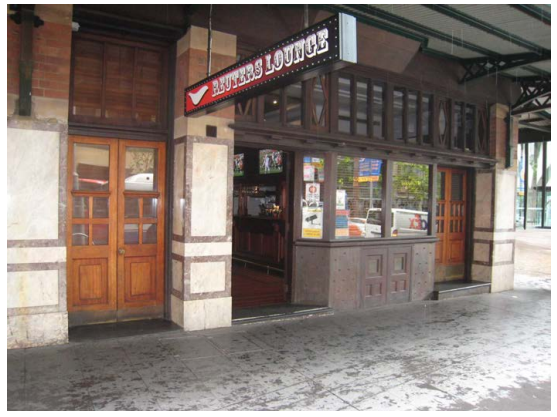
<p>The ground floor shopfront is highly intact and features timber framed glazing and cladding with marble facade treatment. Signage and awning are contemporary new fabric. Façade also features metal sheet cladding to the bay and intact original basement chute doors (disused).</p>

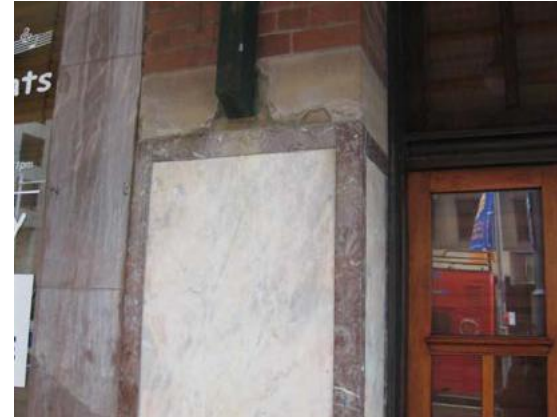
<p>Detail of the two toned marble facade cladding. Condition is generally good though there have been some intrusions to the fabric, probably in association with signage. Sandstone capping over the marble has been repaired, probably in association with works to the downpipes piping and services.</p>

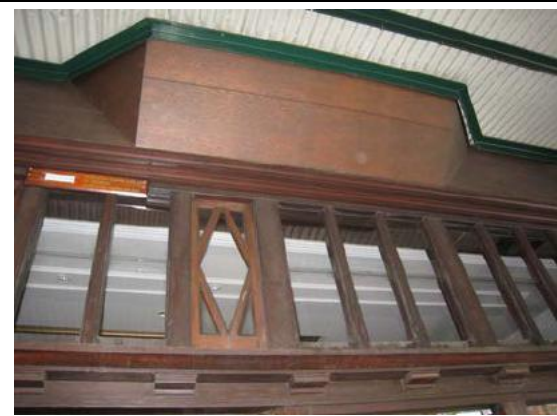
<p>Over the shop front bay the façade features a row of timber framed windows with decorative diamond shaped timber inserts and dentilled trim below. This detail does not correspond with the shopfront façade as indicated on the original plans (refer figure 34). Timber cladding beneath the awning may be new fabric and may correspond to the restoration of the awning in 2003.</p>

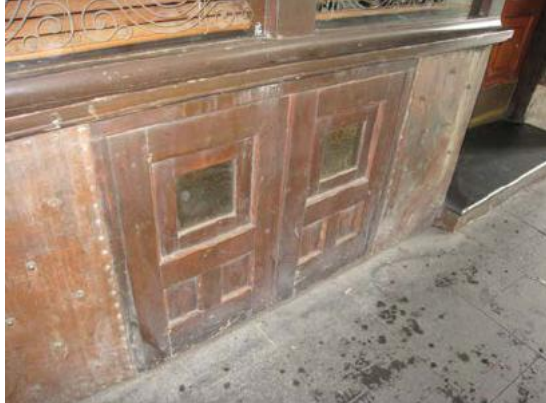
<p>Original doors to basement chute. The original basement was demolished as part of the site works, and the area beneath the Hotel was excavated and redeveloped as part of the sub basement levels to the Grosvenor Tower. Substation and parking facilities have been constructed. The doors are disused and probably no longer operational. The bottom section of the bay is clad in studded metal sheeting (probably copper)</p>

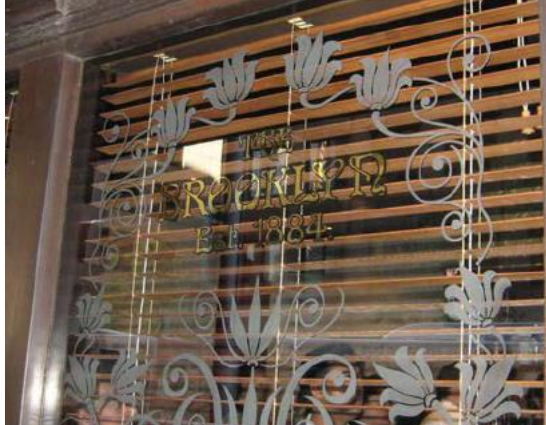
<p>Although the glazing was not affected by the fire, it is understood that the site was vandalised following the fire and that the majority of the façade glazing was lost. The words "The Brooklyn Est. 1884" (sic) have been printed in the shopfront window and it is further understood that the form of the lettering was inspired by remnant fabric at the Johnson's Building⁶⁴. The mid door, now the main entry to The Brooklyn bar features contemporary glazing, with the hotel logo.</p>

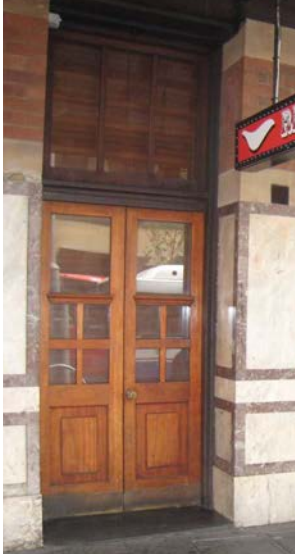
<p>The Hotel has three accesses at the George Street frontage, two to the bar area, with the third opening to the original corridor to stair hall. This latter door is intact but disused as it is now within the gaming room area and similarly the northernmost door is blocked by internal alterations and is no longer in use. All are matching double doors in timber. Although the form of the door panelling does not correspond with the original plans they are of the period and may be original.</p>

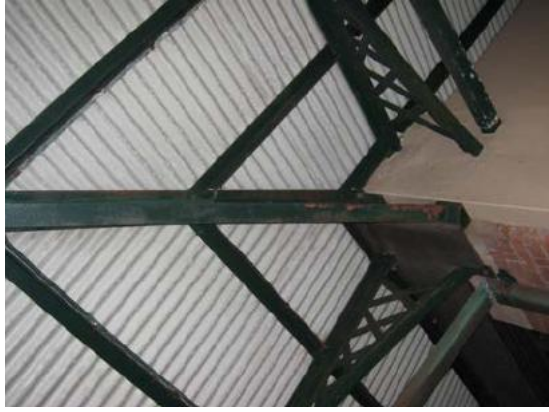
<p>The awning is new fabric, reconstructed as close to the original as possible as part of the 1991 restoration works (although no measured drawings were available) and Arup Façade Engineering undertook further extensive restorative works to the awning in 2003. Some minor corrosion of the members and tie rods is evident.</p>

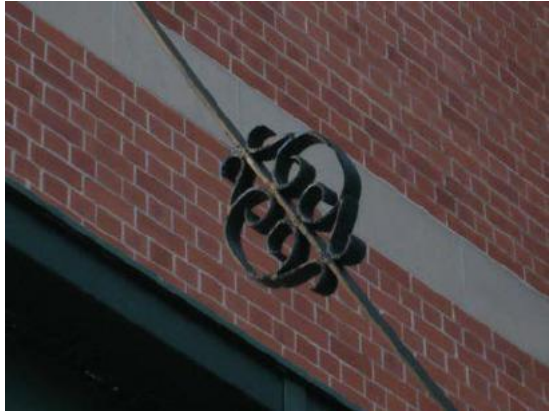
<p>Detail of one of the tie rods on The Brooklyn Hotel (north elevation). These were restored by Arup Façade Engineering in 2003 however some minor corrosion is evident.</p>

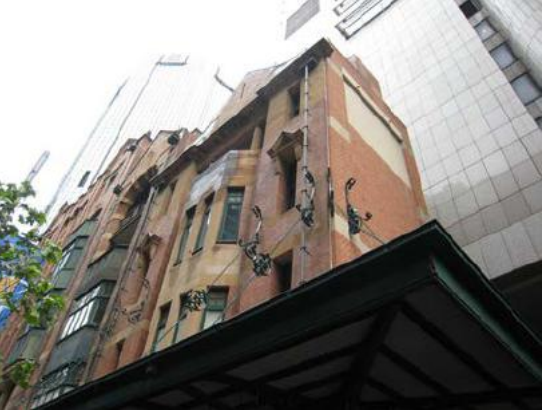
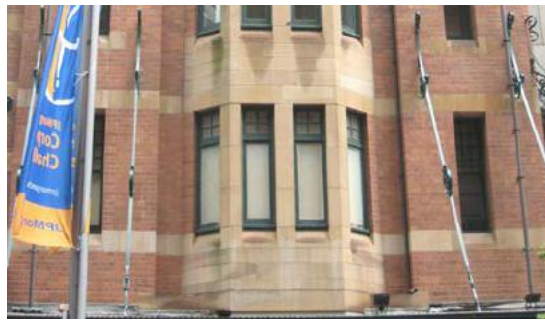
The façade features a central sandstone projecting bay to the first (pictured) and second floors, flanked by narrow windows. All windows are timber framed and multi-paned. The bay windows have been blocked out to ensure privacy to the first floor bathroom and WC facilities. Some evidence of general wear to the sandstone including spalling to the first floor bay, adjacent to the awning.

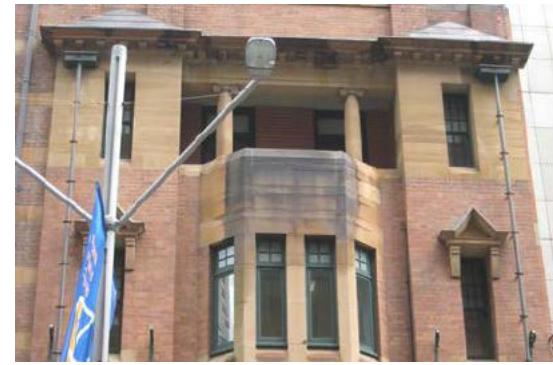
The third floor balcony takes the form of a recessed loggia flanked by sandstone ionic columns⁶⁵ with dentilled cornice over. There is some severe discolouration to the balcony sandstone which potentially suggests some form of fungus. It may be speculated that a waterproofing treatment has been used on the stone, which has had a converse effect of trapping water within the stone.

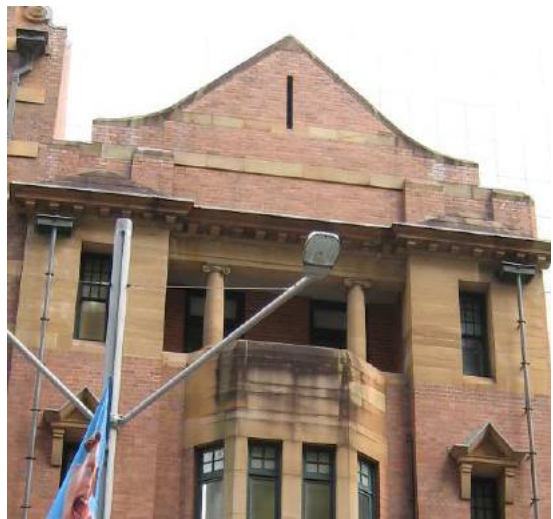
The curved sandstone parapet is typical of the style of W.L Vernon and unites the façade elements into an elegant composition.⁶⁶ Repairs were made to the sandstone and brick work of the northern gable though the exact location and nature of the repairs cannot be determined from a streetscape analysis.

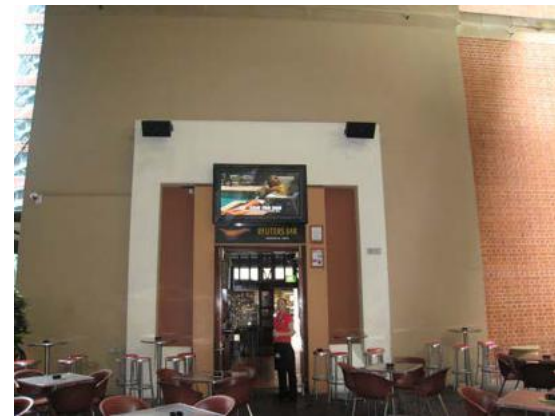
The rear incorporates a small two storey addition, extending the bar area and providing additional store and office areas on the first floor built as part of the 1991 fit-out. The element is rendered and painted with minimal detailing including the sandstone cornice. The element also allowed for the addition of services.

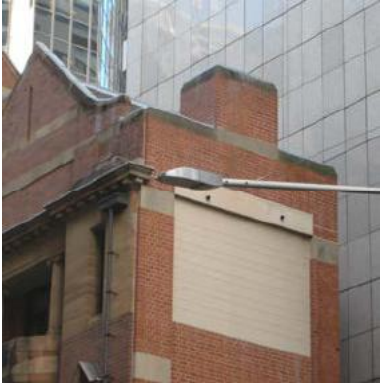
<p>The chimney type element is new (probably contemporary to the 1991 fit out). Original plans and photos (refer figures 34-43) show that the Hotel did feature a chimney in this location however this element was removed before the demolition works.</p>

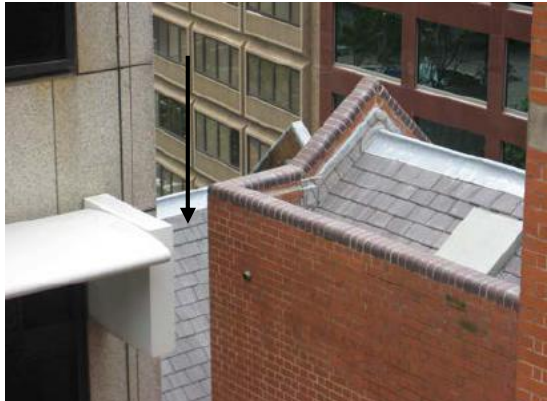
<p>Partial view of The Brooklyn Hotel roof (indicated) clad in Penrhyn slate (as are the Commercial and Johnson's buildings). The roof was restored as part of the 1991 refurbishment works and retains the pitch and form of the original roof.</p>

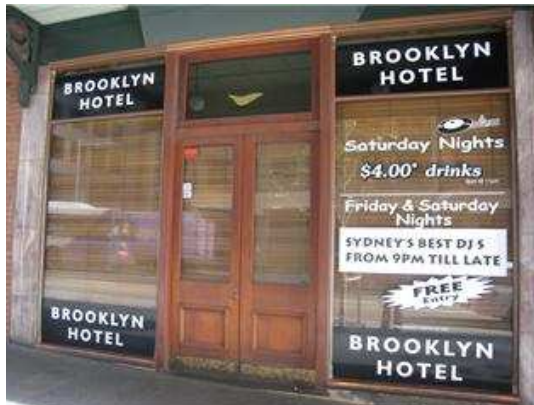
<p>The ground floor façade was refurbished and modified as part of the 1991 DA works and features a central timber double entrance door, flanked by full height glazed window panels with marble cladding to the brickwork at either side of the shopfront. The shopfront glazing is framed in copper, matching the shopfront facade of the refurbished Johnson's building, neighbouring the site to the south.</p>

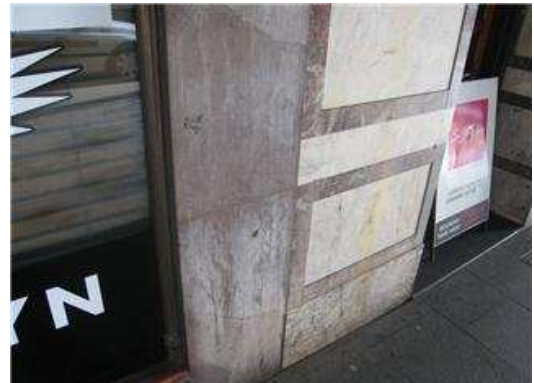
<p>Detail of the pink marble facade cladding (shown adjacent to the Brooklyn Hotel). Condition is generally good. New fabric (1991 refurbishment and fit-out) but consistent with the marble cladding on the Brooklyn Hotel façade.</p>

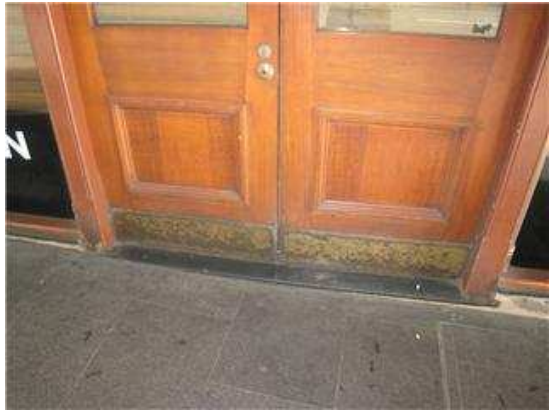
<p>The timber double doors and sandstone threshold date to the 1991 fit-out.</p>

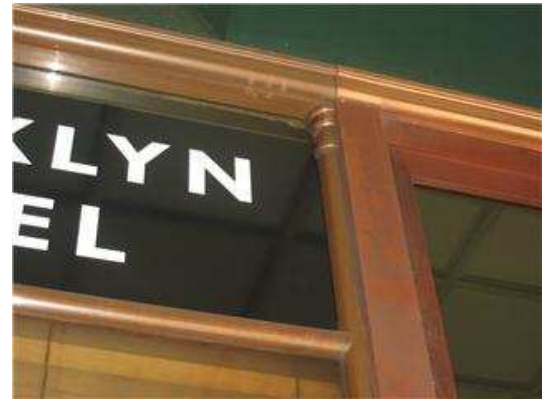
<p>Detail of the copper framing to the glazed shopfront windows. Although dating to the 1991 fit-out, the fabric is appropriate to the period of the facade and conforms to the restoration of the neighbouring Johnson's building.</p>

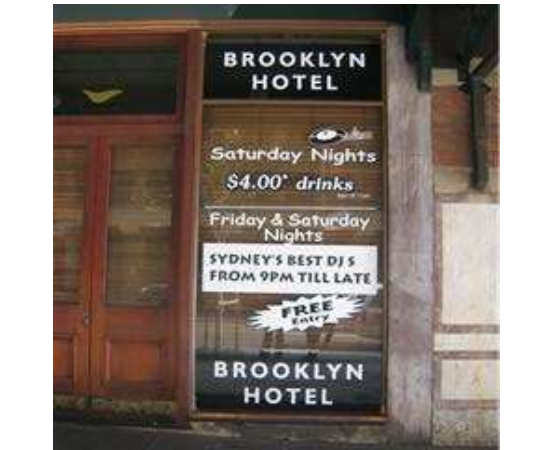
<p>All glazing is contemporary to the 1991 or subsequent fit-outs. Glazing largely covered by contemporary signage in association with the hotel use.</p>
 	<p>The awning is new fabric, reconstructed as close to the original as possible as part of the 1991 restoration works (although no measured drawings were available). The element incorporates a classical medallion, following the form of medallions used on the Johnson's building facade. Under awning lighting is contemporary though appropriate to the period of the facade. Arup Façade Engineering undertook further extensive restorative works to the awning in 2003. Some corrosion to the support brackets is evident.</p>

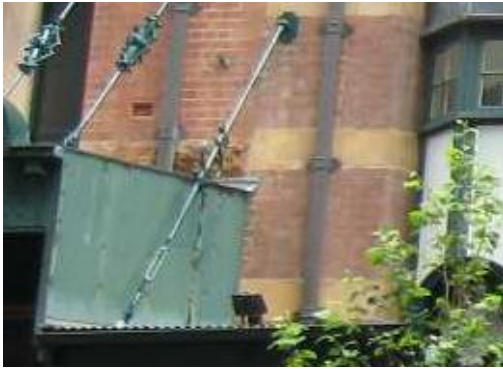
<p>Detail of one of the tie rods on the Commercial Building east elevation. These were restored by Arup Façade Engineering in 2003.</p>

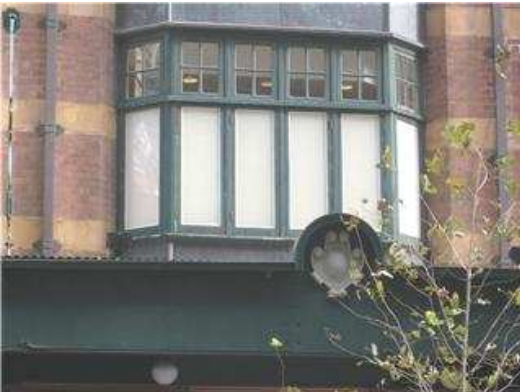
<p>The façade features a central projecting window bay to the first (pictured) and second floors. Windows are timber framed and multi-paned and the bay is clad in metal, probably copper sheeting. On the first floor, the bay window is obscured by the mirrors installed in the hotel WC facilities.</p>

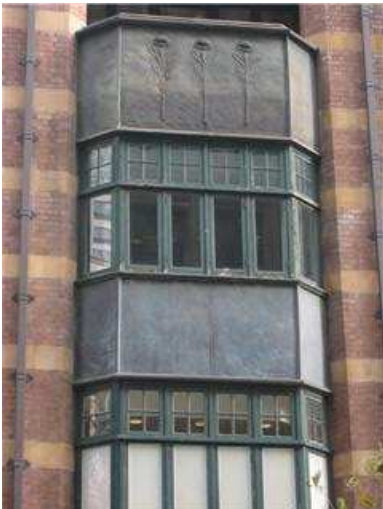
<p>View of the second and (part) third floor bays, showing the embossed triple waratah pattern to the copper cladding on the third floor balcony. Some general corrosion and wear is evident.</p>

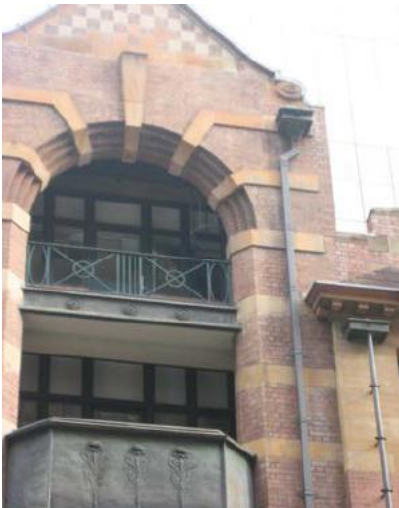
<p>The fourth floor balcony takes the form of a recessed loggia incorporating a simple painted iron balustrade. The façade is dominated by the surmounting arch featuring variegated sandstone and red brick voussoirs.</p> <p>The original third floor balcony window enclosure has been lost (likely in association with the 1991 renovations).</p> <p>Rainwater heads have been restored in copper, and are consistent with the period of the façade.</p>

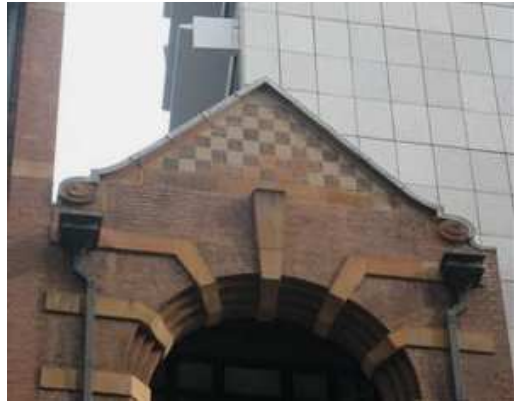
<p>The curved form of the gable follows the form of the neighbouring Brooklyn Hotel building and is characteristic of Vernon. The chequerboard pattern of sandstone and redbrick within the gable ties in the dual materials used in the facade while the terminating spirals are typically Art Nouveau.</p>

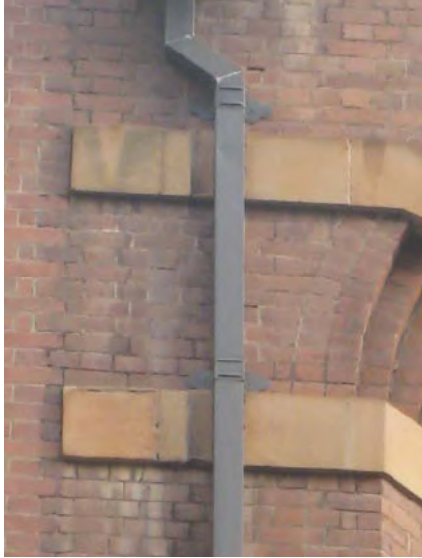
<p>Repairs were made to the sandstone and brick work of the eastern elevation though the exact location and nature of the repairs cannot be confirmed from a streetscape analysis.</p> <p>There is some evidence of repointing/ loss of mortar at the upper level, adjacent to the arch which suggests overflowing or leaking rainwater heads.</p>

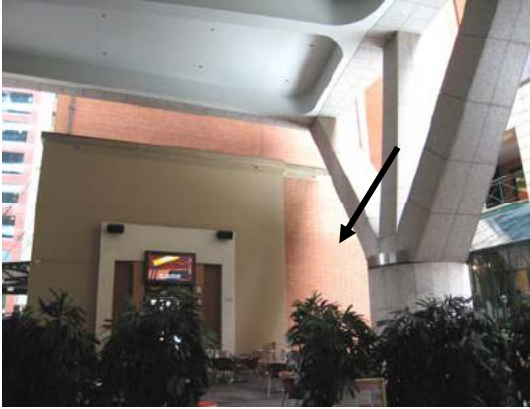
<p>The rear elevation was rebuilt in bonded brick to closely match the colour of the original façade brickwork and incorporates a small two storey addition. No rear access to the Commercial Building is provided within the footprint of the remaining building. The image shows the rear elevation behind the Grosvenor tower pillar adjacent to the Brooklyn Hotel rear entry.</p> <p>Again the copper rainwater heads have been designed matching the period of the building and following the original design.</p>

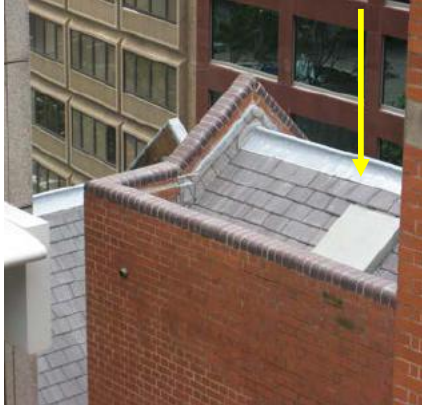
<p>Partial view of the Commercial Building roof (indicated) clad in Penrhyn slate (as are the Brooklyn and Johnson's buildings). The roof was restored as part of the 1991 refurbishment works and retains the pitch and form of the original roof.</p>

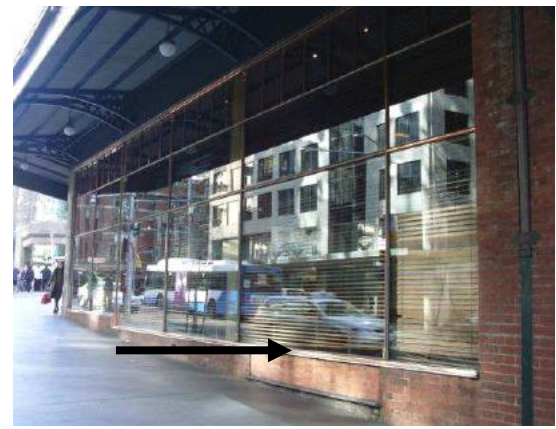
<p>The ground floor red brick shopfront has been refurbished and features full height copper framed windows. A partial view of the Johnson's elevation is shown on the early plans for the neighbouring Commercial Building and it appears that the refurbishment is consistent with the original, with the exception of the deleted George Street entry, the location of which is indicated by the infilled brickwork at the base of the shopfront (indicated on photo).</p> <p>The remainder of the windows were reconstructed either with original fabric or new fabric matching the existing.</p>

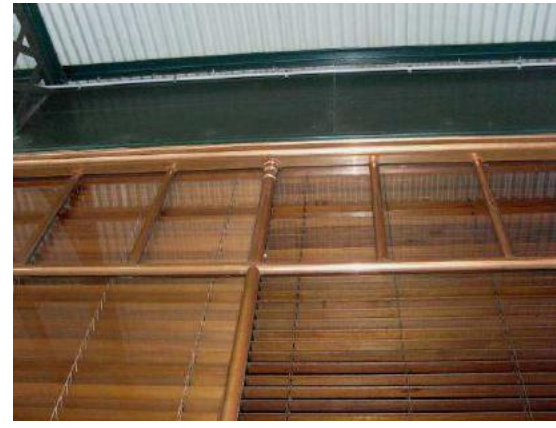
<p>View of the George Street elevation shopfront window framing. Timber Venetian blinds obscure views of the interiors.</p>

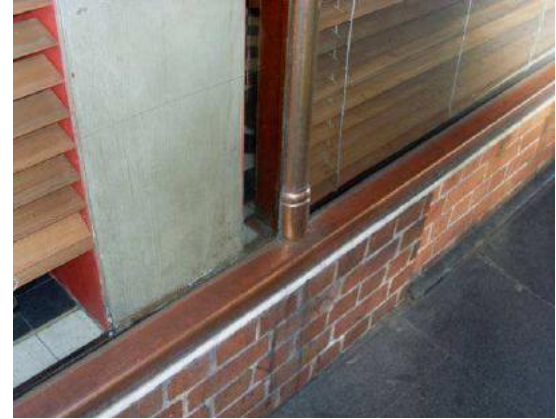
<p>View of the copper window framing, showing a section of internal walling (not original) and the infilled brickwork at right.</p>

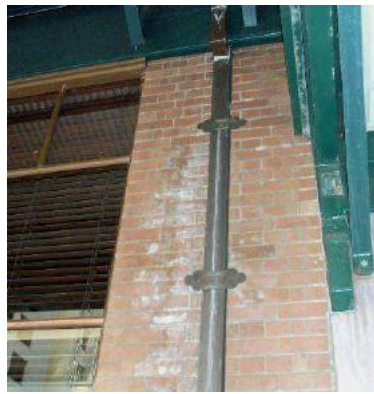
There is some evidence of minor water damage to brickwork and some down pipes have been replaced.

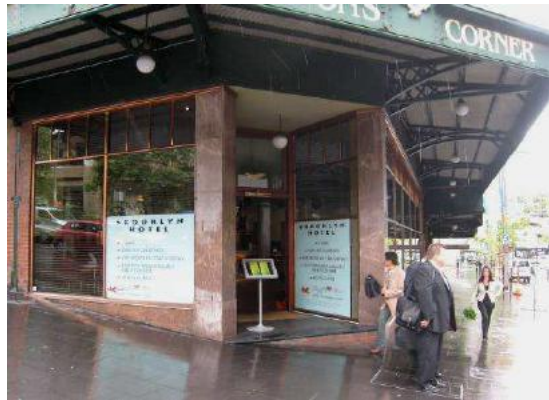
Splayed corner shopfront. This element has also been refurbished, incorporating the same full height copper framed window bays. It is understood that during the restoration works, these windows were restored using the original components already in place, with fabric cannibalised from the George Street window bay where required. The shopfront was also carefully reconstructed.

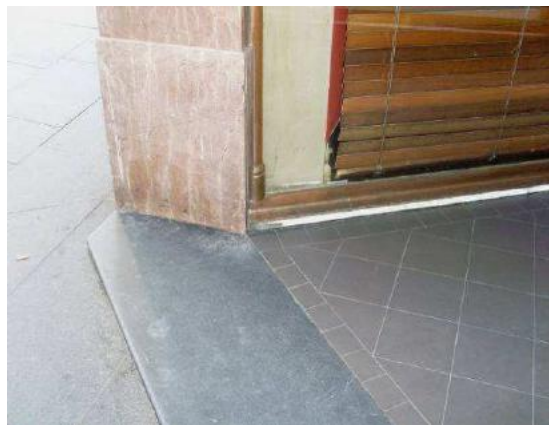
Detail of the pink marble façade cladding, flanking the entry and the contemporary floor tiling. The marble cladding is comparable to that used on the refurbished Commercial Building façade but was probably based on or reconstructed from original fabric based on the brief of works for the restoration of the shopfront entry.

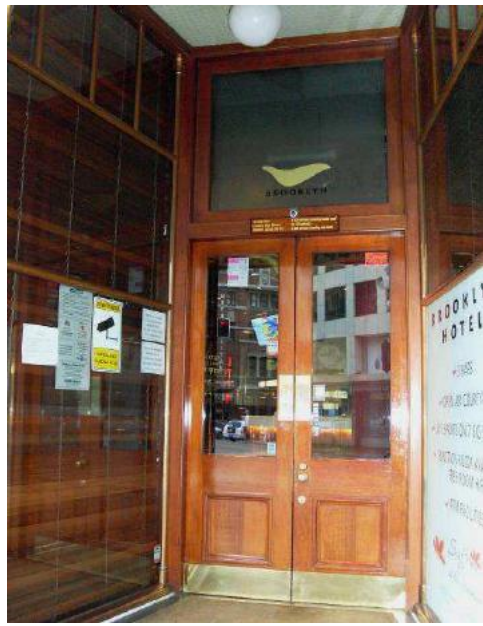
Timber French doors with new glazing. The brief for the facades in the refurbishment works was to retain doors where possible, or restore/ replace in a manner consistent with the original, these were noted as restored in the DA documentation.

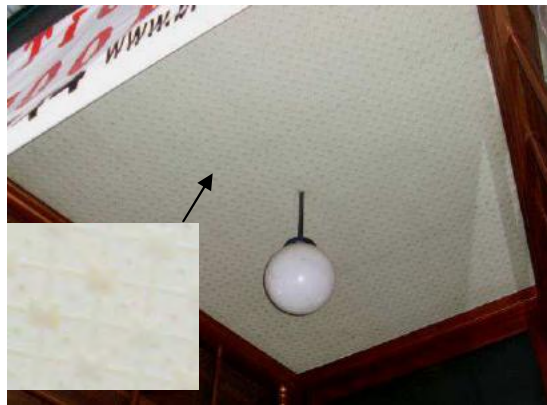
View of the splayed entry foyer ceiling with inset detail of the ceiling fabric. This is probably new fabric, but is consistent with the period and façade of the building.
