JOHNSONS CORNER

229-235 GEORGE STREET, THE ROCKS

CONSERVATION MANAGEMENT PLAN

June 2012

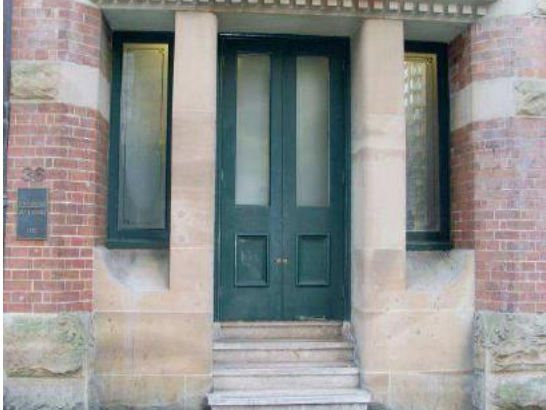
<p>View of the original commercial entry, showing the terrazzo stair and French doors flanked by sandstone pilasters and narrow timber framed windows. The small awning ledge is finished with a sandstone dentilled trim and either side of entry the sandstone courses are finished with a carved leaf pattern.</p>

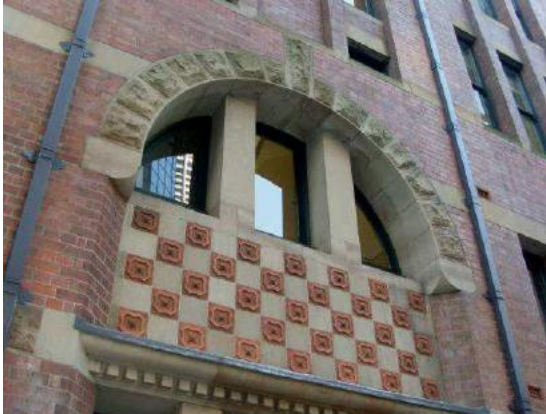
<p>Detail of the sandstone and terracotta chequerboard motif with arched sandstone window bay, over the commercial entry.</p> <p>The 1983 SCRA Conservation plan suggests that the chequerboard element may at one time have been painted⁶⁷ (though not originally) however there is no evidence of this from the street. The sandstone voussoirs are noted as discoloured.</p>

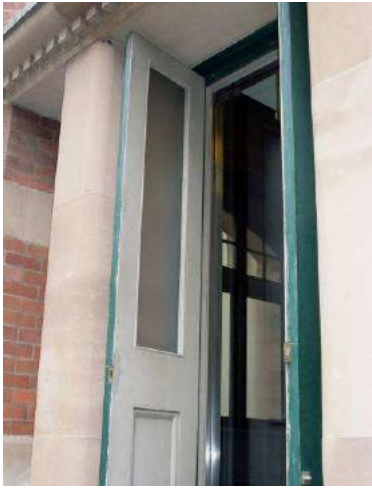
<p>View of the French doors, with contemporary glazed door behind. The 1983 SCRA Conservation plan suggests that the doors had been amended; certainly the door furniture is contemporary as is the glazing⁶⁸.</p> <p>As noted above, the brief for the facades was to retain doors where possible, or restore in a manner consistent with the original. Inspection of fabric suggests that the doors are early if not original.</p>

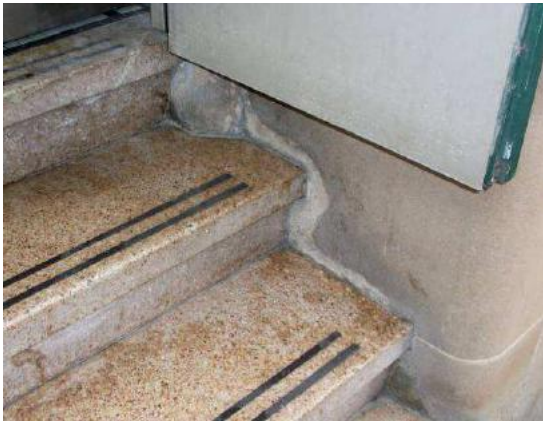
<p>Detail of terrazzo stair to commercial entrance vestibule.</p> <p>The 1983 SCRA Conservation Plan indicates that the stair is not original however it does correspond with the internal stair fabric within the lift lobby⁶⁹.</p>

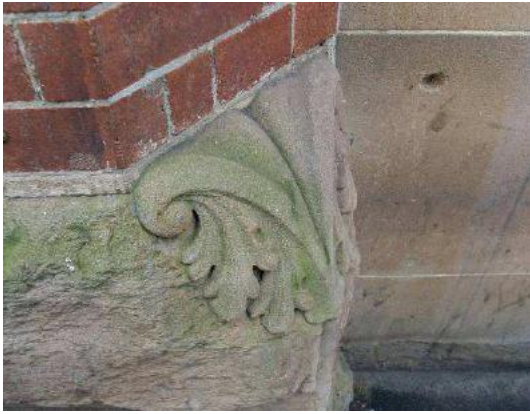
<p>One of the carved sandstone leaf motifs flanking the Commercial Building entry.</p> <p>The sandstone is discoloured and may be associated with water run off from copper façade features but is likely a form of algal growth.</p>

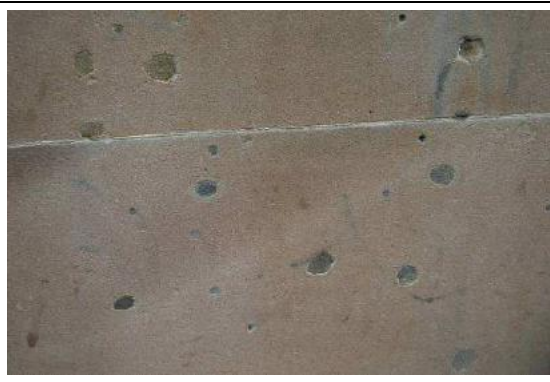
<p>Evidence of filled intrusions to sandstone (probably in association with signage).</p> <p>NB: This section of stone is located to the right of the commercial entry.</p>

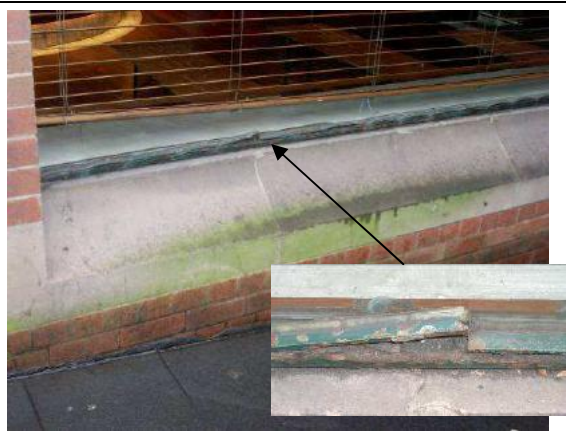
<p>The southern elevation features two arched window bays, finished with sandstone voussoirs and sills. In contrast to the upper floor windows, these windows are metal framed. The metal work on both windows is buckling. (Refer inset picture.)</p> <p>The sandstone on the window arches and sills on the ground and first floor are also noted as discoloured.</p>

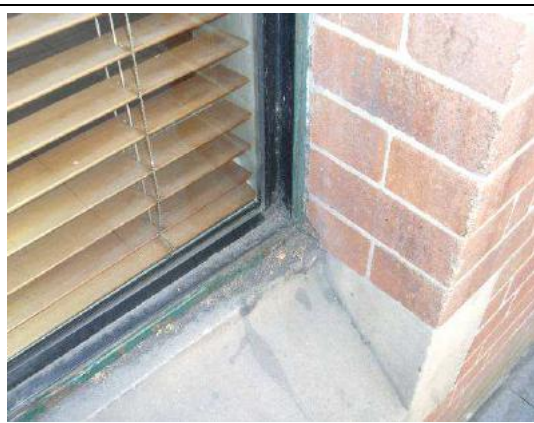
<p>Detail of the western window sill (southern/Grosvenor elevation) with contemporary black probably aluminium frame reinforcing the original metal frame.</p>

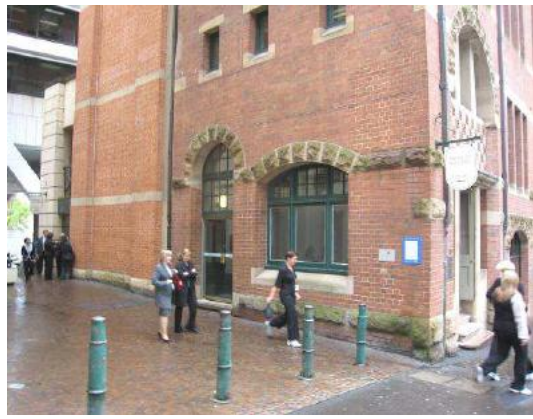
The ground floor of the western elevation incorporates a fire egress, the door extended from a window in the original section of the building, as well as a secondary entry to the lift lobby at the rear, in the contemporary tower addition.

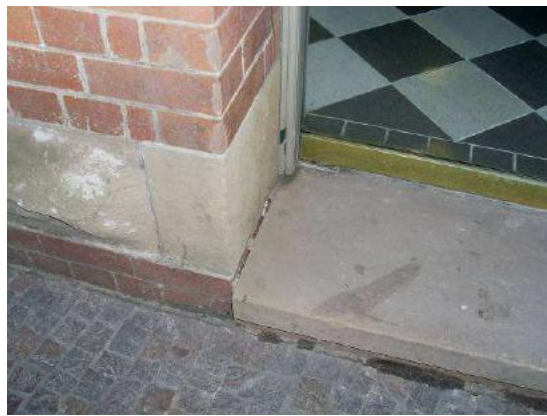
Detail of the new threshold and cut sandstone in the altered fire egress.

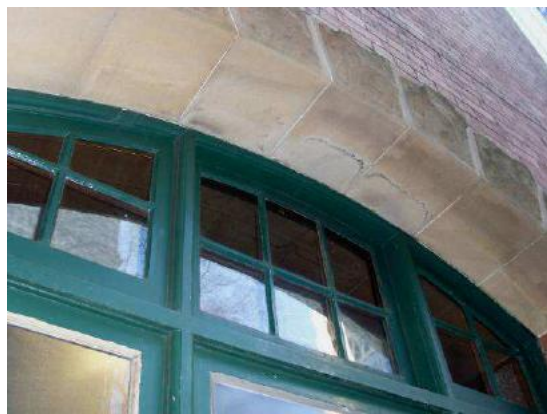
The arched window bay is timber framed and a semitransparent film has been added to the glazing, obscuring views to the lobby. The sandstone voussoirs appear in generally good condition and some discolouration of the sills is evident.

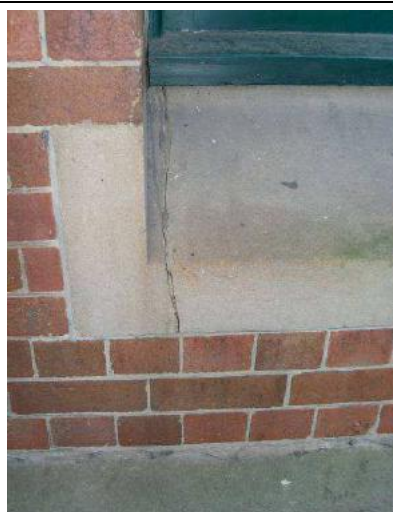
The sandstone sill to the west elevation ground floor window has cracked and repaired, and there is also evidence of minor cracking to brickwork below the window bay. Some repointing is evident.

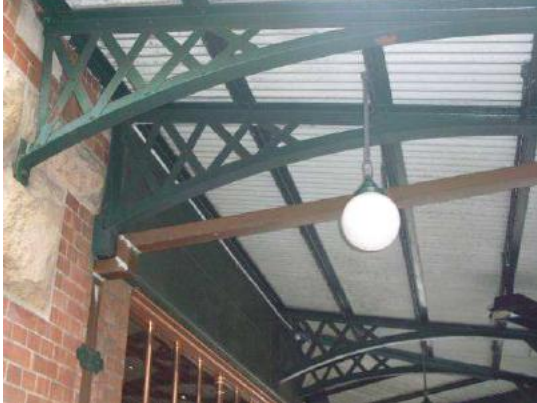
<p>View of the awning showing contemporary lighting and corrugated sheeting, as well as new/ modified down pipes.</p>

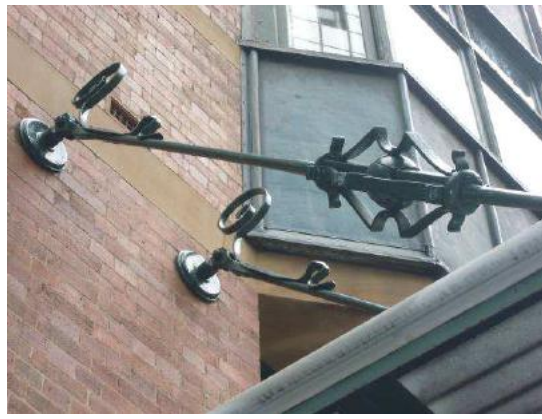
Detail of one of the tie-rods, as viewed from Grosvenor Street.

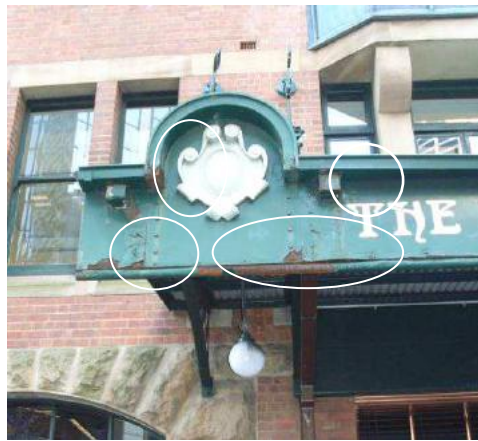
There is evidence of some corrosion to the awning, particularly the fascia, which should be treated and repainted (see indicated areas.)
The first image of the awning is from the Grosvenor Street frontage, the second; the George Street frontage.

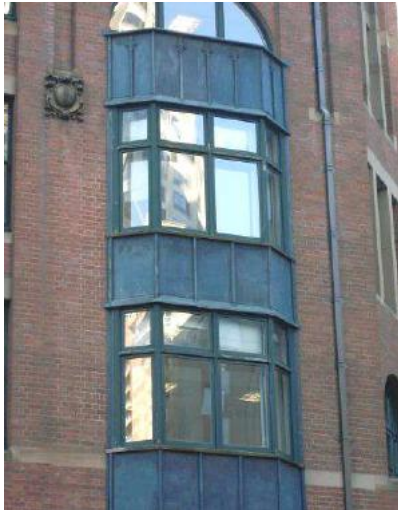
<p>View of the two storey window bay with arched window over. The windows are timber framed, although the bay is clad in copper sheeting. The sheeting is further articulated into sections, which contributes to the vertical character of the façade.</p> <p>Glazing in the northernmost window bay on the George Street elevation has been modified in association with internal uses, as WC and kitchenette facilities have been introduced to this section of the building.</p> <p>(NB: The detail is from the Grosvenor Street elevation).</p>

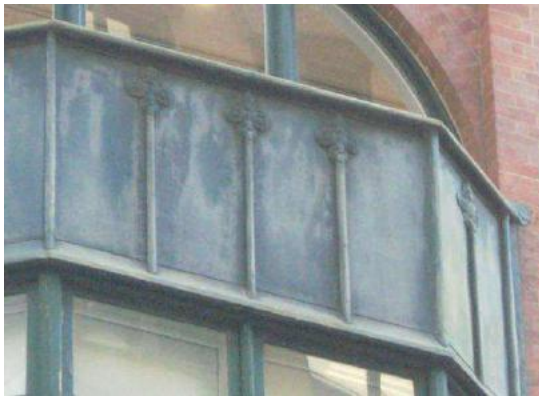
<p>Detail of the oriel window cladding, which appears to be a stylised floral motif, a form of fleur-de-lys.</p>

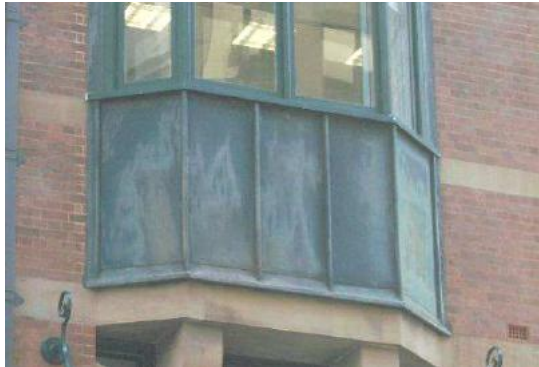
<p>Detail of one of the George Street elevation bays showing the patina of the aged copper cladding</p>

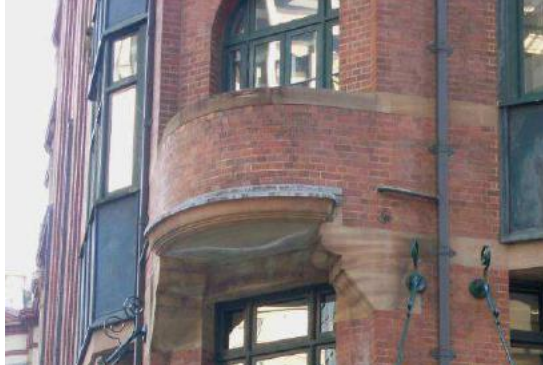
<p>Balcony detail. There are signs of water damage or cracking to the masonry of the underside of the element, which should be assessed.</p>

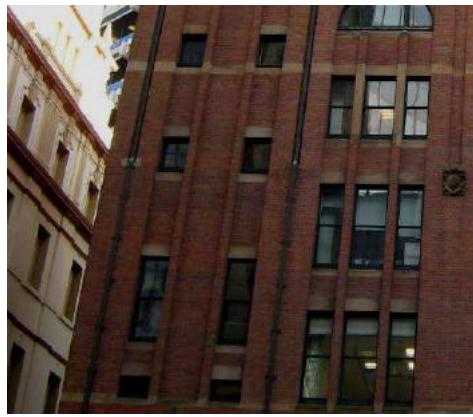
The original stair and lift well is located in the south western corner of the site, and the tower typically features smaller windows, offset from the position of the other façade windows, reflecting their location in the stair well landings between the floor levels (refer also to the western elevation view below).

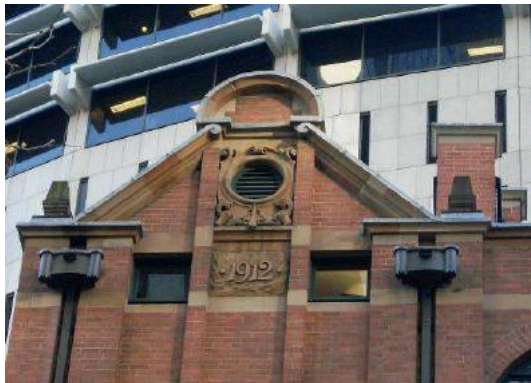
Westernmost gable with semi-circular pediment detail (Grosvenor street elevation). This is the only pediment of this style (with all others being a simplified triangular gable) and responds to the more embellished pediments on the neighbouring Royal Naval House, which have a Dutch flavour. The element incorporates a sandstone plaque, marking the date of the buildings construction, in 1912.

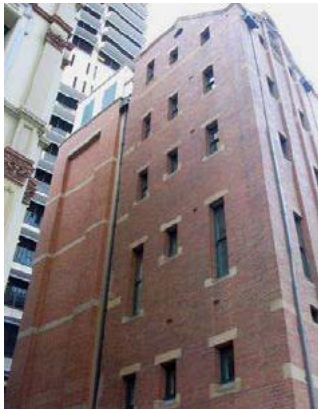
View of the western elevation showing the return of the stair and lift well at the southwest corner of the site, and the adjoining contemporary addition which houses the new lift well. The contemporary element is constructed in bonded brick and is further articulated by sandstone courses that delineate the floor levels. The lift motor room is also shown over the contemporary tower.

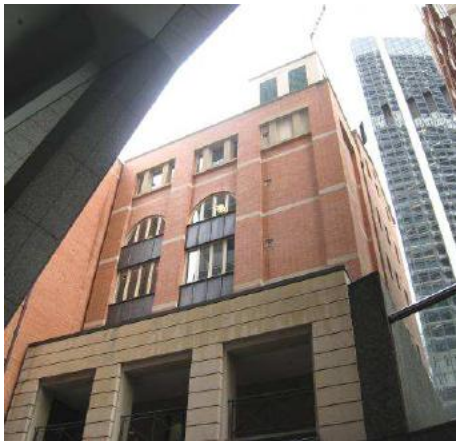
View of the contemporary northern elevation, showing the traditionally proportioned window openings. Comparable materials have been employed, including sandstone courses and sills, and copper cladding to the arched window bays.

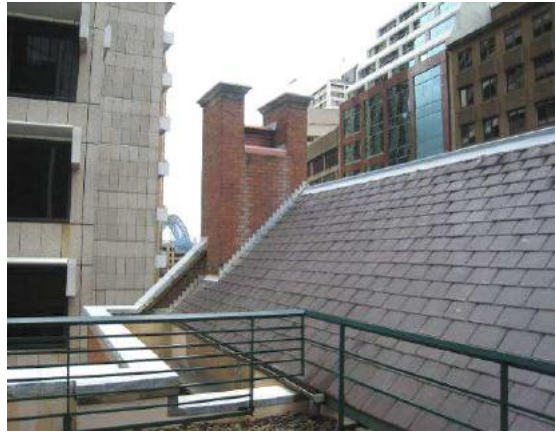
<p>View north, showing a section of the Grosvenor Tower at left and the hipped roof (with chimney) overlooking George Street. The Harbour Bridge is shown in the distant view.</p>

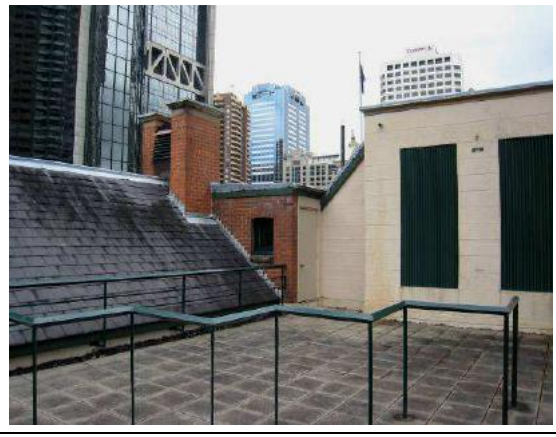
<p>Roof view showing the chimney and original roof access, with contemporary lift motor room/ services shown at right.</p>

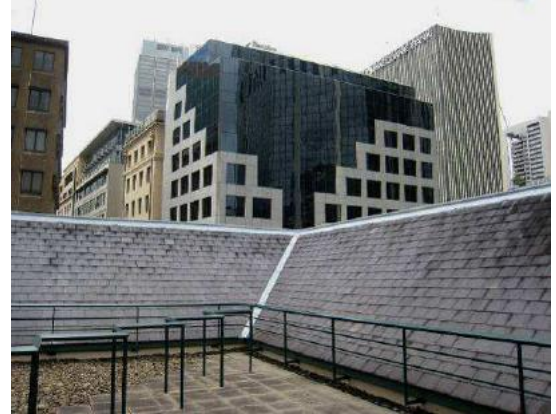
<p>The hipped roof is clad in Penryhn slate (as are the roofs of the Commercial and Brooklyn Hotel buildings). The roof was restored as part of the 1991 refurbishment works and retains the pitch and form of the original roof.</p>

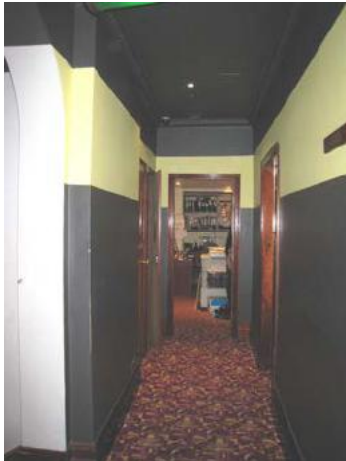
View north along the main hall to office. Walls are masonry, painted charcoal and yellow. Overall the fabric of the first floor is simpler than the ground floor public areas, although there are stylistic elements in common, specifically the joinery including timber skirtings, doors and unpainted door frames as well as the egg and dart ceiling cornice. Ceiling is plain plaster board sheeting. Hall and office areas are carpeted.

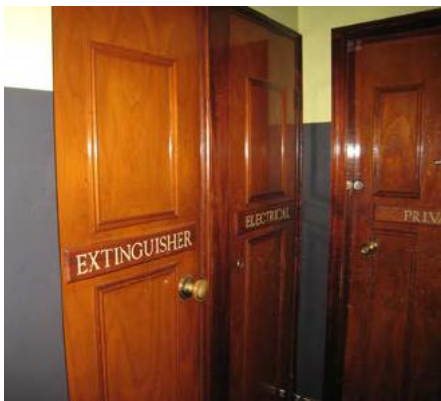
Detail of timber doors to fire extinguisher and electrical services. The office door is partially shown at right. The timber is unpainted, stained in high gloss sheen.

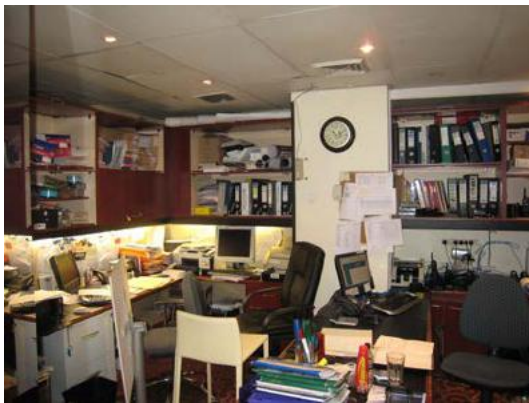
Unremarkable contemporary fit out, with low level suspended sheet ceiling. The projecting section on the north wall (where the clock is mounted) provides for services including the bar exhaust duct.

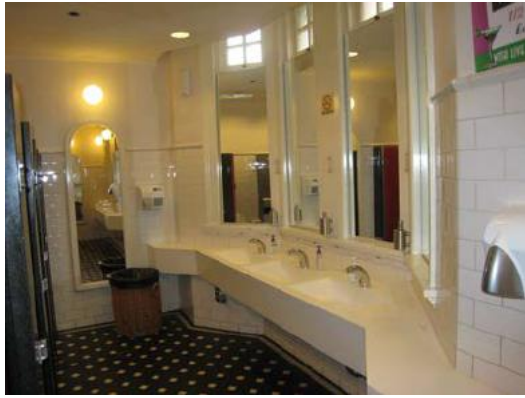
<p>Women's WC facility within the front room of the former Brooklyn Hotel bar. The windows have been enclosed and fitted with mirrors with glazing intact behind. Ceiling has been lowered, (probably to accommodate services) but is setback to allow full visibility of the windows. Flooring is tiled. The bathroom and all internal fabric was constructed as part of the 1991 fit out.</p>

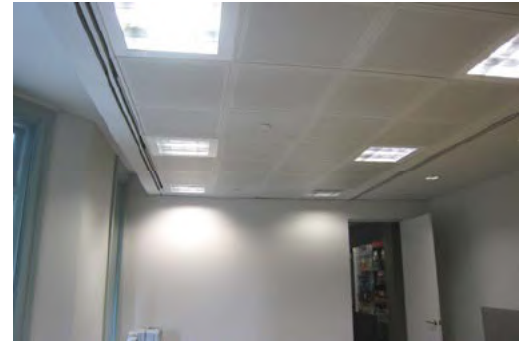
<p>The area within the footprint of the former Brooklyn Hotel is used by the tenants as a Boardroom. The space has been fit out in accordance with the tenant requirements and the bulk of the fabric is new. The ceiling has been lowered to accommodate services, partitions; floor and wall coverings and colours are determined by the tenancy. The partition between the Commercial and Brooklyn buildings does not correspond with the original party wall.</p>

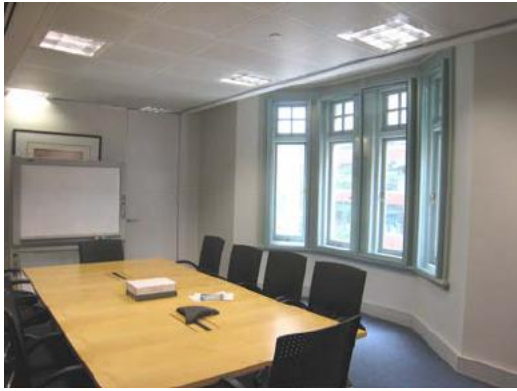
<p>The original window bay has been retained, with additional glazing installed for soundproofing.</p>

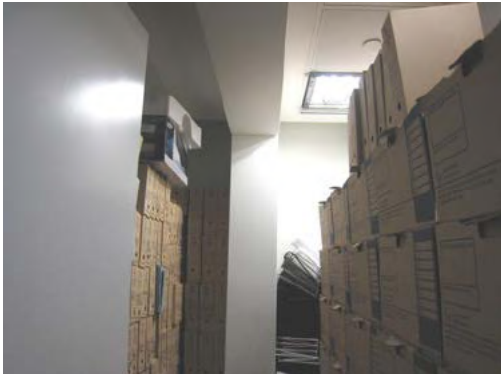
<p>Wall nib and bulkhead within the storage area, between the Commercial and Brooklyn buildings. As discussed above in relation to the retention of nibs on the ground floor, the retention of party walling was not required by the DA approval and it is unlikely that this section of walling is original⁷³. The element has relevance however as it provides for the interpretation of the original spaces.</p>

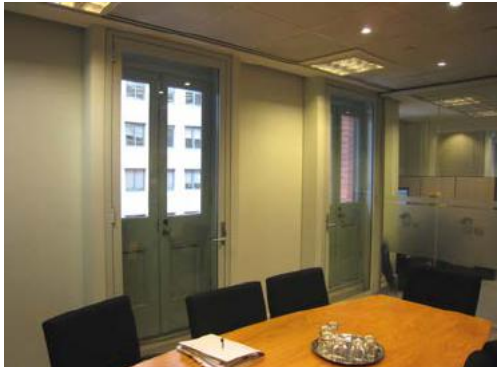
<p>As with the level 3 tenancy the area within the footprint of the former Brooklyn Hotel is used by the tenants largely as a Boardroom. Again, the fit-out and partitioning is contemporary and does not strictly correspond with the original party walling. Partitions are glazed. Paint colour scheme and floor coverings (carpeting) determined by the tenancy.</p>
---	--

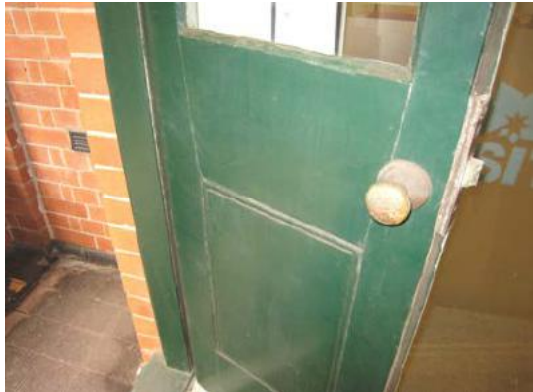
<p>Balcony accessed via two sets of timber double doors. General wear noted, along with corrosion to door furniture. Probably early or original fabric. Painted green, probably as part of the 1991 restoration works. (As previously noted, the paint palette for doors and windows was based on scrapings of the original and developed in consultation with The Foreshore Authority).</p>

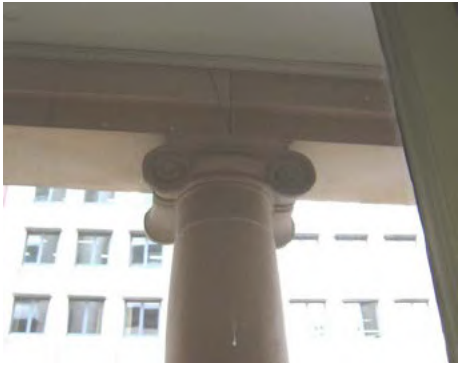
<p>Detail of the Ionic column capping (viewed through the glazing). Condition generally good.</p>

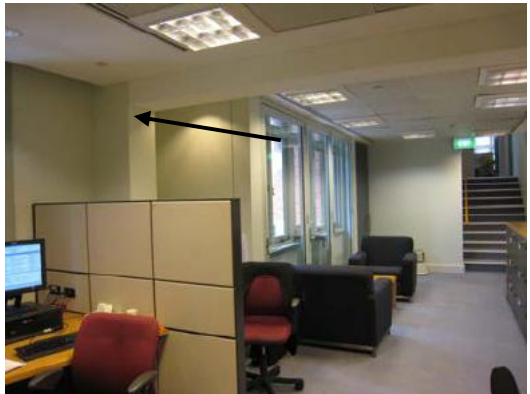
<p>The upper level interior between the Infill and Brooklyn buildings is more open plan in comparison with the lower levels; however a wall nib and bulk head (indicated) have been retained to interpret the original party wall. Again it is unlikely that the element, in particular the bulk head, is original.</p>

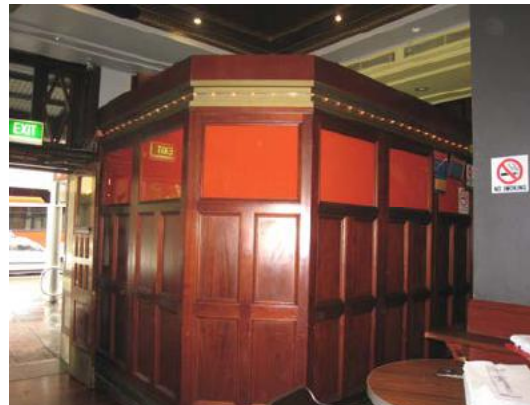
<p>The ground floor of the Commercial Building incorporates the stair access to the first floor (dating to the 1991 fit-out) and the games room which was added more recently, as part of 2003 DA works by Nicholas Dunn Architects.</p> <p>View of the timber clad gaming area from the Brooklyn Bar. Part of the gaming area is within the footprint of the original Brooklyn building and cladding for the gaming area matches the half timbered wall cladding in the bar area.</p>

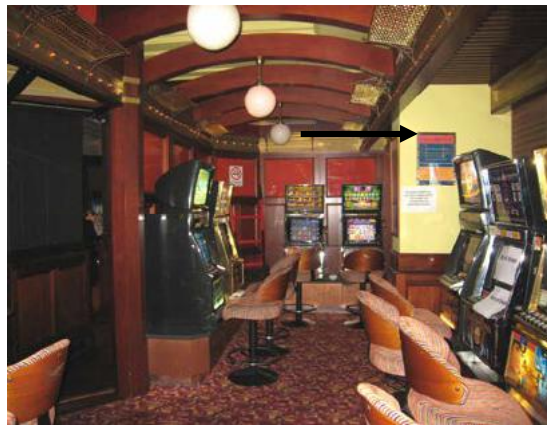
Within the gaming room, a wall nib has been retained, interpreting the location of the original party wall between the Brooklyn and Commercial Building on the ground floor. Correspondence between the then SCRA and Grosvenor Place Pty Ltd has indicated that the retention of party walling was not required by the DA approval and this section of walling may not be original⁷⁴. All carpeting and finishes within the games room are contemporary, probably having been refurbished since the 1991 fit-out.

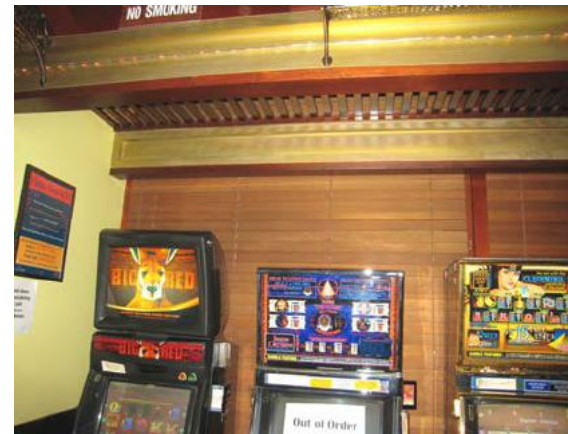
View of the timber framed shopfront glazing. The timber blinds obscure views from the street and the entry is disused.

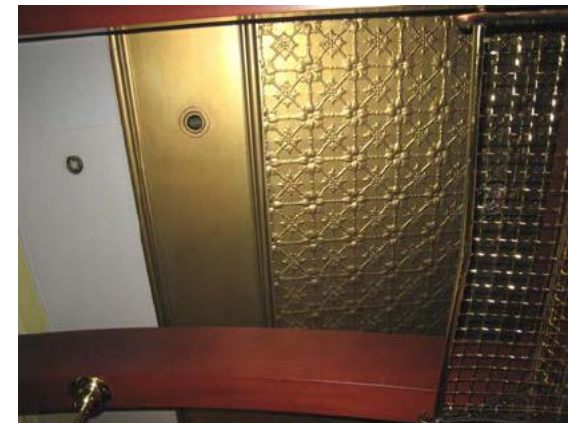
Ceilings are inset pressed metal in period floral design, with egg and dart cornice and fixed ceiling lighting. Gold/ green in colour. Ceiling fabric is common throughout the ground floor bar area across the three sites.

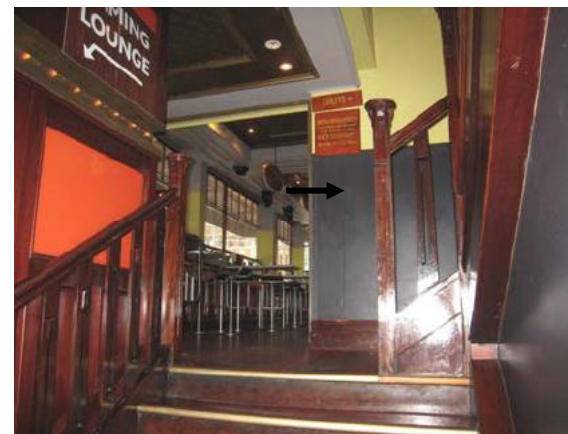
View south to the Johnson's building. The stair compensates for the difference in floor levels between the sites. The arrow indicates the party wall between the two buildings.

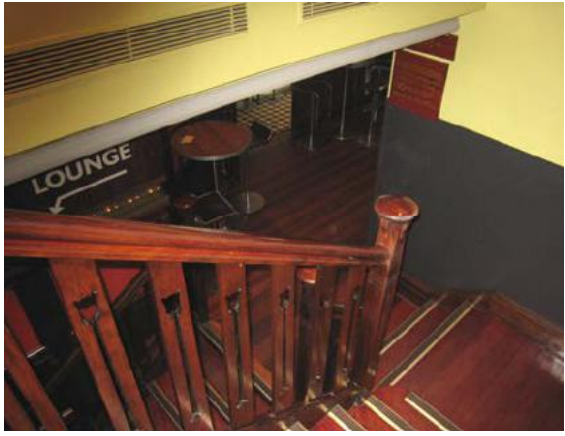
A photograph showing a wooden staircase with a dark wood handrail and balustrade. The stairs lead up to a lounge area with a sign that says "LOUNGE". The walls are painted yellow and dark grey.	<p>Timber stair to first floor office and WC facilities. The upper floor area of the Commercial Building incorporates only a section of the hall and the men's WC facilities.</p> <p>It should be noted that the stair has been designed to compliment the Edwardian character of the building but does not reflect or interpret original fabric.</p>
<p>First Floor (Brooklyn Hotel staff office/ services and public amenities area)</p>

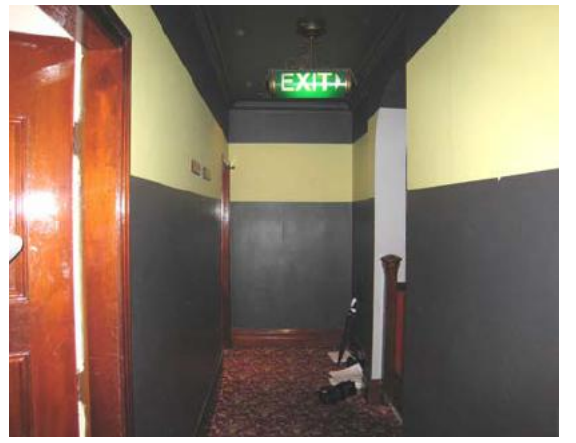
A photograph of a hallway with yellow walls and dark grey wainscoting. A green "EXIT" sign is visible at the end of the hallway. A wooden door is on the left, and a staircase is on the right.	<p>Hall view south (from the Brooklyn building) showing the stair at right and entry to men's WC at the far left of the corridor. The interior finishes including carpeting, render and paint scheme are contemporary, probably having been refurbished since the 1991 fit-out.</p>

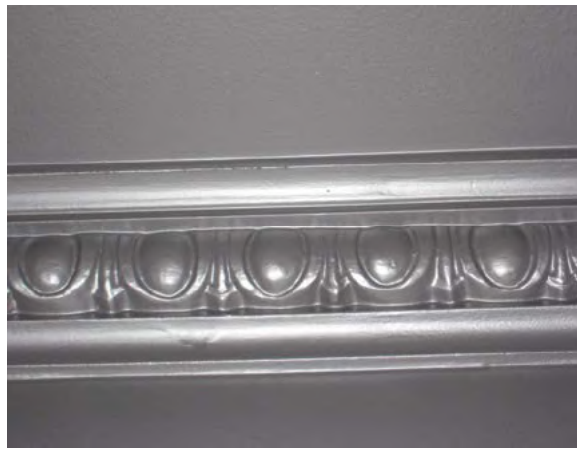
Detail of the egg and dart cornice. New fabric but sympathetic to the Edwardian character of the facade and interior.

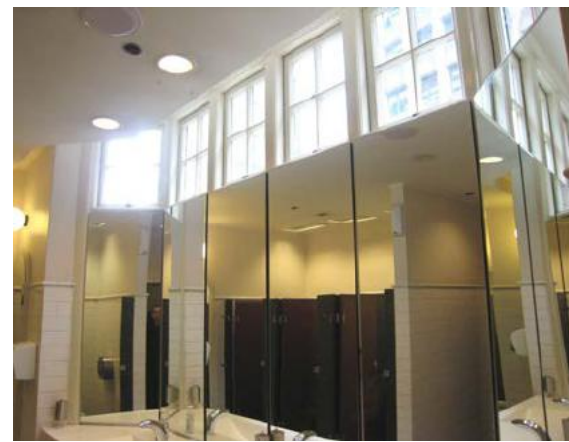
The windows have been enclosed and fitted with mirrors with glazing intact behind. Ceiling has been lowered, (probably to accommodate services) but is set back to allow full visibility of the windows. Flooring is tiled.

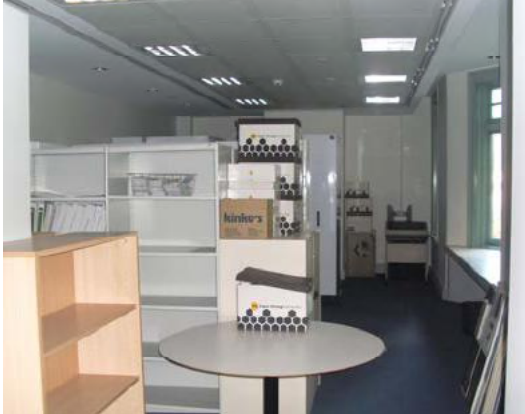
<p>The area within the footprint of the former Commercial Building is currently being used by the tenants as storage/ office area. The space has been fitted out in accordance with the tenant requirements and the bulk of the fabric is new. The ceiling has been lowered to accommodate services, partitions, floor and wall coverings and colours are determined by the tenancy. View north from the Commercial Building to the former Brooklyn Hotel.</p>

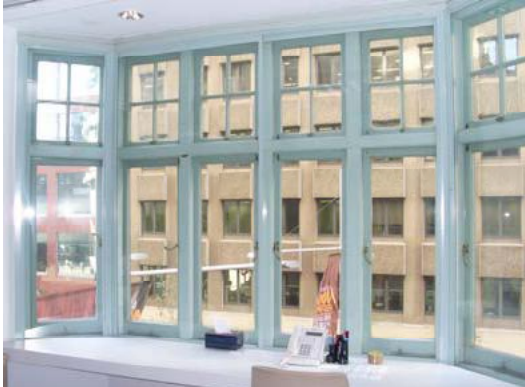
<p>The original window bay has been retained, with additional glazing installed for soundproofing. Desk joinery is new.</p>

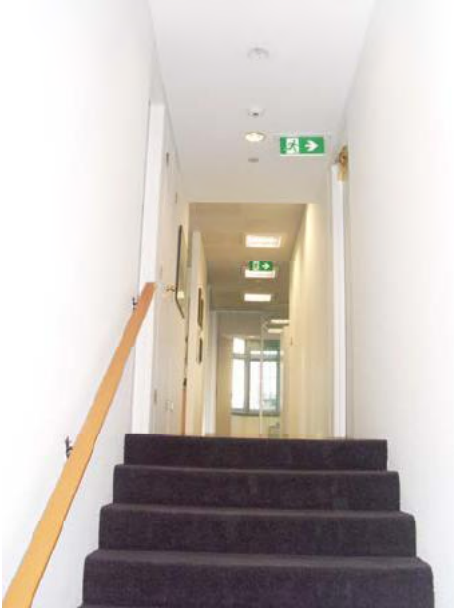
<p>The Brooklyn Hotel and Commercial Building areas have a lower floor level than the Johnson's building and the area is accessed via stairs.</p>
---	---

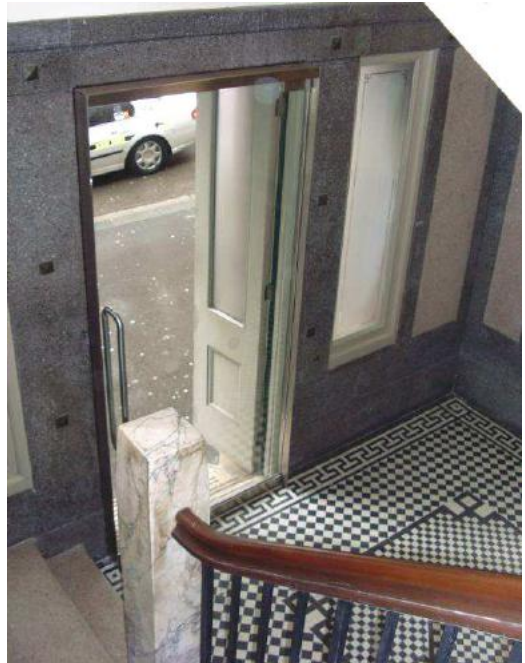
<p>View of the vestibule from the stair. The space features black and white geometric floor tiling with $\frac{3}{4}$ height terrazzo wall cladding. The stair is also marble, with timber and wrought iron balustrade.</p>

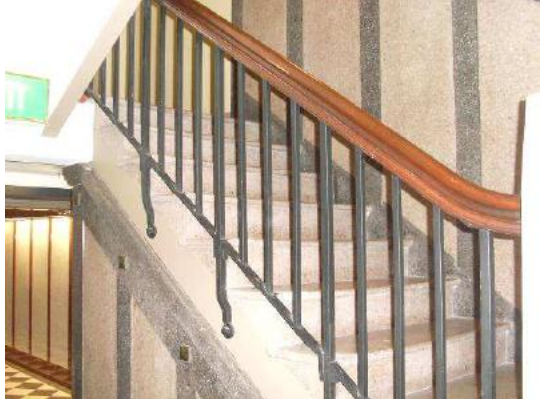
<p>Detail of the balustrade and marble wall cladding, which continues to the first floor stair landing. The contemporary lift lobby is partially visible at left.</p>

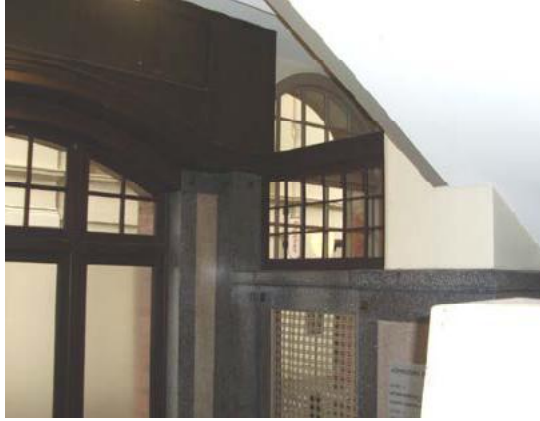
<p>View of the terrazzo wall partitioning and timber cladding over arched window bay.</p>

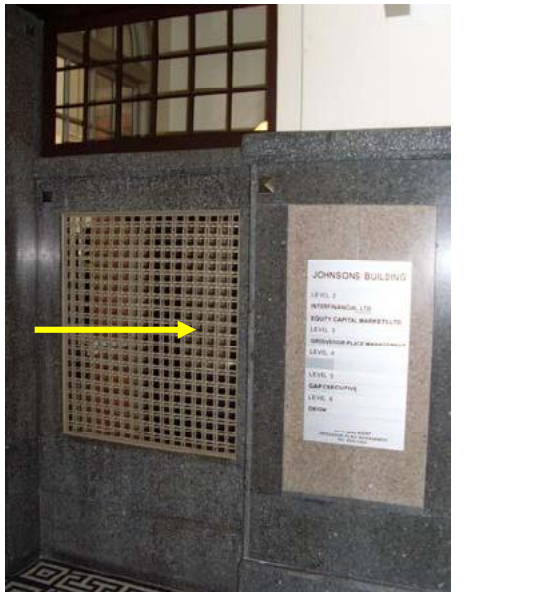
<p>North wall of the original vestibule with contemporary tenancy signage. The original lift was located behind the metal grill indicated.</p>

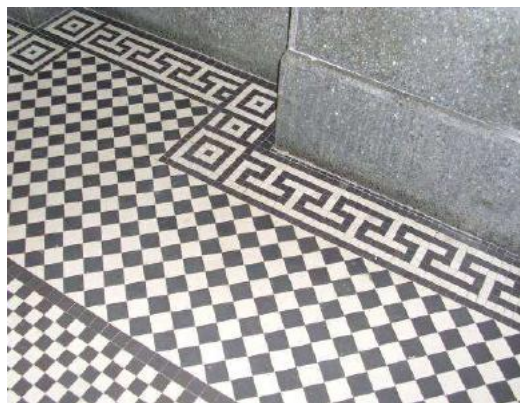
Detail of the classical geometric floor tiling.

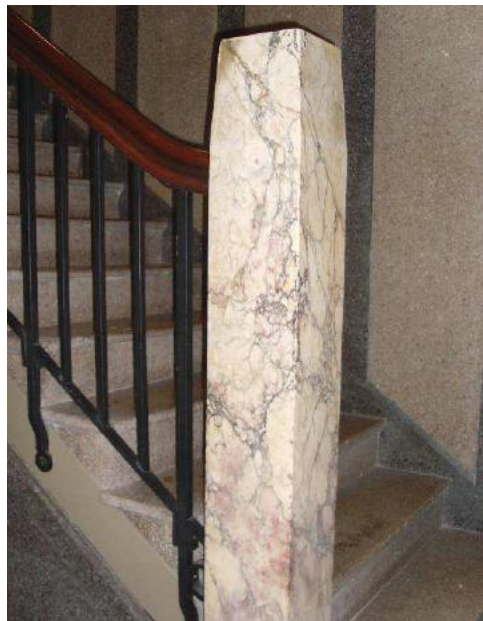
Detail of the marble newel post.

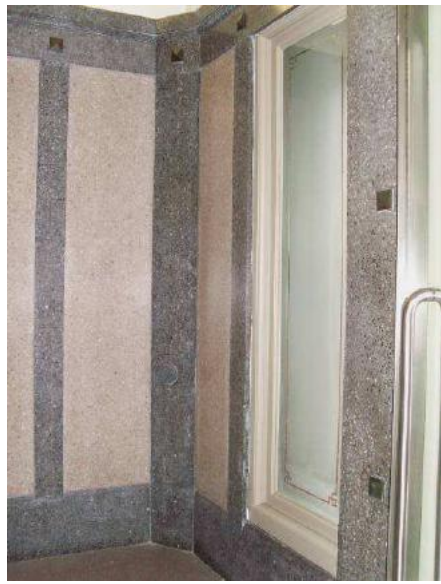
Detail of the marble wall cladding and part view of Grosvenor Street window and contemporary glazed door.

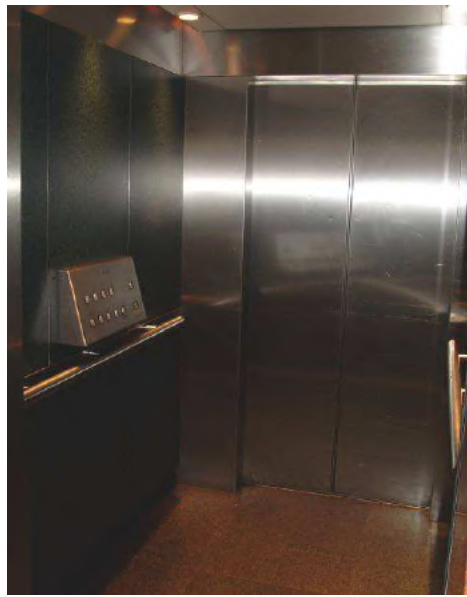
View of the contemporary lift car within the new section of the building.

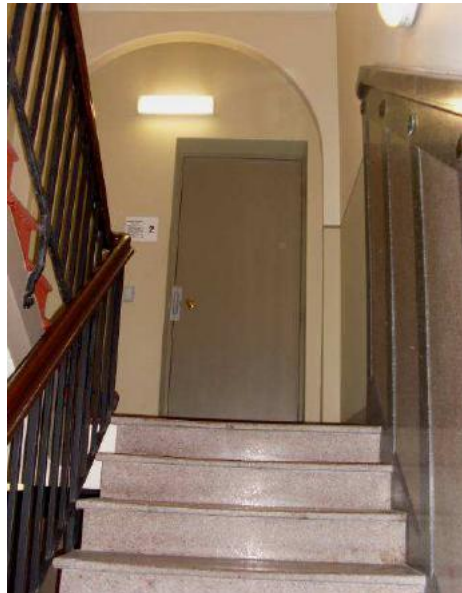
View from the vestibule to the first floor (level 2 stair) landing. The stair was originally the main entrance to the commercial floors and the arched recess has been infilled and the stair is now utilised as a fire stair. In figure 74 the building is shown from the rear as partially demolished and these arches are clearly visible.

Figure 74 – The rear of the Johnson’s Building during the demolition and excavation (1984). The rear wings of The Brooklyn Hotel and the Commercial Building have been demolished, along with part of the Johnson’s Building (indicated). The form of the arched openings are retained in the stair well (refer views of the existing stair shown in section 3.4), though they have been infilled.

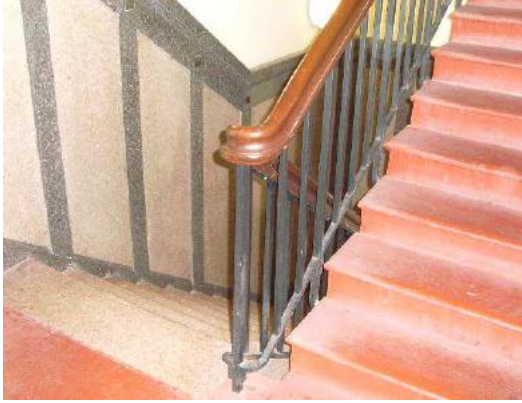
<p>Detail of the stair, balustrade and marble wall cladding from the level 2 landing. The terrazzo stair is discontinued at this point, with a painted concrete stair leading to the upper levels. The balustrade fabric is common throughout all floors.</p>

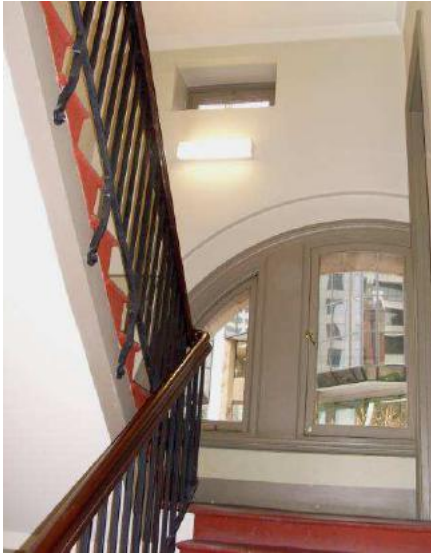
<p>View of the mid level landing from level 2. The arched window shown, is that over the Grosvenor Street commercial entry.</p>

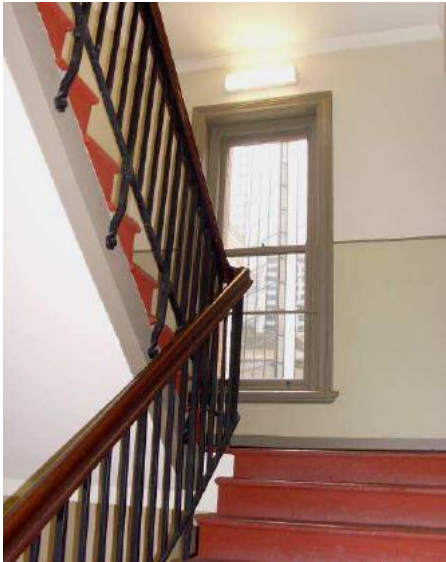
A photograph showing a staircase with red-painted concrete risers and a wrought iron balustrade with a wooden handrail. A window is visible on the landing above.	<p>View from level 3 to return landing.</p>

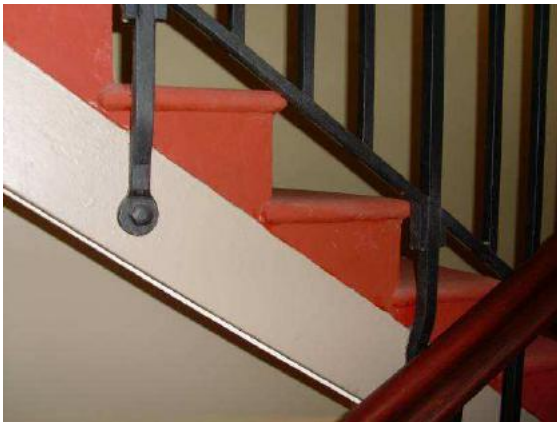
A close-up photograph of the red-painted concrete stair risers and the wrought iron balustrade.	<p>Detail of the painted concrete stair risers and wrought iron balustrade.</p>

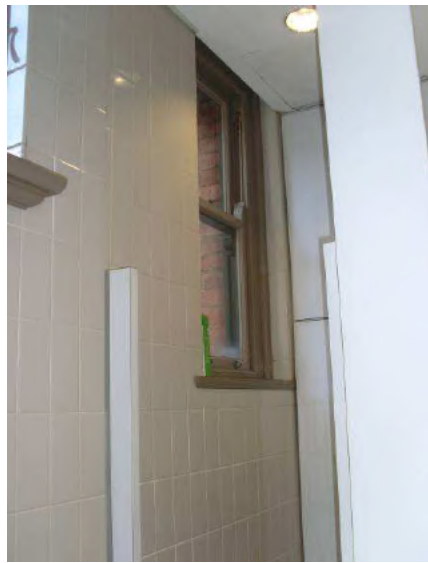
Detail of one of the double hung timber windows within the WC cubicle. Windows on the Milson's Lane elevation have been refurbished or replaced to match the original.

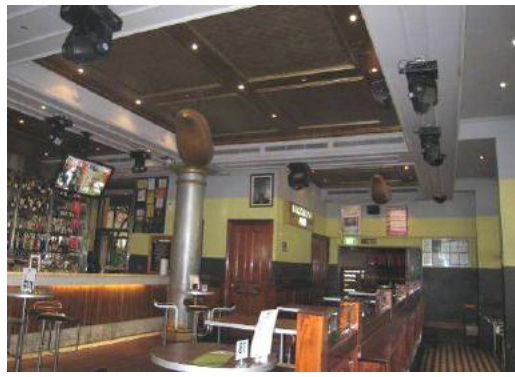
View north showing the contemporary bar at left. The bar was modified in 2003 following a design by Nicholas Dunn and Associates. The 1991 timber and stainless steel bar was replaced with a timber and marble structure.

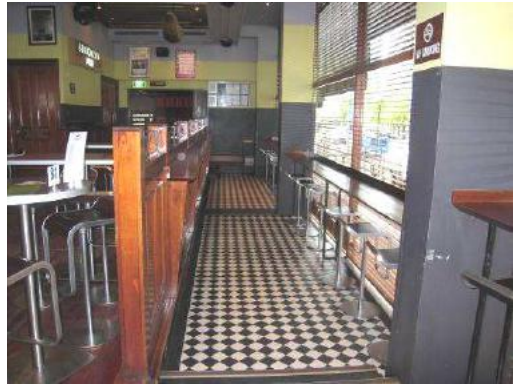
View north showing the window bays overlooking George Street. The window display bays are interpreted through the creation of a lowered floor area, separated from the main bar with timber partitioning. The area also features tiled flooring in contrast to the timber floors utilised throughout the main bar area.

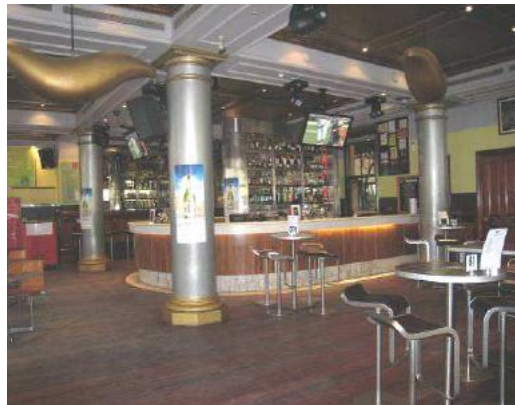
The 2003 bar, surrounded by four structural columns, retained from the original structure, though modified, with works including new render and finish.

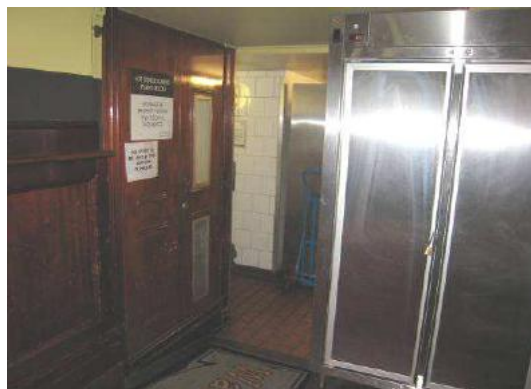
Staff service area, showing service window through to kitchen.
NB the kitchen is located below the original lift lobby (accessed via Grosvenor Street) and the kitchen subsequently has a lower floor level than the former shop area.

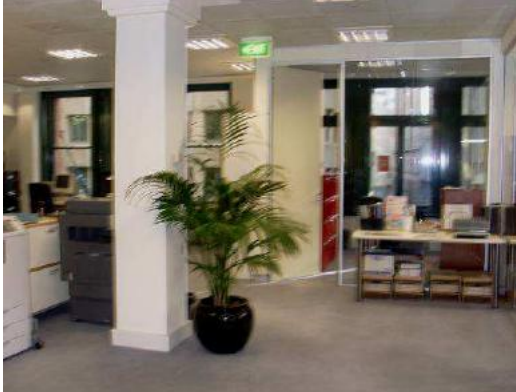
<p>View east showing open plan internal floor plan and windows overlooking George Street. The structural column is not original however interprets the location of one of the original support columns, of which there were originally 6.</p>

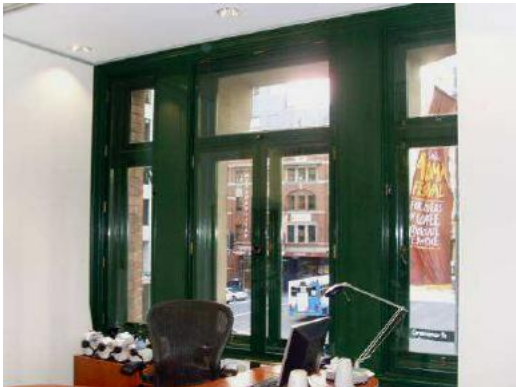
<p>View of the brick and sandstone window bay overlooking Grosvenor Street (adjacent to the splayed corner). Windows are painted timber and additional glazing has been fixed to the interior of the window, for sound proofing.</p>

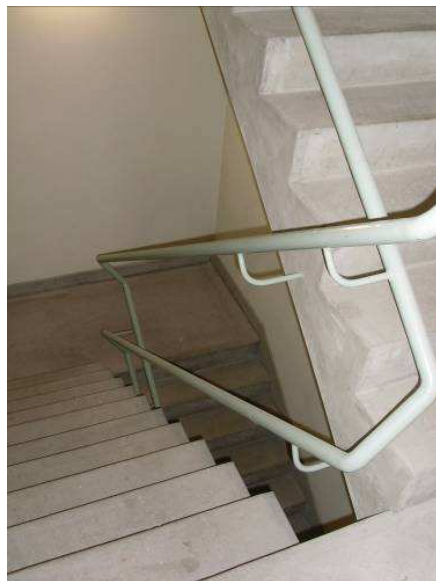
Contemporary fire stair located on the north side of the building, adjacent to the neighbouring Commercial Building. This view is taken from level 3, looking down to level 2, however the stair fabric is the same throughout. The stair is concrete and the balustrade, painted metal.

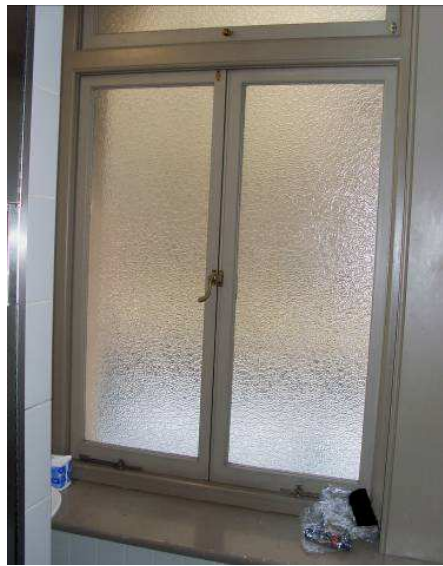
Detail of the window in WC with contemporary frosted glass. The window is part of the northern most window bay on the George Street elevation, part of which has been obscured by partitioning for the adjacent services which are not publicly accessible.

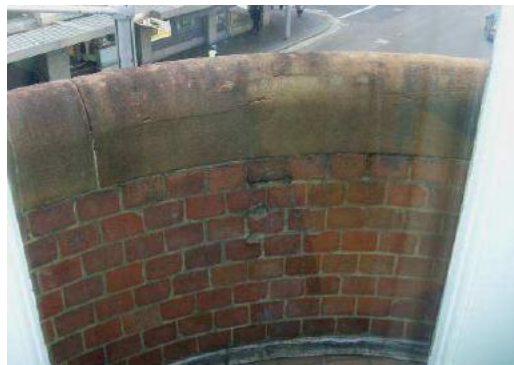
Detail of the brick and sandstone Juliet balcony, at the corner of the building. The element appears to be in good condition though there is some evidence of the re-pointing to brickwork. The balcony is accessed via timber double doors. General wear noted. Likely early or original fabric. Painted white.

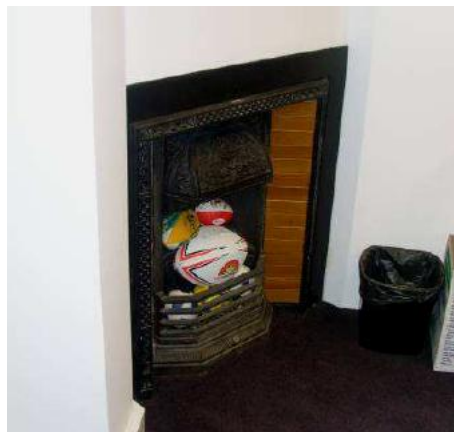
Detail of the fireplace in the corner office. This element is certainly consistent with the period of the building and may or may not be original. This is the only fireplace in the building.

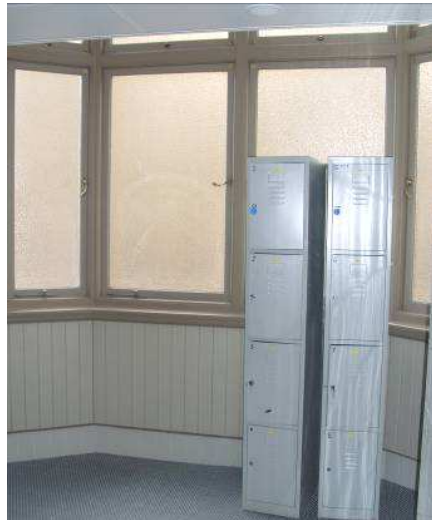
View of the northern George Street window bay with contemporary frosted glazing. As noted above in relation to the first floor fit out, services were introduced in this section of the building following the 1989 refurbishment and frosted glazing was introduced in association with this use. The partitioning is also contemporary and this section of the building was originally open plan.

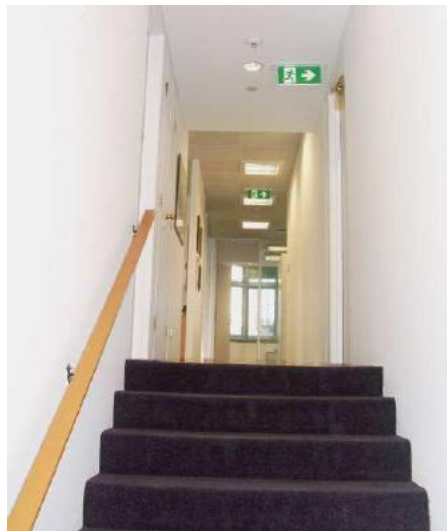
View south from the neighbouring Commercial Building, showing stairs to the Johnson's Building. The tenancy occupies the entire floor across the three sites in the Johnson's group.

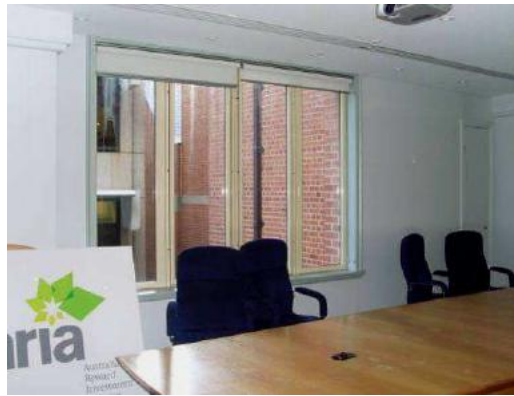
Again it is noted that the fit-out and partitioning is contemporary and determined by tenancy preference and requirements. The floor is currently vacant however at the time of inspection, the fit out was retained from the previous tenancy.

View of the boardroom with views to the Tower and courtyard, to the north of the Johnson's Building.

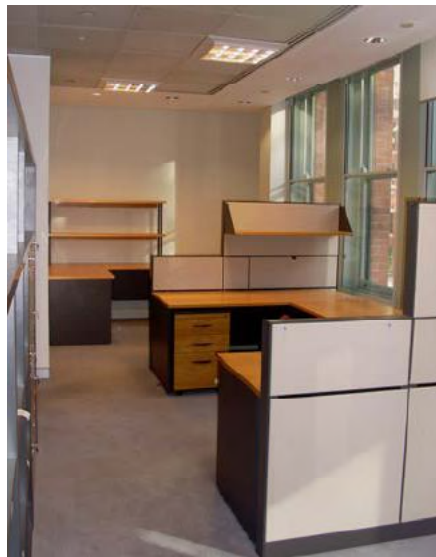
View of office area showing partitioning. The windows overlook George Street. A section of party walling is shown at the rear, though this has been rebuilt.

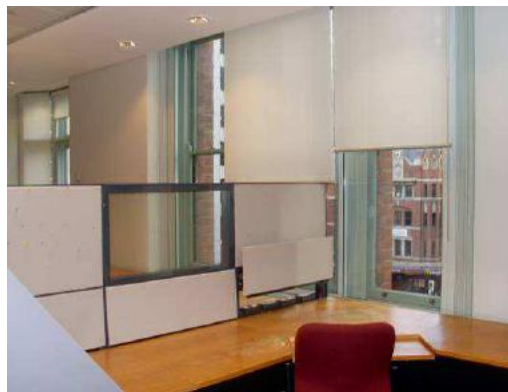
Office area showing partitioning. The windows overlook Grosvenor Street, with the Metropolitan Hotel visible opposite on the corner of George and Bridge Streets.
