JOHNSONS CORNER

229-235 GEORGE STREET, THE ROCKS

CONSERVATION MANAGEMENT PLAN

June 2012

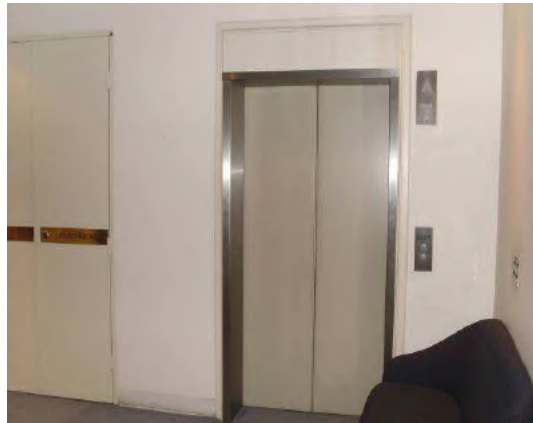
View of the contemporary lift lobby
Again it is noted that the fit-out and partitioning is contemporary and determined by tenancy preference and requirements.

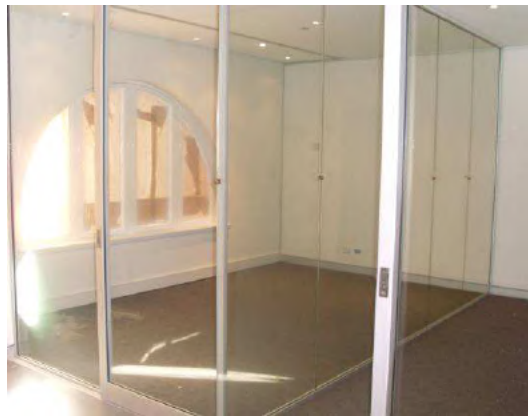
Meeting rooms adjacent to the lift lobby. The rooms had only just been completed at the time of the June 2008 site inspection. The arched window shown overlooks the courtyard between the building group and the Grosvenor Tower.

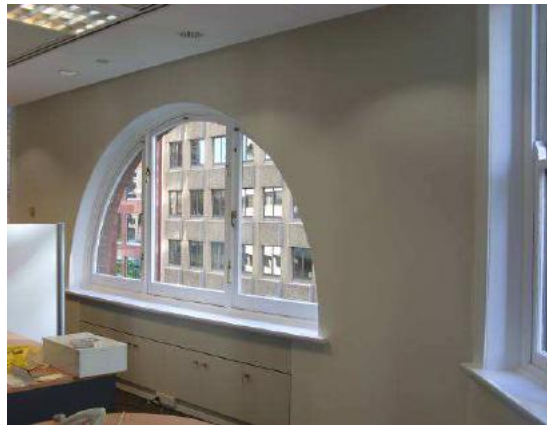
Detail of arched window bay with contemporary joinery below. Windows on this floor had only recently been repainted internally and this floor is noted as the only floor that has not installed sound proofing to glazing.

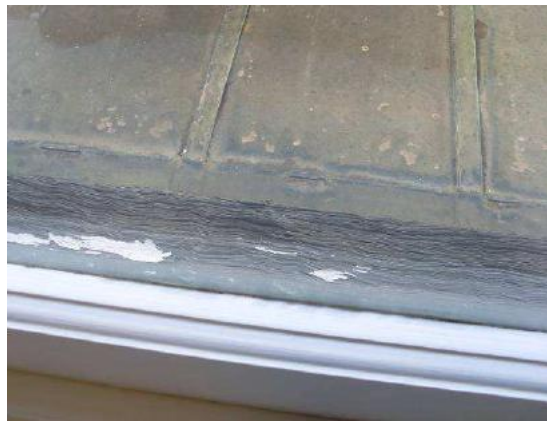
Detail of same window bay as above, showing the condition of the external timbers. The timber requires treatment and repainting.

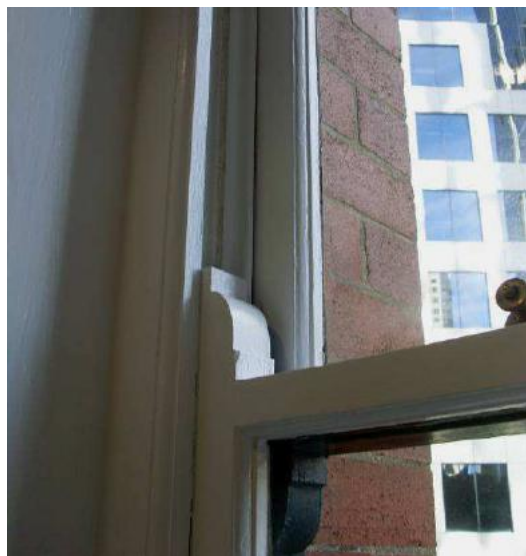
Detail of timber window joinery and furniture showing sash cords.

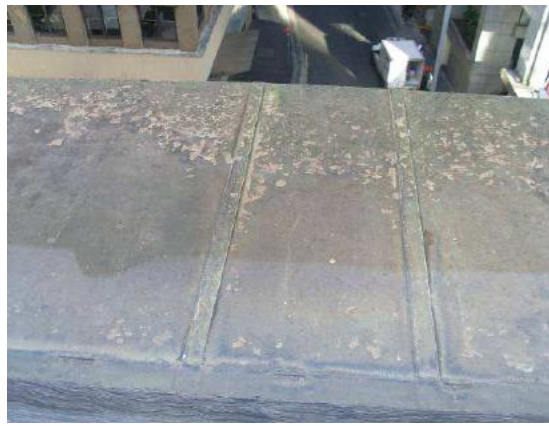
View of the top of the copper window bay. The copper sheeting has a typical patina of wear but appears to be in good condition generally.

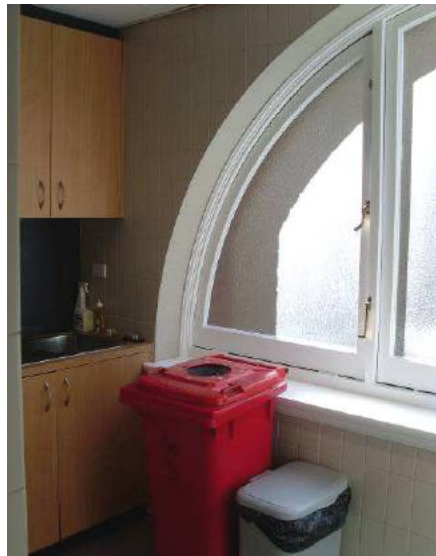
View of the converted contemporary kitchenette with new frosted glazing in the arched window.

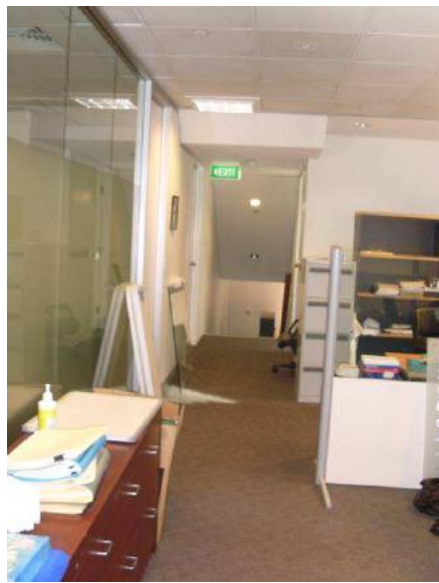
View of the office interior, showing stair access to the section of the commercial floor within the neighbouring Commercial Building.

As noted above, all fixtures and fittings are contemporary, including carpeting, glazed partitions and the suspended ceilings shown in the image.

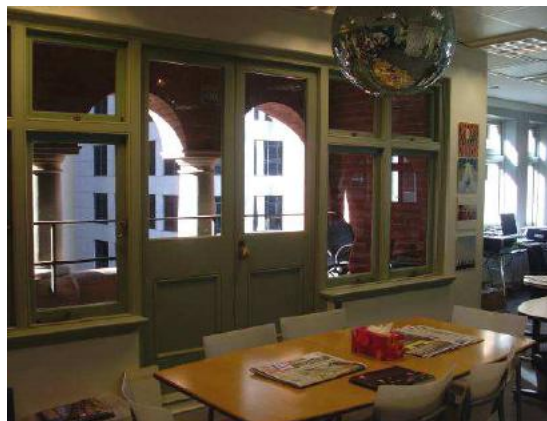
Office view showing access to balcony. The timber doors and flanking double windows are in good condition and may have been restored.

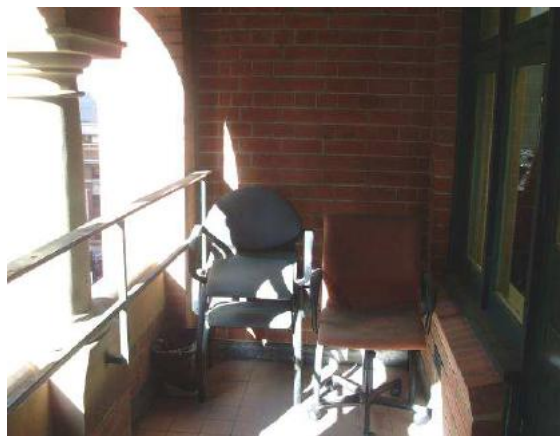
Balcony view. The balcony tiling and ceilings have been refurbished, and the tiling matches that utilised on the neighbouring Commercial Building and Brooklyn Hotel. The balcony features a triple arch colonnade with sandstone columns and brick arched voussoirs. The sandstone balustrade is quite low and there is a secondary metal balustrade behind, setback from the columns to minimise visibility from the street.

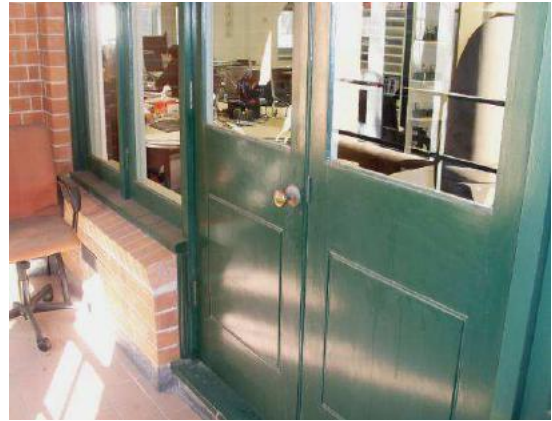
<p>Detail of the timber double doors and flanking double windows. The timber appears to have been recently painted and is in good condition.</p>

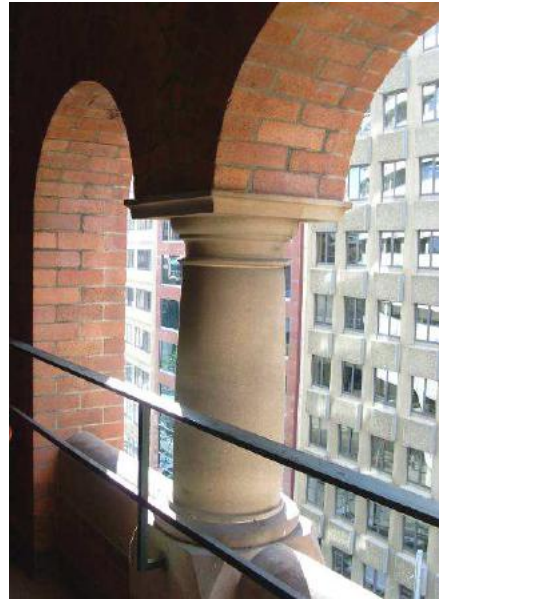
<p>View of the sandstone columns and brick arched colonnade.</p> <p>The metal balustrade is also shown. It is not known whether this is an early or original element. It does not show on early plans and may have been added to comply with BCA, however the original sandstone balustrade is quite low, and some additional balustrading would certainly have been required. The neighbouring Commercial Building also utilises similar materials on the upper floor balcony balustrade.</p>

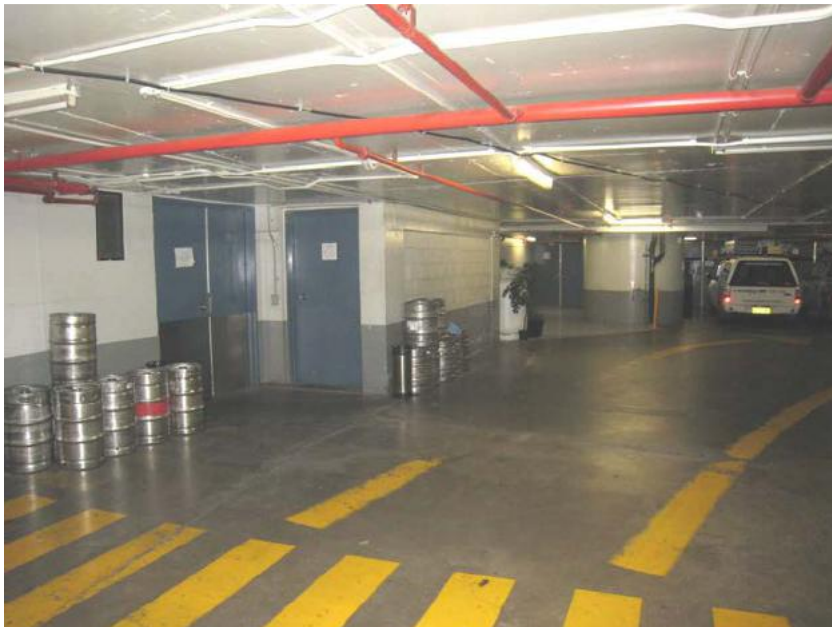
Figure 108 – Subfloor basement view

Deep features such as wells and cesspits would normally be present in former yards however the site has been so extensively excavated that it is unlikely that any such elements would remain. Excavated in association with the tower development, there are three levels of basement parking and services below the subject building group and there are no traces of original basements. Views of the excavation and development were shown at figures 70-74.

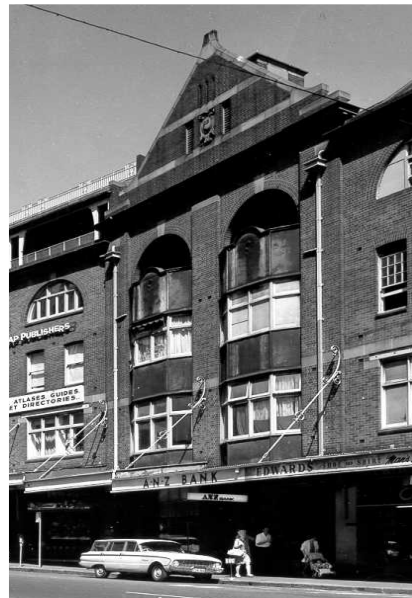
Figure 110– c. 1970 view of George Street west, showing now demolished commercial buildings. The building has stylistic elements in common with the subject Commercial Building, although is comparably less ornate.

This building is believed to have been designed in 1912 by McRae and has since been demolished.

more decorative central building (figure 110 above), with prominent gable and copper clad central bay configuration that although echoed the façade of the Commercial Building, lacked the refined quality of its detailing.

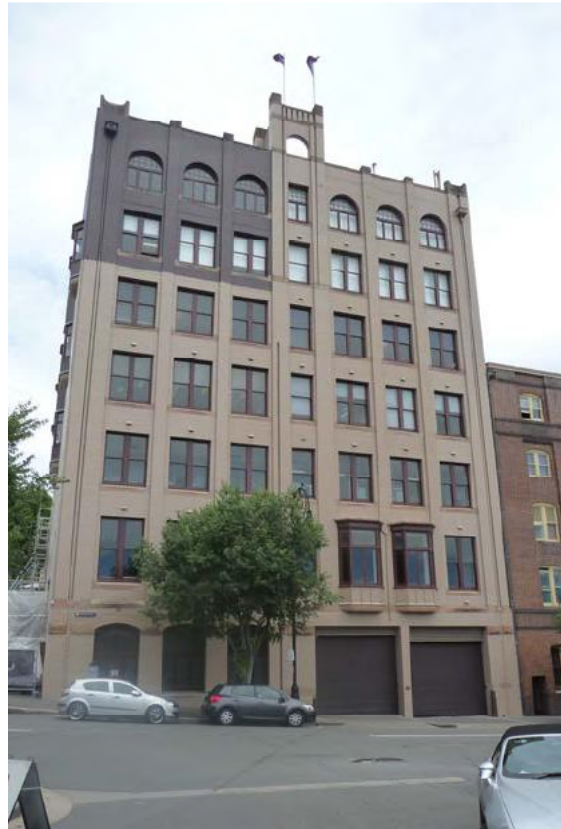
Figure 113 – Bushell's Place elevation, featuring irregular oriel window bays.

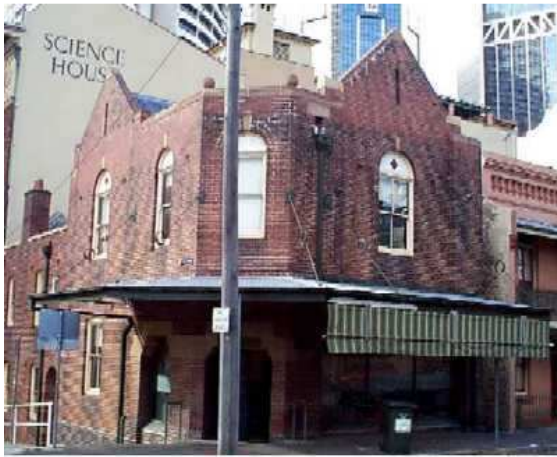
Figure 126– Shop and residence at 182 Cumberland Street, on the corner of Essex Street. This building was designed by Vernon c.1911.

One of the most notable surviving shop and residences of the style and period in The Rocks is the two storey building at the south east corner of Cumberland and Essex Streets (refer figure 126 below). Designed by Vernon and constructed in 1911, the building addresses the street corner, with prominent gables to both street frontages. The building is constructed in red brick with sandstone detailing including stepped sandstone lintels over the corner entry. The ground floor shopfront was modified in the late 1960s and restoration works were undertaken in the 1990s.

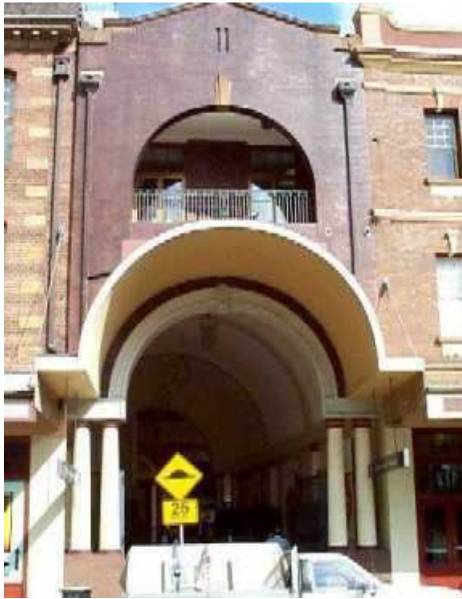
Figure 128– The altered façade of the three storey Federation building at 147 George Street, The Rocks (1914; photographed c.1985)

The Federation dwelling and shopfront at 147 George Street (neighbouring 149-151 George Street discussed above) was even more substantially altered in association with the 1980s works. The simple brick three storey façade is dominated by the contemporary arched mall entry, and the ground floor of the shopfront appears to have been wholly demolished. On the upper level the façade features an arched recessed central balcony, with decorative sandstone keystone, but is comparatively plain and minimal in detailing.

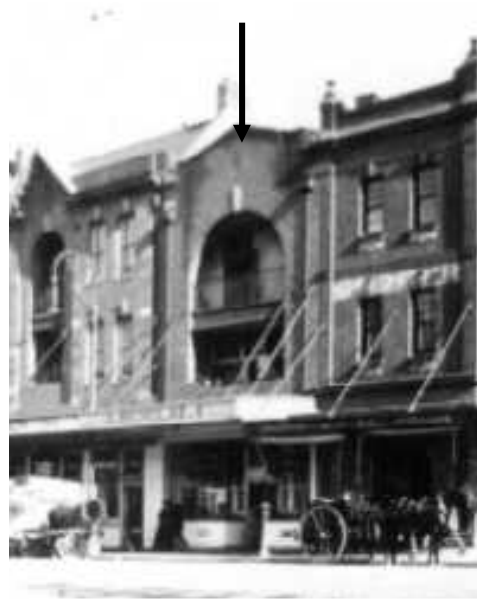
Figure 129– c.1930 view of the 147 George Street showing original shopfront, cantilevered awning and two storey recessed balcony to the upper levels.

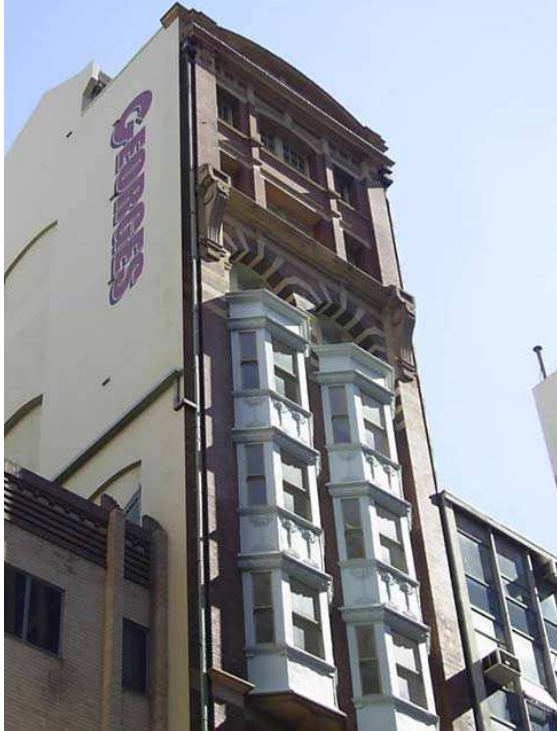
Figure 132– Detail of the upper levels of “Georges House”.

Electronics Store building at 387 George Street, each of which employ a strong vertical articulation to their facades. Both of these buildings were designed by the firm Spain, Cosh and Minnett and when built, Culwulla Chambers (1912) was the first building to reach a height of 50m (14 storeys). This was quite controversial and caused an amendment to building regulations prohibiting the erection of buildings taller than 45 metres⁹⁵. When 387 George Street was constructed the following year, it was built with only 11 storeys.

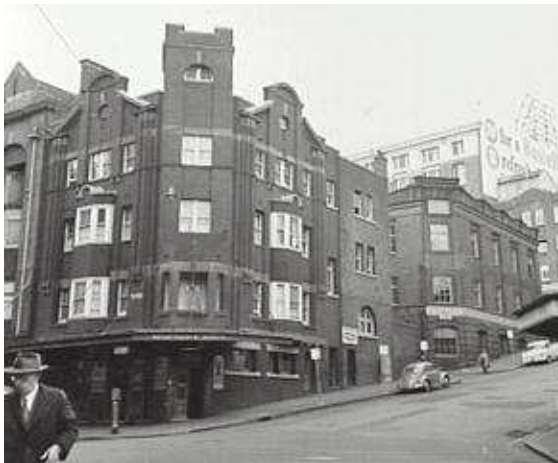
Figure 134– View of the southern side of Essex Street with Vernon’s Newcastle Hotel at the corner of Essex and George Streets (now demolished)

Early photographs demonstrate that Vernon employed the same narrow sandstone pediment windows on The Brooklyn and Commercial Hotels, and a comparable projecting central bay on the Newcastle Hotel which also featured a recessed loggia element although without the classical columns employed at The Brooklyn. Both the Newcastle and Commercial Hotels appear to feature cantilevered awnings.

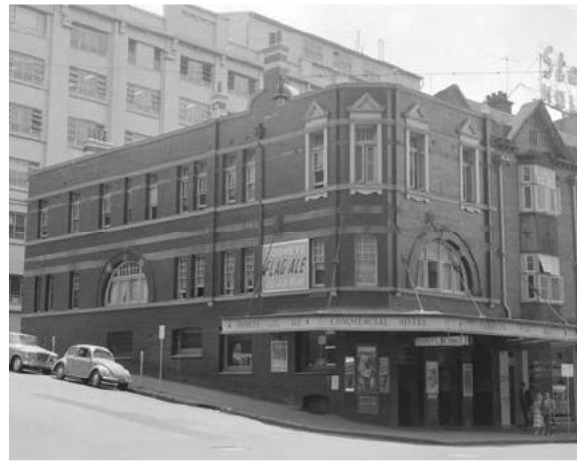
Figure 135– The circa 1909 Commercial Hotel at 199 George Street, on the corner of Essex Street with Harrington Lane (at rear). This hotel was demolished to make way for the Regent Hotel (now known as the Four Seasons)

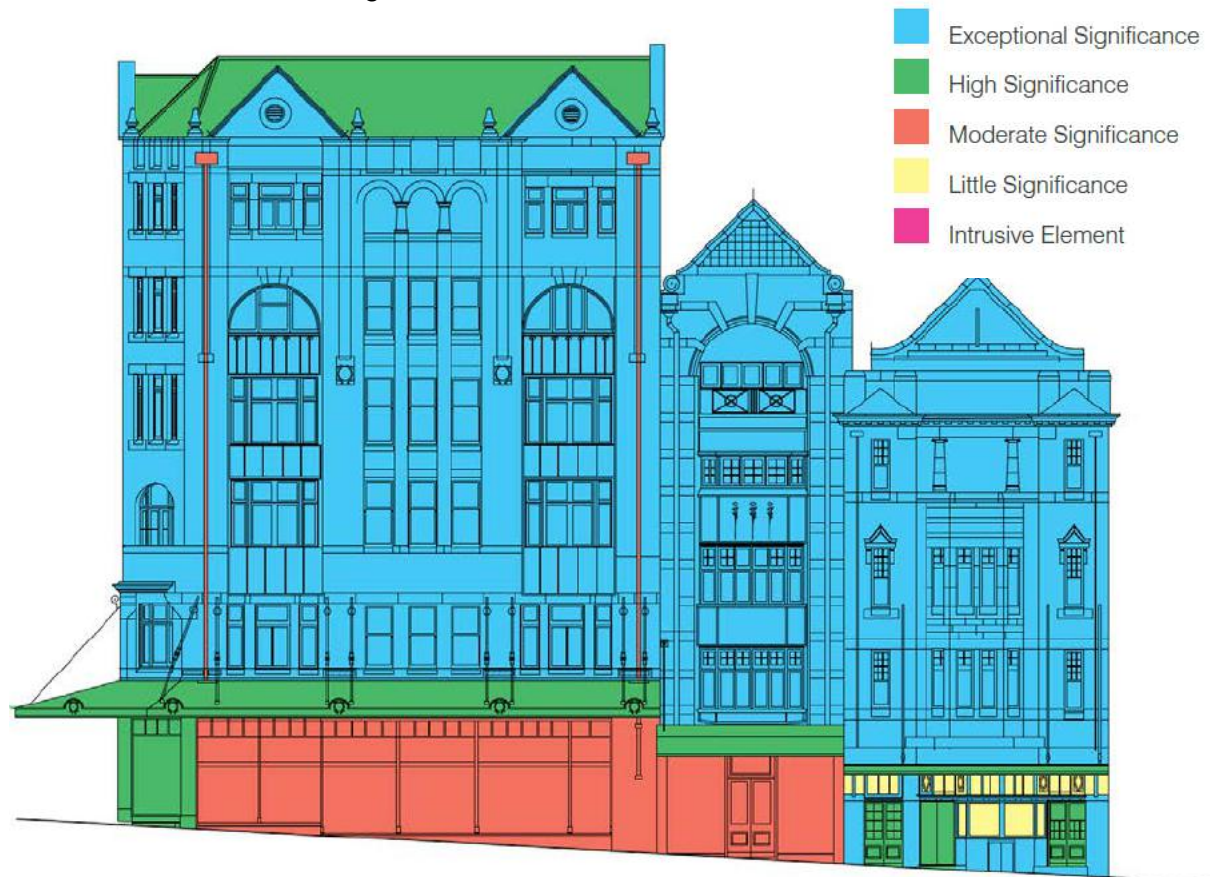
Eastern/ Principal Elevation

General/ all facades

<p><u>The Commercial Building</u> Contemporary signage to shopfront glazing (not indicated on plan)</p>	Intrusive

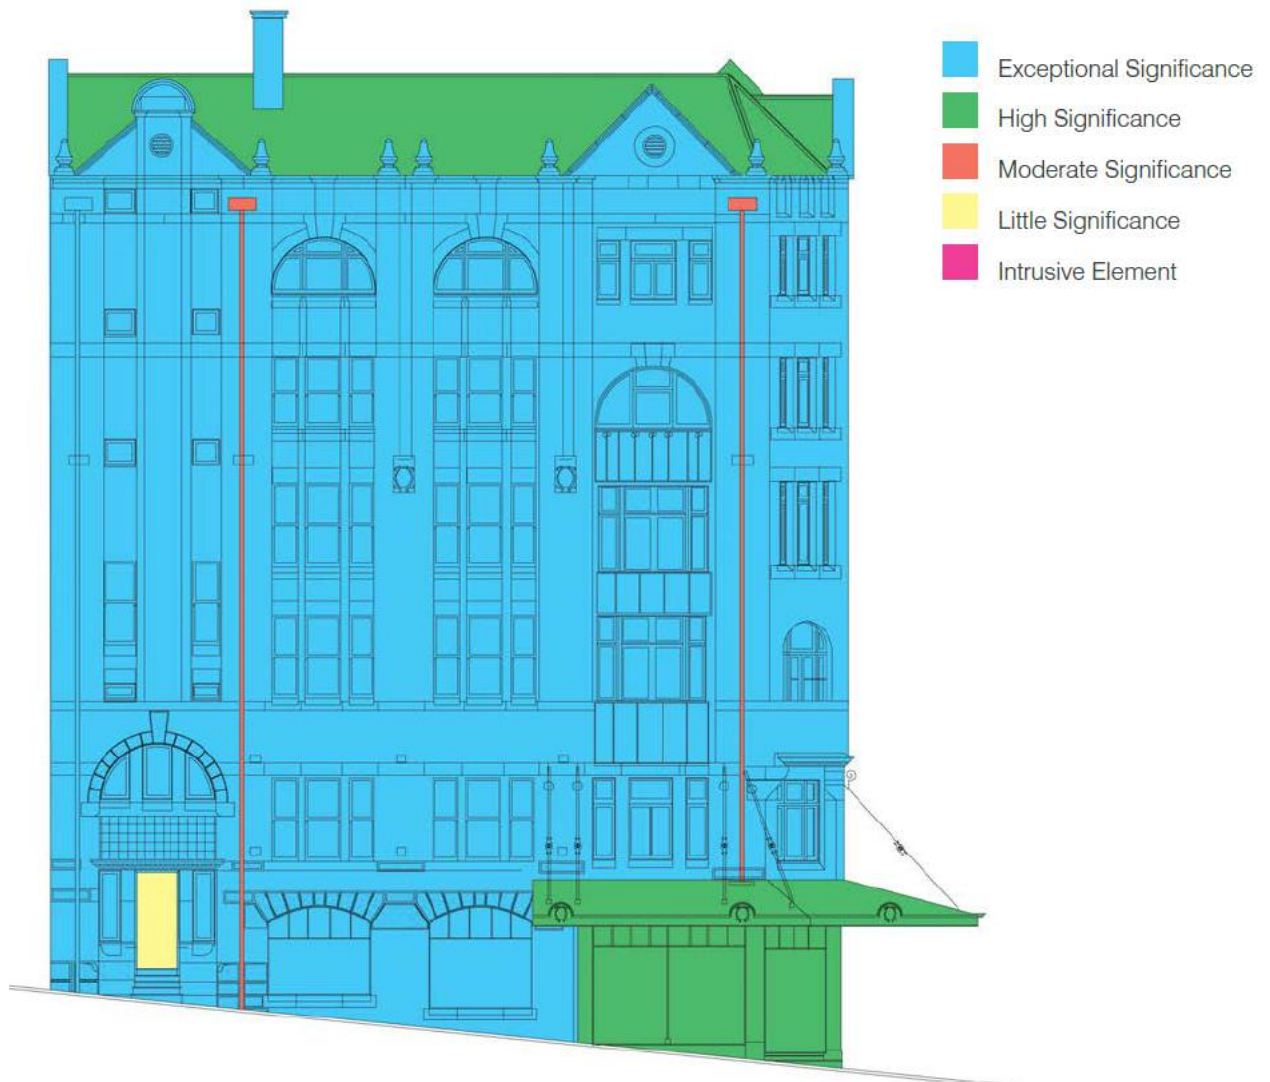
5.1.2 The Southern/ Grosvenor Street elevation

Southern/ Grosvenor Street elevation	
<p>Overall form of the façade</p> <p>All façade sandstone including coursing, window sills, mullions and lintels, pediment and gable detailing including the date plaque and relief elements such as cartouches and carved leaves flanking the commercial entry</p> <p>All façade brickwork</p> <p>All fenestration above street level and the arched steel framed ground floor windows (excluding the contemporary aluminium frame reinforcement)</p> <p>Copper façade cladding to window bays</p> <p>Ground floor commercial entry including associated terracotta chequerboard motif over the entry and retained early timber double doors (not shown on plan)</p> <p>Excluding contemporary glazed entry door</p>	Exceptional
<p>Ground floor splayed shopfront and shopfront fenestration, excluding contemporary tiling and contemporary glazing over entry doors with Brooklyn Hotel signage. Including copper framing, timber double doors and marble cladding. This element was restored using original fabric following the 1980s/1990s works</p> <p>Restored awning and associated tie-rods (excluding signage)</p>	High

Slate roofing (restored to match the original) excluding capping and flashings	
Copper rainwater heads and downpipes	Moderate
The contemporary glazed entry doors to the commercial entry "Johnson's corner" Awning signage Traditional "Brooklyn Hotel" awning signage All signage associated with the commercial usage and all numbered signage Under-awning lighting (not indicated on plan) Metal reinforcement framing to ground floor arched window	Little
N/A	Intrusive

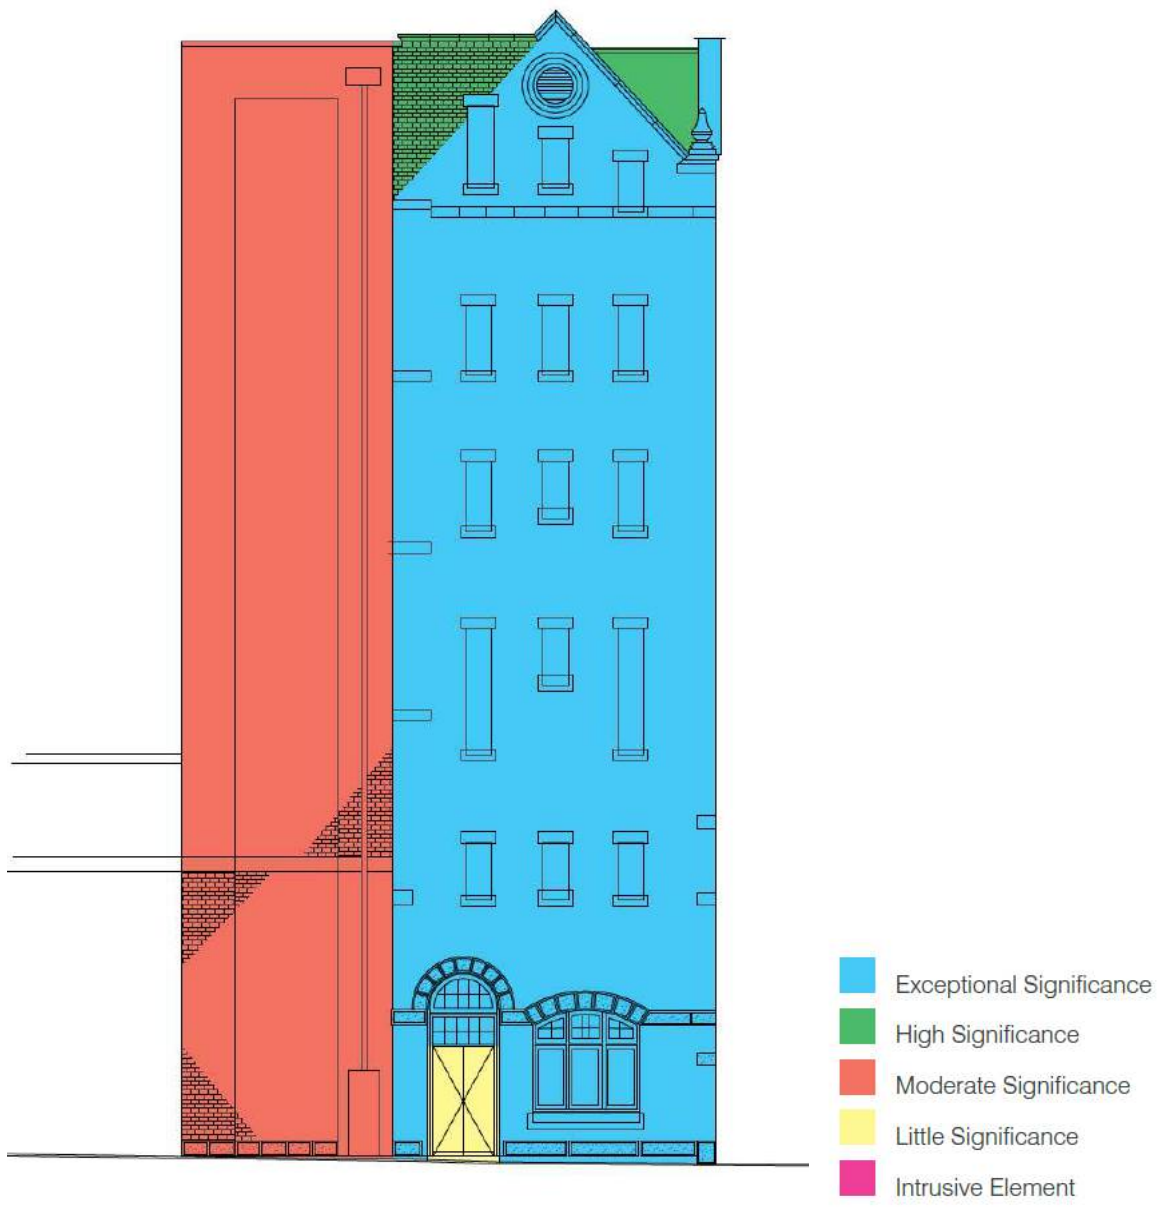
5.1.3 The Western/ Rear elevation

Western/ Rear Elevation	
<p><u>The Johnsons Building</u> Overall form of the original section of the façade on the return Milsons Lane elevation. (This section is demarcated by the differing brickwork and refers only to the portion of the elevation south of the recess with downpipe) All façade sandstone on the original section of the facade, as defined above, including coursing, window sills and lintels, pediment and gable detailing. Includes also those sections of cut sandstone that were partially retained following the 1980s/90s additions All façade brickwork on the original section of the facade, as defined above All fenestration on the original section of the facade, as defined above, including multi-paned glazing over the altered entry and all timber window frames</p>	Exceptional
Slate roofing (restored to match the original) excluding capping and flashings	High
<p><u>General/ All facades</u> Overall form of the façade of the contemporary addition (i.e. all fabric including and north of the recess on the Milsons Lane elevation) All façade brickwork on the contemporary addition as defined above (new wall-1980s/90s works) Sandstone capping and coursing, includes also the masonry base, clad in sandstone sheeting Copper rainwater heads and downpipes</p> <p><u>The Brooklyn Hotel</u> Façade Render/ Masonry Ground floor timber double doors Service down-piping</p>	Moderate

<p>All contemporary glazed doors, (including the altered door within the original section as shown on the plan above) All commercial signage (not indicated on plan)</p>	Little
N/A	Intrusive

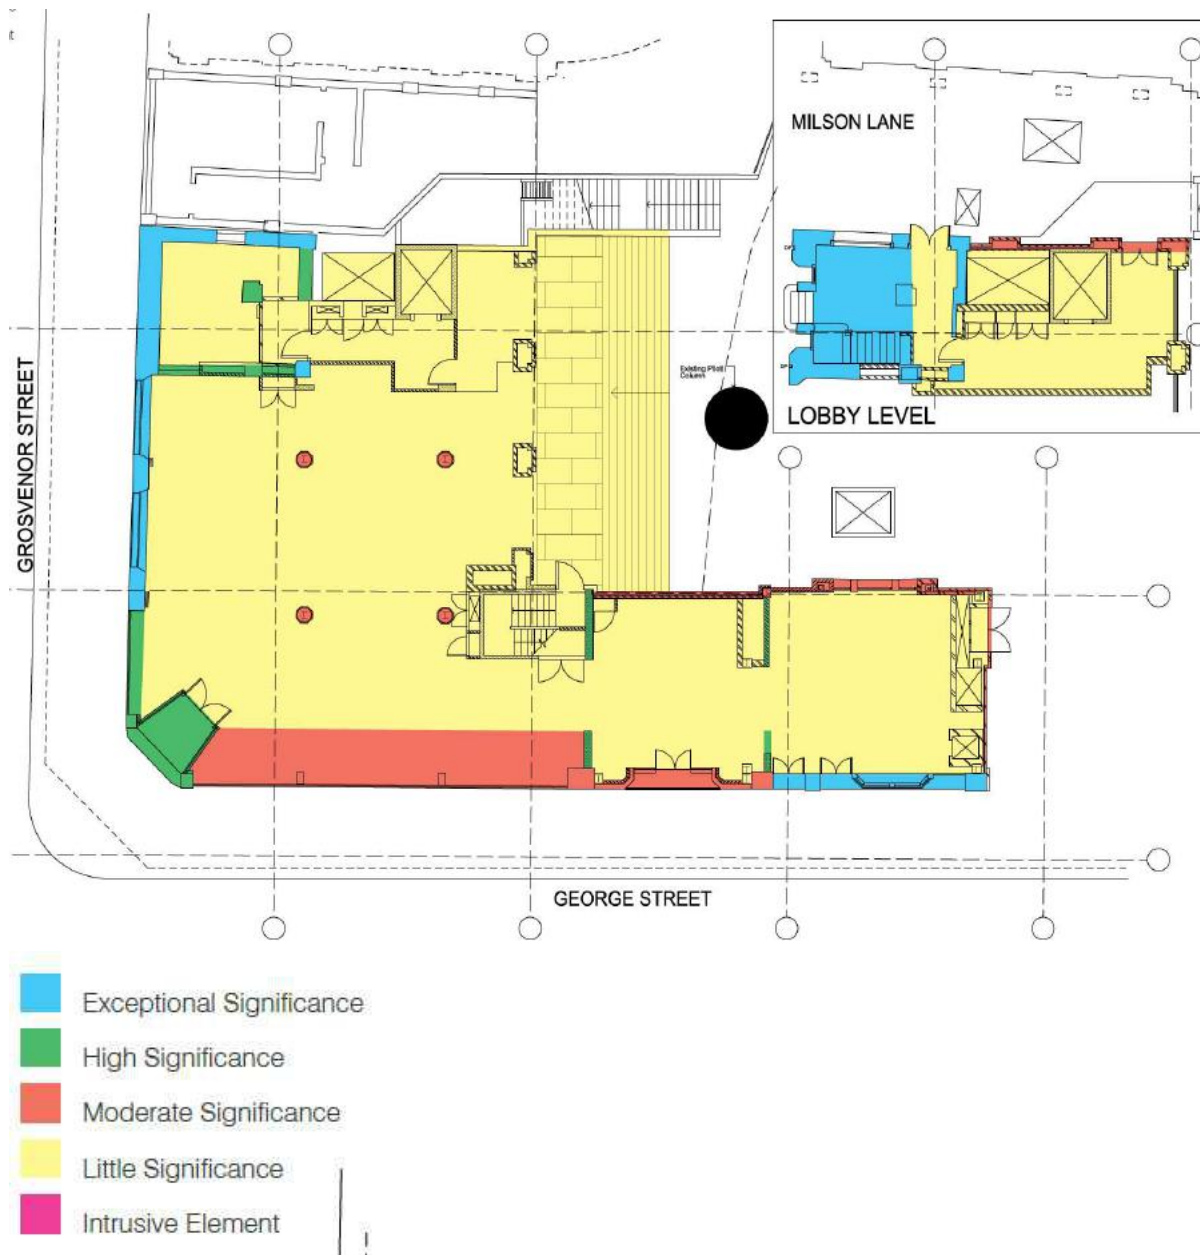
Ground Floor Plan/ Level 1

Ground floor elements	
<p><u>The Brooklyn Hotel</u> Façade as outlined above</p> <p><u>Johnsons Building</u> Ground level Grosvenor Street façade and return Milson's Lane frontage as outlined above</p> <p>Original section of ground floor commercial stair lobby and foyer, including tiled flooring, two toned terrazzo wall cladding and stair risers, timber and iron balustrade and marble stair post, timber window framing and cladding over arched west window bay and retained screening to former lift well. Includes also the arched window over the altered entry and part of the north wall as shown on</p>	<p>Exceptional</p>

Ground floor elements	
<p>the plan above and the retained timber French doors to Grosvenor street. (Excludes the contemporary glazed entry doors on both the south and west elevations and the replaced glazing to vertical windows flanking the Grosvenor street entry)</p> <p>Spatial quality of the original portion of the foyer</p> <p>Spatial quality of the open plan ground floor bar</p>	
<p>Internal cross walls (These rebuilt elements allow interpretation of the original building footprints internally)</p> <p><u>The Johnsons Building</u></p> <p>Splayed shopfront entry and refurbished Grosvenor Street shopfront window (excluding contemporary tiling to entry and contemporary Brooklyn Hotel glazing over entry)</p> <p>North and east wall of the Hotel bistro kitchen, below the commercial entrance vestibule</p>	High
<p><u>The Johnsons Building</u></p> <p>The reconstructed structural support columns, excluding the new render and finish</p> <p>Modern portion of the ground floor Milson's Lane façade as outlined above</p> <p>Spatial quality of the interpreted shopfront window bay (overlooking George Street), excluding the fabric and finishes</p> <p><u>The Commercial Building</u></p> <p>The ground floor shopfront as outlined above</p>	Moderate

<p><u>General/ All floors</u></p> <p>All internal materials and fabric including the joinery, all floor and wall coverings, ceiling fabric and lighting</p> <p>All modern bar fixtures and fittings</p> <p>Service bulkhead and hoist</p> <p><u>The Brookly Hotel / Commercial Buildings</u></p> <p>Overall depth and form of the space (does not reflect the original floor plate)</p> <p><u>Johnsons Building</u></p> <p>The contemporary lift foyer to the rear of the commercial vestibule, including chequered tile flooring, two tone marble wall cladding and ceiling fabric</p> <p>All glazed entry doors to the commercial vestibule</p> <p>The contemporary lift well and car to commercial lobby</p> <p>Refurbished ceiling within commercial entrance lobby</p> <p>All internal materials and fabric within the contemporary bar, the joinery, all floor and wall coverings, ceiling fabric and lighting</p>	Little
N/A	Intrusive

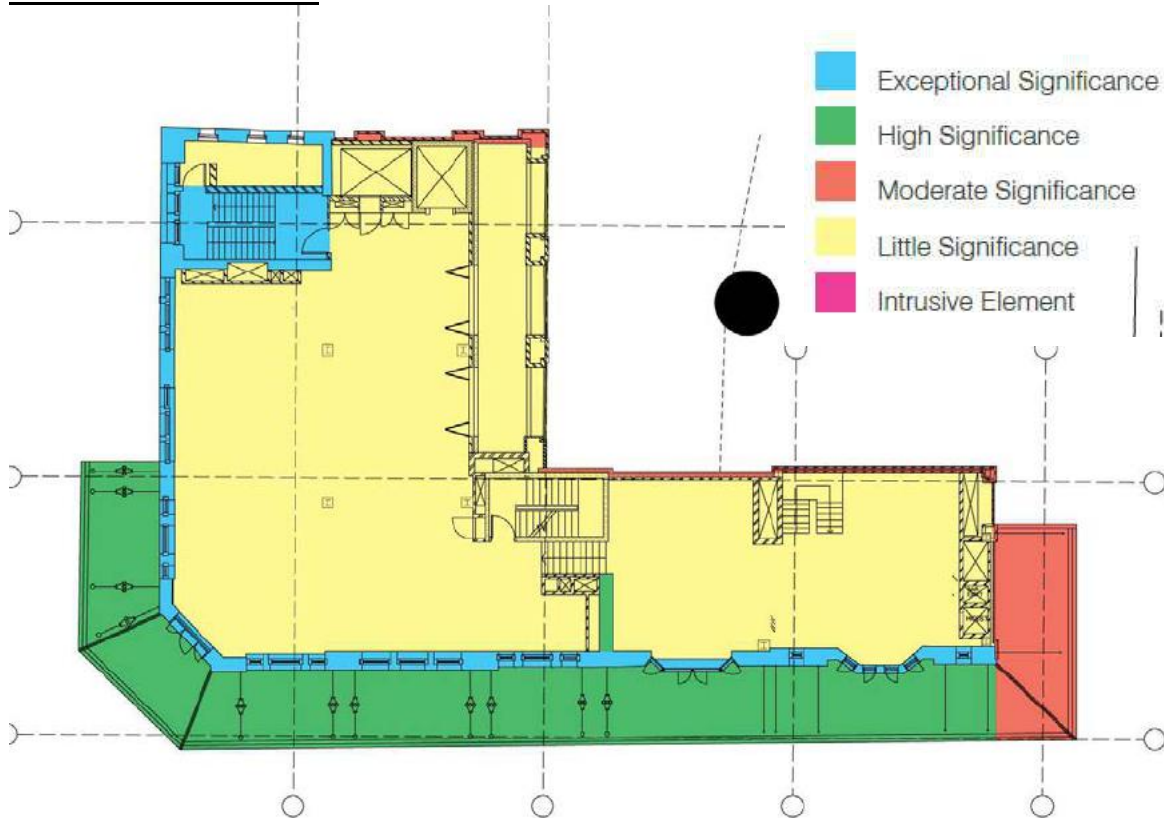
First Floor Plan/ Level 2

First floor elements	
<p><u>General/ All floors</u> Principal façade and fenestration as outlined above <u>Johnsons Building</u> Stair lobby including concrete and terrazzo stair with timber balustrade, and marble wall cladding to the first floor landing. Also including original arched entry to commercial tenancy but excluding the infilled brickwork to the arch and new access doors. Excluding paint finishes Timber door surrounds to landing WCs within original stair lobby, excluding timber doors</p>	Exceptional
<p><u>General/ All floors</u> Eastern façade awning as outlined above Internal cross walling that interprets the extent and location of the original dividing walls <u>Johnsons Building</u> North party wall, adjacent to the Commercial Building</p>	High
<p><u>The Brooklyn Hotel</u> Northern façade awning as outlined above <u>Johnsons Building</u> Contemporary portion of western elevation Timber doors to stair lobby WC</p>	Moderate

<p><u>General/ All floors</u> Tenancy floor plan and partitioning Contemporary lift and lobby All floor coverings and internal colour schemes, finishes and fit out, ceiling materials and finishes including suspended office ceiling and plaster hall ceiling with egg and dart cornice</p>	Little

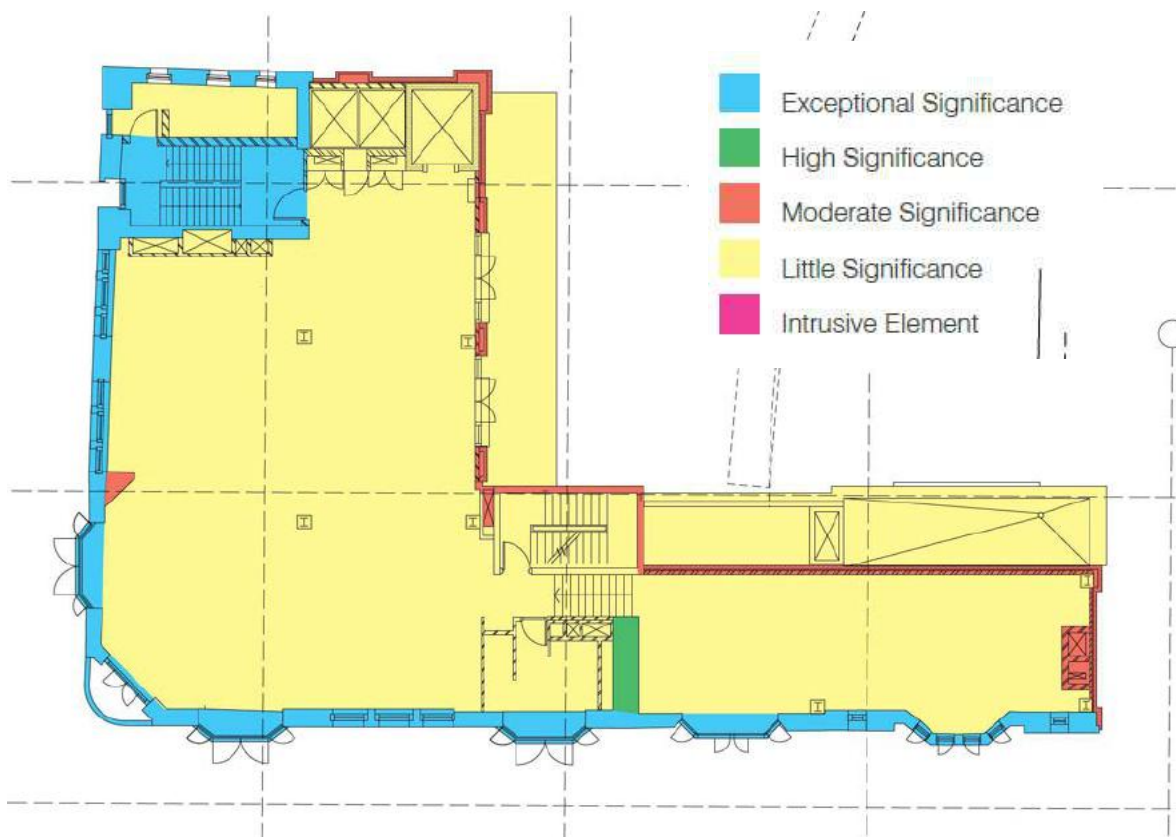
Second Floor Plan/ Level 3

Second floor elements	
<p><u>General/ All floors</u> Principal façade and fenestration as outlined above</p> <p><u>Johnsons Building</u> Stair lobby including concrete stair with timber balustrade. Also including original arched entry to commercial tenancy but excluding the infilled brickwork to the arch and new access doors. Excluding paint finishes Timber door surrounds to landing WCs within original stair lobby, excluding timber doors Splayed corner balcony (excluding contemporary tiling)</p>	Exceptional
<p><u>Brooklyn Hotel and Commercial Buildings</u> Overall depth and form of the space (reflects the approximate area of the original upper level principal front room) including internal cross walling that interprets the extent and location of the original dividing walls</p> <p><u>The Johnsons Building</u> Northern party wall adjacent to the Commercial Building</p>	High
<p><u>Johnsons Building</u> Contemporary portion of western and rear northern elevation Timber doors to stair lobby WC Single fireplace (south wall within the commercial tenancy)</p>	Moderate

<p><u>General/ All floors</u> All contemporary office fit out fabric including partitions, doors, suspended ceiling, floor and wall coverings Contemporary lift and lobby Glazed window sound proofing Service bulkhead</p> <p><u>Commercial Building</u> Joinery including desk in the window bay and any skirtings</p> <p><u>Johnsons Building</u> Terrace/balcony overlooking the courtyard and Grosvenor tower Stair landing WC fit out including floor and wall tiling, partitioning, sink and WC facilities (excluding walls and fenestration) Staff WC including all floor and wall tiling, cubicle partitions, sink and WC facilities Staff kitchenette facilities Contemporary concrete fire stair to northeast corner Splayed corner balcony tiling New walling within original arch and entry doors to commercial tenancies (north wall of stair lobby) All furnishings</p>	Little
N/A	Intrusive

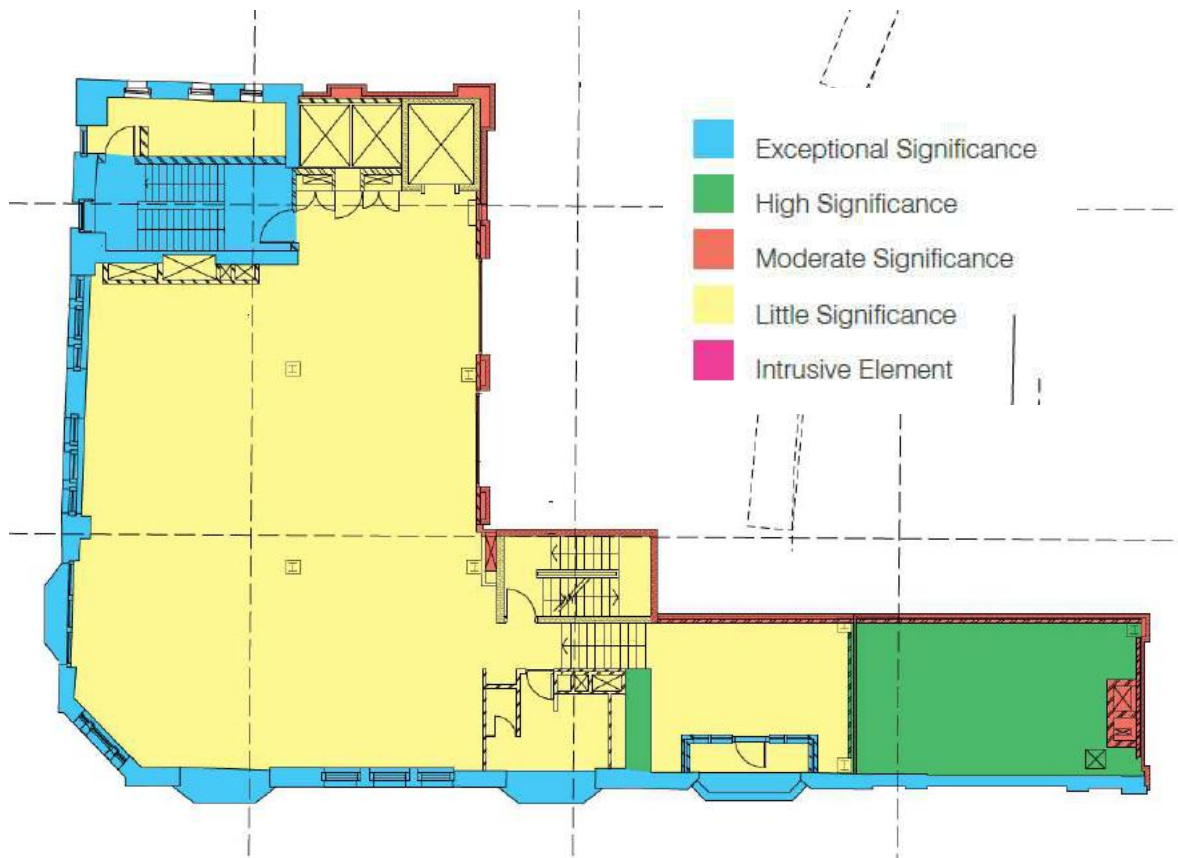
Fourth Floor Plan/ Level 5

Fourth floor elements	
<p><u>General/ All floors</u> Principal façade as outlined above <u>Commercial Building</u> Balcony element including balustrade, timber door (excluding paint scheme), door furniture and fenestration (excluding the balcony tiling, ceiling grate, ladder and cage to roof cavity).</p>	<p>Exceptional</p>

Fourth floor elements	
<p><u>Johnsons Building</u> Stair lobby including concrete stair with timber balustrade. Also including original arched entry to commercial tenancy but excluding the infilled brickwork to the arch and new access doors. Excluding paint finishes Timber door surrounds to landing WCs within original stair lobby, excluding timber doors</p>	
<p><u>General/ All floors</u> Internal cross walling that interprets the extent and location of the original dividing walls. <u>Commercial Building</u> Overall depth and form of the space (reflects the approximate area of the original upper level principal front room) <u>Johnsons Building</u> North party wall adjacent to Commercial Building</p>	High
<p><u>Johnsons Building</u> Contemporary portion of western and rear northern elevation Timber doors to stair lobby WC</p>	Moderate
<p><u>General/ All floors</u> Tenancy floor plan and partitioning Contemporary lift and lobby All contemporary office fit out fabric including partitions, doors, suspended ceiling, floor and wall coverings and finishes. Glazed window/door sound proofing All furnishings <u>Commercial Building</u> Balcony tiling and ceiling grate, painted metal ladder and cage to roof cavity <u>Johnsons Building</u> Stair landing WC fit out including floor and wall tiling, partitioning, sink and WC facilities (excluding walls and fenestration) Staff kitchenette facilities All floor coverings, partitioning and internal colour schemes associated with the office fit out Contemporary concrete fire stair to northeast corner New walling within original arch and entry doors to commercial tenancies (north wall of stair lobby)</p>	Little

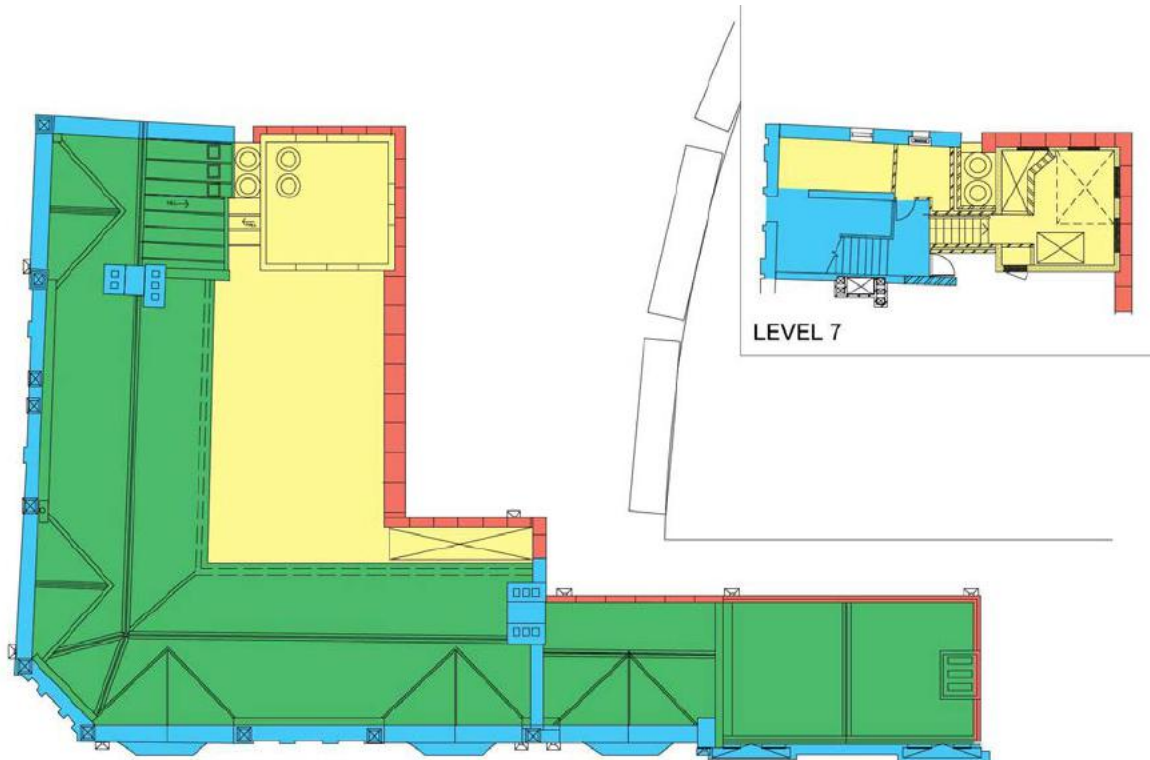
Roof Level

Roof elements	
All facades excluding the contemporary section of the Milsons Lane elevation and part of the north elevation as outlined in section 5.1.1 All chimneys All parapet detailing including gable ends and truncated finials Roof access to stair lobby Stair lobby including concrete stair with timber and metal balustrade; (excluding wall finishes and replaced doors to roof and services accesses)	Exceptional
Roof pitch and materials	High

Contemporary portion of western and rear northern elevation	Moderate
Contemporary lift motor room and services Roof flashings Cement paving and loose stone flooring. Painted metal balustrades	Little
N/A	Intrusive
