Final Draft CONSERVATION MANAGEMENT PLAN

Playfair Street Terraces, Nos. 17-31 Playfair Street The Rocks

Prepared for Sydney Harbour Foreshore Authority
September 2006

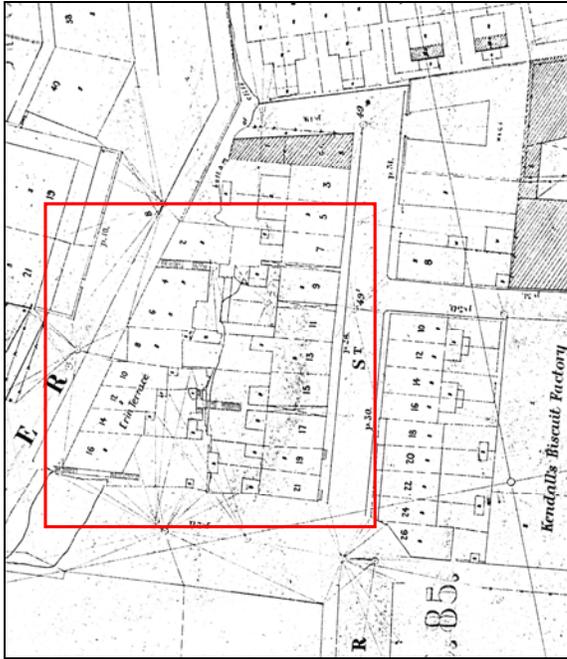
Figure 2.7 Plan dated 1887, amended in 1895 with no changes to the buildings.

A Sydney Water Plan dated 1887 (**Figure 2.7**)⁵⁷ illustrates the footprint and configuration of the buildings. Amended in 1895, there was no change indicated on the plan, however, it would appear that a building was constructed to the north of the grouping (shown hatched) in the time between. The earlier street numbering is clear and most of the buildings have brick and stone rear "wings" or annexes. Three passages are clearly shown between Nos. 7 and 9, Nos. 9 and 11 and Nos. 15 and 17.

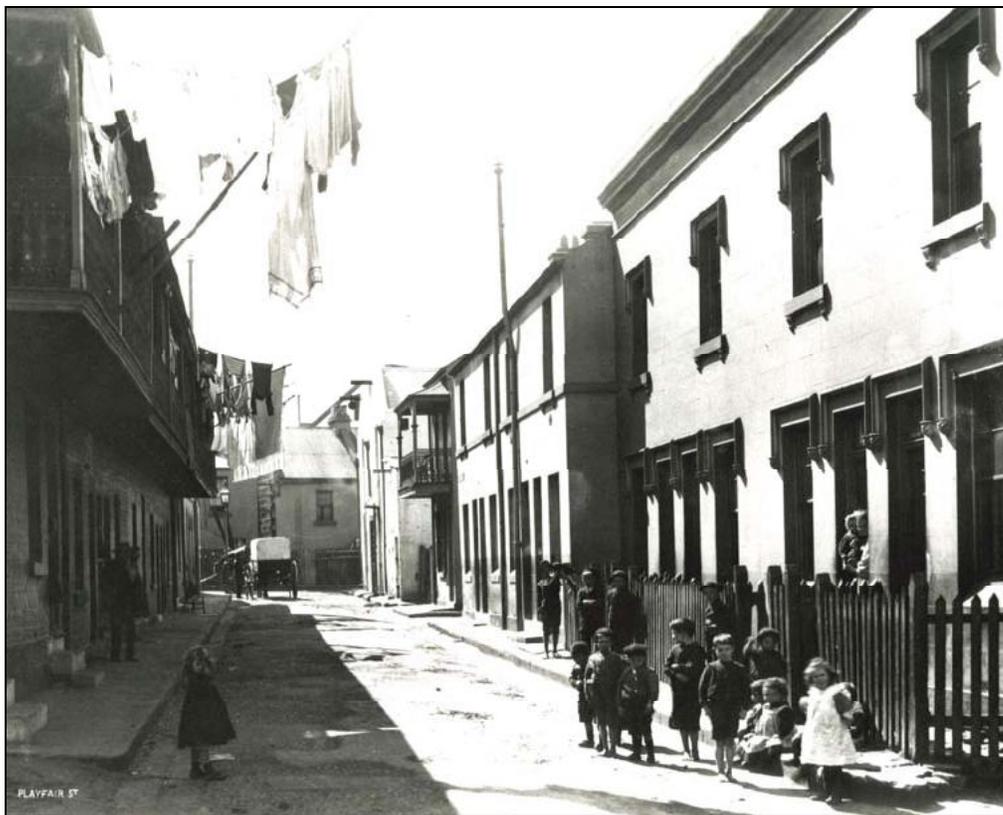
Figure 2.8 Photograph dated c. 1901 looking north along Playfair Street. The subject buildings are on the left. (Source: Foreshore Authority Archives PS 05)

A photograph dated c. 1901 (**Figure 2.8**) shows the context of the buildings and their frontage to Playfair Street. It would appear that the facades were face brick on face stone plinth with step up from the street level. The timber framed first floor balconies feature cast iron lace balustrades and cantilever over the ground floor entries. This section of Playfair Street is noticeably narrow with two storey dwellings also located on the eastern side of the street. Another photograph dated 1910 (**Figure 2.9**) clearly shows the ground floor facades of the buildings. The difference in floor level between Nos. 27 and Nos. 29 and 31 is apparent. The dormer windows, with curved roof and weatherboard cladding are also clear on the front, eastern roof slope facing Playfair Street.

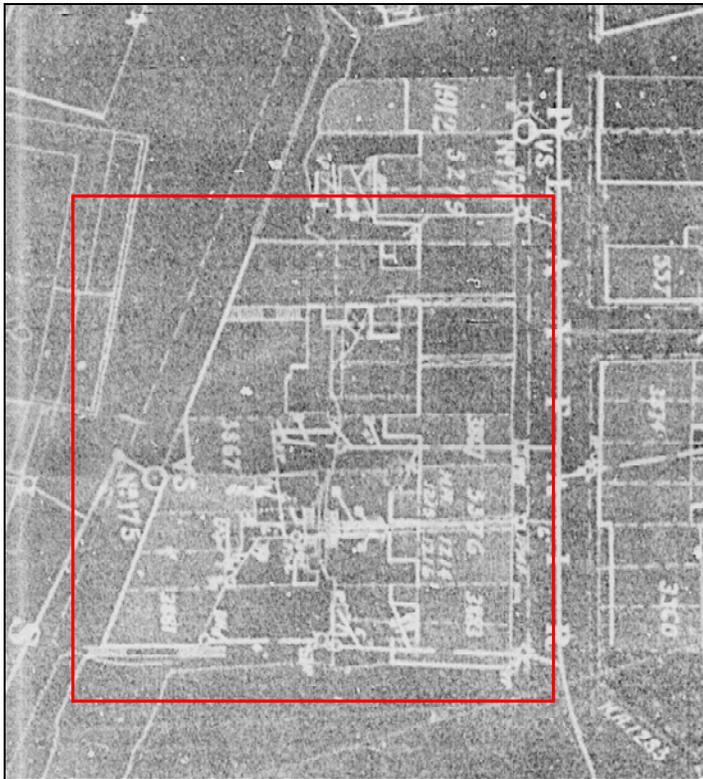
Figure 2.10 Sydney Water plan (c. 1925-1932) indicating virtually no changes to the buildings.

An undated Sydney Water plan (**Figure 2.10**)⁵⁹ revised and re-issued in 1925 and withdrawn from use in 1932 indicates no great change to the building outline between 1895 and 1925. The same configuration and building footprint is shown. Some change is also visible to the buildings to the north of the grouping, noted with “1912”, however, the Cleland Bond Store, which was constructed in 1913–1914⁶⁰ is not shown on the plan.

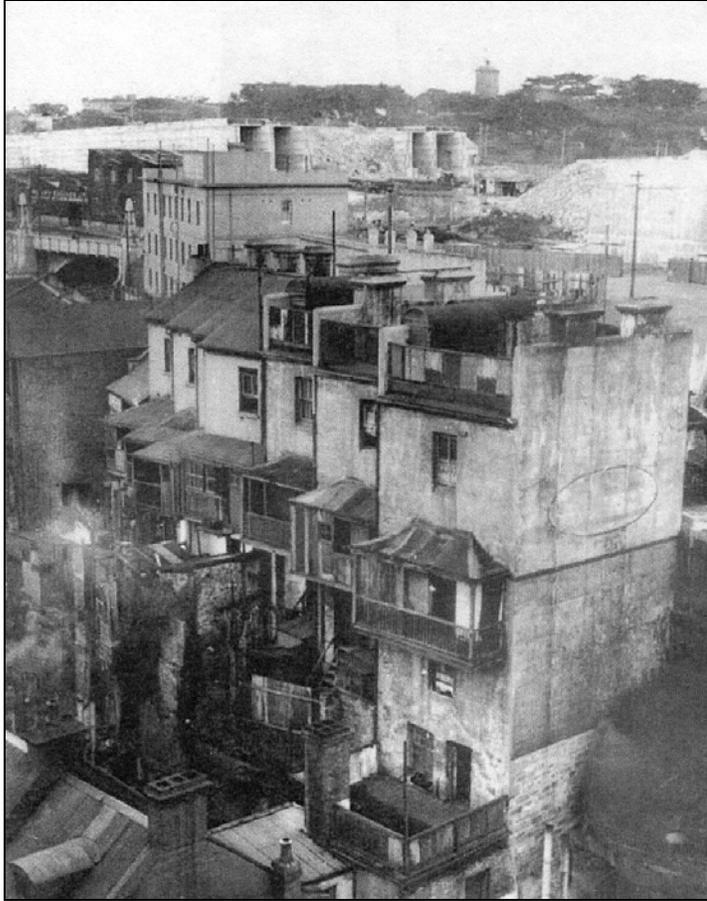
Figure 2.11 Terraces on the Gloucester Street alignment, 1930 (now Gloucester Walk) interpreted in Foundation Park. The subject buildings are just visible at bottom left.

A photograph dated 1930 (**Figure 2.11**) shows the rear of the large, multilevel houses along the Gloucester Street alignment (now Gloucester Walk). It is clear that the buildings were constructed with minimal concern for light and air. Most of the houses were vacated by the mid 1930s. The City Engineer gave approval to demolish in 1938 and the work was apparently completed by July the following year.⁶²

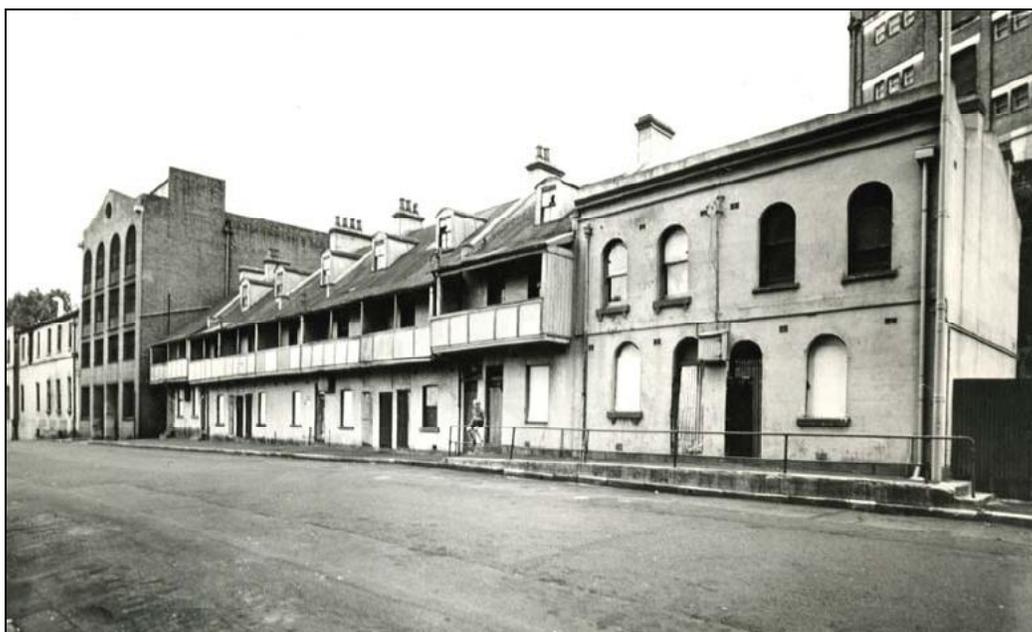
Figure 2.13 The buildings c.1970s prior to the restoration works. (Source: Foreshore Authority Archives PS 01)

In another photograph (**Figure 2.13**), also dating from the c. 1970s, the Playfair Street facade has been rendered. There appears to be no change to the balconies or facades. Meter boxes are fixed to the front façade. A narrow footpath with sandstone kerbing runs across the front of the buildings. The north end of the street falls and a handrail runs across the front of Nos. 13-15. The photographs also highlight other changes in the area, such as the demolition of the earlier residential buildings on the eastern side of Playfair Street and the widening of the road. A photograph of the rear of the buildings also assumed to date from this time (**Figure 2.14**) shows the painted rear façades, rear wings and annexes of the buildings. A two storey building is evident at the rear of No. 17 at this time. The structure is not shown on the 1925-1932 plan, which may indicate that it was constructed some time since the early 1930s. Some of the remains of the terraces that faced Gloucester Street, now Gloucester Walk, are also just visible in the over grown rock face to the right, (west) of the buildings.

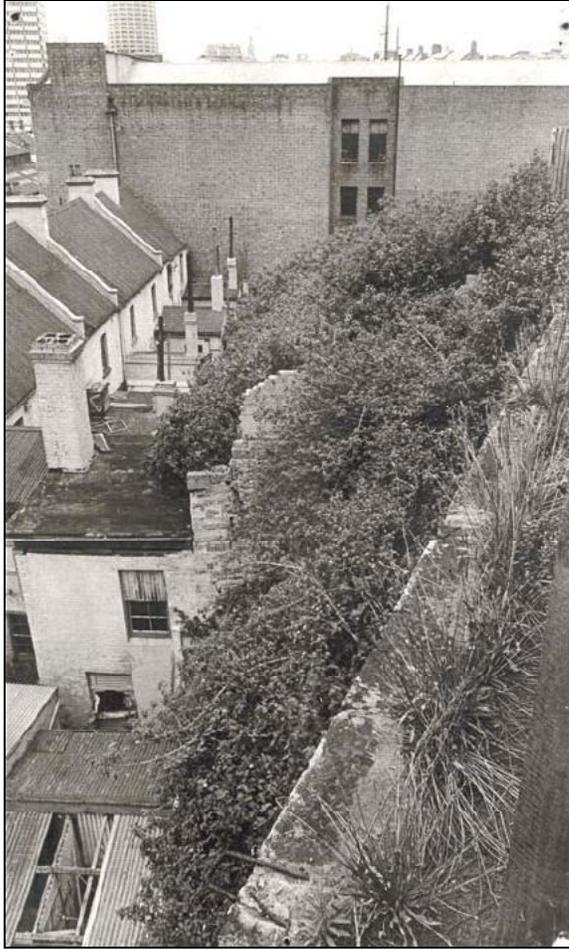
Figure 2.14 The rear of the buildings in early 1970s. It would appear that a two storey building had been constructed at the rear of No. 17.

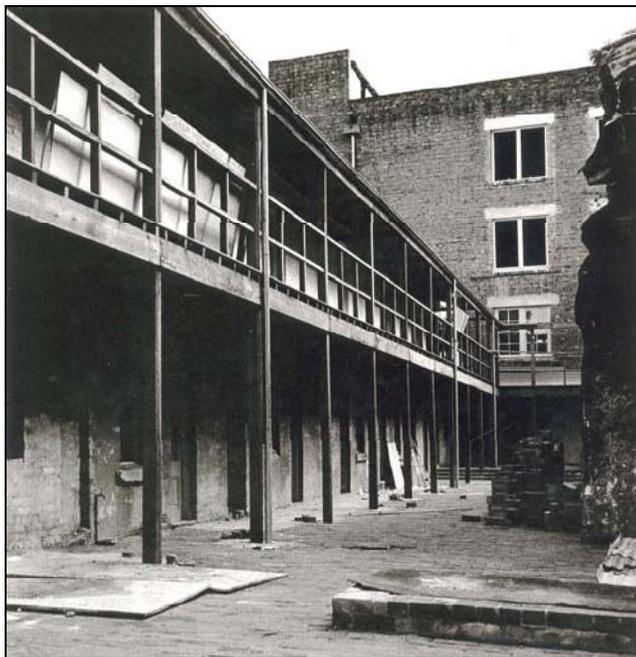
Figure 2.19 A photograph showing the new timber deck and upper floor access spanning across the rear, western façade of Nos. 17-31, constructed as part of the 1972 works. The Cleland Bond Store is also accessed by the stair and walkway.

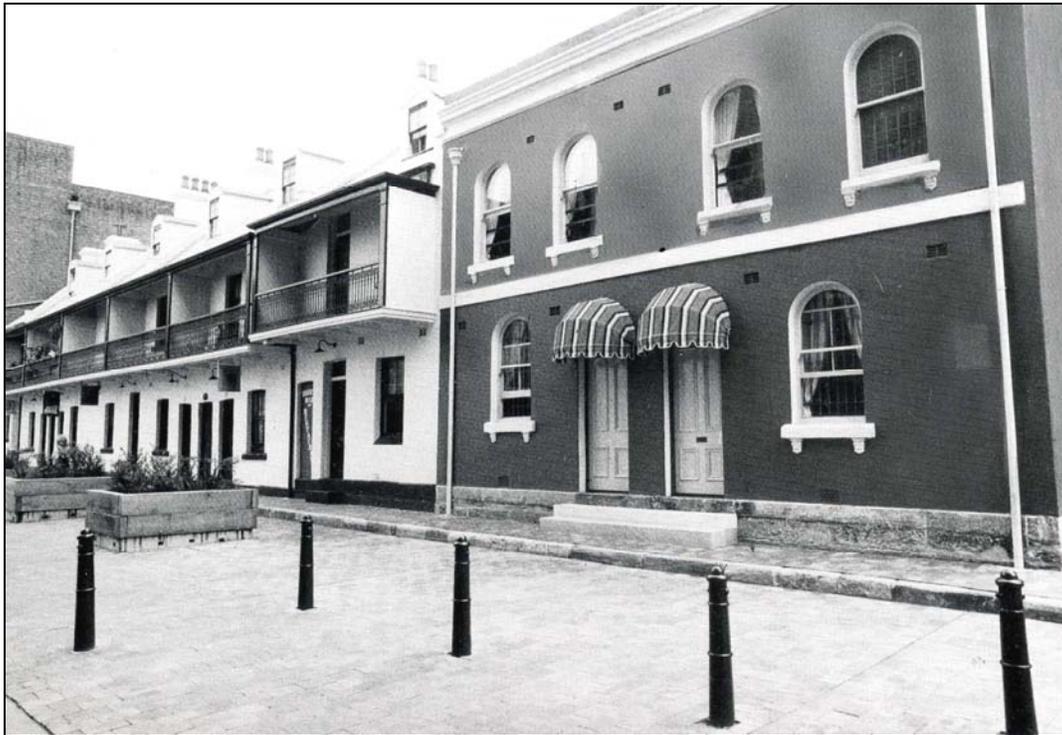
Figure 2.20 The buildings c.1980s after restoration works. (Source: Foreshore Authority Archives PS 07)

A photograph dating from c. 1980s (**Figure 2.20**), shows the newly painted and restored buildings and paving and landscaping to Playfair Street. The buildings appear to be newly painted. The light wall colour is in contrast to the stone plinth/base which appears to be painted in a dark colour. The balconies have clearly been restored with "lace" balustrade reinstated. The photograph incates that the open passage between Nos. 17 and 19 , with simple timber boarded door, remained at this time.

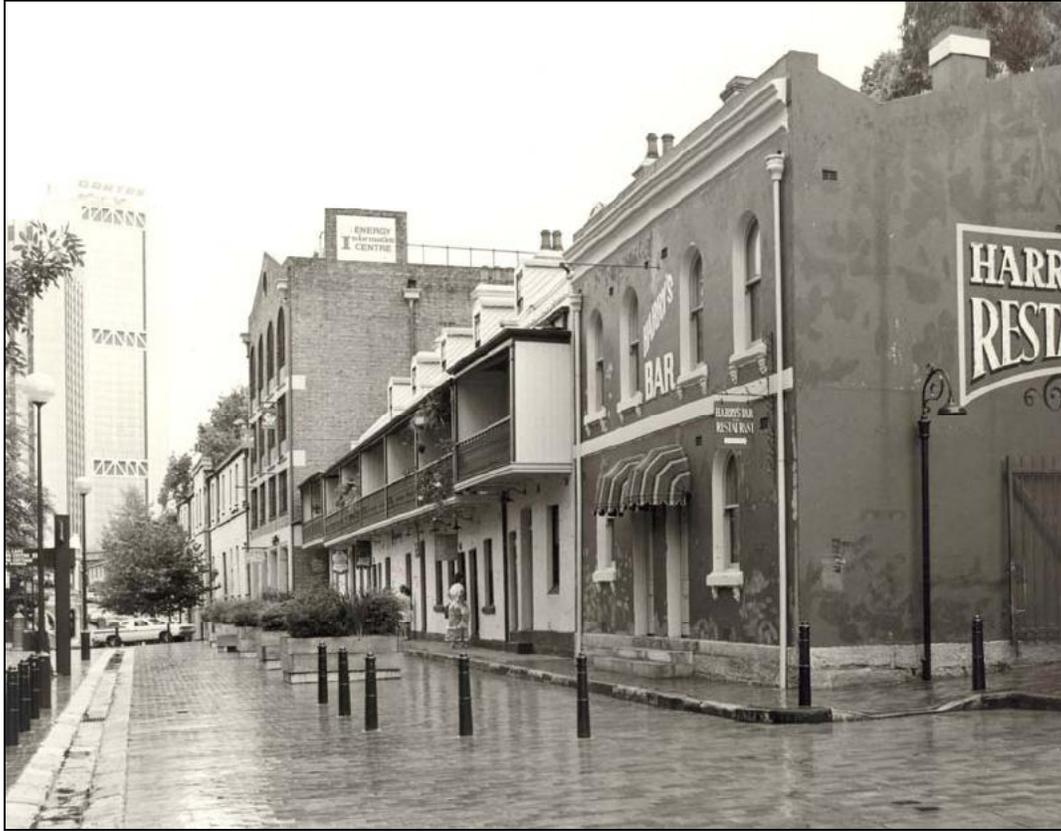
Figure 2.21 The buildings c.1980s after the restoration works. (Source: Foreshore Authority Archives PS 11)

Another photograph taken of the buildings (**Figure 2.21**)⁶⁹ shows the occupied buildings. The addition of signage and repairs to the rendered northern facade are evident. The landscape works and partial closure of the Playfair Street is also evident. A number of bollards and reproduction light fixtures and lamps are located on the western side of the street, associated with the “historic” built context with modern lamps located on the eastern side.

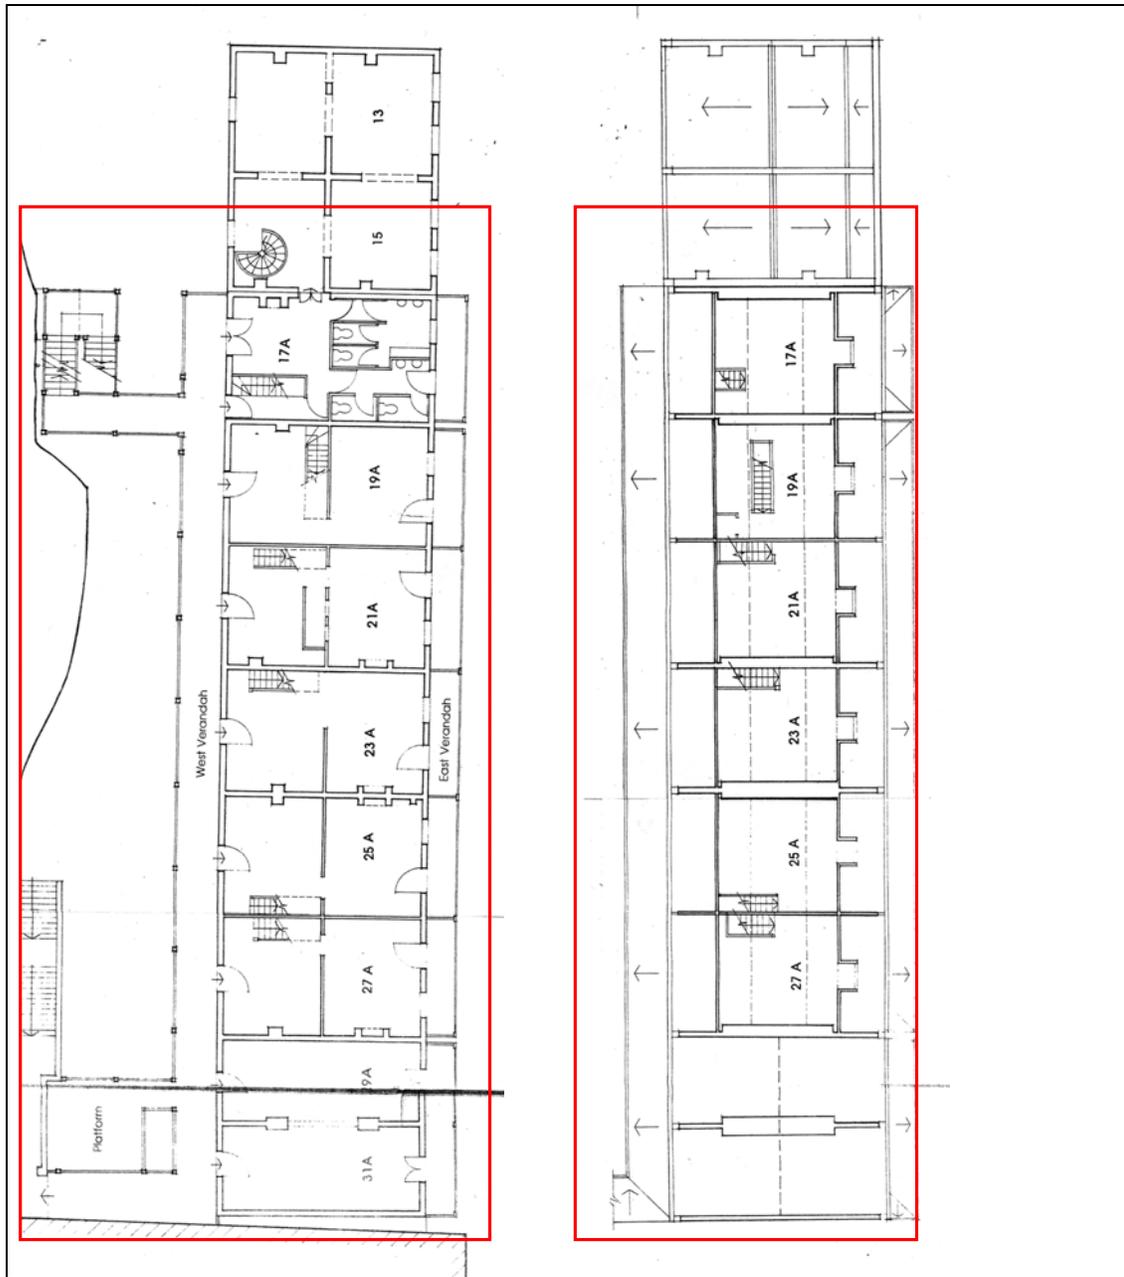
Figure 2.25 The measured first floor (left) and attic (right) plans prepared by Tropman & Tropman Architects. (Source: Foreshore Authority Archives RE 1199.01.01)

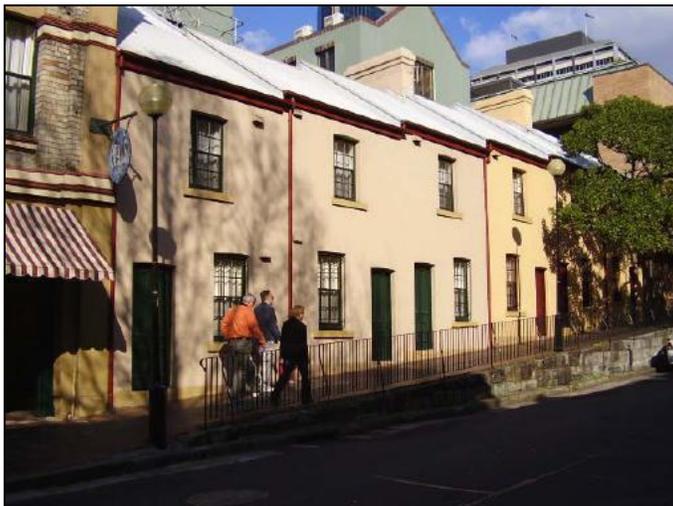
Figure 2.31 Nos. 42-52 Harrington Street are two storey, bald face terraces which date from a similar period from the subject terraces and feature similar scale and characteristics to Nos. 17-27 such as the simple nature of the facades and pitched roof, but also differ in that they do not have exposed party walls or balconies.

The terraces located in the northern end of Harrington Street, closer to the intersection with Argyle Street including Nos. 55-71 and more specifically Nos. 42-52 (**Figure 2.31**) on the eastern side of the street are two storey, bald face terraces with gable roofs and similar simple openings and multipaned windows. Constructed between 1874 and 1880

they date from the same period as Nos. 17-31 and feature similar scale and form, however, do not feature cantilevered upper storey balconies and exposed party walls. Nos. 61-65 Harrington Street (**Figure 2.30**) on the western side of the road also features a similar form with exposed party walls, however, were constructed a little earlier in the c. 1860s.

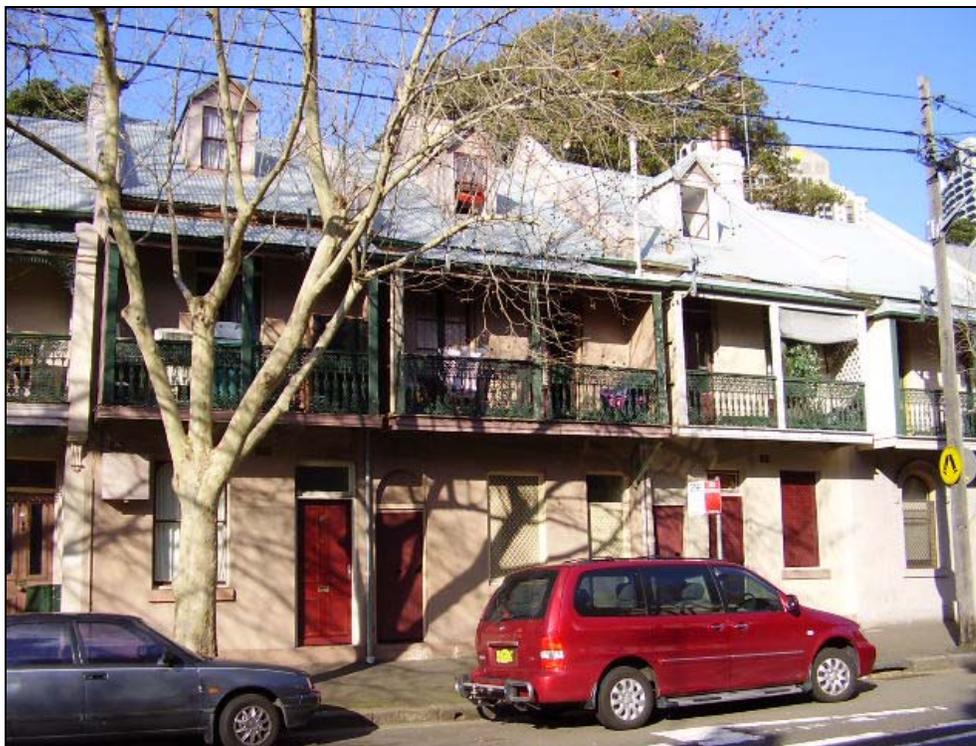
Figure 2.36 Comparable terraces at Nos. 56-62 Kent Street, Millers Point, also feature attic spaces with street facing dormer buildings.

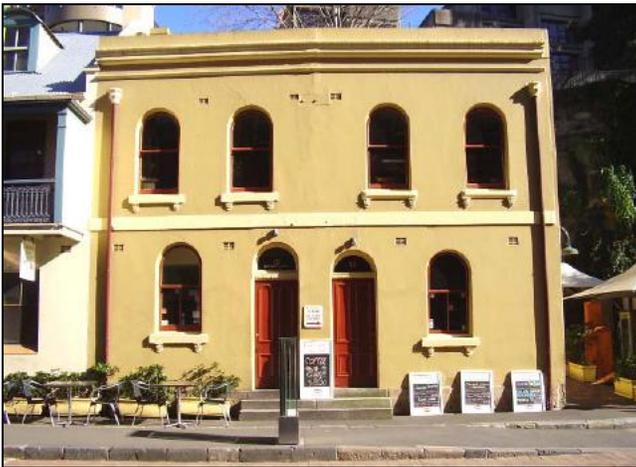
Figure 3.13 Nos. 13 and 15 Playfair Street located to the immediate north of the grouping is a pair of terraces with continuous parapet with profiled cornice and arched headed openings. The façade is also mirrored about the concealed central party wall.

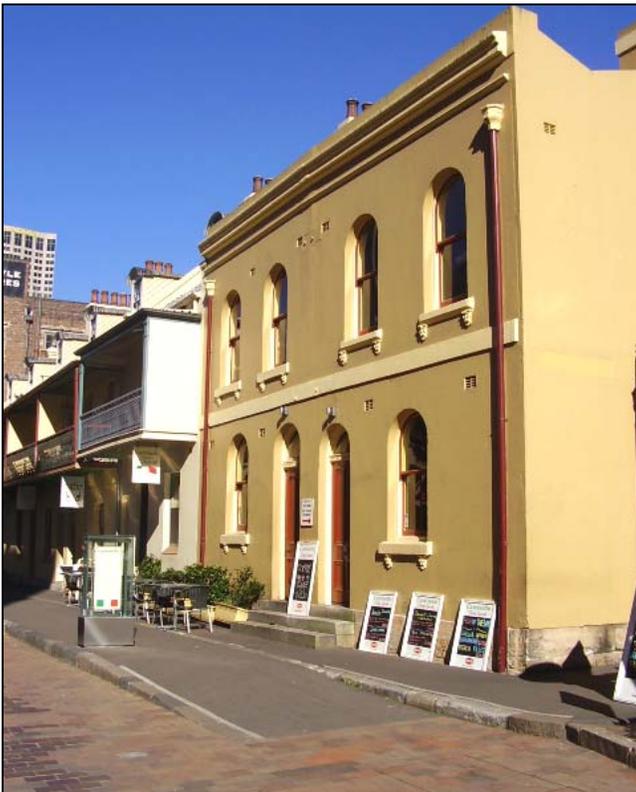
Figure 3.14 The rendered building sits on a face stone plinth and also features rendered moldings and window sills.

The internal connection with No. 17 is not apparent from the street façade.

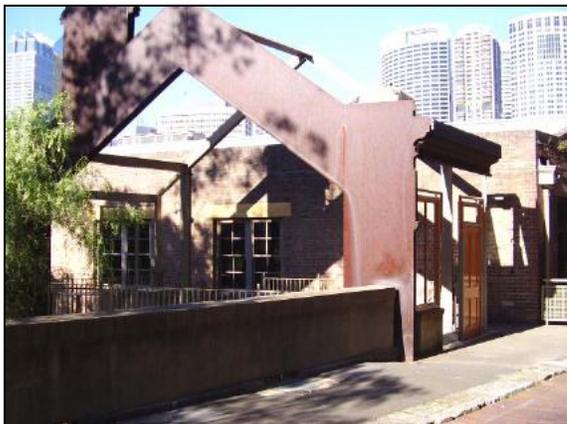
Figure 3.17 Sculptures at the south western corner of the Park interpret the former terrace and dwelling that occupied this area. The “tower” element incorporates a stairwell and platforms below that provide a pedestrian link to Playfair Street but also interpret the various levels of the earlier dwelling.

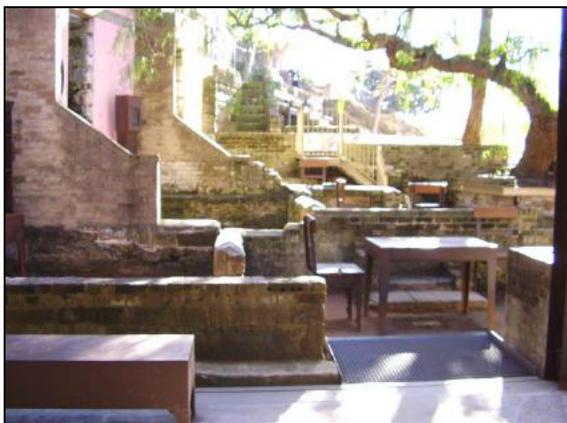
Figure 3.21 View of the Park, mid level looking north. The configuration and layout of the various dwellings and living spaces have been interpreted.

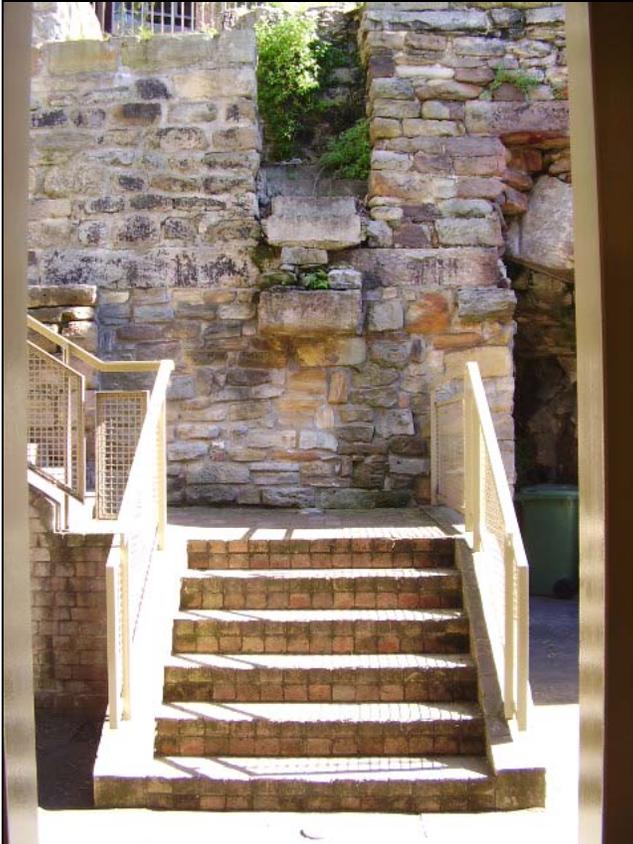
Figure 3.26 The southern stair which extends down from the tower and southern end of Foundation Park corresponds to the open passage between Nos. 25 and 27 Playfair Street and connection to Playfair Street.

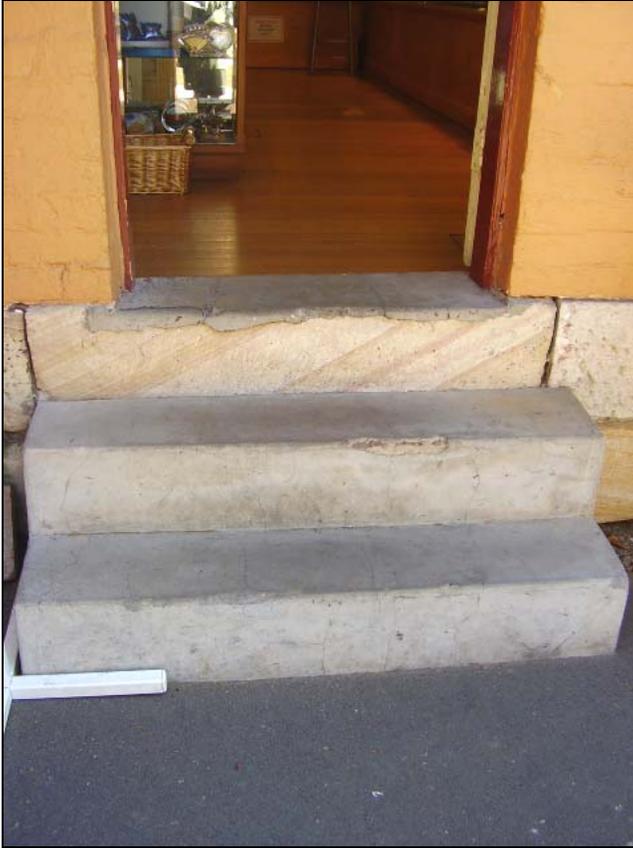
Figure 3.37 The floor level of Nos. 29-31 is slightly higher than the other terraces in the grouping. A cement screed has also been added to level the worn sandstone steps.

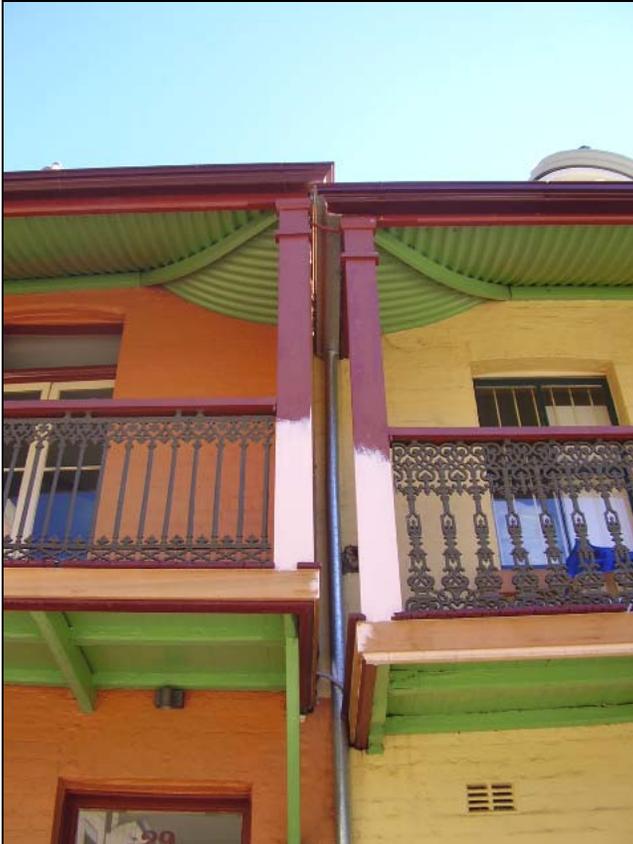
Figure 3.38 The junction between Nos. 29 and 27 which emphasises the staged construction of the terraces. There are differences including opening pattern, however, the first floor cantilevered balconies feature the same details including hipped curved roof. A simple timber strut has been added to the northern end of the balcony over No. 29.

The verandahs were reconstructed as part of the 1970s works and also repaired as part of the 1990s works. Some recent works and patching is also apparent.

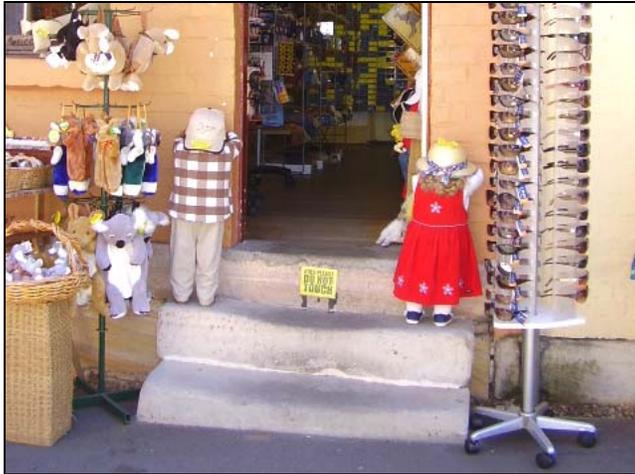
Figure 3.39 The ground floor entry to No. 29 from Playfair Street. A cement screed has been added to the top step/ door threshold, however, wear and tear is evident on the lower two steps. Building tenants also use the external footpath to display merchandise and draw customers into the shop spaces.

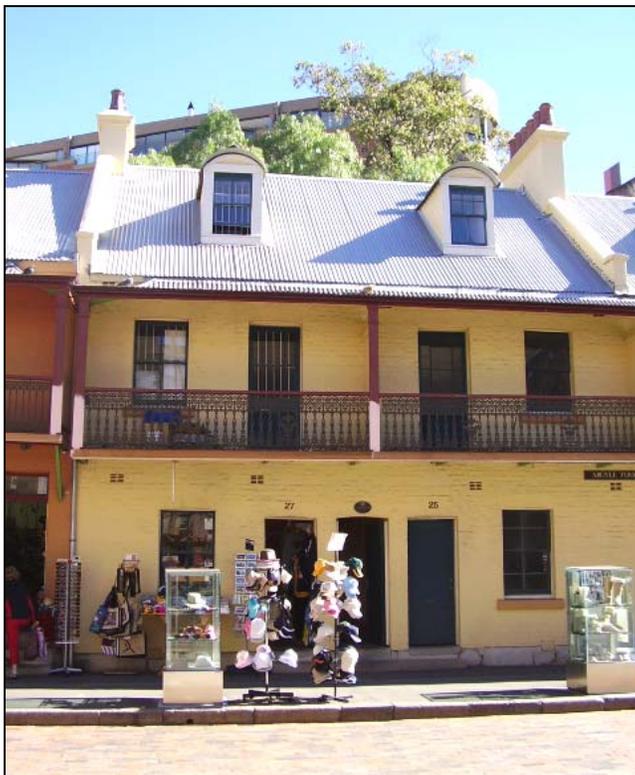
Figure 3.40 Nos. 25 and 27 are mirrored about the central, ground floor passage that extends through the building. The southern pair of the grouping of five that were first constructed on the site, they are bounded by projecting party walls and rendered chimneys with profiled capping and terracotta chimney pots. The facades feature single window and door openings on both the ground and first floor. The ground floor features multipaned double hung windows, timber panelled doors with flat arch over with single, four pane window and timber and glass panelled door accessing the first floor balcony. The main roof which extends over both dwellings also features two dormer windows on the eastern, front roof slope with curved roof and double hung timber framed windows.

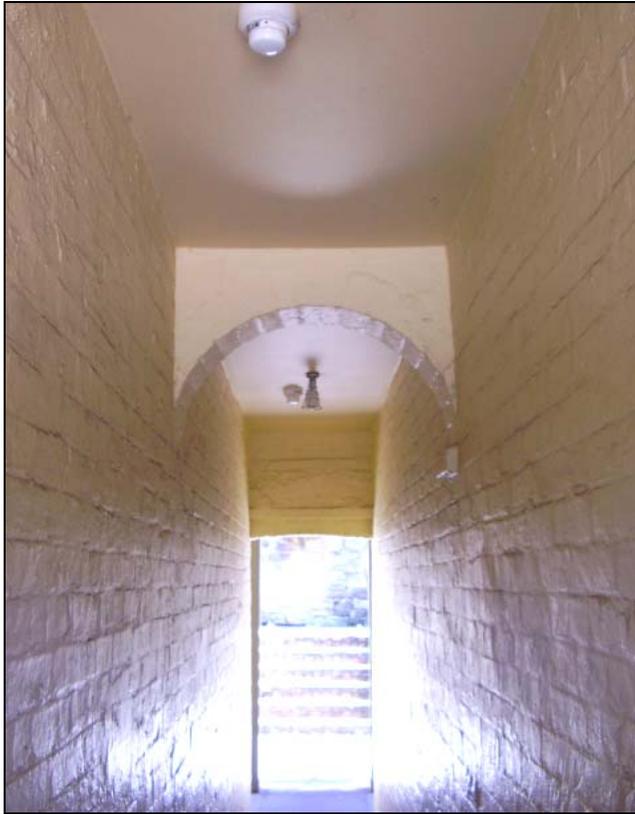
Figure 3.42 The open, ground floor passage located between Nos. 25 and 27 features simple finishes including painted brick walls. A simple brick arch is located halfway.

This passage corresponds with a stair that leads up to Foundation Park and the Gloucester Walk.

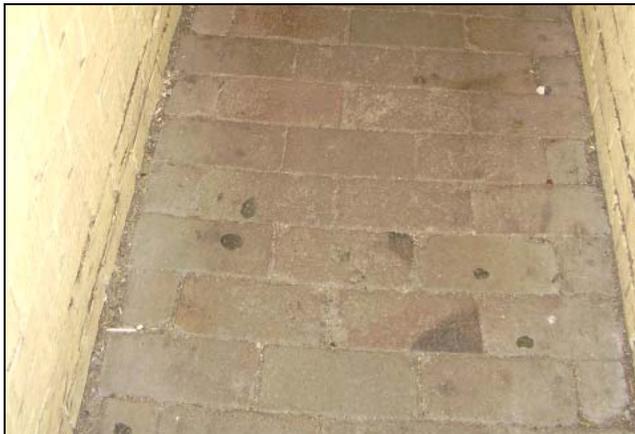
Figure 3.43 The floor of the southern passage has been finished with concrete block pavers which it is assumed date from the 1970s works and remain in good condition.

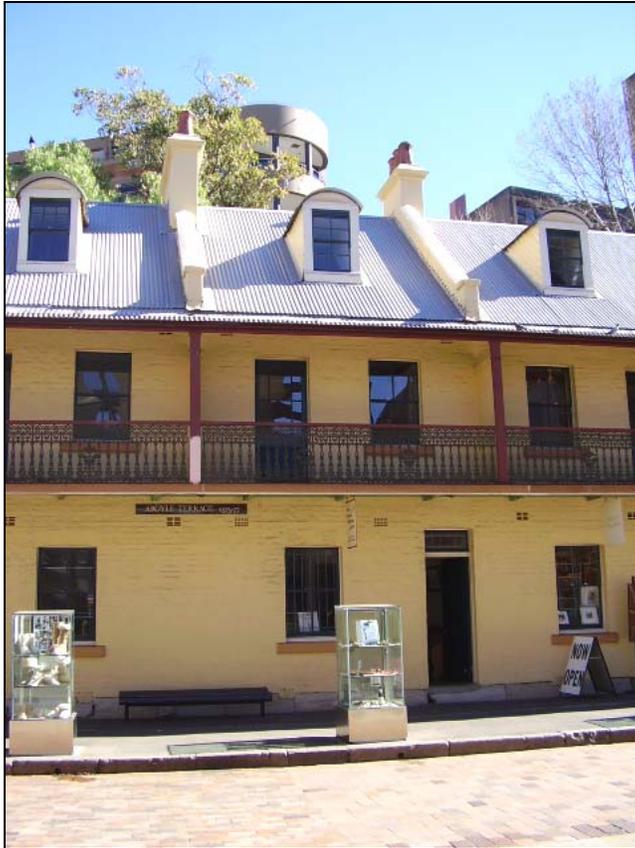
Figure 3.45 No. 23 Playfair Street is the centre terrace of the grouping of the five that were first constructed. The front façade also features single window and door opening to both the ground and first floors and single curved roof dormer window on the front, eastern roof slope. The ground floor door, however, also features a glazed toplight over.

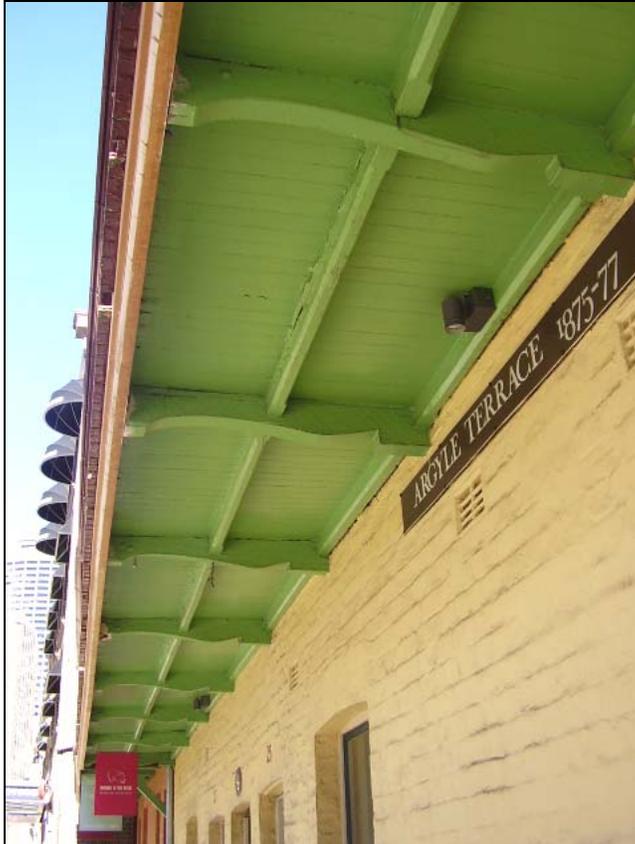
Figure 3.46 The cantilevered balconies were reconstructed as part of the 1970s works and also repaired as part of the 1990s works. It is assumed that details matched the earlier form and fabric including the decorative bearers. The verandah framing appears to be in good condition, although some recent patching and repairs are evident at the northern and southern end.

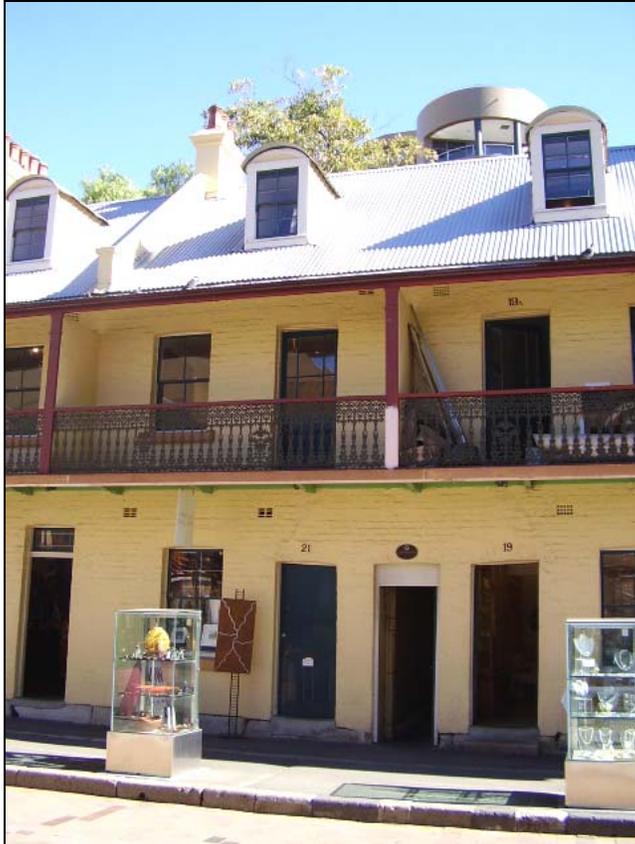
Figure 3.48 Nos. 19 and 21 Playfair Street located at the northern end of the central five terraces. Like Nos. 25 and 27, these terraces are located about the ground floor open passage that extends through the building and they share the same roof between the two end projecting party walls. Like the terraces to the south, they also feature single door and window openings to both the ground and first floor facades.

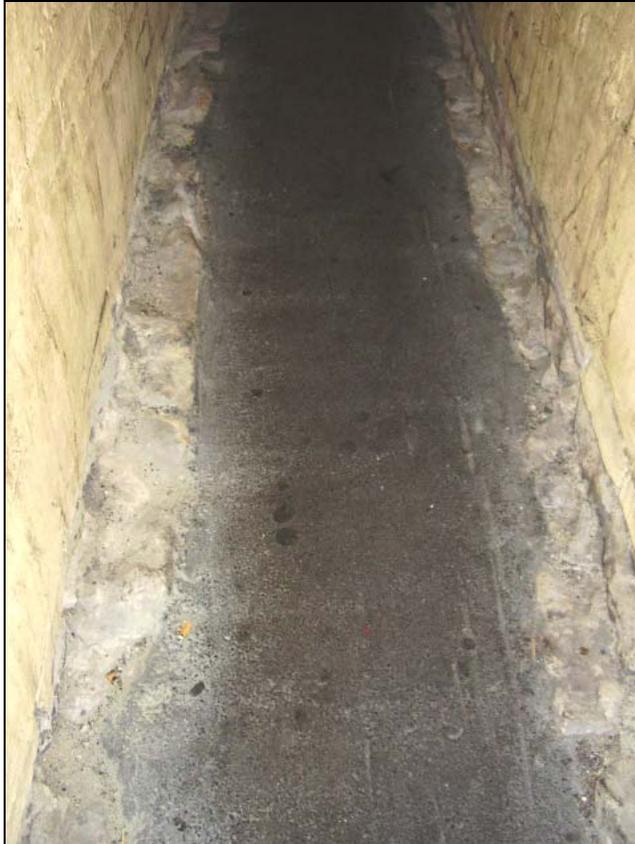
Figure 3.50 The floor of the northern passage, however, features face stone along the wall/floor junction with asphalt finish between. It is assumed that the stone edging is original, it is not clear when the asphalt finish was added.

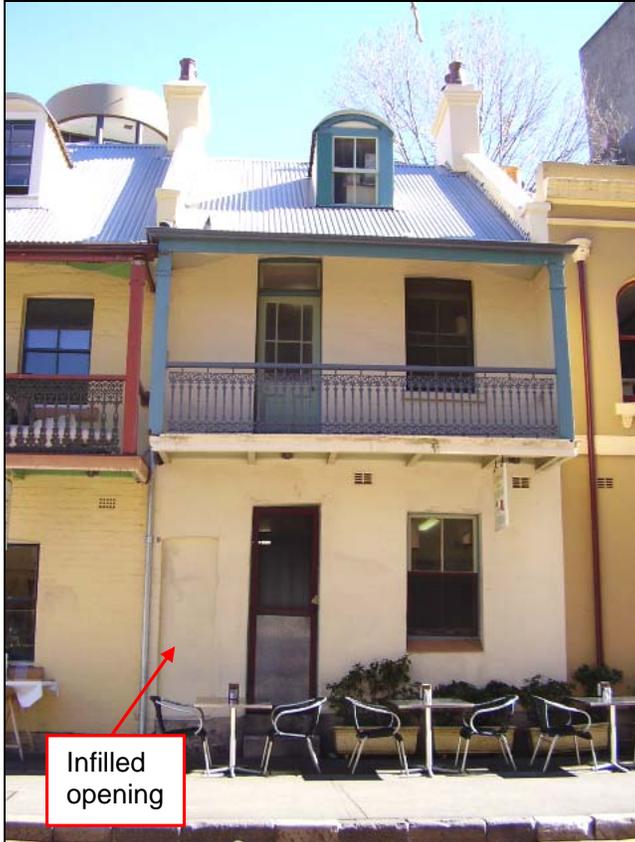
Figure 3.52 No. 17 Playfair Street is the only “single” terrace, however, internally has now been incorporated with nos. 13 and 15. The façade also features a single window and door opening on both the ground and first floor. Both the ground and top floor door openings also feature toplights. The ground floor also features a blind opening which was infilled as part of the 1970s works and conversion of the ground floor to a kitchen. The opening originally was part of a passage that provided access to a dwelling constructed at the rear of No. 17. The eastern roof slope also features a single dormer window with curved roof and double hung timber framed window with two panes on the top and bottom window sashes.

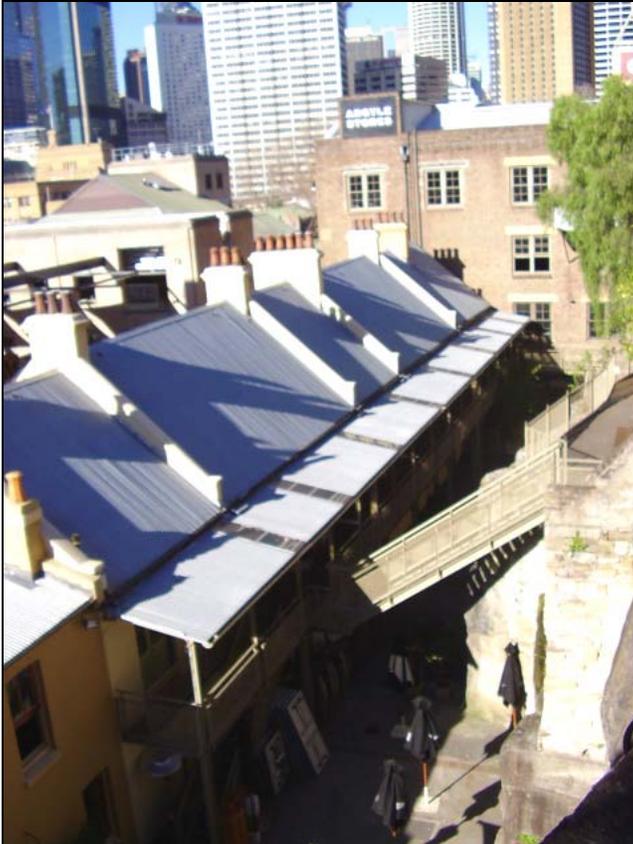
Figure 3.54 The roofscape of Nos. 17-31. The roofs, party walls and associated chimneys and pots all appear to be in very good condition. The roof cladding was replaced in the 1970s and as part of the 1990s works.

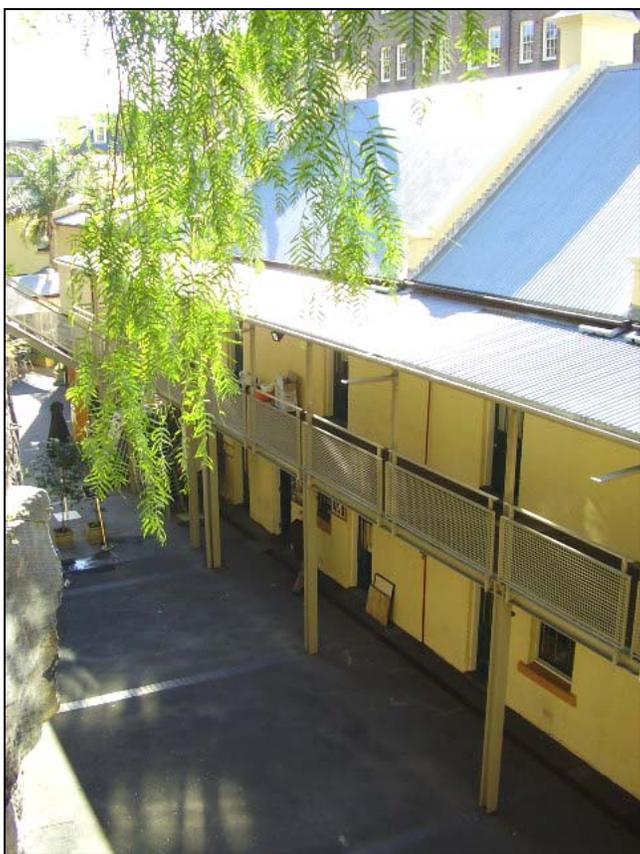
Figure 3.56 The painted brick, rear façades of the terraces are in good condition.

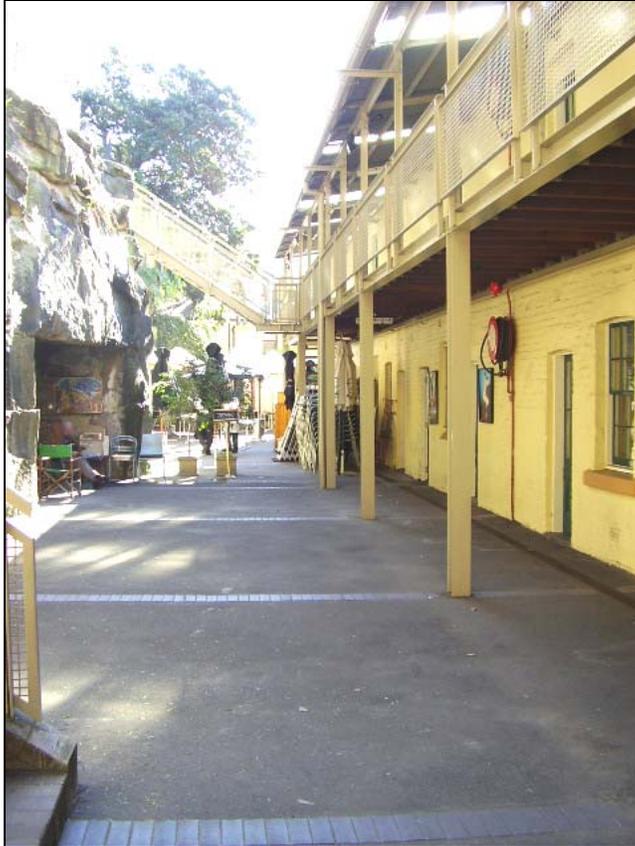
Figure 3.57 View of the open courtyard at the rear of the terraces looking north. The courtyard was opened up and formed as part of the 1970s works. The former boundary and fence lines are interpreted by brick paving.

The linking stair with Foundation Park and Gloucester Walk and steel framed deck were added in the 1990s.

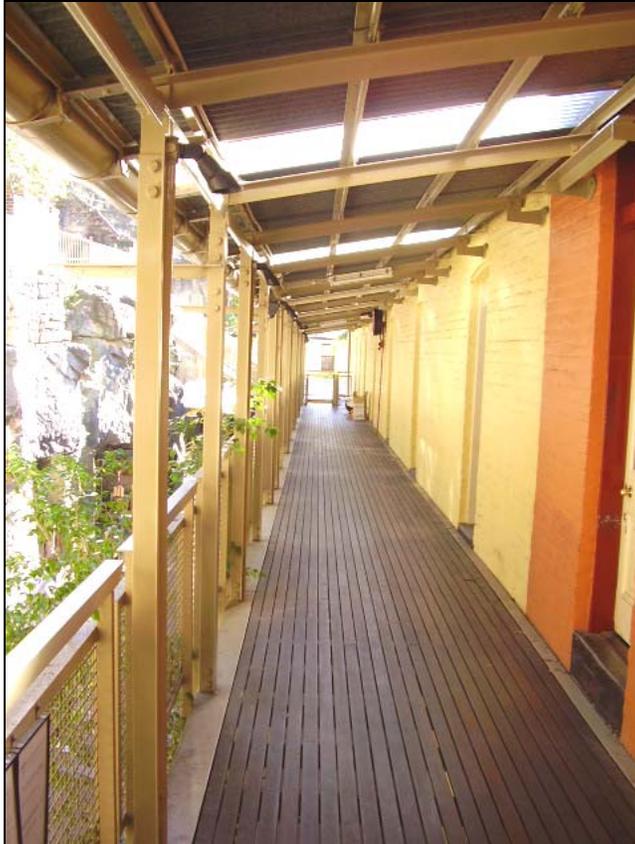
Figure 3.58 View of the steel framed access walkway and deck that accesses the upper floor tenancies. Clear roof sheets have been incorporated to provide additional daylight.

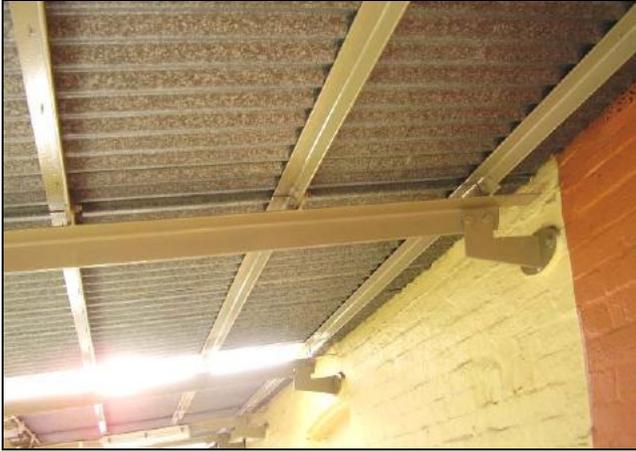
Figure 3.59 Detail of the steel framed roof to the western balcony and deck. The steel framing has been fixed to the painted brick facades.

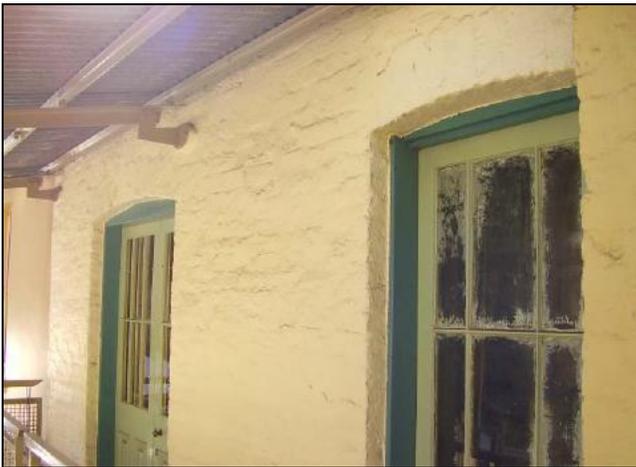
Figure 3.60 View of the upper floor openings on the western façade of No. 17. The original window openings were altered and doorways formed as part of the original restaurant fitout works in the 1970s.

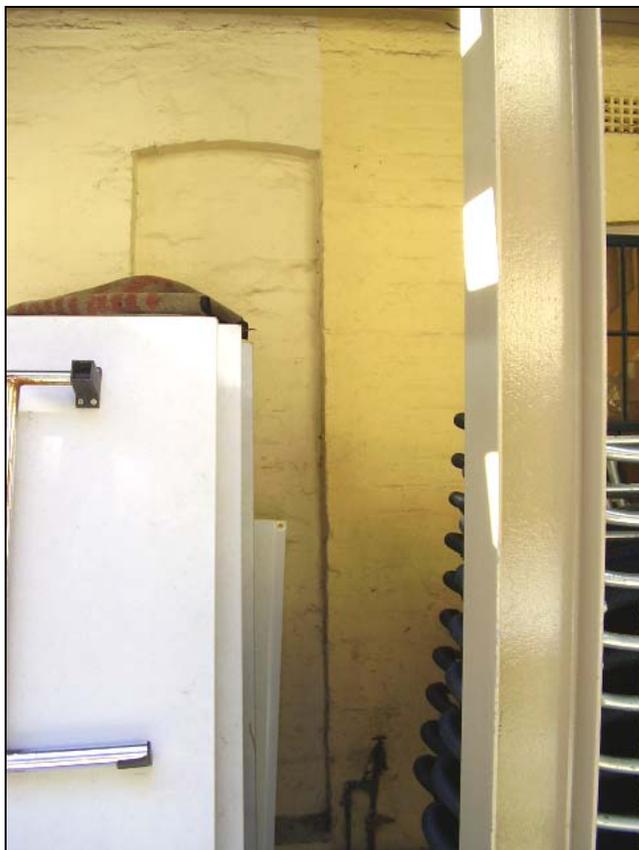
Figure 3.62 The infilled, blind opening to the former open passage located on the ground floor between Nos. 17 and 19. The openings on both the eastern and western facades were infilled as part of the 1970s works.

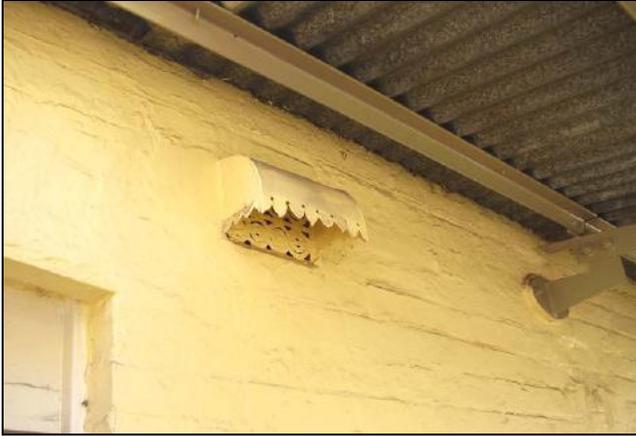
Figure 3.64 The façade retains some earlier building elements and finishes such as hooded vents.
