Final Draft CONSERVATION MANAGEMENT PLAN

Playfair Street Terraces, Nos. 17-31 Playfair Street The Rocks

Prepared for Sydney Harbour Foreshore Authority
September 2006

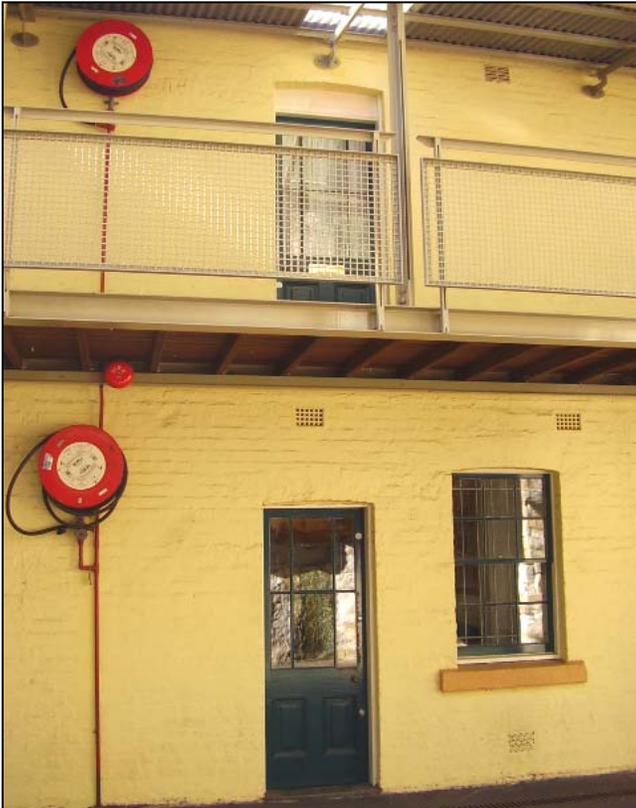
Figure 3.65 The rear façade generally retains original openings and introduced services and elements such as the stair and western balcony.

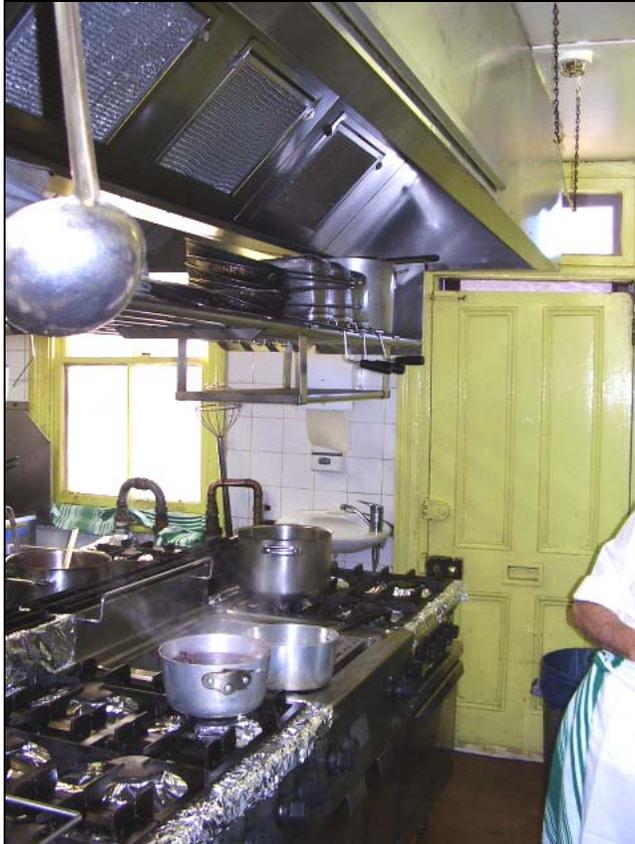
Figure 3.70 View of the ground floor kitchen looking east to the Playfair Street façade. The space features vinyl floor finish on concrete floor slab, ceramic tiles to the walls and modern stainless steel fixtures and fittings. The kitchen was originally created as part of the 1970s works to the building. The space now incorporates the open passage that existed between Nos. 17 and 19.

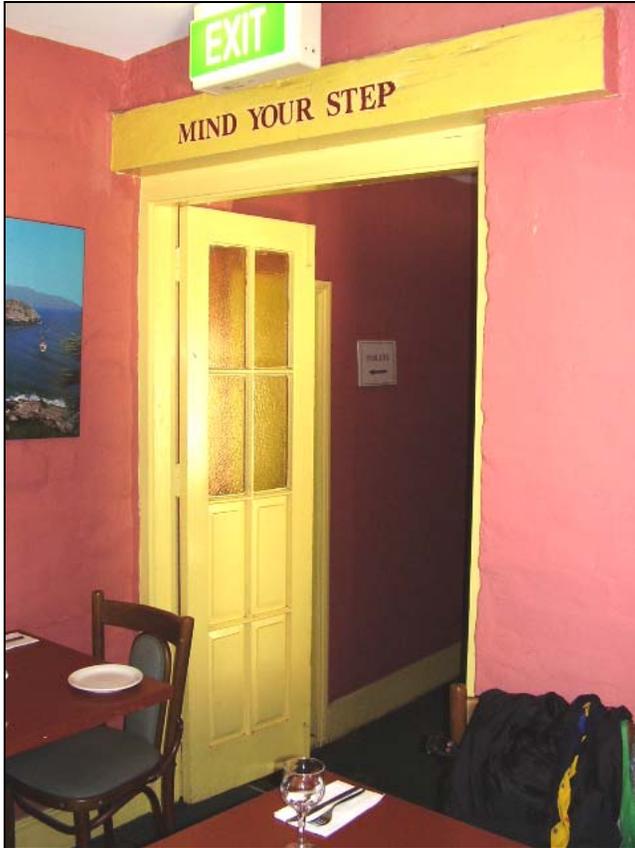
Figure 3.71 View of enlarged opening and doorway made in the upper, western party wall between Nos. 15 and 17 (1970s) leading to the rear, western room of No. 17. The transition between the two buildings is evident with a change in floor level and “step”.

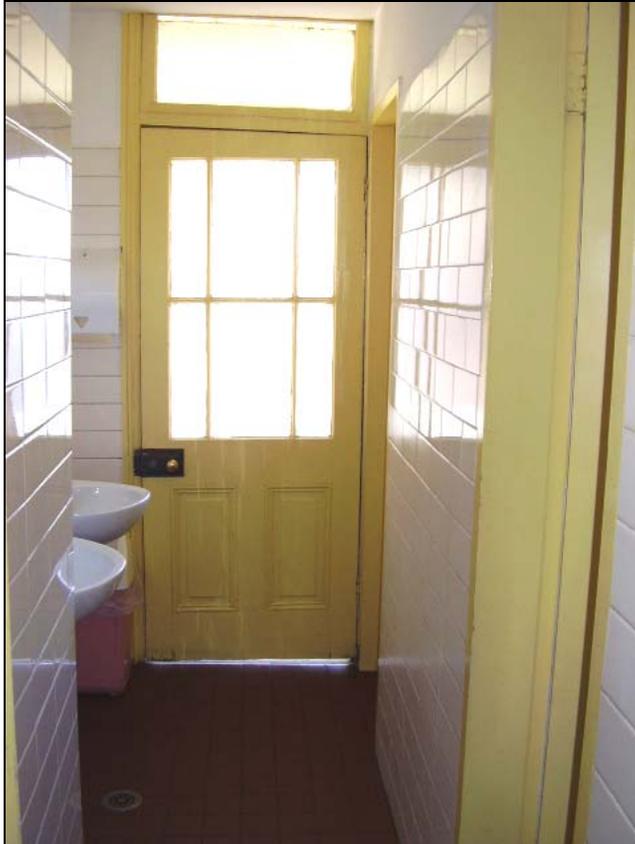
Figure 3.72 View of the female WCs added to the front, eastern room of No. 17 as part of the 1970s works. The bathrooms, which feature lightweight stud walls and ceramic tile finishes to floors and walls have been upgraded with modern fixtures and features appear to be in good condition.

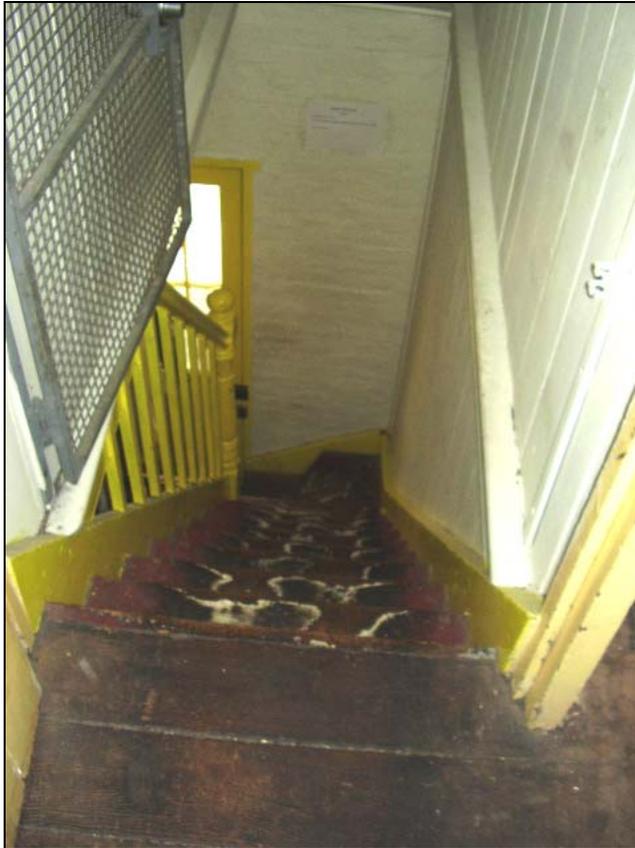
Figure 3.73 Narrow, timber stair access to the attic over No. 17. The stair, which features simple turned timber newell post and simple square balustrade is located in the rear, western room of No. 17. The stairwell is also partially enclosed by timber boarded partition. The stairwell and associated elements appear to be in good condition. The stair treads are slightly worn and retain evidence of several coats of paint and finishes.

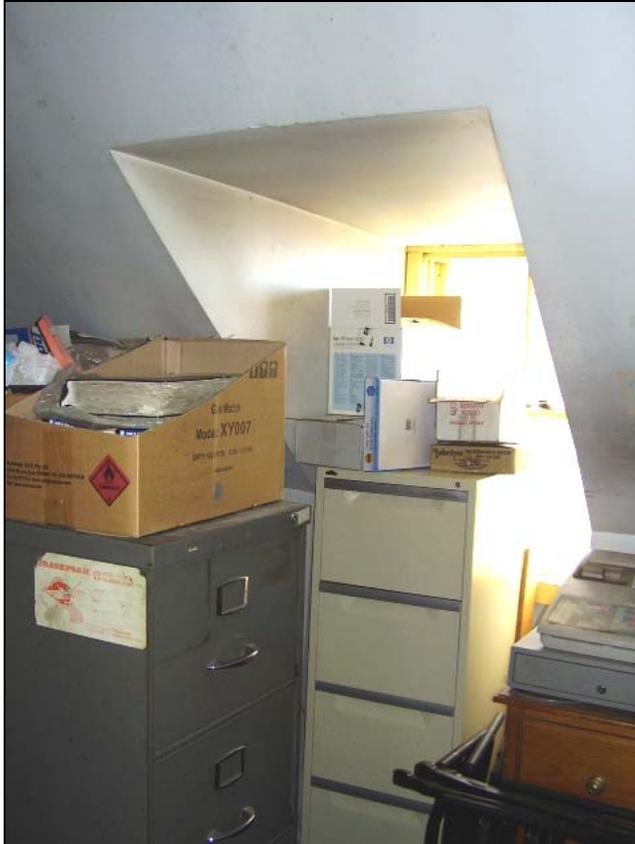
Figure 3.74 View of the attic and dormer window on the eastern roof slope.

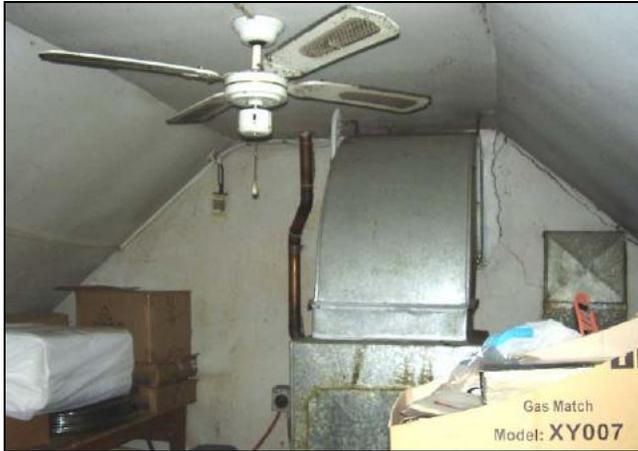
Figure 3.75 View of the northern wall and attic space which is simply finished with timber floors, plaster walls and raked ceiling which are in fair condition. A crack is visible to the right of the exhaust duct.

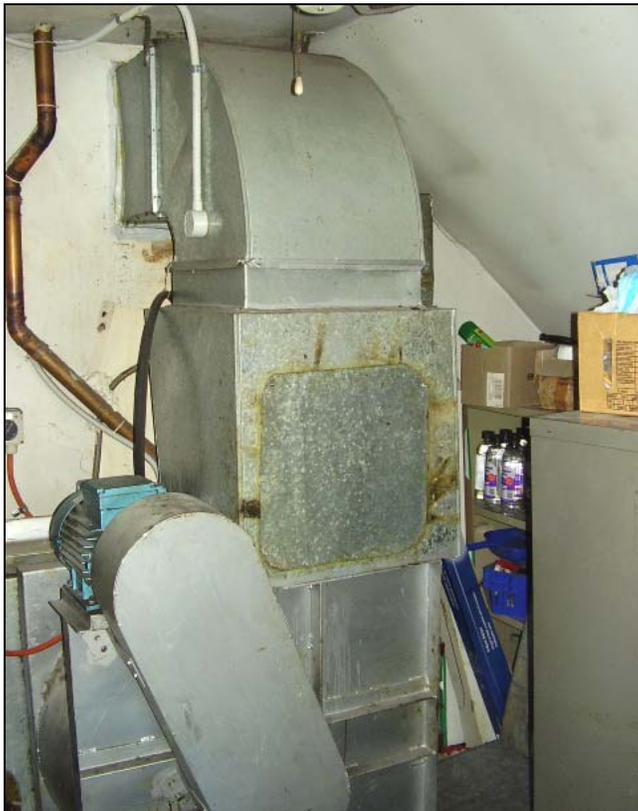
Figure 3.76 The attic features the exhaust from the ground floor kitchen added as part of the 1970s restaurant fitout.

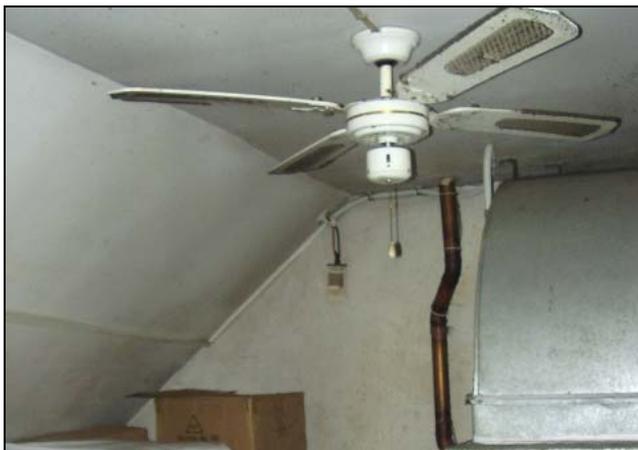
Figure 3.77 A fan and services have been added to the attic space. The space requires additional ventilation as the mechanical equipment generates some heat in the confined area.

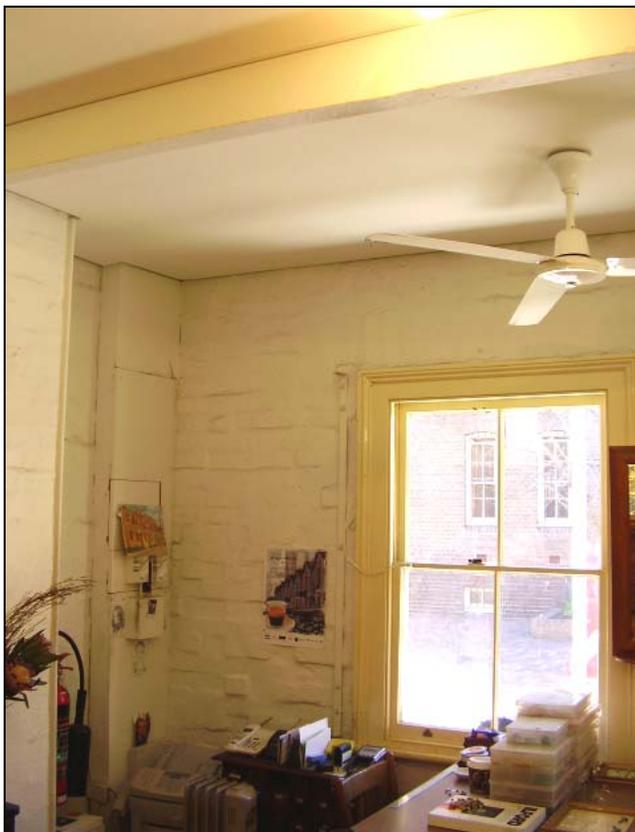
Figure 3.79 View of the north eastern corner of the ground floor of No. 19. The rooms are simply finished and in good condition with timber floors, painted and bagged brick walls and plasterboard ceiling. An aluminium shadow line/track has been added to the ceiling and wall junction to allow hanging. A ceiling beam extends across the width of both rooms.

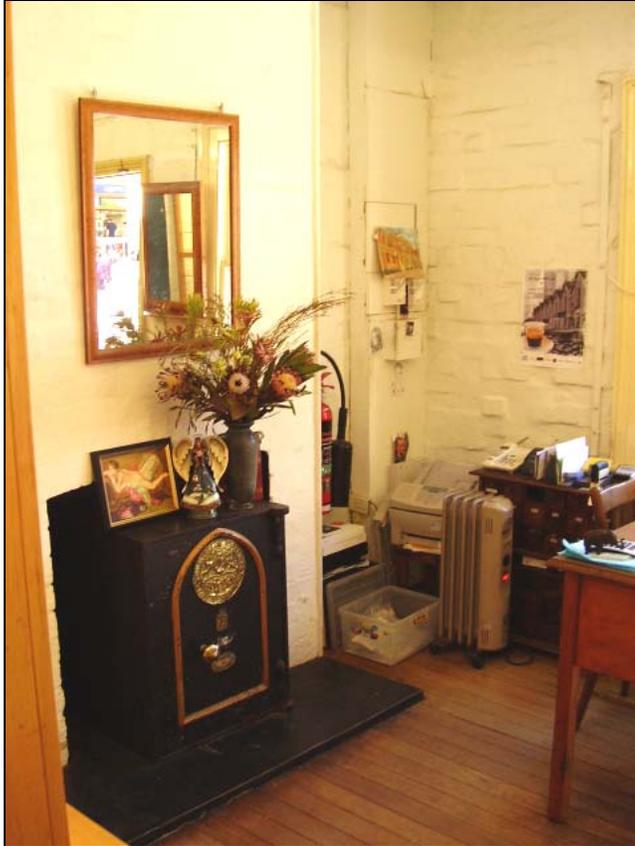
Figure 3.80 The front, eastern room of No. 19 retains a chimney breast on the northern wall with simple, flat arched opening. A concrete screed and step has been added to the hearth. A services duct, assumed to have been added as part of the 1990s works, extends up the north eastern corner of the room.

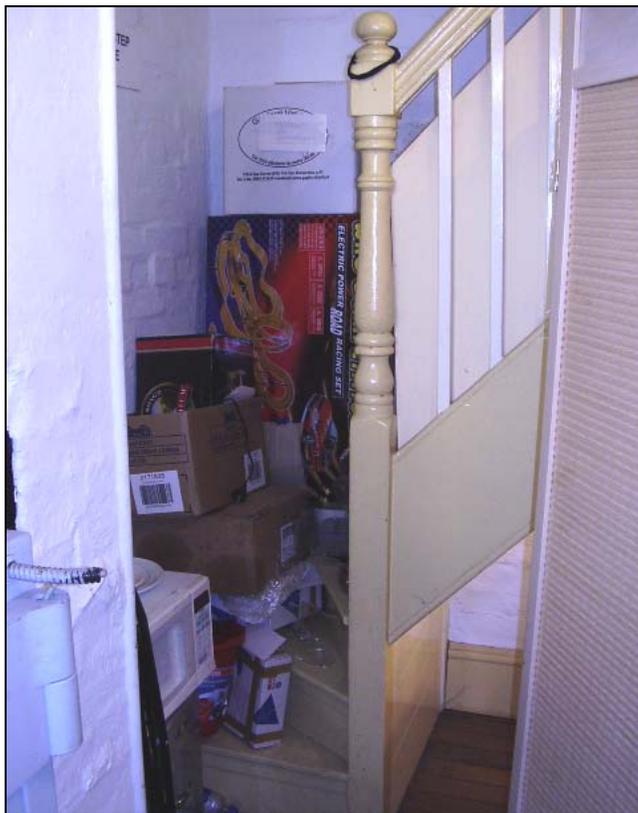
Figure 3.83 A narrow timber stair with turned timber newell post, profiled rail and simple balustrade extends up the western face of the cross wall.

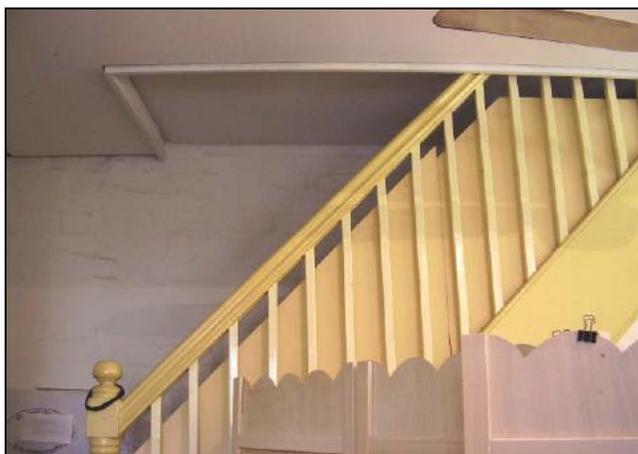
Figure 3.84 The stair remains, however, the opening above the stair has been infilled, with upper floor accessed from the western balcony and deck.

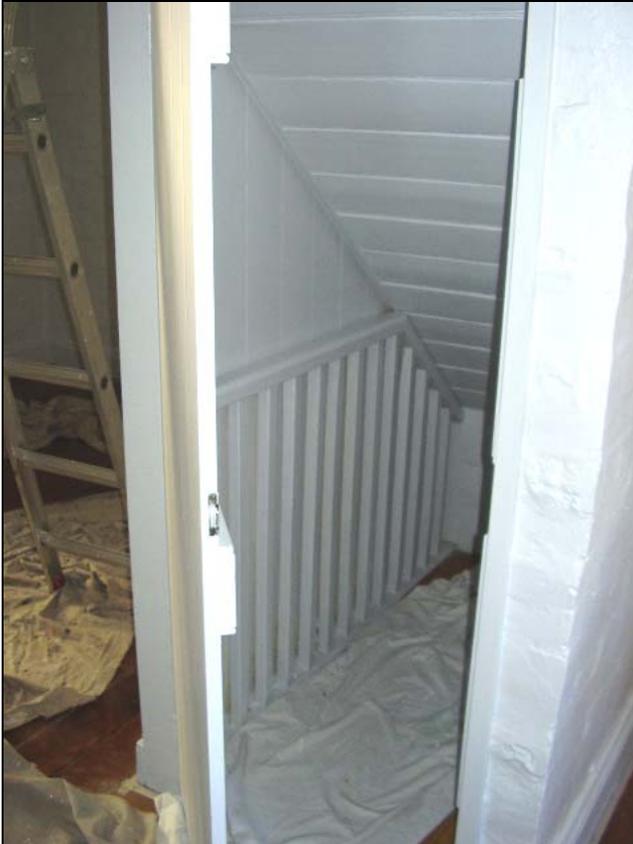
Figure 3.86 View of the blocked off stair between No. 19 (ground floor) and No. 19a. A cupboard has been formed around the base of the stair which continues up to the attic space.

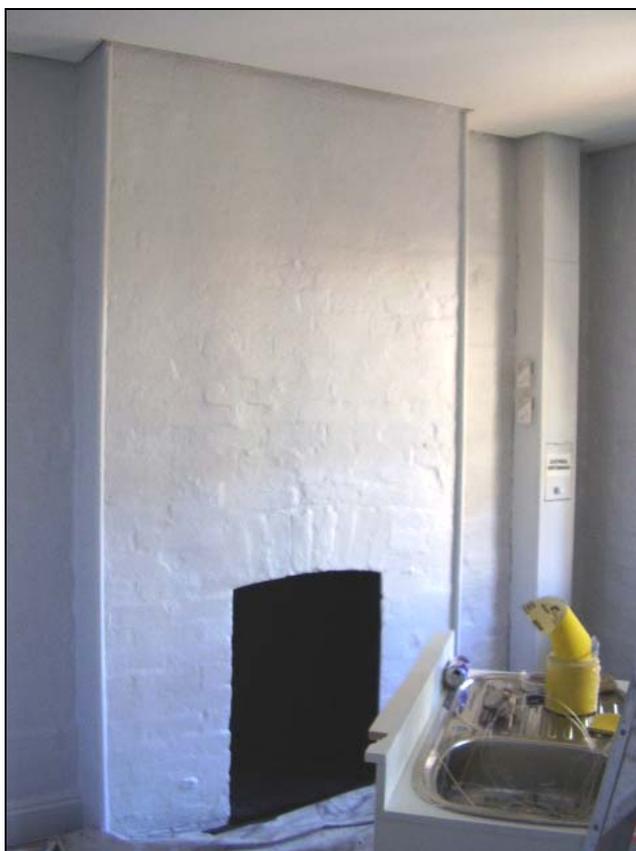
Figure 3.87 The northern wall of the front eastern room retains the chimney breast with brick flat arched opening.

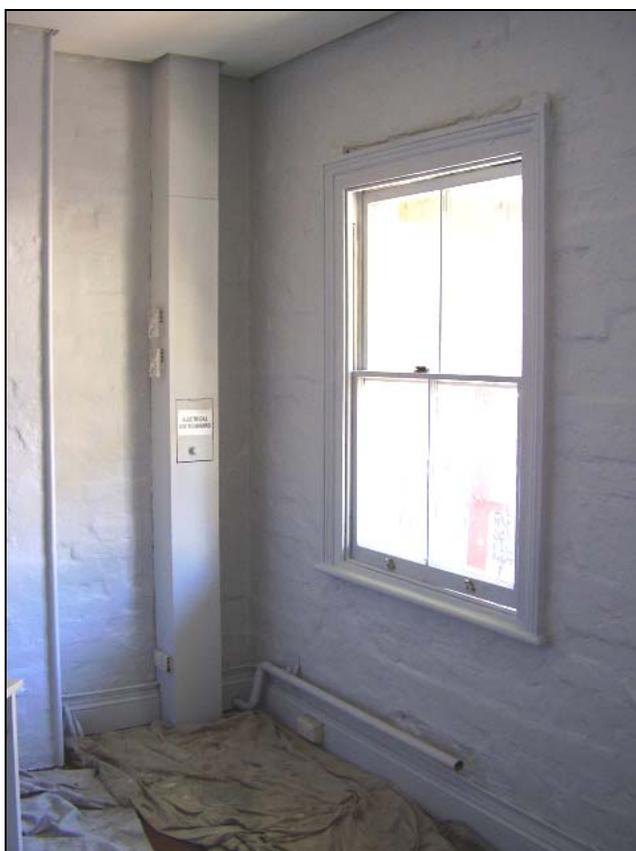
Figure 3.88 The north eastern corner of the front room features a service duct assumed to have been added as part of the 1990s works and window overlooking the eastern cantilevered balcony and Playfair Street.

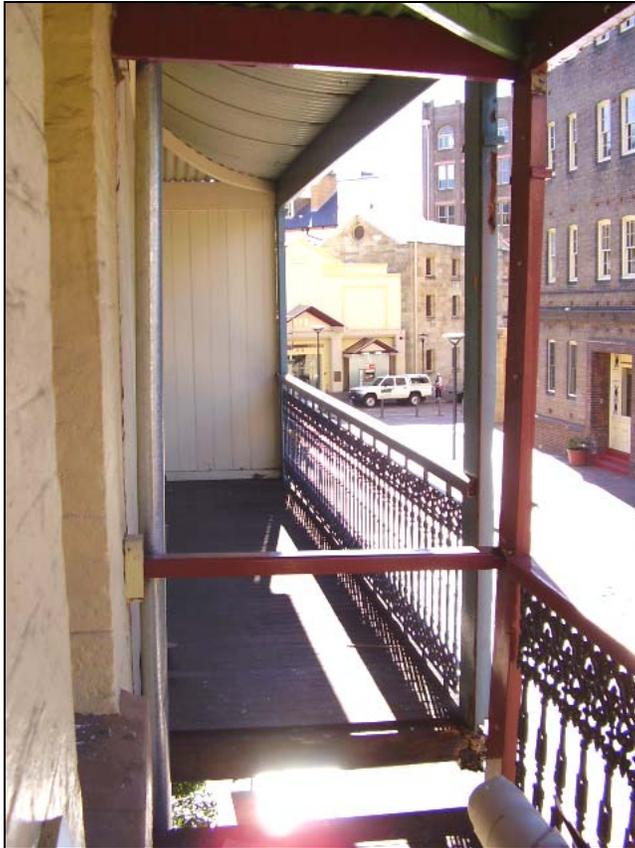
Figure 3.89 View of the balcony spaces looking north.

The reproduction lace balustrade was reinstated as part of the 1970s works. The repairs and replacement of the verandah timbers were also undertaken during the 1970s and 1990s works.

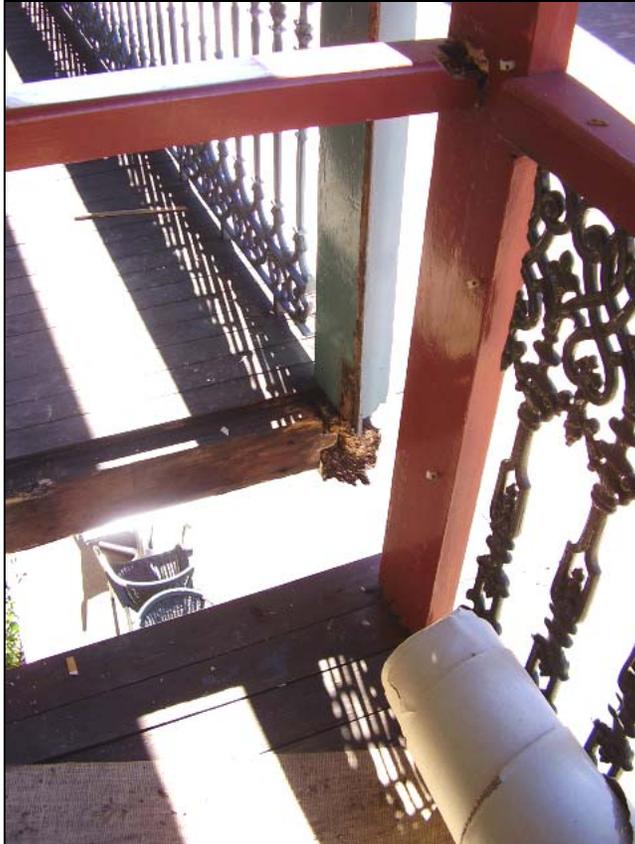
Figure 3.90 Some of the balcony timber framing of No. 17 is in poor condition.

- repairs to the timber framing and finishes of the eastern, cantilevered balconies; and
- minor repairs and finishes to the windows and entry doors.

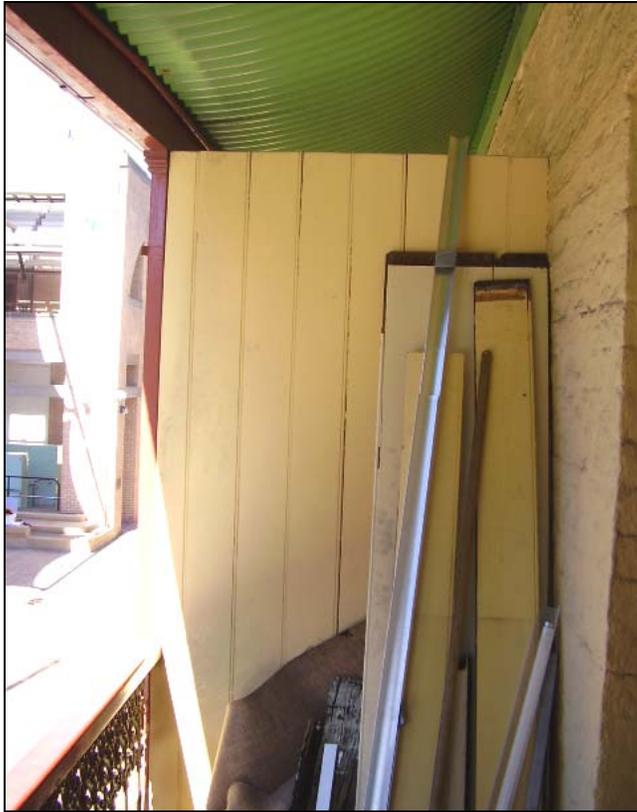
Figure 3.91 Simple timber screens have been added between the terraces and tenancy spaces as part of the 1990s works.

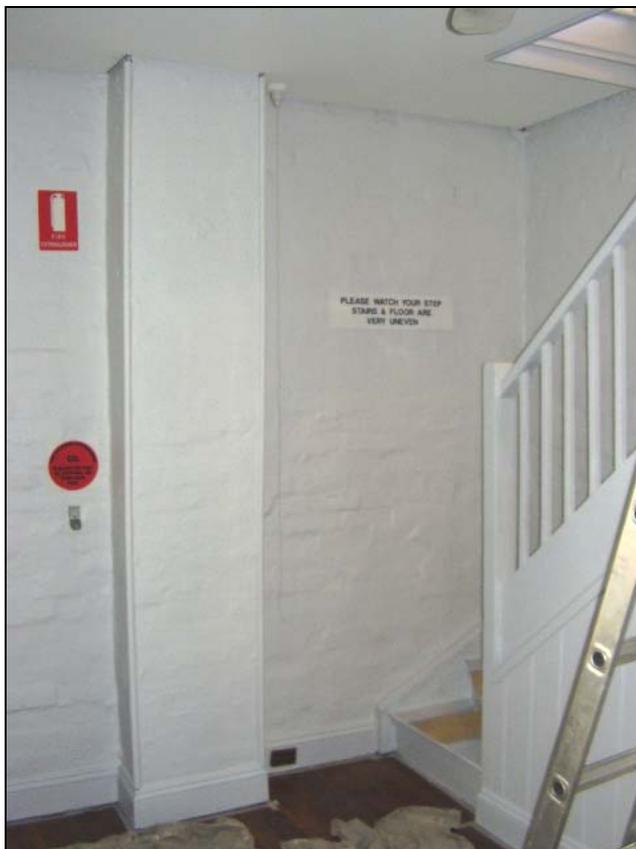
Figure 3.94 The western room features a chimney breast on the northern wall and timber stair extends up the cross wall to access the attic.

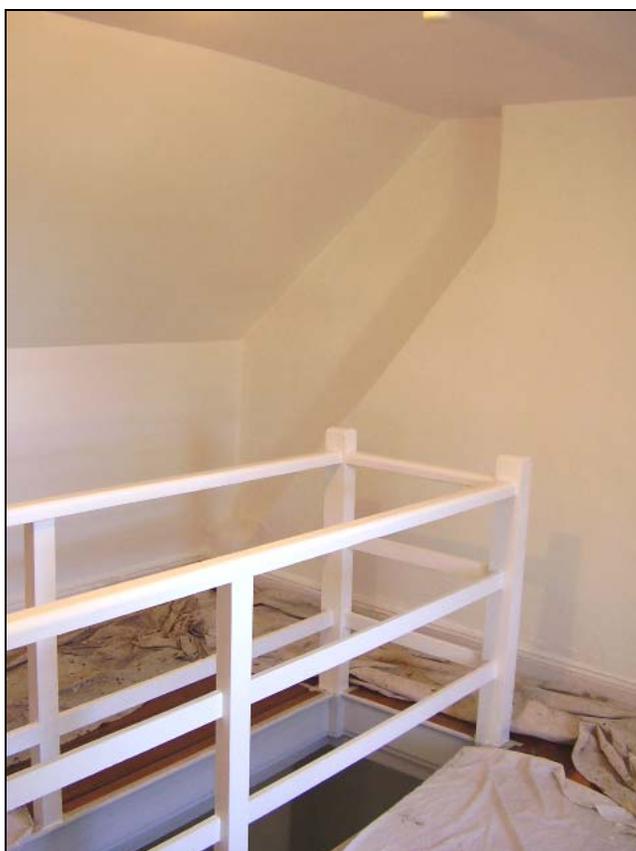
Figure 3.95 The stair to the attic features simple timber treads and post and rail balustrade.

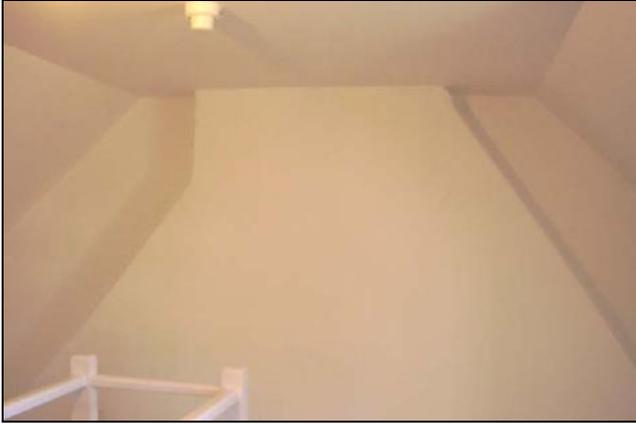
Figure 3.96 The northern wall in the attic features splayed chimney breast. The space has generally been lined with plasterboard and features modern fixtures and fittings.

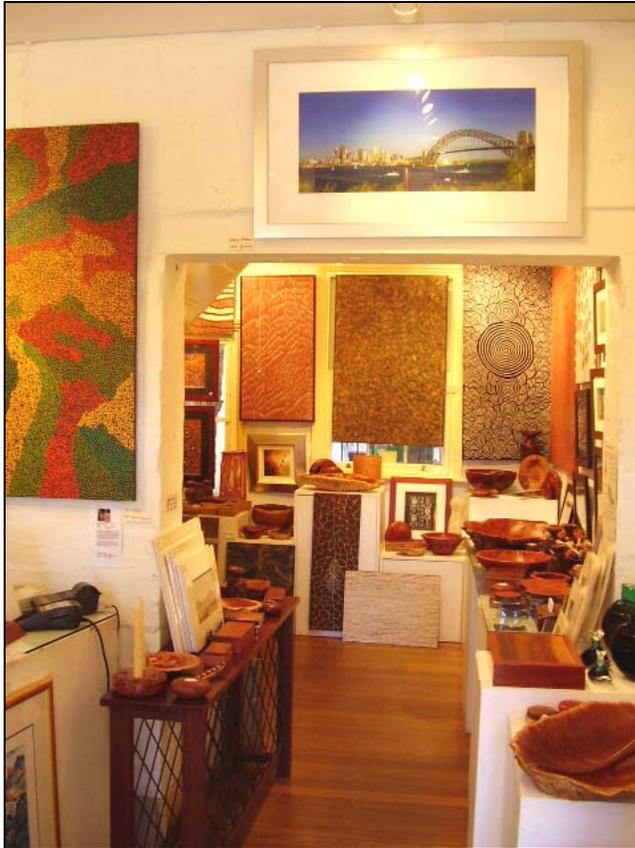
Figure 3.99 View of the ground floor rooms looking west. The terrace is typically finished with timber floors, painted and bagged brick walls and plasterboard ceiling with aluminium angle at the wall/ceiling junction.

Like the other terraces, some patching and repairs to the timber floor is visible.

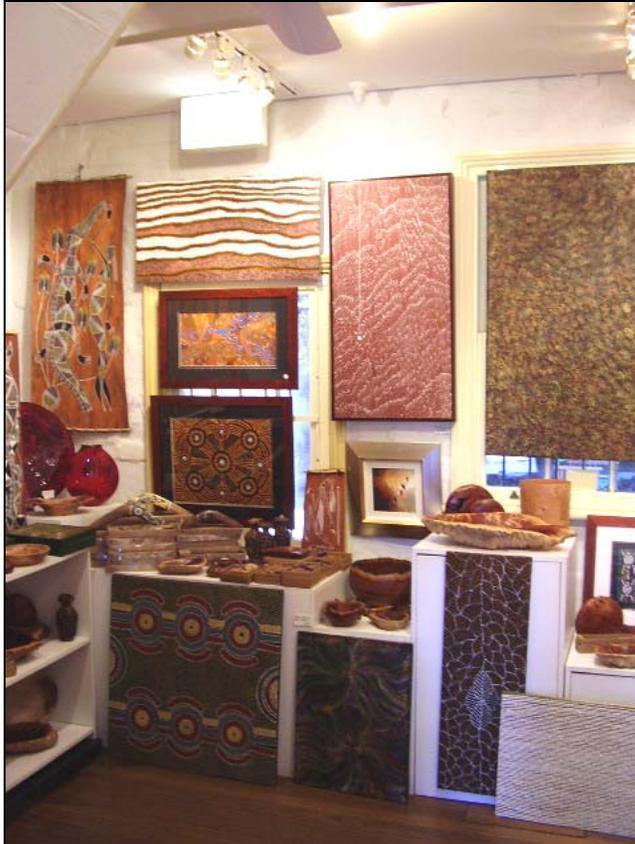
Figure 3.100 The back, western wall of the ground floor. Essential services and ceiling fans have also been added to the ceilings.

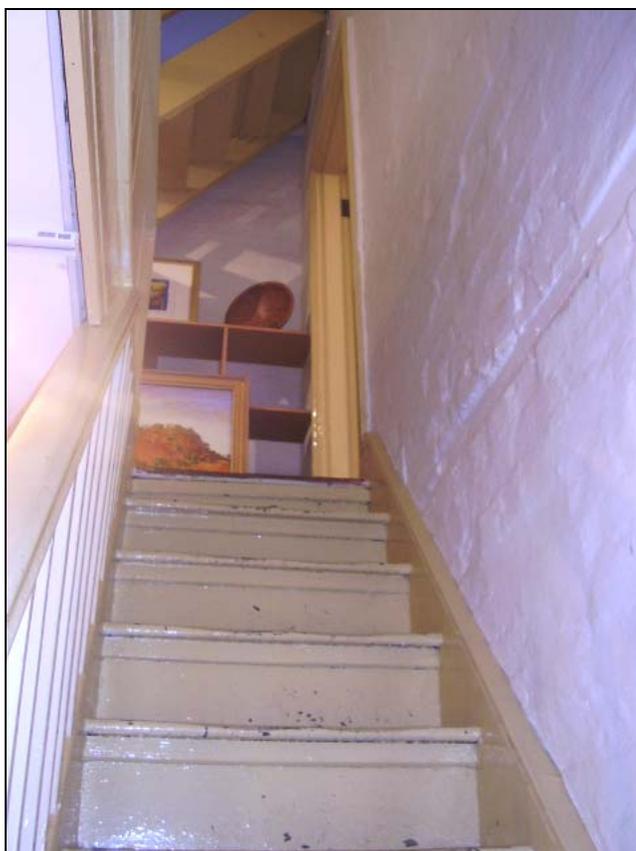
Figure 3.103 View looking up the timber stair to the first floor. The stair features simple timber treads and risers and simple timber balustrade.

The stair appears to be in good condition. Some of the treads are slightly worn but are sound.

The adjacent wall retains some evidence of earlier patches and works.

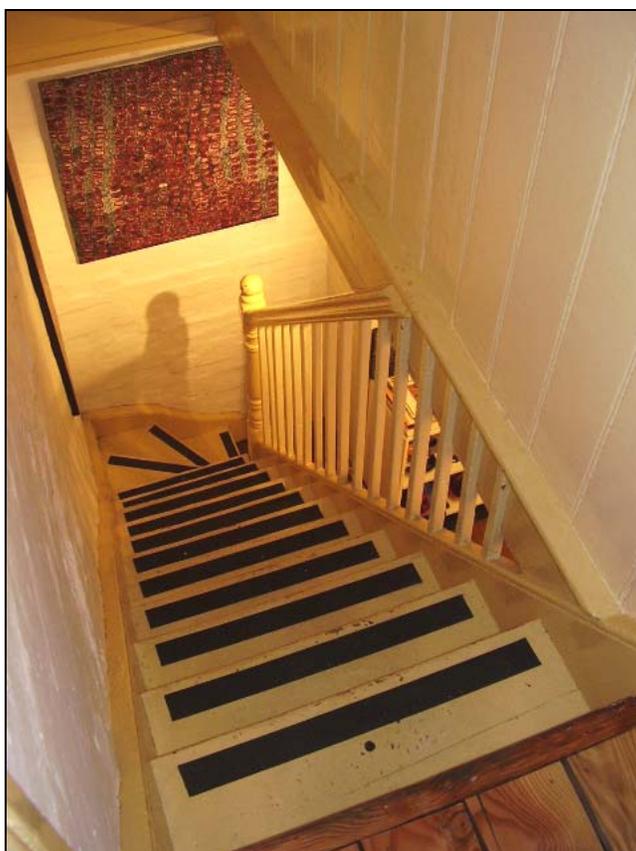
Figure 3.104 View looking down the stair. The top of the stair is enclosed by a timber boarded partition.

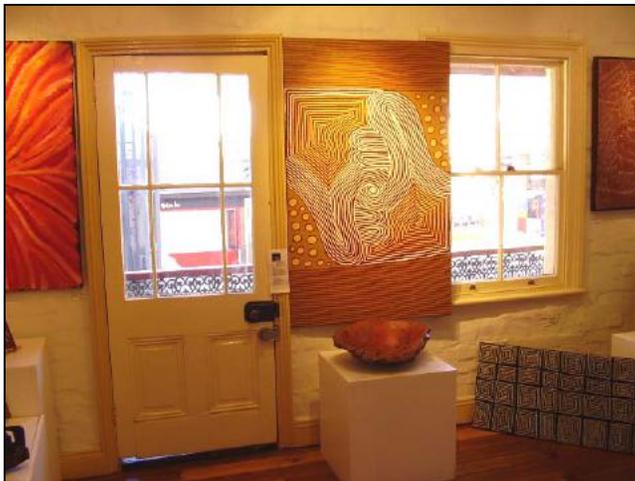
Figure 3.106 The eastern façade on the first floor features single window openings with double hung timber framed window and simple architrave, and single glass and timber panelled door accessing the cantilevered balcony.

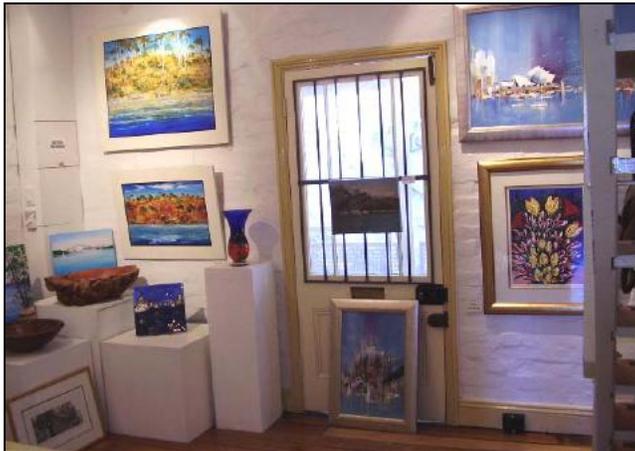
Figure 3.108 The western façade features single door openings with timber and glass panelled door which opens out to the western balcony and deck. The door opening was originally a window converted as part of the 1970s works.

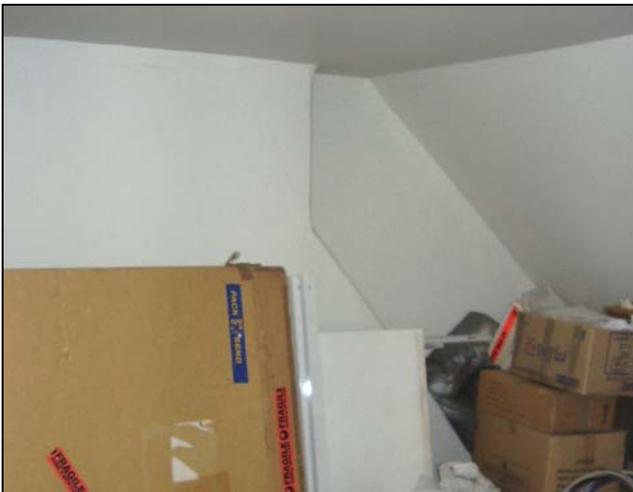
Figure 3.112 View of the south western corner of the attic which appears to be clad in plasterboard and is in very good condition.

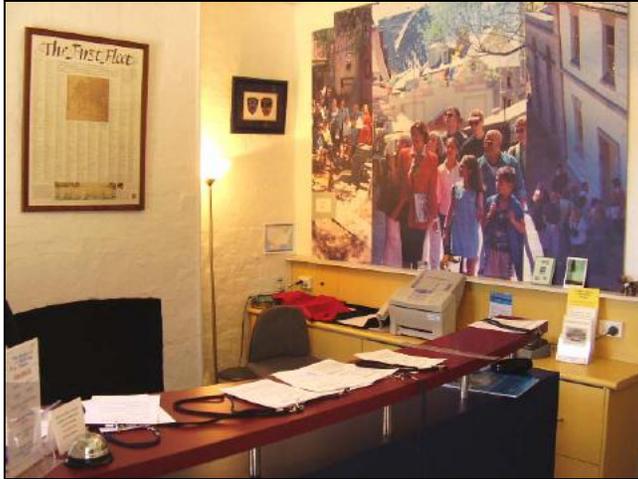
Figure 3.115 The front, eastern room of the ground floor is used as a reception area and features the original chimney breast with flat arched opening on the southern wall. Modern freestanding joinery cabinets and desks have been added to the space.

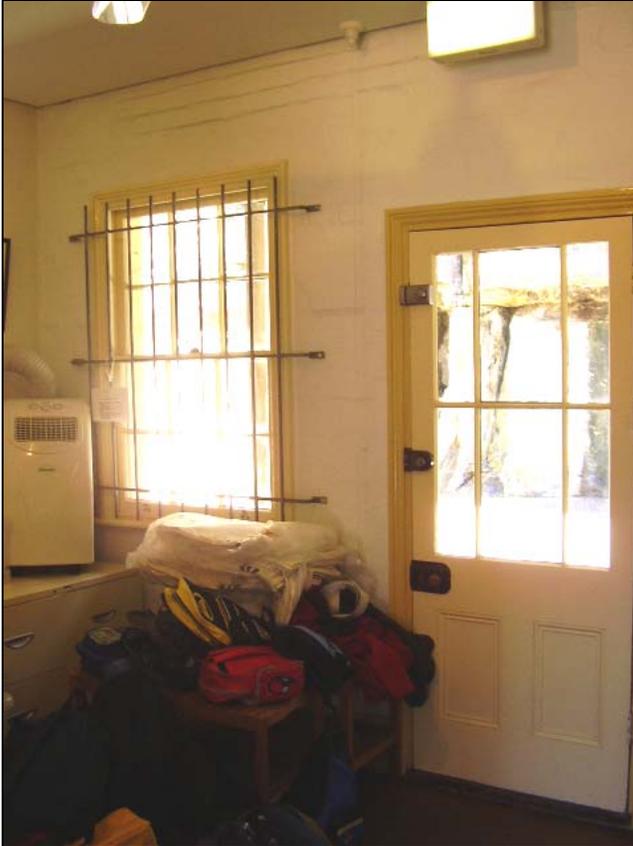
Figure 3.117 The western façade of the ground floor. The original window and door opening which would have accessed the rear wings of the building have been retained. The joinery has generally been replaced and repaired as part of the 1970s and 1990s works to the buildings.

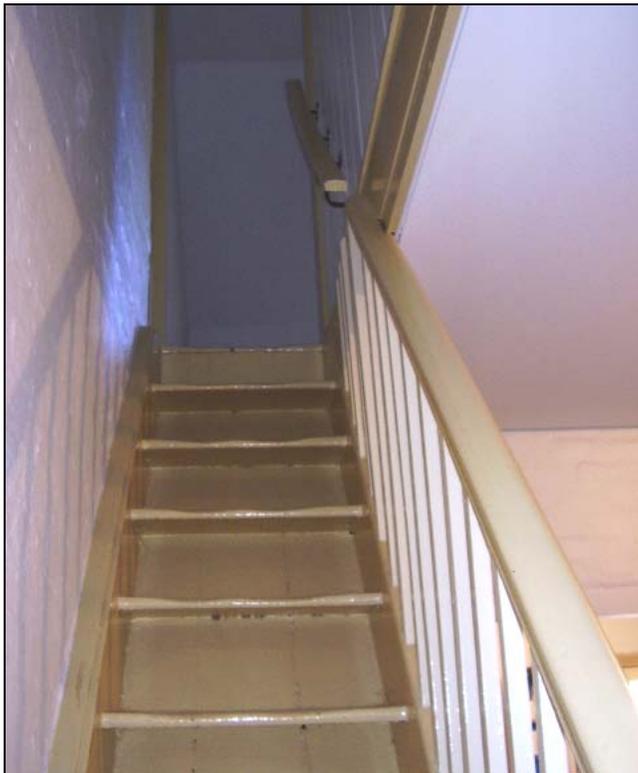
Figure 3.123 View of the simple and narrow stair to the attic. It is assumed that this stair is earlier than the attic stair in No. 21. The stair which is in good condition is detailed like an open tread stair but the soffit is lined with timber boarding that has also been painted. The treads are worn but sound.

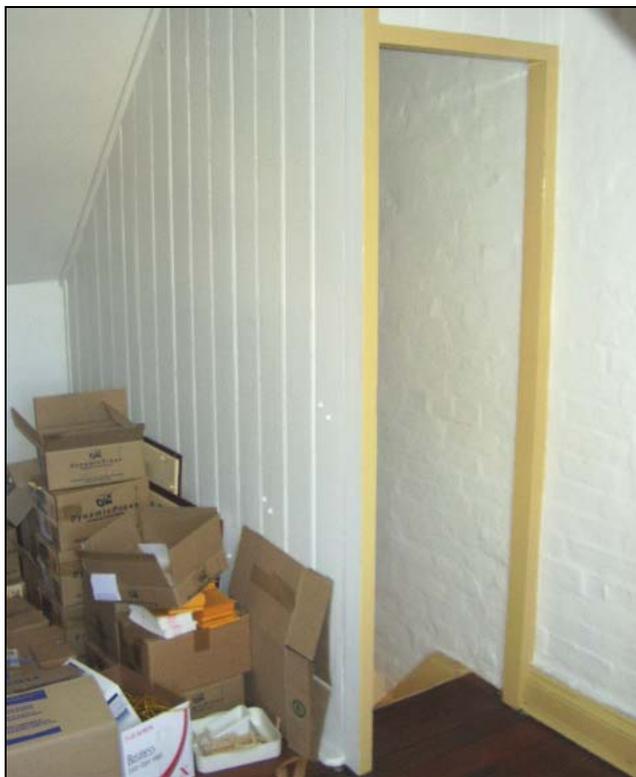
Figure 3.124 The top of the attic stair is enclosed by a timber boarded partition.

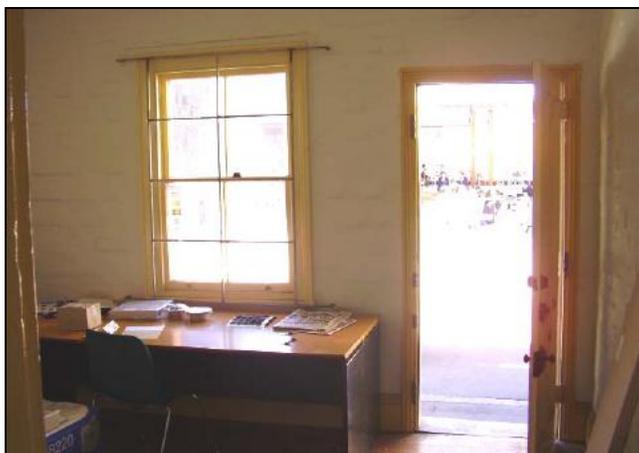
Figure 3.128 The eastern wall on the ground floor.

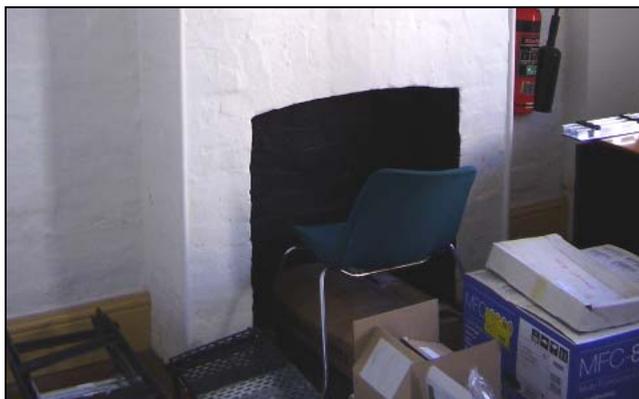
Figure 3.129 The front, eastern room retains a typical chimney breast on the northern wall.

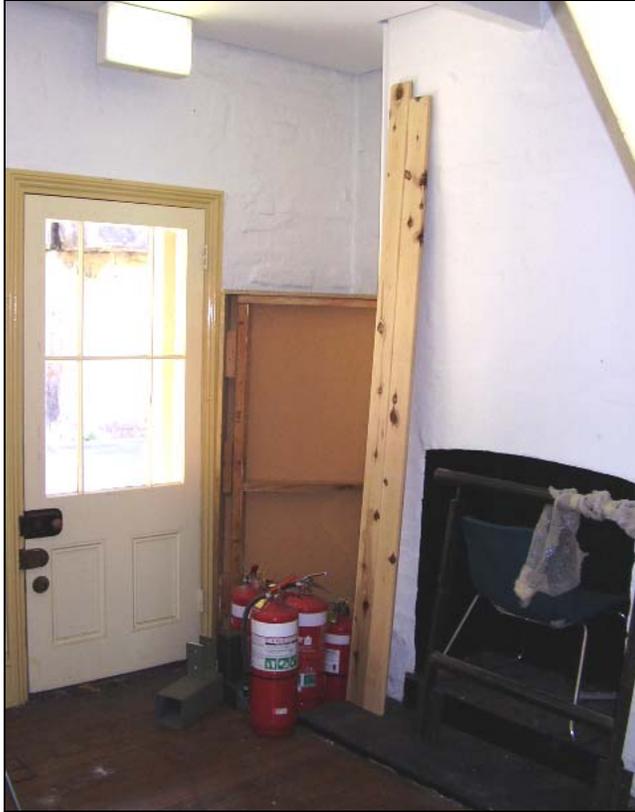
Figure 3.130 The rear, western wall features access to the rear courtyard and also retains a chimney breast with brick arched fireplace opening on the northern wall. The stair to the first floor (soffit just visible at top right) extends up the western face of the central cross wall.

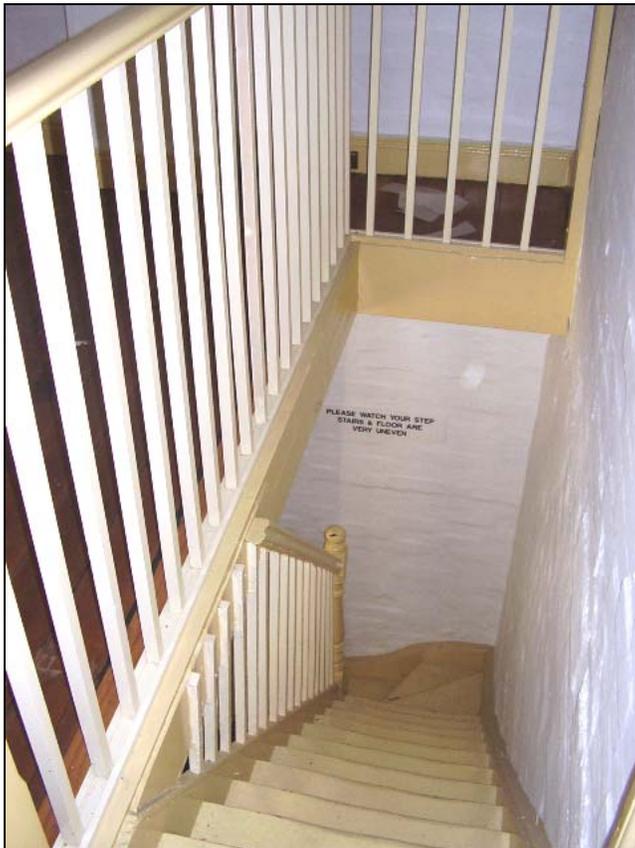
Figure 3.131 View of the timber stair to the first floor which is in good condition and features simple turned timber newel post and simple timber balustrade.

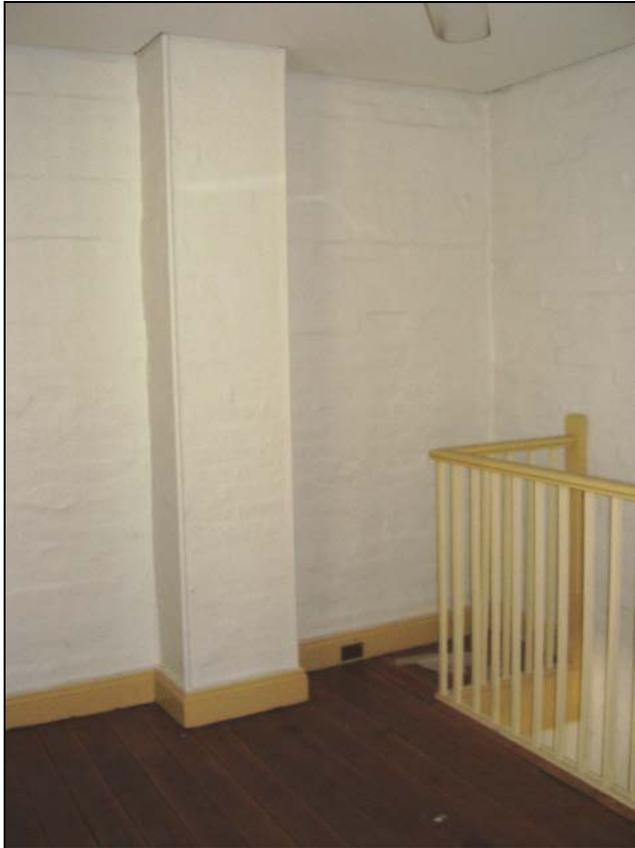
Figure 3.132 The north western wall of the first floor features a narrow chimney breast. The stair void is enclosed by a simple timber balustrade.

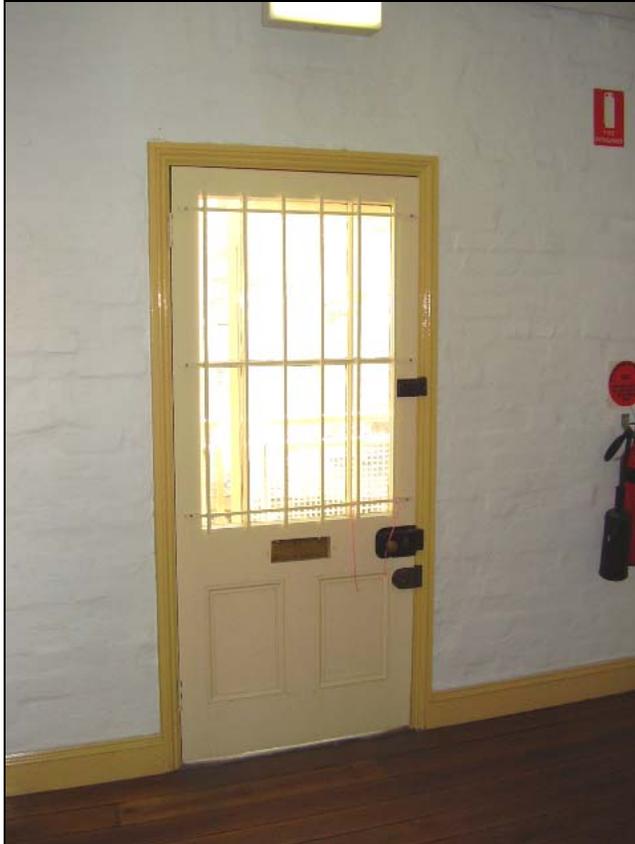
Figure 3.133 The original window on the western façade of the upper level was converted into a doorway to provide access to the western balcony and deck.

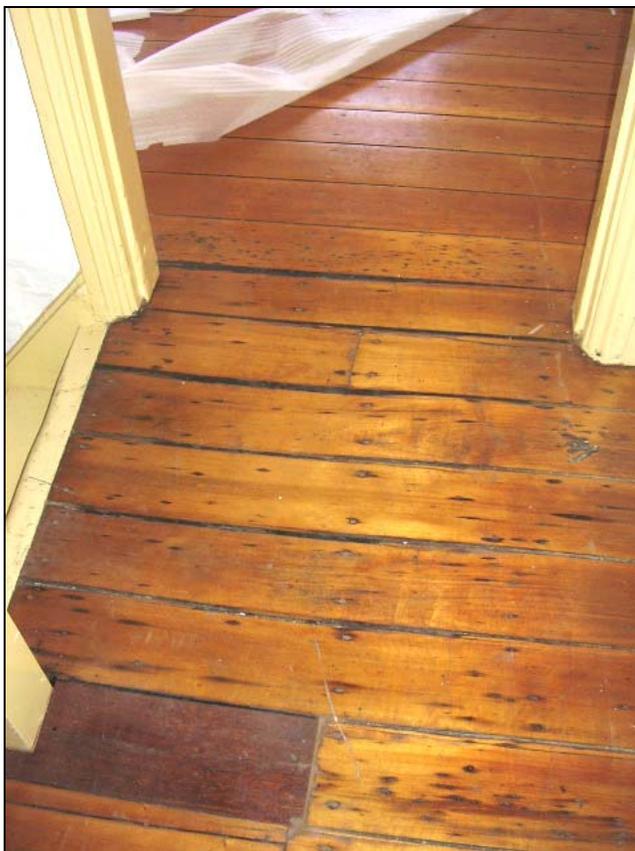
Figure 3.134 The floorboards have typically been patched and repaired and replaced in areas. Here some shrinkage is visible, however, the floors appear to be in good condition and are sound despite some creaking in places.

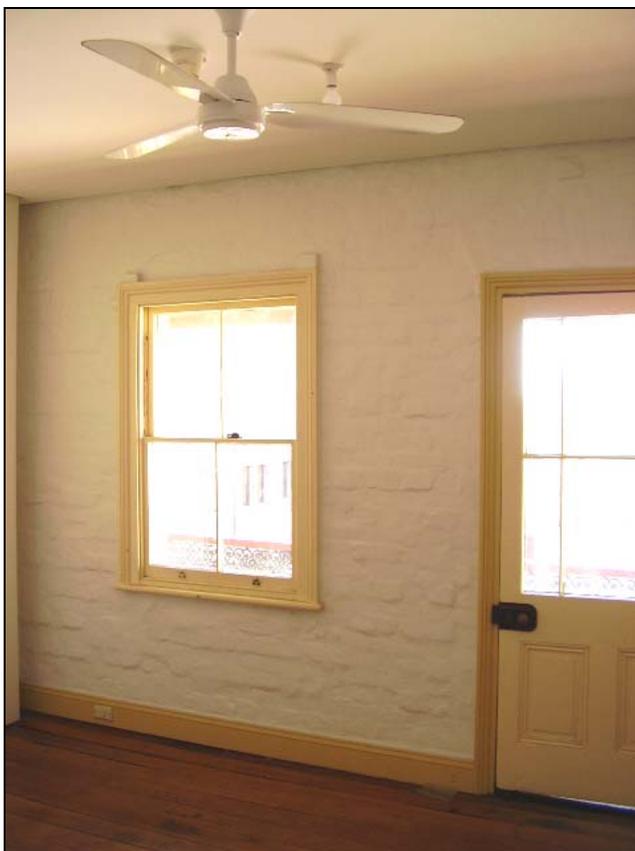
Figure 3.135 View of the eastern wall and access to the eastern balcony overlooking Playfair Street.

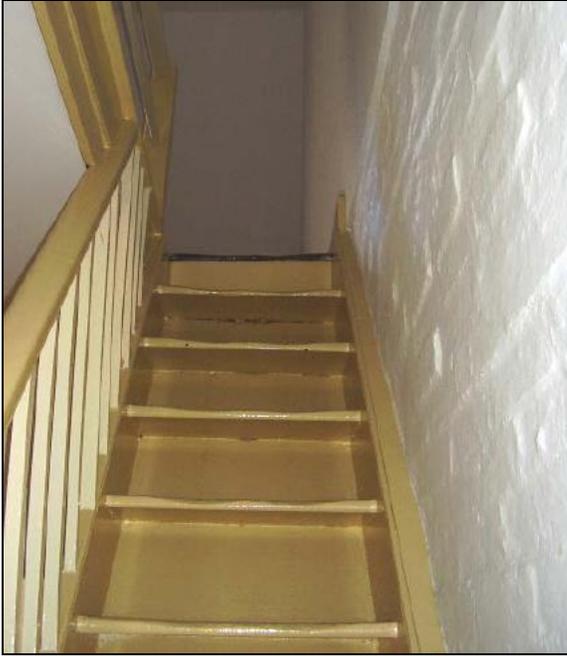
Figure 3.136 View looking up what is assumed to be an early, if not original attic stair which extends up the south western wall of the second floor. The stair is the same, narrow type that also remains in No. 23 and whilst some of the treads are worn, is in good and sound condition.

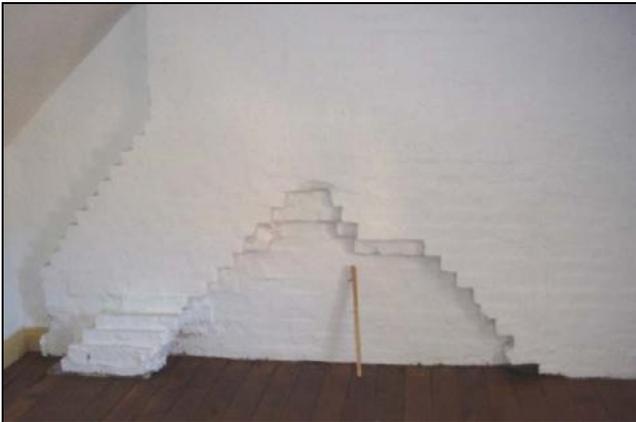
Figure 3.137 View of the northern wall in the attic, with stepped brick chimney breast.

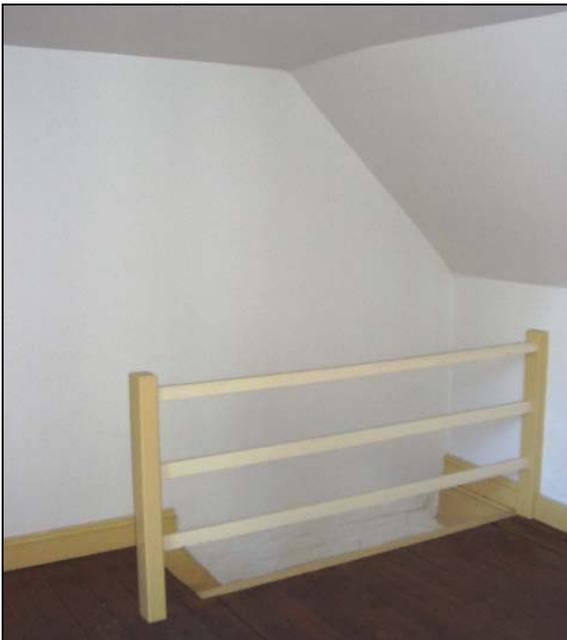
Figure 3.138 View of the top of the stair and south western corner of the attic, which is in very good condition.
