Final Draft CONSERVATION MANAGEMENT PLAN

Playfair Street Terraces, Nos. 17-31 Playfair Street The Rocks

Prepared for Sydney Harbour Foreshore Authority
September 2006

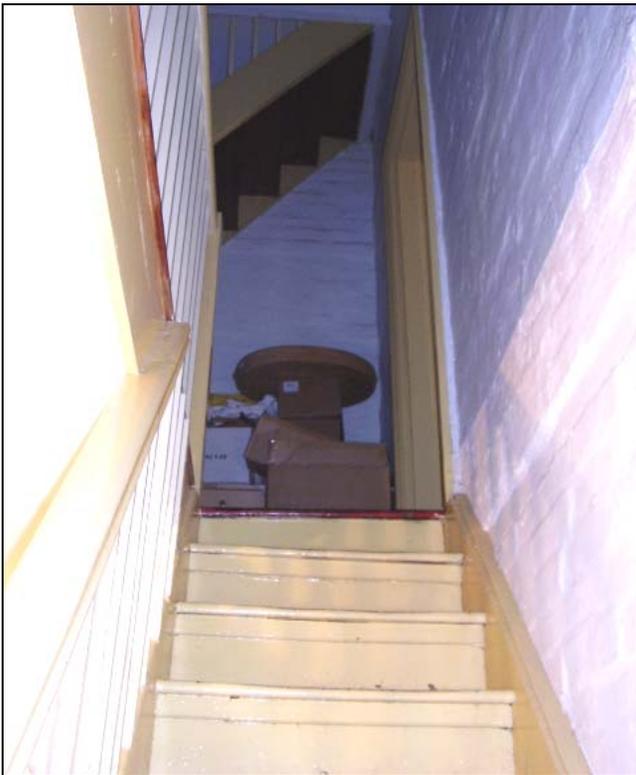
Figure 3.142 View of the typical timber stair which extends up the western face of the cross wall. Like the other terraces, the stair treads are slightly worn, however, the stair and balustrade overall appear to be in good and sound condition.

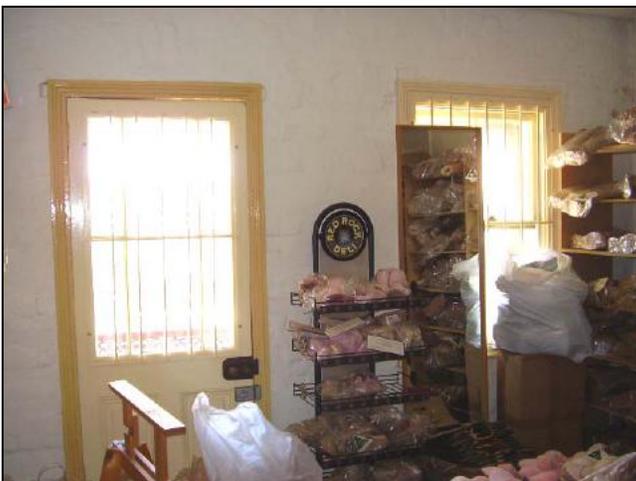
Figure 3.143 View of the eastern wall on the first floor. Some steel security bars have been added to some of the openings in a number of the terraces.

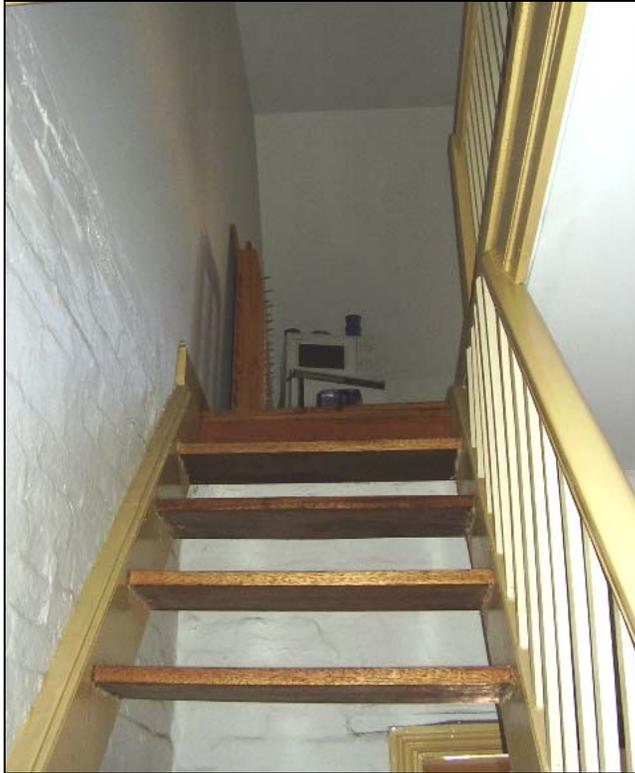
Figure 3.144 The timber attic stair is an open tread stair that extends up the north western wall of the first floor. Like the stair in No. 21, the stair is wider and it is assumed replaced an earlier stair as part of the 1970s works. It is also clear that the treads have been subsequently replaced at some stage.

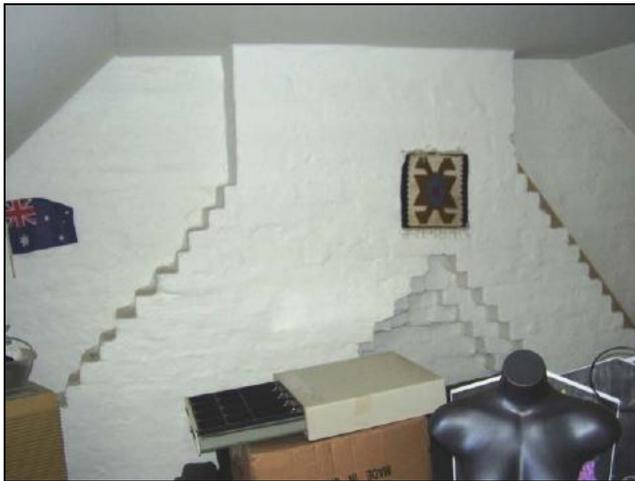
Figure 3.145 View of the southern wall in the attic with stepped chimney breast.

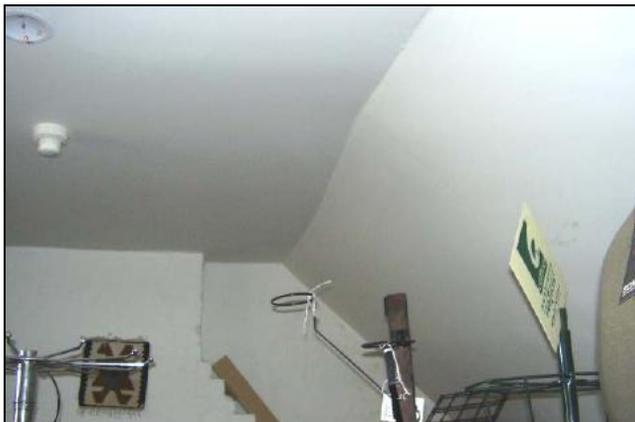
Figure 3.146 Detail of the attic ceiling/wall lining which is in good condition having been successively repaired and replaced.

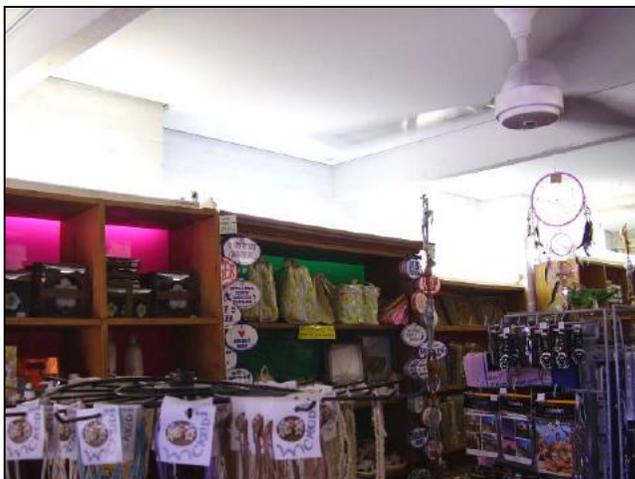
Figure 3.148 View of the plasterboard ceiling that is divided into four bays by three ceiling beams that span the space.

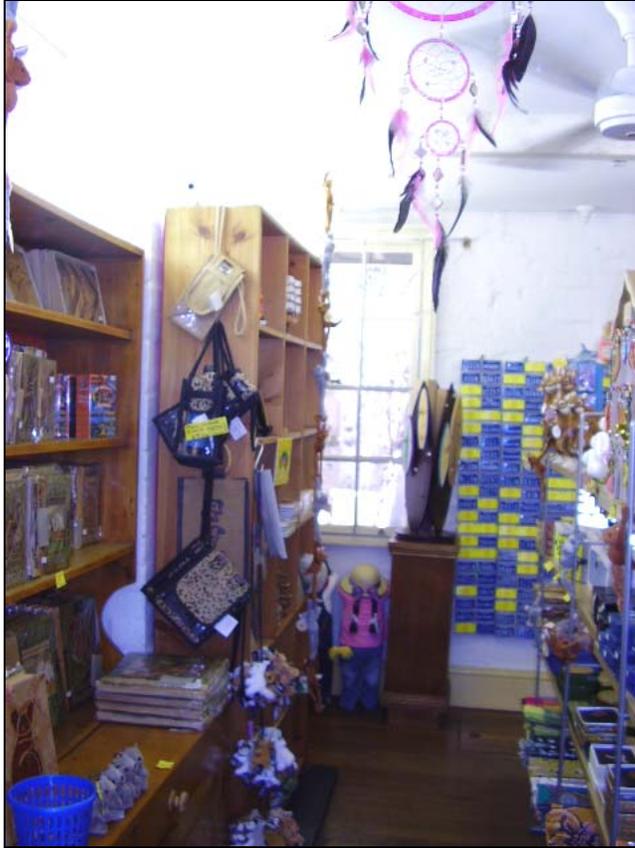
Figure 3.149 The western section of the ground floor retail shop in No. 29. The space generally features timber floors, bagged and painted brick walls and plasterboard ceilings with modern fixtures and fittings. Free standing display units and shelving occupies the space. The large units along the walls also incorporate additional lighting.

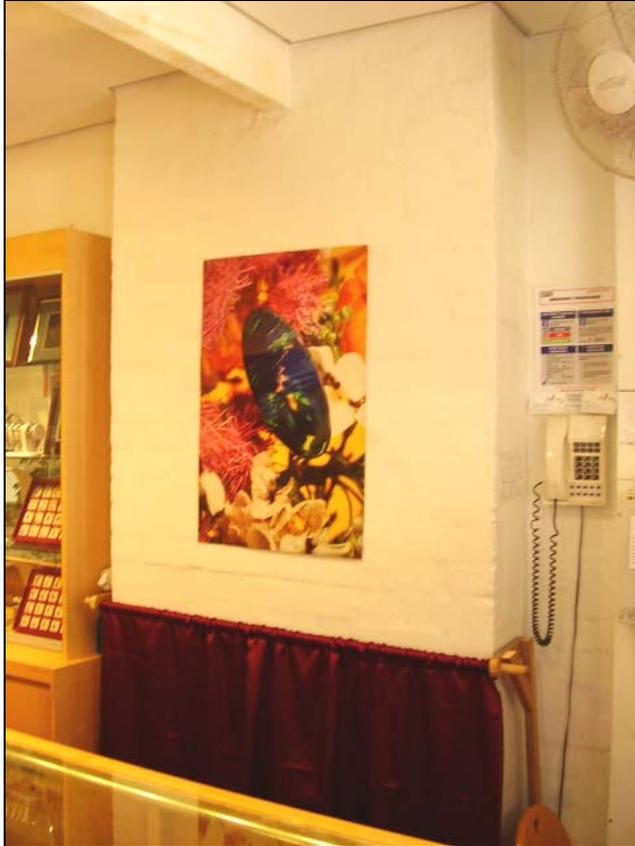
Figure 3.151 Two simple brick chimney breasts remain on the northern wall of the ground floor of No. 31. The fireplace opening however has been concealed by a curtain. The wall between the two chimney breasts was removed as part of the 1970s works and reinstated during the 1990s.

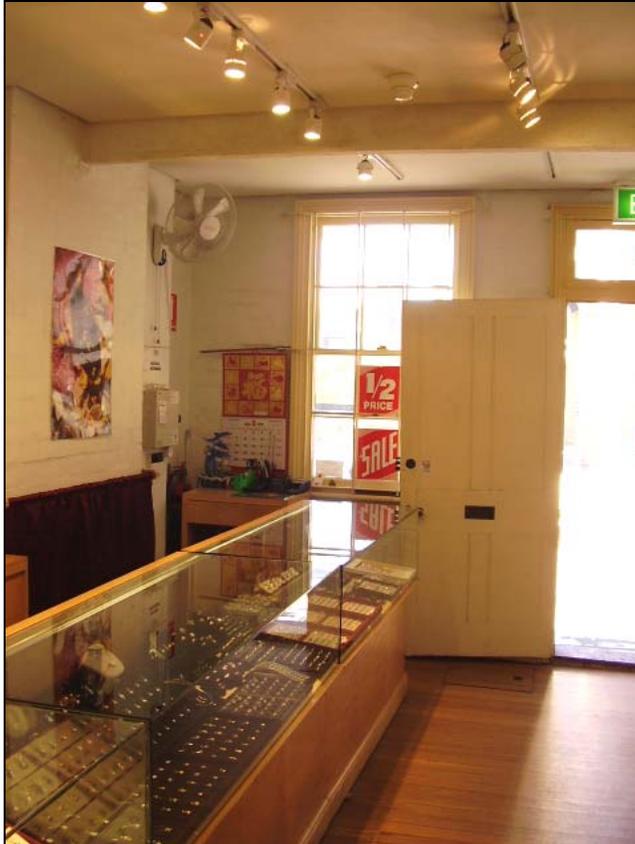
Figure 3.152 View looking to the eastern wall and entry of the ground floor shop of No. 31. Track lighting has also been fixed to the plasterboard ceiling.

The spaces and floor and ceiling fabric are all in very good condition.

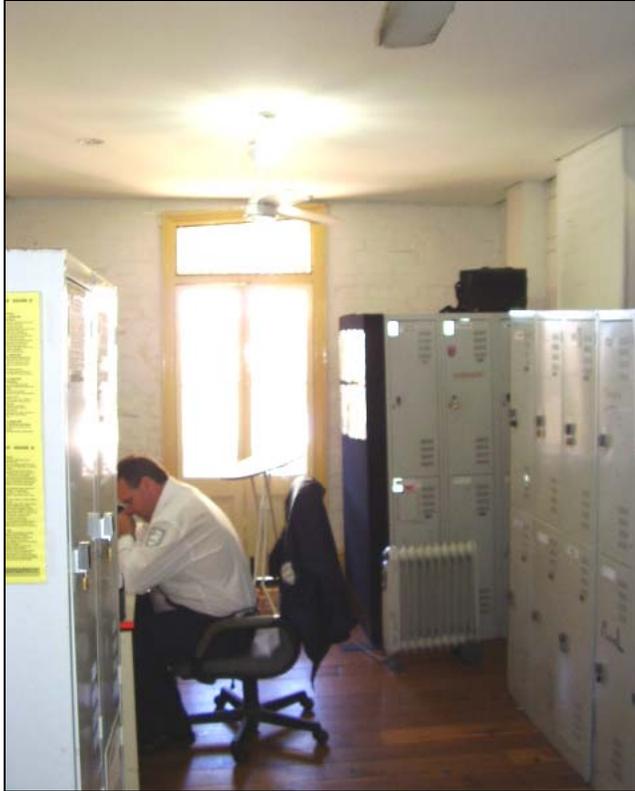
Figure 3.153 View of the office space on the first floor of No. 29 (No. 31 is the same).

The floor boards have clearly been patched and repaired and partly replaced and a new plasterboard ceiling has been added.

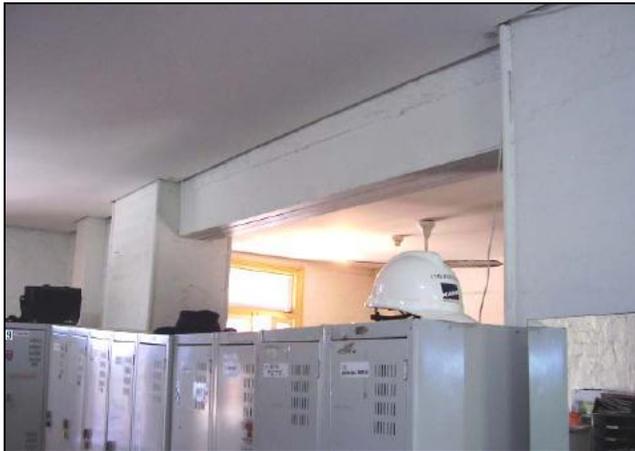
Figure 3.154 View of the large opening in the party wall of the upper floor of Nos. 29 and 31.

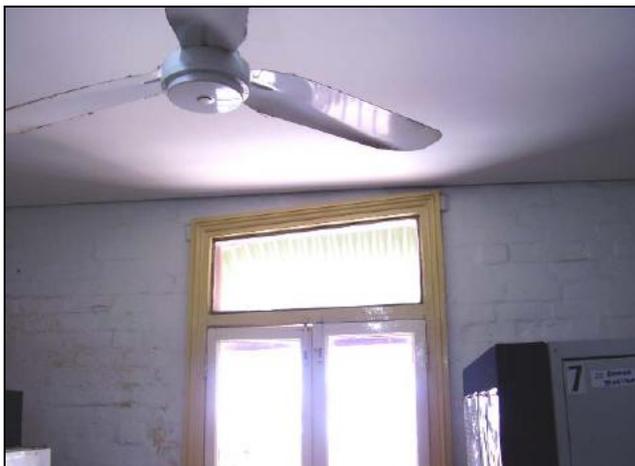
Figure 3.155 Detail of the toplight over the French doors to No. 29 which is not square. New ceilings and services were added as part of the 1990s works.

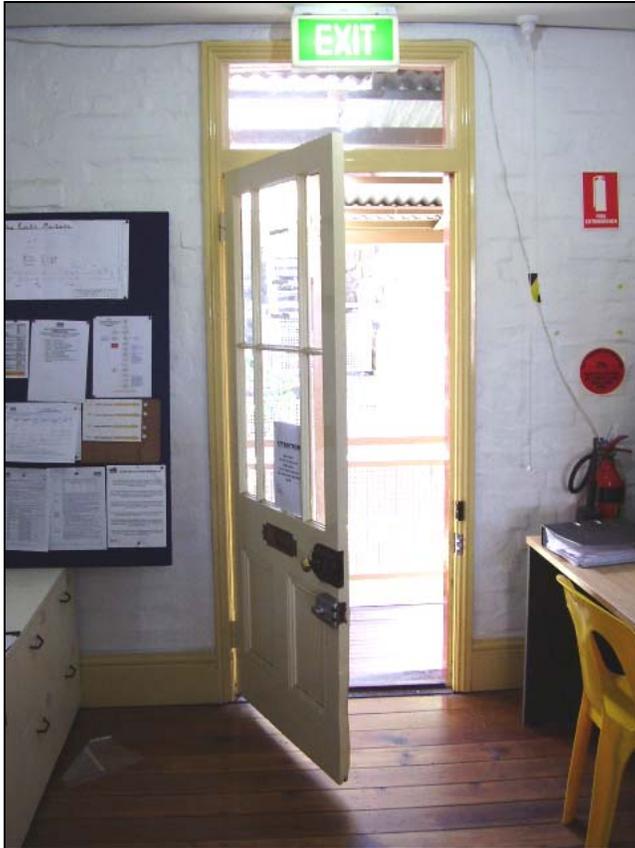
Figure 3.156 View of the entry of No. 29A. The access to the upper tenancy is via the western balcony and deck. The western openings to Nos. 29 and 31 also feature toplights. The doorways were formed from the original window openings as part of the 1970s works.

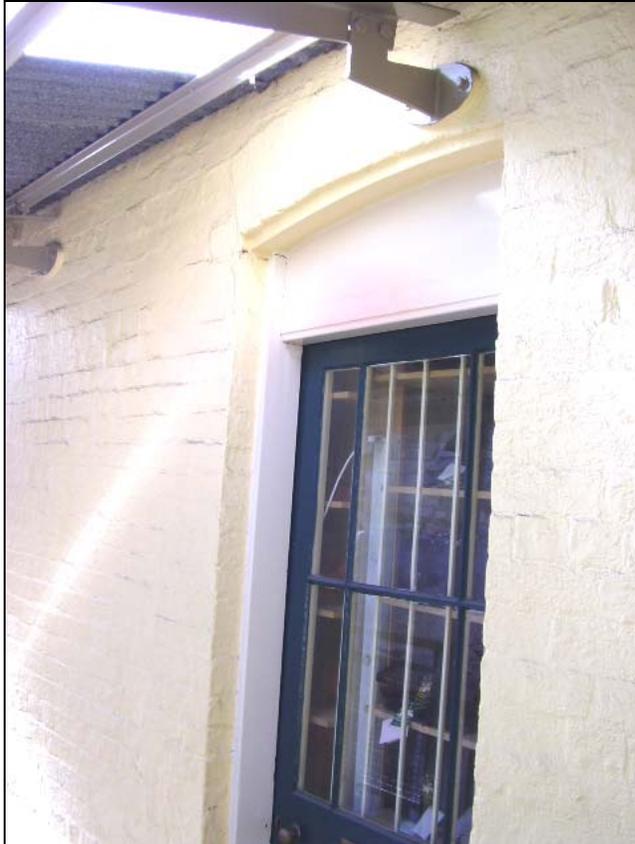
Figure 3.157 Some of the other openings along the western façade also may have featured toplights. The heads of a number of openings are not “square”.

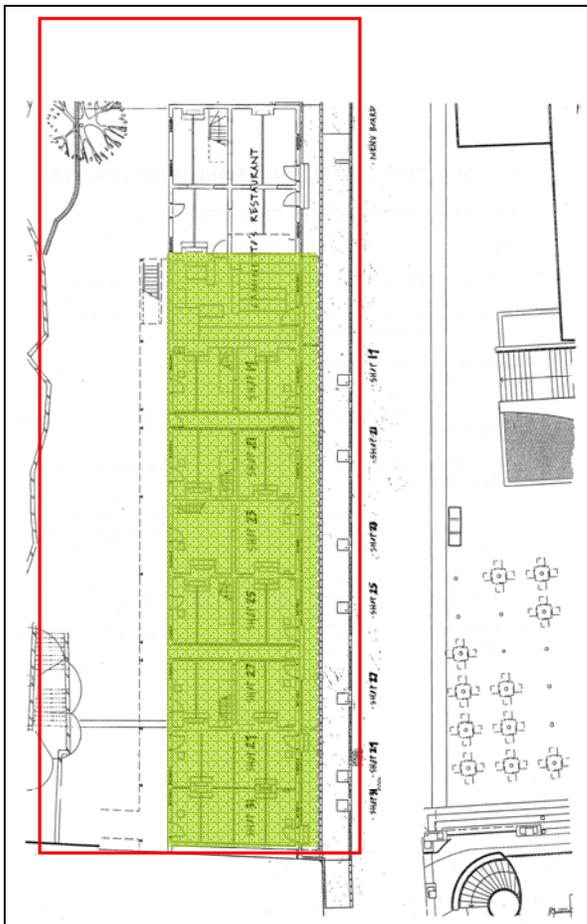
Figure 4.2 The recommended curtilage of the buildings follows the line of the rock face to the west, incorporates the open area to the north of the terrace grouping and also includes the original footpath in front of the buildings.

The expanded curtilage includes the open space around the terraces including Foundation Park, Playfair Street and The Rocks Square (at right).
