Conservation Management Plan

Russell Hotel and
Fortune of War Group

137–143A

George Street, The Rocks

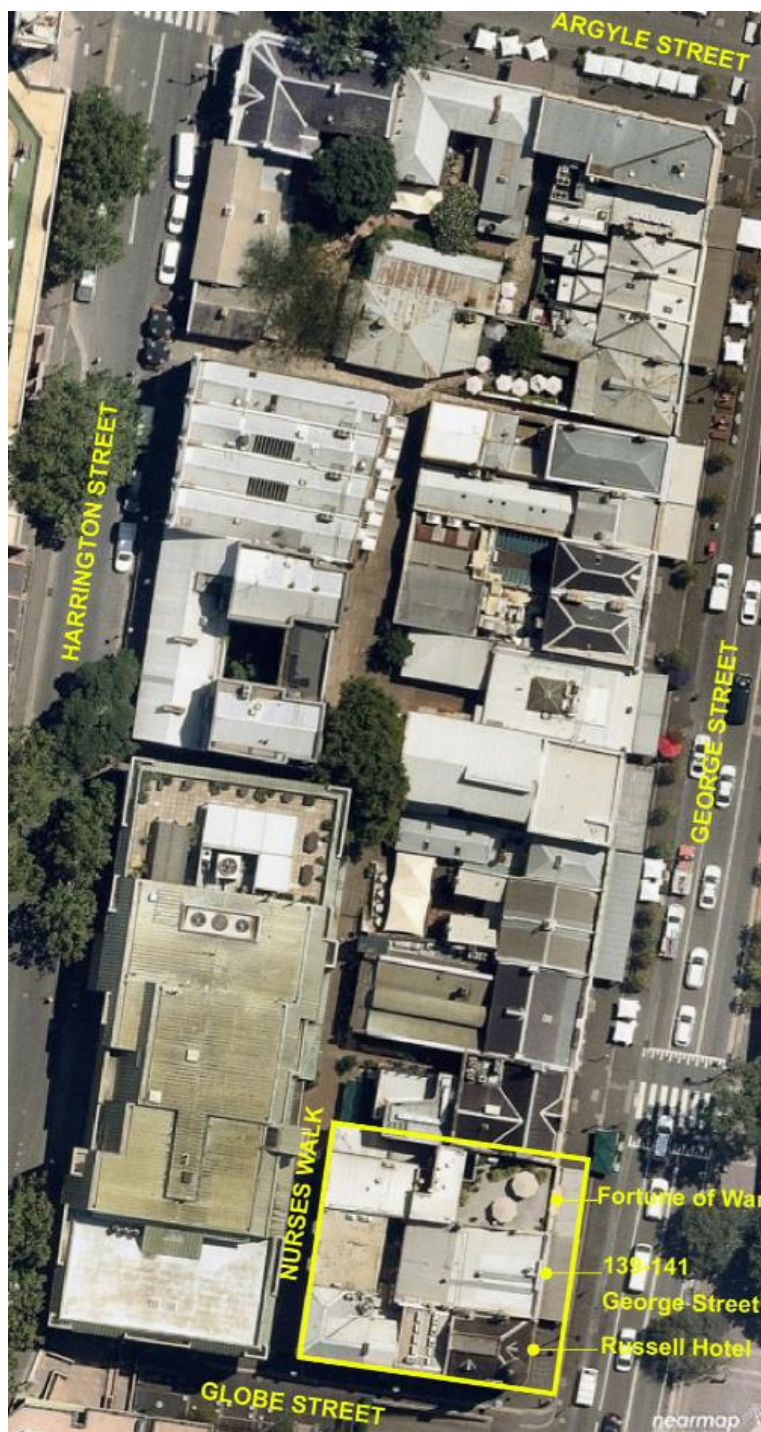
Figure 3: Site Plan showing location of the Russell Hotel and Fortune of War shown outlined in yellow. Source: NearMap with TKD Architects overlay.

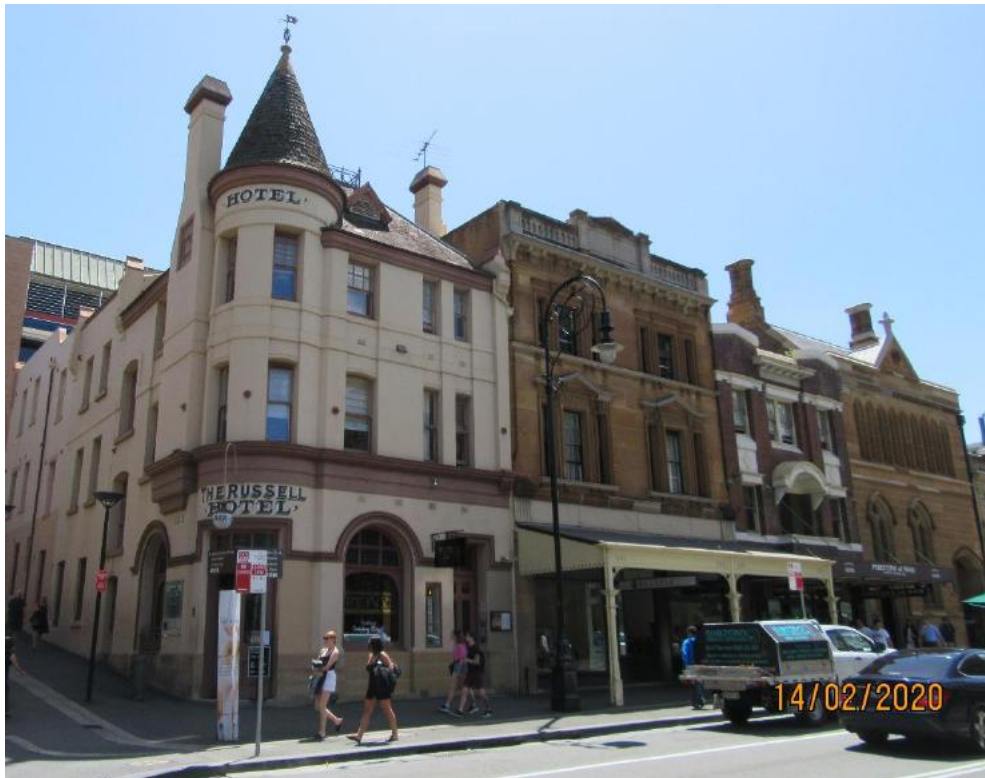
Figure 5: Eastern elevation on George Street of the study area. The façade of The Russell Hotel on the corner of George and Globe Streets is rendered and painted masonry, the shops at 139-141 George Street are of sandstone and The Fortune of War has a face brick façade. 139-141 George St has an awning supported by three timber posts, and The Fortune of War has a cantilevered steel awning over the footpath. Source: TKD Architects 2020.

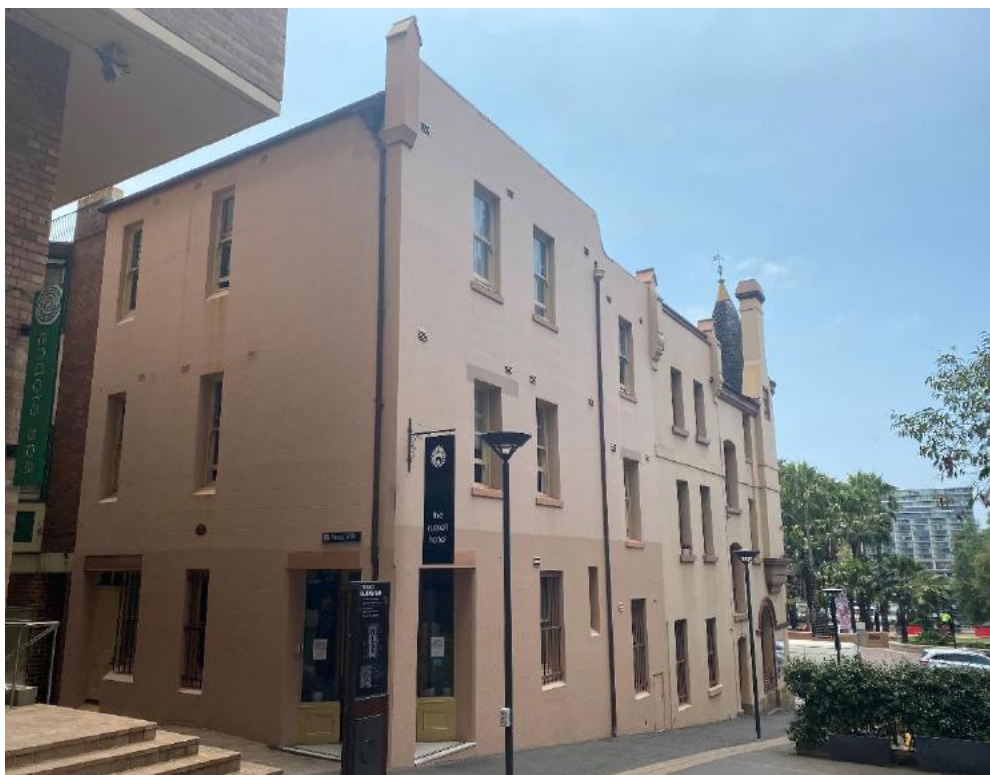
Figure 6: Southern Elevation of the study area, featuring the façade of the Russell Hotel along Globe Street. The rear portion of the building is a 1913 addition. Source: TKD Architects 2020.

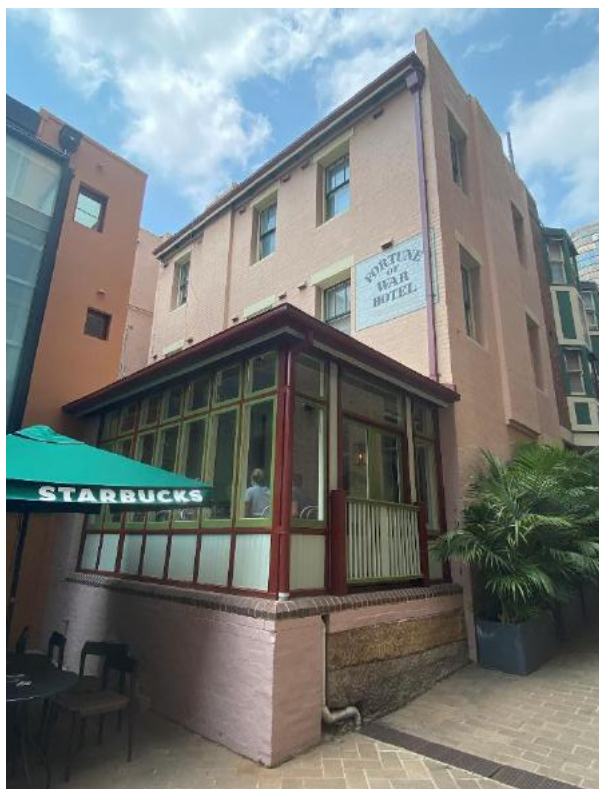
Figure 7: Northern elevation of the study area, featuring the façade and verandah addition to the Fortune of War. Source: TKD Architects 2020.

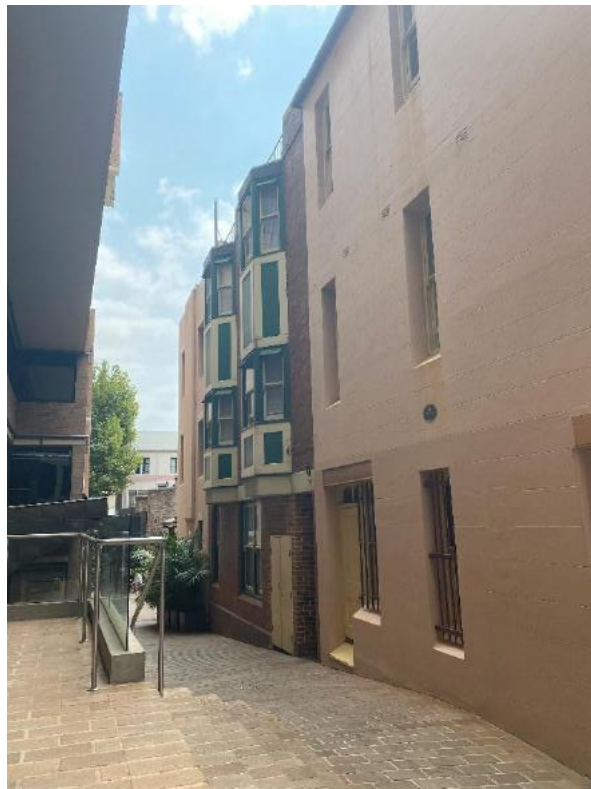
Figure 8: Western elevation of the study area, featuring the rear facades and 1913 additions to the Russell Hotel, and 139-141 George Street buildings. Source: TKD Architects 2020.

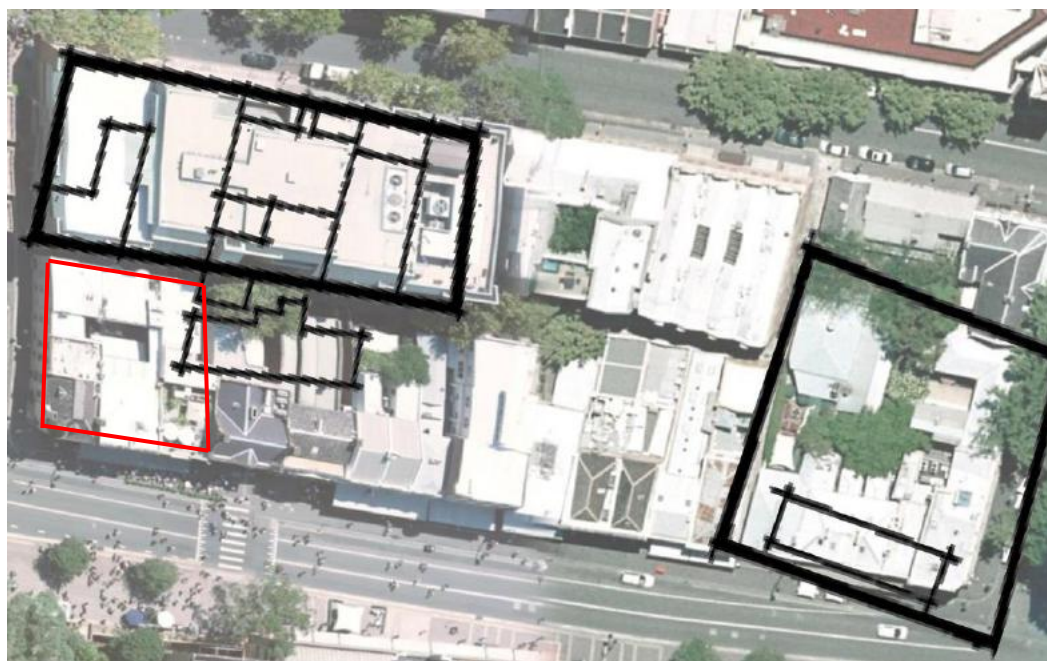
Figure 15: Harper's Plan of 1823 (tracing over contemporary aerial photograph) shows the location of the portable hospital in relation to today's 137–143a George Street, The Russell Hotel/Fortune of War Group, which is outlined in red. Source: Copy obtained from PMNSW.

Harper's plan of 1823 (**Error! Reference source not found.**) clearly shows the portable hospital, and a building of similar proportions existed on the site until 1880. Today's 139–143a George Street sit directly south of the former location for the hospital building, and its southern end extended over the site of 137 George Street. Two photographs taken in this period (in 1871 and 1879, Figure 33 and Figure 34) show the roof of this building and indicate it is not inconsistent with the early paintings of the hospital.

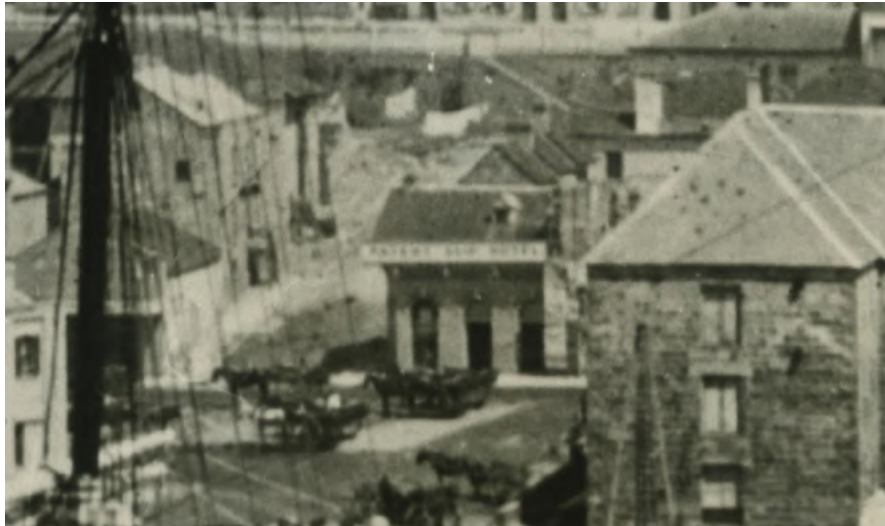
Figure 25: The George Street facade of the Patent Slip Hotel (on the site of today's 143–143a George Street) is shown in a photograph panorama of Circular Quay West of 1879. The photograph shows three windows, each with arched lintels, a gable roof (with dormer window), a splay at the corner of Globe and George Streets, and painted timber sign mounted on the roof eaves. The roofs of the Globe Street terraces are also visible behind. The pedimented central building of Samuel Terry's development (see Figure 22 above) had been demolished by this time.

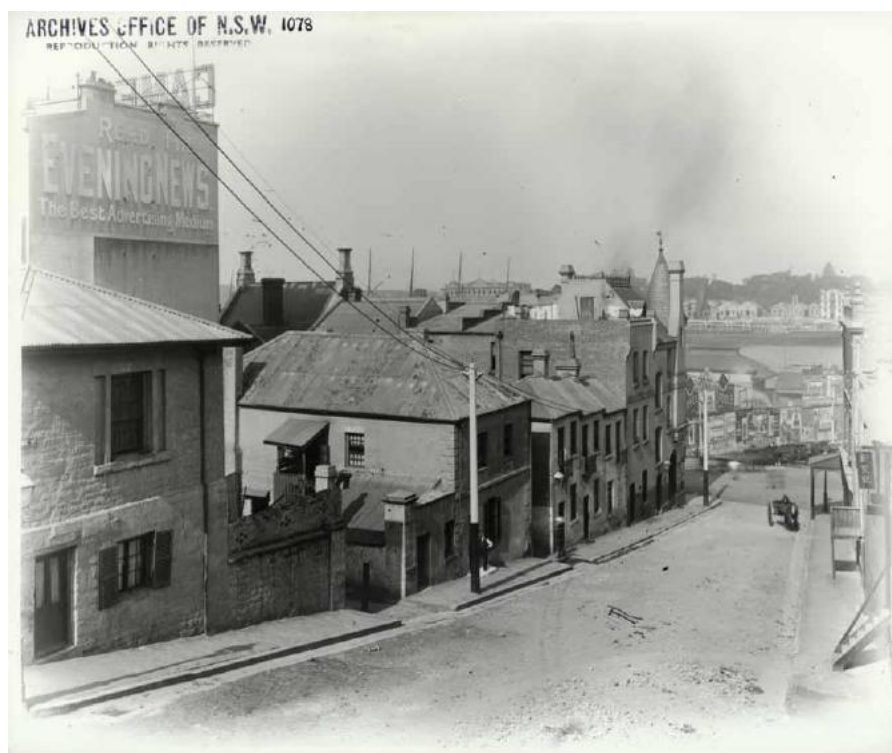
Figure 26: The Globe Street terraces shown in plan in Figure 24, are also illustrated in a photograph of c.1901 (detail). These buildings appear to have been typical inner-city mid-nineteenth century working men's houses with each floor of each terrace comprising one room. Above the roofs of the terraces, the rear window of the original dining room to the Port Jackson Hotel is visible (western window of reception area, space 1.13). Washing can be seen drying on the roof terrace of the Port Jackson Hotel (now the Russell Hotel). Also visible in this photograph are the roofs of 139–141 George Street, with its projecting parapet (now mostly demolished) and the original Fortune of War Hotel. The gabled wall to the southern (right) side of the Fortune of War Hotel appears to be the one still visible on the southern side of the roof terrace today.

A photograph of Globe Street c.1900 (Figure 26) shows the rear and Globe Street elevations of the building. In addition to the terraces facing Globe Street, the photograph shows:

A photograph taken c.1901 (Figure 26) shows the roof of the building viewed from Globe Street. The skillion form over the front section is clearly visible. The stepped parapet wall dividing No. 139 from No.141 has now been cut back to a point quite close to the George Street façade.

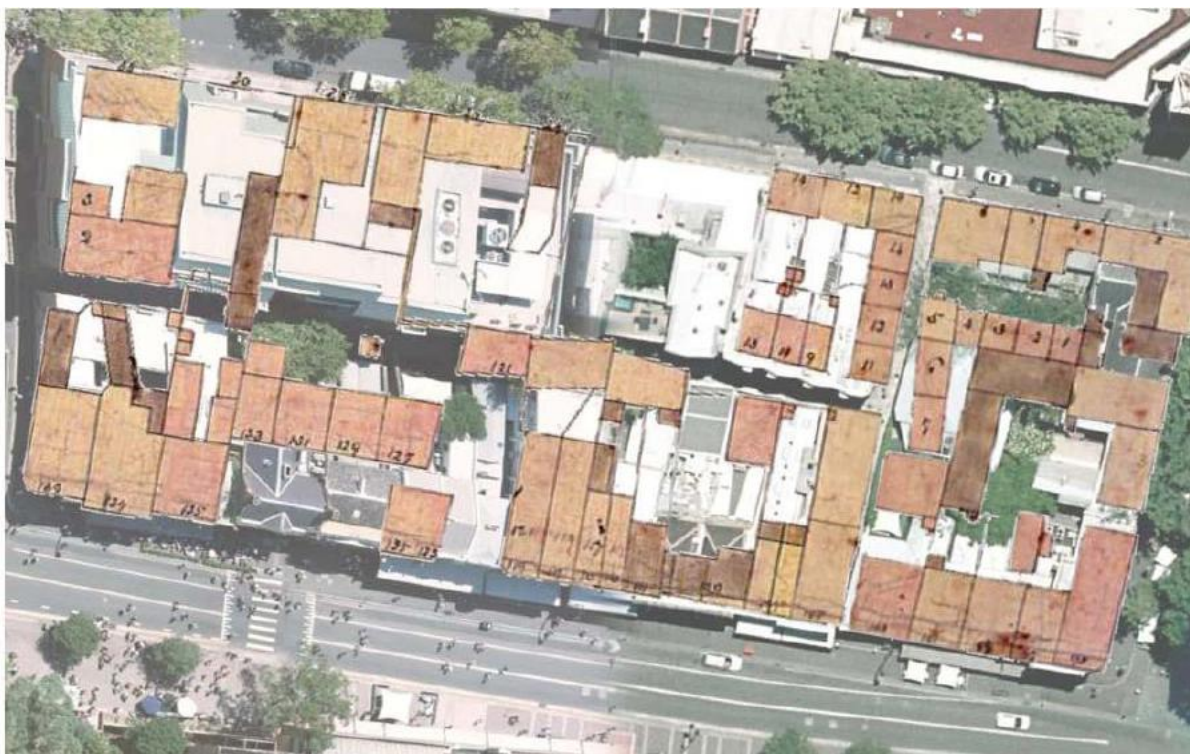
Figure 29: The Trigonometrical Survey of Sydney of 1865 identifies 137–143a George Street with street addresses No. 135, 137 and 139 George Street. It shows 143–143a George Street fronting George Street and with a rear extension and rear yard inclusive, possibly, of stables, which were located in the area of present day No. 141 George Street. Today's 139–141 George Street (shown here as No. 137) replaced the building shown in this plan. The footprint of the buildings on the site of today's 137 George Street (shown here as No. 135) is similar to that indicated in Dove's 1880 plan (Figure 30). Source: Copy obtained from the PMNSW.

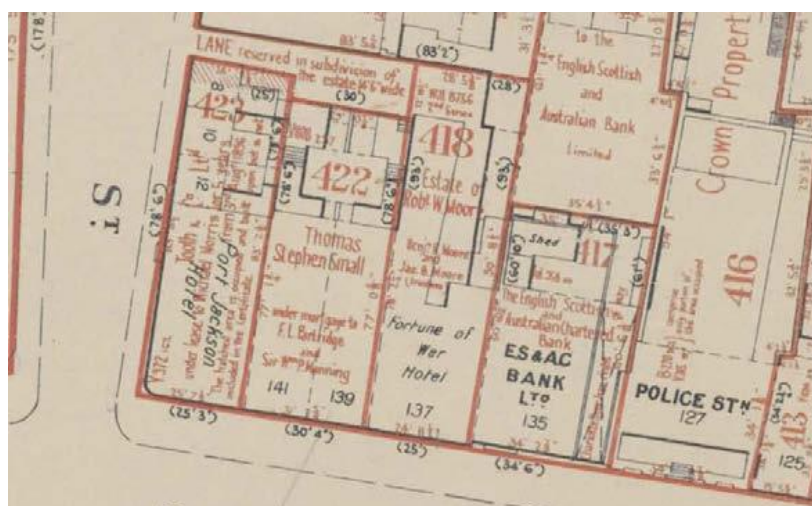
Figure 34: The footprints for 137–143a George Street shown in the Darling Harbour Resumptions within Sections 76, 77, 78, 79, 80, 82 and 84, dated 1901, are very similar to those indicated in the 1888 plan (Figure 32 above). The lane at the rear of 139–141 is in the general location of today's Nurses Walk. Source: Copy obtained from PMNSW.

The survey undertaken in 1901 following the government's resumption (Figure 34) is similar in detail to the 1888 plan below, except that it shows the construction of the western most terrace on Globe Street had encroached on the rear lane reservation.

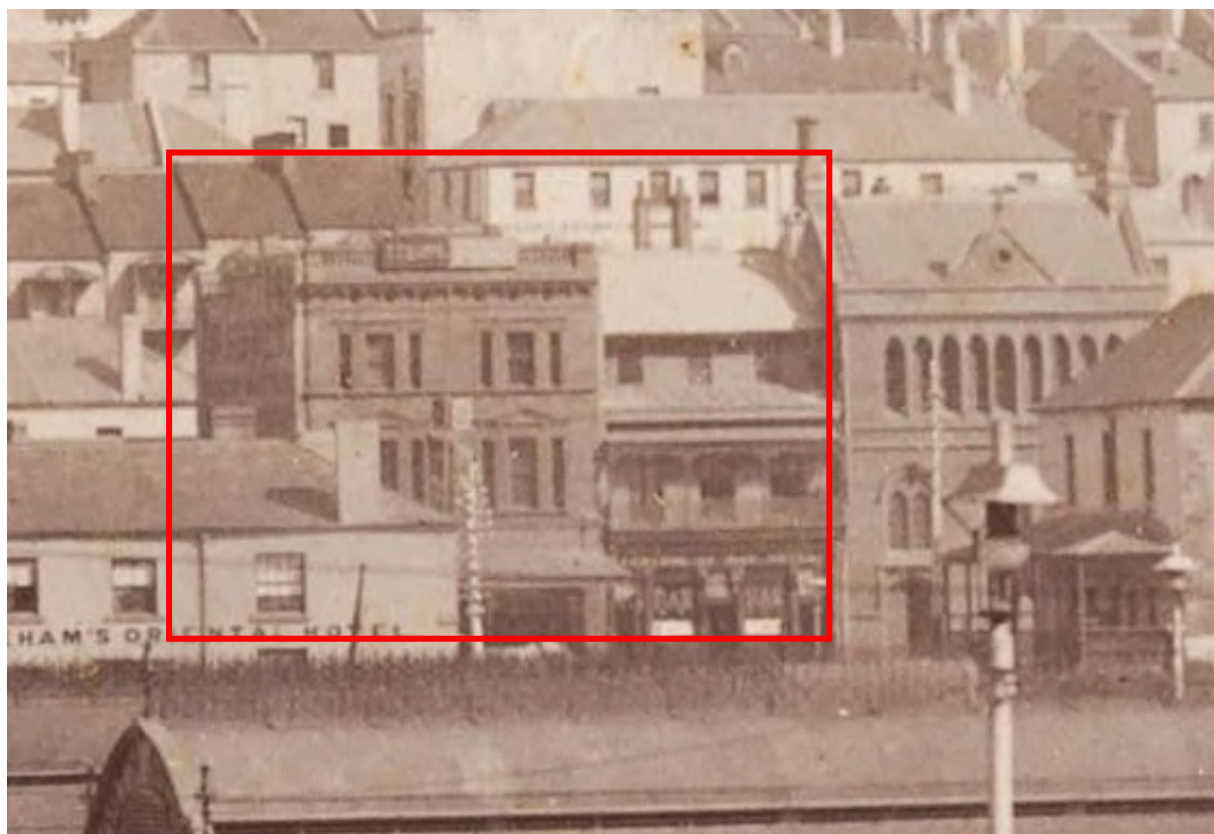
Figure 35 Detail of photograph showing 139-141 George Street and 137 George Street (Fortune of War Hotel), circa 1880-1890. Source: Museum of Applied Arts and Sciences Object no. 2013/23/54-4.

The use of the upper floors at this time would seem to have been for accommodation associated with the restaurant operations. A photograph of the neighbouring The Fortune of War Hotel of around 1900 includes a glimpse of the shopfront and awning of No. 139 George Street with advertising for dining rooms (See Figure 35).

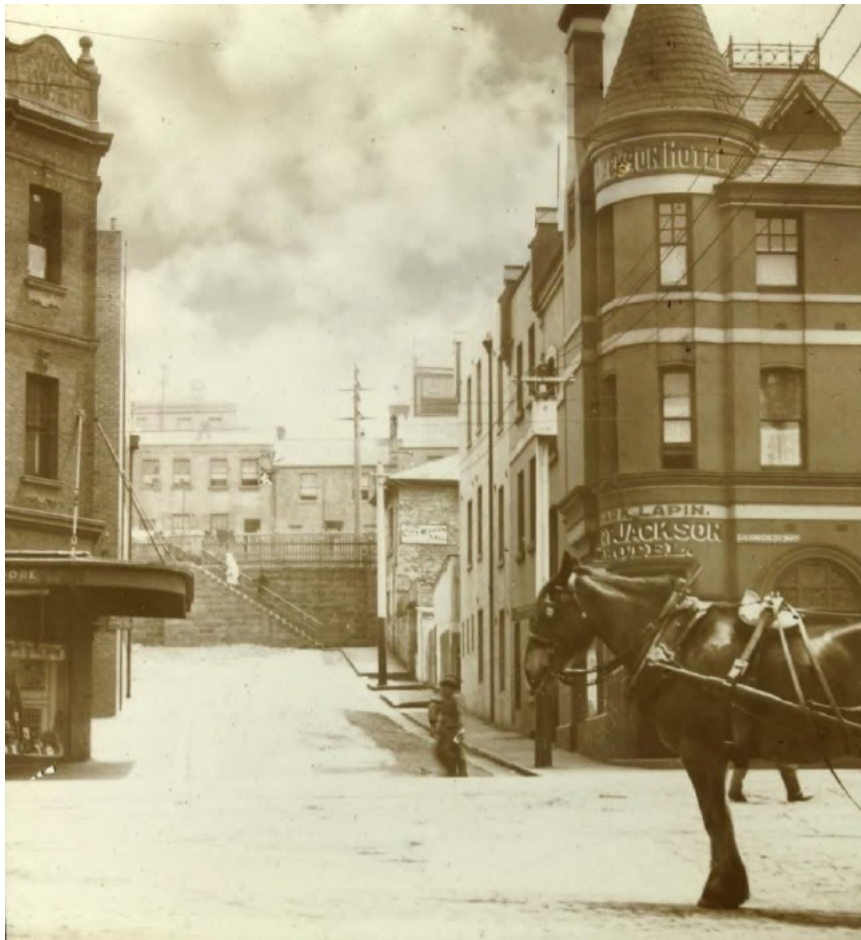
Figure 38 The Port Jackson Hotel, circa 1916. The replacement 1913 Globe Street buildings can also be seen. Source: State Library Victoria Identifier H2009.100/164 – John Henry Harvey photograph.

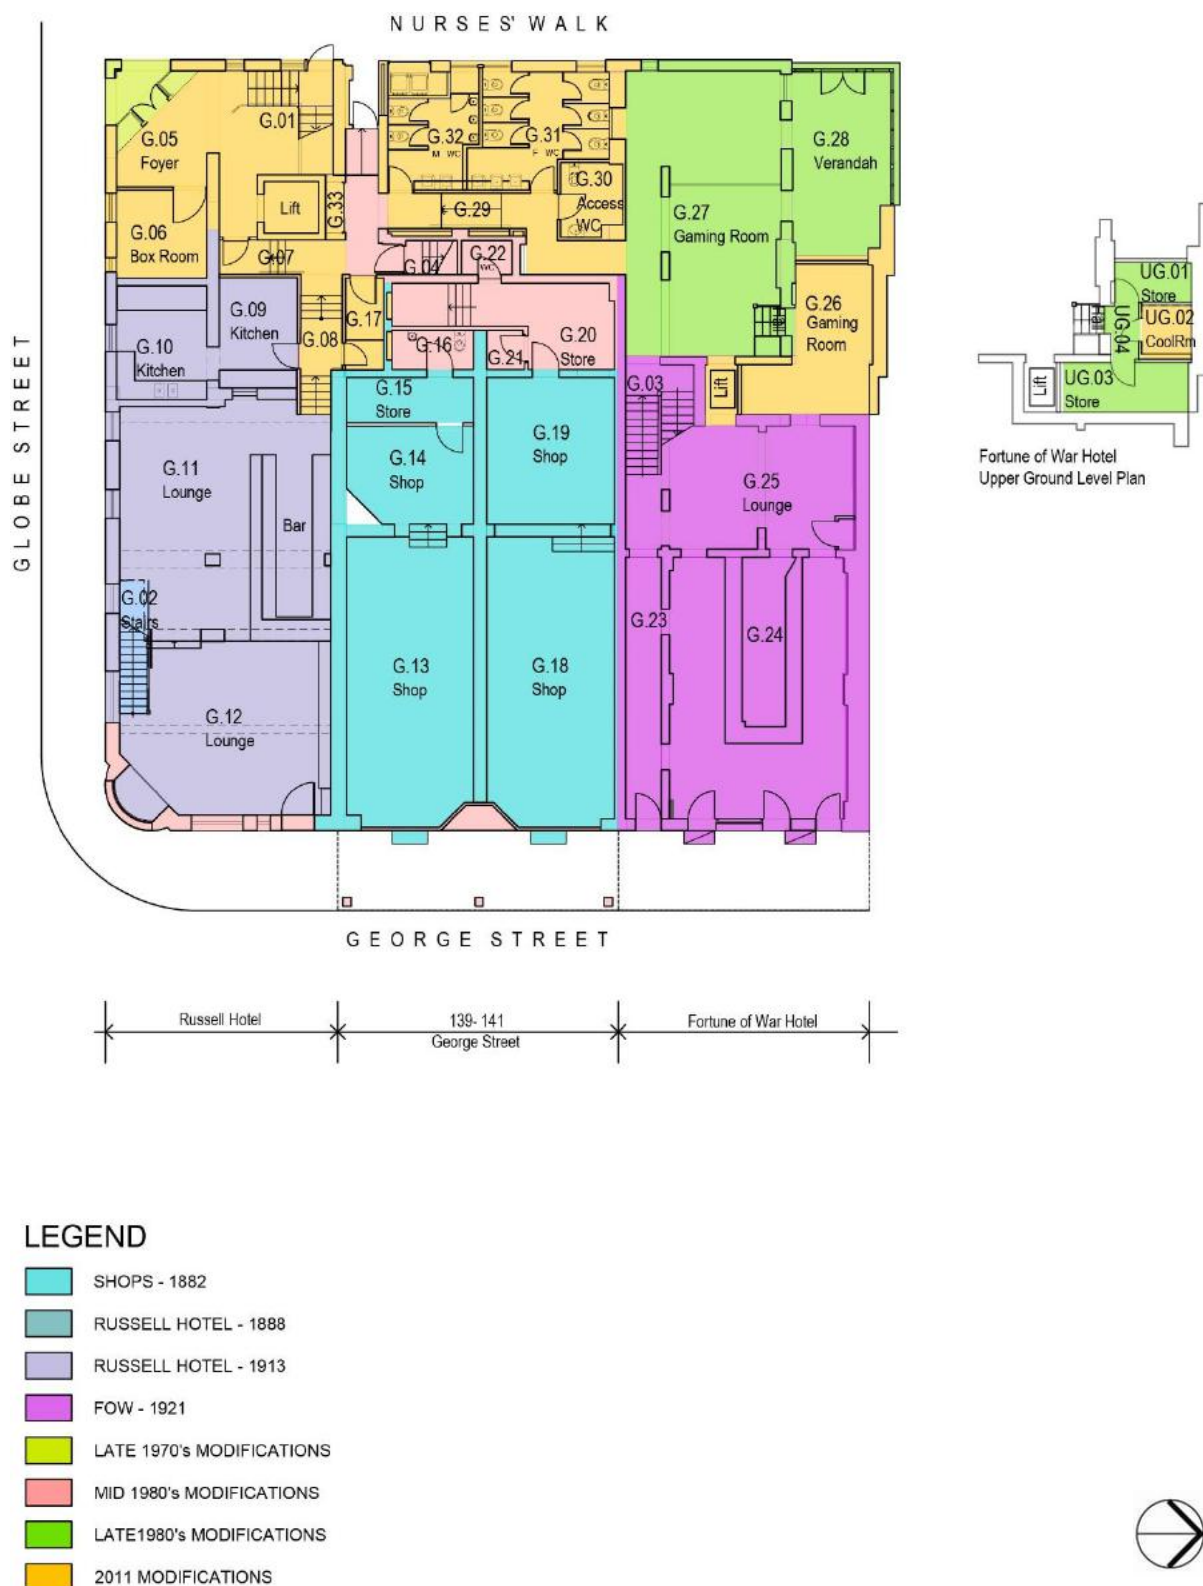
Figure 42: Phases of Development, Ground Floor Plan Level, TKD Architects (NTS)

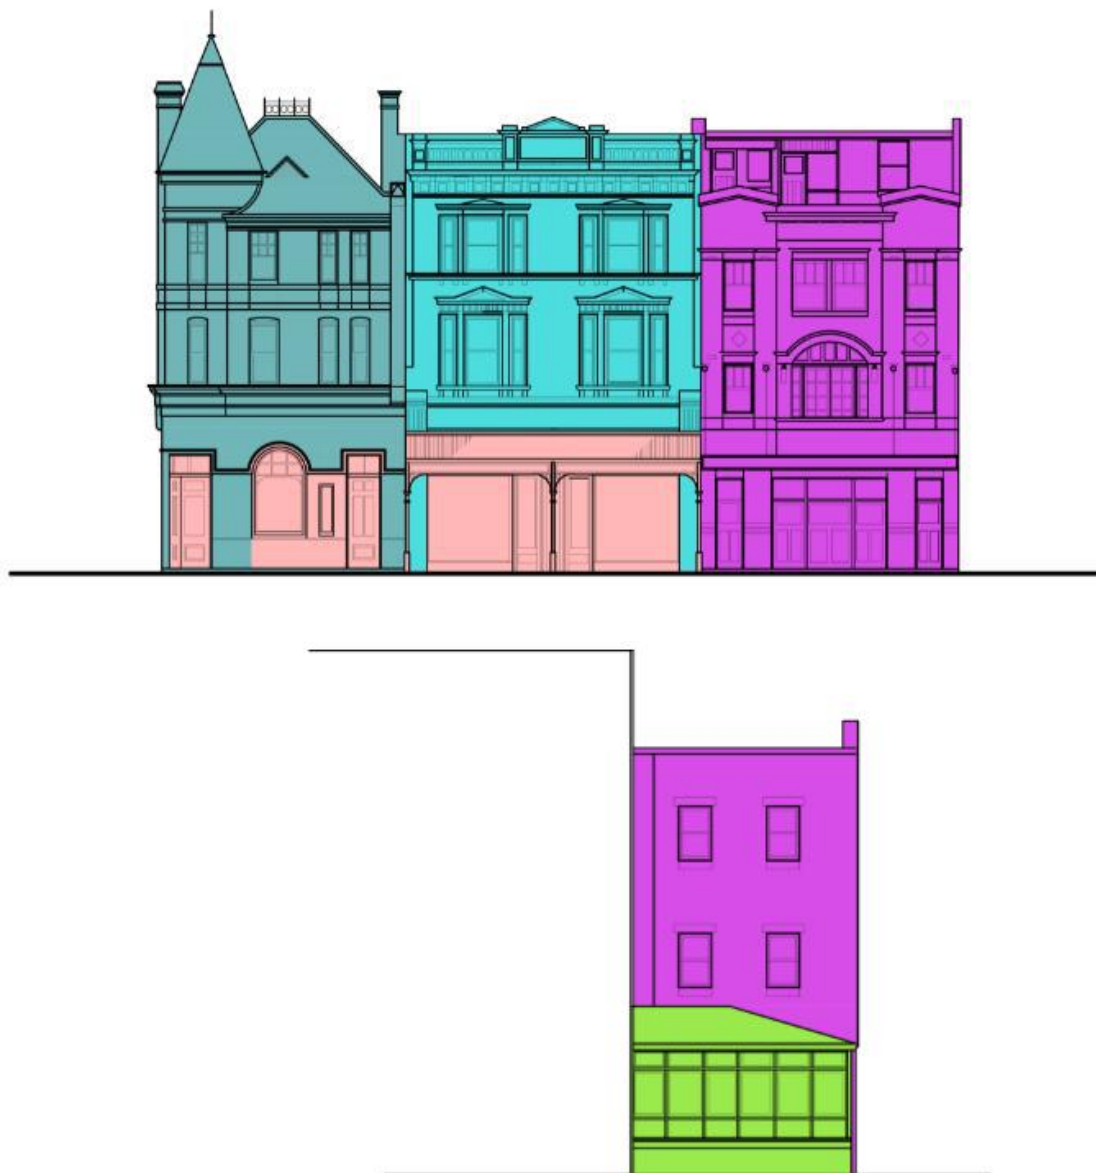
Figure 48: Phases of Development, West (Top) and South (Bottom) Elevation, TKD Architects (NTS)

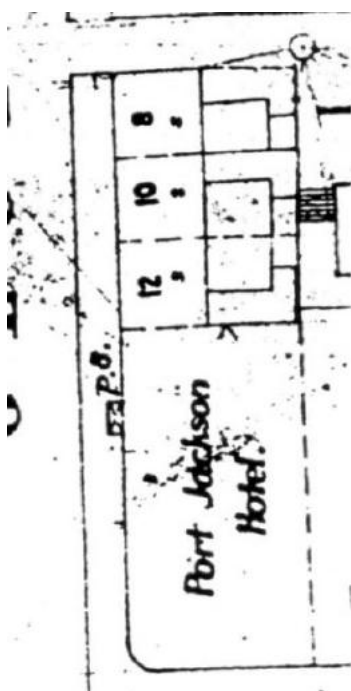
Figure 50: The Trigonometrical Survey of Sydney of 1888 (detail) shows the recently completed Port Jackson Hotel. Source: Sydney Water Plan Room.

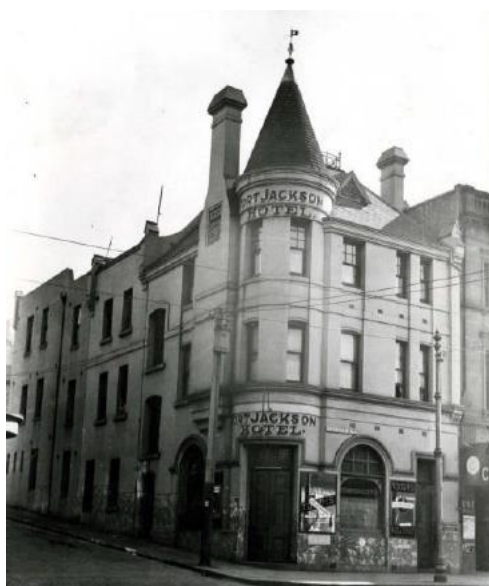
Figure 52: A photograph of the Port Jackson Hotel (143–143a George Street) taken about 1923. This shows the original/early appearance of the building. Source: PMNSW.

The c.1923 photograph (Figure 52) of the Port Jackson Hotel (dated by the tenancy of W. Cordingley) indicates the original/early appearance of the George and Globe Street facades of the building. It shows:

- vents (probably cast iron) in the upper courses of the ground and first floors of the George Street façade;
- the name of the premises (Port Jackson Hotel) painted with two-tone lettering above the main entrance door at the junction of Globe and George Streets as well as on the upper courses of the tower;

- a curved, timber-lined main entrance door of two leafs with fanlight over, and curved door threshold;
- the rendered masonry, three-storey rear addition (1913) in the location of the former (c.1865) terraces on Globe Street.

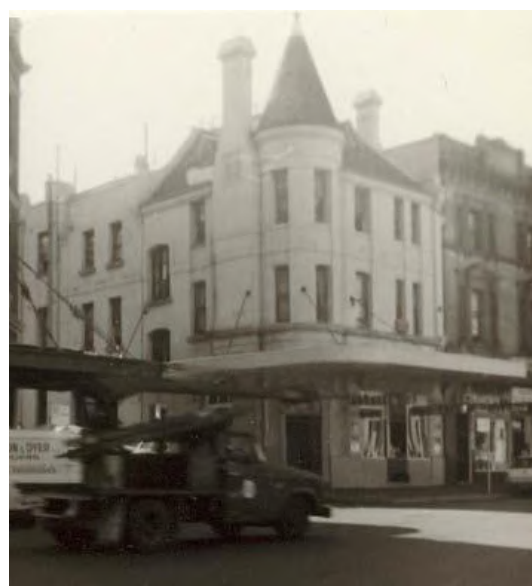
Figure 53: 143–143a George Street in 1972. A suspended steel awning had been added to the building and the ground floor elevation to George Street had been altered. Source: PMNSW.

Views taken in 1970 and 1972 show:

- a steel framed, suspended street awning to George and Globe Streets, with 1960s suspended under-awning illuminated signs and a painted sign identifying Allen's Cafe. The underside of awning is sheeted in boarding and battened over;
- the original large window with circular head on Globe Street;
- a new George Street shop front with centre recessed door for Allen's Café (c.1950s?);

- remnant sections of dressed sandstone masonry below the awning;
- a slate roof to the front building (including corner tower and gable), iron work railing to the roof and metal weather vane to the tower;
- Double-hung first and second floor timber windows as visible in the c.1923 photograph.

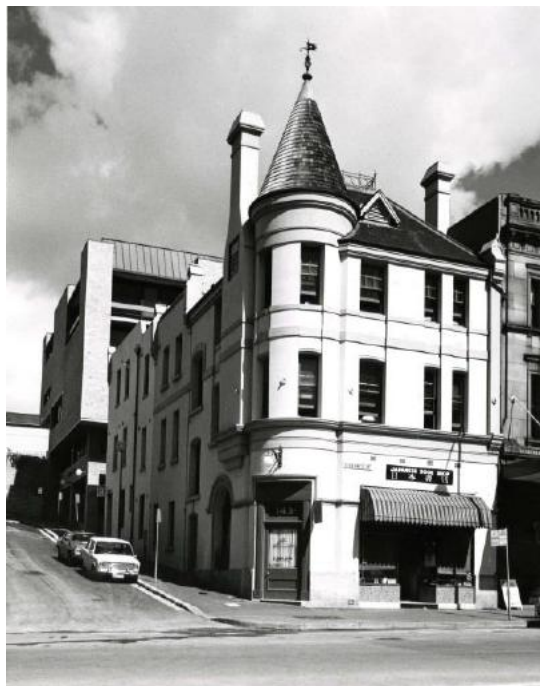
Figure 54: 143–143a George Street, c.1978. The suspended steel awning had been removed by this stage. The original, curved double doors to the corner entrance had also been removed. Source: copy obtained from PMNSW.

Between 1972 and 1978 (Figure 54), the suspended awning was removed and a canvas awning fitted to the George Street shopfront. Some minor works to the George Street shopfront were undertaken in 1973.

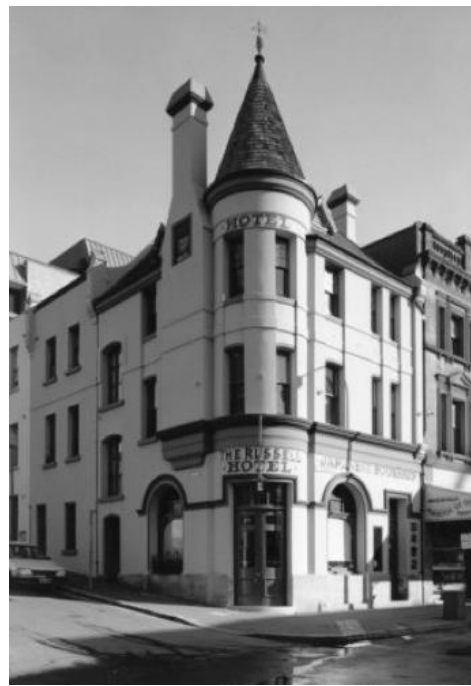
Figure 55: 143–143a George Street, 1985, following reconstruction of the corner entrance and George Street façade. Source: PMNSW image HP8/38.

The 1985 photograph (Figure 55) records the external restoration and reconstruction work undertaken by SCRA. The presentation of the building we see today largely results from this SCRA work, which included:

- Demolishing existing shop front and entry door;
- Constructing new window and door openings on George Street (matching detail on extant original on Globe Street);
- Fitting new entry doors to the corner entry;
- Painting heritage themed signage;
- New cantilevered pendant light.

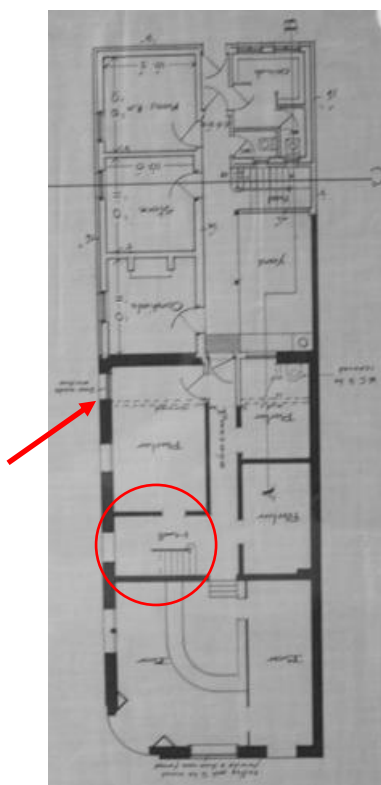
Figure 56: 143–143a George Street, alterations undertaken in 1913, Ground Floor Plan.

Note position of stairs and main side entry from Globe Street (circled). This doorway was later converted to a window (pre 1943). Note also the internal walls to be demolished at the rear of the original section of the building, and the side door to be converted to a window (marked with arrow).

The 1913 plans prepared by the Housing Board for the extension of the building is the earliest known plan of the existing building. The plans (refer to Figure 56 to Figure 59) shows the building in a configuration indicative of the licensed hotel use. The original (1887) section of the building has walls shaded in black while the walls of the rear addition are unshaded. The current room numbers (as allocated in this CMP) are indicated in red.

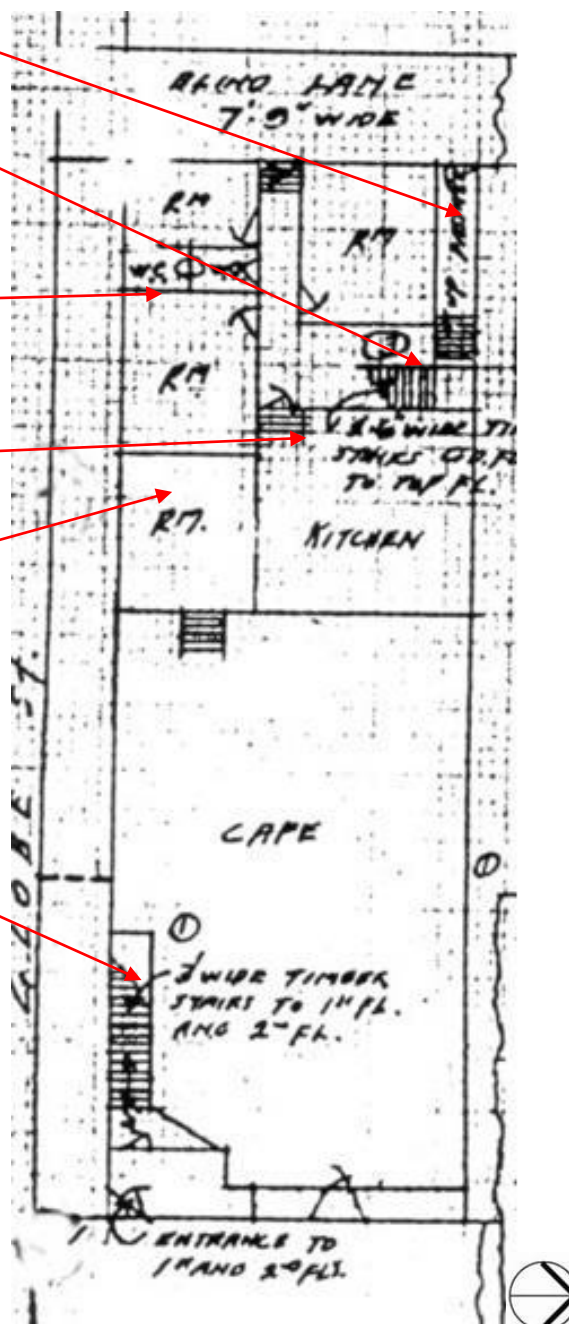
Figure 60: 143–143a George Street, Ground Floor Sketch Plan, 1943.

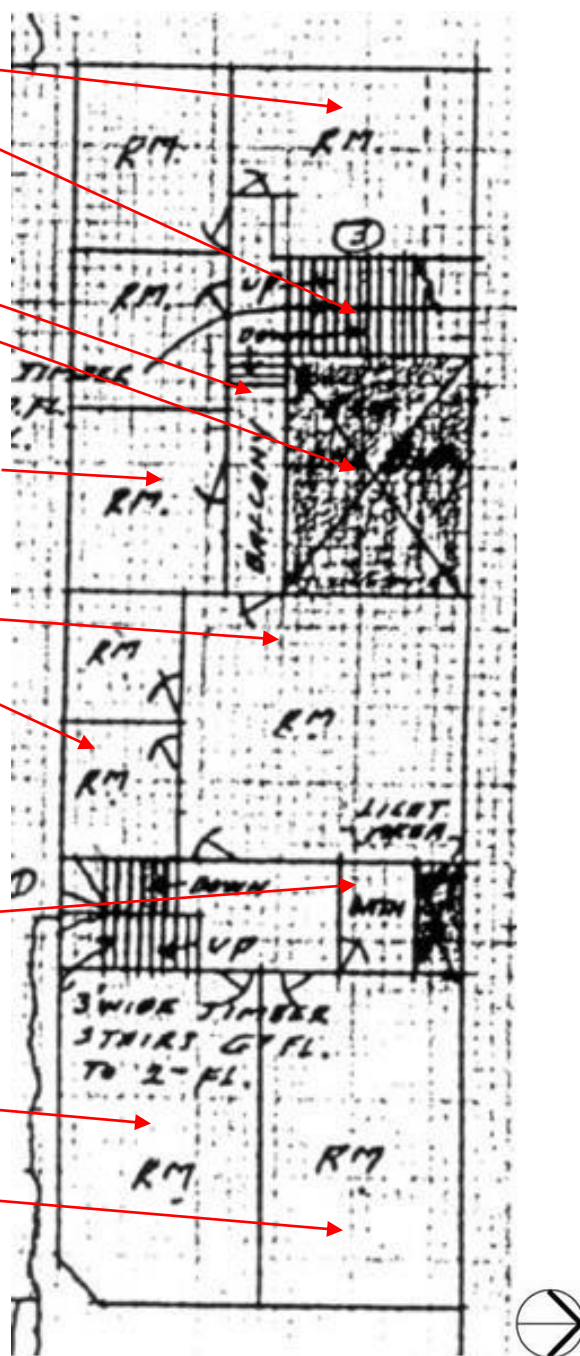
Figure 61: 143–143a George Street, First Floor Sketch Plan, 1943.

Notes in italics are those taken from the survey and reproduced in the Clive Lucas, Stapleton and Partners Conservation Management Plan of 1999. Source: City Council Surveyor's sketches, Nov. 1943.

A survey undertaken by the Architect and Building Surveyor's Department of the City Council in November 1943 plots, in sketch form, the interior planning of the building and indicates space uses at the time (see Figure 60 - Figure 62). The survey also includes an addition made to the rear of the premises around 1910/20.¹²² The survey noted the roof as timber framed throughout with sheeting materials as follows:

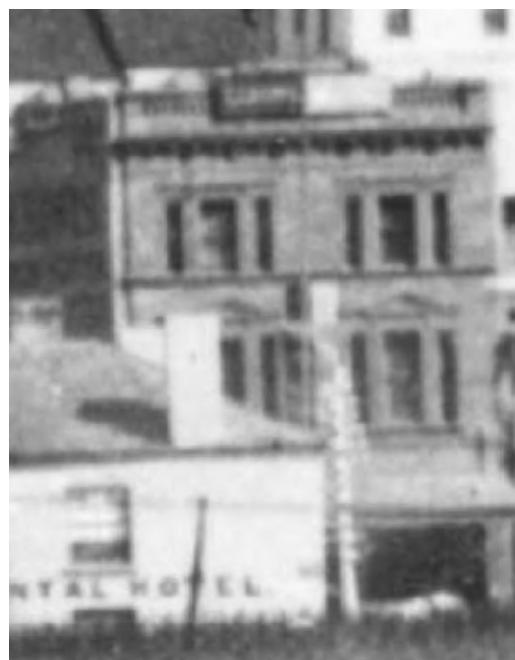
Figure 68: A photograph of Circular Quay in the early 1880s shows the existing building at 139–141 George Street with its street awning and posts. The exposed southern boundary wall (facing the site of today's 143–143a George Street) with painted advertising. Source: Shore, H., *From the Quay*, Kensington, 1981.

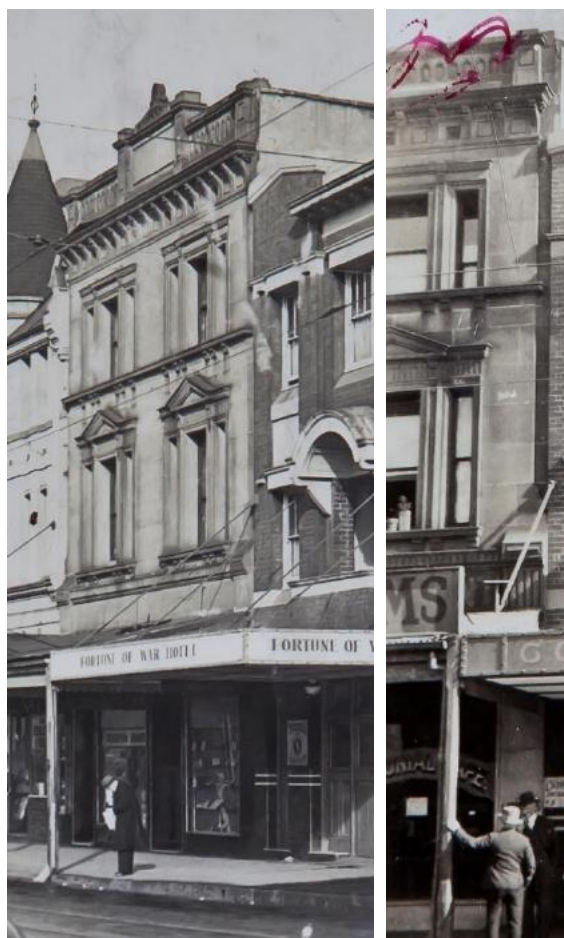
Figure 69: Photographs of 139–141 George Street in 1930 show some details of the building, such as a chamfered timber awning post, painted timber advertising sign, stone facade and double-hung timber window joinery. The Russell Hotel, 143–143a George Street, and the Fortune of War Hotel, 137 George Street, can be seen on either side of 139–141 in the image on the left. Source: ANU - Tooth & Co. N60/1471.

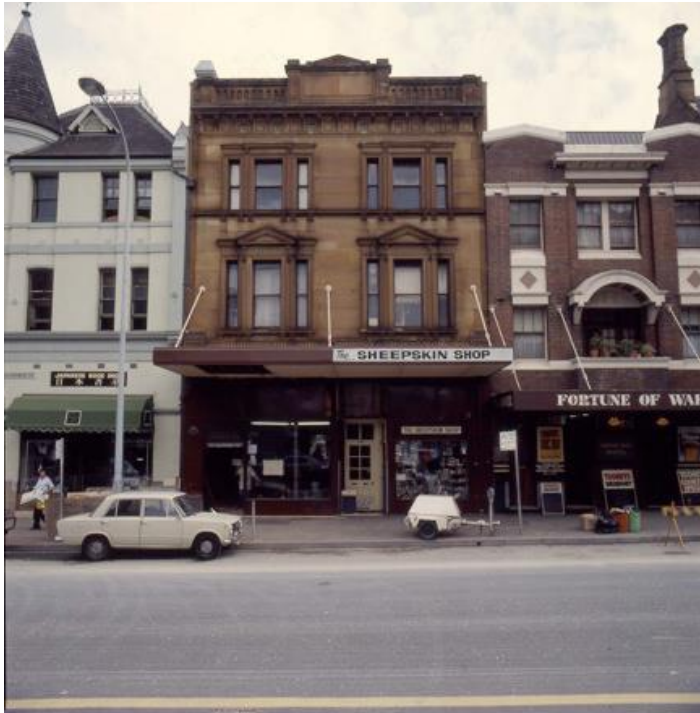
Figure 70: This undated, but 1970s era, photograph of the front elevation of 139–141 George Street, The Russell Hotel and the Fortune of War Hotel shows that, above awning level, 139–141 George Street had changed little since the time of its completion. The original streetfront awning with its timber posts had, however, been demolished and replaced by a suspended awning by this stage, and the shop fronts had been altered to provide two shops and a ground level entry to the accommodation levels above. Source: PMNSW, DW GE-38.

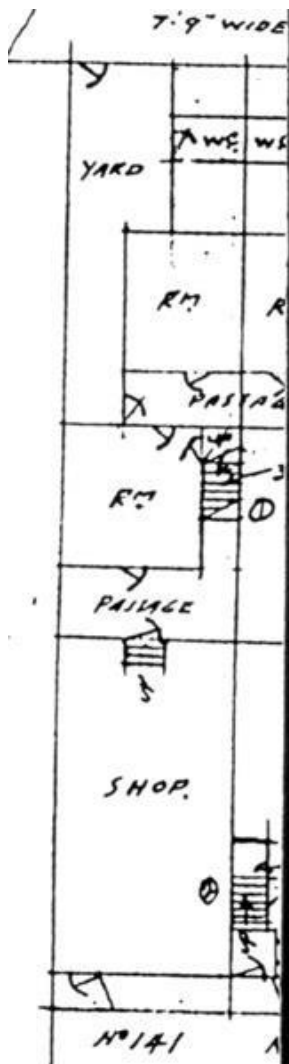
Figure 71: 141 George Street, Ground Floor Sketch Plan, 1943. At ground floor level, 141 George Street consisted of two main rooms, the rear room partitioned to separate it from the adjacent passage and stair to the first floor. To the west, a narrower wing with a side breezeway contained a passage with a door to the rear breezeway and yard. A WC at the rear of the property was accessible via the yard. Running behind the property is a lane 7 feet 9 inches wide. This lane was also noted behind 143 – 143a George Street (see Figure 60). Source: City Council Surveyor's sketches, Nov. 1943.

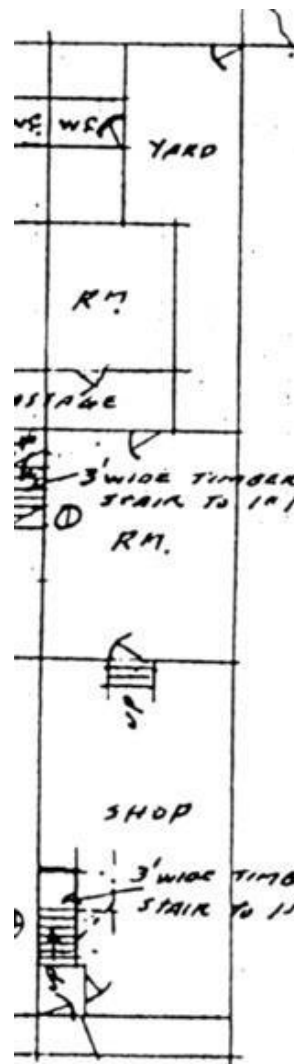
Figure 72: 139 George Street, Ground Floor Sketch Plan, 1943. The plan of 139 George Street was very similar to that of 141, except that there was a three foot wide timber stair connecting an entrance on George Street to the levels above. The rear room of the front section of the building was single storey. Source: City Council Surveyor's sketches, Nov. 1943.

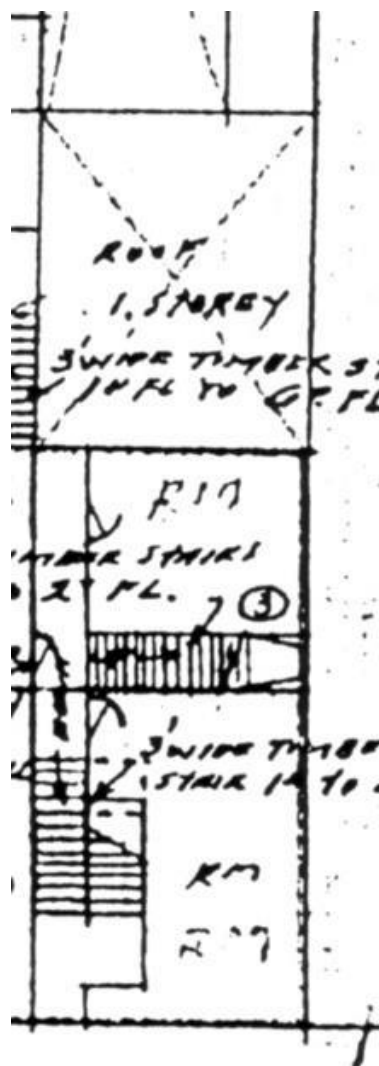
Figure 74: 139 George Street, First Floor Sketch Plan, 1943. At first floor level, 139 George Street contained two rooms. A roof over the single-storey rear room of the front section of the building is noted. As for 141 George Street, access to the second floor was via a stair running parallel to George Street. Source: City Council Surveyor's sketches, Nov. 1943.

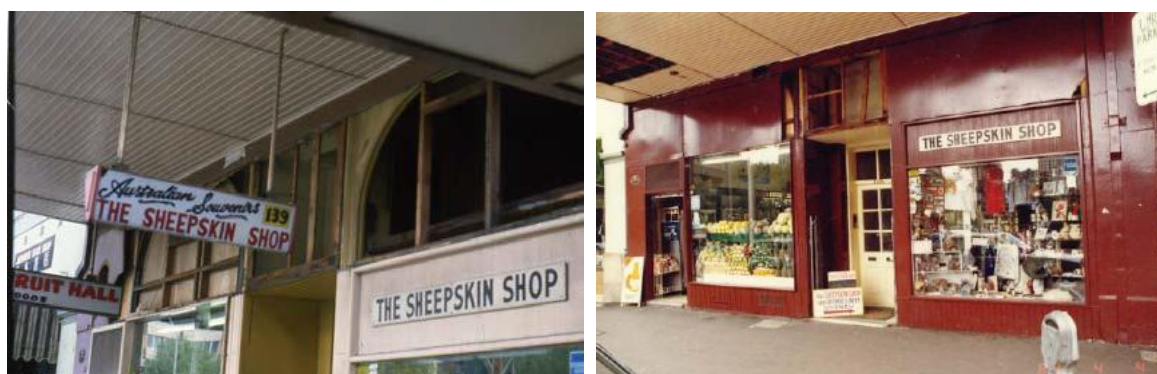
Figure 80: In the 1985 staged reconstruction of the shopfronts (No. 141 was the first completed), SCRA staff undertook investigation of the existing structure to reveal part of the original shop front detail. Source: PMNSW Library.

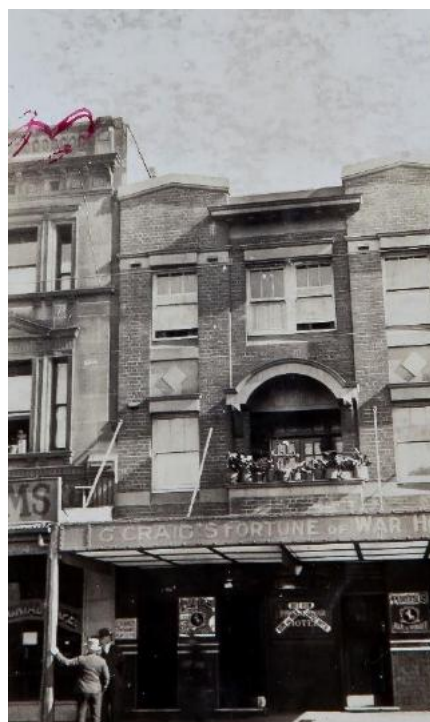
Figure 90: Comparison of this photograph of the George Street elevation of the Fortune of War Hotel in August 1930 confirms that the elevation of the building today has a high level of intactness. Source: Noel Butlin Archives Centre (ANU) 'Tooth & Co. Yellow Cards'.

Presumably, these photographs were taken by Tooth & Co to record the respective management of the property by its tenants. The earliest Tooth & Co. photograph was taken in August 1930. It records the face brick facade with rendered cement detail, large sash windows with their three-paned upper sashes, curtains and blinds to the windows, the tiled wall to underside of suspended awning, and an awning with the sign 'C. Craig's Fortune of War Hotel'¹²⁹ (Figure 90).

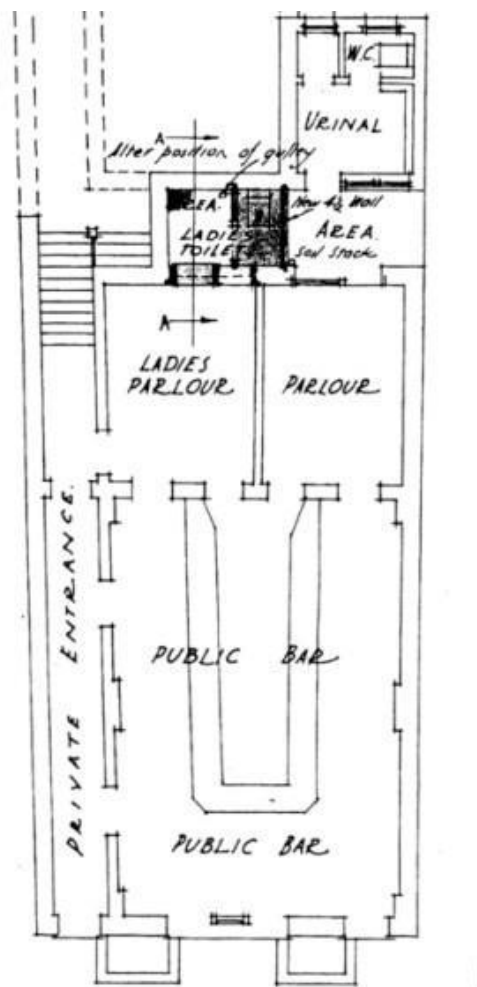
Figure 98: Fortune of War Hotel, 137 George Street, works to the Front Light Area (now gaming room G.26), 1940. The ladies' toilets were created within the outdoor 'Area' (yard) and a window to the ladies' parlour was converted to a door. The alteration was undertaken to comply with an order made under S.40A of the Liquor Act.¹³² Source: SRNSW Plan No. 72428.
