Conservation Management Plan

Russell Hotel and
Fortune of War Group

137–143A

George Street, The Rocks

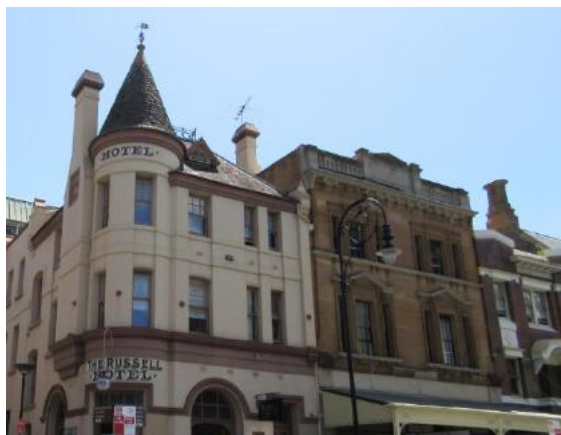
Figure 107: The rendered and painted façade of The Russell Hotel, 143–143a George Street, on the left and the sandstone façade of 139–141 George Street on the right. Source: TKD Architects 2020.

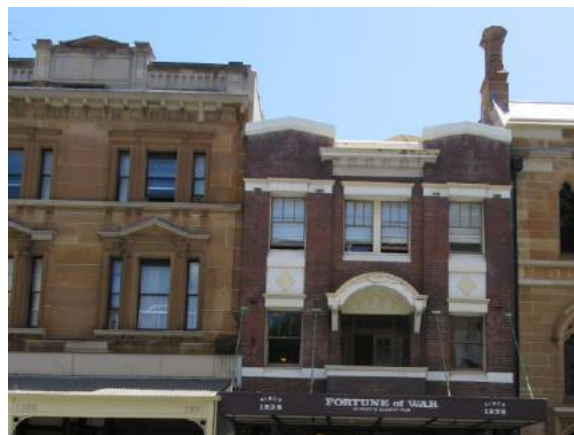
Figure 108: 139–141 George Street on the left and the face brick and render façade of The Fortune of War Hotel, 137 George Street, on the right. Source: TKD Architects 2020.

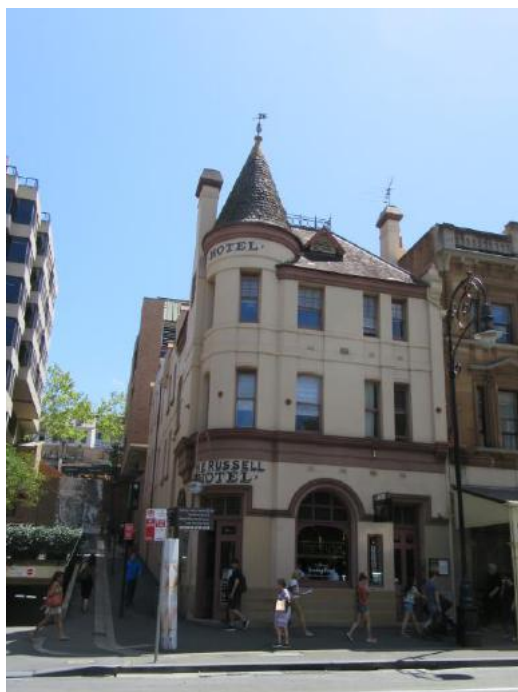
Figure 121: 143–143a George Street, The Russell Hotel, George Street elevation. This elevation is highly intact, in part due to the reconstruction of the ground floor portion of the elevation in the mid 1980s. Source: TKD Architects 2020.

The principal elevations are to George Street and Globe Street but the building also has a rear elevation facing Nurses Walk, to the west. Figure 121 - Figure 126 **Error! Reference source not found.** show the elevations and external details of the building.

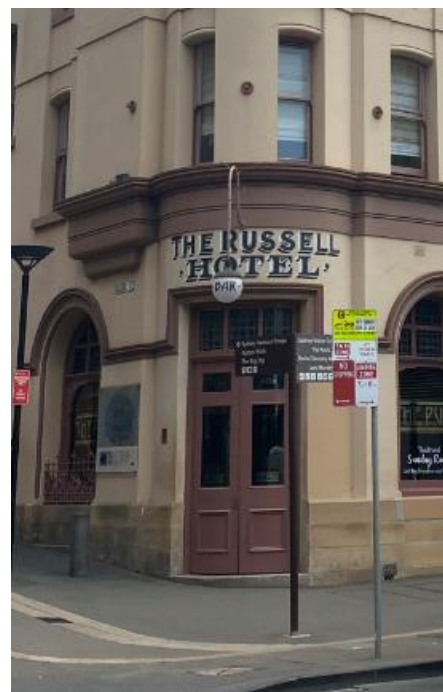
Figure 122: The Russell Hotel, corner entry to wine bar. The curved double doors and fanlight date from the 1980s reconstruction. The arched window, to the left, facing Globe Street is original. Source: TKD Architects 2020.

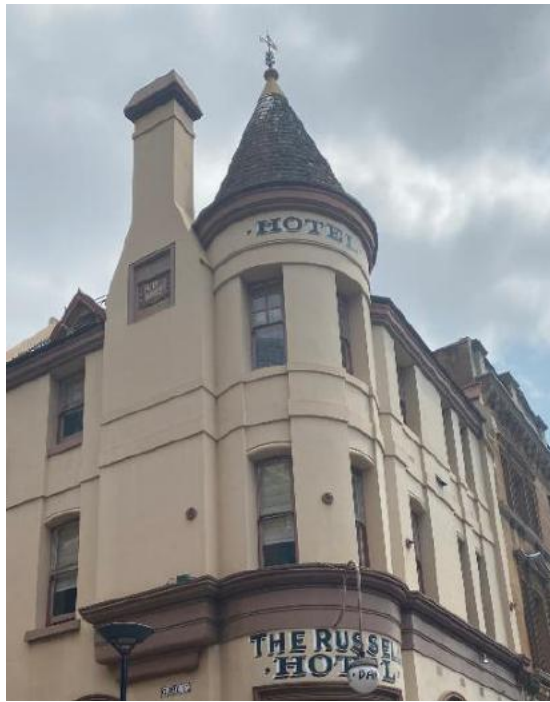
Figure 123: The corbelled chimney and distinctive conical tower of The Russell Hotel. The date plaque on the chimney reads 1887, the date of the construction of the original portion of the building. Source: TKD Architects 2020.

The roof of the original portion of the building is an important element in its design and in its contribution to the streetscape of George Street. The main roof is hipped, steeply pitched and clad in slate. The roof planes are broken on the east and south by gablets venting the attic space. The main roof is crowned by a platform enclosed by a decorative cast iron railing. The predominant element of the roof is, however, the conical, shingle-clad corner tower and the balancing painted masonry chimney flue.

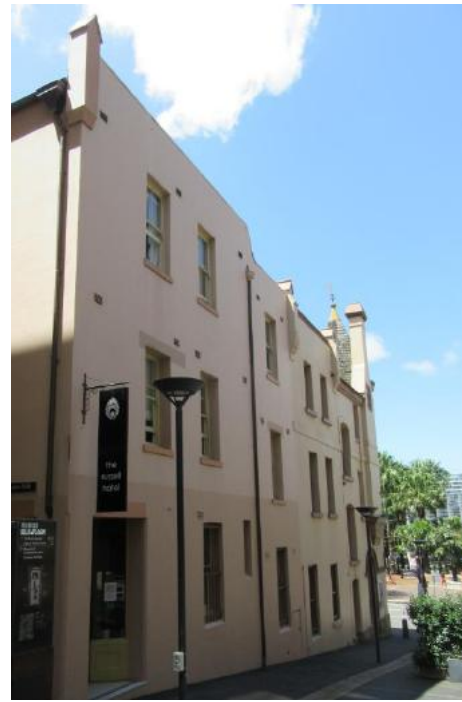
Figure 124: Globe Street elevation, The Russell Hotel. The rear section (painted in a paler colour) dates from 1913. The corner entrance at the Globe Street/Nurses Walk corner (left hand end of the elevation) dates from the late 1970s. The small, high level window further right was formed for a small bathroom (now demolished) at the same time. Source: TKD Architects 2020.

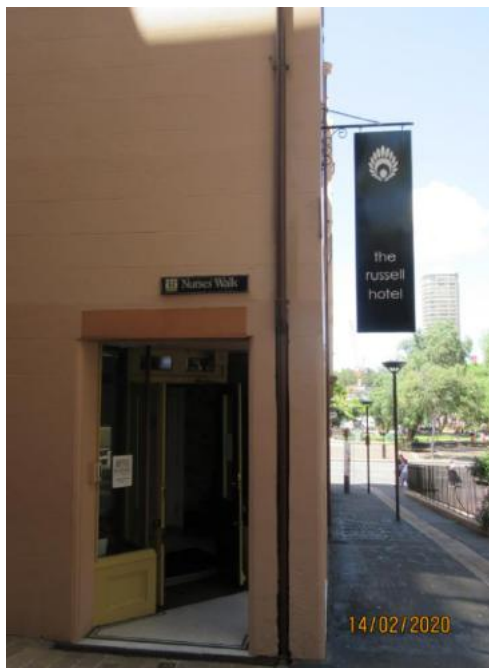
Figure 125: The current entrance to The Russell Hotel was formed in the 1970s to provide access to a shop. The ground floor window to the left also dates from this period. The windows above, originally to guest rooms but now to stair 1.01/2.01, are original. Image taken 2012. Source: TKD Architects 2020.

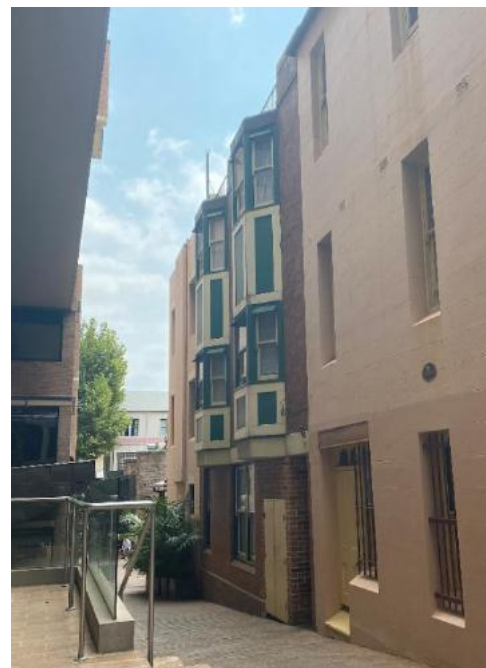
Figure 126: The door and window opening (bottom right) to the western elevation was created post 1913. The window directly above, originally to a guest room, now to stair 1.01, is original. To the left sit the rear elevations of 137–141 George Street. Source: TKD Architects 2020.

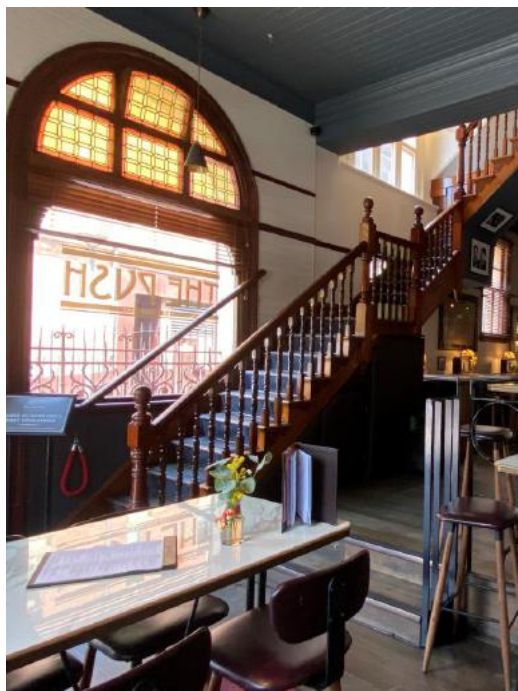
Figure 127: The Russell Wine bar, space G.12. The stair was re-built in this location pre 1943, mainly re-using original joinery elements. The timber boarded ceiling is mostly a reconstruction/restoration of early fabric. The arched window on the left is original. Source: TKD Architects 2020.

The timber stair (G.02) that previously led to the reception area of The Russell Hotel has now been blocked off at ground floor level (as well as first floor level). Access into the hotel is now via the entrance at the corner of Globe Street and Nurses Walk and a recent lift. The timber stair was re-built in G.12 pre 1943, mostly re-using original joinery elements that are still in situ. The Clive Lucas, Stapleton report notes that the timber board soffit is a modern reproduction. Originally, the stair (in a different configuration) sat within a stair hall entered from Globe Street (see Figure 56). The stair was re-furbished in the mid-1980s, when some new turned balusters were fitted.¹⁵⁴ (See Figure 127, Figure 128, Figure 132).

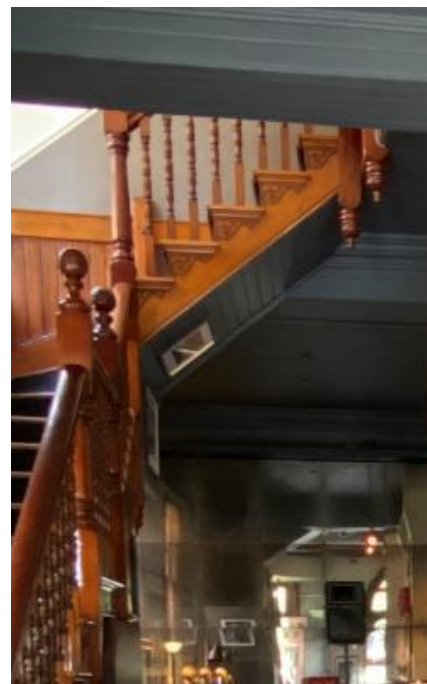
Figure 128: The Russell Wine bar, space G.11. The beams at ceiling level in this image and Figure 66 indicate the former locations of original internal walls. The wine bar fitout is recent. The timber boarded stair soffit is modern. Source: TKD Architects 2020.

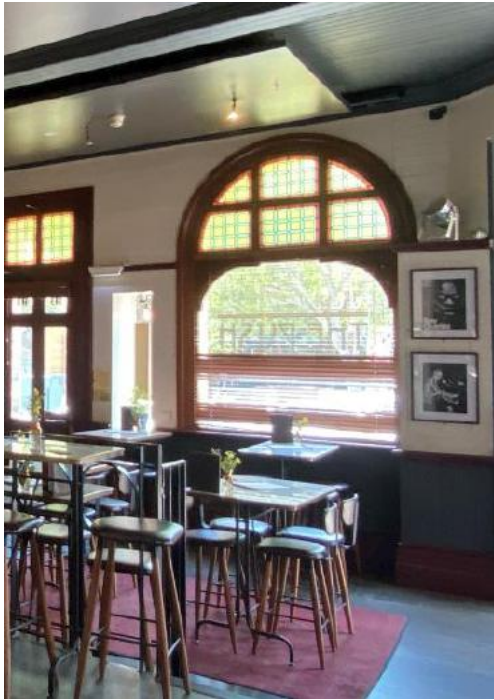
Figure 129: The Russell Wine bar, space G.12. The arched window and door are mid 1980s reconstructions based on documentary and physical evidence. The timber boarded wall cladding is early but was restored and painted in the 1980s, and probably several times since. Source: TKD Architects 2020.

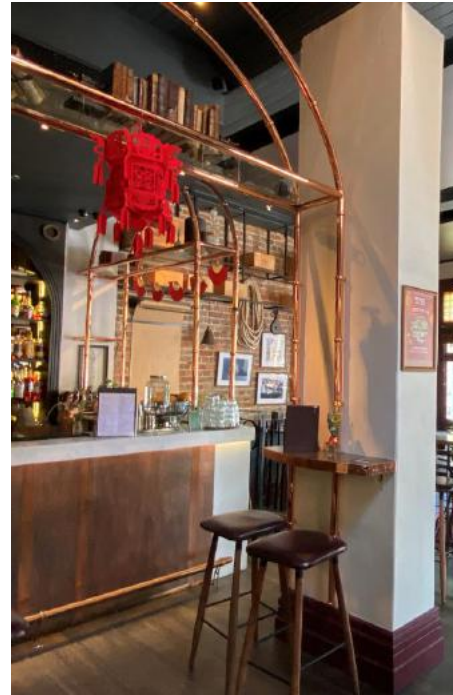
Figure 130: The recent bar fitout in space G.11. The 'column' on the right is part of an original internal wall. Source: TKD Architects 2020.

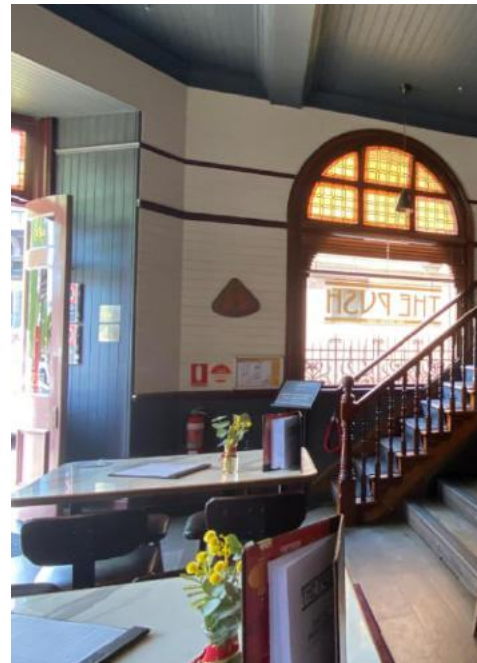
Figure 132: Base of stair G.02, looking towards the Russell Wine Bar entry at the corner of George and Globe Streets. The curved entrance doors and fanlight are mid 1980s reconstructions based on documentary and physical evidence. The arched window above the base of the stair is original. Source: TKD Architects 2020.

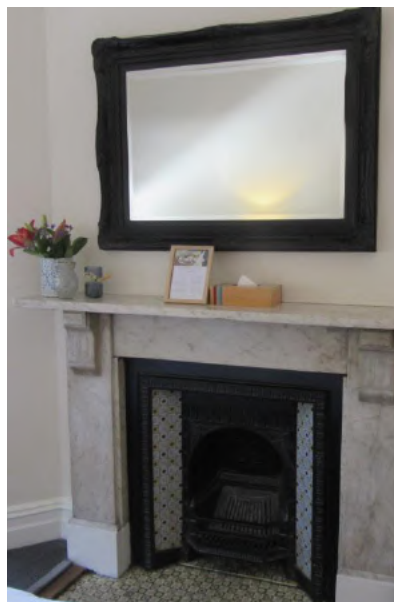
Figure 134: This white marble chimney piece to 1.16 (Room 1), and its cast iron fire place register grate, are original. Spaces 1.17 and have similar chimney pieces, while 2.18 (Room 10) has a painted timber chimney piece. The moulded timber skirtings are also original. Source: TKD Architects 2020.

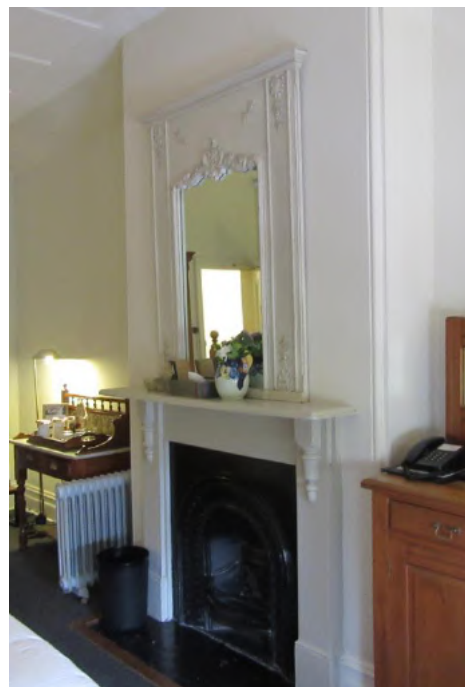
Figure 138: Room 19 (2.18) has a painted timber chimney piece. This is the only chimney piece of this type in the original section of the building and it is possible that it is a later replacement of the original. However, the Clive Lucas Stapleton CMP of 1999 notes it as being original. Source: TKD Architects 2020.

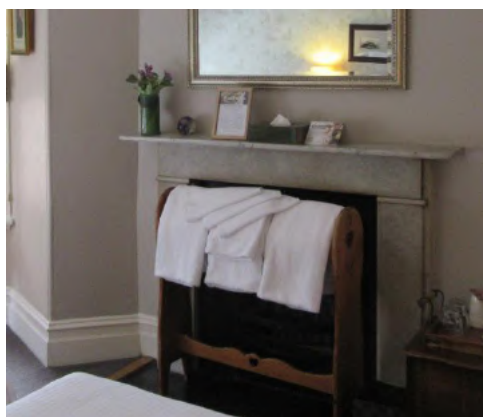
Figure 139: This white marble chimney piece to 2.17 (Room 9) is original. Source: TKD Architects 2020.

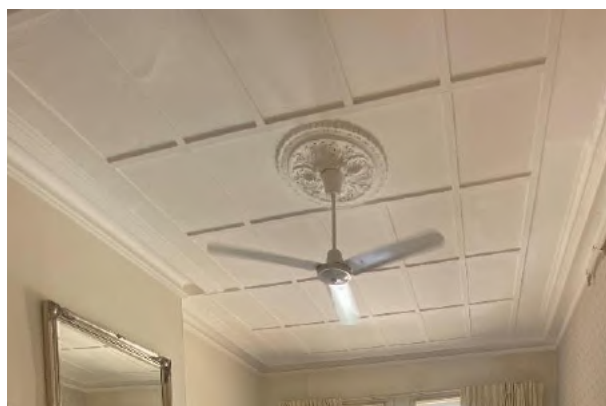
Figure 140: The battened ceiling to Room 2 (1.17) is typical of the ceiling finish to the original section of the building (1887) except for in the smaller guest rooms, which had timber boarded ceilings. Source: TKD Architects 2020.

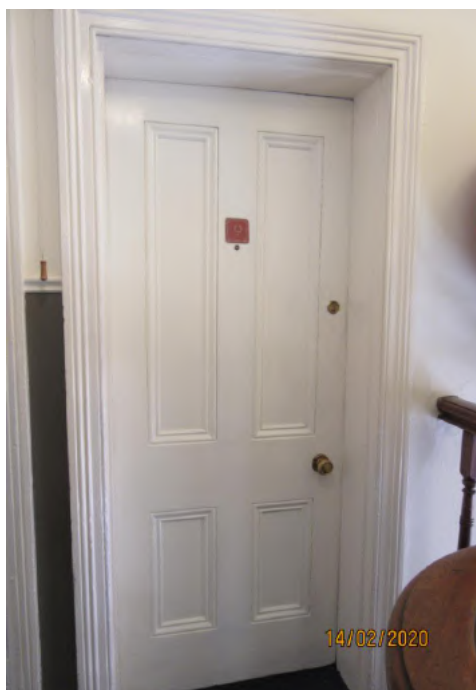
Figure 143: The door leading from space 2.02 to space 2.17 (Room 9). The four panel door joinery is typical of the original (1887) section of the building and the door leaf, architraves and skirtings are original. Source: TKD Architects 2020.

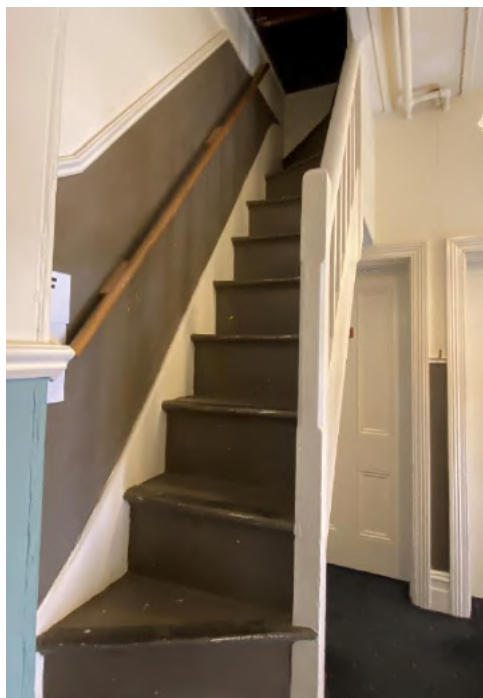
Figure 145: The steep timber stair leading to the attic from the second floor, space 2.02, is original. The set plaster wall finish is original, but the timber dado rail is a modern reproduction. The stair originally led to the hotel's rooftop laundry and drying area. Source: TKD Architects 2020.

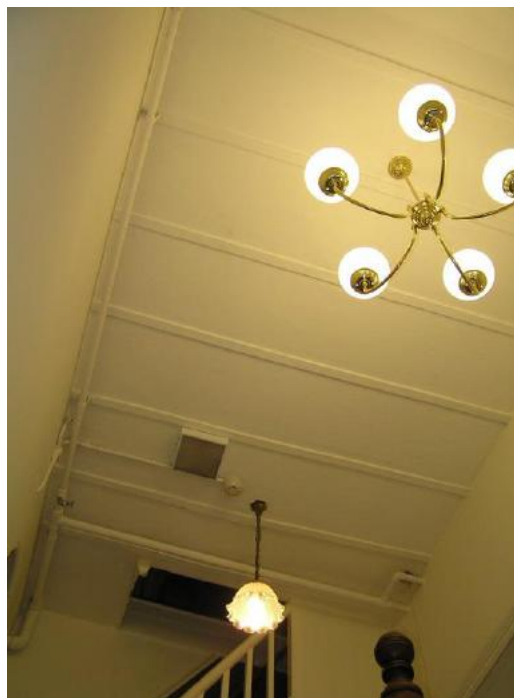
Figure 146: The batted ceiling of the stairhall, 2.02, showing the opening in the ceiling through which the attic is reached. The ceiling is lath and plaster and is 2.022 original, although the timber battens may be later, possibly Edwardian, additions. Source: TKD Architects 2020.

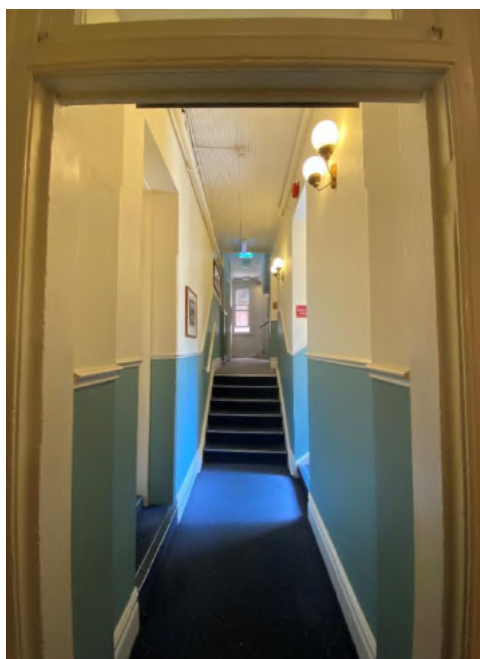
Figure 147: View from The Russell Hotel reception, space 1.13, looking west along hallway 1.07. The opening to 1.07 was made during the 1913 construction of the rear wing of the building. A similar opening directly above, on the second floor, was made at the same time. Source: TKD Architects 2020.

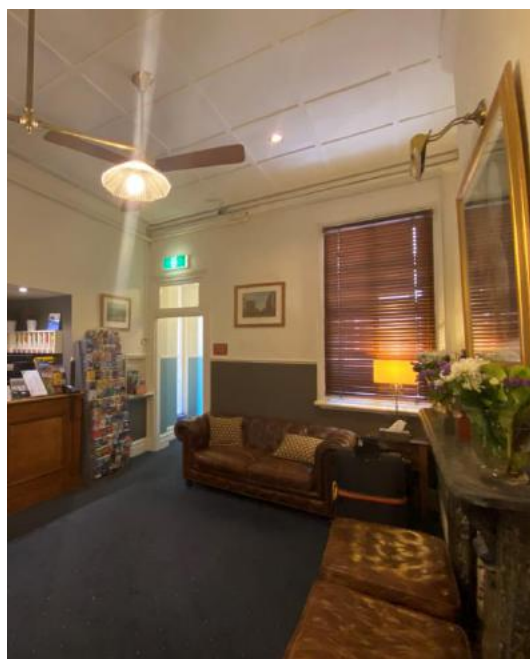
Figure 148: This space, 1.13, now forms the reception lounge for The Russell Hotel. In combination with the adjacent office 1.14, the room was originally the hotel's dining room. The marbled timber fireplace, painted, batted ceiling, window and skirtings are original. The marbled timber mantle shelf and the timber dado rail are modern reproductions. Source: TKD Architects 2020.

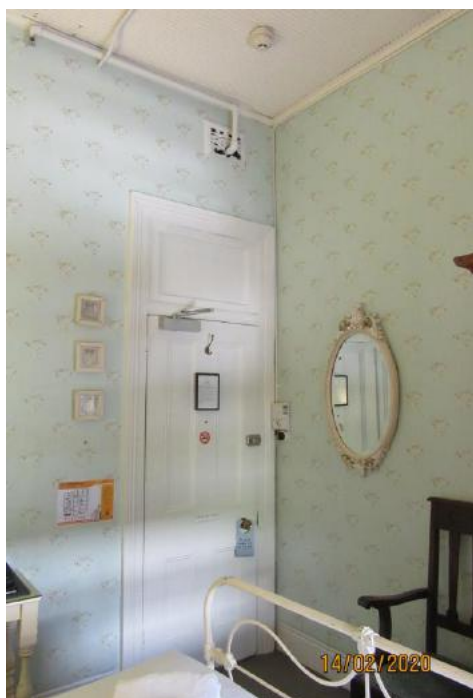
Figure 149: Door and fanlight (painted over) to space 1.05 (Room 5). This original door joinery is typical of the rooms to the 1913 rear wing of The Russell Hotel (1.05, 1.06, 1.09, 2.05, 2.06, 2.09). Source: TKD Architects 2020.

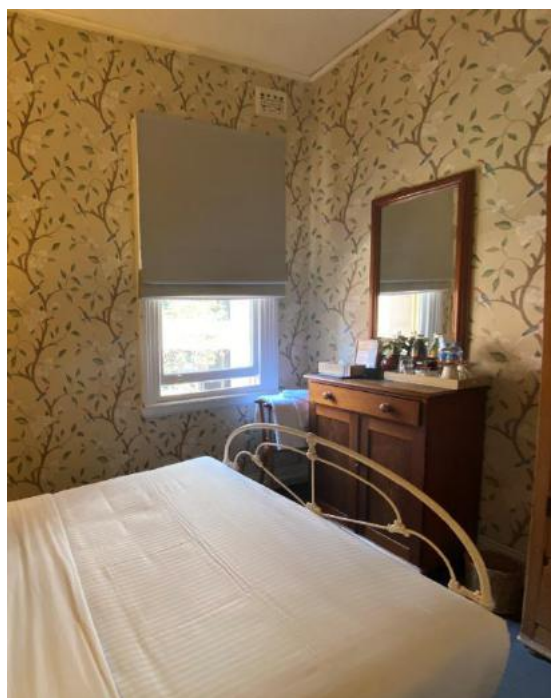
Figure 150: View of space 1.06 (Room 4). The size of the room, and the window joinery, are also typical of the 1913 rooms of the hotel. Source: TKD Architects 2020.

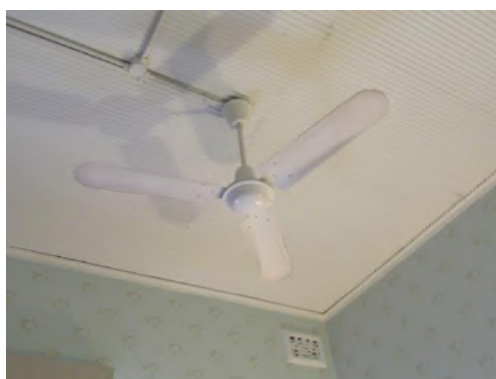
Figure 151: The original ripple iron ceiling, cast iron wall vents and timber cornice of space 1.05 (Room 5) are typical of the ceilings of the guest rooms in the 1913 rear wing of The Russell Hotel (1.05, 1.06, 1.09, 2.05, 2.06 and 2.09). Some of the electrical installation to this wing is original. Source: TKD Architects 2020.

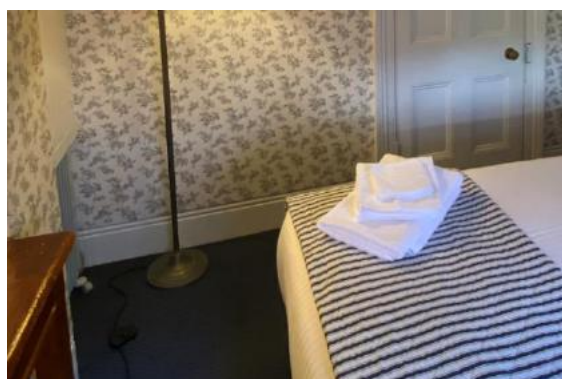
Figure 152: The painted, rendered bead flush skirting in space 1.09 (Room 3) is also typical of the skirtings to the guest rooms of the 1913 rear wing. Source: TKD Architects 2020.

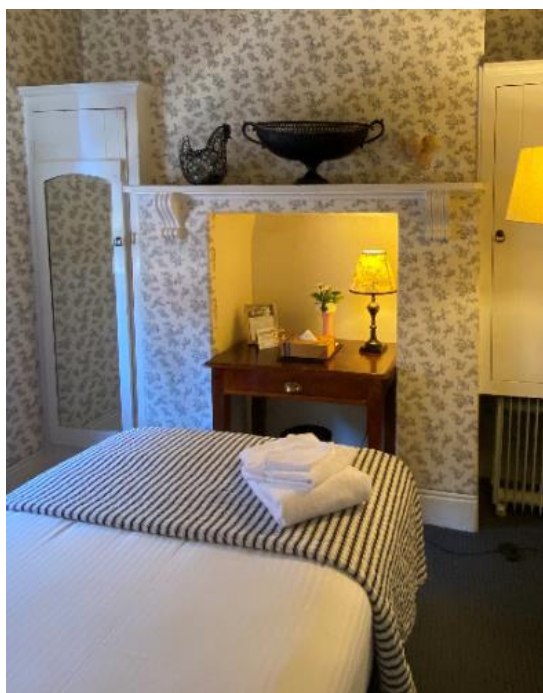
Figure 153: Room 3 (space 1.09) was shown as a kitchen in the 1913 plan, and the large fireplace is consistent with this use. The timber cupboards on either side of the fireplace may also date from the period when the room was used as a kitchen. Source: TKD Architects 2020.

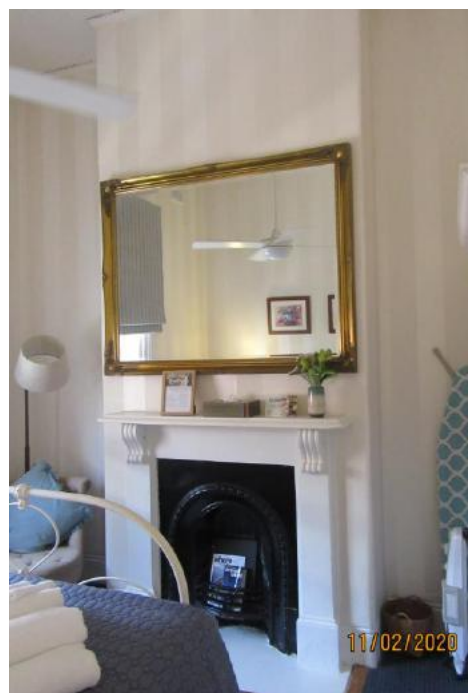
Figure 154: Simple painted timber chimney piece to the fireplace in space 2.09 (Room 11). Source: TKD Architects 2020.

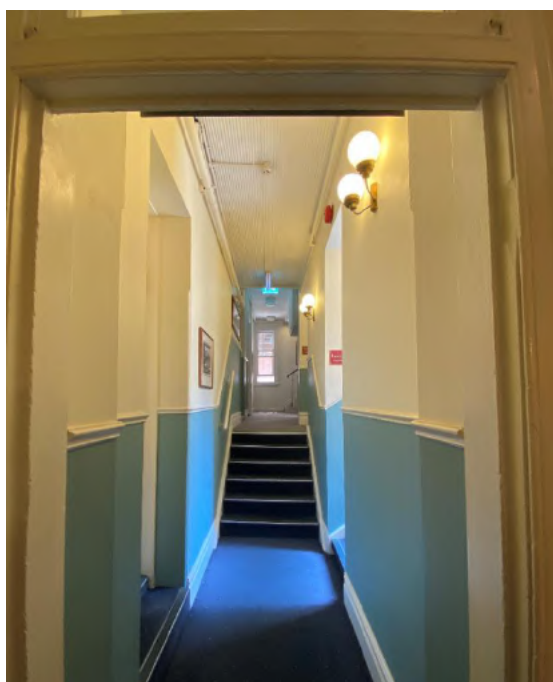
Figure 155: Hallway 1.07, looking west towards the new stair 1.01, was formed by enclosing an open verandah that originally provided access from the front (1887) wing of the building to the rooms of the rear (1913) addition and the rear stair. Most of the fabric dates from the mid 1980s and later, although there are some remaining Edwardian features. Source: TKD Architects 2020.

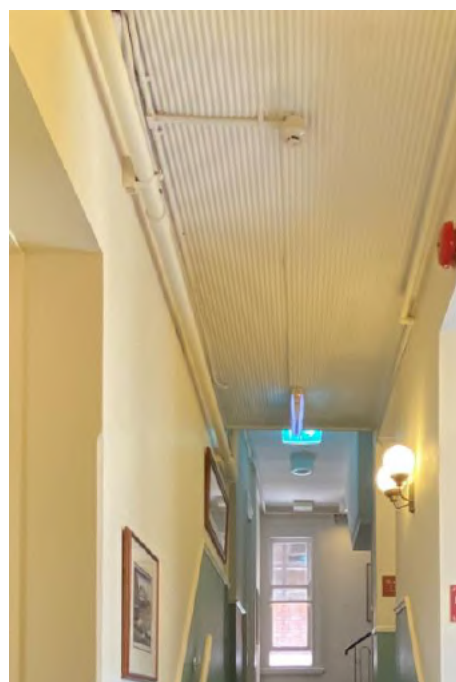
Figure 156: Ceiling of hallway 1.07. The ceiling of the space would originally have been the underside of the verandah above. The Clive Lucas, Stapleton and Partners report notes this ceiling as being Edwardian (and therefore original). Source: TKD Architects 2020.

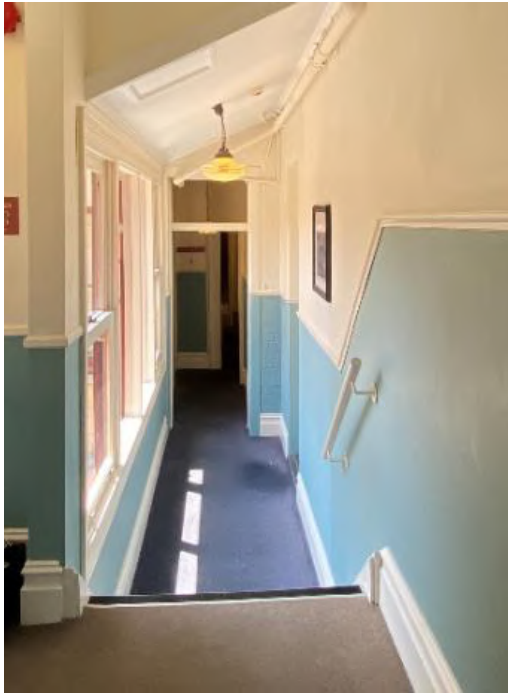
Figure 157: Hallway 2.07, looking east towards the front of the building, was formed in the 1980s by enclosing an open verandah that originally provided access from the front (1887) wing of the building to the rooms of the rear (1913) addition and the rear stair. Most of the fabric is modern, but some elements are original. Source: TKD Architects 2020.

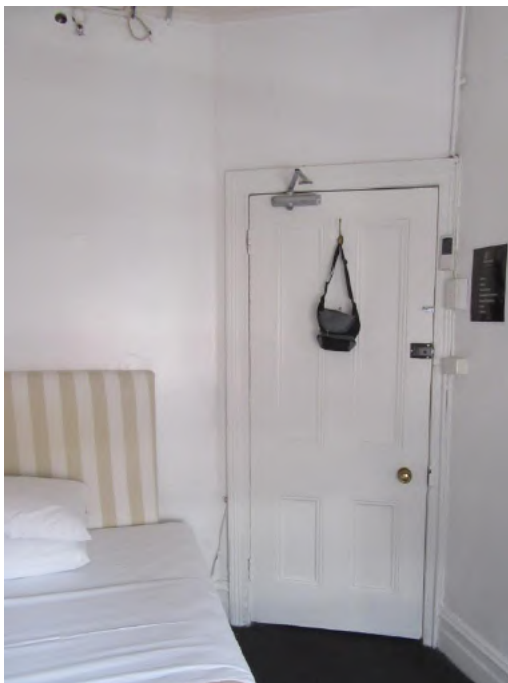
Figure 159: Staff changeover room 2.15, originally a small guest room. Rooms 2.15 and 2.14, have much simpler finishes than the large rooms at the front of the building. These include original beaded timber lining board ceilings and lightweight lath and plaster walls. Source: TKD Architects 2020.

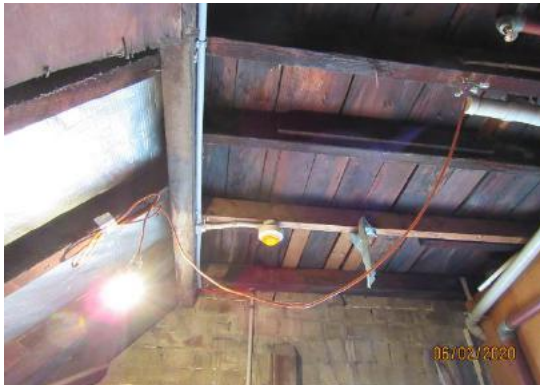
Figure 161: Attic, space R02, showing the internal face of the original brick wall separating the western section of the attic, originally a laundry, from the external drying area. Source: TKD Architects 2020.

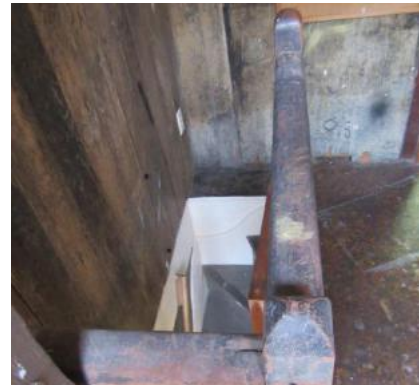
Figure 162: The top of the stair in space R02. The beaded timber lining boards on the wall adjacent to the stair are original. Source: TKD Architects 2020.

The Clive Lucas, Stapleton and Partners CMP of 1999 noted that the western attic space (R 02, containing the original stair) retains original timber stud walls to the east (with modern linings), north and south (with original beaded timber board linings). To the west is an original brick wall that separates the pitched and flat sections of the roof of the building. The ceiling of the western room retains some original exposed timber lining boards.

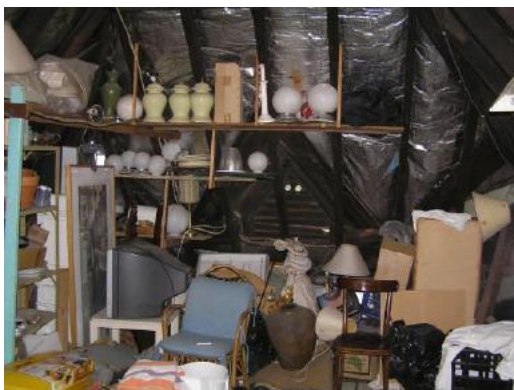
Figure 163: The eastern attic space (R 03), looking east. The timber louvres to the small gablet in the eastern roof plane are visible. Source: Source: CMP 2013.

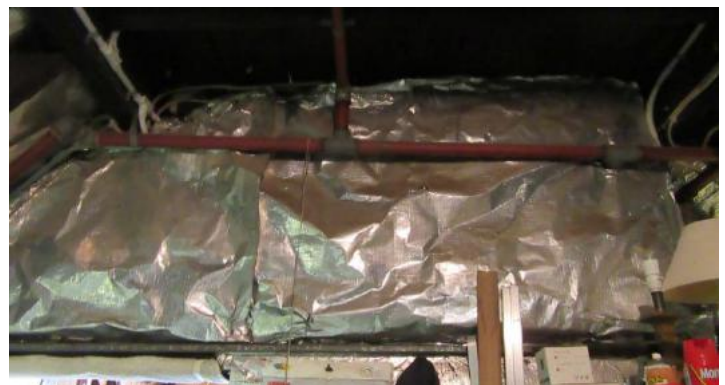
Figure 164: Attic spaces R02 and R03 retain original roof structure and the timber board ceiling lining that sits below the flat section of the roof. Source: TKD Architects 2020.

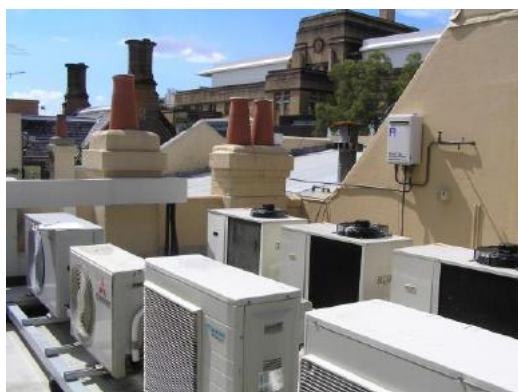
Figure 165: Flat section of the roof of the original part of the building (1887). This corner of the roof originally contained the 'wash shed' (see Figure 48). Source: CMP 2013.

The attic space leads out onto a flat roof that originally served as a laundry drying area (see Figure 165, Figure 166). The 1913 plan (Figure 59) shows a 'wash shed', since removed, at the north-eastern corner of the flat roofed section. The flat roof now houses air-conditioning units that are concealed from street level view by a parapet.

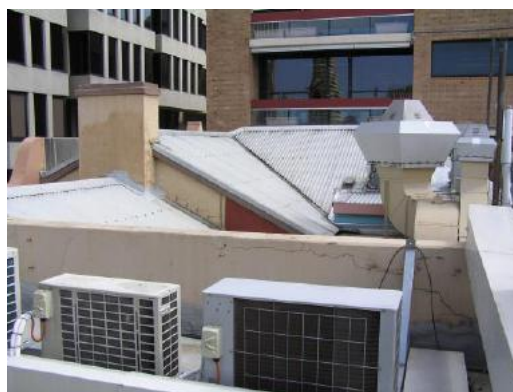
Figure 166: Flat section of the roof looking towards the hipped and gabled roof of the 1913 rear wing. Source: CMP 2013.

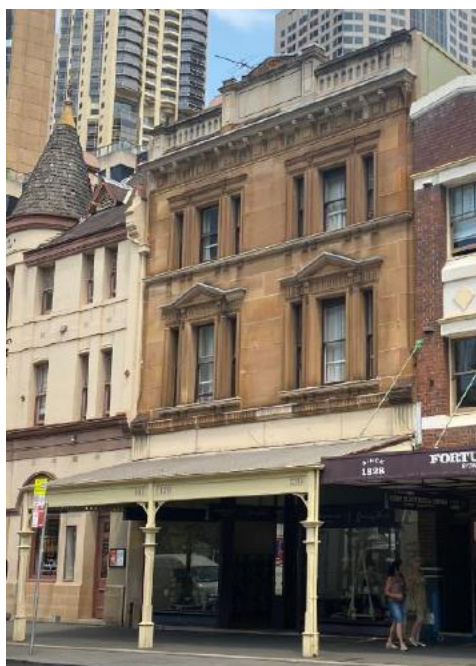
Figure 167: 139–141 George Street, George Street elevation, 2012. This sandstone façade dates from the construction of the building in 1882. The parapet has recently been repaired and conserved. The timber post awning is a mid 1980s reconstruction by the Sydney Cove Redevelopment Authority. Source: TKD Architects 2020.

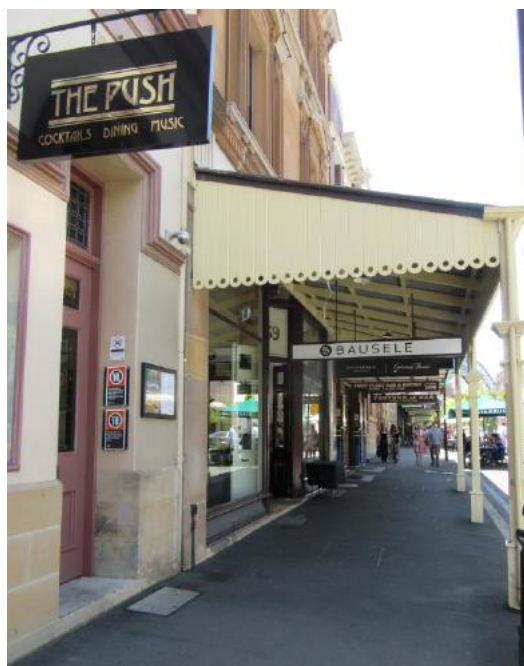
Figure 168: View looking north along George Street showing the side elevation of the reconstructed timber post awning to 139–141 George Street. Source: TKD Architects 2020.

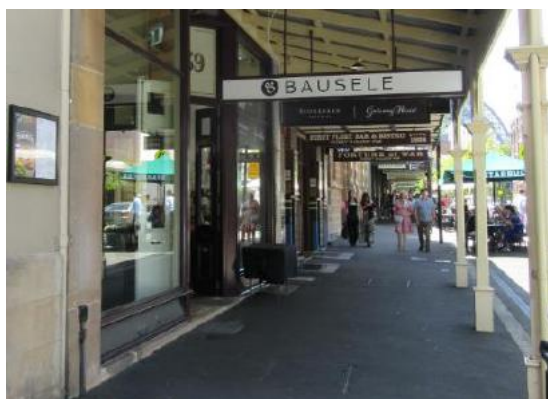
Figure 169: The shopfronts to 139 and 141 George Street are largely mid 1980s reconstructions by the Sydney Cove Redevelopment Authority. The shopfront on the left (No. 141 George Street) retains several original elements. Source: TKD Architects 2020.

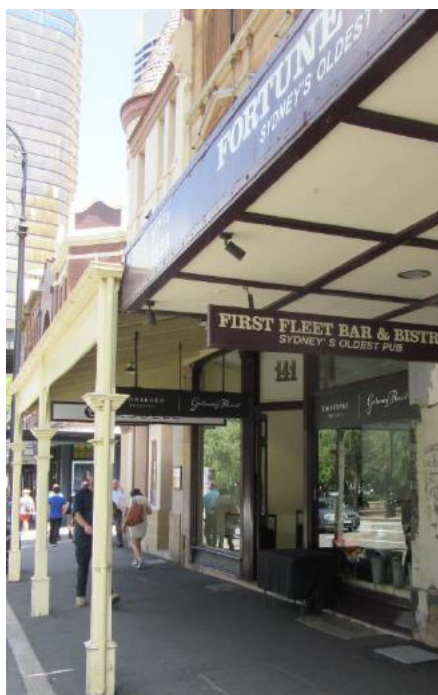
Figure 171: Shop entrances, 139 and 141 George Street. These entrances are largely 1980s reconstructions but some original fabric remains to the shopfront of No. 141 George Street. Source: TKD Architects 2020.

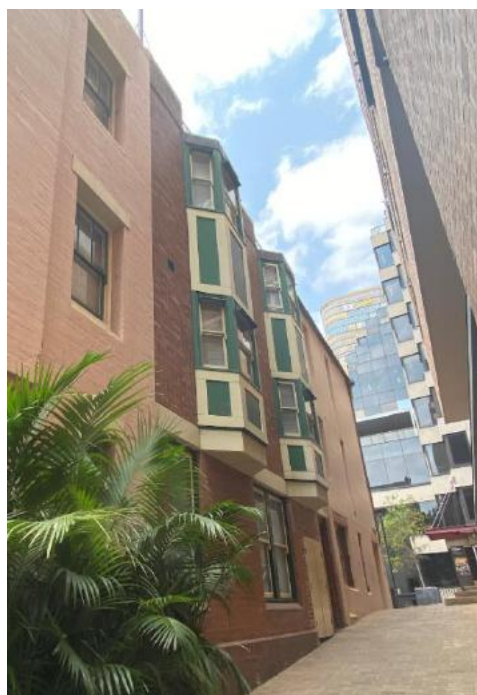
Figure 172: View south along Nurses Walk, showing the ground floor level of 139–141. The ground floor windows are to the male and female toilet areas. To the left is the painted brick façade of the Fortune of War Hotel, and to the right is the rear elevation of The Russell Hotel. Source: TKD Architects 2020.

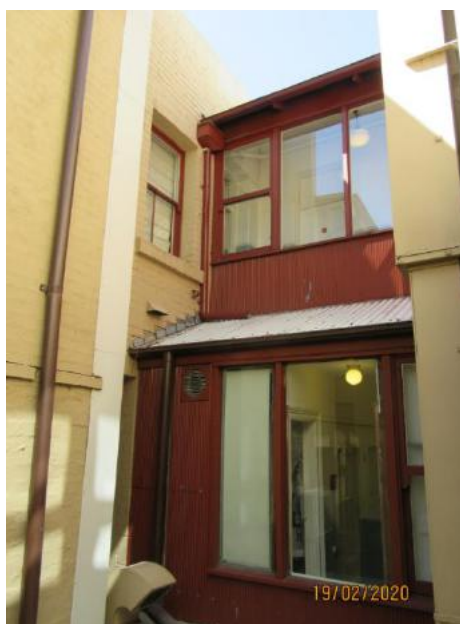
Figure 173: Internal courtyard of 139–141 George Street, facing the small northern elevation of 143–143a George Street (The Russell Hotel, spaces 1.11 and 2.07). The painted brick facades on the left and right are to 139–141 George Street and date from the mid 1980s and the 2010–2011 works. Source: TKD Architects 2020.

There is a small section of northern elevation contained within an internal courtyard that connects the three buildings of The Russell Hotel/Fortune of War Group (refer Figure 173 – Figure 176). The open verandahs of the 1913 wing would originally have been visible from the north, but these have now been enclosed and the elevation today is composed of elements dating from the 1980s and later.

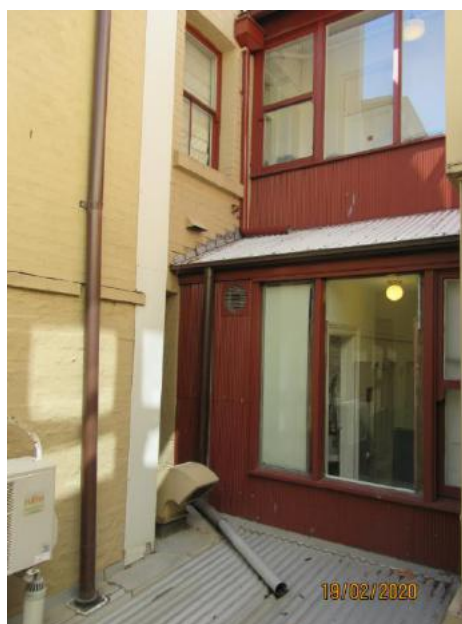
Figure 174: Internal courtyard of 139–141 George Street. The window at the top is to space 1.11 of The Russell Hotel. The lower section of roof, part of the 2010–2011 works, sits above the keg room (G.17) and the adjacent hallway to The Russell Hotel (G.08). Source: TKD Architects 2020.

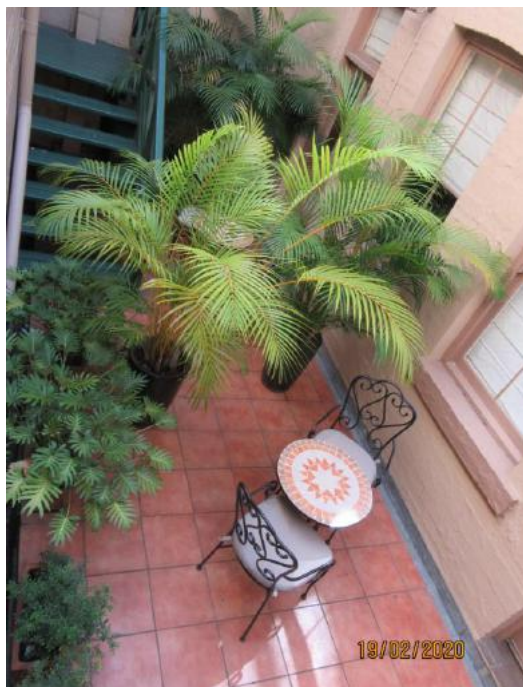
Figure 175: The courtyard terrace was created as part of the 1980s works. The door and window on the right are to Room 20 of The Russell Hotel (1.21). The timber stairs lead to the fire stair (1.04). Source: TKD Architects 2020.

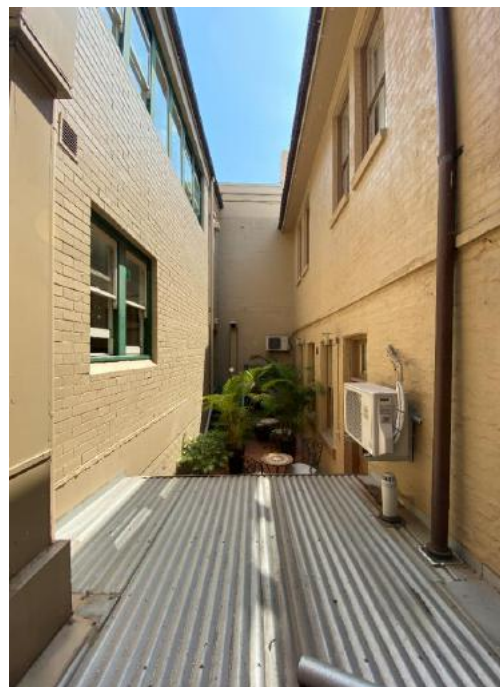
Figure 176: Internal courtyard of 139–141 George Street, facing north. The wall in the centre is the southern wall of The Fortune of War Hotel and dates from the construction of the building in 1921. The painted brick facades on the left and right are to 139–141 George Street. Source: TKD Architects 2020.

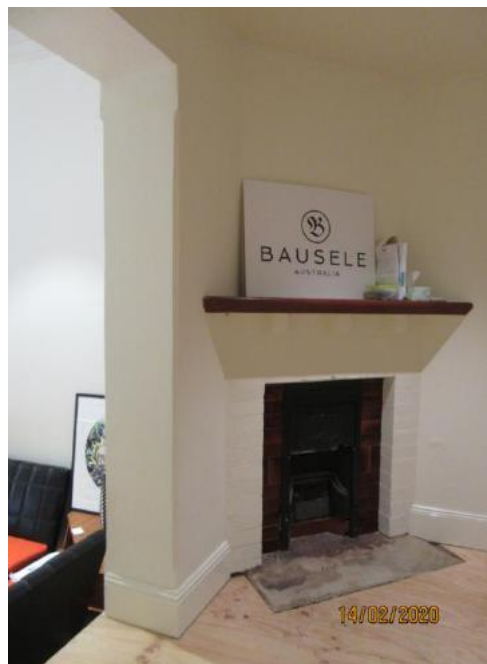
Figure 178: This chimney piece in 141 George Street (G.14) dates from c.1900. It is not original to the 1882 construction of the building but G.13, G.14 the fireplace opening is probably original. Source: TKD Architects 2020.

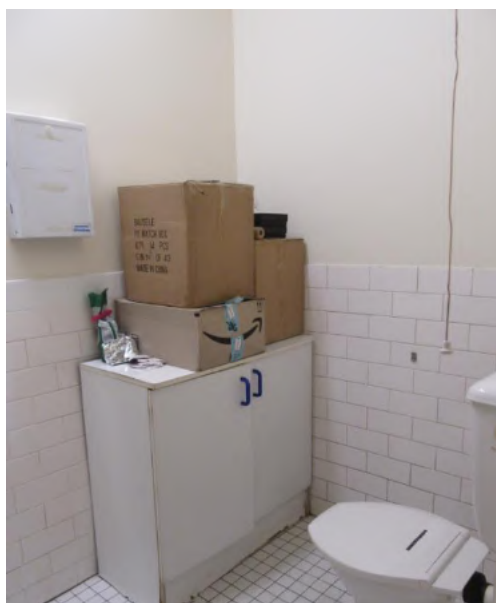
Figure 179: Bathroom (G.16) to the shop at 141 George Street. West of the western wall bounding G.15 and G.19, the fabric of 139–141 George Street generally dates from the 1980s or later. Source: TKD Architects 2020.

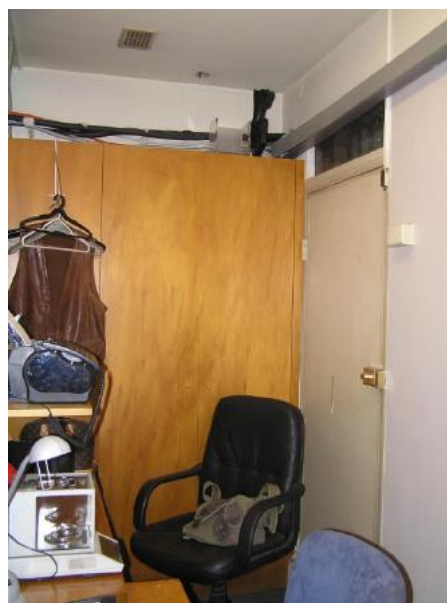
Figure 180: Comparison of the location of this door opening in the rear section of the shop at 141 George Street (G.15) with early plans suggests that it may have been an original window opening. Source: CMP 2013.

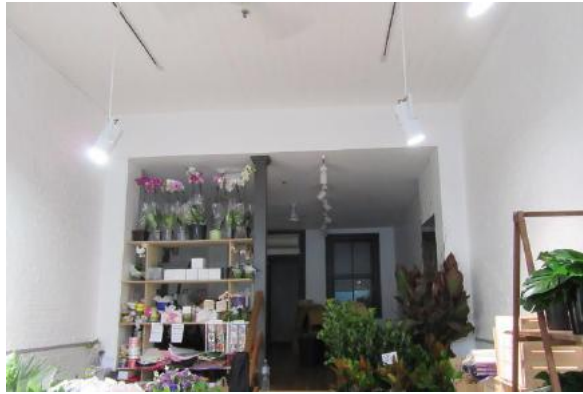
Figure 181: Interior of the shop at 139 George Street (G.18), looking west. The opening between G.18 and the upper area (G.19) was made prior to 1978. Source: TKD Architects 2020.

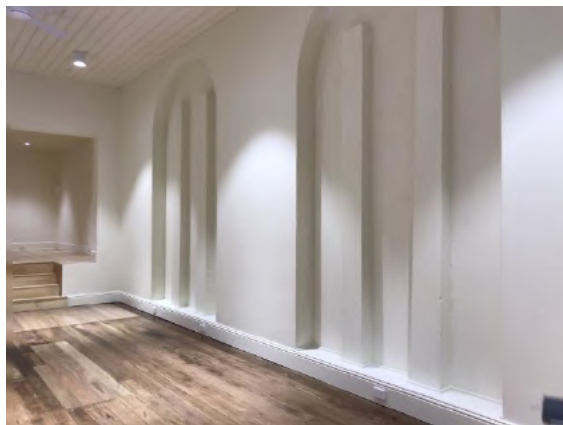
Figure 183: Painted brick party wall between 139 and 141 George Street (taken from G.18). The original structural brick arches are clearly visible. Source: PMNSW 2019

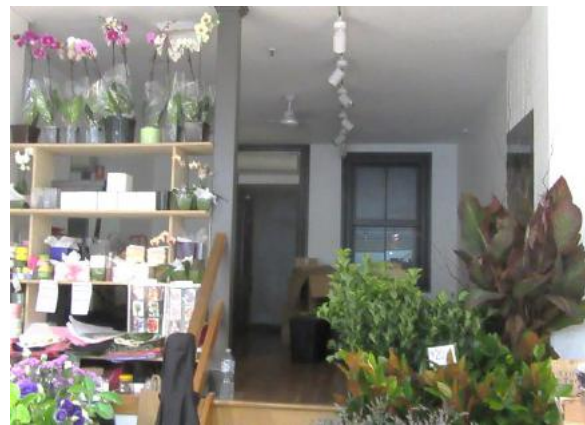
Figure 184: Comparison of the locations of these door and window openings with early plans suggests that they may be original openings. Some of the timber joinery may also be original. Source: TKD Architects 2020.

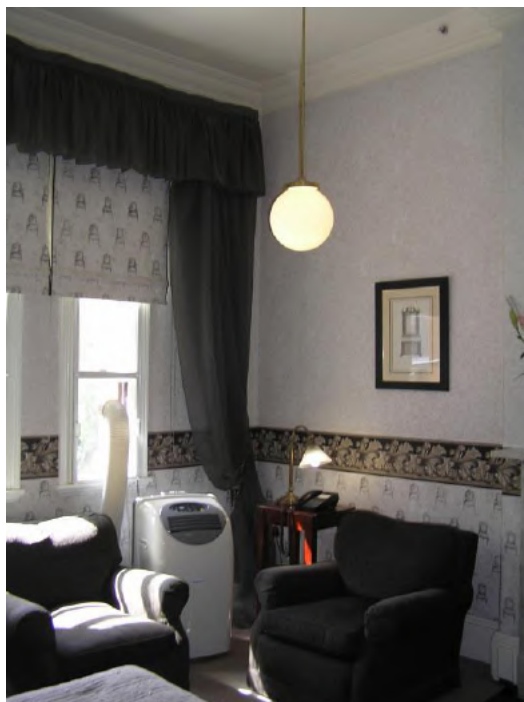
Figure 185: 139–141 George Street, Room 22 on the first floor of The Russell Hotel (1.23). There is little original fabric remaining in this room, however the timber windows facing George Street, and their architraves, are original. Source: CMP 2013.

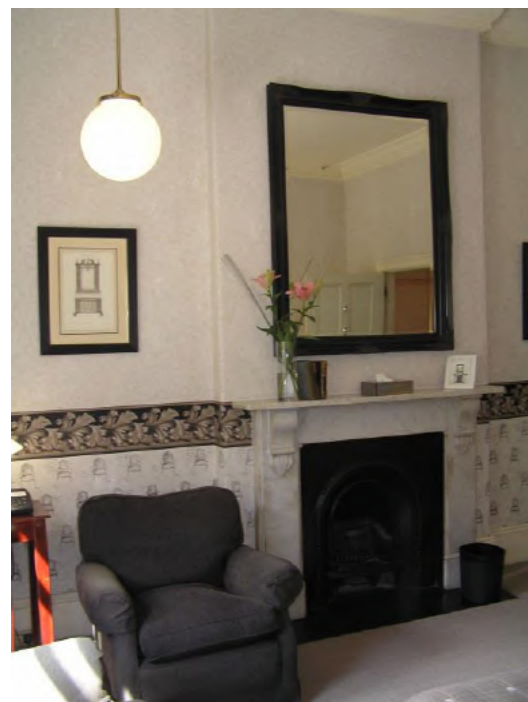
Figure 186: The original marble chimneypiece to Room 22 of The Russell Hotel (1.23) is one of the few surviving elements of early fabric in this area of the building. It is probably original. Some of the timber skirtings in this space are original, while others are modern reproductions. Source: CMP 2013.

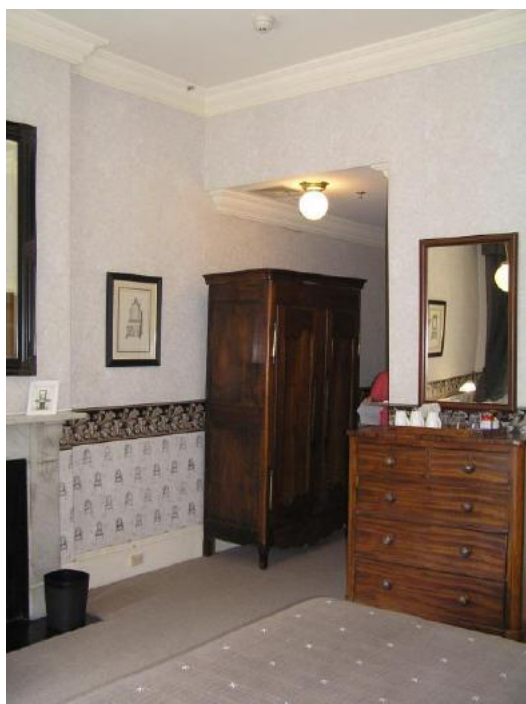
Figure 187: Room 22 of The Russell Hotel (1.23), showing the hallway and wall (to en suite bathroom 1.24) that date from the late 1980s. Source: CMP 2013.

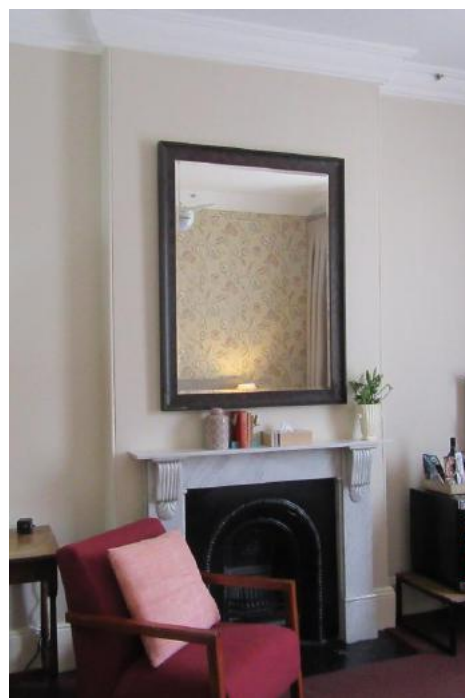
Figure 188: Room 21 of The Russell Hotel (1.28) showing the chimney piece which is original but has been restored. The remainder of the room contains very little original fabric. Source: TKD Architects 2020.

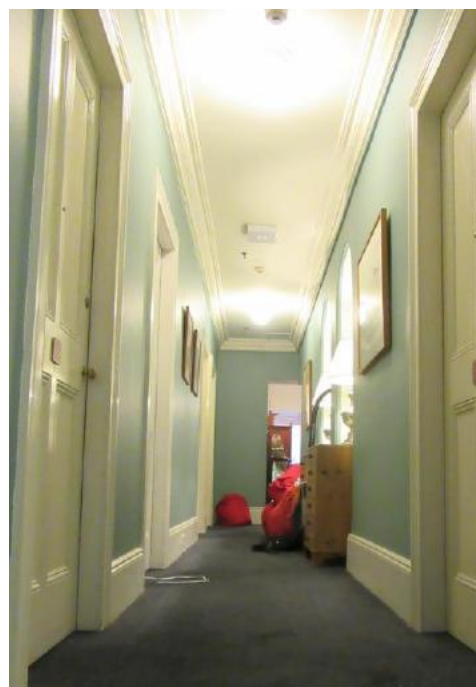
Figure 190: Hallway 1.18, on the first floor of 139–141 George Street, was created in the late 1980s. Parts of the wall on the right are likely to be original fabric. The Clive Lucas Stapleton 1999 CMP notes that the two arched openings on the right may be original (possibly the locations of staircases that have been demolished). Source: TKD Architects 2020.

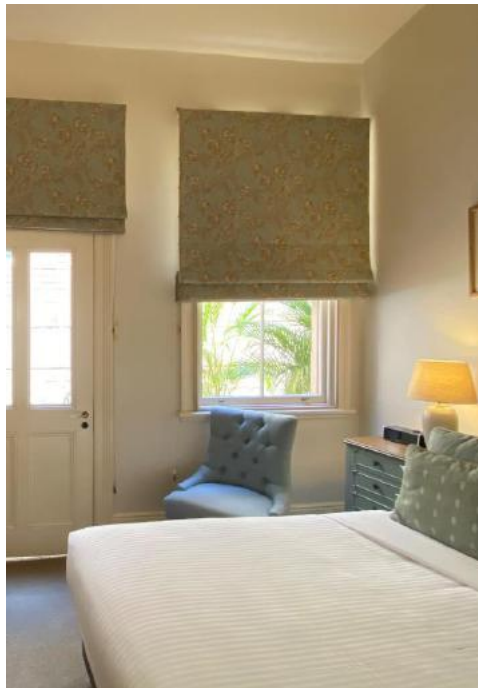
Figure 191: Room 19 of The Russell Hotel (1.19) was built as part of the 1980s works to 139–141 George Street. It opens onto the internal courtyard created at the same time. Source: TKD Architects 2020.
