Conservation Management Plan

Russell Hotel and
Fortune of War Group

137–143A

George Street, The Rocks

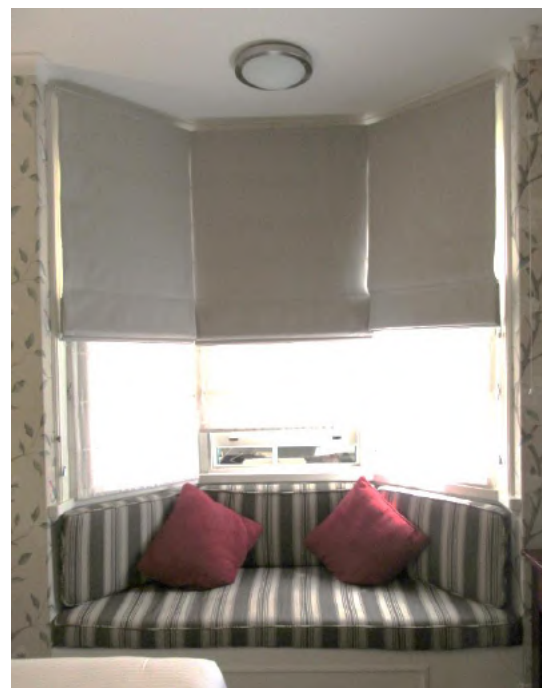
Figure 194: Room 7 of The Russell Hotel (1.45) sits adjacent to Room 8. This room was altered during the 2010–2011 works to provide an accessible bathroom. Source: TKD Architects 2020.

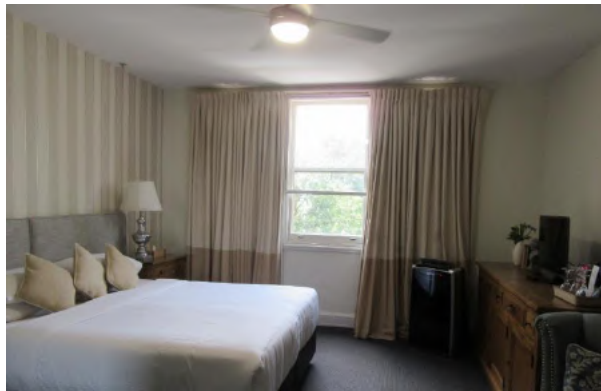
Figure 195: Room 17 of The Russell Hotel (2.24) was created during the 2010–2011 works. Although it is located within the original section of 139–141 George Street, it retains little original internal fabric, however the windows facing George Street, and their architraves, are original. Source: TKD Architects 2020.

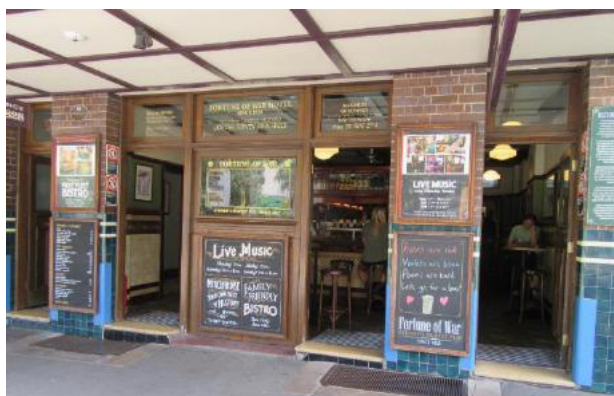
Figure 203: Original tiled dado, yellow terrazzo thresholds to the George Street elevation. The trachyte margins around the steel grilles to the keg drops are also visible. Source: TKD Architects 2020.

The area below the awning retains its original tiled dado, yellow terrazzo thresholds to the doors and trachyte margins around the iron and steel grilles to the keg drops. Some of the dado tiles were replaced with new tiles to match the existing tiles c.2010.

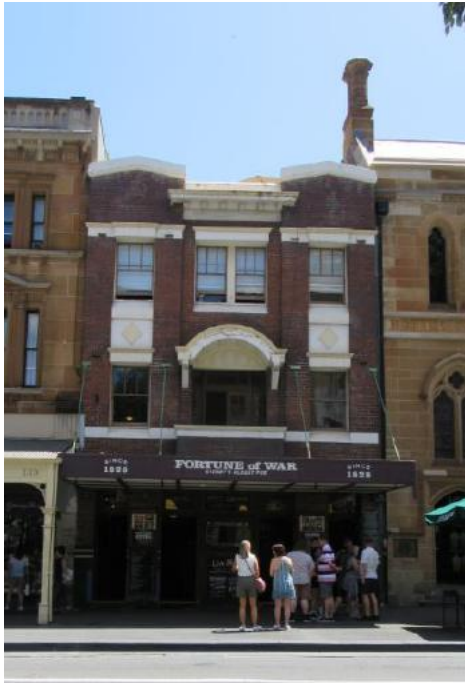
Figure 205: George Street façade of 137 George Street. The 1920s elevation is face brick in English bond with cement render decorative details (cornices, parapet ridge, window sills, lintels, spandrels and arched canopy to the central balcony) and timber windows with three paned upper sashes. Source: TKD Architects 2020.

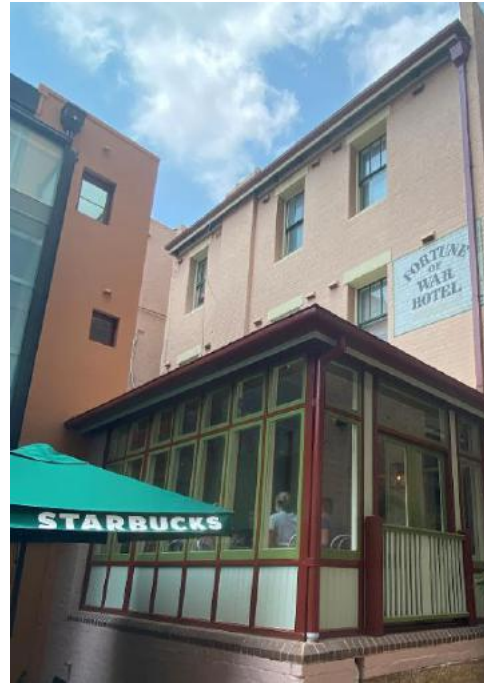
Figure 206: Painted brick rear (western) elevation of 137 George Street. The flat roof over the front section of the building is concealed from view by the roof level laundry structure. The roof of the rear section of the building is visible from Nurses Walk and has exposed eaves. Source: TKD Architects 2020.

The breezeway area on the northern side of the building, above which the steel fire stair was originally fixed (see Figure 206), was infilled at ground floor level in the late 1980s to provide a glazed-in verandah space. This addition was designed with timber joinery detailing inspired by the period of the building's original design.

The flat roof over the front section of the building is set behind a masonry parapet on the George Street elevation. It is concealed from view from Nurses Walk by the roof level laundry and its skillion roof. The roof of the rear section of the building is visible from Nurses Walk and has exposed eaves.

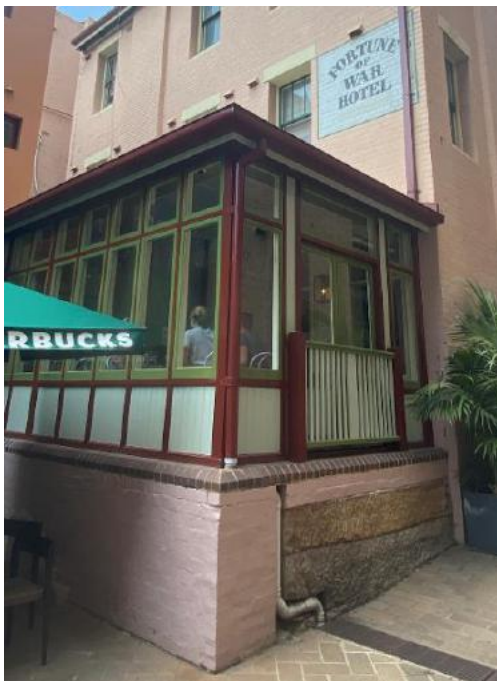
Figure 207: Part of the northern elevation of 137 George Street, showing original windows and the late 1980s verandah addition. The sandstone visible below the balustrade is part of a rock ridge on which the portable hospital once sat. Source: TKD Architects 2020.

⁶ This rock ridge is still clearly evident at the rear of 123–137 George Street (see Figure 207). A driveway through the arch of the former ES&A Bank cuts through the stone which is clearly visible as the foundation of the south wall of the Police Station.

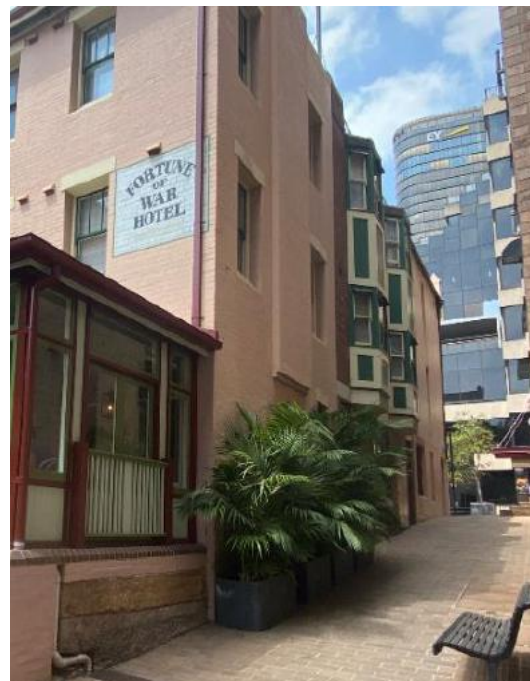
Figure 208: Looking south along Nurses walk, at the rear of 137 George Street, showing original windows and the late 1980s verandah addition. Source: TKD Architects 2020.

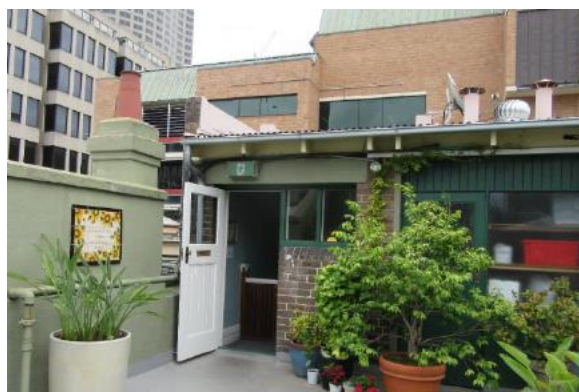
Figure 210: Doorway from stairhall 2.03 to the roof terrace. The planning of the roof terrace and laundry are as shown in the approved drawings of 1920. Source: TKD Architects 2020.

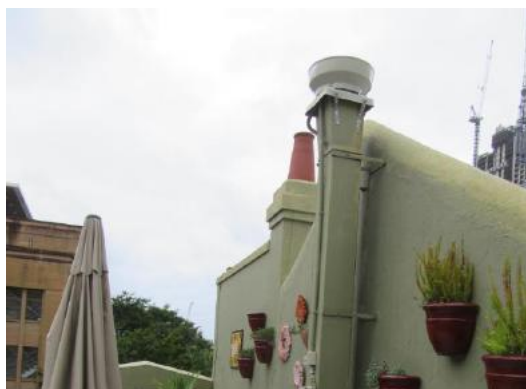
Figure 211: This rendered masonry gable on the southern side of the roof terrace at 137 George Street is probably the original southern wall of the original Fortune of War Hotel. Source: TKD Architects 2020.

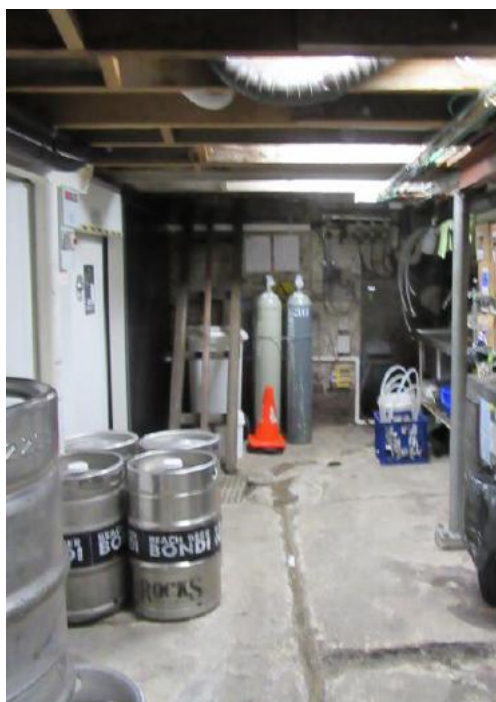
Figure 213: Cellar, 137 George Street. Looking towards George Street from C.02. Source: TKD Architects 2020.

The cellar is located under the main bar (G.24). Access to the cellar is via a modern steel ladder which sits within the bar serving area. Originally, the cellar was a single space (C.03) but it was extended in the late 1970s to form C.02¹⁵⁵, apparently with a floor level above that of C.03. A 1989 drawing¹⁵⁶ suggests that C.02 was altered at that time (possibly to reduce the floor level) as it includes the note 'brick up around existing foundations'. The wall between C.02 and C.03 has been substantially removed and the two spaces now form one large room with a modern cool room on the northern side. The date of the excavation of the smaller room to the west, C.01, is not clear.

The walls of the cellar spaces are generally of painted brickwork, but the rock bed is exposed on some areas. The floors are concrete. Space C.03 has an original (or early) floor with drainage channels leading to a floor waste. The underside of the timber framing and flooring to the ground floor form the ceilings and, in some areas, and retain traces of whitewash finish. The newer sections of floor (replaced in the 1970s following termite damage) are easily visible.

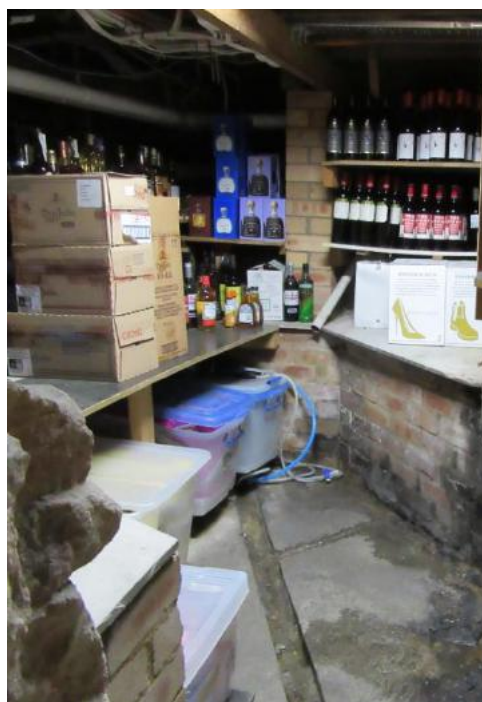
Figure 214: Cellar, 137 George Street. View from C.02 into C.01. Source: TKD Architects 2020.

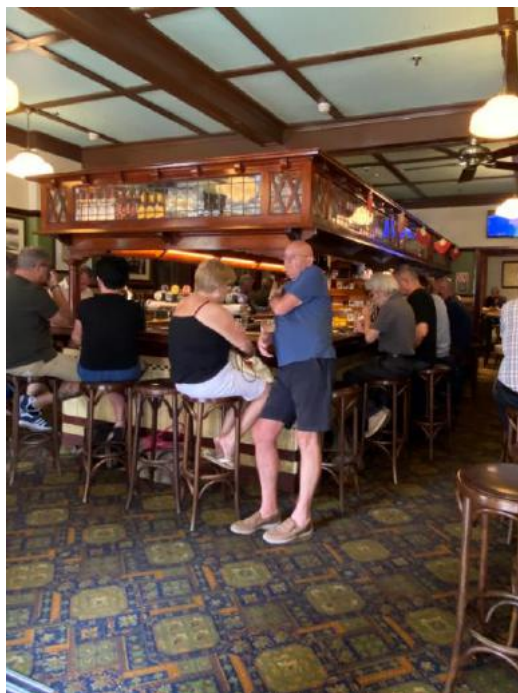
Figure 215: Fortune of War Hotel, main bar G.24, 2012. The hamper above the bar is intact and, because of its rarity, is highly significant. The tiled bar front, counter and ceilings are also original. Source: TKD Architects 2020.

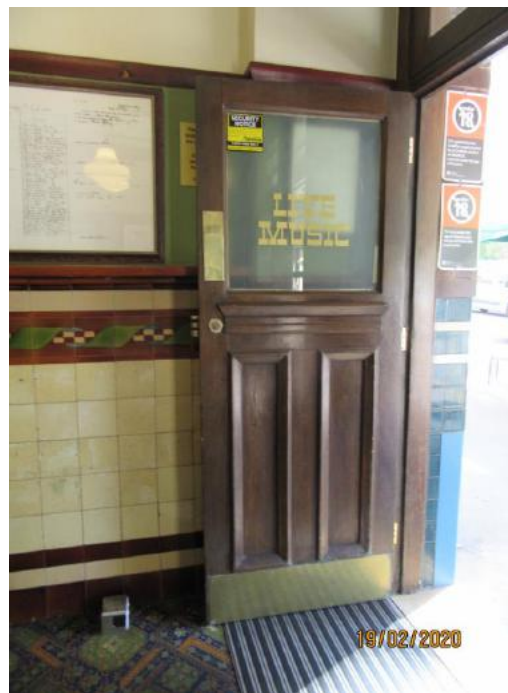
Figure 216: Entrances to the main bar (G.24) from George Street. The tiled dado and door and fanlight joinery are original. Source: TKD Architects 2020.

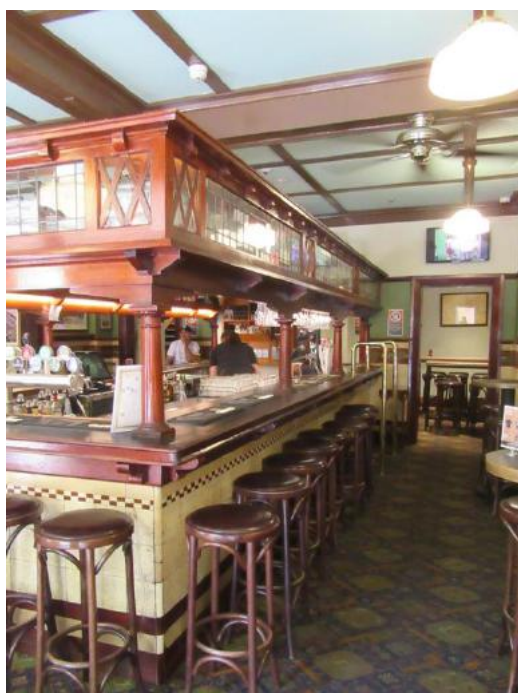
Figure 217: View along the northern side of the main bar (G.24). The U shaped bar plan is one of only a few remaining in Sydney and it is now rare. Source: TKD Architects 2020.

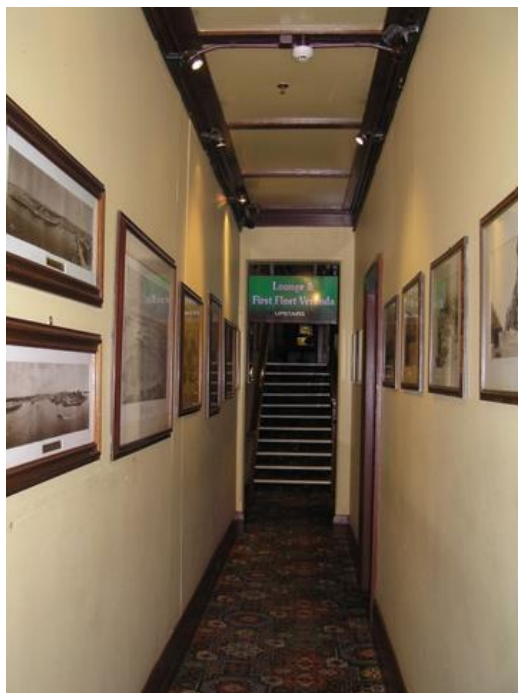
Figure 219: Hallway G.23 is one of the most intact spaces in The Fortune of War Hotel. It provided access to the dining room and first and second floors for the hotel's guests. Source: CMP 2013.

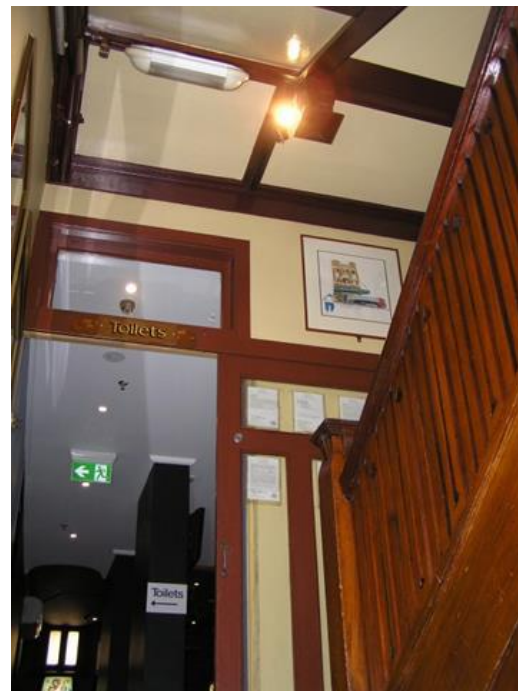
Figure 224: Stairhall G.25G.03 looking up towards rear lounge G.27. The stair balustrade and handrail are original. Source: CMP 2013.

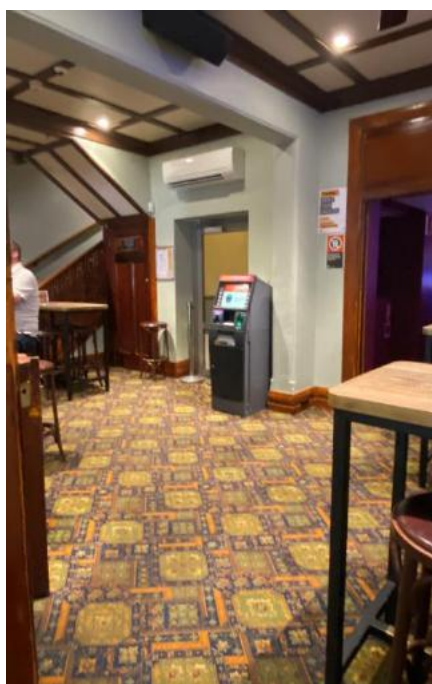
Figure 225: Lounge G.25 was formed from the two original parlours behind the main bar. Large sections of the internal walls to this space were demolished in the late 1980s. Source: TKD Architects 2020.

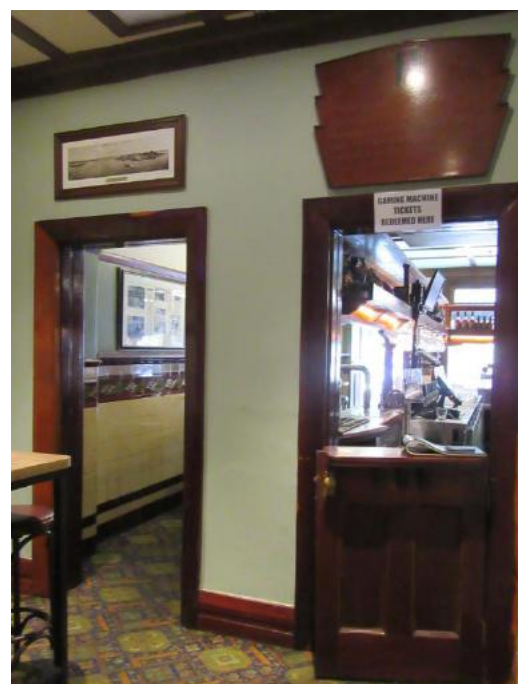
Figure 226: View from lounge G.25 into the bar serving area in G.24. This door opening is original. Source: TKD Architects 2020.

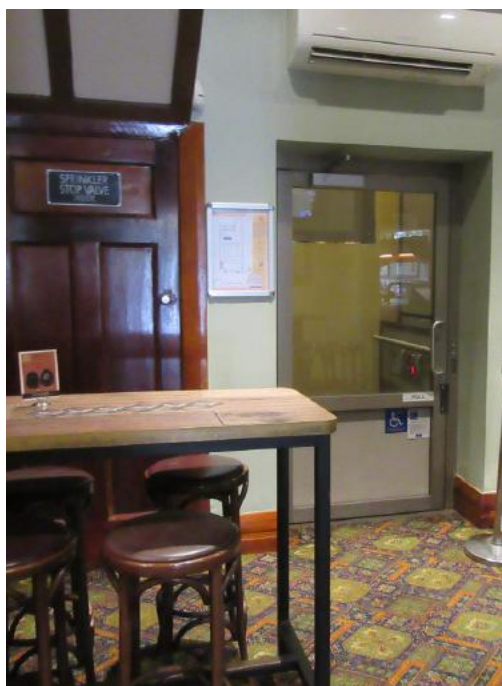
Figure 227: The wheelchair lift was added in 2010–2011 to provide access from G.25 to G.27, on the upper section of the first floor. Source: TKD Architects 2020.

The rear lounge (G.27) is an adaptation of the original dining room and kitchen of the hotel but it has been considerably altered. The space retains original fabric in the fireplace (Figure 229), skirting boards (re-configured in places) and sections of the north and east walls. A chair lift was installed during the 2010–2011 works to provide access from the front bar level to the rear lounges.

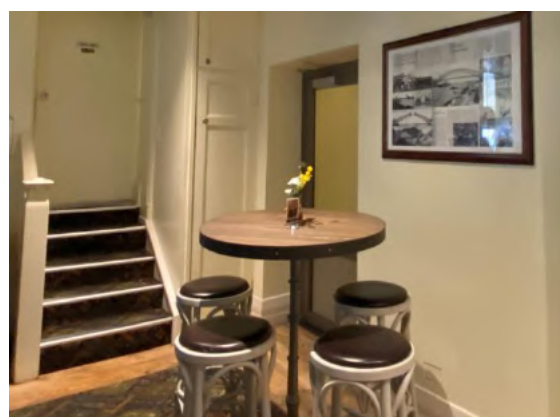
Figure 230: Rear lounge (G.27) with recent wheelchair lift. The stairs lead to the stores and coolroom UG.01, 02, 03. Source: TKD Architects 2020.

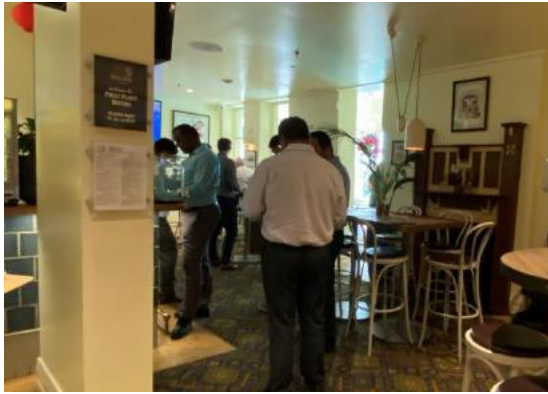
Figure 231: Rear lounge (G.27). On the right is the original chimney piece to the Fortune of War's dining room. The fitout dates from 2010–2011. Source: TKD Architects 2020.

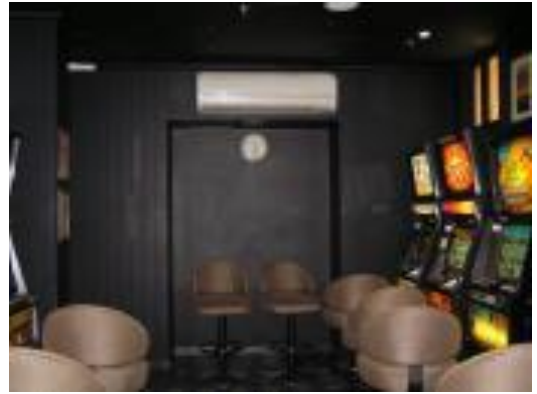
Figure 232: Gaming room (G.27), facing south. The new bathrooms are on the other side of the wall and the small window, originally to the pantry, can be seen at the top right of the image. Source: CMP 2013.

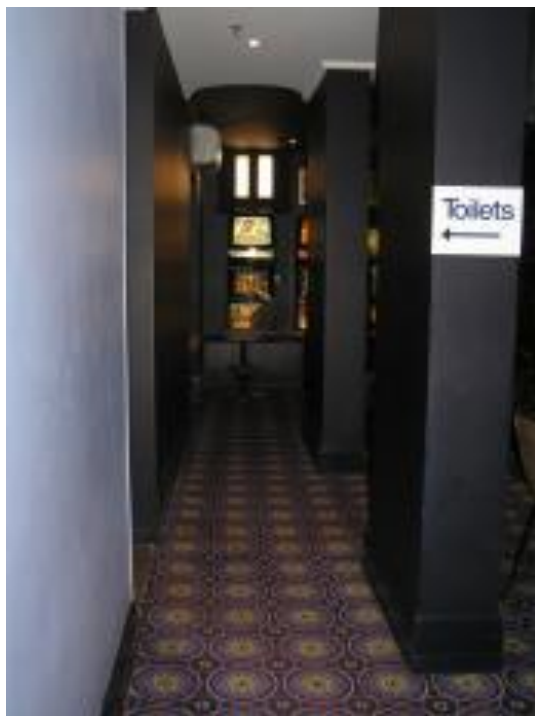
Figure 233: Recent fitout to the rear lounge (G.27), looking along what was once a hallway adjacent to the Fortune of War's dining room. At the end of the hallway was the pantry, and the small pantry window is visible at the rear of the image. The sections of wall on the right are remnants of the original dining room wall. Source: CMP 2013.

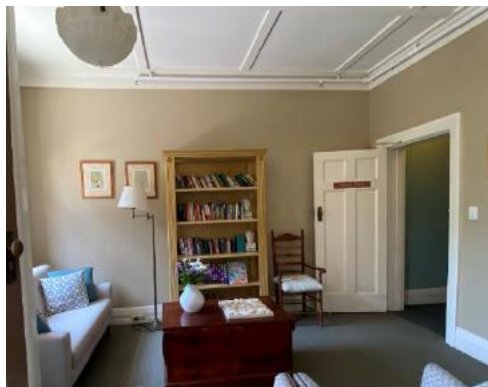
Figure 235: 137 George Street, Fortune of War Hotel, sitting room (1.30), 2020. The plan of the sitting room is as shown in the original building plan. The four-panelled door, and glazed wall and doors to the balcony are also original. Source: TKD Architects 2020.

Apart from the stair hall, the most intact space within the upper floors of The Fortune of War is the sitting room (1.30). This room was used as a bedroom in the 1980s, when en suite bathroom 1.31 (now a store) was added, but it has now been returned to its original function. The room retains its timber battened ceiling, timber windows and glazed walls and doors to the balcony. The balcony, again with a timber battened ceiling, is also largely intact although the floor has been finished with tiles relatively recently.

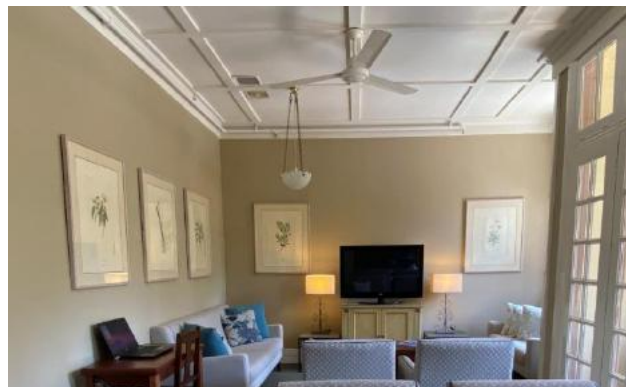
Figure 236: 137 George Street, Fortune of War Hotel, sitting room (1.30), 2020. The timber battened ceiling is original. Source: TKD Architects 2020.

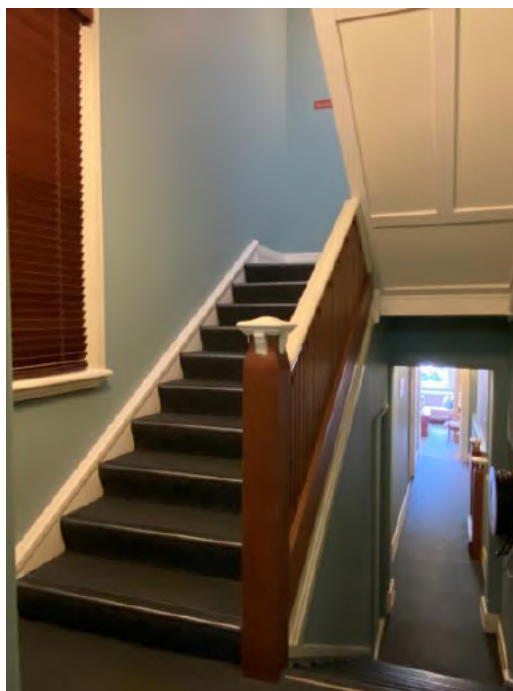
Figure 239: The stair (1.03) retains its original timber balustrades and handrails. Source: TKD Architects 2020.

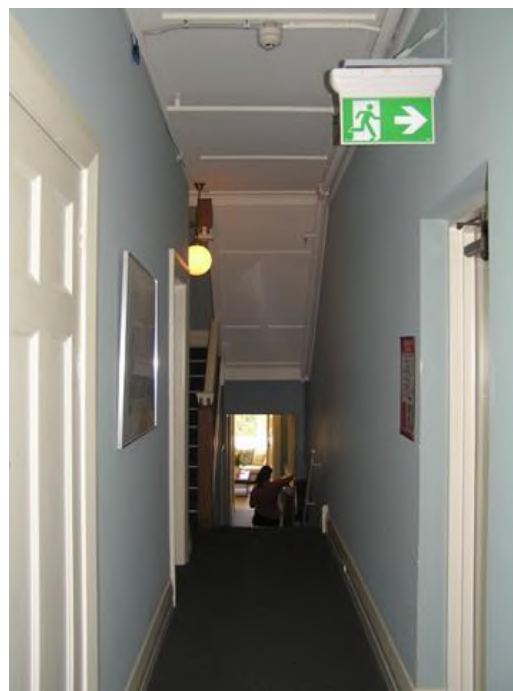
Figure 240: View along hallway 1.39 towards the stair (1.03). The timber battened ceiling and stair soffit are original. On the right is a door to fire stair 1.04. The fire stair and door were mid 1908s alterations. Source: CMP 2013.

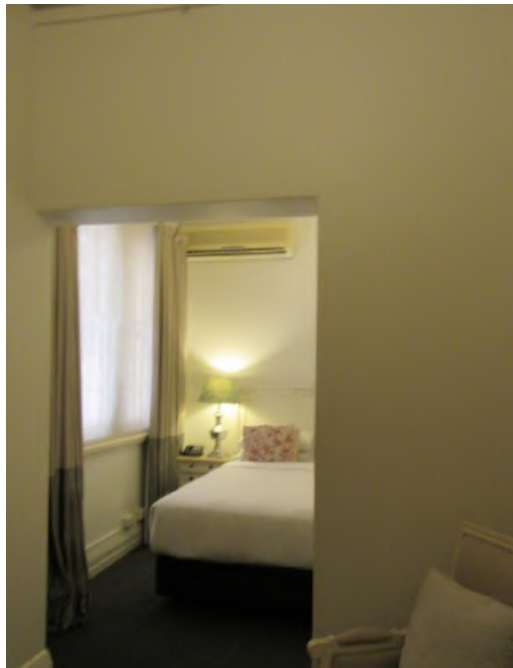
Figure 241: Hallway 1.32 (within the suite of spaces forming Room 23 of The Russell Hotel) occupies part of an original bedroom. Space 1.33 (at rear) is reached via an opening to one of the original internal walls. The timber battened ceiling to the original bedroom remains but the wall to the left is recent. Source: TKD Architects 2020.

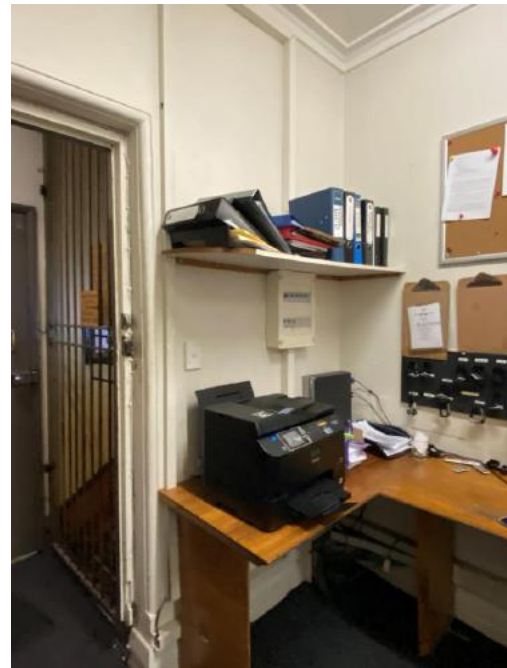
Figure 242: The Fortune of War office (1.36), looking towards the stairhall (1.03). This space originally contained a bathroom, separate WC and small lobby that was reached via the stair landing. Source: TKD Architects 2020.

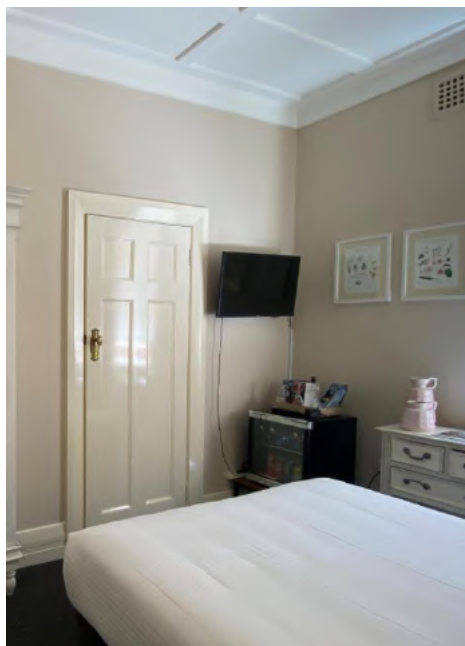
Figure 245: Room 24 (1.37) is one of the two most intact bedrooms in hotel, even with the later en suite door addition. Source: TKD Architects 2020.

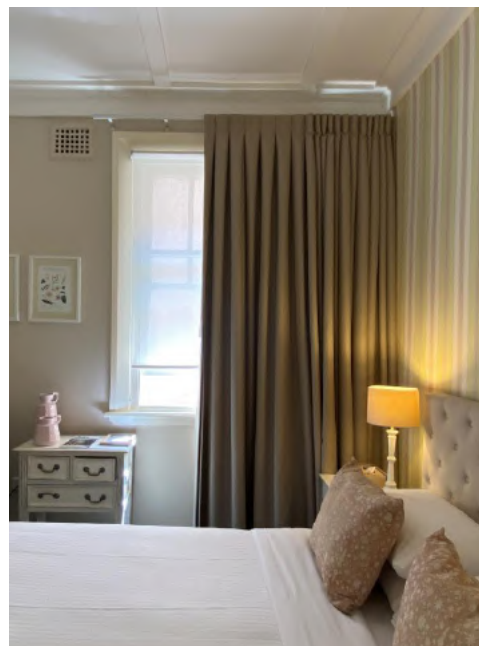
Figure 246: Room 24 (1.37) of The Russell Hotel, 2020. The layout and detail of the battened ceiling are intact. Source: TKD Architects 2020.

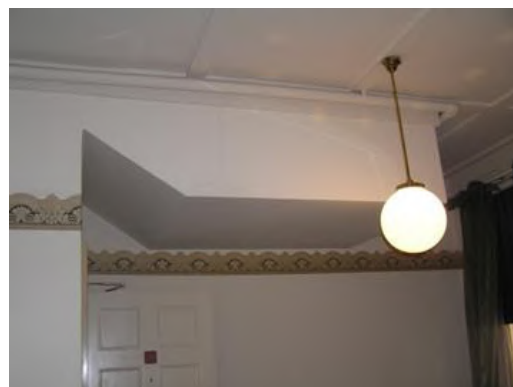
Figure 248: In Room 25 (1.41), the mid 1980s fire stair projects below ceiling level interrupting the original battened ceiling. Source: CMP 2013.

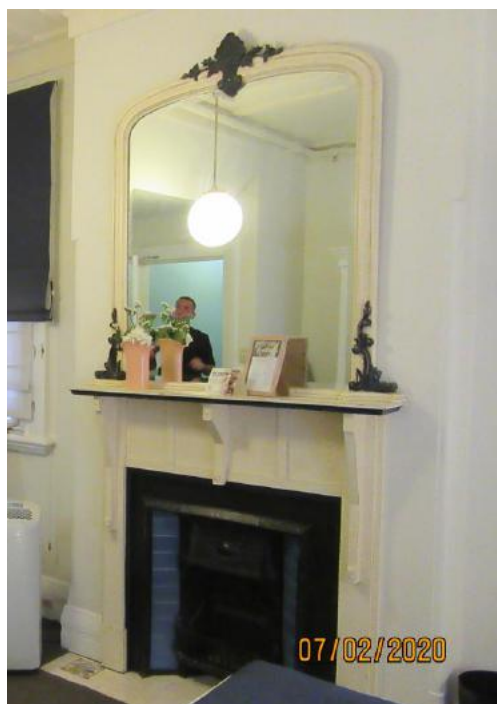
Figure 249: Original chimney piece to Room 25 (1.41).
Source: TKD Architects 2020.

In addition to the timber battened fibrous plaster ceilings, original fabric remaining to the upper floors of the building includes timber chimney pieces (in 1.41 and 2.43), painted timber skirting boards, four panel doors (some are newer doors that are copies of the original doors), window and door architraves and sashes and timber picture rails. These features are consistent throughout the spaces of the upper floors and they provide a distinct identity for this part of The Russell Hotel/Fortune of War Group.

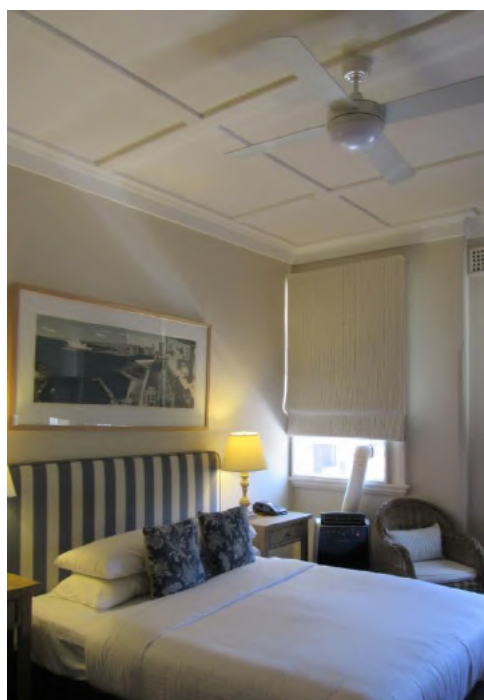
Figure 251: Room 28 (2.29) faces George Street at the front of the building. The dividing wall between 2.29 and the adjacent room (2.36) appears to be original. Source: TKD Architects 2020.

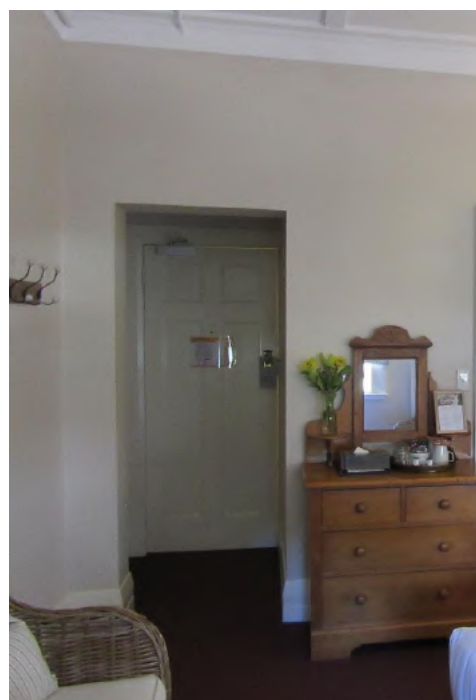
Figure 252: Room 28 (2.29), looking towards hallway 2.28. The entrance to the room is not original. Source: TKD Architects 2020.

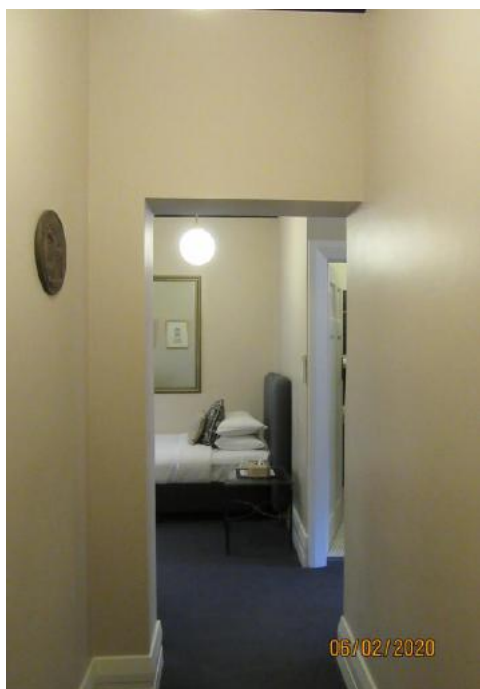
Figure 253: Hallway 2.32, which is within the suite of spaces that forms Room 27 of The Russell Hotel, sits within the space occupied by one of the original bedrooms. The wall on the right is probably original, at least in part, but that on the left is recent. The wall at the rear, with opening to 2.33, is original. Source: TKD Architects 2020.

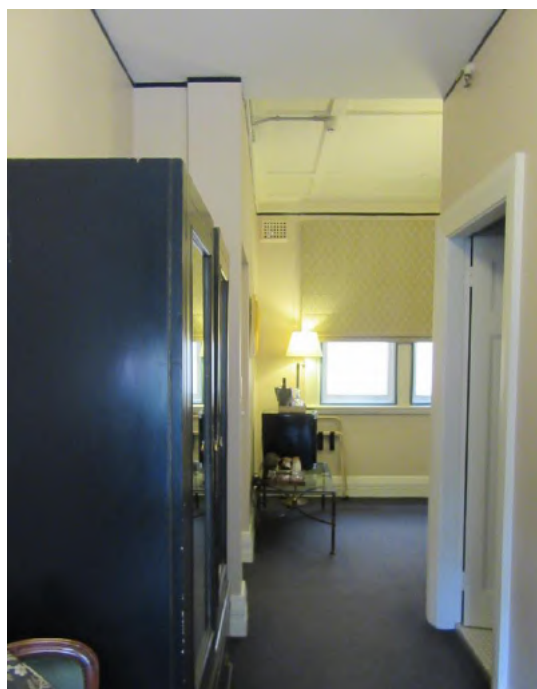
Figure 254: Space 2.34 (also in Room 27) has a relatively recent ceiling. An original section of battened ceiling can be seen in 2.33, at the rear. To the right of 2.34 is an en suite bathroom (2.35) added in the late 1980s. Source: TKD Architects 2020.

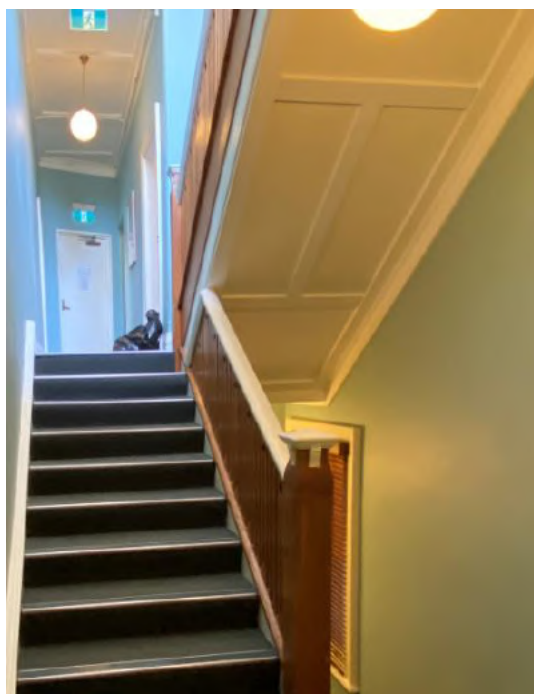
Figure 255: Original timber balustrade, handrail and newel post to stair 2.03. The battened soffit is also original. Source: TKD Architects 2020.

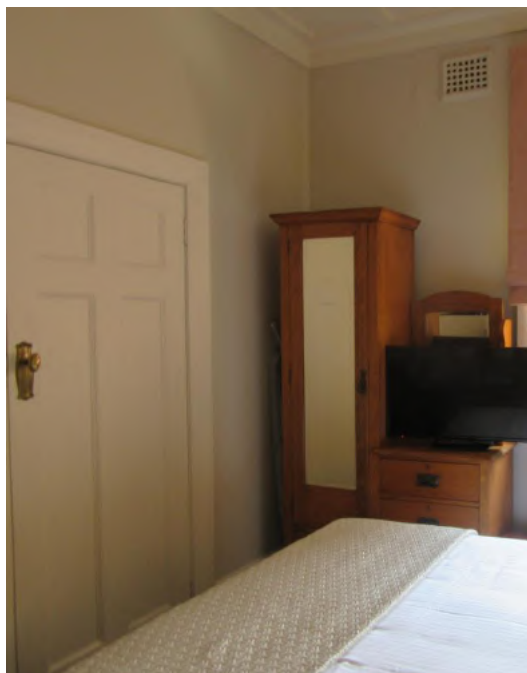
Figure 257: Room 29 of The Russell Hotel (2.41) is, along with 1.37, one of the two most intact bedrooms in The Fortune of War Hotel. The layout and detail of its battened ceiling are intact. The door in the original internal wall is to the en suite bathroom and neither the door nor bathroom is original. Source: TKD Architects 2020.

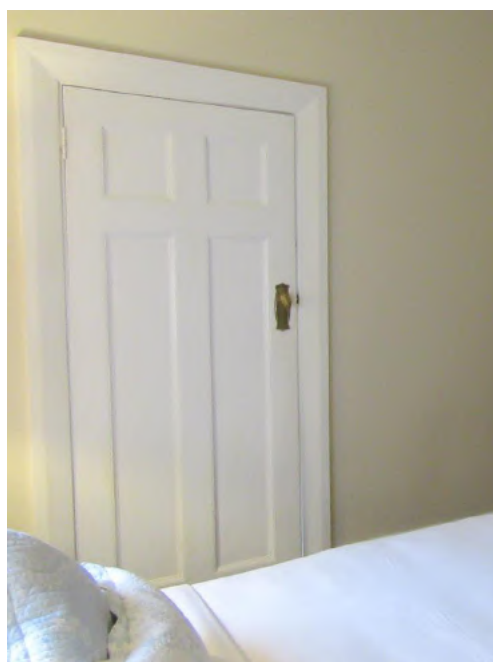
Figure 260: The opening and door leaf to en suite bathroom 2.44 are not original, but the door leaf has been designed to match the original doors in the building. Source: TKD Architects 2020.

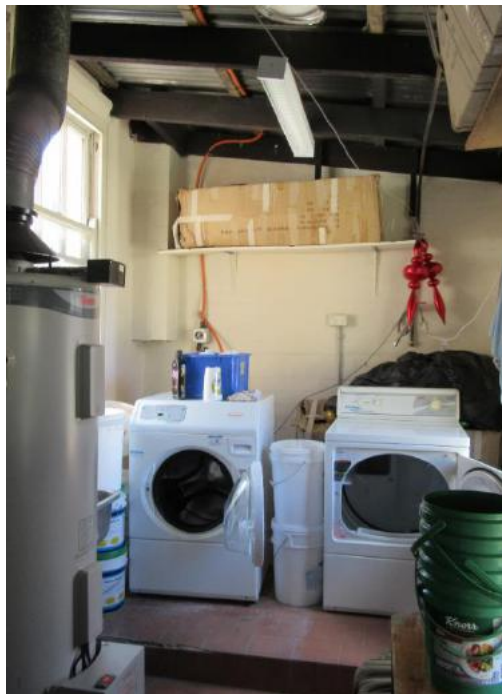
Figure 261: The rooftop laundry, looking north. Source: TKD Architects 2020.

The flat roof of the eastern portion of the building houses a brick laundry with a skillion roof (Figure 261, Figure 262) as well as the guests' roof terrace (the former clothes drying area).

The laundry retains its original planning, although some alterations have been made to the door/window joinery on its eastern façade. It retains its original windows facing east, over the lightwell, and west towards Nurses Walk.

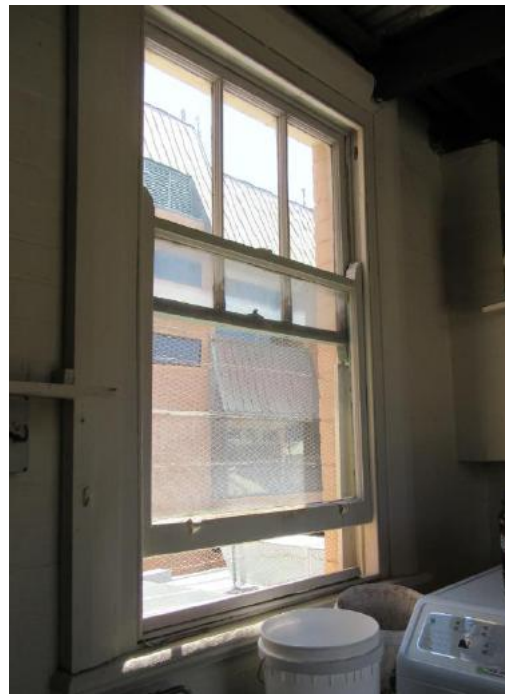
Figure 262: Laundry window, facing west. Source: TKD Architects 2020.

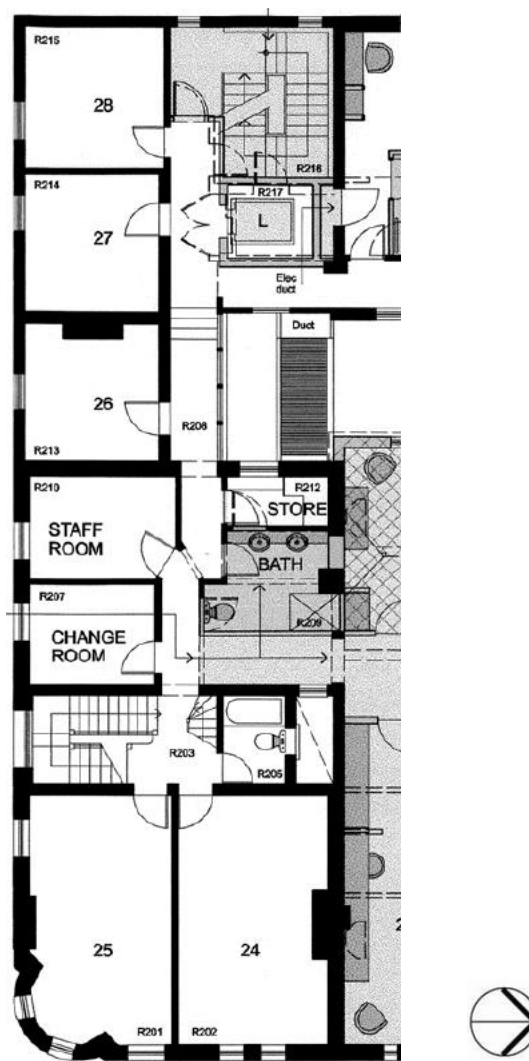
Figure 264: 143–143a George Street, The Russell Hotel, ground floor plan, development application 2009. Source: PMNSW Drawing ROX-410-DA-0028-CP.

The Russell Hotel, the 2010–2011 works included (refer Figure 263, Figure 264):

- Fitout to G.11 and G.12 as a wine bar,
- Conversion of the retail tenancy at the rear of the building (adjoining Nurses Walk) to provide a new ground floor foyer, stair and passenger lift for the Russell Hotel (G.05, G.01). This work involved the demolition of walls and the removal of the WC cubicle (see Figure 263),
- Creation of hallways G.07 and G.08 to connect the hotel entrance to the front of the building and also to 139–141 and 137 George Street, The Fortune of War Hotel.

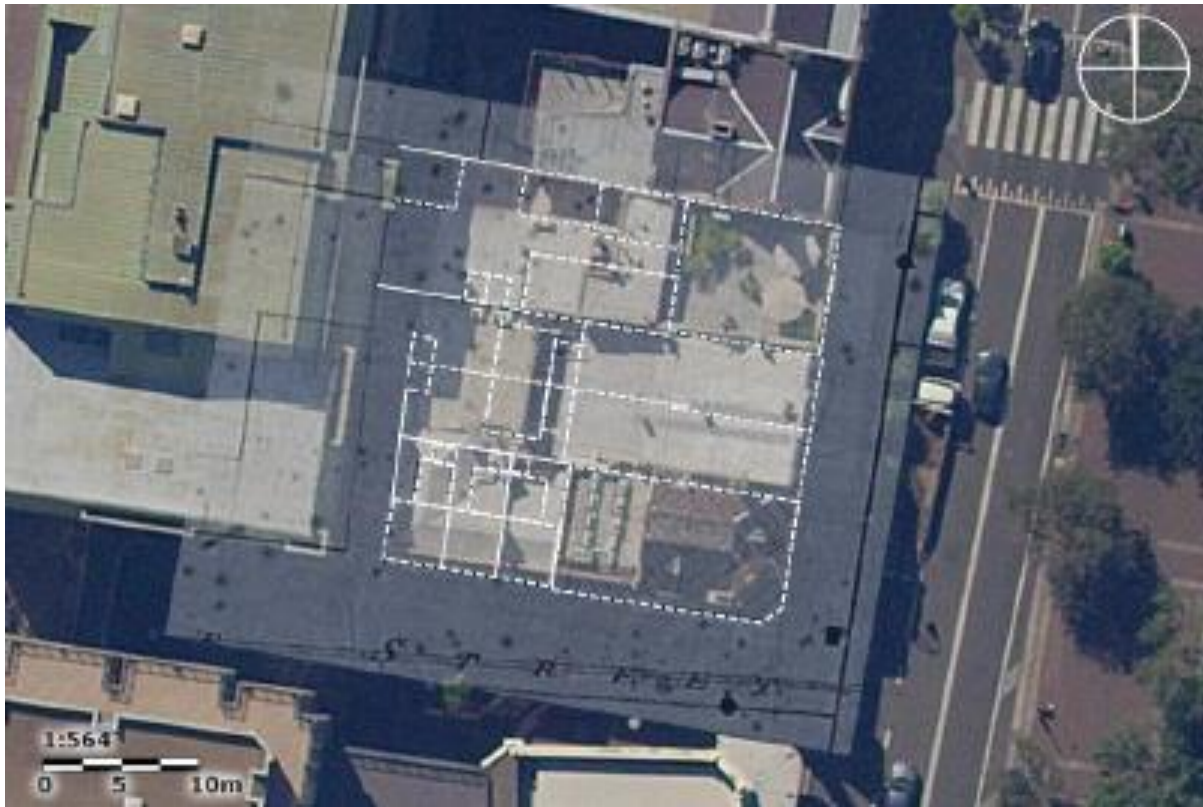
Figure 270: Current aerial of the study area overlaid with detail of 1865 Trigonometrical Survey (Figure 24). Note: former structural elements have been identified with dashed lines (Source: Historical Atlas of Sydney, Map 4; <https://maps.six.nsw.gov.au/>).

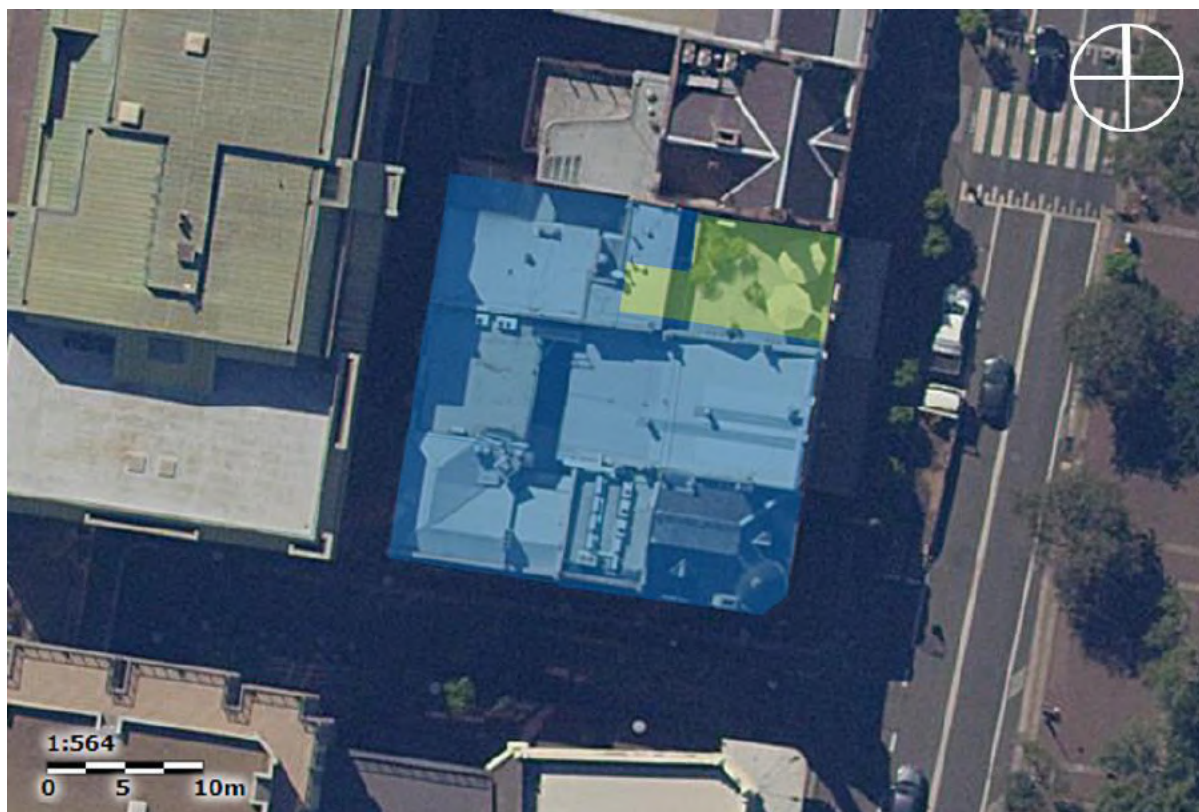
Figure 271: Aerial of the study area, marked with areas of archaeological sensitivity (moderate is blue, and little to none is green) (<https://maps.six.nsw.gov.au/>).

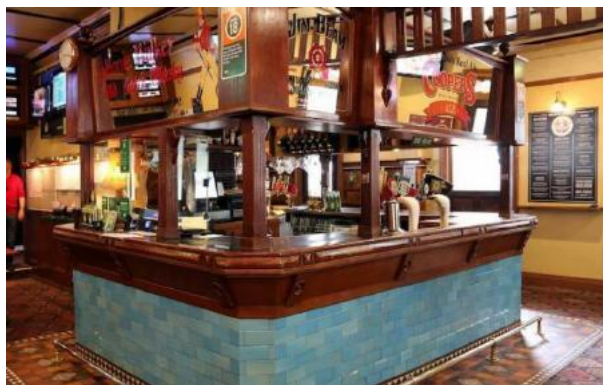
Figure 298: The bar top hamper of the Shakespeare Hotel, 200 Devonshire Hotel, Surry Hills, built 1879 and altered c.1920s. Source: <http://www.hotelssydney.org/en/property/shakespeare-hotel.html>

The interior of the Fortune of War Hotel contains a rare example of a bar top hamper. While these hampers were at one time common in hotels, the example at The Fortune of War is one of four authentic known extant examples in the City of Sydney identified in 1999 in the Clive Lucas, Stapleton CMP, and the only one in The Rocks; the others being on the fringe of the City CBD at:

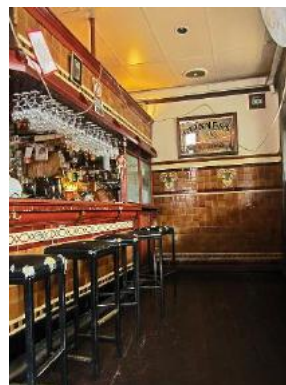
Figure 299: The Cricketer's Arms Hotel, 106 Fitzroy Street, Surry Hills, built 1921, retains its original bar top hamper. Source: https://www.flickr.com/photos/newtown_graffiti/6430035359

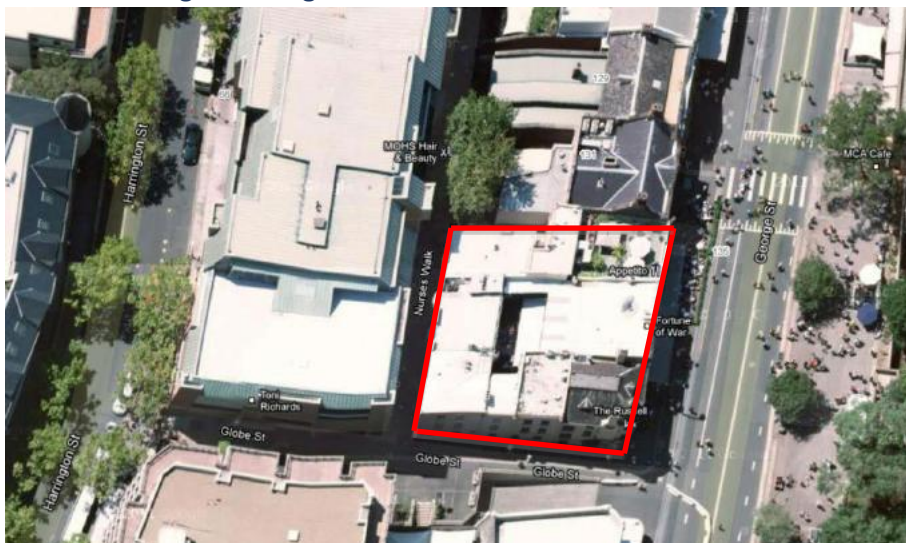
Figure 307: The lot property boundary and listed curtilage of The Russell Hotel/Fortune of War Group (Lot 1 of DP 790997), is indicated by the red lines above. Source: SIX Maps with TKD Architects overlay.

In keeping with the analyses of previous Conservation Management Plans (prepared in 1999 and 2007), it is noted that the core cultural values of each of the buildings in The Russell Hotel/Fortune of War Group are contained within their historic property boundaries. In addition, the State Heritage Register listings for the buildings in the group state that the individual buildings are all located within Lot 1 of DP 790997. The curtilage for each building is therefore defined as its boundaries as shown in (Figure 307).
