SYDNEY HARBOUR FORESHORE AUTHORITY

CONSERVATION MANAGEMENT PLAN

182 CUMBERLAND STREET

THE ROCKS

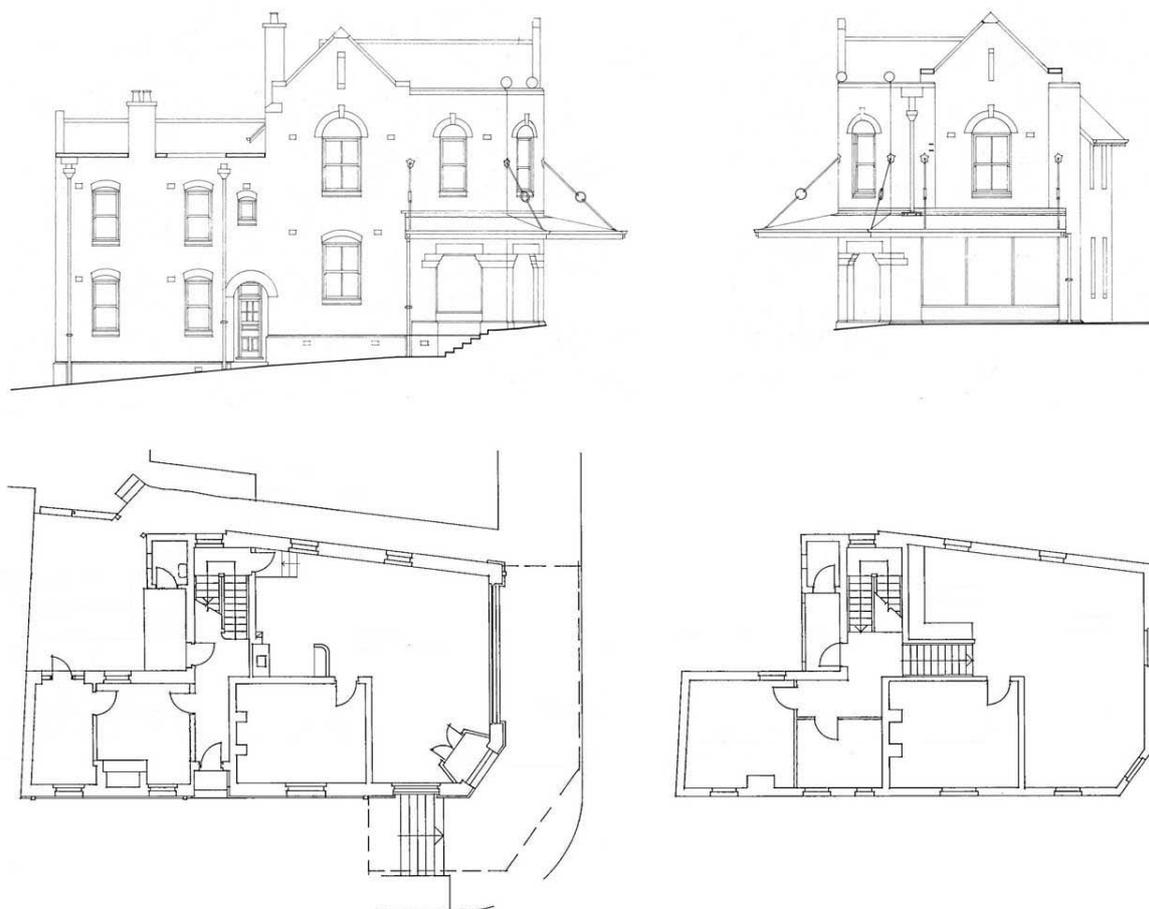
Figure 4

Plans and elevations of 182 Cumberland Street

The building at 182 Cumberland Street has an L-shaped plan with two storey frontages to both Cumberland Street and Essex Street, although the Essex Street wing is half a floor below the Harrington Street wing because of the steep slope of the site. The building has face brick walls with sandstone dressings, timber framed doors and windows and a slate roof. It has a suspended steel framed and sheeted awning to the corner shop, and a rear two-storey timber verandah. Internally, the building has timber floors, clear finished in the upper ground floor and mostly carpeted elsewhere (the bathroom floor is tiled, and the laundry and WC floors are concrete), cement rendered and painted brick walls (with some timber framed walls sheeted in plasterboard) and plasterboard ceilings. Refer to Figure 4.

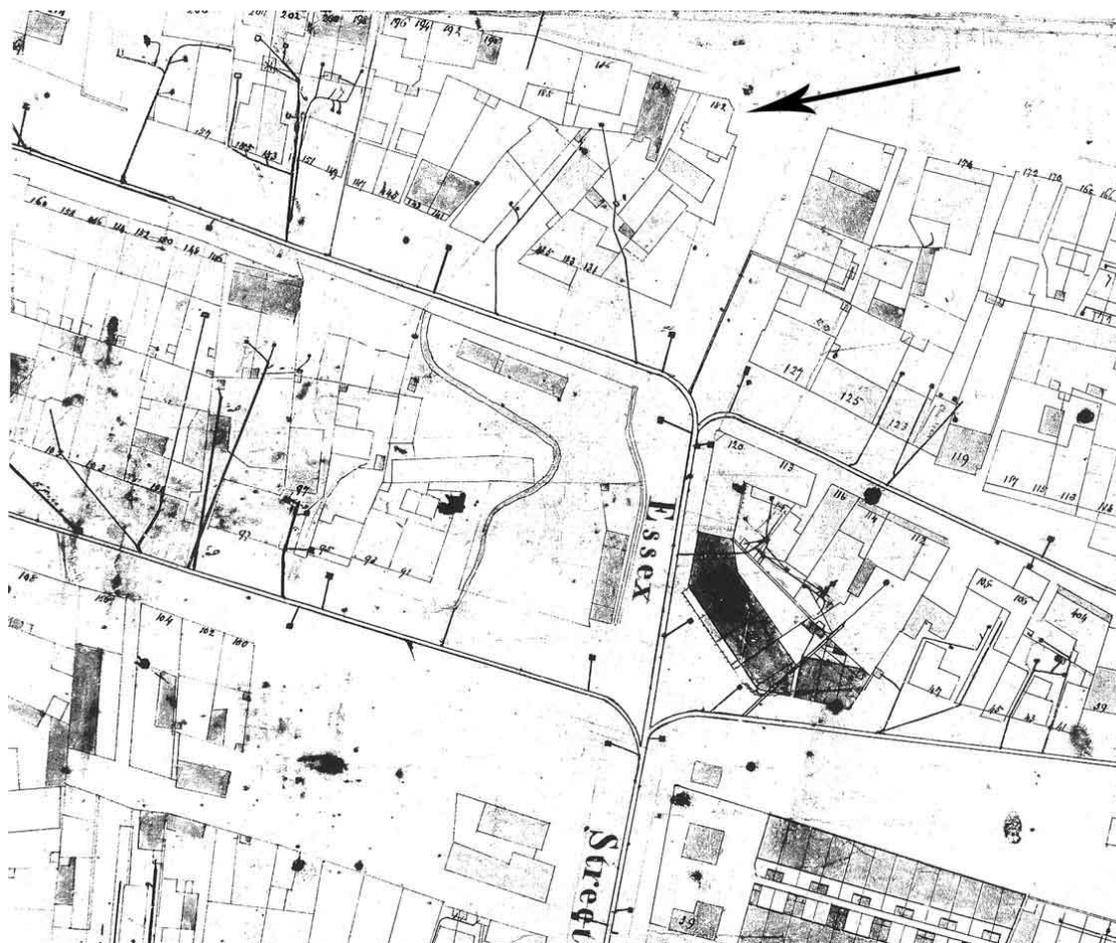
Figure 9

The shop at 182 Cumberland Street in 1865. A detached building has been added at the back of the shop and a small porch at the north-east corner of the old house

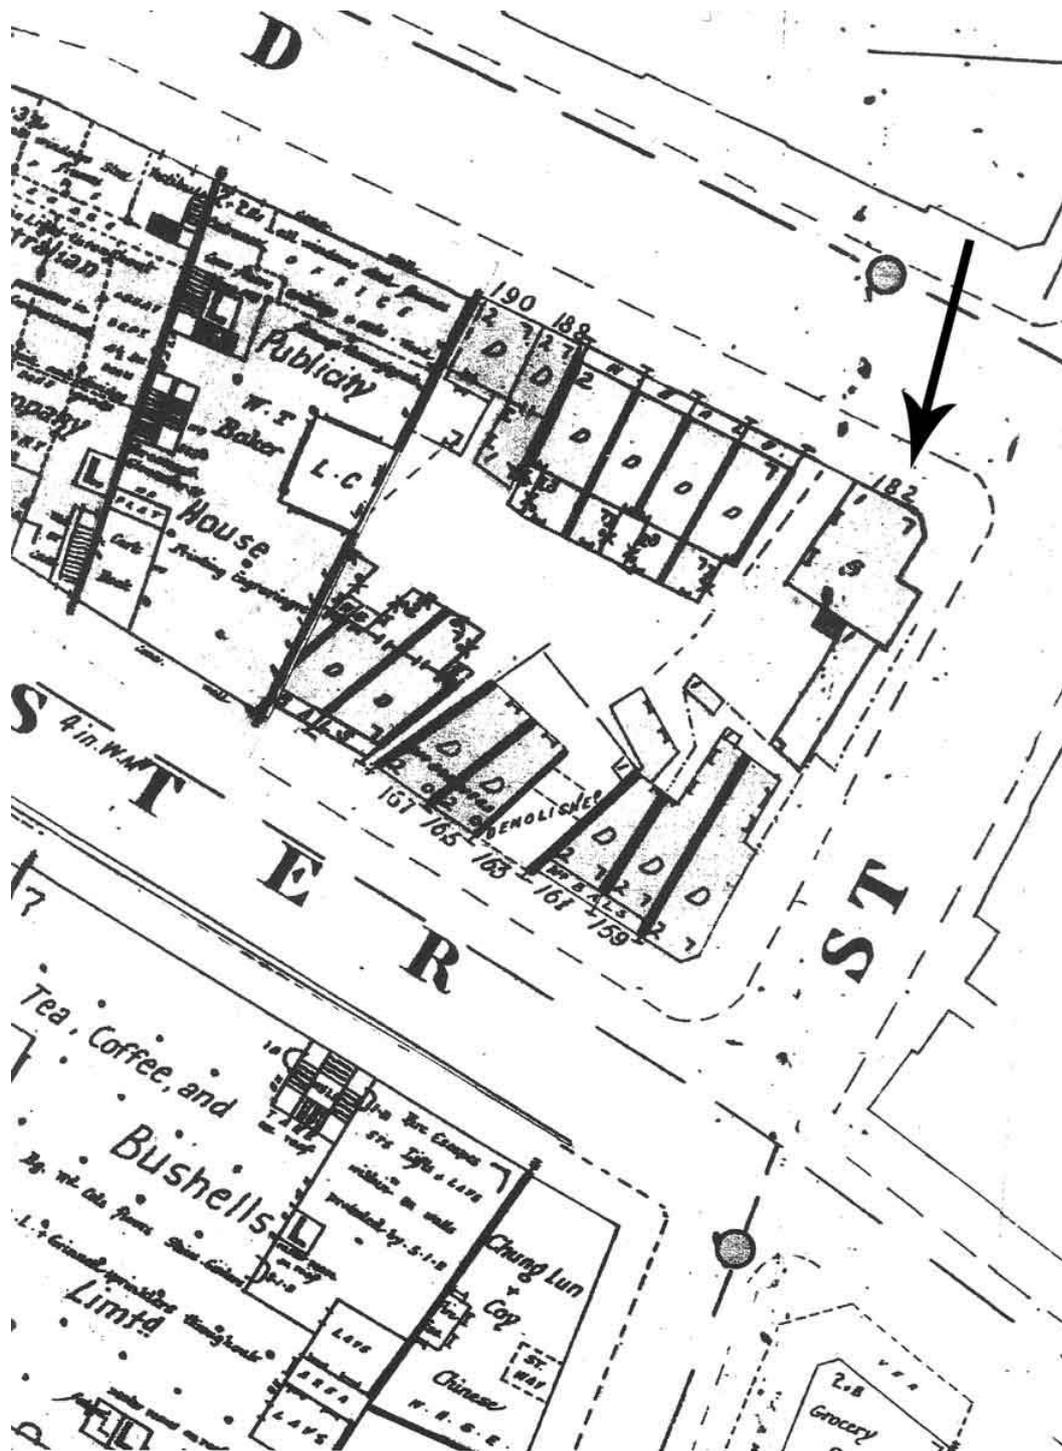
Figure 12

In the early 1900s the original house and shop were apparently unaltered but a new building along the Essex Street frontage had replaced earlier outbuildings

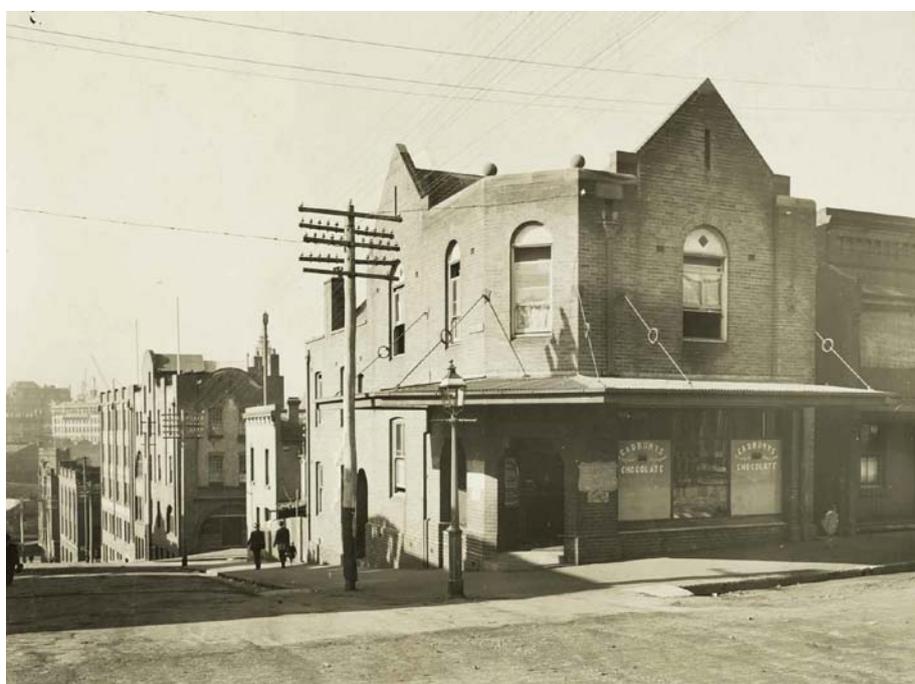
Figure 17

The new combined shop and residence at the corner of York Street North and Essex Street (now 182 Cumberland Street), built in 1911-1912 and photographed in July 1914

The evidence of the original drawing of the present building (Figure 16), early photographs (such as Figure 17) and physical evidence indicate that the building was constructed much as documented. Robertson & Hindmarsh noted in 1994 that:

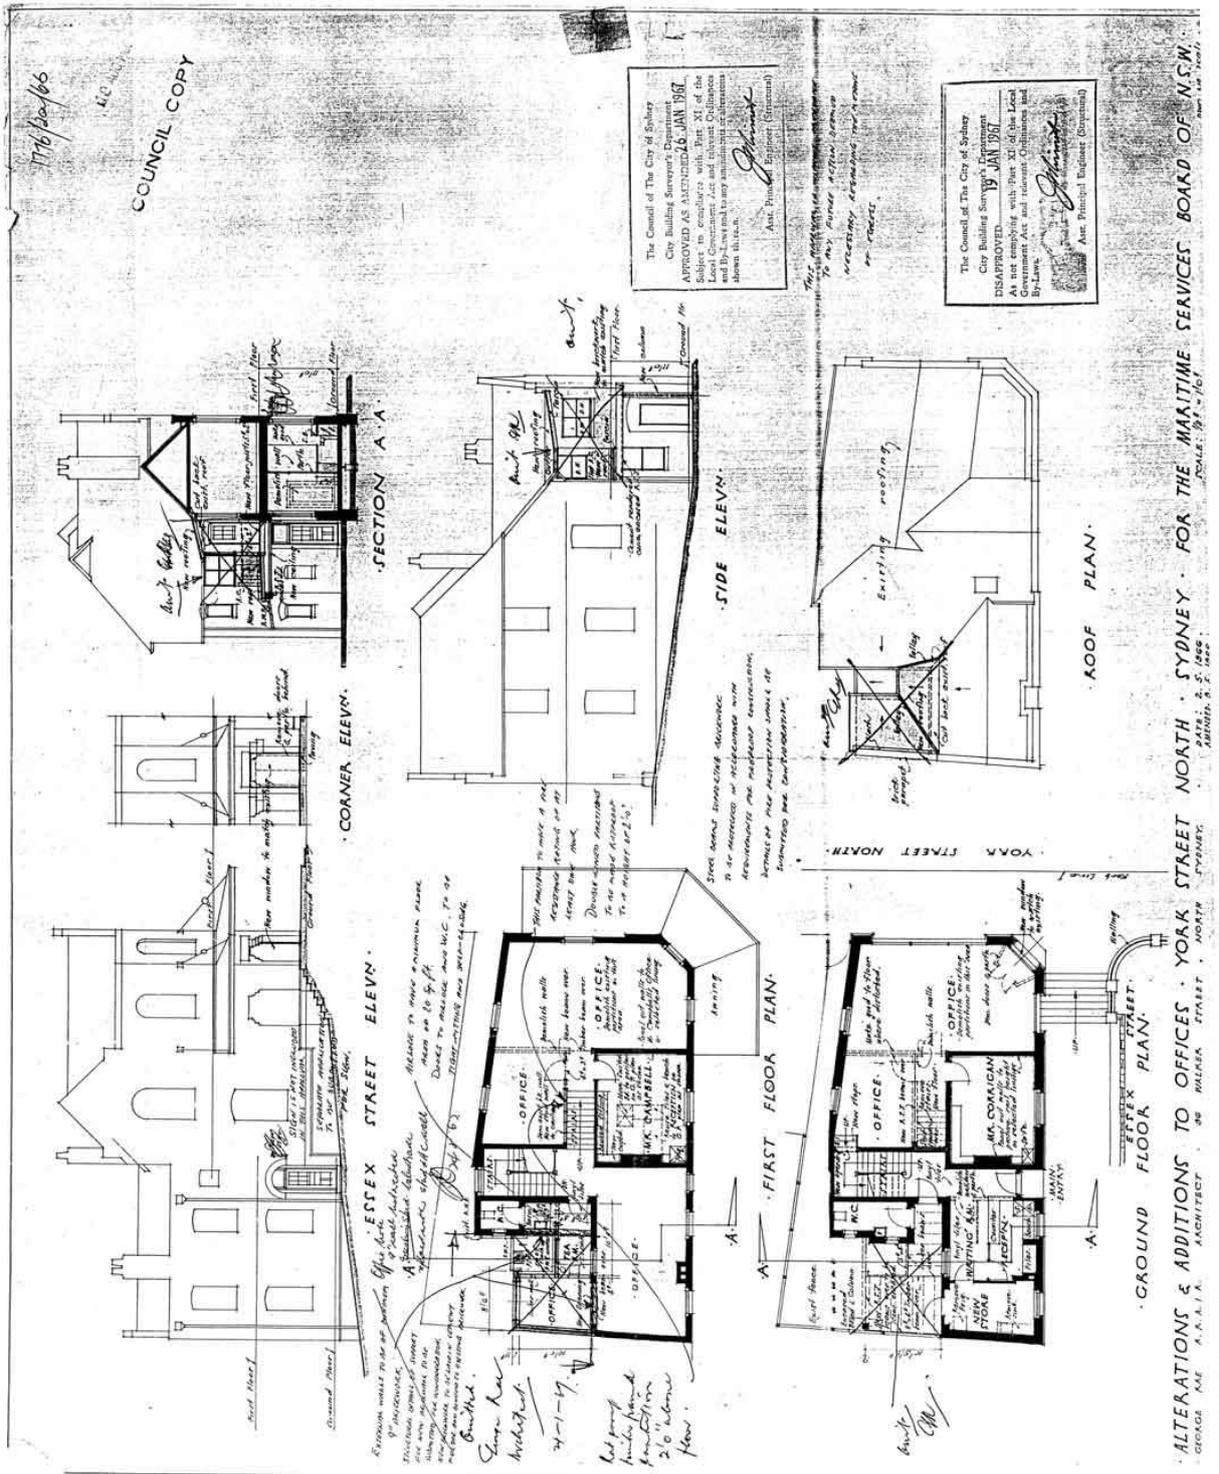
Figure 23

Plans for alterations and additions to 182 Cumberland Street in 1966, with amendments
Source: BA plan 1776/2a/66 City of Sydney Archives

The Rae drawings of May 1966 (Figure 23) indicate that there had been little change to the building since its construction. Robertson and Hindmarsh noted in 1994:

The alterations undertaken following approval of the Rae drawings by Council included the demolition of the stairs between the hallway off the Essex Street entrance and the corner shop, and the removal of part of the wall between this hallway and the former kitchen to create a reception area. Two other walls on the upper ground floor were demolished and replaced by beams, creating a large open office area. Corresponding walls on the first floor were also demolished and replaced with partitions. The corner entrance to the former shop was bricked up, and the rear first floor balcony was enclosed with new timber framed windows above an existing 3' 0" (900 mm) high fibro partition. Alterations to the building between 1967 and 1994 included the removal of the awning (which Robertson and Hindmarsh deduce occurred between 1975 and 1980), and the replacement of the roof in 1993. The Sydney Cove Authority photographed the building during reroofing in 1993, and the same year Tony Lowe, archaeologist, photographed the building before and after removal of internal debris.

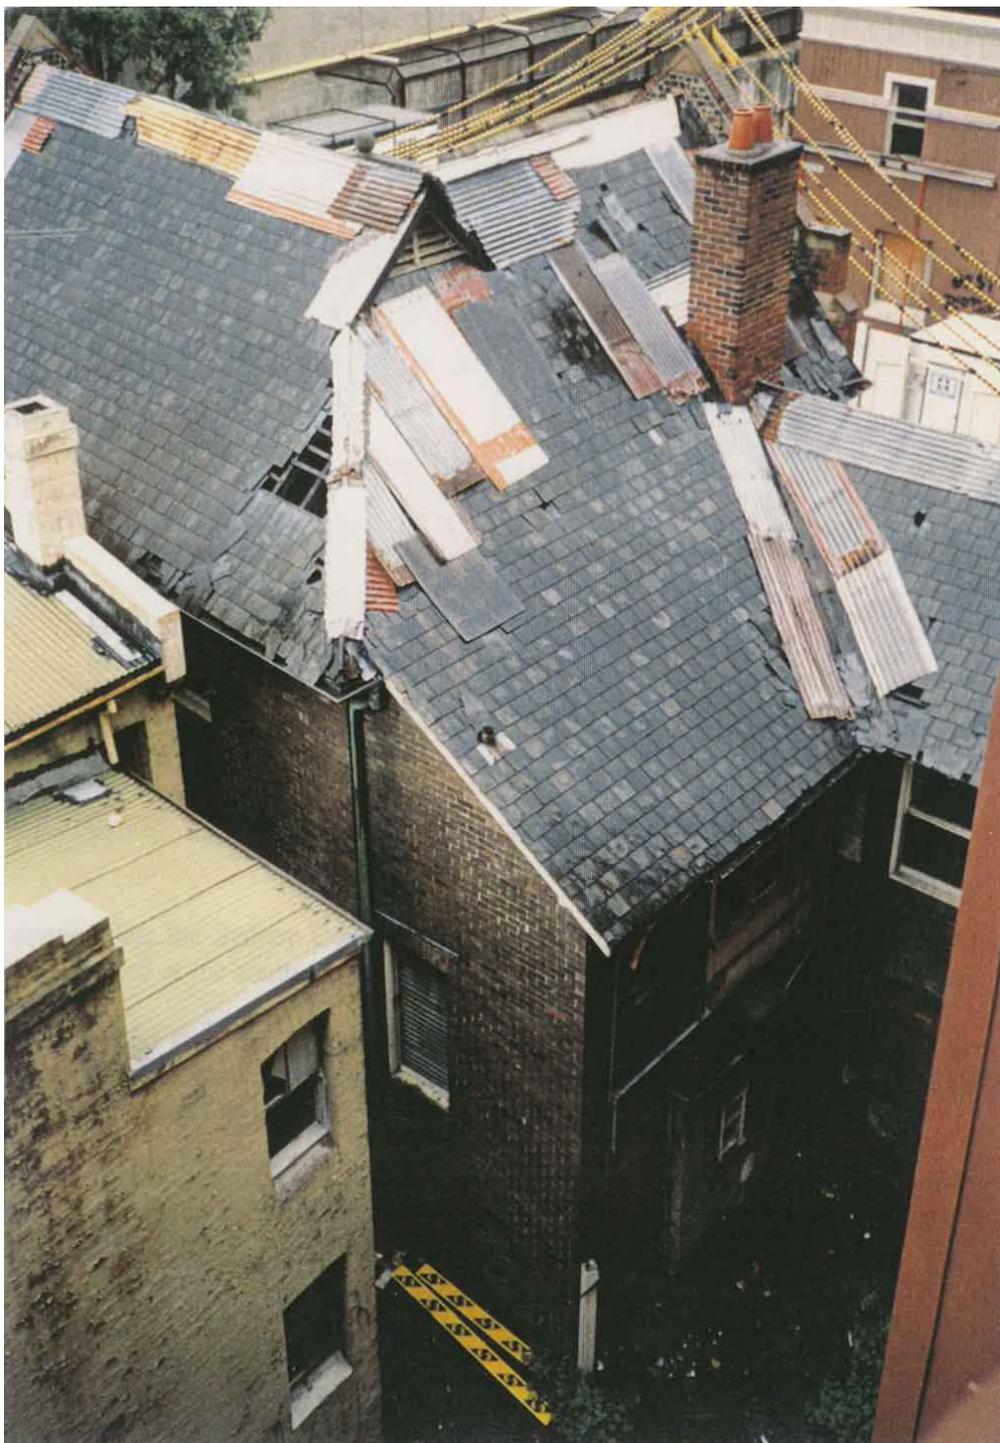
Figure 25

The roof of the building in 1993, after a long period of neglect in the 1970s and 1980s.
Source: Photograph by Rod Howard in Sydney Harbour Foreshore Authority File for 182 Cumberland Street RE 1216.03.01

In the early 1990s, after almost twenty years of neglect, the building was derelict and work began to repair the damage. In 1993 the building was re-roofed by Dynamic Roofing Pty Ltd using 'Spanish cupa' slate, chosen because it was the same colour as the original Welsh slate, which was not then available.

Photographs taken during the work show the extent of the replacement of battens, vents, barge boards and cornice mouldings required because of dry rot.⁷⁷

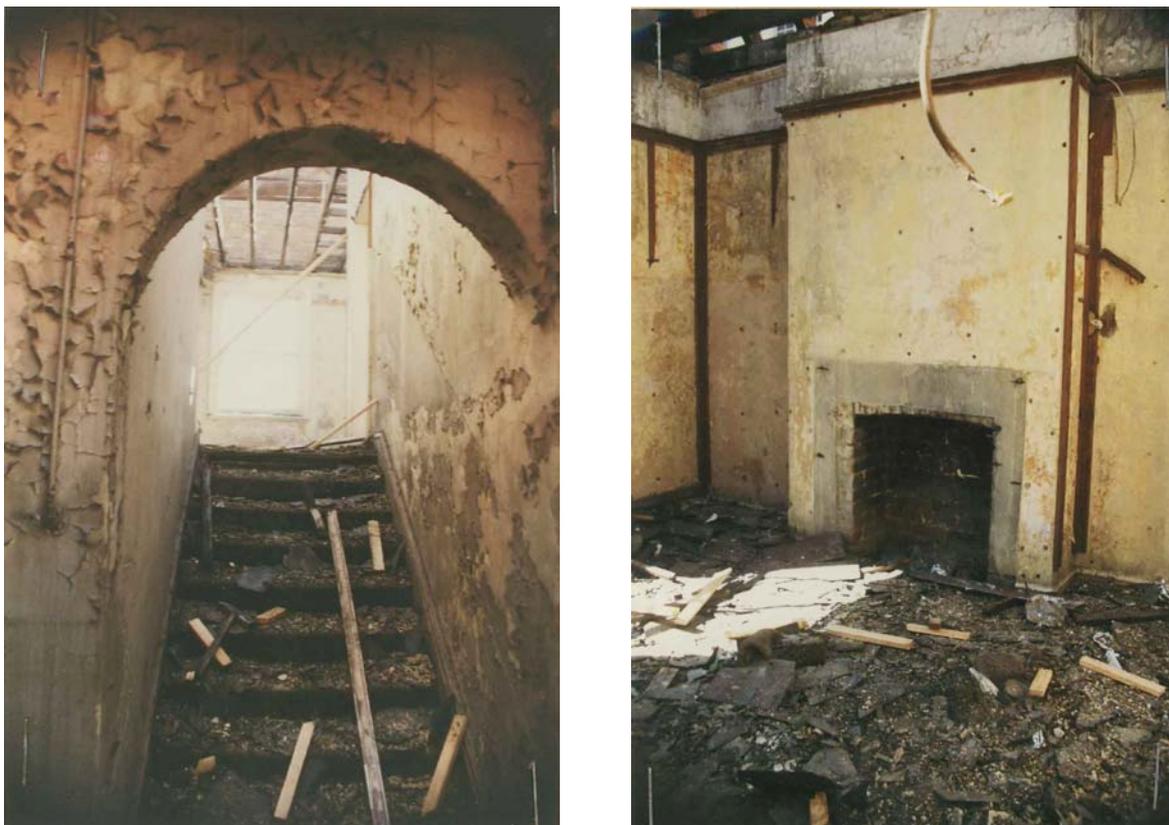
Figure 27

Interior of 182 Cumberland Street during reroofing, 1993: looking up stairs to main front room, first floor (left) and looking towards fireplace in former bedroom, first floor (right)

Main stair from landing (left), showing reconstructed balustrade (compare with Figure 29) and reconstructed wall to bathroom (with highlights) beyond. At right is the small office at the top of the last flight of stairs, with reconstructed fireplace (compare with Figure 27)

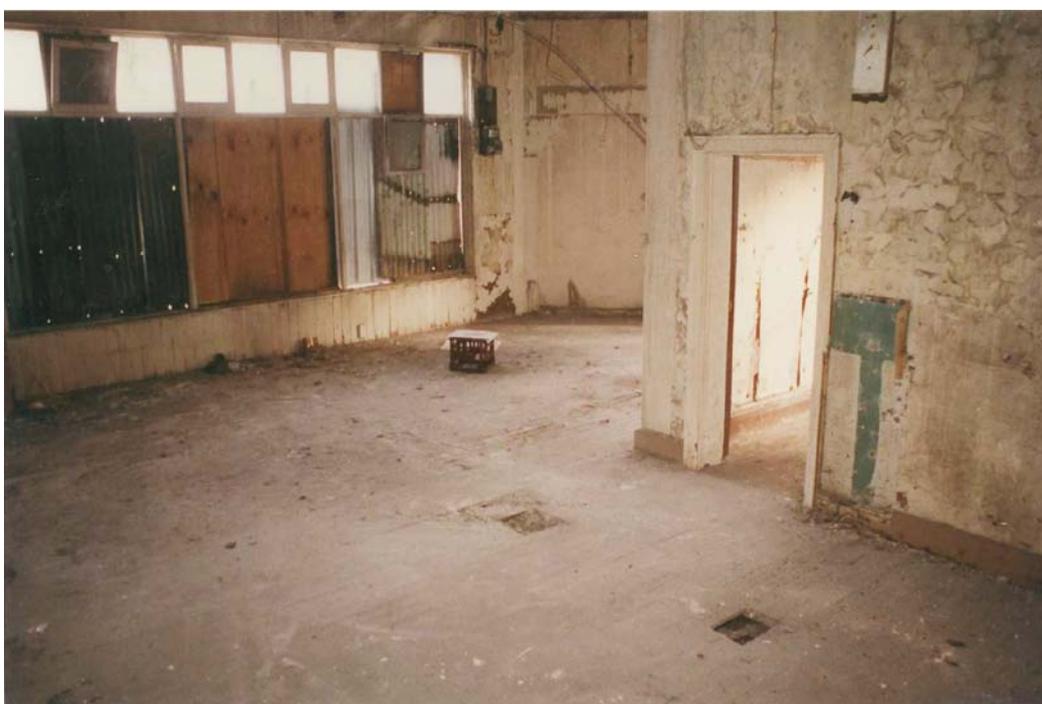
Figure 28

Interior of 182 Cumberland Street photographed by Tony Lowe, archaeologist, after removal of debris 1993: looking towards former entrance of corner shop, ground floor

The main front room (former corner shop) at 182 Cumberland Street, looking towards reconstructed entrance (above – compare Figure 28) and towards door to main stairs (below). Note floor grilles for air conditioning. The curved partition wall enclosing the kitchenette is visible on the left.

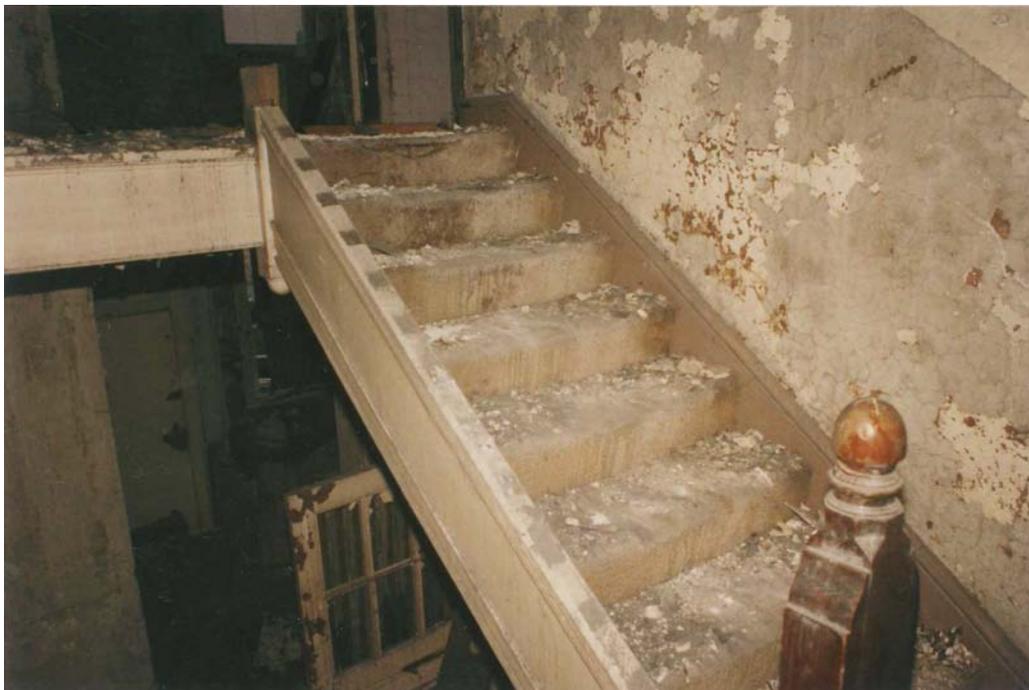
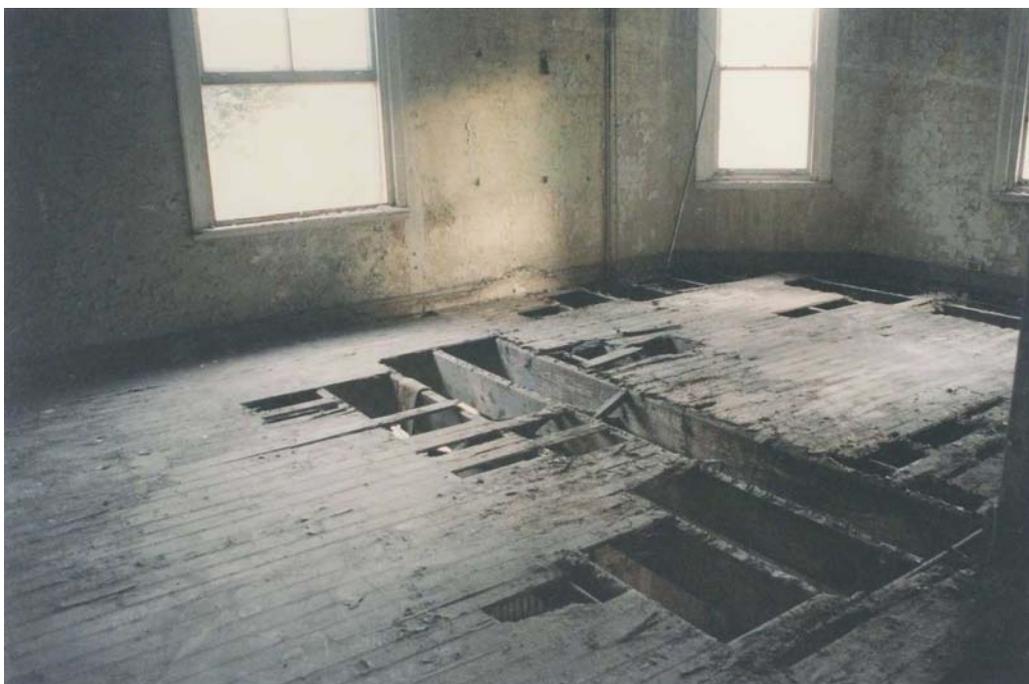
Figure 29

Interior of 182 Cumberland Street photographed by Tony Lowe, archaeologist, after removal of debris 1993: looking north at upper flight of stairs to first floor (above) and looking north-west towards corner of main room, first floor (below)

Main office on first floor, looking east (above) towards stair, archway and hall (note kink in cornice indicating change of roof structure and slope above), and looking north-west (below) towards splayed corner (compare Figure 29).

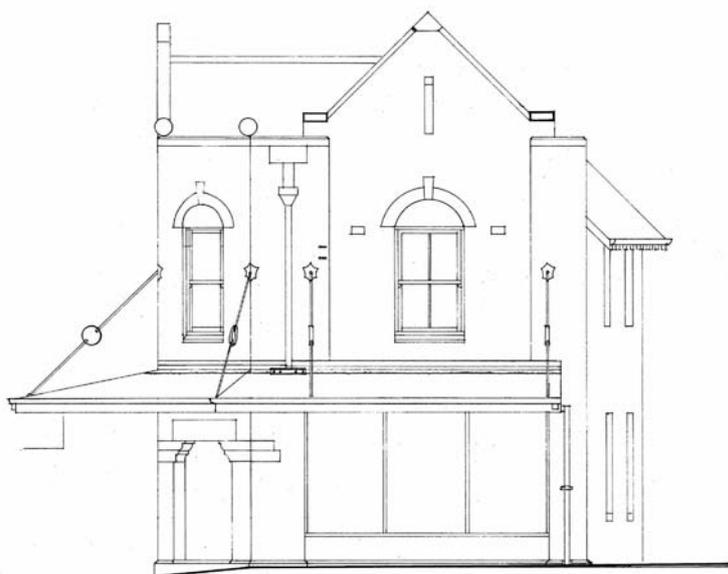
Figure 37

Current drawings of 182 Cumberland Street 2008: west elevation to Cumberland Street
Source: Drawings by Robertson & Hindmarsh Pty Ltd from Sydney Harbour Foreshore Authority Archives, amended by Orwell & Peter Phillips 2008.

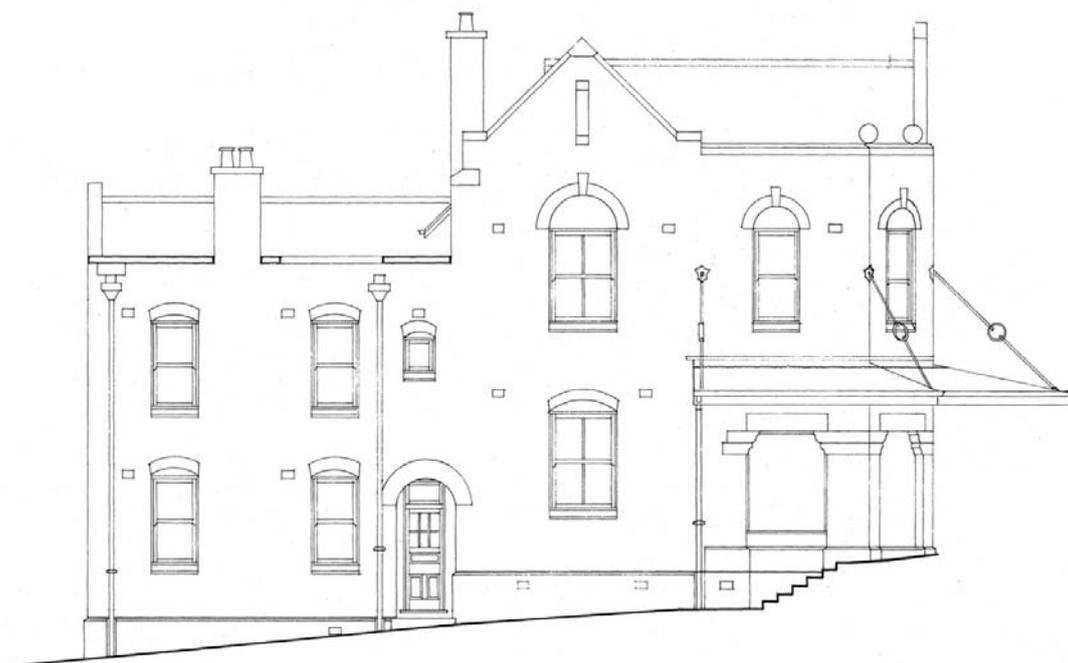
Figure 38

Current drawings of 182 Cumberland Street 2008: north elevation to Essex Street
Source: Drawings by Robertson & Hindmarsh Pty Ltd from Sydney Harbour Foreshore Authority Archives, amended by Orwell & Peter Phillips 2008.

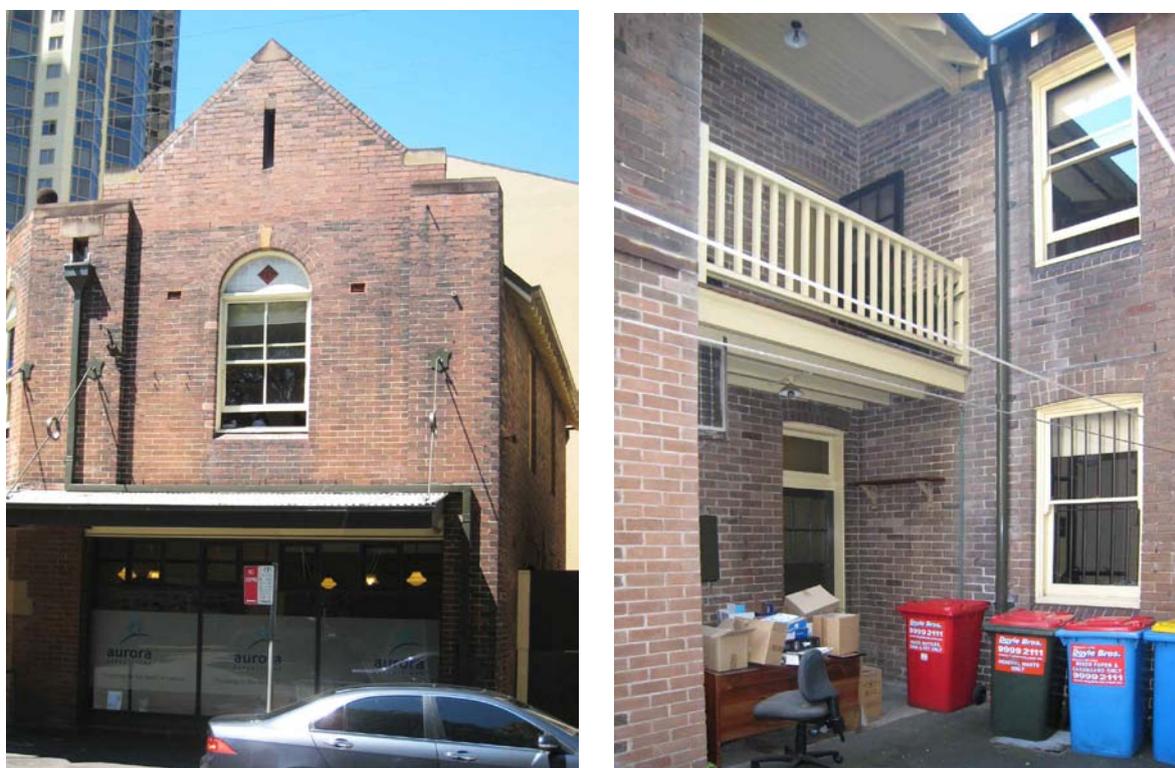
Figure 41

Cumberland Street facade showing the reconstructed awning (left), and view of rear verandah (right) showing evidence at left of reconstructed brickwork after removal of WC addition

The building fabric externally is largely original and intact, with some reconstruction (mainly the awning) and repair (some stone dressings). Brickwork in protected reveals shows evidence of original tooled pointing, which has disappeared on more exposed surfaces. At the rear, evidence of the former alterations remains in the brickwork. Typically for the period, the bricks and brickwork of the street facades are of a higher quality than at the rear: stone dressings were not used at the rear, and the brickwork is of a uniform colour.

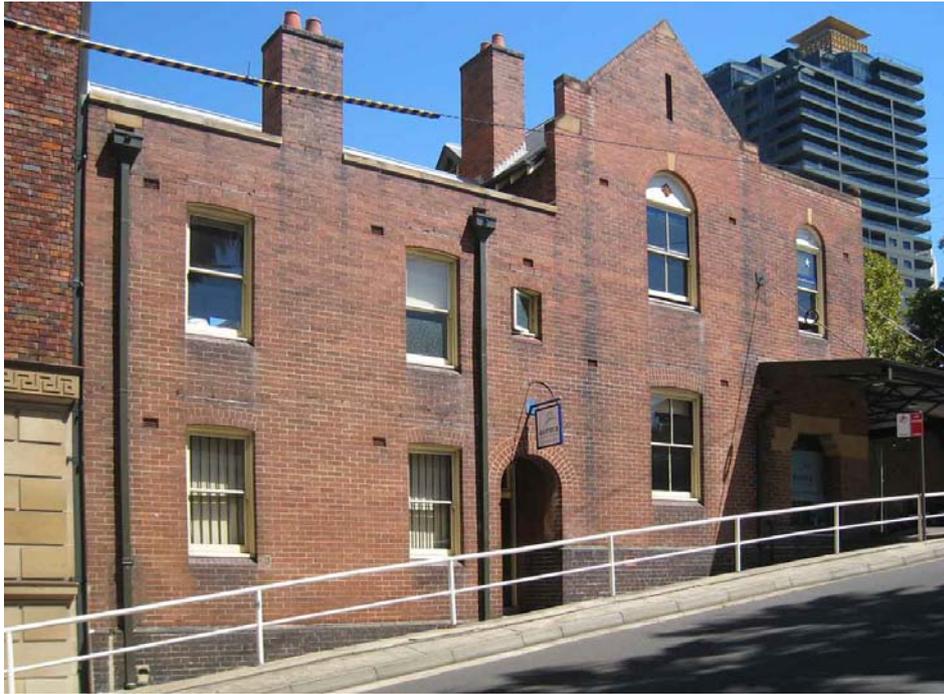
Figure 42

The Essex Street elevation shows the steep slope of the site, and the darker brick used for the base course. The arched opening at ground level is the original residence entrance.

Doors and windows have arched openings, more elaborate semi-circular arches being used on the upper story of the street facades, and at the entrance to the former residence. A darker brick has been used for the base course, most visible on the Essex Street façade. Roofs have exposed rafters, with v-jointed timber lining boards above. The same timber boarding has also been used for the ceiling of the upper rear verandah.

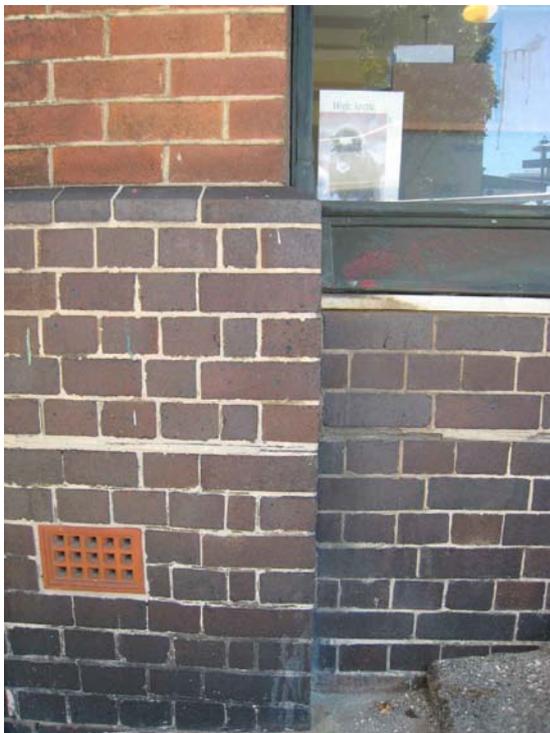
Figure 43

Detail of base course (left) shows slate dampcourse, marble sill and metal base of shopfront. Detail of top of shopfront (right) shows metal-sheathed framing and remnant of brick pointing.

The shopfront framing is encased in sheet metal, and has a marble sill with a sloping metal hamper above it. The dampcourse, a double row of slates set in cement mortar, is clearly visible in the base course. The original brick pointing (a darker mortar, carefully tooled slightly proud of the surface) is still present on surfaces such as reveals which have been protected from the weather. The main entrance to the shop is now below footpath level, and the formerly open archway to the laundry has been enclosed with a modern timber boarded wall and door.

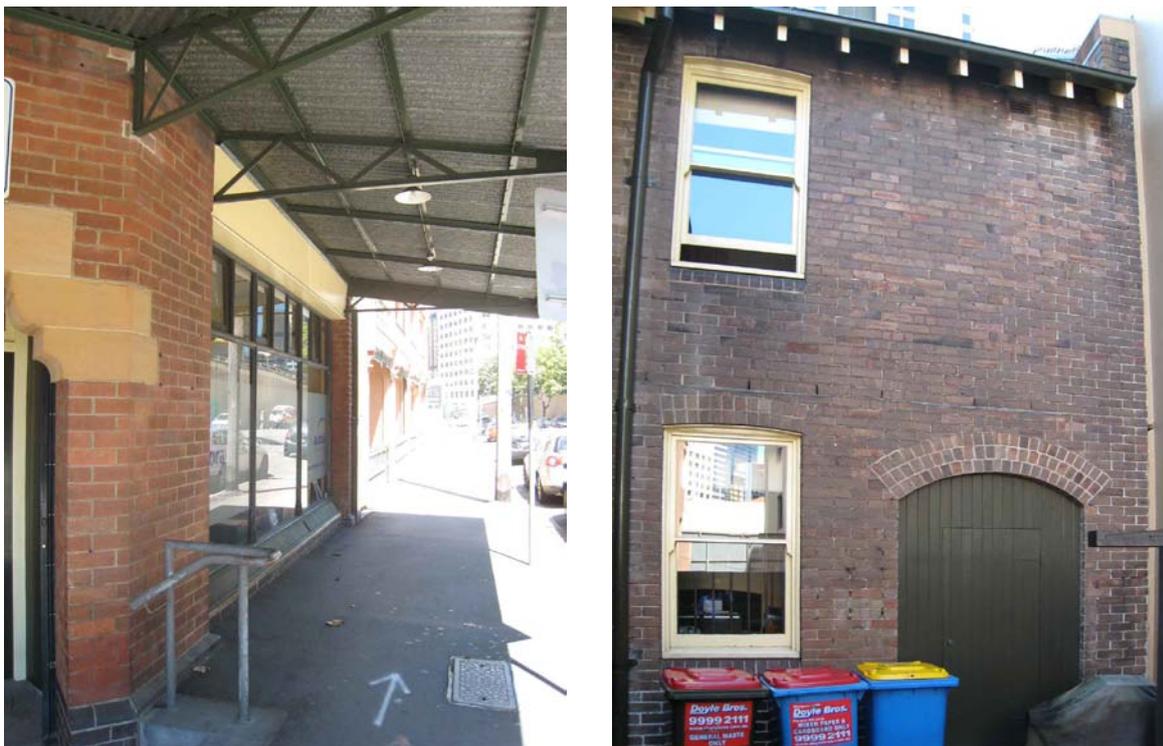
Figure 44

View along Cumberland Street (left) showing corner entrance below footpath level (note handrail) and underside of reconstructed awning. South elevation to rear courtyard (right) shows infilled archway to laundry

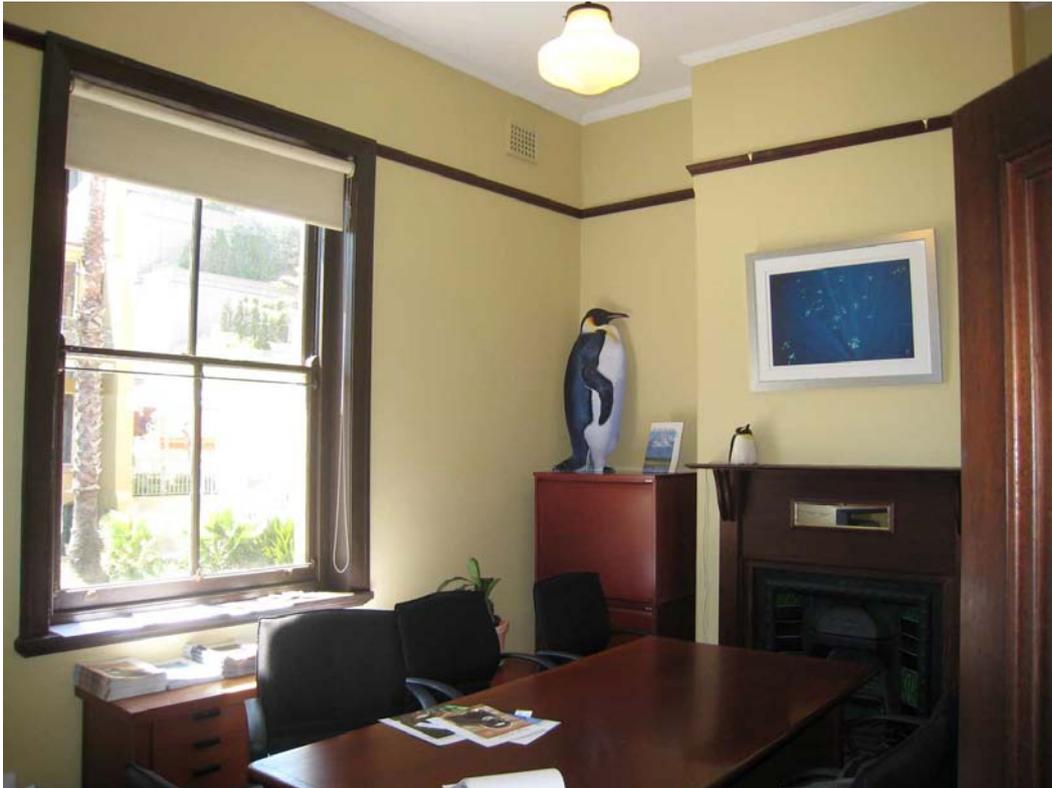
Figure 46

The office on the upper ground floor, showing the reconstructed chimneypiece and other joinery, including picture rail and door.

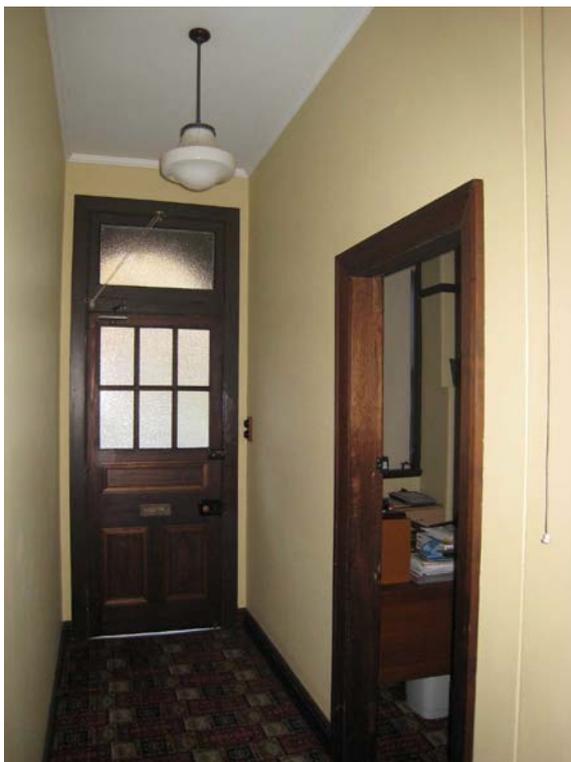
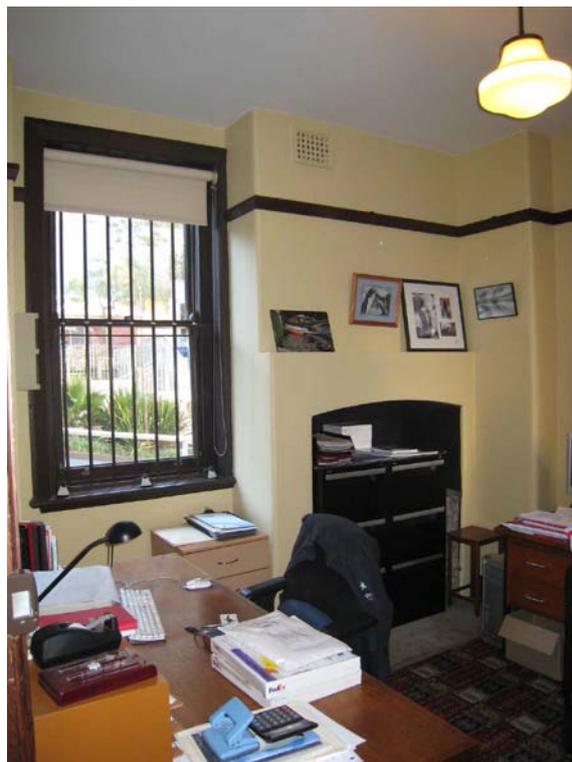
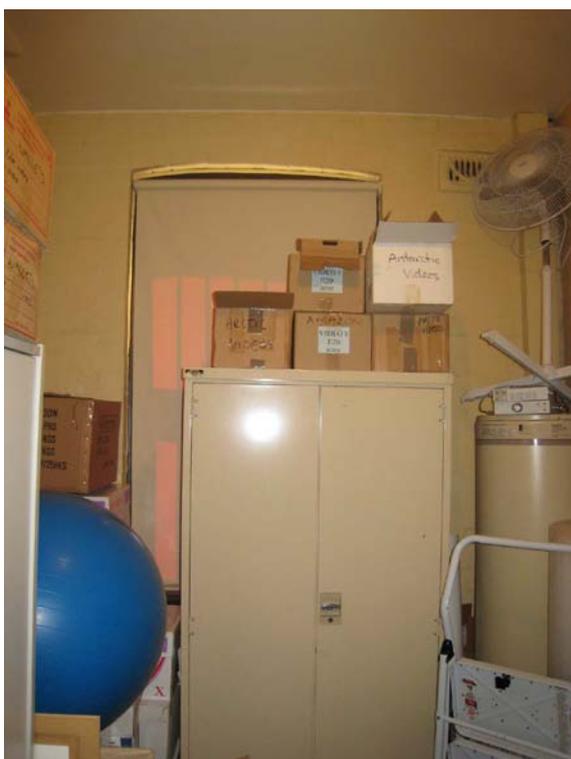
Figure 47

Entrance hall of lower ground floor (upper left) looking towards Essex Street; note vertical groove in render on right, indicating extent of reconstructed wall. Interior of original kitchen (upper right) shows former fireplace and flue to adjacent laundry copper. The laundry (lower left) and WC (lower right) at this level are now used mainly for storage.

On the lower ground floor, the original kitchen has been converted to an office, although it retains its fireplace. The former laundry, although again equipped for its original function, is now used for storage, as is the WC that is reached from the rear verandah. The ceiling of the WC is the underside of the concrete slab for the WC above, with the edges curved down to make a coved cornice.

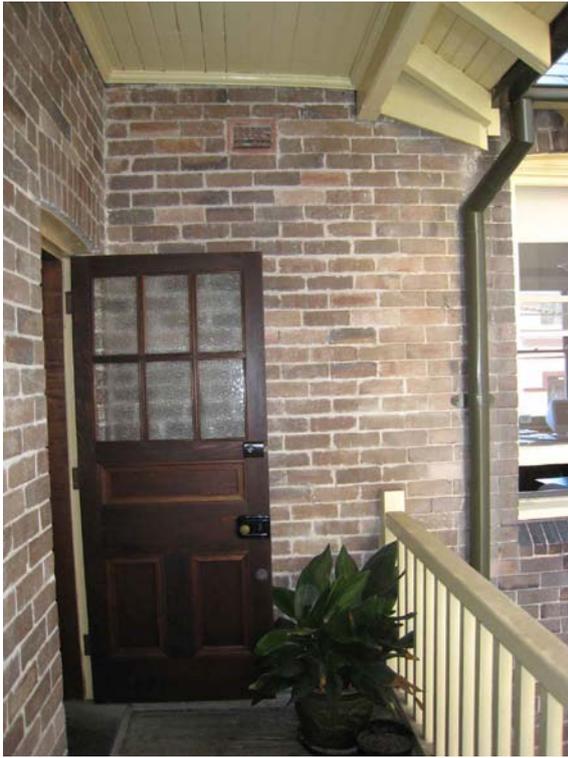
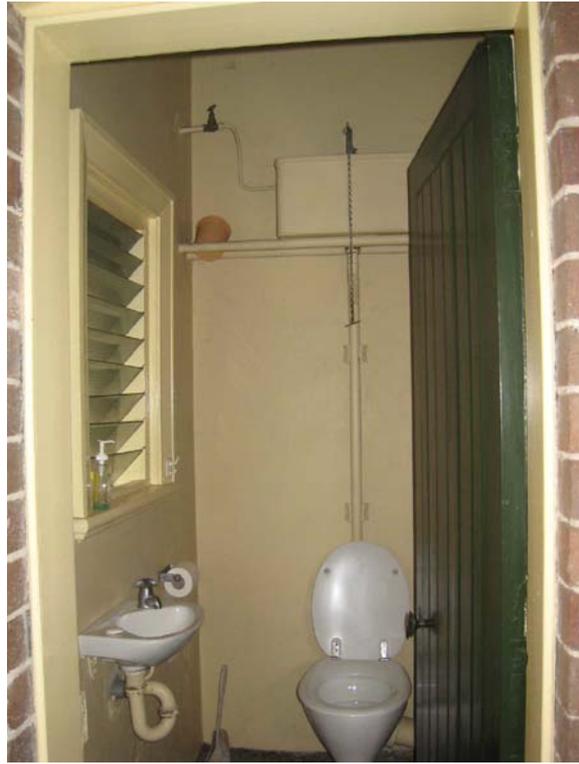
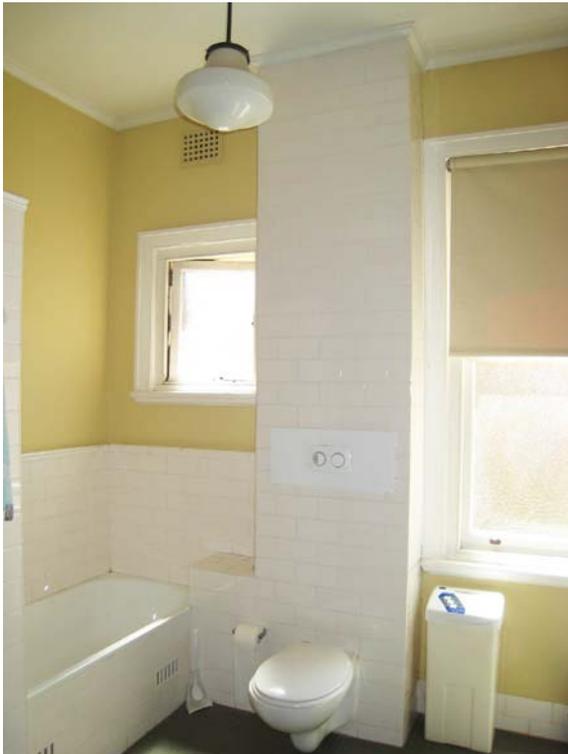
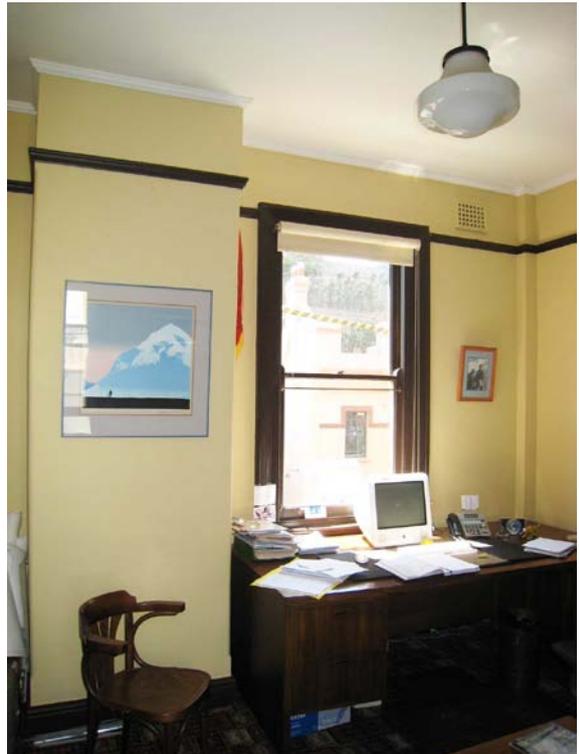
Figure 50

Upper floor areas: rear balcony (upper left), WC (upper right), bathroom (lower left) - note small window formerly to linen press - and adjacent rear office (lower right)

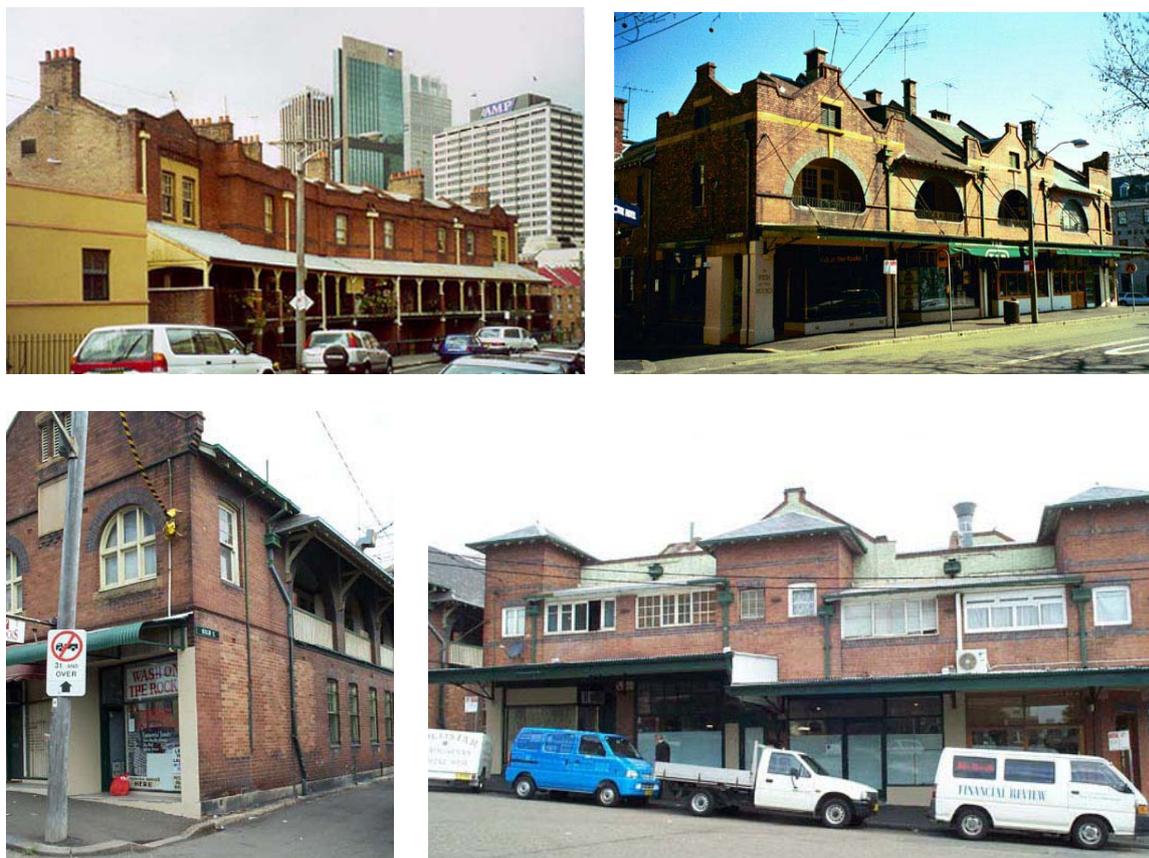
Figure 51

Comparative examples of early 20th century shops and residences in Millers Point: 46-56 Gloucester Street (above left - residences only), 21-29 Kent Street (above right - shops with residences above), 9 Argyle Street (below left - shop and residence) and 1-7 Argyle Street (below right - shops and residences)

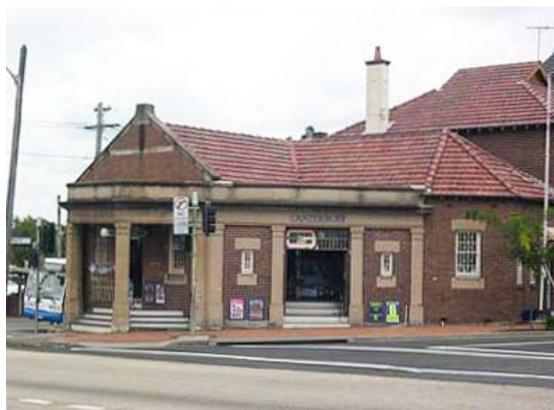
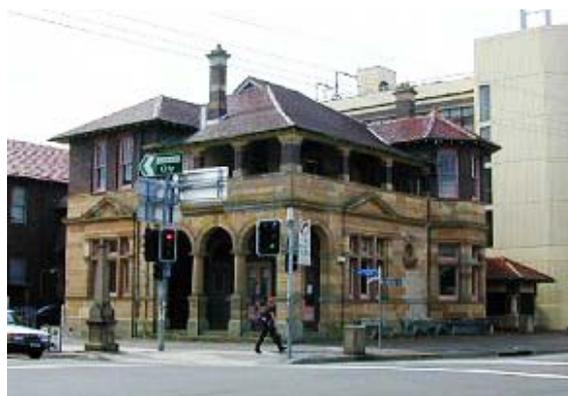
Figure 52

Comparative example of Vernon's small-scale Post Office and residences: Canterbury (left) and Randwick (right)

The Canterbury Post office has some similarities of style to 182 Cumberland Street, while the Randwick Post Office is an altogether grander building of a slightly earlier period. Vernon also designed several buildings in this style on a larger scale: three within The Rocks area are the former Coroner's Court, and the former Chamber of Commerce building and Brooklyn Hotel, all in George Street.
