SYDNEY HARBOUR FORESHORE AUTHORITY

CONSERVATION MANAGEMENT PLAN

182 CUMBERLAND STREET

THE ROCKS

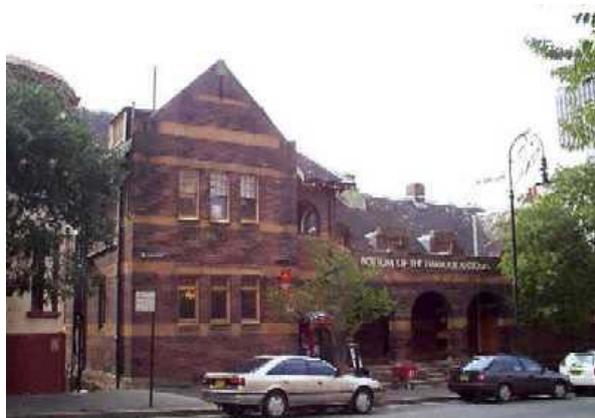
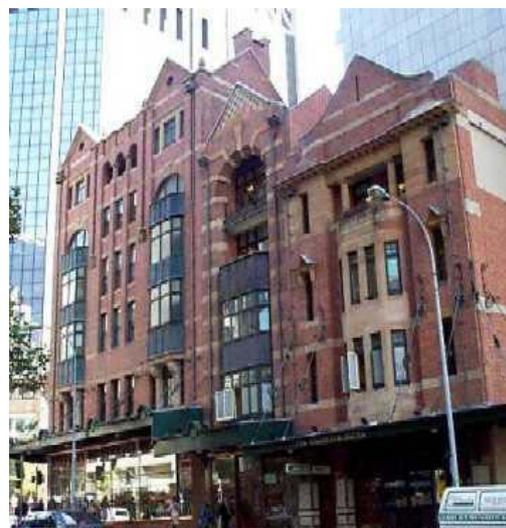
Figure 53

Comparative example of Vernon's Federation style buildings in George Street, The Rocks: the former Coroner's Court (left) and the former Chamber of Commerce and Brooklyn Hotel (right)

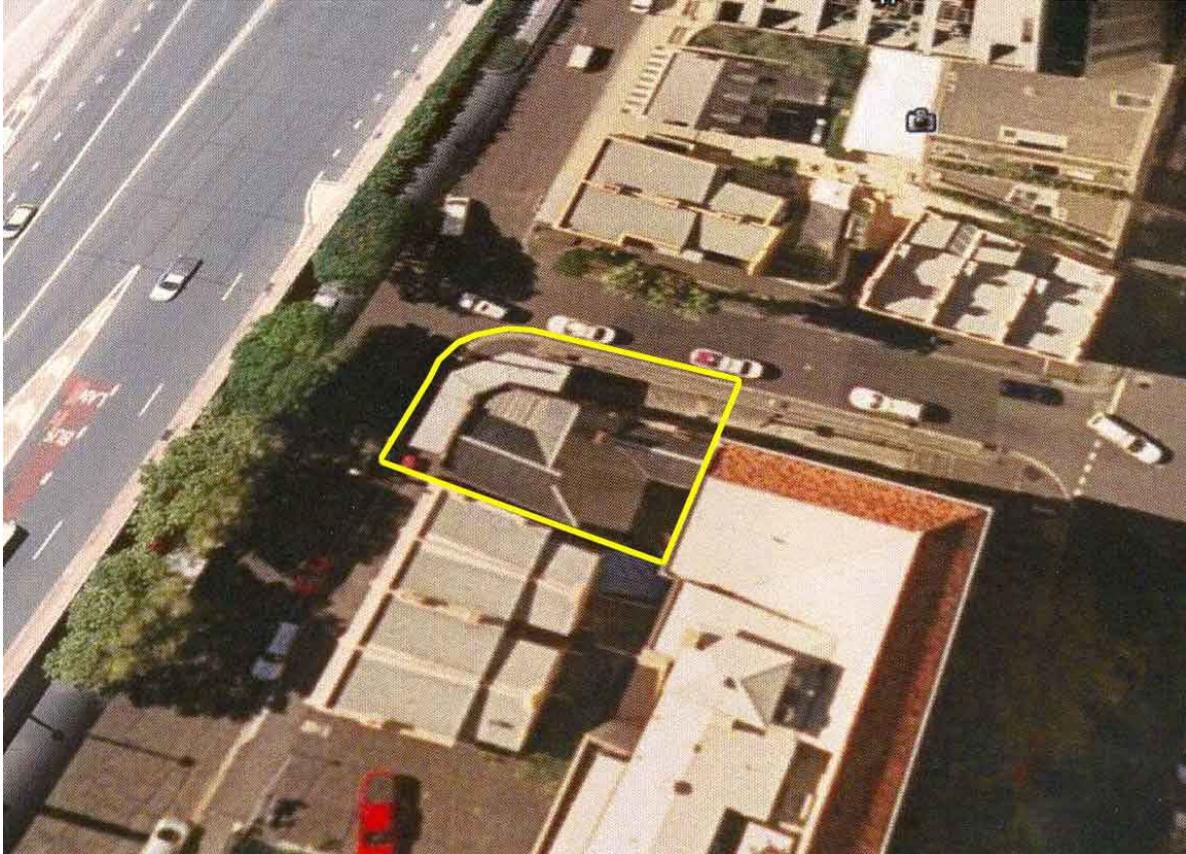
Figure 54

Recommended curtilage for 182 Cumberland Street, The Rocks
Source: (base map) Google Earth

The appropriate curtilage for the building is delineated by the footpath kerbs of the street corner to the north and west, and the boundary walls of the adjoining sites, Science House to the east and the terrace group to the south.

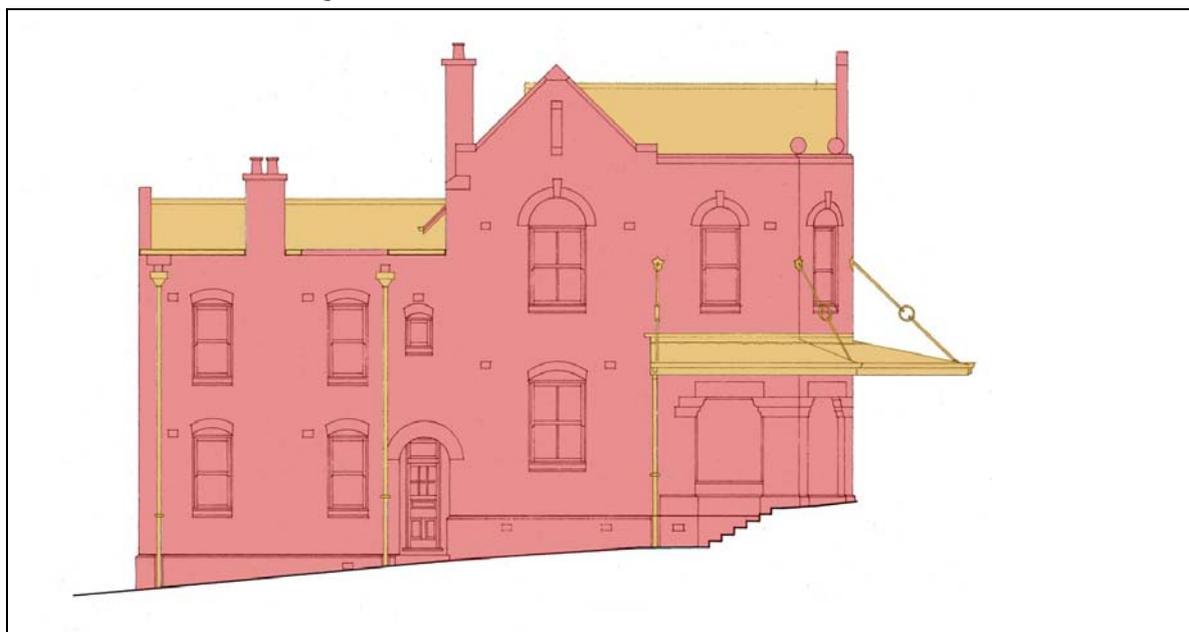
5.1.1 Northern Façade External Elements

– Original and early face brick and stone walls, timber doors and windows, shopfront	Exceptional (red)	■
– Reconstructed slate and galvanised steel roofing and accessories, cast iron and steel downpipes and rainwater heads, awning, and stone copings	High (orange)	■

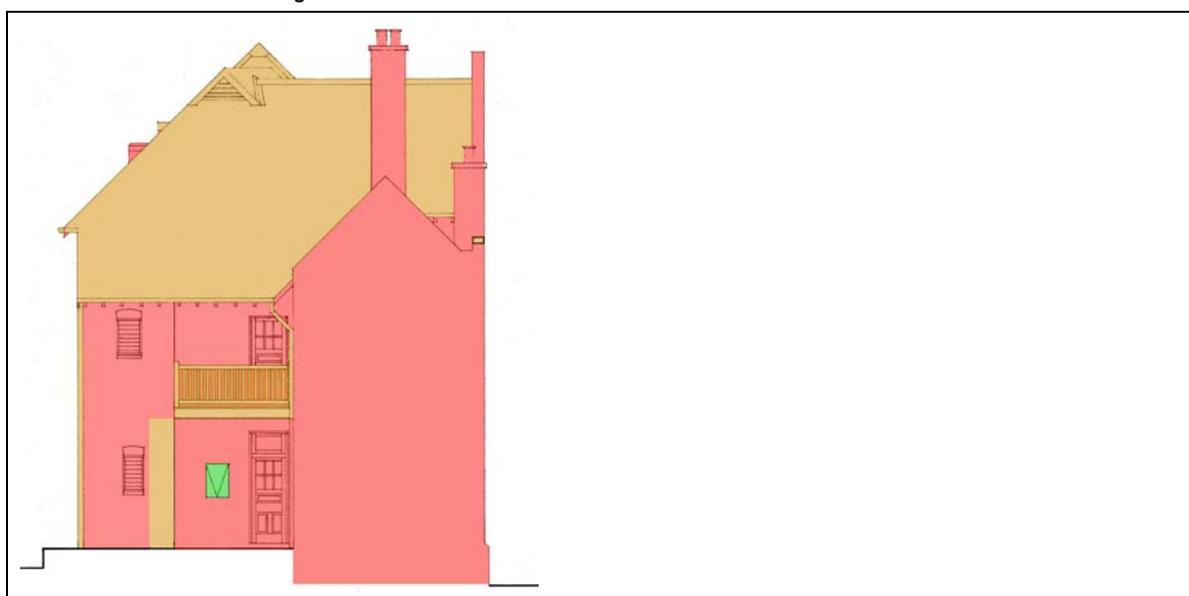
5.1.2 Eastern Façade External Elements

– Original and early face brick and stone walls, timber doors and windows	Exceptional (red)	■
– Reconstructed slate and galvanised steel roofing and accessories, cast iron and steel downpipes and rainwater heads, brickwork and timber verandah	High (orange)	■
– Meter box	– Little (green)	■

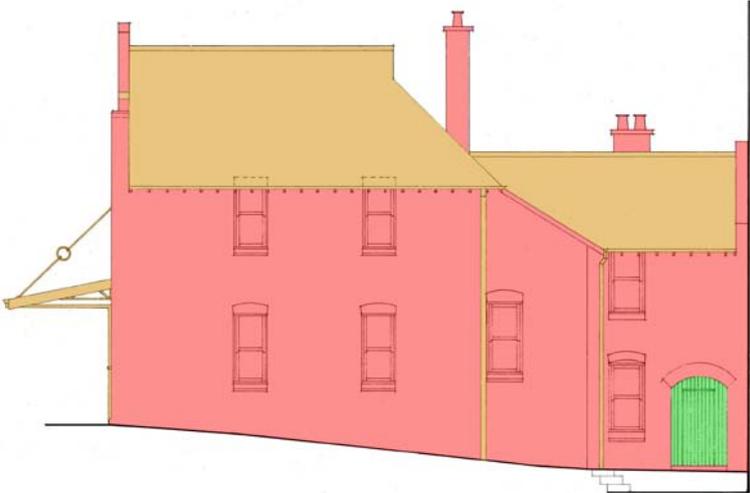
5.1.3 Southern Façade External Elements

<ul style="list-style-type: none"> Original and early face brick and stone walls, timber doors and windows 	Exceptional (red)

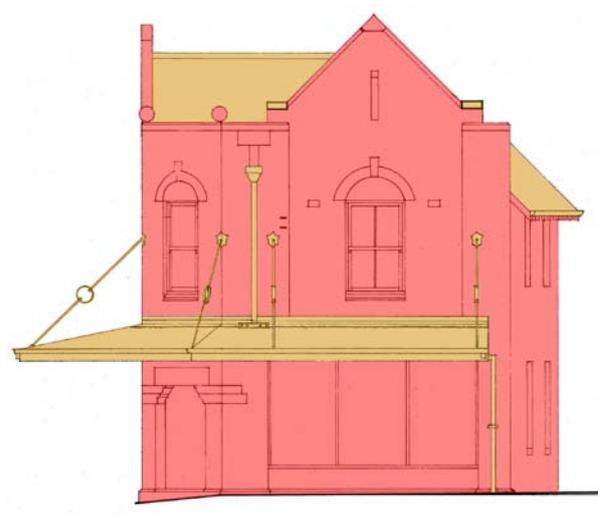
5.1.4 Western Façade External Elements

<ul style="list-style-type: none"> Original and early face brick and stone walls, timber doors and windows, shopfront 	Exceptional (red)
