95-99 GEORGE STREET

THE ROCKS

CONSERVATION MANAGEMENT PLAN

Prepared for the Sydney Harbour Foreshore Authority

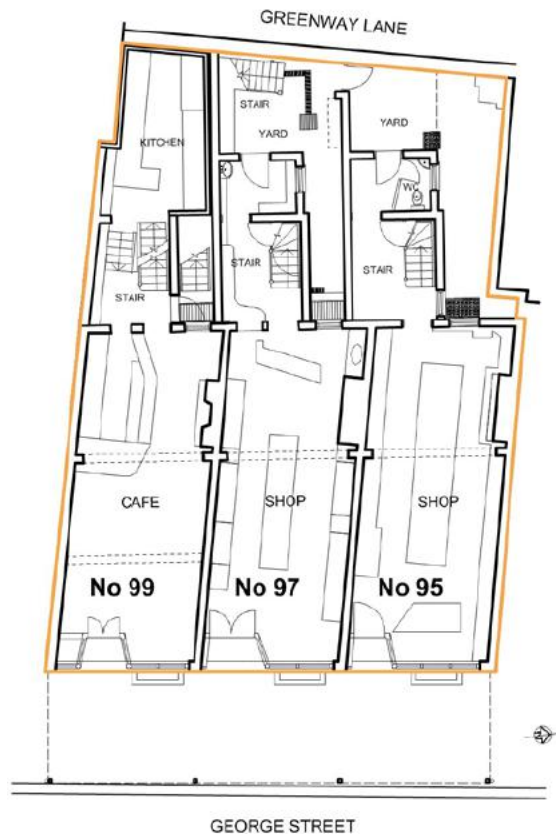
Figure 4

Site plan of 95-99 George Street, with leased area outlined and main elements labelled

The site boundary shown in Figures 2 and 4 is the combined lease boundary. The side boundaries to the north and south lie along the wall alignments of earlier buildings at No 93 (since rebuilt) and No 101.

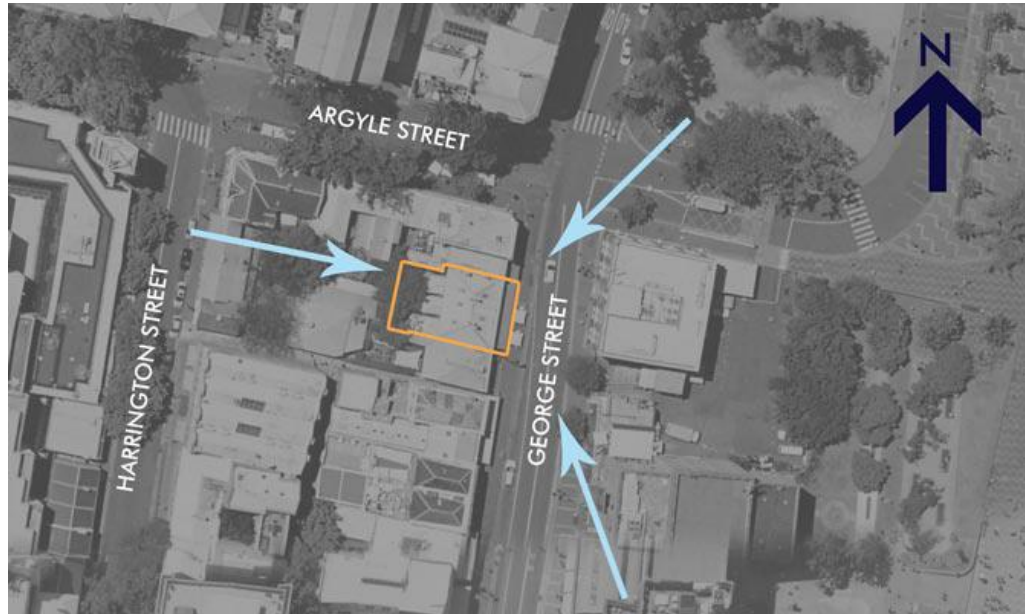
Aerial photograph of Nos 95-99 George Street in its townscape context, showing significant views to the property (light blue) and the present lease boundary (orange). (Source (base plan): Google Maps)

Figure 7 shows the present views to the place from George Street and the internal courtyard across Greenway Lane.

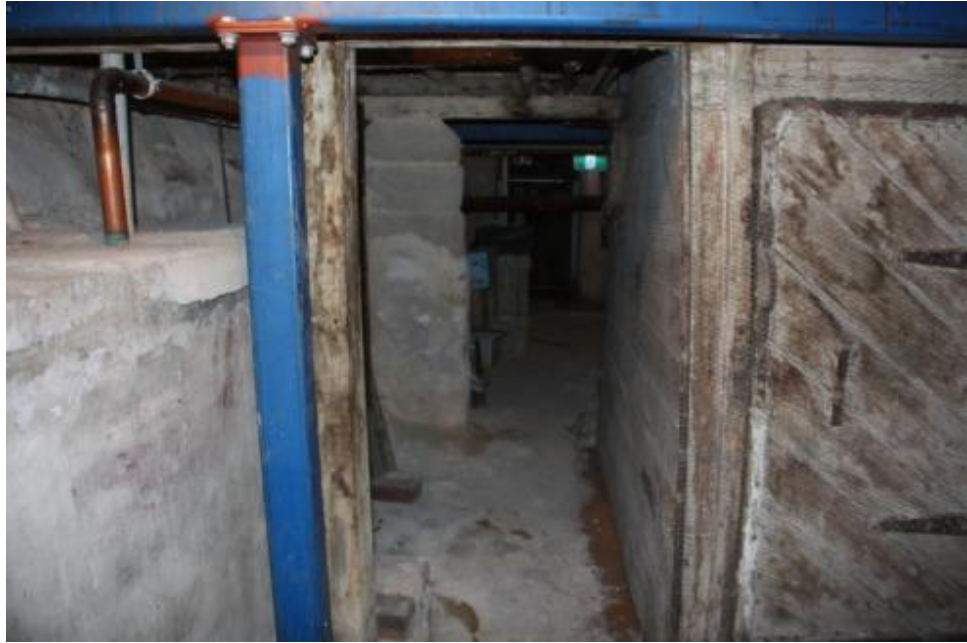
Figure 11

This image shows the cellar of 95 George Street looking west towards Greenway Lane. This cellar covers only one section of 95 George Street and does not extend beyond the rear service area into the yard (Source – Justin Hewitt)

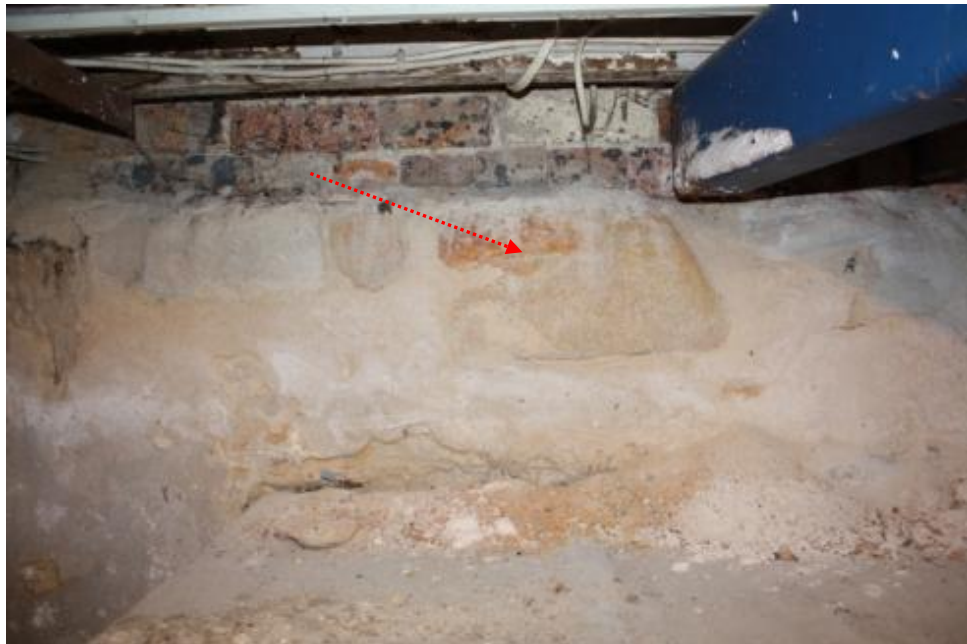
Figure 12

This image shows the cellar of 95 George Street looking east towards George Street. Note the sandstone foundations (highlighted in red) abutting the sand stock bricks of the 1867 reconstruction (Source – Justin Hewitt)

It is evident that the three existing cellars were constructed in a single phase. All three cellars share common walls made of sandstone. These are most evident in the cellar of 95 George Street which is, at present, not being utilised.

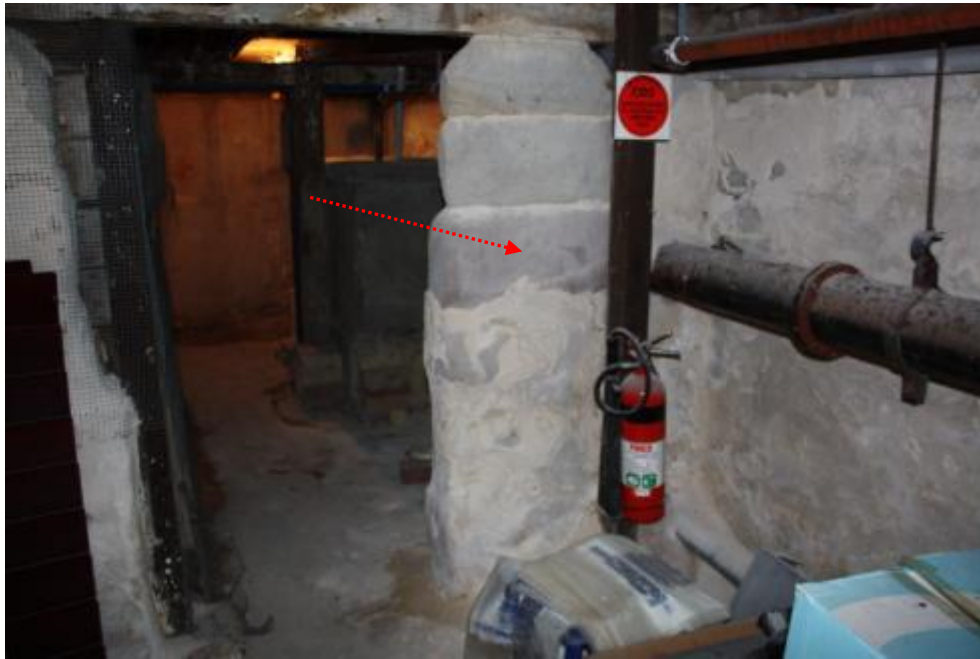
Figure 13

This image shows the cellar of 95 George Street looking east towards George Street. Note the sandstone dividing wall (highlighted in red) abutting a common wall with 97 George Street to the south (*Source – Justin Hewitt*)

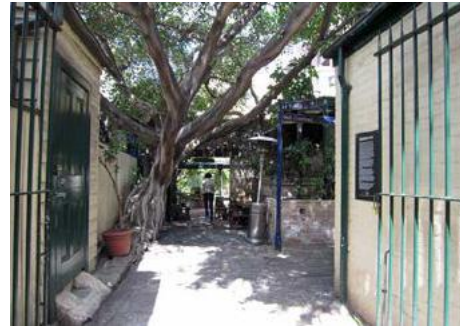
Figure 15

Greenway Lane in 2012, with the mature fig growing against the rear wall of No 97, 2012.

The stone retaining wall to the rear yards may date from the c1840s period of construction by Gannon and is of exceptional significance. The roots of the fig tree are growing into this wall and causing some damage to it (refer to Figure 35).

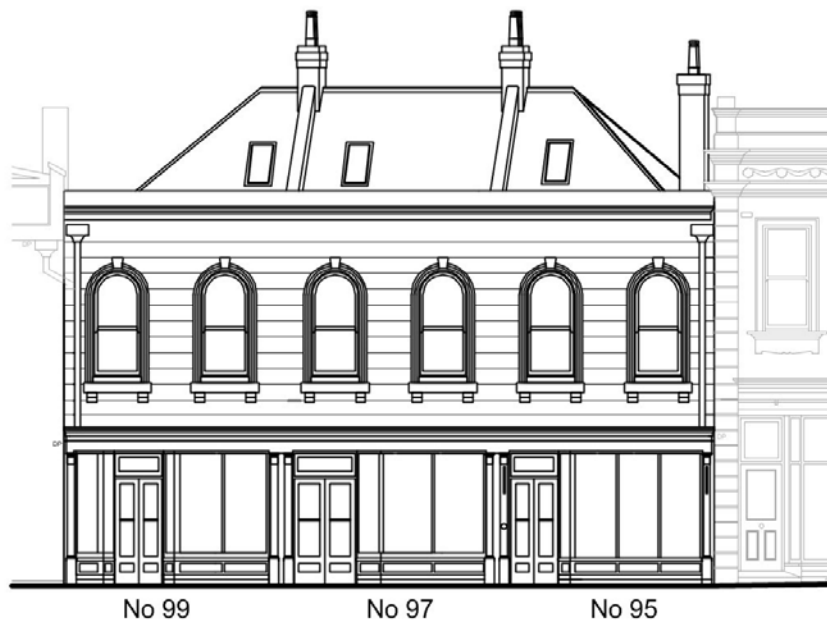
Figure 16

East elevation of 95-99 George Street. Adapted by Orwell & Peter Phillips from SHFA Drawing No 500-AR-1000.

The George Street facade is of rendered masonry, with Italianate stucco decoration, and appears largely original. The facade has a horizontal plain parapet and moulded cornice, behind which can be seen the top of the roof and rendered party walls, surmounted by chimneys with faceted terracotta pots. The plain stucco band below the cornice has painted signage. The wall below the cornice retains traces of ashlar coursing, and arched window openings have heavily moulded stucco architraves and projecting sills supported on simple stucco brackets. The timber framed shopfronts also appear to incorporate a good deal of original fabric, although documentary and physical evidence indicates some reconstruction and repair. They have bolection moulded panels beneath the shop windows, splayed window returns to the entrance door which is set back from the street, and painted signage on the glass. The awning was constructed in 1985, reproducing detailing from the original shopfront pilasters. All of the rooflights are of recent construction, although those at Nos 95 and 97 appear to be replacements of original elements. The front rooflight at No 99 was introduced in 2006.

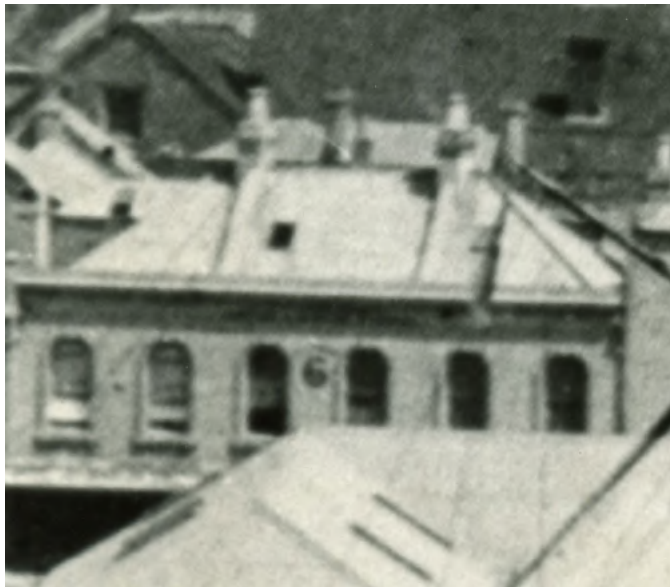
Figure 17

Detail from Panorama, 1879: The buildings have a street awning, and rooflights are visible at Nos 95 and 97. Source: SHFA Image NO 33949_CQ_9.3.

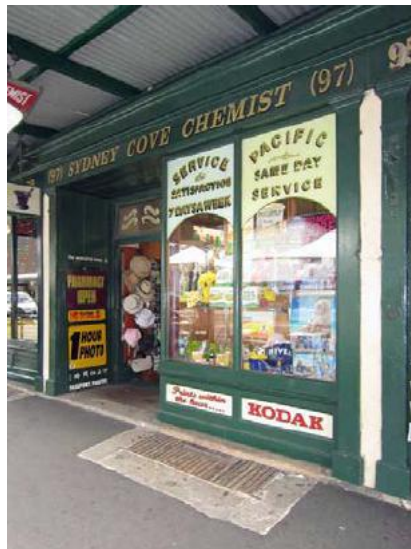
Figure 19

Detail of the shopfront at No 97, 2012

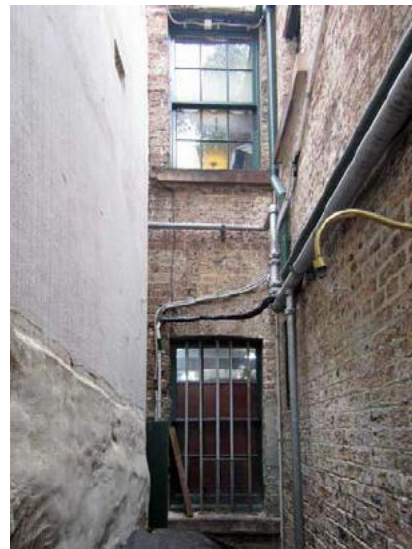
Figure 20

Detail of original rear windows at No 95, 2012

The rear elevation has undergone rather more changes, with the additions and alterations to rear wings between 1978 and 2006. The rear rooflights to Nos 95 and 99 appear to have been added after 1973. The original rear walls are face brick, and walls of the extensions (except for the 2006 works at No 99) also in face brick, either modern sandstocks or second-hand bricks; only the chimneys and parapet to party walls are rendered and painted. There is little decorative detail on the rear facades except for brick arches and plain projecting stone sills to windows. Most rear windows on the main section are original or reconstructed; those to the rear wings are also timber framed but of recent origin. Fences are timber.

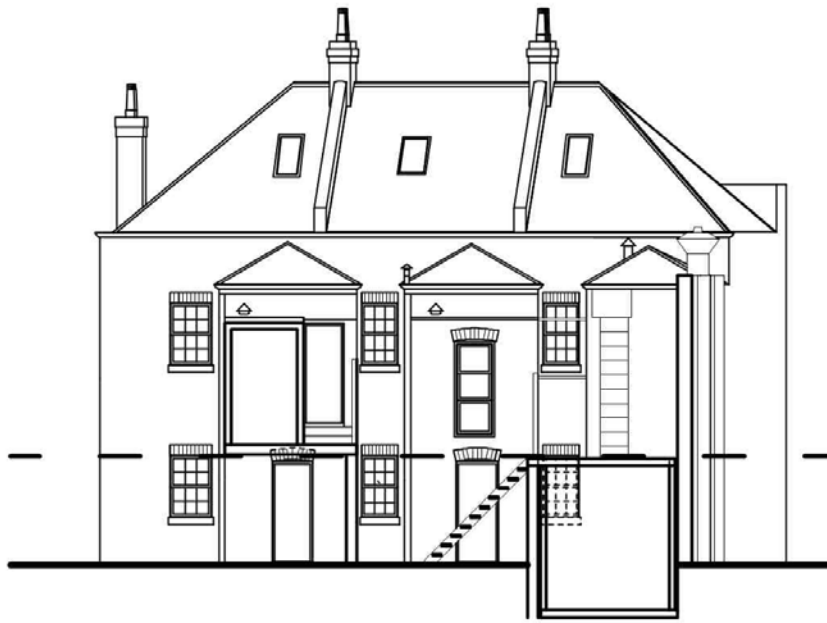
Figure 21

West elevation of 95-99 George Street. Adapted by Orwell & Peter Phillips from SHFA Drawing No 500-AR-1000.

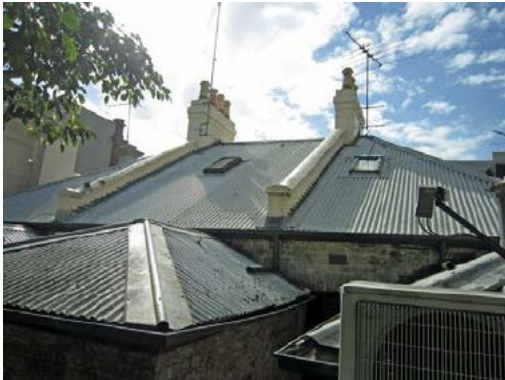
Figure 22

Main section and original rear wings of 95-99 George Street, from the plant area at No 99, 2012.

The roofs have been resheeted with corrugated galvanised steel in single lengths. A number of services, including a satellite dish at No 97, television aerials, and air-conditioning units are visible above the roof, as are the kitchen exhaust and plant area at the rear of No 99.

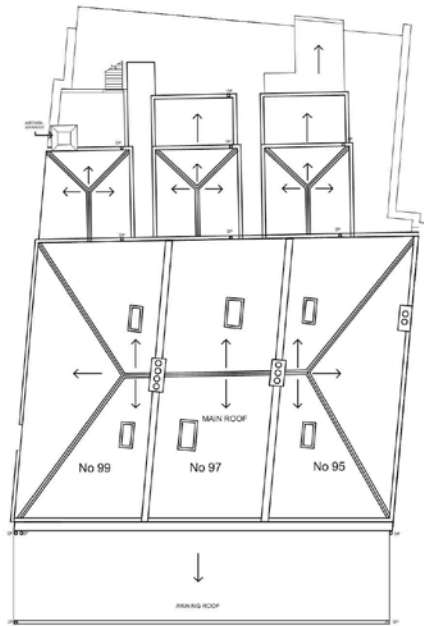
Figure 24

Roof plan of 95-99 George Street. Adapted by Orwell & Peter Phillips from SHFA Drawing No 500-AR-1000.

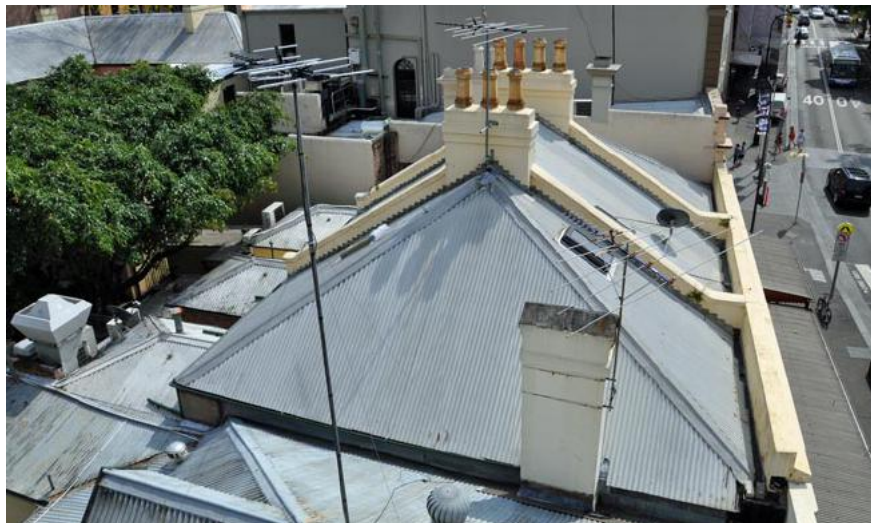
Figure 25

Roofscape of 95-99 George Street, photographed from scaffolding during roof repairs at No 103, 2012.

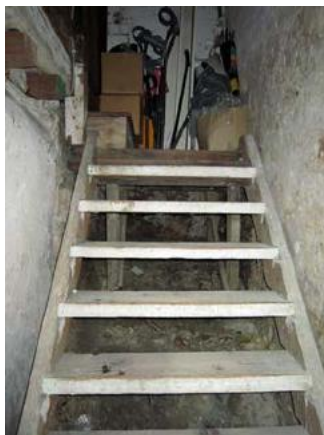
Figure 27

Cellar steps at No 97, in their original configuration which led to an external access opening, 2012.

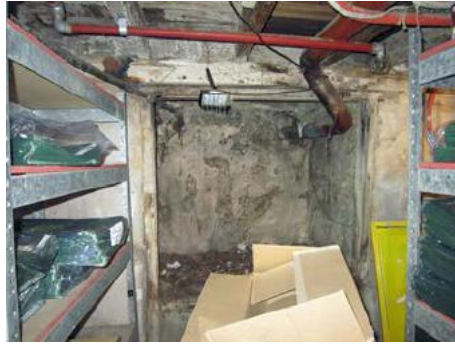
Figure 29

The eastern end of the cellar to No 97, showing access opening to George Street, and underside of timber floor (including repaired section), 2012.

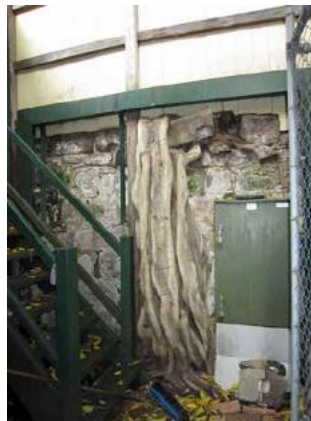
Figure 37

Retaining wall at rear of No 97, showing timber stair to Greenway Lane and roots of ?self-sown fig, 2012.

The rear sections are largely modernised in all three properties. In the rear yards of Nos 95 and 97 (at George Street level, one floor below Greenway Lane at the rear) the stone retaining wall remains, with a small area of stone paving in the north-west corner of No 95 – the remainder of the paving is modern brick. At No 99 this area is now occupied with a kitchen, the flat roof of which gives access to Greenway Lane via a new steel stair covered with a glass roof.

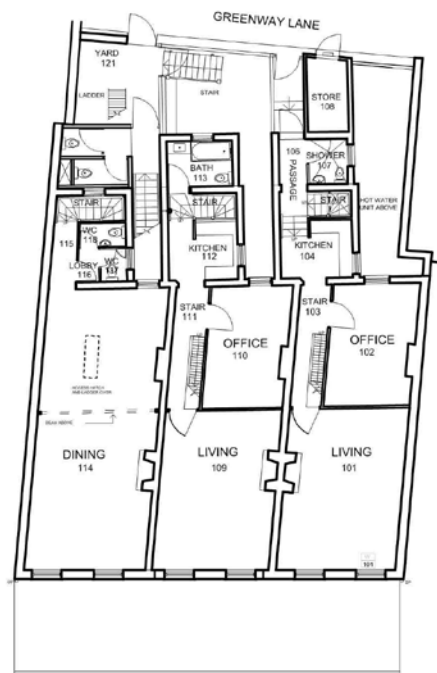
Figure 38

First floor plan of 95-99 George Street. Adapted by Orwell & Peter Phillips from SHFA Drawing No 500-AR-1000.

The first floors of Nos 95 and 97 retain their early configuration of front parlour and rear bedroom. New kitchens have been inserted into the area at the top of the main stair, with a bathroom beyond towards the rear. In No 99 the internal partitions have been removed to provide a single large space.

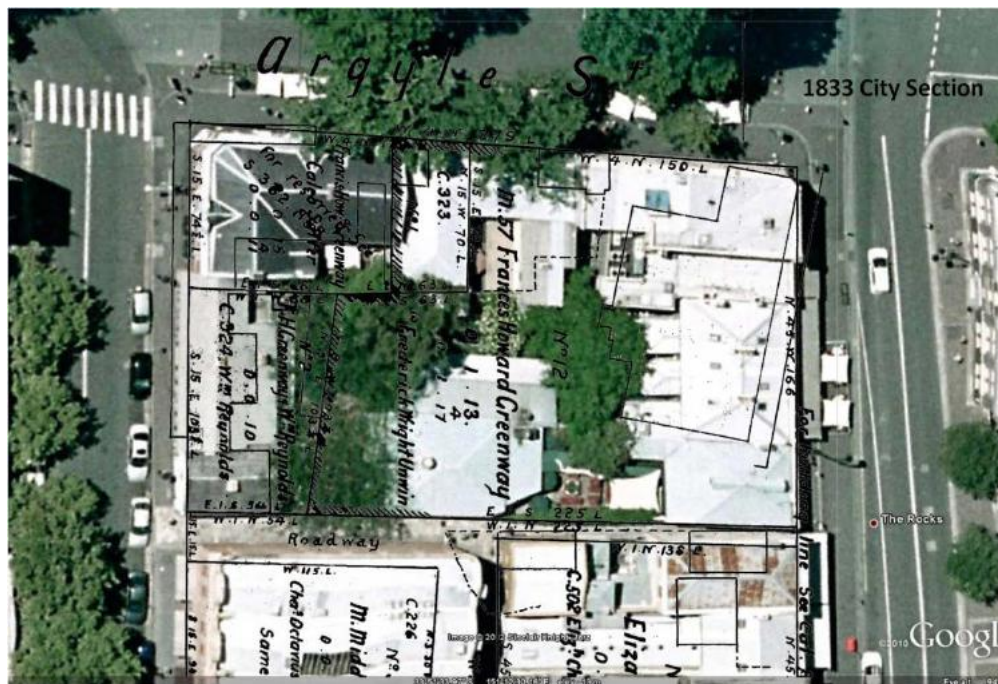
Figure 57

The location of these structures represented in the image above in relation to the current structures is indicated by the following overlay of Russell's map.

By the 1840s the block was fully built over, with many of the structures built at this time or their successors remaining today. The layout of buildings with interior laneways and yards was once common to many parts of Sydney, but while other areas of central Sydney changed enormously during the boom decades of the 1860s-1880s, this block remained highly intact. Google Map 2012 overlaid with City Section Survey Plans 1833 Section 84 City of Sydney Archives

The site area of 95-99 George Street is located within the area on which the first and second houses for the Assistant Surgeon were constructed. The house was constructed soon after settlement in 1788 and then reconstructed c.1796 after the original building fell into disrepair. Historical maps (refer to Figure 57) show that some or part of the original house fell within the boundaries of 95-99 George Street. If present, remains are more likely to be evident towards the eastern boundary and footpath where the geography provides a flatter surface.

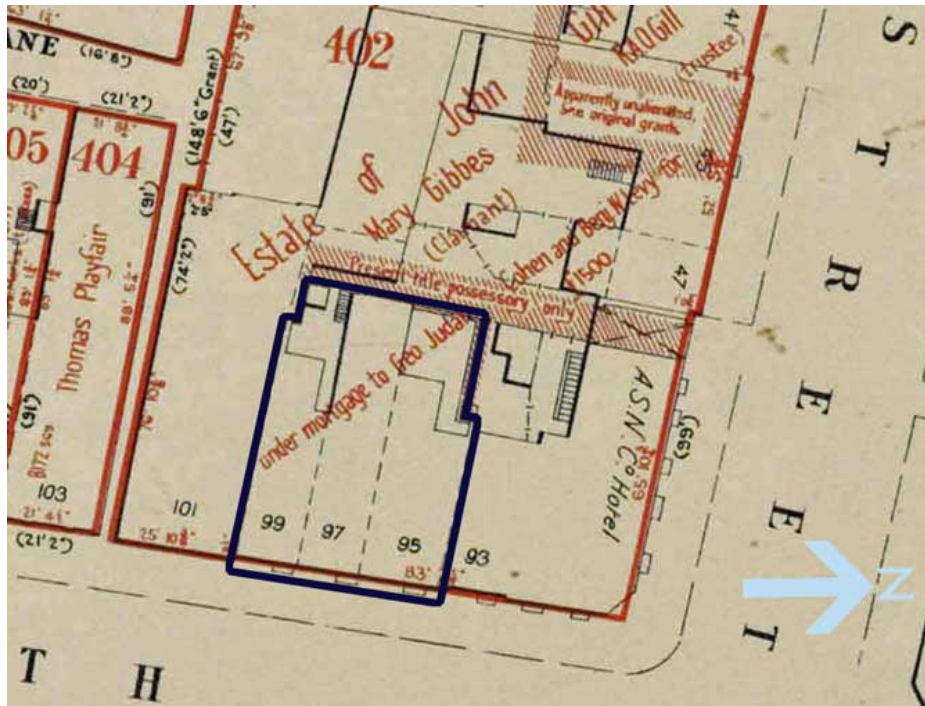
Figure 90

Detail from Darling Harbour Resumptions plan 1900. The present lease boundary is overlaid. Source: City of Sydney Archives.

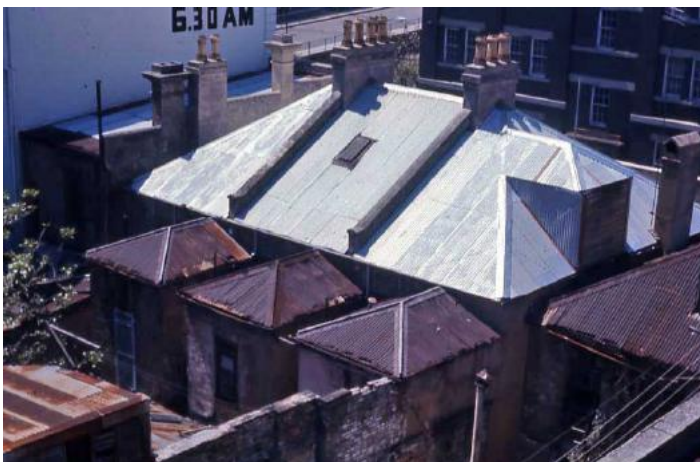
Figure 95

Photograph of the rear of 93-101 George Street taken in 1973. Note the attic projection to No 99 and the sole rooflight at No 97. Source: SHFA Image No 154274 HP 24.

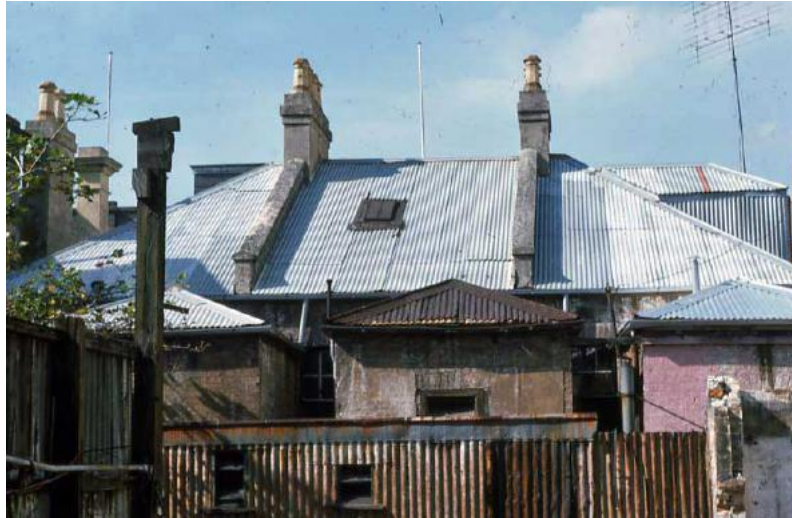
Figure 96

Photograph of the rear of 95-99 George Street taken in 1975. There is still what appears to be a corrugated iron shed at the rear of No 97. Source: SHFA Image No 154289 HP 44.

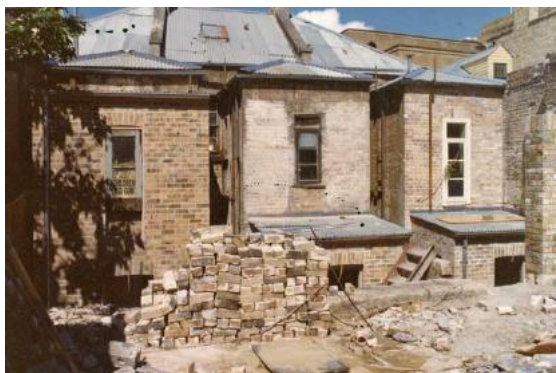
Figure 98

Rear wings of 95-99 George Street under construction, 1978. The outbuilding at the rear has been demolished. Source: SHFA Image No 41154 GEM 95.15.

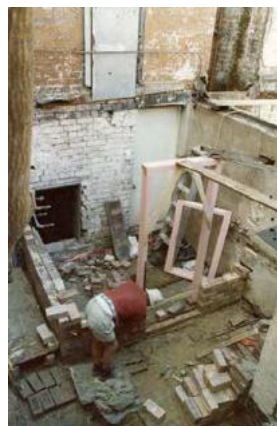
Figure 99

Rear wing of No 95 under construction. Note the evidence of a former single storey structure, and the former entrance to the cellar which is now internal in all properties. Source: SHFA Image No 41228 GEM 95.30

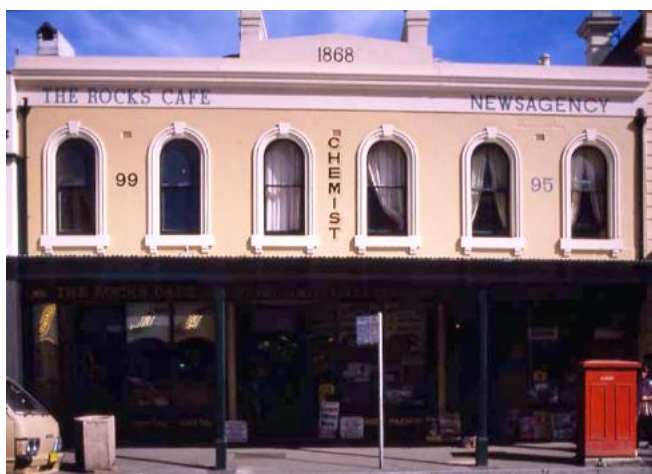
Figure 103

The facade of 95-99 George Street taken in 1985, showing the reconstructed awning and new pediment (since removed) and painted signage. Compare with Figures 18 and 102. Source: SHFA Image No 15143 HP 521.

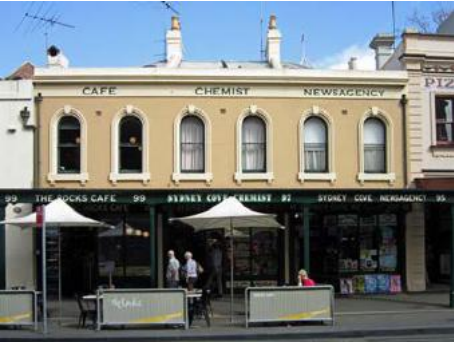
</div> <div>Figure 109 George Street facade of Nos 95-99</div>	<p>The present buildings were constructed in 1867. The rear wings were altered and extended in 1978, and the street awning was reconstructed in 1985, both by the Authority. No 97 was fitted out as a pharmacy in 1983. The garbage room at the rear of No 95 was constructed in 1989, and major alterations at No 99 were undertaken in 2006.</p>	Exceptional	Good	<p>The place should be retained and conserved, and used for commercial and preferably associated residential purposes. Only uses or licences which respect the heritage values of the place should be approved. Future works at the place should be designed to interpret the history of the property, especially at the rear, in the context of the design principles for the entire block bounded by George, Argyle and Harrington Streets and Suez Canal. Refer to Part 2 and Appendix B.</p>

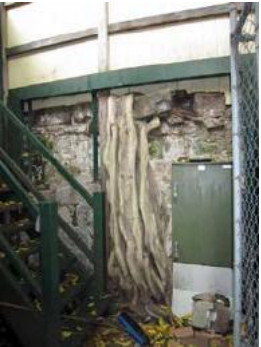
The stone retaining wall at the rear of the property may date from the Gannon period of the 1840s	Exceptional	Fair to Good	The wall should be inspected to determine what damage is being caused by the roots of the fig tree, and if removal of the tree is necessary to avoid further damage, the wall should be repaired following removal, using matching stone and a lime-based mortar that is weaker than the stone.
<p>Figure 111</p> <p>Stone retaining wall and timber fence and stairs at the rear of No 97, with roots of fig tree in Greenway Lane (2012)</p>

- Inspect stone wall at the rear of No 97 to ascertain whether it has been or is likely to be damaged if the fig tree remains in place.
- If it is decided that the actual or potential damage to the wall warrants removal of the tree, remove the tree under the supervision of an experienced professional arborist and undertake conservation and repair works to the wall.
