TENEMENTS

117-117A Gloucester Street, The Rocks

CONSERVATION MANAGEMENT PLAN

Prepared by Hector Abrahams Architects Pty Ltd

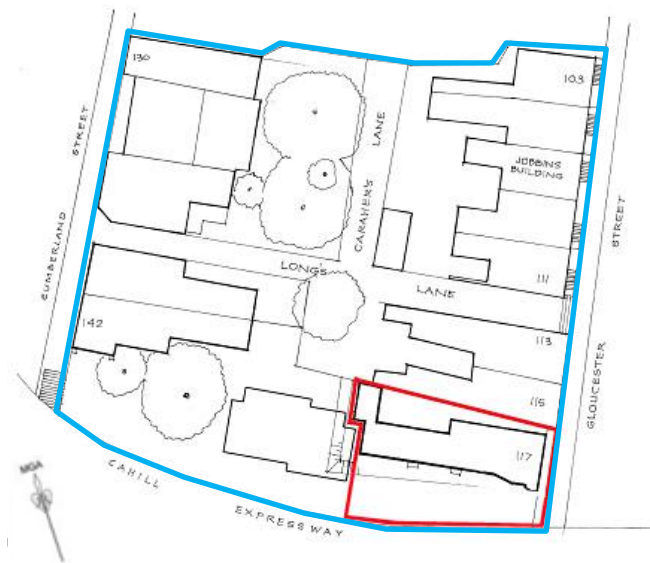
Figure 2: Plan showing the study area for 117-117A Gloucester Street (outlined in red) and its location in the Longs Lane precinct in The Rocks (outlined in blue). Source: CLSP

The study area includes at the Tenements at 117-117A Gloucester Street and to it south a driveway, parking and street access for vehicles to the neighbouring properties at 1-3 Longs Lane. The study area (shown in red) is bounded to the east by Gloucester Street, to the north by the terrace at 115 Gloucester Street, to the south by the Cahill Expressway, and to the west by the two residences at 1-3 Longs Lane. (see Figure 2).

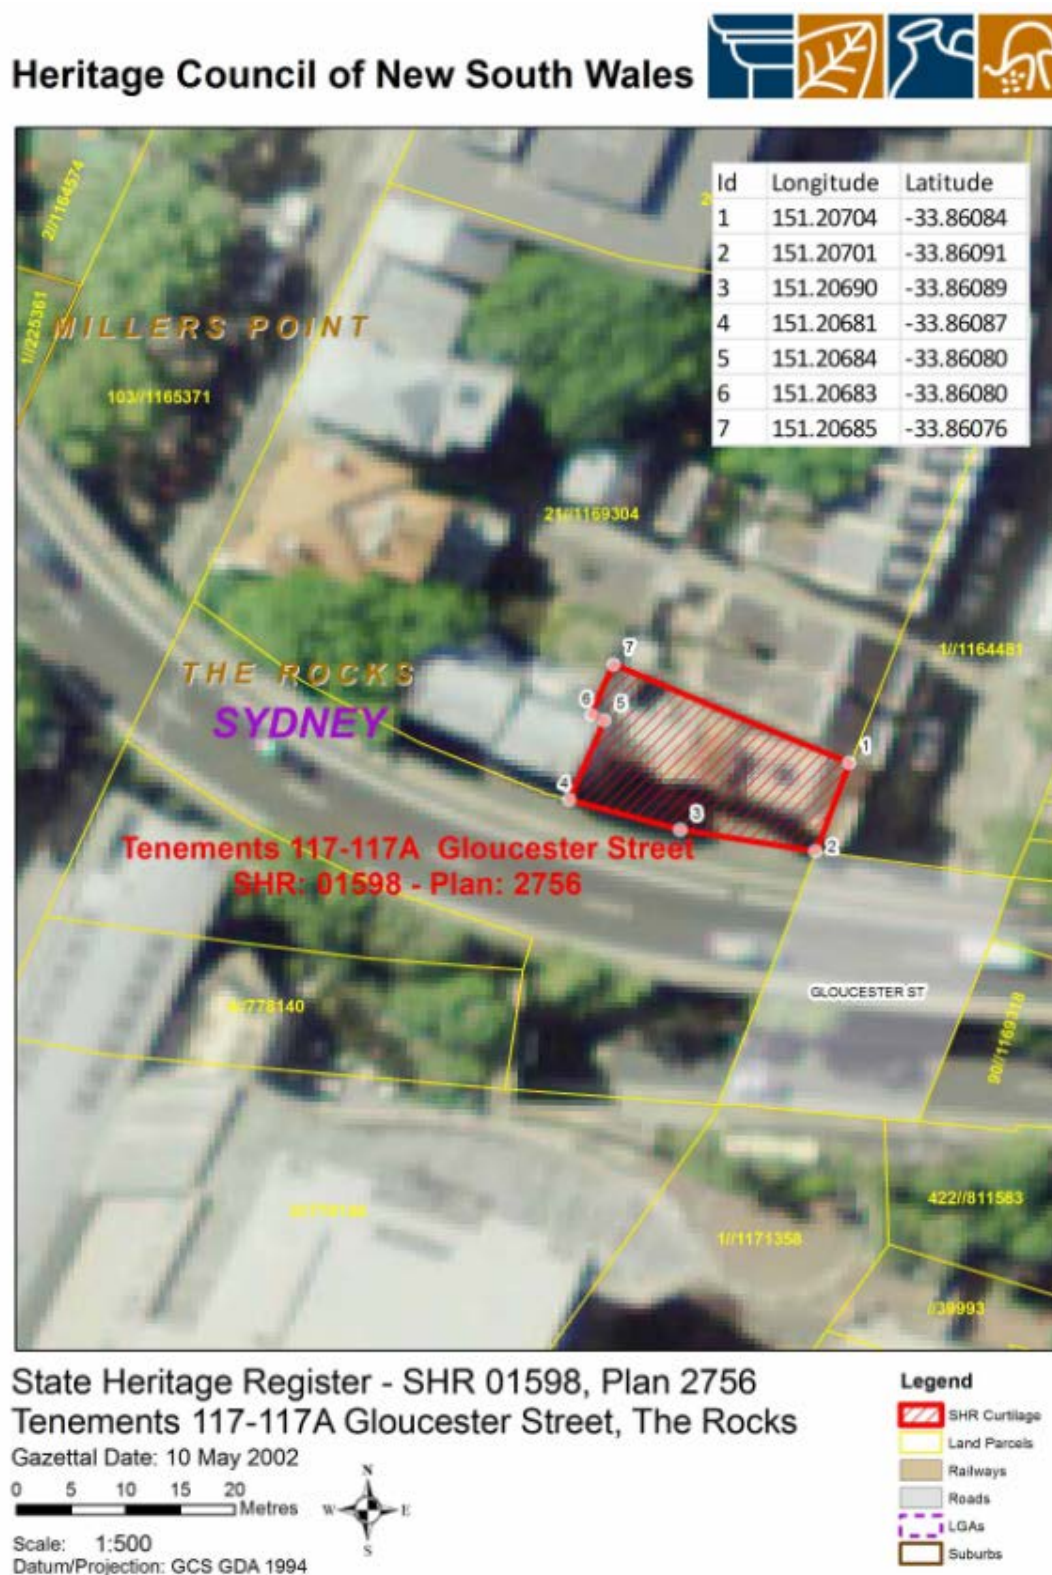
Figure 4: Current SHR heritage listing boundary Plan 2756 Source: Heritage Division, Office of Environment and Heritage State Heritage Register database.

The current SHR heritage listing boundary Plan 2756 is shown in Figure 4. The property description is Part of Lot 21 DP 1169304. The recommended SHR heritage listing boundary is shown in Section 4.3, Figure 78 matches that of the current SHR heritage listing boundary in Figure 4.

The recommended SHR heritage listing boundary for the tenements at 117-117A Gloucester Street is the northern side boundary to 115 Gloucester Street, the front boundary onto Gloucester Street to the east, extending south to the wall of the Cahill Expressway, and the rear boundary to the west to 1-3 Longs Lane duplex (shown bounded by the red line in Figure 99). The recommended SHR heritage boundary agrees with the current SHR heritage listing boundary Plan 2756 shown in Figure 4.

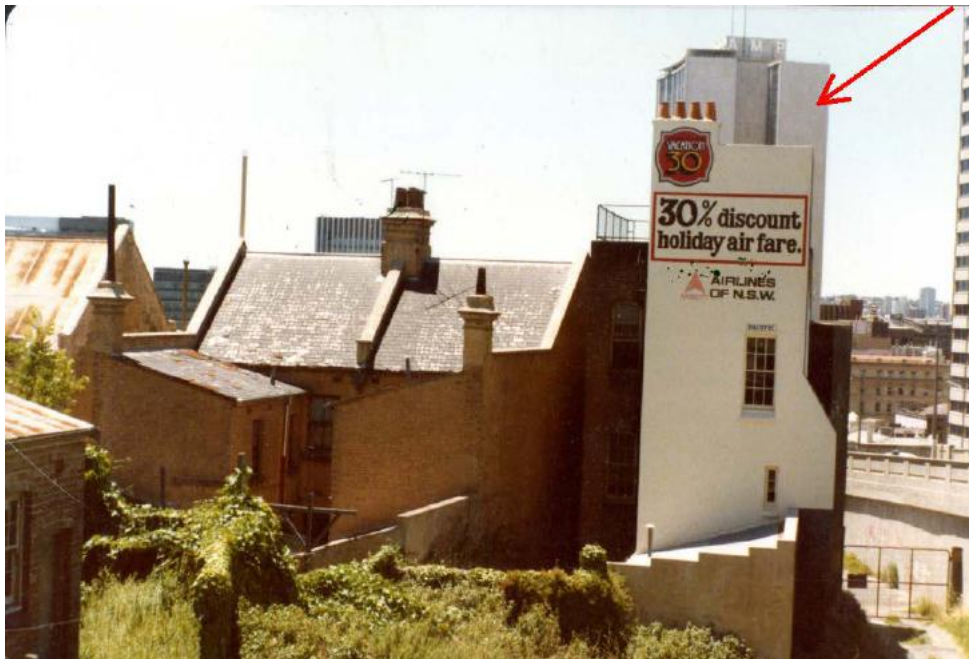
Figure 14: Western elevation of 117-117A Gloucester Street (at right, indicated by the red arrow), 1978. The three-storey façade was the site of prominent advertising following the construction of the Cahill Expressway in 1958. Render was applied to this façade about that time in order to facilitate painted signage. Source: Sydney Harbour Foreshore Authority 48870 GLM24

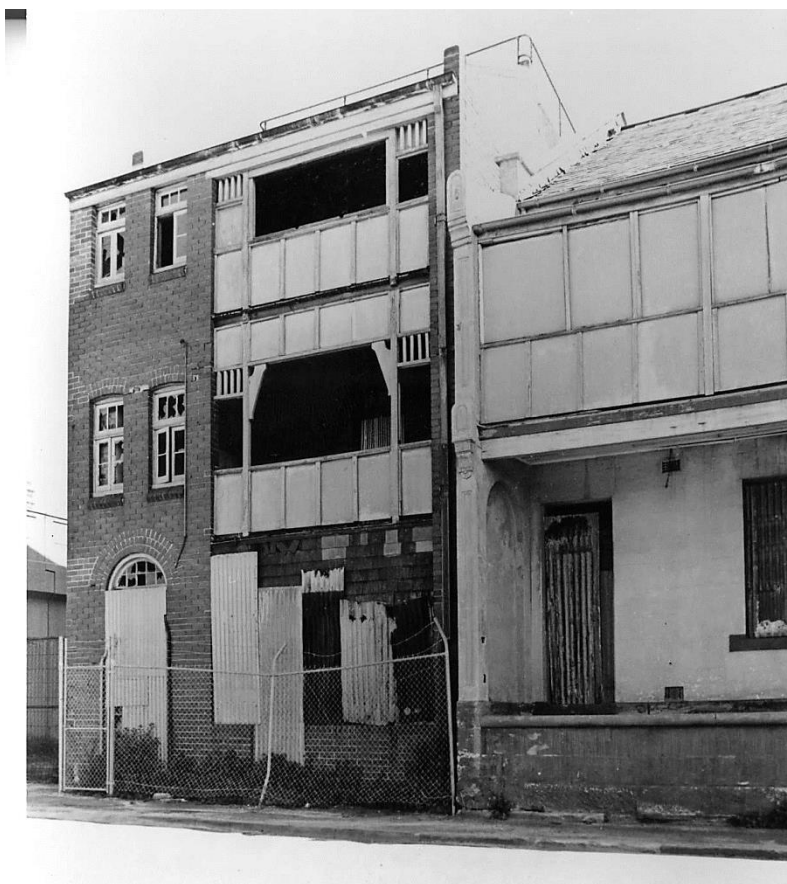
Figure 16: 117-117A Gloucester Street (at left), c1970. The ground floor verandah was enclosed with sheets of corrugated iron and the front door of the house was boarded over. A mesh fence surrounded the site. See for the present appearance of the building. Source: Sydney Harbour Foreshore Authority 31820 GL49

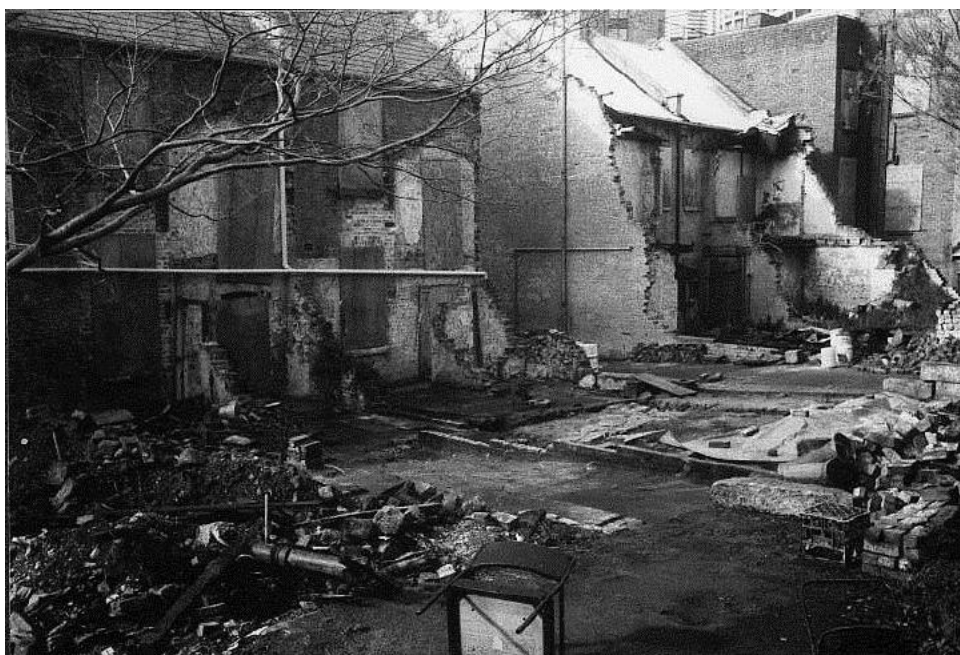
Figure 18: View across the rear yards 107-111 Gloucester Street (at left), 113-115 Gloucester Street (centre), to 117-117A Gloucester Street far right, c1992-3. The windows of 117-117A Gloucester Street were boarded up as were the other buildings in the precinct, the rear wing of No. 117-117A was not demolished and rebuilt. Source: Clive Lucas Stapleton & Partners

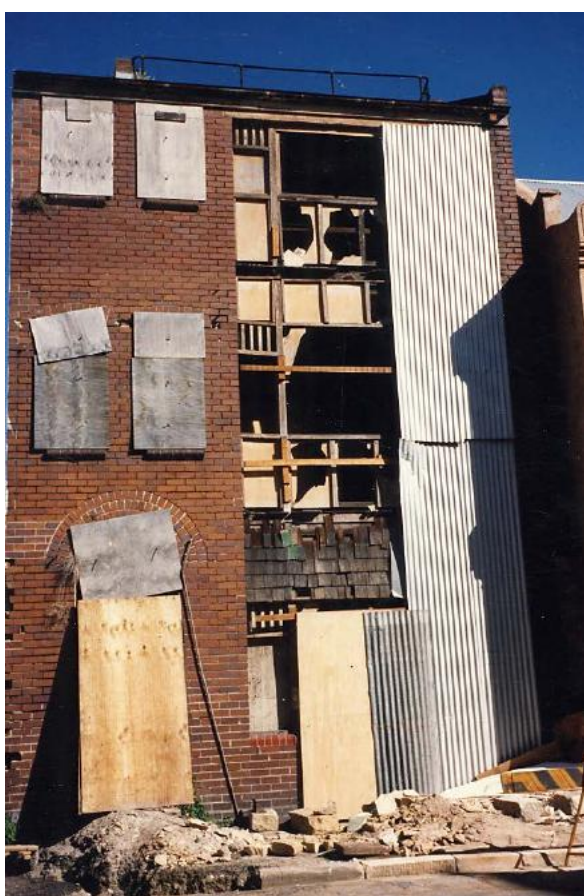
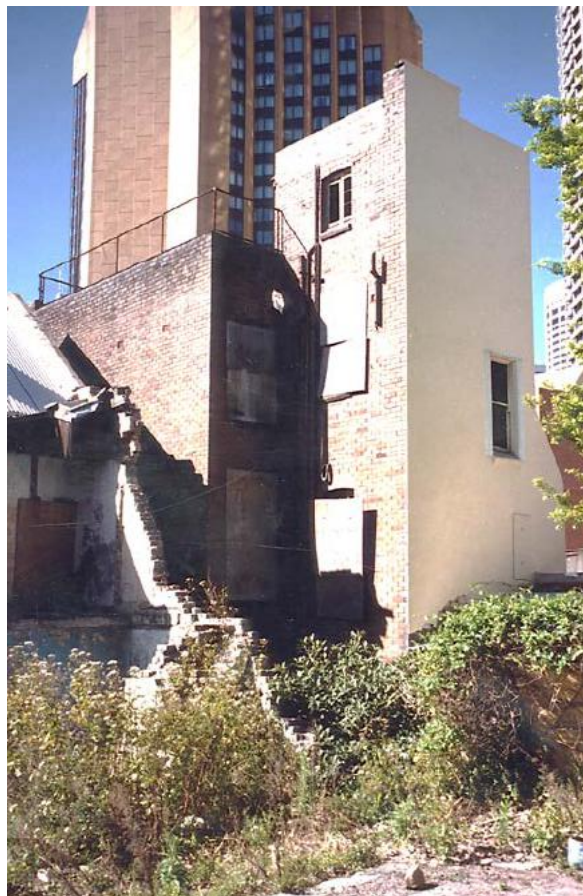
Figure 19: 117-117A Gloucester Street, Front (East) and Rear (West) Elevations c1993. Source: Sydney Harbour Foreshore Authority

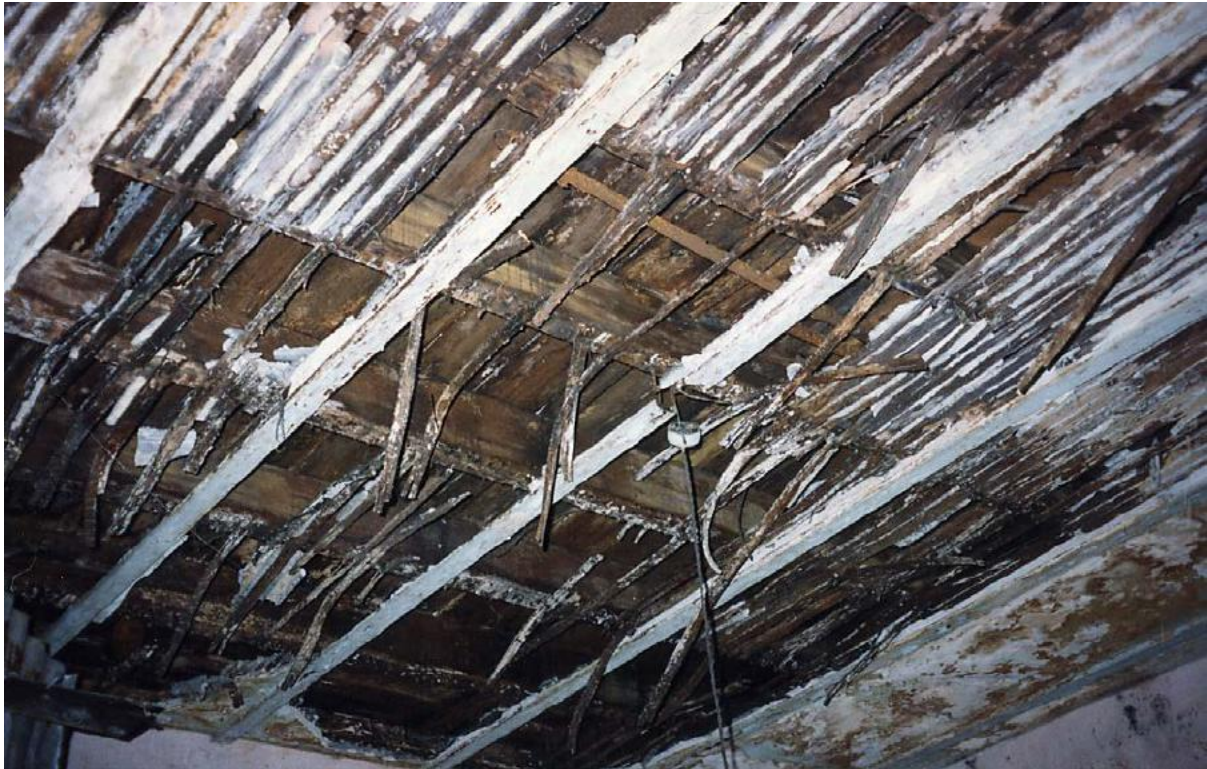
Figure 22: 117-117A Gloucester Street, Remains of lathe and plaster ceiling and underside floor joinery c1993. Source: Sydney Harbour Foreshore Authority

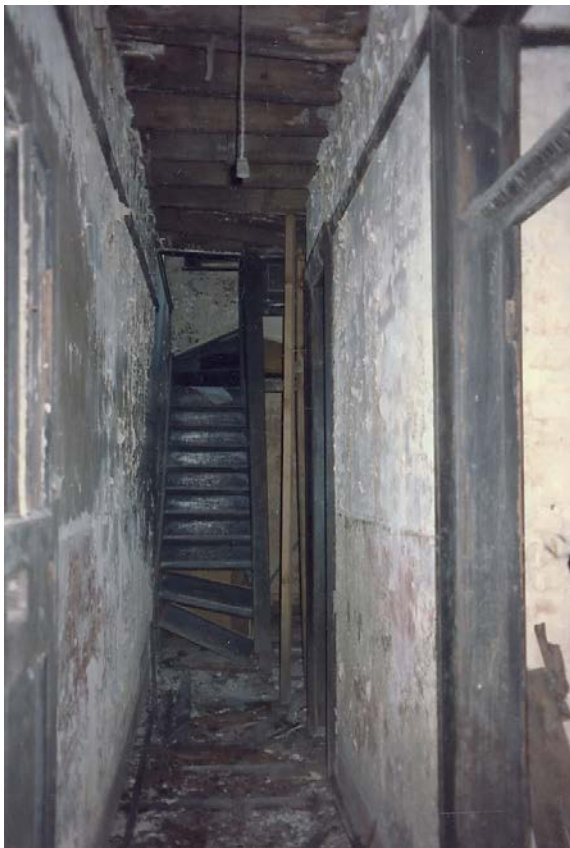
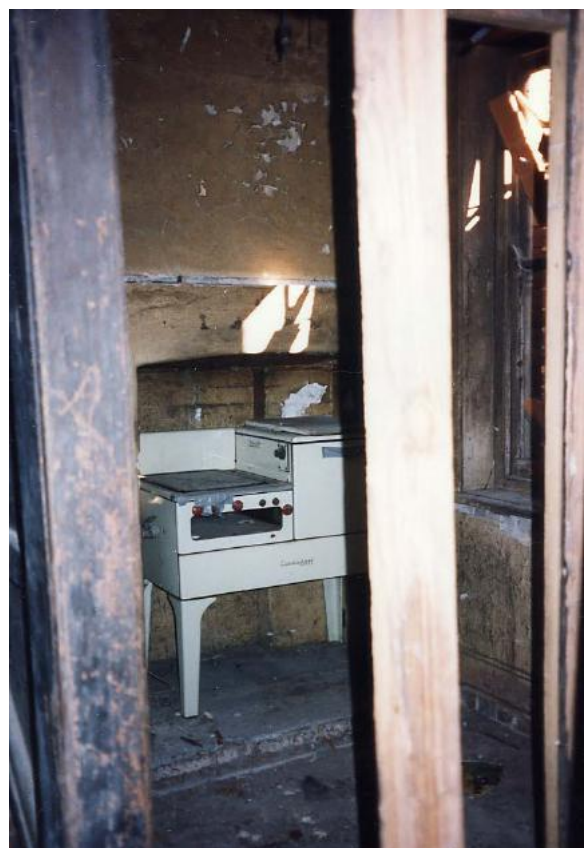
Figure 23: 117-117A Gloucester Street, Entry hall and staircase remains and kitchen, c1993. Source: Sydney Harbour Foreshore Authority

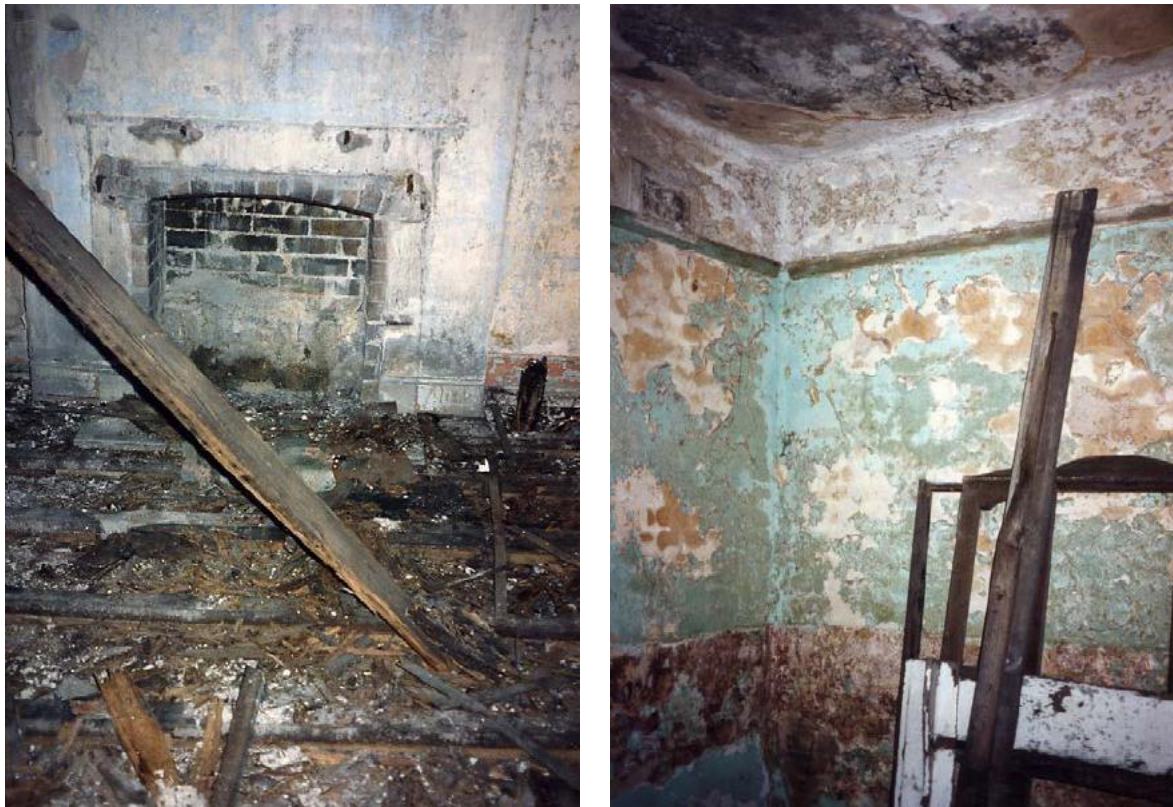
Figure 24: 117-117A Gloucester Street, Remains of interiors with fireplace, plaster ceiling and walls and paint scheme, c1993. Source: Sydney Harbour Foreshore Authority

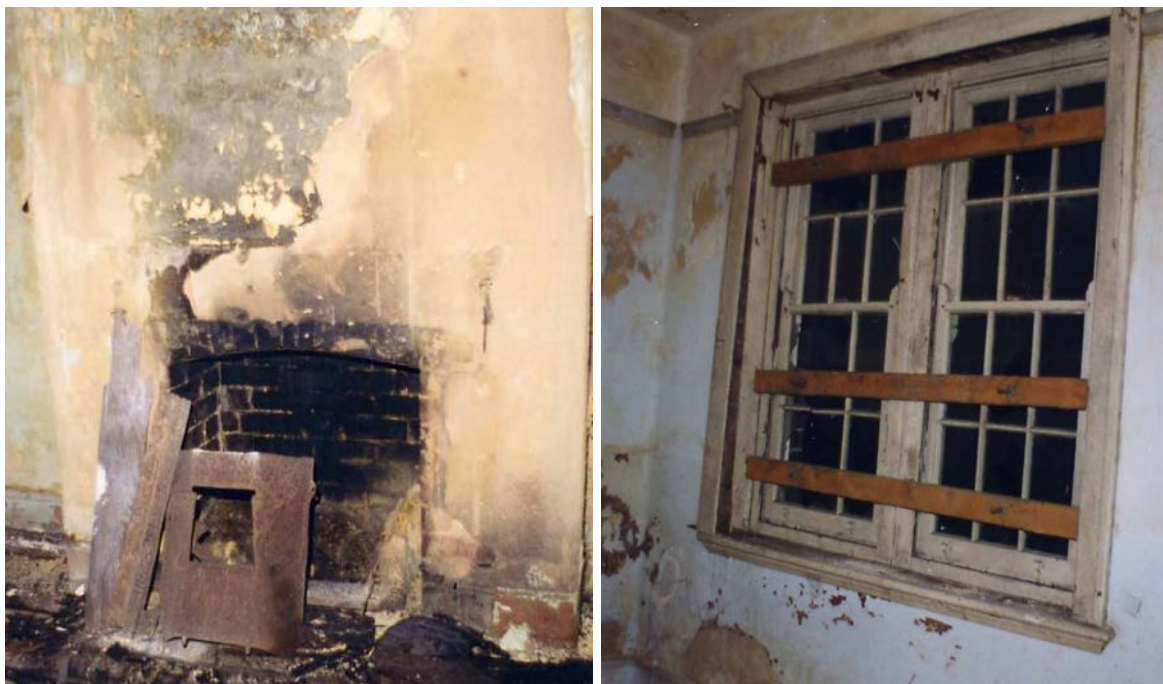
Figure 25: 117-117A Gloucester Street. Dilapidation photos of first floor living room and front room windows, c1993. Source: Sydney Harbour Foreshore Authority

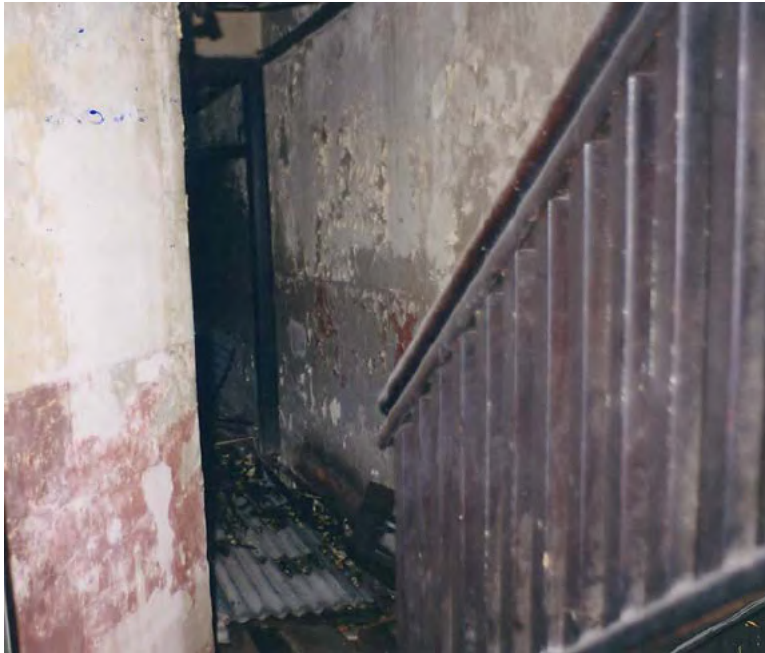
Figure 26: 117-117A Gloucester Street. Dilapidation photos of entry hall and staircase, c1993.
Source: Sydney Harbour Foreshore Authority

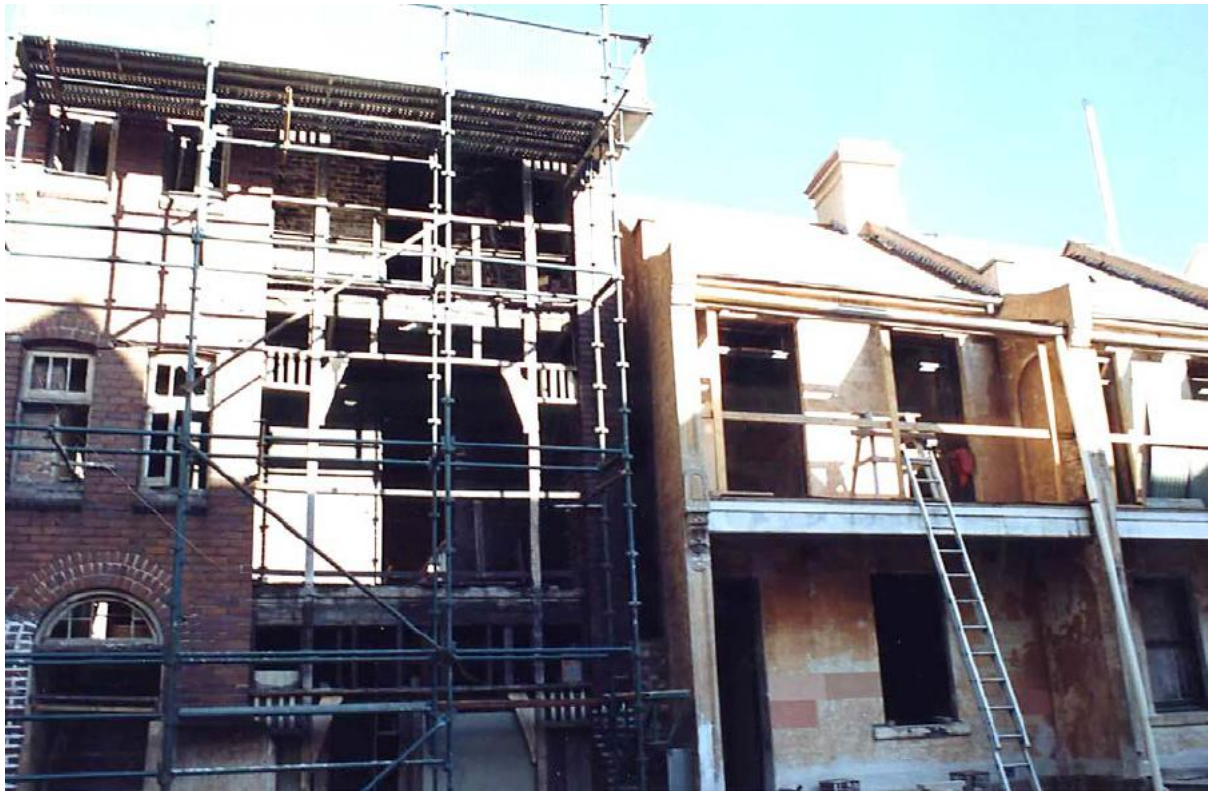
Figure 27: 117-117A Gloucester Street. Scaffolding and conservation works underway in 1995.
Source: Sydney Harbour Foreshore Authority

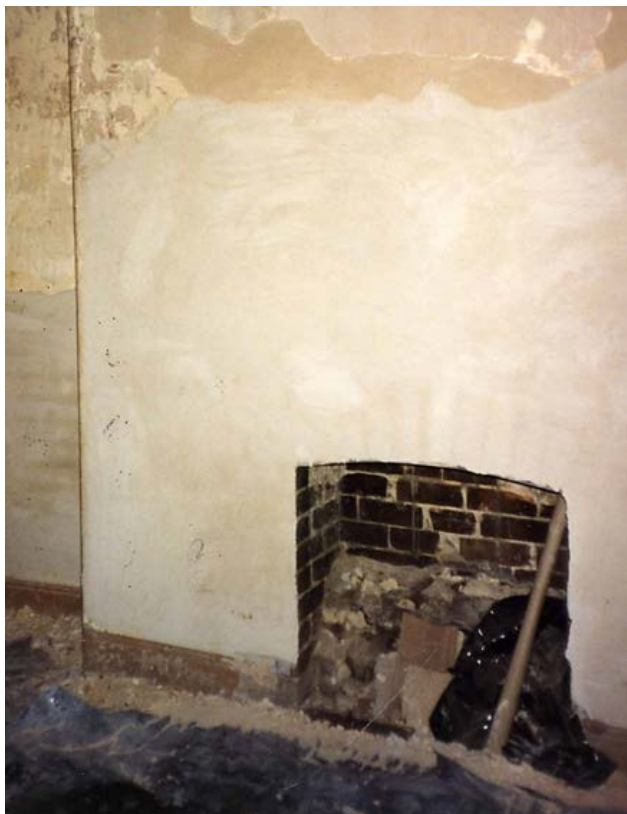
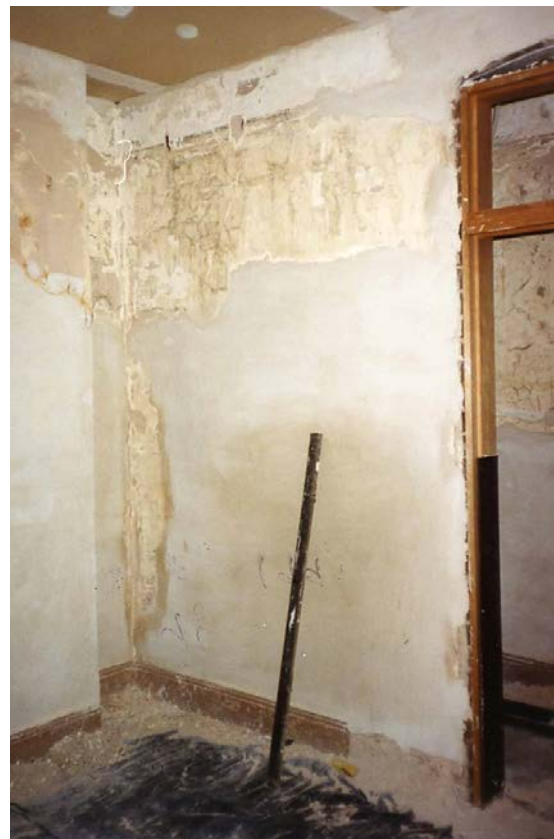
Figure 28: 117-117A Gloucester Street. Replastered walls and chimney breast and repaired door joinery, 1995. Source: Sydney Harbour Foreshore Authority

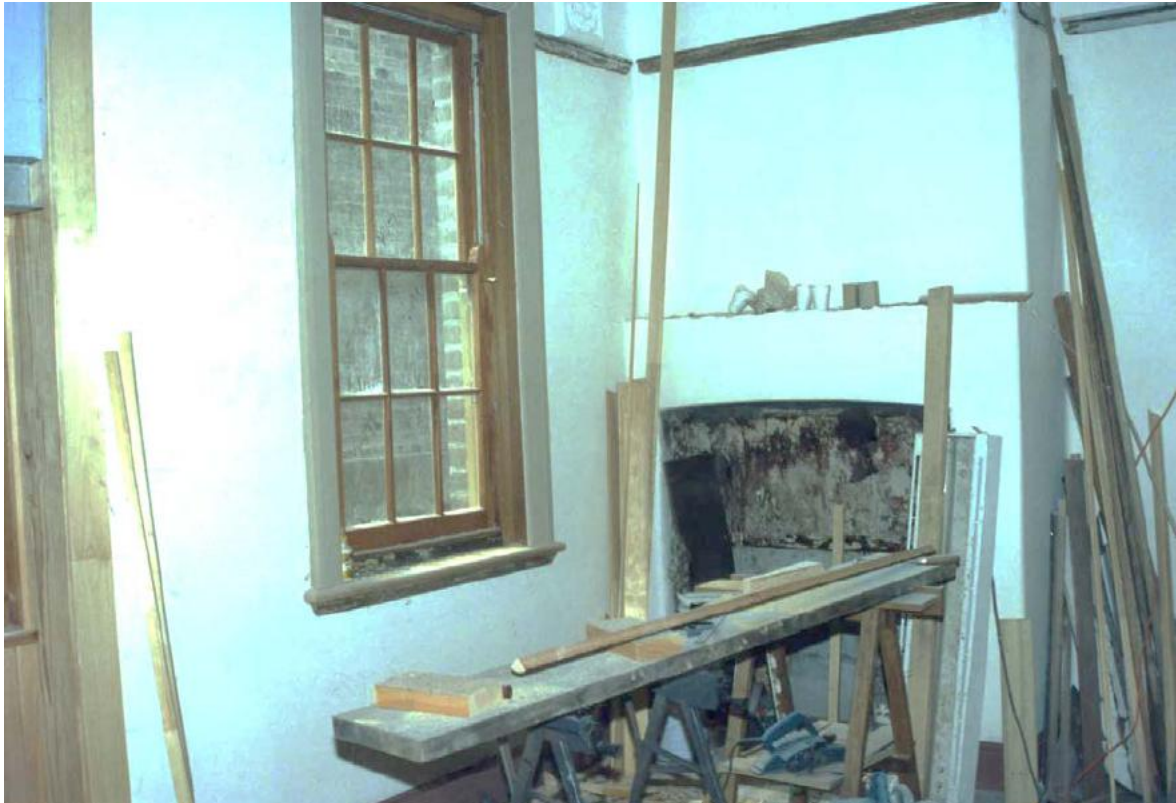
Figure 29: 117-117A Gloucester Street. Replastered walls and chimney breast and repaired window joinery, ground floor rear kitchen, 1995. Source: Sydney Harbour Foreshore Authority

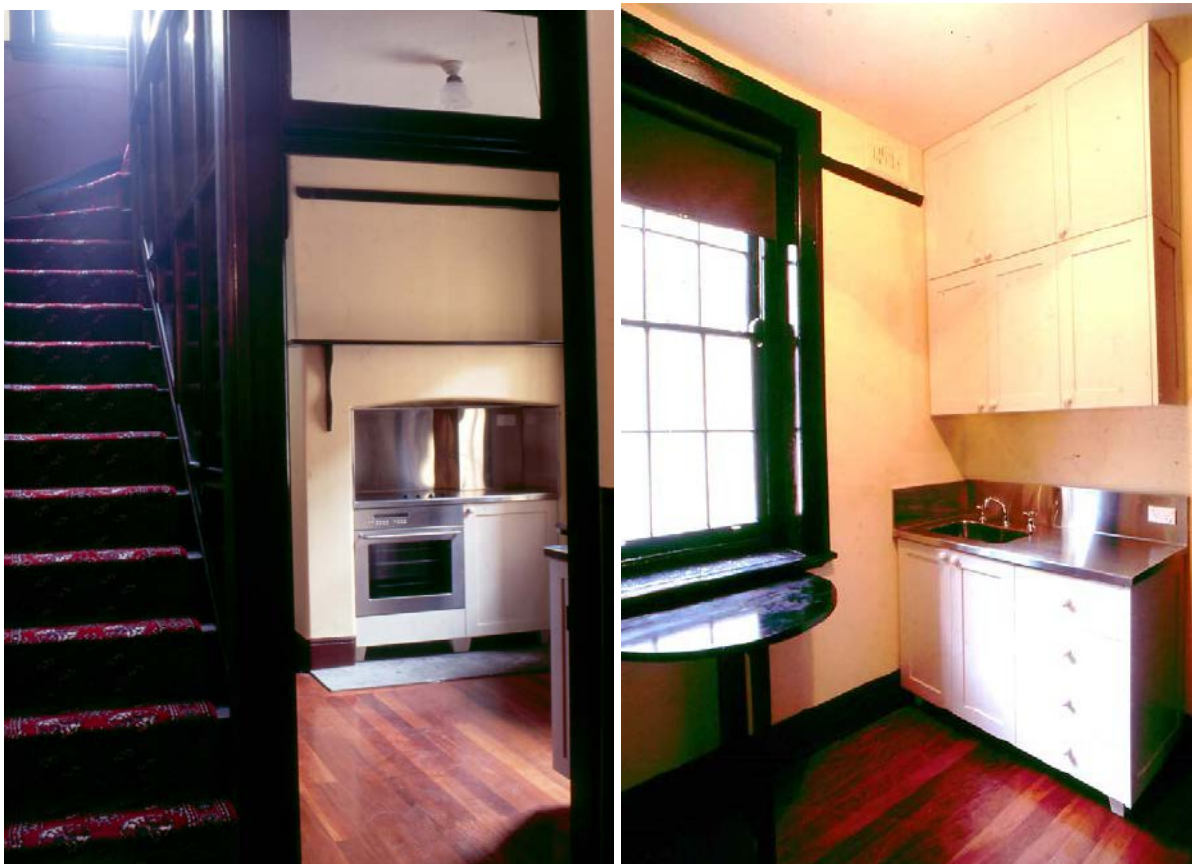
Figure 30: 117-117A Gloucester Street. Kitchens after conservation works, 1996. Source: Sydney Harbour Foreshore Authority

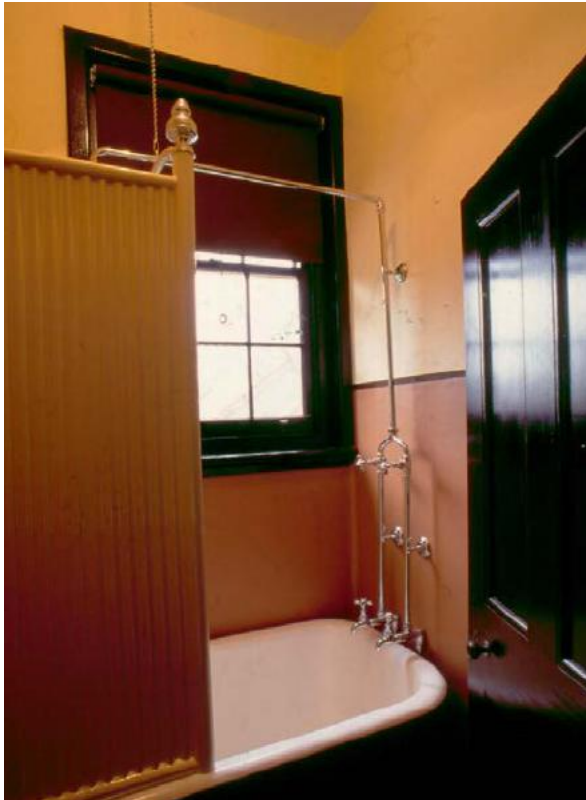
Figure 31: 117-117A Gloucester Street. Bathroom after conservation works, 1996. Source: Sydney Harbour Foreshore Authority

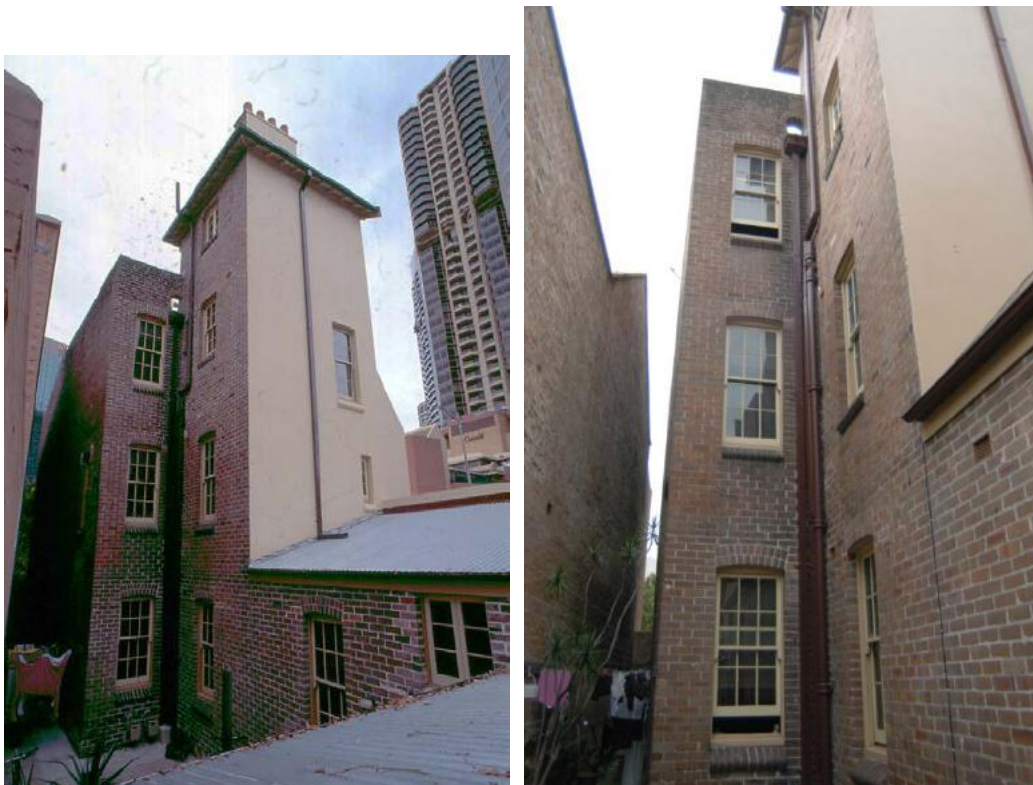
Figure 32: 117-117A Gloucester Street after conservation showing the restored window sashes in 1996 and 2007. Source: Sydney Harbour Foreshore Authority

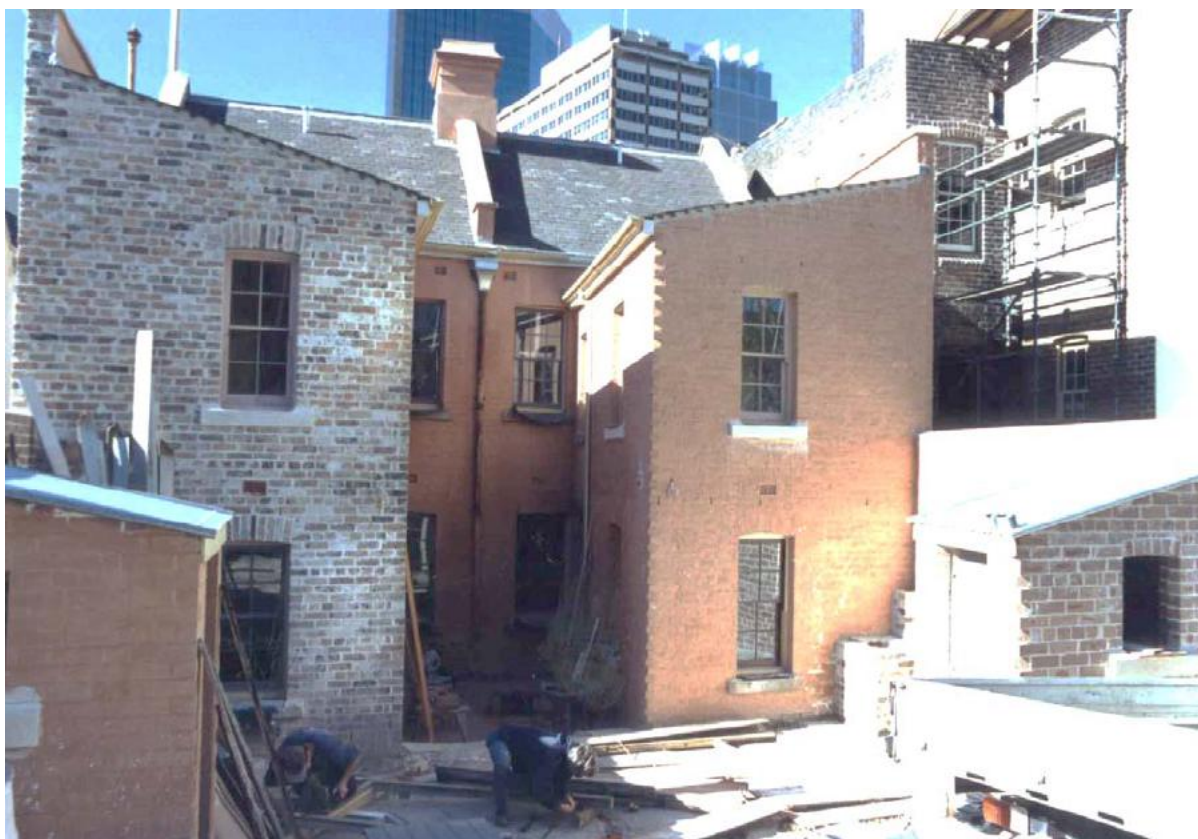
Figure 33: Rear of 113-115 and 117-117A Gloucester Street during conservation works, 1995.
Source: Sydney Harbour Foreshore Authority

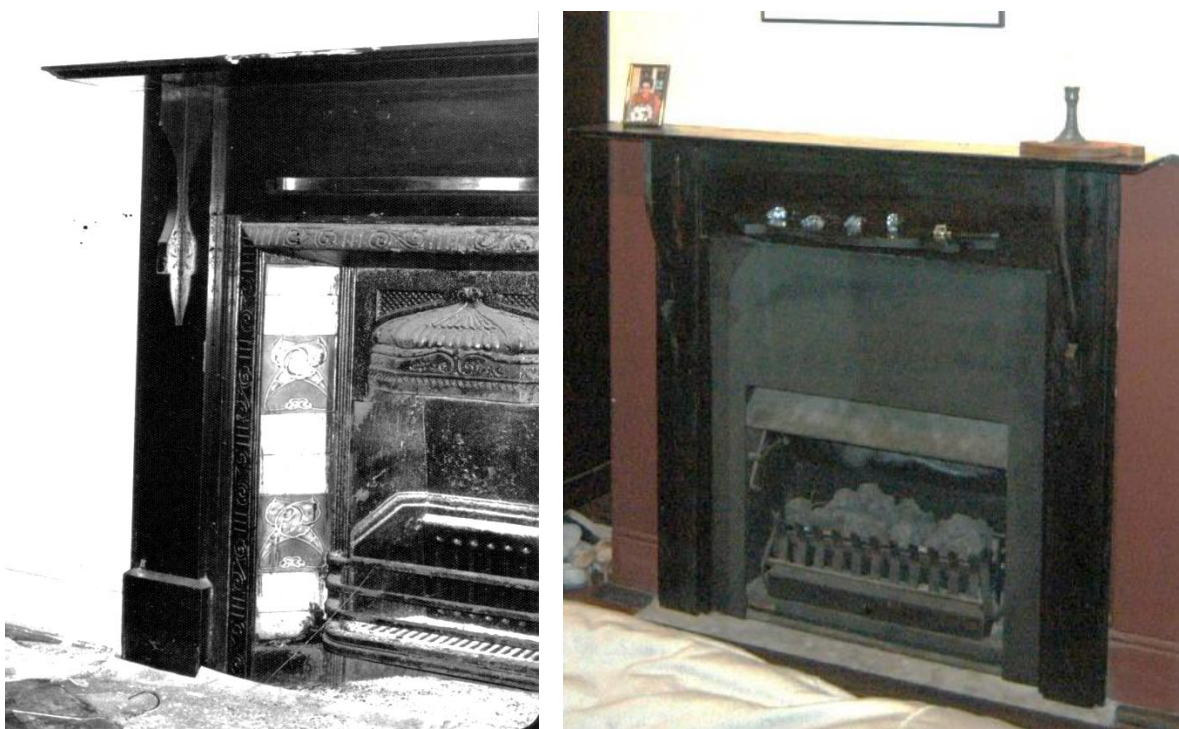
Figure 34: Typical fireplace in 117-117A Gloucester Street; (left) 1970s, (right) 2007. While the timber chimney pieces survive or were reconstructed as part of the conservation works in 1994, the tile firebox surrounds and iron grates have been removed and replaced. (Source: (left) Sydney Harbour Foreshore Authority 48991 GLM65, (right) Clive Lucas Stapleton & Partners).

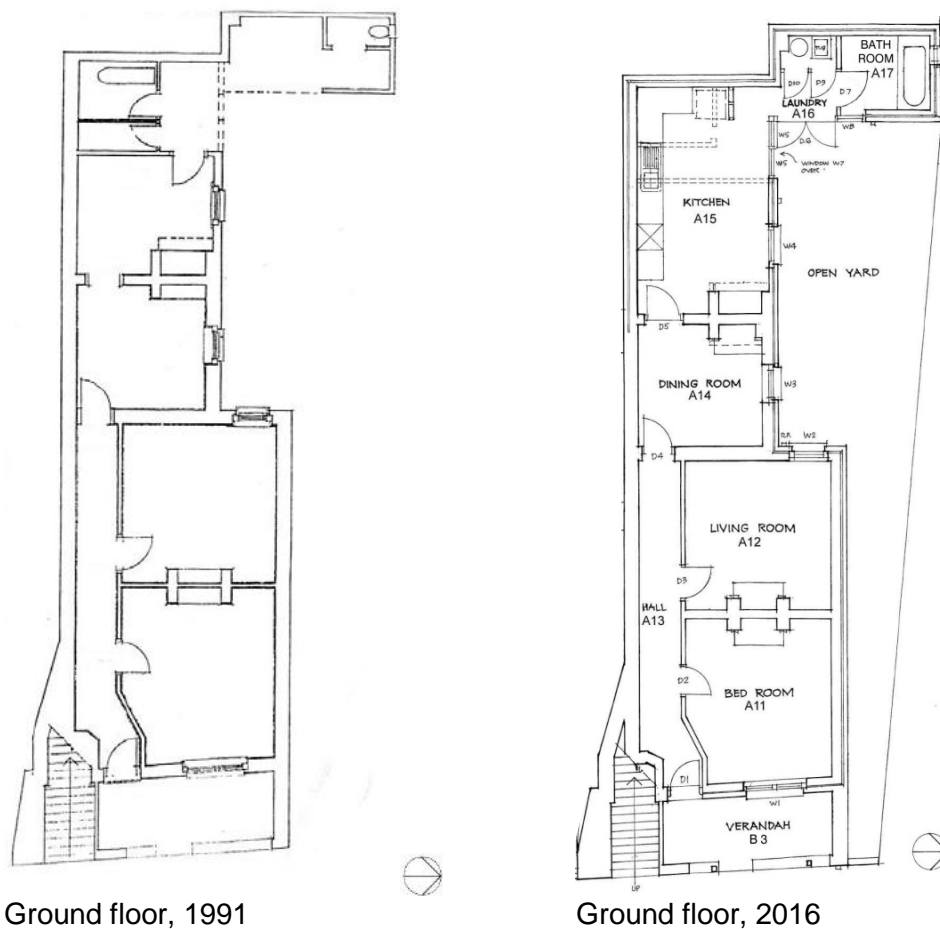
Figure 35: Comparison of plans, ground floor 117-117A Gloucester Street. Left: prior to conservation works (1991); Right: following conservation works (drawn 2007 and verified in 2016). While plan form of the front (east) portion of the ground floor remains intact, the rear wing was altered to create a larger kitchen (from the former kitchen and bathroom spaces), and to insert a laundry and bathroom in the western end of the building in a space which was added to the building in the mid-20th century.

The only internal change made at this time was to the ground floor tenement at 117 Gloucester Street, with the removal of the original bathroom and wall that separated the bathroom and kitchen and replacement with an enlarged kitchen and eating area facing onto the northern rear yard. The original ripple iron ceiling over the original bathroom is still intact. Changes were also made to the external wall and windows to the original bathroom and rear wing laundry were removed and replaced with the current casement windows and external door that opens onto the external rear yard. The original room for the toilet was redesigned and fitted out with a combined bathroom and toilet.

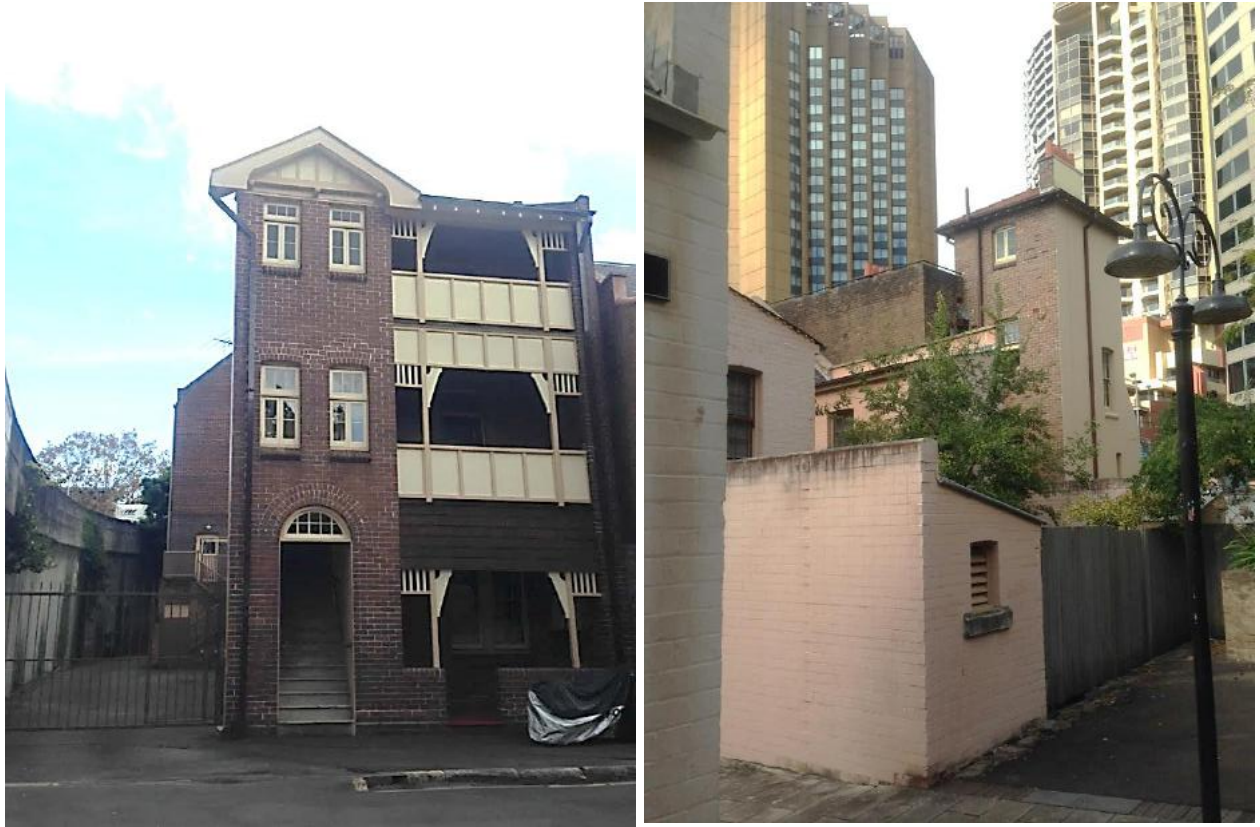
Figure 55: Front (east) elevation of 117-117A Gloucester Street, and side (north) and rear (west) elevations from Longs Lane, 2016. Source: Sydney Harbour foreshore Authority

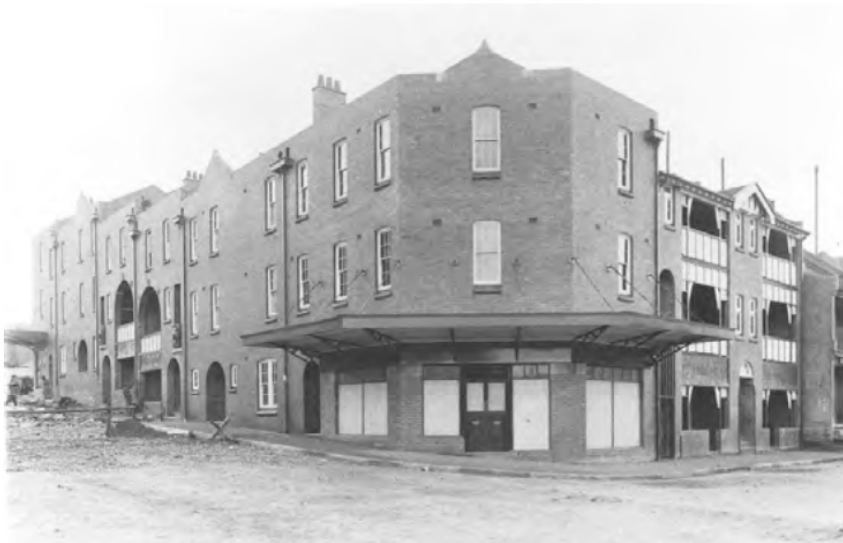
Figure 56: 1914 photo taken on the completion of the construction, shows the tenements at 117-117A Gloucester Street in the context of the original tenement housing development that was largely demolished in 1956 for the construction of the Cahill Expressway. . Source: NSW Government Printer Series – Housing Board ML GPO 1 Still 32252

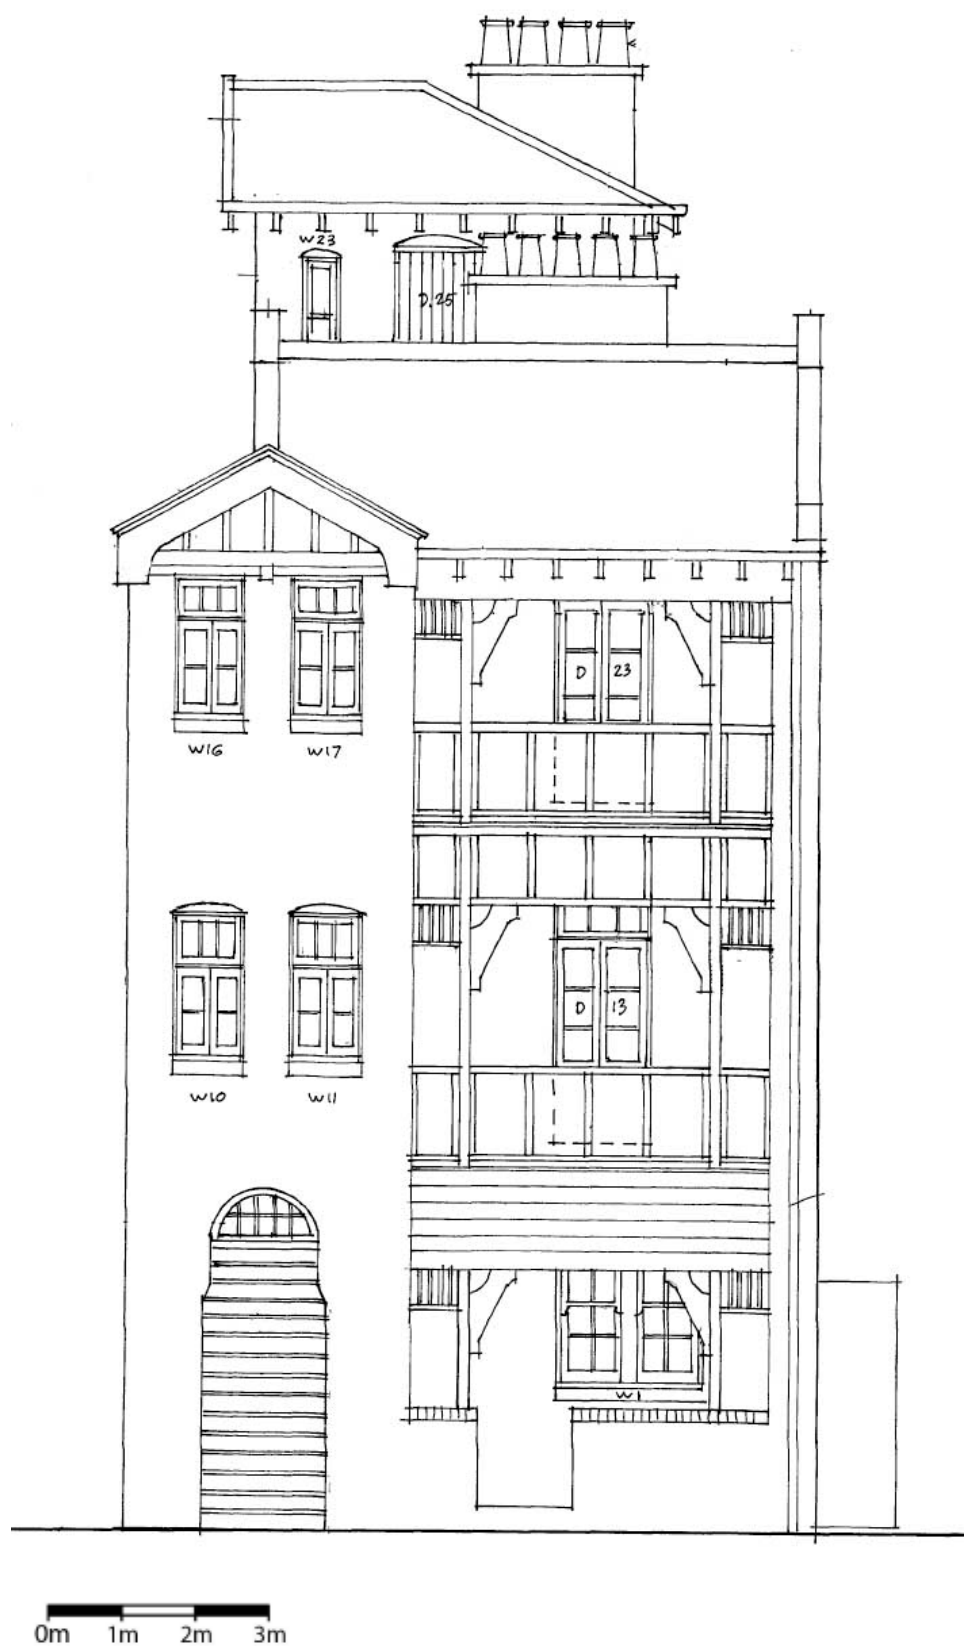
Figure 57: 117-117A Gloucester Street – Front (East) elevation. Source: CLSP
