TENEMENTS

117-117A Gloucester Street, The Rocks

CONSERVATION MANAGEMENT PLAN

Prepared by Hector Abrahams Architects Pty Ltd

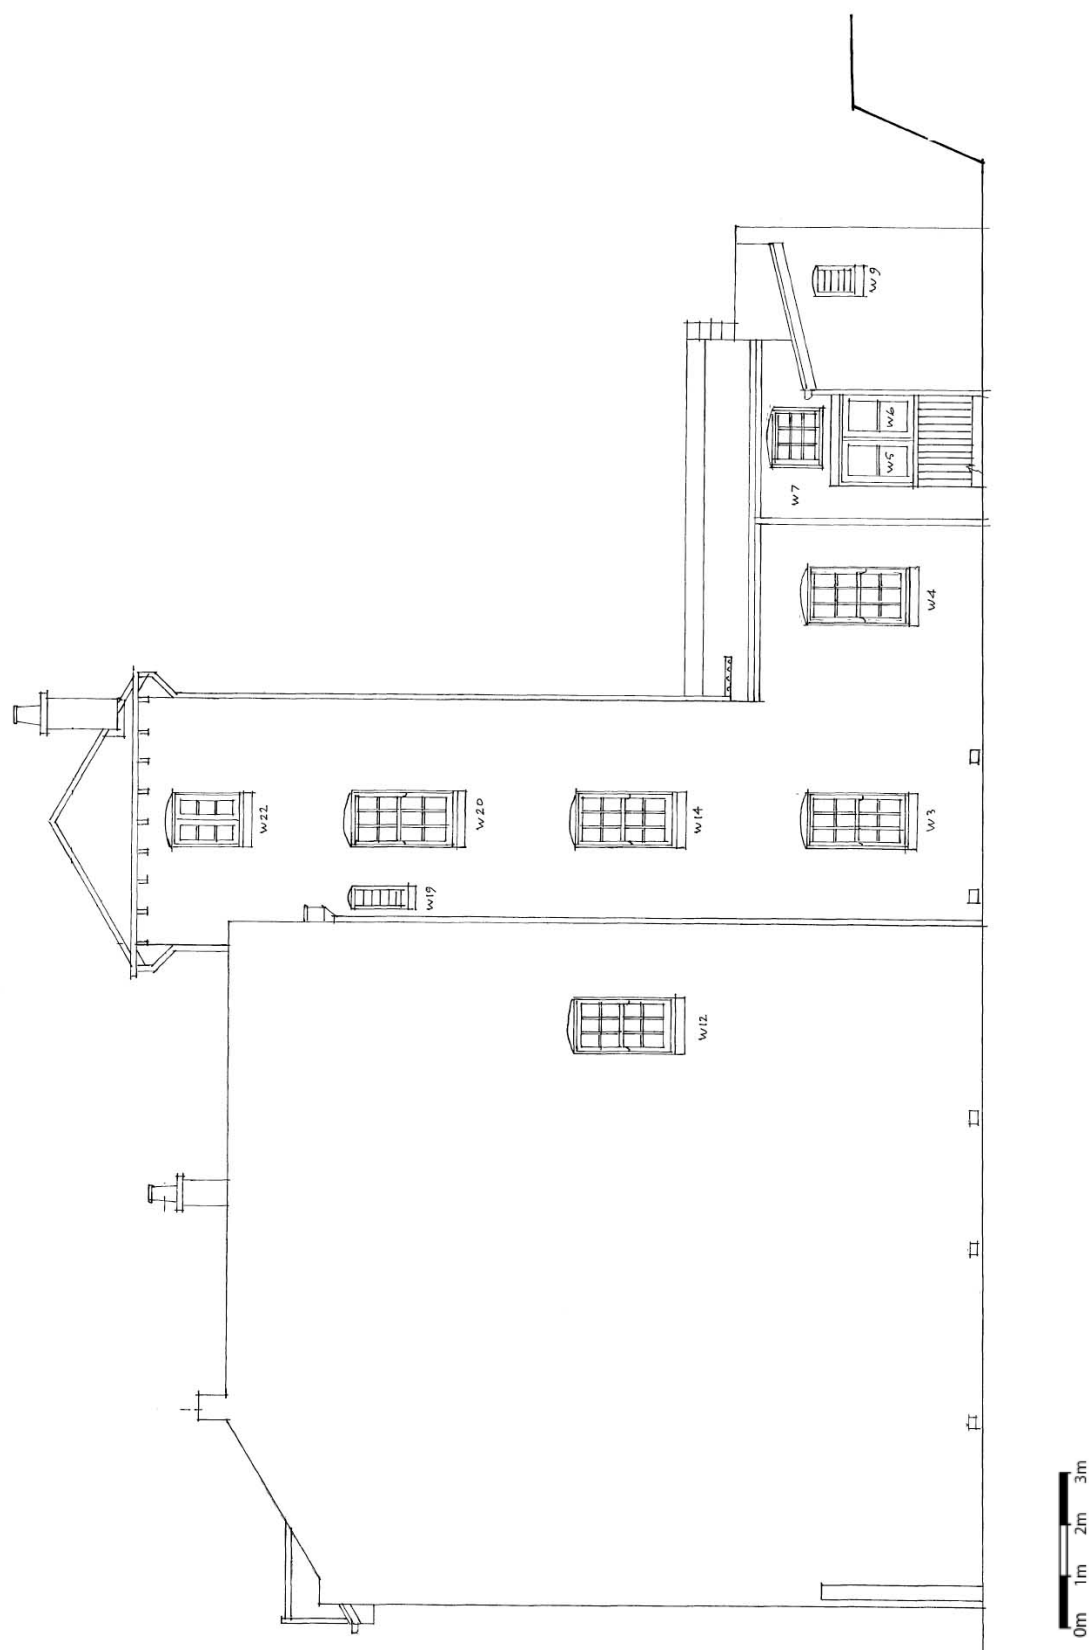
Figure 58: 117-117A Gloucester Street – North elevation. Source: CLSP.

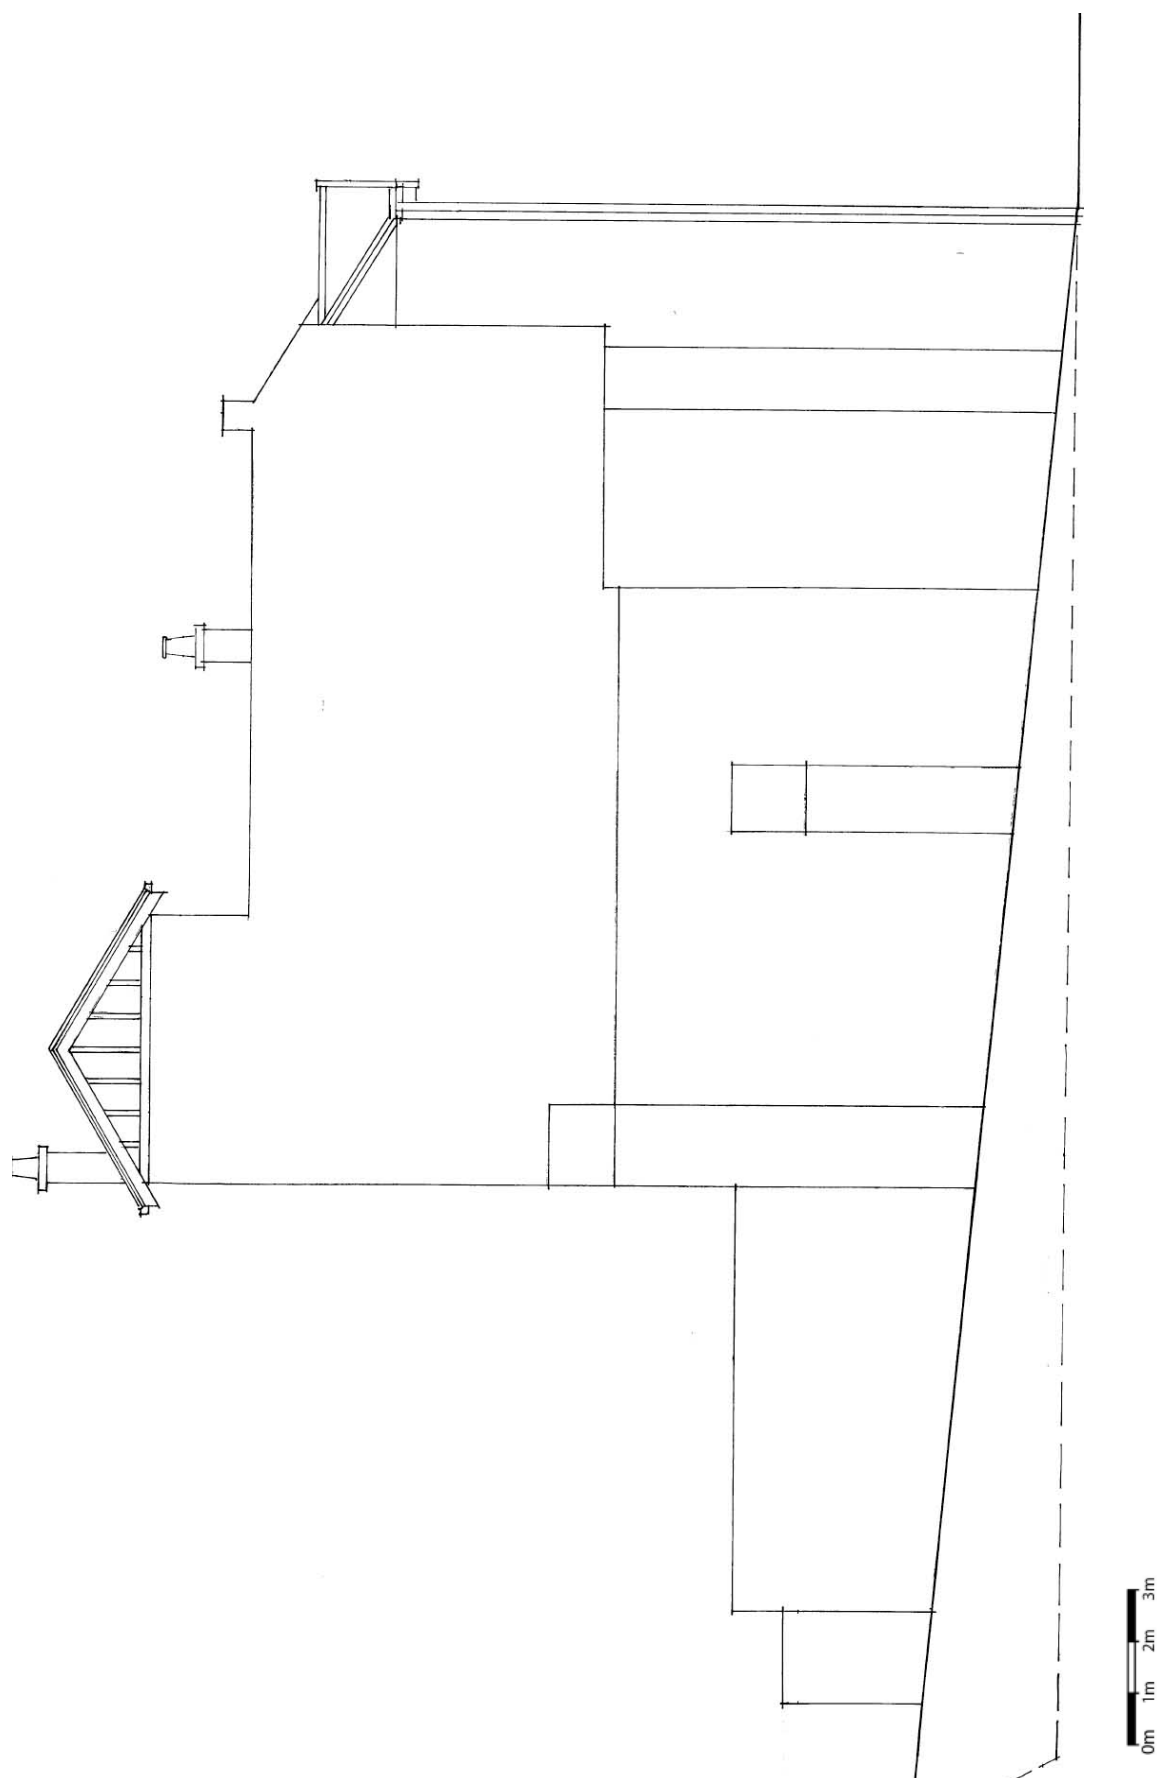
Figure 59: 117-117A Gloucester Street – South elevation. Source CLSP

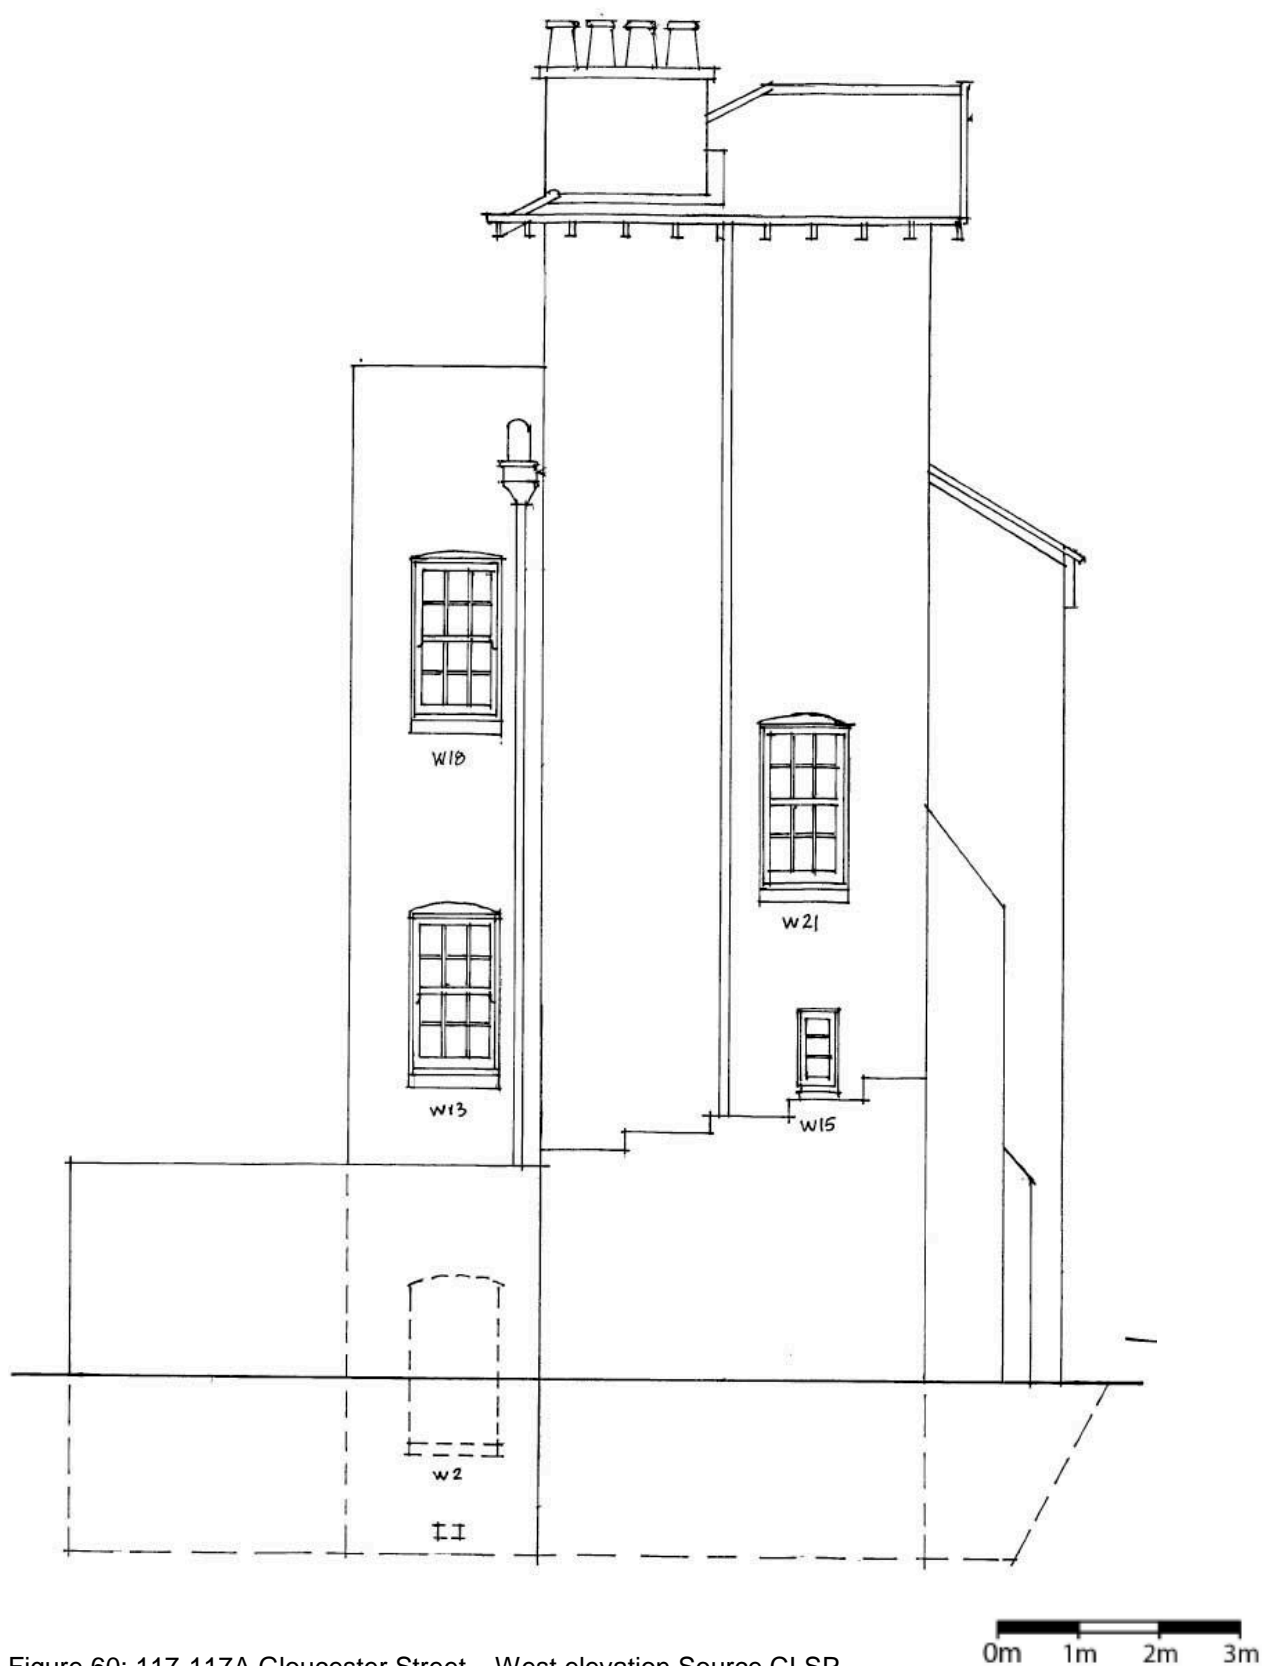
Figure 60: 117-117A Gloucester Street – West elevation Source CLSP

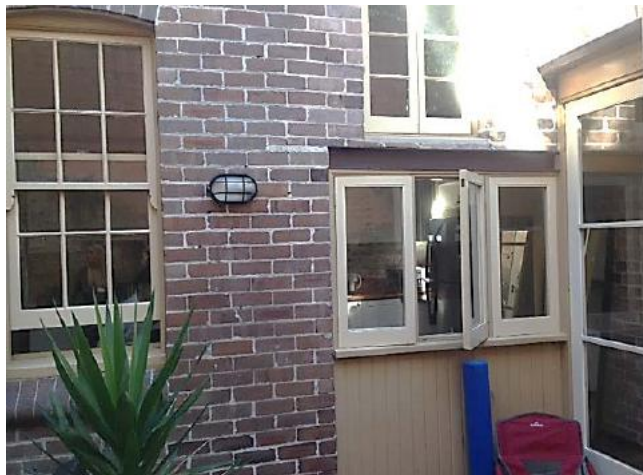
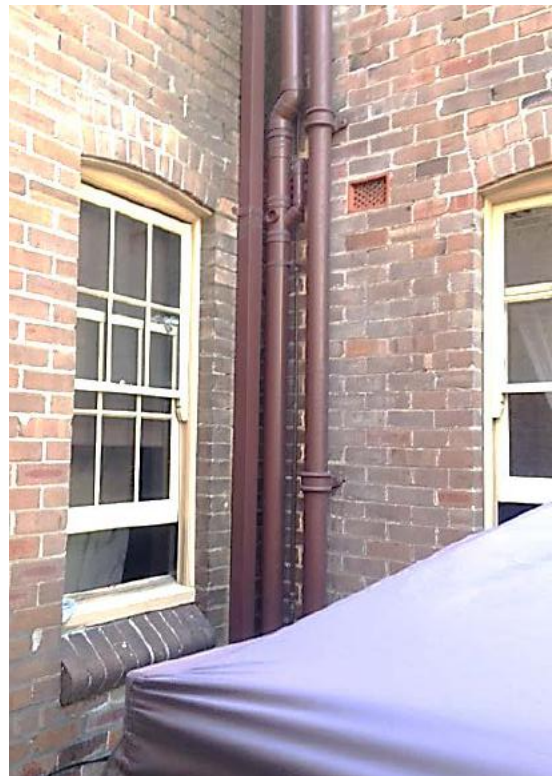
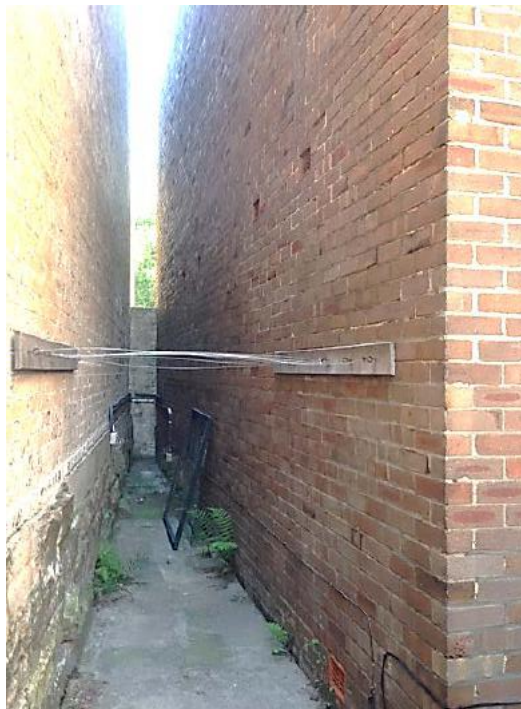
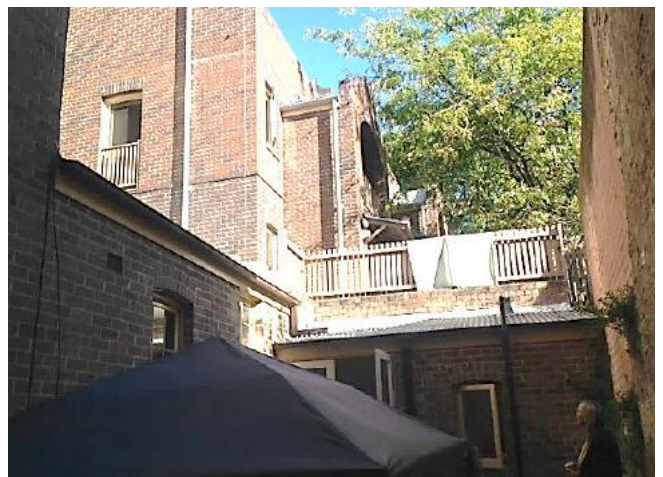
Figure 61: Rear yard, casement windows to kitchen (A15), double hung sash windows to A14 and A12, single rear wing with Laundry (A16) and Bathroom (A17), external walls and passage between 117 and 115 Gloucester Street window, 117 Gloucester Street, 2016. Source: Sydney Harbour Foreshore Authority, M Stacy.

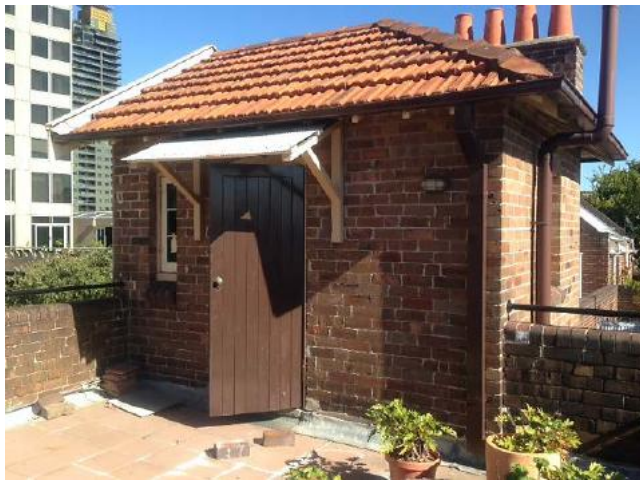
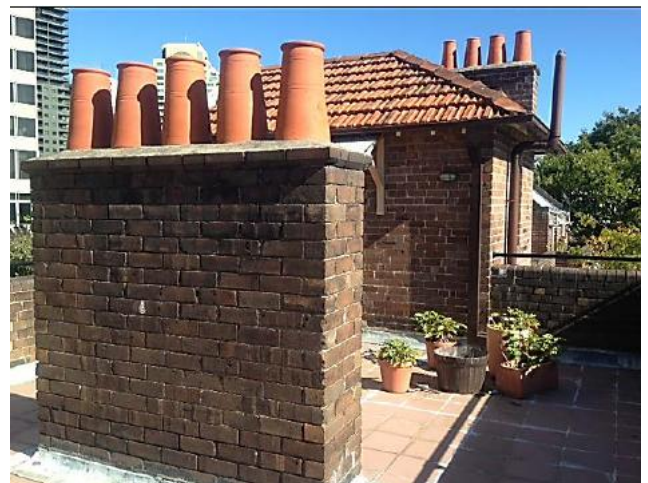
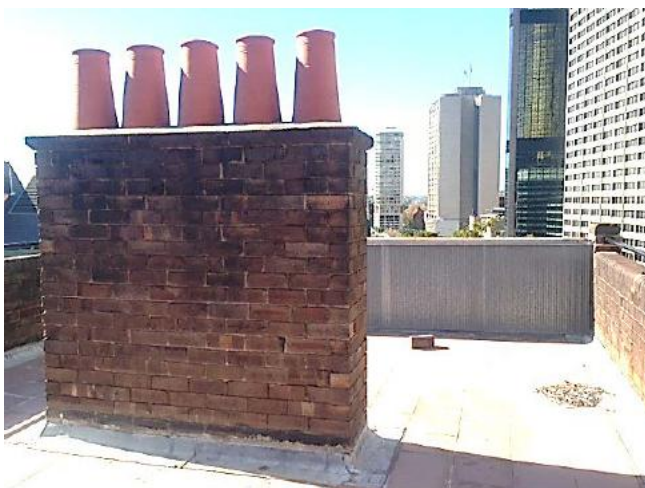
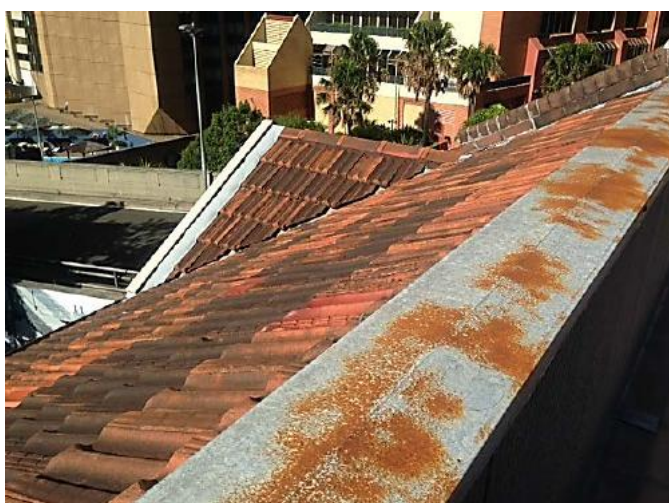
Figure 62: Exterior of Laundry (A1) and open rooftop terrace, chimney stack and chimney pots, tiled roof, 117A Gloucester Street, 2016. Source: Sydney Harbour Foreshore Authority, M Stacy

Identification of Fabric 117-117A GLOUCESTER STREET - EXTERIOR		
Element	Description	Date
Roof		
Roof generally	Flat section, galvanised steel roof sheeting (see also separate listing for Roof Terrace – Third Floor), chimneys and chimney pots	1990s
	Sloped section, Marseilles terracotta pattern tiles	Reconstructed 1994
Rainwater goods generally	Metal quad gutters, rectangular metal downpipes	1990s
East Elevation		
Fascia	Timber fascia, battens, and bargeboards to gable	Reconstructed 1994
Wall	Face brick, evidence of former building to south in brickwork.	Original
Verandahs generally	100mm timber posts, timber handrails, brackets, shingling to ground floor	Original/ Reconstructed
	Timber and compressed cement balustrade infill, timber valance and brackets	Original
Other	Window sills – bullnose brick	Original
	Window heads – brick arches	Original
External steps to 117A	Concrete steps and landing with steel pipe handrails	Original

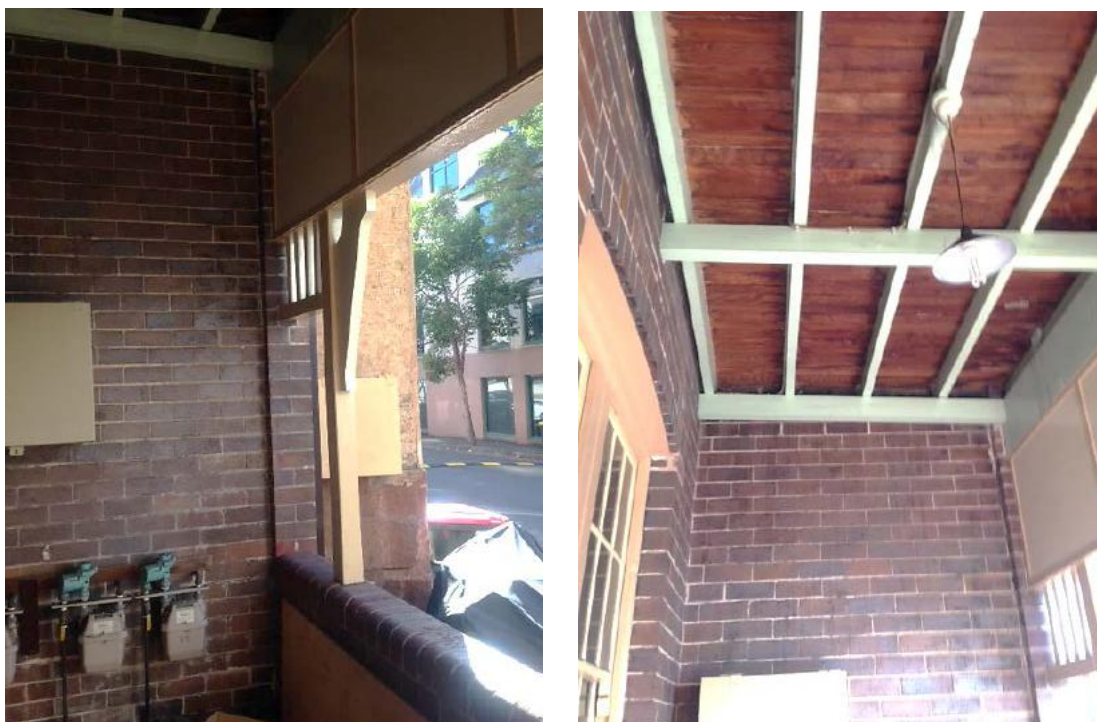
Figure 64: Verandah and entry (B3), 117 Gloucester Street, 2016. Source: Sydney Harbour Foreshore Authority, M Stacy

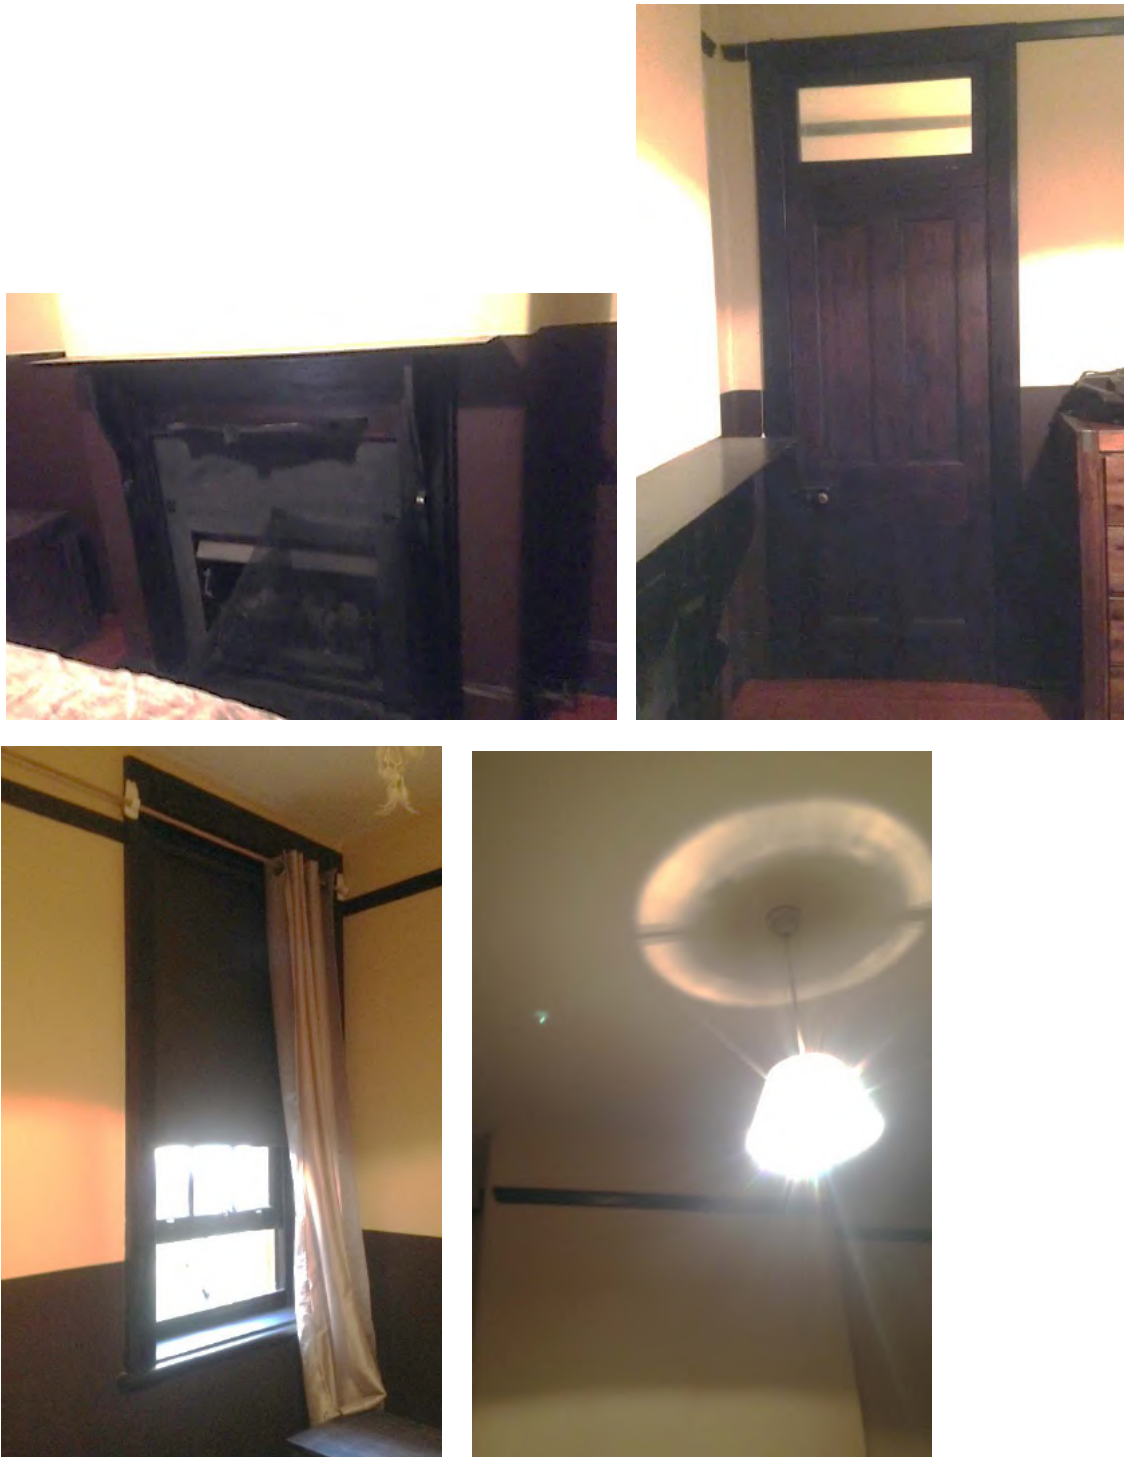
Figure 67: Living Room (A12) fireplace, door, double hung sash window, picture rail and pendant light, 117 Gloucester Street, 2016. Source: Sydney Harbour Foreshore Authority, M Stacy

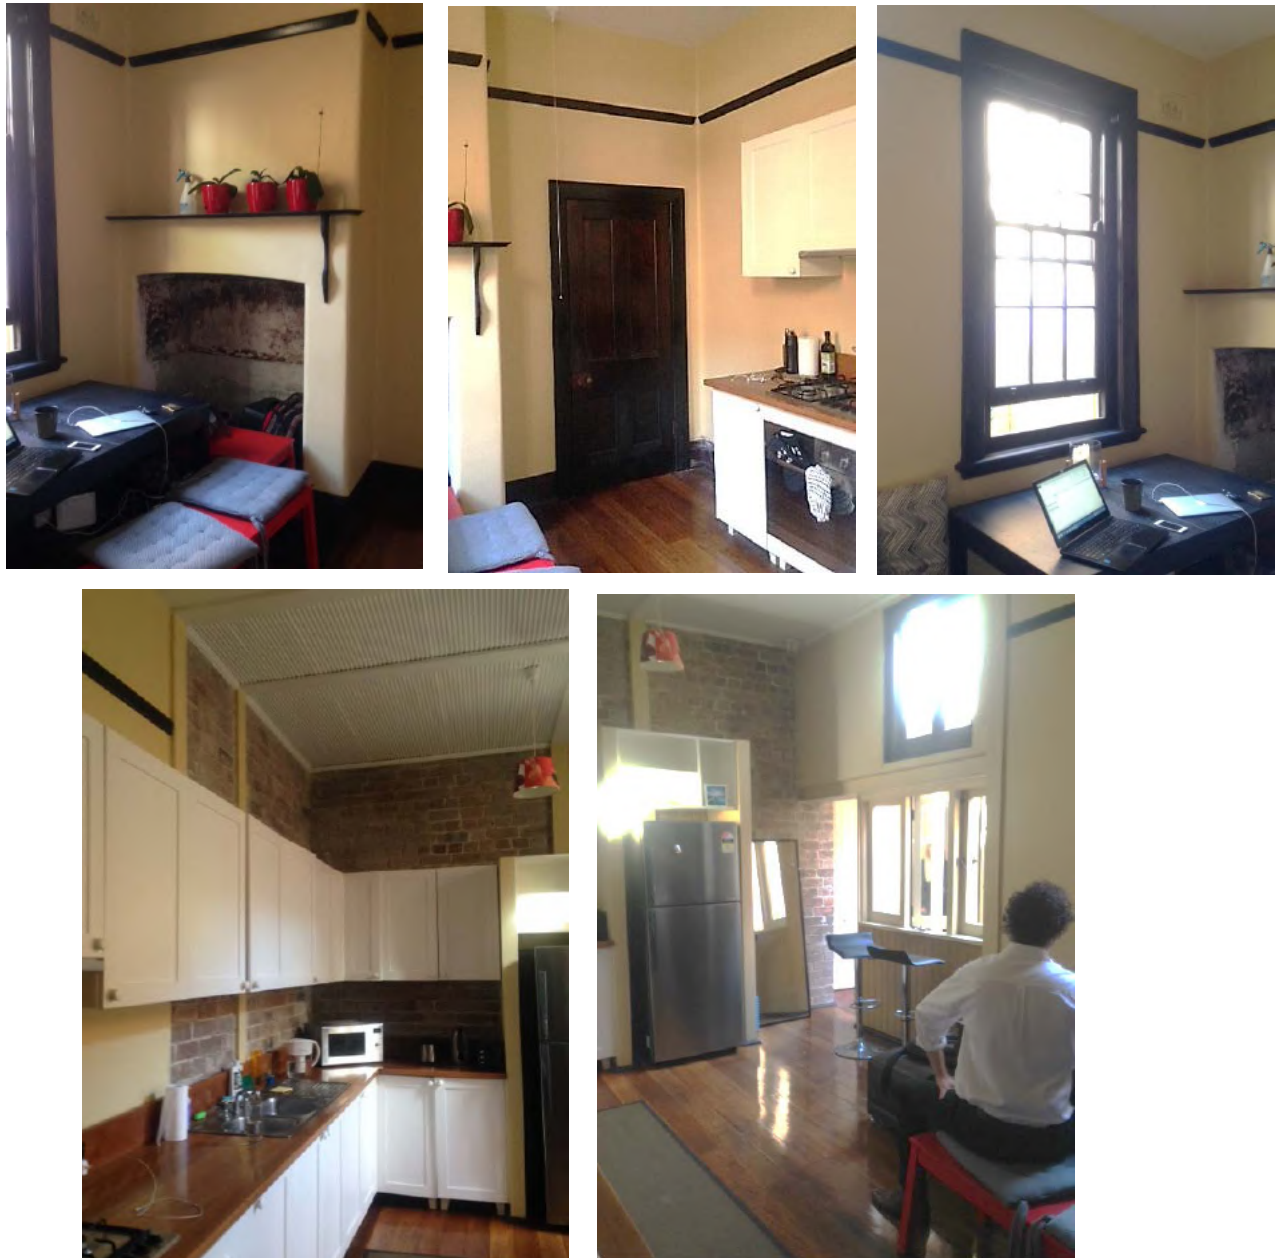
Figure 69: Kitchen (A15) kitchen hearth, internal door, double hung sash window, modern kitchen and pendant light, external casement windows, 117 Gloucester Street, 2016. Source: Sydney Harbour Foreshore Authority, M Stacy

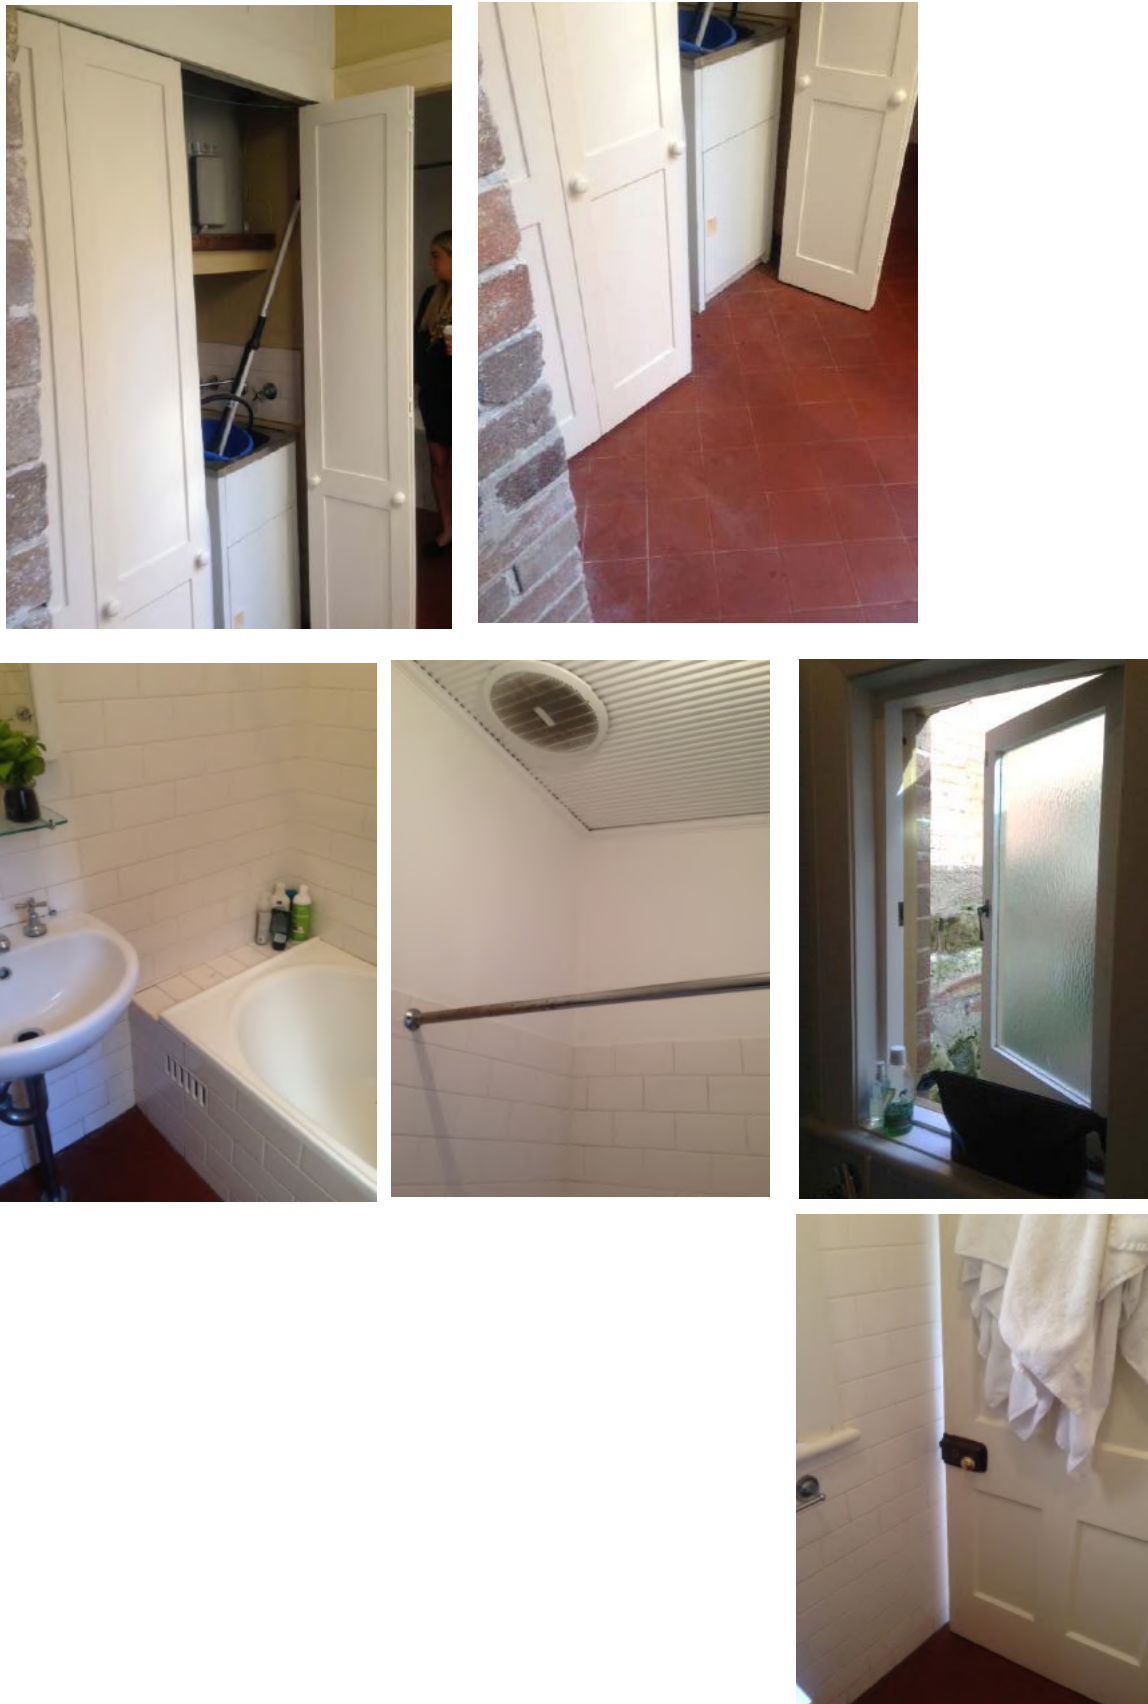
Figure 70: Laundry (A16) and Bathroom (A17), modern fitouts, external casement window, 117 Gloucester Street, 2016. Source: Sydney Harbour Foreshore Authority, M Stacy

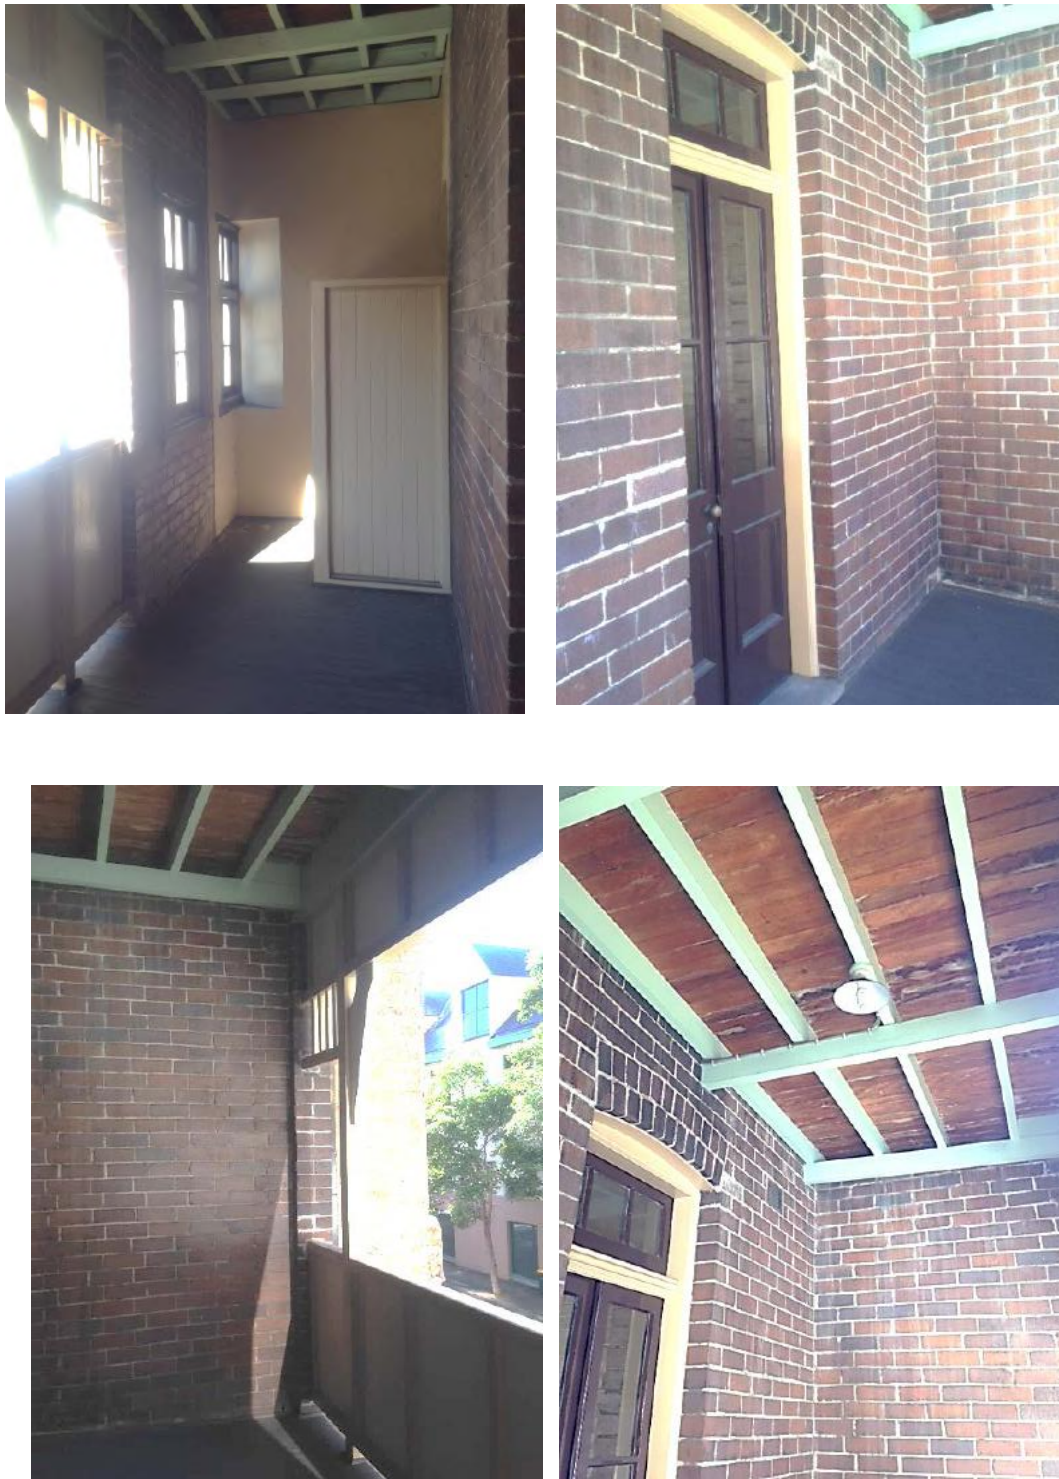
Figure 75: Balcony (B2) front verandah decorative timberwork, enclosure over external entry stairs, french doors, floor substructure to balcony over to 117A Gloucester Street, 2016. Source: Sydney Harbour Foreshore Authority, M Stacy.

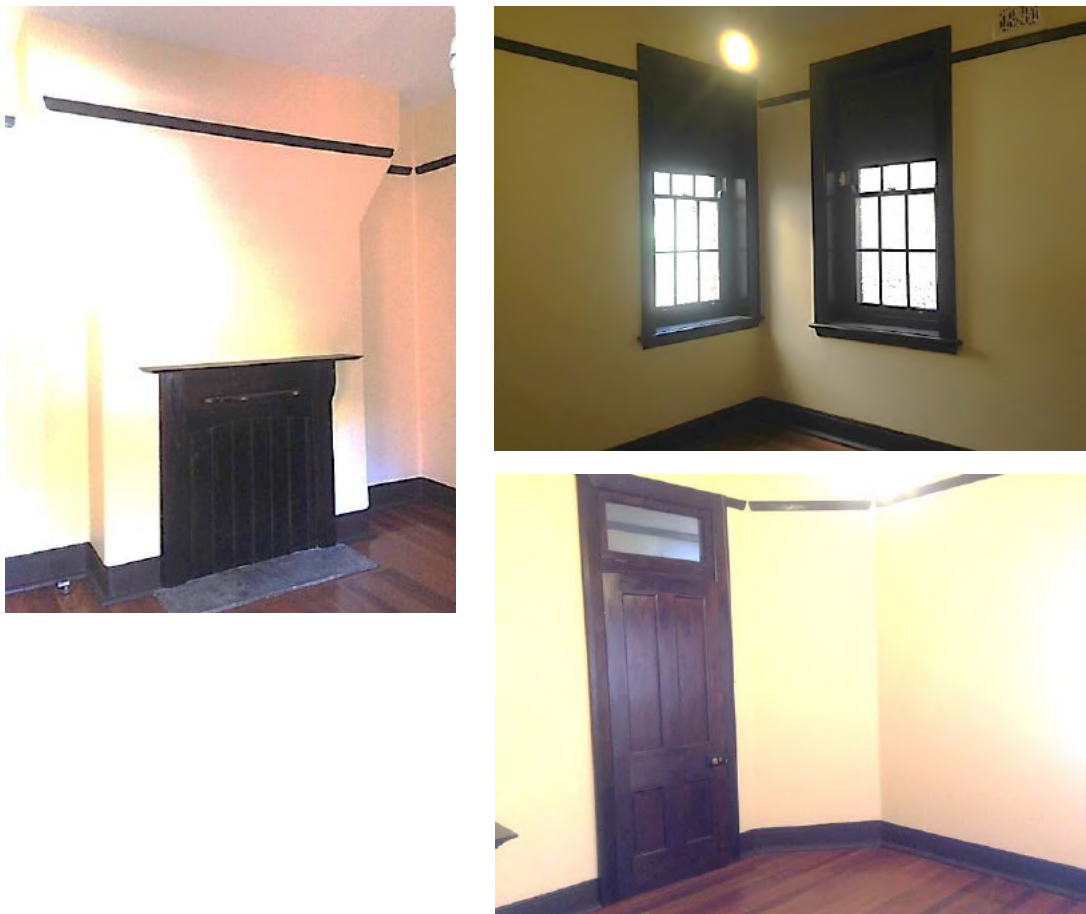
Figure 76: Dining Room (A8) fireplace, double hung sash windows and internal door to 117A Gloucester Street, 2016. Source: Sydney Harbour Foreshore Authority, M Stacy.

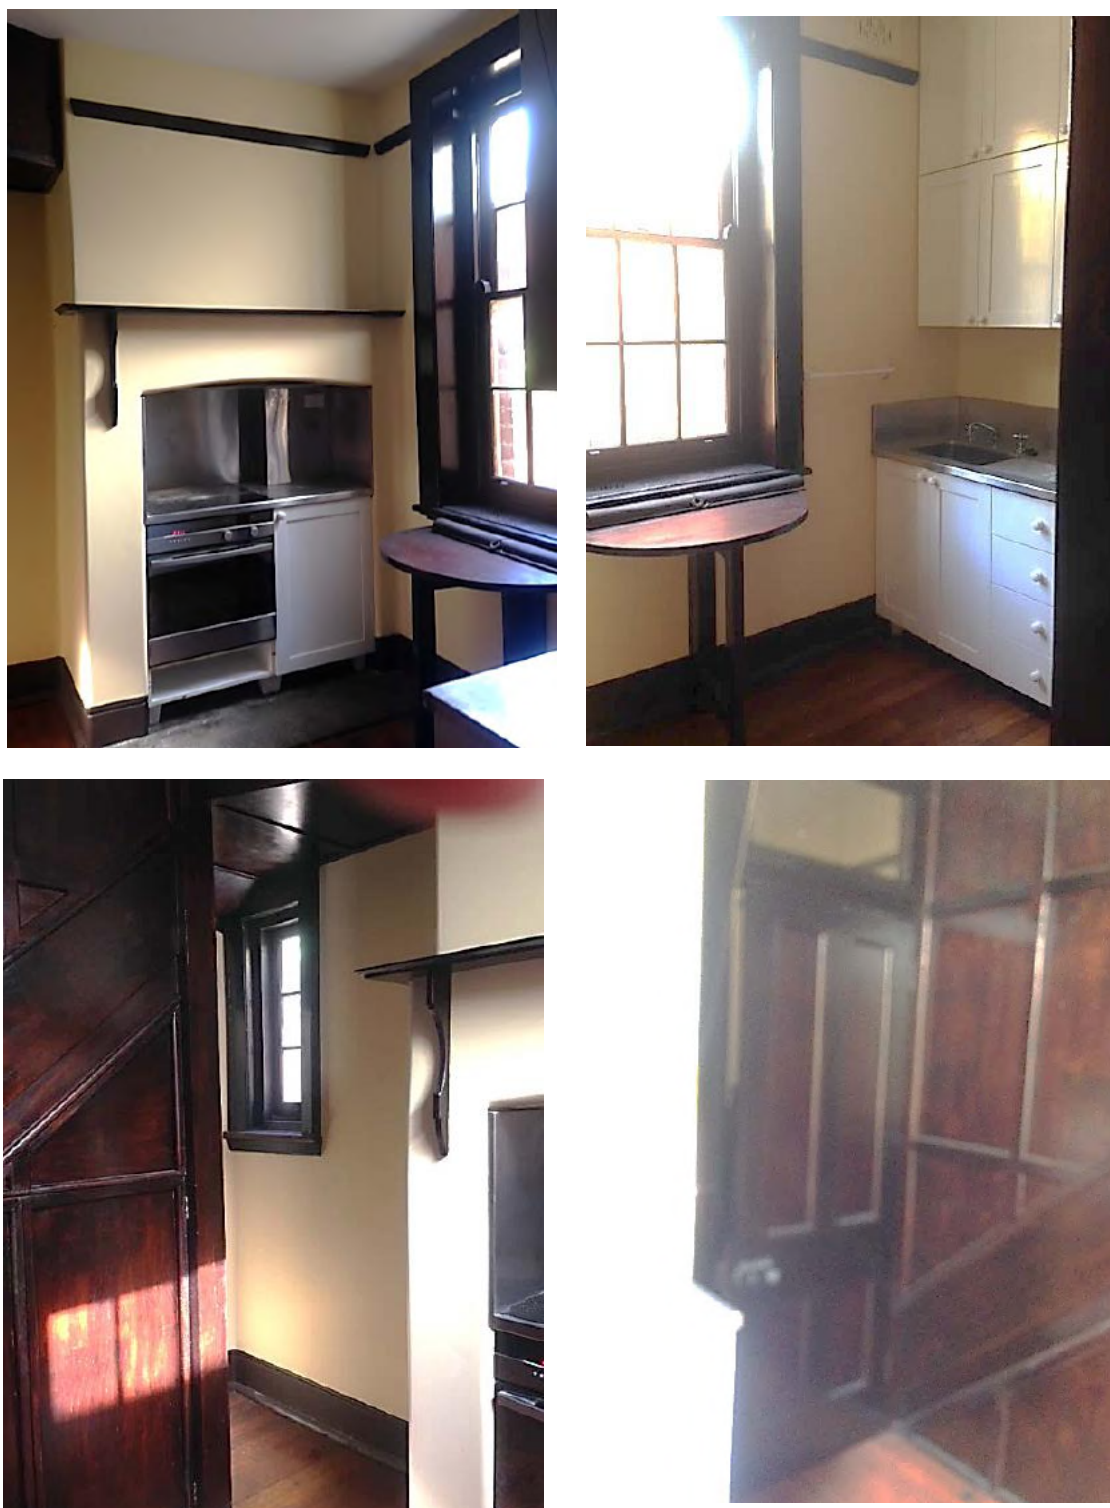
Figure 77: Kitchen (A10) hearth and mantelshelf, double hung sash windows and kitchen fitout, small window, timber stairs and internal door to 117A Gloucester Street, 2016. Source: Sydney Harbour Foreshore Authority, M Stacy.

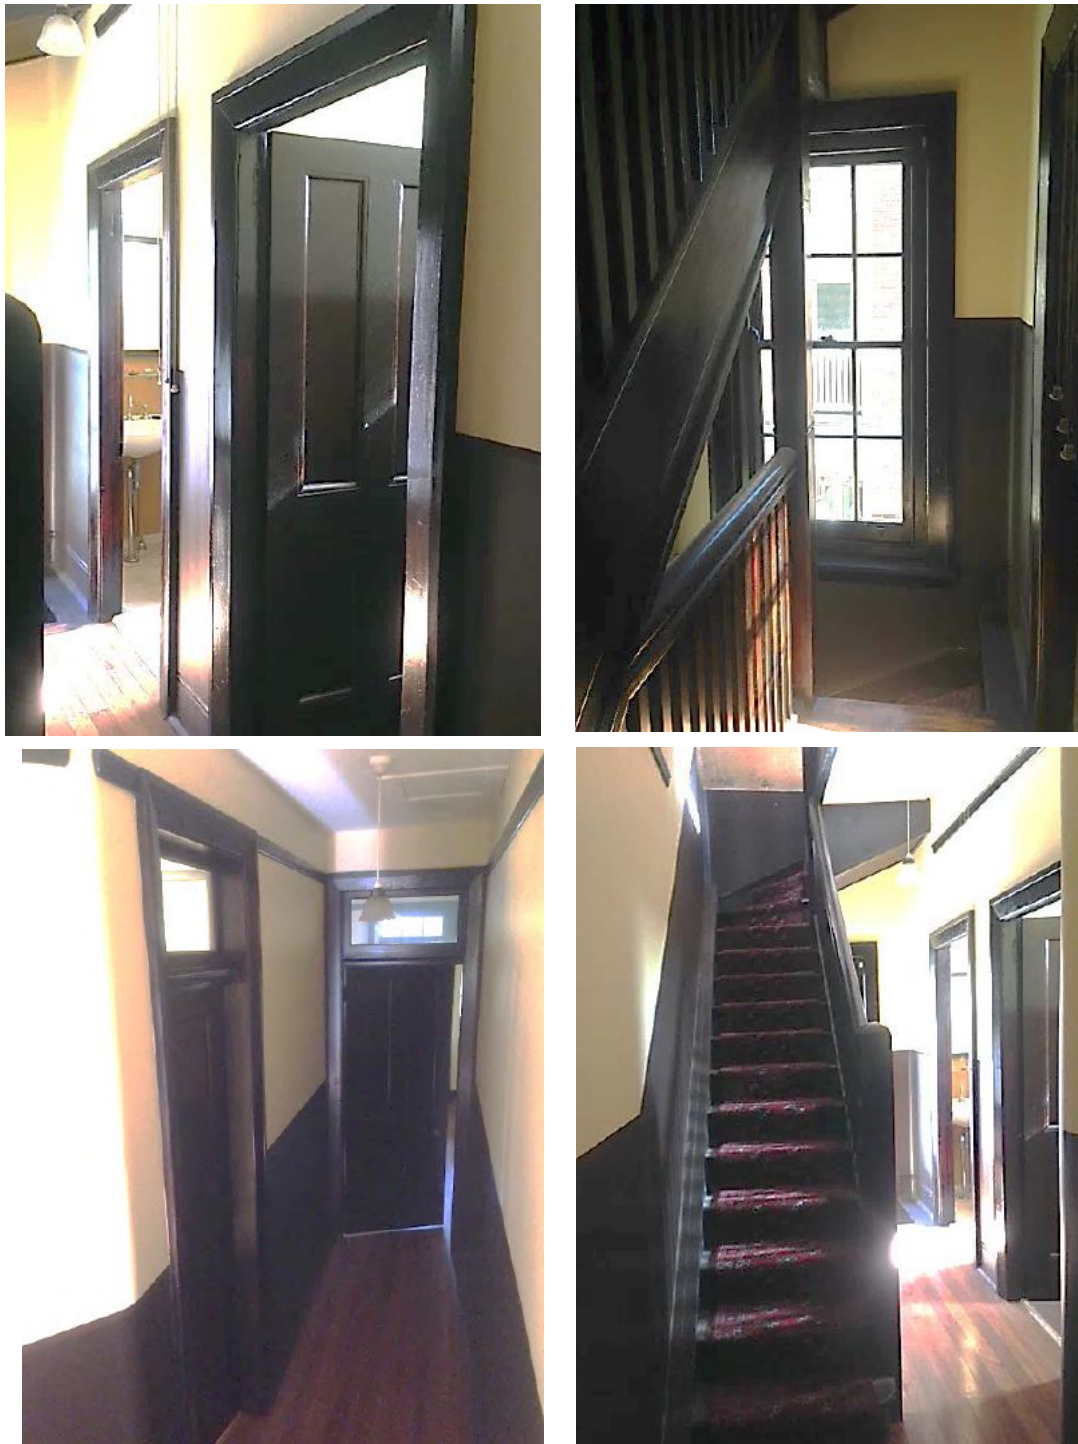
Figure 78: Hall (A4) top of internal stairs and hall outside bath and WC, and internal stairs to level 3 laundry and rooftop, 117A Gloucester Street, 2016. Source: Sydney Harbour Foreshore Authority, M Stacy.

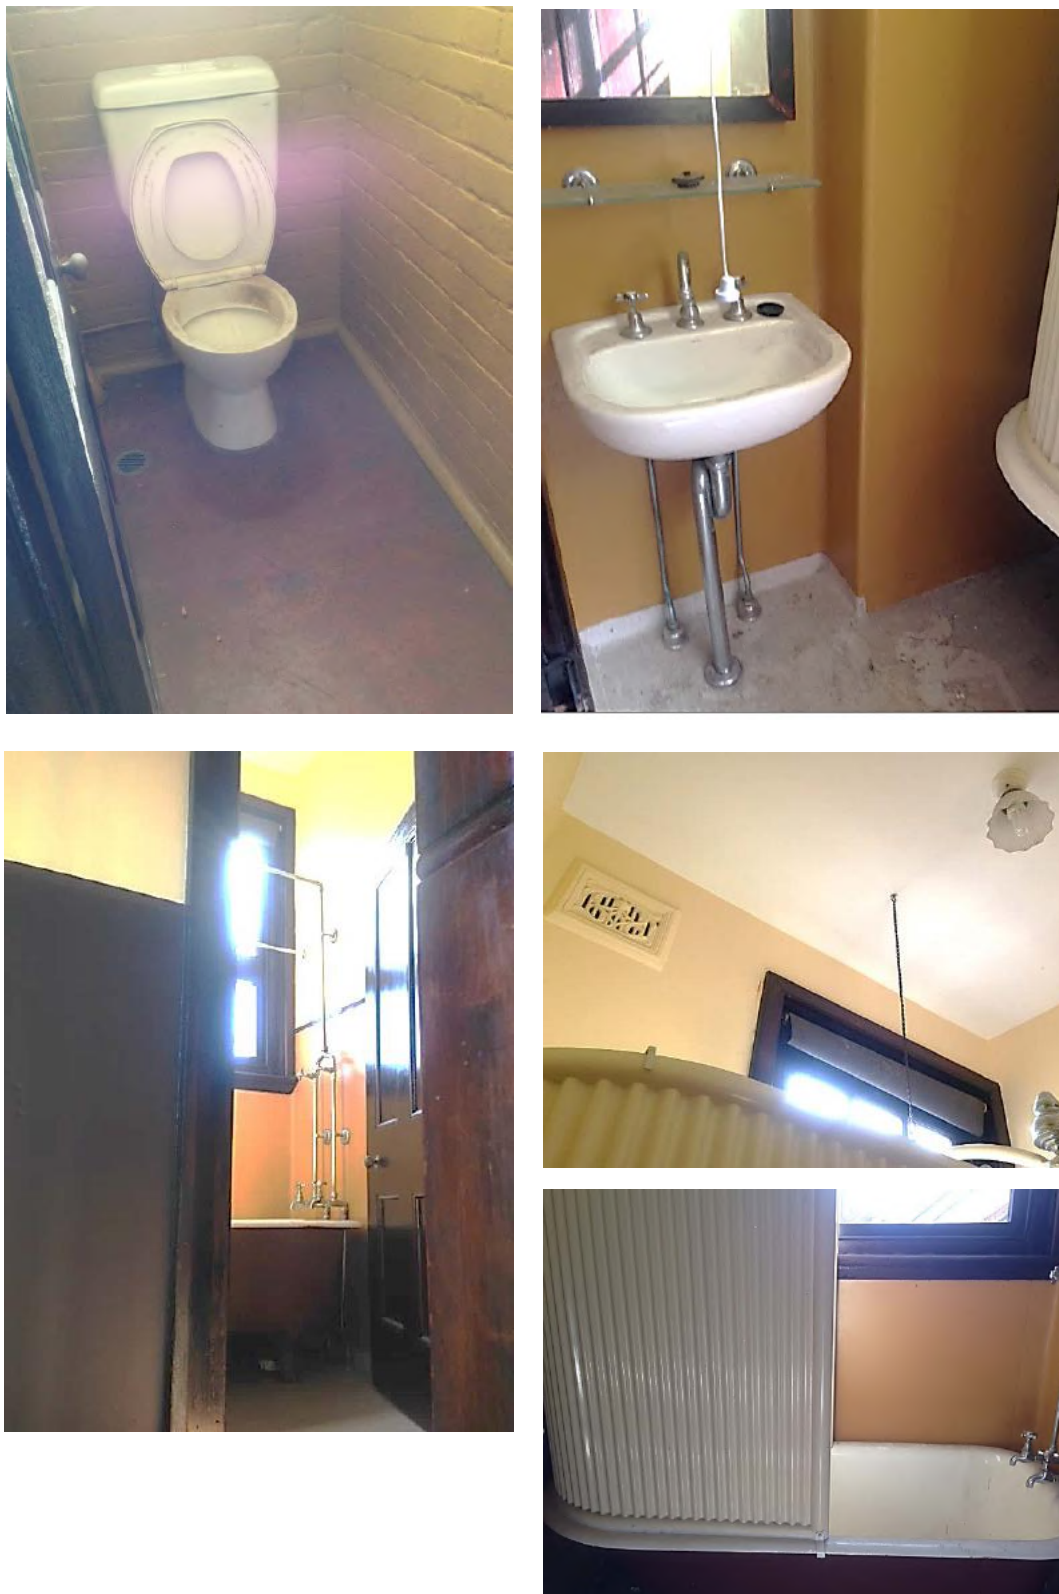
Figure 80: Toilet (A5) and Bath Room (A6) cast iron bath with ripple iron shower screen over, double hung sash window, air vent and light fitting, 117A Gloucester Street, 2016. Source: Sydney Harbour Foreshore Authority, M Stacy
