TENEMENTS

117-117A Gloucester Street, The Rocks

CONSERVATION MANAGEMENT PLAN

Prepared by Hector Abrahams Architects Pty Ltd

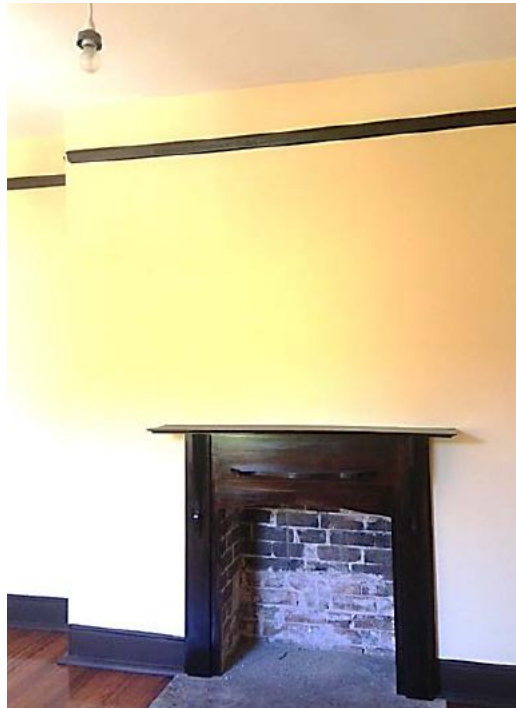
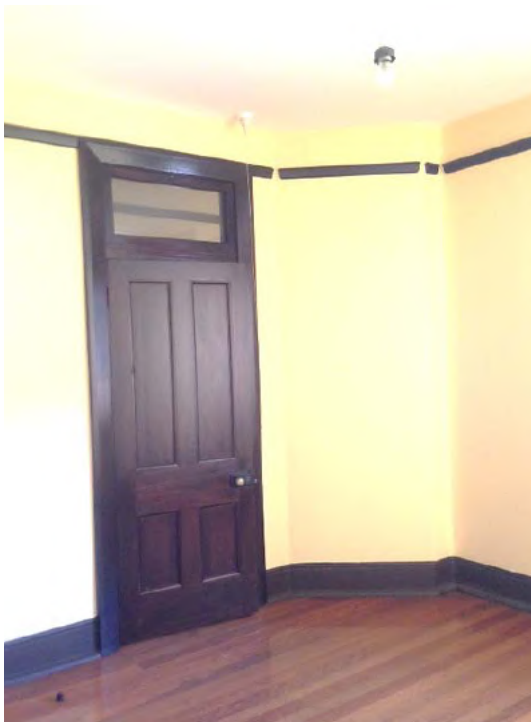
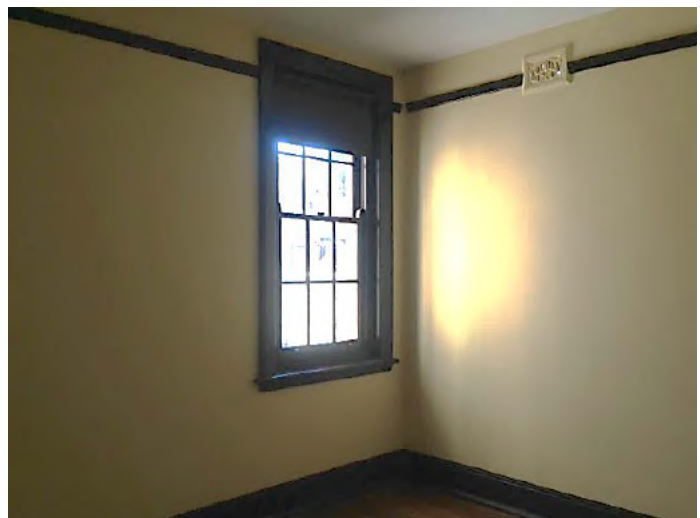
Figure 81: Bedroom #2 (A3) fireplace without grate, air vents and picture rails, double hung sash window, internal door, 117A Gloucester Street, 2016. Source: Sydney Harbour Foreshore Authority, M Stacy

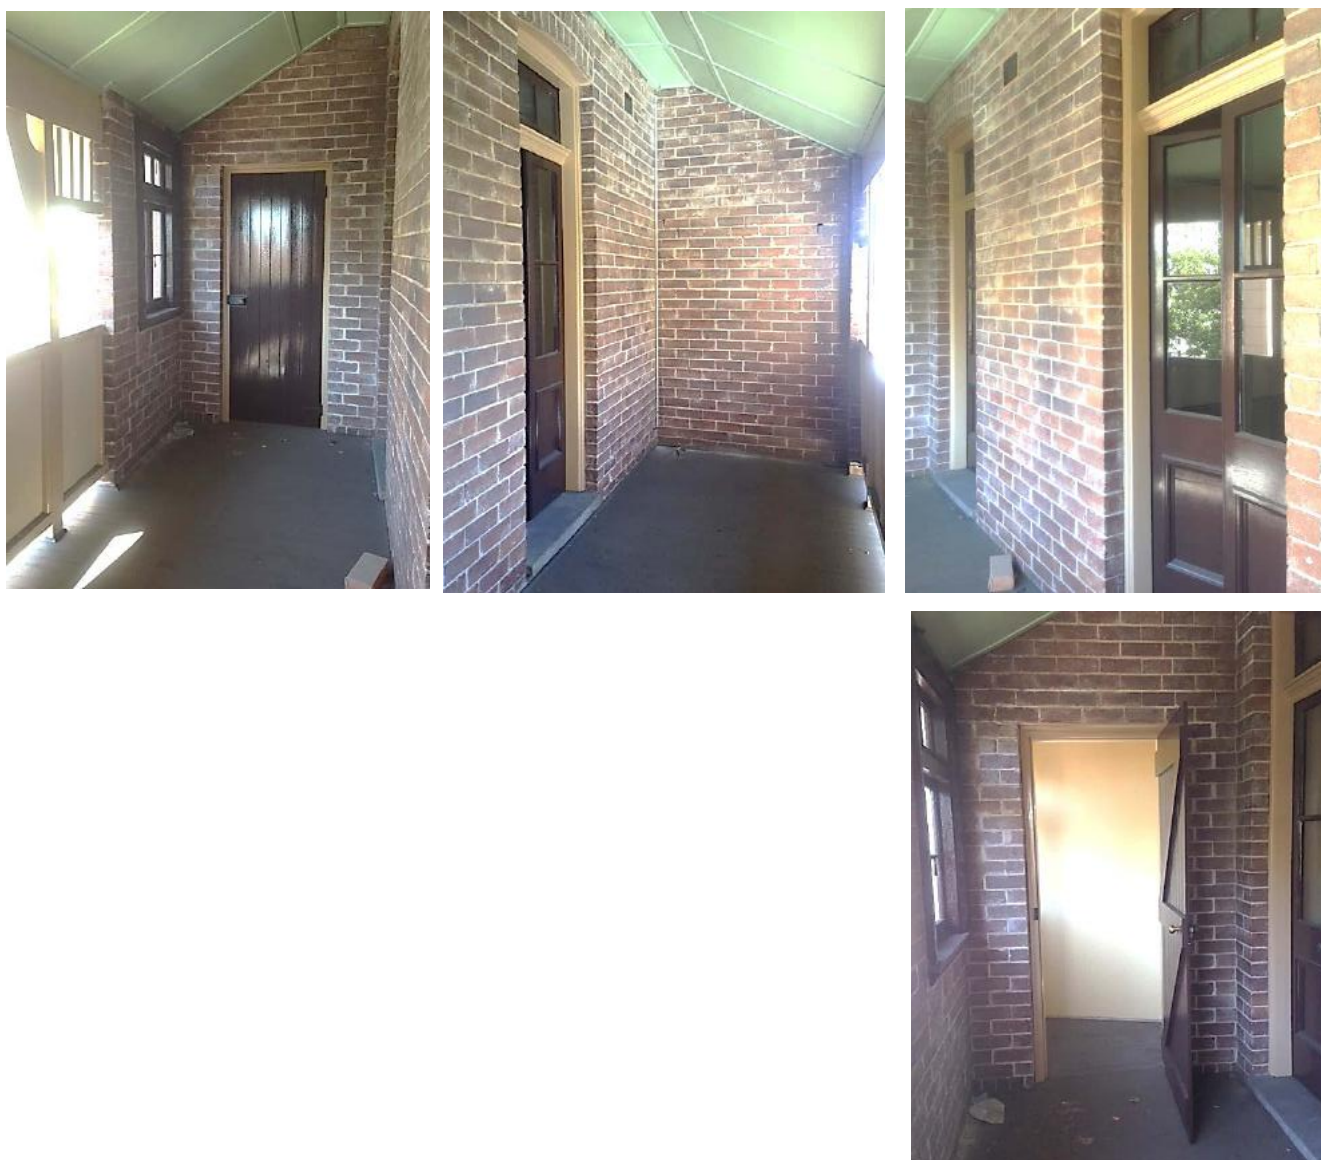
Figure 84: Balcony (B1) front verandah decorative timberwork, enclosure over external entry stairs, french doors, ceiling, 117A Gloucester Street, 2016. Source: Sydney Harbour Foreshore Authority, M Stacy.

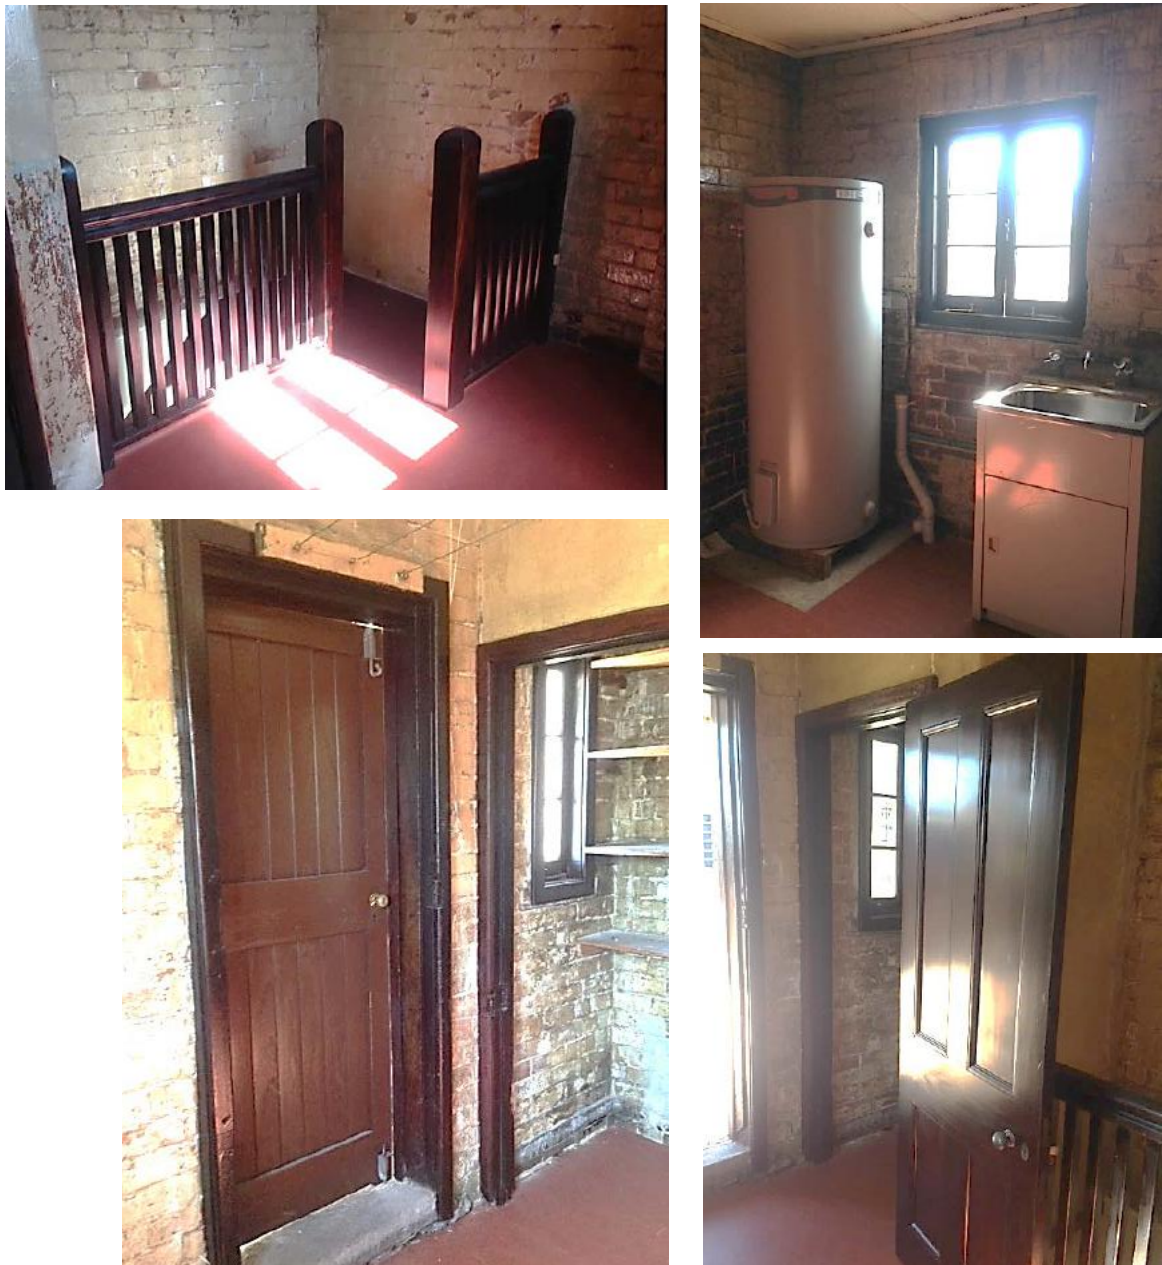
Figure 86: Laundry (A1) Internal stairs, laundry tub and water heater, external door to rooftop and cupboard, cupboard door, 117A Gloucester Street, 2016. Source: Sydney Harbour Foreshore Authority, M Stacy

Identification of Fabric 117-117A GLOUCESTER STREET – THIRD FLOOR		
<i>Element</i>	<i>Description</i>	<i>Date</i>
Laundry A1		
Ceiling	Ripple iron	Original
Cornices	31mm ovolo	Original
Wall	Face brick painted	Original
Floor	Linoleum finish over timber boards.	1990s
DoorD24	Frame and architrave	Original
	4 panel leaf	Reconstructed 1994
Door D25	Framed and architrave	Original
	Sheet timber door	Reconstructed 1994
Windows W22 and W23	Timber double and single casement three pane sash	Original
Roof terrace		
Wall	Face brick balustrade with bullnose coping (north, south, part west)	Original
	Galvanised ripple iron balustrade with galvanised steel capping	1990s
Floor	Vitrified clay tiles with lead flashing to perimeter	1990s
Other	Chimney pots	Reconstructed 1994

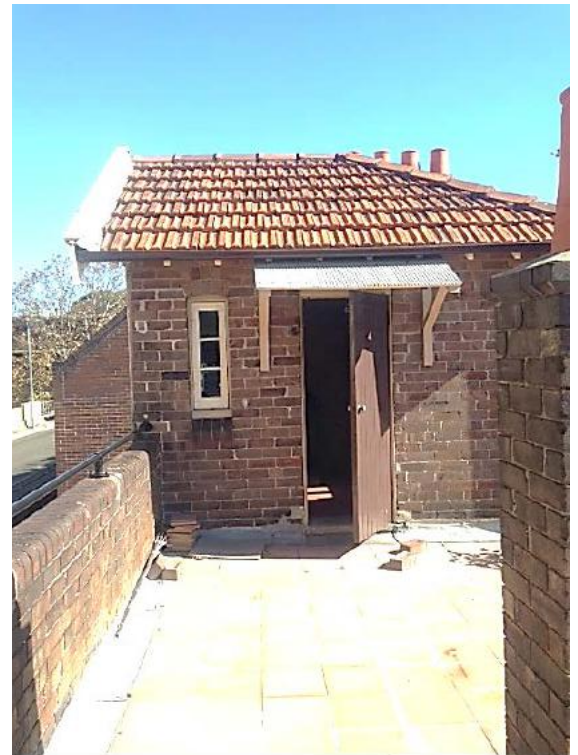
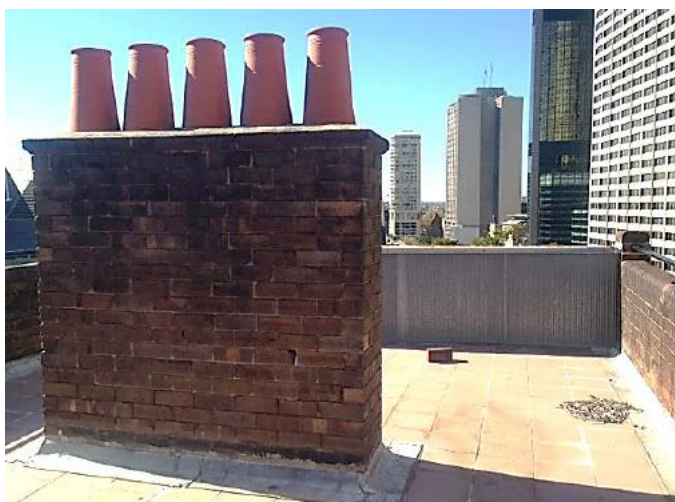
Figure 87: Open root terrace and Laundry (A1) external door to rooftop from laundry, chimneys and terrace, 117A Gloucester Street, 2016. Source: Sydney Harbour Foreshore Authority, M Stacy

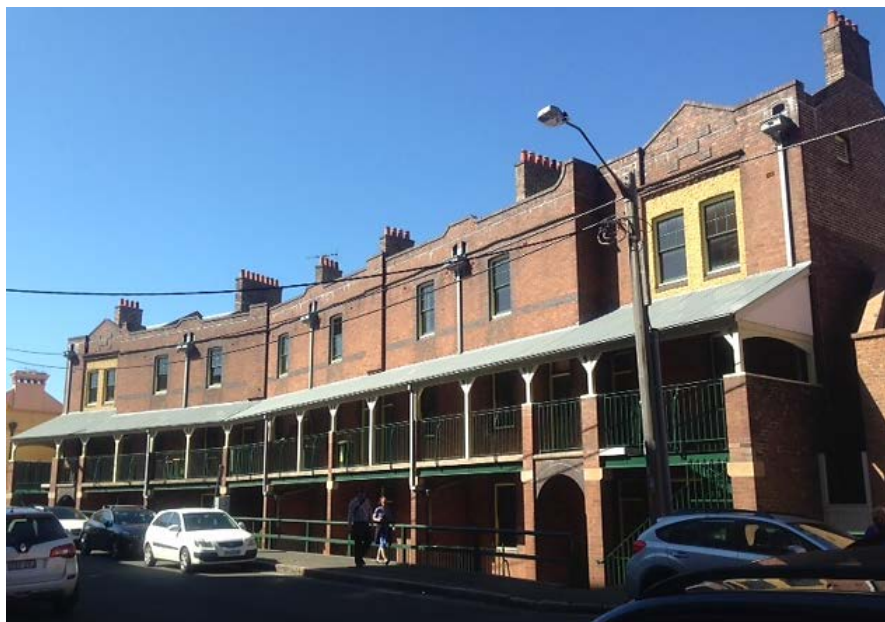
The Government Architect's Branch did design an unusual row of houses for the narrow and precipitous site at 46–56 Gloucester Street between 1908 and 1911. The row incorporates 16 residences; in effect, two rows of eight two-storey terraces stacked one atop the other. On the Gloucester Street level the lower terraces were entered at street level, and stairs took occupants to a lower floor. A stair from the street led to the first floor terraces, accessed by a verandah across the front of the building. Garbage chutes took waste from the rear of the buildings to yards on Cambridge Street.⁴⁵

Figure 89: Workmens' Dwellings, 46-56 Gloucester Street, The Rocks designed by Government Architects Branch, NSW Government Architect Vernon, built 1910. Source: Sydney Harbour Foreshore Authority, M Stacy.

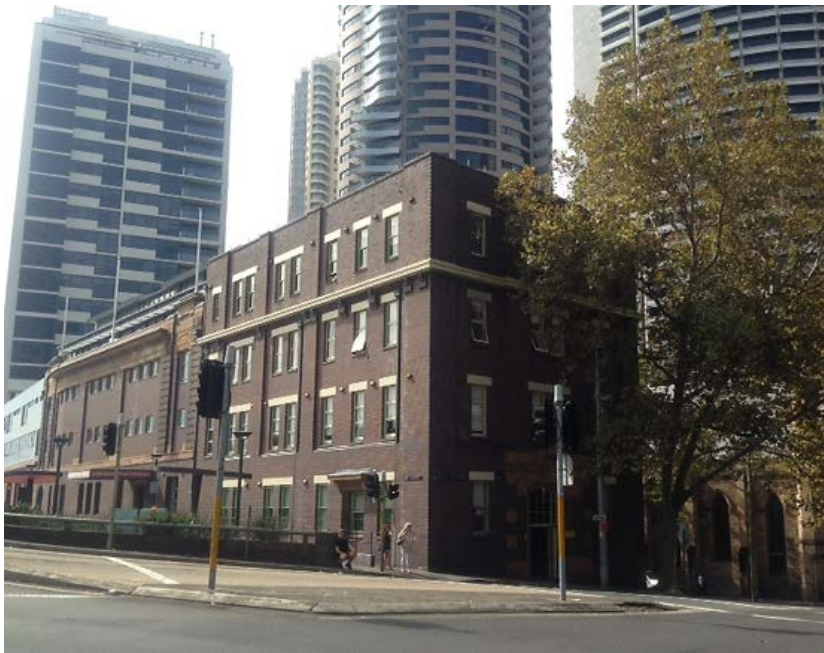
Figure 96: Resumed Properties Branch and Housing Board building government office building 16-18 Grosvenor Street, designed by Housing Board Principal Architect, Foggitt built 1920-21. Source: Sydney Harbour Foreshore Authority, M Stacy, 2016.

- NSW Housing Board building at 16-18 Grosvenor Street, The Rocks, built as a government office built 1920-21.
- The Ajax Building, a warehouse built 1917 an innovative design by William Henry Foggitt by the recently formed NSW Housing Board, believed to be the first building in Sydney constructed with a reinforced concrete skeleton, a method to become standard in building construction.⁵¹

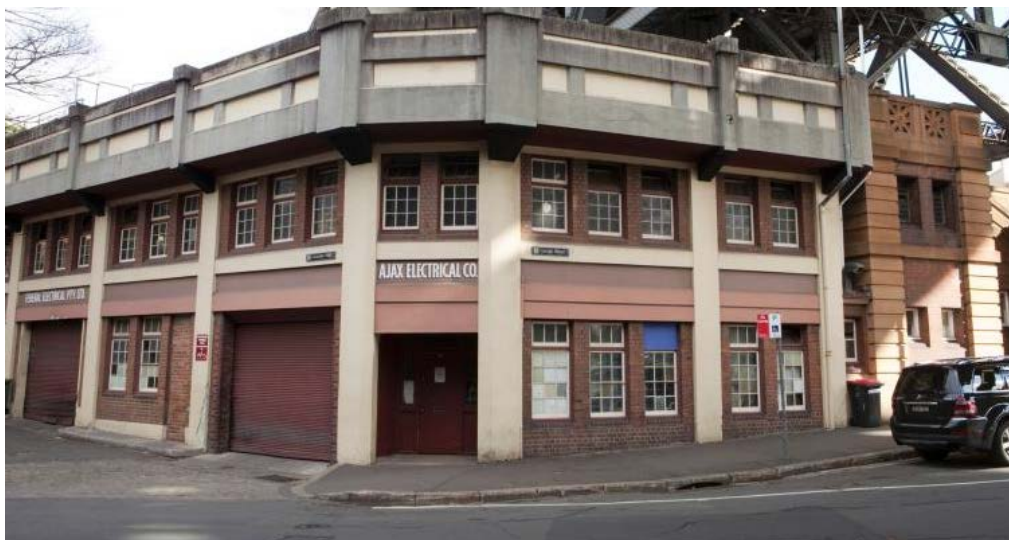
Figure 97: Ajax Building, 23 George Street, The Rocks. An innovative warehouse building designed by Housing Board Principal Architect, Foggitt built 1917. Source: Sydney Harbour Foreshore Authority S170 Register.

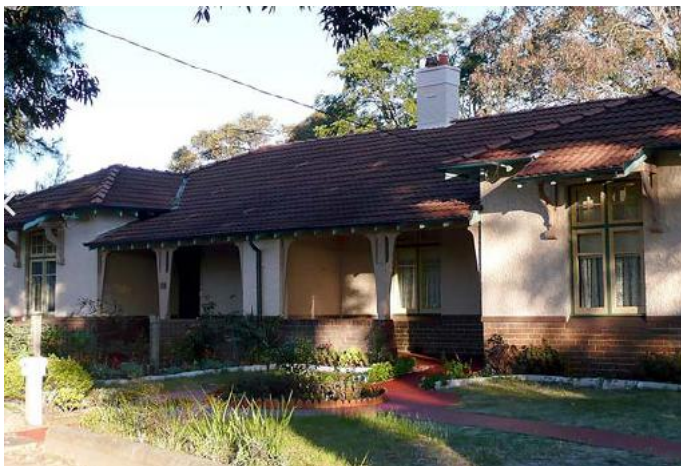
Figure 98: Daceyville housing designed by Housing Board Principal Architect, Foggitt built 1912-1920 <https://en.wikipedia.org/wiki/Daceyville>, Wikipedia, downloaded April 2016.

The houses were designed as free standing cottages as Interwar Bungalows with Queen Anne timber features, face brick construction with pebblecrete wall finishes and chimneys

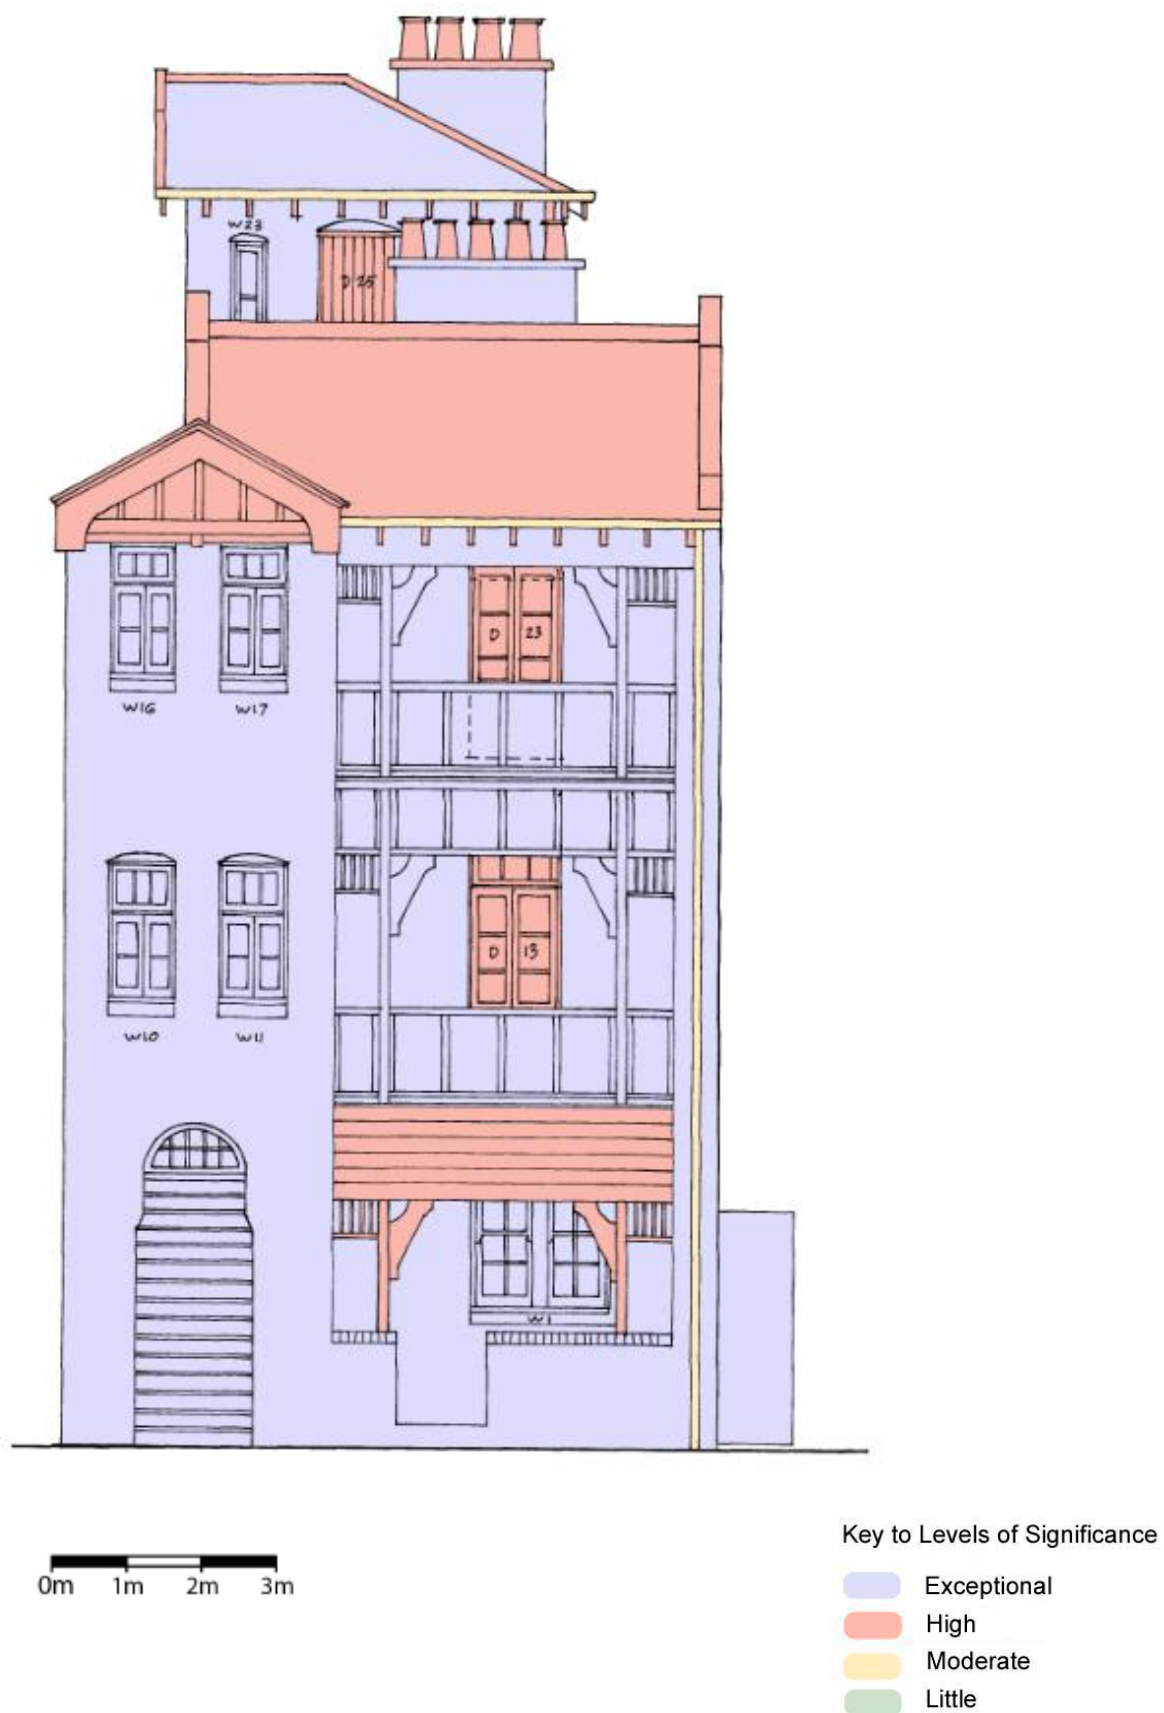
Figure 100: 117-117A Gloucester Street – East elevation grading of significant elements and fabric

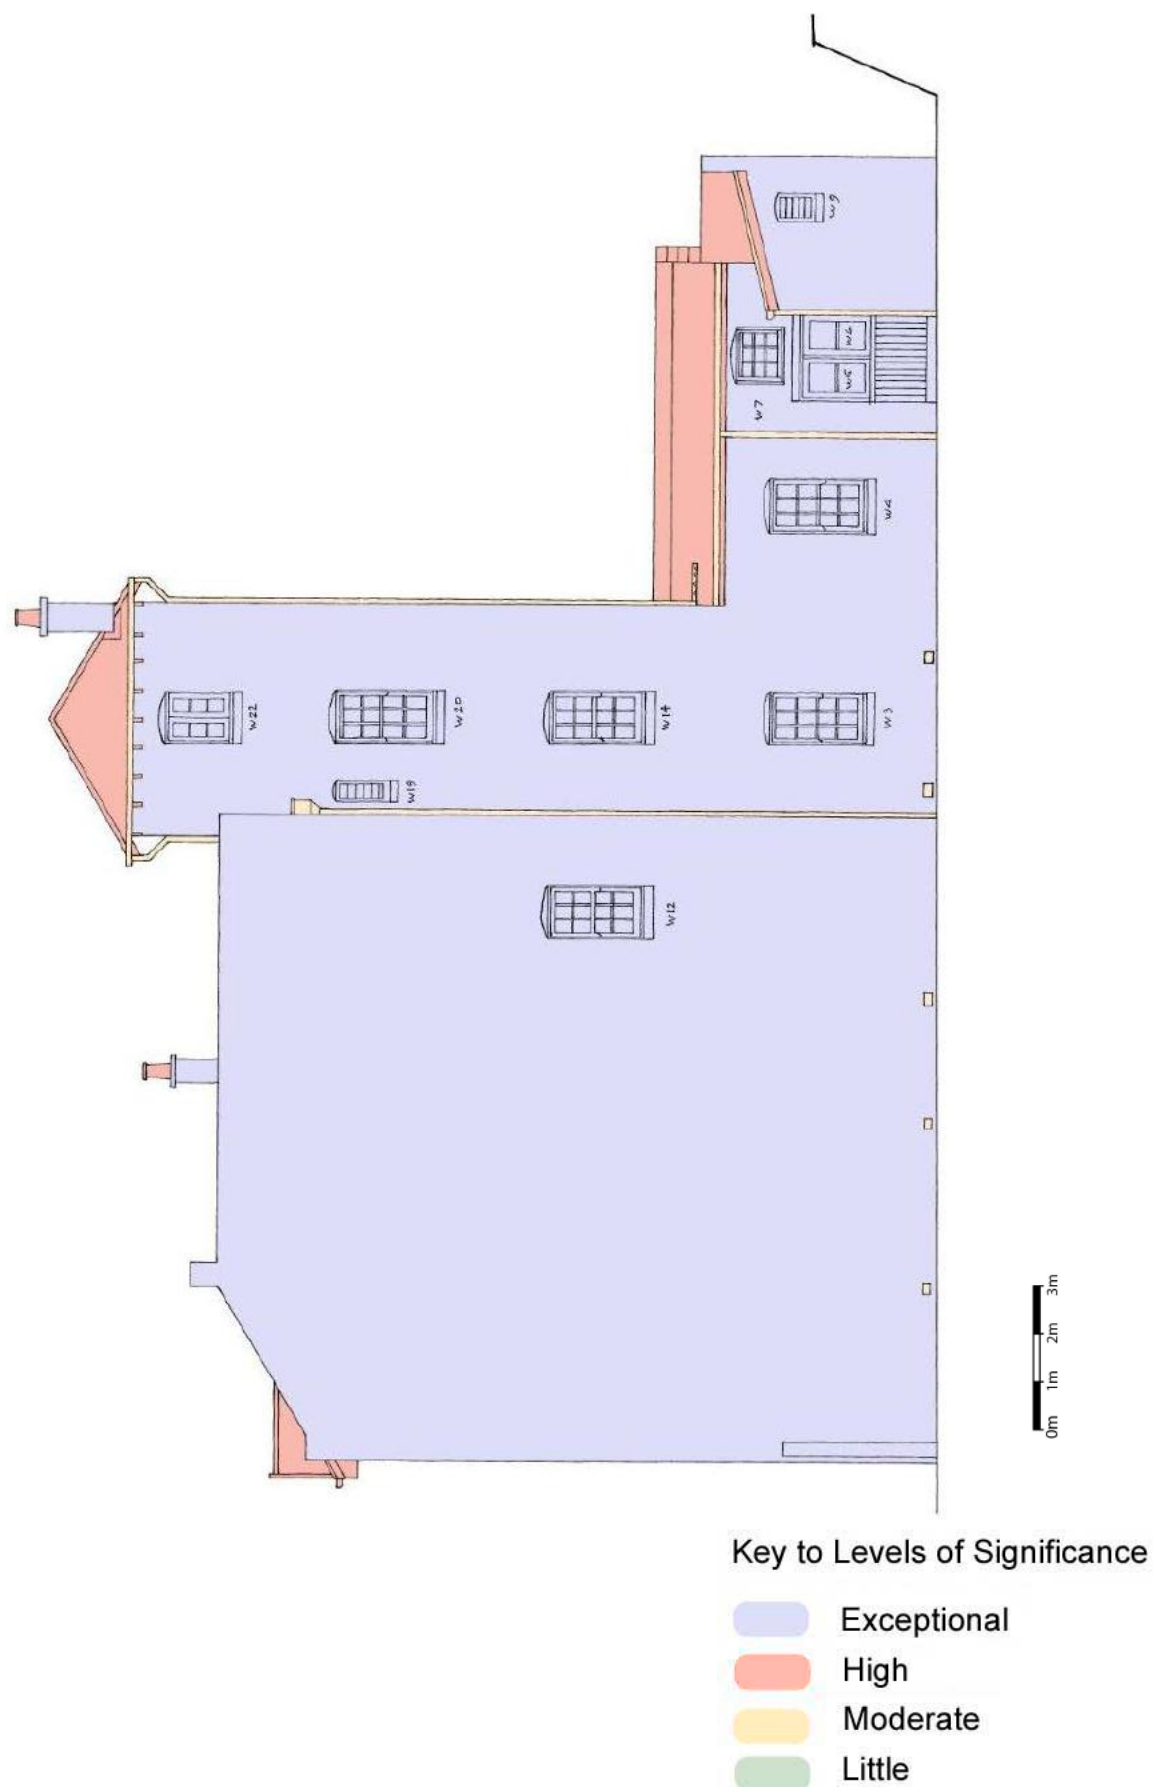
Figure 102: 117-117A Gloucester Street – North elevation grading of significant elements and fabric

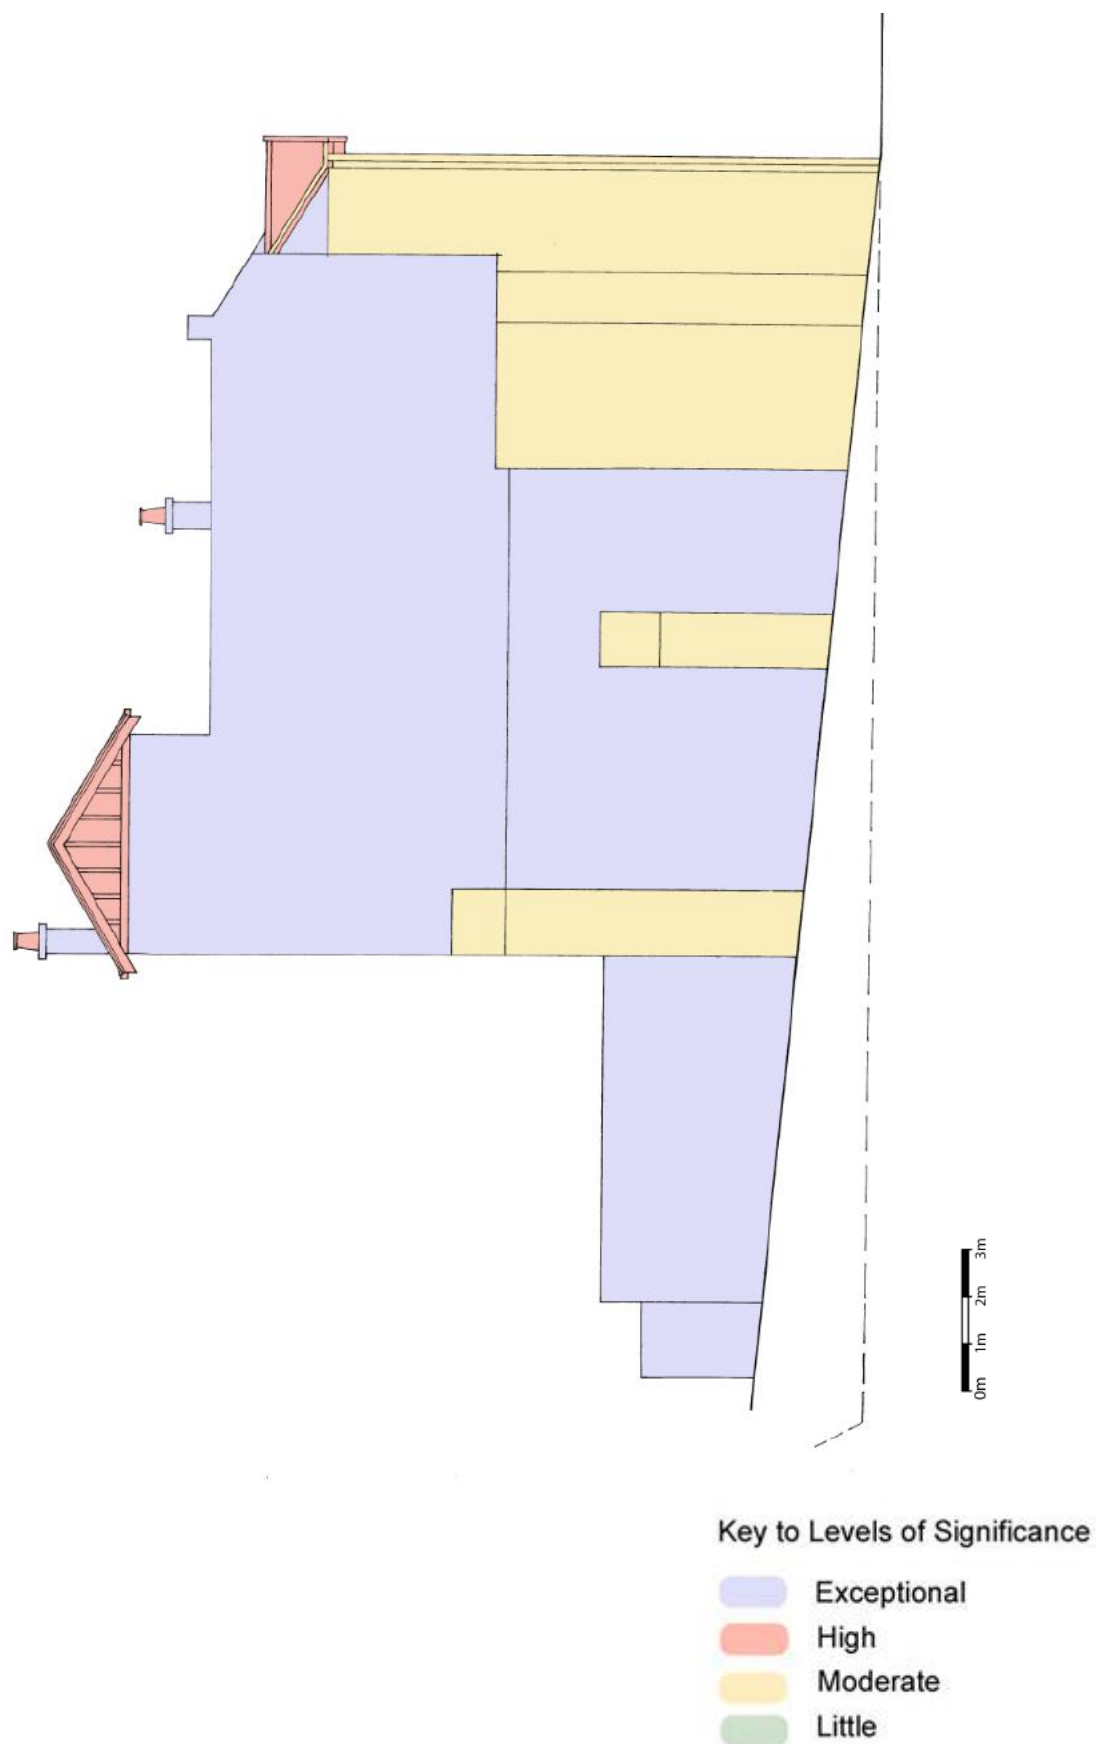
Figure 103: 117-117A Gloucester Street – South elevation grading of significant elements and fabric

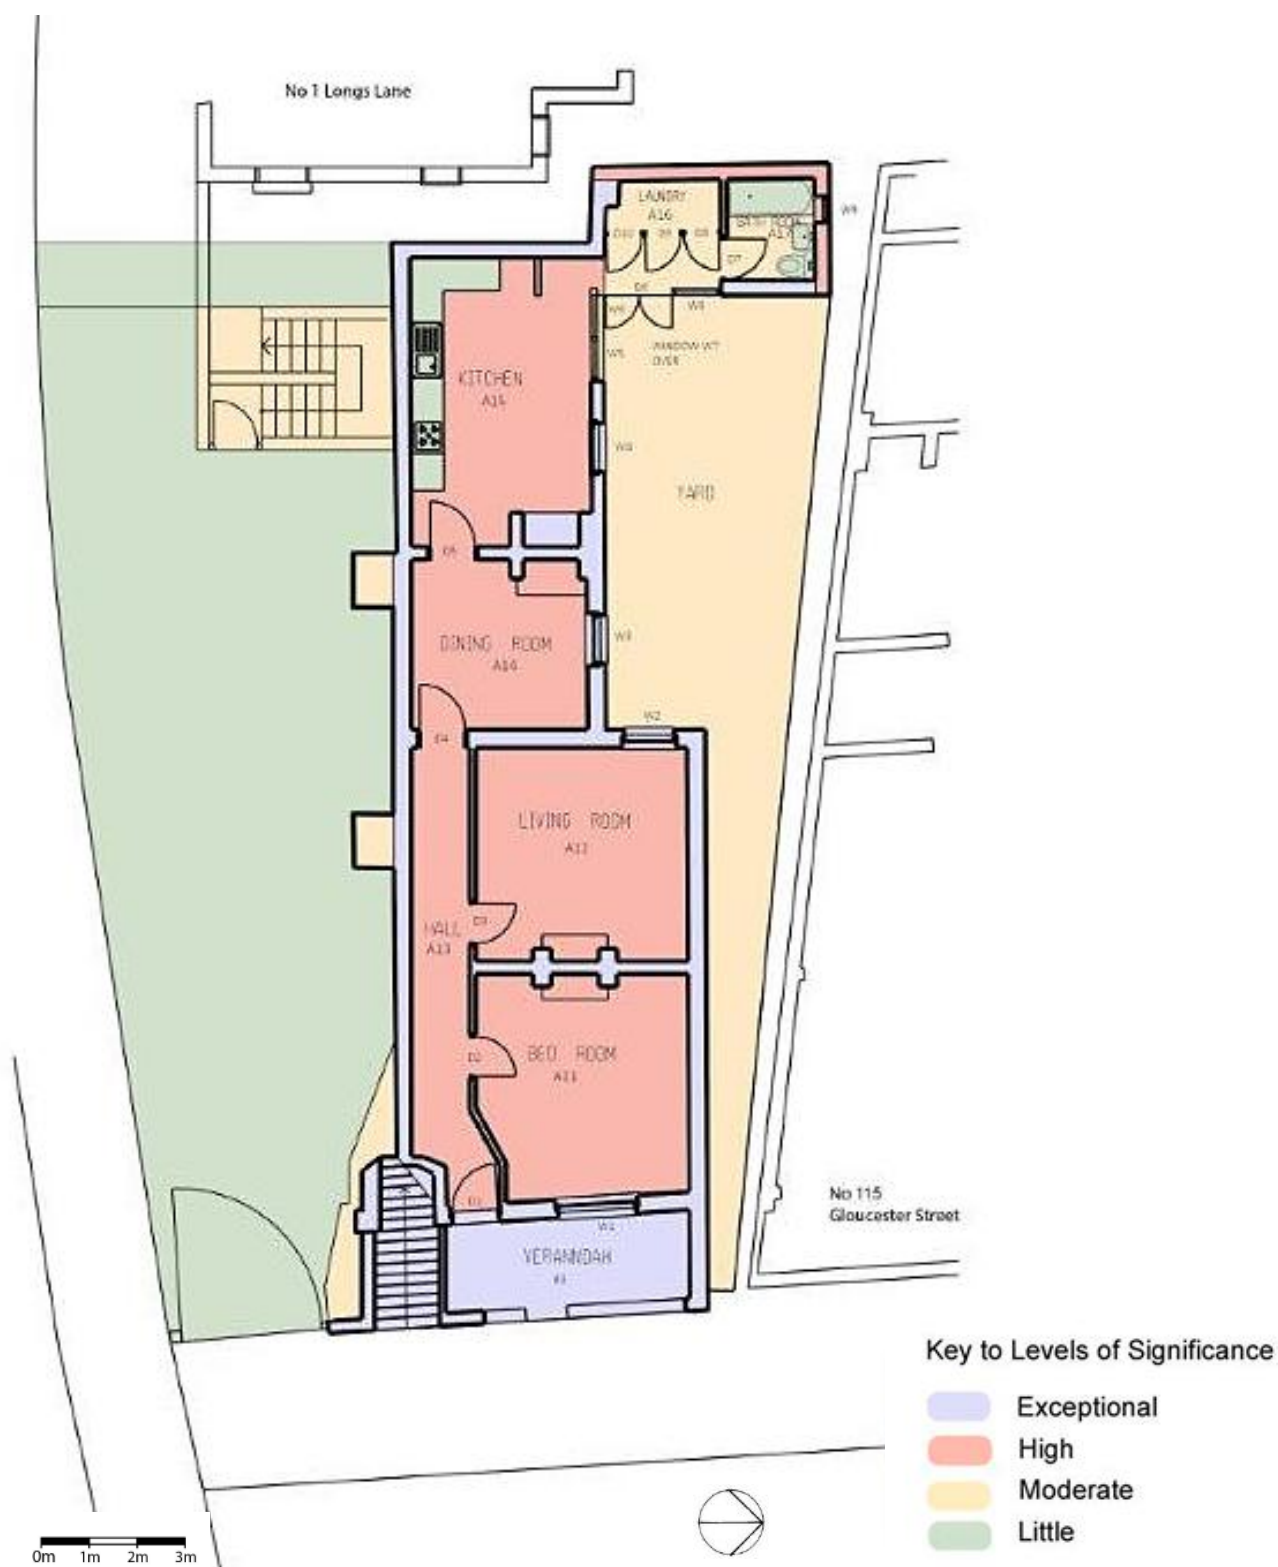
Figure 104: 117-117A Gloucester Street – Ground floor grading of significant elements and fabric

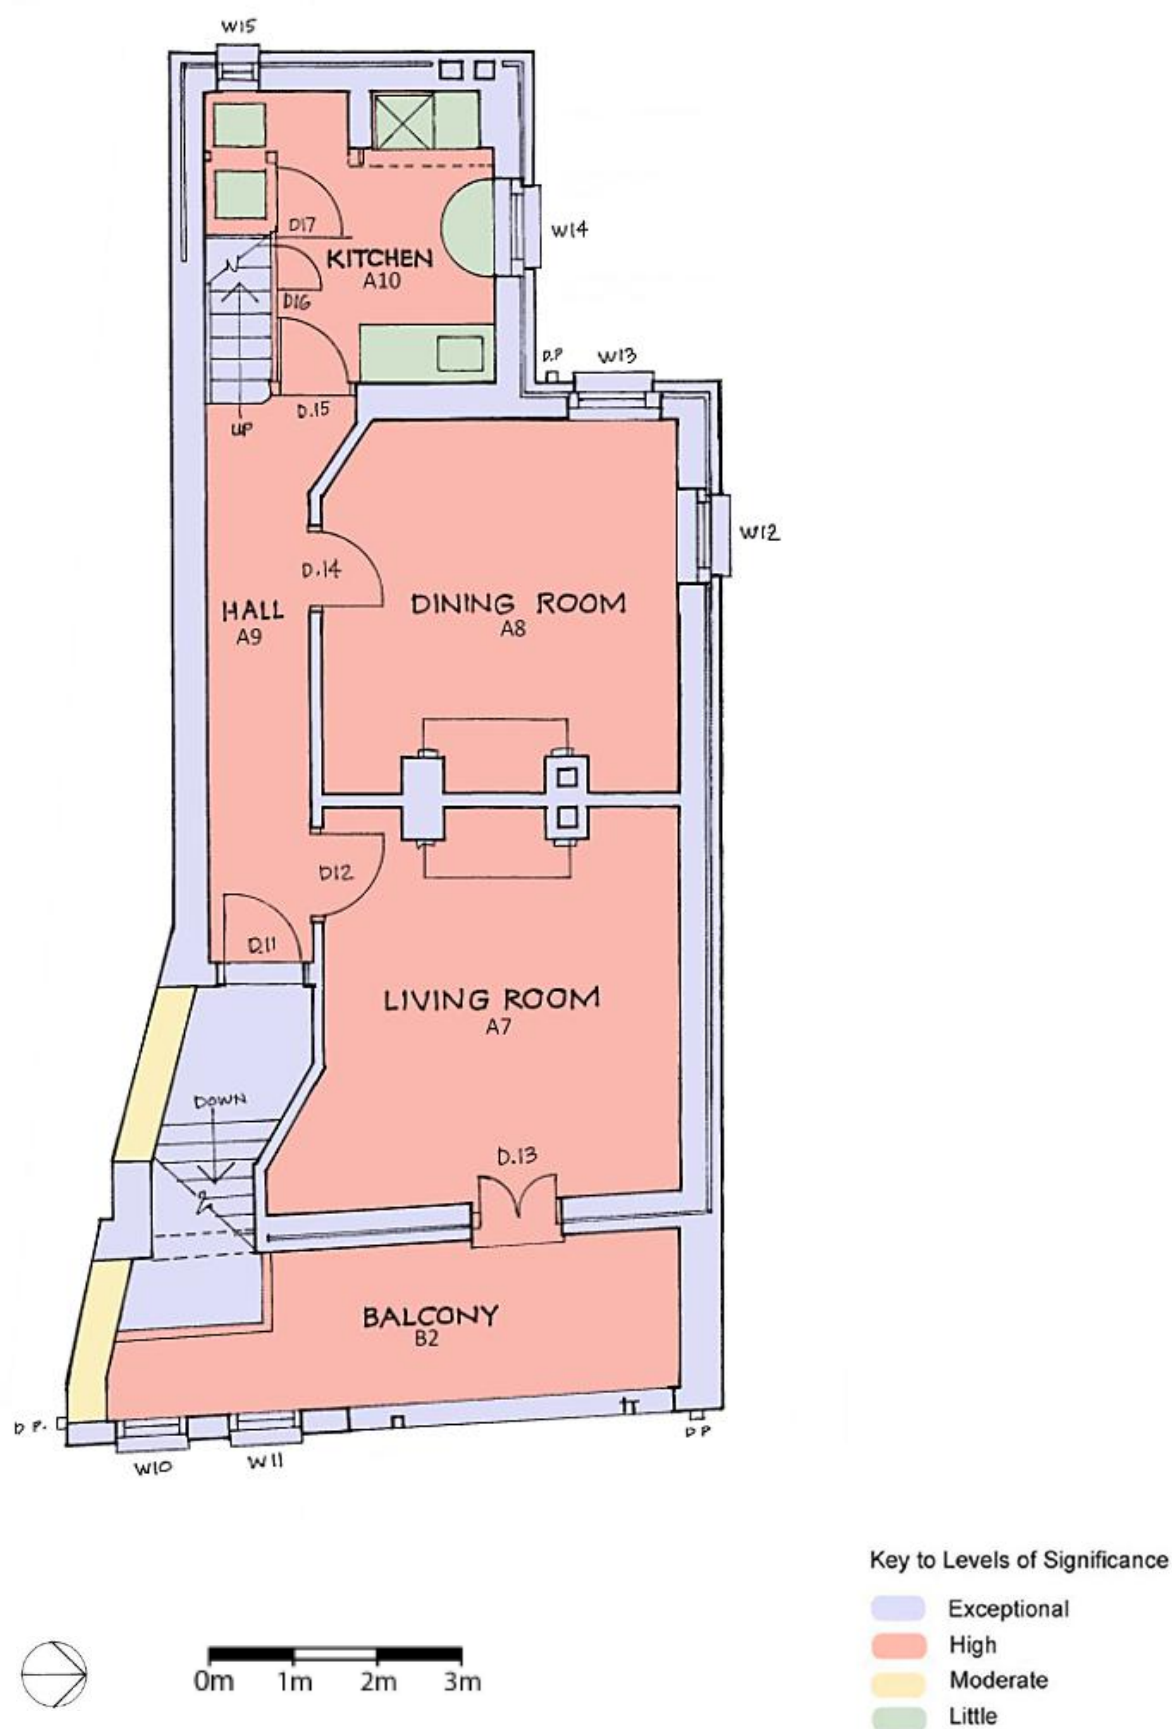
Figure 105: 117-117A Gloucester Street – First floor grading of significance

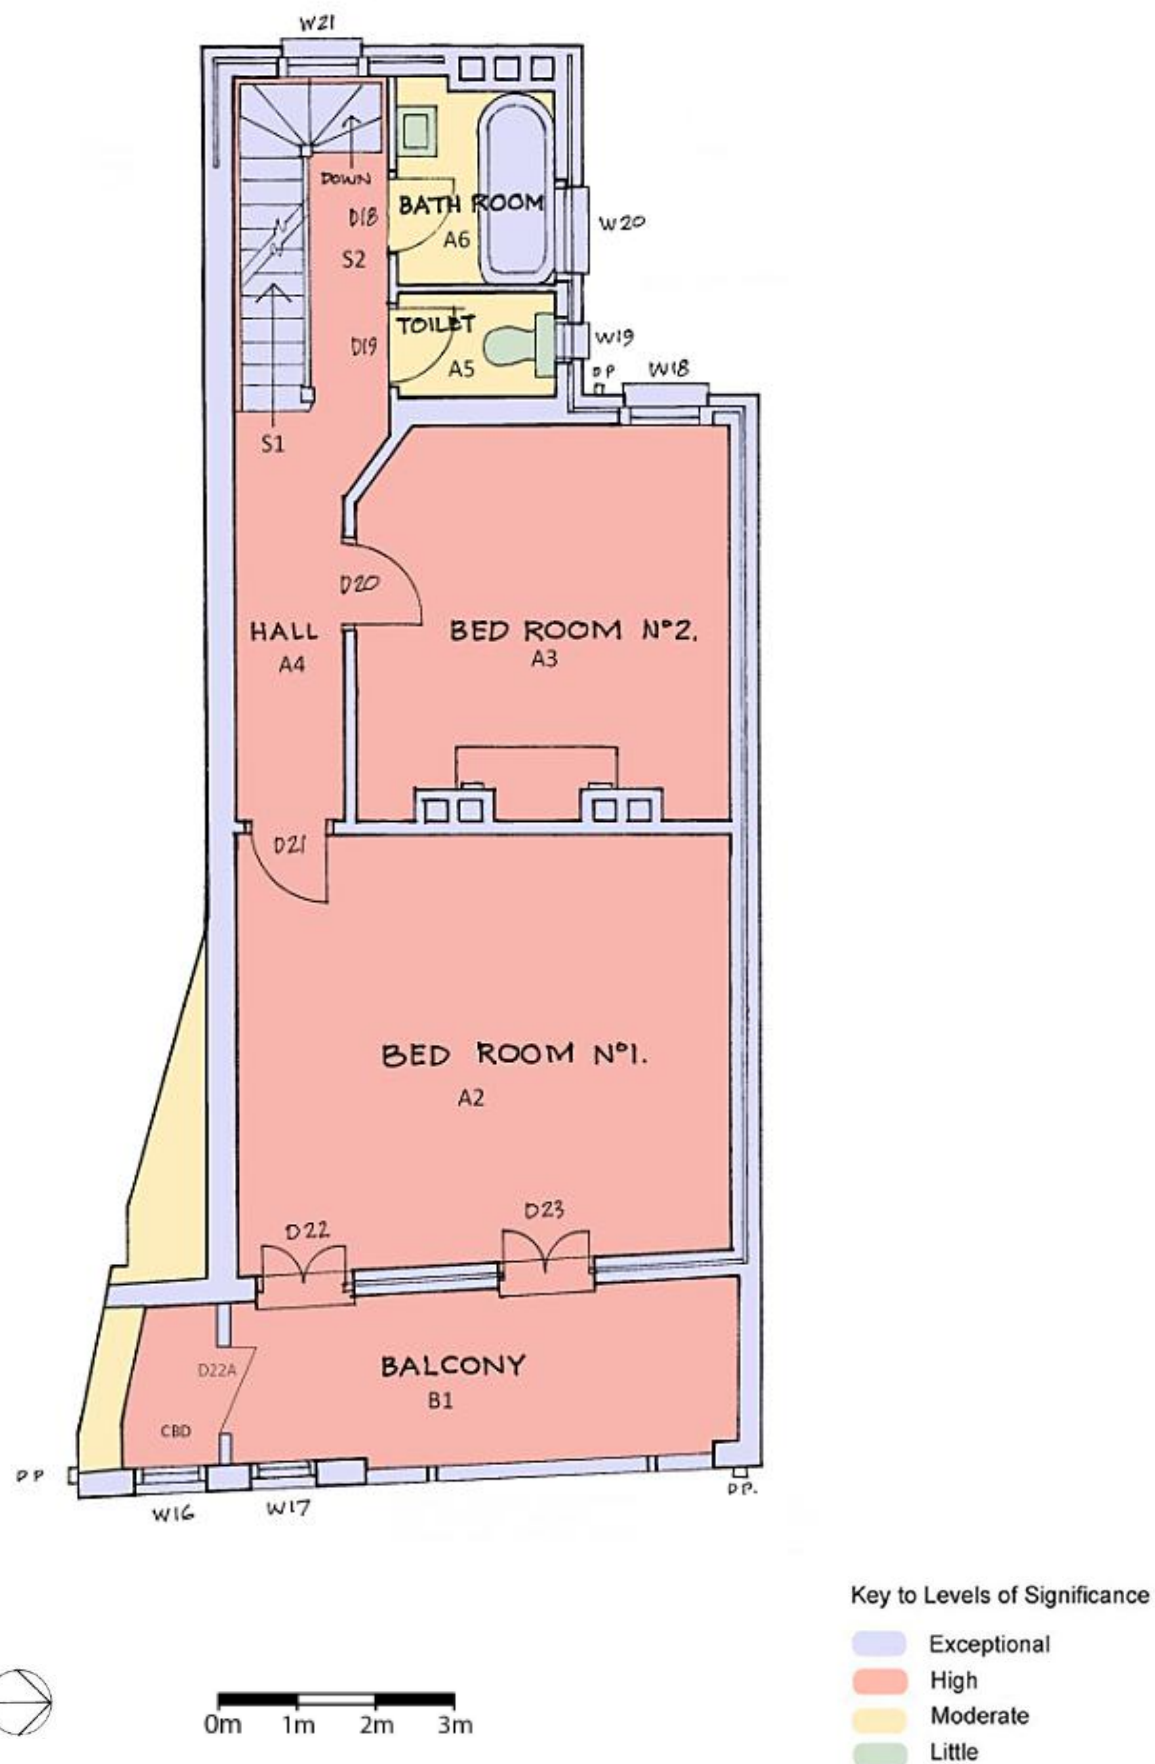
Figure 106: 117-117A Gloucester Street – Second floor grading of significance.
