# 136-138 Cumberland Street, The Rocks, Conservation Management Plan

October 2024

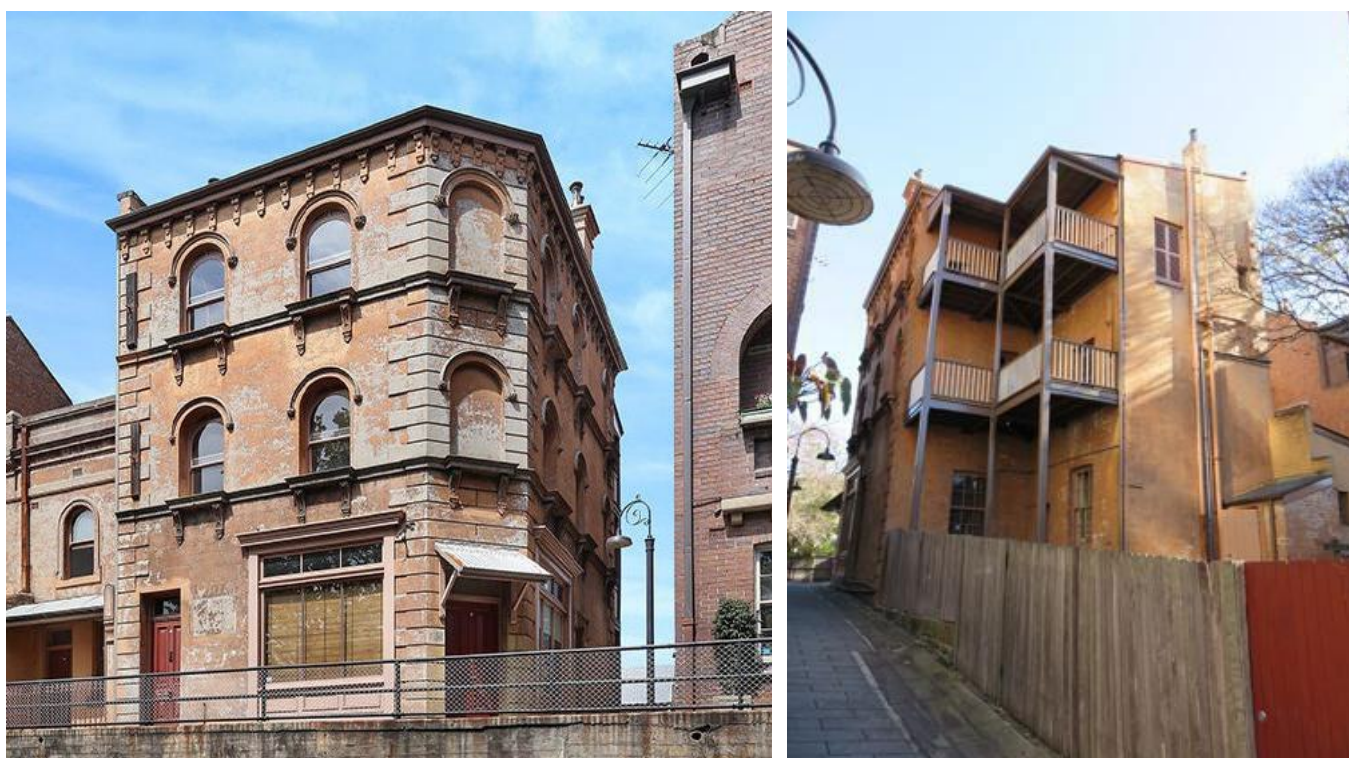
Figure 4 and Figure 5: 136-138 Cumberland Street, front and rear elevation, showing the subject property. Source: PMNSW

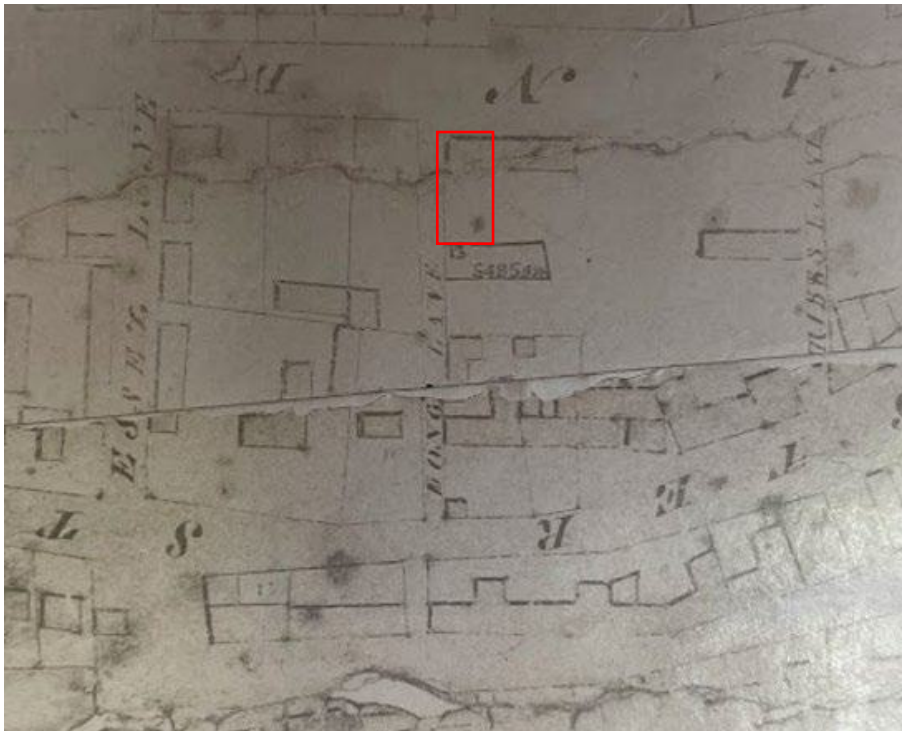
Figure 12: Excerpt from the Stewart 1880 tracing of Barkers 1823 Map showing the Longs Lane Precinct in 1823, the location of the subject site is outlined in red. Source: SLNSW

These cottages were erected in rows that followed the naturally occurring rock ledges. One such sandstone ledge passes through the study site. The remnants of the rows of cottages built following the sandstone ledges can be seen on surveys prepared by Harper and Stewart dating from c. 1822-25 (Figure 12). These rock outcrops were often quarried to provide stone blocks for building, as was found on the Big Dig site immediately to the north of 130 Cumberland Street.

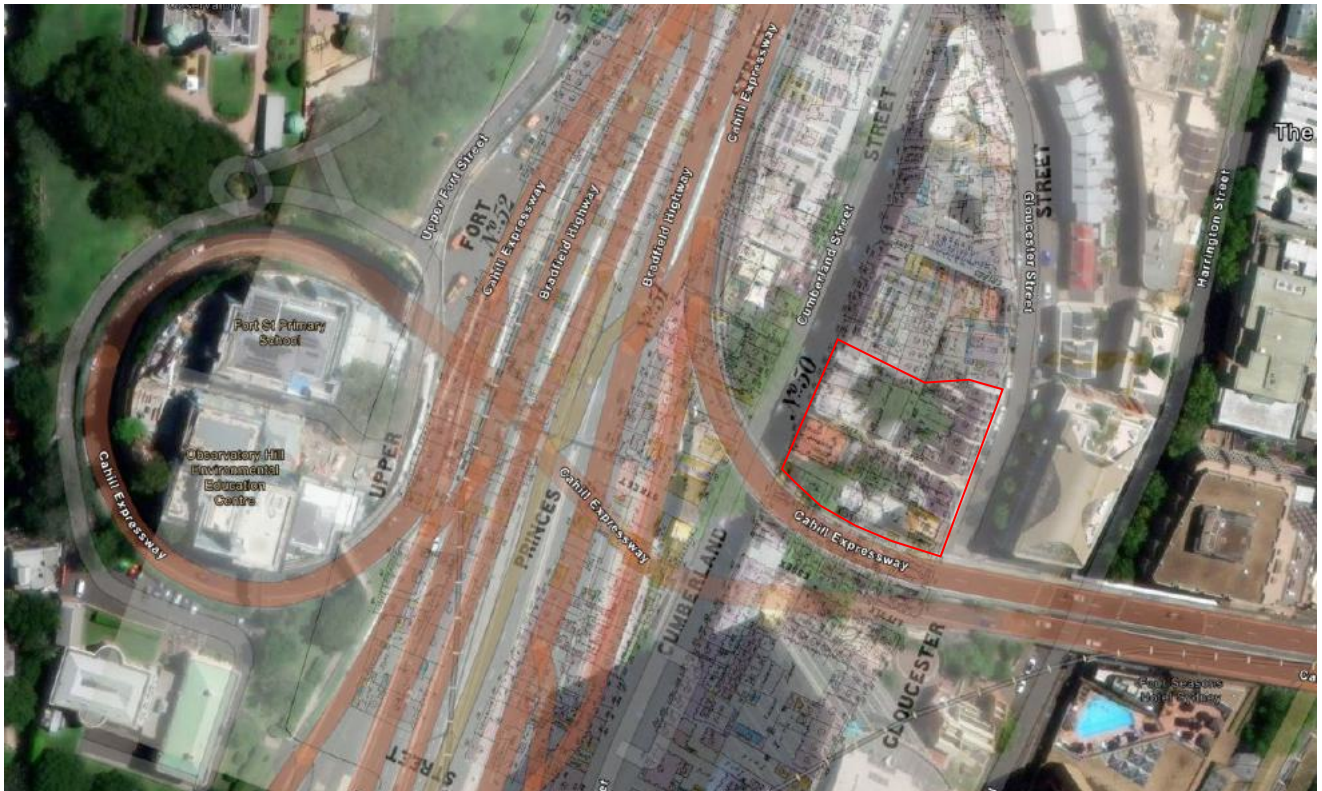
Figure 13: Dove's Plans of Sydney, 1880 Map 21 - Blocks 50, 51, 52, overlayed on modern map, showing the previous alignment of Princes Street and its now demolished housing stock, now completely covered by the Cahill Expressway and Bradfield Highway. The Longs Lane Precinct is outlined in red. Source: PMNSW, ESRI Basemap.

The construction of the Sydney Harbour Bridge between 1923 and 1932 saw the demolition of some 400 houses in Princes Street, Upper Fort Street, and the western side of Cumberland Street. Princes Street itself disappeared from the map beneath the Bradfield Highway and the Cahill Expressway, with the alignment of the street following the approach to the Harbour Bridge only. This development can be seen in the overlay of Map 21 of Dove's Plan of Sydney 1880 over modern day Sydney (Figure 13).

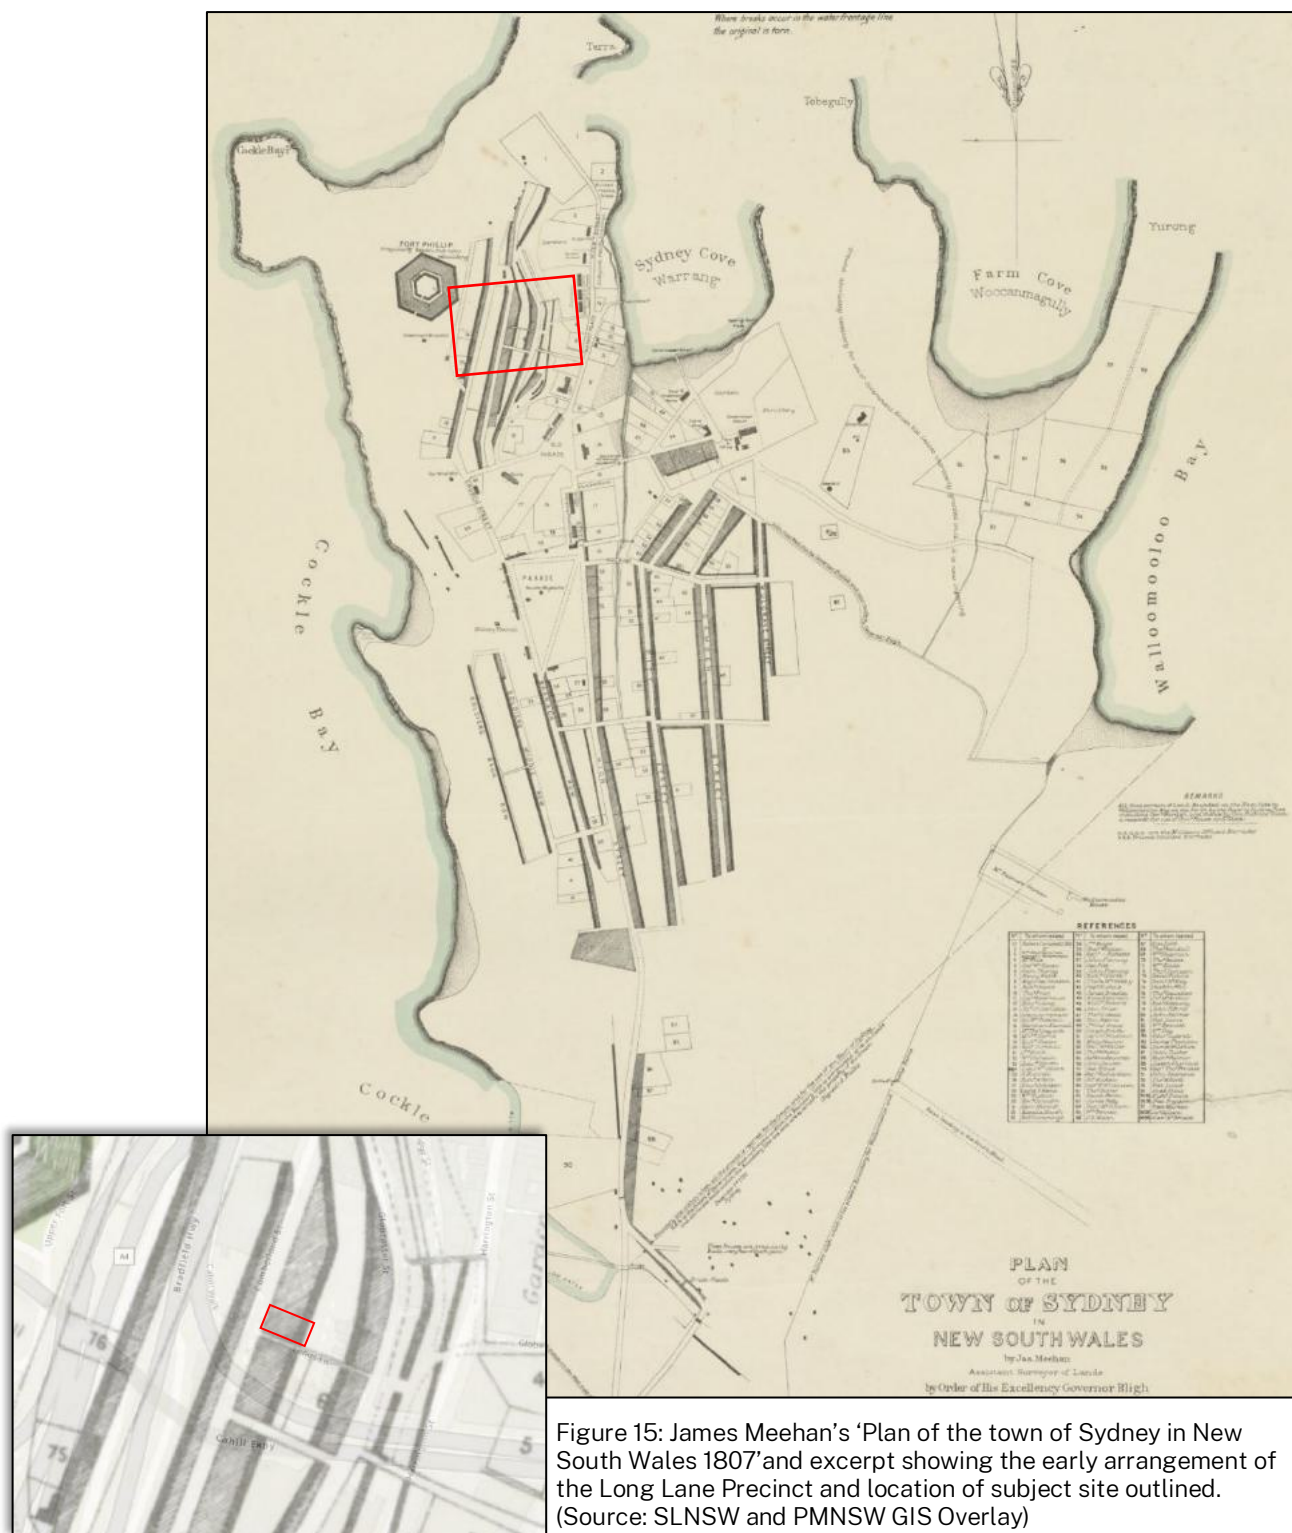
Figure 15: James Meehan's 'Plan of the town of Sydney in New South Wales 1807' and excerpt showing the early arrangement of the Long Lane Precinct and location of subject site outlined. (Source: SLNSW and PMNSW GIS Overlay)

Early plans and images, such as Watling's (attrib.) c. 1800 painting *Sydney - Capital New South Wales* (Figure 14) and Meehan's 1807 *Plan of Sydney Town* (Figure 15) show that present-day Gloucester Street between Essex and Argyle Streets was closely settled along a defined building alignment. These dwellings are likely to have been flimsy timber houses, built by the occupants (convicts and free settlers)<sup>27</sup>.

The earliest reference to Long's Lane is made in Meehan's 1807 map, where the present-day lines of Cumberland and Gloucester Streets are shown to have been formed with an interconnection along the alignment of Long's Lane. Development within the precinct occurred predominantly in the 1880s and in the first decades of the 20th century.

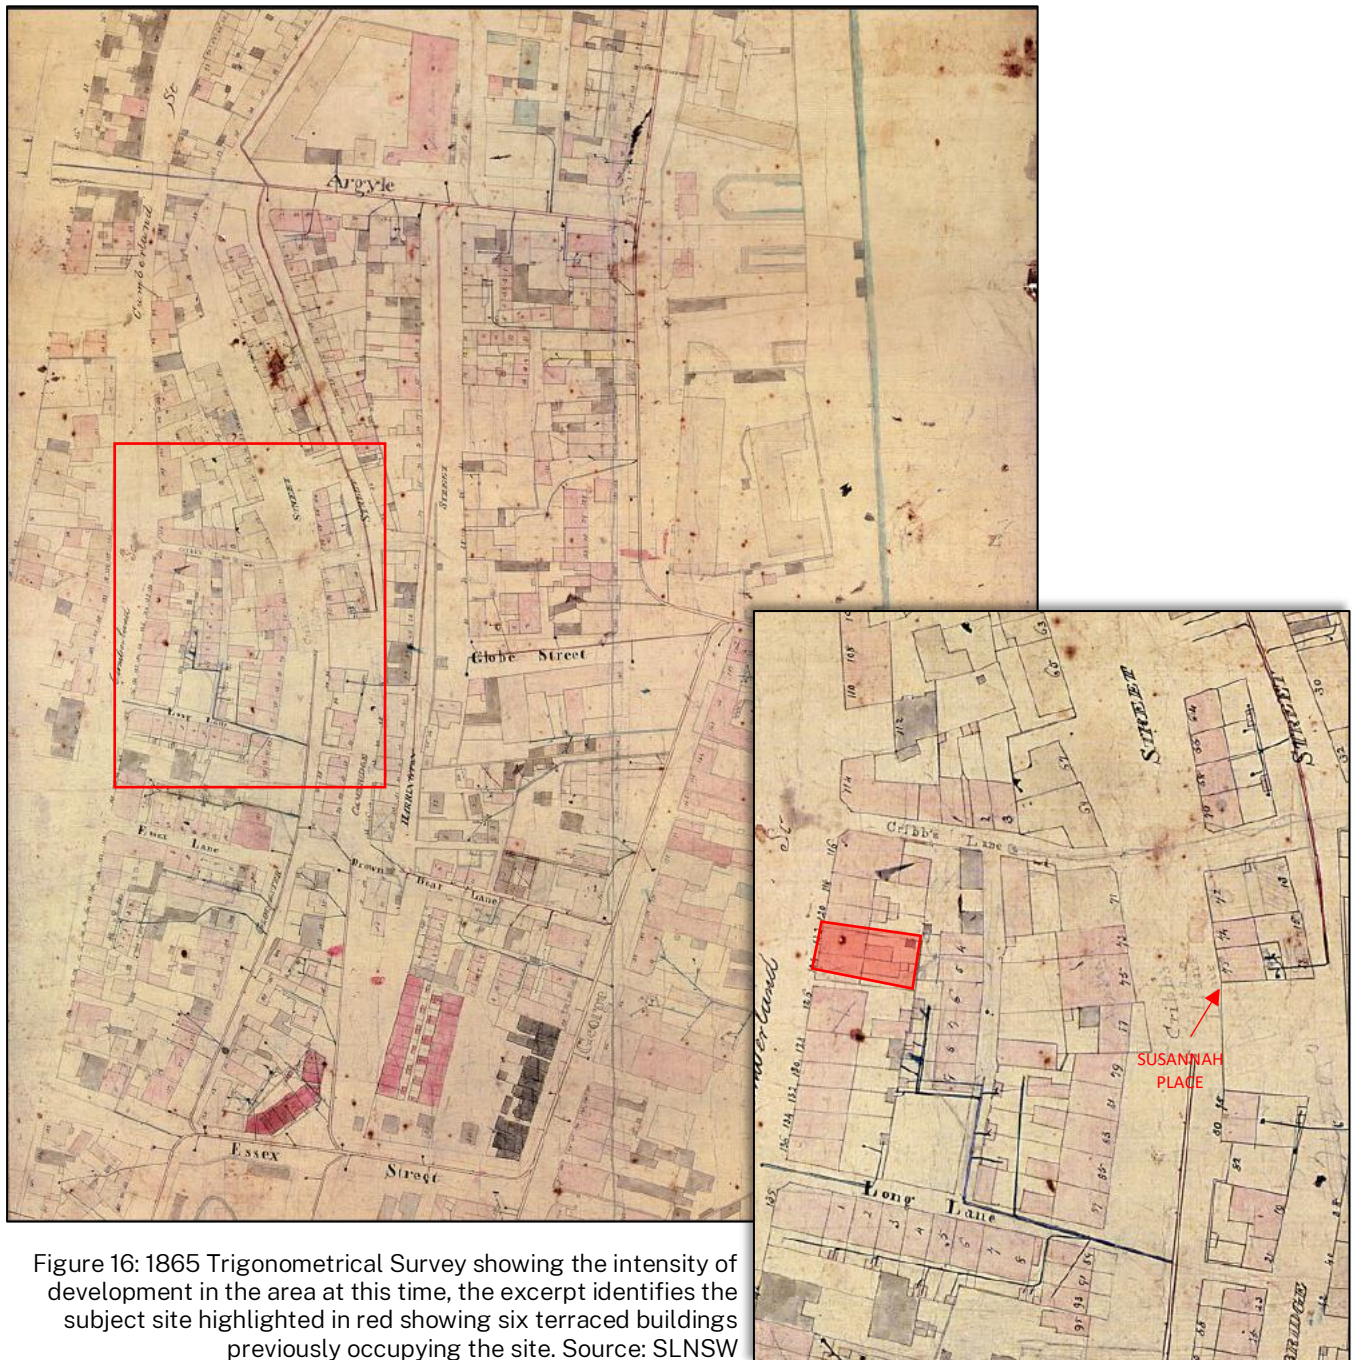
Figure 16: 1865 Trigonometrical Survey showing the intensity of development in the area at this time, the excerpt identifies the subject site highlighted in red showing six terraced buildings previously occupying the site. Source: SLNSW

The 1865 Trigonometrical Survey of Sydney (Figure 16) shows the dense development occurring along the Cumberland and Gloucester Street alignment at this time. The subject site was on the location of previous terraces numbered 134 & 136, with 138 Cumberland Street located on the opposite side of Longs Lane, (the current day 140 Cumberland Street).

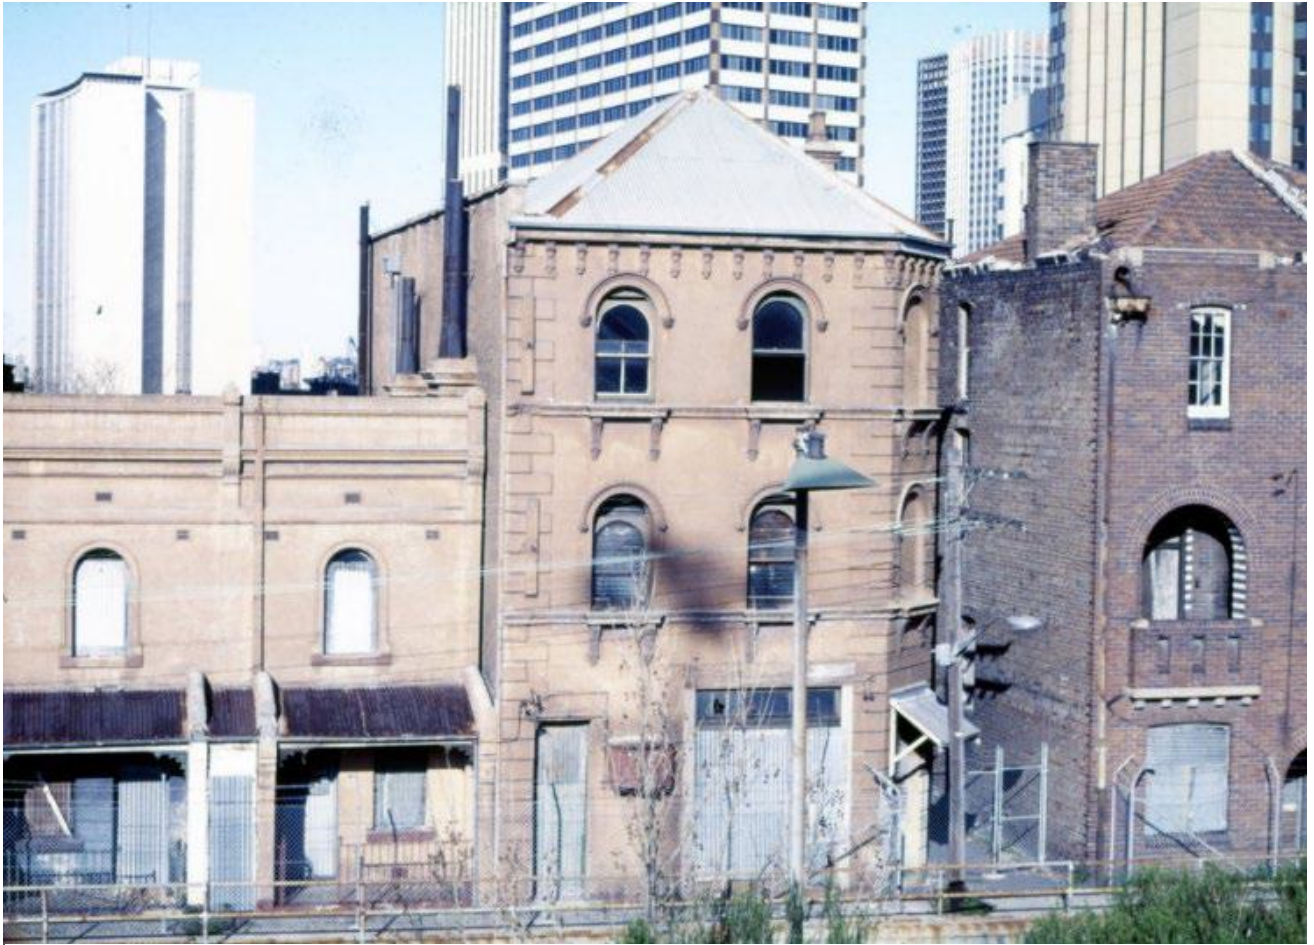
Figure 26: View east from Sydney Harbour Bridge of terrace houses, 130-138 and 140-142 Cumberland Street, The Rocks, with Longs Lane between them, 1983. All are derelict, with corrugated iron on ground floor windows, and wire mesh fence with barbed wire around them. Source: City of Sydney Archives

The terraces along Cumberland Street were vacated by the early 1970s, were boarded up to deter vandalism and became home to squatters. They continued to fall into a dilapidated state throughout the 1980s (Figure 26) until their conservation in the 1990s.

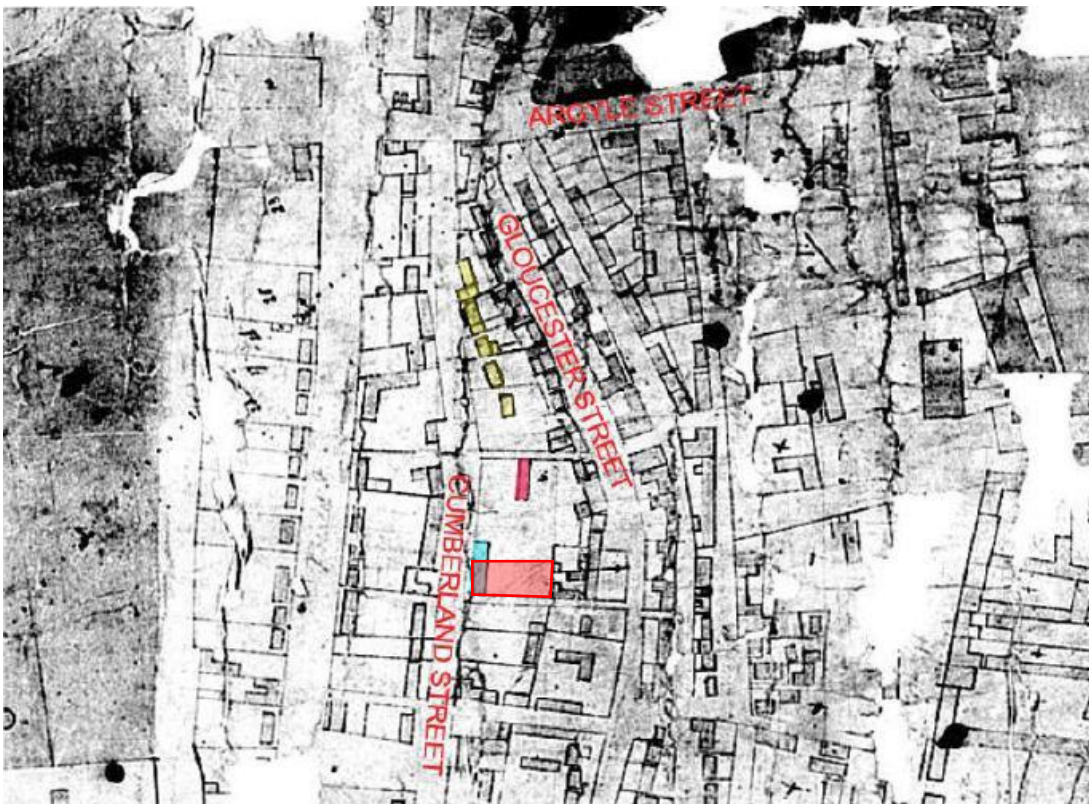
Figure 27: Extract from Stewart's 1823 survey showing the Longs Lane precinct (outlined in red dash line). Source CMP for 140-142 Cumberland Street by CLSP, using SRNSW SZ 469 as a base.

Harper's survey of 1823 shows a long narrow building on the corner of Long's Lane and Cumberland Street. There was a stable building on this lot, which was of a similar scale, located to the south of Cribb's Lane, for which archaeological remains can be seen in the "Big Dig" site (shown Figure 27). The building erected on the corner of Cumberland Street and Long's Lane is likely to have been a row of attached cottages, one room deep. The building erected on the corner of Cumberland Street and Long's Lane was a row of attached cottages, one room deep. The houses were built in the early 1820s by George Cribb, and among the tenants in 1822 were John and Mary Seabrook, Thomas Kinnaird, Catherine Murphy and Mary Massagora and their respective children<sup>50</sup>.

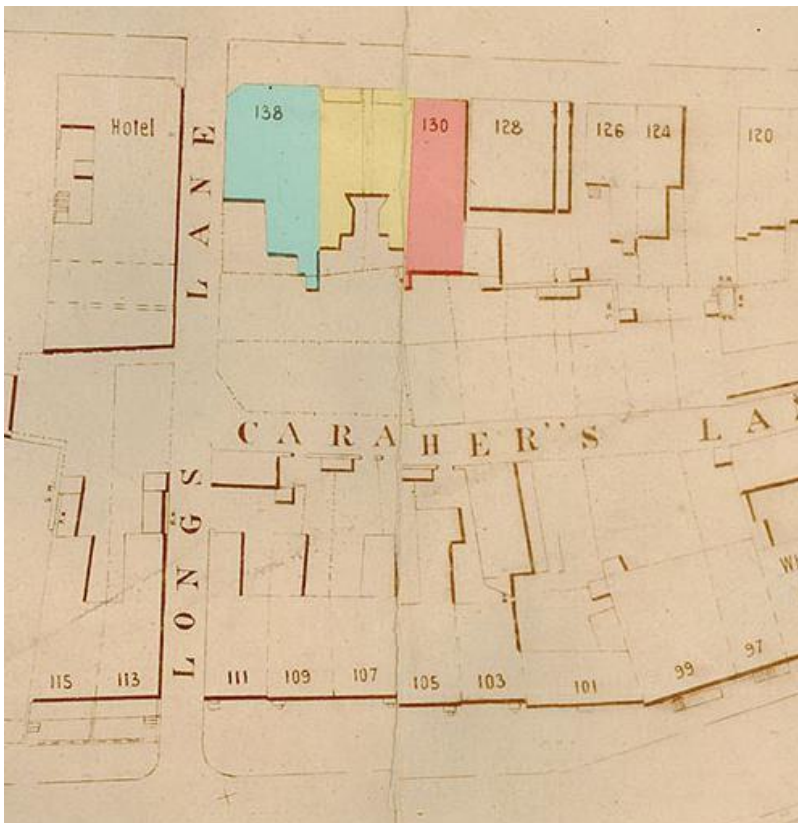
Figure 35: Extract from the 1890 Metropolitan Detail Series block plan of Section 74 showing the three buildings erected during the 1880s and early 1890s, No. 130 (pink), 132-134 (yellow) and No. 138 (blue).

By 1882 the two houses on the corner of Long's Lane had been pulled down and a new three-storey shop erected for Kellas Watson. By 1886, No.130 had been rebuilt and was in operation as a boarding house. Nos 132-134 were the last buildings to be rebuilt as they do not appear on the 1889 metropolitan detail series plan (Figure 34) but can be seen on the plan dating from 1890 (Figure 35).

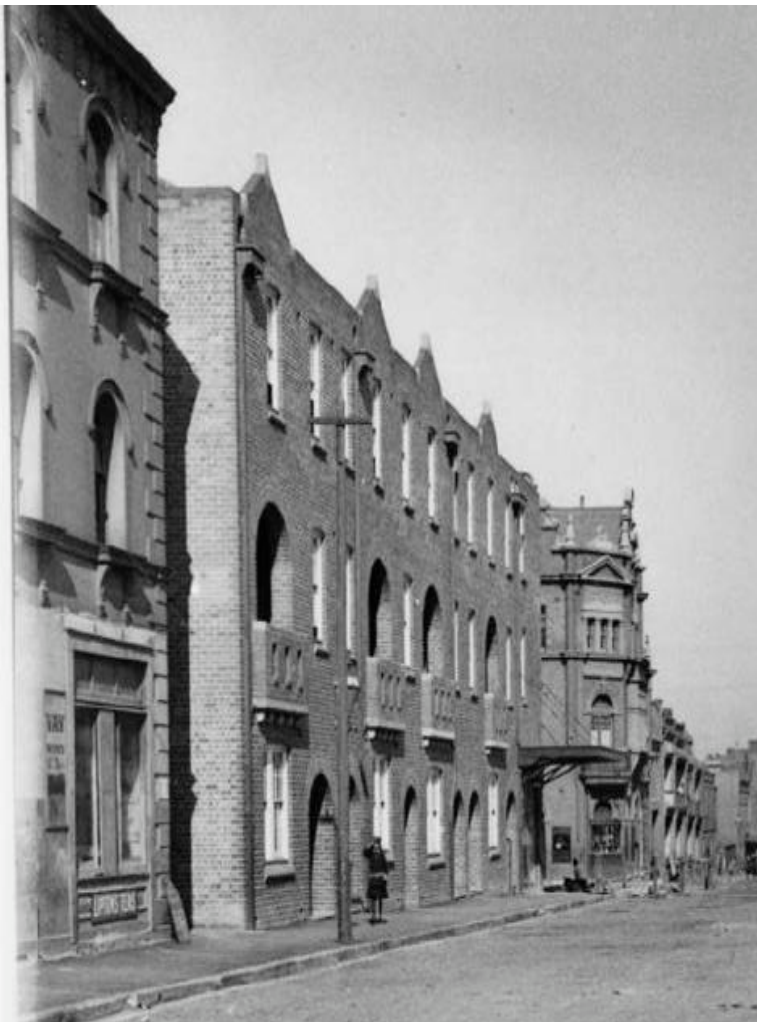
Figure 41: View of the completed workmen's dwellings in Cumberland Street showing the shop front of 136-138 Cumberland Street on the left. Photo NSW Government Printer July 1914. The awning over the footpath had been removed by this time. Source: SHFA

A glimpse of part of the shop front at No. 138 can be seen in the photograph of the recently completed block of workers housing at that extended south from No. 140, turning the corner into Little Essex Street, and returning into Gloucester Street (Figure 41). This block was one of the first erected by the NSW Housing Board following its formation in March 1912. The majority of this block was demolished when the Cahill Expressway was constructed. The awning to the shop front of No 136-138 Cumberland Street that had extended to the edge of the pavement, which can be seen in the resumption photographs (Figure 40), had been removed and the pavement narrowed by the time the photograph was taken. Post- supported awnings were not permitted by

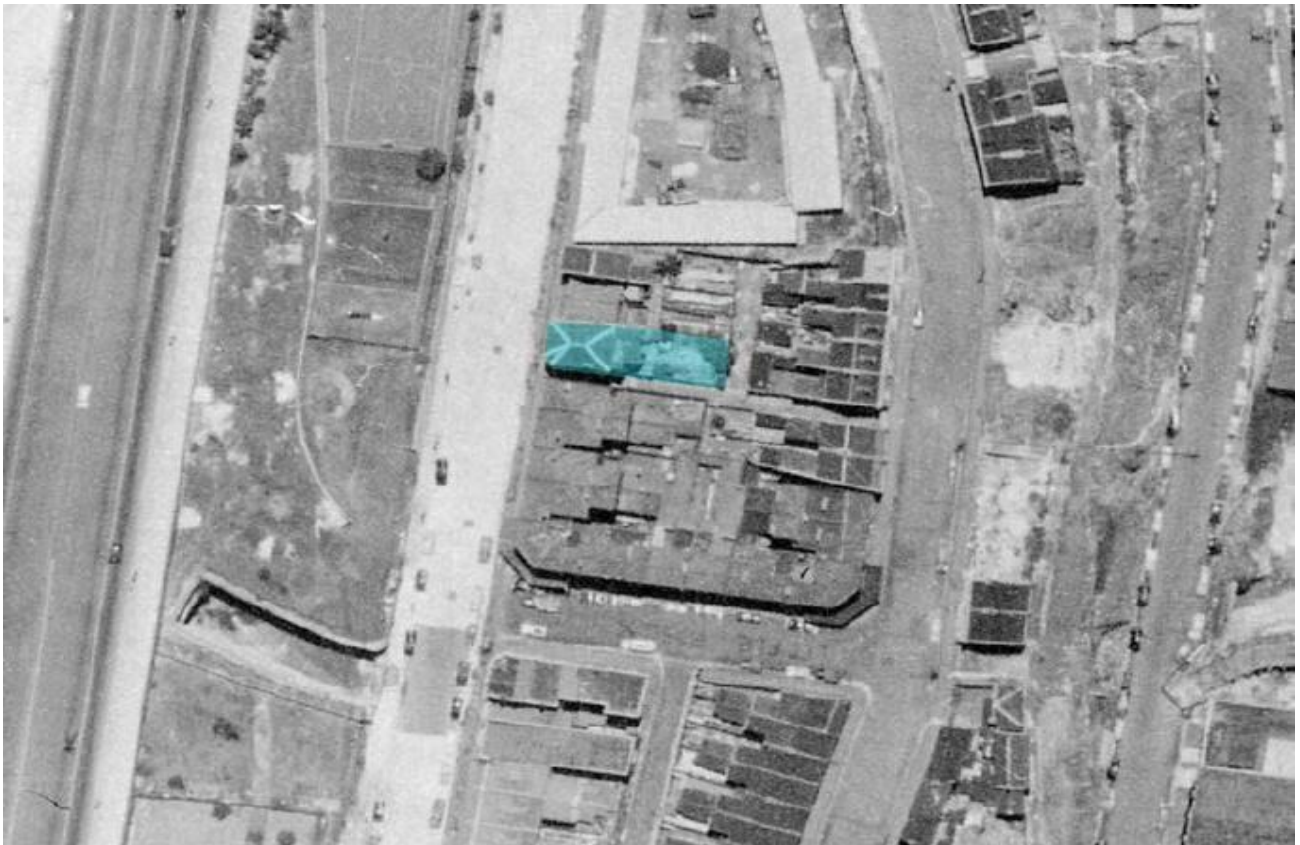
Figure 44: 1949 Aerial view showing the entrance to the circular cutting. Note also the intact Housing Board buildings around the southern end of the precinct (prior to demolition for the Cahill Expressway). The subject building is highlighted blue. Source: SCC Historic Atlas

In 1942 the National Emergency Services made an application to the MSB to use the premises as a Section Post. Following the attack by the Japanese on Sydney Harbour, a series of 203 sector warden posts was established across the city, one of which was located in the shop at 138 Cumberland Street. Partially excavated city railway tunnels were to be used as air raid shelters. The 1949 aerial photograph shows the extent of the King George V Park and the commencement to the circular cutting of the Bradfield Highway (Figure 44).

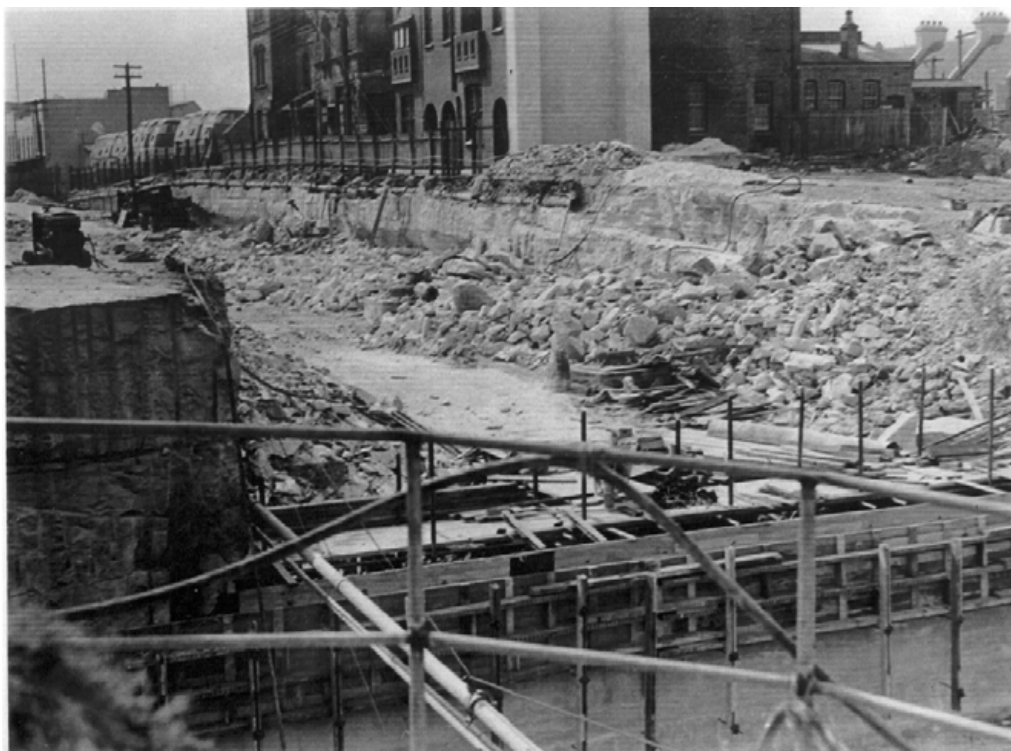
Figure 46: The lowering of Cumberland to allow the construction of the Cahill Expressway overpass over Cumberland Street, 1958. Source: SHFA

In the mid-1950s the Cahill Expressway was constructed, which necessitated the removal of the southern half of the block of workmen's dwellings erected by the Housing Board. The dwellings at the end of Gloucester Street and in Cumberland Street were retained, and the street level was cut down so that traffic could pass under the expressway.

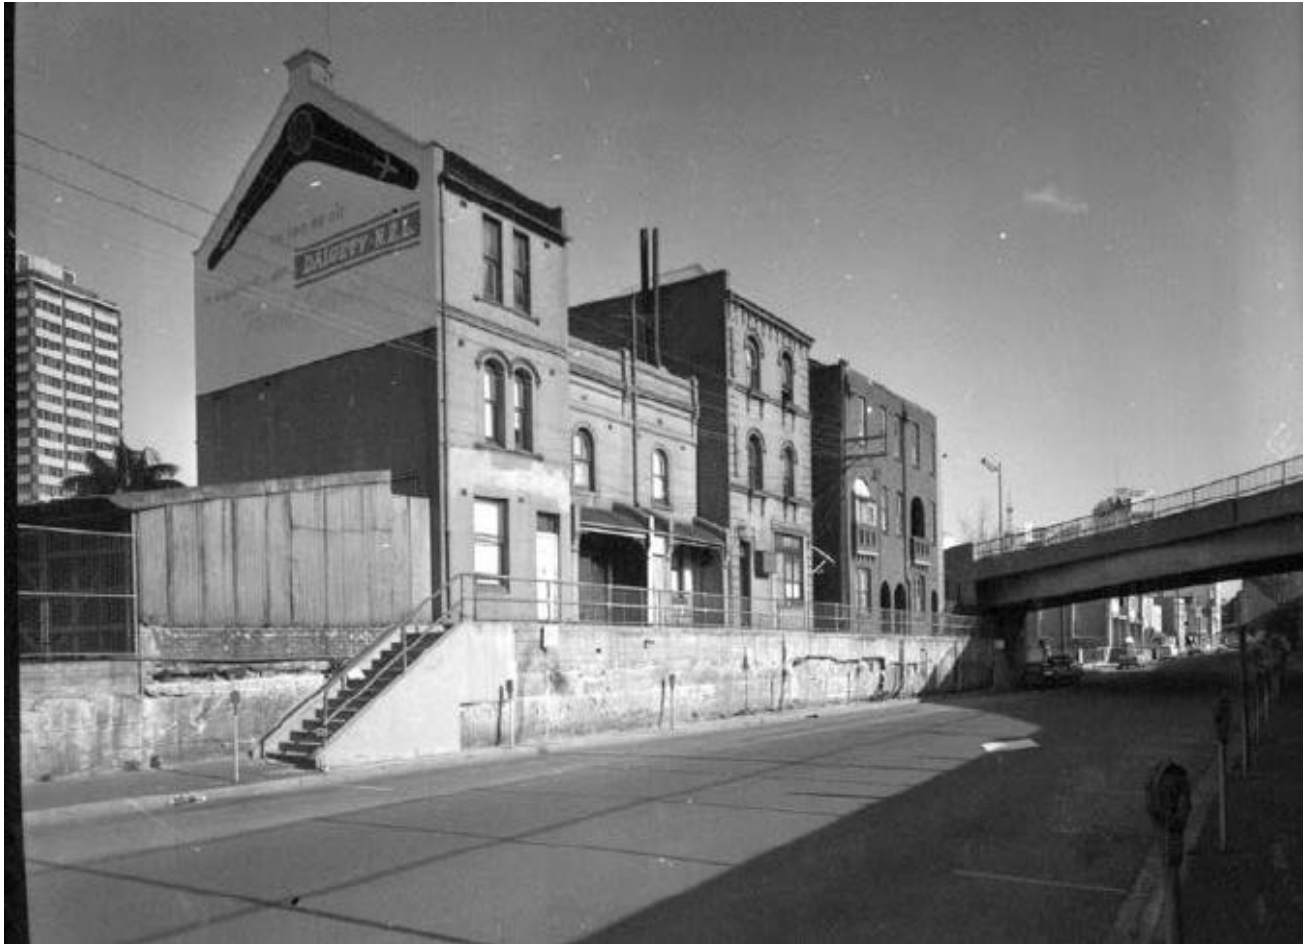
Figure 48: 1970s record photo showing the group above Cumberland Street. Source: SHFA A742-142

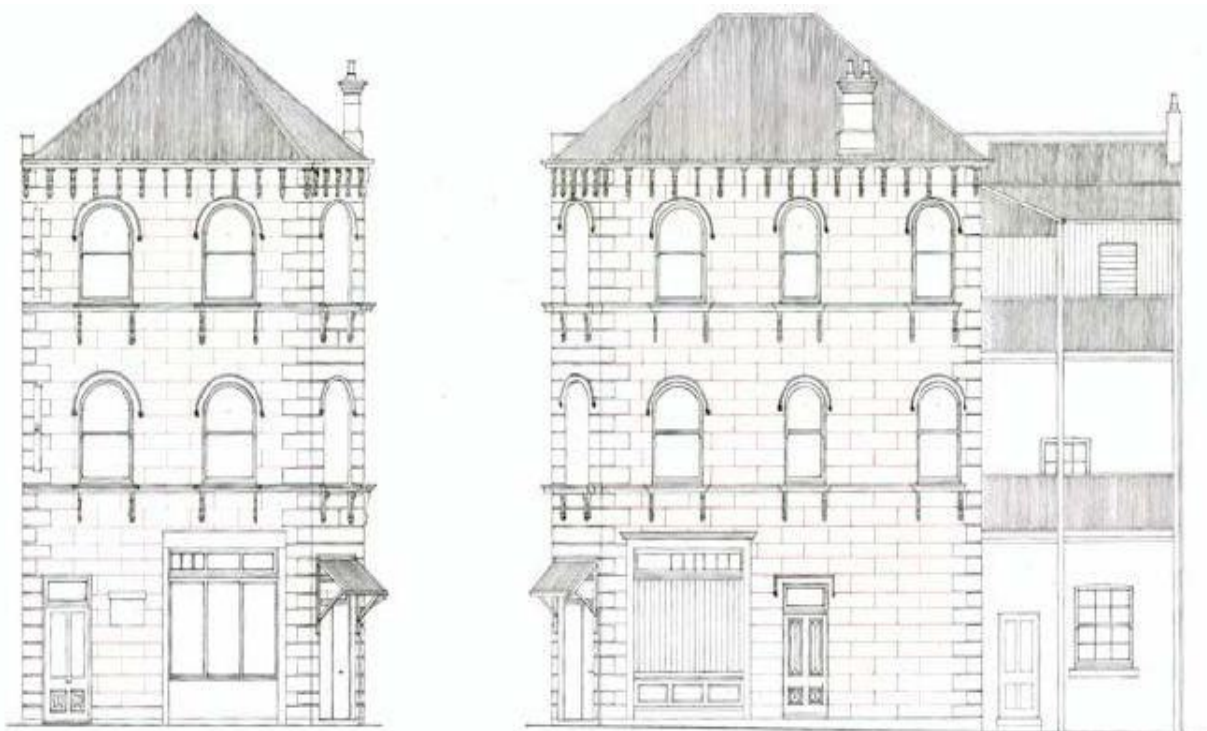
Figure 51: Sketch plans prepared in 1978 by SCRA. Another version of this drawing survives with some room uses added. Architectural drawings of Cumberland Street, CU5/S7. Note, sketches with room and element measurements also survive in the SHFA files. Source: SHFA

The in-house architect, Neil Maitland, prepared the detailed report, assisted by two casual staff (Figure 51 & Figure 50). Five of the buildings were still tenanted, including the shop at No. 138 Cumberland Street that was operating as the SCRA Community Information Centre.

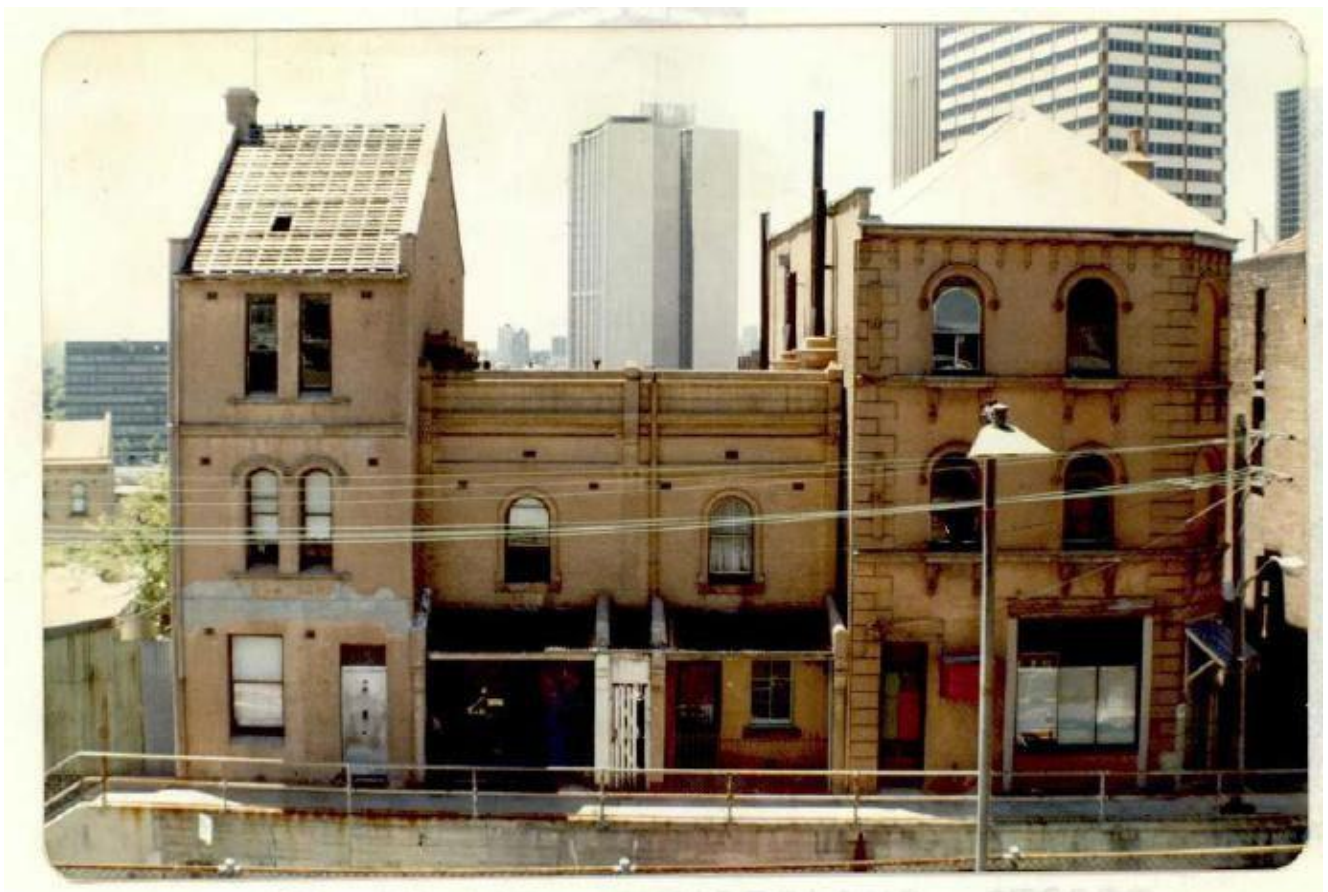
Figure 52: Nos. 130-136 Cumberland Street from the 1979 Condition Report. Source: SHFA

In May-June 1979 a detailed report on the buildings on site C8 was prepared which included detailed conditions reports, measured drawings and a photographic record (Figure 52).

The report noted that 15 of the houses within the group were the subject of an Interim Heritage Order imposed by the Heritage Council of NSW. The area covered by the Conservation Area only included the nineteenth century houses and not the housing erected by the NSW Housing Board. This housing has subsequently come to be seen as an important phase of the development of the area and has also been listed. It was also noted that the building services were inadequate and that nearly all of the fittings in the properties had been vandalised.

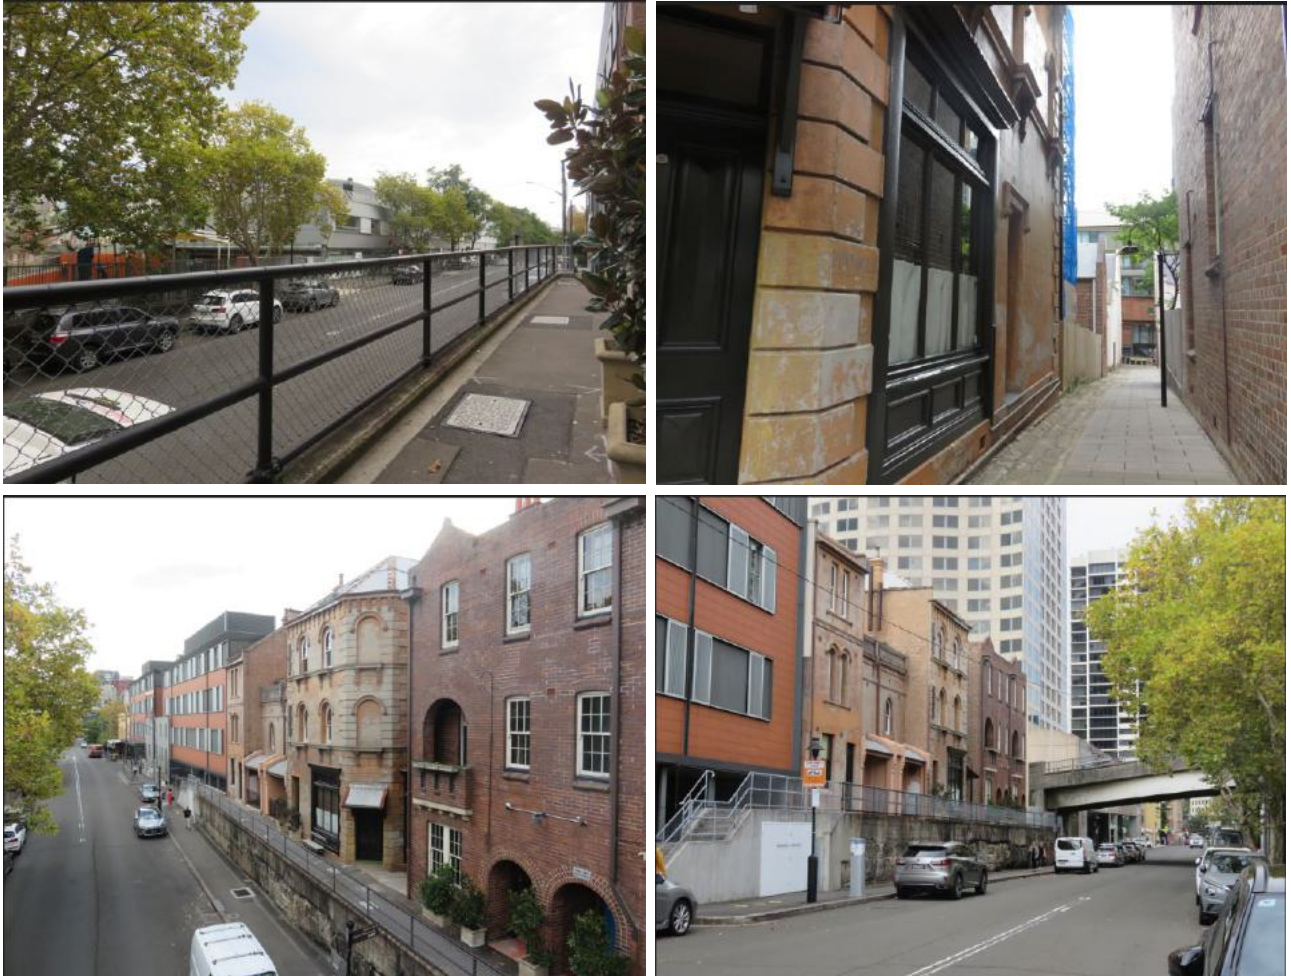
Figure 61: The Local Streetscape. Cumberland Street looking north showing the prominent cliff in front of the buildings at 130-142 Cumberland Street and contemporary youth hostel building beyond (top left). Looking south towards the subject site and the concrete overpass of the Cahill Expressway (top right). Looking north along Cumberland Street from the top of the cliff outside the subject site, towards the King George V Recreation Centre (bottom left). Looking east along Long's Lane with the subject site on the left side of the image (bottom right).

The local streetscape of Cumberland Street and Long's Lane is illustrated in Figure 61.

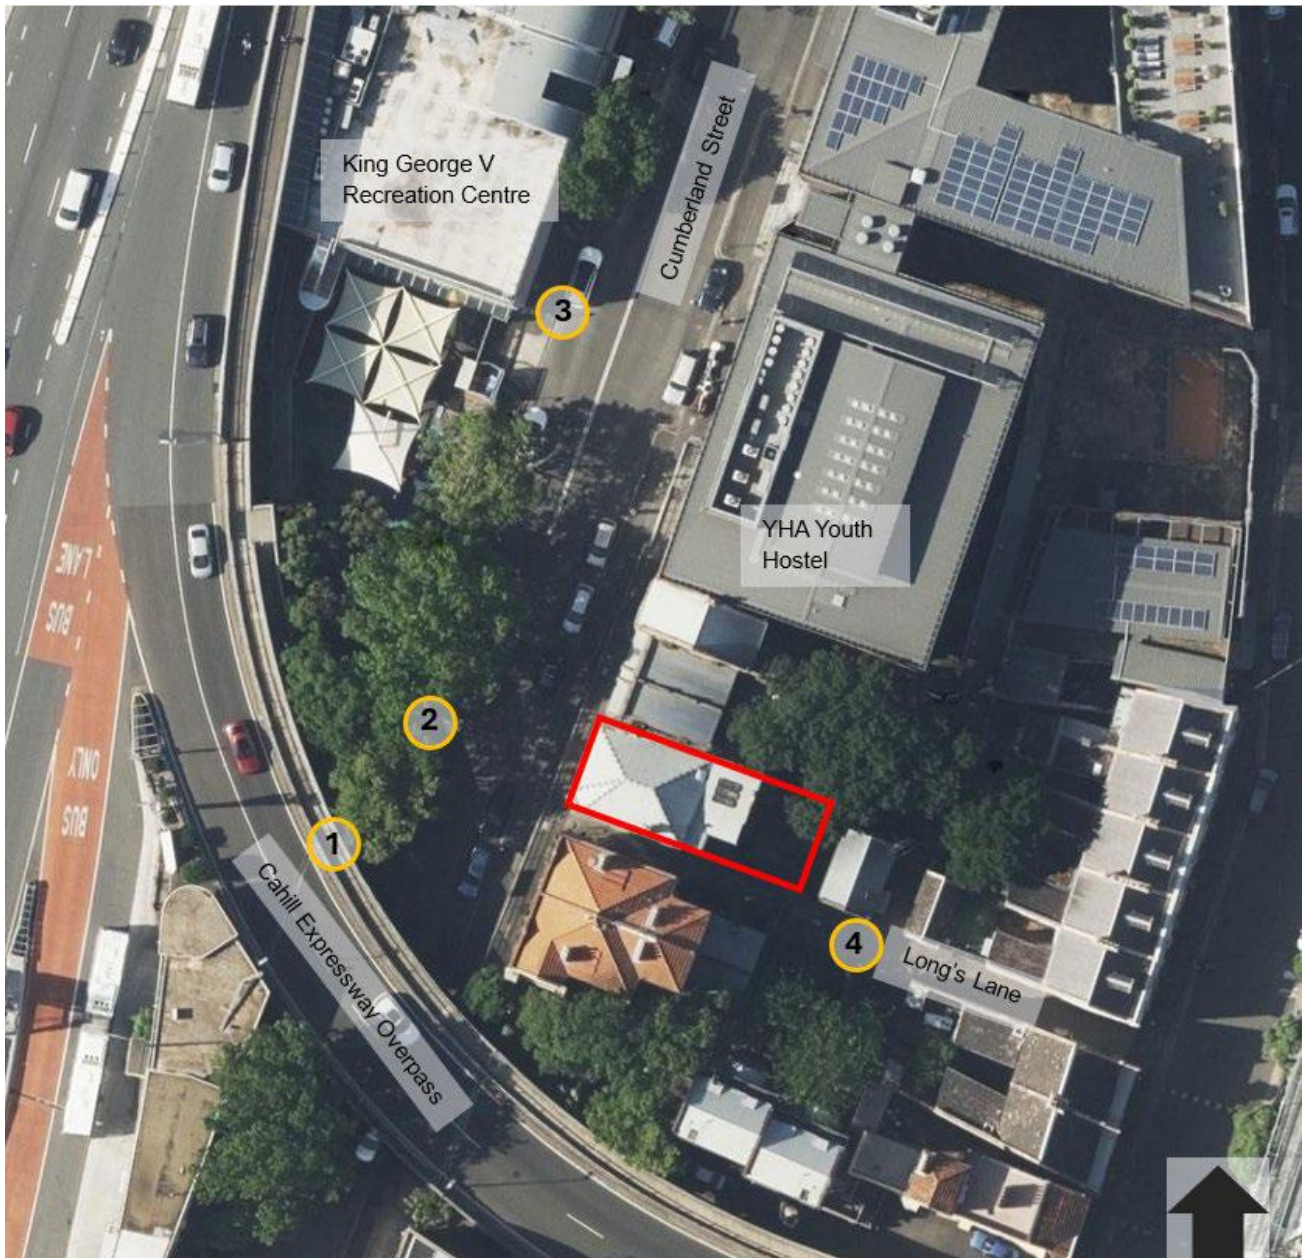
Figure 62: Location of key views towards the building at 136-138 Cumberland Street (outlined in red). Source: SixMaps with PMNSW overlay 2024

This section analyses the setting and establishes key views and vistas to and from 136-138 Cumberland Street that are shown in Figure 62.

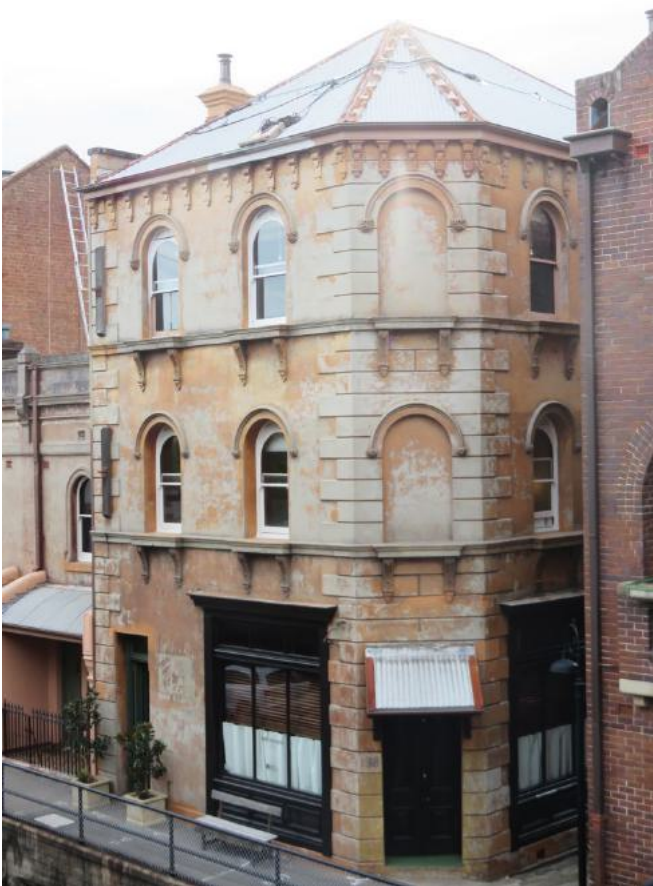
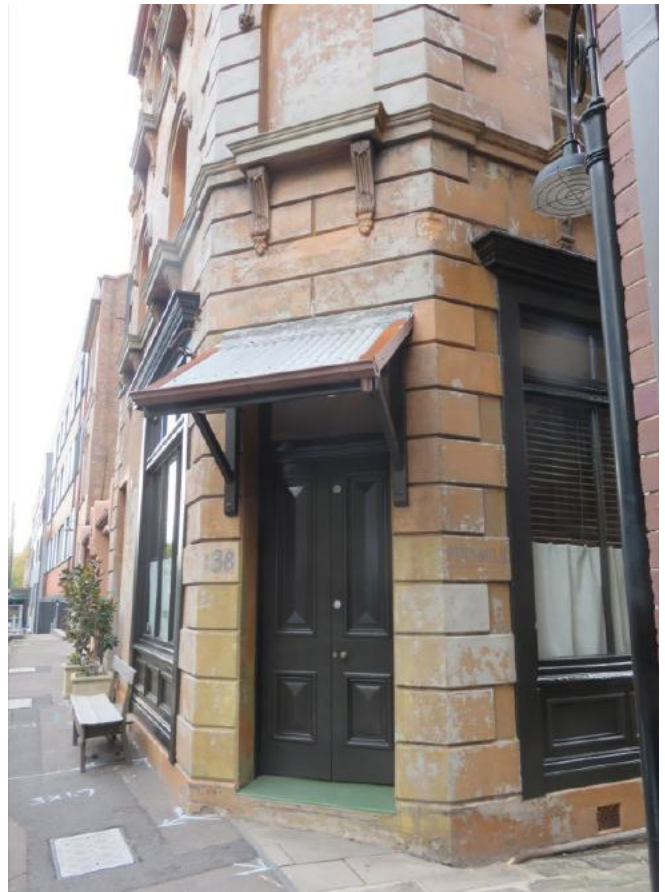
Figure 73: The main (west) elevation, chamfered south-western corner and part of the Long's Lane (southern) elevation. The richly detailed mouldings and faded patina of the wall paint is evident.

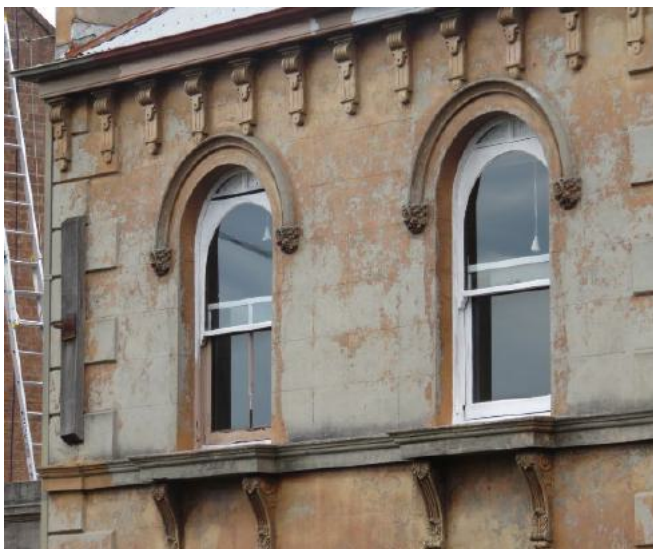
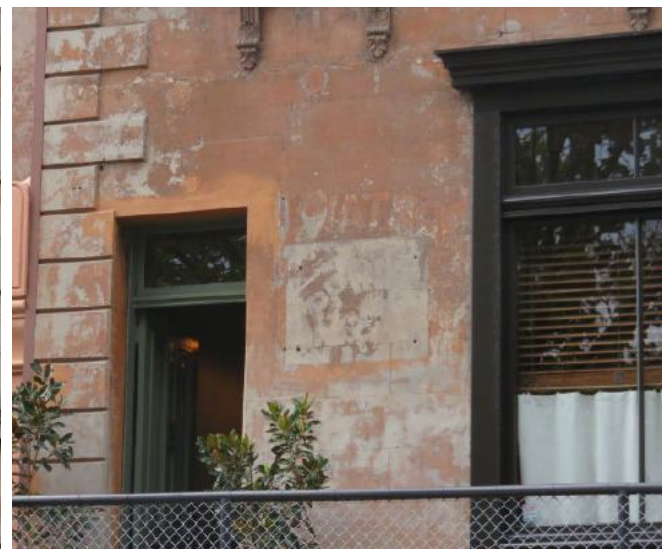
Figure 71: Second floor arched windows. The perforated panels above the top sash are typical of all of the building's double-hung windows. To the left of the windows is one of the timber structural bracings that exist on all elevations.
