# 136-138 Cumberland Street, The Rocks, Conservation Management Plan

October 2024

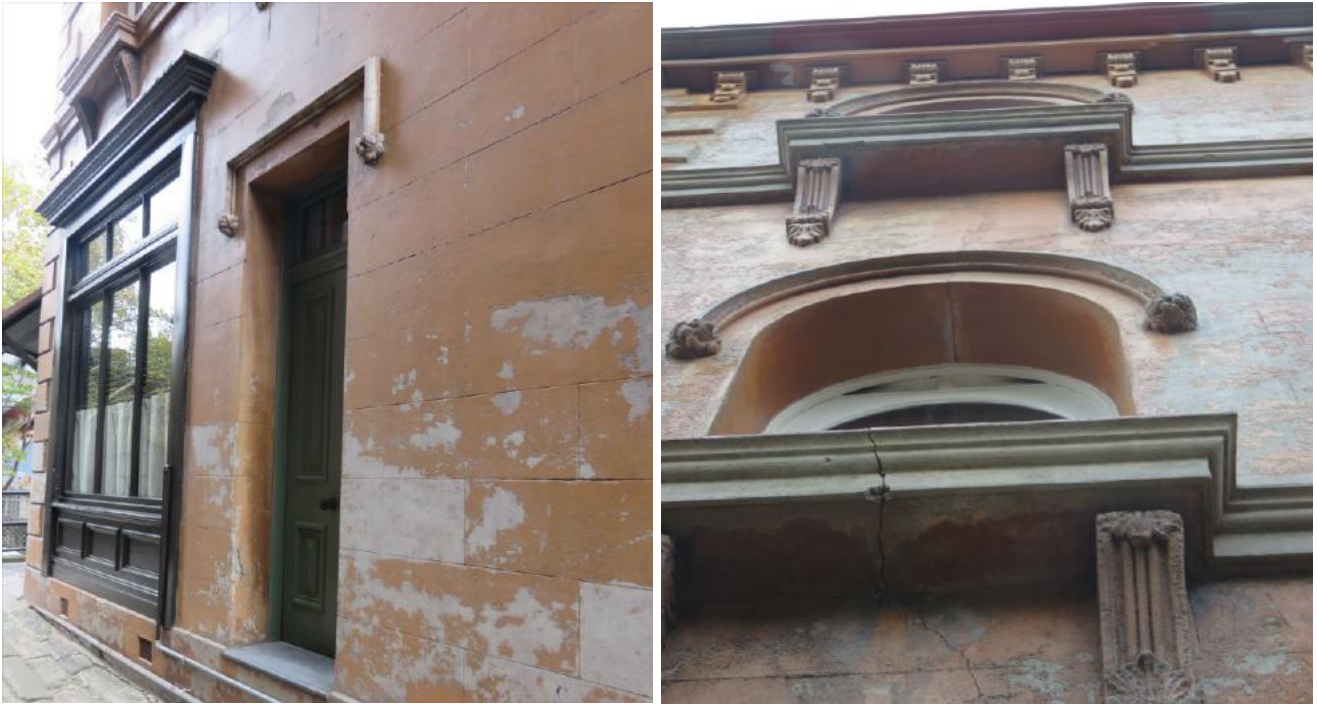
Figure 75: Detail of the Long's Lane (south) elevation showing the original shopfront and parlour door which is no longer operable.

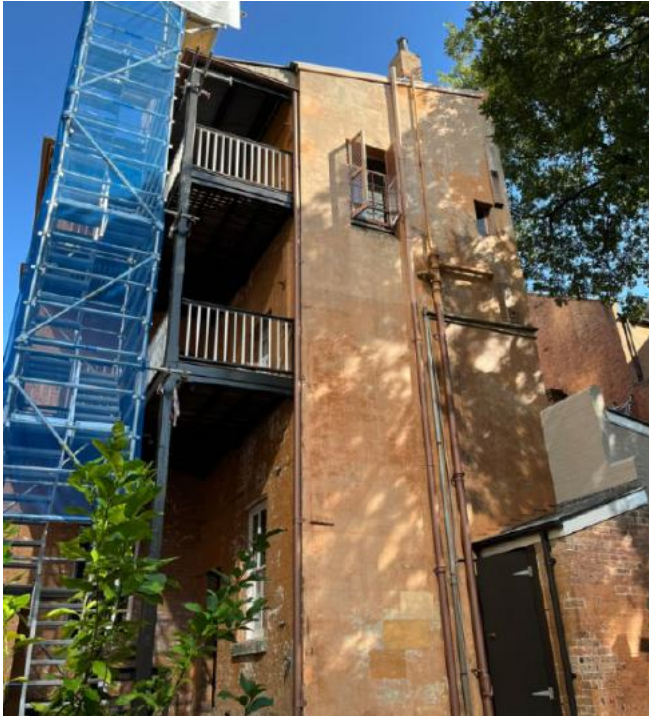
Figure 77: Rear (east) elevation of the rear wing. The wall is rendered with ashlar markings but there are no decorative mouldings.

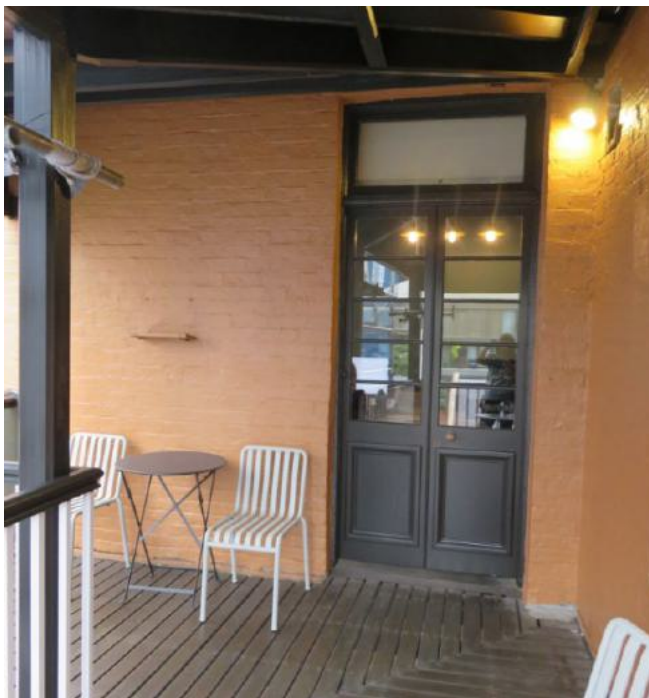
Figure 79: Level 2 east wall of the main part of the building with French doors opening onto the reconstructed veranda. The wall paint is in good condition on the upper floors.

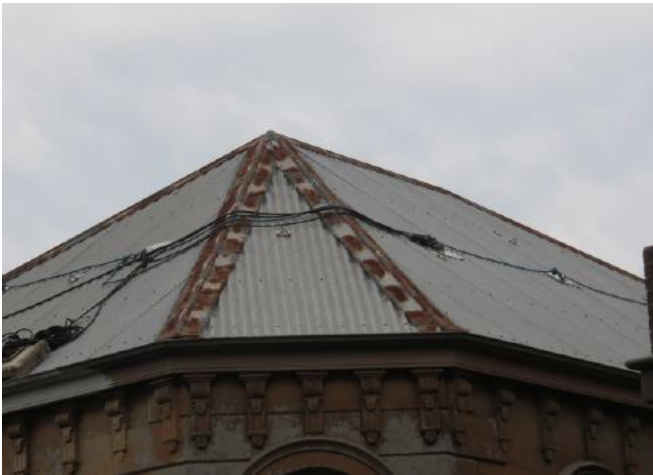
Figure 83: Detail of the main roof, showing the rust affected galvanized steel cappings. The ropes indicate that the roof harness system is in use.

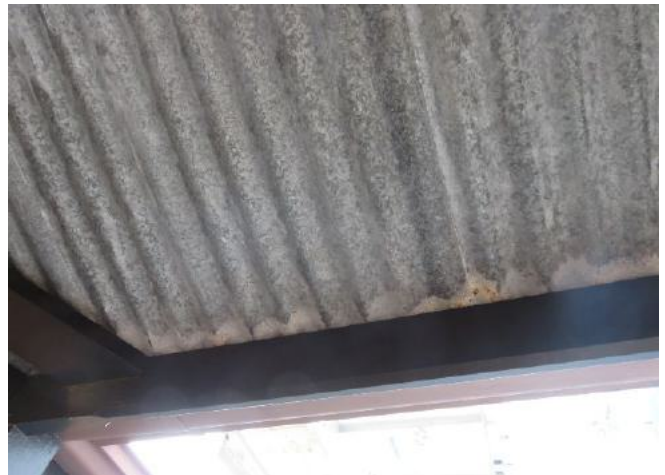
Figure 84: Underside of the galvanized steel roofing, where preliminary deterioration is evident near the eaves gutter.

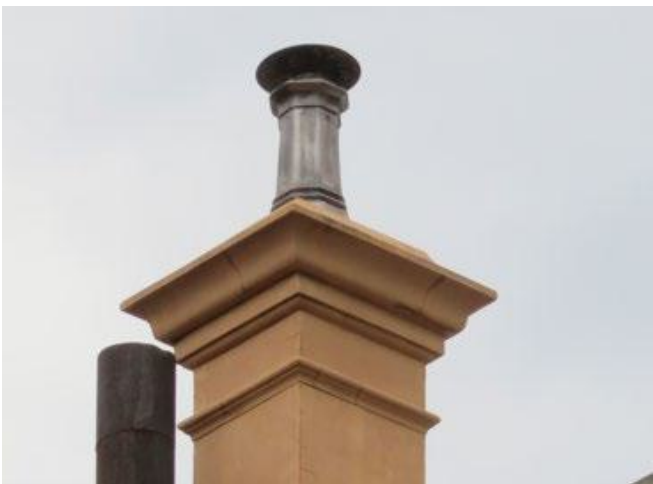
Figure 81: One of the two rendered chimneys with decorative mouldings and glazed ceramic chimney pot.

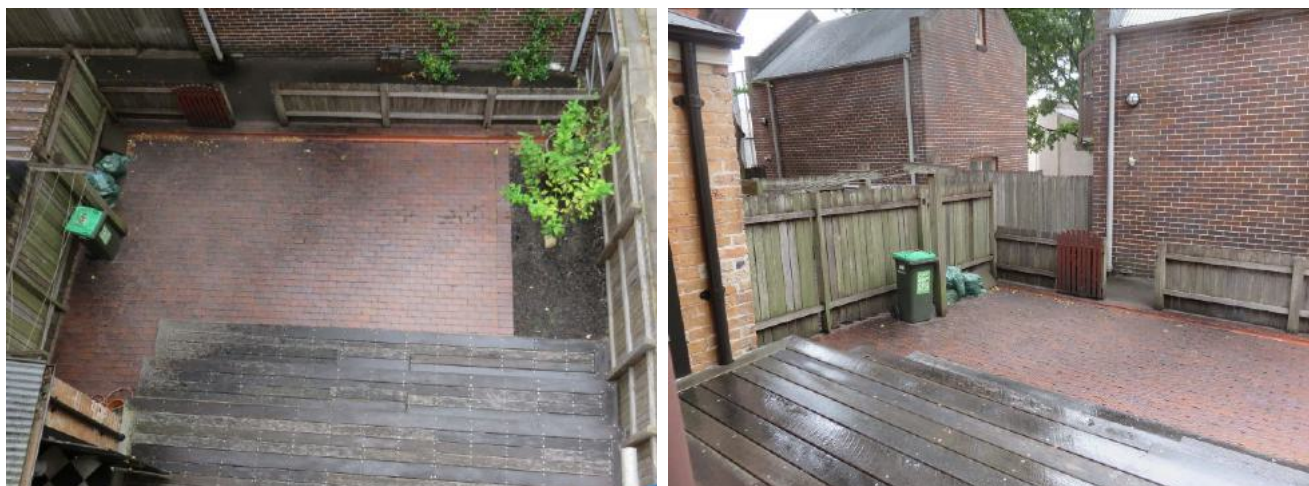
Figure 85: Aerial view over the rear yard showing the brick paving, small garden bed and part of the timber deck.

Figure 86: Looking north-east across the rear yard.

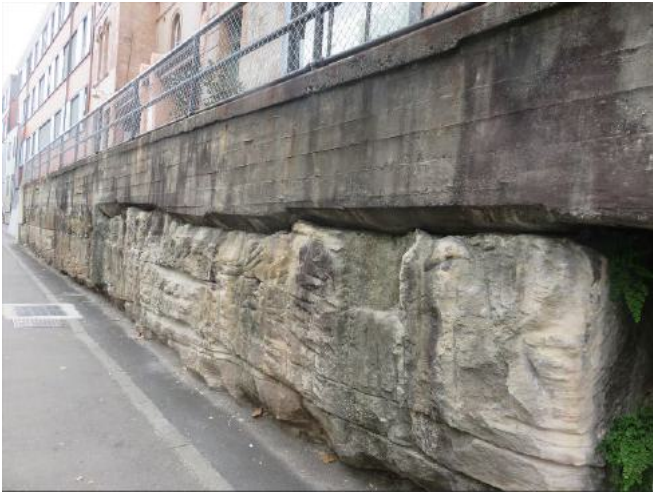
Figure 87: Stone cliff on Cumberland Street

A prominent landscape element related to the subject site is the Cumberland Street sandstone cutting/ cliff adjacent to the front of the property (Figure 78). The cutting indicates the lowering of the level of the Cumberland Street carriageway to enable the Cahill Expressway overpass to pass over the street. The cliff has a cut sandstone base with formed concrete above.

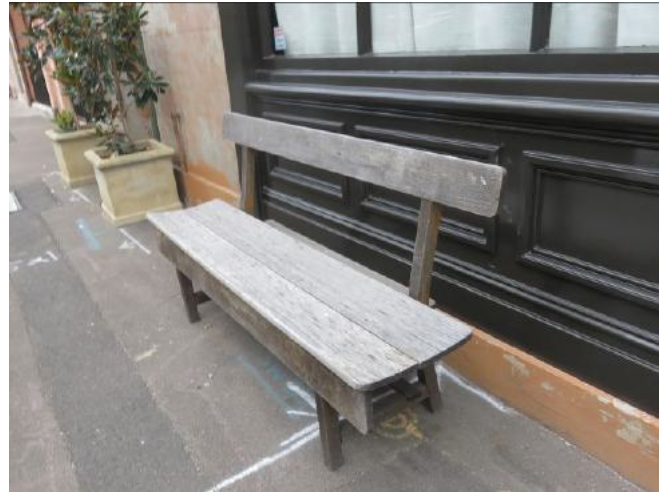
Figure 88: Timber bench and potted plants in front of the building on the Cumberland Street footpath.

Adjacent to the building on the Cumberland Street footpath are the two potted plants and timber bench (Figure 79). The square concrete plant pots mark the main entrance doors and are in good condition. The pots are consistent in style with those used in front of neighbouring properties. The timber bench, which is unpainted, is in sound condition, but its condition should be monitored.

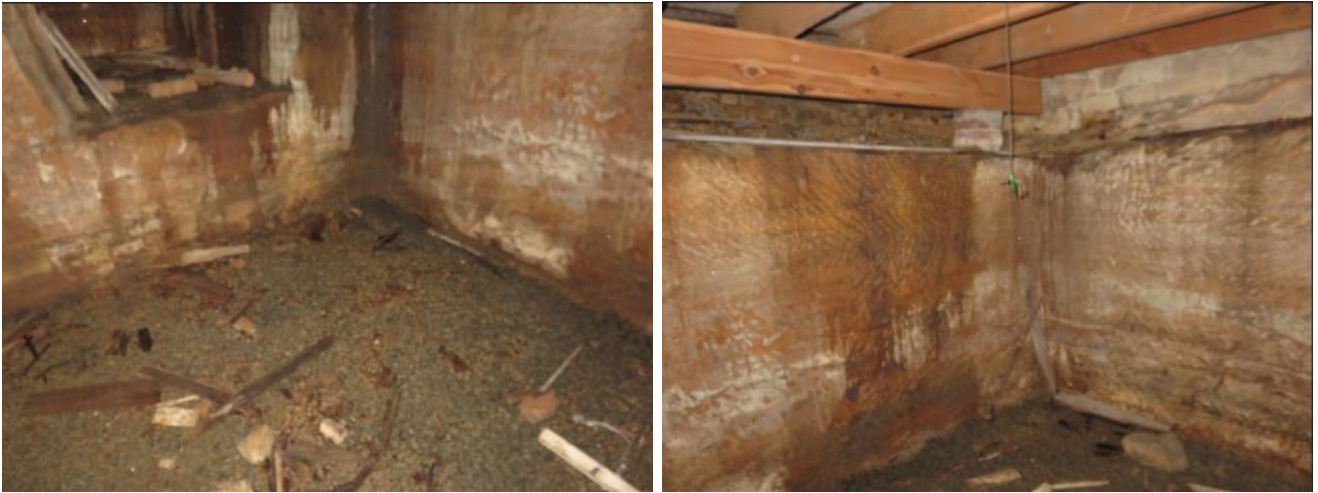
Figure 91: North-eastern corner of the basement, with cut sandstone walls. The framing of the false ceiling, supported on brick piers built off the stone, can be seen.

Figure 92: Blue metal covers the floor. Timber and metal elements are scattered across the floor.

It has been stated in other reports that the basement (also referred to as the cellar) is a remnant of earlier buildings on the site and is not associated with the construction of the current building. It has been excavated out of the solid bedrock with the pick marks clearly evident. The floor is covered with a layer of blue metal and lies approximately 2500mm below the floor level of the former shop (G.1) (Figure 86). A timber framed false ceiling has been constructed approximately 400mm below the G.1 floor and appears to have been constructed as a part of the 1996-97 conservation works. The reason for the false ceiling is not known, but it may have formed a work platform over the basement during the works.

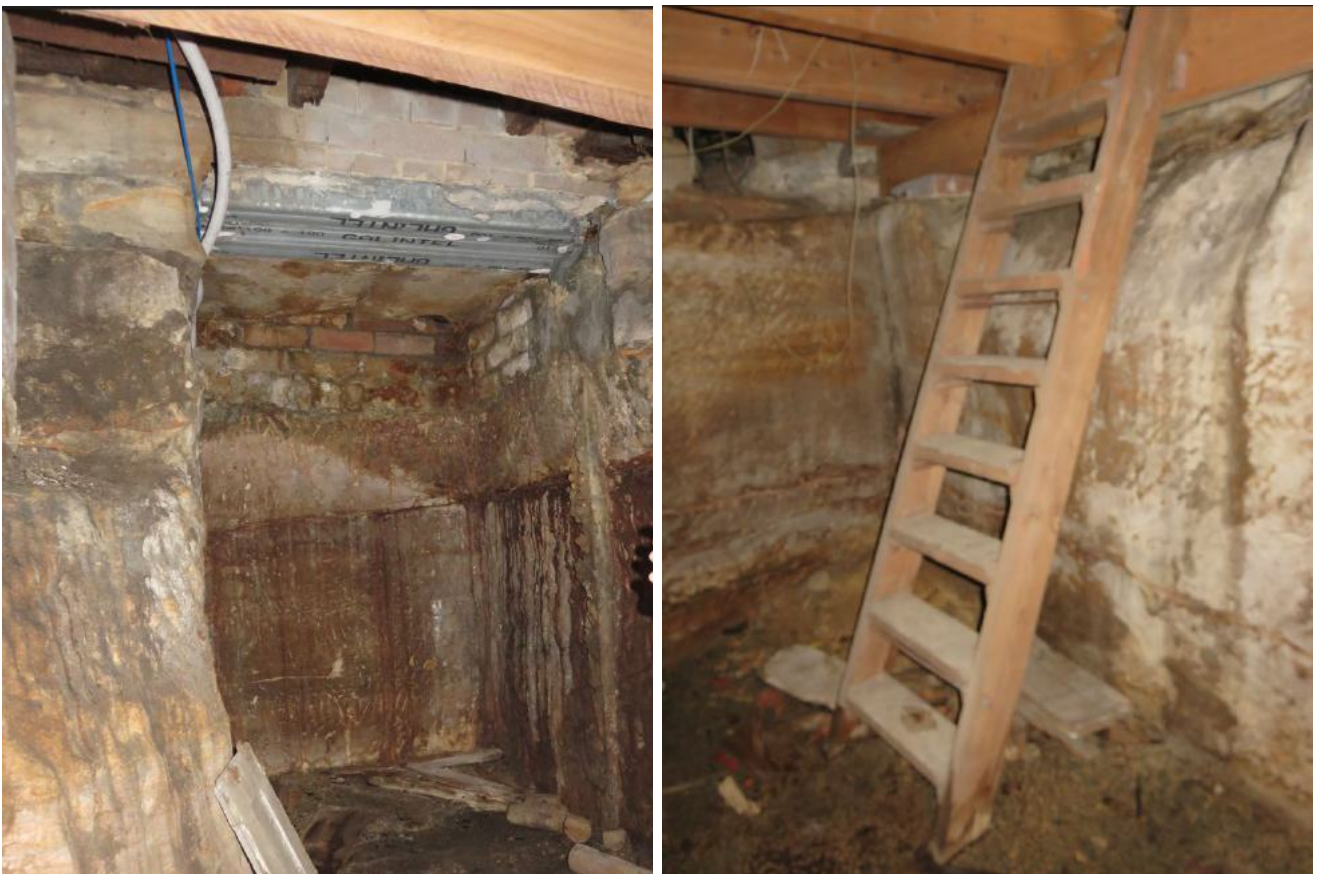
Figure 93: The delivery chute in the western wall.

Figure 94: The 1990s timber ladder stair and south-eastern corner of the basement.

On the west side of the space a recess has been cut out of the bedrock (Figure 84). This recess is similar to the recesses for keg chutes in hotels as well as the ventilation areas for house cellars. However, the depth of the recess would indicate it was constructed to allow for the delivery of

goods. It appears that the chute is contemporary with the remainder of the cellar. There is a modern (1990s) access hatch and timber ladder giving access to the cellar from G.1 (Figure 85).

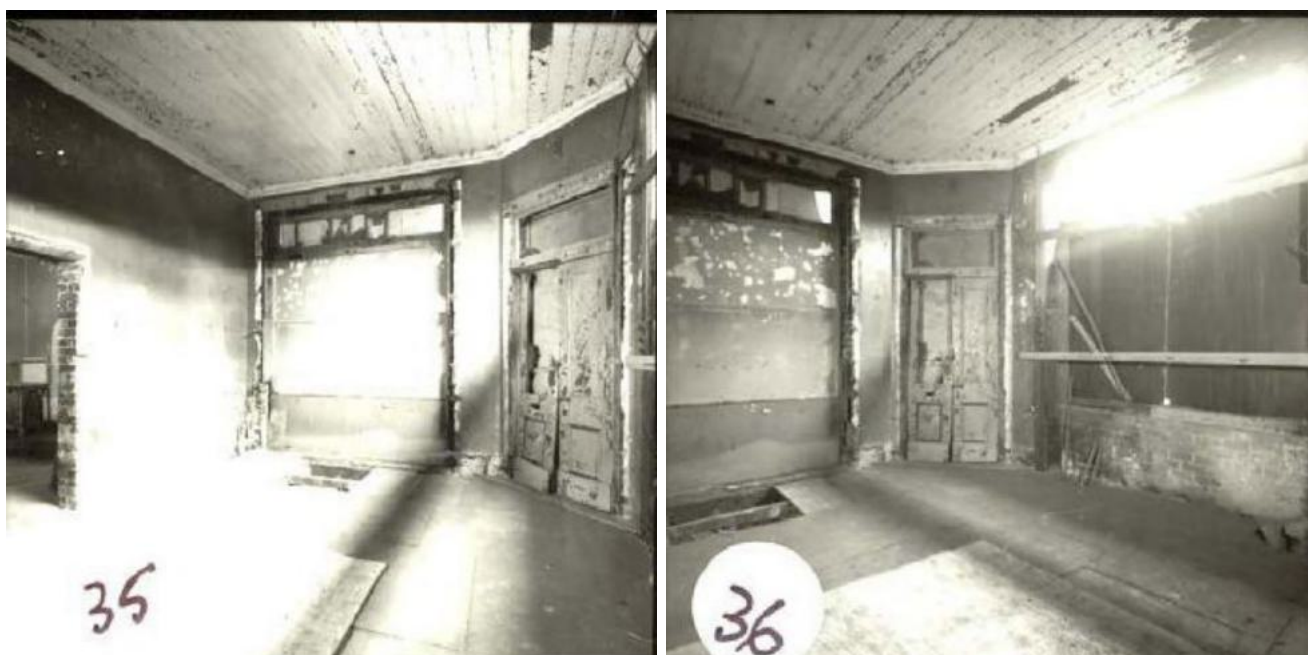
Figure 95: Looking south across room G.1 in 1995, prior to conservation works commencing. (Source: PMNSW image 35, as reproduced in the 2015 CMP, p 115)

Figure 96: Looking south-west across room G.1 in 1995, prior to conservation works commencing. (Source: PMNSW image 36, as reproduced in the 2015 CMP, p 115)

Dilapidation photographs taken in 1995 show that much of the floor, and all the interior joinery was missing by that date (Figure 89 and 90). Very little of the shopfront to Cumberland Street existed and the opening had been partly bricked up. The timber panelling beneath the window of the Long’s Lane shopfront was either missing or sheeted over with plywood. The two door leaves of the corner entry door remained in a very decrepit state. A few floorboards are visible beneath the plywood over-sheeting. They appeared to be standard width and also appear not to have had any finish, indicating that they were originally covered with a floor sheeting (possibly linoleum).

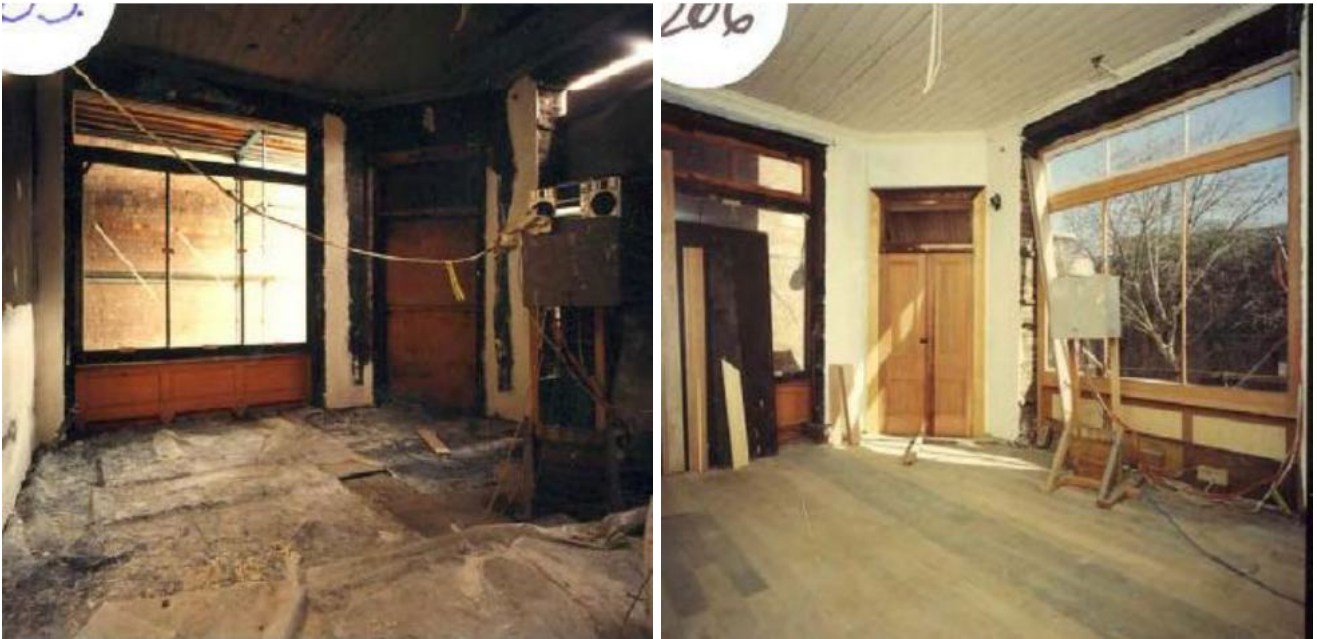
Figure 99: Looking south across room G.1 in 1997, with conservation works underway. (Source: PMNSW image 163, as reproduced in the 2015 CMP, p 115)

Figure 100: Looking south-west across room G.1 in 1997, with conservation works underway. (Source: PMNSW image 206, as reproduced in the 2015 CMP, p 115)

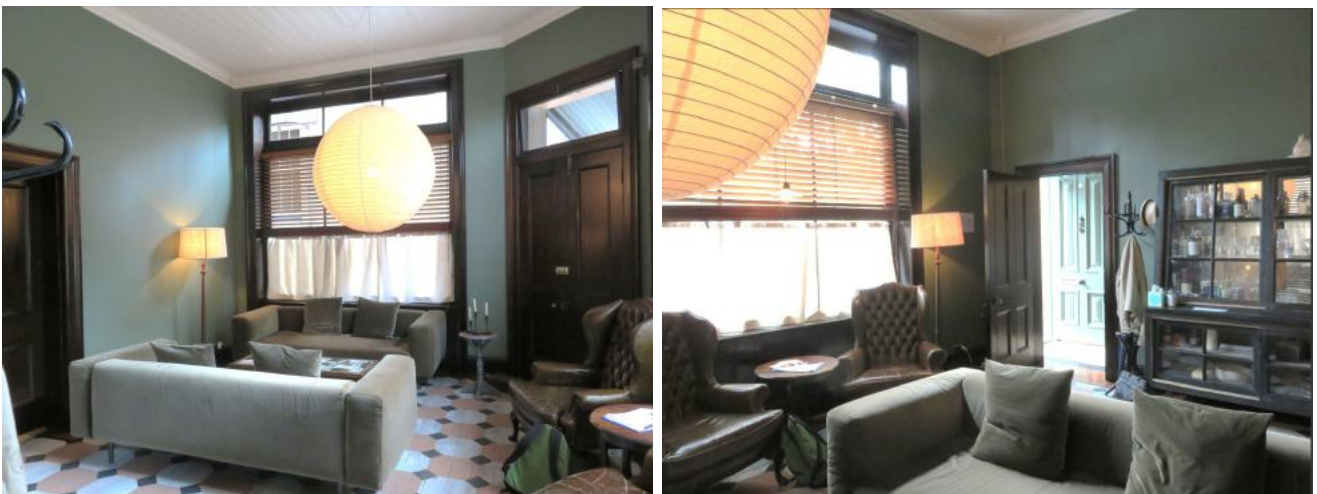
Figure 97: Looking south across room G.1 in 2024. The floor features a decorative painted 'rug'.

Figure 98: Looking north-west across room G.1 in 2024.

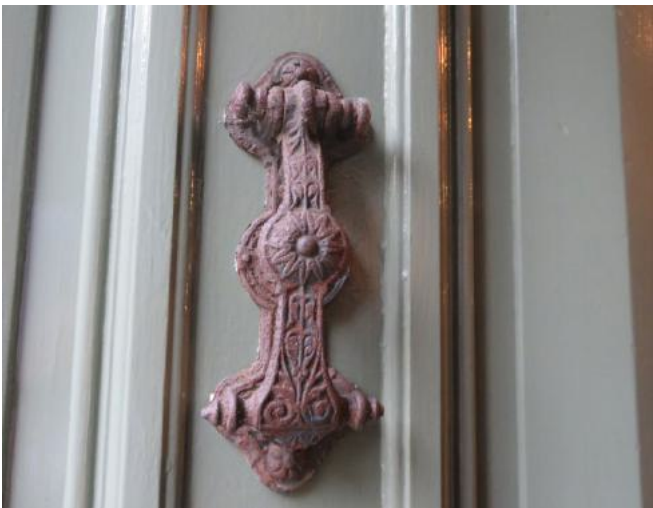
Figure 103: The cast metal knocker on the main entrance door may be an original item, although the door leaf itself is a replica.

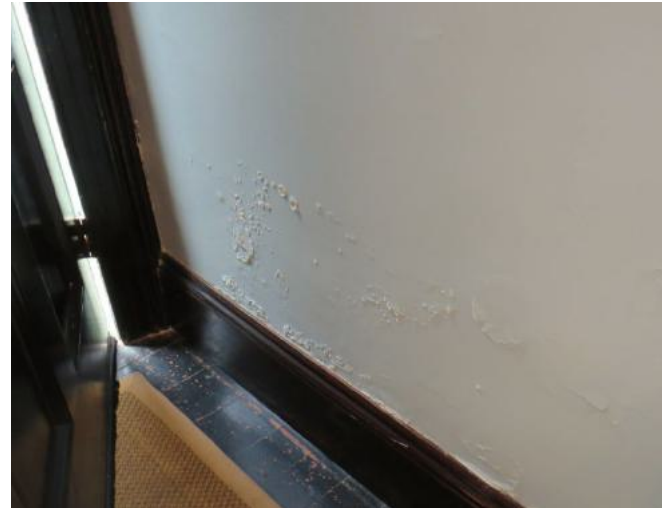
Figure 104: Damp evident in the north wall behind the front door.

The condition of the spaces is good, but damp is evident on the north wall behind the front door.

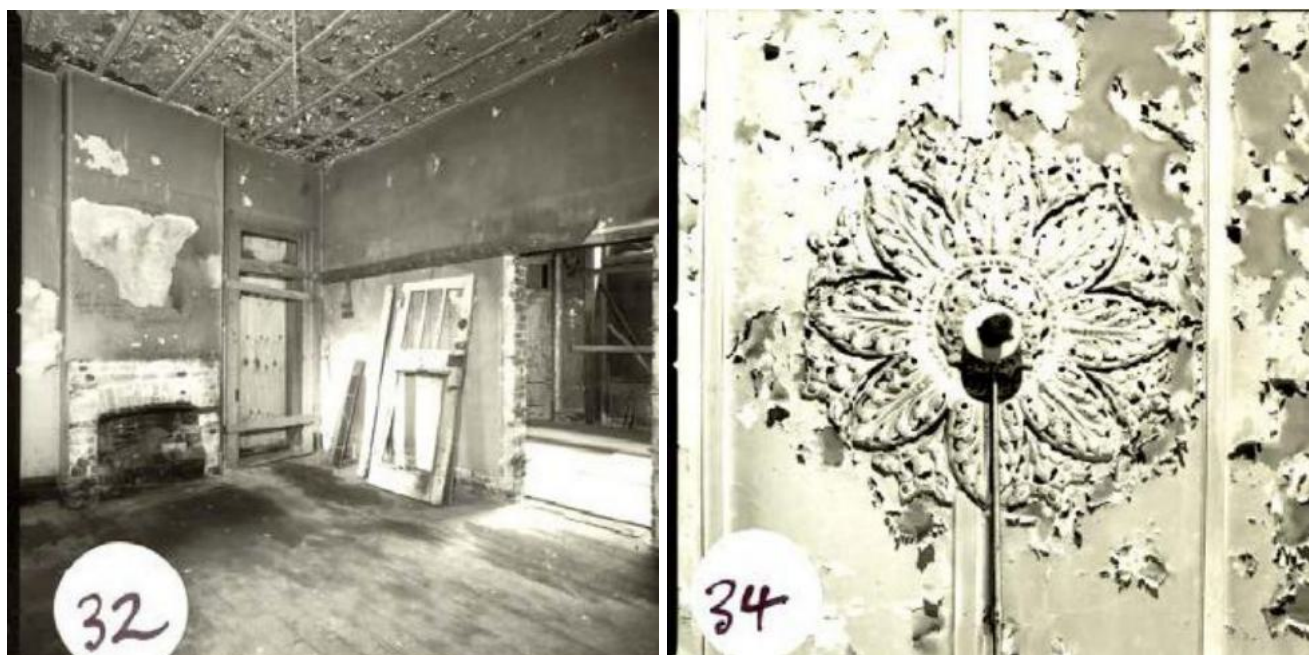
Figure 107: looking south-west in 1995. (Source: PMNSW image 32, as reproduced in the 2015 CMP, p 119)

Figure 108: The original ceiling rose was intact o 1995. (Source: PMNSW image 34, as reproduced in the 2015 CMP, p 119)

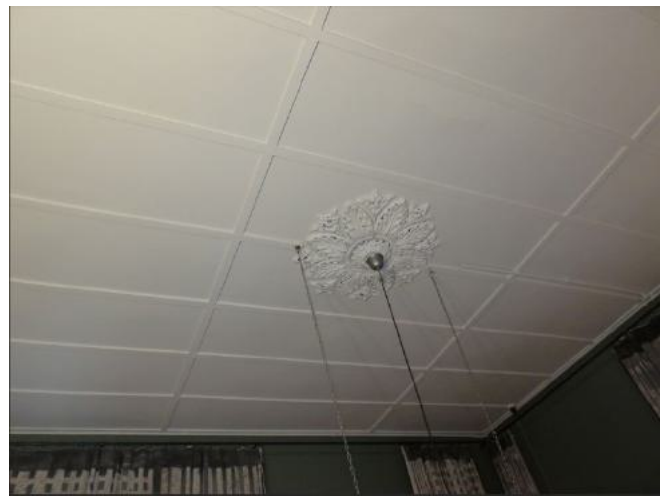
Figure 110: The refurbished ceiling with the original ceiling rose, 2024.

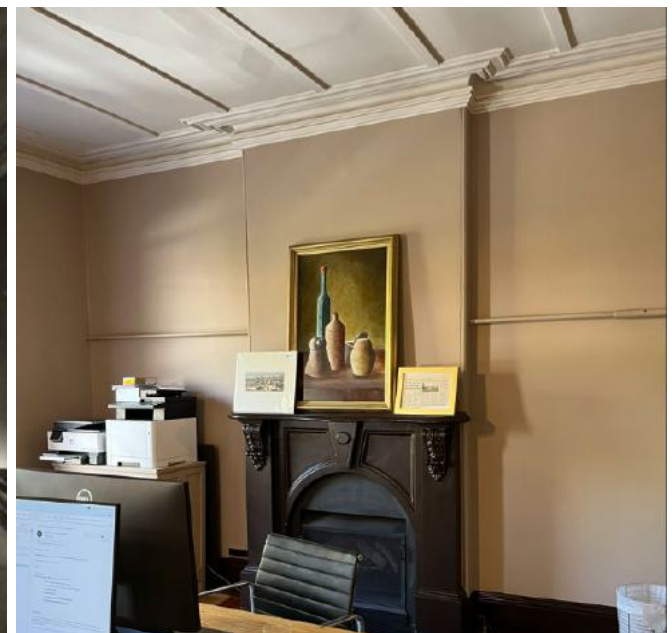
Figure 119: Room 1.1, north wall and fireplace, 2024.

Figure 120: Room 1.1, Detail of windows in the western wall, 2024. The top sash cannot be fully closed because of the perforated panel fixed into the top of the window frame.

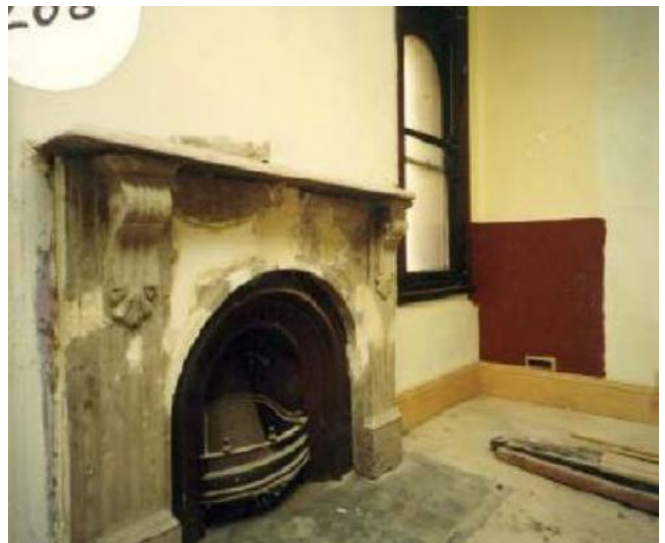
Figure 124: Room 1.2 looking south-west showing the repaired plaster fire surround, 1997. (Source: PMNSW image 208, as reproduced in the 2015 CMP, p 122)

The fireplace surround is an original plaster surround that presumably was found on site in pieces. The 1997 conservation report photos show the surround re-adhered to the wall and labelled “jigsaw fireplace”. The fireplace surround has been painted although the 1997 photograph shows the surround being unpainted and resembling stone in colour and texture.

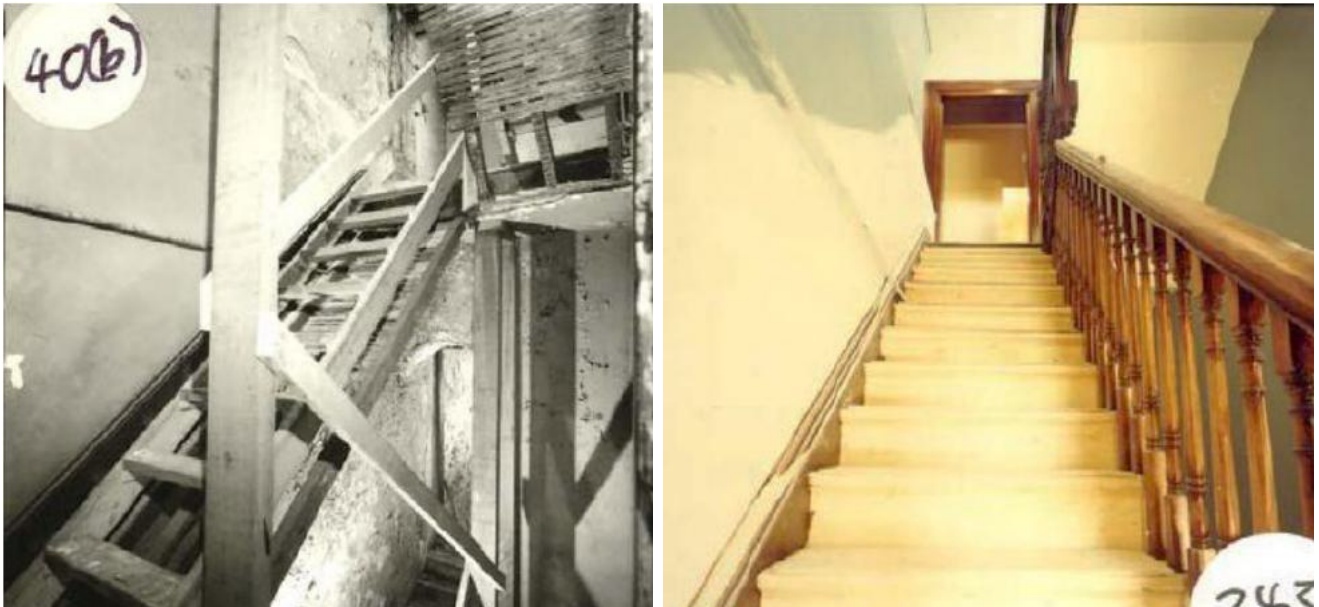
Figure 127: Room 1.3 looking north-east, 1995. (Source: PMNSW image 40b, as reproduced in the 2015 CMP, p 123)

Figure 128: The newly built stairs, 1997. (Source: PMNSW image 243, as reproduced in the 2015 CMP, p 123)

The stair is a contemporary reconstruction of the original stair which was mostly destroyed prior to 1995. A 1997 photograph show the stair newel post as being laminated pine. There is a carpet runner up the centre of the stairs, and timberwork is dark stained and clear finished. Ceilings are lath and plaster without decoration or cornices, and walls are plastered and painted. The metal tie rod from the front room continues through the stair well along the north wall of room 1.3.

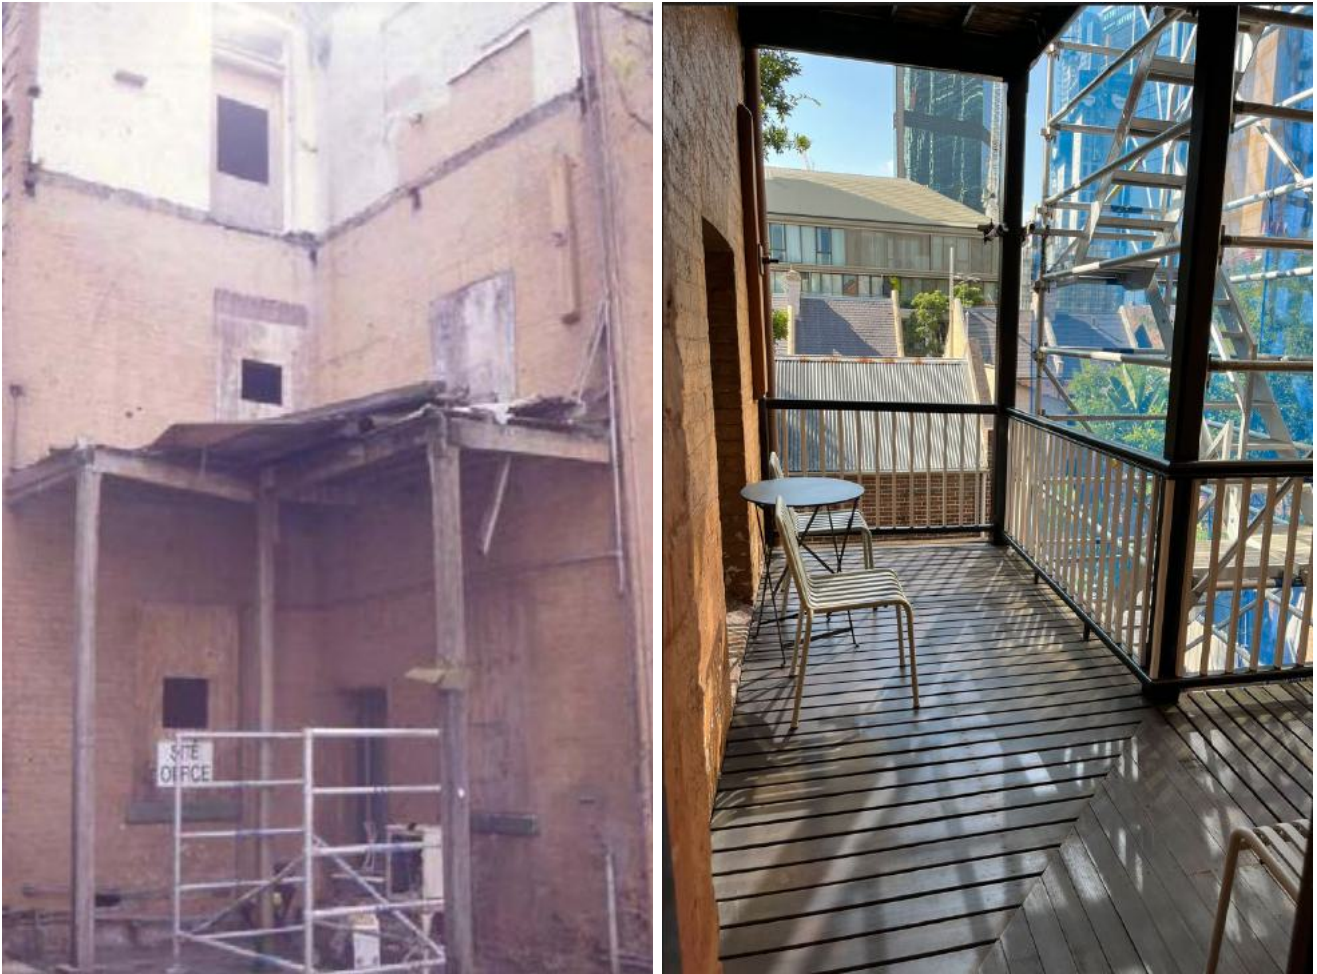
Figure 131: Remnants of rear verandah being demolished, 1996. (Source: PMNSW image 188808\_CU\_19-11, as reproduced in the 2015 CMP, p 124)

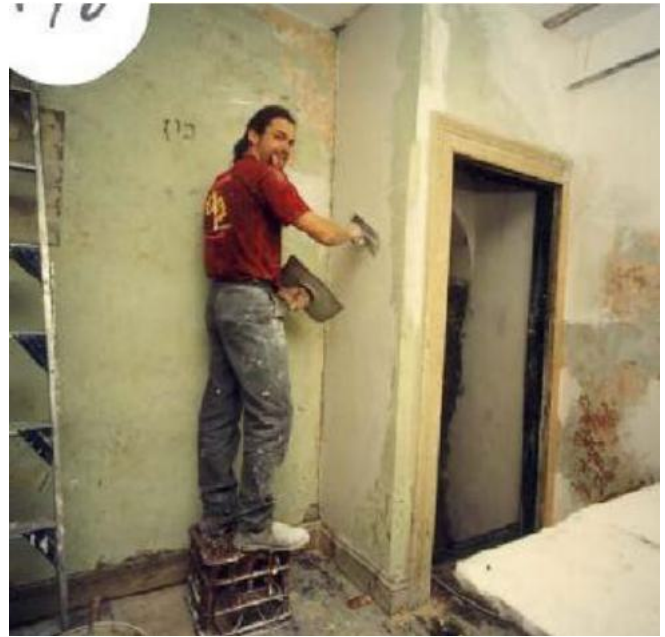
Figure 136: Replastering lath and plaster wall in Room 1.5, 1997. (Source: PMNSW image 178, as reproduced in the 2015 CMP, p 125)

Room 1.5, the level 1 kitchen, is accessed off the stair's mid-landing of the between ground and first floors. The room was fitted out as a kitchen in the 1997 conservation works but it was originally probably a bedroom. The pine floorboards are a mixture of new and recycled boards. The floor has a painted 'rug, with floorboards around the perimeter clear finished. Walls are plastered and painted and were repaired during the 1990s conservation works.

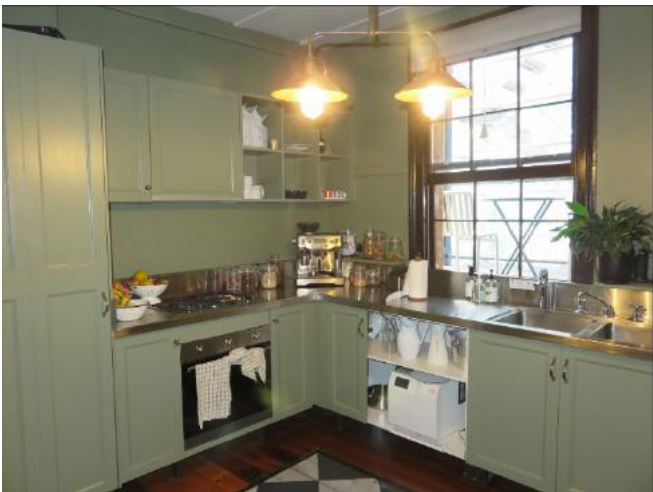
Figure 133: Room 1.5 looking south-west, 2024.

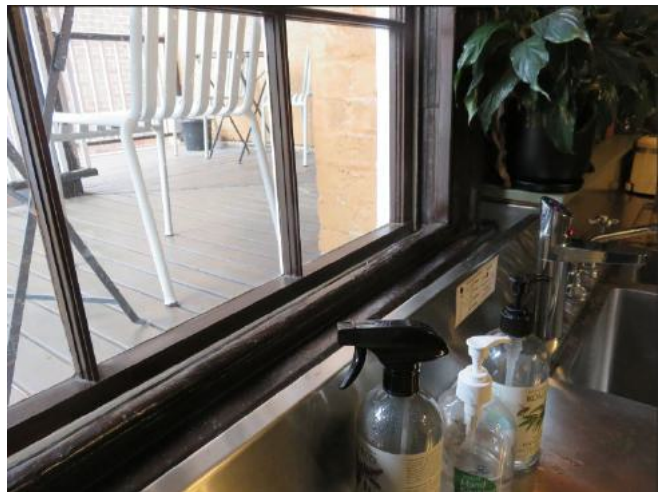
Figure 134: Detail of the careful detailing of the splashback of the contemporary bench unit and the windowsill.

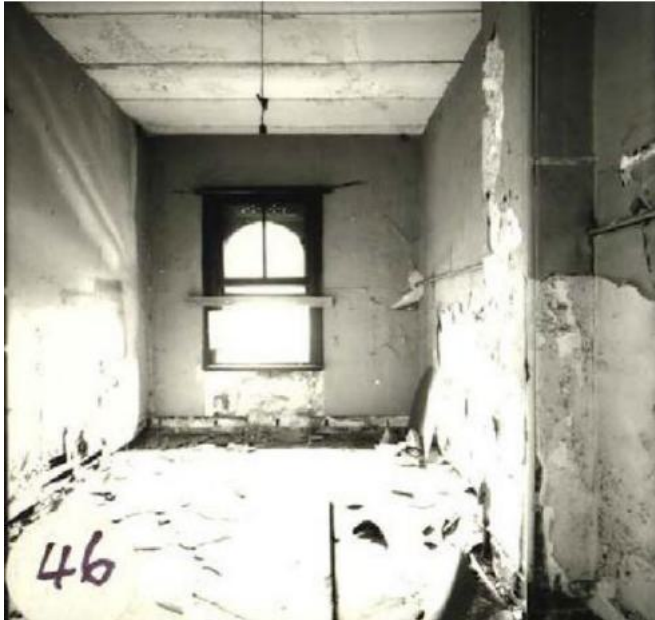
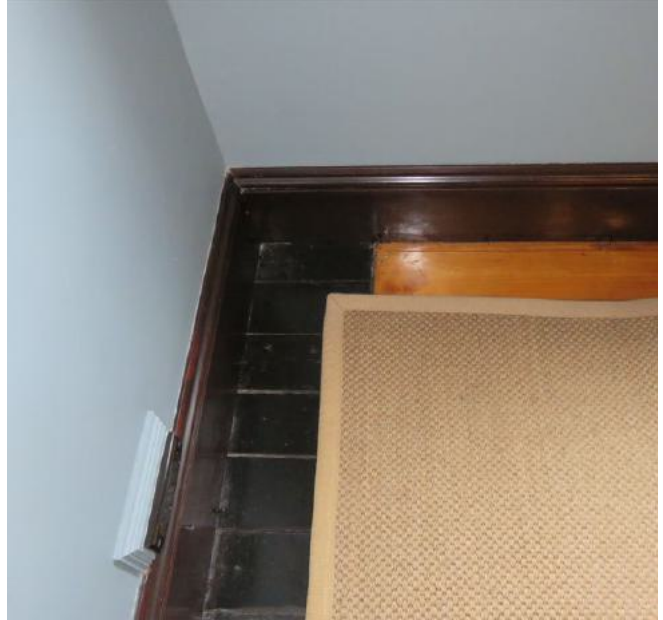
Figure 139: Room 2.1 looking west, 1995. (Source: PMNSW image 46, as reproduced in the 2015 CMP, p 126)

Figure 140: Room 2.1 looking west, 1995. (Source: PMNSW image 46, as reproduced in the 2015 CMP, p 126)

The window cannot be closed fully because of the perforated timber ventilation board installed above the top sash. All the joinery in the room is painted a gloss dark brown. The 1995 dilapidation photograph shows that none of the skirting remained in this room. However, the window sashes, perforated board and architraves survived. The photograph also shows that the wall between Room 2.1 and Room 2.2 is a framed lath and plaster wall.

Walls are plastered and painted. There is a tie rod running from east to west along the north wall of the room at about eye height that passes through the chimney flue. The tie rod continues along the north wall of the stair well.

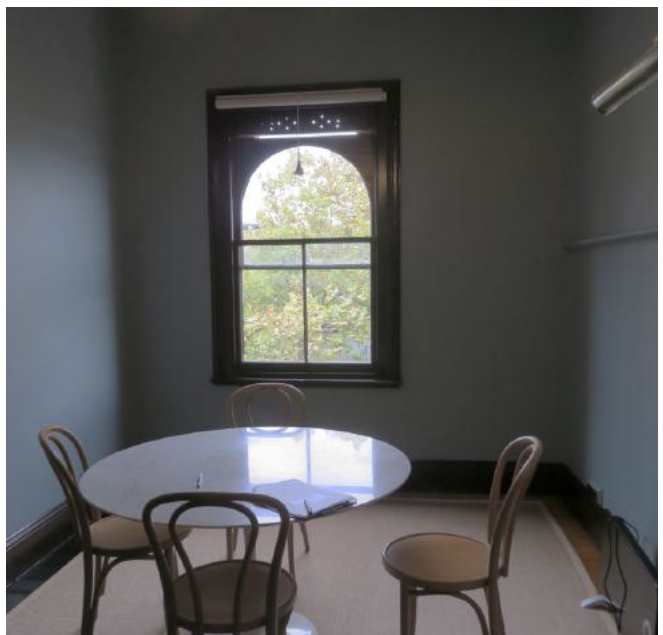
Figure 138: Room 2.1 looking north-east, 2024

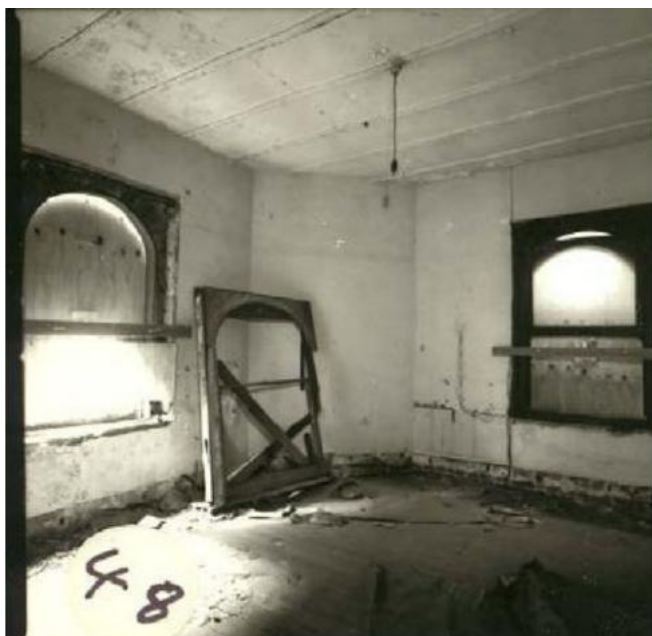
Figure 141: Room 2.2 looking south-west, 1995. (Source: PMNSW image 48, as reproduced in the 2015 CMP, p 127)

Room 2.2 has painted plastered walls and lath and plaster ceilings with timber strapping (Figure 132 and Figure 134). There are no cornices or other decorative ceilings detailing. There is a window in each of the two exterior walls that cannot be closed fully because of the perforated timber ventilation boards installed above the top sashes. The clear-finished pine floorboards are new as is most of the gloss dark brown painted joinery. A contemporary rug covers most of the floor.

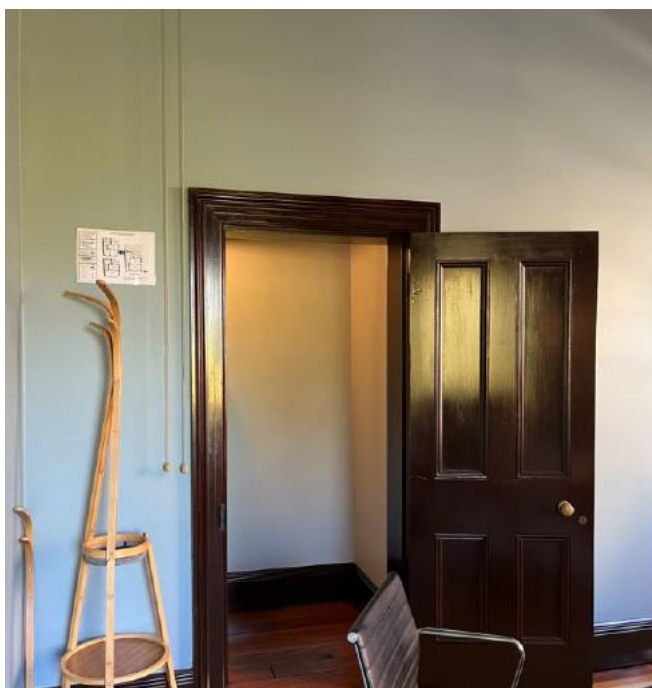
Figure 143: The east wall and door to room 2.2, 2024.

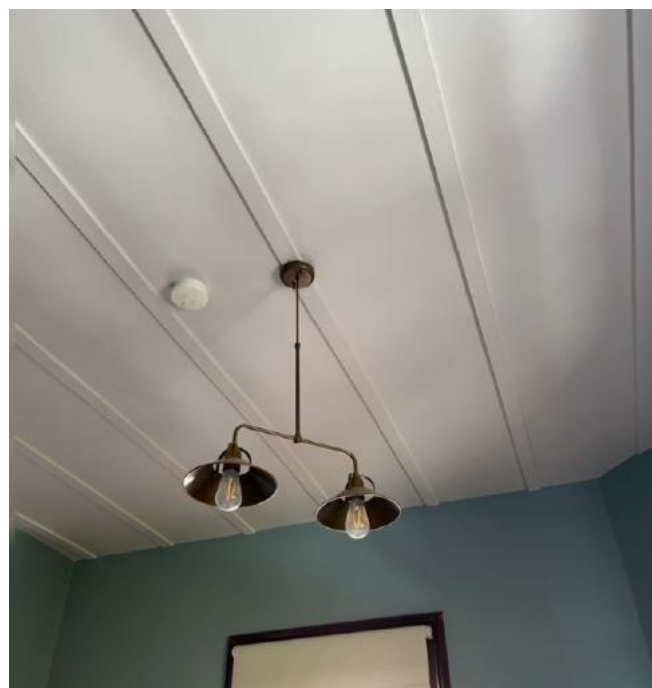
Figure 144: Room 2.2 ceiling detail, 2024.

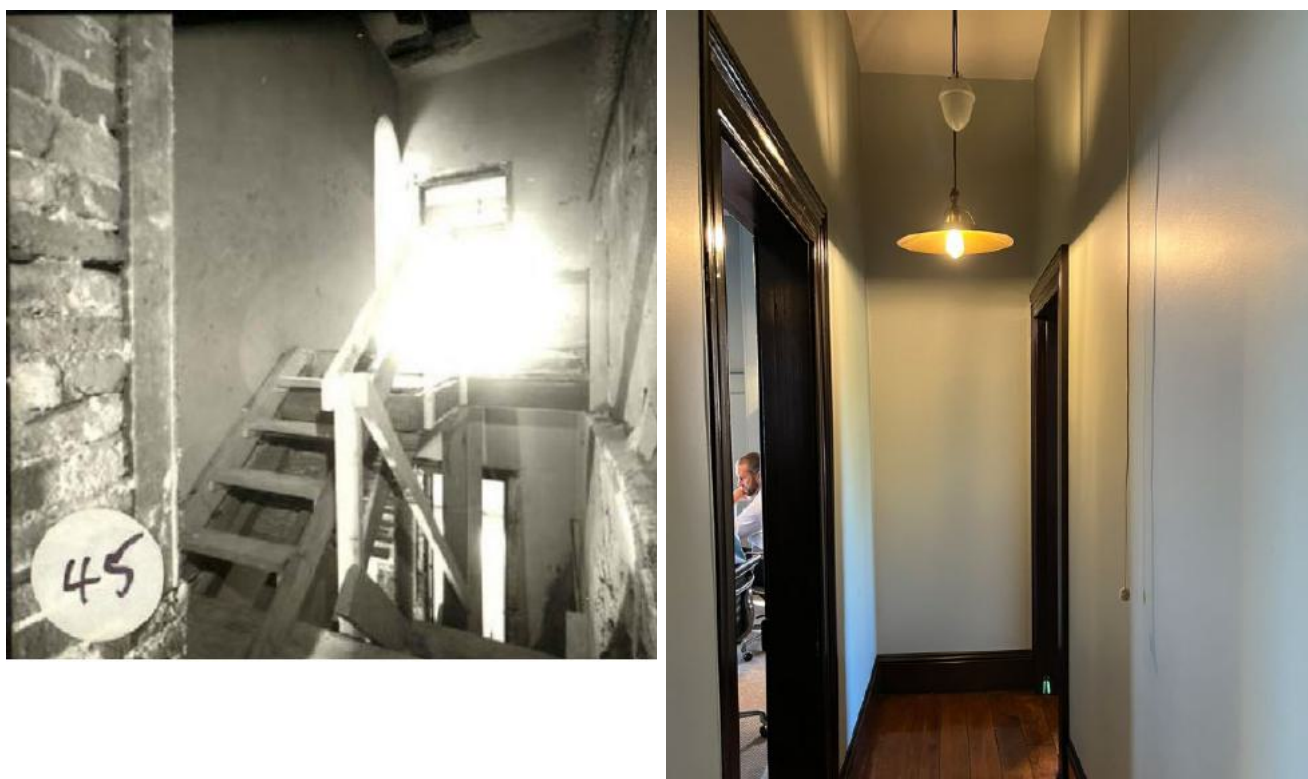
Figure 145: Room 2.3 looking west, 1995. (Source: PMNSW image 45, as reproduced in the 2015 CMP, p 128)

Figure 146: The corridor extending from the level 2 stair landing.

Room 2.3 comprises the stair mid-landing and uppermost flight, level 2 stair landing and adjacent corridor. The stair is a new reconstruction of the original stair (Figure 136). There is a carpet runner up the centre of the stair, but it is not continued on the level 2 landing, where original timber boards are clear finished and exposed. The 1995 dilapidation photographs confirm that the current stair is a 1997 reconstruction as only the carriage pieces and some laths from the stair soffit lining remained in 1995.

Walls are plastered and painted. The metal tie rod from the front room continues through the stair well along the north wall. The west wall of the hall to Room 2.2 is a framed wall and the 1995 dilapidation photograph and the 1997 conservation works photograph confirm it was a lath and plaster wall.

The ceiling is lath and plaster with timber strapping but no cornices. There is a skylight over the mid-landing.

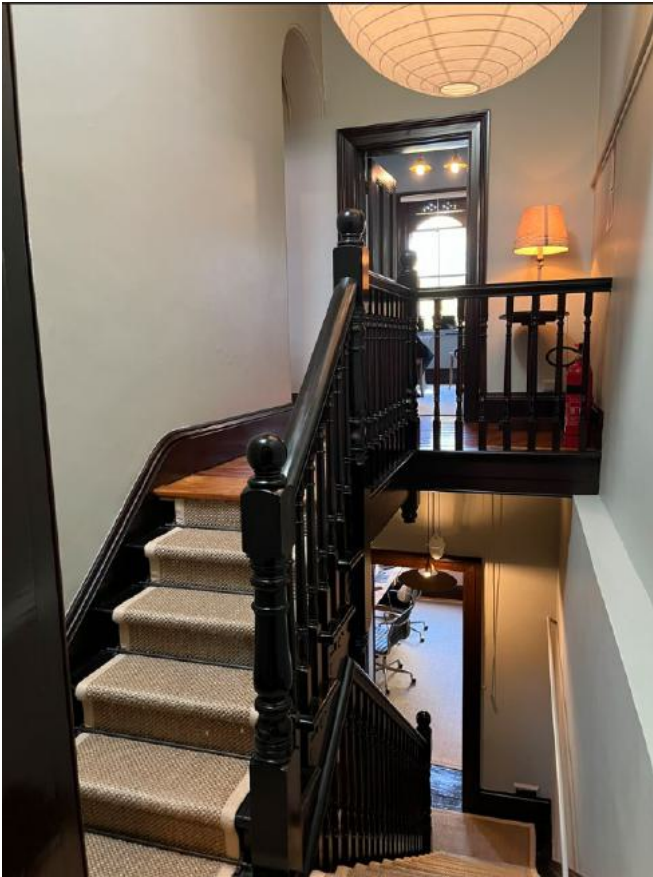
Figure 147: The uppermost flight of stairs and level 2 landing, 2024.

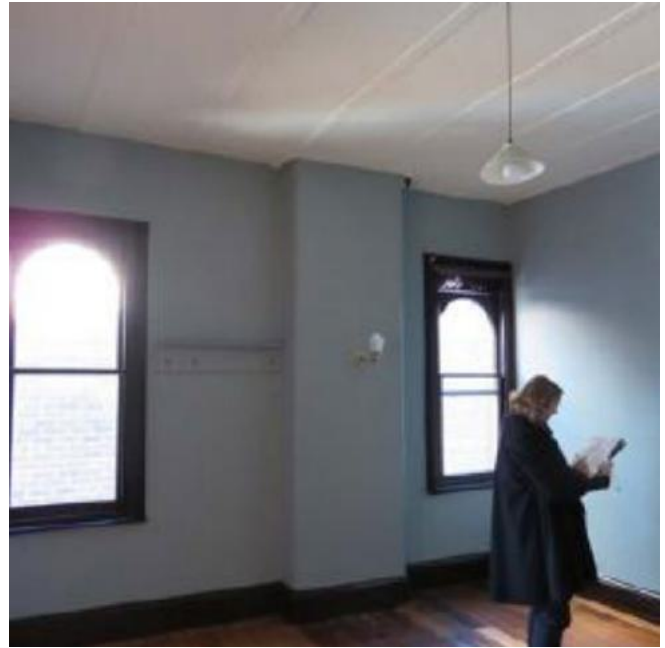
Figure 151: Room 2.4 looking south-west, 1995. (Source: PMNSW image 47, as reproduced in the 2015 CMP, p 128)

Figure 152: Room 2.4 looking south-west in 2014. The difference in the new and old floor boards is evident. (Source: Roberts and Hindmarch Pty Ltd, as reproduced in the 2015 CMP p128).

The clear-finished timber floorboards are a mixture of new and old boards and most of the gloss dark brown painted joinery appears to be new. The plaster walls are painted. The ceiling is lath and plaster as clearly shown in the 1995 dilapidation photograph Figure 140) with timber strapwork to support the ceiling. There is no decorative cornice but a simple square set junction between the ceiling and walls.

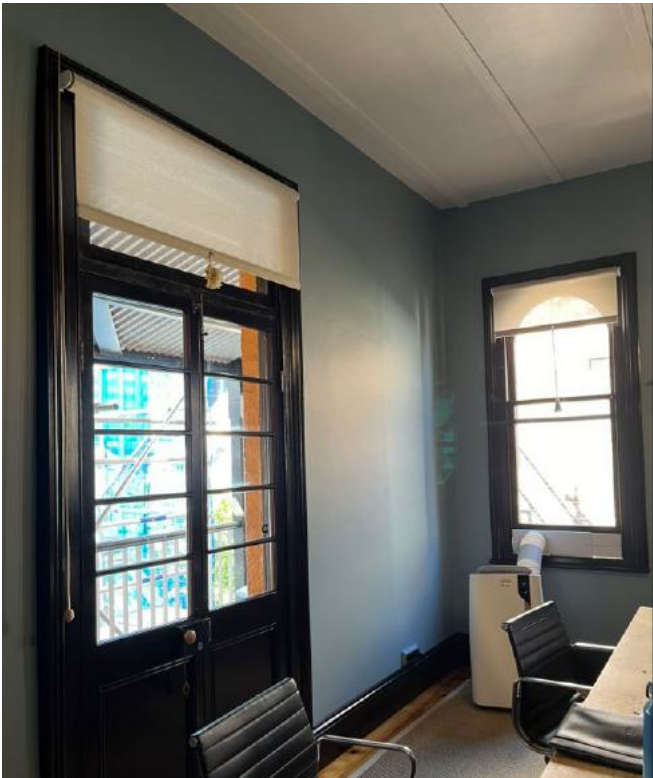
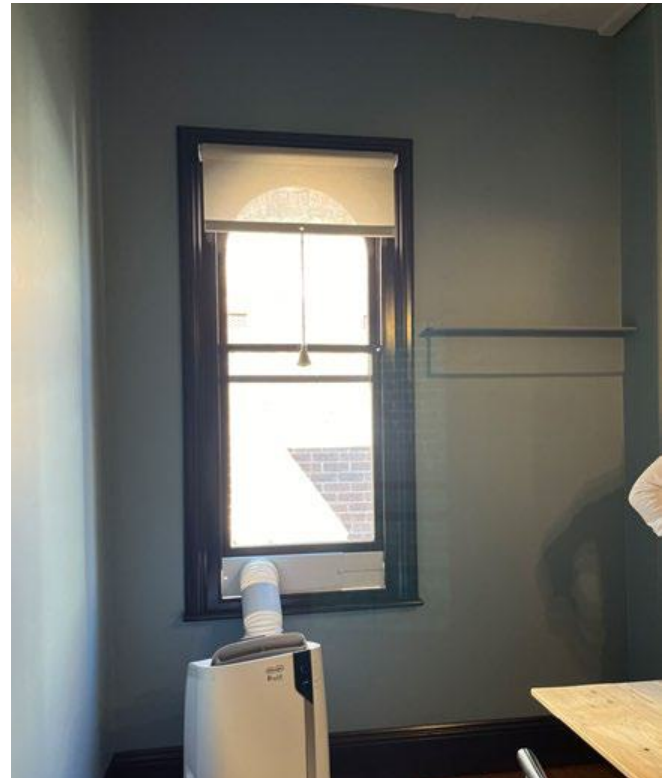
Figure 149: Room 2.4 looking south-east.

Figure 150: The timber wall shelf on the south wall of room 2.4 appears to exist in the 1995 photographs.

Room 2.4 was likely to have been a bedroom. It would be almost square if the hall to room 2.2 did not cut through one corner of the room. There are two windows in the south wall of the room: one on each side of the chimney flue. The windows cannot be closed fully because of the perforated timber ventilation boards installed above the top sashes. There is a timber wall shelf adjacent to the chimney flue which appears to pre-date the 1990s conservation works. A pair of French doors leading to the rear verandah (room 2.8).
