# 136-138 Cumberland Street, The Rocks, Conservation Management Plan

October 2024

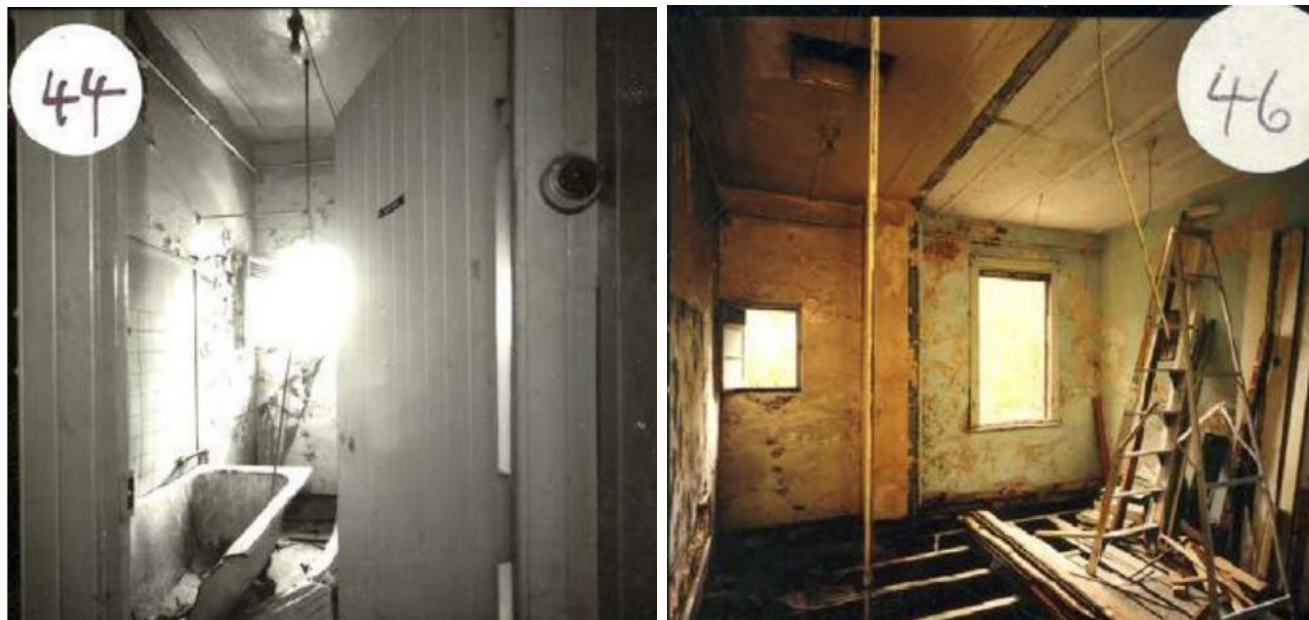
Figure 153: Room 2.6 looking east, 1995. (Source: PMNSW image 44, as reproduced in the 2015 CMP, p 130)

Figure 154: Rooms 2.6 & 2.7 during conservation works, 1996. The framed wall between the rooms has been removed but appears to have been reinstalled after the floor was rebuilt. (Source: SHFA image 46, as reproduced in the 2015 CMP, p 130)

Room 2.6 contains a WC suite and pedestal hand wash basin. It also contains a cupboard concealing the electric storage hot water unit is evidence of damp in the east wall adjacent to the toilet. The 1995 dilapidation photograph of this room shows a bath located in this room (Figure 144). The room is in good condition but there is evidence of damp on the eastern wall.

There is no 1995 dilapidation photograph of room 2.7 and so it is not possible to discern the use of the room at that time. It now contains a built-in bath, a shower recess, and a pedestal hand wash basin. The floor tiles date from 1997 as do the wall tiles around the shower recess and all the fittings themselves. The wall dividing this room from Room 2.6 is a timber stud wall with vertical timber boards on one side, and most likely dates from the early to mid-20<sup>th</sup> century, although it was dismantled and rebuilt in the 1990s.

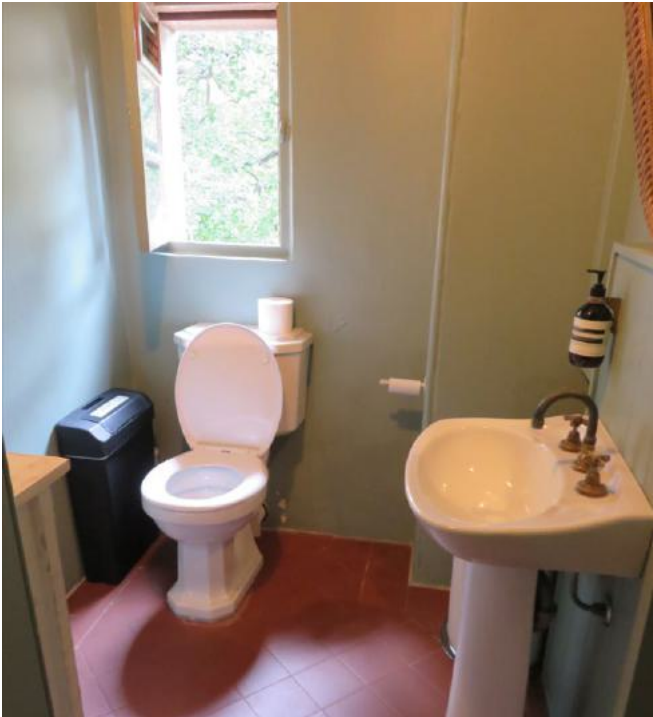
Figure 155: Room 2.6, looking east in 2024. The room retains its finishes and fittings from 1997 but has been repainted since.

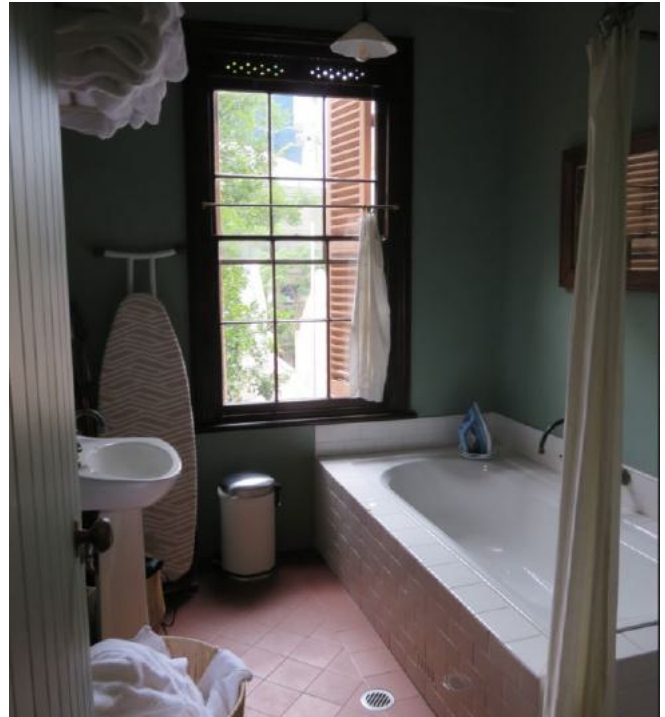
Figure 156: Room 2.7 looking east in 2024. The room retains its finishes and fittings from 1997 but has been repainted since.

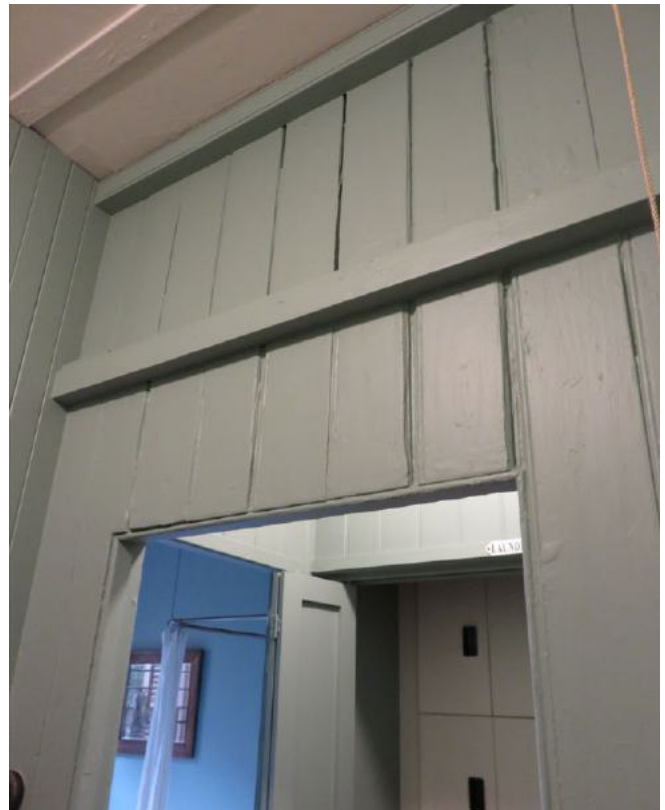
Figure 158: Detail of the wall that divides room 2.5 and extends to separate rooms 2.6 and 2.7. The fabric of this wall suggests it dates from the early to mid-20th century.

Room 2.5 comprises a lobby bisected by a framed wall (Figure 149), and a locker room. The locker room was built as a laundry as part of the 1997 conservation works but was later converted to its current use. The 1991 fabric survey plans by Clive Lucas Stapleton & Partners show the rear wing divided into a small lobby, Room 2.6 and a larger room combining Room 2.7 and the laundry and the southern part of Room 2.5. This confirms that the locker cupboard is a post-1991 construction, as is the west wall of room 2.7. The locker room retains its 1997 tiled floor and bi-fold doors.

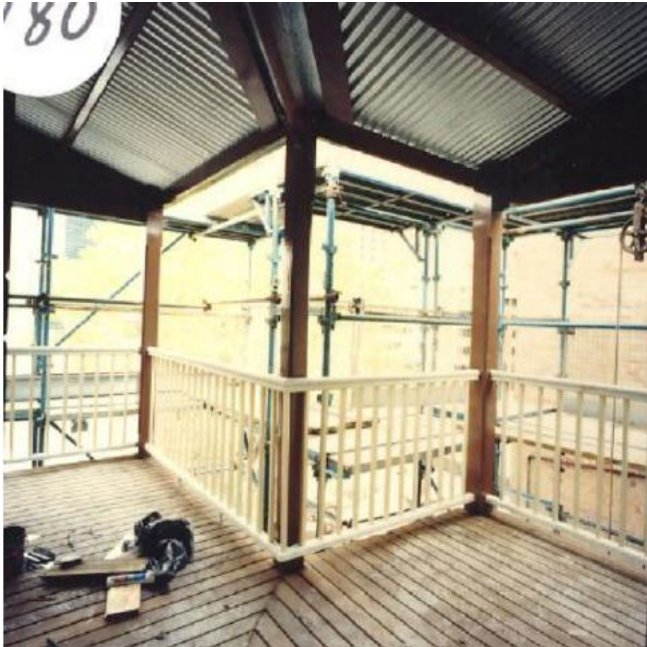
Figure 159: Second floor rear verandah (Room 2.8) reconstruction, 1997. (Source: PMNSW image 180, as reproduced in the 2015 CMP, p 131)

Room 2.8 forms level 2 of the two-storey verandah which was constructed in 1997. The verandah is based on the extant original verandah which was demolished in 1996. The verandah is timber framed with timber balustrades, 1010mm in height. Floorboards are square edged and are clear finished. The underside of the roof sheeting and the roof framing are exposed above. The verandah has recently been painted.

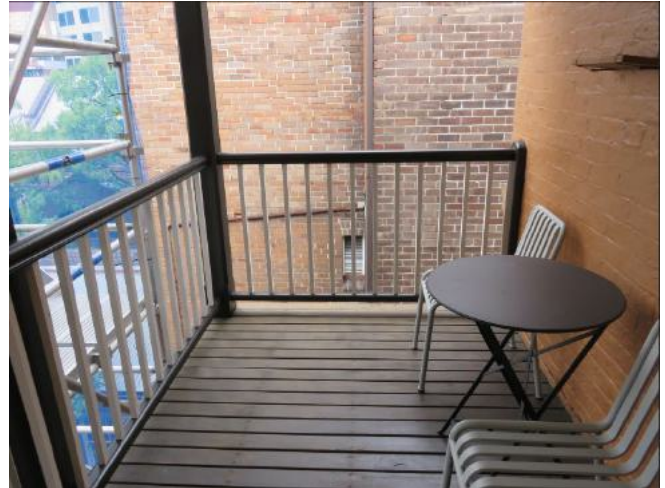
Figure 160: Room 2.8, 2024

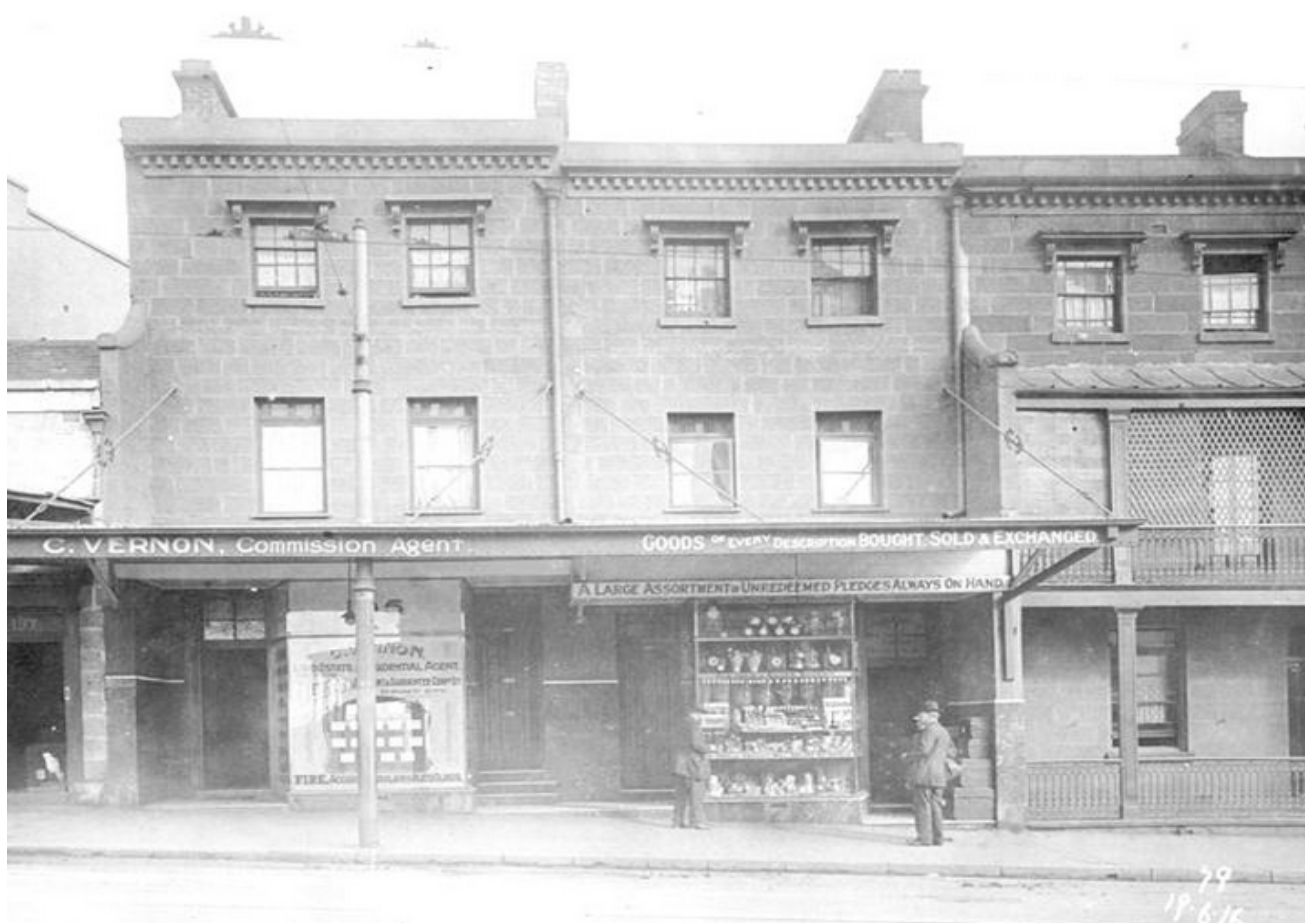
Figure 164: Pair of shops at 191-195 William Street Source: SCC Demolition Books

The demolition photographs taken by the Sydney City Council provide some indication of the evolution of the form and its internal planning. An example once located at 191-195 William Street in Darlinghurst shows a row that contains two shops (each with a separate entrance to the residential portion of the house), and a townhouse with a verandah with a balcony over (or two-storey verandah) to the right-hand side. The windows to the upper floors are identical. The planning of the first and second floors is also likely to have been identical. The ground floor was a shop, that may have been used as an office in a mid-nineteenth century merchant's townhouse, with a parlour and dining room over and bedrooms on the upper floors (Figure 164).

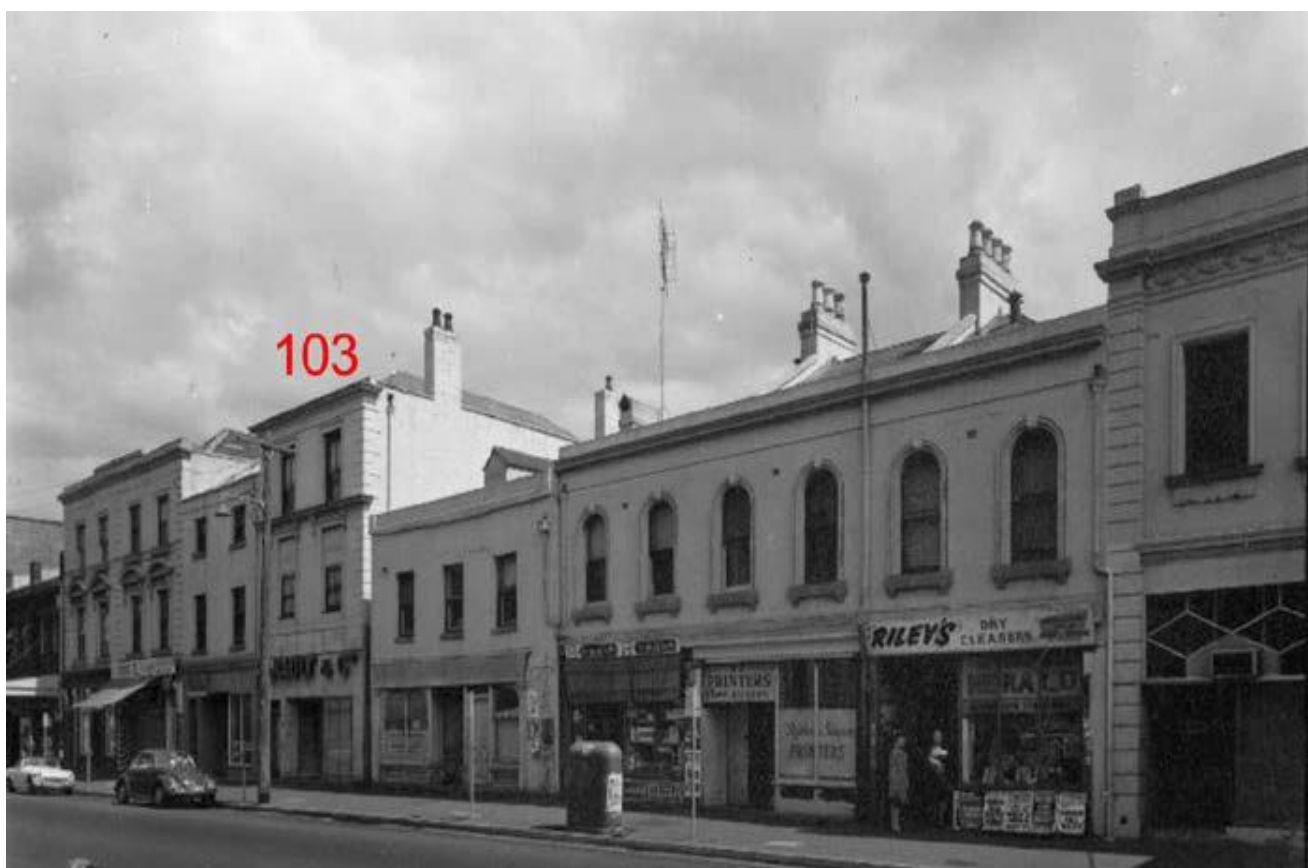
Figure 172: 1970 view of George Street North including the shop/dwelling erected by Thomas Playfair at No. 103 George Street North. This view shows the buildings before they were repainted, conserved and altered and show the details extant at that time. Source: SHFA

Butcher shops have been located in The Rocks, with examples dating back to 1812, however, the building stock no longer survives. Much of the meat was supplied to shipping, and some firms were dedicated to supplying provisions for voyages. Shops in George Street North had been rented by shipping butchers (Figure 172), such as Thomas Playfair, prior to erecting their own premises.

Most of the butcheries occupied shops not specifically erected as butcheries and there is very little within the area today to indicate this long-standing use by butchers, including Thomas Playfair, other than the naming of Playfair Street and his premises at 103 George Street (Figure 172). The purpose-built premises erected by Playfair after 1910 have been demolished and replaced by the Clocktower development.

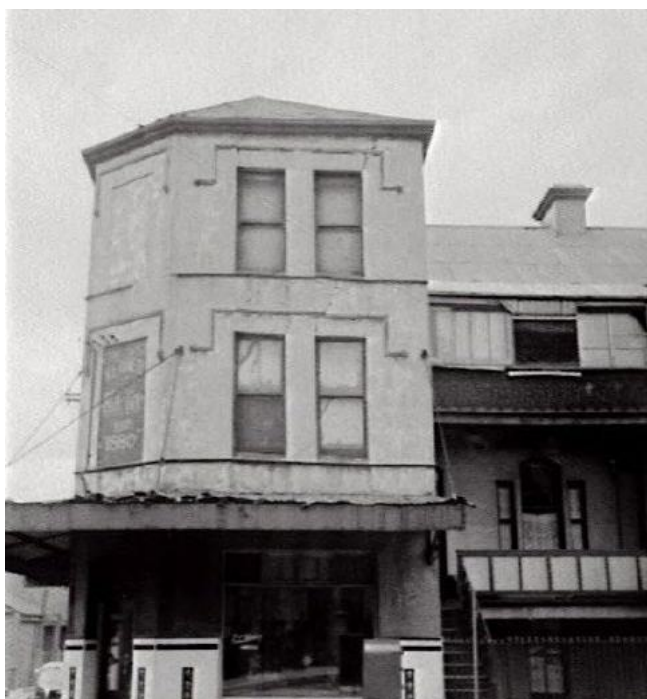
Figure 173: Corner shop at 271 Bridge Road, Glebe, W. E. Turneth Butcher, established 1880, photographed in 1953. Source: SCC Archivespix

Traditional butcher shops survive in suburban areas, some of which were long-standing uses (Figure 161). Artisan butcher shops, with a display counter are now popular however, this would not have been the form of a nineteenth century butcher shop, as there was no refrigeration or cool room. Most shops did have a cellar that could be used for the cool storage of goods but specific cool rooms for butcher shops do not appear in the literature before the early 1880s. An article on the *Sydney Mail*, 26 March 1881, described a purpose-built butcher's shop with cool room using a refrigeration plant designed by Thomas Mort.

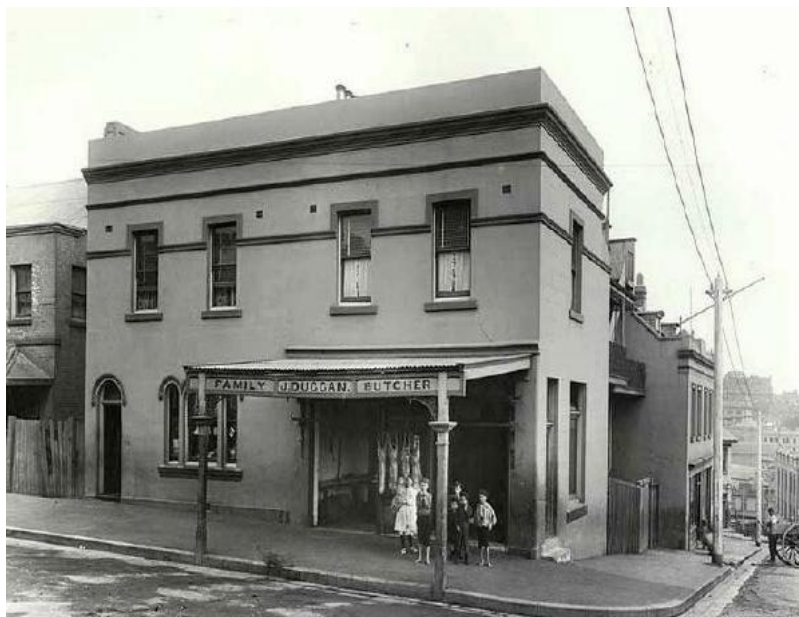
Figure 174: J. Duggan Butchery, 178 Cumberland Street, October 1901. Source: SRNSW

The use of the shop on the corner of Long's Lane as a butchery was short-lived. Other later uses such as newsagents can still be found in the area. In contrast, Duggan's Butchery and Grubb's butchery survived for a lot longer, until each property was resumed. Grubb's butchery was rebuilt whereas Duggan moved to a shop in Argyle Place. Duggan's shop on the corner of Cumberland Street survives (Figure 174). Other shop dwellings around the corner in Essex Street have had their shopfronts removed and they appear as terrace houses (Hart's building).

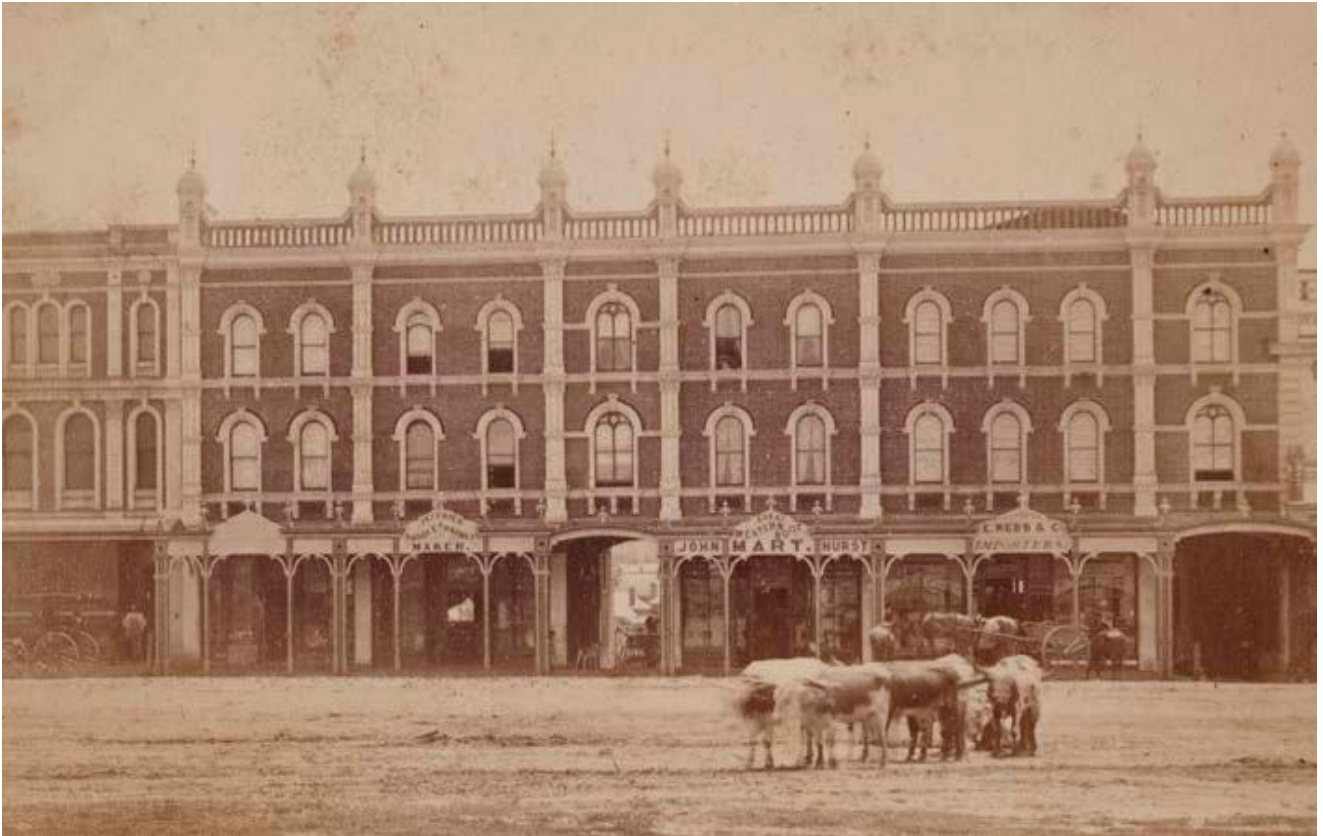
Figure 175: Welch photo of Webb's building, George Street, Bathurst, 1870s. Source: Sydney Living Museums

The scale of building including a shop and two storeys of residence above was also erected in country towns. The Webb Stores in George Street, Bathurst, a row of four shops, appears as a three-storey Italianate commercial building in the 1870s photograph, but began as a single storey building. Some of the first and second floors appear to have been used as residences by the shopkeepers, as can be seen in Figure 175<sup>93</sup>.

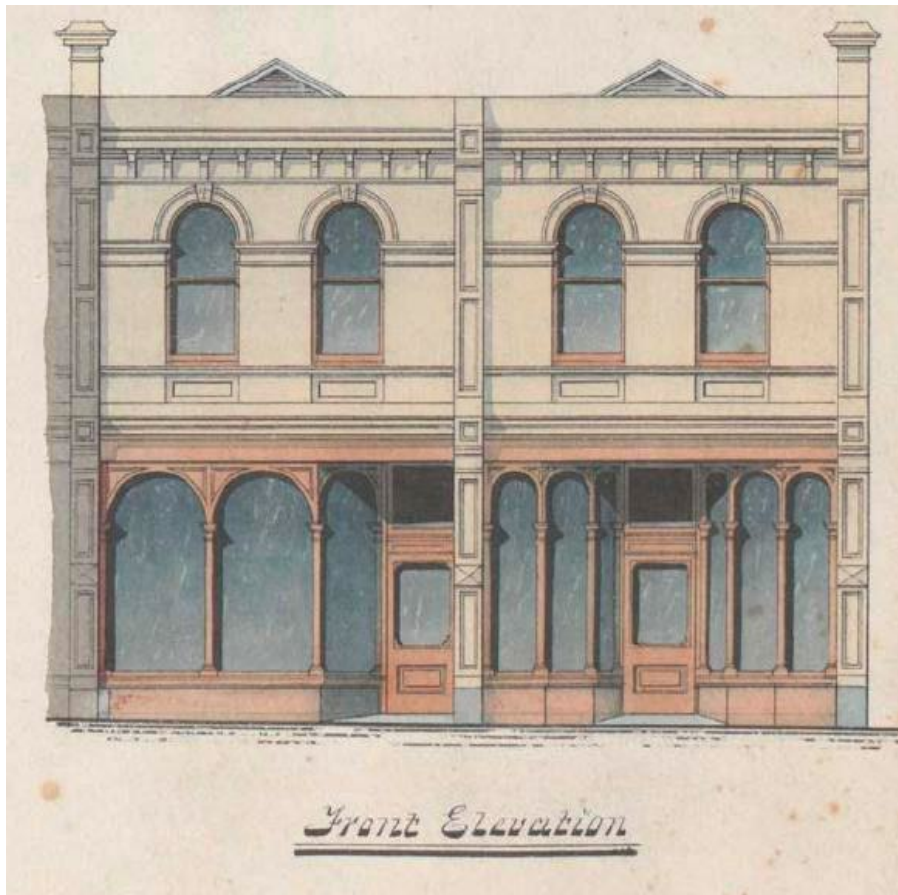
Figure 177: Campi Buildings, Clifton Hill, Melbourne. Source: SLVIC

The architectural drawings for two shops and dwellings to be erected for A. Campi at Queens Parade, Clifton Hill in Victoria (Figure 177) show the construction of a shop and dwelling in detail. Although only two-storey, these shops are of a similar architectural character to the shop and dwelling at No. 136-138 Cumberland Street. The plans were prepared by the firm of Twentymen & Askew for Abbondio Campi.

At ground level are the shops, which would most likely have been fitted out by the tenants, as no counter is shown. There is no separate entrance to the residential portion, the stair hall is beyond the shop and is located in the rear wing, as is the living room, kitchen and scullery with sinks and copper. The privy is located in the rear yard. The drawing room is the large room extending across the front at first floor level. The 'best bedroom' is behind this room. Beyond the staircase in the rear wing are the bathroom (which only contains a bath), a small bedroom with no fireplace and a larger bedroom to the rear. The building is a pair of shops, and the plan is mirror reversed.

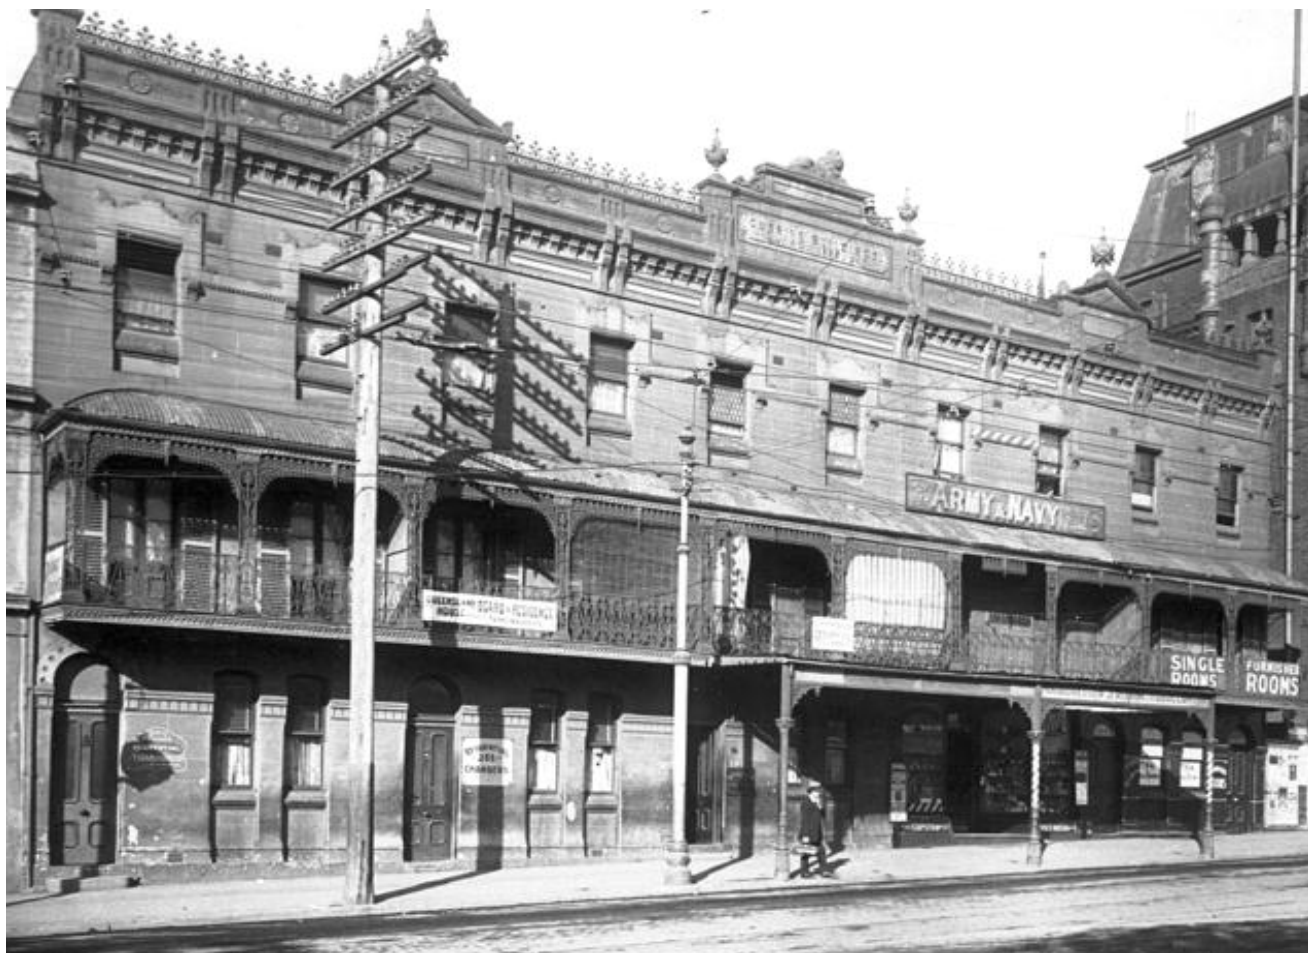
Figure 178: Guerin's Building, 286-292 Elizabeth Street part of which was occupied as a boarding house. Source: SCC Demolition books

Photographs in the Sydney City Council Demolition books also provide an indication of the scale and character of buildings used as boarding houses. The now-demolished Guerin's building at 286-292 Elizabeth Street was a row of substantial townhouses and shops (Figure 178). Erected in the early 1880s<sup>47</sup> by the saddle maker, P Guerin, the row of residences was described as being first class (i.e. the highest standard of town house according to the London – and Sydney – system of rating housing types) and of rare architectural beauty.

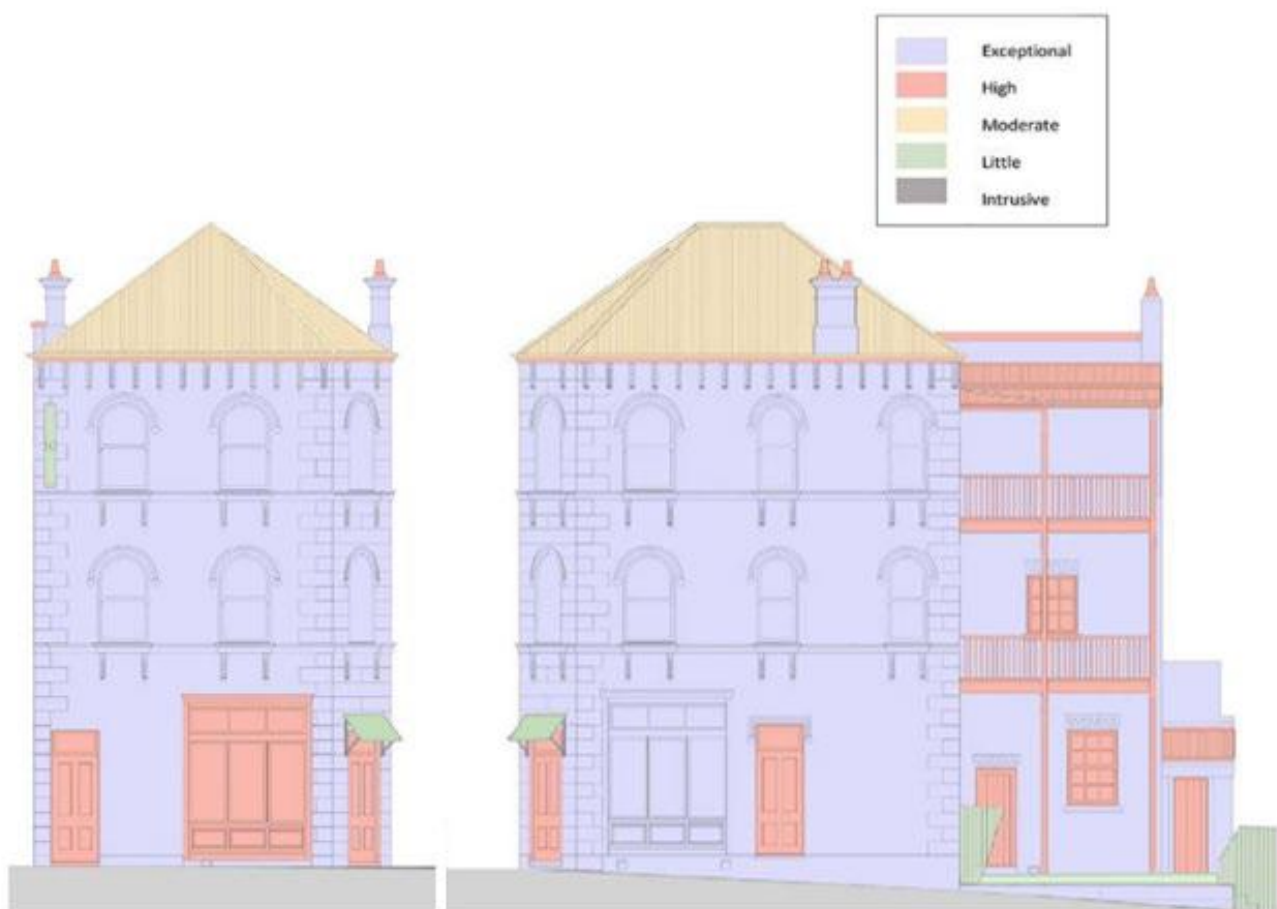
Figure 180: West elevation (left) and south elevation (right) showing grading of significant elements. (Source: 2015 CMP pp163-164, with PMNSW overlay 2024)

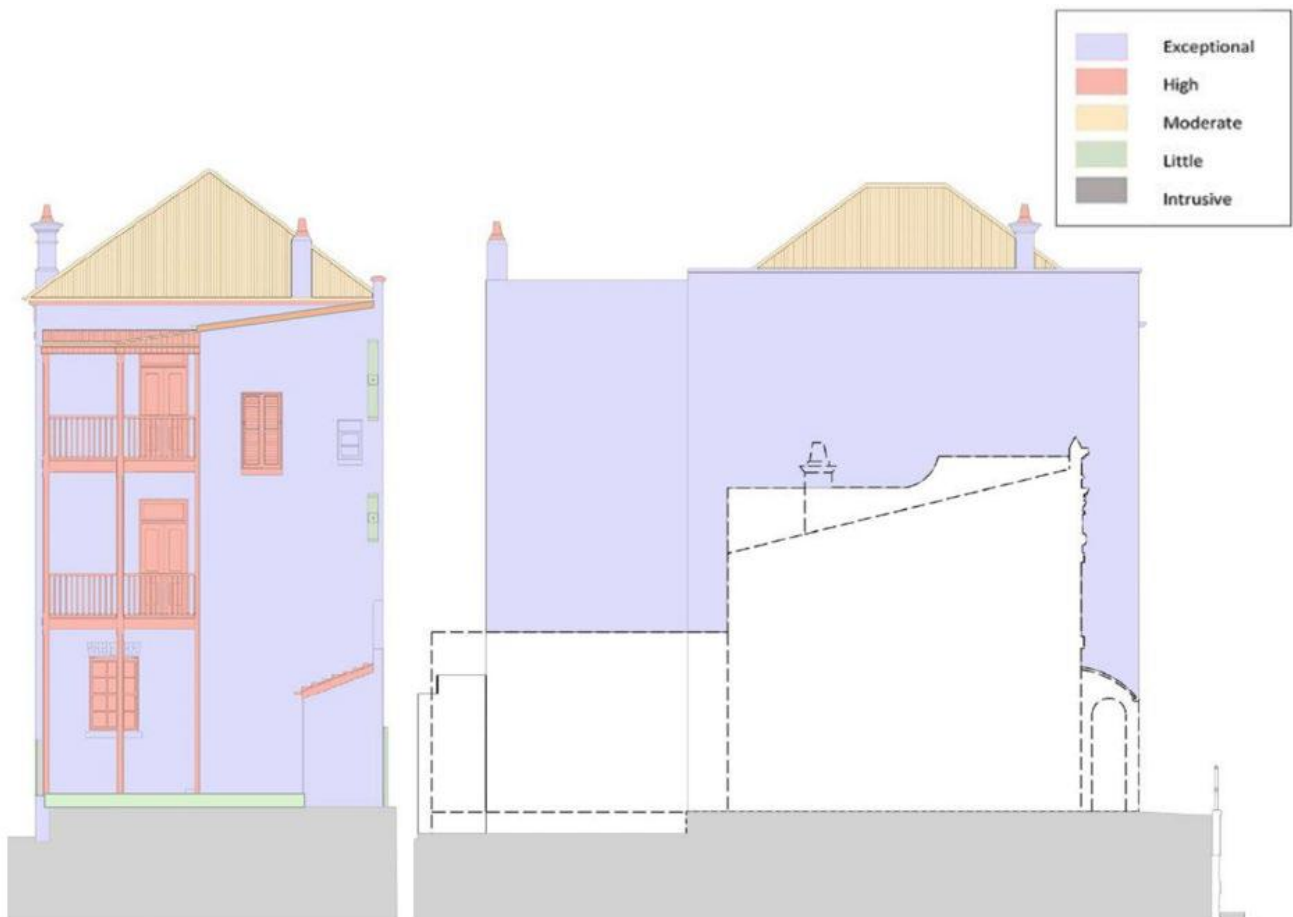
Figure 181: East elevation (left) and north elevation (right) showing grading of significant elements. (Source: 2015 CMP pp163-164, with PMNSW overlay 2024)

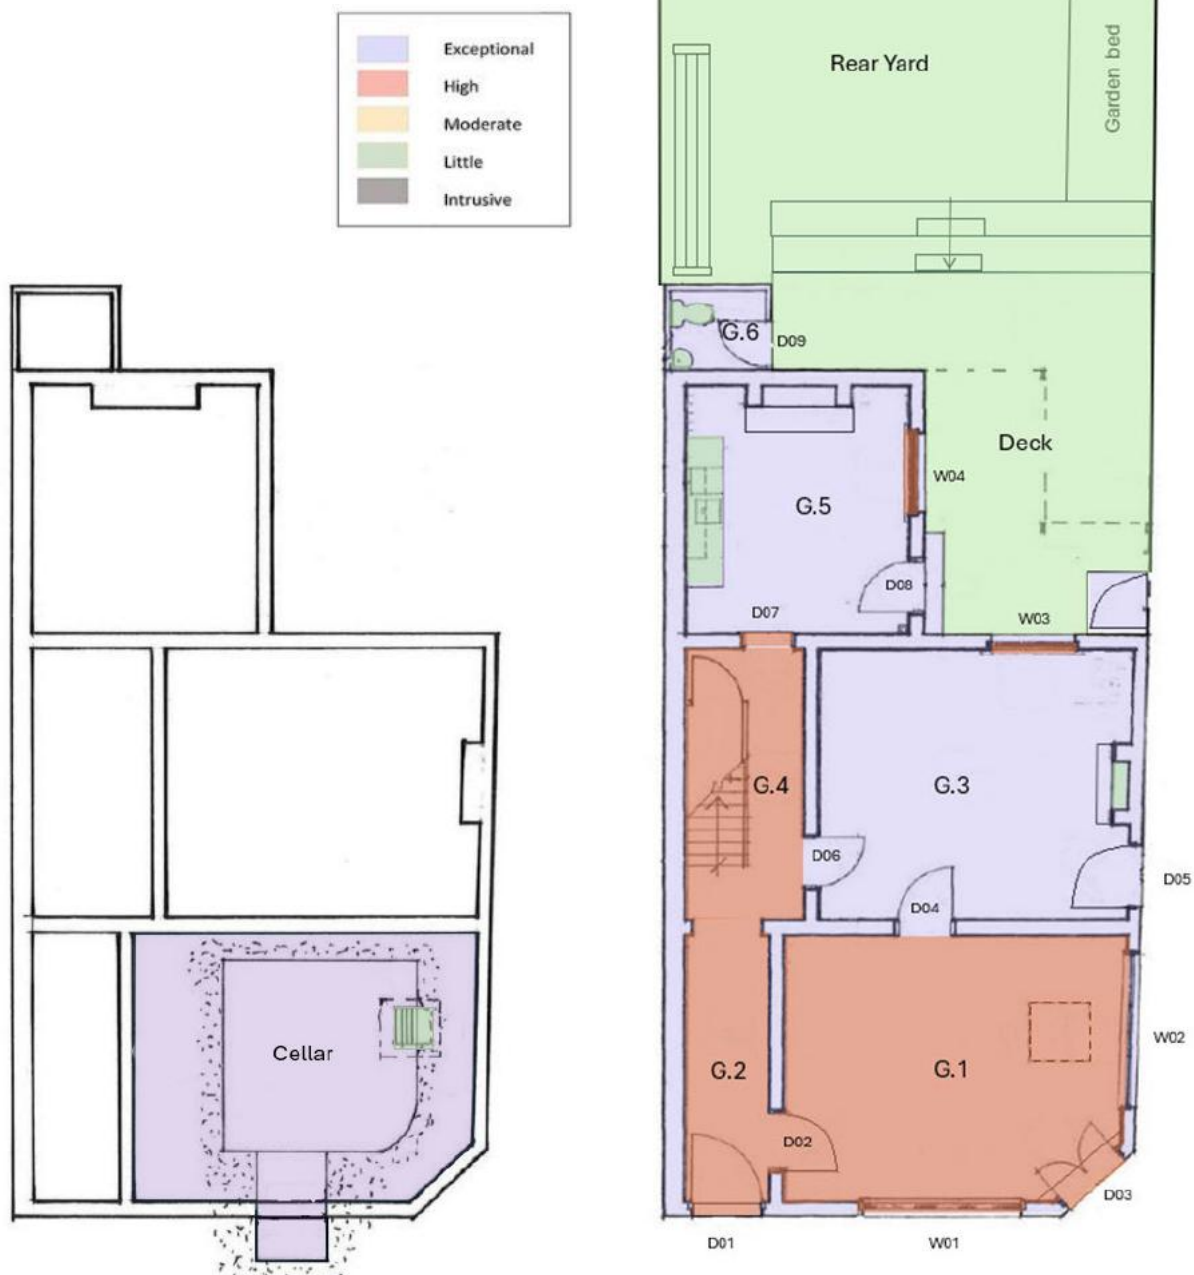
Figure 182: Basement plan showing grading of significant elements. (Source: 2015 CMP p159, with PMNSW overlay 2024)

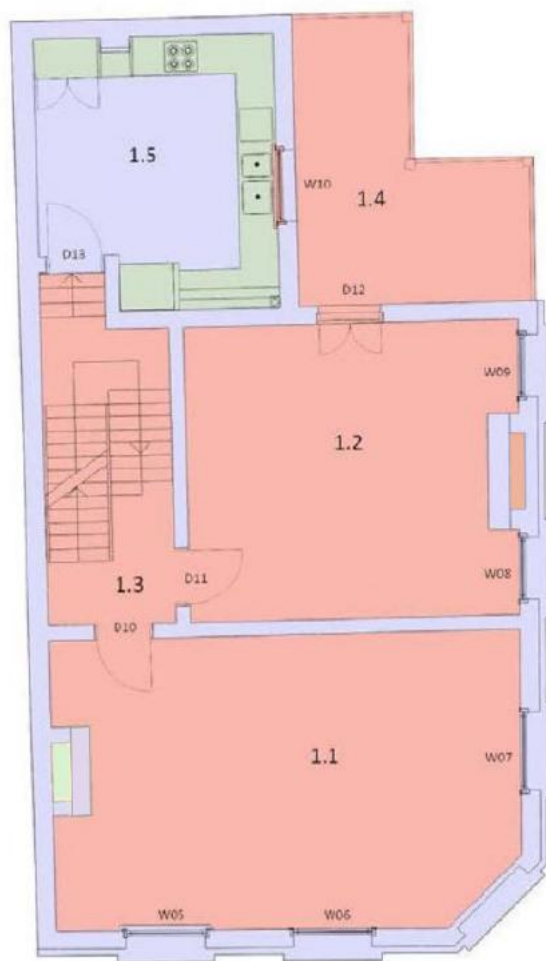
Figure 184: First floor plan showing grading of significant elements. (Source: 2015 CMP p161, with PMNSW overlay 2024)

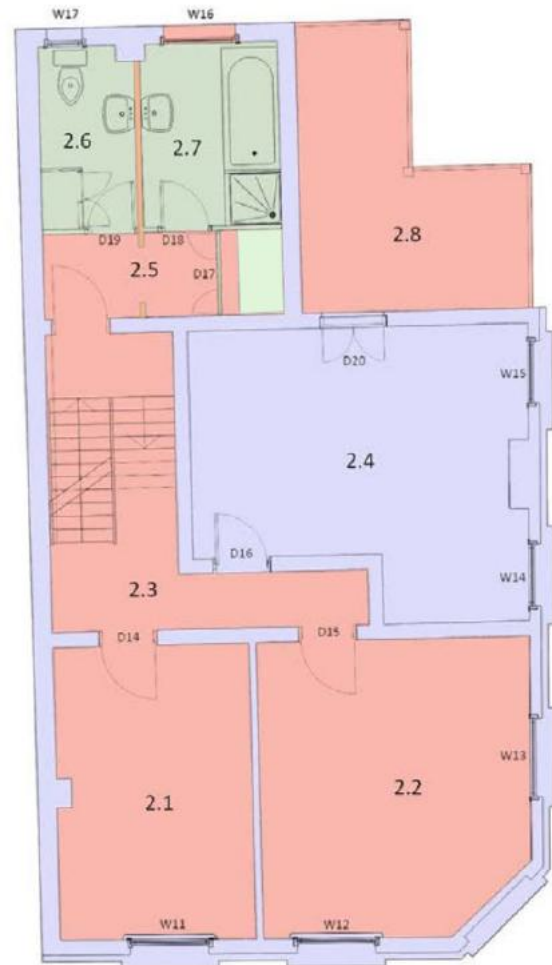
Figure 185: Second floor plan showing grading of significant elements. (Source: 2015 CMP p162, with PMNSW overlay 2024)
