# HARTS BUILDINGS

10-14 Essex Street, The Rocks

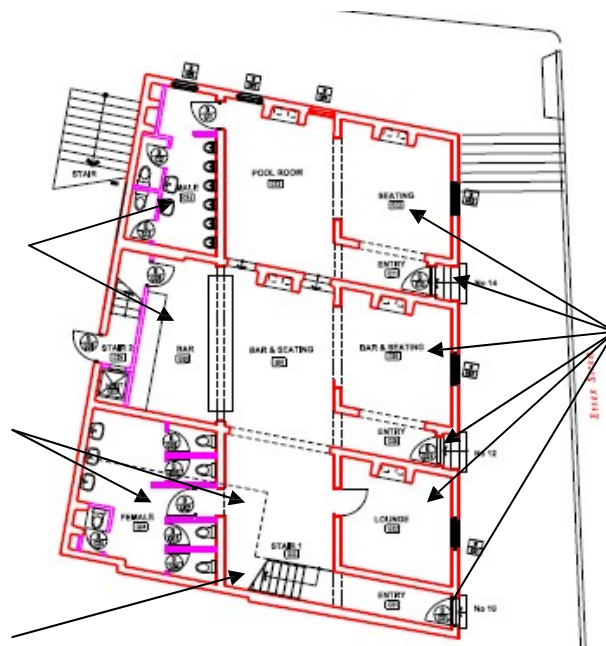
**Figure P.1** Ground floor plan

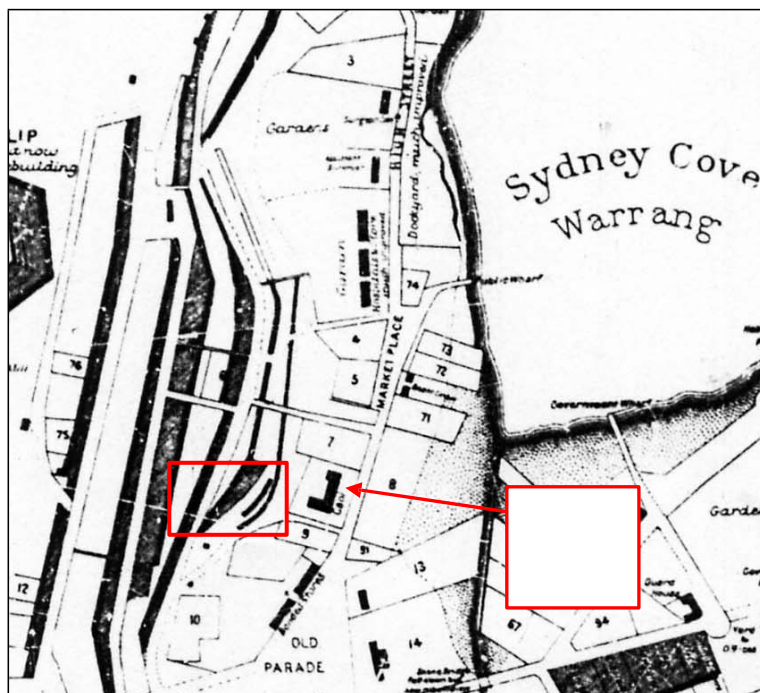
**Figure 2.1** Meehan's Plan of the Town of Sydney, 1807, showing the general arrangement of the area.

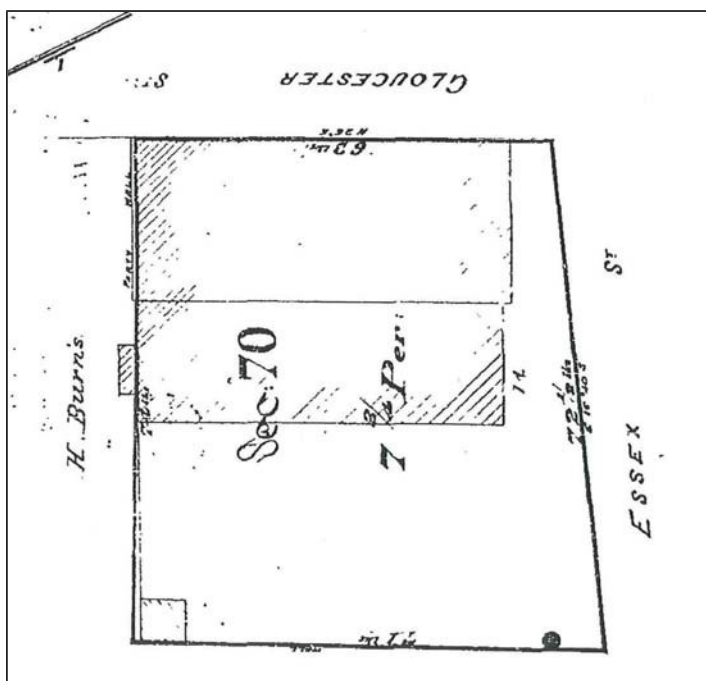
**Figure 2.5** Plan on the 1877 land title showing the footprint of the earlier buildings on the site.

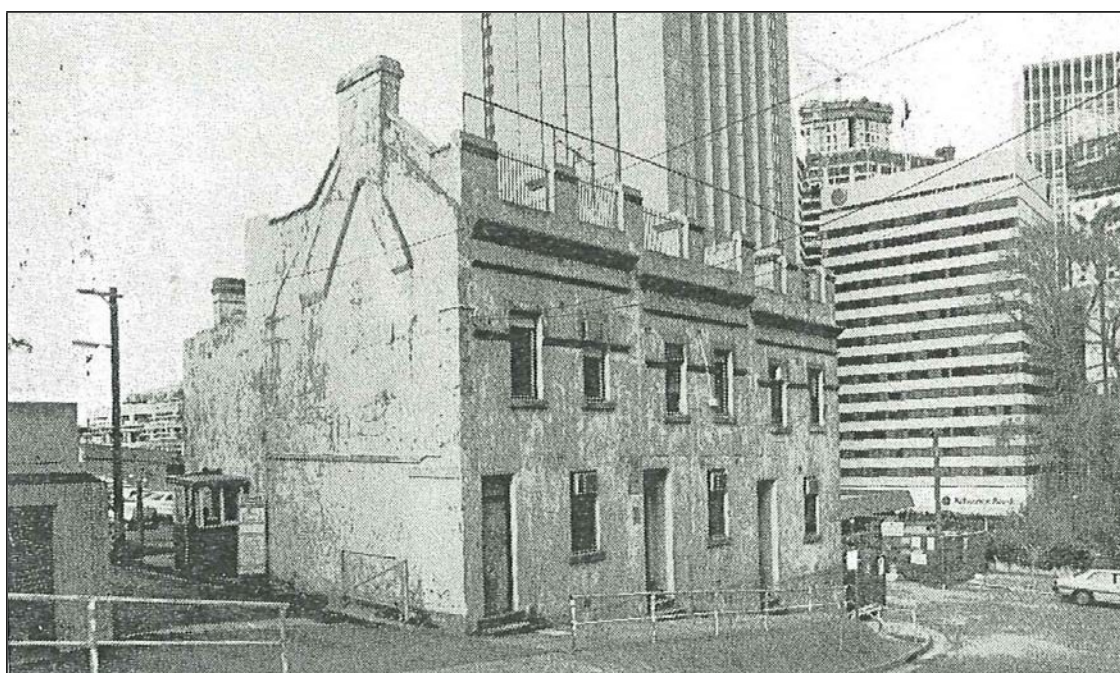
**Figure 2.23** The buildings c. 1988. The Gloucester Lane alignment along the western façade of the buildings (at left) is clear. (Source: Planning Workshop, EIS, 1988)

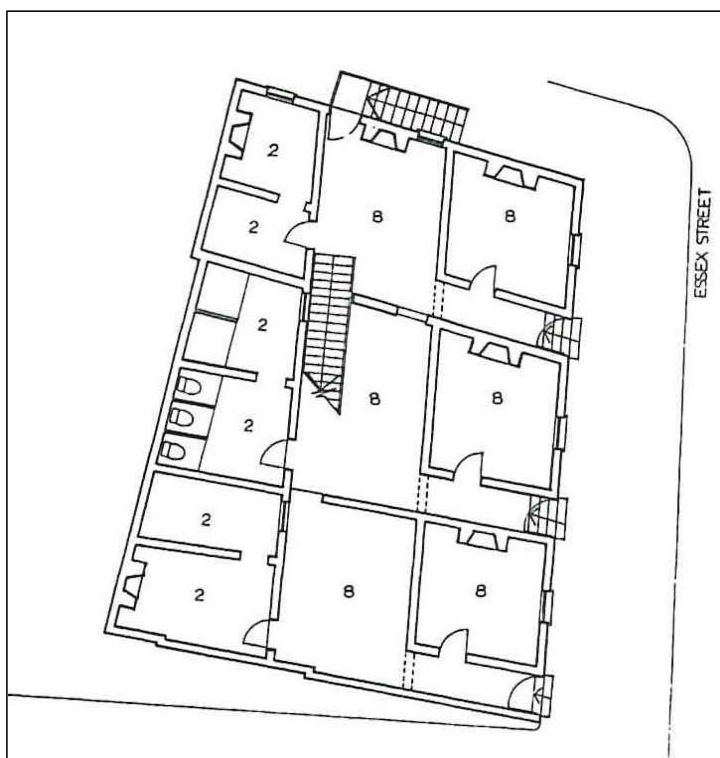
**Figure 2.25 c.** 1989 Ground Floor Plan. The buildings were converted to site offices in 1988, when openings were made in the internal party walls, the original stairs were removed and replaced with a single stair and rear yard was covered over and wings converted to staff amenities. Windows to the Essex Street façade were also replaced and a new door opening formed in the Gloucester Street façade to enable access to the construction site opposite the buildings, on the north eastern corner of Essex and Gloucester Street.

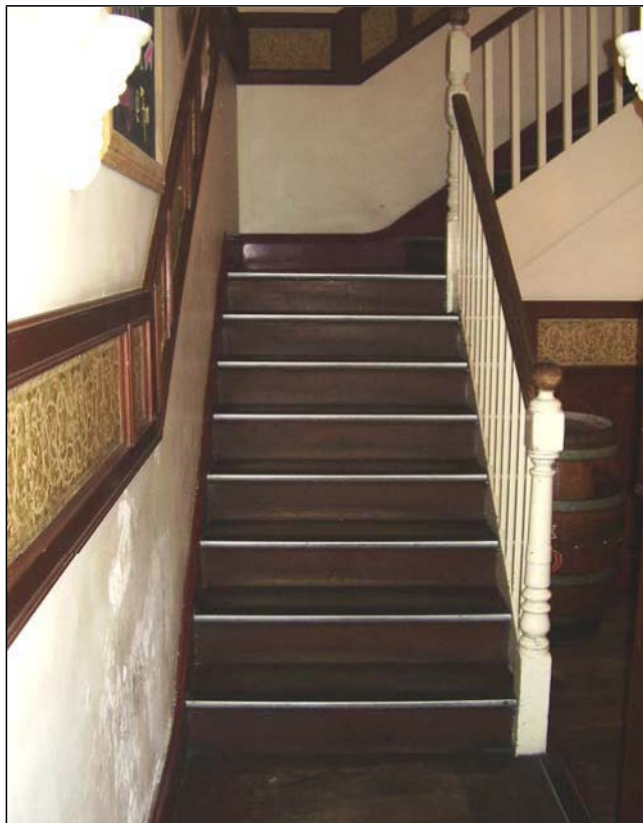
**Figure 3.67** The stair was constructed as part of the 1990s works and has timber treads and risers and balustrade.

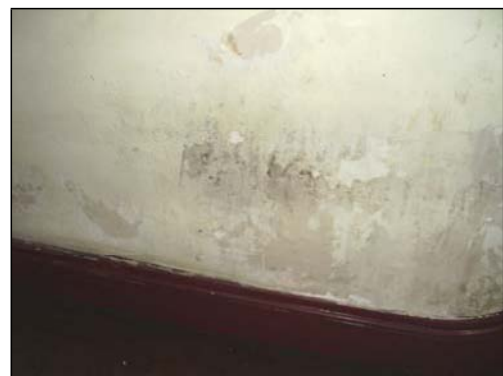
### 3.5.2 First Floor

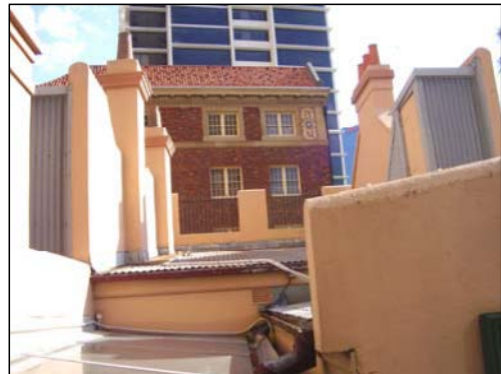
## 3.6 Building Condition

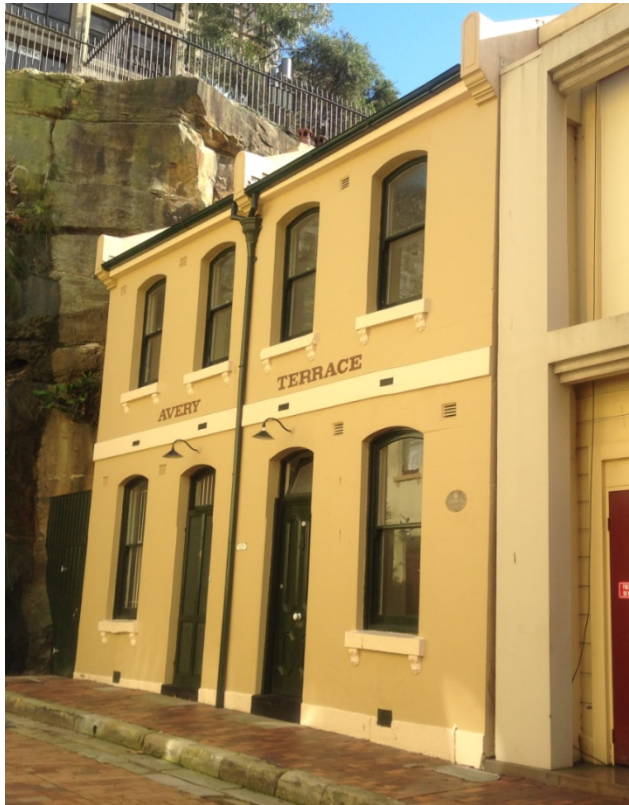
**Figure 4.6** Avery Terrace, Nos. 2-4 Atherden Street.

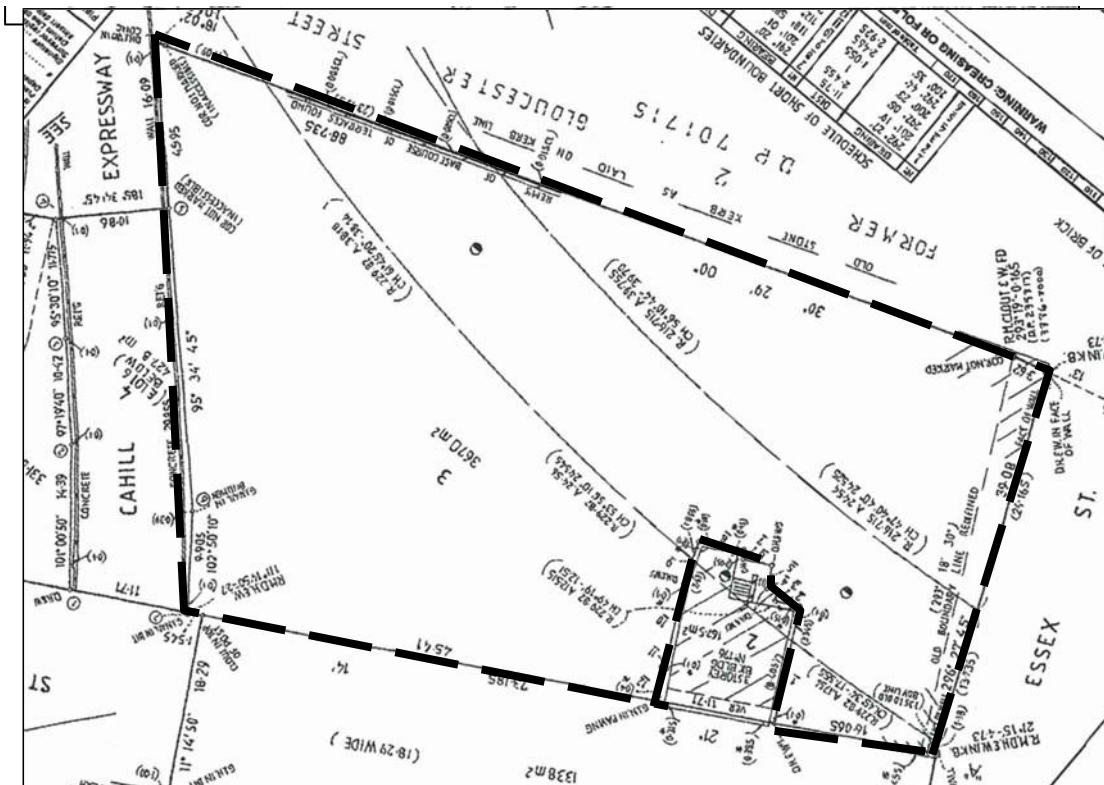
**Figure 4.9** Lot 3, DP 778140 incorporates land bounded by the Cahill Expressway, Cumberland, Essex and Gloucester Streets except for Lilyvale which is on Lot 2. The red box indicates the approximate location of the Harts Buildings recommended SHR listing boundary which is defined as Part of Lot 3 DP778140. (Source: Land and Property Information).

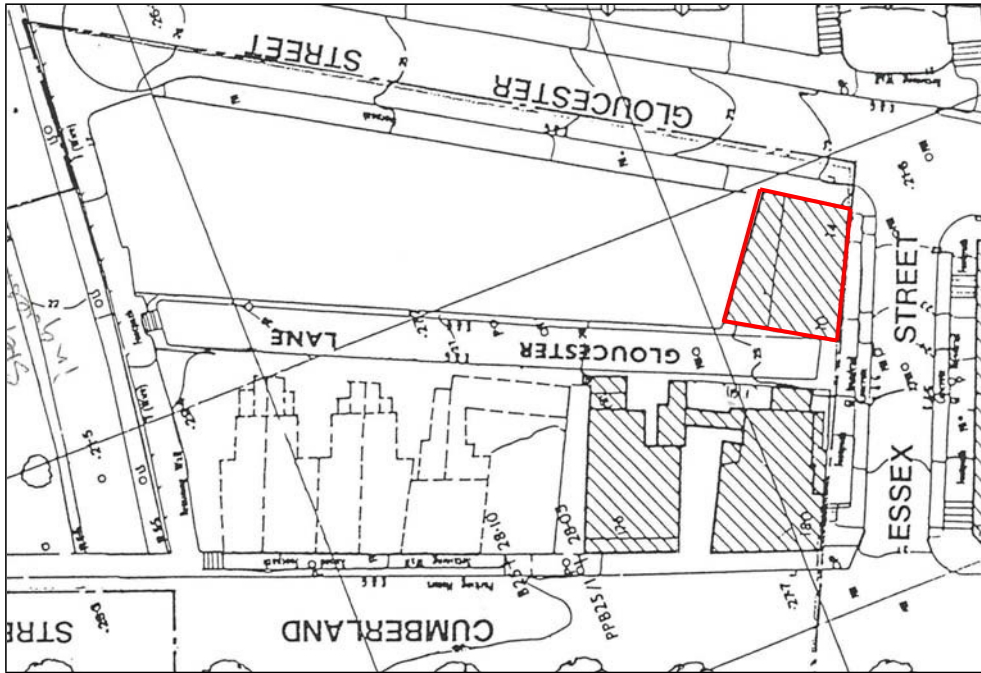
**Figure 4.10** The recommended SHR listing boundary for the Harts Buildings is the building footprint, as shown above outlined in red and is Part of Lot 3 DP 778140. Source: Foreshore Authority Building Files, RE0529.01.06

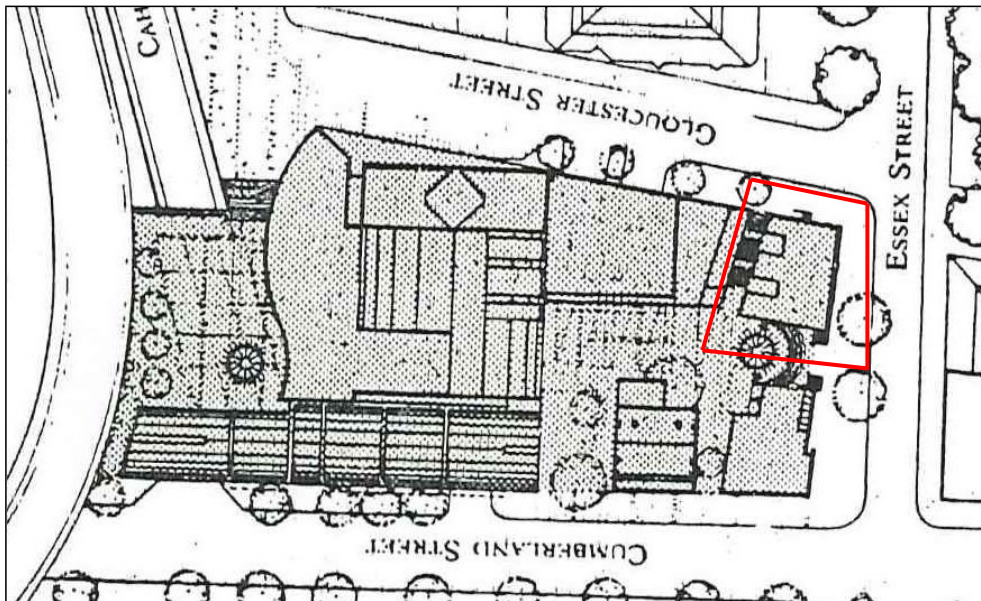
**Figure 4.11** The extended curtilage incorporates the pedestrian footpaths and associated features, stairs and open spaces around the buildings. (Source: Authority Building Files, RE0529.01.05)

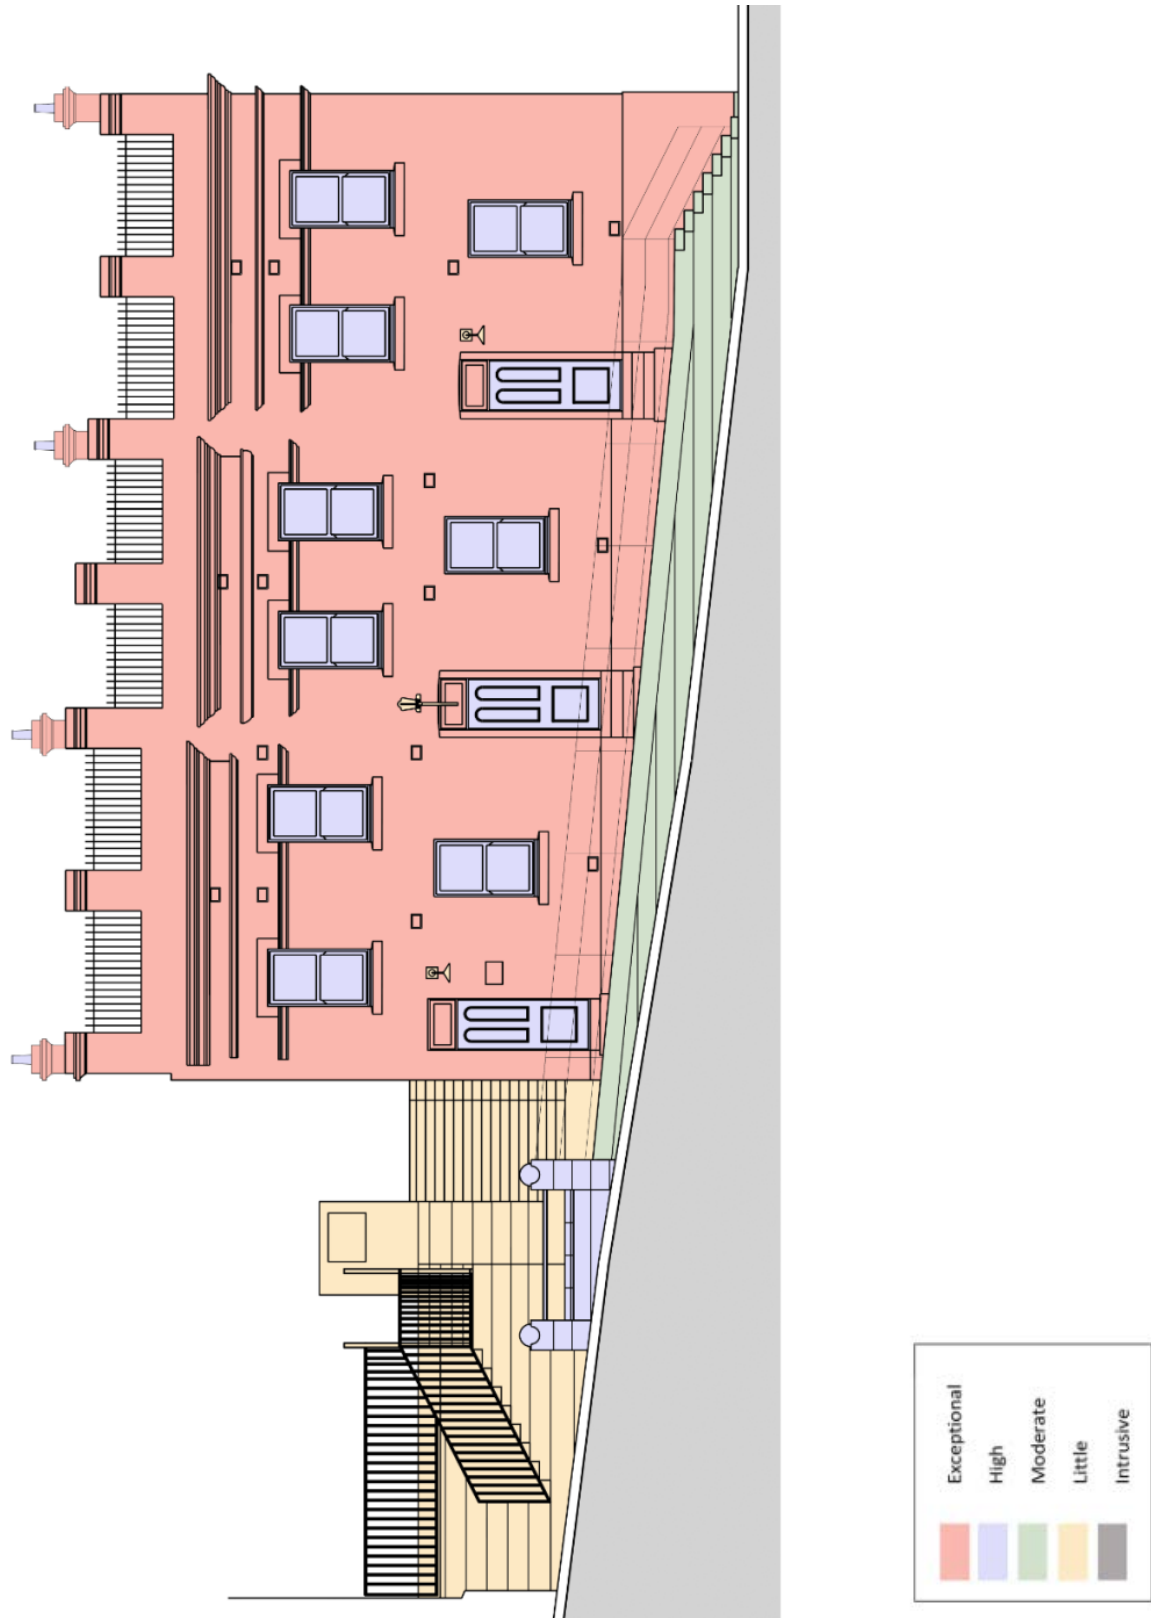
Figure 5.1 Essex Street (Southern) elevation grading of elements

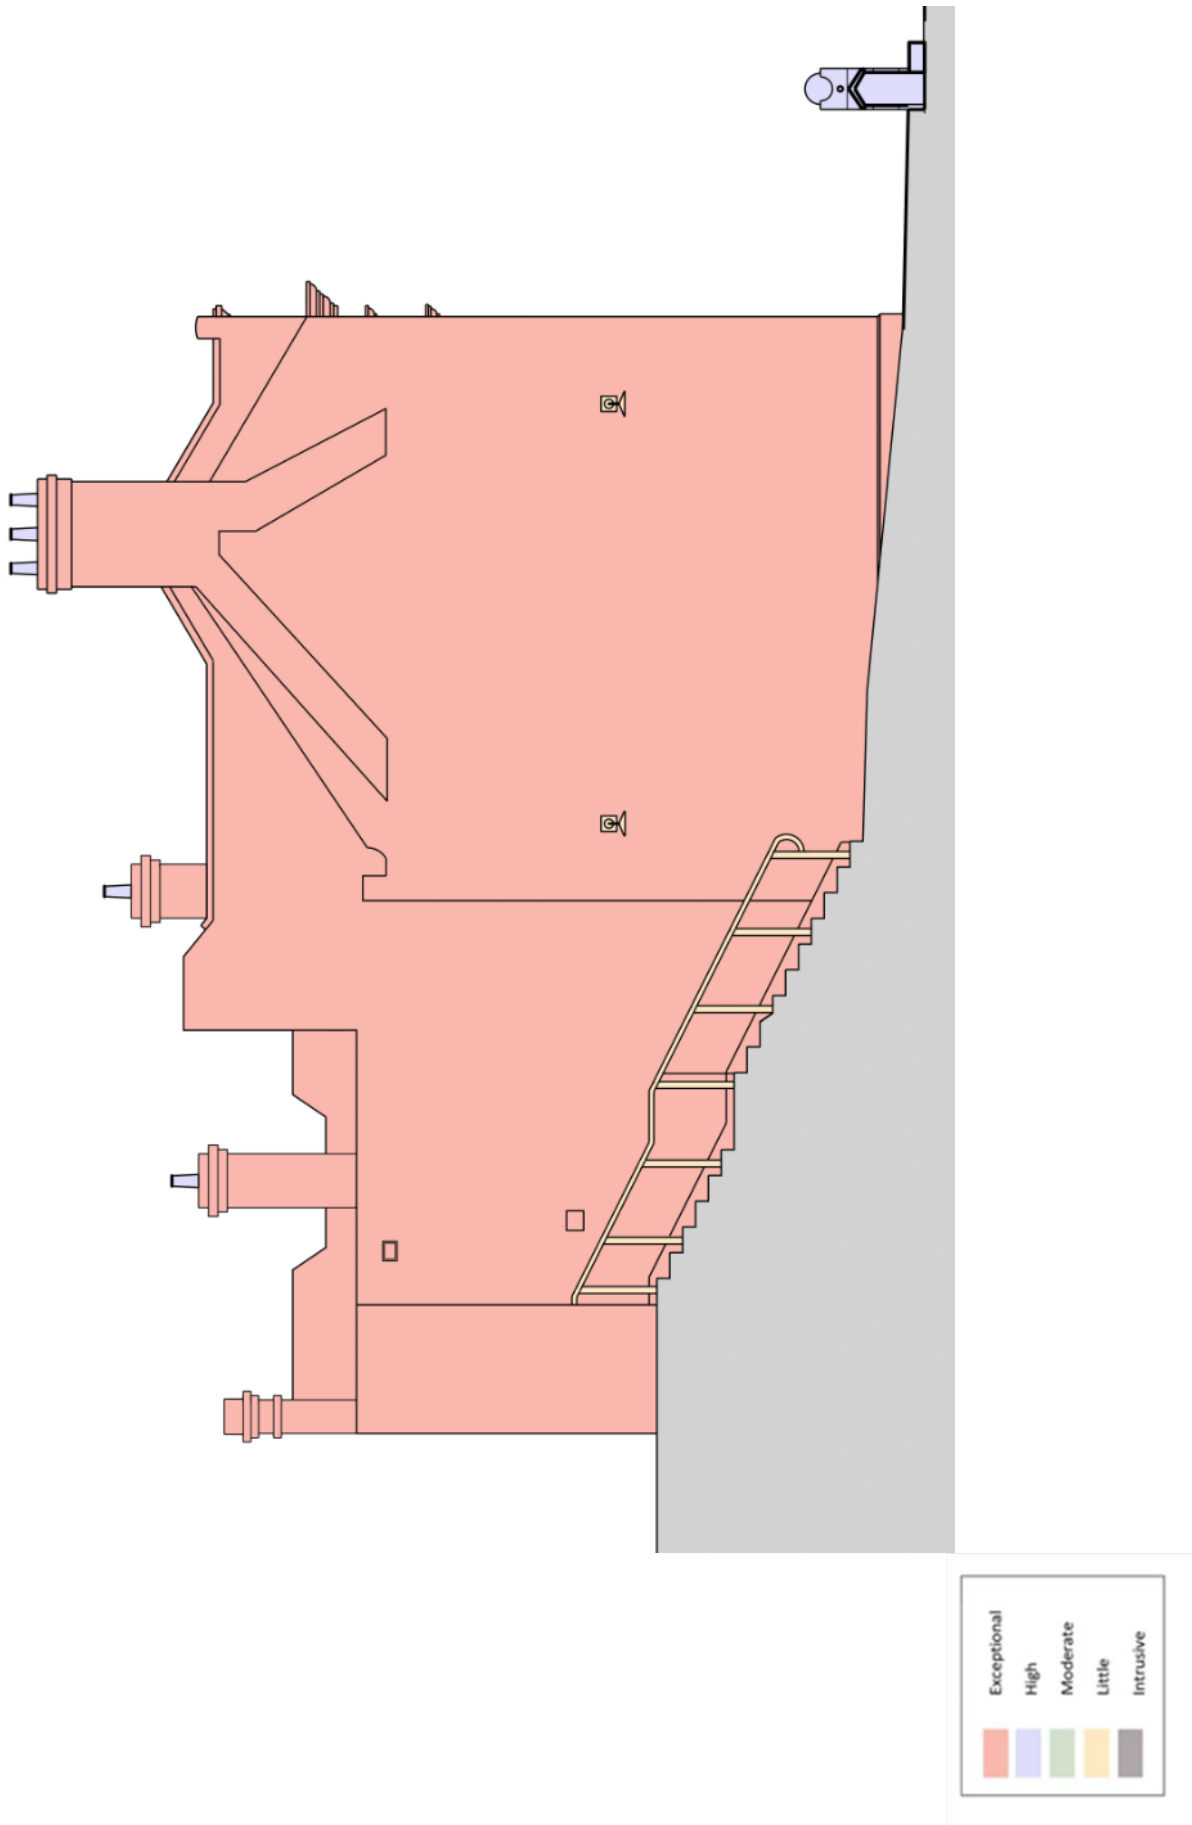
**Figure 5.3** Side (Western) elevation grading of elements

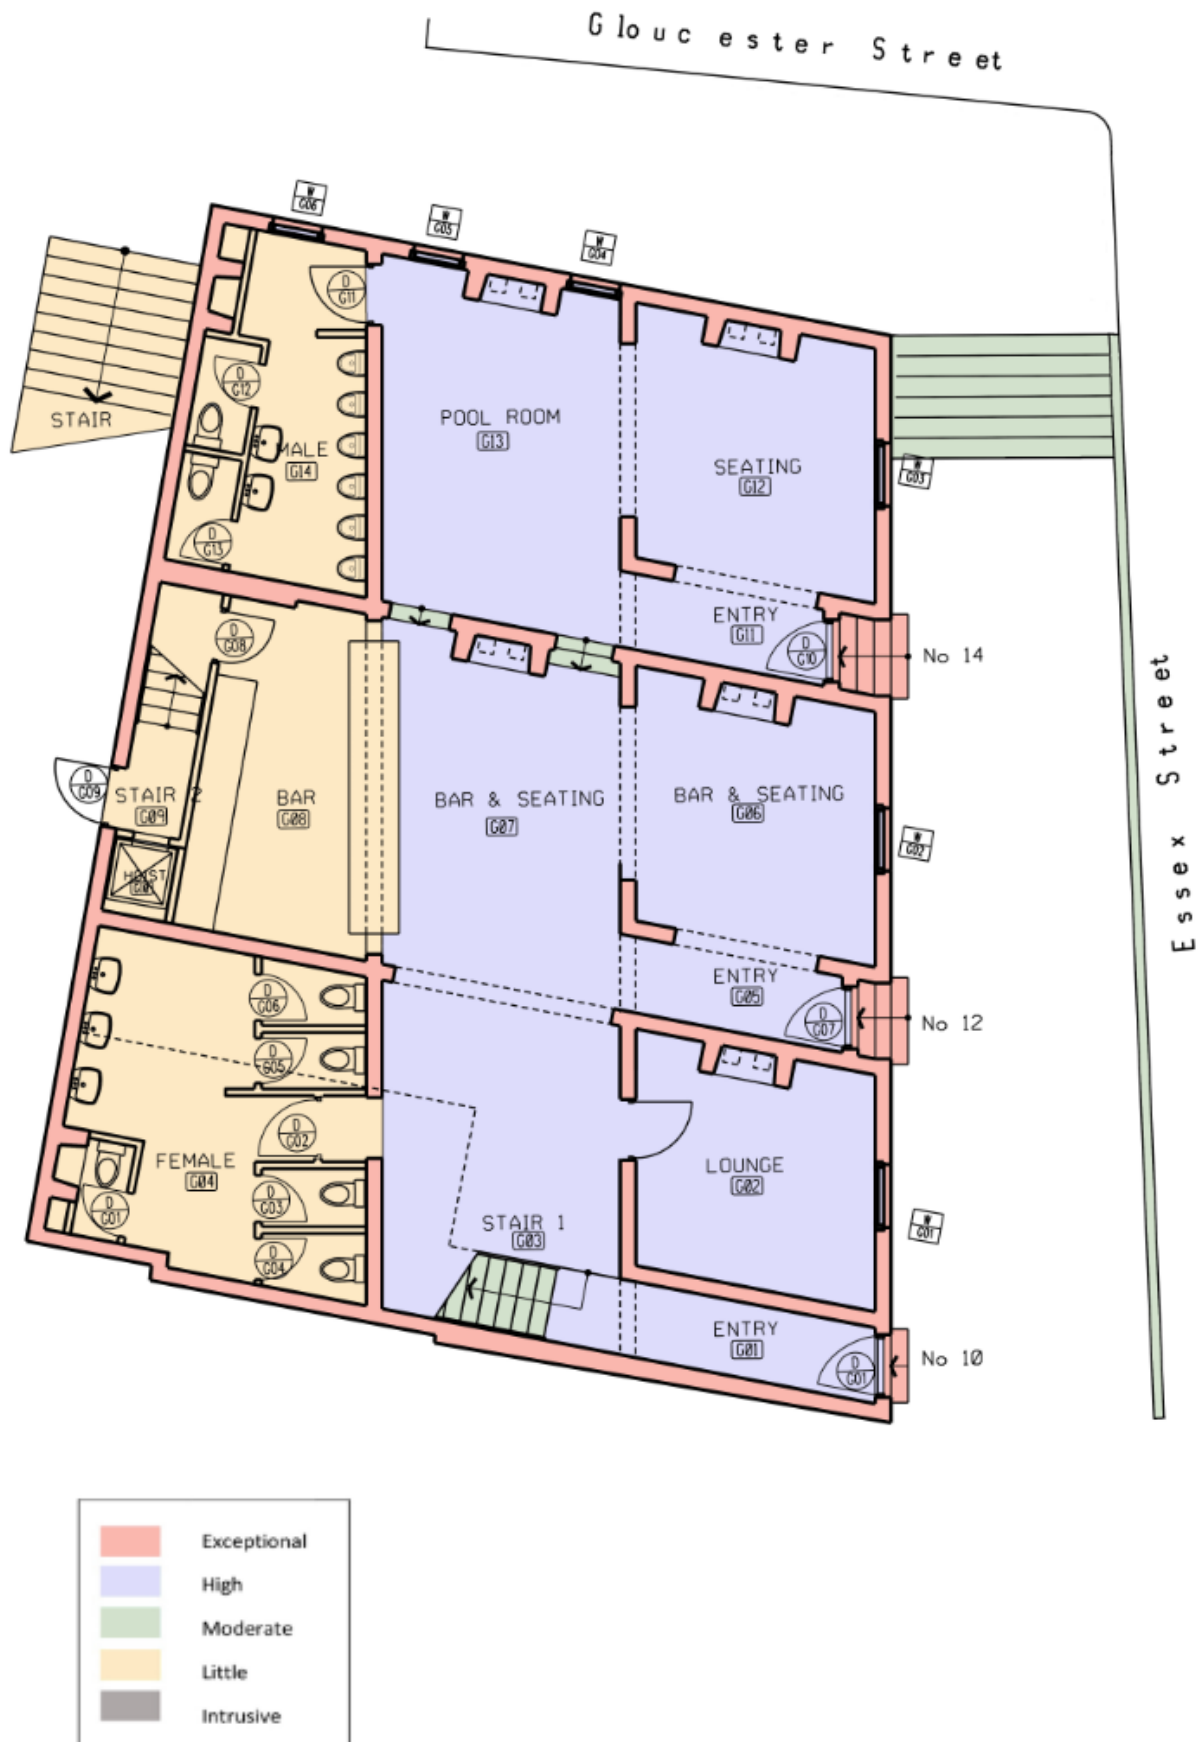
Figure 5.5 Ground floor plan grading of elements
