# Cleland Bond Store 33 Playfair Street, The Rocks Conservation Management Plan

CONSERVATION MANAGEMENT PLAN

**PLACE  
MANAGEMENT  
NSW**

**22 September 2026**

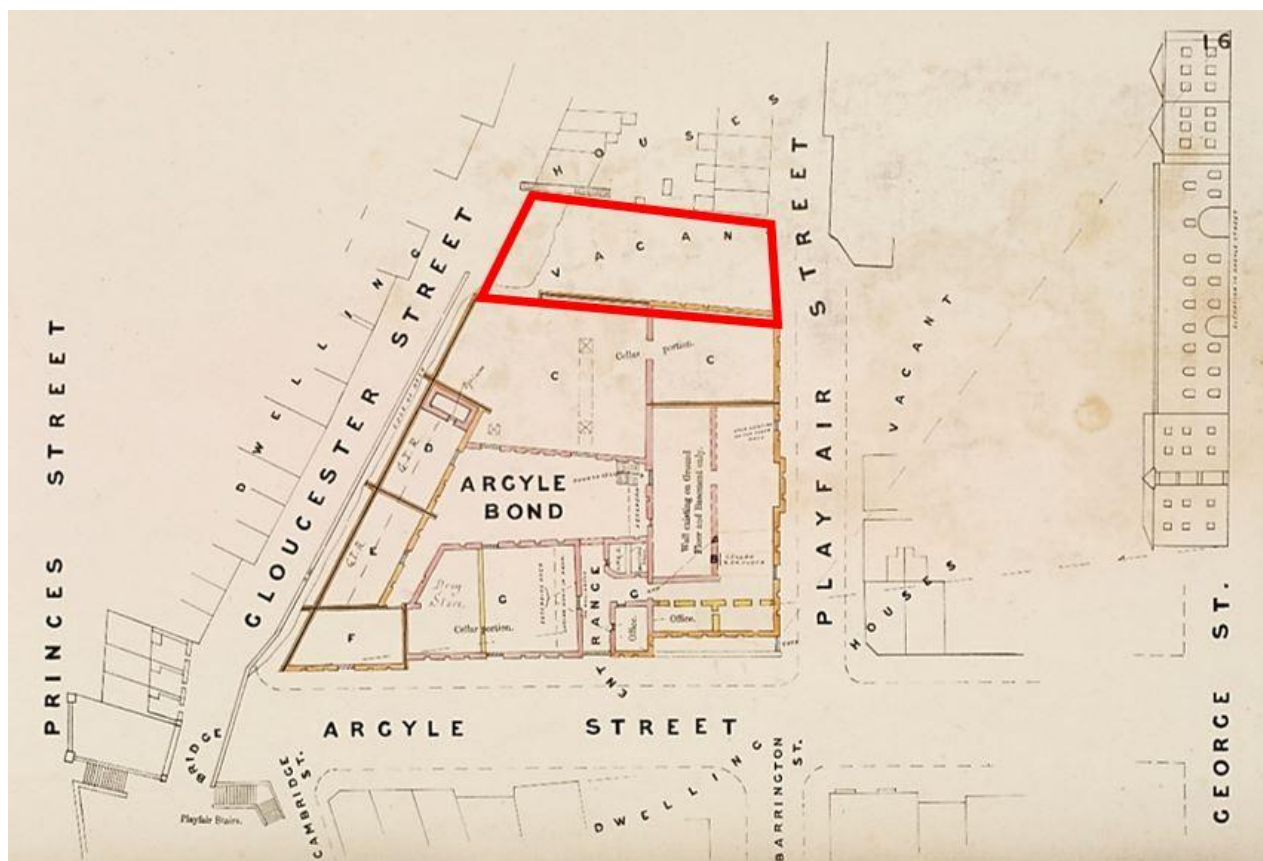
Figure 21: G Mahlstedt's Sydney Bonded and Free Store plans in 1894, p 16, showing the completed layout and form of Argyle Stores. Also includes elevation to Argyle Street. Plan oriented to north at top of page. (Source: State Library of NSW, X/36, with GML overlay)

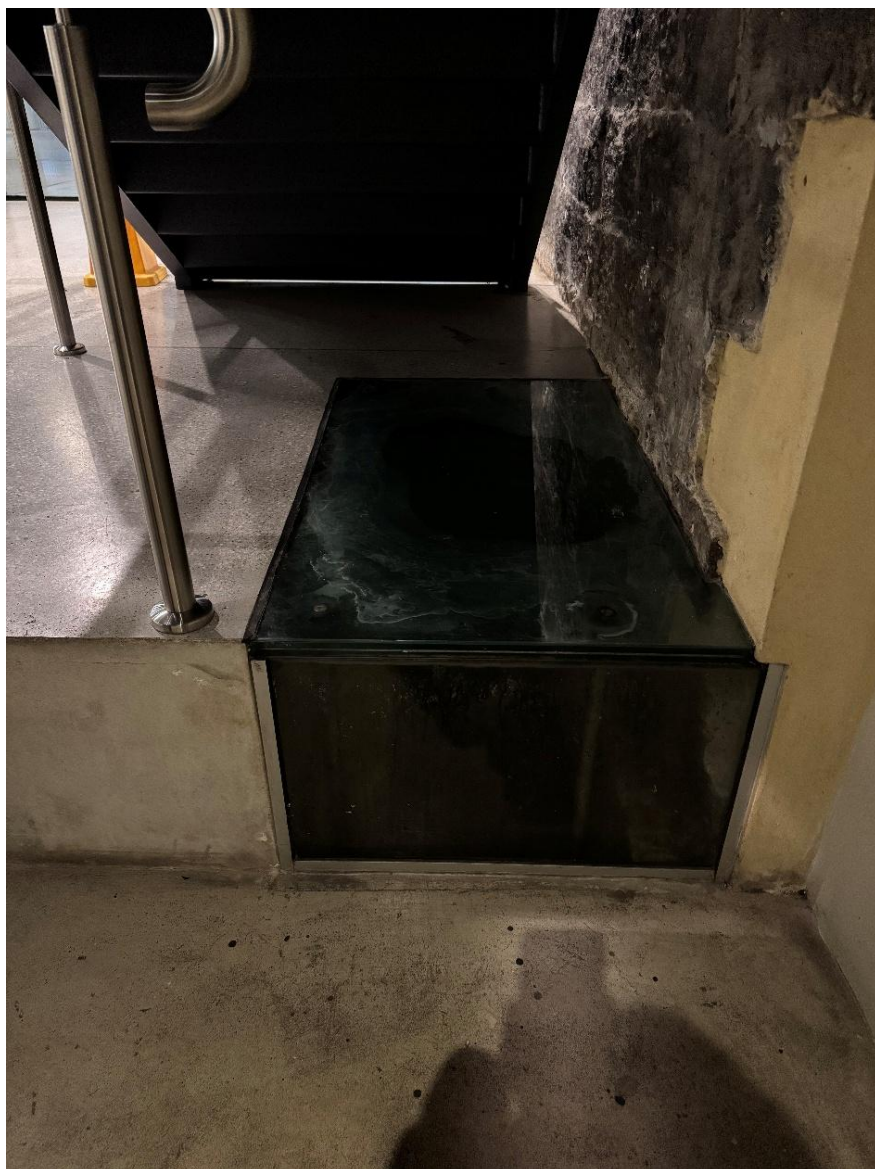
Figure 32: Glass-covered sandstone box drain below curved staircase, associated with part of the Argyle Stores erected by Unwin in c1828's Stores. (Source: PMNSW 2026)

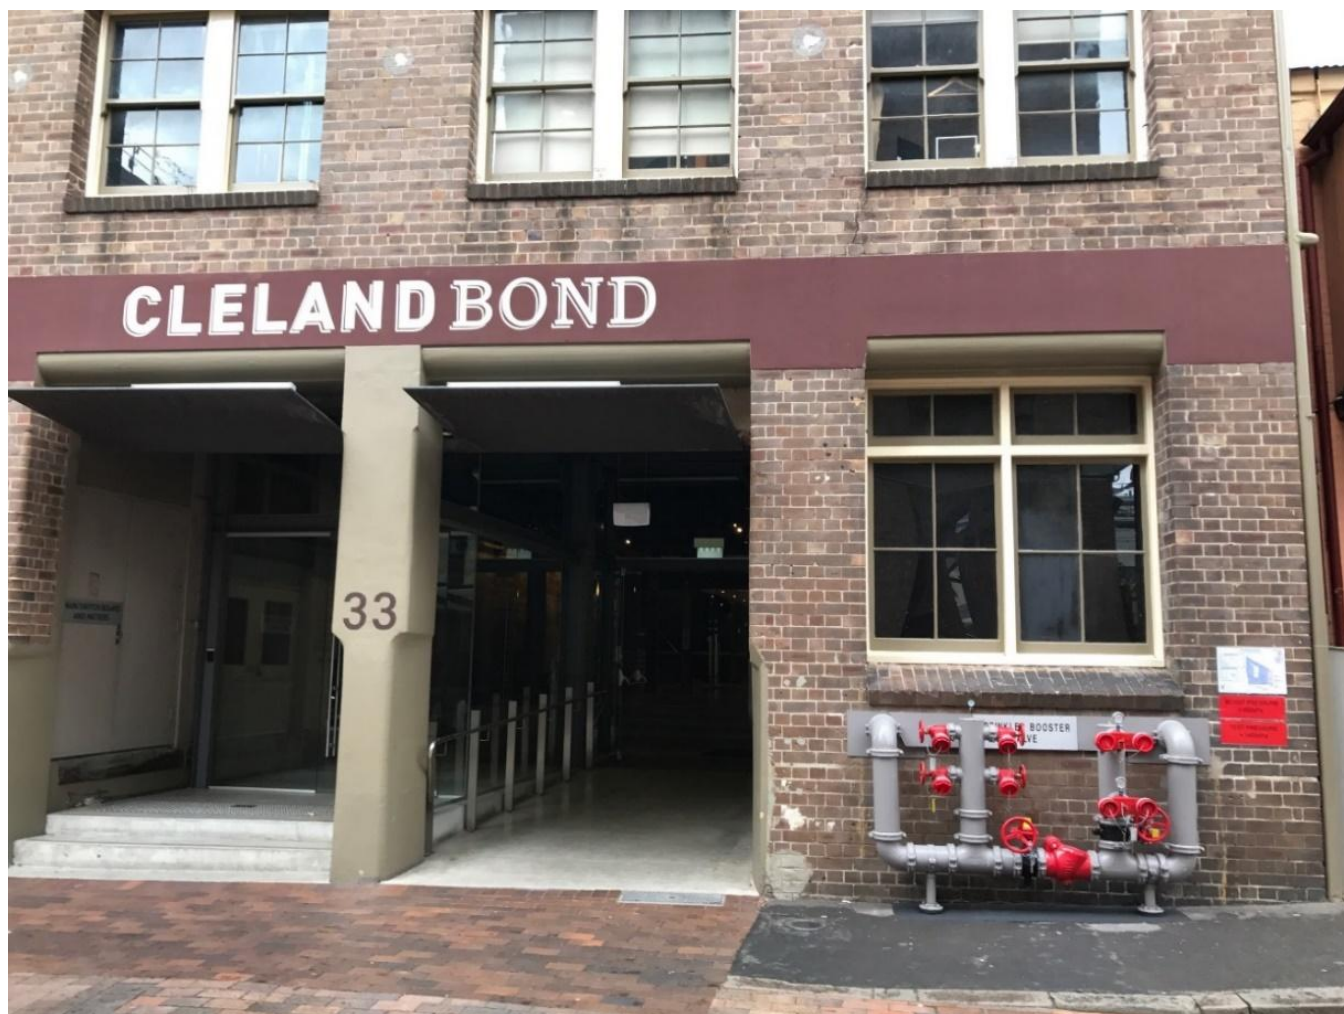
Figure 36: New booster system adjoining the main entrance to Cleland Bond Store, 2021. (Source: Gartner Rose [gartnerrose.com.au](http://gartnerrose.com.au))

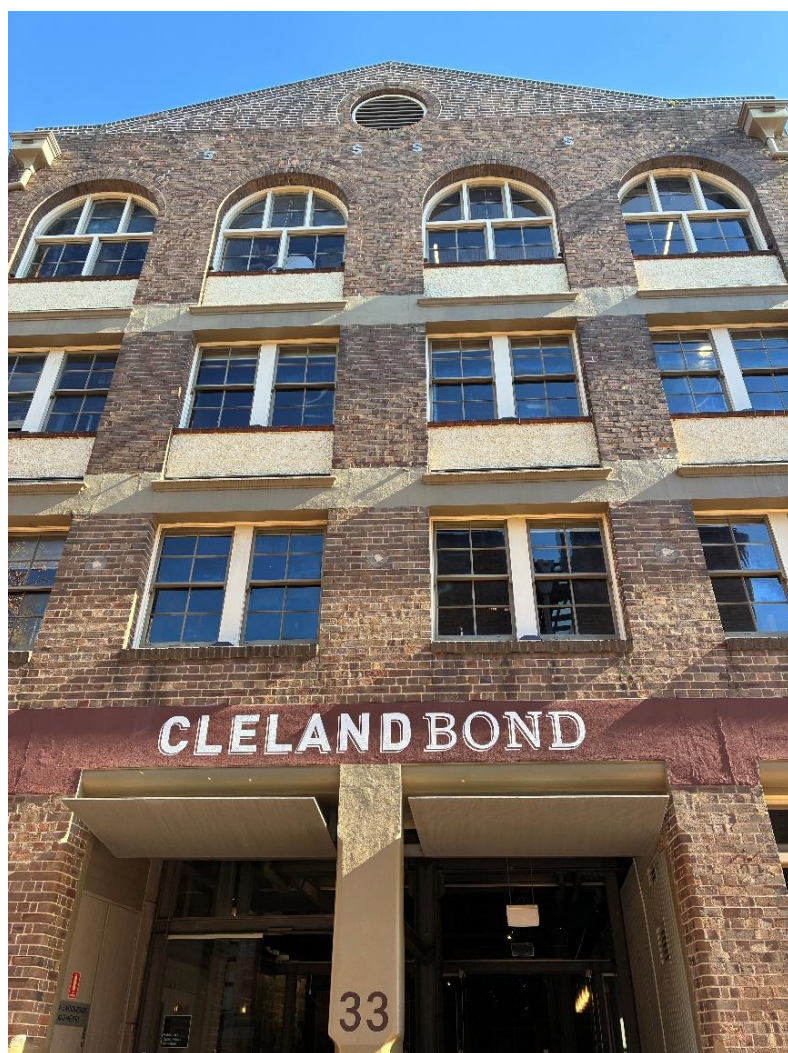
Figure 53: East elevation, front facade on Playfair Street entrance. (Source: PMNSW 2026)

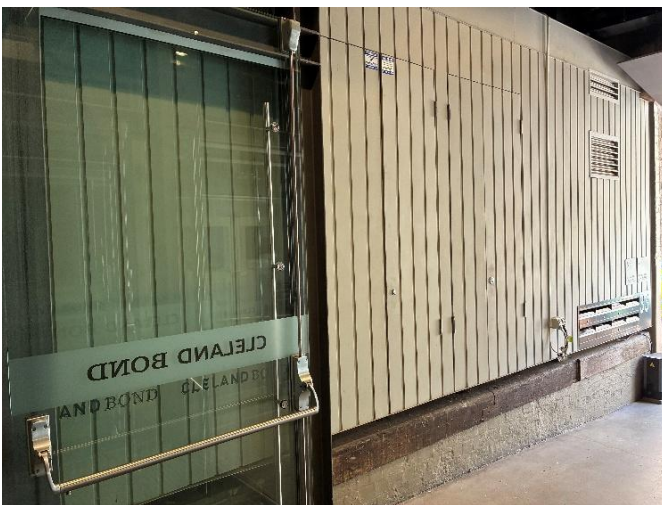
Figure 91: Looking northeast to removed lift to the north of the entrance off Playfair street. (Source: PMNSW 2026)

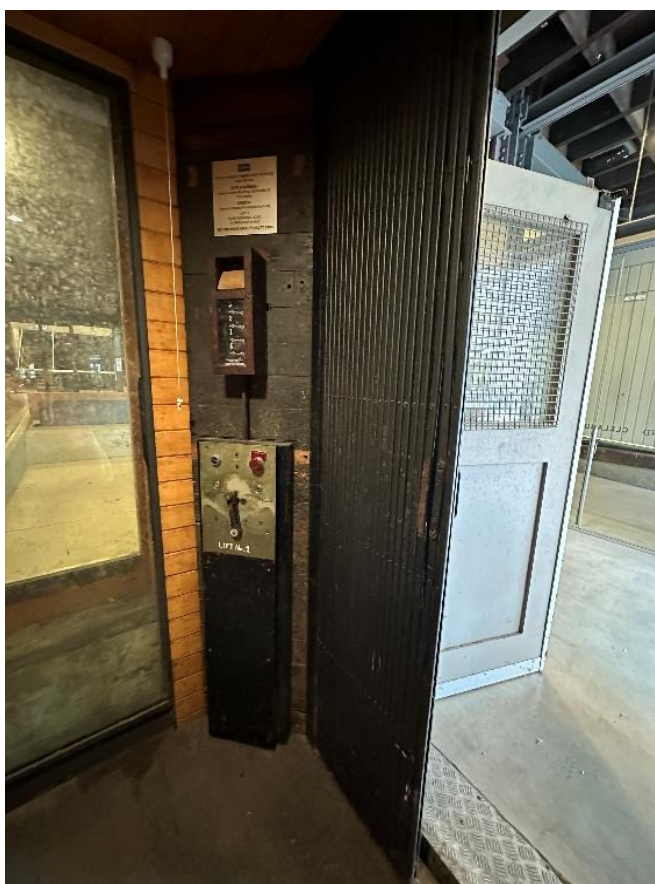
Figure 99: The original lift control panels.

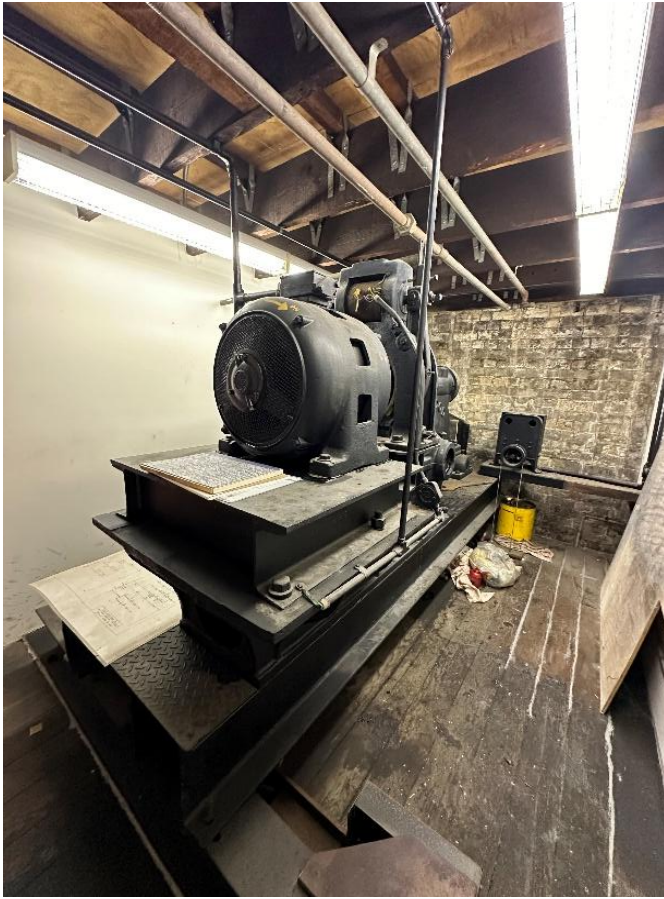
Figure 101: The lift room on mezzanine floor above Level 3. (Source: PMNSW 2026)

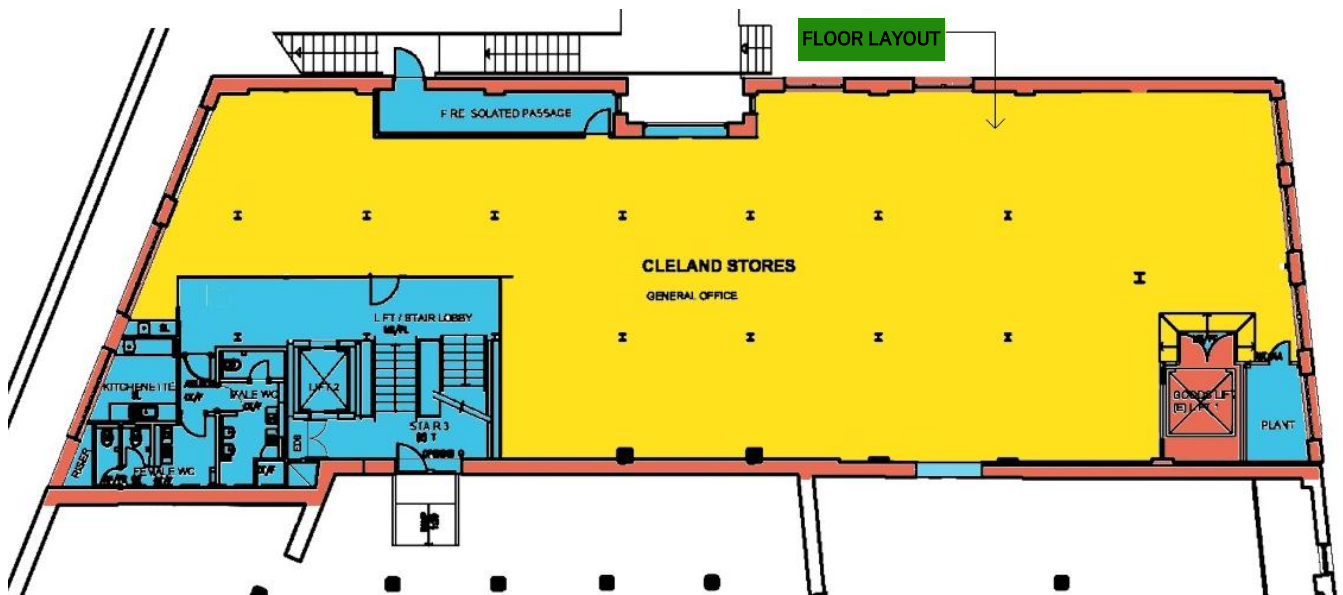
Figure 130: Second floor plan. (Source: Clive Lucas Stapleton & Partners, 2008 with GML overlay 2022)
