WHITE BAY POWER STATION

CONSERVATION MANAGEMENT PLAN 2026

VOLUME 2 : HERITAGE INVENTORY – STRUCTURES, SPACES & ELEMENTS

**WHITE BAY POWER STATION CONSERVATION
MANAGEMENT PLAN 3RD EDITION**

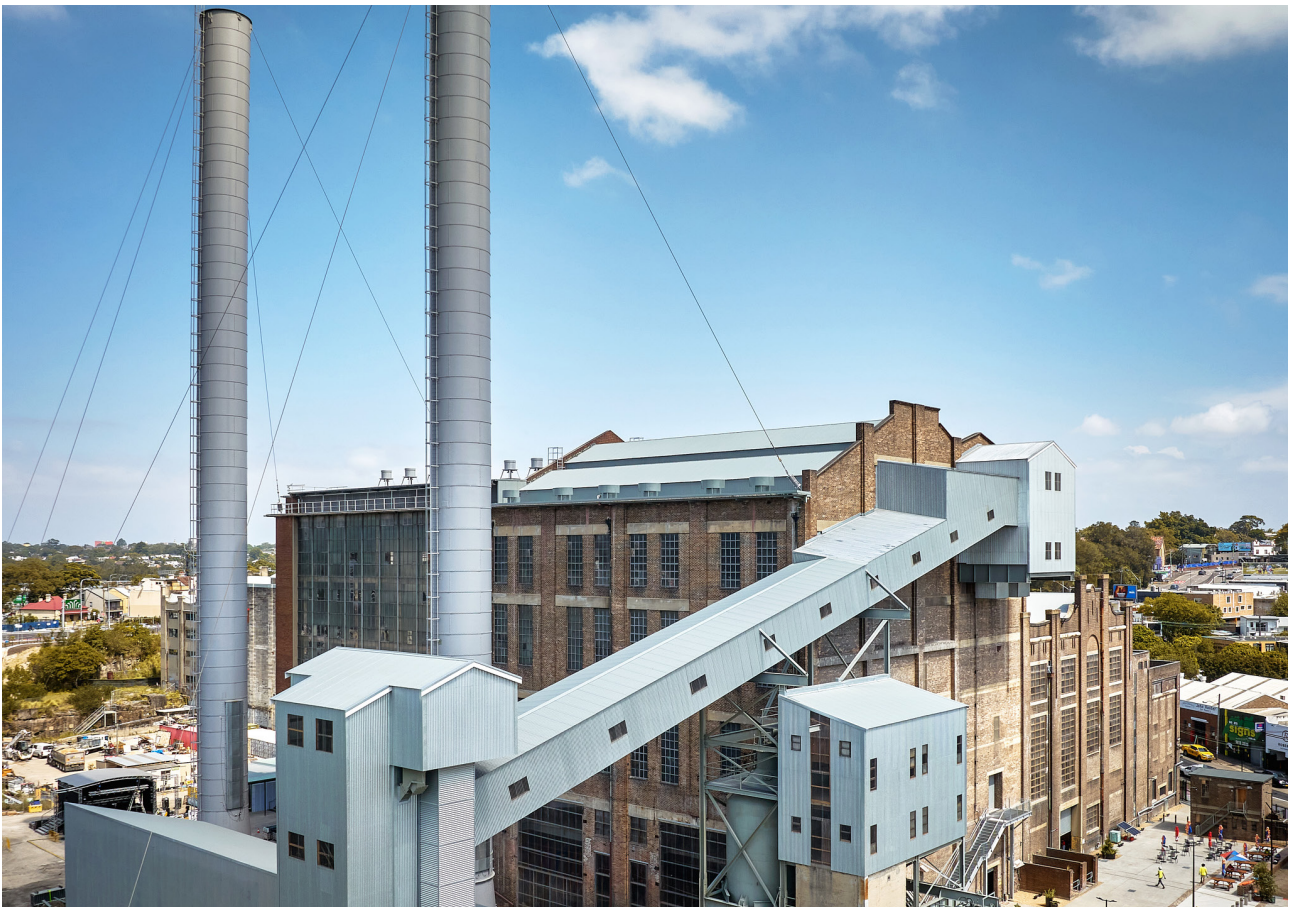
Figure 1.9 Coal Handling Shed connecting to Transfer House with External Conveyor, 2024 (courtesy of Toby Peet)

Following the decommissioning of White Bay Power Station in 1983, the Coal Handling Shed's corrugated galvanised steel cladding became heavily corroded and was no longer serving as a weatherproof enclosure. The building's structure and equipment suffered from water ingress and associated corrosion damage and loss of structural integrity in some areas. The coal bunker (basement) was gradually filled with water due to ground water seepage and up until May 2022, was fully submerged to the height of approximately two metres below ground level. Other threats to the space include pigeon and pest entry and to a lesser extent, vandalism.

The 2022–24 remediation works for the Coal Handling Shed have focussed on essential maintenance, restoration, and preservation. This includes re-cladding, structural remediation, bird proofing, draining water from the basement, and stabilising and treating for corrosion. Other works have included safety, security, and lighting. These are discussed in general terms below:

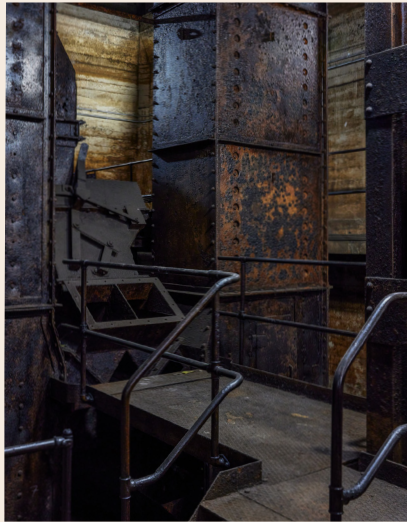
| Room / Item | Basement 3 (lower) | |
|---|--|--|
| Description | <p>Bottom level of Coal Handling Shed basement accessed by concrete stairs from B.2 level. The space is fully enclosed in concrete walls and contains the base of the short elevators the Coal Handling Shed's pump out pit for water. It also contains the tension rollers for the long conveyors.</p> <p>The space was fully submerged until May 2022 when water was drained, the space was cleaned, and the equipment was repaired and treated with a rust converter.</p> | |

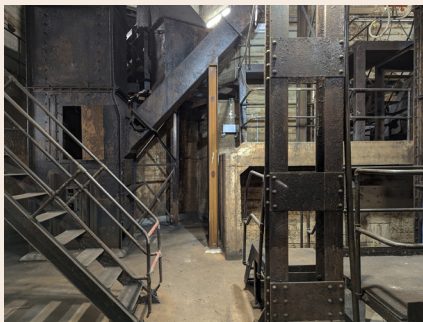
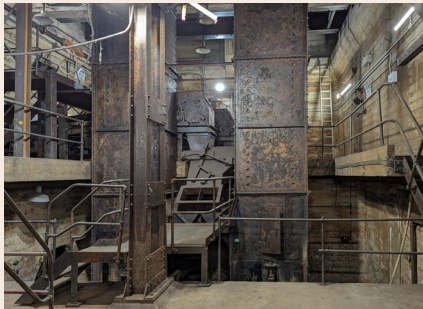
| Description | <p>This is the base of the 90-Foot Elevators and includes off-form concrete walls and floor. The space is accessed by steel stairs from the B.1 to the west or from the mezzanine to the east. Access to B.3 is by steel stair or concrete stair in the southwest corner.</p> <p>The space was fully submerged until May 2022 when water was drained, the space was cleaned, and the equipment was repaired and treated with a rust converter.</p> | <p>(courtesy of Chris Bennett: Evolving Picture, 2024)</p> <p>(Design 5 - Architects, 2023)</p> |

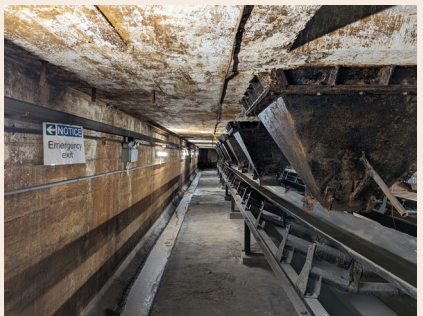
| Description | <p>The basement floor of the Coal Handling Shed was used for receiving sorted coal for transport to the Short Elevators via the Conveyors. The space contains the Pneumatic Feed Gates to the underside of the Hoppers, the Conveyors, and conveyor motors at the north end.</p> <p>The space was fully submerged until May 2022 when water was drained, the space was cleaned, and the equipment was repaired and treated with a rust converter.</p> | <p>(courtesy of Chris Bennett: Evolving Picture, 2024)</p> |

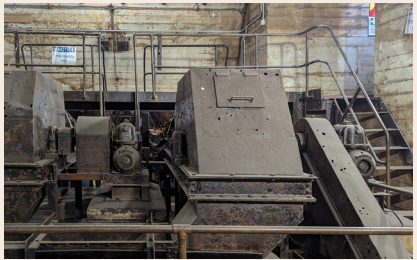
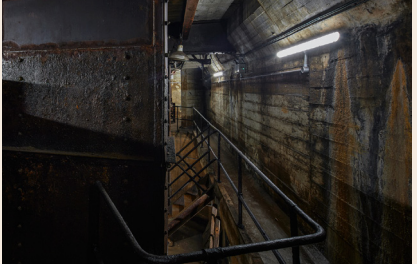
| Room No. | CH BM | |

| Description | <p>Entry level to the basement accessed by concrete stair at the northeast corner. Steel walkways and stairs provide access to the B.1 level. Walkways on the eastern side of the space overlook lower levels. At the north and south ends of the east mezzanine space are two additional hoppers that connect to their own set of pneumatic feed gates and conveyors. Both conveyors connect direct to the north and south 90-Foot Elevators and would accept coal direct via truck from the Dry Coal Store which was located east of the building.</p> <p>The space was fully submerged until May 2022 when water was drained, the space was cleaned, and the equipment was repaired and treated with a rust converter.</p> | <p>(Design 5 – Architects, 2023)</p> <p>(courtesy of Chris Bennett: Evolving Picture, 2024)</p> <p>(courtesy of Toby Peet, 2024)</p> |
| Floor | Metal check plate flooring with handrails and stairs accessing B.1 level. The east side of includes concrete walkways with drainage channels. | |

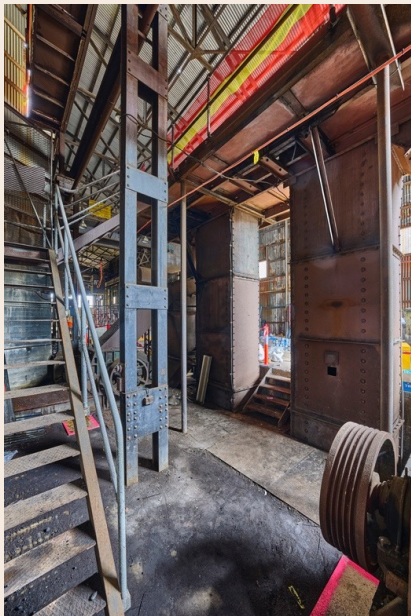
| Description | <p>The space contains the first stage Coal Crushers and Coal Elevators. The space is set approximately 1m lower than the adjacent ground floor spaces G.1 and G.2. The space is accessed via concrete stairs from the G.2 to the west and G.1 to the north,</p> | |
| Floor | Suspended concrete floor with steel check plate in some sections covering penetrations for machinery and basement beneath. | |

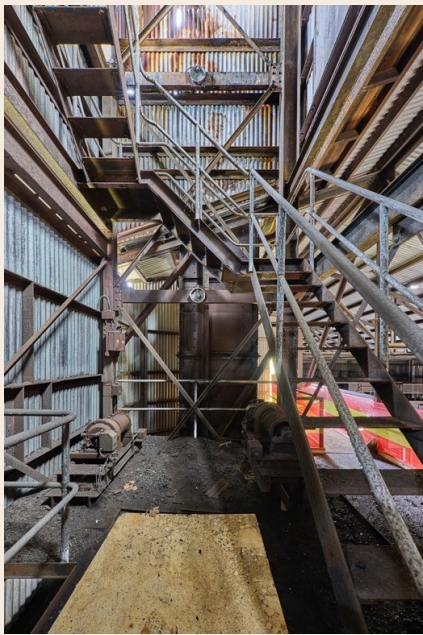
| Description | <p>Steel-framed and steel check plate floor with pipe handrails accessed by stair to Transfer House. The space has a penetration in the middle for a hoist and two motors. A steel-framed and steel check plate walkway provides access to an opening on the southeast wall which would have overlooked the Dry Coal Store.</p> |
| Floor | Steel check plate floor |
| Walls | Cladding replaced in 2022–24. Steel pipe handrails with mid-rail. External steel cladding on east wall. |

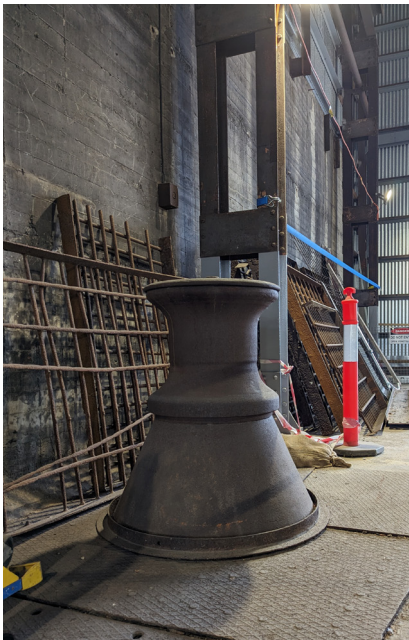
| Machine / Ref. | The Capstan – 1.2 | |

| Description | <p>Located towards the east side of the shed, the Capstan is a massive cast iron post mounted on a central shaft coupled to a motor and gearbox located beneath the floor level accessed by the steel plate. The Capstan was used with a cable and pulley which is located at the north end near the Short Elevators. It would move the rail trucks filled with coal into the shed for unloading.</p> <p>Significance</p> <p>The Capstan, with its associated motor and gearbox, is now a rare item formerly used in many rail goods sidings. It is indicative of the traditional techniques of moving rail trucks short distances within confined areas without the use of locomotives. The Capstan is a relic of early, more time-consuming work practices.</p> | |

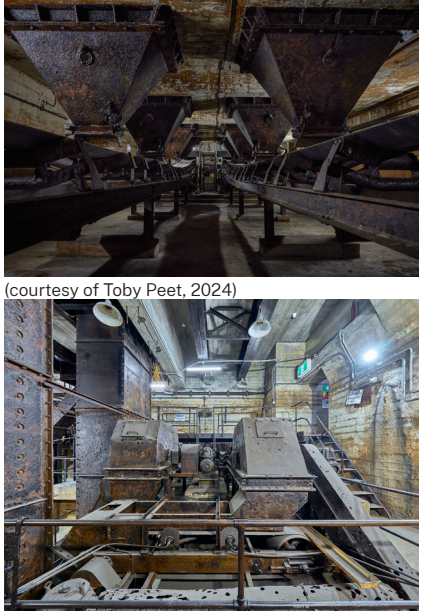
| Machine / Ref. | Conveyors – 1.5 | |

| Description | <p>Two long conveyors are located in the basement (CH B.1) at the base of the Hoppers and are used to transport coal to the elevators. The two conveyors extend the full length of the basement while a second pair of smaller conveyors are located at the north end, perpendicular to the main conveyors. The conveyors are rubber belts supported on steel rollers and are powered by electric motors.</p> <p>Two further small conveyors are located on the mezzanine level located underneath the hoppers from the Dry Coal Store.</p> <p>Significance</p> <p>The Conveyors throughout the coal terminal are integral elements of the Coal Handling System and form part of the original components of the Coal Handling Shed. They evidence the means by which coal flow was regulated and directed to processing and storage points. They are representative examples of mid-twentieth century conveyor technology.</p> | |

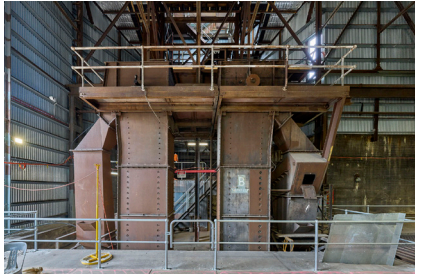
| Machine / Ref. | Short Elevators and Motors – 1.6 | |

| Description | <p>Two short elevators designated “A” (north elevator) and “B” (south elevator) are located at the north end of the Coal Handling Shed and extend from B.3 to the ground level. The elevators are used to lift coal from the Conveyors and into the chutes to the Coal Crushers.</p> <p>They consist of a square shaft made up of steel plates and bolted angled connections. Internally, the shaft guides a continuous link of connected buckets, approximately 600mm wide, 300mm deep and 300mm high. The buckets contain two wheels running on a rail or guide that pass a massive cog at the top which is in turn powered by electric motors.</p> <p>Significance</p> <p>The Short Elevators and Motors are integral parts of the Coal Handling System. They evidence the use of predominantly English technology in all aspects of the power station. The items are sturdy and functional and are representative examples of post-World War II coal-elevating equipment.</p> | |

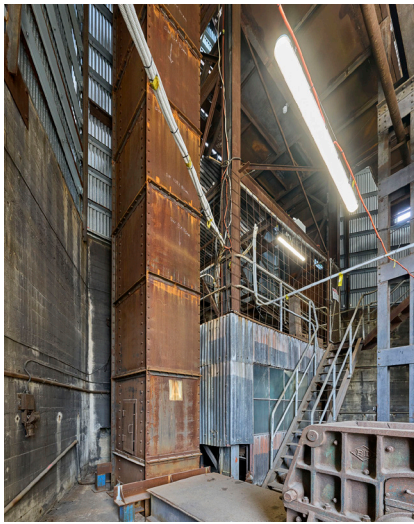
| Description | <p>Two 90-foot elevators designated “A” (north elevator) and “B” (south elevator) are located at the north end of the Coal Handling Shed, near the east wall, and extend from Basement B.2 to the top level of the Transfer House (CH 4.1). The elevators are used to lift coal from the basement to the Transfer House to the External Conveyor.</p> <p>Similar to the Short Elevators, they consist of a square shaft made up of steel plates and bolted angled connections. Internally, the shaft guides a continuous link of connected buckets, approximately 600mm wide, 300mm deep and 300mm high. The buckets contain two wheels running on a rail or guide that pass a massive cog at the top which is in turn powered by electric motors.</p> <p>In 2022–24, a section of the south elevator, between the Coal Handling Shed roof and the top floor (CH 4.1), was partially dismantled due to corrosion. At the time of writing, the coal buckets are stored in Switch House Ground Level.</p> <p>Significance</p> <p>The 90-Foot Elevators are an integral part of the Coal Handling System. They evidence the use of predominantly English technology throughout the power station. They are sturdy and functional industrial items and are representative of coal-elevating equipment of the period immediately after World War II.</p> | <p>(courtesy of Chris Bennett: Evolving Picture, 2024)</p> |

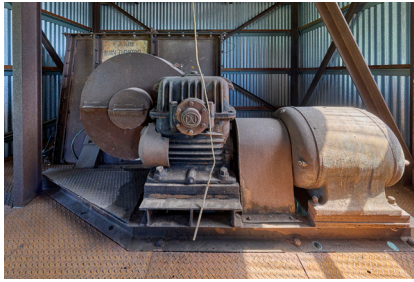
| Machine / Ref. | Transfer Houses and Equipment – 1.9 | |

| Description | <p>They are steel and timber framed corrugated iron structures located at the top of the coal shed and attached to the exterior of the north wall of the Boiler House. They contain the motors and gearboxes for several of the machines operating in the Coal Handling Shed. Here, coal is dropped from the 90-Foot Elevators onto the External Conveyor for transporting to the Boiler House.</p> | <p>(courtesy of Chris Bennett: Evolving Picture, 2024)</p> |

| Description | <p>Significance</p> <p>The Transfer Houses are an integral part of the Coal Handling System. They have aesthetic qualities as framing elements to the overhead conveyor. The Transfer Houses evidence the methods used to control the transfer of coal from the coal store via Crushers and Elevators to the Hoppers within the Boiler House. The Transfer Houses evidence the predominantly English technology used throughout the power station.</p> | |

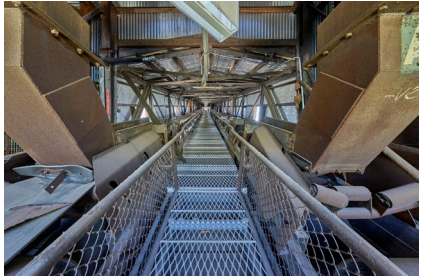
| Machine / Ref. | External Conveyor – 1.10 | |

| Description | <p>The External Conveyor is a steel and timber framed corrugated ironclad structure that runs from the lower coal shed Transfer House to the upper Boiler House Transfer House and is key to the industrial aesthetic of the White Bay Power Station.</p> <p>Significance</p> <p>The External Conveyor is an integral part of the Coal Handling System. It evidences the method by which coal is transferred from the coal shed to the upper Transfer House and, ultimately, the Coal Hoppers. The Conveyor is a prominent feature on the northern side of the Boiler House and illustrates the industrial architectural approaches of the period following World War I. It is a representative example of mid-twentieth century conveyor technology.</p> | |

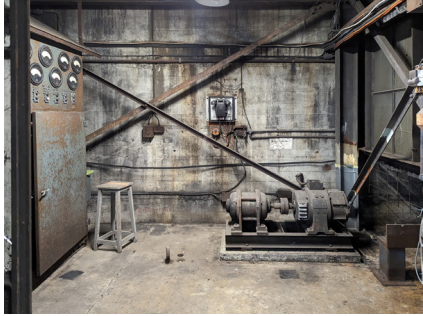
| Machine / Ref. | Coal Handling Control Room – 1.13 | |

| Description | <p>The Coal Handling Control Room is located between the 90-foot elevators and behind the Coal Crushers on the ground floor level. The Control Room comprised the control panels and cabinets that controlled the motorised operations of the Coal Handling System, separate from the rest of the control panels throughout the power station.</p> <p>Significance</p> <p>The Coal Handling Control Room is an integral part of the Coal Handling System. The Control Room illustrates the way in which the coal was delivered as</p> | |

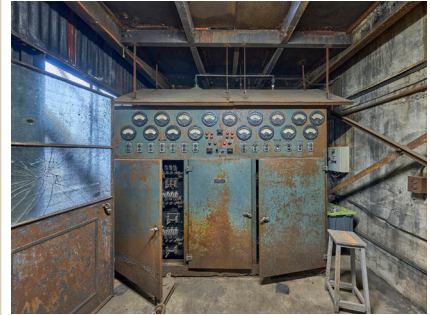
| Machine / Ref. | Coal Handling Control Room – 1.13 (cont.) | |
|---|--|--|
| Description | <p>regulated quantities via the Conveyors and Elevators to the coal store and the Crushers and, via the External Conveyor system, to the Boiler Hoppers. The Control Room switchboard demonstrates the power distribution arrangements within the power station and the decentralised nature of certain operations within the power station.</p> | <p>(courtesy of Chris Bennett: Evolving Picture, 2024)</p> |

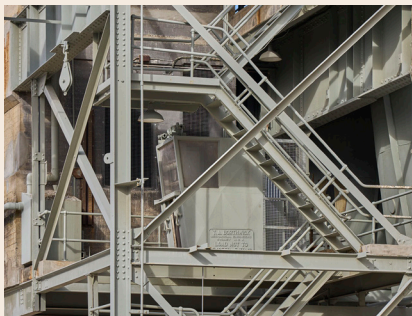
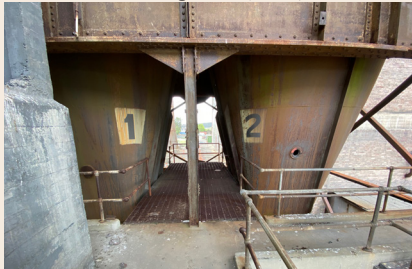
| Room / Item | Level 1 / Ash Handling Tower | |
|---|--|--|
| Description | <p>Level 1 is an open space divided into two halves, north and south. The north part contains a steel-framed and concrete catwalk accessed by a set of steel stairs in the northwest corner. Permanent access to ground level has been removed and replaced with ladder access to prevent unauthorised entry. A crane cabin is located adjacent to the stairs which was used to operate the Kibble Crane. The cabin is steel framed with timber floor and contains crane operating controls. It is covered to prevent bird entry by clear acrylic and mesh. The northeast corner is the double-height concrete enclosure called the “Oil Tank Chamber”.</p> <p>The southern half of the level is occupied by the steel Ash Storage Tanks, numbered “1” for the east tank and “2” for the west tank. A galvanised steel walkway grate is located between the ash storage tanks.</p> | |
| | <p>Northern half of the level, crane cabin (courtesy of Chris Bennett: Evolving Picture, 2024)</p> <p>Southern half of the level, prior to 2022-24 works. Storage tanks subsequently painted and steel grate floor replaced. (Design 5-Architects, 2021)</p> | |

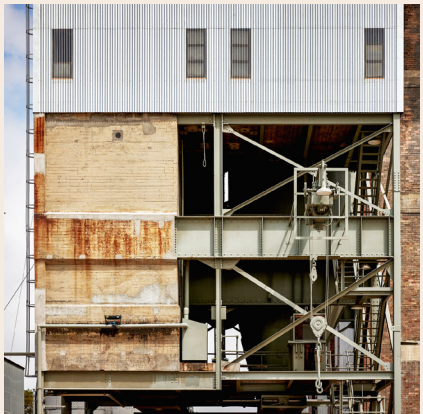
| Description | <p>Level 2 comprises a single concrete walkway running east and west, accessed by steel-framed stairs located in the northwest corner. A Kibble Crane is located at the northwest corner, comprising an electric hoist with a rigid lifting beam and twin hooks suspended from the cable. The Oil Tank Chamber continues from Level 1 but has no openings and is not accessible.</p> <p>The Ash Storage Tanks continue in the southern half of the building. A steel-plated walkway between the two tanks was removed in 2022-24 due to corrosion. The walkway was formerly connected to a set of stairs on the south side of the Tower to the now removed electrostatic precipitators.</p> | <p>(courtesy of Toby Peet, 2024)</p> |

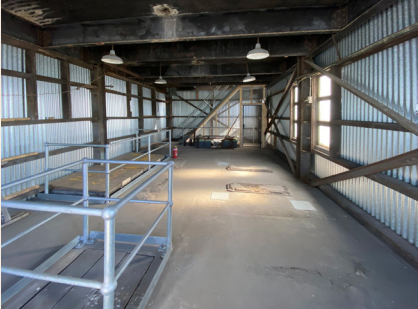
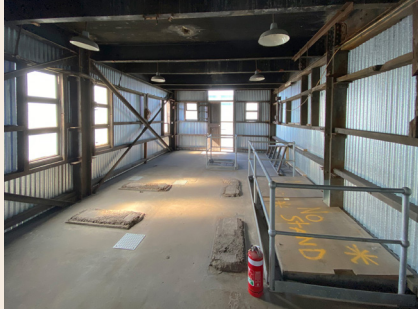
| Room No. | Level 3 | |

| Description | <p>Level 3 is an internal space accessed by stairs located on the west wall. The floor is a concrete slab with penetrations and is protected by steel handrails. The walls are steel framed (main structure) with timber framing that supports the corrugated galvanised steel cladding. There are four windows on the north wall and two windows on the east wall clad externally with polycarbonate. The east also contains a doorway, though only one of the timber doors remains. The ceiling is steel I-beams supporting a concrete slab from which hang pendant dish lamps. As part of the 2022-24 works, safety handrails were installed around two penetrations in the floor, and a timber-framed mesh enclosure was installed around the stairwell for bird-proofing</p> | <p>Level 3 looking west (Design 5 – Architects, 2023)</p> <p>Level 3 looking east (Design 5 – Architects, 2023)</p> |
| Floor | Concrete floor with two penetrations covered by plywood and steel handrails. | |

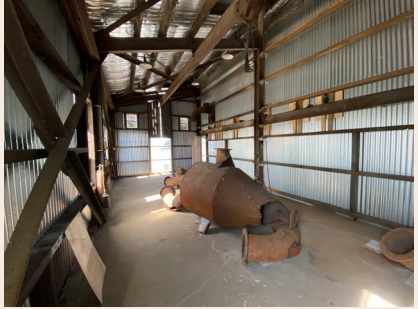
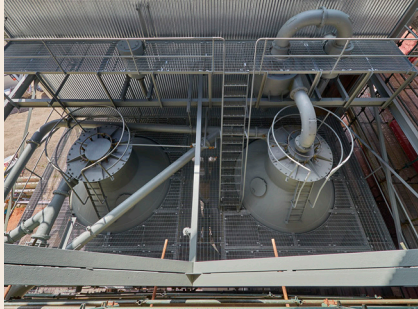
| Description | <p>Level 4 comprises two main spaces: in the northern half, a corrugated galvanised steel-clad internal space, and the southern half, a steel grate platform with the tops of the pair of Ash Storage Tanks. Steel stairs access the level on the western wall. Near the centre of the outdoor platform is a ladder that accesses a narrow, high-level steel-framed walkway along the north side.</p> <p>Like level 3, there are four windows on the north wall and two windows on the east wall and clad externally with polycarbonate. There is a door on the east wall that provides access to the hoist beam and pulley that extends externally. The ceiling is steel framed with timber purlins supporting the corrugated roof, replaced in 2022. The ceiling contains a hoist beam, pulley and several pendant dish lamps.</p> | <p>Level 4 Northern half section (Design 5 – Architects, 2023)</p> <p>Level 4 Southern half section (Design 5 – Architects, 2023)</p> |

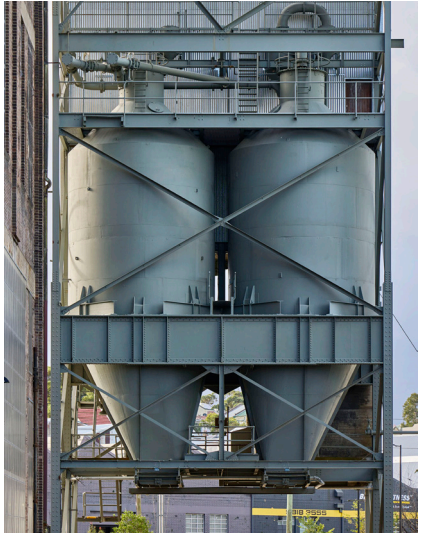
| Machine / Ref. | Ash Storage Tanks | |

| Machine / Ref. | Ash Storage Tanks | |
|---|--|--|
| Description | <p>Located on the south side of the building underneath the External Conveyor, the Ash Storage Tanks comprise large cylindrical steel Hoppers into which the ash was conveyed. They are mounted to the steel framing and make up a large volume of the tower.</p> <p>Significance</p> <p>The Ash Storage Tanks are an integral part of the Ash Handling System and are now rare examples of mid-twentieth century ash-handling and disposal procedures.</p> | |

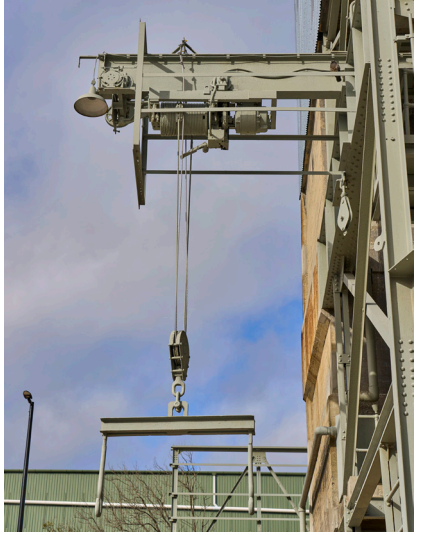
| Machine / Ref. | Ash Storage Tanks | |
|---|--|--|
| Machine / Ref. | Ash Kibble Crane | |

| Machine / Ref. | Ash Storage Tanks | |
|---|--|--|
| Description | <p>Located on the north side of the Tower, the Ash Kibble Crane comprises an I-beam with an electric hoist and lifting beam. This beam is fitted with a winch and cable with twin hooks that would latch onto the trunnions of the Ash Kibbles. The winch would then lift the Kibbles to empty the ash into the Ash Trucks.</p> <p>Significance</p> <p>The Ash Kibble Crane is an integral part of the Ash Handling System and is now a rare example of mid-twentieth century ash-handling and disposal procedures.</p> | |

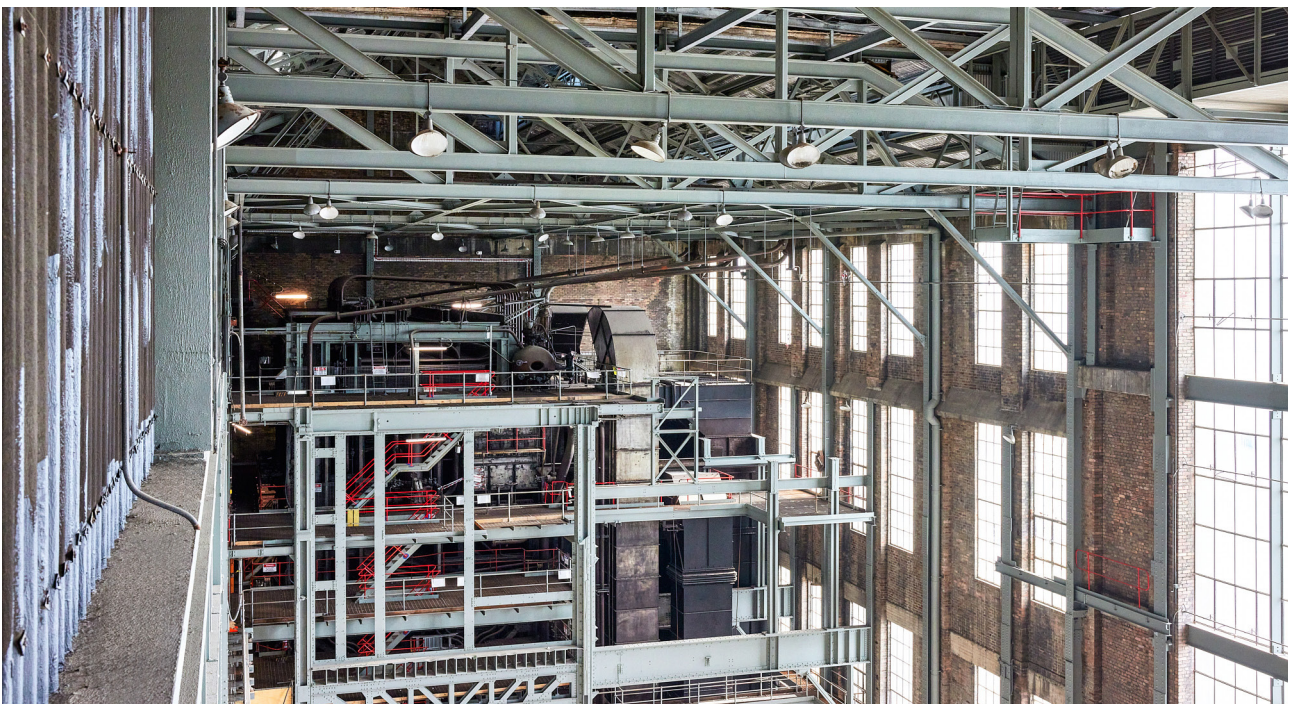
Figure 3.6 Extant Boiler No. 1, 2024 (courtesy of Toby Peet)

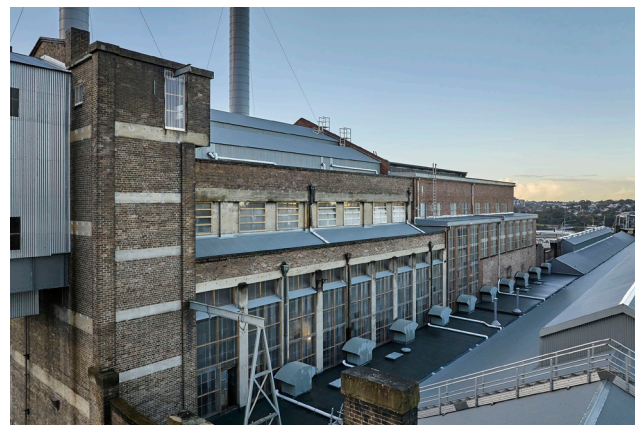
Figure 3.9 Boiler House Western Elevation, 2024 (courtesy of Chris Bennett: Evolving Picture)

The western brick wall of the Boiler House is shared with the Pump House and is the original wall of the 1917 demolished Boiler House. The evidence of the original wall is within the various cut-off steel beams as well as some of the remnant windows and blocked openings. At the base of the western elevation are a series of small brick rooms with timber doors added in the 1950s—two near the middle (BH G.6 & BH G.7) and two towards the northwest corner (BH G.8 and BH G.9). The east wall of ground floor Boiler House contains four large openings that are covered with polycarbonate sheet and extend to the first level. These openings housed the removed ash precipitators that were part of the Ash Handling System.

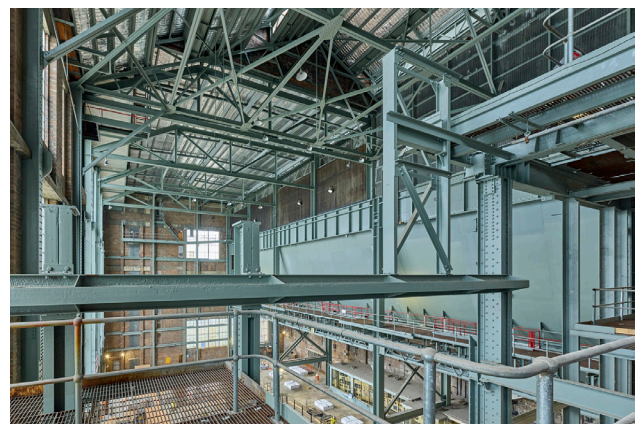
Figure 3.10 Boiler House internal roof trusses, 2024 (courtesy of Chris Bennett: Evolving Picture)

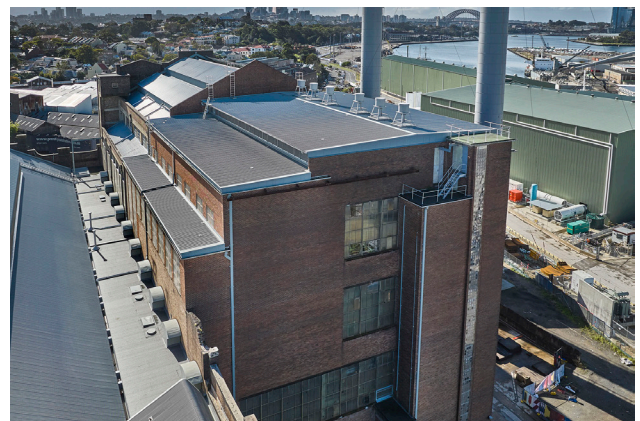
Figure 3.11 Boiler House Roof from southwest, 2024 (courtesy of Chris Bennett: Evolving Picture)

The western side of the roof is a series of flat roofs covering the main Boiler House, the coal hopper, a small section of roof on the east elevation and small roof areas over the south stairwell and the lift overrun. These roofs were constructed of precast concrete panels, with waterproof lining and caulking, and supported on steel structure below. The concrete panels over the main Boiler House space have been replaced with a lightweight steel and Colorbond roof (c. 2015), but the original trusses remain. The east awning and Coal Hopper roofs remain but have been covered with a torch on membrane and an added Colorbond roof, respectively.

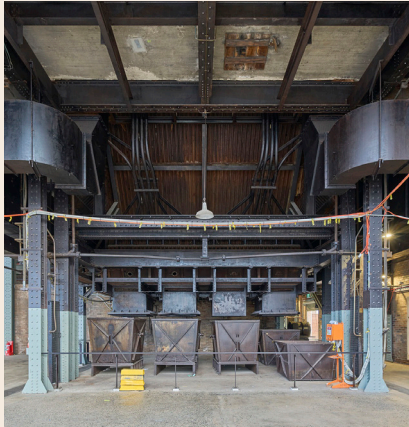
| Room / Item | No. 1 Boiler – Ground (East) | <p>(courtesy of Chris Bennett: Evolving Picture, 2024)</p> |

| Description | <p>This space currently contains the lower section of the single extant Boiler of the Power Station, which was used for fuel combustion and steam raising. It also includes the Ash Kibble Sets that collected waste ash from the Boilers and the Selenium Rectifier that was used to charge the Ash Trucks.</p> <p>In 2022–24, the extant machinery and equipment underwent treatment and repainting. Floor remediation and replacement of some floor hatches for accessibility.</p> | |
| Floor | <p>Concrete floor.</p> <p>The original heavy-duty cast iron grates were removed and stored in the Switch House Ground Floor, some have been reused to replace missing grates at Coal Handling Shed southern end. They were replaced with steel hatches and Fibre Reinforced Plastic (FRP) for safety and accessibility reasons.</p> <p>Some areas of the floor located behind handrails were not remediated in order to retain the original surfaces.</p> | |
| Doors and Windows | <p>There is a large opening on the eastern wall (former openings housed the removed ash precipitators that were part of the Ash Handling System). The opening is clad with transparent polycarbonate sheeting. The polycarbonate sheeting was replaced in 2022–24.</p> | |
| Other | <p>The base of rivetted steel columns throughout the space was repaired in c. 2008. It included encasing some of the column bases in concrete.</p> <p>Extant machinery and equipment are balustraded.</p> | |
| Machinery | <p>The Pulverised Fuel Feed Pipes (2.3)</p> <p>The Boiler (No. 1) (2.4)</p> <p>The boiler machinery has been treated for corrosion and repainted.</p> <p>Ash Kibble Sets (7.1)</p> <p>Selenium Rectifier for charging Ash Carts (8.11)</p> | |

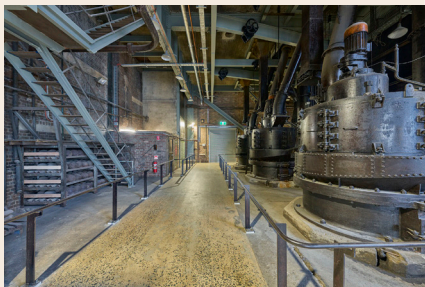
| Description | <p>This area facilitated the pulverisation of the coal into powder using the three Mills, with the connecting Pulverised Fuel Feed Pipes to the floor above. The fuel would then be combusted in the adjacent Boiler to generate heat and steam.</p> <p>In 2022–24, the extant machinery and equipment were coated with a clear rust treatment, barriers were installed, and the floor was remediated for public access.</p> | <p>(courtesy of Chris Bennett: Evolving Picture, 2024)</p> |

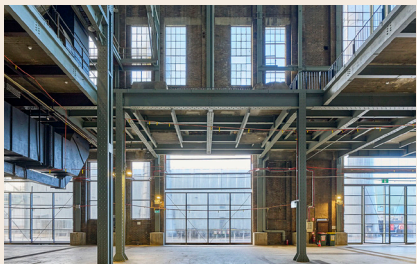
| Description | <p>This space formerly contained a High Pressure Boiler, which was used for fuel combustion and steam raising.</p> <p>In 2022–24, the floor was remediated for public access.</p> | <p>(courtesy of Chris Bennett: Evolving Picture, 2024)</p> |

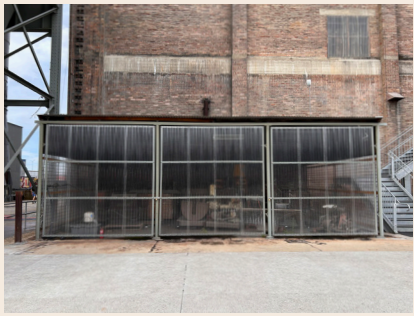
| Description | <p>The Ash Truck Storage is a small shed located on the northern façade of the Boiler House. It housed the battery-run Ash Trucks, which transported the Ash Kibbles, which contained waste ash, from the boiler house to the Ash Handling Tower.</p> | <p>(Design 5 – Architects, 2024)</p> |

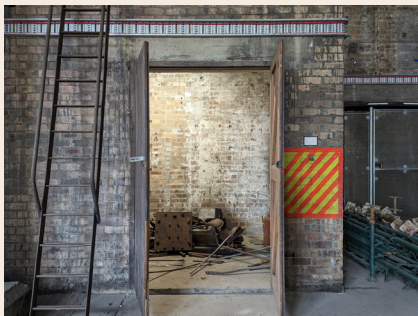
| Description | <p>This room would have once housed the No. 1 2.2 KV/45 V Auxiliary Transformer. It is located along the western wall of the Boiler House.</p> | |
| Floor | The concrete floor was raised above the level of the Boiler House floor by 60mm. | |

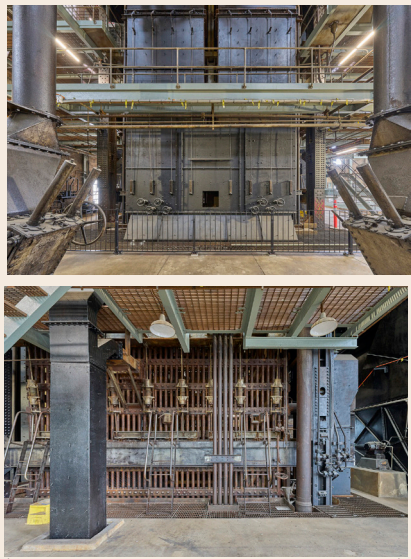
| Description | <p>This space is dominated by the single extant Boiler of the Power Station and its associated equipment, which was used for fuel combustion and steam-raising. The Pulverised Fuel Feed Pipes and the Forced Draft Fans fed the pulverised coal into the furnace.</p> <p>In 2022–24, the extant machinery and equipment underwent treatment and repainting. Floor remediation and replacement of some floor hatches for accessibility.</p> | |

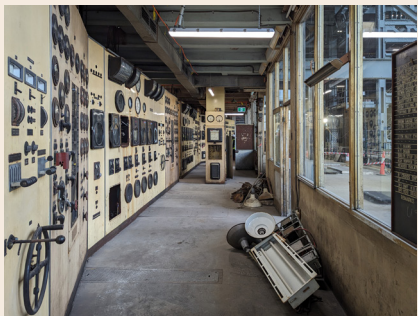
| Description | <p>The Boiler House Control Room was used to monitor and control the operations of the Boilers. Masonry walls enclose the space, and large glazed windows face the Boiler House.</p> | |
| Floor | <p>Raised concrete floor. Recessed cable paths are covered with a steel check plate.</p> | |

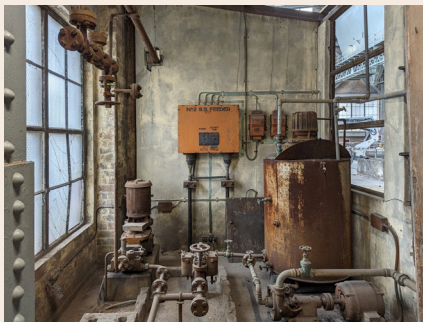
| Description | <p>This room contains the Sulphite Tank and associated No. 2 Stainless Steel Feeder, along with a series of pipes and valves that extend outside the room to the No. 1 Boiler.</p> <p>The room was used to feed sulphite into the feedwater supply to eliminate dissolved oxygen and prevent corrosion and pitting in the Boiler equipment.</p> | <p>(courtesy of Chris Bennett: Evolving Picture, 2024)</p> |

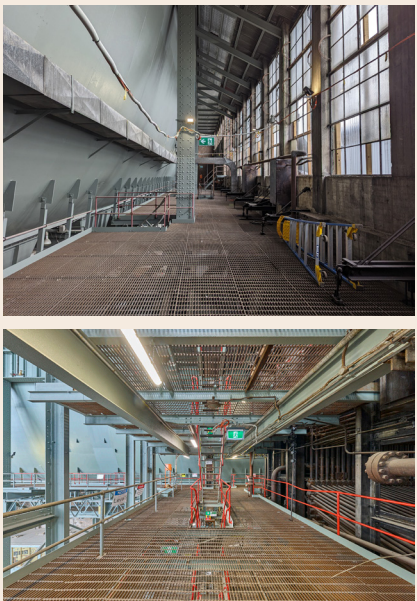
| Room / Item | Mezzanine Below Hoppers – Walkway | |

| Description | <p>This space comprises the metal mesh walkways surrounding the sides of the large Hoppers, where crushed coal was distributed and dropped down to the Chutes and Mills for pulverising. The metal mesh walkways surround the No. 1 Boiler.</p> | |
| Floor | <p>Steel mesh grate supported on steel frame. The type of grate changes from north to south half.</p> <p>Reviewed in 2022–24 with some clamps replaced. Minor replacement of some metal mesh panels.</p> | |

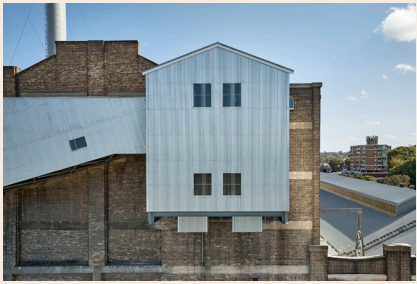
| Description | <p>The Transfer House is a steel and timber-framed structure clad in corrugated galvanised steel located on the northern façade of the Boiler House. It has two levels. The bottom level connects to the Boiler House level BH3.2 and consists of the conveyors. The top level connects to the conveyors from the inclined conveyor.</p> <p>The purpose of the Transfer House was to receive the coal transported by the External Conveyor from the Coal Handling Shed and transfer it to the conveyors within the Boiler House for sorting and pulverising.</p> | <p>(courtesy of Chris Bennett: Evolving Picture, 2024)</p> |
| Floor | Steel check plate on both levels. | |

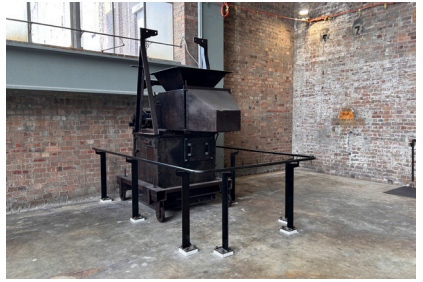
| Machine / Ref. | Coal Weigher – 1.11 | |

| Description | <p>The Coal Weigher received coal from the second Transfer House and transferred it to the high-level Hoppers in the Boiler House. When in use, they were inserted between the Chute and the Mill. The automatic weighing machines provided a precise measure of coal to each of the Hoppers for combustion. Only one of these Coal Weighers has been retained.</p> <p>Significance</p> <p>The Coal Weigher is an integral part of the Coal Handling System. It is a rare item, evidencing the processes and precision of coal delivery to the mills and furnaces, and it demonstrates the need for precision in the regulation of coal supply and temperature control for the functioning of the boilers.</p> | |

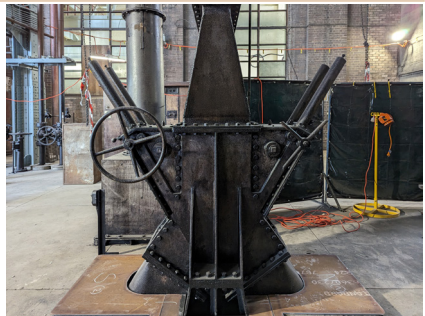
| Machine / Ref. | Chutes from Hopper to Mill – 2.2 | |

| Description | <p>The Chutes from Hopper to Mill are cylinders of welded steel that fed coal from bunkers down to the Pulverising Mills.</p> <p>Significance</p> <p>The Chutes from the Hopper to Mill are integral to the transfer of coal from the Coal Handling System to the Steam Raising System. The chutes evidence the travel of coal from the Hopper to the Mills and are highly visible items within both the firing floor and the basement.</p> | |

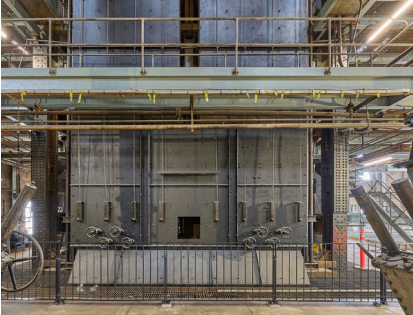
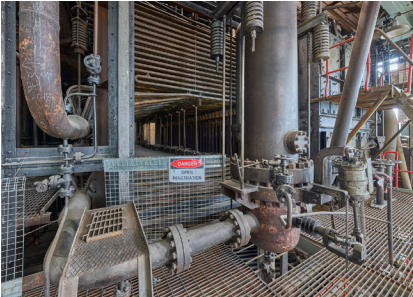
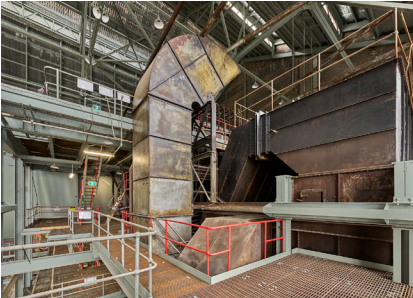
| Machine / Ref. | The Boiler – 2.4 | |

| Description | <p>The Boiler (No. 1) combusted fuel and generated steam. It comprises several key components:</p> <p>a) The Furnace The Furnace is a rectangular chamber located at the base of the Boiler, where fuel combustion takes place, producing hot air to heat water to steam.</p> <p>b) Superheaters The Superheaters are a set of boiler tubes carrying steam produced from feedwater in the lower part of the boiler. The Superheaters heated the steam to a desired output temperature, maintaining temperature control.</p> <p>c) Attemperators The Attemperators are large steel cylinders located on the upper floors of the Boiler. They reduced the temperature of the steam from the Boilers for processing by the early Turbo-Alternators. As these Turbo-Alternators were phased out, the Attemperators were rendered obsolete.</p> <p>d) Economisers The Economisers are chambers containing a set of pipes carrying incoming, pre-heated feedwater from the Condensers to the Furnace.</p> <p>e) Air Heaters The Air Heaters are of the cross-floor tubular type of two banks arranged in parallel with a total of 1878 tubes. Hot gases entered the air preheater tubes from the multiclone collectors and were discharged into the electrostatic precipitators.</p> <p>f) Air Ducts The air ducts ran down either side of the Boiler and were responsible for carrying primary air to the Pulverising Mills and secondary air to the Furnace.</p> <p>Significance</p> <p>The No. 1 Boiler is the principal element in the Steam Raising System. It illustrates the development of steam-raising technology in the early second half of the twentieth century. With its visible steam pipes, tank, and suspension springs, it is a massive industrial item evocative of older technologies and industrial environments now rarely seen.</p> | |

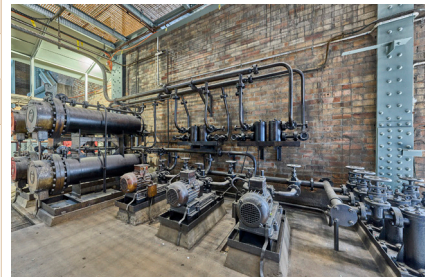
| Description | <p>The Oil Heater Pumps and Valves were used to start the Boilers after they had been shut down, by pumping oil into the furnace to increase temperatures until they reached firing levels, upon which pulverised coal fuel mixed with air would be introduced.</p> <p>Significance</p> <p>The Oil Heater Pumps and Valves are an integral part of the Steam Raising System. They provide evidence of the need for a volatile start-up fuel for pulverised coal-fuelled boilers and illustrate past industrial processes.</p> | |

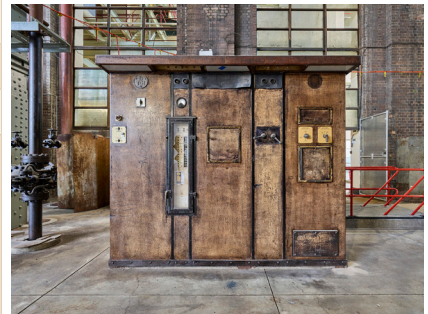
| Machine / Ref. | Soot Blower Cabinet – 2.9 | |

| Description | <p>The Soot Blowers were compressed-air lances that removed soot from the top of the water tubes within the Boiler chamber. The operating panel cabinet (one of thirteen that once existed in the power station) is the only remaining element of the Soot Blowers.</p> <p>Significance</p> <p>The Soot Blower Cabinet is an integral part of the Steam Raising System. As the operating panel for the remote control for the Soot Blower (now removed), it is visible evidence of the need to control the deposition of soot on the Boiler tubes.</p> | |

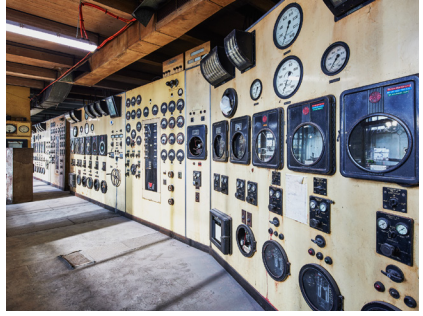
| Machine / Ref. | The Boiler House Control Room – 2.10 | |

| Description | <p>Comprising a series of panels of metres and switches, this room allowed for monitoring and controlling the operation of the Boiler.</p> <p>Significance</p> <p>The Boiler House Control Room is an integral part of the Steam Raising System. It retains remnant evidence of the operation of the original four boiler systems and can provide information on the processes of steam generation associated with electrical power. The Boiler Control Room is a rare example of a mid-twentieth-century semi-automatic materials flow control system.</p> | <p>(courtesy of Toby Peet, 2024)</p> |

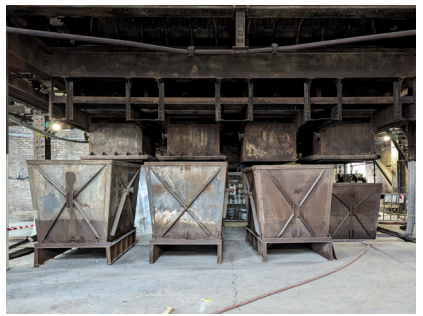
| Machine / Ref. | Ash Kibble Sets – 7.1 | |

| Description | <p>The Ash Kibble Sets held ash – a waste product – which was passed through ash chutes from the Boilers to the Kibbles. They were then carried by the Ash Trucks to the Ash Handling Tower, where they were lowered onto motor lorries by the Kibble Crane via trunnion pins and emptied for offsite transportation.</p> <p>Significance</p> <p>The Ash Kibble Sets are an integral part of the Ash Handling System. They demonstrate one of the ash handling processes utilised at White Bay and are evocative of the labour-intensive nature of the system when in operation.</p> | <p>(Design 5 – Architects, 2023)</p> |

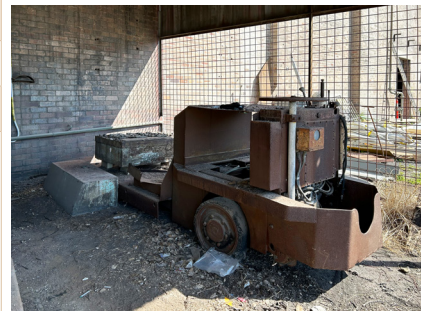
| Machine / Ref. | Ash Trucks – 7.2 |

| Description | <p>The Ash Trucks were purpose-built, low-loading, rigid frame, battery-powered trucks that removed the ash-filled Ash Kibbles from beneath the discharge chutes and conveyed them to the Kibble Crane located on the Ash Tower.</p> <p>Significance</p> <p>The Ash Trucks are an integral part of the Ash Handling System. They provide evidence of the labour-intensive methods of removal of ash from the Boiler. The Ash Trucks are early examples of electrically powered industrial vehicles.</p> |

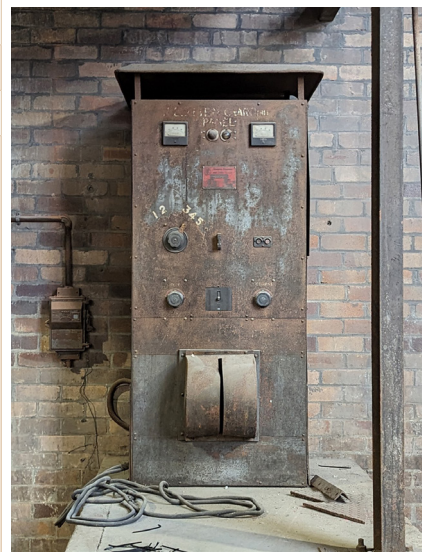
| Machine / Ref. | Selenium Rectifier for charging Ash Carts – 8.1 |

| Description | <p>The Selenium Rectifier for charging Ash Carts are located in the northeast corner of the Boiler House and was used to charge the batteries of the ash carts.</p> <p>Significance</p> <p>The Selenium Rectifier for charging Ash Carts is an integral part of the Auxiliary Electrical System. It provides a link between the Ash Handling System and the efficient disposal of the ash waste from the Electrical Generating System. The Battery Charging System indicates the method of charging the batteries of the Ash Trucks.</p> |

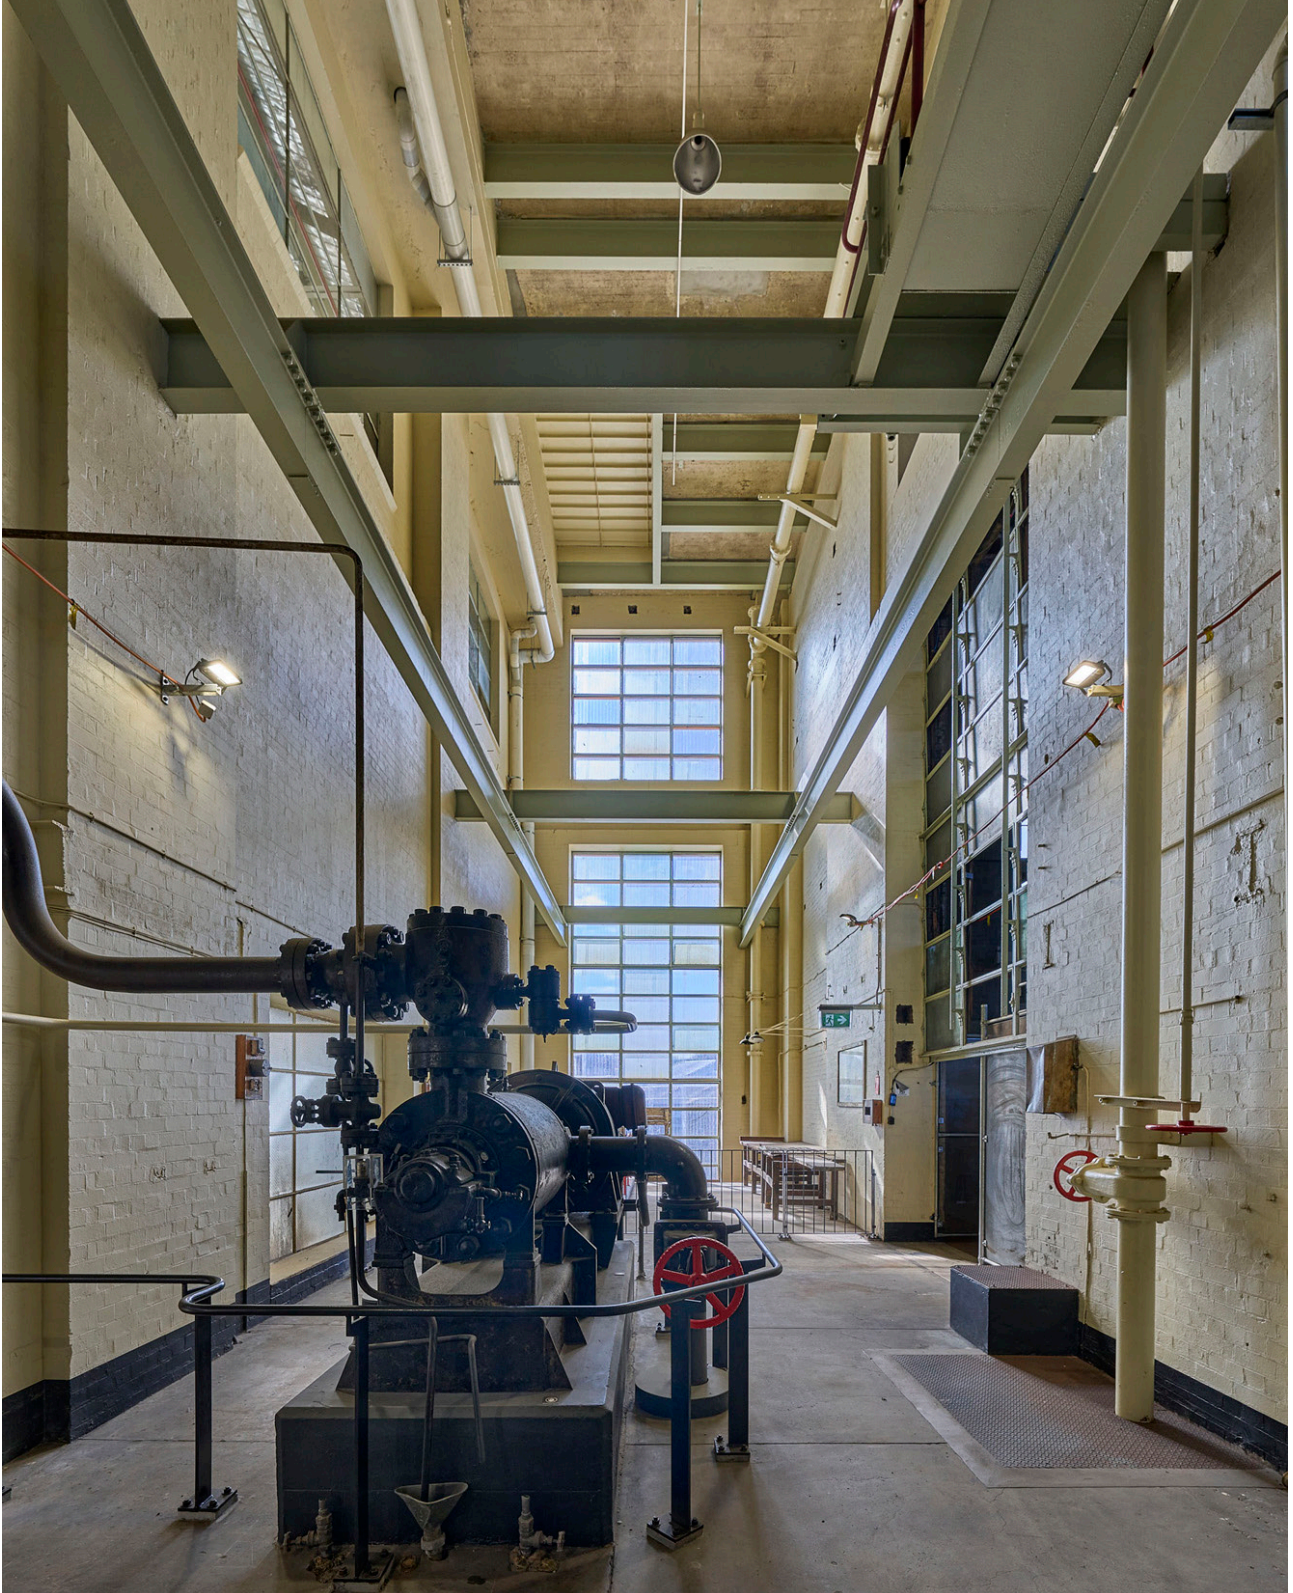
Figure 4.1 Pump House Internal, facing north, 2024 (courtesch of Chris Bennett: Evolving Picture)

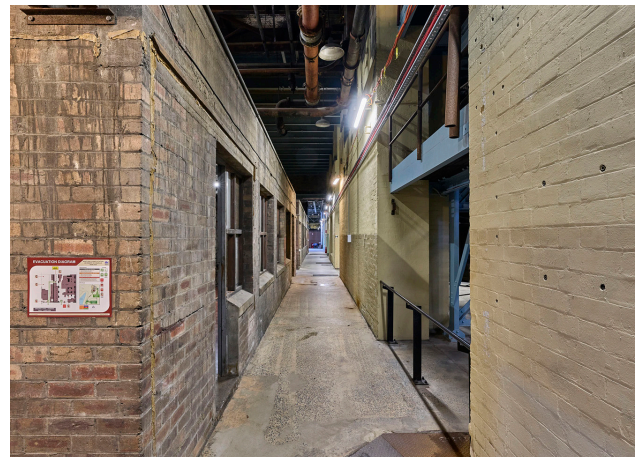
Figure 4.5 Pump House north, Ground Floor, 2024 (courtesy of Chris Bennett: Evolving Picture)

| Element / Room | Reference |
|--|--|
| Ground floor north end | The floor slab of the space PHM.1 remains in poor condition and are supported from below with temporary props. Internal rooms received minimal attention. |

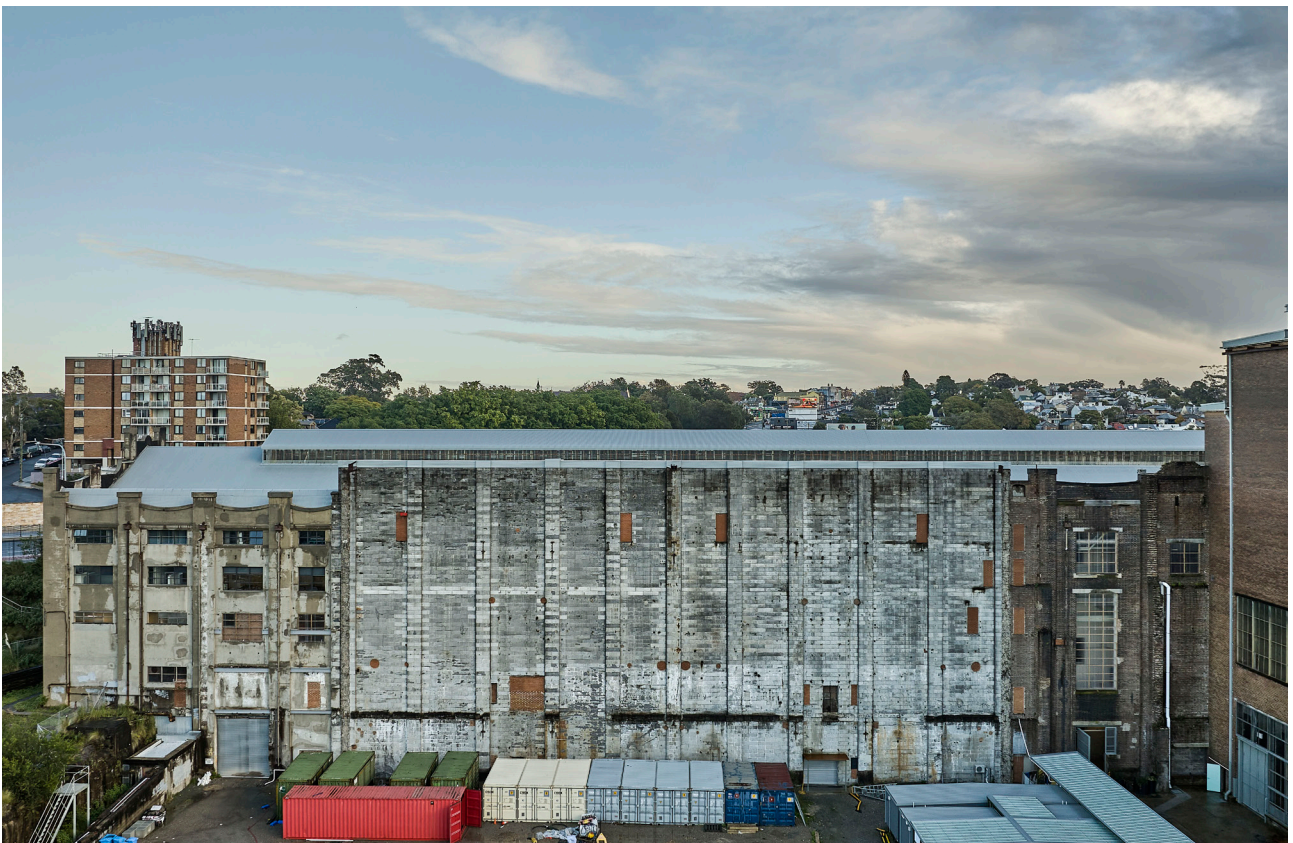
Figure 4.7 Pump House East Elevation, between Administration and Staff Building (left) and Boiler House (right), 2024 (courtesy of Chris Bennett: Evolving Picture)

| Element / Room | Reference |
|--|--|
| External east wall | The east wall remains exposed and has un-remediated spalling concrete blocks. |
