WHITE BAY POWER STATION

CONSERVATION MANAGEMENT PLAN 2026

VOLUME 2 : HERITAGE INVENTORY – STRUCTURES, SPACES & ELEMENTS

**WHITE BAY POWER STATION CONSERVATION
MANAGEMENT PLAN 3RD EDITION**

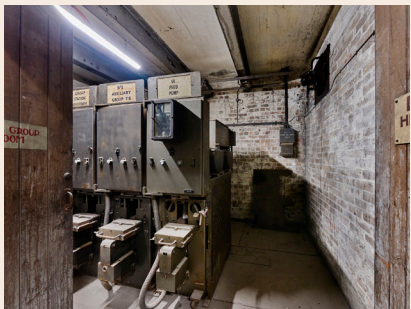
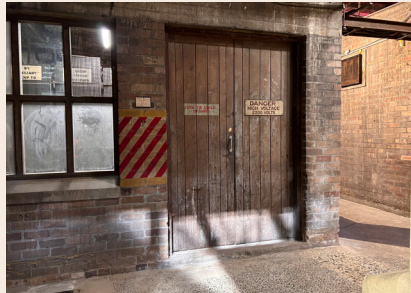
| Description | <p>This small brick room is located near the north end of the Pump House ground level. It hosts the Oil Circuit Breakers for the Tie Group No. 1 Station Transformer, No. 1 Auxiliary Group Tie, Tie Group No. 2 Station Transformer, No. 2 Auxiliary Group Tie, and the 1A Feed Pump.</p> | |
| Floor | Concrete, large pit/cable trench running longitudinal into PH G.2. Steel channels with extant machinery. | |

| Doors and Windows | Timber double doors on south end of west wall. Door repaired and closed in 2024. Timber frame window along west wall. One broken pane replaced in 2022–24, one filled in with mesh wire. | |

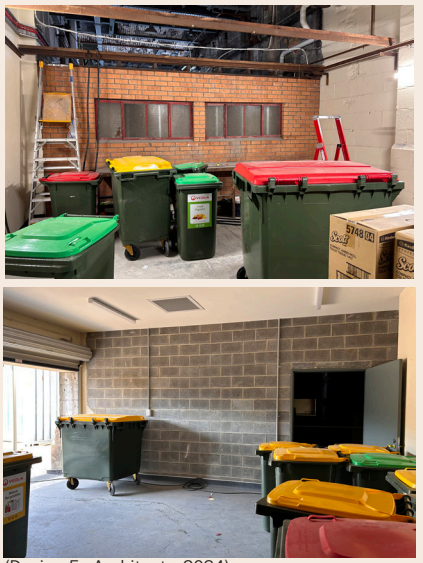
| Room No. | PH G.8 | |

| Description | <p>This room is located in the south half of the Pump House ground level, near the middle. The use of the space is unknown. The brick partition at the northern end dates from the 1970s.</p> <p>In 2022–24, the room was divided in two and repurposed to a Bin Room and storage room which included internal modifications.</p> | <p>(Design 5 – Architects, 2024)</p> |

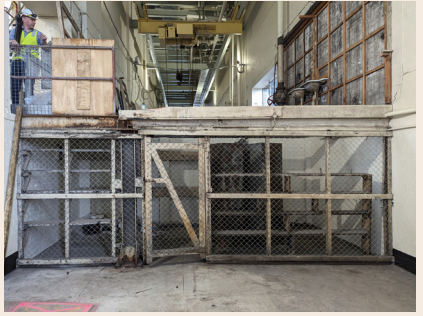
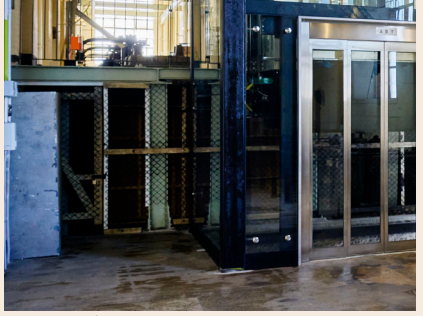
| Description | <p>This room is located at the north end of Pump House Level 1. It was likely used for storage.</p> <p>The space was dramatically altered as part of the lift installation including the renewal of the floor slab over the top and the timber and wire screen.</p> | |
| | <p>Existing Condition (Design 5 – Architects, 2023)</p> <p>After work (courtesy of Chris Bennett: Evolving Picture, 2024) cropped</p> | |

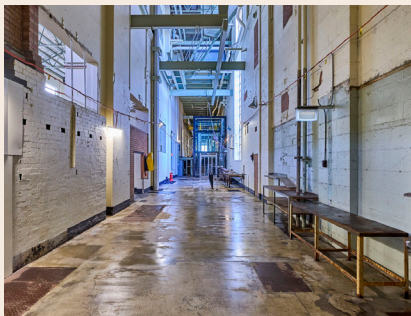
| Room No. | PH 1.2 | |

| Description | <p>The construction for the southern part of the Pump House was completed in 1928. The space connects at the same height with level 2 of the Turbine Hall to the west and would have connected to Boiler House No. 2, to the east. The Boiler House No. 2 was demolished in c.1976 which is evidenced by blocked up doors.</p> <p>Any machinery, pumps and water tanks that was inside the space has been removed leaving the first floor and the area above as an empty void. Some of the high-level walkways and platforms remain but there is evidence of many more having been removed.</p> <p>Along the east wall is an old lathe and at the northern end, is a workbench with grinding wheels. The newly installed steel and glazed passenger lift occupies the north end of the space.</p> | <p>(courtesy of Chris Bennett: Evolving Picture, 2024)</p> |
| Walls | <p>Walls painted in 2022–24.</p> <p>North: Steel framed and glazed passenger lift 2022–24.</p> <p>East wall: Original concrete block wall (painted) with multiple bricked up openings is evidence of connection with former Boiler House No. 2. Former steel sheeted partitions (post 1950s) forming workshops were demolished in 2022–24 due to condition. Evidence retained on perimeter walls with paint colours and fixings.</p> <p>South: The external wall of Administration block is above the first-floor level. It is rendered masonry supported by steel I-beam.</p> <p>West: Rendered concrete/masonry wall with multiple bricked up openings.</p> | |

| Floor | Concrete, remediated in 2022–24 for compliance. | |

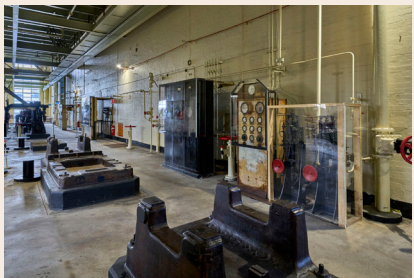
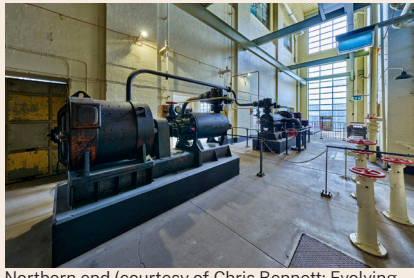
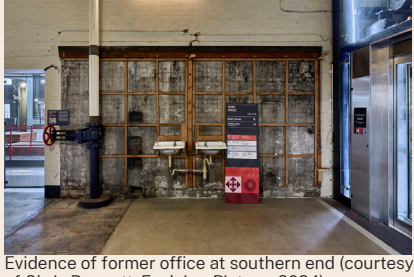
| Description | <p>This space forms the entirety of the Pump House Level 2. The construction of this building was completed 1917. However, most the contents, including the floor, high level steel beams, flat concrete roof, and machinery, tanks and high. Level walkways, machinery and flat concrete roof all date from the 1950s modernisation.</p> <p>The space is connected flush with Level 1 of the Boiler House through openings at the north and south ends and to the Boiler House Control Room via a sliding door located approximately midway. The space also connects flush with Level 2 of the Turbine Hall by openings between almost each structural bay.</p> <p>The Feedwater pumps and control valves and panels are retained. The Feedwater Pumps that would receive feedwater from the Deaerators and pump it to the Feed Heaters. Located above the space are the Feedwater and Condensate Tanks supported on steel I-beam girders that span east to west masonry walls. The tanks stored feedwater which would be fed into the Boilers in the event of a pump systems failure.</p> | <p>Southern end (courtesy of Chris Bennett: Evolving Picture, 2024)</p> <p>Northern end (courtesy of Chris Bennett: Evolving Picture, 2024)</p> <p>Evidence of former office at southern end (courtesy of Chris Bennett: Evolving Picture, 2024)</p> |

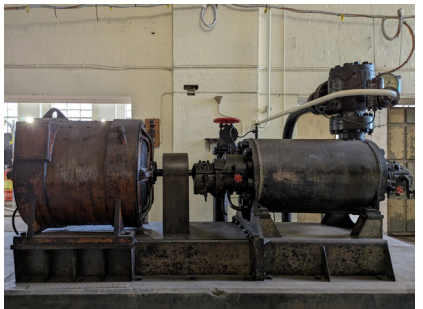
| Machine / Ref. | Electric High Pressure Feedwater Pumps – 4.1 | |
|---|--|--|
| Description | <p>The Electric High-Pressure Feedwater Pumps are three multi-stage centrifugal pumps powered by an electric motor. They receive the feedwater from the Deaerator, which is then pumped to the Feed Heaters..</p> <p>Significance</p> <p>The Electric High Pressure Feedwater Pumps are integral to the Feedwater System. They demonstrate the technique by which feedwater is constantly reused in power generation. They are robust and representative of electric high pressure feedwater pumps used in power stations in the mid-twentieth century.</p> | |

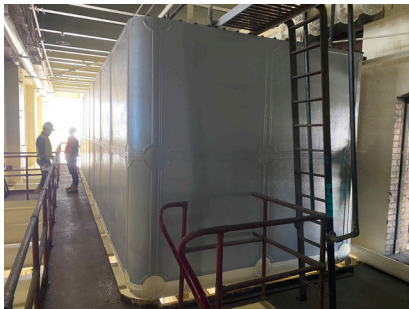
| Machine / Ref. | Feedwater and Condensate Tanks – 4.6 | |

| Description | <p>The Feedwater and Condensate Tanks are a set of large cast iron water tanks and were suspended above the Pump Gallery floor for the economical, gravitational feed of feedwater into the Boilers in the event of a pump systems failure.</p> <p>Significance</p> <p>The Feedwater and Condensate Tanks are integral to the Feedwater System. They demonstrate the technology by which feedwater is constantly reused in power generation and are representative of the size, design, and layout of water storage arrangements in a large Boiler House.</p> | |

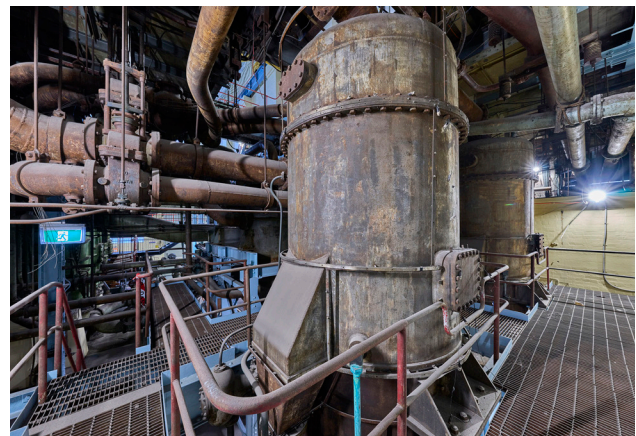
Figure 5.6 Mezzanine level, 2024 (courtesy of Chris Bennett: Evolving Picture)

along the eastern wall and is accessed via several sets of steel stairs from the ground floor. These stairs are located near the middle of the mezzanine space, at multiple points at its south end, and at the northwest end. This mezzanine comprises a concrete platform at the northern end, whilst the rest of the level is made up of a series of steel grate catwalks at varying heights connected by flights of steel stairs. These walkways interweave amongst the Ground Floor machinery (notably, the De-aerators and the Condensers) and are surrounded by extensive sets of extant pipes and valves. TH M.A has two separate openings along the eastern elevation that connect to Mezzanine Level of the Pump House and has a ceiling of concrete slab with boarded formwork supported by a steel structure. Next to the northern opening is a series of switches and buttons for operating vent fans, sluice valves, alternative electricity supplies, and exchange pumps. A new steel stair was installed in 2022–24 connecting ground floor and Level 2 above.

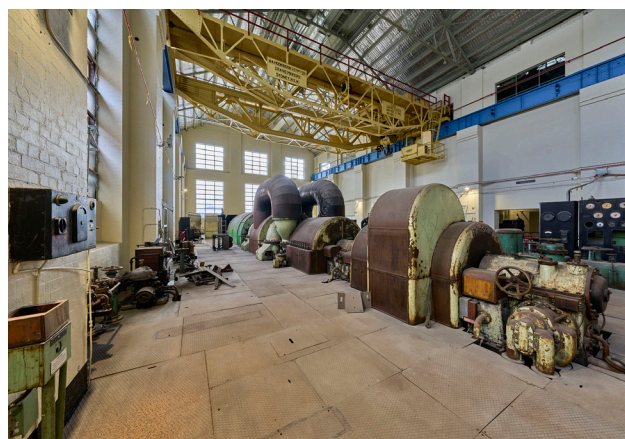
Level 2 occupies the northern half of the Turbine Hall. It contains the single remaining Parsons Turbo-Alternator Set, the Steam Control Valves, and the bright yellow Overhead Cranes at its northwest end (TH 2.A.1), all of which are a part of the Power Generating System. During the power station’s active years, steam was sent to the Turbo-Alternator for the generation of electricity. The cranes are supported by gantry crane rails that run the length of the eastern and western walls and are supported by the capitals of the brick piers. Level 2 is accessed by a pair of stairs from Level 1, a pair of stairs

Figure 5.8 Level 2 extant Parsons Turbo-Alternator Set, 2024 (courtesy of Chris Bennett: Evolving Picture)

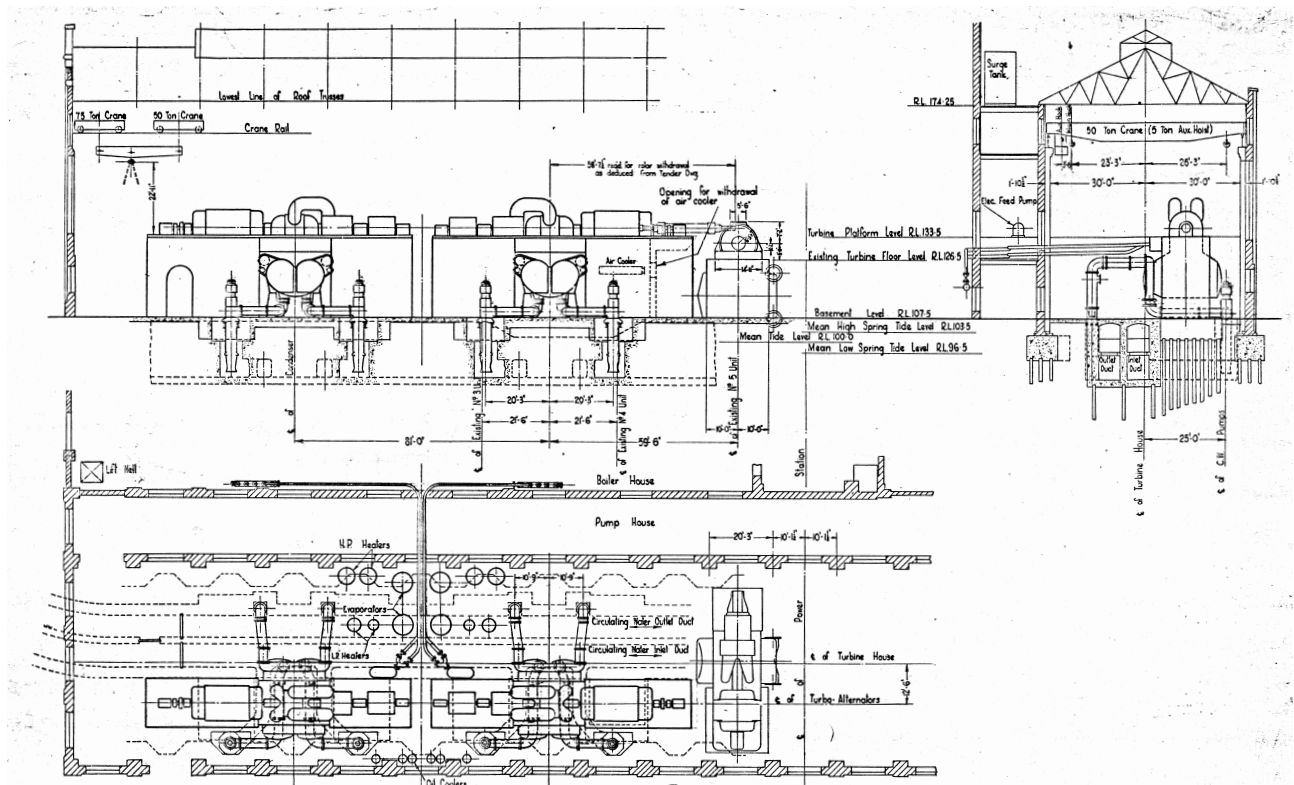
Figure 5.11 Archival drawing showing Turbine Alternator Set 1, 2 and 3. Only No. 1 remains now, 1947 (courtesy of PMNSW Archive, 12079) cropped

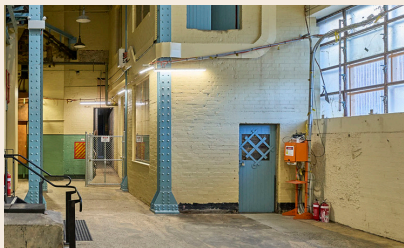
| Room No. | TH G.A.2 | |

| Description | <p>This small room is located in the northwest corner of the Turbine Hall Ground Level. It is not known exactly what this room was used for, but it is likely that it acted as a storage space during the active years of the power station.</p> | <p>(courtesy of Chris Bennett: Evolving Picture, 2024)</p> <p>(Design 5 – Architects, 2023)</p> |
| Floor | Concrete, water channel running through the space covered by concrete block covers. | |

| Doors and Windows | <p>Boarded timber door with window at east end.</p> <p>Boarded timber door to small storage closet at west end of the room. Door repainted, glass replaced in 2022–24.</p> <p>Two 8 pane frosted and wired glass windows on south wall. Covered with clear acrylic sheeting externally in 2022–24.</p> <p>Single pane window above door.</p> | |

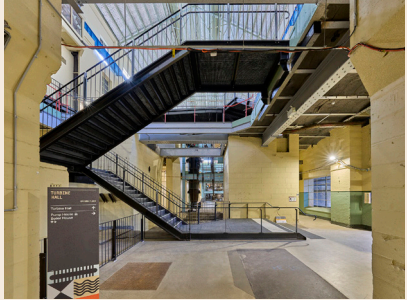
| Room / Item | Ground Floor – Section C | |
|---|--|--|
| Description | <p>Section C comprises the middle section of the Ground Floor of the Turbine Hall. The space once hosted extensive amounts of equipment and machinery relevant to the operations of the Turbine Hall.</p> <p>A new steel framed stair installed in 2022–24 providing access to Level 1.</p> | |
| Floor | Concrete. Numerous channels, drains, and covered shafts. Evidence of rail track to Pump House. Parts of northern area remediated for level access. Southern end central passage is covered with reversible lightweight deck. | |

| Room / Item | Ground Floor – Section C | |
|---|--|--|
| Doors and Windows | <p>Steel frame 12 pane window frame in northmost east bay, glazing missing.</p> <p>Unequal double door on west wall leading to Transformer Alley reinstated in 2022–24.</p> | |

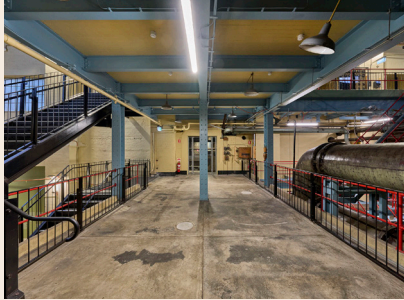
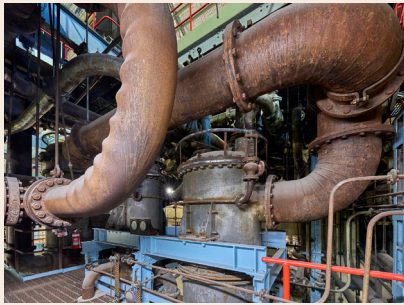
| Room No. | TH M.A.1 | |

| Description | <p>The mezzanine floor is located near the northern end of the Turbine Hall. It is accessed via steel framed stairs and also connects to the Pump House mezzanine level (PH M.1). The mezzanine area forms a U-shaped space comprised of a concrete slab at the northeast end, a series of catwalks and contains various equipment and pipes on the platform at its southwest end (not connected to catwalks or northeast area).</p> <p>New steel framed stair installed in 2022–24, connecting from ground floor to level 2.</p> | <p>(courtesy of Chris Bennett: Evolving Picture, 2024)</p> |
| Floor | <p>Northeast platform: concrete with scribed margins. Multiple steel checker cover plates over holes in the floor.</p> <p>The rest of the space comprises a series of steel grate walkways that span the width of the Turbine Hall.</p> | |

| Other | <p>Painted red tubular balustrades on north and south sides of northeast platform and throughout walkway spaces. Some parts cut to allow for new stairs. Repainted in 2022–24. New steel balustrades installed internally of existing in 2022–24.</p> <p>Northeast platform: pipes, wires, and conduits on east and west walls. Orange switch cabinet and other small buttons and switches mounted on east wall for operating vent fans, sluice valves, alternative electricity supplies, and exchange pumps. Cabinet covered with timber framed perspex in 2022–24.</p> <p>Southeast end: steel frame stairs leading up to platform with various extant pipes and equipment.</p> | |

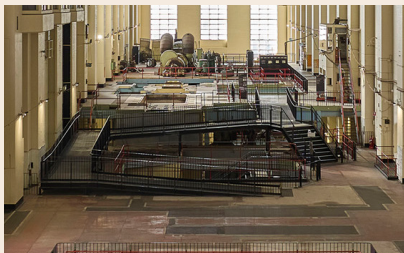
| Room No. | TH 1.C.1 | |

| Description | <p>Section C is the northmost area of Level 1 of the Turbine Hall. It is accessed via newly installed stairs from the Ground Level within the void and an opening to the Pump House, and also a ramp and stair set to Level 2 of the Turbine Hall to its north. The space once hosted turbo-alternators used to receive steam from the Boiler House to generate electricity.</p> | <p>(courtesy of Chris Bennett: Evolving Picture, 2024) cropped</p> |
| Floor | Concrete with scribed margins and steel checker plates. Four voids in floor, one large and three smaller voids to its north. | |
| Doors and Windows | <p>Double steel door in northmost bay of west wall, made operable in 2022–24.</p> <p>Windows: all panes originally frosted, figured, and wired.</p> <p>East wall: upper level of each bay is a steel frame 12 pane window. Glazing around doorway of first bay. Broken panes removed in 2022–24.</p> <p>West wall: steel windows framing removed due to deterioration in 2022–24, stored in Switch House ground floor. Currently covered with temporary timber framed clear corrugated polycarbonate sheeting.</p> | |

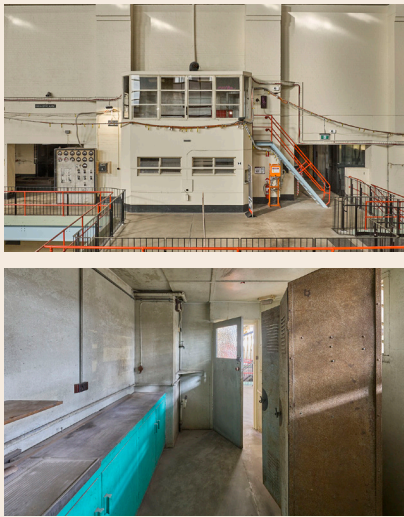
| Description | <p>The lower floor of the control room is located at the south end of the east wall of Level 2 of the Turbine Hall. It, along with the upper floor of the Control Room (TH 2.B.3), was used to monitor the operations of the Turbine Hall.</p> | |
| Doors and Windows | <p>Timber door half-glazed on south wall. Hatch in wall on chamfered south end, with shutter missing. Steel frame 4 pane frosted and figured glass louvre windows on west wall. Single operable bar running across windows. Broken louvre panes removed in 2022–24.</p> | |
| Other | <p>Low level cupboard along east wall with benchtop and stainless-steel sink with a single tap. Small timber shelf mounted above sink. Small metal shelf mounted on south end of west wall.</p> | |

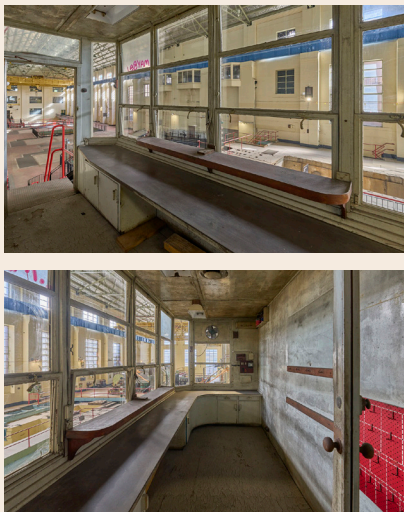
| Description | <p>The upper floor of the control room is accessed by a set of stairs on its south. It, along with the lower floor of the Control Room (TH 2.B.2), was used to monitor the operations of the Turbine Hall.</p> | |
| Doors and Windows | <p>Timber frame half glazed door on south wall. Pane repaired in 2022-24. Steel frame windows on north wall (3 pane with extract fan on upper window) and west wall. Panes replaced, covered with acrylic externally in 2022-24.</p> | |
| Lighting | <p>Original fluorescent light casings from ceiling. Lightbulbs missing. New temporary lights and catenary wires installed 2022-24 (externally).</p> | |

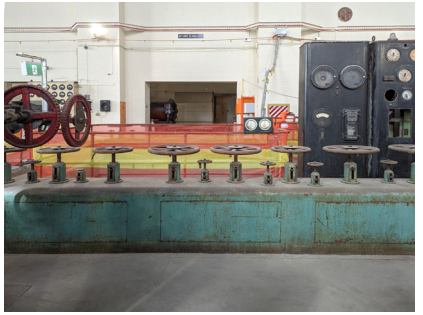
| Machine / Ref. | Steam Control Valves – 3.1 | |

| Machine / Ref. | Steam Control Valves – 3.1 | |
|---|---|---|
| Location | Level 2 – Section A (TH 2.A.1) | |
| Significance | 1 – Exceptional | |

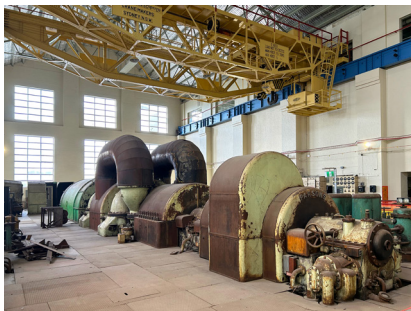
| Machine / Ref. | The Turbo-Alternator Set – 3.2 | |

| Location | Level 2 – Section A (TH 2.A.1) | <p>(Design 5 – Architects, 2023)</p> |
| Significance | 1 – Exceptional | |

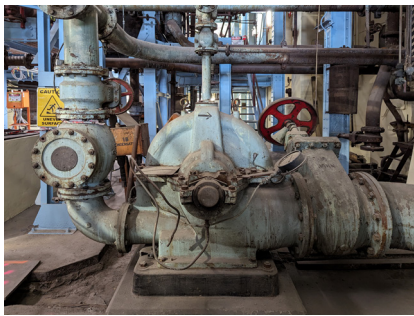
| Machine / Ref. | The Condensate Pumps – 4.3 | |

| Description | <p>The Condensate Pumps sent the water from the Condenser through the Economisers and De-aerators, eventually sending the water back into the Boiler.</p> <p>Significance</p> <p>The Condensate Pumps are an integral part of the Feedwater System. They are representative of medium-capacity, electrically driven pump technology by which feedwater is constantly reused in power generation.</p> | |

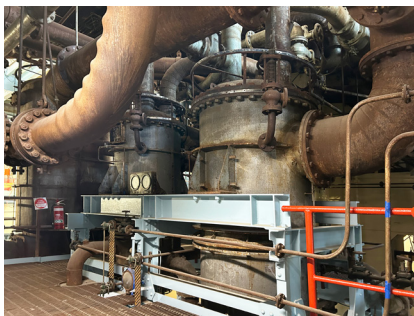
| Machine / Ref. | The De-aerators – 4.4 | |

| Description | <p>The De-aerators are large steel cylinders with domed tops that used low pressure and heat to remove dissolved oxygen and other gases from the Condensate.</p> <p>Significance</p> <p>The De-aerators are an integral part of the Feedwater System. They are characteristic of early to mid-twentieth century power station technology.</p> | |

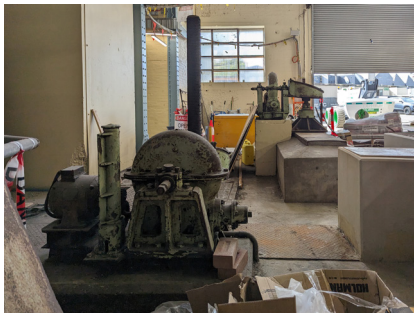
| Machine / Ref. | Sluice Gate and Motors – 5.1 | |

| Description | <p>The Sluice Gates and Motors could exclude water from passing into suction wells and isolate each of the Condensers for the respective Turbo-Alternator Sets for maintenance of the well or pump.</p> <p>Significance</p> <p>The Sluice Gate and Motors are an integral part of the Circulating Water System. They evidence the way circulating water is controlled throughout the power station and admitted to the Condenser Pump Wells.</p> | |

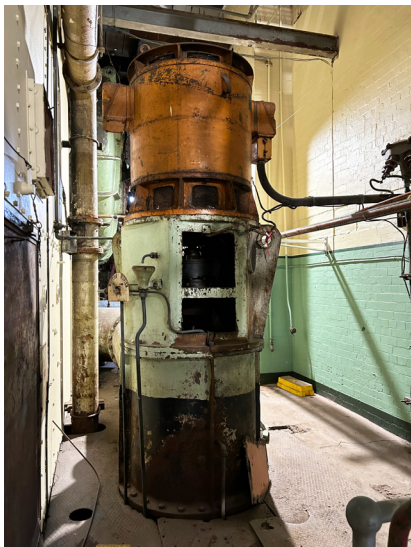
| Machine / Ref. | Circulating Water Pumps – 5.2 | |

| Location | Ground Floor – Section A (South) (TH G.A.1) | |
| System | The Circulating Water System | |

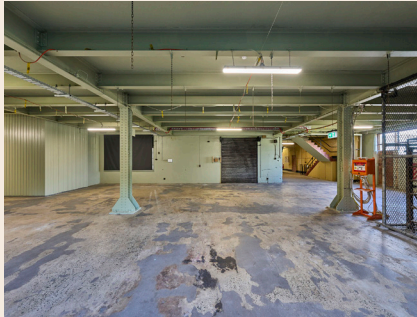
| Room No. | AS 1.1 | |

| Description | <p>This space is accessed via the Pump House and is a vast open space that was likely once used for storage. The metal cage area in the southeast corner of the room contains shelves indicative of storage space for uniforms.</p> | <p>(courtesy of Chris Bennett: Evolving Picture, 2024)</p> |
| Floor | Concrete. Smoothened and sealed in 2022–24. | |
| Doors and Windows | <p>Wire mesh door to caged area in southeast corner on the east wall.</p> <p>Metal roller door to Turbine Hall on south wall. Made operational in 2022–24.</p> <p>North wall: steel frame 9 pane window overlooking Turbine Hall with one exhaust fan. Broken window panes replaced in 2022–24.</p> <p>East wall: two 6 pane windows with exhaust opening on southern part, externally covered with clear Perspex. Under the window on northern end is bricked up opening.</p> <p>South wall: three 6 pane windows. East window is bricked up externally. Middle and west steel windows were reinstated in 2022–24.</p> <p>New opening on west of the lift connecting to AS 1.3 and Turbine Hall was made in 2022–24.</p> | |

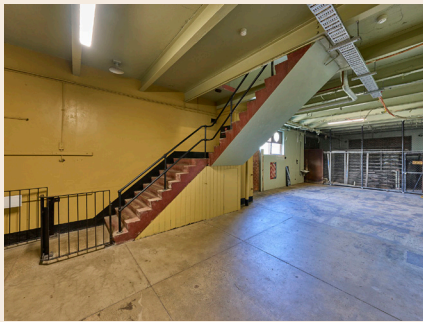
| Description | <p>This space connects Level 1 of the Pump House to the Administration and Staff Accommodation Level 1. It appears to have primarily been a connecting circulation space, with some switch boxes mounted on the west wall. The space is also connected to Level 2 of the Administration and Staff Accommodation.</p> | |
| Floor | Concrete with scribed margins. Smoothened and made compliant as part of 2022–24 works. | |

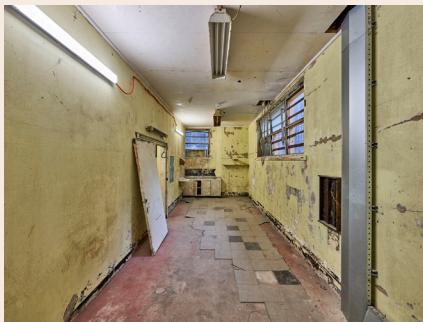
| Description | <p>The First Aid Room is accessed via the Foyer to its north. It was used to provide first aid treatment to workers at the power station who experienced injuries or unwellness from the dangerous and often extreme working environment.</p> | |
| Floor | Painted concrete with grey linoleum tiles on top. Around half the tiles are missing / have been removed | |
| Doors and Windows | <p>Half-glazed 4 panel painted timber French doors with figured glass windows above. Door repaired and repainted in 2022/2024.</p> <p>Sliding door on east wall, unmounted and resting against wall.</p> <p>Steel frame 6 pane louvre window with frosted glass (on three panes) externally cladded with clear corrugated polycarbonate. Operable via a pulley mechanism with linked chain.</p> <p>Steel frame 2 pane window on south wall that continues into AS 1.5, externally cladded with clear corrugated polycarbonate.</p> <p>Windows externally cladded with timber framed corrugated polycarbonate in 2022–24.</p> | |
| Other | <p>Stainless steel metal sink cupboard in southeast corner.</p> <p>Ceramic sink mounted on south end of east wall with paper towel dispenser above. Sink cupboard doors repaired in 2022–24.</p> <p>Fuse box on west wall.</p> <p>Conduits running along south and west walls.</p> | |

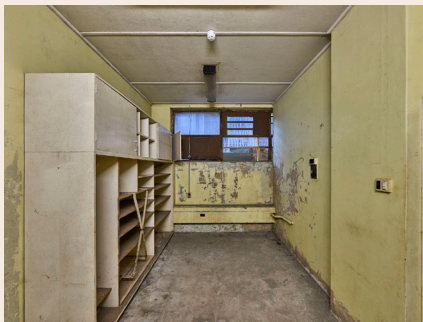
| Description | <p>A small room along the south wall of Level 1 of the Administration and Staff Accommodation accessed from the First Aid Room. It was used for medical treatment of workers at the power station who experienced injuries or unwellness from the dangerous and often extreme working environment.</p> | |
| Floor | Concrete | |

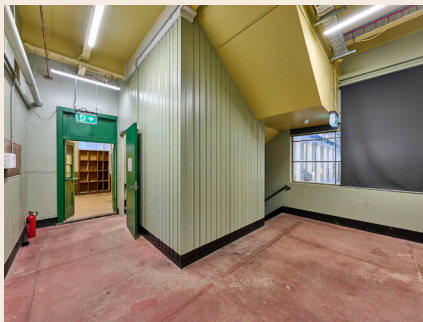
| Description | <p>The central lift lobby and stair connects to all levels of the Administration and Staff Accommodation. It comprises a central lift shaft with stairs and lobby space running around it in an approximate square shape.</p> | |
| Floor | Painted concrete with scribed margins. Crack approximately 1500mm long running near west wall. | |
| Doors and Windows | <p>5 panel (4 glazed) timber French doors to AS 2.5, and AS 2.6. AS 2.5 door has a blocked fanlight above door. Doors painted in 2022–24.</p> <p>Steel frame 12 pane window with clear glass overlooking Turbine Hall. Glazing of window to Turbine Hall repaired and blackout blinds installed internally in 2022–24.</p> <p>Meshed-over opening high up on south wall.</p> | |

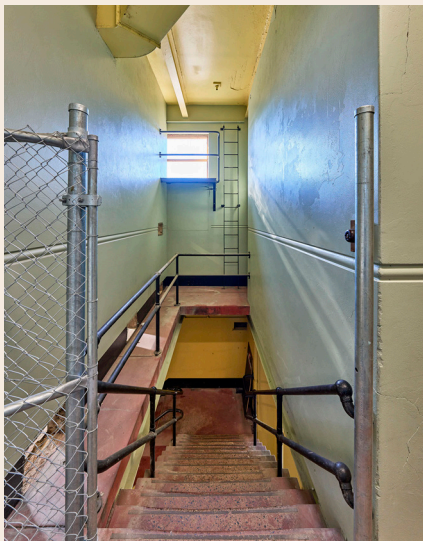
| Description | <p>The stairs provide access to the northeast part of Level 2 of the Administration and Staff Accommodation from Level 1.</p> | |

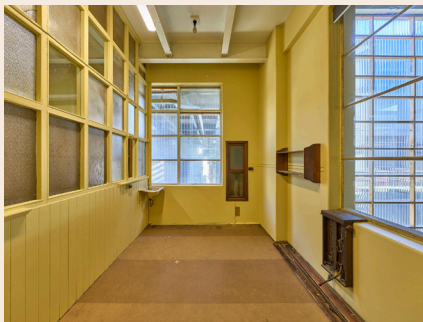
| Description | <p>The washroom is located in the northwest corner of Level 2 of the Administration and Staff Accommodation. It is accessed via the Cloak Room to its south and overlooks the Turbine Hall.</p> | |
| Floor | Temporary particle board floor raised up over concrete floor, installed in 2022-24. | |
| Other | <p>Ceramic sink mounted to south wall at west end. Cupboard (fuse box) with a glazed 2 panel door.</p> <p>Timber shelving and an open fuse box on north wall.</p> | |

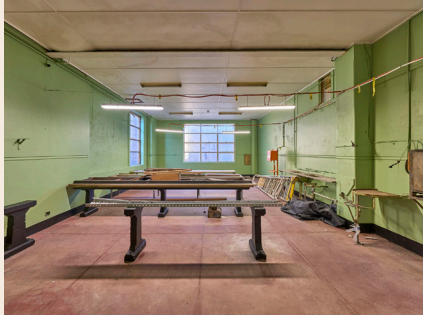
| Room No. | AS 2.6 | |

| Other | Four tables with timber tabletops fixed to the floor, two with concrete stands and two with pipe stands. Along north wall: terrazzo sink bench with steel frames and ceramic bowls (1 missing). Steel frame bench, and wall-mounted steel pie warmer. Fuse box on north end of west wall. Projection screen: white and black painted canvas on wall. | |

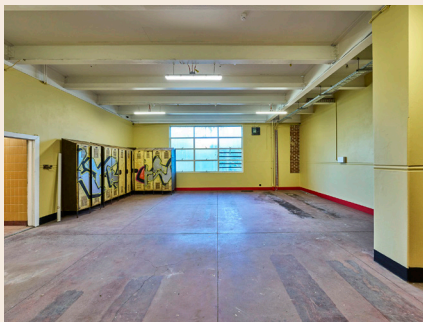
| Room No. | AS 2.7 | |

| Description | <p>The Locker Room (south) is located along the south end of Level 2 of the Administration and Staff Accommodation. It is accessed via the corridor to its north (AS 2.2) and via the Dining Room to its east (AS 2.6) and was used as a Locker Room by the workers of the power station.</p> | <p>(courtesy of Chris Bennett: Evolving Picture, 2024)</p> |
| Floor | Concrete with scribed margins. | |
| Movable heritage | <p>Lockers from level 3 currently stored in this space, some with loose / missing doors, graffitied.</p> <p>Door painted red, possibly from the east wall double door.</p> | |

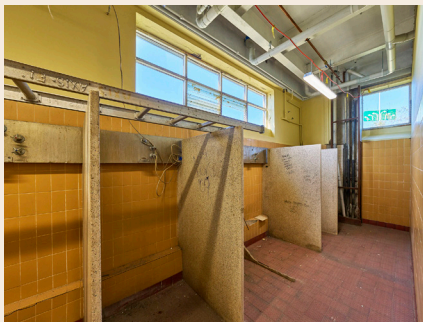
| Room No. | AS 2.8 | |

| Description | The Lavatory (south) is located in the southeast corner of Level 2 of the Administration and Staff Accommodation. It is accessed via the Locker Room to its west (AS 2.7) and comprises an area partitioned into three spaces: a main space with shower cubicles, and two rooms in the northwest corner and southwest corner. | |
| Doors and Windows | Door to northwest internal room. Repainted in 2022–24. Doorway on west wall of main space with architraves, door leaf missing. Steel frame 8 pane window with two exhaust fans and wired glass louvres along bottom row and figured wired glass along the top row. Externally covered with clear polycarbonate sheeting in 2022–24. | |

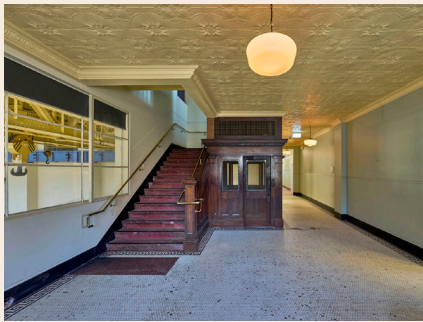
| Description | <p>The Main Lobby and Stair is located in the northwest corner of Level 3 of the Administration and Staff Accommodation and was the front of house for visitors to the White Bay Power Station. It is accessed from the Victoria Road Access Bridge (AS 3.10).</p> | |
| Floor | Tiled floor on concrete–black and white Greek key pattern margin, and white hexagonal body tiles. Added timber floor to reception desk and behind. | |
| Ceiling | Pressed metal ceiling with cornice. Pressed metal cleaned and repainted, rusted portions removed and replaced with panels identical to the original in 2022–24. | |

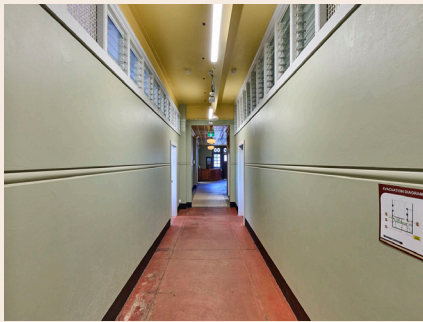
| Room / Item | Level 3 – Hall | |

| Doors and Windows | <p>Refer to individual rooms. High level opening along east-west corridor replaced with louvred (woven mesh parts remain), whilst along north south corridor, most glazing remained, broken ones replaced.</p> | |

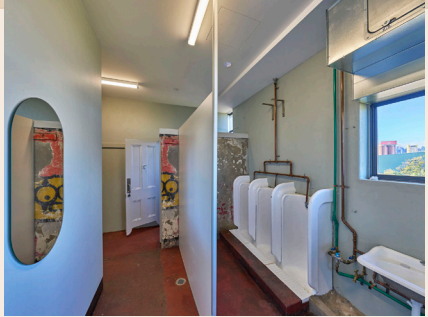
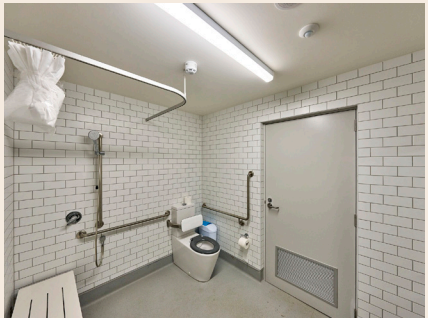
| Room No. | AS 3.6A-C | |

| Description | The Lavatory is located in the southeast corner of Level 3 of the Administration and Staff Accommodation. It contains a large shower space in its southwest corner as well as sinks, urinals, and a toilet cubicle with a bowl cistern. As part of the 2022–24 activation works, the space has been repurposed: the large shower space has been converted to a janitor’s closet (AS 3.6A), a male toilet (AS 3.6B), and a unisex accessible toilet (AS 3.6C). | <p>(courtesy of Chris Bennett: Evolving Picture, 2024)</p> |
| Floor | Concrete with scribed margins. A raised threshold in the southwest corner of the room to the shower area with drainage channels along the east and west walls, and a raised floor to the showers along the east wall of shower area. AS 3.6C: new vinyl flooring installed in 2022–24. | |
| Walls | AS 3.6A: tiling (white) to door head height on west wall, part of the north and south walls in the shower area. AS 3.6B: painted rendered masonry mostly. North wall new lightweight wall painted, separating AS 3.6B and AS 3.6C. Eastern side to urinals left unpainted showing remnants of graffiti. New lightweight cubicle partition giving privacy to urinals. AS 3.6C: white tiled walls. Walls repaired and repainted in 2022–24 works. | |
| Doors and Windows | New door opening for AS 3.6C on north wall. Steel framed windows replaced in 2022–24. High level windows on facing corridor AS 3.2 at AS 3.6 | |

| Other | New male bathroom, unisex accessible bathroom/shower, and janitor’s closet fitout installed in 2022–24. Existing urinals and basins reconditioned. | |

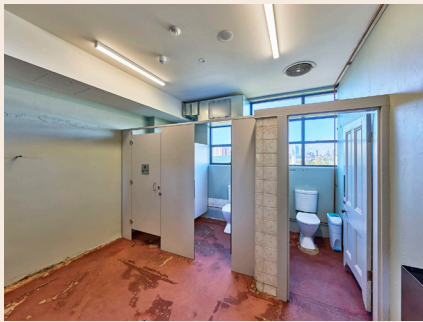
| Room / Item | Female Toilet (Former Foreman's Showers) | |

| Walls | <p>Rendered masonry. Tiling (white with light brown marbled pattern) to door head height at cubicle wall. Some existing tiles remained on eastern wall, most removed due to drumminess. Render repaired and repainted in 2022–24.</p> | |
| Doors and Windows | <p>Door opening on west wall and window opening on east wall (opening partially cut off by south wall). New door installed in 2022–24. Steel windows replacement in 2022–24. High level opening on western wall with frosted glass and woven wire mesh.</p> | |

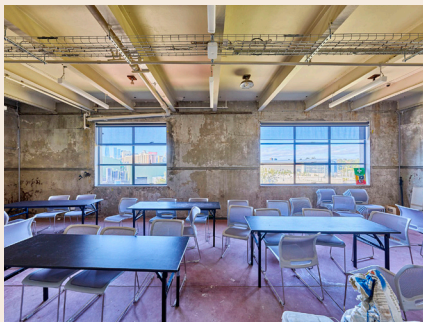
| Room No. | AS 3.8 | |

| Description | The Locker Room (north) is located in the northeast corner of Level 3 of the Administration and Staff Accommodation. It is accessed via the end of the Hall (AS 3.2), and housed the lockers used by the workers of the power station. | <p>(courtesy of Chris Bennett: Evolving Picture, 2024)</p> |
| Doors and Windows | Steel windows replaced on 2022–24, blinds installed. New door on south wall. | |

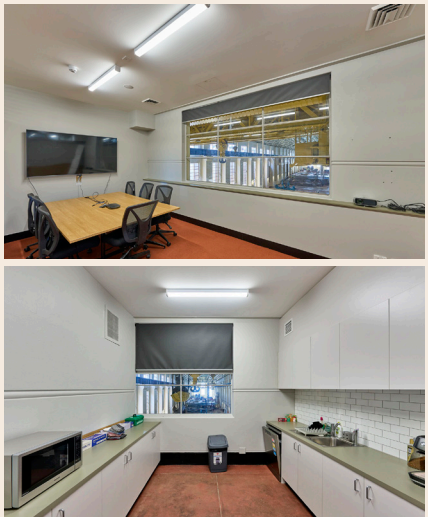
| Description | <p>The former Shift Engineers Room is located along the north wall of Level 3 of the Administration and Staff Accommodation. It is accessed via the Hall (AS 3.2) and in 2022-24 works, was divided into two separate spaces that were fitted out as a kitchen (AS 3.9A) and meeting room (AS 3.9B).</p> | |
| Doors and Windows | <p>AS 3.9A: door on south wall. Steel frame 9 pane window with steel I-beam through the middle on north wall. Window is partially cut off by west wall, only 6 panes are located within the space. Blackout blinds installed internally.</p> <p>AS 3.9B: doors on east wall and south wall. Steel frame 9 pane window overlooking Turbine Hall on north wall, panes repaired in 2022-24. Blackout blinds installed internally.</p> | |

| Other | <p>AS 3.9A: new kitchen fitout installed in 2022-24 comprising benches along the east and west walls, and overhead cabinetry on east wall.</p> <p>AS 3.9B: meeting room fitout.</p> | |

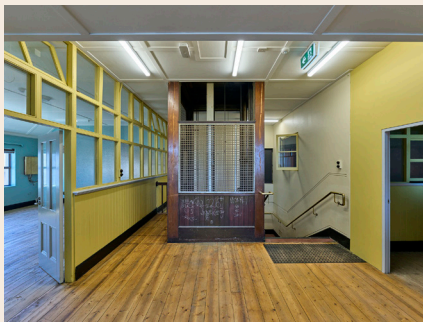
| Room / Item | Level 4 – Lift Lobby and Stair | |

| Doors and Windows | Timber 4 pane (upper two glazed) doors to majority of adjacent spaces – refer to individual room inventories. Repaired and repainted in 2022–24. New lock to doors. Steel frame 2 pane (continues into neighbouring AS 4.21) window. Timber casement 4 pane operable window on east wall above upper flight of stairs. Glazing to partitions elsewhere. New door on east wall to AS 4.2 installed in 2024. | |

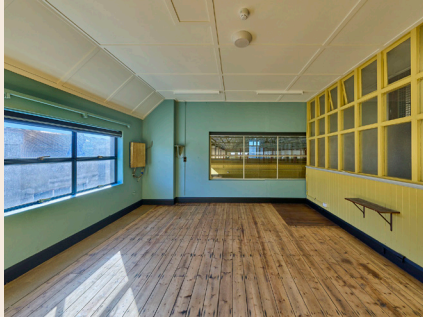
| Room / Item | Office 1 (Former Mechanical Super / Ass. Mech. Super) | |

| Floor | Existing flooring removed to deterioration, replaced with particle board. | |
| Doors and Windows | <p>4 panel half glazed door on east wall. Door repaired in 2022–24. Window opening on west wall. Works to install new steel frame windows are ongoing at the time of writing this report. Steel frame 6 pane window on north wall overlooking turbine hall. Replaced in 2022–24.</p> | |

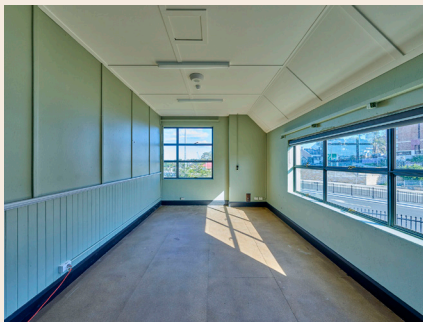
| Room No. | AS 4.4 | |

| Description | <p>The Powerhouse Superintendent 1 Office is located in the southwest corner of Level 4 of the Administration and Staff Accommodation building. It is accessed via the Lift Lobby and Stair (AS 4.1) area and was an office space used by the Powerhouse Superintendent. Activation works in 2022–24 have turned this space into an office again.</p> | <p>(courtesy of Chris Bennett: Evolving Picture, 2024)</p> |
| Floor | Existing floor replaced with particle board flooring in 2022–24. | |
| Doors and Windows | <p>Door opening at north end of east wall and window openings on west and south walls. New door installed in 2022–24. Steel windows replaced in 2022–24.</p> | |
| Other | <p>Distribution panel installed in 2022–24. Megawatt dials on northern wall missing.</p> | |

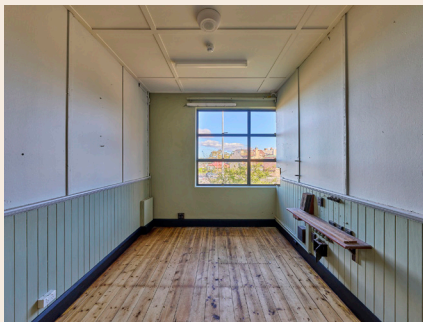
| Room / Item | Office 3 (Powerhouse Super 2) | |

| Doors and Windows | <p>4 pane half glazed timber door on north wall. Repaired, repainted, and new hardware installed in 2022–24. Window opening on south wall (continues east into AS 4.5). New steel frame windows installed.</p> | |

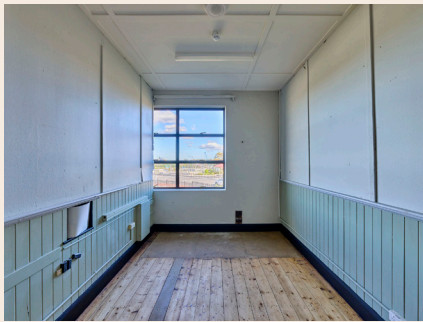
| Description | <p>The Timekeeper Room is located towards the west side of the south wall of Level 4 of the Administration and Staff Accommodation. It is accessed via the Lift Lobby and Stair (AS 4.1) to its north and was used by the power station's timekeeper as an office space. Activation works in 2022–24 have turned this space into an office again.</p> | |
| Floor | Existing timber flooring cleaned in 2022–24. | |
| Doors and Windows | <p>Door repaired, repainted, and new hardware installed in 2022–24. New steel frame windows installed in window opening on south wall in 2024.</p> | |

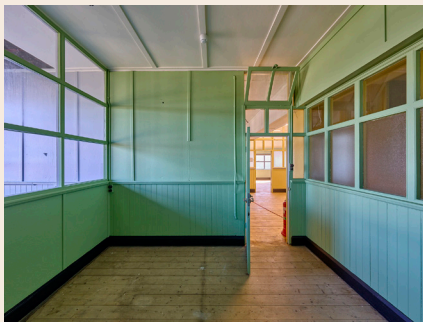
| Room No. | AS 4.7 | |

| Description | The Former Correspondence Records (North) is located along the south end of Level 4 of the Administration and Staff Accommodation. It is accessed via the Lift Lobby and Stair space (AS 4.1) and was used as an administrative space for keeping correspondence records of the powers station. | <p>(courtesy of Chris Bennett: Evolving Picture, 2024)</p> |
| Doors and Windows | 4 panel half glazed door on west wall with fanlight above. Door repaired, repainted, and new hardware installed in 2022–24. | |

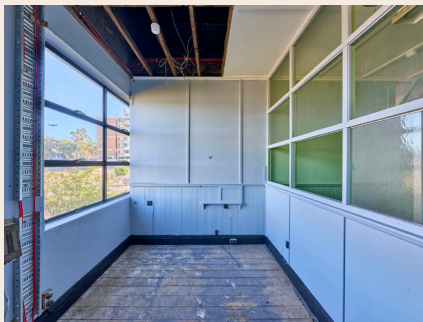
| Room No. | AS 4.8 | |

| Description | The Former Correspondence Records (South) is located along the south end of Level 4 of the Administration and Staff Accommodation. It is accessed via the adjacent Statistical room (AS 4.9) and was used as an administrative space for keeping correspondence records of the powers station. | <p>(courtesy of Chris Bennett: Evolving Picture, 2024)</p> |
| Doors and Windows | <p>Half glazed hollow core door on east wall.</p> <p>Steel frame 9 pane window on south wall (only 6 full panes visible, continues into adjacent AS 4.6). Windows replaced in 2022–24.</p> | |
| Other | <p>Small ledge and sliding hatch on west wall to adjacent space (AS 4.6). Similar-sized hatch on east wall.</p> <p>Telephone console panel on south wall.</p> | |

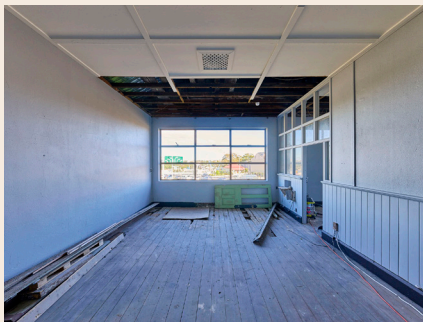
| Room / Item | Statistical | |

| Doors and Windows | Half glazed door on north wall (4 panel) and west wall. Steel frame 9 pane window on south wall. Windows replaced in 2022–24. Externally clad with clear corrugated polycarbonate. | |

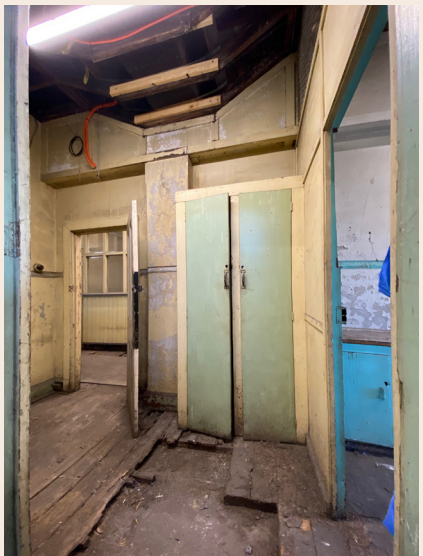
| Description | <p>The Lobby is located in the southeast area of Level 4 of the Administration and Staff Accommodation. It is accessed via the main Hall (AS 4.2) and connects to the Kitchenette (AS 4.12) and the Stores Officer Room (AS 4.11), with which it used to form one room.</p> | |
| | <p>Existing condition before work, 2022 (Design 5 – Architects)</p> | |
| Floor | Temporary particle board floor raised up over concrete floor, installed in 2022–24. | |

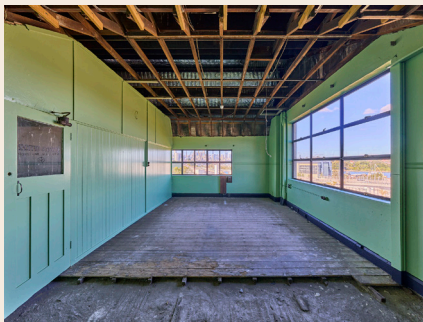
| Description | <p>The Stores Officer Room is located in the southeast corner of Level 4 of the Administration and Staff Accommodation. It is accessed via the small Lobby (AS 4.10) off from the main Hall and was used by the Stores Officer.</p> | |
| Floor | Timber tongue and groove floor on concrete. Rotted timber boards in the east section have been removed. | |
| Doors and Windows | <p>Timber door with higher glazed panel and three lower panels on north wall. Repainted in 2022-24.</p> <p>Steel frame window on east wall, 4 full panes visible (continues into neighbouring AS 4.12).</p> <p>Steel frame 9 pane window on south wall. Replaced in 2022-24.</p> | |
| Other | <p>Evidence of electric clock on north wall.</p> <p>Telephone outlet on east wall, multiple pipes on south at east end.</p> <p>Frame on east wall, likely for blackboard.</p> | |

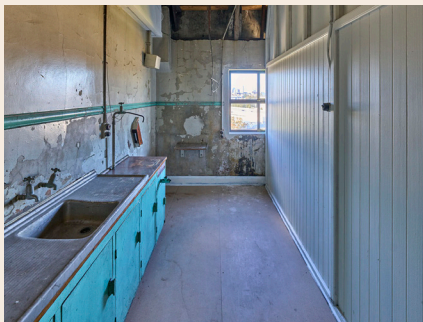
| Room / Item | Kitchenette | |

| Doors and Windows | <p>Ledged, boarded, and sheeted timber door on west wall.</p> <p>Steel frame window on east wall, two full panes visible, the rest cut off by south wall. Externally clad in temporary timber frame clear corrugated polycarbonate. Replaced in 2022–24.</p> | |
| Other | <p>Original kitchenette fitout with timber bench, sink and cupboards along almost full length of north wall.</p> <p>Small timber shelf on east wall.</p> | |

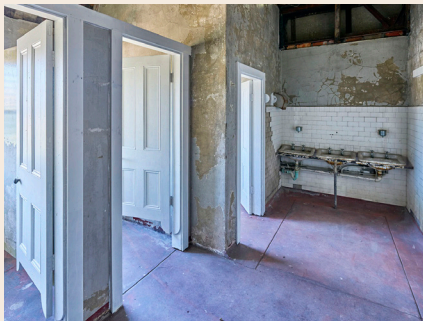
| Room / Item | Level 4 – Lavatory | |

| Doors and Windows | <p>4 panel timber door for entry on west wall and shower. 4 panel cubicle doors to three toilets. Steel frame 4 pane louvre window on east wall across shower and two toilet cubicles. Windows replaced in 2022–24.</p> | |

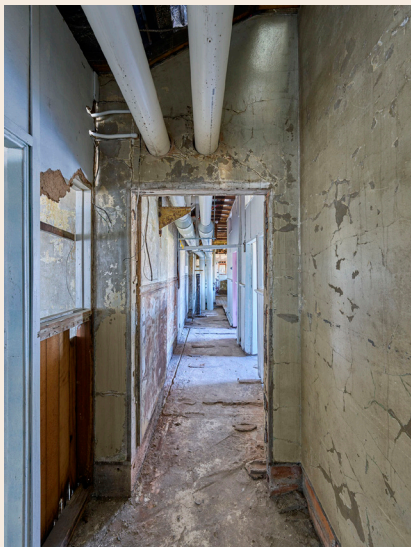
| Description | <p>The Lab Hall is a circulation space located in the northeast section of Level 4 of the Administration and Staff Accommodation. It is connected to and accessed via the main Hall (AS 4.2) and leads to the three lab spaces (AS 4.13–4.17).</p> |
| Floor | Concrete: removed timber tongue and groove flooring. |
| Walls | <p>North wall: timber and glass partition.</p> <p>East wall: painted timber partition wall with framing for glazing, glazing replaced with fibre cement panels. Hole in one panel for mechanical fan vent.</p> <p>South and west wall: rendered masonry wall with incised dado moulding.</p> |
| Other | Downpipes running along west wall. Downpipes and gutter replaced in 2022–24 works. |

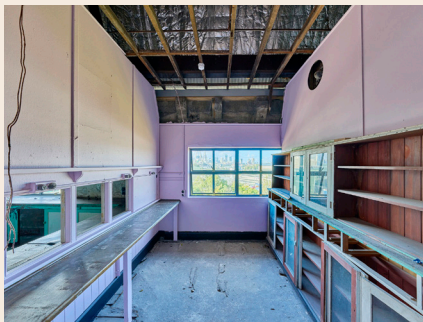
| Room No. | AS 4.16 | |

| Description | <p>Lab 2 is located in the northeast section of Level 4 of the Administration and Staff Accommodation. Similar to its larger Laboratory (AS 4.17) and its counterpart (AS 4.15), it was used for tests to ensure that the power station was operating at an optimal efficiency and output.</p> | <p>(courtesy of Chris Bennett: Evolving Picture, 2024)</p> |
| Floor | Concrete with evidence of removed timber tongue and groove flooring. | |
| Walls | <p>North wall: painted timber partition with row of glazing above bench and fibre cement panels above.</p> <p>East wall: painted rendered masonry with incised dado moulding.</p> <p>South and west walls: timber partitions with framing for glazing, glazing replaced with fibre cement panels. South wall has a mechanical vent fan, west wall has an opening for a mechanical vent fan (missing).</p> <p>Walls repainted in 2022–24.</p> | |
| Doors and Windows | <p>Timber 4 panel door on west wall.</p> <p>Steel frame window on east wall. Windows replaced in 2022–24.</p> | |
| Lighting | <p>Fluorescent light casing from ceiling. Light missing.</p> <p>New temporary lighting and catenary wires installed 2022–24.</p> | |

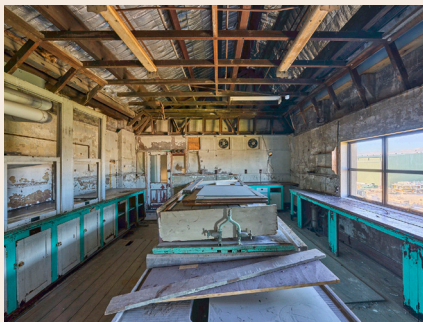
| Room No. | AS 4.17 | |

| Description | <p>The Laboratory is located in the northeast corner of Level 4 of the Administration and Staff Accommodation and is accessed via the Lab Hall (AS 4.14). It was used by the workers to conduct various tests, such as the testing of coal samples to ensure that the station was optimising its energy output through steam raising.</p> | <p>(courtesy of Chris Bennett: Evolving Picture, 2024)</p> |
| Floor | Timber tongue and groove floor on concrete. Rotted timber boards in the north section and southeast corner of the room have been removed. | |
| Doors and Windows | <p>Timber 4 panel door (half glazed) at west end of north wall connecting to former landing overlooking the Pump House).</p> <p>Steel frame 3 pane casement window on east wall, replaced in 2022-24.</p> | |
| Other | <p>Laboratory fitout with cupboards, drawers, sinks, and shelves.</p> <p>Large downpipes in southwest area of room, are a new replacement from 2022-24.</p> | |

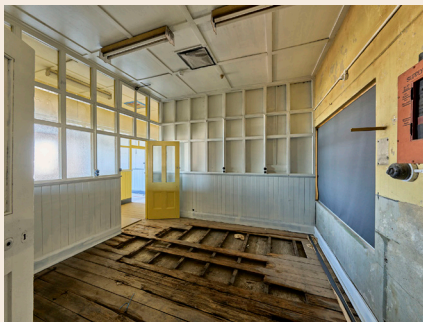
| Room No. | AS 4.18 | |

| Description | <p>The Assistant Engineers Room is located along the north end of Level 4 of the Administration and Staff Accommodation. It overlooks the neighbouring Turbine Hall to its north and was likely used by the Assistant Engineer of the power station as an office space.</p> | <p>(courtesy of Chris Bennett: Evolving Picture, 2024)</p> |
| Floor | Timber tongue and groove floor on concrete. Approximately half of the timber boards have been removed, mostly in the western half of the room. | |
| Lighting | <p>Fluorescent light casing from ceiling. Light missing.</p> <p>New temporary lighting and catenary wires installed 2022–24.</p> | |

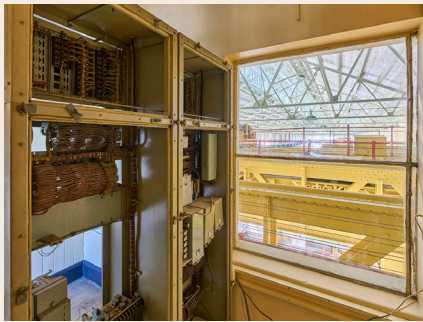
| Description | <p>The Stationery Store (North) is located along the north end of Level 4 of the Administration and Staff Accommodation. It houses an electrical box and switch gear, though its exact use is not known.</p> | |
| Floor | Timber tongue and groove floor on concrete. | |
| Lighting | <p>Fluorescent light casing from ceiling. Light missing. New temporary lighting and catenary wires installed 2022-24.</p> | |
| Other | Electrical box and switch gear. Conduits running along walls. | |

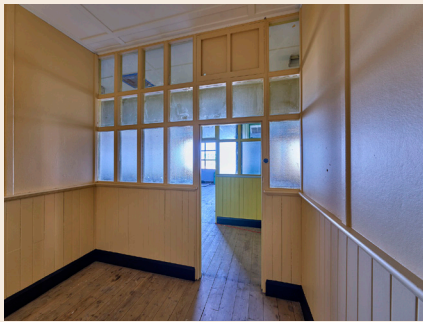
| Room / Item | Stationery Store (North) | |

| Doors and Windows | Timber 4 panel (top 2 panels frosted glass) door on south wall. Glazing on south wall partition: timber frame, combination of frosted glass (lower half) and clear glazing (upper half). | |
