WHITE BAY POWER STATION

CONSERVATION MANAGEMENT PLAN 2026

VOLUME 2 : HERITAGE INVENTORY – STRUCTURES, SPACES & ELEMENTS

**WHITE BAY POWER STATION CONSERVATION
MANAGEMENT PLAN 3RD EDITION**

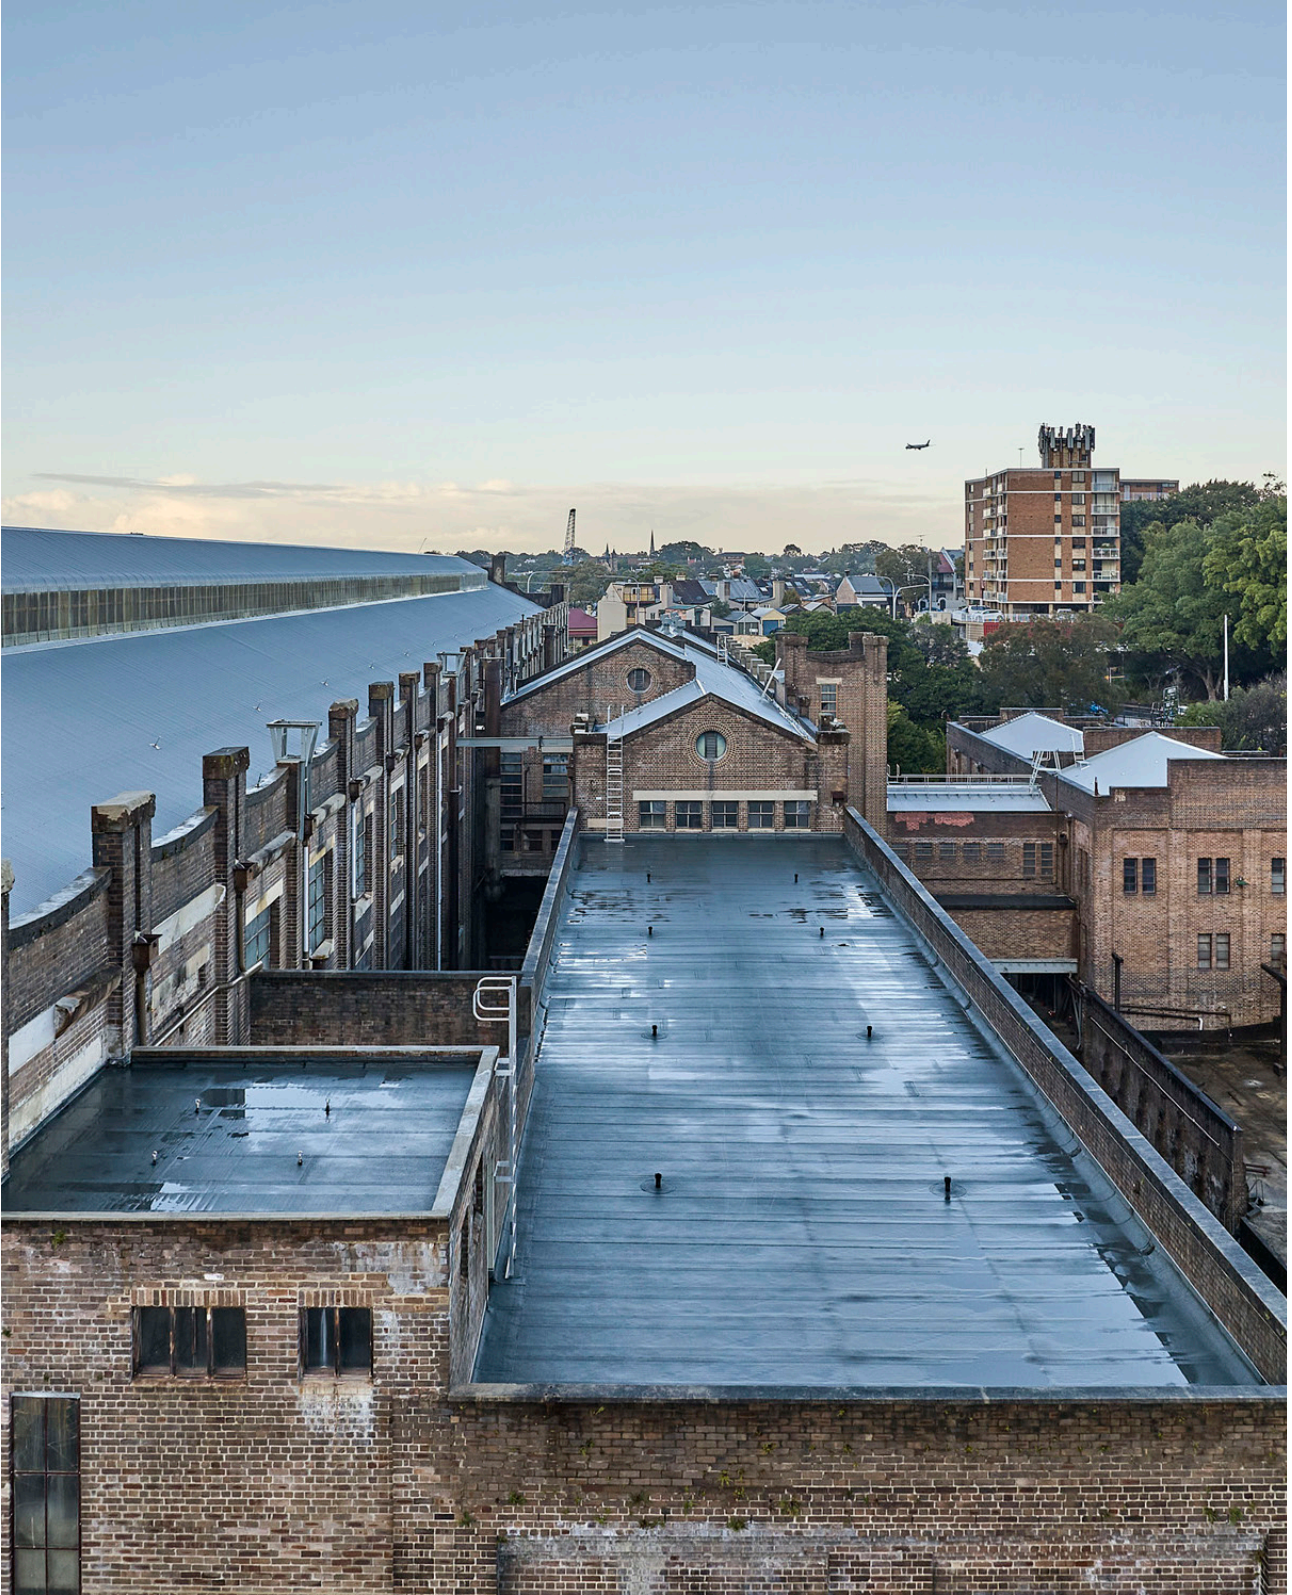
Figure 7.1 Switch House Roof from North, 2024 (courtesy of Chris Bennett: Evolving Picture)

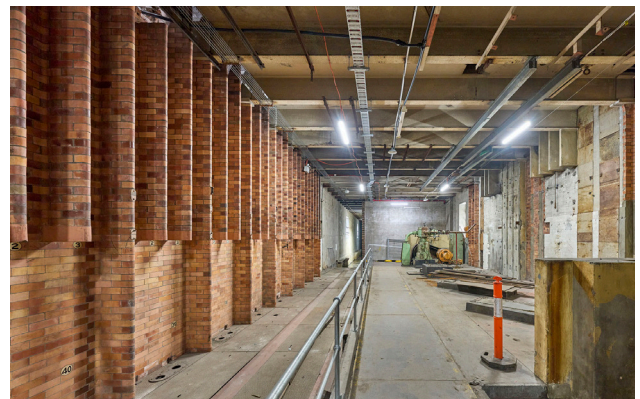
Running along the western side of these eight spaces is a narrow corridor (SH G.4A) that has walls of rendered masonry and a sunken floor. Following the decommissioning of the power station, this corridor was filled with water. The corridor continues (SH G.4B) into the northern section of the next space (SH G.5) and has brick cable channels along its west wall. The space it continues into houses a Broom & Wade air compressor, as well as concrete plinths that once supported extant equipment.

Figure 7.5 Switch House Ground Floor, SH G.5 looking north, 2024 (courtesy of Chris Bennett: Evolving Picture)

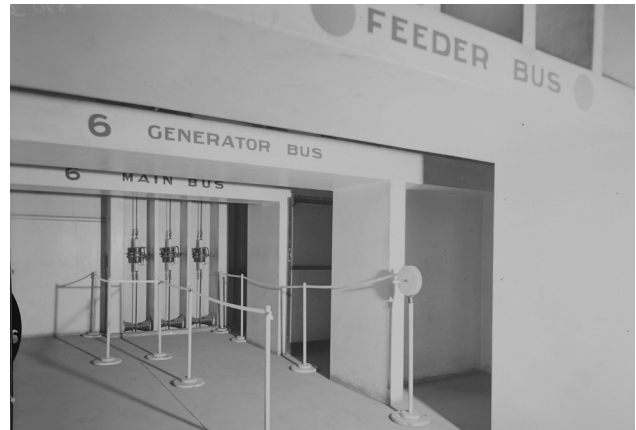
Level 1 of the Switch House is accessed by the lift and stairwell halfway along the western side of the building, and by the lift and stairwell in the northeast corner (SH 1.1A). The floor of this level is concrete, and the ceiling is concrete expressed timber planks with steel I-beams. South of this space is a small set of two connected rooms – the Electric Oil Filter Room with an extant electric oven, and the Inner Electric Oil Filter Room, which houses an elevated metal tank with a ladder screwed to its side. In the northern half of Level 1 is a series of Reactor Tie Spaces (SH 1.4 A–R), some of which retain a set of concrete footings arranged in a circle which once supported equipment and machinery. Each of these Reactor Tie Spaces – with the exception of the southernmost one (SH 1.4R) – have a pair of locked metal-framed steel mesh doors. Running along the northern half of the western side of the level is a narrow corridor (SH 1.3), with four evenly spaced metal-framed windows on the western wall. At the southern end of this corridor is a series of brick cable runs on the western wall, which have been partially sprayed with grey paint from a movie shooting. The space (SH 1.5) neighbouring these brick cable runs is enclosed by walls on its south, east, and west sides, the latter two of which have concrete cable runs.

Figure 7.6 Switch House Level 1 Bus Floor, 1964 (courtesy of ECNSW Archive, 05370D)

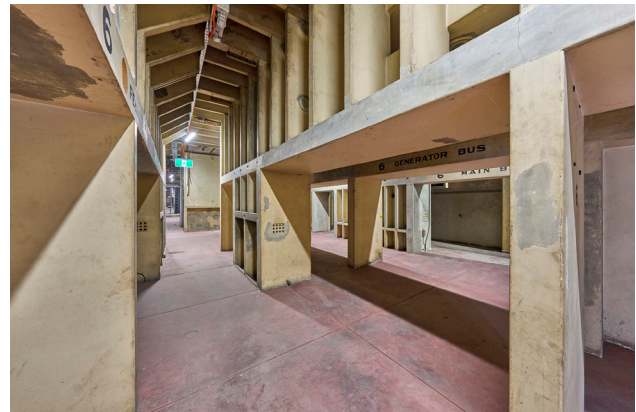
Figure 7.7 Switch House Level 1 Bus Floor, 2024 (courtesy of Chris Bennett: Evolving Picture)

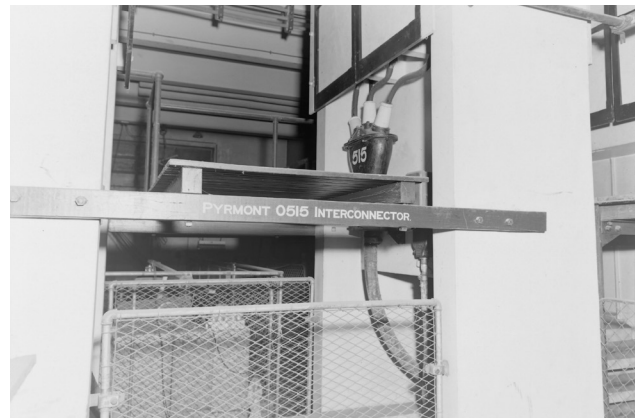
Figure 7.8 Switch House Level 1 cable groups, 1957 (courtesy of ECNSW Archive, 01029 White Bay 1)

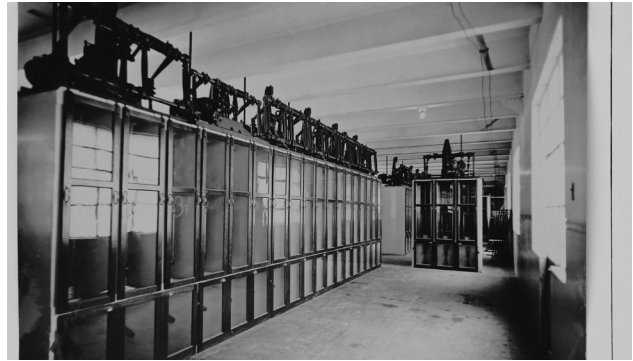
Figure 7.9 Switch House Level 2 cycle switches, date unknown, pre-1950s (courtesy of Railway Department Archive Photo Cards, 1693-105)

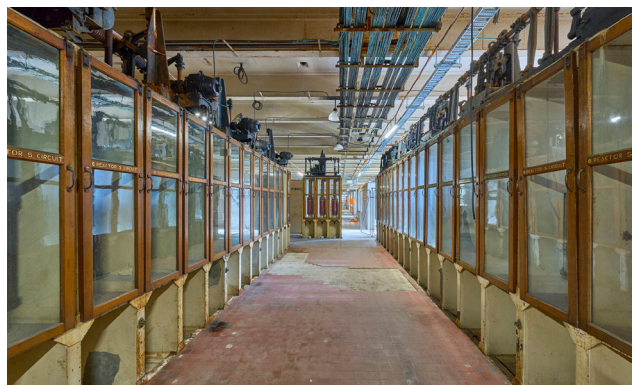
Figure 7.10 Switch House Level 2 cycle switches, 2024 (courtesy of Chris Bennett: Evolving Picture)

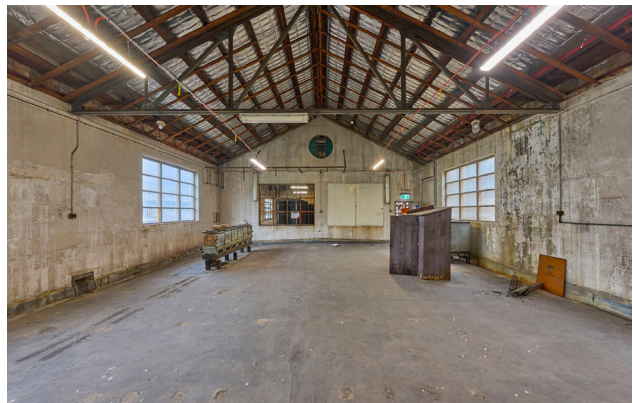
Figure 7.11 Switch House Level 3 battery room, 2024 (courtesy of Chris Bennett: Evolving Picture)

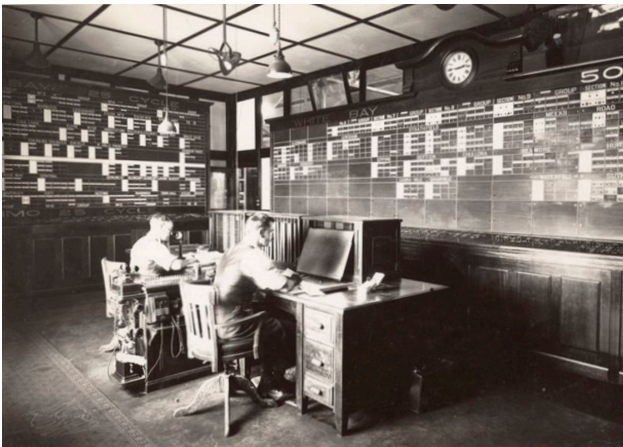
Figure 7.14 Trouble Room on Level 3 (SH 3.12), 1930 (courtesy of ECNSW Archive, 0363-069)

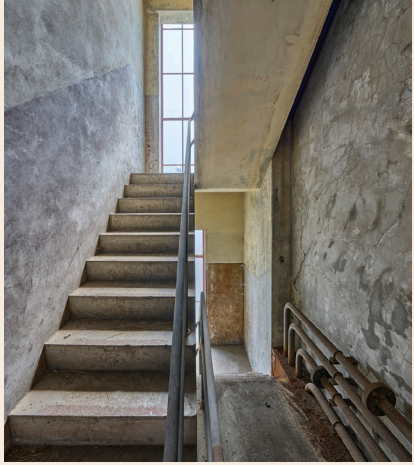
| Room / Item | Lift and Stairwell (North) | |
|---|---|--|
| Description | <p>The lift and stairwell provide access to all floors of the Switch House and are located in the northeast corner of the building.</p> | |
| Floor | Concrete stair set within steel frame structure. | |
| Other | <p>Small brick enclosure at SH G.1 used to be electrical Foremans Office. Sink remains, niche on eastern wall used to be cupboard.</p> <p>Tubular steel handrail to stair.</p> <p>Conduits running along walls around Level 2 and 3 of the stairwell.</p> <p>Pipes along stairwell at Level 1.</p> | |

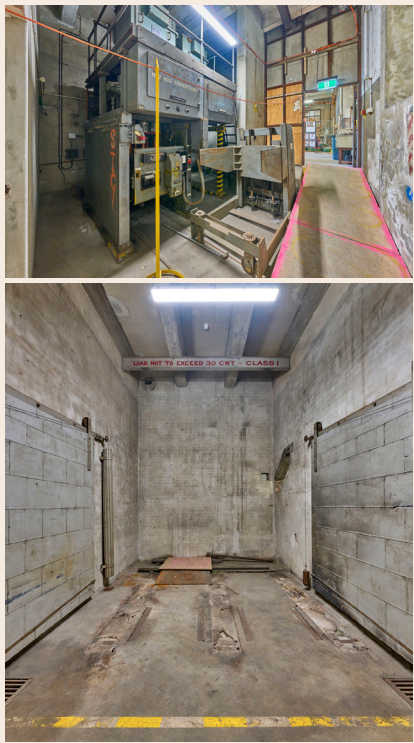
| Description | <p>The series of adjacent spaces connected by openings along the eastern end are located in the north half of the Ground Floor of the Switch House. The first (northmost) of the spaces houses the switches for the No. 2 Auxiliary Transformer, and the second houses the switches for the Bus Bar Circuit Breaker. The remaining six spaces are empty but have channels and grooves that indicate they once housed similar machinery.</p> | |
| Doors and Windows | <p>Timber door at east end of north wall of SH G.3A. Between each space: metal-clad sliding fire doors on suspended rollers. Between SH G.3F and SH G.3G: single metal-clad timber door on west wall connecting to SH G.4A. Steel frame wire mesh door on south wall of SH G.4H. Varying number of windows along east wall of each space: all 4 panes high, some running into partition walls (evidence of walls being a later addition), some fixed, some operable with either wired or frosted glass. With the exception of the windows in SH G.3A and B, all other windows are externally clad with timber frame corrugated clear polycarbonate.</p> | |

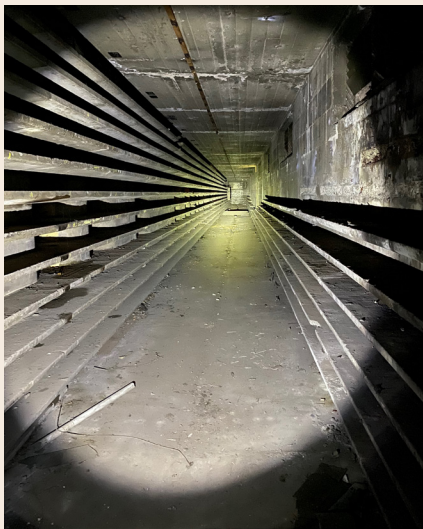
| Description | <p>The Cable Tunnel is located in the south half of the exterior of the Ground Floor of the Switch House. It travels along the south and west walls of the Switch House main building, and once housed vast number of cables that carried electricity throughout the power station.</p> | |
| Doors and Windows | Single metal door to the cable tunnel located at the north end on the west wall of Switch House, and another at southern end of Turbine Hall. Some high level openings and timber framed louvers, bricked up from outside, on Switch House western side. | |

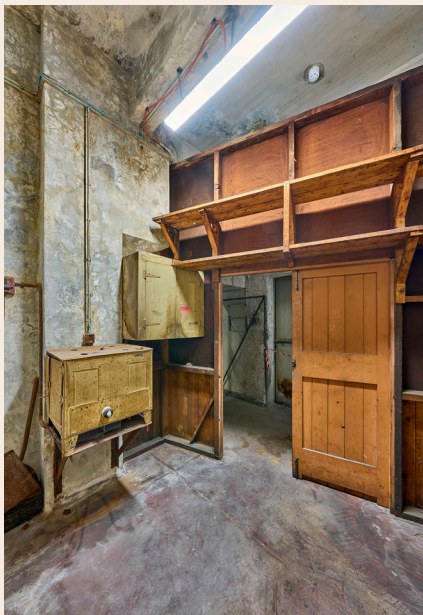
| Description | <p>The Electric Oil Filter Room is a small room located in the northeast corner of Level 1 of the Switch House. It is accessed via the small lobby from SH 1.1A to its north and houses various shelves and storage cabinets.</p> | |
| Floor | Concrete with scribed margins. | |
| Doors and Windows | North wall: framed and ledged timber double doors. South wall: steel framed, figured, and frosted windows, seven wired panes, 12 panes in total. | |

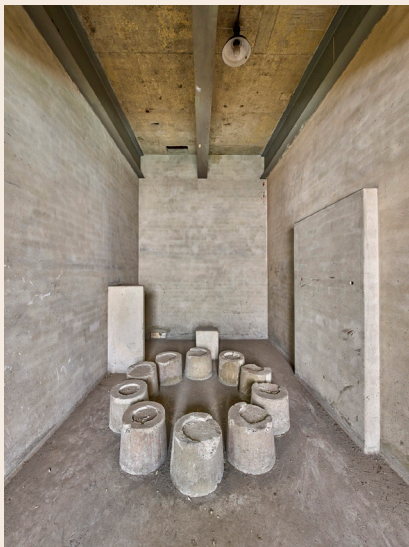
| Description | <p>The Reactor Tie Spaces are a series of 18 rooms located in the north half of Level 1 of the Switch House. They once housed the reactor ties on concrete footings (extant in most spaces) and are accessed by the corridor to their east (SH 1.2).</p> | |
| Doors and Windows | Each space has a set of woven steel mesh double doors fitted with security locks, except for SH 1.4R, which is missing its doors. | |

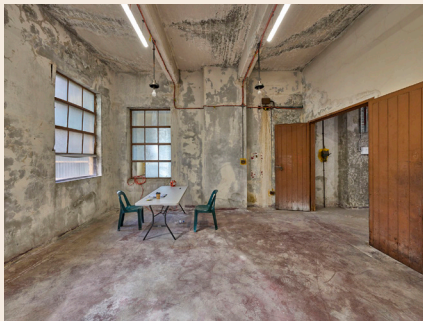
| Description | <p>The room is located at the northeast corner of Level 2 of the Switch House. It is accessed via the lobby from the lift and stairwell in the northeast corner (SH 2.1), and it used to be High Voltage Testing Room.</p> | |
| Doors and Windows | <p>Timber double doors on north wall: framed and ledged.</p> <p>Two windows on south wall: both formerly steel framed with frosted panes (some wired), 12 pane. West window retains original window with lower row of panes replaced with acrylic (east has window removed), and both openings are externally clad with timber frame clear acrylic.</p> <p>West wall: steel frame figured frosted (some wired) window, 12 pane.</p> | |
| Lighting | <p>Former pendant lights hanging from ceiling, dish shades missing.</p> <p>New temporary lighting and catenary wires installed in 2022–24.</p> | |

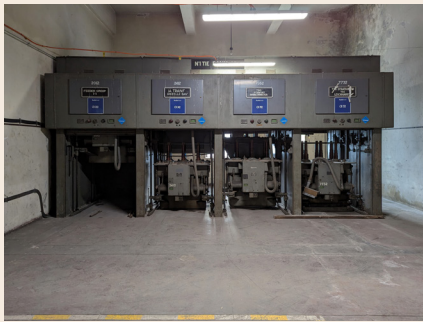
| Room No. | SH 2.3 | |

| Doors and Windows | East and south wall: weighted sliding timber door with metal cladding and pulley system. West wall: two steel frame, figured, frosted and wired pivot windows, 12 pane. | |

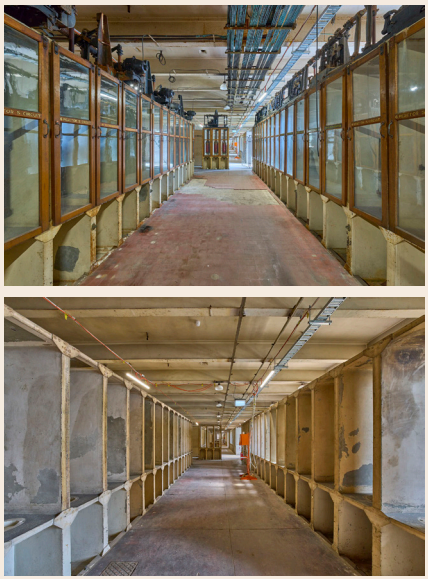
| Room No. | SH 2.6–2.10 | |

| Description | <p>These spaces make up the south half of Level 2 of the Switch House. They once housed a full set of the cycle switches, though only some remain in SH 2.6.</p> | <p>(courtesy of Chris Bennett: Evolving Picture, 2024)</p> |
| Floor | Scribed concrete to SH 2.7–2.8. Red tiling to SH 2.6, 2.9 and 2.10. | |
| Doors and Windows | <p>East wall: nine steel frame figured and frosted windows, 12 pane. Every second window has a door leading to walkway overlook-ing Transformer Alley (TA2).</p> <p>West wall: ten evenly spaced steel frame figured and frosted windows, 12 pane. Framed and ledged double doors at north end of west wall to stairwell (SH 2.11) with fanlight. Recessed steel frame frosted fig-ured (some wired) fixed window, 8 pane, near door.</p> <p>South: two steel frame figured and frosted windows, 12 pane. Windows externally clad with timber frame clear corrugated polycarbonate.</p> | |

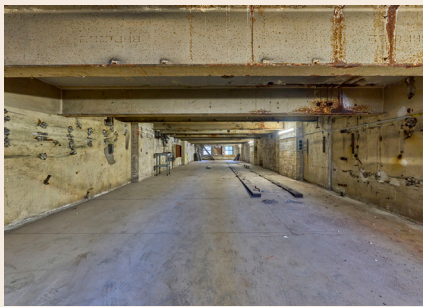
| Room No. | SH 2.12 | |

| Description | <p>The mezzanine space is located at the middle of Level 2 of the Switch House. It is accessed via stairs from the Control Room on the floor above (SH 3.13), hangs over the middle of the Transformer Alley and is separate from the rest of Level 2.</p> | <p>(courtesy of Chris Bennett: Evolving Picture, 2024)</p> |
| Floor | Concrete, slopes down towards south side. Steel chequer plates covering openings and patches in the floor. Lengths of timber embedded in floor (running north-south) with protruding metal fixtures indicative of former placement of equipment. | |
| Doors and Windows | <p>North wall: three steel frame, figured and frosted pivot windows, 4 pane. Middle window removed and opening boarded up.</p> <p>South wall: steel frame figured and frosted pivot window, 6 pane.</p> <p>All windows externally clad with timber framed clear corrugated polycarbonate.</p> | |

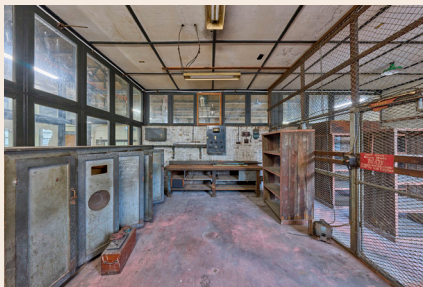
| Room No. | SH 3.12 | |

| Description | <p>The room is located near the middle of Level 3 of the Switch House along the west wall. It is accessed via a corridor from the Control Room (SH 3.13). The space contains a wire mesh caged area and was likely used as a storage and workshop space. It was a Trouble Room before the construction of the 1948 Control Room and Switch House.</p> | <p>(courtesy of Chris Bennett: Evolving Picture, 2024)</p> |

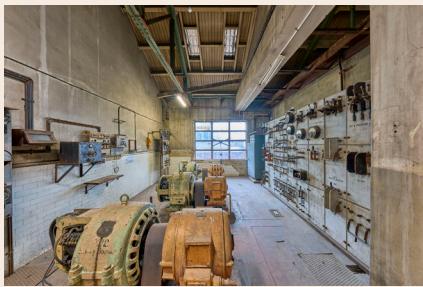
| Room No. | SH 3.14 | |

| Description | The Motor-Generator Switch Room is located in the southern half (towards the middle) of Level 3 of the Switch House. It houses vast amounts of switch house machinery and equipment, including the generators and switchboards. It is accessed via the Control Room (SH 3.13) and leads to the Battery Workshop (SH 3.15). | <p>(courtesy of Chris Bennett: Evolving Picture, 2024)</p> |
| Floor | Painted concrete with steel checker plates near machinery covering cable trenches. | |
| Machinery | Motor-Generator No. 3 (8.3) Motor-Generator No. 4 (8.4) Battery Charger Unit (Mercury Arc Rectifier) (8.5) No. 1 Battery Booster (8.6) Rectifier Sets 1 and 2 (8.7) Switchboard (marble) in Motor-Generator Room (8.8) Switchboard in Motor-Generator Room (8.13) Battery Charging Switchboard (8.14) | |

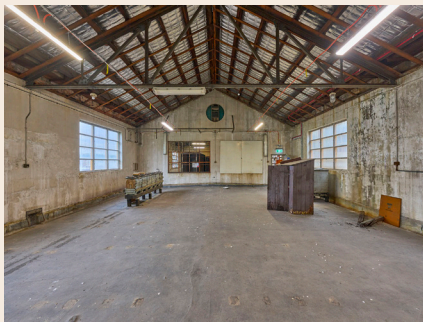
| Description | <p>The Battery Room is located in the southern section of Level 3 of the Switch House. It was part of the 1952 additions made to the Switch House and was used to store batteries, of which only six remain in the room (51–56).</p> | |
| Floor | Concrete, lead cover removed in 2022–24. | |

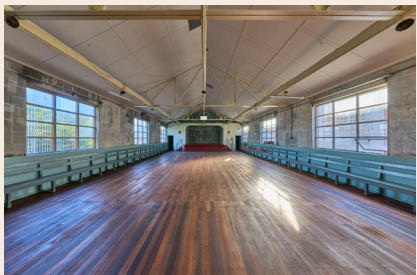
| Room No. | SH 3.18 | |

| Description | <p>The Entertainment Hall was a place of relaxation, recreation and entertainment for the workers and staff of the White Bay Power Station. It was constructed in late 1952 as part of the new floor addition to the Switch House. The hall is accessed via the Victoria Road Access Bridge (AS 3.10) and is separate from the rest of Level 3 of the Switch House.</p> | <p>(courtesy of Chris Bennett: Evolving Picture, 2024)</p> |
| Floor | Tongue and groove timber boards. Existing boards were cleaned, sanded, patched, and repaired; deteriorated boards replaced in 2022–24. | |

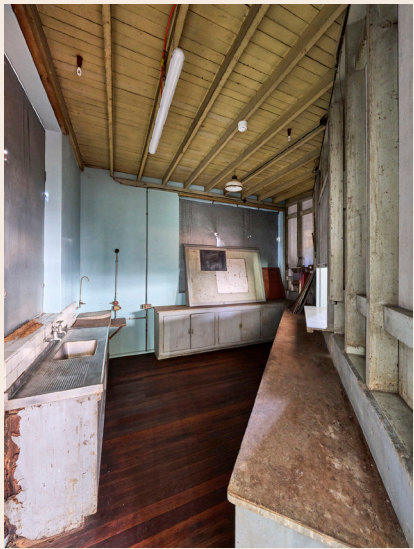
| Description | <p>The Entertainment Hall Kitchen provided food and kitchen amenities to the workers. It was constructed in late 1952 as part of the new floor addition to the Switch House.</p> <p>Like the rest of the Entertainment Hall, extensive restoration works were required during 2022–24 due to severe damage and droppings from pigeons.</p> | |
| Floor | Tongue and groove timber boards. Boards were cleaned, sanded, patched, and repaired in 2022–24. | |

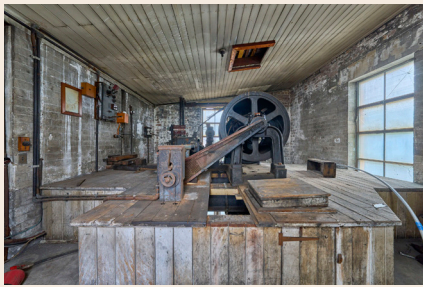
| Room No. | SH 4.1 | |

| Description | The Lift Overrun is located in the northeast corner of the Switch House Level 4. It is a small room on top of the lift and accessed through via the ladder on SH 3.11 on the north east side. It houses the elevator machinery that sits on top of timber platform in the middle of the space. | |

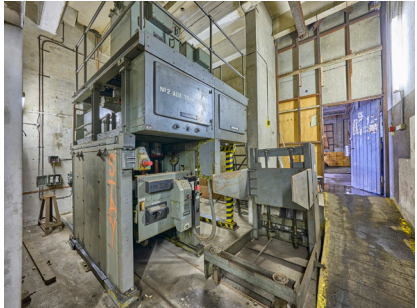
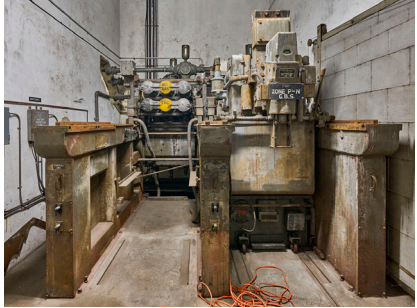
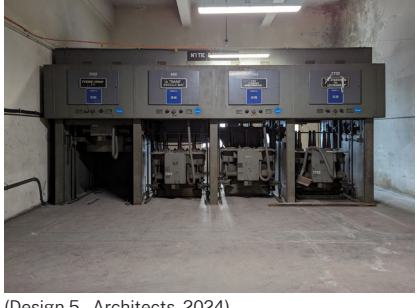
| Machine / Ref. | Motor-Driven Oil-bath Switches–6.4 | |

| Description | <p>The Motor-Driven Oil-bath Switches include the Transformer and Oil Circuit Breaker Switches, the Tie Bank Group, and the Bus Bar Circuit Breaker.</p> <p>Significance</p> <p>The Motor-Driven Oil-bath Switches are an integral part of the Power Reticulation System. They are representative of mid-twentieth century electrical control, metering, and distribution equipment. They are also representative of technological developments in the supply of electricity in the first half of the twentieth century.</p> | (courtesy of Chris Bennett: Evolving Picture, 2024) |

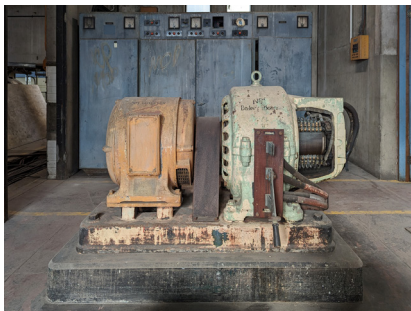
| Machine / Ref. | Motor-Generator No. 2 – 8.2 a | |

| Description | <p>The Motor-Generator No. 2 is the largest of the Motor-Generators at White Bay Power Station.</p> <p>Significance</p> <p>The Motor-Generator No. 2 is an integral part of the House Electrical and Auxiliary Supply System. It is among the oldest items in the power station, and evidences early electrical power technology with DC generated via an AC motor. It is also representative of early manufacturing technology.</p> | |

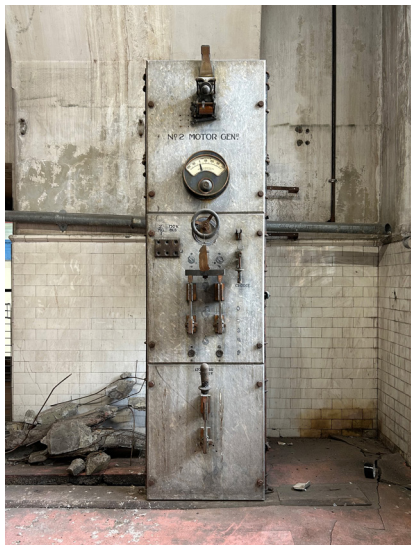
| Machine / Ref. | Motor-Generator No. 2 Switchboard – 8.2 b | |

| Description | <p>The Motor-Generator No. 2 Switchboard controlled Motor-Generator No. 2 and is located in the former Control Room.</p> <p>Significance</p> <p>The Motor-Generator No. 2 Switchboard is an integral part of the House Electrical and Auxiliary Supply System. It is representative of the influences of English technology and engineering design.</p> | |

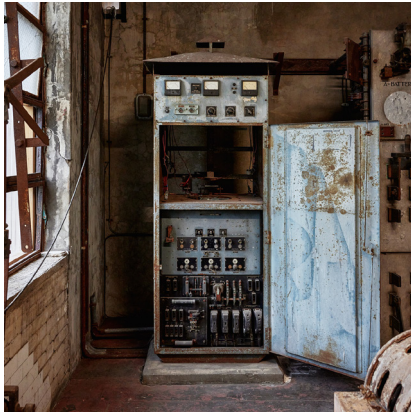
| Machine / Ref. | Battery Charger Unit (Mercury Arc Rectifier) – 8.5 | |

| Description | <p>The Battery Charger Unit (Mercury Arc Rectifier) comprises a rectifier cabinet that charged and modified the electrical current of the Batteries.</p> <p>Significance</p> <p>The Battery Charger Mercury-Arc rectifier is an integral element of the House Electrical and Auxiliary Supply System. It is representative of English technology and engineering and has particular and impressive aesthetic qualities.</p> | |

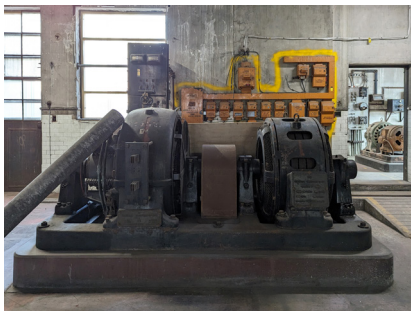
| Machine / Ref. | No. 1 Battery Booster – 8.6 | |

| Description | <p>The No. 1 Booster is an integral part of the Electricity Supply + Auxiliary Systems. It was used to boost the current from the Batteries for the house system.</p> <p>Significance</p> <p>The No. 1 Battery Booster is an integral part of the House Electrical and Auxiliary Supply System.</p> | |

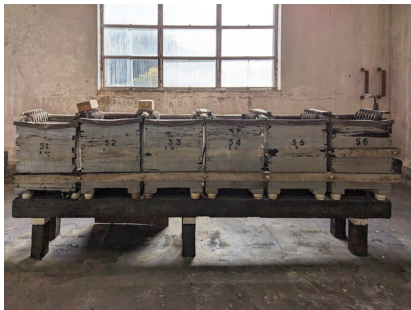
| Machine / Ref. | Batteries – 8.9 | |

| Description | <p>The Batteries are lead-acid Wet Cells. There are six open-celled batteries (51–56) remaining in the Battery Room, each lead-lined and wooden-framed.</p> <p>Significance</p> <p>The Batteries are an integral part of the House Electrical and Auxiliary Supply System. They evidence the need for an emergency supply of power and the remaining wet cells illustrate the method by which electrical power was stored in the early twentieth century.</p> | |

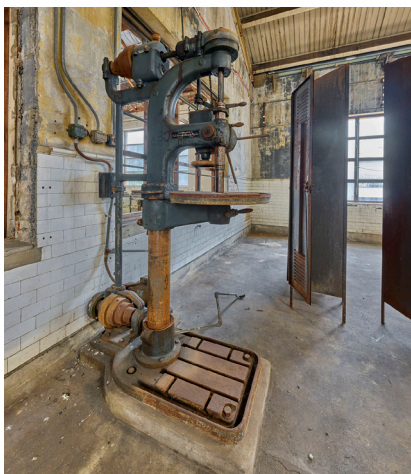
| Machine / Ref. | Pedestal Drill – 8.10 | |

| Description | <p>The Pedestal Drill is a precision instrument located in the Battery Workshop. It was manufactured in Australia prior to 1920.</p> <p>Significance</p> <p>The Pedestal Drill is evidence of the need of an in-house workshop. It is representative of a class of power tools which could be powered by a standalone motor or a lineshaft belt.</p> | |

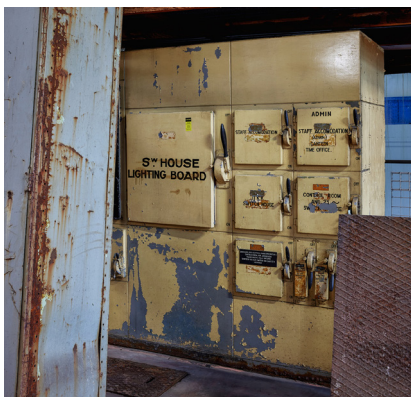
| Machine / Ref. | Switch House Lighting Board – 8.12 | |

| Description | <p>The Switch House Lighting Board distributed regular and emergency power supply to the Switch House.</p> <p>Significance</p> <p>The Switch House Lighting Board is an integral part of the House Electrical and Auxiliary Supply System. It is representative of mid-twentieth century power board technology.</p> | |

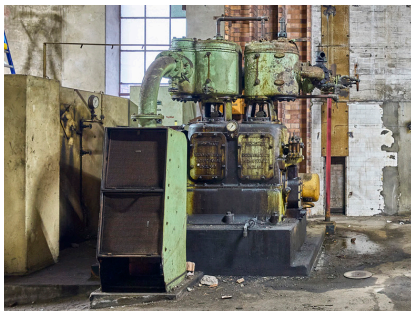
| Machine / Ref. | Air Compressor – 8.15 | |

| Description | <p>The Air Compressor produced compressed air to power switching devices in high temperature environments.</p> <p>Significance</p> <p>The Air Compressor is an integral part of the House Electrical and Auxiliary Supply System. It is representative of air compressors used in power stations during the twentieth century.</p> | |

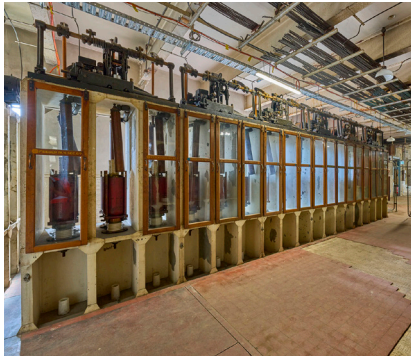
| Machine / Ref. | 50 Cycle Switches – 8.16 | |

| Description | <p>The 50 Cycle Switches are motor-driven oil-bath switches that run vertically and were used during the earlier period of electricity production at White Bay. The 50 Cycle Switches found in the Switch House are associated with the earlier period of electricity production at White Bay.</p> <p>Significance</p> <p>The 50 Cycle Switches are an integral part of the House Electrical and Auxiliary Supply System. They provide information on the operation of early tramway electrical systems and are representative of motor-driven and manual oil-immersion switches.</p> | |

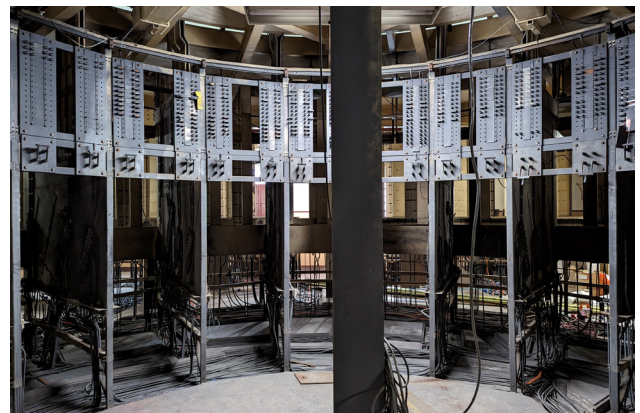
Level 1 of the Control Room Building is an L-shaped level that is accessed via the southeast staircase and from doors leading from the outside area of the site into the Cable Room. It comprises a concrete floor, a concrete slab ceiling supported by steel I-beams, and rendered masonry walls. The Cable Room (CS 1.1) is located in the northwest section of the floor and houses an extensive series of cables and switchboards. The room has an operating desk near its centre, and the switchboards and frames with cables affixed to them arranged in a radial, semi-circular arrangement towards the west of the desk. Parallel to the western wall are two rows of steel frames and boards with cables fixed to them. The floor comprises several cable trays carved out of

Figure 8.5 First Floor Cable Room, 2024 (Design 5 - Architects)

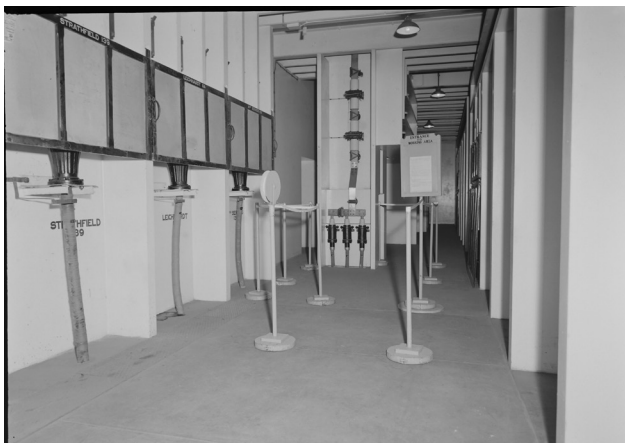
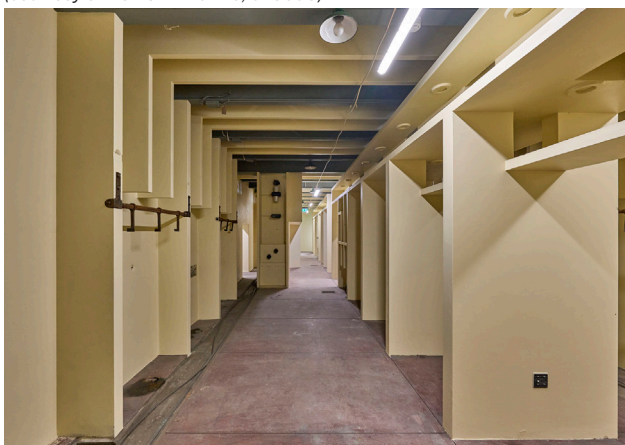
Figure 8.7 First Floor Bus Floor (CS1.2) with white taping method, 1958 (courtesy of ECNSW Archive, 02360C)

Figure 8.8 First Floor Bus Floor (CS1.2), 2024 (Design 5 – Architects)

Separate to this northern section of Level 1 and south of the Cable Room are the East and West Bus Floors (CS 1.2). The Bus Floor is accessed via the southeast stairwell, which has a woven wire cage around it. Throughout the bus floors are corridors of concrete boxings and cut multi-cable as well as painted labelling noting the different electricity distribution areas.

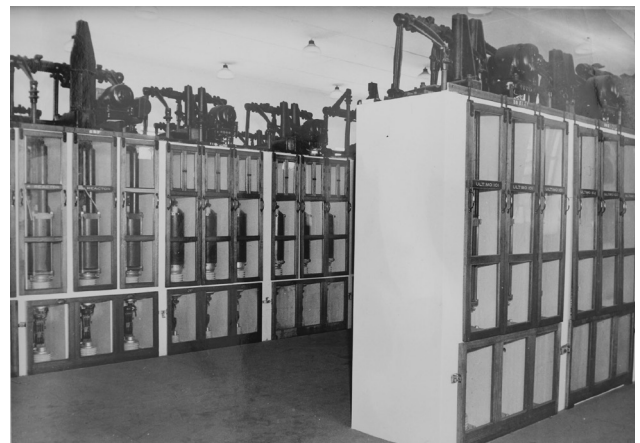
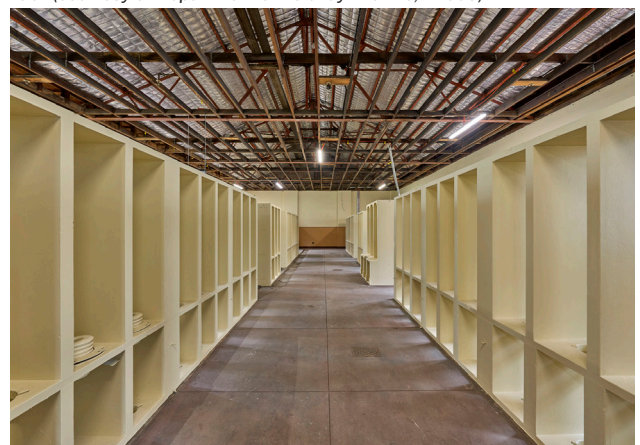
Figure 8.9 Second Floor Switch Floor (CS2.2) with oil circuit-breakers, 1951 (courtesy of Department of Railway Archive, E2603)

Figure 8.10 Second Floor Switch Floor (CS2.2), 2024 (Design 5 – Architects)

west, and south walls, and all walls have been painted. The fibre cement sheeting that once lined the ceiling has been removed, exposing the timber trusses and underside of the insulated gabled roof. In line with some of the housing boxes are cable trays that are flush with the floor and have steel plate covers. The 25 Cycle Switch Floor has an opening at the north end of the western wall which leads to a Passage (CS 2.4). This space protrudes from the main volume of the Control Room Building and connects to the main Passage from the Switch House (CS 2.3). At the southern end of its eastern wall is a boarded pair of timber doors with a beam protruding from just below the lintel – likely used to hoist up equipment directly to Level 2 from the Southwest Yard below. Further north is another door that opens onto an outdoor balustraded concrete platform adjacent to the Link Building. This platform has a set of steel-framed stairs along its southern side which connects down to Switch House Level 1 Cable Tunnel Roof. North of these stairs is a ladder leading to the roof of the Link Building, which also has a ladder along its south that leads to the roof of the Control Room Building.

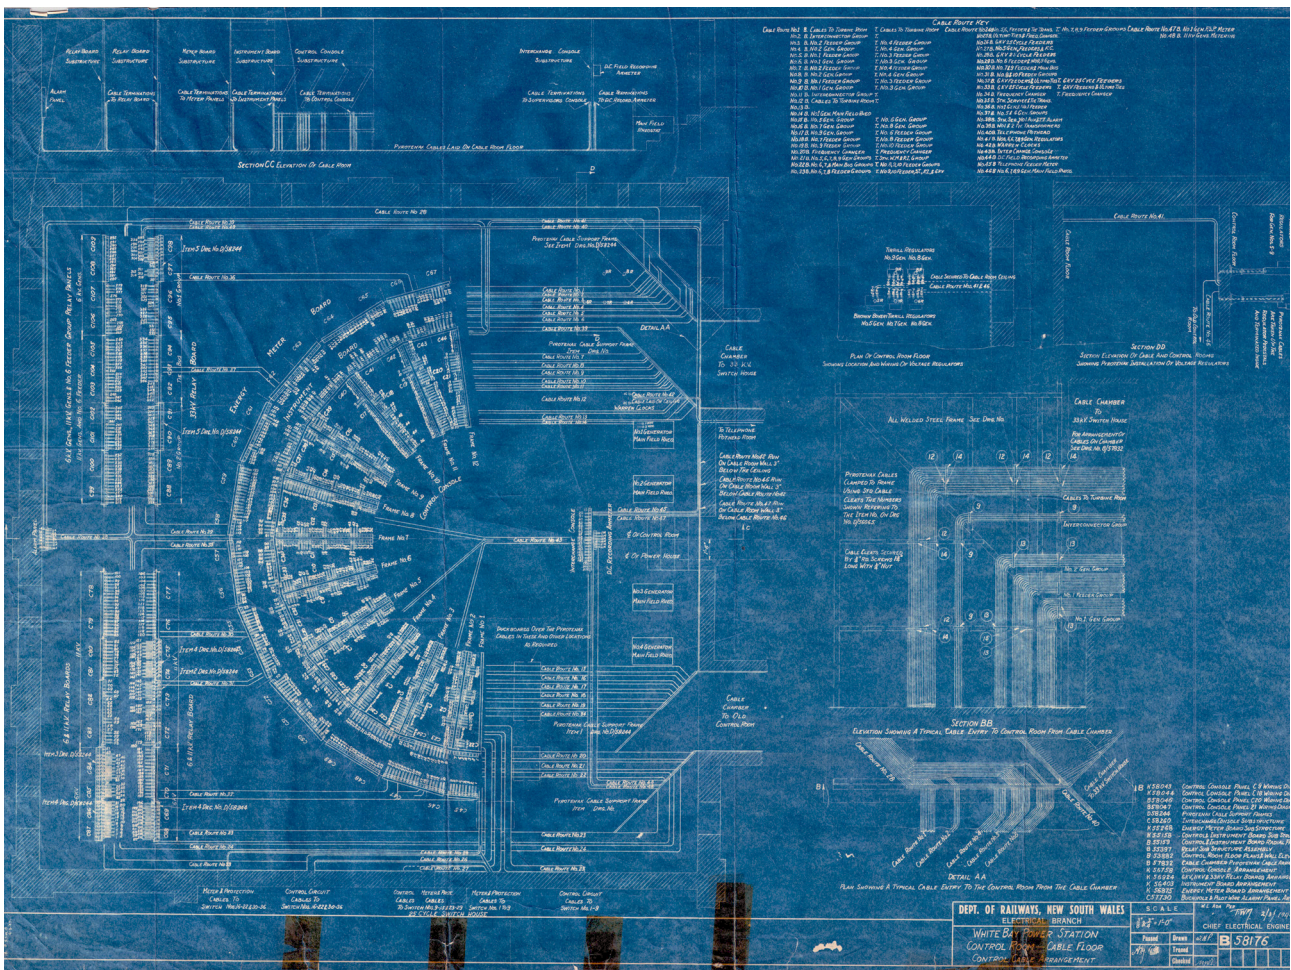
Figure 8.11 Archival drawing of First Floor Cable Floor cable arrangement, 1949 (courtesy of PMNSW archive, 12163)

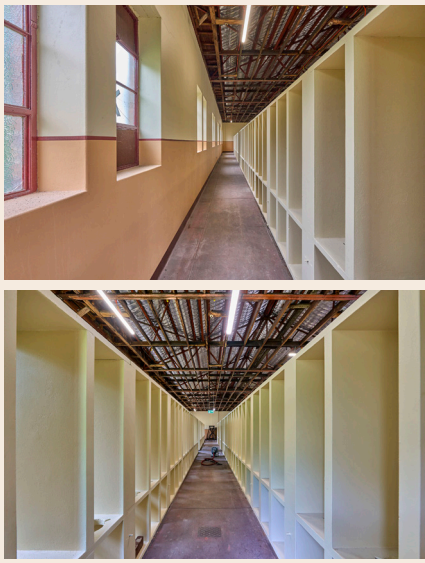
| Room / Item | 25 Cycle Switch Floor | |

| Ceiling | Southeast stairwell: woven mesh wire to north side with painted red steel framing. Timber battens and underside of building roof: corrugated galvanised steel and sarking supported by steel trusses. Original fibre cement sheets were removed in 2022–24 due to water damage. | |
| Doors and Windows | Steel frame woven wire door to stairwell at southeast corner of the Bus Floor East. Blue door frame (doors missing) at north end of east wall. Steel framed 4 pane pivot windows (two middle panes pivot) with figured (and some wired) glass: five pairs on east wall, three on south wall, six pairs on west wall. | |

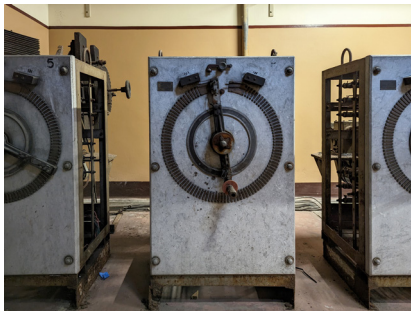
| Machine / Ref. | Rheostats – 6.2 | |

| Location | Rheostat Room (CS 1.4) | <p>(Design 5 – Architects)</p> |

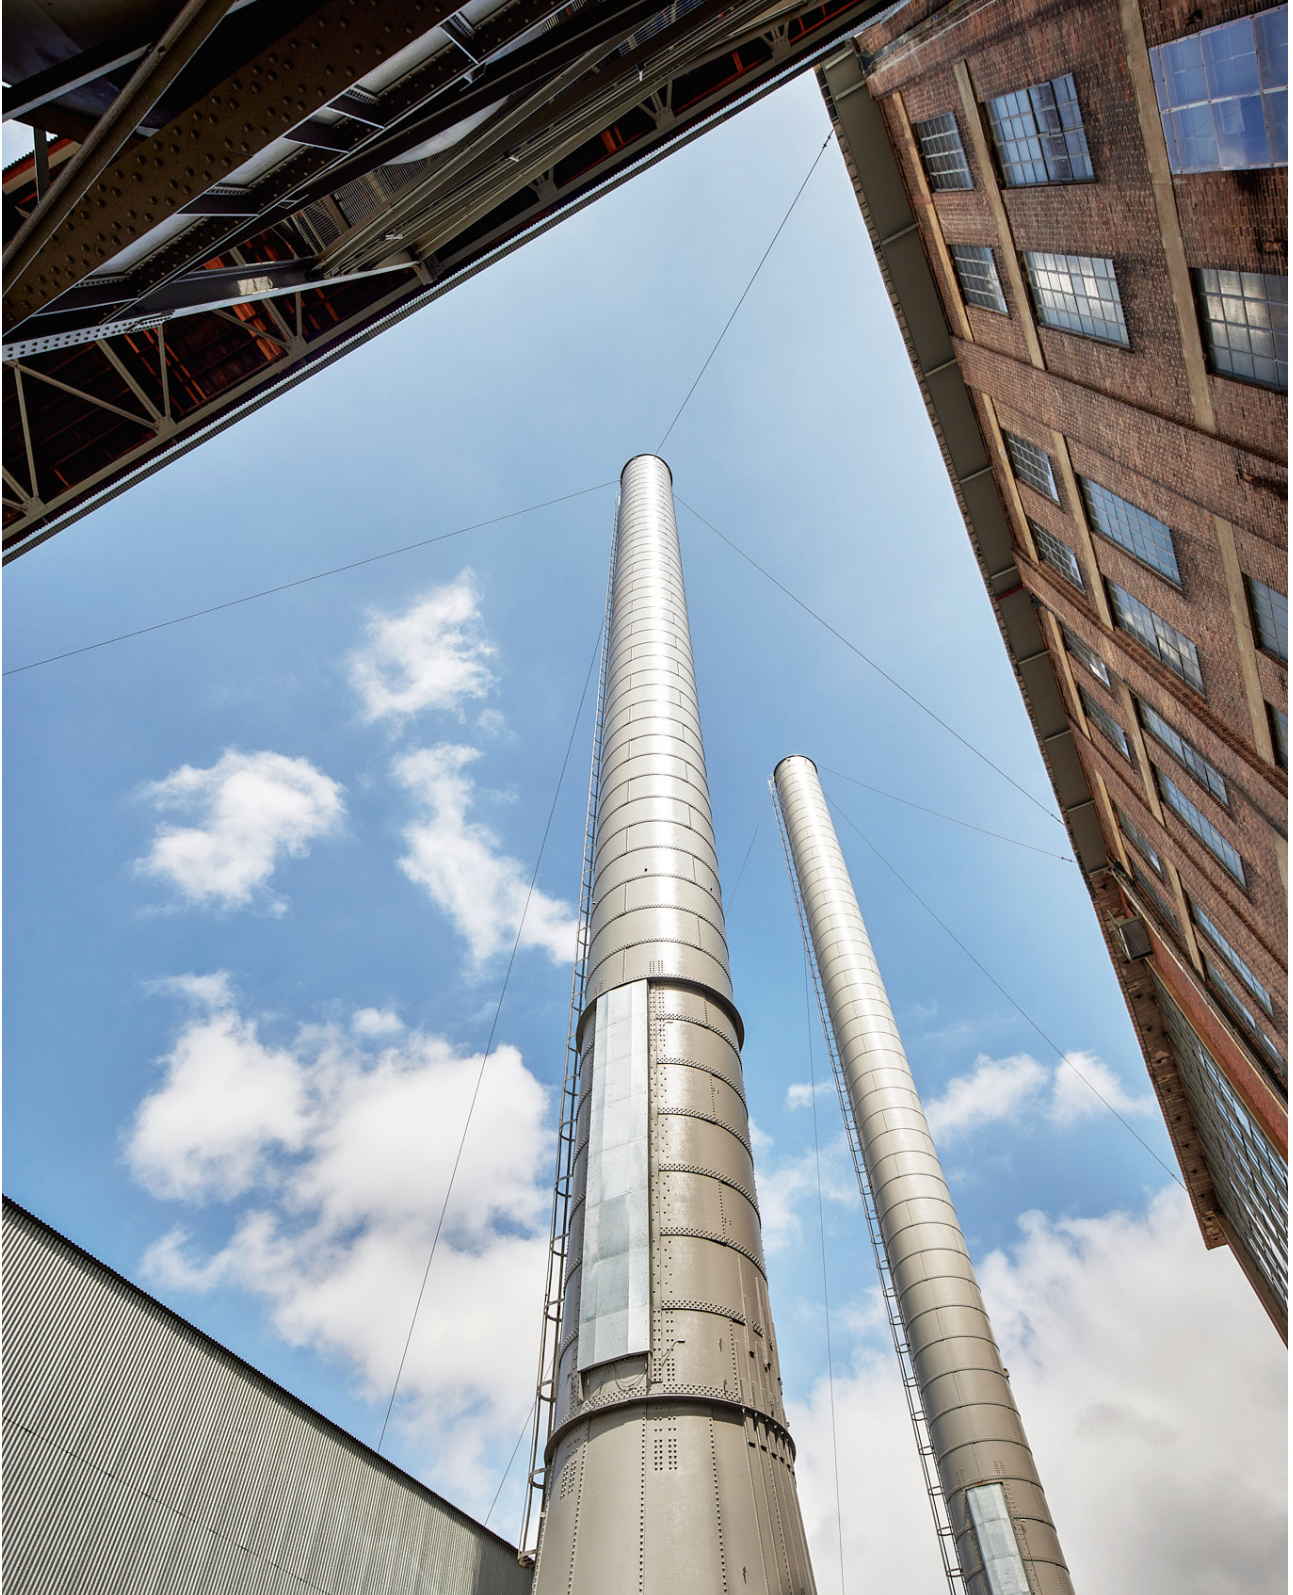
Figure 9.1 Chimney Stacks, 2024 (courtesy of Toby Peet)

| Description | <p>The Chimney Stacks are located towards the northeast corner of the White Bay Power Station complex, and are considered a landmark feature of the power station. They are riveted steel plate chimneys approximately eighty metres (80m) high and taper from the base to approximately nine metres (9m) above ground and is cylindrical to the top. Each stack has internal bracing, but this does not extend to the top of each stack. A steel ladder runs up the eastern side of each stack.</p> <p>Four guy wires are attached to the top of each stack, with two secured to the roof of the Boiler House, and two secured on concrete plinths at ground level towards the eastern edge of the site. The concrete footings and plinths for the induced draft fans are located on the ground on the north and south sides of each stack but no machinery remains. The electrostatic Ash Precipitators through which the fans sucked the gases and microparticles from the Boiler House for emission via the Stacks have also been removed.</p> | |

| Alterations & Condition | Major restoration works were carried out in 2022–24 to address corroded cladding, structural and safety issues. The steel ladders were removed, and repaired and majority was replaced before reinstalled. The outer walls of the chimneys were treated for rust, minor patching and repair and repainted using an epoxy paint system. The internal areas were cleaned, and some strengthening and bracing installed. An access system was also installed with new galvanised sheets, including flashing to prevent water entry. |

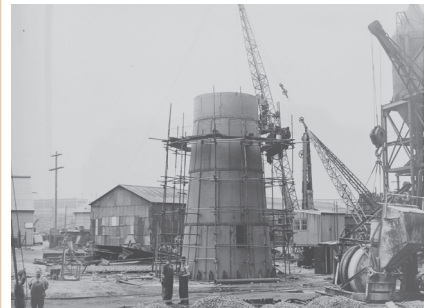
Chimney Stack during construction, 1949 (courtesy of Railways Department Archives, A5115; E1391)

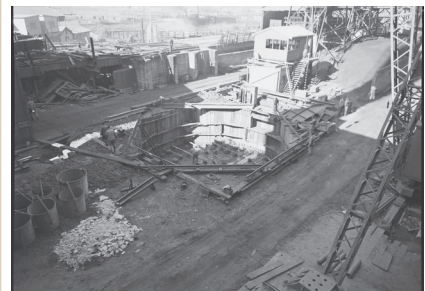
Chimney Stack base, 1957 (courtesy of NSW State Archives, NRS 20347-1-001210_B)

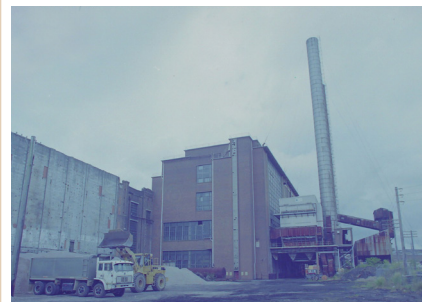
View north of Boiler House, precipitators and Chimney Stacks, 1994 (courtesy of ECNSW Archive, CN7.0016-F)

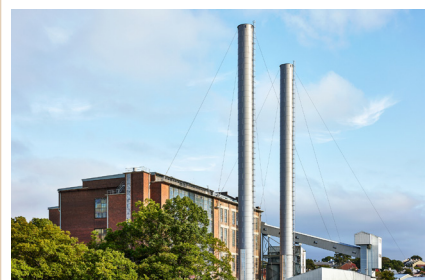
The pair of Chimney Stacks as seen from the south, 2024 (courtesy of Toby Peet)

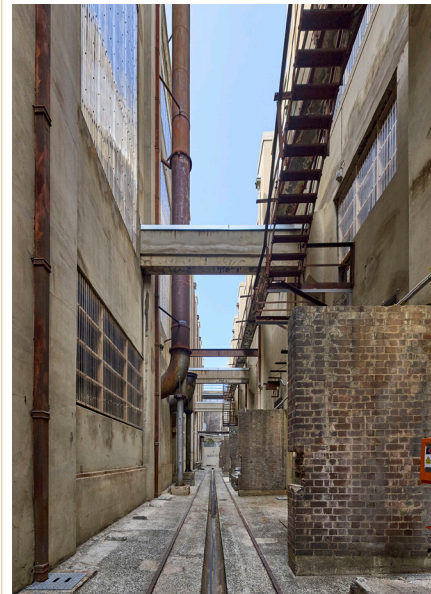
Transformer Alley looking south, 2024 (courtesy of Chris Bennett: Evolving Picture)

| Alterations & Condition | <p>In 2022–24, the following remediation and new works were carried out:</p> <ul style="list-style-type: none"> • Walkways: The high-level steel-framed walkways, attached to the east elevation of the Switch House, were treated for corrosion, reinforced and painted with clear protective coatings. To minimise the load on the steel frames, the concrete decks were removed from the walkways in the northern half of the Transformer Alley, while only some of the concrete decks were removed from the southern side. • Drainage: The surface water drainage was cleaned. Subsurface drainage was cleaned and flushed. Downpipes on the Switch House and Turbine Hall were repaired. • External walls: External walls (brick and render) were repaired to remove spalling and loose materials. • External openings: The external walls of the Switch House and Turbine Hall, which contain mainly steel-framed window openings, were mostly retained and covered with clear acrylic. The steel-framed windows at the south end of the Turbine Hall were removed, and the openings covered. • Soffit of the Switch House and Lavatory (middle of Transformer Alley): Extensive concrete remediation and patching (concrete cancer). Large pipes and hanging equipment were strengthened or reinforced. • Other: The concrete cable duct at the south end, next to the Turbine Hall, was removed due to its poor condition. A small section was repaired and retained. |

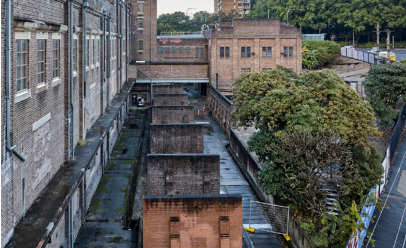
| Description | <p>The Transformer Yard is located on the western side of the White Bay Power Station complex, west of the Switch House and north of the Control Room Building. There were formerly two transformers north of the Control Room Building, and four on the west of the Switch House. No extant machinery and equipment remains; only masonry blast walls and concrete plinths remnants provide evidence of the cells where the Transformers used to be. Transformers were also located within the existing masonry walls at the north end of the Pump House, in the northern courtyard, and in the southern courtyard, next to the south Penstock. Evidence for transformers near the south penstock is based on photographs, but no physical evidence remains.</p> | <p>Transformers that once populated the Transformer Yard, with Switch House in the background, 1949 (courtesy of Railways Department Archive, A5115:E1641)</p> <p>Transformer Yard looking south, 2024 (courtesy of Chris Bennett: Evolving Picture)</p> |

| Alterations & Condition | <p>In 2022–24, the following remediation and new works were carried out:</p> <ul style="list-style-type: none"> • Blast walls: The blast walls were retained and underwent minor repairs. • Drainage: Surface drainage channels and underground drains were cleared and improved. • Other: Some of the concrete slabs between the north-south rail lines have been replaced or reinforced. These slabs span over a subsurface culvert, which aligns in between the rail lines. | |

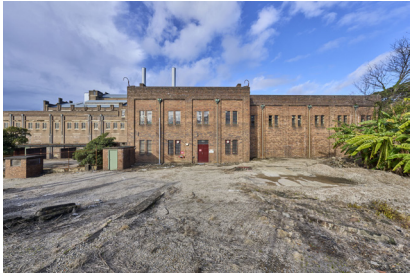
| Description | <p>The West Yard is located at the western edge of the place adjacent to Robert Street and comprises the areas to the north, west, and south of the Control Room Building. It is partially overgrown with trees and vegetation at its south end along the edge adjacent to Victoria Road.</p> | <p>West Yard looking east towards the building complex of the White Bay Power Station, 2024 (courtesy of Chris Bennett: Evolving Picture)</p> |

| Alterations & Condition | <p>In 2022–24, the following remediation and new works were carried out:</p> <ul style="list-style-type: none"> • Invasive trees close to the Control Room were removed. • Some of the spaces adjacent to the Control Room were regraded to improve surface drainage. | |

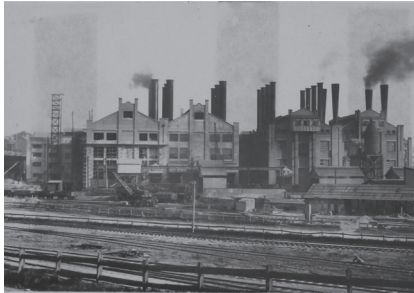
| Description | The site of former Boiler House No. 2 is currently a hard landscaped area. The area may contain underground passages or tunnels associated with the former Boiler House and coal handling. | <p>Boiler House No. 1 (right) and Boiler House No. 2 (left), 1927 (courtesy of ECNSW Archives, 0363-065)</p> |

| Alterations & Condition | <p>In 2022-24, the following remediation and new works were carried out:</p> <ul style="list-style-type: none"> • Stored materials unrelated to the White Bay Power Station, were relocated and the area cleaned • Drainage: Surface drainage channels and underground drains were cleared. Subsurface drainage at the northern end of the space was removed and replaced with new drainage and stormwater pits. • Fences and barriers were installed for public safety. • New public toilets, constructed with prefabricated demountable buildings, were installed to facilitate events and public use. | |
