46–56 Gloucester Street, The Rocks

SHR No. 01609

Conservation Management Plan

Report prepared for NSW Land and Housing Corporation

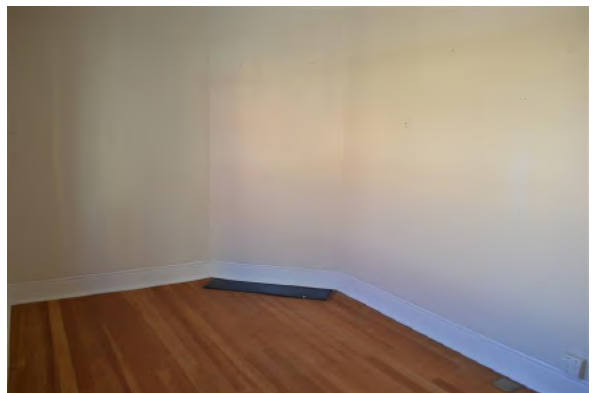
Figure 2.48 Original corner fireplace (blocked off and rendered and skirted over to match adjacent) with concrete hearth (space 2.4)—46A / 46–56 Gloucester Street. (Source: GML Heritage, July 2016)

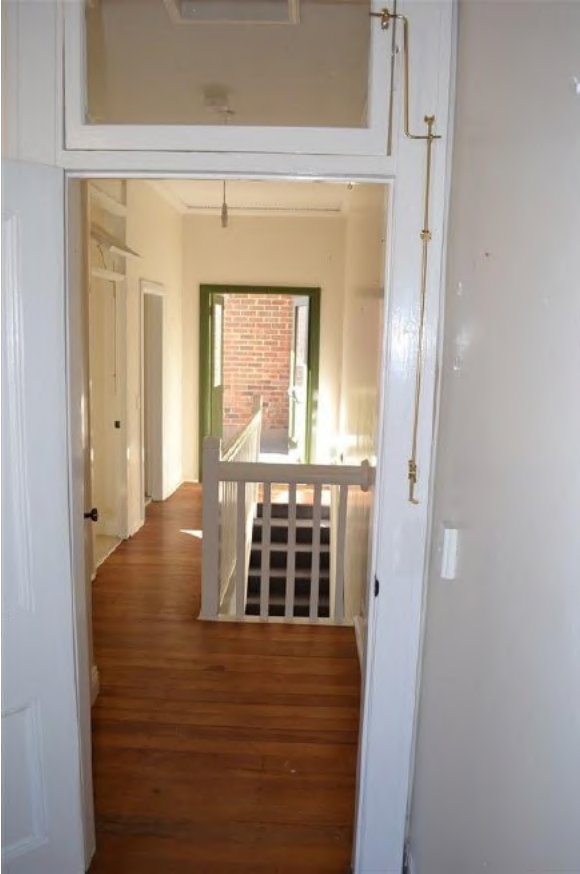
Figure 2.49 Original (?) doorway to the dining room (space 2.4) with fanlight and opening mechanism above—46A / 46–56 Gloucester Street. (Source: GML Heritage, July 2016)

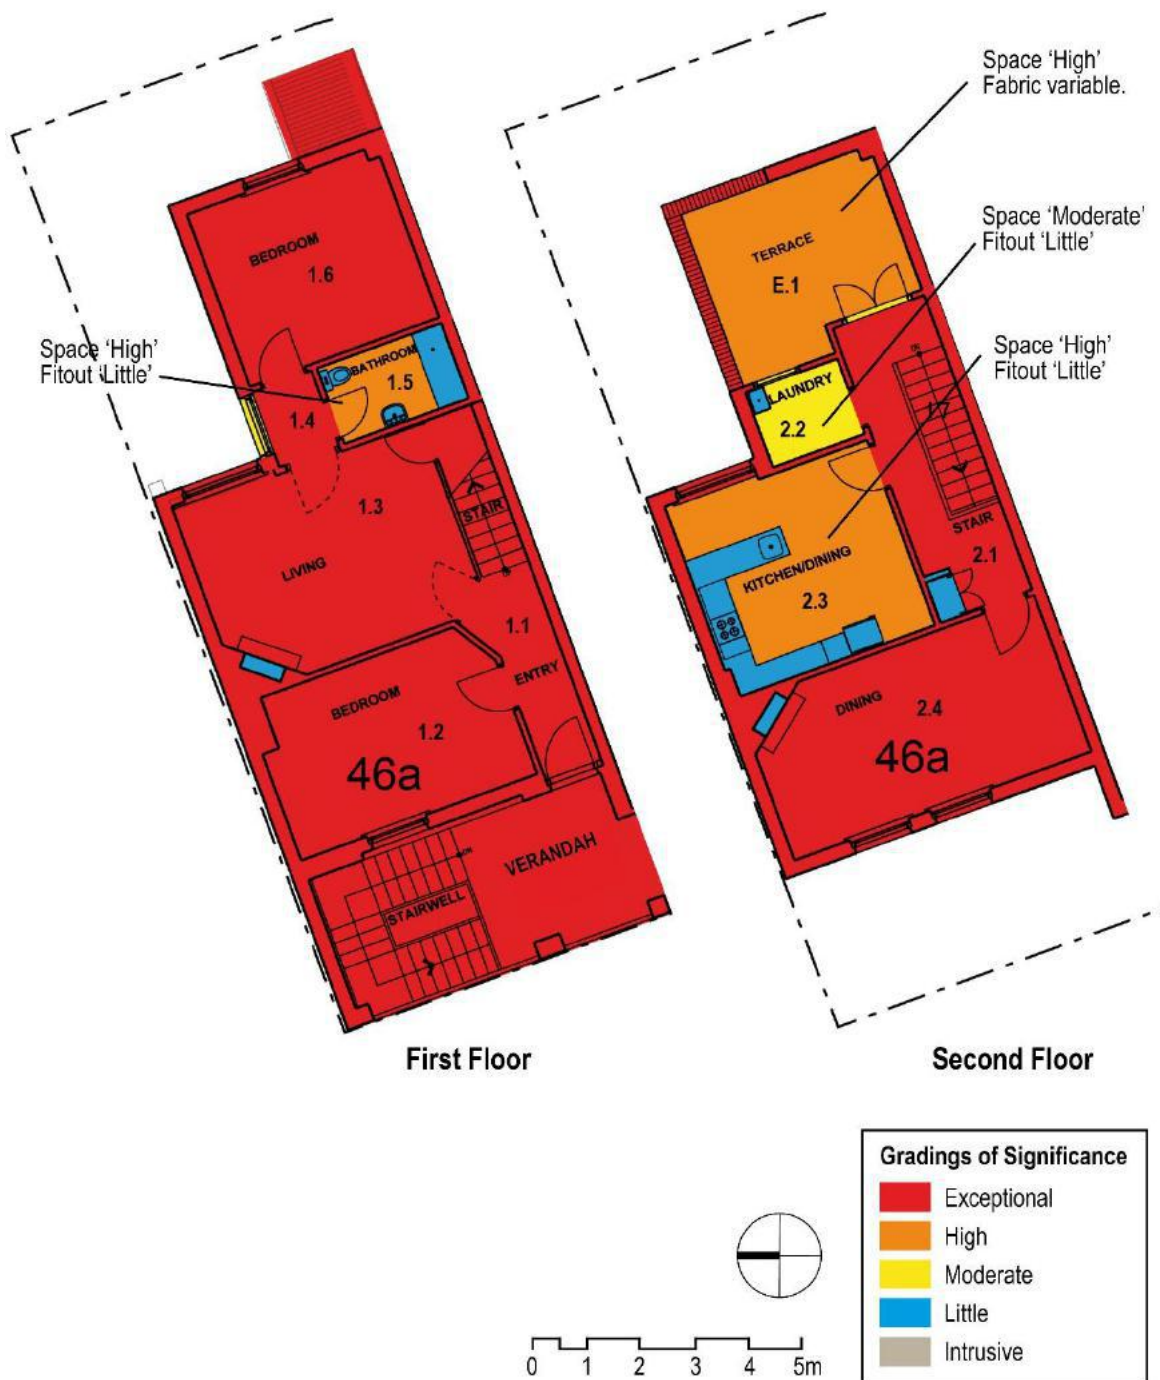
Number 46a—Plans, Gradings of Significance

Figure 2.50 Plans showing gradings of significance—Flat 46A / 46–56 Gloucester Street. (Source: LAHC, with GML overlay 2016)

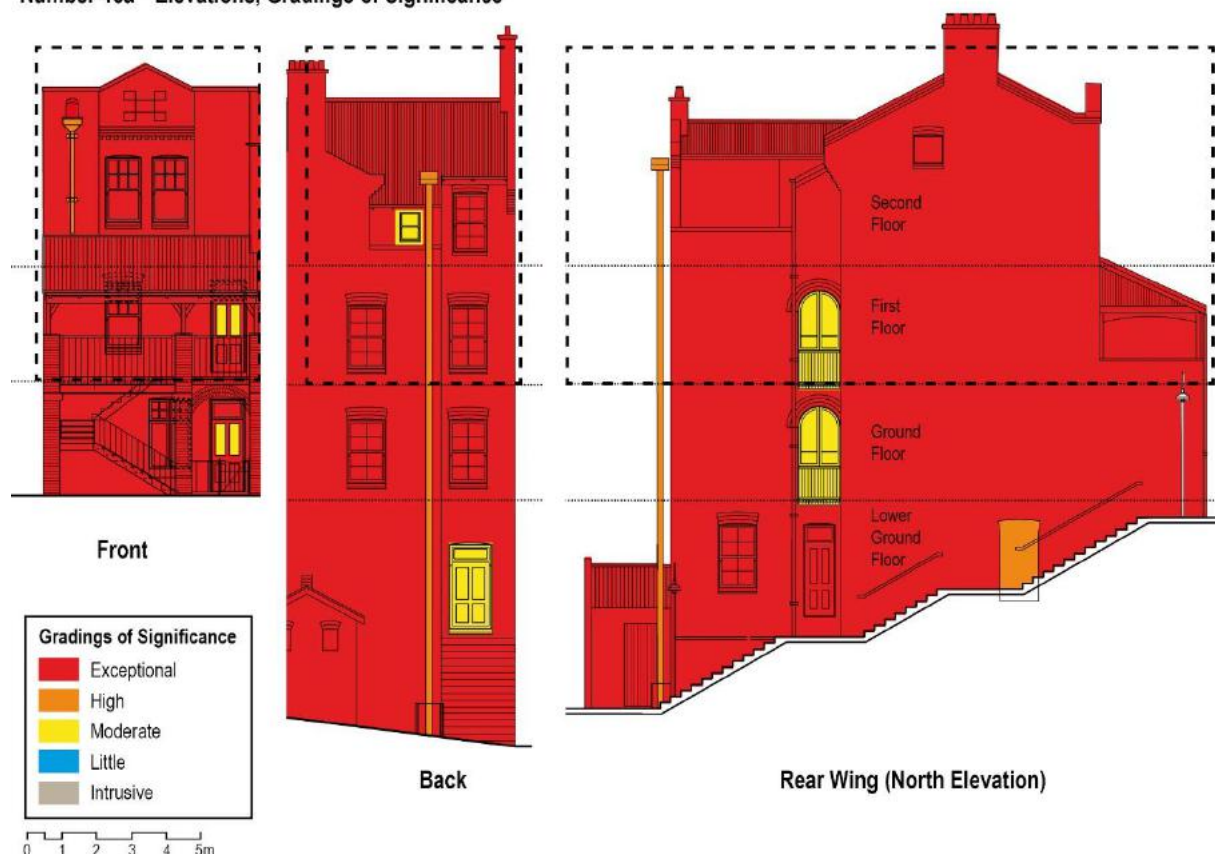
Number 46a—Elevations, Gradings of Significance

Figure 2.51 Elevations showing gradings of significance—Flat 46A / 46–56 Gloucester Street. (Source: LAHC, with GML overlay 2016)

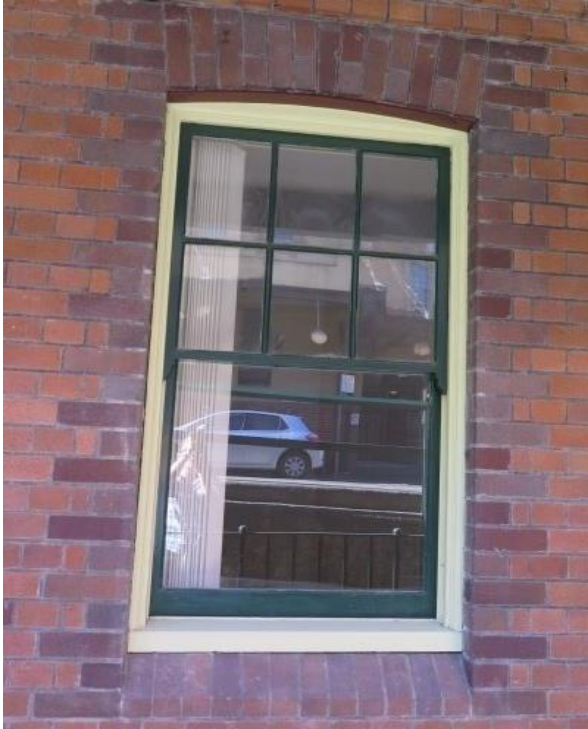
Figure 3.10 Double-hung window with chamfered brick sill, twenty-first century glass in the lower sash, and dark brick surrounds—48 / 46–56 Gloucester Street. (Source: GML Heritage, May 2016)

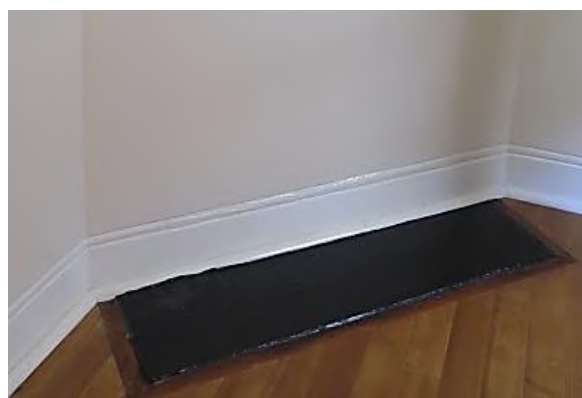
Figure 3.17 Timber floor and original corner fireplace, concrete hearth blocked off and rendered and skirted in the front bedroom (space G.2)—48 / 46–56 Gloucester Street. (Source: GML Heritage, May 2016)

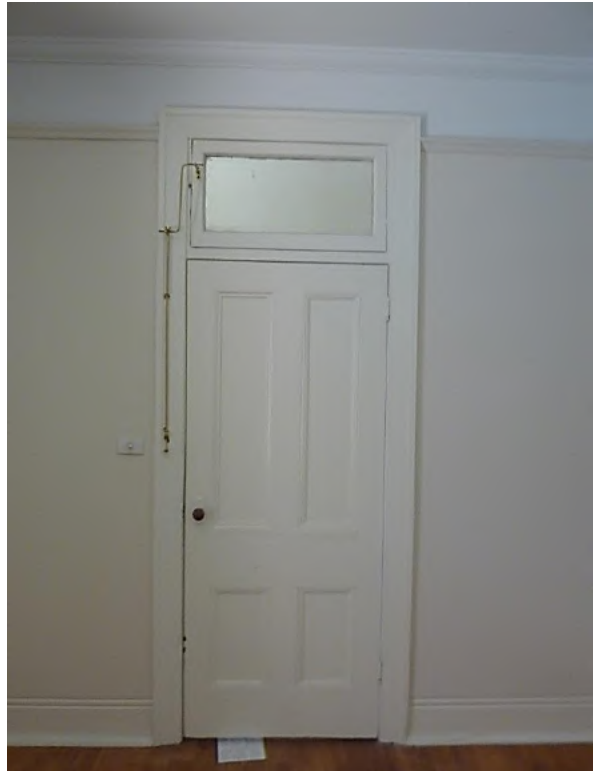
Figure 3.19 Run cement skirtings, four-panel timber door with fanlight above and reproduction mechanism between the front bedroom (space G.2) and entry (space G.1)—48 / 46–56 Gloucester Street. (Source: GML Heritage, November 2015)

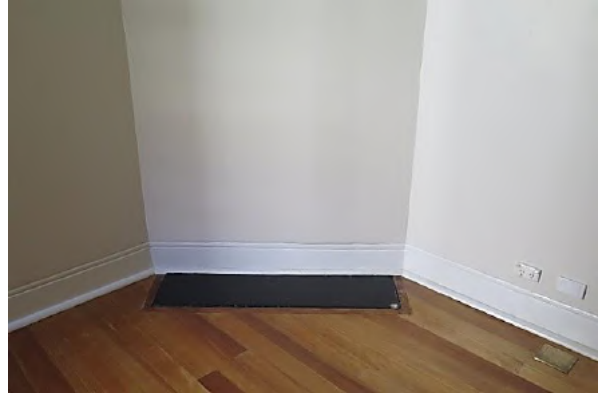
Figure 3.23 The original corner fireplace with concrete hearth is blocked in the living room (space G.3). Note original cement run skirtings have been replicated across new section—48 / 46–56 Gloucester Street. (Source: GML Heritage, May 2016)

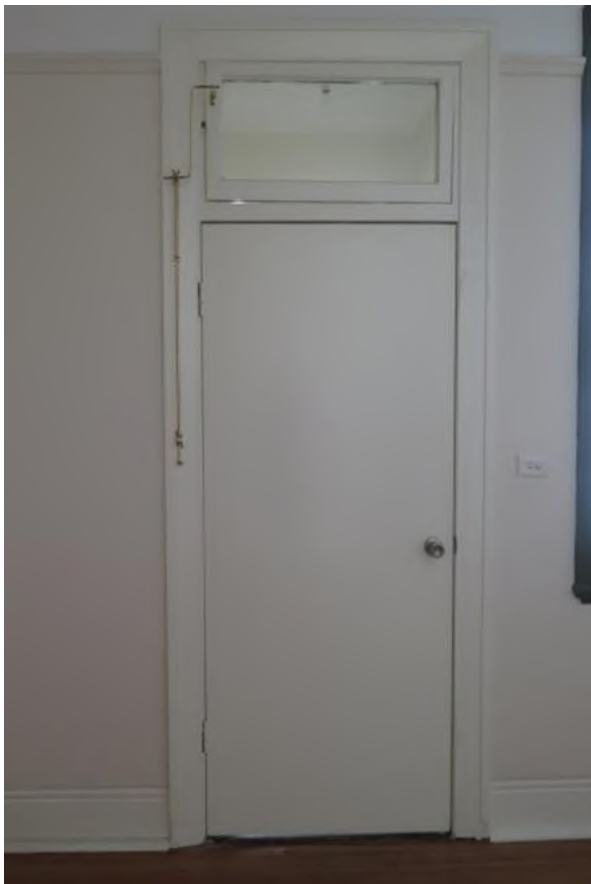
Figure 3.24 Modern hollow core door with original transom light above and reproduction mechanism between the living room (space G.3) and the former rear porch (space G.4)—48 / 46–56 Gloucester Street. (Source: GML Heritage, May 2016)

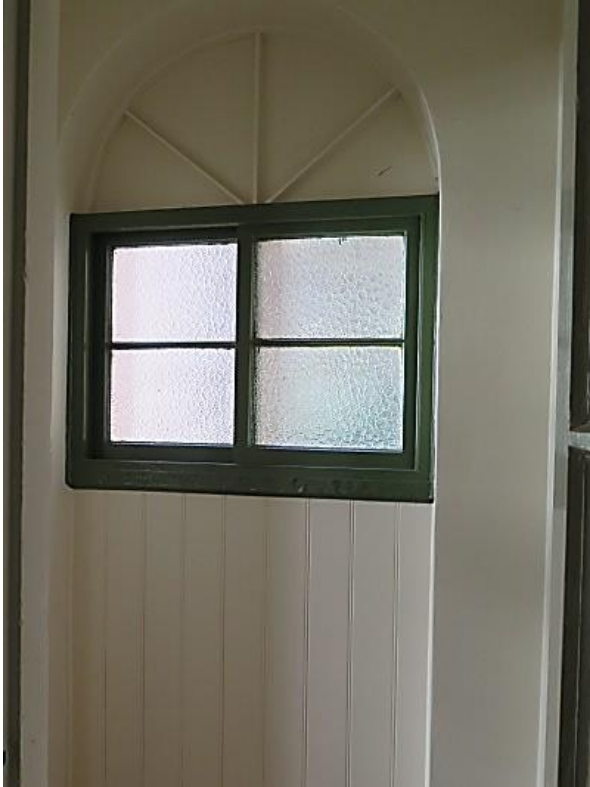
Figure 3.26 Infilled former rear porch opening (space G.4), with horizontal sliding sash window and modern T&G boarding below—48 / 46–56 Gloucester Street. (Source: GML Heritage, May 2016)

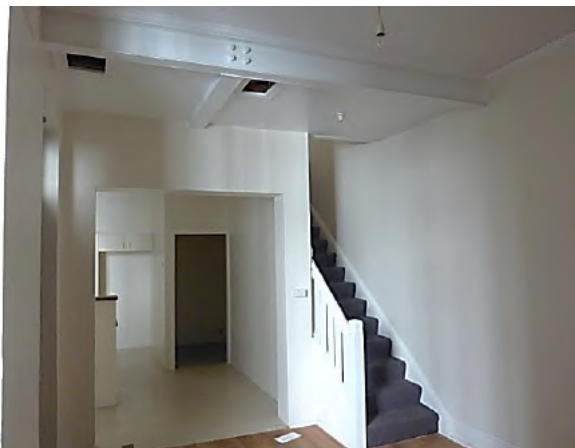
Figure 3.32 The dining room (space LG.1) showing the opening created in the brickwork to the kitchen and modern partition wall dividing the laundry—48 / 46–56 Gloucester Street. (Source: GML Heritage, November 2015)

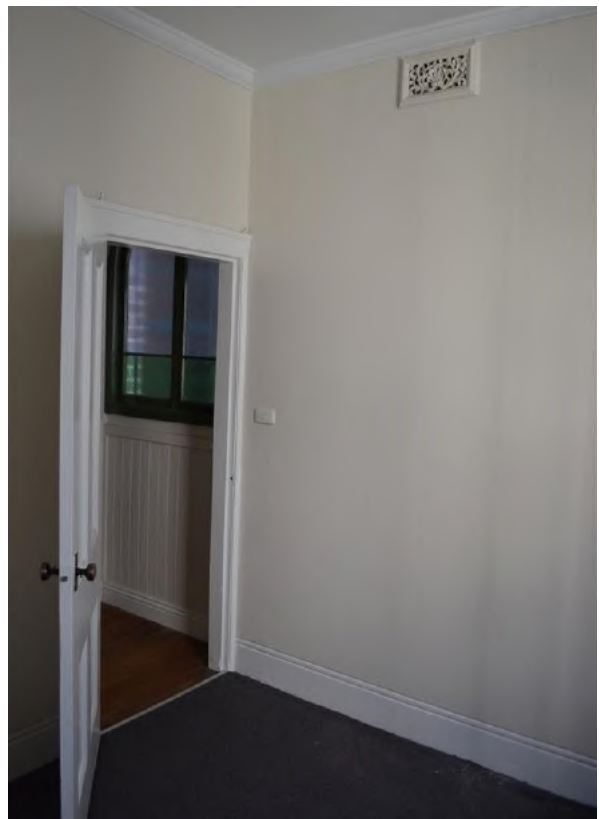
Figure 5.29 Rear bedroom (space G.6) showing the decorative plaster wall vent, plaster board ceiling and original door frame, with four panel timber door to the infilled former porch (space G.4)—50 / 46–56 Gloucester Street. (Source: GML Heritage, June 2016)

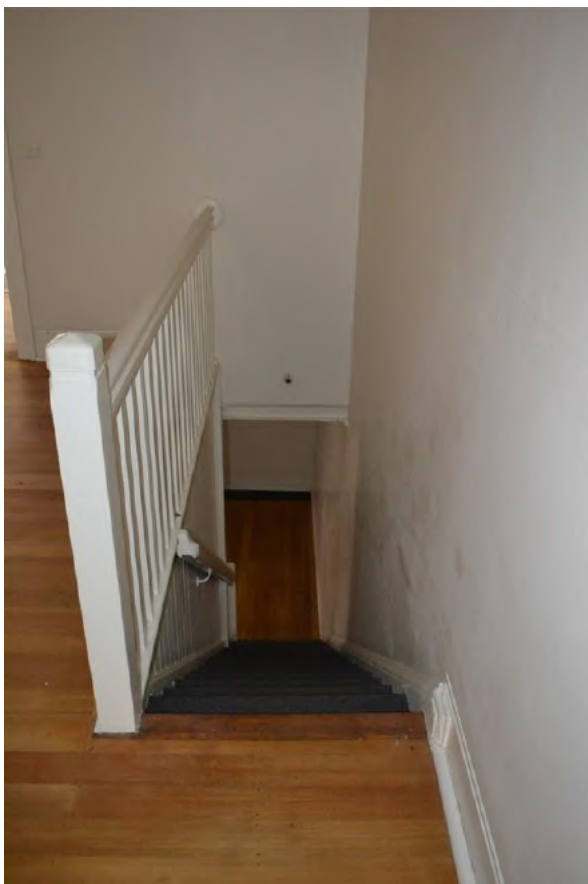
Figure 5.30 The stair (space G.7) showing original timber handrail—50 / 46–56 Gloucester Street. (Source: GML Heritage, June 2016)

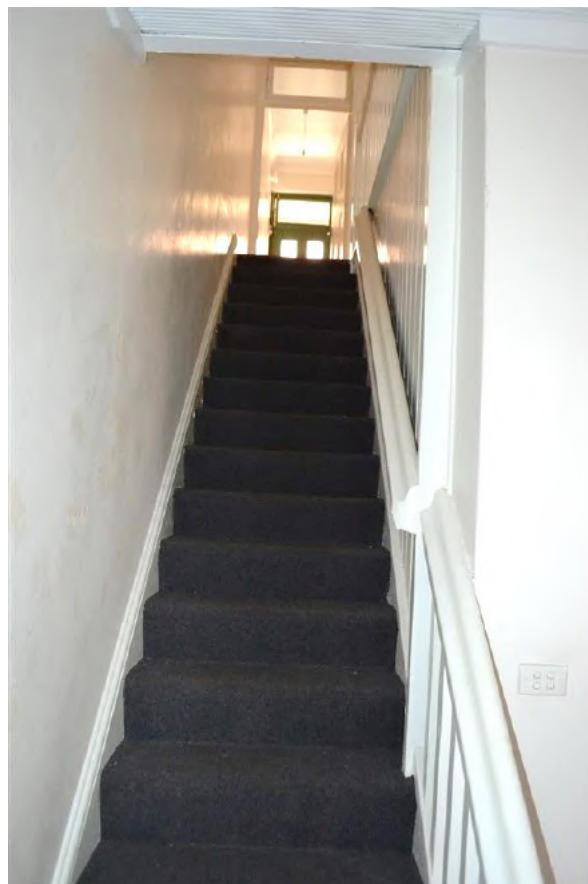
Figure 5.31 The stair (space G.7) showing the original timber handrail and timber boarded wall—50 / 46–56 Gloucester Street. (Source: GML Heritage, June 2016)

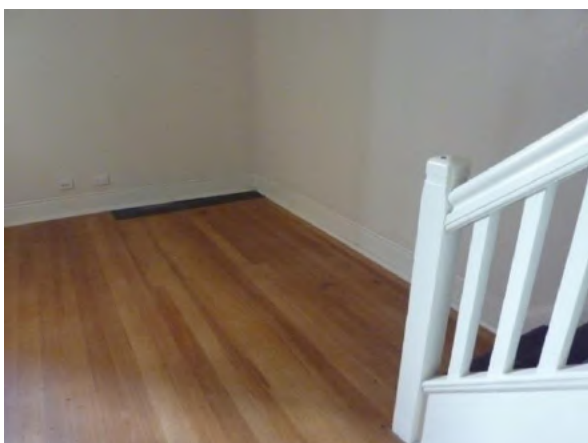
Figure 5.32 Dining room (space LG.1) showing the original fireplace with concrete hearth, boarded up, timber floor and the cement run skirting—50 / 46–56 Gloucester Street. (Source: GML Heritage, June 2016)

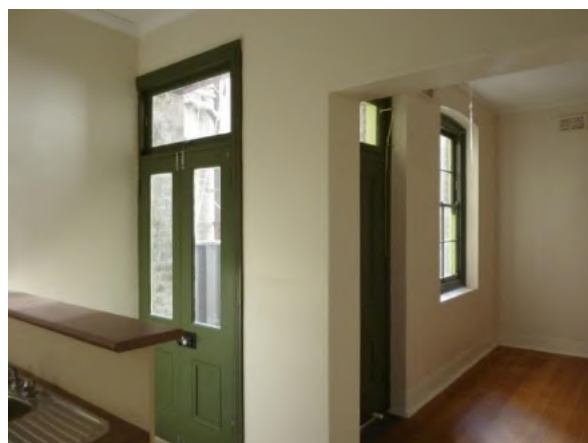
Figure 5.33 Dining room (space LG.1) and kitchen (Space LG.2) showing the double-hung sash window to the dining room and the two four panel doors with fanlights above to the rear yard (space E.2)—50 / 46–56 Gloucester Street. (Source: GML Heritage, June 2016)

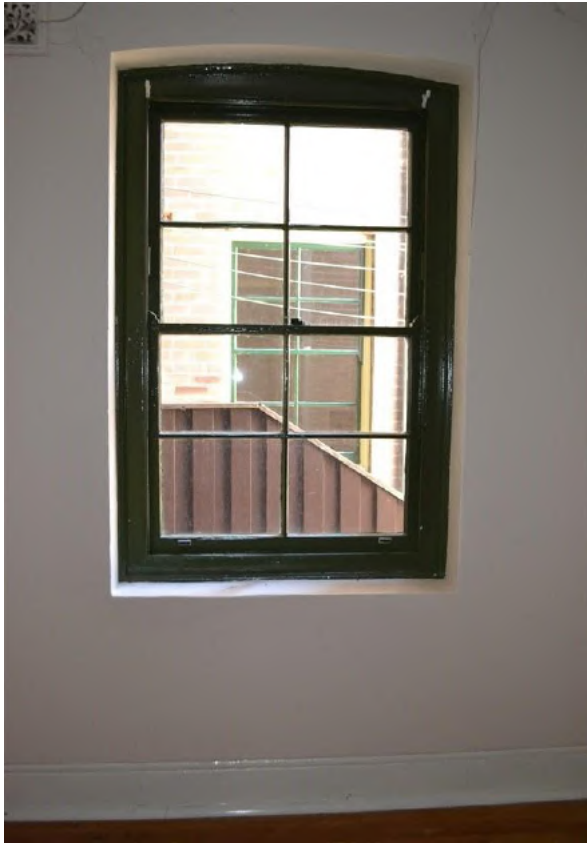
Figure 5.34 Dining room (space LG.1) showing the cement run skirting and timber double hung sash window—50 / 46–56 Gloucester Street. (Source: GML Heritage, June 2016)

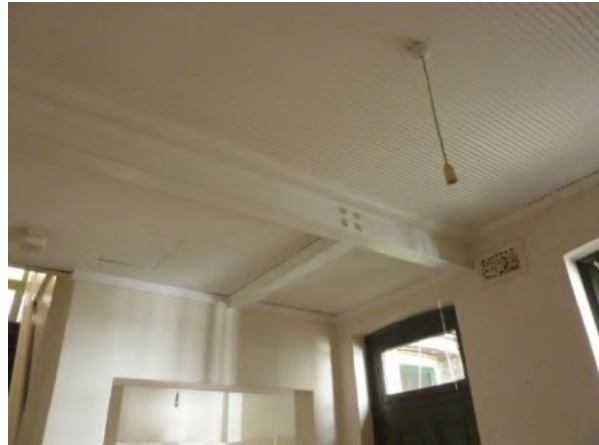
Figure 5.35 Dining room (space LG.1) showing the ripple iron ceiling, decorative plaster wall vent and fanlight above door to rear yard—50 / 46–56 Gloucester Street. (Source: GML Heritage, June 2016)

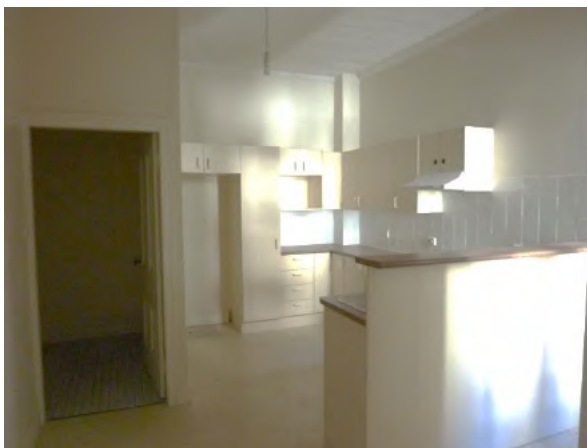
Figure 5.36 Kitchen (space LG.2) showing the modern fitout, original ripple iron ceilings and entrance to the laundry (space LG.3)—50 / 46–56 Gloucester Street. (Source: GML Heritage, June 2016)

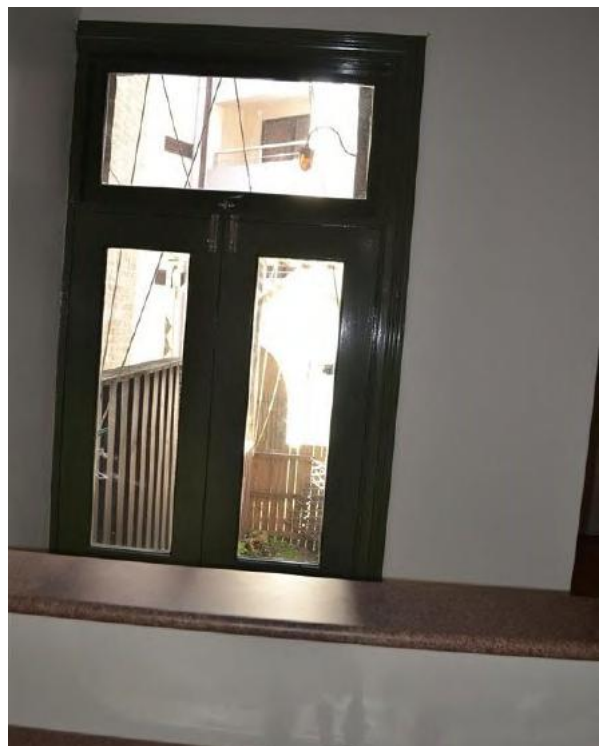
Figure 5.37 Half-glazed timber door, with fanlight above, leading from the kitchen (space LG.2) to the rear yard (space E.2)—50 / 46–56 Gloucester Street. (Source: GML Heritage, June 2016)

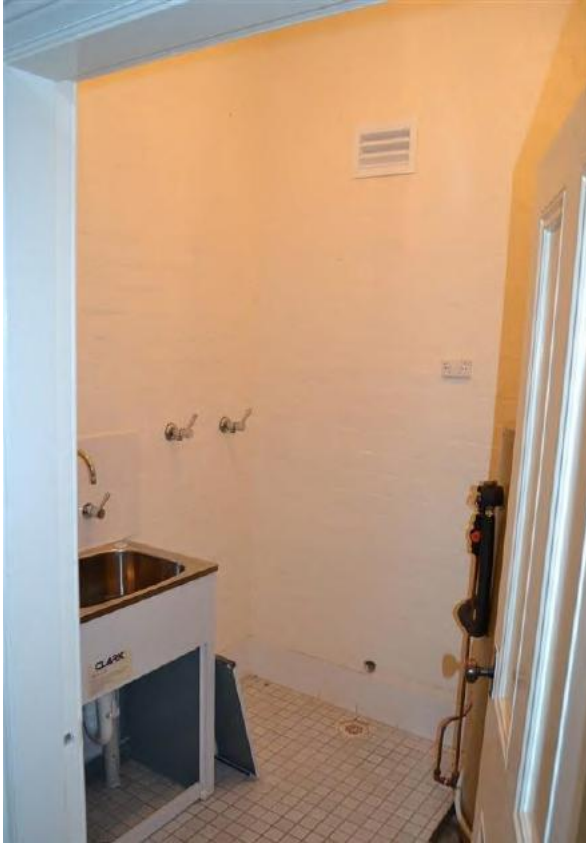
Figure 5.38 Laundry (space LG.3) showing modern fitout and original painted brick walls—50 / 46–56 Gloucester Street. (Source: GML Heritage, June 2016)

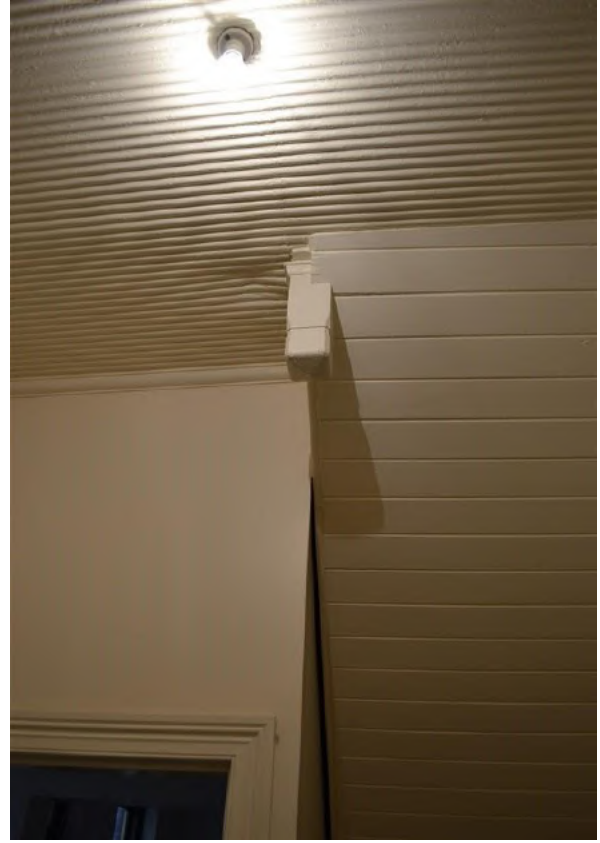
Figure 5.39 Laundry (space LG.3) showing the original ripple iron ceiling, T&G boarded timber stair soffit and newel post extending from ceiling above—50 / 46–56 Gloucester Street. (Source: GML Heritage, June 2016)

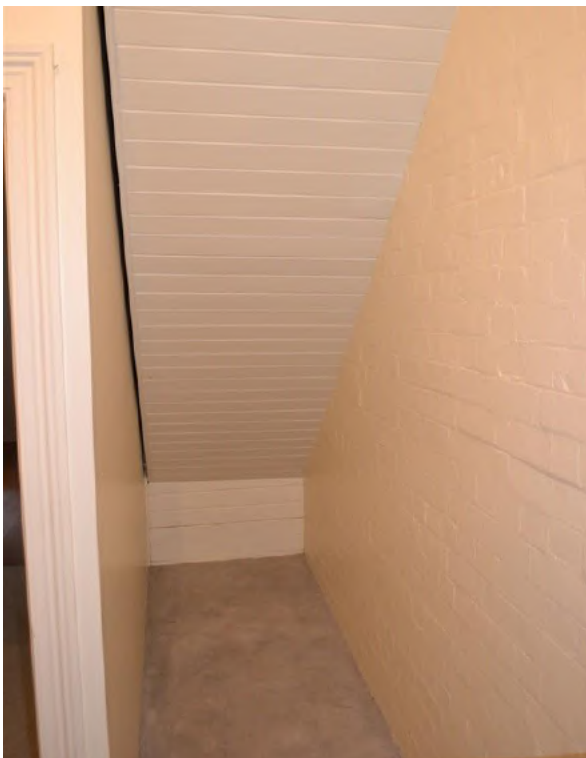
Figure 5.40 Laundry (space LG.3) showing the T&G soffit to the stair and original painted brick walls—50 / 46–56 Gloucester Street. (Source: GML Heritage, June 2016)

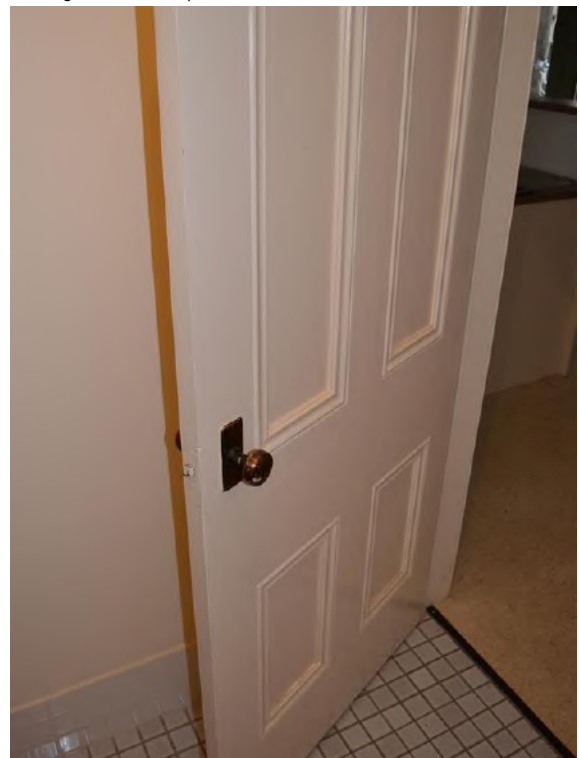
Figure 5.41 Four panel timber door to the laundry (space LG.3)—50 / 46–56 Gloucester Street. (Source: GML Heritage, June 2016)

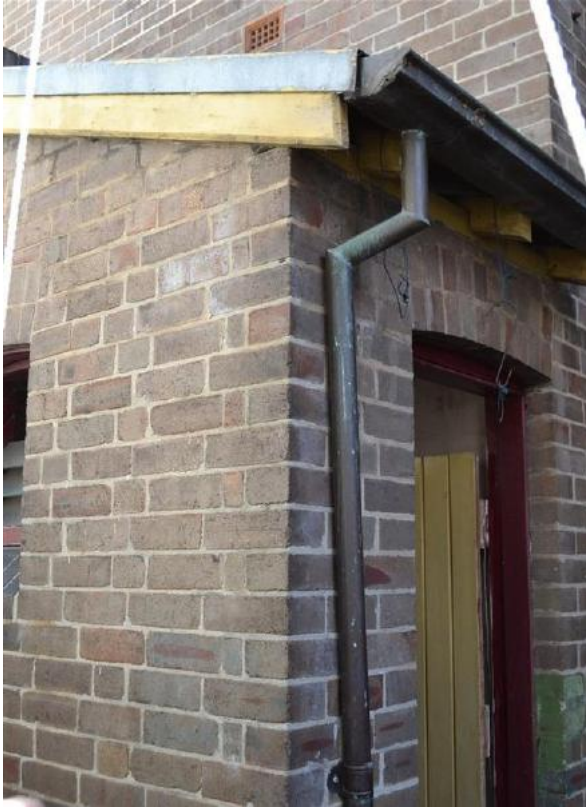
Figure 5.42 Former external WC (space E.3) showing, exposed rafter eaves, brick walls, brick arched doorway and timber boarded door—50 / 46–56 Gloucester Street. (Source: GML Heritage, June 2016)

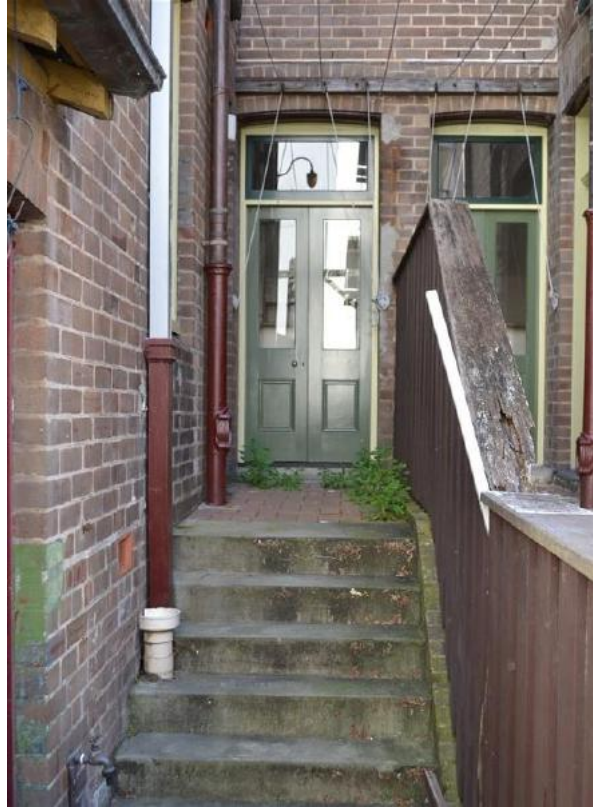
At the rear, the property shares rainwater services with Flat 50A above (steel square section downpipes) (Figure 5.43)

Figure 5.43 Exterior walls of the rear wing showing concrete steps, original cast iron and modern stainless and copper downpipes, and terracotta wall vents (space E.2)—50 / 46–56 Gloucester Street. (Source: GML Heritage, June 2016)

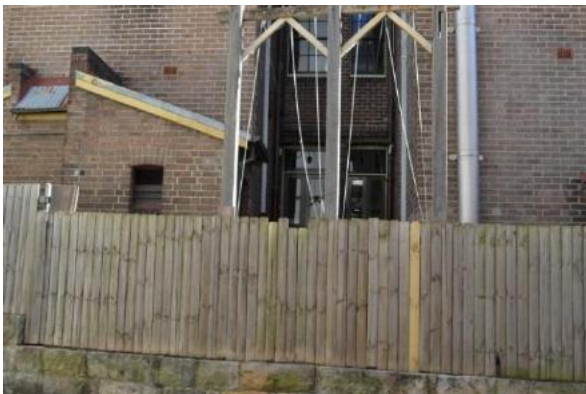
Figure 5.44 Exterior walls in common brick, timber fence and squared rock faced perimeter retaining wall. Rear wing looking west—50 / 46–56 Gloucester Street (Source: GML Heritage, June)

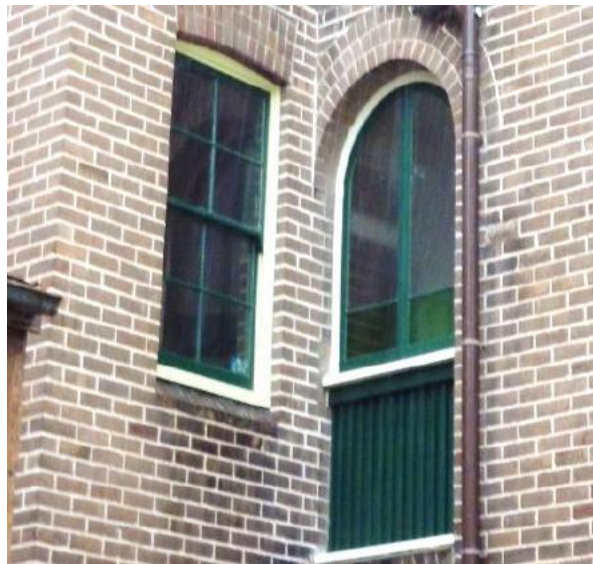
Figure 5.45 Round arched window of the infilled former rear porch—50 / 46–56 Gloucester Street. (Source: GML Heritage, July 2016).

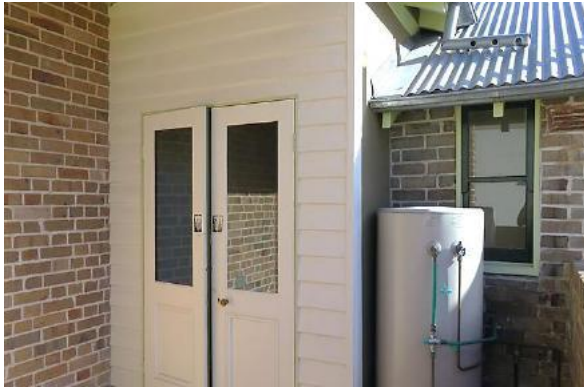
The roofed area of the roof top terrace is partially enclosed by two brick walls (Figure 6.13 and Figure 6.15). The roof terrace has a modern tiled floor, which drains to a floor drain adjacent to the balustrade. The opening to the former garbage chute previously located on the rear wall has been blocked up. There is evidence of the former laundry copper having been removed from the skillion roofed area. The glass doors opening onto the terrace are set in a weatherboard wall (Figure 6.14).

Figure 6.15 Roof terrace (space E.1)—50A / 48–56 Gloucester Street, showing tiled floor and evidence of the original garbage chute (blocked up). (Source: GML Heritage, July 2016)

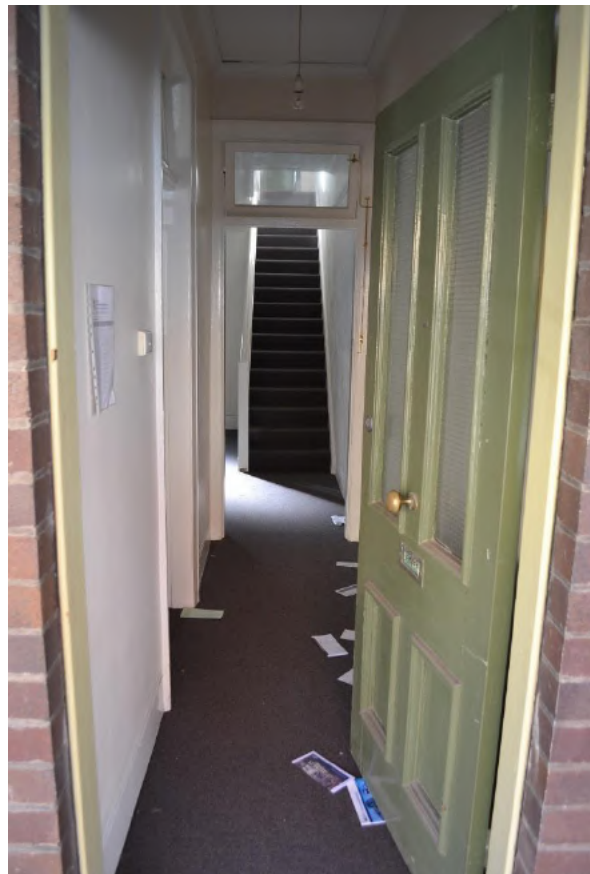
Figure 6.18 Original pivot internal fanlight to main entry door, reproduction mechanism and moulded timber cornice. Space 1.1—50A / 48–56 Gloucester Street. (Source: GML Heritage, July 2016)

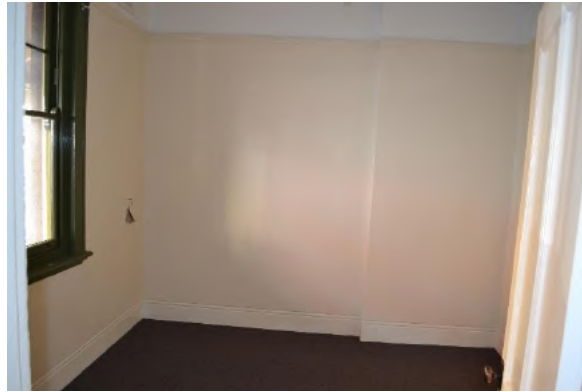
Figure 6.19 Front bedroom (space 1.2)—50A / 48–56 Gloucester Street, showing timber double hung sash window, moulded timber picture rail, run cement skirtings, flue and ripple iron ceiling with moulded timber cornice. (Source: GML Heritage, July 2016)

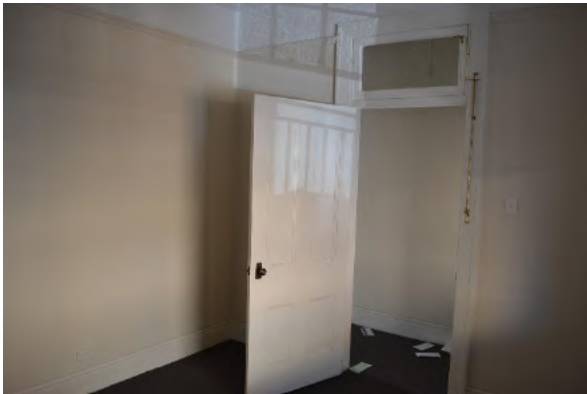
Figure 6.20 Front bedroom (space 1.2)—50A / 48–56 Gloucester Street, with cement rendered skirting, picture rail and original four-panel timber door with sunk moulds, original architrave and fanlight over. (Source: GML Heritage, July 2016)

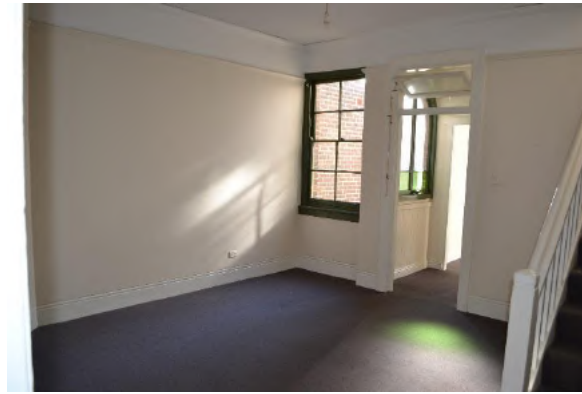
The living room (space 1.3) has timber floor (carpeted), cement run skirtings, ripple iron ceiling, moulded timber cornice and timber picture rail (Figure 6.21–Figure 6.24). There is a timber double-hung sash window (four panes over four) to the rear with original architraves, sill board and moulding. There is a corner fireplace (blocked up and rendered with the opening expressed) with concrete hearth.

Figure 6.21 Living room (space 1.3)—50A / 48–56 Gloucester Street, showing cement rendered skirtings, timber picture rail, ripple iron ceiling and moulded timber cornice. Original sash window with original architraves. (Source: GML Heritage, July 2016)

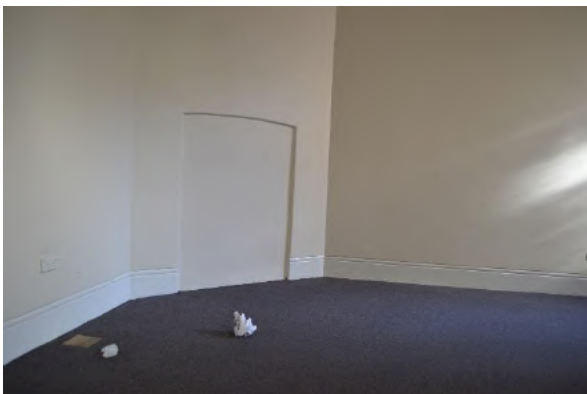
Figure 6.22 Living room (space 1.3) showing fireplace blocked off and rendered over, with opening expressed—50A / 46–56 Gloucester Street. (Source: GML Heritage, July 2016)

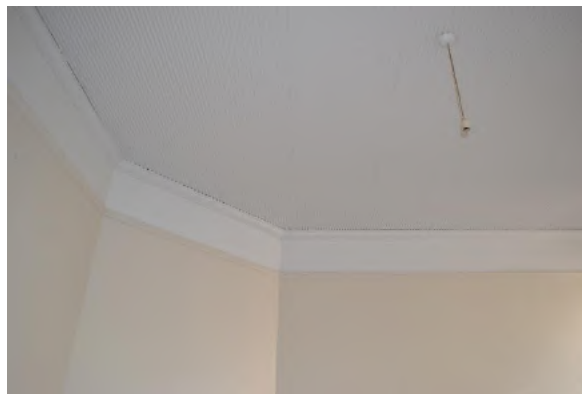
Figure 6.23 Living room (space 1.4) showing corner chimney breast, timber picture rail, cornice and ripple iron ceiling—50A / 46–56 Gloucester Street. (Source: GML Heritage, July 2016)

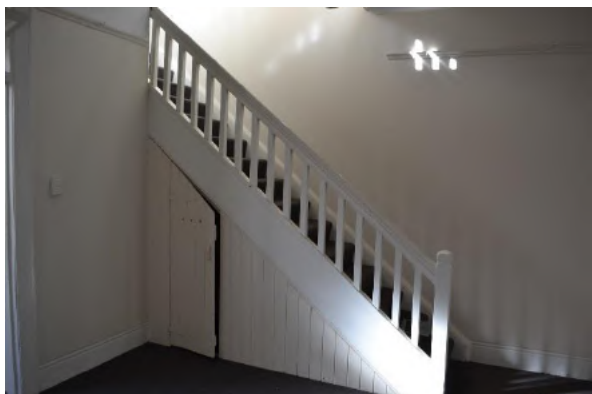
A timber staircase with stop chamfered newel posts, a moulded timber handrail is set against the south wall. The bottom of the top newel post extends down below the ceiling of space 1.3. The stair soffit is lined with V-joint timber boarding. The area under the stair is enclosed with timber vertical boarded wall to form a cupboard and is fitted with traditional timber shelving. A ledged and sheeted timber door, with air holes drilled through its top, is hung on strap hinges and provides access (Figure 6.24).

Figure 6.24 Living room (space 1.3)—50A / 48–56 Gloucester Street, showing original timber stair with closed sting, square balusters, moulded handrail, newel posts, and under stair cupboard. (Source: GML Heritage, July 2016)

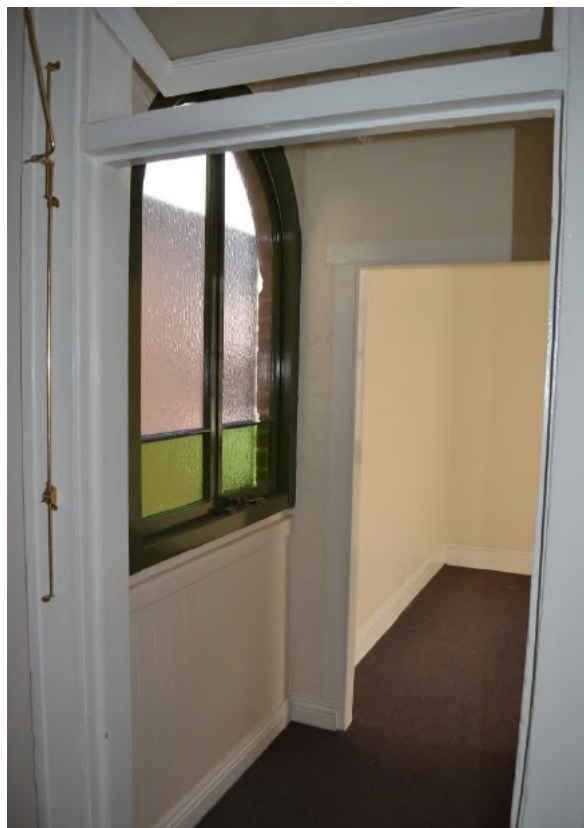
Figure 6.25 Original arched opening to former porch in rear wing (space 1.4) —50A / 48–56 Gloucester Street, infilled with pair of casement windows and vertical boarded panel below. Also shows original door frame and architrave between spaces 1.3 and 1.4, and original fanlight above. (Source: GML Heritage, July 2016)

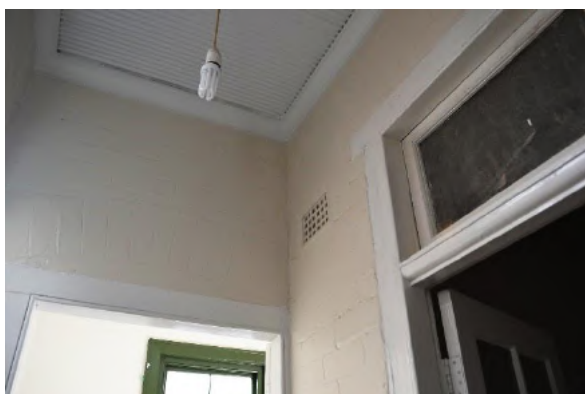
Figure 6.26 Original brick arched head above doorway opening to rear bedroom (space 1.6)—50A / 48–56 Gloucester Street, showing original wall vent, door frames without architraves, brick walls and ripple iron ceiling. (Source: GML Heritage, July 2016)

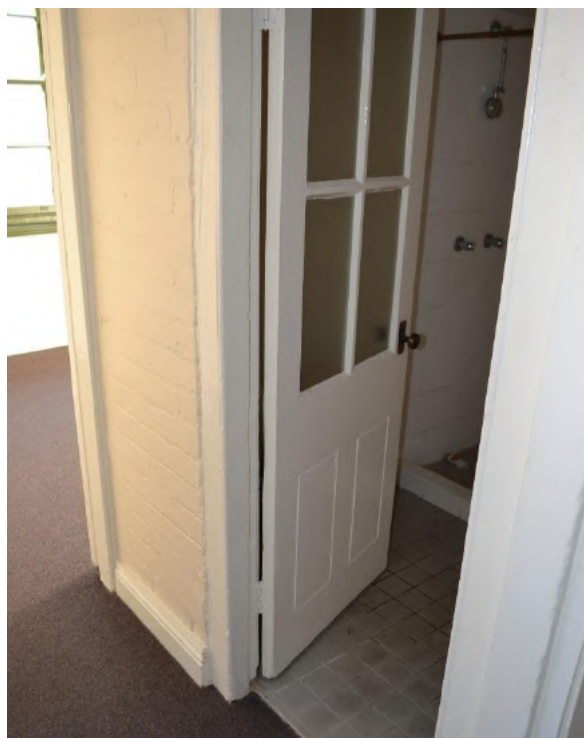
Figure 6.27 Original half-glazed door to the bathroom (space 1.5)—50A / 48–56 Gloucester Street. (Source: GML Heritage, July 2016)

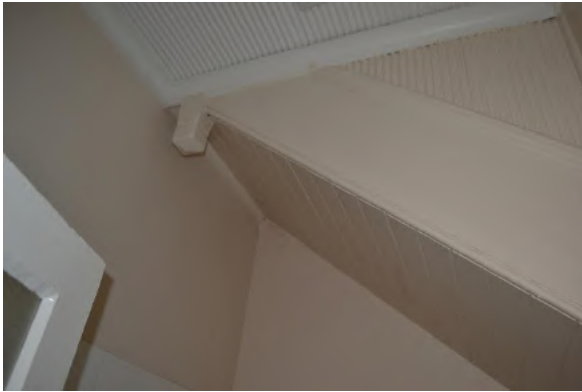
Figure 6.28 Bathroom (space 1.5)—50A / 48–56 Gloucester Street showing modern fit out, v-jointed timber stair soffit with ripple iron to ceiling and side of stair above the string. (Source: GML Heritage, July 2016)

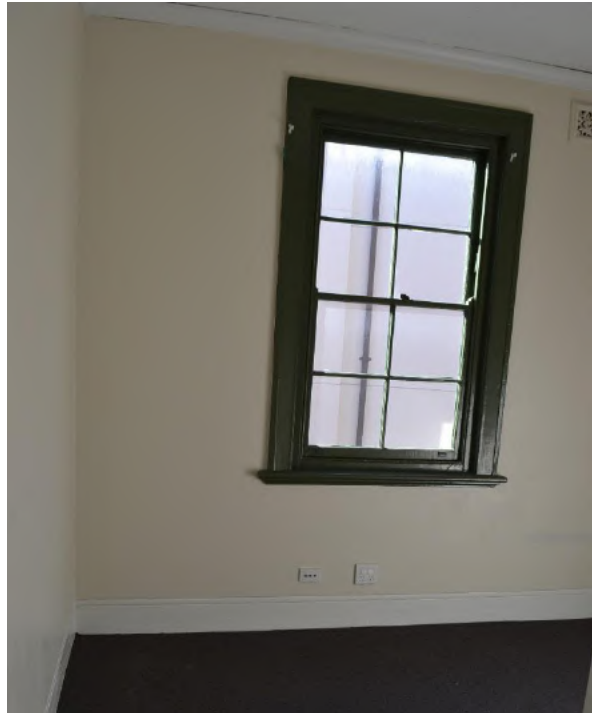
Figure 6.29 Rear bedroom (space 1.6) showing timber double hung sash window and cement run skirting—50A / 48–56 Gloucester Street. (Source: GML Heritage, July 2016)

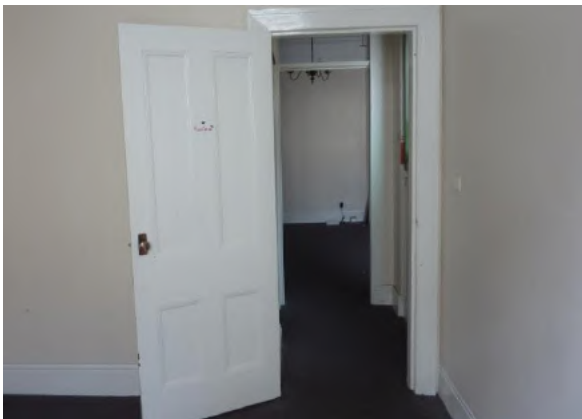
Figure 6.30 Original timber four-panel door to the rear bedroom (space 1.6)—50A / 46–56 Gloucester Street. (Source: GML Heritage, July 2016)

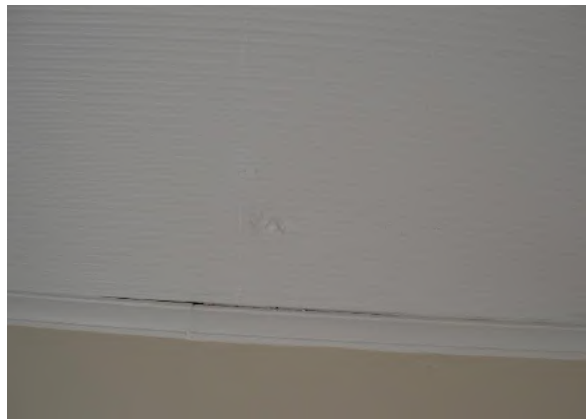
Figure 6.31 Ripple iron ceiling in the rear bedroom—50A / 48–56 Gloucester Street, with moulded timber cornice and remnant gas-light services (space 1.6). (Source: GML Heritage, July 2016)

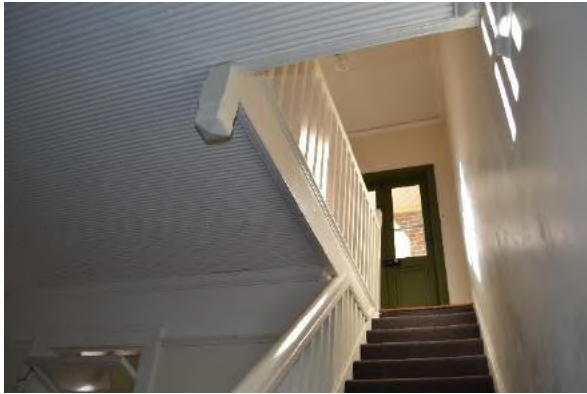
Figure 6.32 Stair (space 1.7)—50A / 48–56 Gloucester Street, showing the original ripple iron ceiling, timber balustrade and handrail and newel post projecting below stair (Source: GML Heritage, July 2016)

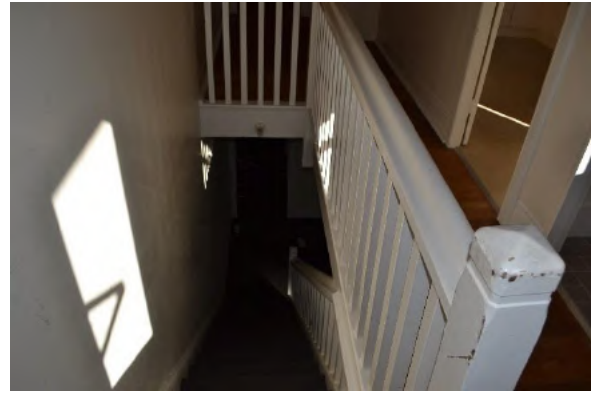
Figure 6.33 Timber balustrade and newel post to the hall/landing (space 2.1)—50A / 48–56 Gloucester Street. (Source: GML Heritage, July 2016)

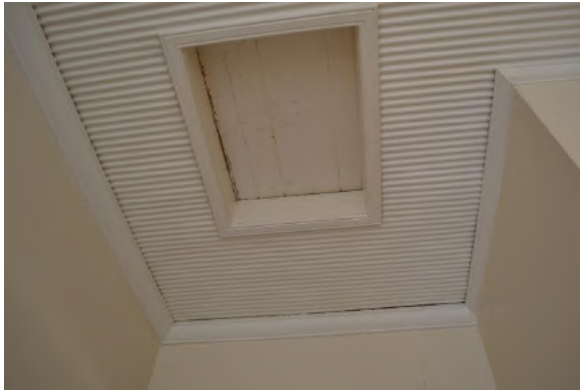
Figure 6.34 Ceiling of space 2.1 showing original roof hatch, timber cornice and ripple iron ceiling—50A / 46–56 Gloucester Street. (Source: GML Heritage, July 2016)

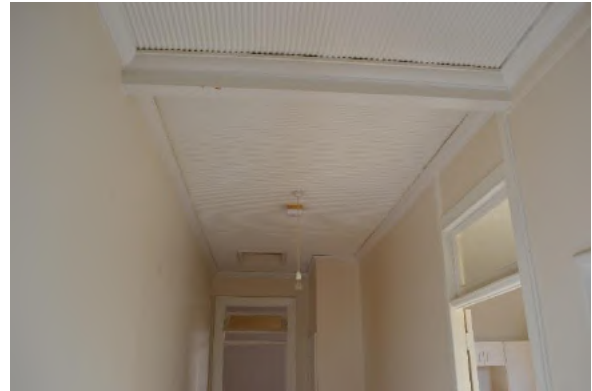
Figure 6.35 Second floor landing ceiling (space 2.1)—50A / 46–56 Gloucester Street, showing the ripple iron ceiling laid in different directions on either side of the transverse I-beam. (Source: GML Heritage, July 2016)

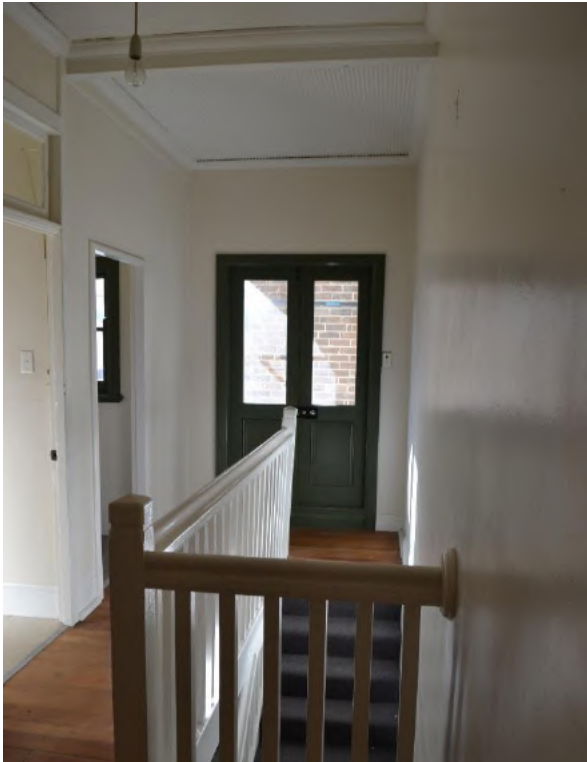
Figure 6.36 Second floor landing (space 2.1)—50A / 48–56 Gloucester Street looking east showing ripple iron ceiling and transverse I-beam, original timber balustrade with moulded handrail, newel posts, door frame to the kitchen, and later architrave to the laundry and half glazed timber doors to the roof terrace. (Source: GML Heritage, July 2016)

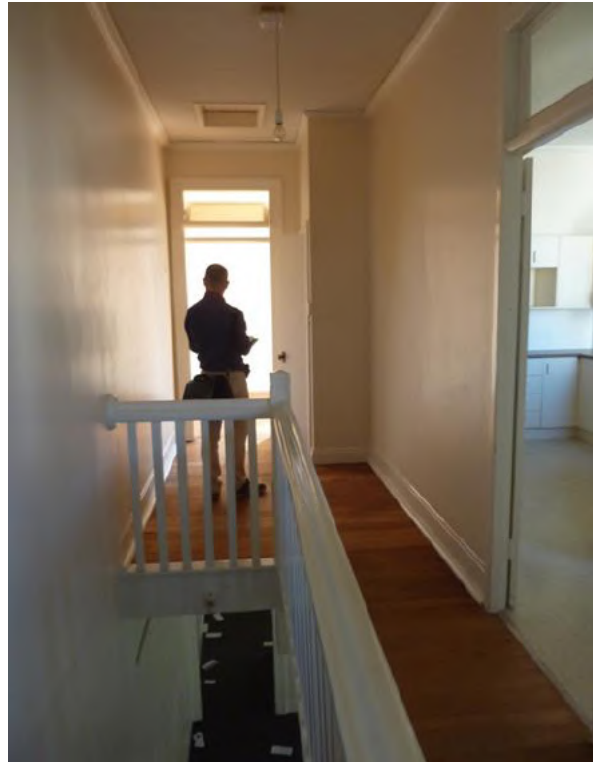
Figure 6.37 Second floor landing (space 2.1)—50A / 48–56 Gloucester Street, looking west, showing the original timber floors and modern built in cupboard at end of hall adjacent to bedroom (space 2.4). (Source: GML Heritage, July 2016)

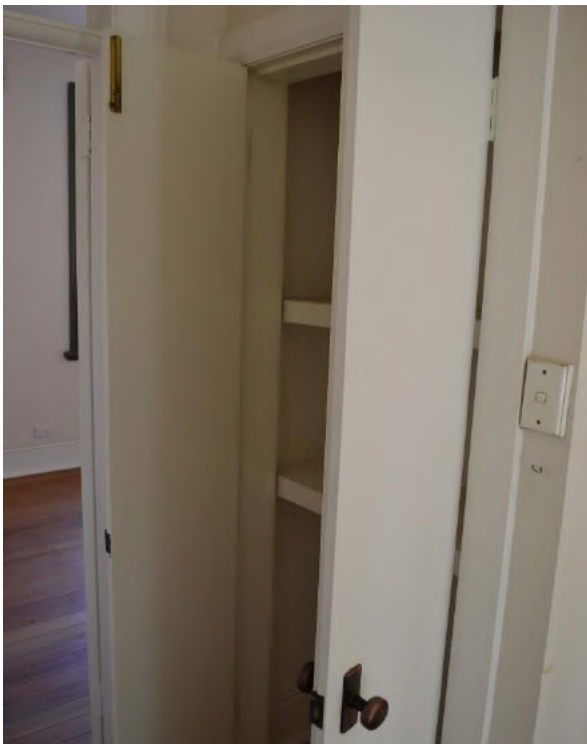
Figure 6.38 Modern cupboard built into the second floor landing (space 2.1)—50A / 48–56 Gloucester Street. (Source: GML Heritage, July 2016)
