46–56 Gloucester Street, The Rocks

SHR No. 01609

Conservation Management Plan

Report prepared for NSW Land and Housing Corporation

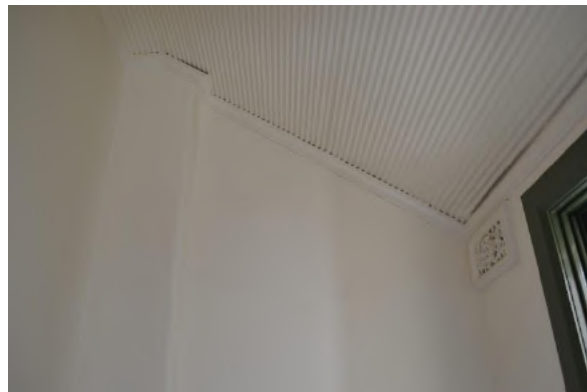
Figure 6.39 Laundry (space 2.2) showing original raked ripple iron ceiling, decorative wall vent and timber cornice—50A / 48–56 Gloucester Street. (Source: GML Heritage, July 2016)

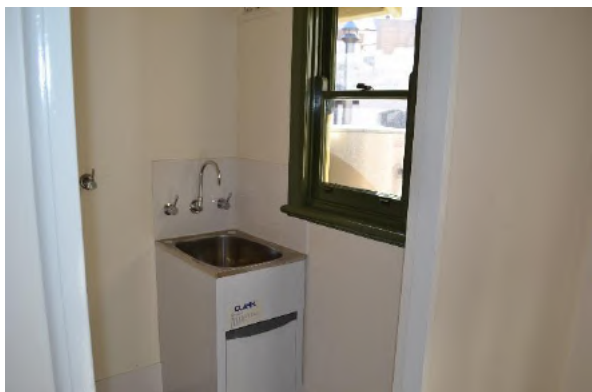
Figure 6.40 Laundry (space 2.2)—50A / 48–56 Gloucester Street, showing the modern fitout and window (Source: GML Heritage, July 2016)

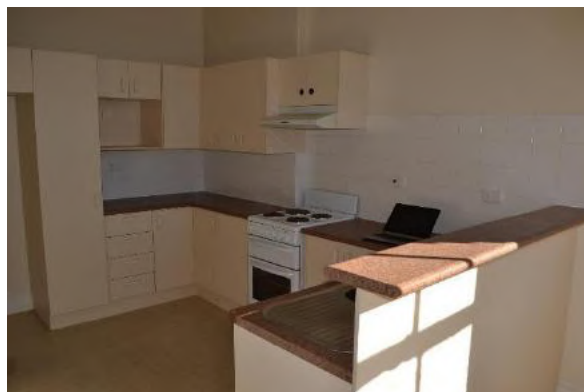
Figure 6.41 Kitchen (space 2.3) showing the modern fitout—50A / 48–56 Gloucester Street (Source: GML Heritage, July 2016)

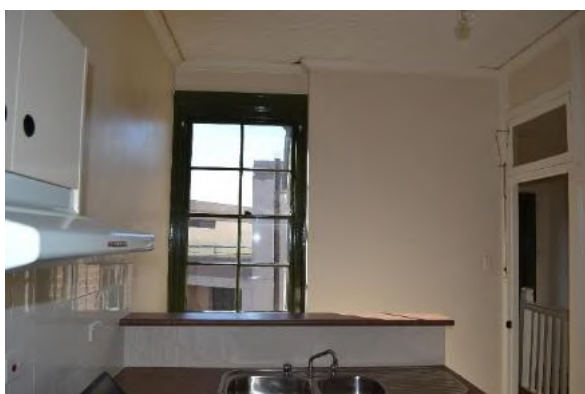
Figure 6.42 Kitchen (space 2.3) showing the original ripple iron ceiling, moulded timber cornice, timber door frame and fanlight, and original double hung window joinery—50A / 48–56 Gloucester Street (Source: GML Heritage, July 2016)

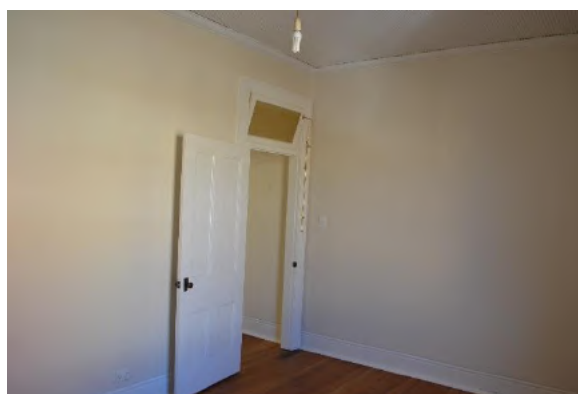
Figure 6.43 Dining Room (Space 2.4)—50A / 48–56 Gloucester Street, showing four panel door and original architrave. Original cement run skirting with timber quad mould and original timber floor. (Source: GML Heritage, July 2016)

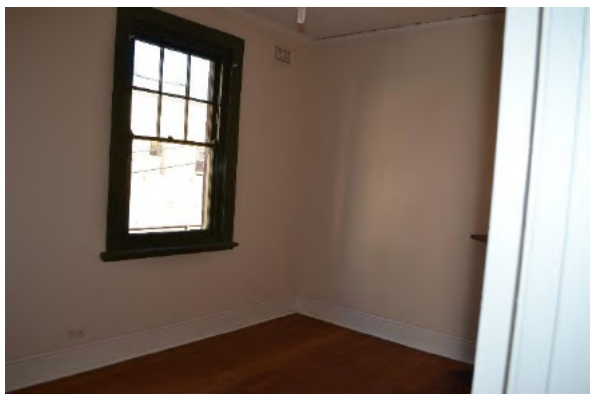
Figure 6.44 Dining room (space 2.4) showing the original double hung window, ripple iron ceiling and timber floor—50A / 48–56 Gloucester Street. (Source: GML Heritage, July 2016)

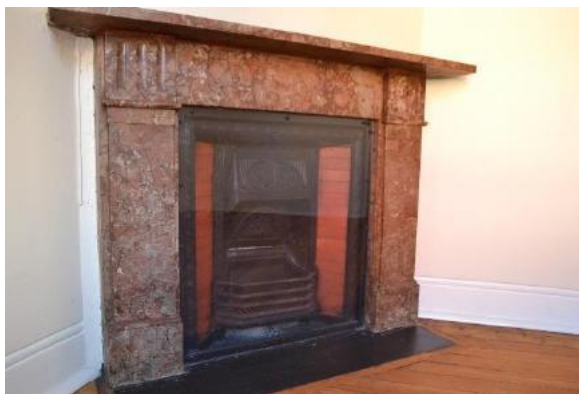
Figure 6.45 Fireplace (space 2.4) with early cast iron grate with tiled sides, and red marble chimney piece—50A / 48–56 Gloucester Street. (Source: GML Heritage, July 2016)

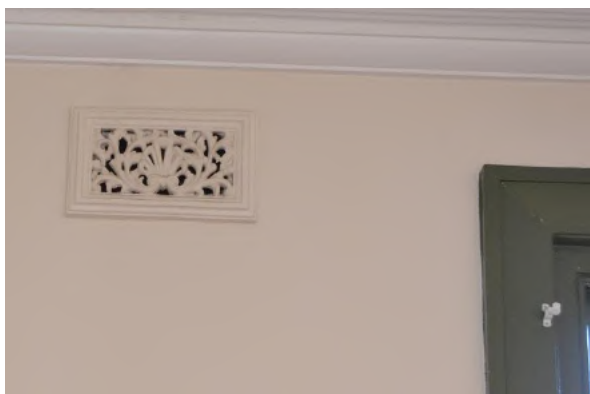
Figure 6.46 Decorative plaster wall vent (space 2.4)—50A / 48–56 Gloucester Street. (Source GML Heritage July 2016)

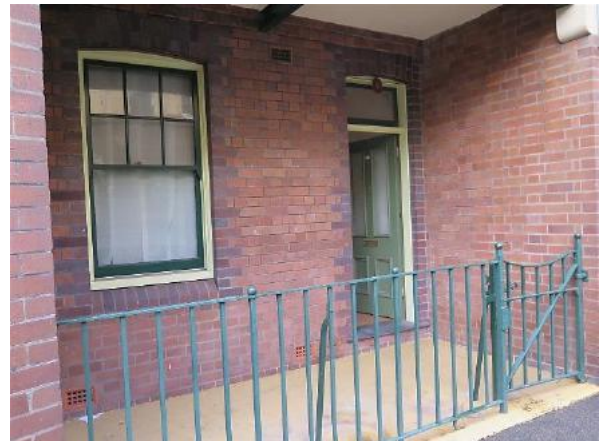
The front elevation, which presents only the ground floor to the street, is single-fronted, in fair-faced brickwork in English bond, flush jointed in grey mortar (Figure 7.7). The flat has its own ornamental wrought iron gate with mid-rail and diagonal brace, with a hinge fixed to the flank wall and a socket fixing for the hinge-stile (Figure 7.7). The gate has an original wrought iron latch and latch plate with iron rivets. A wrought iron palisade fence with square section pales and top and bottom rail extends to the opposite wall flank, the uprights having ball finials (matching the stiles of the gate). The four-panel, bolection moulded entry door has glazed upper panels in wired glass, letterbox, spyhole, enamelled number plaque and modern mortise lock and improvised door-pull (the central knob is missing) (Figure 7.8). There is a pivot fanlight over (Figure 7.7). The entry door and window have dark brick surrounds. Both have segmental arches supported on flat iron arch bars (Figure 7.7, Figure 7.9). The window is a six-over-one double hung sash window, and has a chamfered brick sill. The door has a slate threshold (Figure 7.8, Figure 7.9).

Figure 7.7 Front porch (space E.1) showing external brick walls, timber entry door with fanlight, wrought iron fence and gate, double-hung window with chamfered brick sill—52 / 46–56 Gloucester Street (Source: GML Heritage, July 2016)

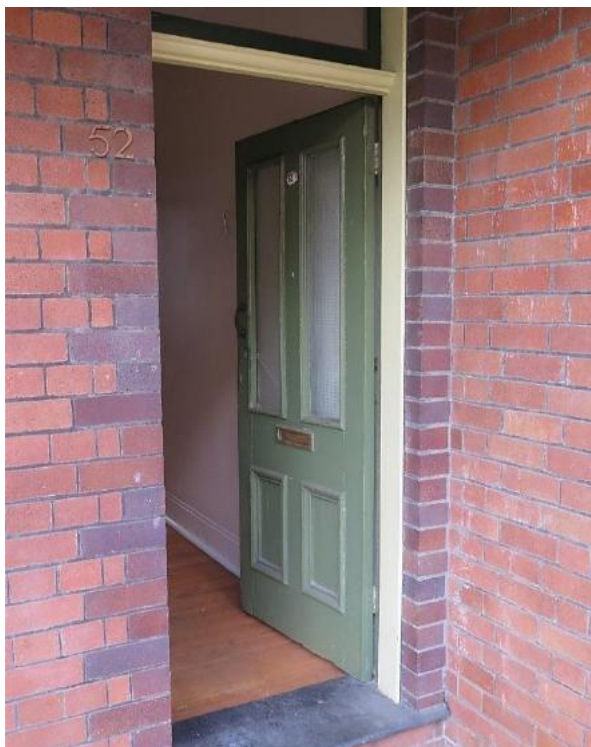
Figure 7.8 The four-panel front door with bolection moulds to bottom panels and wired glass to top panels, fanlight above, dark brick surround, number plate and slate threshold—52 / 46–56 Gloucester Street (Source: GML Heritage, July 2016)

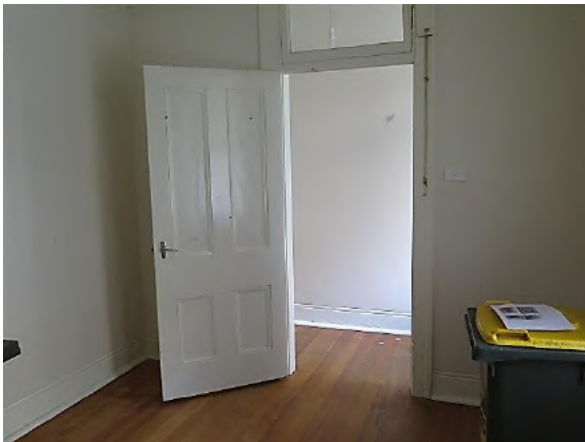
Figure 7.12 Four-panel timber door with fanlight above and reproduction fanlight mechanism between front bedroom (space G.2) and entry (space G.1)—52 / 46–56 Gloucester Street. (Source: GML Heritage, July 2016)

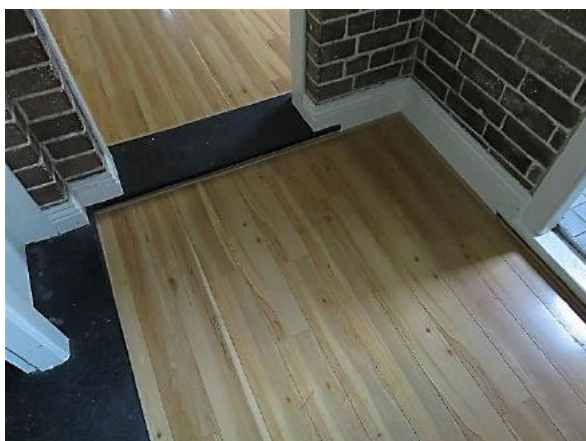
The rear wing contains the former rear porch (space G.4), bathroom (space G.5) and rear bedroom (space G.6). The former porch (space G.4) has a modern timber floor with wider-than-usual boards, which is set lower than the slate thresholds of the doors opening into the space (Figure 7.16). The former porch walls are unrendered and unpainted red-brown brick with a timber skirting and a plaster cornice to the plasterboard ceiling (Figure 7.17). The door openings have arched brick heads supported on flat iron arch bars (Figure 7.17). The bathroom door appears to have been relocated. The original arched opening to the porch has been infilled (c.1988) with a round-headed double casement window with textured glass and vertical vertical V-jointed tongue and groove boarding below (Figure 7.15).

Figure 7.16 Modern timber-laminate floor of the former rear porch (space G.4). The original slate thresholds survive in the doorways to the living room (space G.3) and rear bedroom (space G.6)—52 / 46–56 Gloucester Street. (Source: GML Heritage, July 2016)

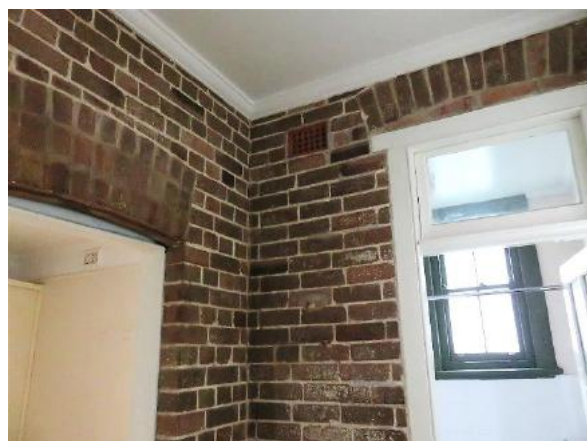
Figure 7.17 Former rear porch (space G.4) showing the brick arched heads above the doors to the rear bedroom (space G.6) and bathroom (space G.5). the latter appears to have been altered—52 / 46–56 Gloucester Street. (Source: GML Heritage, July 2016)

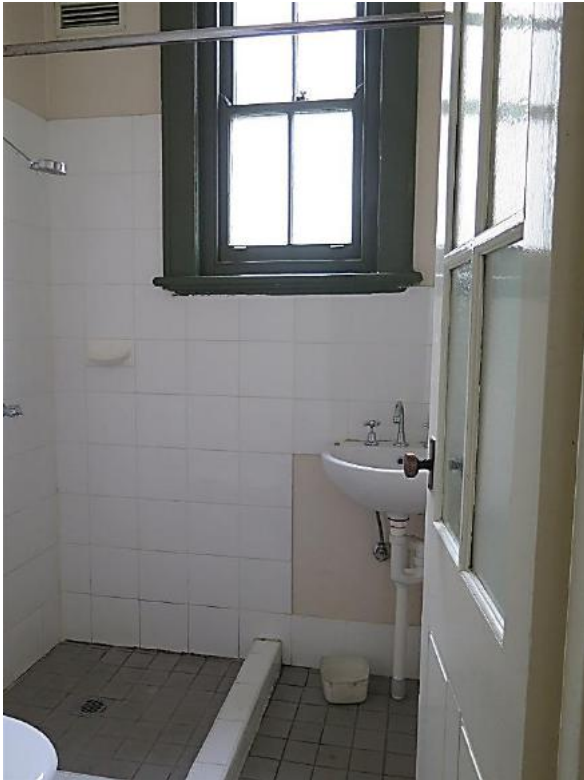
Figure 7.18 The bathroom (space G.5) showing modern tiling and fitout—52 / 46-56 Gloucester Street. The double-hung window with its sillboard and architrave is original (Source: GML Heritage, May 2016)

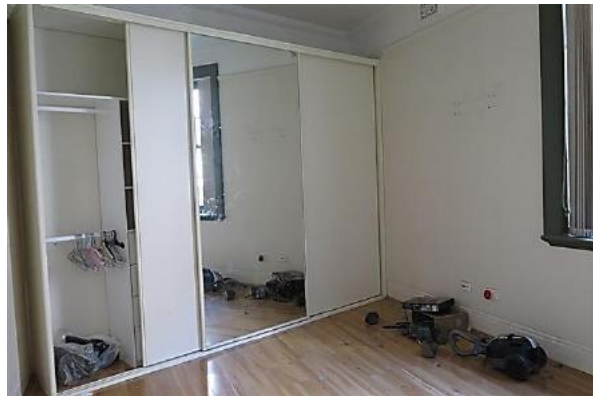
Figure 7.21 Rear bedroom (space G.6) showing modern wardrobe addition and timber floor covering—52 / 46-56 Gloucester Street. (Source: GML Heritage, July 2016)

Element	Description (Material, Form, Type, Construction, Missing)	Date	Significance Ranking	Condition
Architraves	Moulded timber	O	E	G
Wall vents	Decorative plaster, scroll pattern	O	E	G
Other	Light fittings Modern wardrobe	L 20 th L 20 th / E 21 st	L I	F F

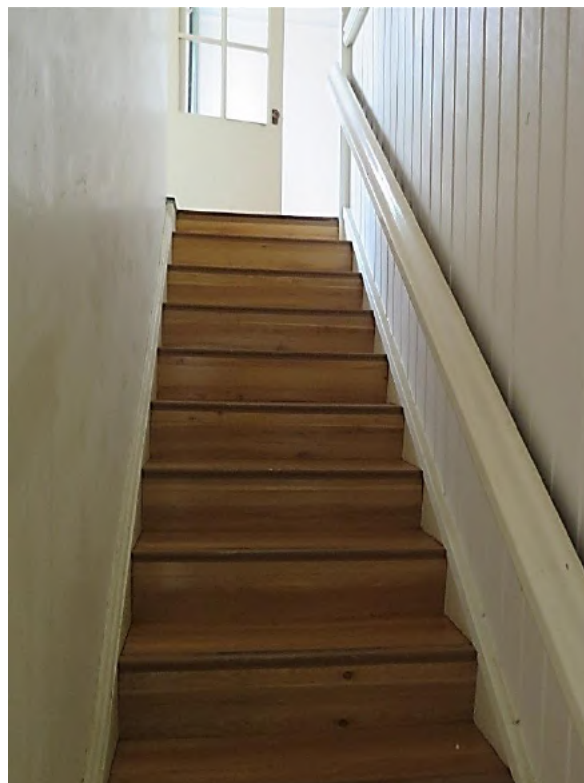
Figure 7.23 The stair (space G.7) showing replaced stair treads, original timber handrail and T&G boarding to the western wall—52 / 46–56 Gloucester Street. (Source: GML Heritage, July 2016)

Stairs	Timber stair—original strings, chamfered newel post and moulded timber handrail on metal brackets	O	E	G
	Timber stair—treads and risers replaced/alterd and boarded soffit	L 20 th	M	G
	Timber stair—lower flight extending into space LG.1—with closed strings and open timber balustrade consisting of square newel post and balusters and moulded timber handrail	O (treads are L20th replacement)	E/M	G
Walls	Painted cement render dado	O	E	G
	Painted set plaster above dado	O	E	G
	Vertical V-joint boarding to west wall	L 20 th	H	G

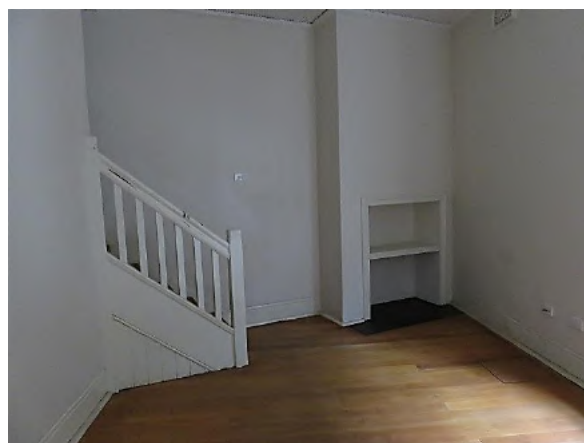
Figure 7.26 Timber floor in dining room (space LG.1) and vinyl floor in former porch. The half-glazed doors and fanlight are late 20th century—52 / 46–56 Gloucester Street. (Source: GML Heritage, July 2016)

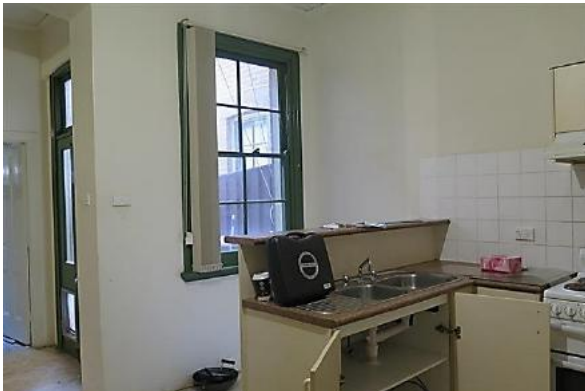
Figure 7.28 The kitchen (space LG.2) showing the double hung sash window, which has been relocated, and late-twentieth century fitout—52 / 46–56 Gloucester Street. (Source: GML Heritage, July 2016)

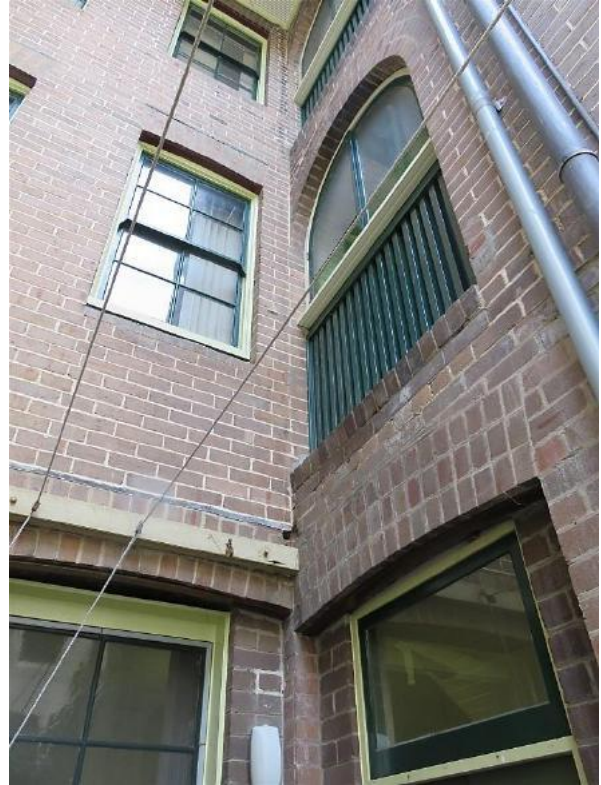
Figure 7.39 Brick arch and iron lintel bar over the rear door fanlight, also showing laundry hoist fixings above the window and brick arched head—52/46–56 Gloucester Street. (Source: GML Heritage, June 2016)

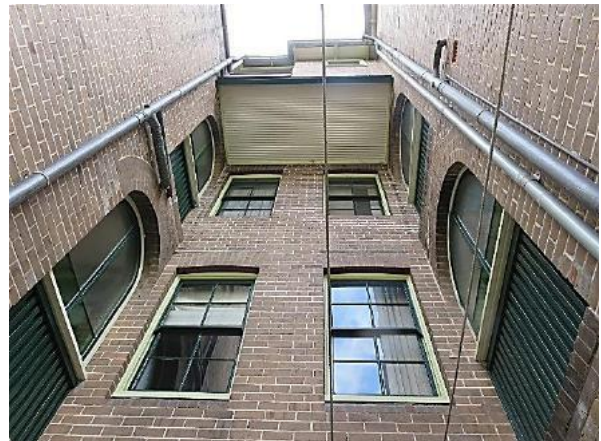
Figure 7.41 Round-arched window of the former rear porch on the southern elevation showing modern infill. Also original brick arched head to and chamfered window sill to the window of space G.3—52 / 46–56 Gloucester Street. (Source: GML Heritage, July 2015)

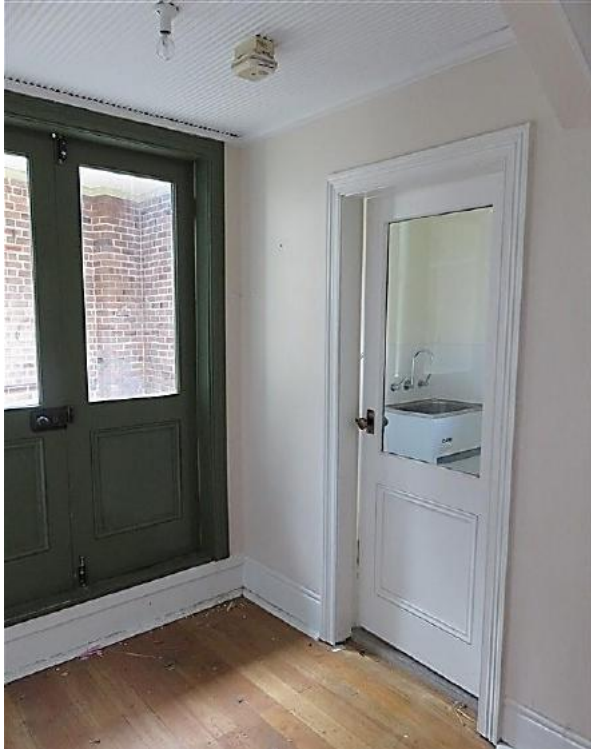
Figure 8.42 Second floor landing (space 2.1) showing the cement rendered skirting and later half glazed doors to the roof terrace and laundry—52A / 46–56 Gloucester Street. (Source: GML Heritage, July 2016)

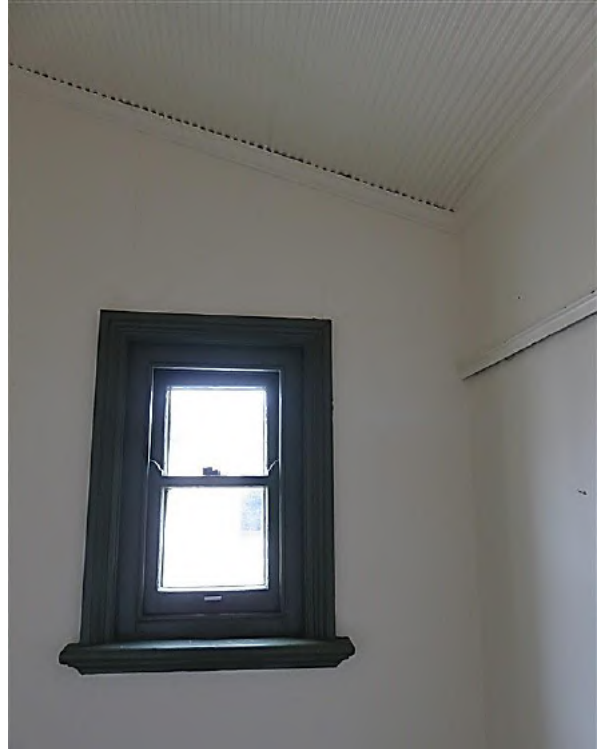
Figure 8.43 Laundry (space 2.2) showing original raked ripple iron ceiling and modern sash window—52A / 46–56 Gloucester Street. (Source: GML Heritage, July 2016)

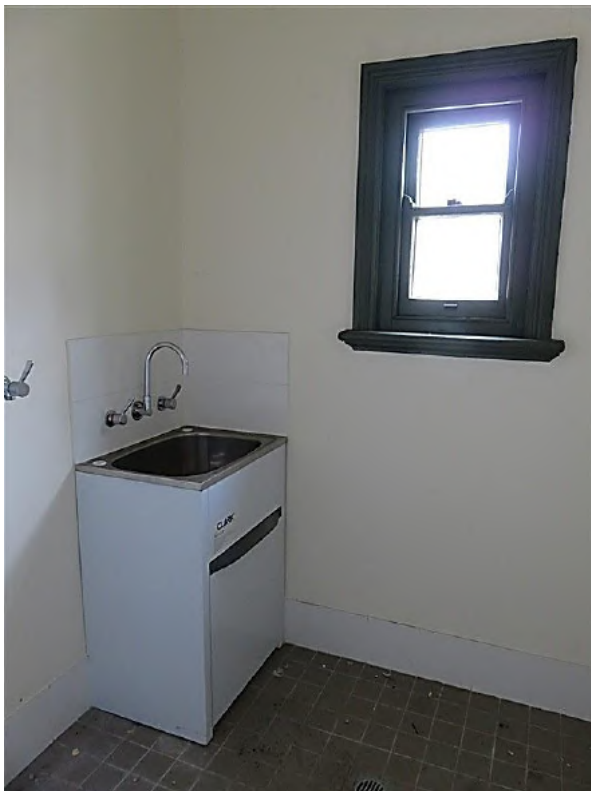
Figure 8.44 Laundry (space 2.2) with modern flooring, skirting and fitout—52A / 46–56 Gloucester Street. (Source: GML Heritage, July 2016)

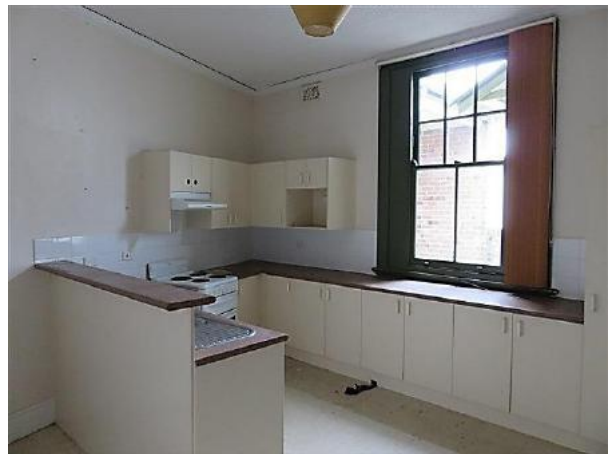
Figure 8.45 Kitchen (space 2.3) showing modern fitout and ripple iron ceiling with moulded timber cornice. Window matches others in the block but may have been relocated—52A / 46–56 Gloucester Street. (Source: GML Heritage, July 2016)

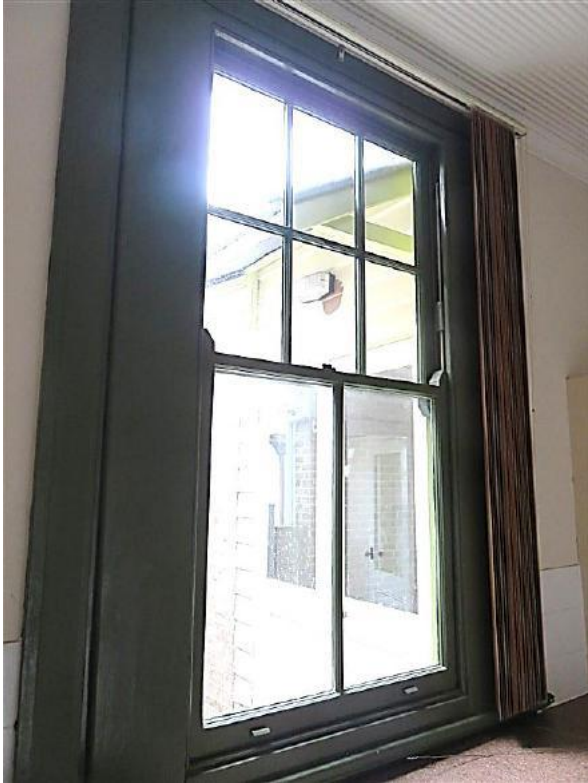
Figure 8.46 Double hung sash window to kitchen (space 2.2), with six lights over two (the window may have been relocated from elsewhere in the building)—52A / 46–56 Gloucester Street. (Source: GML Heritage, July 2016)

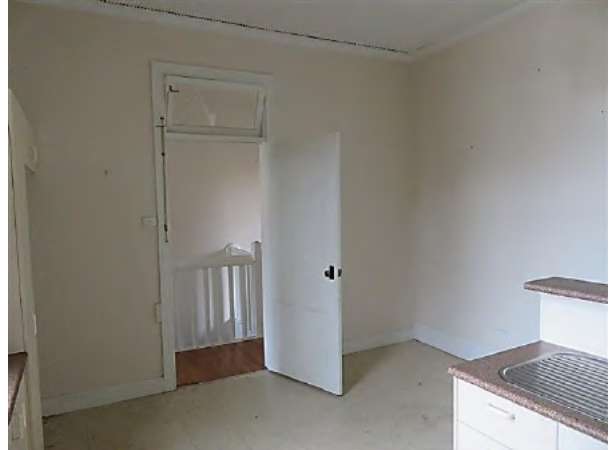
Figure 8.47 Kitchen (space 2.3) showing original four panel door, with architraves and fanlight above, original floor with later lino tiles and original cement skirtings—52A / 46–56 Gloucester Street. (Source: GML Heritage, July 2016)

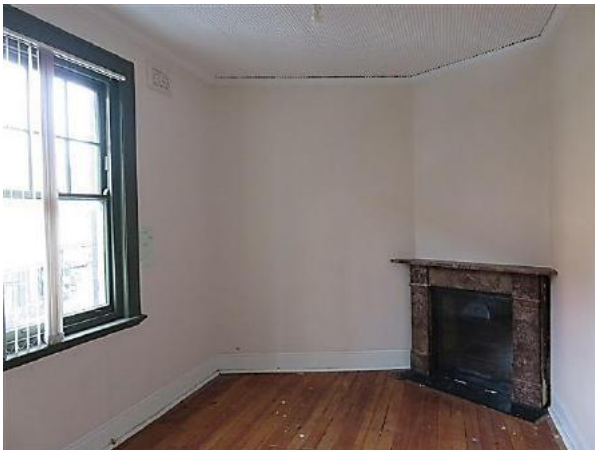
The dining room (space 2.4) has almost identical features to the downstairs front bedroom, but with no picture rail. It has two original double hung window in its western wall, complete with architraves, sill board and moulding (Figure 8.48). The corner fireplace has a marble chimney pieces, cast iron grate and concrete hearth (Figure 8.49). The fireplace has a Perspex cover. The door to this room has been replaced with a modern four panel door with raised panels, although the frame, fanlight and architraves are original (Figure 8.51). The room retains its original double hung window with its original architraves, sill board and moulding (Figure 8.50).

Figure 8.48 Front room on second floor (space 2.4) showing the original double hung window, ripple iron ceiling, cement skirtings, timber floor and marble chimney piece to fireplace—52A / 46–56 Gloucester Street. (Source: GML Heritage, July 2016)

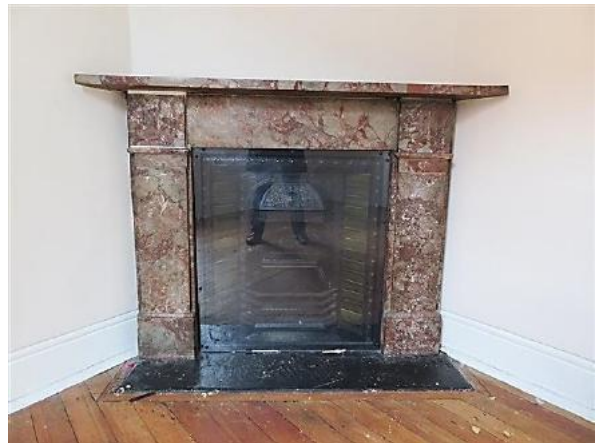
Figure 8.49 Fireplace in the front room on second floor (space 2.4) with early cast iron grate with tiled sides (covered with perspex), and red marble chimney piece—52A / 46–56 Gloucester Street. (Source: GML Heritage, July 2016)

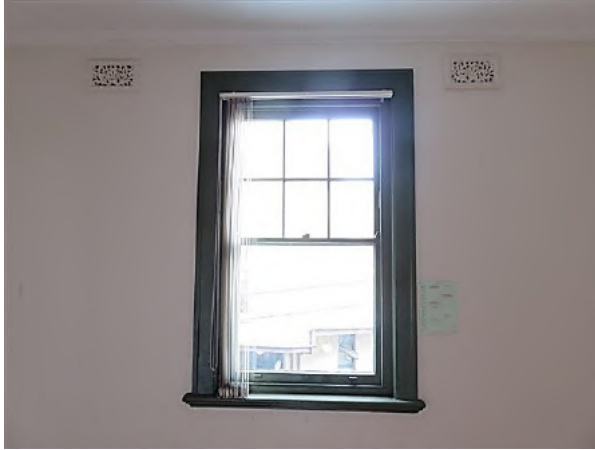
Figure 8.50 Original double hung timber window in the front room (space 2.4) flanked by a pair of decorative plaster wall vents—52A / 46–56 Gloucester Street. (Source: GML Heritage, July 2016)

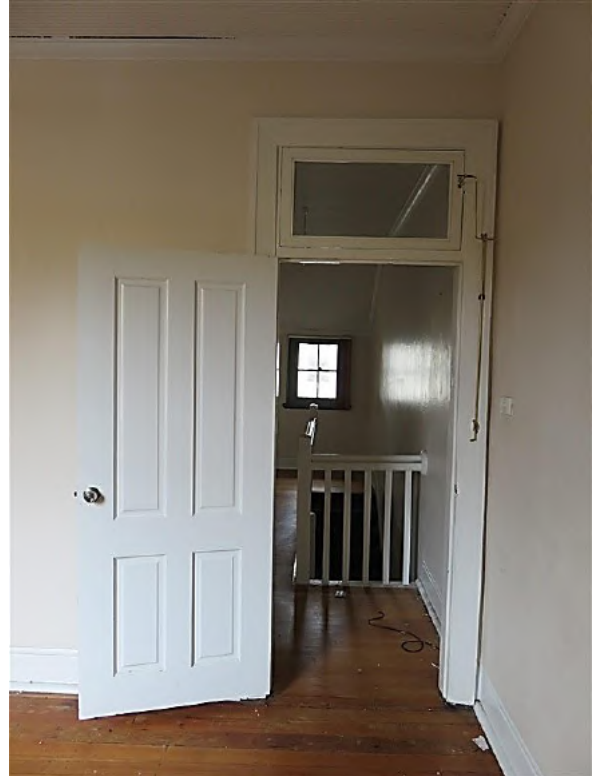
Figure 8.51 Four panel door and fanlight to space 2.4 with original architraves and original cement rendered skirting with timber quad mould—52A / 46–56 Gloucester Street. (Source: GML Heritage, July 2016)

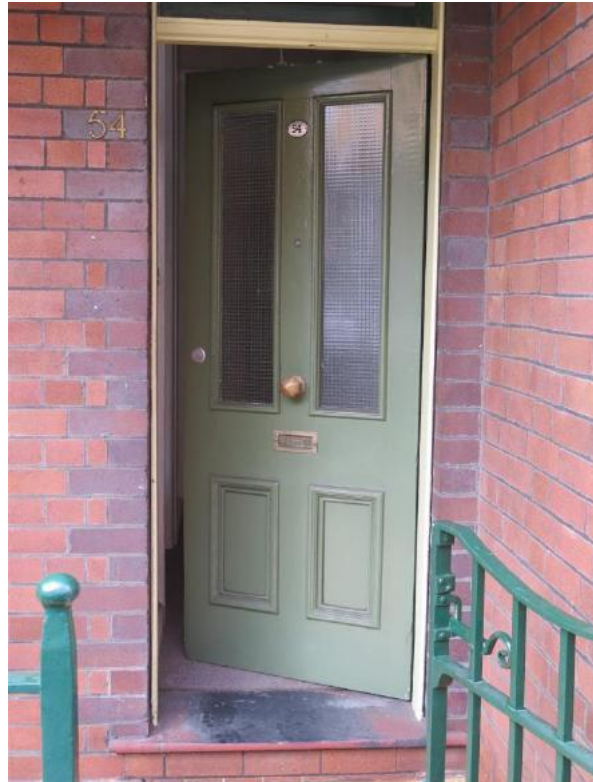
The front elevation, which presents only the ground floor to the street, is single-fronted, in fair-faced brickwork in English bond, flush jointed in grey mortar (Figure 9.8). The flat has its own ornamental wrought iron gate with mid-rail and diagonal brace, with a hinge fixed to the flank wall and a socket fixing for the hinge-stile (Figure 9.8). The gate has an original wrought iron latch and latch plate with iron rivets. A wrought iron palisade fence with square section pales and top and bottom rail extends to the opposite flank wall, the uprights having ball finials (matching the stiles of the gate). The four-panel, bolection moulded entry door has glazed upper panels in wired glass, a central brass knob, letterbox, spyhole, enamelled number plaque and modern night latch (Figure 9.7, **Figure 9.9**). There is a pivot fanlight over. The entry door and window have dark brick surrounds. Both have arched heads supported on flat iron arch bars. The window is a six-over-one double hung sash window, and has a chamfered brick sill. The door has a slate threshold (Figure 9.10)

Figure 9.8 Front porch (space E.1) showing external brick walls, timber entry door with fanlight, wrought iron fence and gate, double-hung window with chamfered brick sill—54 / 46–56 Gloucester Street. (Source: GML Heritage, July 2016)

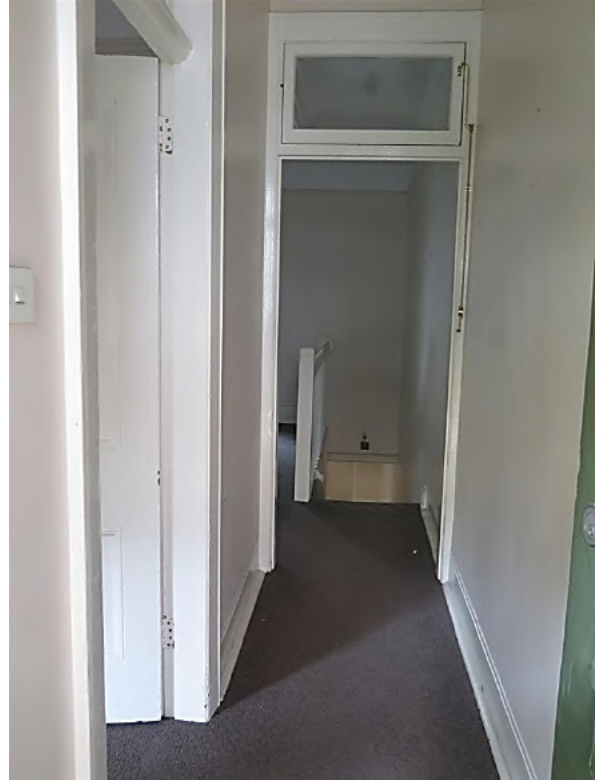
Figure 9.12 Four-panel timber door with fanlight above and reproduction mechanism between the front bedroom (space G.2) and entry (space G.1)—54 / 46–56 Gloucester Street. (Source: GML Heritage, July 2016)

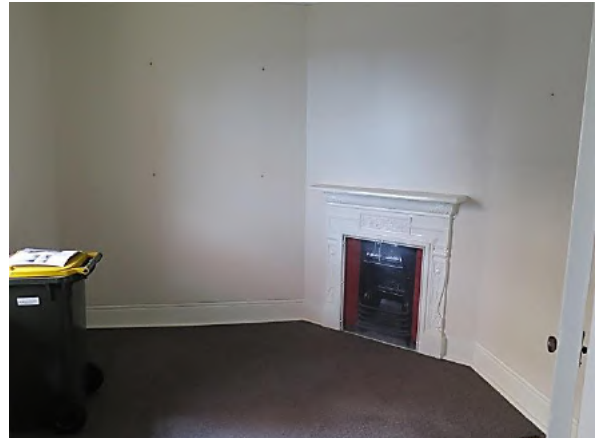
The living room (space G.3) has timber floor, corner fireplace (blocked up) with concrete hearth, cement run skirtings, timber cornice, and timber double-hung sash window to the rear (Figure 9.14 and Figure 9.15). There is a painted timber balustrade with square balusters to the staircase giving access to the lower ground floor.

Figure 9.14 The living room (space G.3) showing cement run skirtings, timber cornice, picture rail and timber double-hung sash window—54 / 46–56 Gloucester Street. (Source: GML Heritage, June 2016)

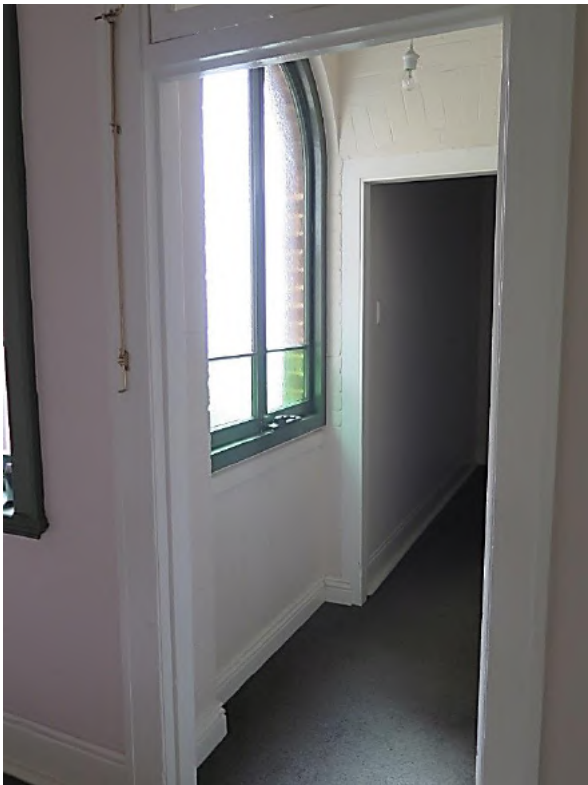
The bathroom (space G.5) has a modern fit-out with modern ceramic tiled floor and walls, modern or repaired original plaster above, and plasterboard ceiling (Figure 9.17 and Figure 9.19). The bathroom has an original half-glazed timber door and pivot fanlight over.

Figure 9.17 Half-glazed timber door to the bathroom (space G.5)—54 / 46–56 Gloucester Street. (Source: GML Heritage, July 2016)

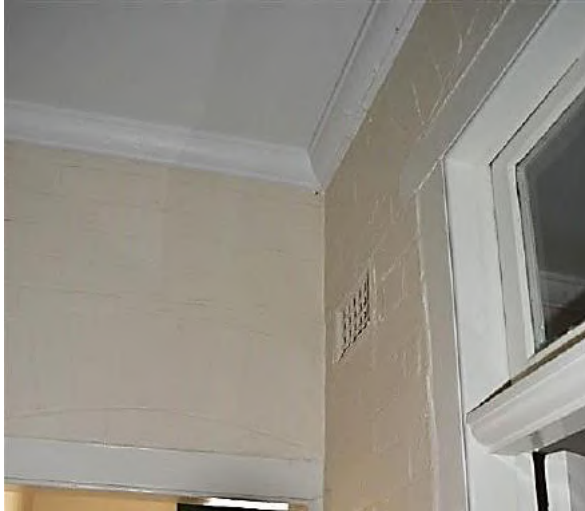
Figure 9.19 Bathroom (space 1.5) showing the plaster ceiling, timber cornice and decorative plaster wall vent—54 / 46–56 Gloucester Street. (Source: GML Heritage, July 2016)

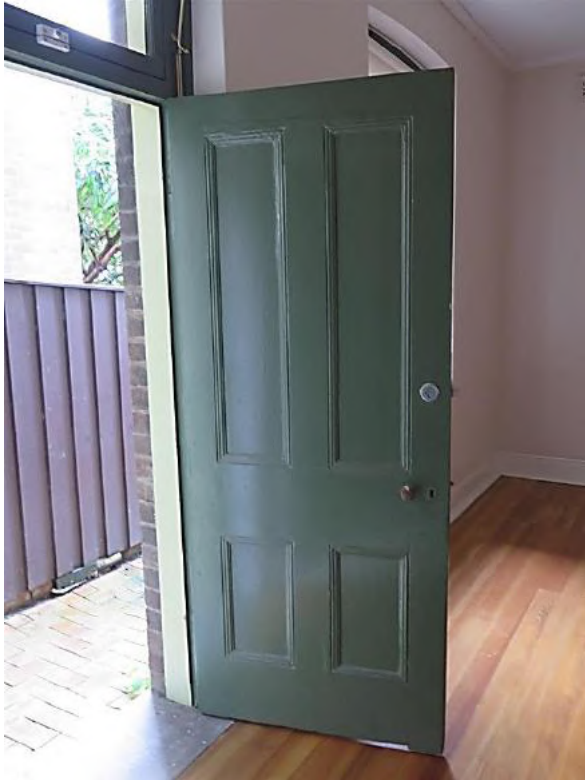
Figure 9.26 Four panel sunk-moulded external door on lower ground-floor level (space LG.1)—54 / 46–56 Gloucester Street. (Source: GML Heritage, July 2016)

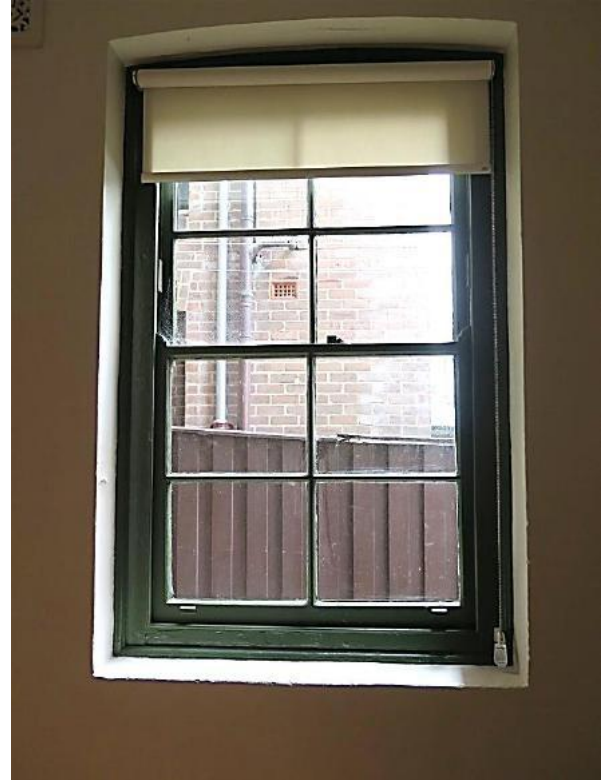
Figure 9.27 Lower ground-floor level timber double hung sash window with rendered reveals (space LG.1)—54 / 46–56 Gloucester Street. (Source: GML Heritage, July 2016)

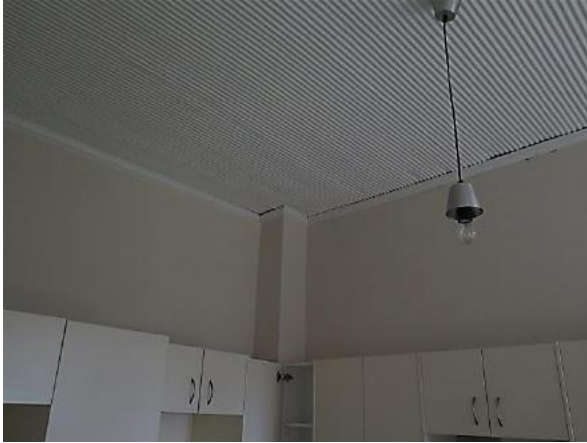
Figure 9.30 Original ripple iron ceiling in kitchen and modern light fixture (space LG.2)—54 / 46–56 Gloucester Street. (Source: GML Heritage, July 2016)

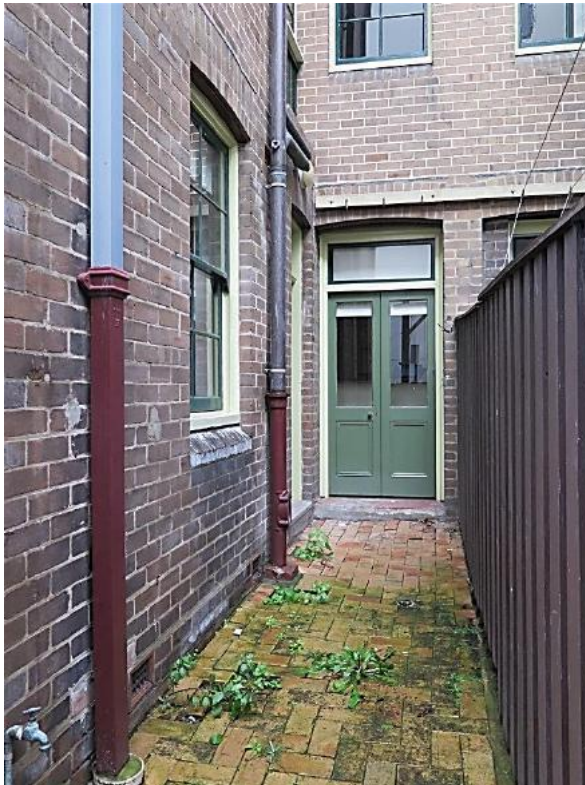
Figure 9.35 Rear wing and rear façade showing copper service pipes and later porch opening infill—54 / 46–56 Gloucester Street. (Source: GML Heritage, July 2016)

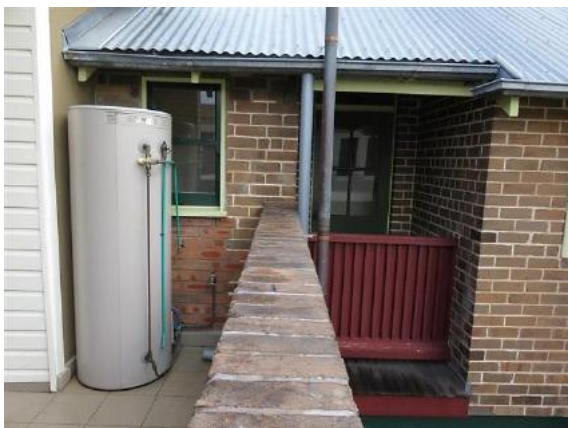
Some alterations have been made to incorporate the laundry (space 2.2) into what was most likely an external WC accessed from the roof terrace (Figure 10.42). A window has been introduced where the door originally was located (Figure 10.14, Figure 10.42). The laundry (space 2.2) and kitchen (space 2.3) have modern fit-outs and floor/wall finishes (tiled floor in the laundry and vinyl squares in the kitchen), but retain original cement run skirtings, ripple iron ceilings and moulded timber cornices (Figure 10.42, Figure 10.43, Figure 10.44). The door openings and joinery to the kitchen and laundry are modern (Figure 10.39). The original door opening to the kitchen (evidenced by the remaining timber door frame) has been blocked up (Figure 10.44). A chimney flue runs up the southwest corner of the kitchen from the fireplace and flat below (Figure 10.43). An original half glazed door, with fanlight over, opens from the kitchen out onto a small balcony (Figure 10.16, Figure 10.45, Figure 10.46). The door retains its original architraves. The timber floor of the balcony has been replaced, but the boarded ceiling is original (Figure 10.15, Figure 10.16).

Figure 10.14 Rear elevation of flat 54A showing the recessed balcony off the kitchen (space 2.3) and new brickwork and window to the laundry (space 2.2)—54A / 46–56 Gloucester Street. (Source: GML Heritage, July 2016)

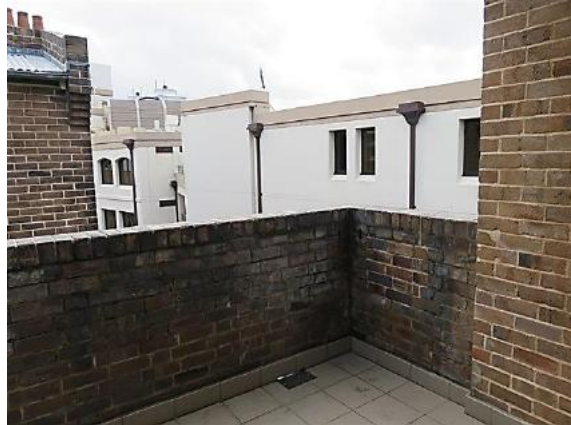
The roofed area of the roof top terrace is partially enclosed by two brick walls (Figure 10.18). The roof terrace has a modern tiled floor, which drains to a floor drain adjacent to the balustrade (Figure 10.17, Figure 10.18). The opening to the former garbage chute previously located on the rear wall has been bricked up (Figure 10.17). There is evidence of the former laundry copper having been removed from the skillion roofed area. The glass doors opening onto the terrace are set in a weatherboard wall (Figure 10.19). The side wall of the stair landing is rendered and painted (Figure 10.19). The hot water system is located on the roof terrace, outside the laundry.

Figure 10.17 Roof terrace (space E.1) showing tiled floor and evidence of the original garbage chute (bricked up)—54A / 46–56 Gloucester Street. (Source: GML Heritage, July 2016)

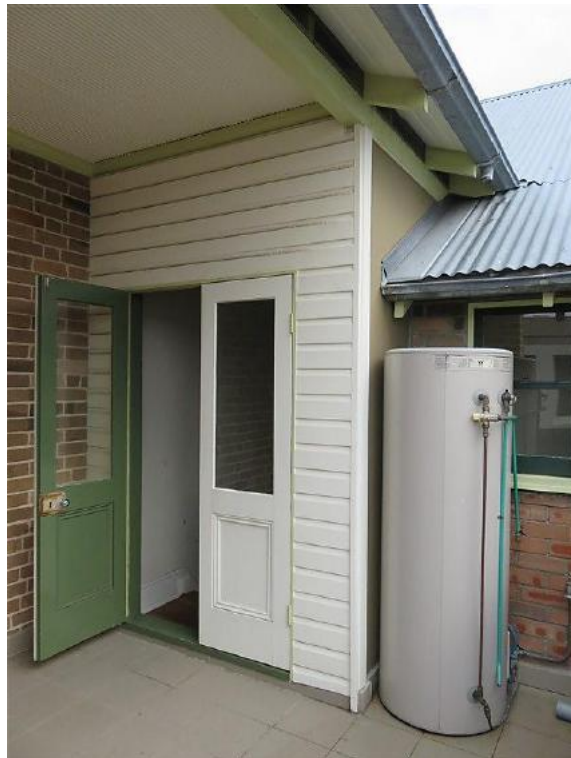
Figure 10.19 Rear wall of the flat opening onto the roof terrace (space E.1), showing recent weatherboard wall, pair of half glazed doors and rendered finish to stair hall wall. The window is also recent, replacing a previous door—54A / 46–56 Gloucester Street. (Source: GML Heritage, July 2016)

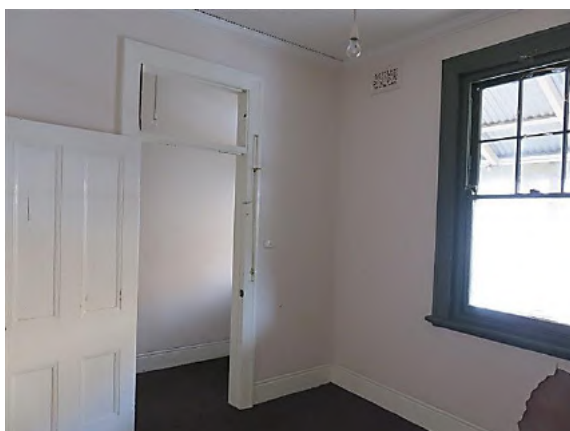
Figure 10.22 Front bedroom (space 1.2) showing original four panel door, frame and fanlight above, with original architraves. The room has two decorative plaster wall vents—54A / 46–56 Gloucester Street. (Source: GML Heritage, July 2016)

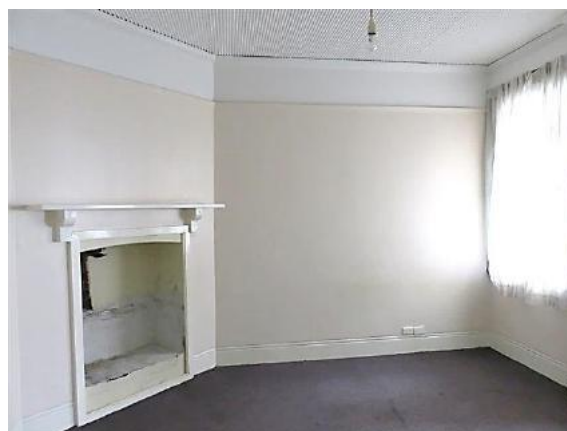
The living room (space 1.3) has timber floor (carpeted), cement run skirtings, ripple iron ceiling, moulded timber cornice and timber picture rail (Figure 10.23, Figure 10.25). There is a timber double-hung sash window (four panes over four) to the rear with original architraves, sill board and moulding in the east wall and a doorway through to space 1.4 (Figure 10.25). There is a corner fireplace with brick hob and original mantel shelf supported on brick brackets (Figure 10.23, Figure 10.24). The concrete hearth exists beneath the carpet.

Figure 10.23 Living room (space 1.3) showing cement run skirting, ripple iron ceiling, moulded timber cornice, timber picture rail and original fireplace with mantel shelf supported on curved brackets—54A / 46–56 Gloucester Street. (Source: GML Heritage, July 2016)

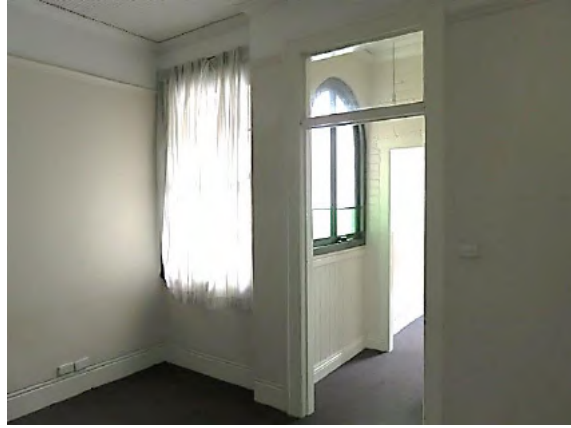
The rear wing contains the former rear porch (space 1.4), bathroom (space 1.5) and rear bedroom (space 1.6). Although the opening to the rear wing retains its original door frame with its original timber architraves, the door and fanlight are missing (Figure 10.25, Figure 10.28). The former porch has a

Figure 10.25 Living room (space 1.3) showing the original opening through to space 1.4. The frame and architrave are original. The door is missing and the fanlight has been replaced with fixed glazing—54A / 46–56 Gloucester Street. (Source: GML Heritage, July 2016)

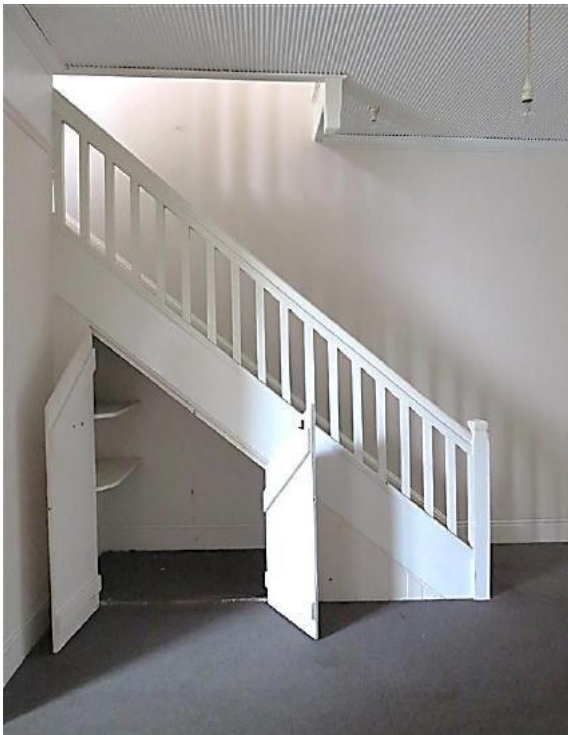
A timber staircase with stop chamfered newel posts, a moulded timber handrail is set against the south wall (Figure 10.26). The bottom of the top newel post extends down below the ceiling of space 1.3. The stair soffit is lined with V-joint timber boarding. The area under the stair is enclosed with timber vertical boarded wall to form a cupboard and is fitted with traditional timber shelving (Figure 10.26, Figure 10.27). A ledged and sheeted timber door, with air holes drilled through its top, is hung on strap hinges and provides access (Figure 10.27). The side of the stair where it passes the bathroom (space 1.5) is lined with ripple iron (Figure 10.37).

Figure 10.26 Living room (space 1.3) showing original timber stair against south wall, with closed stinger, simple square balusters, moulded handrail and newel posts—54A / 46–56 Gloucester Street. (Source: GML Heritage, July 2016)

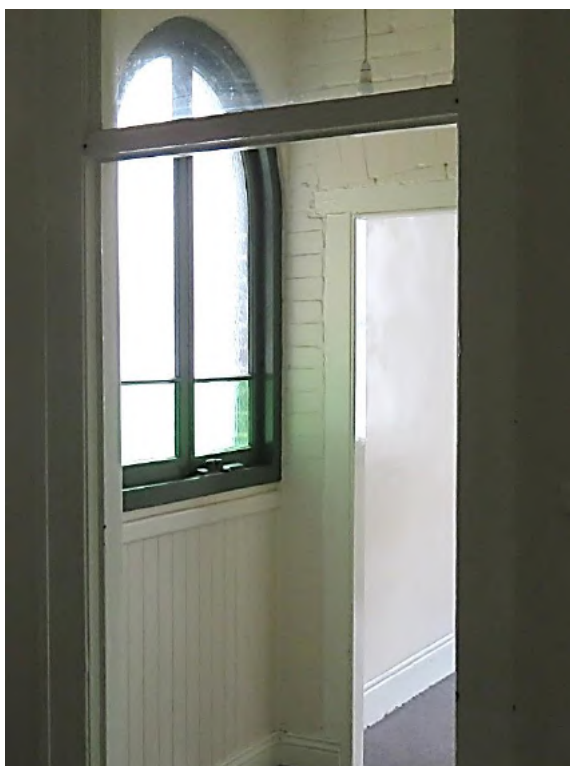
Figure 10.30 Casement windows and v-jointed vertical boarded panel below are late twentieth century infill to the original arched opening of the former rear porch—54A / 46–56 Gloucester Street. (Source: GML Heritage, July 2016)

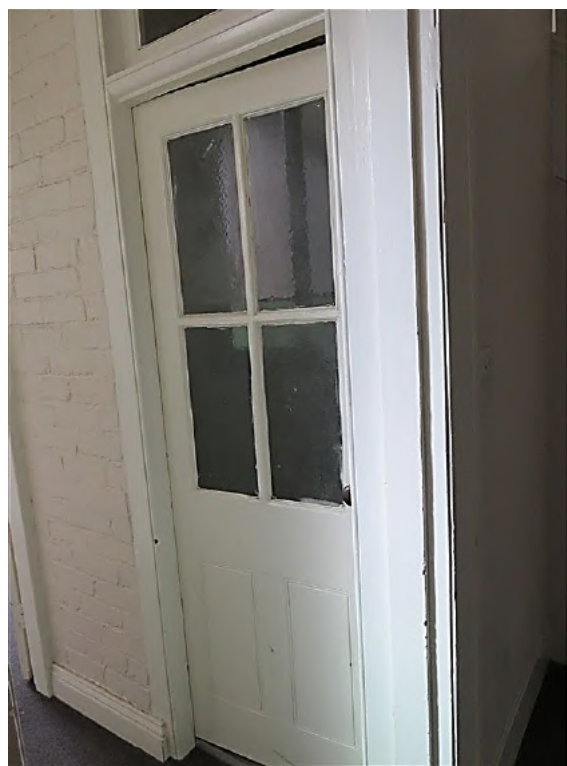
Figure 10.31 Original half glazed door to bathroom (space 1.5) showing obscured glass and bead flush panels. The transom detail over the door is original. The timber skirting is late twentieth century—54A / 46–56 Gloucester Street. (Source: GML Heritage, July 2016)

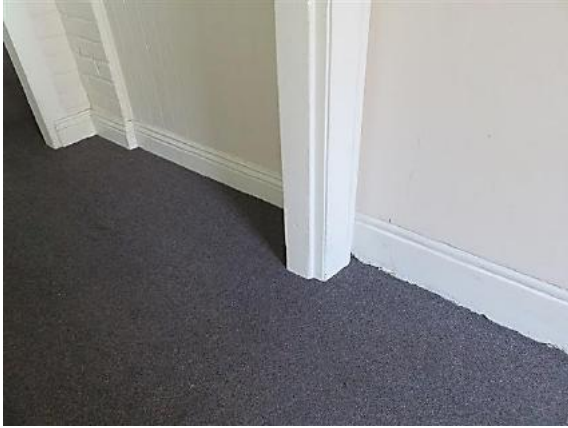
Figure 10.32 Detail of original skirting run in cement on the right and later timber skirting on the left (space 1.4)—54A / 46–56 Gloucester Street. (Source: GML Heritage, July 2016)

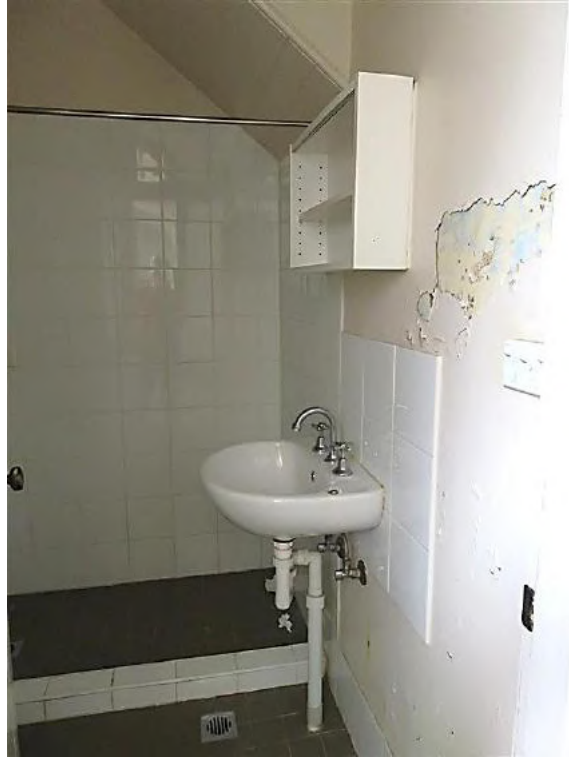
Figure 10.33 Bathroom (space 1.5) with modern refit—54A / 46–56 Gloucester Street. (Source: GML Heritage, July 2016)

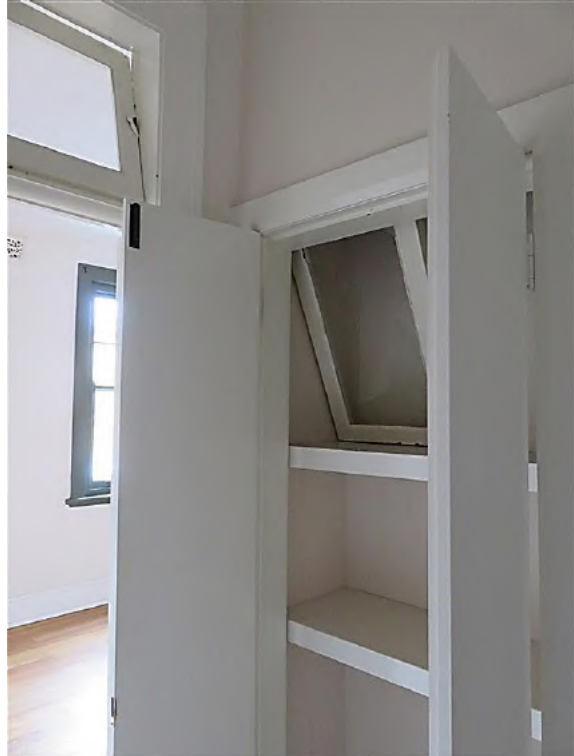
Figure 10.41 Modern cupboard with flush timber doors built into the second floor stair hall (space 2.1). The fanlight from one of the doorways on the first floor is stored in the cupboard—54A / 46–56 Gloucester Street. (Source: GML Heritage, July 2016)
