46–56 Gloucester Street, The Rocks

SHR No. 01609

Conservation Management Plan

Report prepared for NSW Land and Housing Corporation

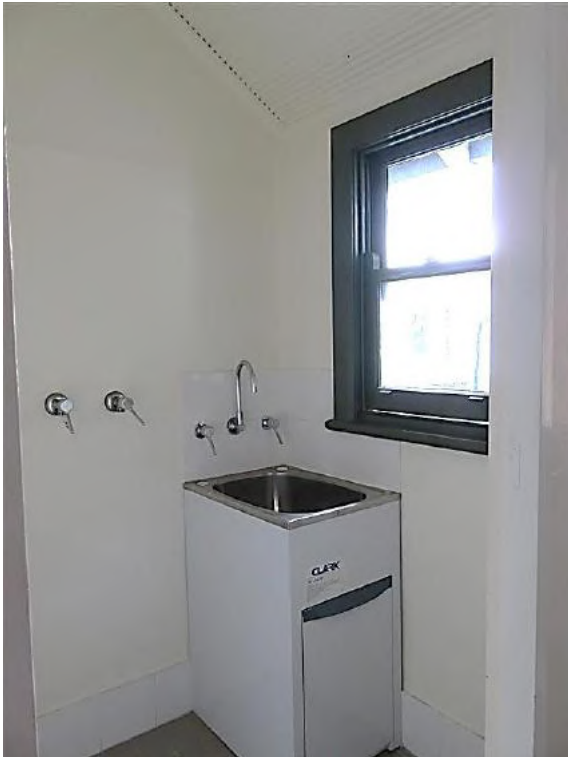
Some alterations have been made to incorporate the laundry (space 2.2) into what was most likely an external WC accessed from the roof terrace (Figure 10.42). A window has been introduced where the door originally was located (Figure 10.14, Figure 10.42). The laundry (space 2.2) and kitchen (space 2.3) have modern fit-outs and floor/wall finishes (tiled floor in the laundry and vinyl squares in the kitchen), but retain original cement run skirtings, ripple iron ceilings and moulded timber cornices (Figure 10.42, Figure 10.43, Figure 10.44). The door openings and joinery to the kitchen and laundry are modern (Figure 10.39). The original door opening to the kitchen (evidenced by the remaining timber door frame) has been blocked up (Figure 10.44). A chimney flue runs up the southwest corner of the kitchen from the fireplace and flat below (Figure 10.43). An original half glazed door, with fanlight over, opens from the kitchen out onto a small balcony (Figure 10.16, Figure 10.45, Figure 10.46). The door retains its original architraves. The timber floor of the balcony has been replaced, but the boarded ceiling is original (Figure 10.15, Figure 10.16).

Figure 10.42 Laundry (space 2.2) showing modern laundry tub unit and original raked ripple iron ceiling. The window is late 20th century—54A / 46–56 Gloucester Street. (Source: GML Heritage, July 2016)

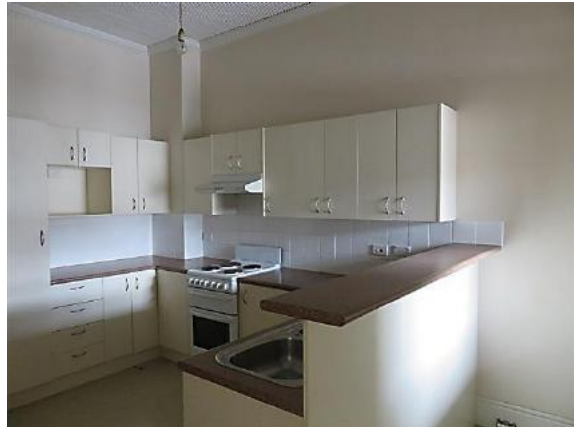
Figure 10.43 Kitchen (space 2.3) showing late twentieth century fitout, original ripple iron ceiling and timber cornice. A chimney flue rises in the northwest corner—54A / 46–56 Gloucester Street. (Source: GML Heritage, July 2016)

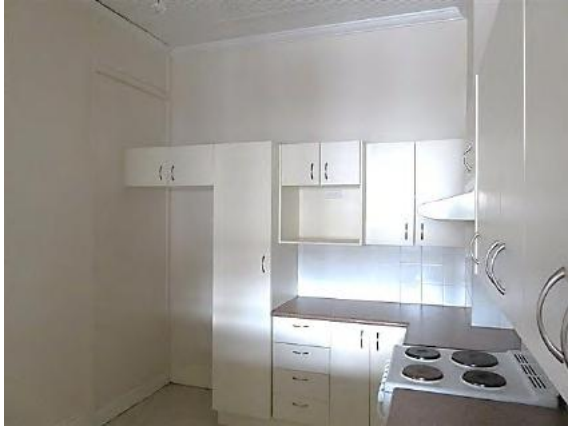
Figure 10.44 Kitchen (space 2.3) showing location of the original door frame in southwest corner. The opening is infilled—54A / 46–56 Gloucester Street. (Source: GML Heritage, July 2016)

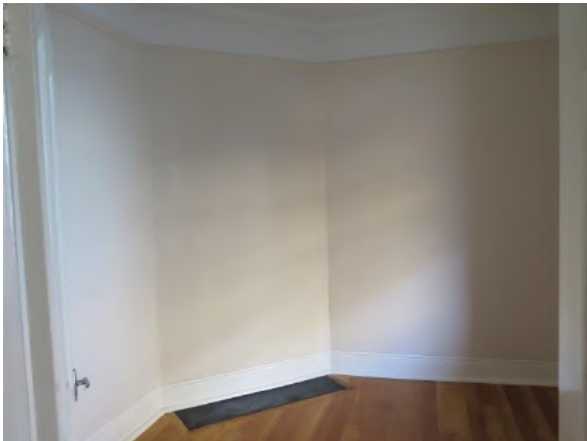
As with other Type 1 flats, entering via the front door on Gloucester Street, the entry hall (space G.1) has timber floors, cement run skirtings, timber cornice and a timber door frame to the living room with pivot fanlight over. In Flat 54B the door between the hall (space G.1) and the living room (space G.3) has been removed, although the frame and fanlight survive (Figure 11.10). The front bedroom (on the right) has timber floor, cement run skirtings, timber cornice, timber picture rail, scroll pattern fibrous plaster wall vents, four-panel solid timber door with fanlight over, and one double-hung timber sash window (six lights over one) (Figure 11.11 Timber double-hung sash window in the front bedroom (space G.2)—54B / 46–56 Gloucester Street. (Source: GML Heritage, July 2016) and Figure 11.12). It has a corner fireplace (blocked up and mantel piece removed) with concrete hearth.

Figure 11.12 Front bedroom (space G.2) showing timber floors, rendered wall finishes, fireplace blocked up with cement rendered skirting over and original concrete hearth—54B / 46–56 Gloucester Street. (Source: GML Heritage, July 2016)

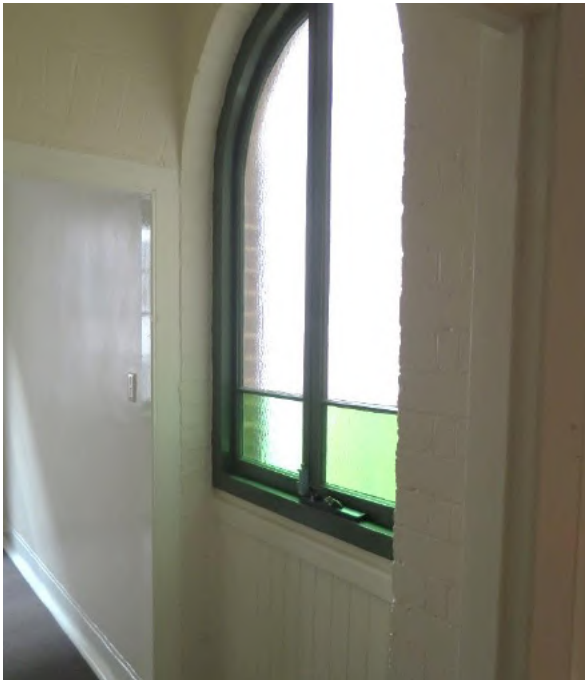
The rear wing contains the former rear porch (space G.4), bathroom (space G.5) and rear bedroom (space G.6). Access to the former porch is via a doorway with fanlight over. The former porch (space G.4) has a timber floor, painted unrendered brick internal wall faces, and modern and original timber skirting (Figure 11.19–Figure 11.21). The timber floor has been raised to the level of the former timber thresholds of the living room and rear bedroom. The opening opposite the bathroom (space G.5) has been infilled (c.1988) and consists of a round-headed double casement window with textured glass, with modern vertical tongue-and-groove boarded panelling under.

Figure 11.20 Infilled former rear porch opening (space G.4), with unrendered brick walls, arched modern casement window and modern T&G boarding below—54B / 46–56 Gloucester Street (Source: GML Heritage, July 2016)

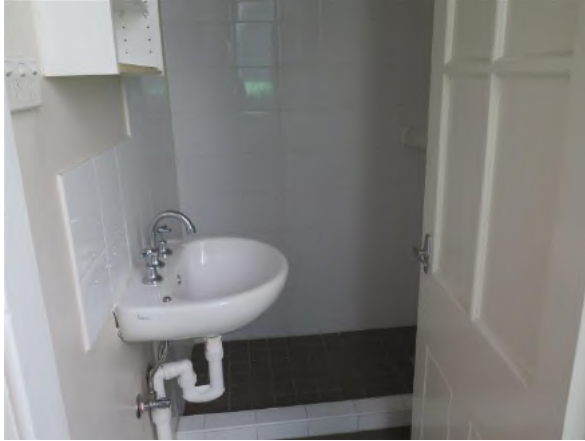
The bathroom (space G.5) has a modern fit-out with modern ceramic tiled floor and walls, modern or repaired original plaster above, and plasterboard ceiling (Figure 11.22 and Figure 11.23). The bathroom has an original half-glazed timber door and fanlight over.

Figure 11.22 Bathroom (space G.5) with modern fitout. Glazing of timber door has been painted—54B / 46–56 Gloucester Street. (Source: GML Heritage, July 2016)

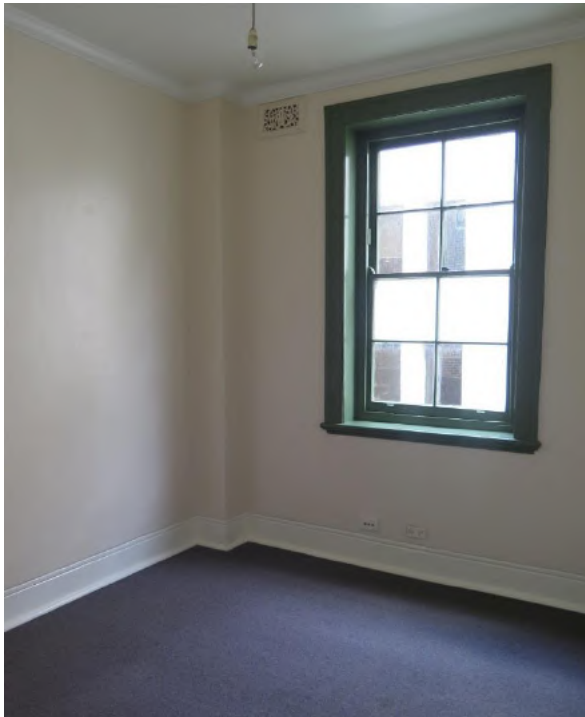
The rear bedroom (space G.6) has features similar to the front bedroom: cement run skirtings, timber picture rail and timber cornice, scroll pattern vents, timber floor (carpeted), four-panel solid timber door, and one timber double-hung sash window (four lights over four) (Figure 11.24).

Figure 11.24 Rear bedroom (space G.6) showing modern carpeted floor (over original timber), original cement rendered skirtings, cornice, decorated wall vent and timber double-hung sash window—54B / 46–56 Gloucester Street. (Source: GML Heritage, July 2016)

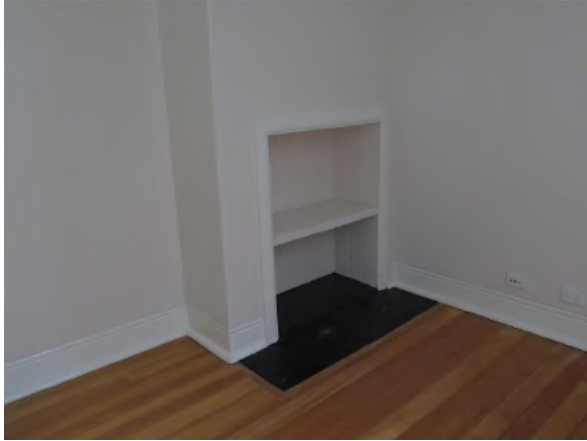
Figure 11.30 Shelving in original fireplace at lower ground-floor level (former kitchen, Flat 54B)—54B / 46–56 Gloucester Street. (Source: GML Heritage, July 2016)

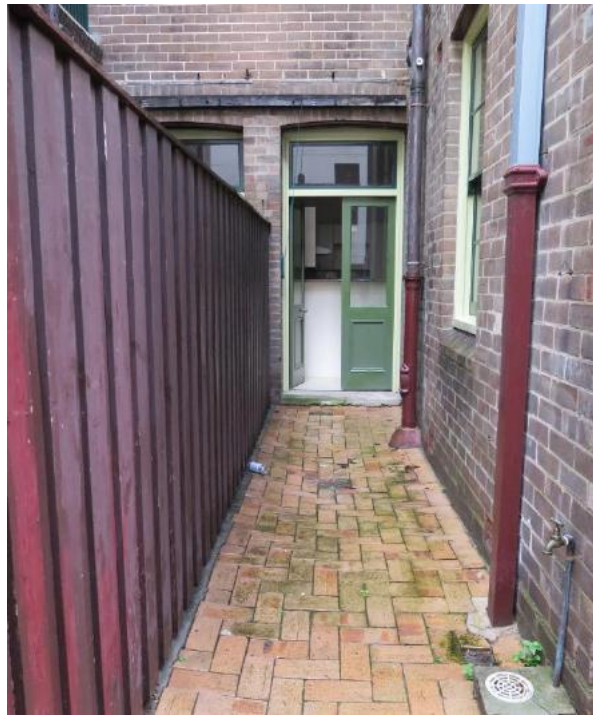
At the rear, the property shares rainwater services with Flat 54C above (steel square section downpipes) (Figure 11.37).

Figure 11.37 Exterior walls of the rear wing showing original cast iron and modern stainless and copper downpipes and paved yard area (space E.2)—54B / 46–56 Gloucester Street. (Source: GML Heritage, July 2016)

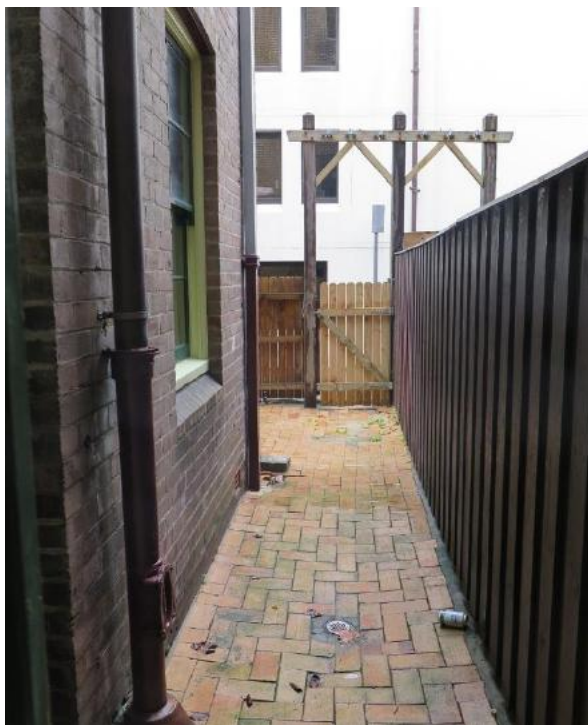
Figure 11.38 Rear yard (space E.2) showing reconstructed laundry hoist, original cast iron and modern stainless and copper downpipes and modern timber fencing (space E.2)—54B / 46–56 Gloucester Street. (Source: GML Heritage, July 2016)

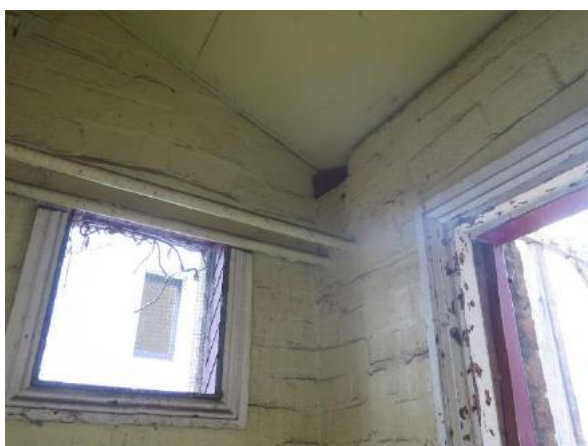
Figure 11.40 Interior of WC showing rendered painted brick (space E.3)—54B / 46–56 Gloucester Street. (Source: GML Heritage, July 2016)

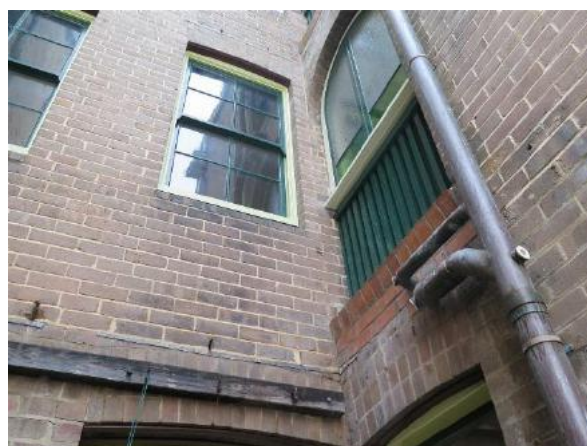
The rear elevation is of common brick in stretcher bond, flush jointed (the ground floor rear elevation has been re-pointed with a pale buff mortar). Doors and windows have segmental-arched brick heads with flat iron arch bars, as on the front elevation (Figure 11.41). The exception is the round-arched

window of the former rear porch, which faces towards the rear wing of Flat 56 (Figure 11.41). This window (like all such windows on this floor of the block) has been infilled, in this case with a timber casement window, wooden T & G boarded spandrel and false balustrade externally. The lower ground floor has a solid timber bolection moulded-four panel door to the rear wing dining room, and half-glazed double doors with fanlight to the kitchen, both of which have concrete thresholds (Figure 11.37).

Figure 11.41 Rear wing and rear façade showing copper service pipes and later porch opening infill—54B / 46–56 Gloucester Street. (Source: GML Heritage, July 2016)

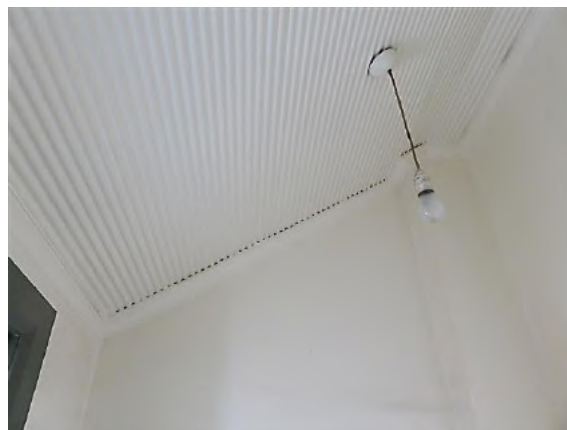
Figure 12.41 Laundry (space 2.2) showing the raked ripple iron ceiling and moulded timber cornice—54C / 46–56 Gloucester Street. (Source: GML Heritage, July 2016)

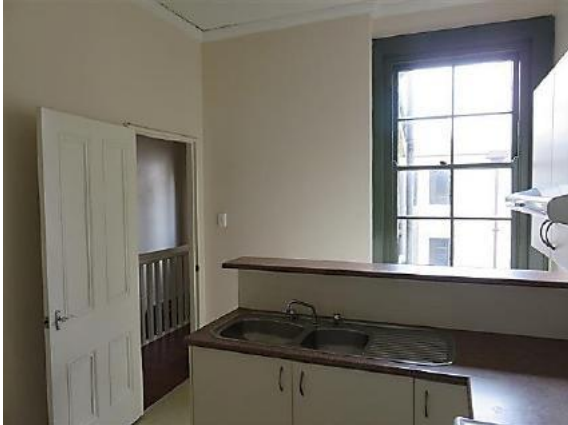
Figure 12.42 Kitchen (space 2.3) showing the original timber double hung window and relocated door—54C / 46–56 Gloucester Street. (Source: GML Heritage, July 2016)

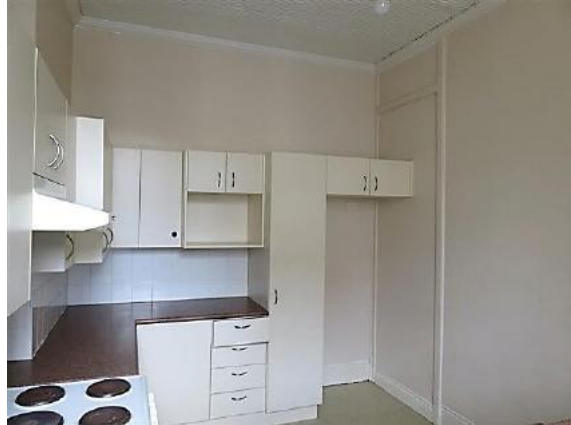
Figure 12.43 Kitchen (space 2.3) showing modern refit, ripple iron ceiling, timber cornice and cement run skirting. The original door frame survives in the wall at the northwest corner of the room—54C / 46–56 Gloucester Street. (Source: GML Heritage, July 2016)

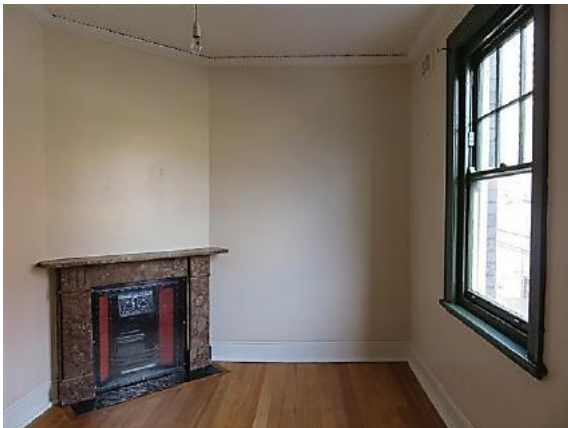
The front bedroom (space 2.4) has almost identical features to the downstairs front bedroom but with no picture rail (Figure 12.44). It retains its original fireplace with a red marble chimney piece and cast iron grate with tiled side panels (Figure 12.45). It also retains its original concrete hearth. The room retains its original four panel timber door (bottom panels replaced) with original architraves and central pivot fanlight over (Figure 12.46) and double hung window with original architraves, sill board and moulding). It also has a decorative plaster wall vent similar to those in other rooms (Figure 12.44, vent similar to Figure 12.23).

Figure 12.44 Front room on the second floor (space 2.4) showing the fireplace, timber double hung window, cement run skirting, ripple iron ceiling and moulded timber cornice—54C / 46–56 Gloucester Street. (Source: GML Heritage, July 2016)

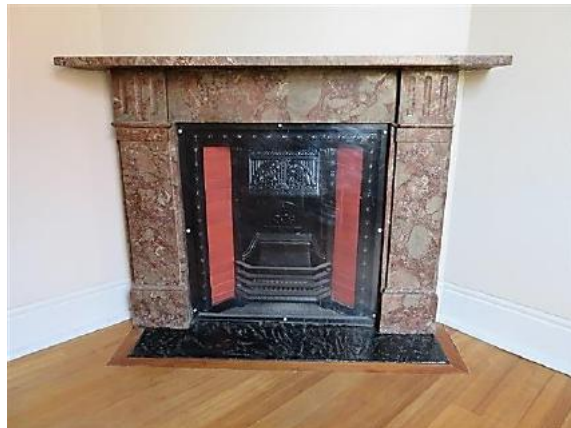
Figure 12.45 Fireplace (space 2.4) with marble chimney piece and cast iron grate with tiled sides and concrete hearth—54C / 46–56 Gloucester Street. (Source: GML Heritage, July 2016)

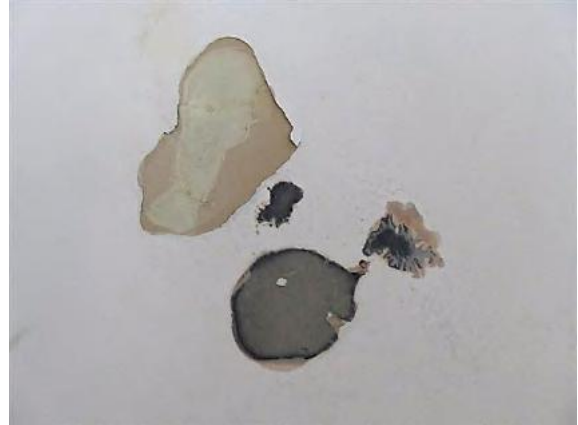
All the walls in the front portion of the flat, including the stair above the stringer, show evidence of a dado line in the plaster wall surface (Figure 12.47).

Figure 12.47 Paint scrapes above the stair reveal a dark painted dado and a lighter colour on the wall above—54C / 46–56 Gloucester Street. (Source: GML Heritage, July 2016)

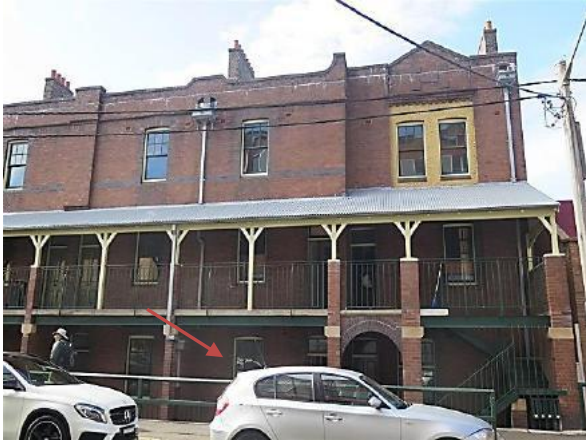
The front yard (ground level, space E.1), is located on the lower level of the western verandah of the building, which is on the same level as Gloucester Street (Figure 13.6). The flat has its own ornamental wrought iron gate with mid-rail and diagonal brace, with a hinge fixed to the flank wall and a socket fixing for the hinge-stile (Figure 13.8). The gate has an original wrought iron latch and latch plate with iron rivets. A wrought iron palisade fence with square section pales and top and bottom rail extends to the opposite flank wall, the uprights having ball finials (matching the stiles of the gate).

Figure 13.6 Overall façade of 46–56 Gloucester Street, showing front verandah (common property), shared guttering and downpipe on the boundary between 54C and 56, and flat 56 Gloucester Street marked with an arrow (Source: GML Heritage, July 2016)

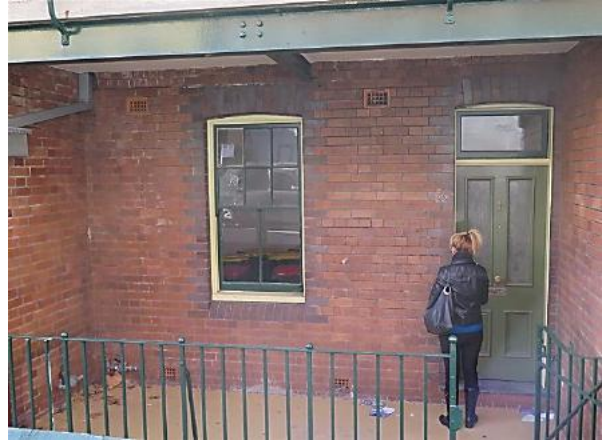
The front elevation, which presents only the ground floor to the street, is single-fronted, in fair-faced brickwork in English bond, flush jointed in grey mortar (Figure 13.6 and Figure 13.7). The four-panel, bolection moulded entry door has glazed upper panels in wired glass, a central brass knob, letterbox, spyhole, bell and modern mortise lock. There is a pivot fanlight over (Figure 13.7). The entry door and window have dark brick surrounds. Both have arched heads supported on flat iron arch bars. The window is a six-over-two double hung sash window, and has a chamfered brick sill. The door has a slate threshold (Figure 13.10).

Figure 13.7 Front porch of western façade showing original casement window and timber panel door with fanlight. The steel beam supports the verandah above—56 / 46–56 Gloucester Street. (Source: GML Heritage, July 2016)

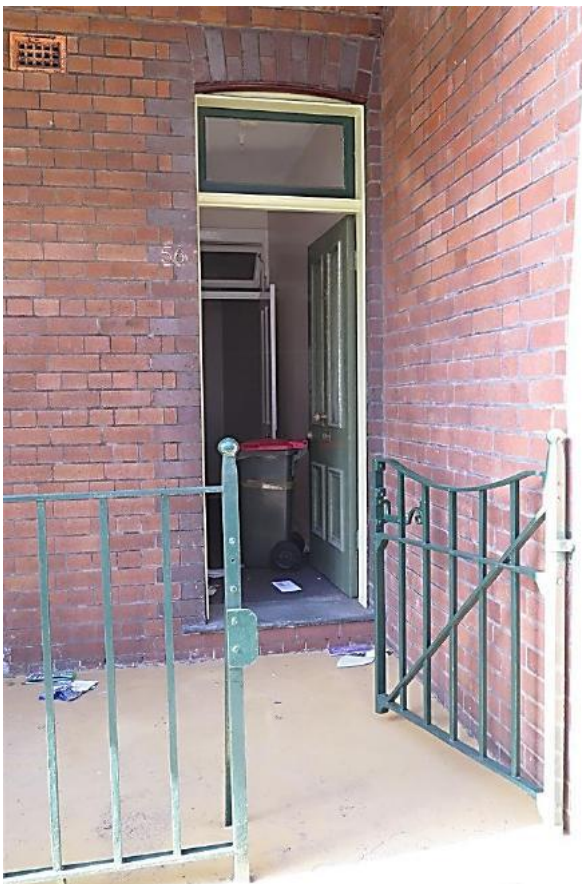
Figure 13.8 Entry to Flat 56 (space E.1) with four-panel timber front door with bolection moulds to bottom timber panels and wired glass to upper panels, and fanlight above. The opening has dark brick surround and arched brick head. A wrought iron fence and gate enclose the front yard located on the verandah—56 / 46–56 Gloucester Street. (Source: GML Heritage, July 2016)

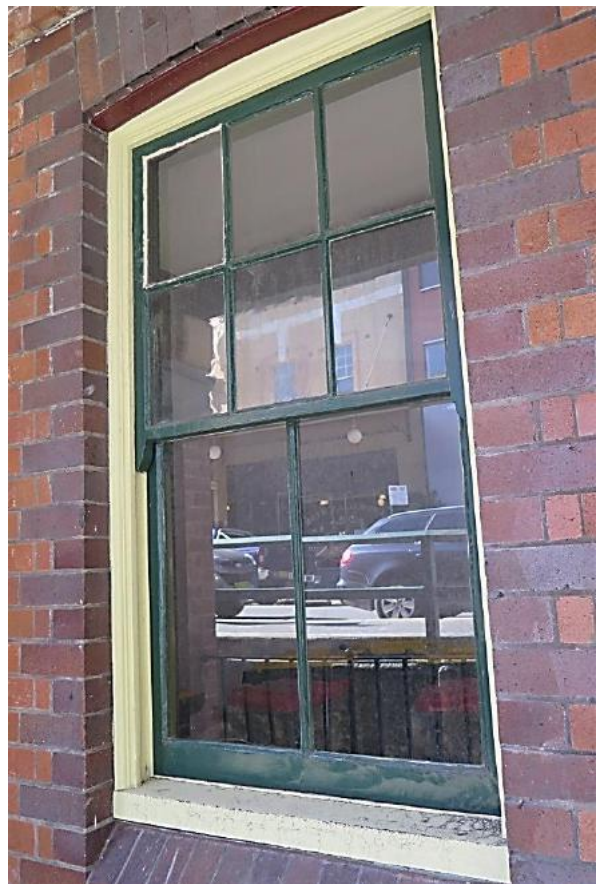
Figure 13.9 Double hung sash window with dark brick surround, chamfered brick sill and arched brick head. The two pane bottom sash varies from other windows on this elevation—56 / 46–56 Gloucester Street. (Source: GML Heritage, July 2016)

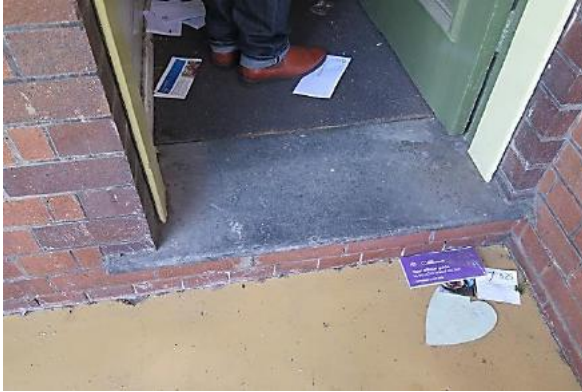
Figure 13.10 Original slate threshold to front door—56 / 46–56 Gloucester Street. (Source: GML Heritage, May 2016)

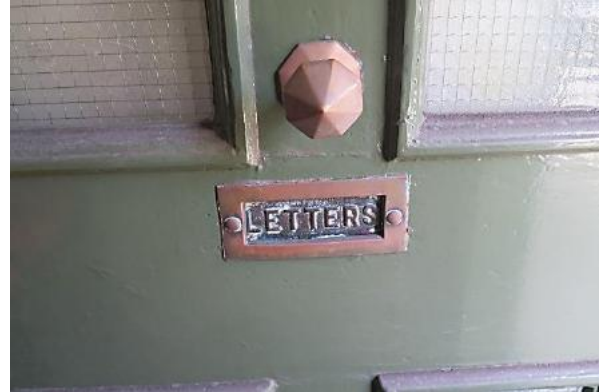
Figure 13.11 Brass door knob and letter slot on front door—56 / 46–56 Gloucester Street. (Source: GML Heritage, July 2016)

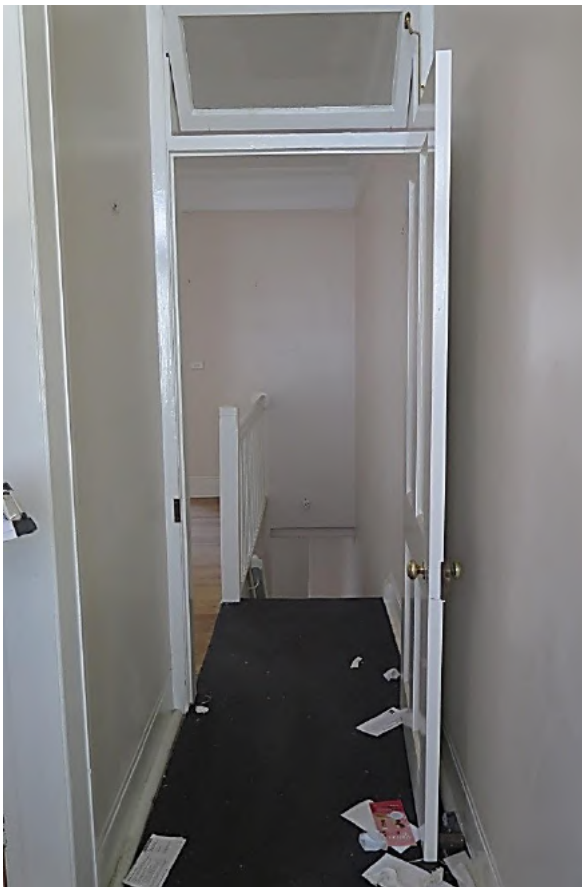
Figure 13.12 Entry (space G.1) of 56 / 46–56 Gloucester Street, showing carpeting over timber floor, cement run skirtings, and timber door frame with fanlight to the living room (space G.3). (Source: GML Heritage, June 2016)

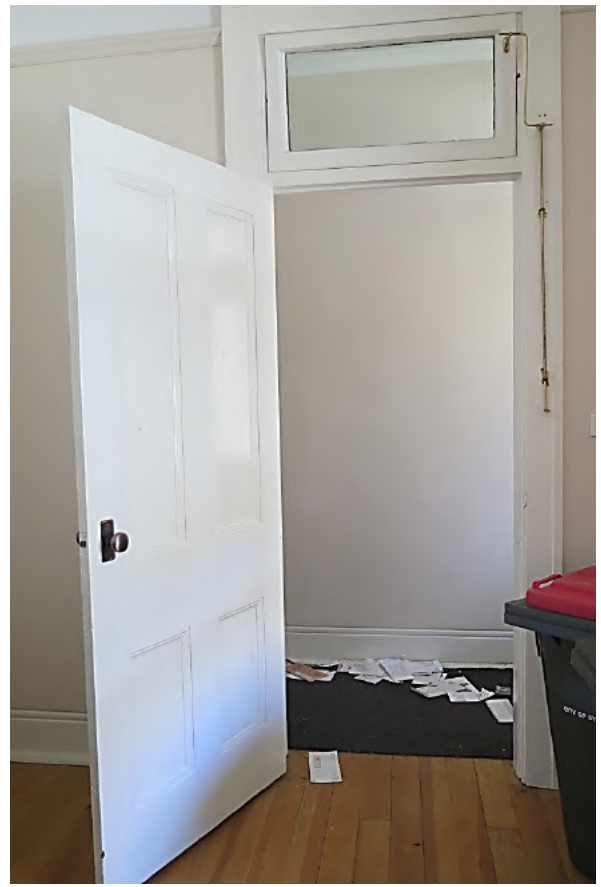
Figure 13.13 Four-panel timber door with fanlight above with reproduction mechanism—located between front bedroom (space G.2) and entry (space G.1). the cement run skirting and timber picture rail are also visible—56 / 46–56 Gloucester Street. (Source: GML Heritage, July 2016)

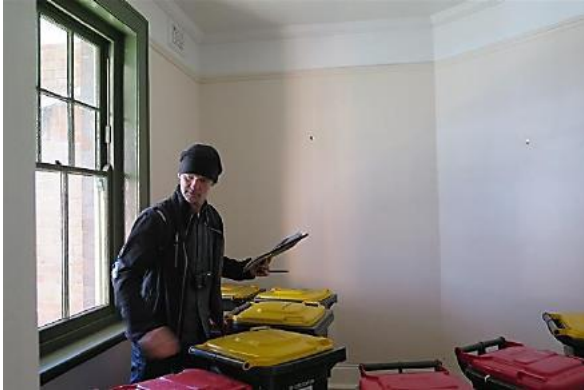
As with other Type 1 flats, entering via the front door on Gloucester Street, the entry hall (space G.1) has timber floors, cement run skirtings, fibrous plaster cornice and a timber door frame to the living room with pivot fanlight over. In Flat 56 the door between the hall (space G.1) and the living room (space G.3) has been removed, although the frame and fanlight survive (Figure 13.12). The front bedroom (on the right) has timber floor, cement run skirtings, fibrous plaster cornice, timber picture rail, scroll pattern fibrous plaster wall vents, four-panel solid timber door with fanlight over, and one double-hung timber sash window (six lights over two) (Figure 13.13 and Figure 13.14). It has a corner fireplace (blocked up and mantel piece removed) with concrete hearth.

Figure 13.14 Front bedroom (space G.2)—56 / 46-56 Gloucester Street, showing fibrous plaster cornice, timber picture rail, decorative plaster wall vent and blocked up fireplace to far right of image. (Source: GML Heritage, July 2016)

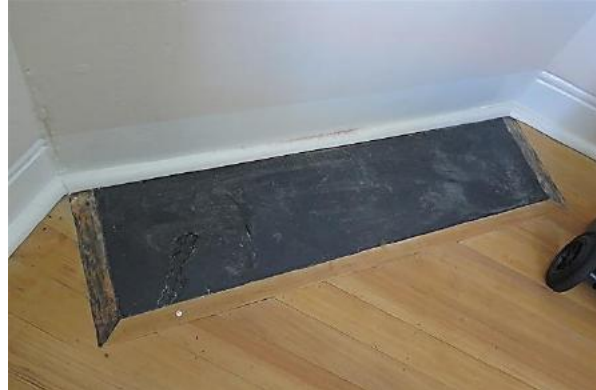
Figure 13.15 Original corner fireplace blocked up with concrete hearth (space G.2). Note skirtings have not been continued across fireplace wall—56 / 46-56 Gloucester Street. (Source: GML Heritage, July 2016)

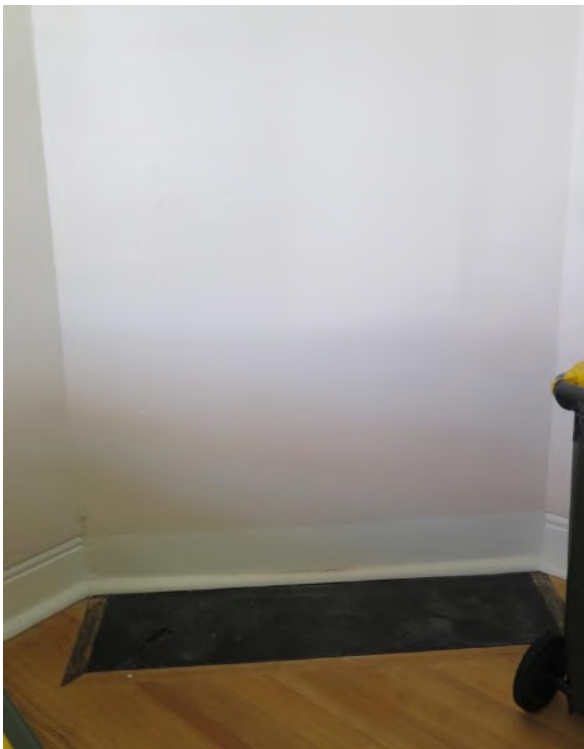
Figure 13.16 Original, now blocked off, corner fireplace (space G.2)—56 / 46-56 Gloucester Street. (Source: GML Heritage, July 2016)

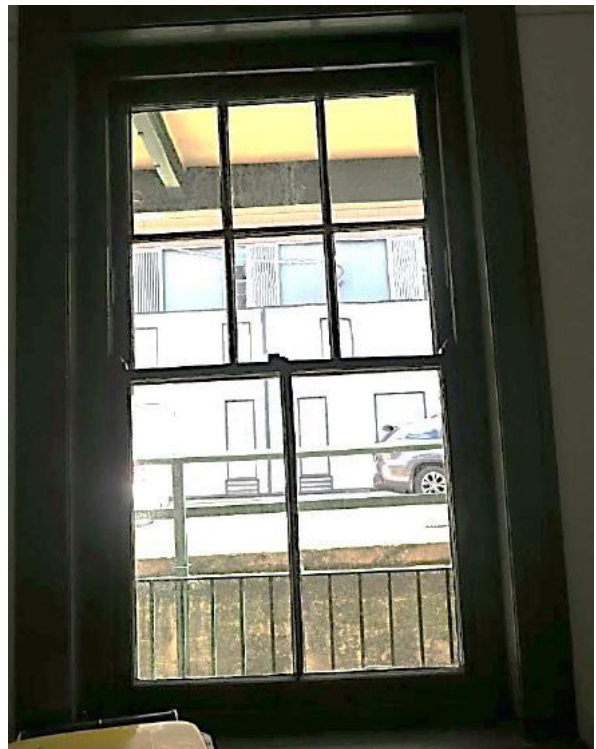
Figure 13.17 Timber double-hung sash window, architrave and sill board in front bedroom (space G.2)—56 / 46-56 Gloucester Street. (Source: GML Heritage, July 2016)

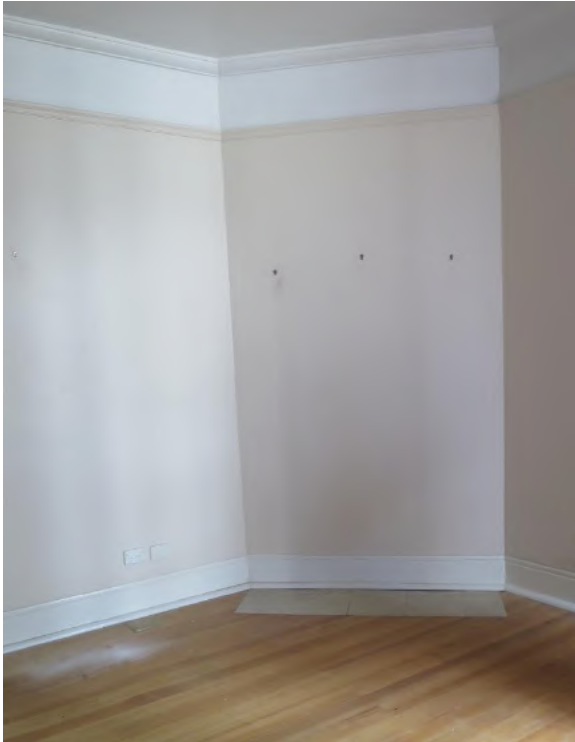
Figure 13.18 Living room showing blocked off fireplace, skirting, picture rail and cornice (space G.3)—56 / 46–56 Gloucester Street. (Source: GML Heritage, July 2016)

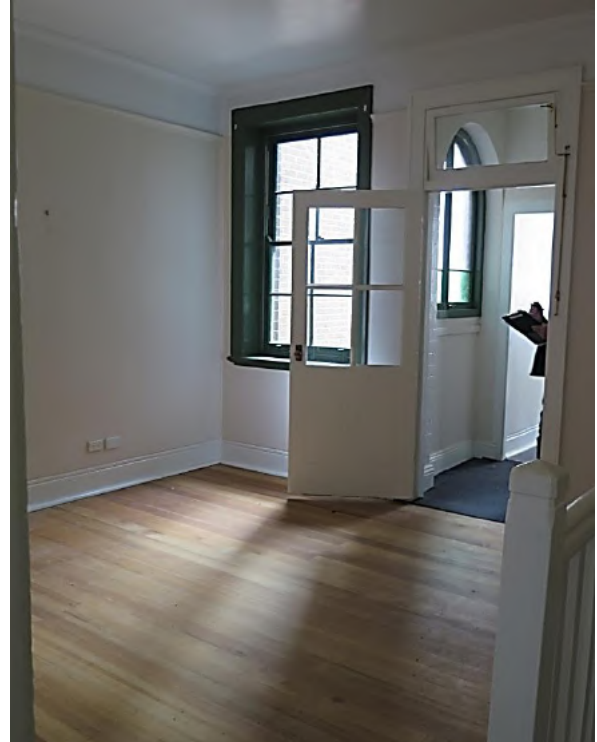
The living room (space G.3) has timber floor, corner fireplace (blocked up) with concrete hearth (with vinyl tiles added), cement run skirtings, fibrous plaster cornice, and timber double-hung sash window to the rear (Figure 13.19). There is a painted timber balustrade with square balusters to the staircase giving access to the lower ground floor.

Figure 13.19 Living room (space G.3)—56 / 46–56 Gloucester Street, showing cement run skirtings, timber flooring, picture rail, and timber double-hung sash window and half-glazed timber door to rear porch (space G.4). (Source: GML Heritage, July 2016)

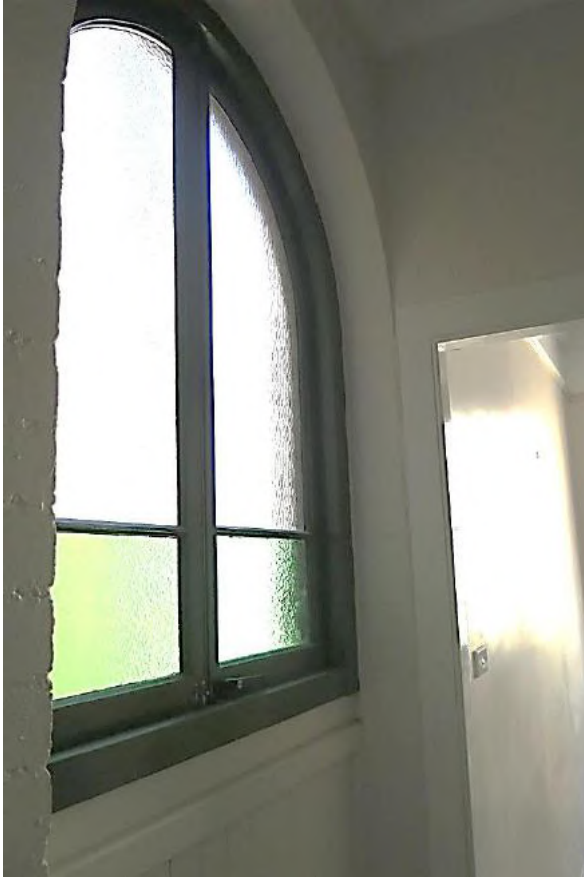
Figure 13.20 Infill to arched opening of former rear porch (space G.4) consisting of casement windows with textured and coloured glass, and modern T&G boarding below—56 / 46–56 Gloucester Street. (Source: GML Heritage, July 2016)

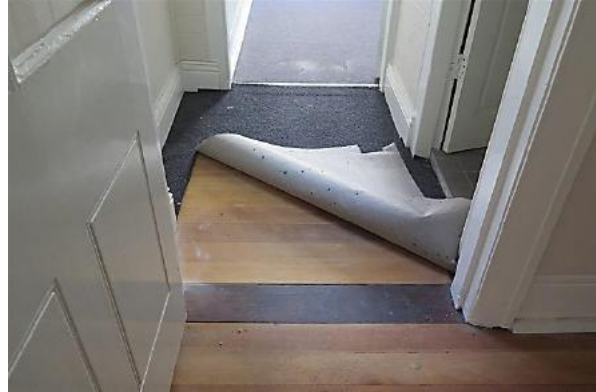
Figure 13.21 Original timber threshold to doorway from living room (space G.3) to rear porch (space G.4). The half glazed door between space G.3 and G.4 is a modern reproduction. The timber floor of the porch has been raised—56 / 46–56 Gloucester Street (Source: GML Heritage, July 2016)

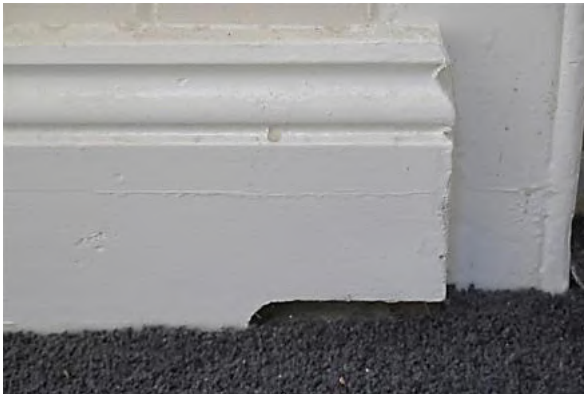
Figure 13.22 Moulded skirting to the infilled former porch (space G.4)—56 / 46–56 Gloucester Street (space G.4) (Source: GML Heritage, July 2016)

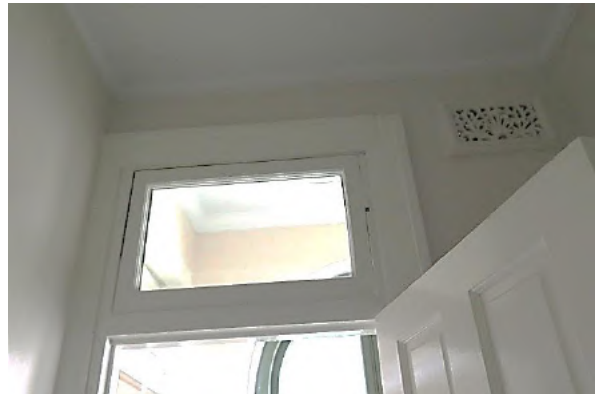
The bathroom (space G.5) has a c1980s fit-out with modern ceramic tiled floor and walls, modern or repaired original plaster above, and plasterboard ceiling (Figure 13.23 and Figure 13.24). The bathroom has a reproduction solid timber door in place of the original part glazed door, and fixed fanlight over.

Figure 13.23 Fanlight over door and decorative plaster wall vent in the bathroom (space G.5). The panel door to the bathroom (space G.5) is a modern reproduction—56 / 46–56 Gloucester Street. (Source: GML Heritage, July 2016)

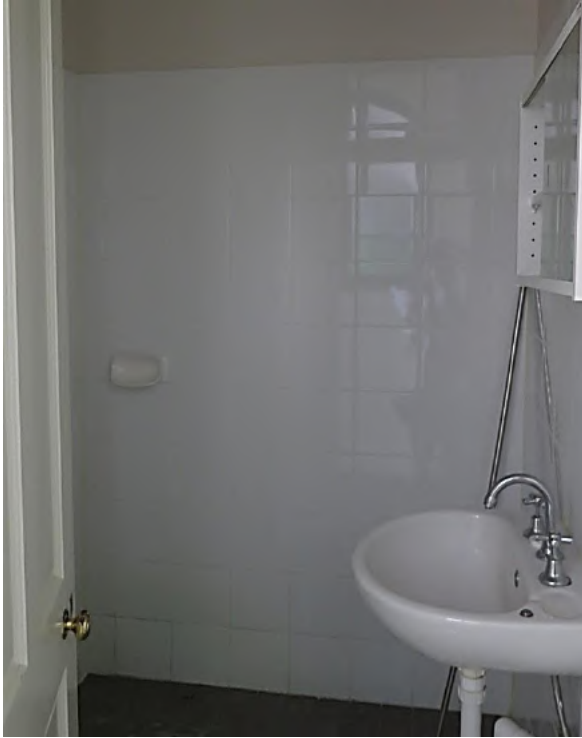
Figure 13.24 Bathroom (space G.5) showing modern fit-out—56 / 46—56 Gloucester Street. (Source: GML Heritage, July 2016).

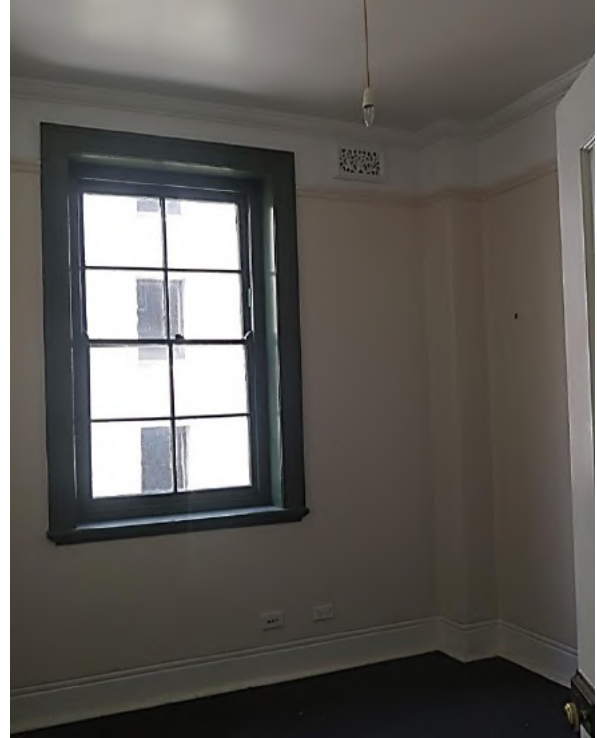
The rear bedroom (space G.6) has features similar to the front bedroom: cement run skirtings, timber picture rail and fibrous plaster cornice, scroll pattern vents, timber floor (carpeted), four-panel solid timber door, and one timber double-hung sash window (four lights over four) (Figure 13.25)

Figure 13.25 Rear bedroom (space G.6) showing carpeted floor, original cement run skirtings, timber picture rail, plaster cornice (not original) and decorative plaster wall vent. The timber double-hung sash window is original and retains its original architrave, sill board and moulding. A chimney flue rises in the southeast corner—56 / 46—56 Gloucester Street. (Source: GML Heritage, July 2016)

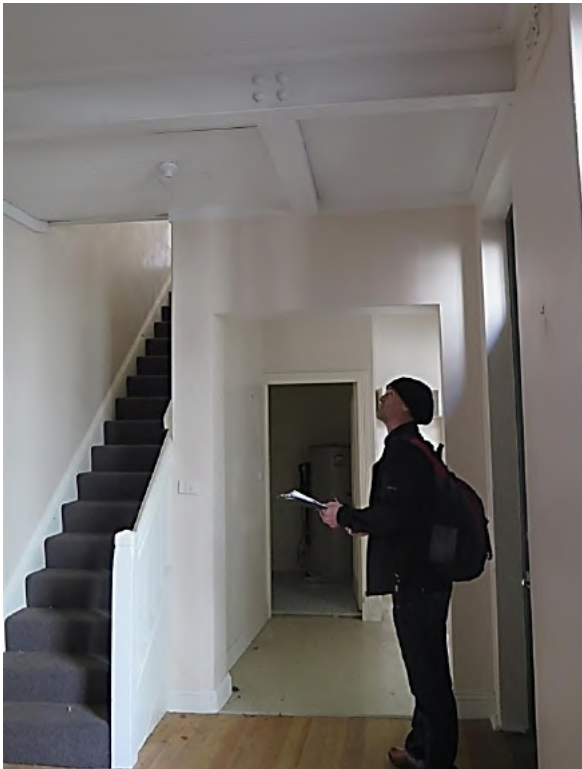
The staircase (space G.7) has vertical timber boarding on the handrail side, original timber handrail and balustrade (to the lower section), newel posts, timber skirtings and stringers (Figure 13.26 and Figure 13.27). The downstairs dining room (space LG.1) has a ripple iron ceiling and exposed steel transverse I-beam connected to secondary steel beam supporting the floor above (Figure 13.29) Part of the ceiling has had a void for services created behind a ceiling panel in matching ripple iron. The dining room (space LG.1) has timber floor and cement run skirtings (with modern quad bead edging to the floor), an original fireplace (boarded-out and converted to shelving) with concrete hearth (with vinyl tiles added), scroll pattern fibrous plaster wall vents, four-over-four double-hung timber sash window, and four-panel timber external door with fanlight.

Access to the kitchen (space LG.2) has been created through a wide opening formed in the brickwork of the transverse wall (Figure 13.26). Kitchen and laundry fit-outs and floor and wall finishes are recent. Original ripple iron ceilings and fibrous plaster cornices have been retained. The laundry (space LG.3) has been divided from the kitchen by a modern partition wall. It has unrendered painted brickwork on the party wall and boarded soffit lining to the staircase (Figure 13.34 and Figure 13.35).

Figure 13.26 Stair descends into dining area (space LG.1). Original steel beams support the walls above. The ceiling is ripple iron—56 / 46—56 Gloucester Street (Source: GML Heritage, July 2016).

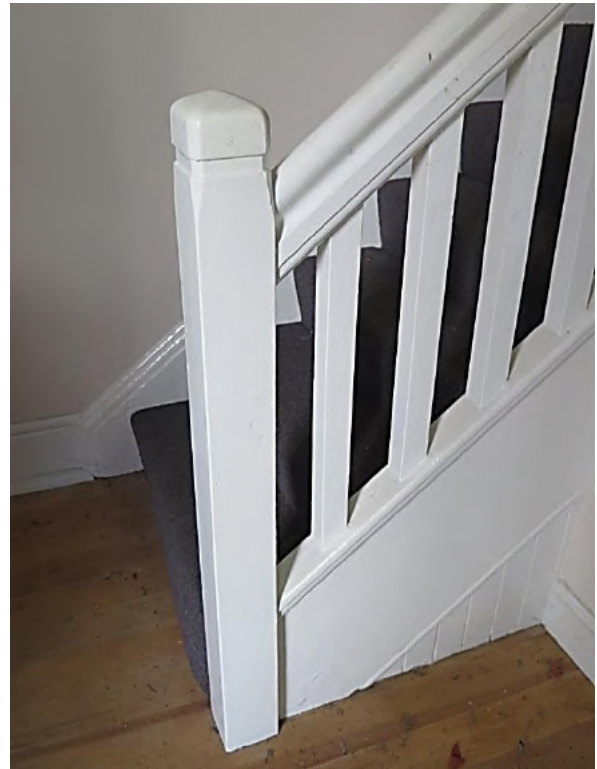
Figure 13.27 Dining area (space LG.1). Original timber balustrade to stair consisting of square newel post, and balusters and moulded timber handrail. The stair has closed strings—56 / 46—56 Gloucester Street. (Source: GML Heritage, July 2016)

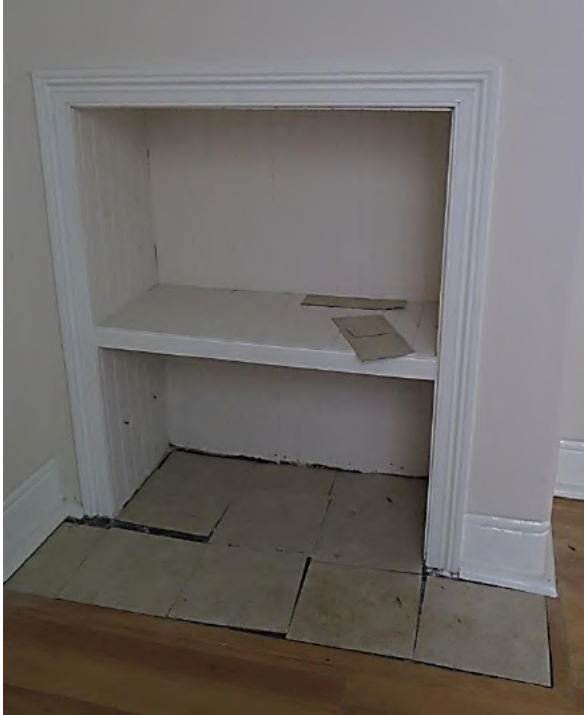
Figure 13.28 Fireplace in the dining room (space LG.1) with 1980s boarding, shelf and architrave—56 / 46–56 Gloucester Street. (Source: GML Heritage, June 2016)

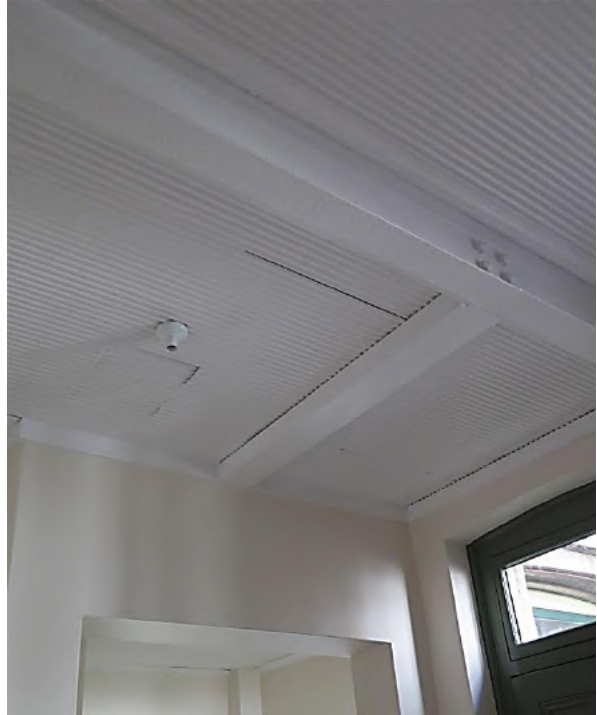
Figure 13.29 Original ripple iron ceiling and dropped ceiling over western portion of space LG.1—56 / 46–56 Gloucester Street. (Source: GML Heritage, June 2016)

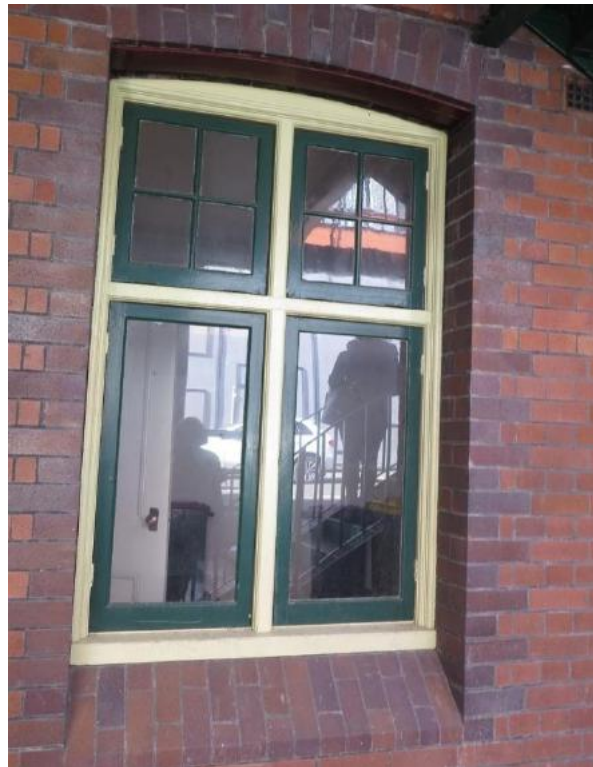
Figure 15.9 Detail of western elevation to Flat 56B at ground-floor level, showing original casement window—56B / 46–56 Gloucester Street. (Source: GML Heritage, July 2016)

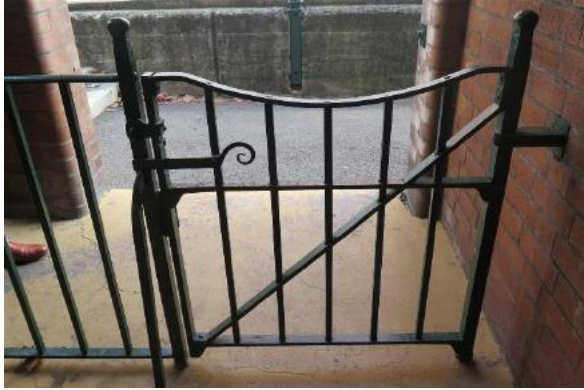
Figure 15.10 Detail of the wrought iron gate with original gate latch—56B / 46–56 Gloucester Street. (Source: GML Heritage, July 2016)

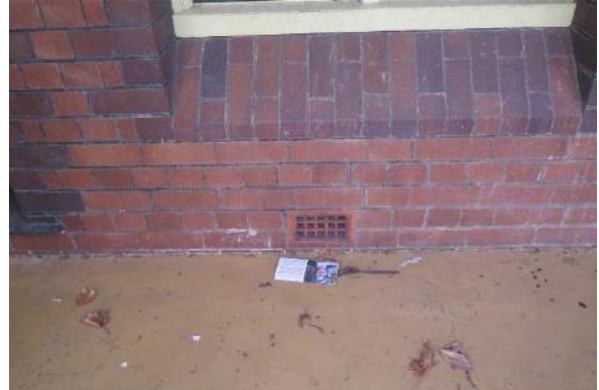
Figure 15.11 The front yard (space E.1) showing the chamfered brick sill to the window, terracotta wall vent as typical in all external spaces and concrete yard paving—56B / 46–56 Gloucester Street. (Source: GML Heritage, July 2016)

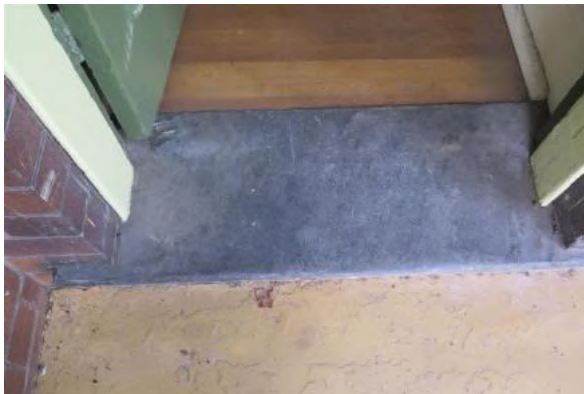
Figure 15.12 Original slate threshold to front door—56B / 46–56 Gloucester Street. (Source: GML Heritage, July 2016)

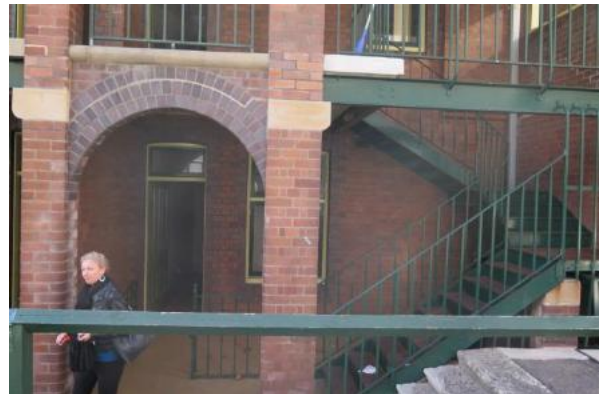
Figure 15.13 Detail of exterior staircase to first floor at the southern end of the building. Sandstone bolsters supporting the steelwork—56B / 46–56 Gloucester Street. (Source: GML Heritage, July 2016)

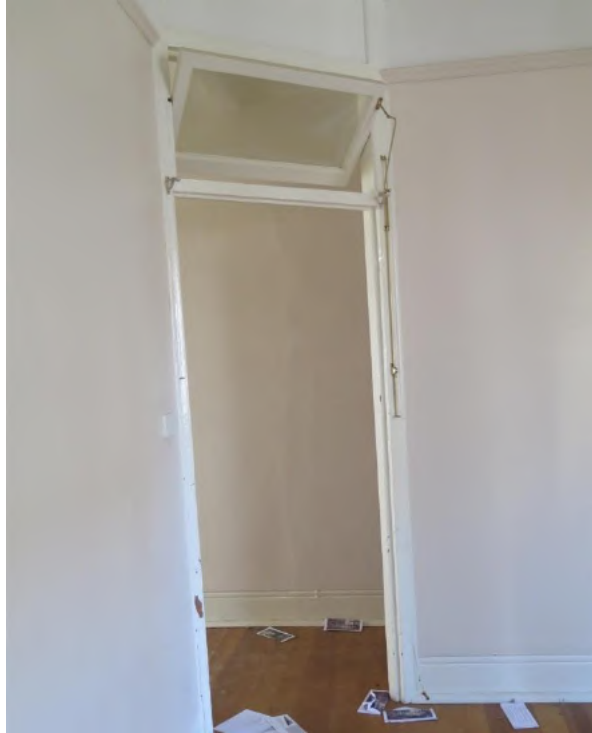
Figure 15.23 Living room (space G.3) showing new opening with the repurposed original fanlight of removed door to entry hall—56B / 46–56 Gloucester Street. (Source: GML Heritage, June 2016)

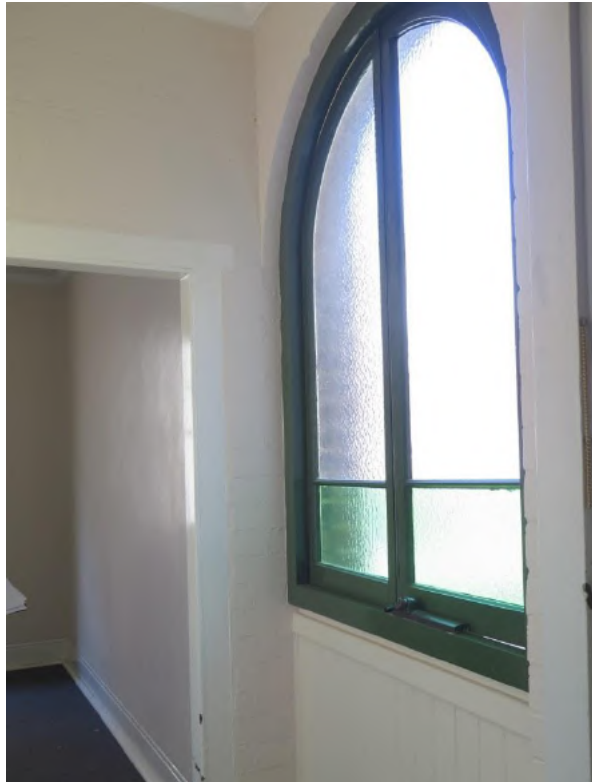
Figure 15.25 Infilled former rear porch opening (space G.4). The original arched opening has been infilled with vertical boarding and casement windows—56B / 46–56 Gloucester Street. (Source: GML Heritage, July 2016)

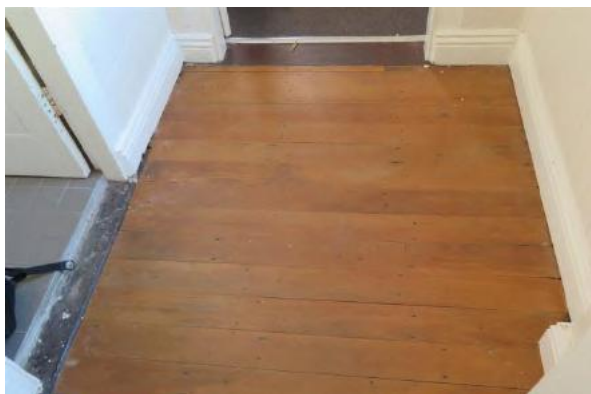
Figure 15.26 Infilled former rear porch opening (space G.4) with timber flooring and original timber step treads—56B/46–56 Gloucester Street—56B / 46–56 Gloucester Street. (Source: GML Heritage, July 2016)
