46–56 Gloucester Street, The Rocks

SHR No. 01609

Conservation Management Plan

Report prepared for NSW Land and Housing Corporation

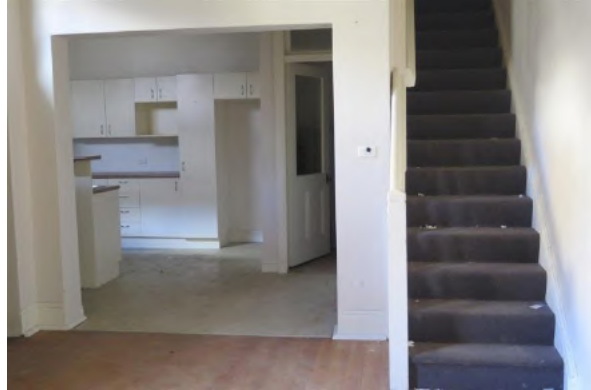
Access to the kitchen (space LG.2) has been created through a wide opening formed in the brickwork of the transverse wall (Figure 15.39). Kitchen and laundry fit-outs and floor and wall finishes are recent. Original ripple iron ceilings and timber cornices have been retained. The laundry (space LG.3)

Figure 15.39 Lower ground-floor level showing original timber stair, large opening cut through to kitchen (space LG.2) and enclosure to create laundry under stairs c1988 (space LG.3)—56B / 46–56 Gloucester Street. (Source: GML Heritage, July 2016)

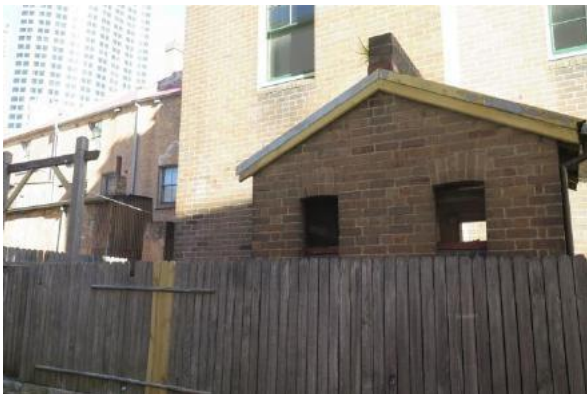
The rear yard (space E.2), as described above, has a brick-built external WC (space E.3, now a 'store') with galvanised iron skillion roof and exposed rafters at the eaves (Figure 15.50). The WC shares a party wall/parapet with the WC of the neighbouring flat. It has a concrete floor, and segmental-arched door opening with single-ledged, braced and sheeted timber door. It has a single light window facing Cambridge Street. The louvre glazing panels are missing and replaced with wire mesh.

Figure 15.48 Eastern aspect of 56B Gloucester Street, as viewed from Cambridge Street, showing external WC and missing glass in louvres—56B / 46–56 Gloucester Street. (Source: GML Heritage, July 2016)

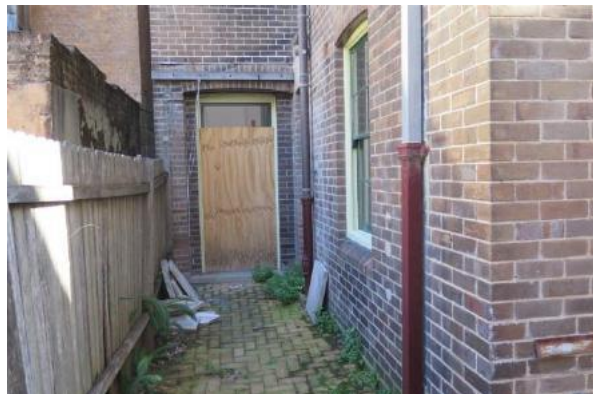
Figure 15.49 Rear yard with brick paving (space E.2), timber fencing and boarded up double doors—56B / 46–56 Gloucester Street. (Source: GML Heritage, July 2016)

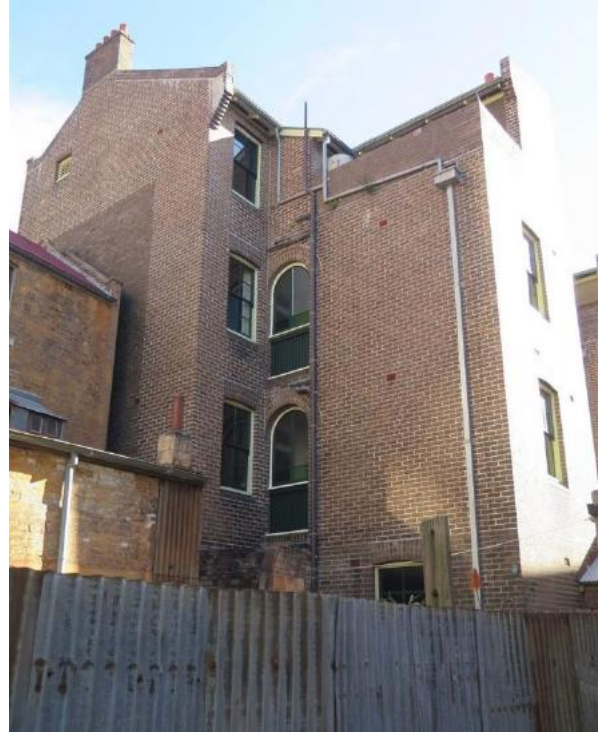
Figure 15.51 Southeastern rear elevation of Flat 56B showing rear porch window infill—56B / 46–56 Gloucester Street. (Source: GML Heritage, July 2016)

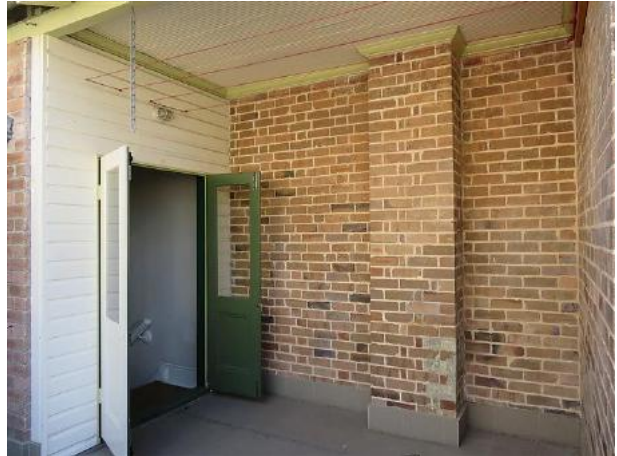
(**Figure 16.16**). There is some evidence of the former laundry copper having been removed from the skillion roofed area in the patching of the wall and remnant fixings (**Figure 16.16**).

Figure 16.15 Roof over terrace (space E.1) showing the ripple iron ceiling, timber cornice. Patching of brickwork provides evidence of former laundry copper which has been removed—56C / 46–56 Gloucester Street. (Source: GML Heritage, July 2016)

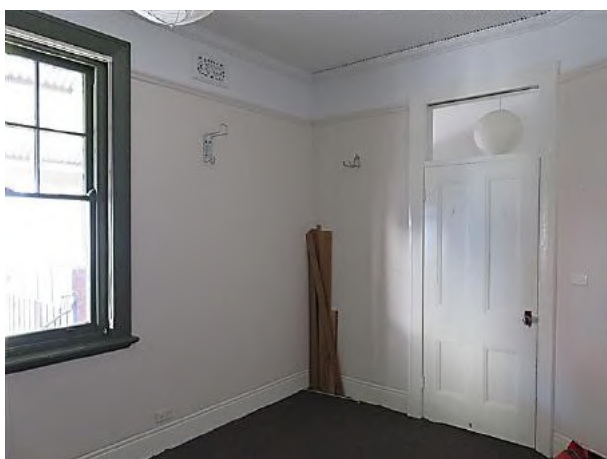
Figure 16.20 Front bedroom (space 1.2) showing the cement rendered skirting, picture rail, cornice and ripple iron ceiling, as well as decorative plaster wall vent, timber double-hung sash window with original architrave, sill board and moulding and original four panel door. The fanlight over has been removed, but the architraves have been retained—56C / 46–56 Gloucester Street. (Source: GML Heritage, July 2016)

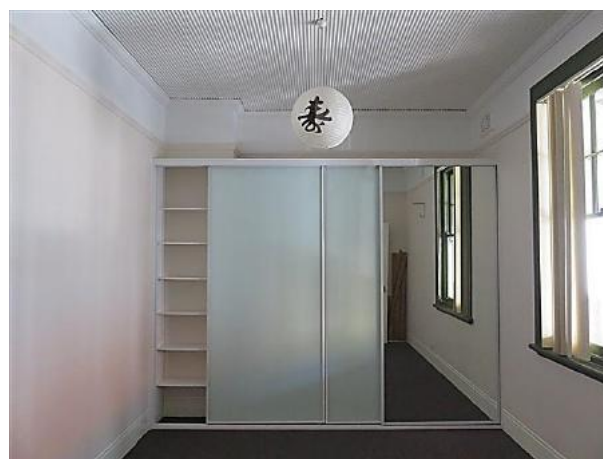
Figure 16.21 Front bedroom (space 1.2) showing the cement rendered skirting, moulded timber picture rail, timber cornice and ripple iron ceiling. The modern wardrobe is not significant—56C / 46–56 Gloucester Street. (Source: GML Heritage, July 2016)

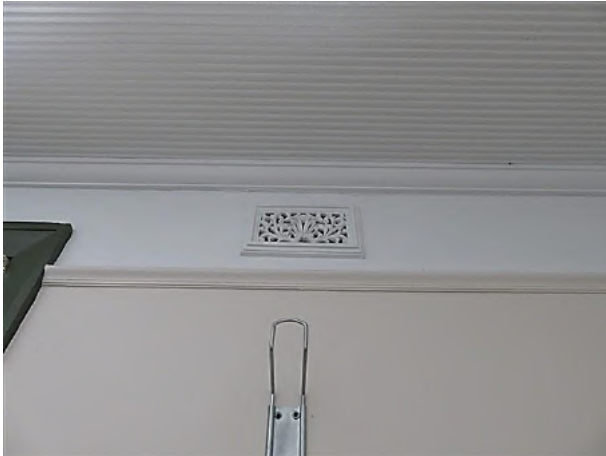
Figure 16.23 Original architrave, picture rail and cornice details. Pivot fanlight sash missing from above front bedroom door (space 1.2)—56C / 46–56 Gloucester Street. (Source: GML Heritage, July 2016)

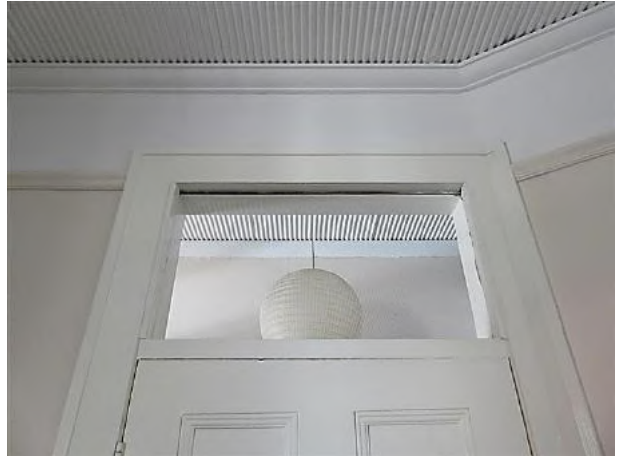
Figure 16.24 Living room (space 1.3) showing the original door frame, with fanlight dislodged from pivot fitting and broken fanlight mechanism. The room has run cement skirtings, picture rail, cornice and ripple iron ceiling. The small door opens to the space under the enclosed stairs—56C / 46–56 Gloucester Street. (Source: GML Heritage, July 2016)

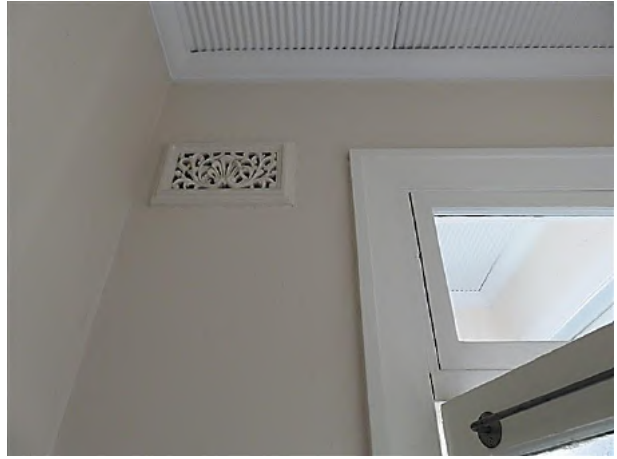
The bathroom (space 1.5) has a recent fit-out with modern ceramic tiled floor and walls, with plaster above, ripple iron ceiling, moulded timber cornice and decorative plaster wall vent (**Figure 16.31**, **Figure 16.32**). The stair stringer is expressed and the soffit of the stair, which rises over the northern portion of the space, is lined with timber V-joint boarding (**Figure 16.32**). The bottom of the stair newel post projects through the ceiling. The bathroom retains its original half-glazed timber door and pivot fanlight over, and architraves internally (**Figure 16.33**).

Figure 16.31 Decorative plaster wall vent in the bathroom (space 1.5)—56C / 46–56 Gloucester Street. (Source: GML Heritage, July 2016)

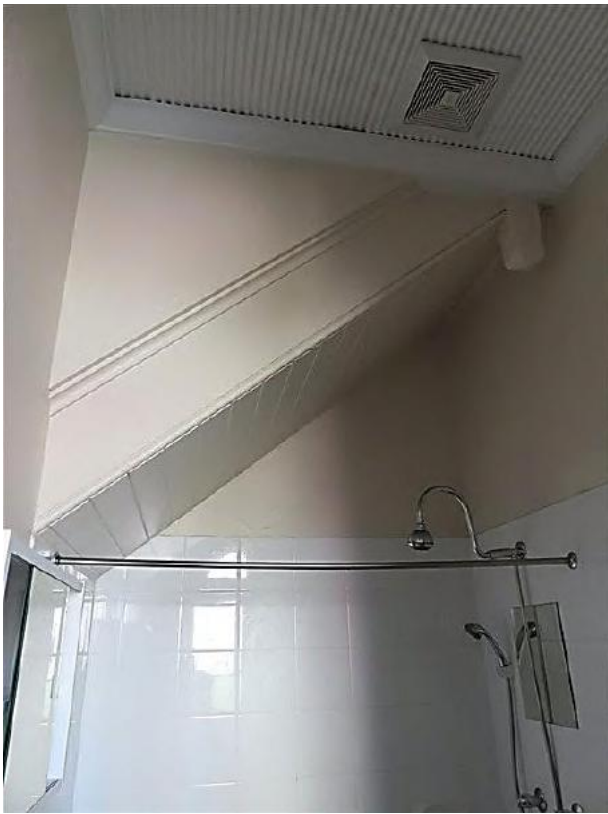
Figure 16.32 Bathroom (space 1.5) showing modern fit out, expressed stair stringer and bottom of newel post protruding through ceiling, v-jointed timber stair soffit and ripple iron ceiling with timber cornice—56C / 46–56 Gloucester Street. (Source: GML Heritage, July 2016)

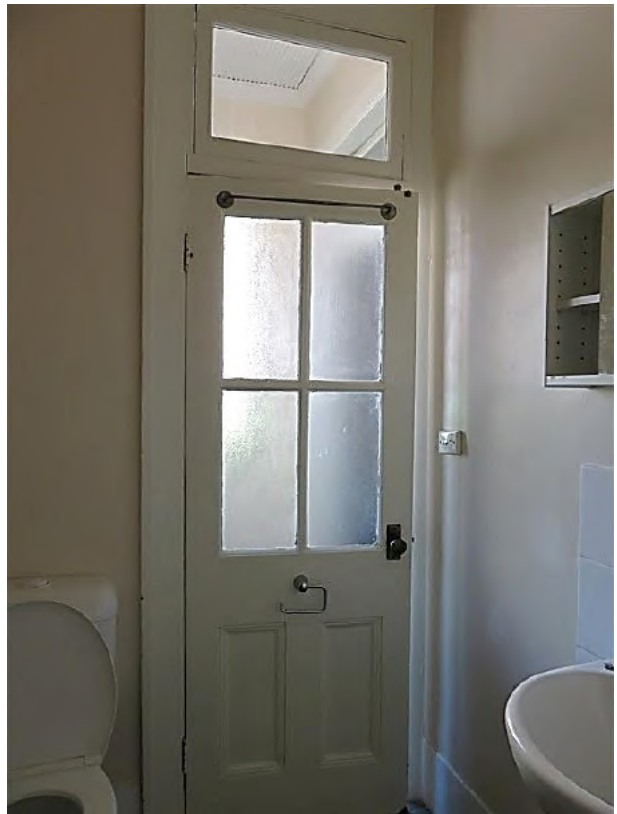
Figure 16.33 Original half-glazed door to bathroom (space 1.5), with original fanlight and architrave—56C / 46–56 Gloucester Street. (Source: GML Heritage, July 2016)

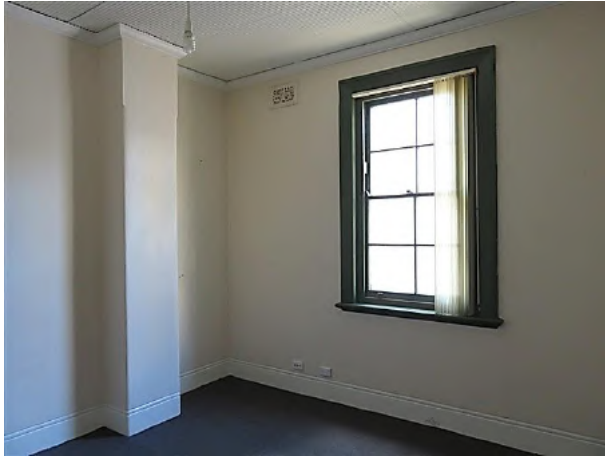
original timber architraves, sill board and moulding. A chimney flue from the flat below rises against the north wall (**Figure 16.34**).

Figure 16.34 Rear bedroom (space 1.6) showing original double-hung window, complete with original architrave, sill board and moulding, chimney flue against north wall, decorative plaster wall vent and ripple iron ceiling with timber cornice—56C / 46–56 Gloucester Street. (Source: GML Heritage, July 2016)

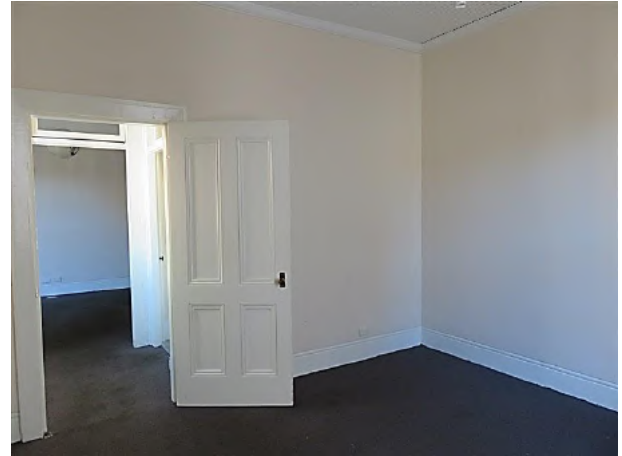
The rear bedroom (space 1.6) has features similar to the front bedroom: carpeted timber floor, cement run skirtings, ripple iron ceiling, moulded timber cornice and decorative plaster vents (**Figure 16.34**, **Figure 16.35**). A reproduction four-panel door is hung in the original door frame leading into the space (**Figure 16.35**). The space retains its original double-hung sash window (four panes over four) with

Figure 16.35 Rear bedroom (space 1.6) showing cement rendered skirtings and four panel door (reproduction) and original architrave—56C / 46–56 Gloucester Street. (Source: GML Heritage, July 2016)

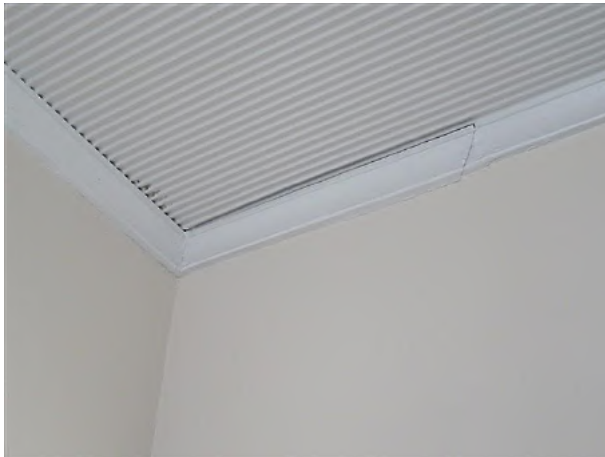
Figure 16.36 Ripple iron ceiling and moulded timber cornice in south-west corner of the rear bedroom (space 1.6)—56C / 46–56 Gloucester Street. (Source: GML Heritage, July 2016)

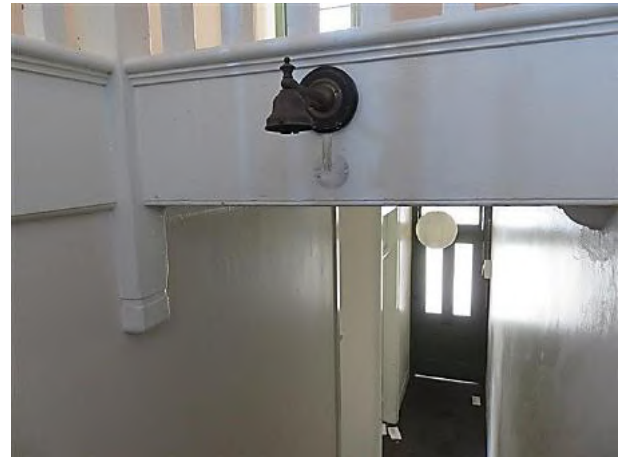
Figure 16.37 Original gas light fixture over the stairs (space 1.7). Bottom of stair newel post extends down stair hall wall below ceiling—56C / 46–56 Gloucester Street. (Source: GML Heritage, July 2016)

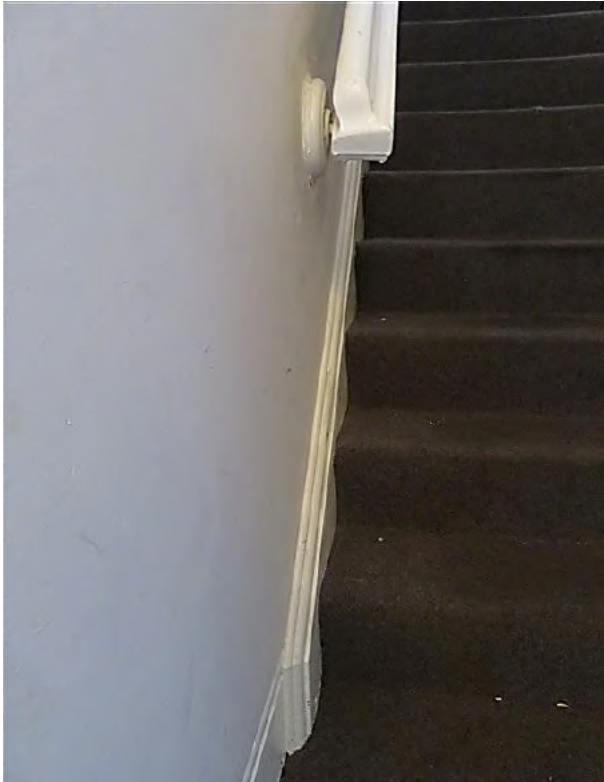
A timber staircase rises to the upper floor between two walls (space 1.7) (**Figure 16.18**). It has a moulded timber handrail supported on metal brackets mounted on timber wall roses (**Figure 16.38**). The bottom of the top newel post extends down the southern wall below the floor above (**Figure 16.37**). The stair soffit is lined with V-joint timber boarding (**Figure 16.32**). A ledged and sheeted timber door, with air holes drilled through the top, is hung on strap hinges (space 1.3) and provides access to the storage space below the stair, which is fitted with timber shelves supported on traditional timber brackets. (**Figure 16.24** and **Figure 16.25**).

Figure 16.38 Staircase (space 1.7) showing closed moulded timber stringer and timber handrail supported on metal brackets mounted on timber roses fixed to wall—56C / 46–56 Gloucester Street. (Source: GML Heritage, July 2016)

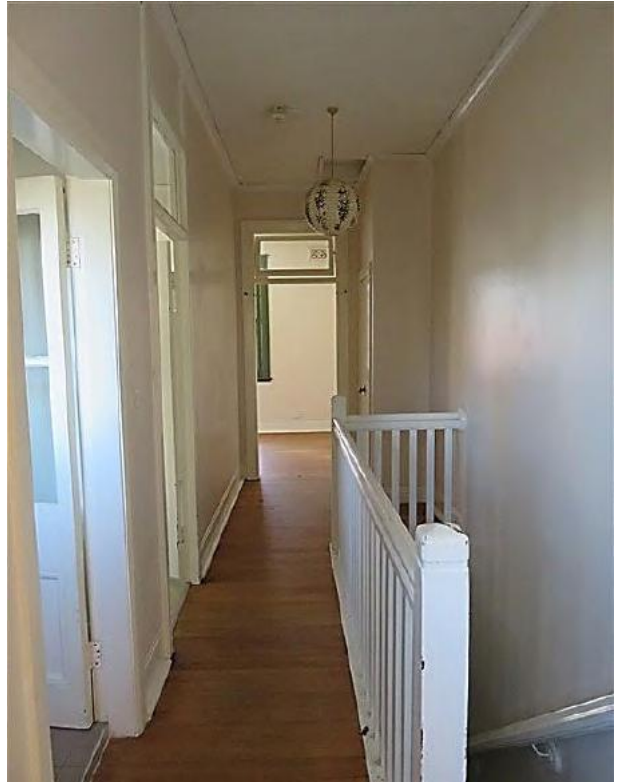
A timber balustrade with handrail and square balusters extends around the top edge of the stair void in space 2.1 (**Figure 16.39**, **Figure 16.40**). An early gas light bracket survives over the stair (**Figure 16.38**). A modern built-in cupboard has been built against the north wall adjacent to the entrance to the front bedroom (space 2.4) (**Figure 16.39**). The double glazed doors at the eastern end of the space, giving access to the roof terrace are not original, most likely introduced during the late twentieth century (**Figure 16.40**).

Figure 16.39 Second floor landing (space 2.1) looking west, showing the timber balustrade with moulded handrail, square balusters and chamfered top to newel post, cement rendered skirting with quad moulding—56C / 46–56 Gloucester Street. (Source: GML Heritage, July 2016)

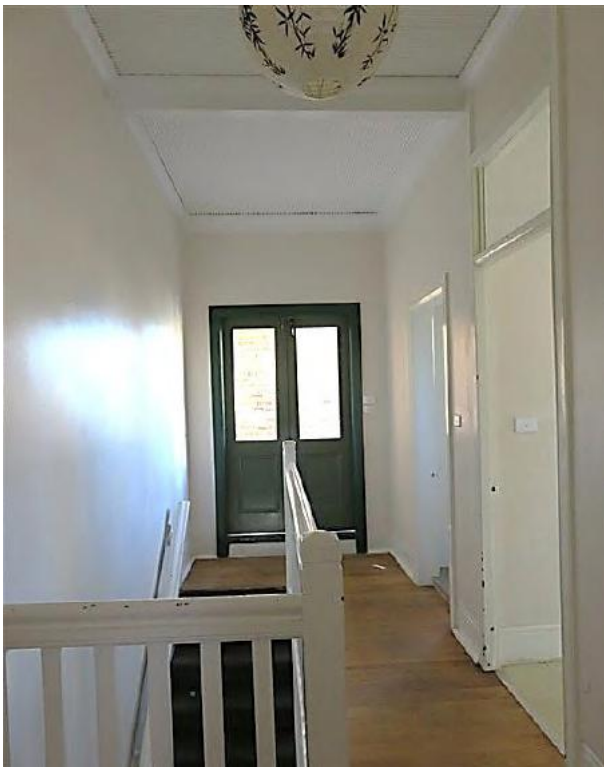
Figure 16.40 Upper stair hall (space 2.1) showing ceiling beam over space, ripple iron ceiling and timber cornice, half glazed timber doors to roof terrace (recent), and original timber frame to kitchen door on right—56C / 46–56 Gloucester Street. (Source: GML Heritage, July 2016)

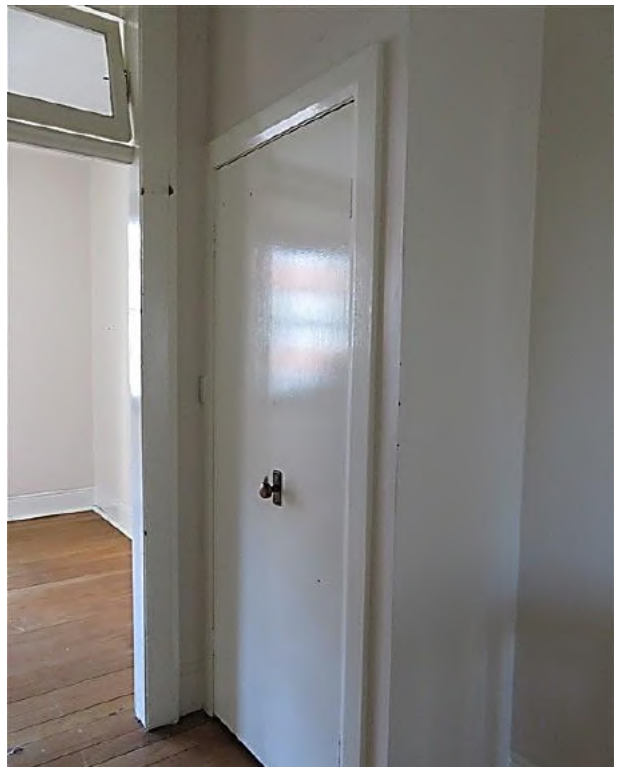
Figure 16.41 Modern cupboard built into the second floor landing (space 2.1) with flush timber doors—56C / 46–56 Gloucester Street. (Source: GML Heritage, June 2016)

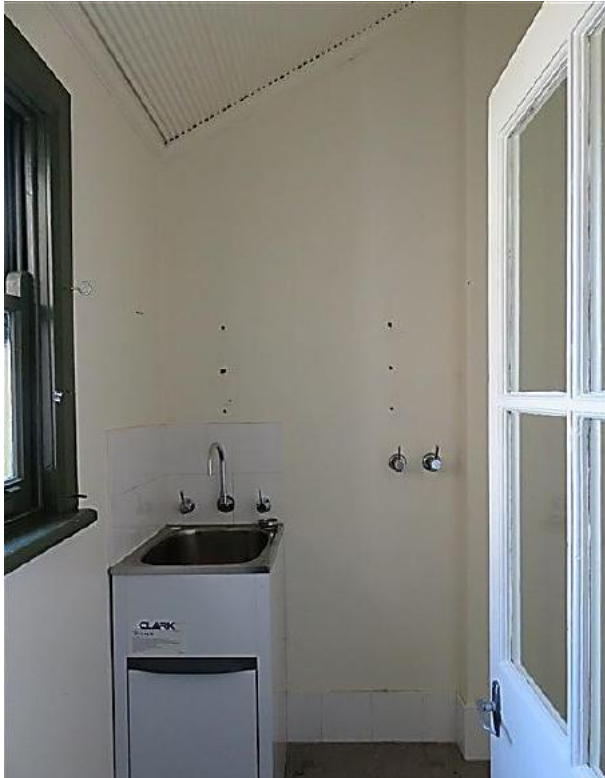
Some alterations have been made to incorporate the laundry (space 2.2) into what was most likely an external WC accessed from the roof terrace (**Figure 16.42**). A window has been introduced where the door originally was located (**Figure 16.14**, **Figure 16.43**). The laundry (space 2.2) and kitchen (space 2.3) have modern fit-outs and floor/wall finishes (tiled floor in the laundry and vinyl squares in the kitchen), but retain ripple iron ceilings and moulded timber cornices. The kitchen retains its original cement run skirting (**Figure 16.42**, **Figure 16.44**, **Figure 16.45**). The door opening and joinery to the laundry is modern, but that to the kitchen is original. It features an expressed timber frame with a fanlight over the door (fanlight sash replaced with fixed glass), four panel door (**Figure 16.46**). The kitchen retains its original double hung window, with original architrave, sill board and moulding, although the bottom sash has been replaced with a single paned sash (**Figure 16.47**).

Figure 16.42 Laundry (space 2.2) showing the original raked ripple iron ceiling and modern fitout—56C / 46–56 Gloucester Street. (Source: GML Heritage, July 2016)

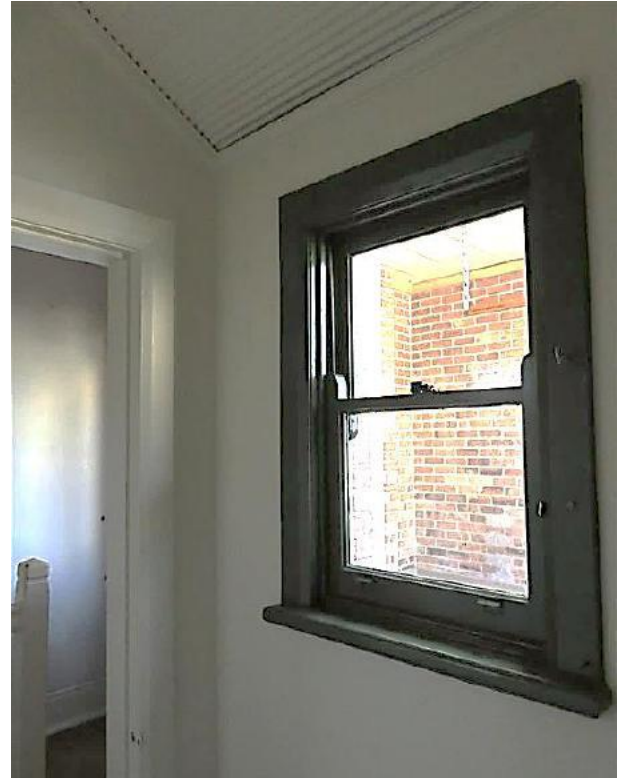
Figure 16.43 Laundry (space 2.2) showing the double-hung window from the 1980s refurbishment—56C / 46–56 Gloucester Street. (Source: GML Heritage, July 2016)

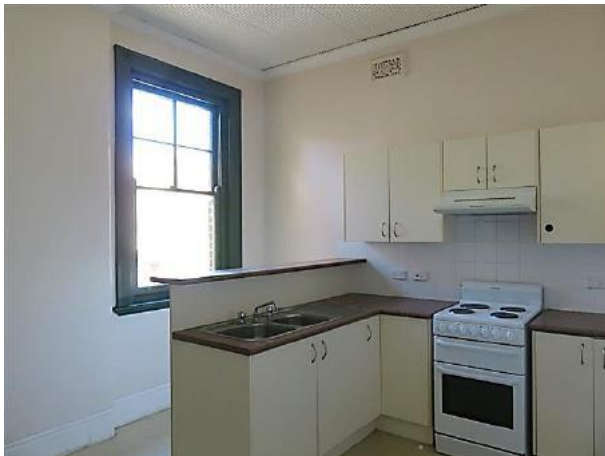
Figure 16.44 Kitchen (space 2.3) showing original window with architrave, sill board and moulding, cement run skirting, timber cornice and ripple iron ceiling—56C / 46–56 Gloucester Street. (Source: GML Heritage, July 2016)

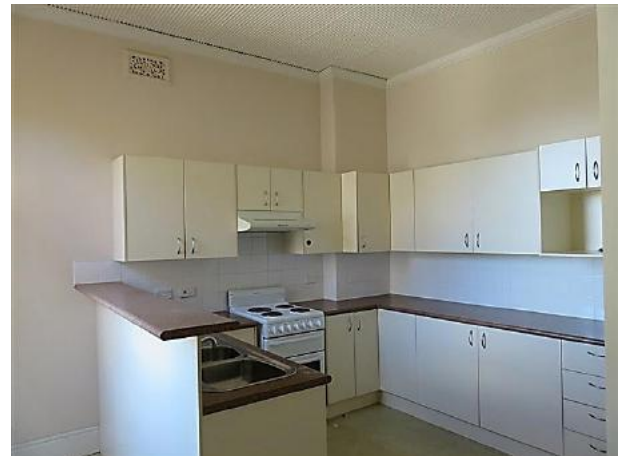
Figure 16.45 Kitchen (space 2.3) showing late twentieth century fitout and chimney flue in corner of room—56C / 46–56 Gloucester Street. (Source: GML Heritage, July 2016)

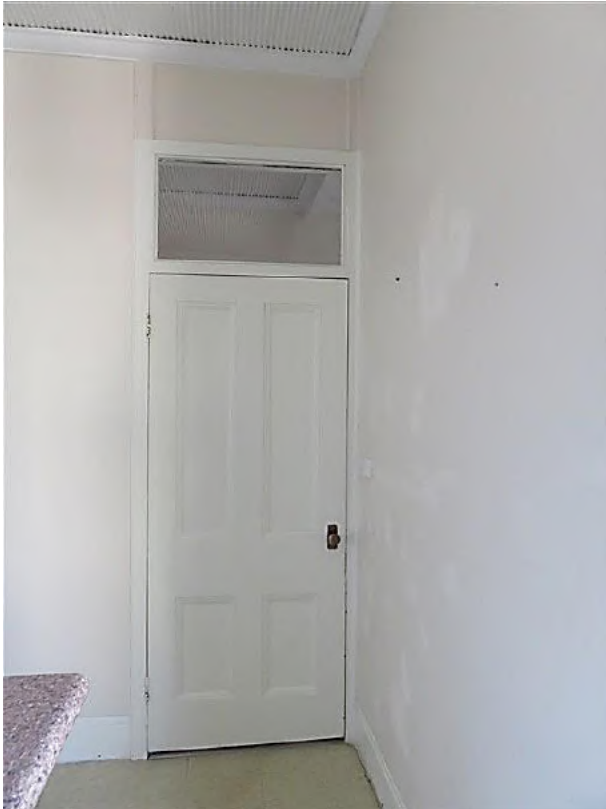
Figure 16.46 Original door in light weight concrete wall and original four panel door (space 2.3). Fanlight is missing—56C / 46–56 Gloucester Street. (Source: GML Heritage, July 2016)

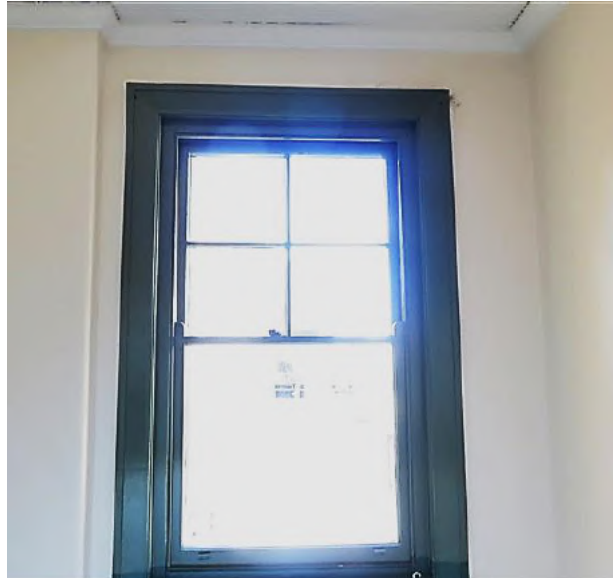
Figure 16.47 Original double hung window with four-pane upper sash (original) and single pane bottom sash (replaced), and original architrave—56C / 46–56 Gloucester Street. (Source: GML Heritage, July 2016)

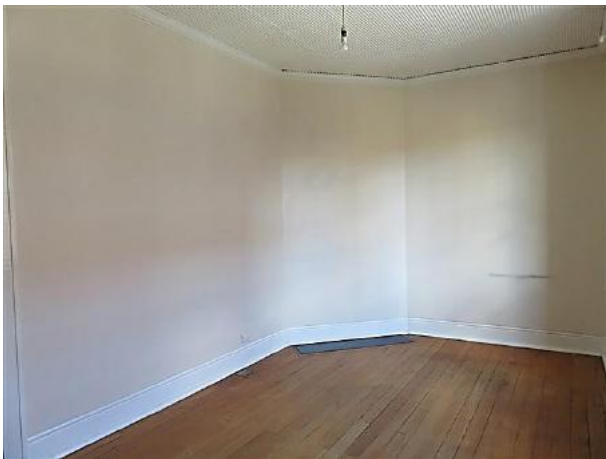
Figure 16.48 Front room on the second floor (space 2.4). The fireplace has been blocked up and chimney piece removed. Concrete hearth remains—56C / 46–56 Gloucester Street. (Source: GML Heritage, July 2016)

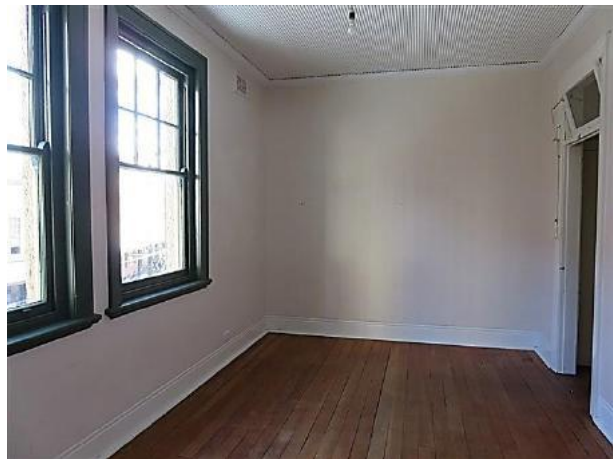
The front bedroom (space 2.4) has almost identical features to the downstairs front bedroom, but with no picture rail. It has two original double hung windows in its western wall, complete with architraves, sill board and moulding (**Figure 16.49**). The corner fireplace is blocked up, but retains its original concrete hearth (**Figure 16.48**). The door to this room has been removed, although the original frame, fanlight and architraves remain (**Figure 16.50**).

Figure 16.49 Front room on the second floor (space 2.4) showing the original double hung sash windows, cement rendered skirting, ripple iron ceiling and timber cornice—56C / 46–56 Gloucester Street. (Source: GML Heritage, July 2016)

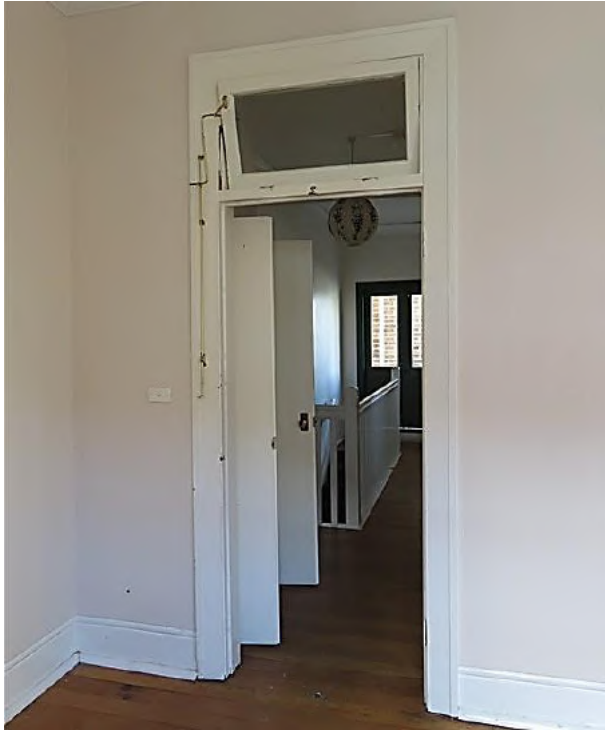
Figure 16.50 Original door frame, fanlight and architrave (door is missing) (space 2.4)—56C / 46–56 Gloucester Street. (Source: GML Heritage, July 2016)

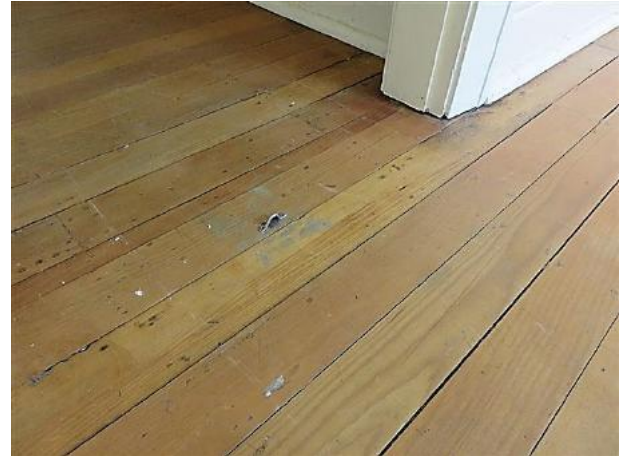
Figure 16.51 Timber floors to the second floor, with oiled finish. Metal keeper in doorway is not significant and can be removed—56C / 46–56 Gloucester Street. (source: GML Heritage, July 2016)

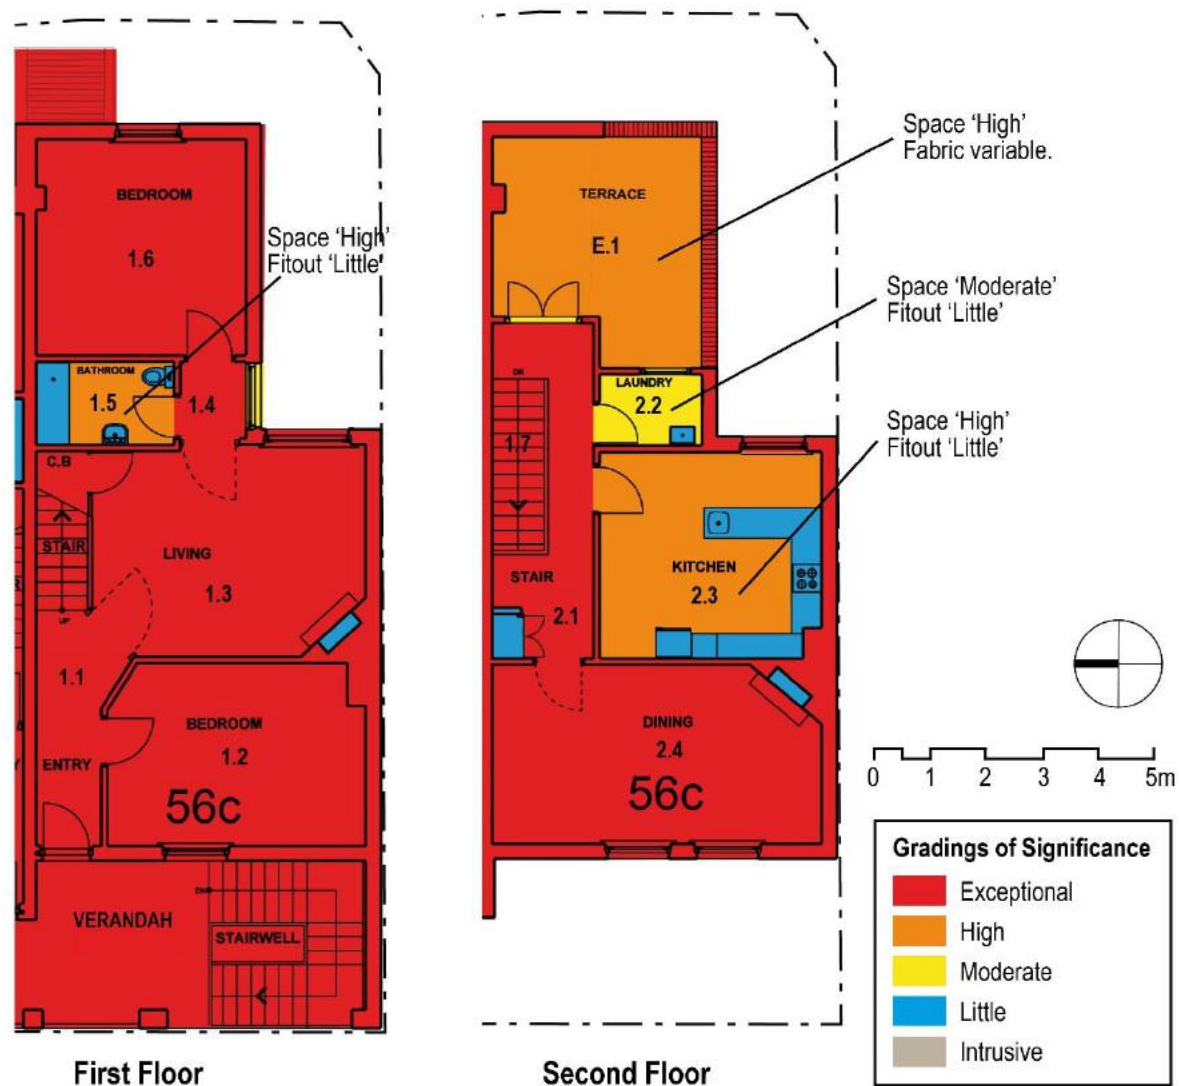
Number 56c—Plans, Gradings of Significance

Figure 16.53 show the relative significance of internal spaces and exteriors of the flat, with certain key fabric elements also graded for reference. Grading of spaces is based on intactness (the extent of subdivision or overall integrity of layout) and use (service spaces having been upgraded or refurbished more extensively). Specific fabric within the spaces (which cannot be shown in detail on the diagram) may be graded differently from the space itself (refer to Tables 16.1 to 16.6).

Figure 16.52 Plans showing gradings of significance of spaces—Flat 56C / 46–56 Gloucester Street. The fabric is graded in Tables 23.1–23.4. (Source: LAHC, with GML overlay 2016)

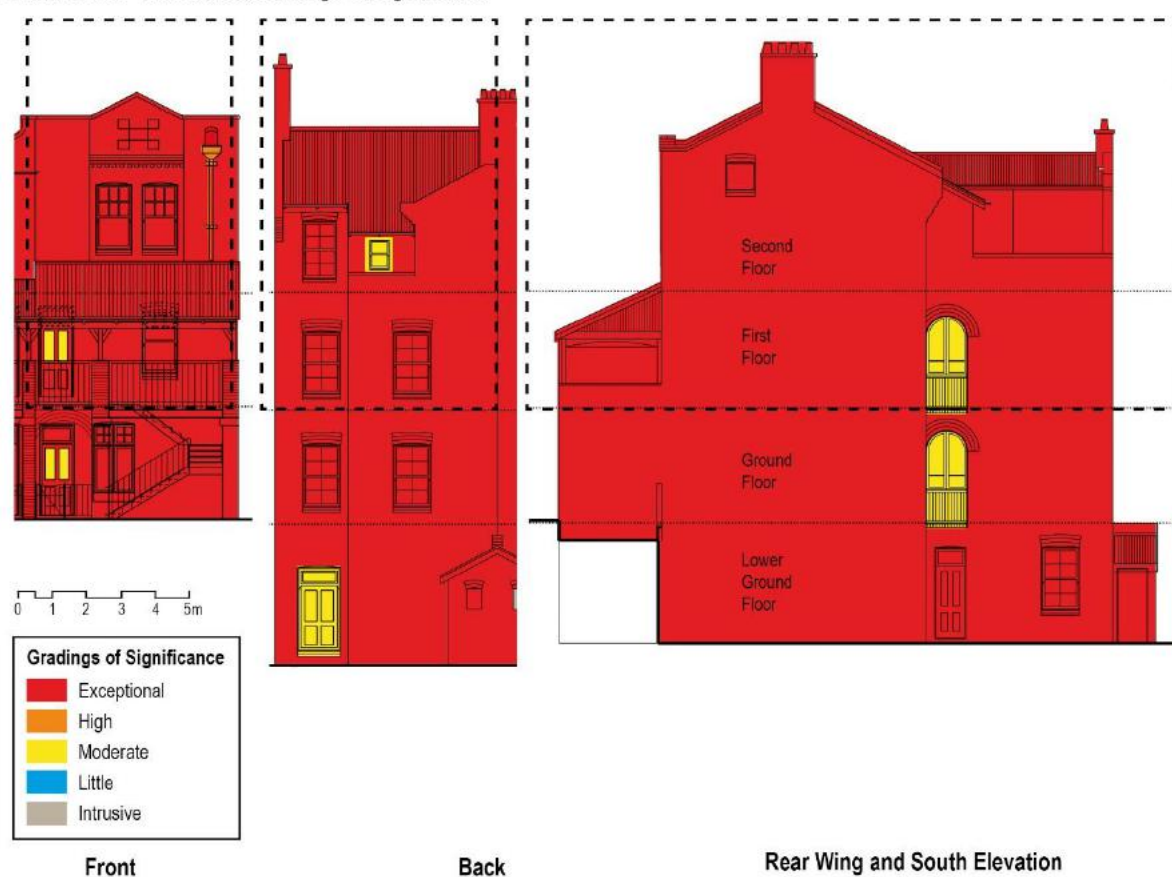
Number 56c—Elevations, Gradings of Significance

Figure 16.53 Elevations showing gradings of significance—Flat 56C / 46–56 Gloucester Street. (Source: LAHC, with GML overlay 2016)
