Campbell's Stores, The Rocks Conservation Management Plan

Report prepared for the Sydney Harbour Foreshore Authority
July 2014

This Conservation Management Plan (CMP) reviews and updates a 1996 CMP and a 2004 CMP for Campbell's Stores to reflect the changes that have occurred since then to 2010. The CMP has been prepared as a policy document to guide future planning for the site with regard to its heritage value and to provide clarity on future heritage requirements.

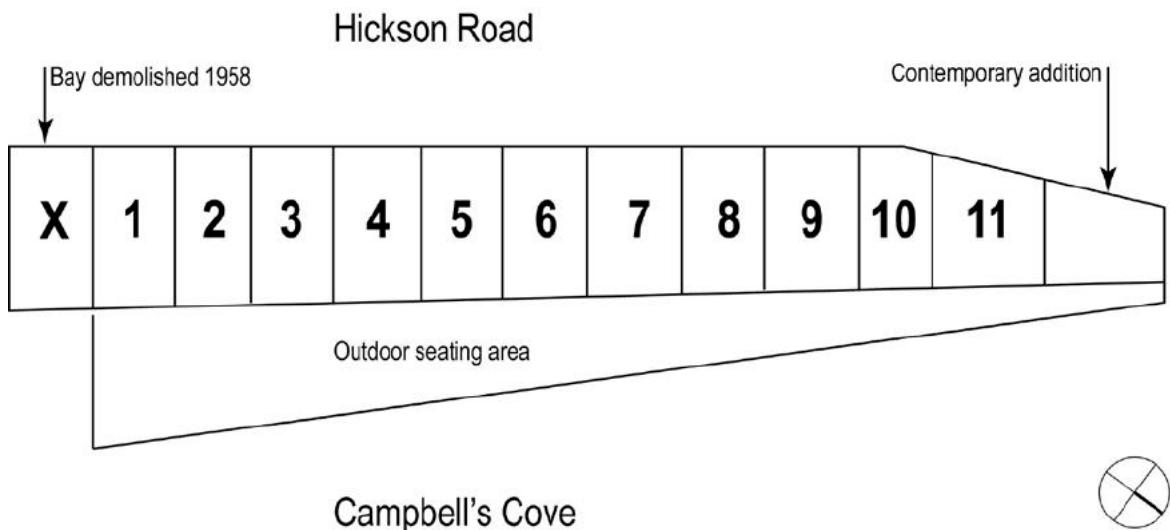
Figure 0.1 Campbell's Stores, diagram illustrating bay numbers used in this report

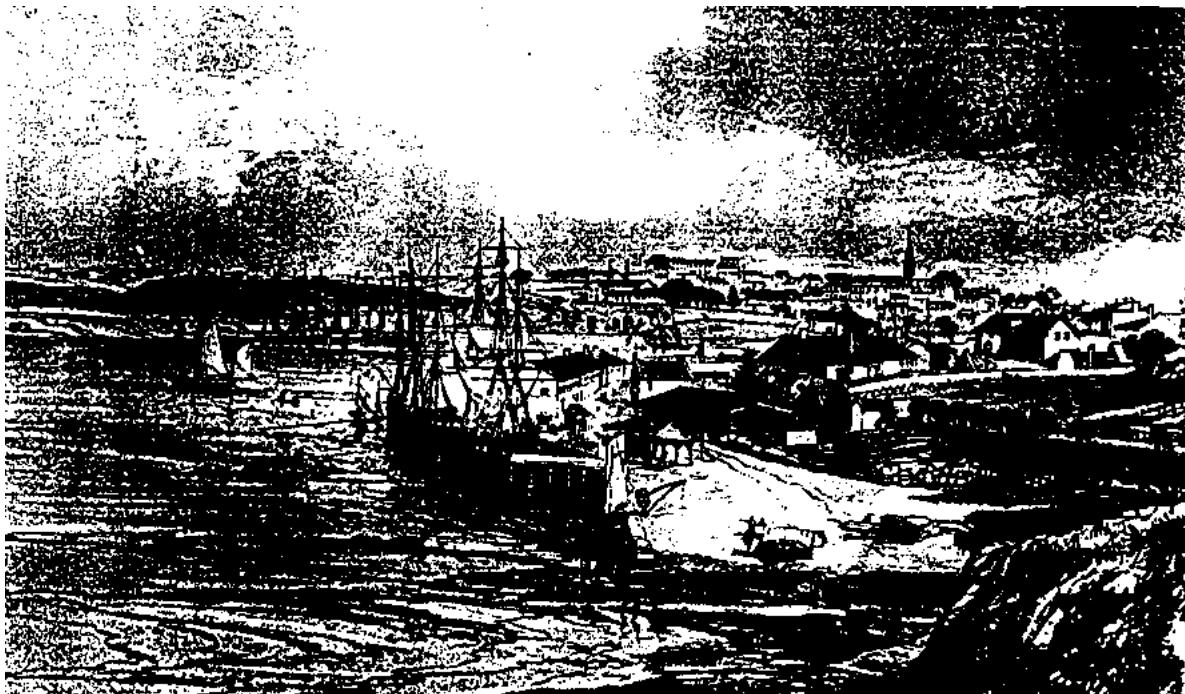
Figure 2.4 Campbell's Wharf, 1842. JS Prout's lithograph provides a view of the wharf. No buildings can be identified as part of the Campbell's Stores. (Source: JS Prout and John Rae, *Sydney Illustrated*, Part II, Sydney 1842, opp p 11)

A lithograph showing Campbell's Wharf by JS Prout published in 1842 showed no sign of the current Campbell's Stores (Figure 2.4). The accompanying text noted that 'Campbell's Wharf in particular, which forms the principal object in the picture, has been sketched with minute attention to particulars'.²⁶

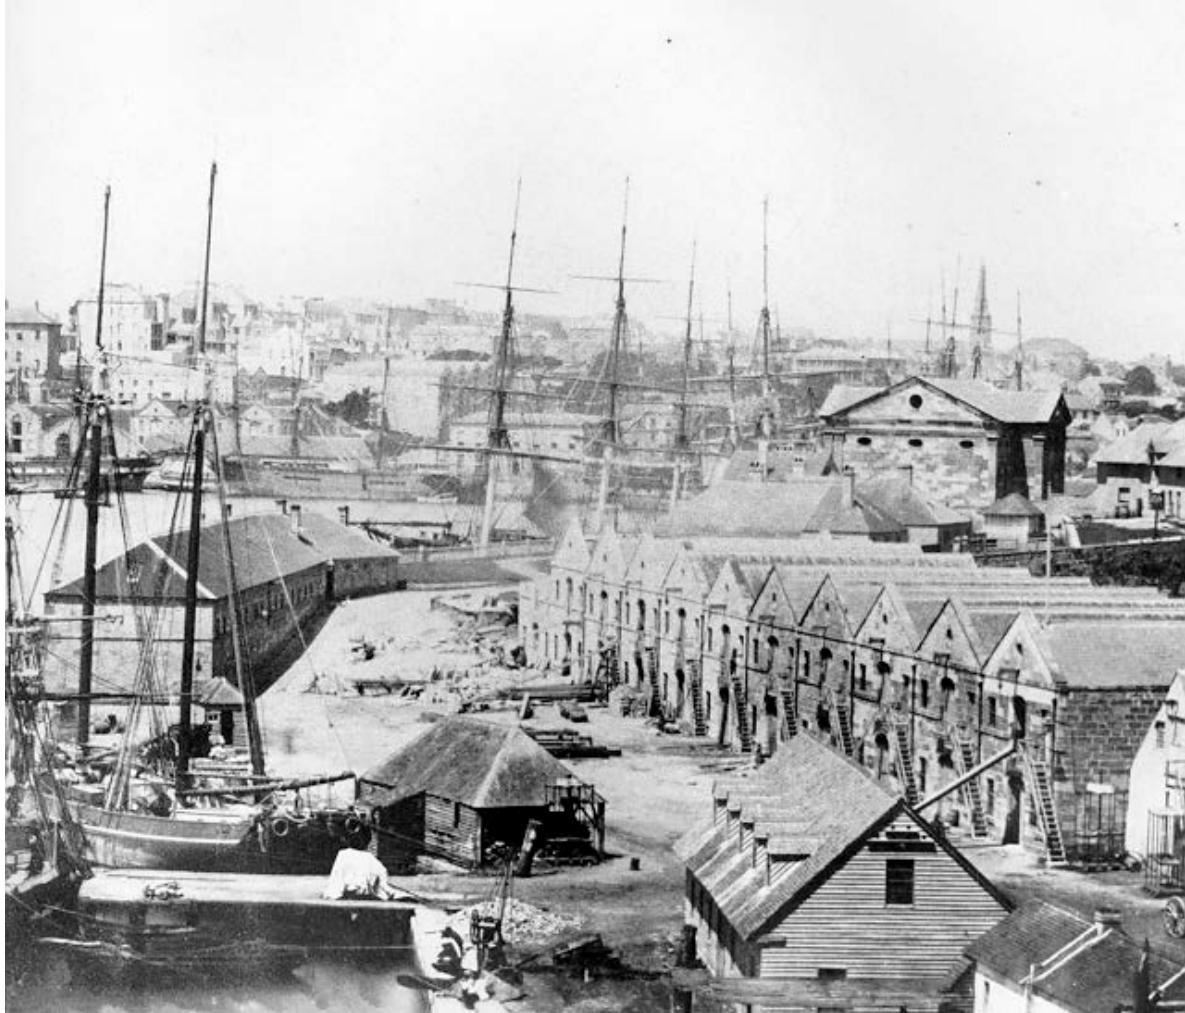
Figure 2.5 Campbell's Wharf, 1856–60. This image from the Moresby Album shows ten bays of the warehouses complete with the eleventh one awaiting its roof. (Source: PXA 9, Mitchell Library)

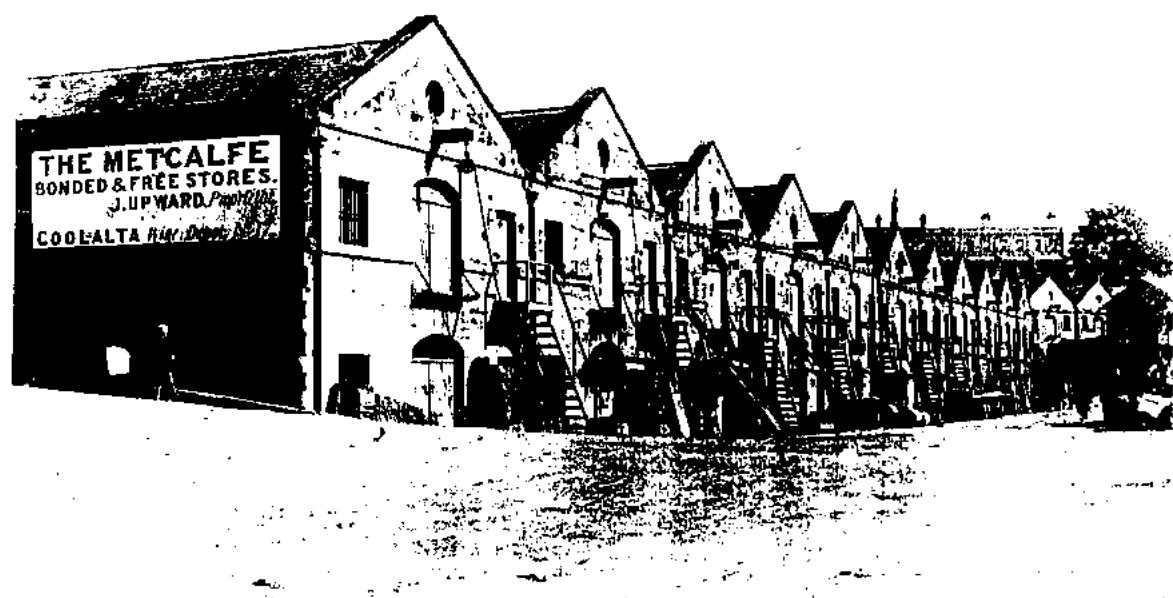
Figure 2.11 Metcalfe Bond, early 1880s. This photograph shows the stores still as two storeys. They would soon be enlarged to three storeys. (Source: SCA Photo, CC7)

The manual handling phase of the operation of Campbell's Stores covers the majority of the nineteenth century. Each of the bays of the building was fitted with a loading door in the east facade of each of the two levels (and maintained when the third level was added in the late 1880s). Each bay had a cat-head beam projecting from the centre of the gable, over the loading doors and each cat-head beam had a substantial tackle block (pulley) suspended from its outer end (typically from a ring-bolt) (evident in the 1880s photograph, Figure 2.11).

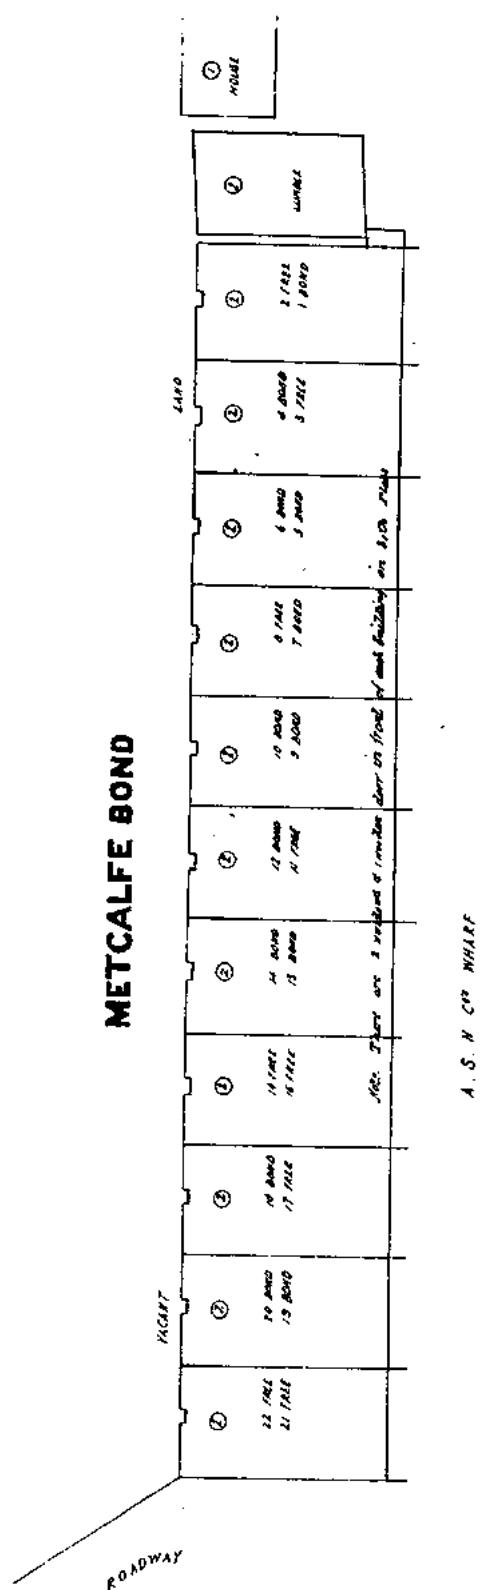
Figure 2.12 Metcalfe Bond, 1882. HP Dove's plan of 1882 showed the earlier layout of the Stores with two storeys before they were enlarged to three storeys by 1887. (Source: HP Dove, *Plans of Sydney Executed for Insurance Companies*, Sydney, 1882)

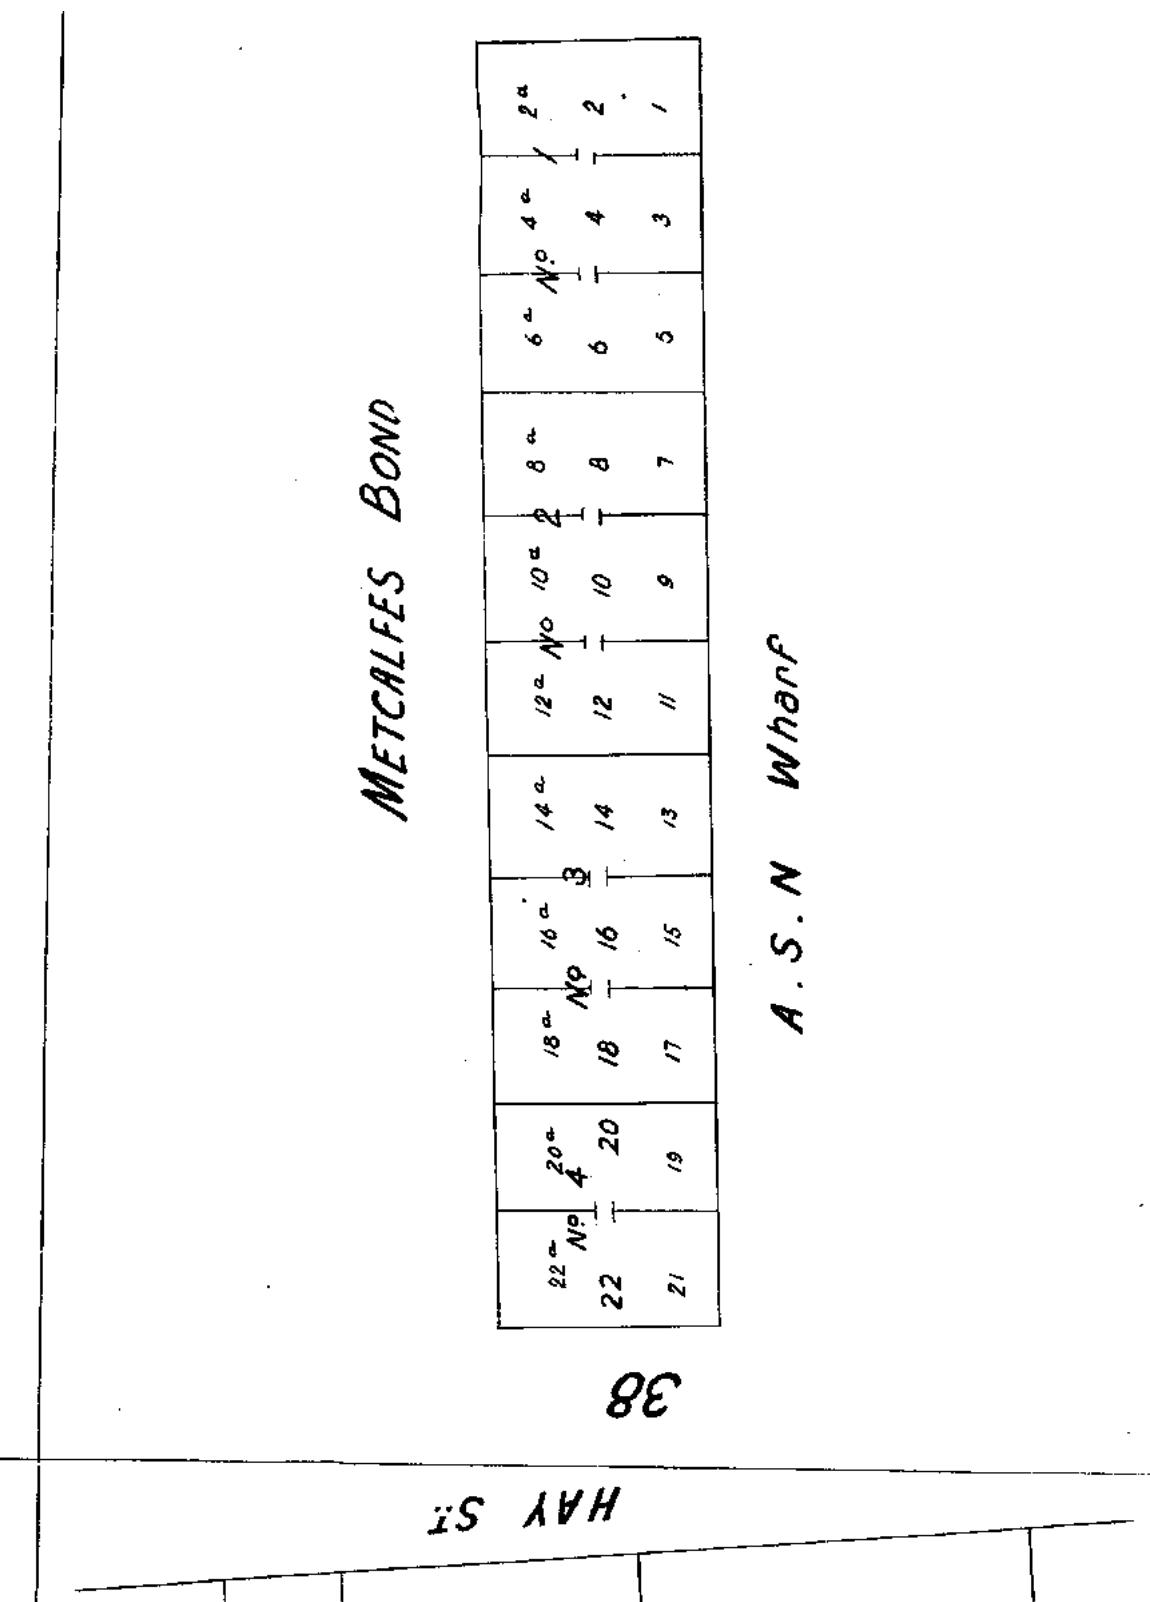
Figure 2.13 Metcalfe Bond, 1887. HP Dove's plan of 1887 showing layout of the Stores with enlargement to three storeys from the original two. (Source: HP Dove, *Plans of Sydney Executed for Insurance Companies*, Sydney, 1882)

The Percy Dove Plan Revision, published in 1887 (Figure 2.13), shows there were openings in the Level 3 longitudinal walls between existing Bays 2/3 and 3/4 as well as between Bays 5/6, 6/7, 8/9,

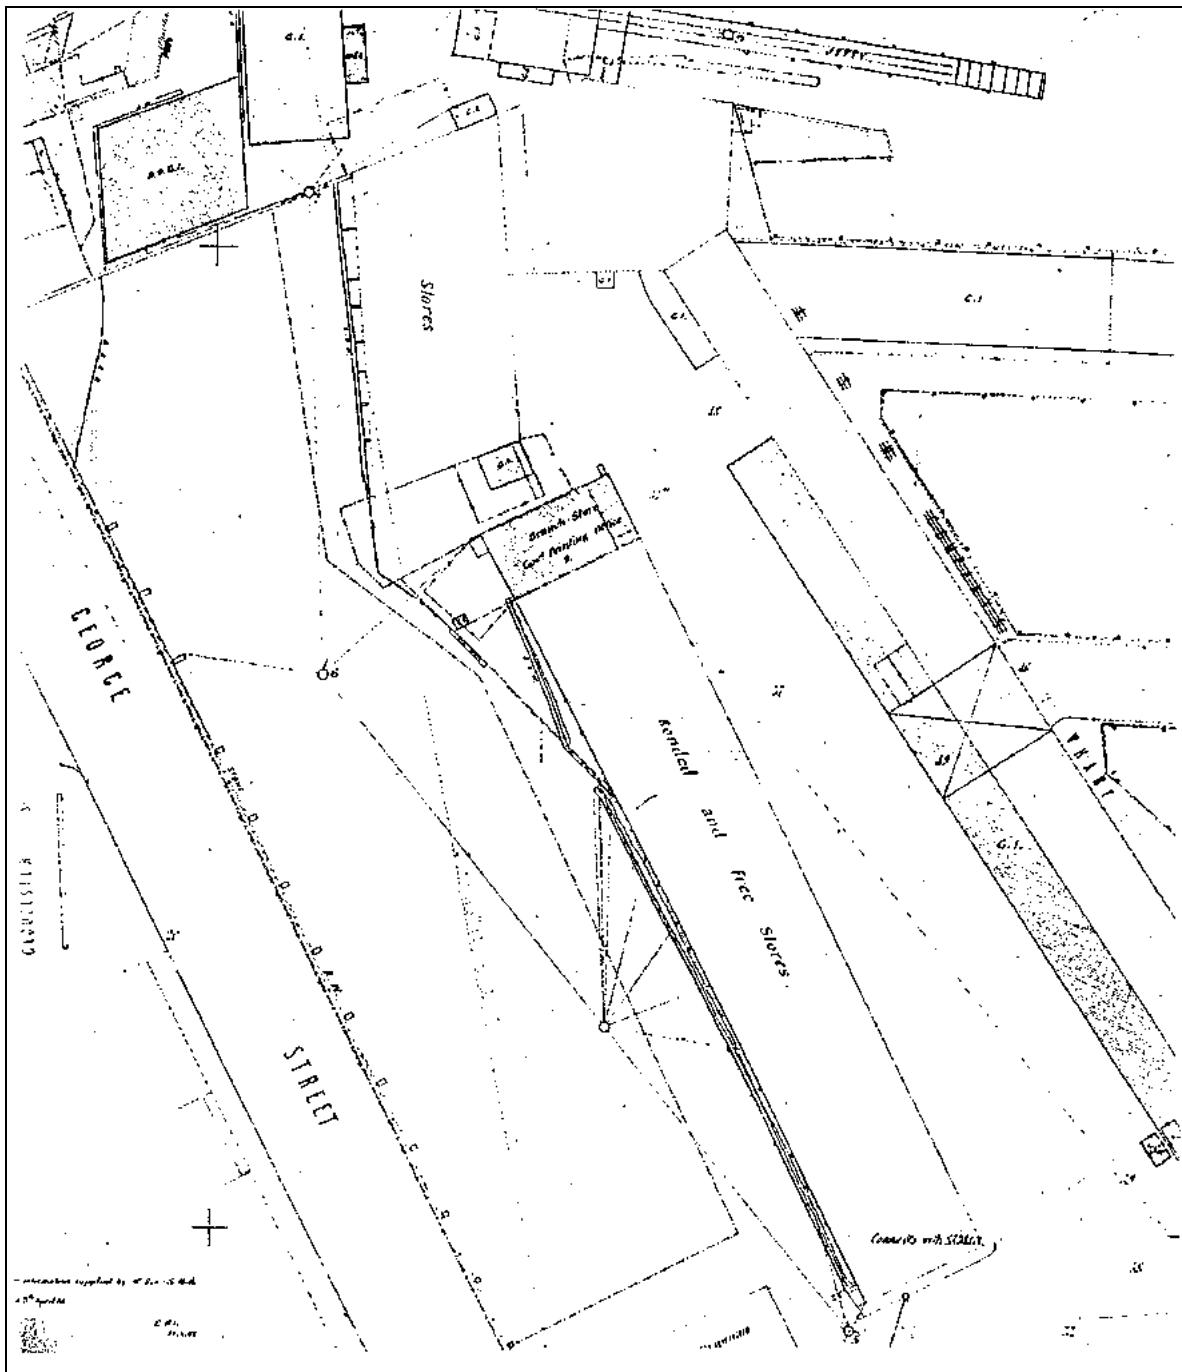
Figure 2.15 Metcalfe Stores, 1882. This survey by Charles Bullock of 1882, showed details of the stores. Additional details were added to the plan until 1895 so it more accurately shows the details at 1895. (Source: S.46.1544.Sh4)

16. Historical Aspect: Evidence of the Government acquisition is provided by the establishment of a section of the Government Printing Office adjacent to the northern end of the Campbell's Stores prior to 1895.
Physical Evidence: Government Printer building may have originally occupied a corrugated-iron shed with an addition at its eastern end, see 1895 Bullock Plan (Figure 2.15).

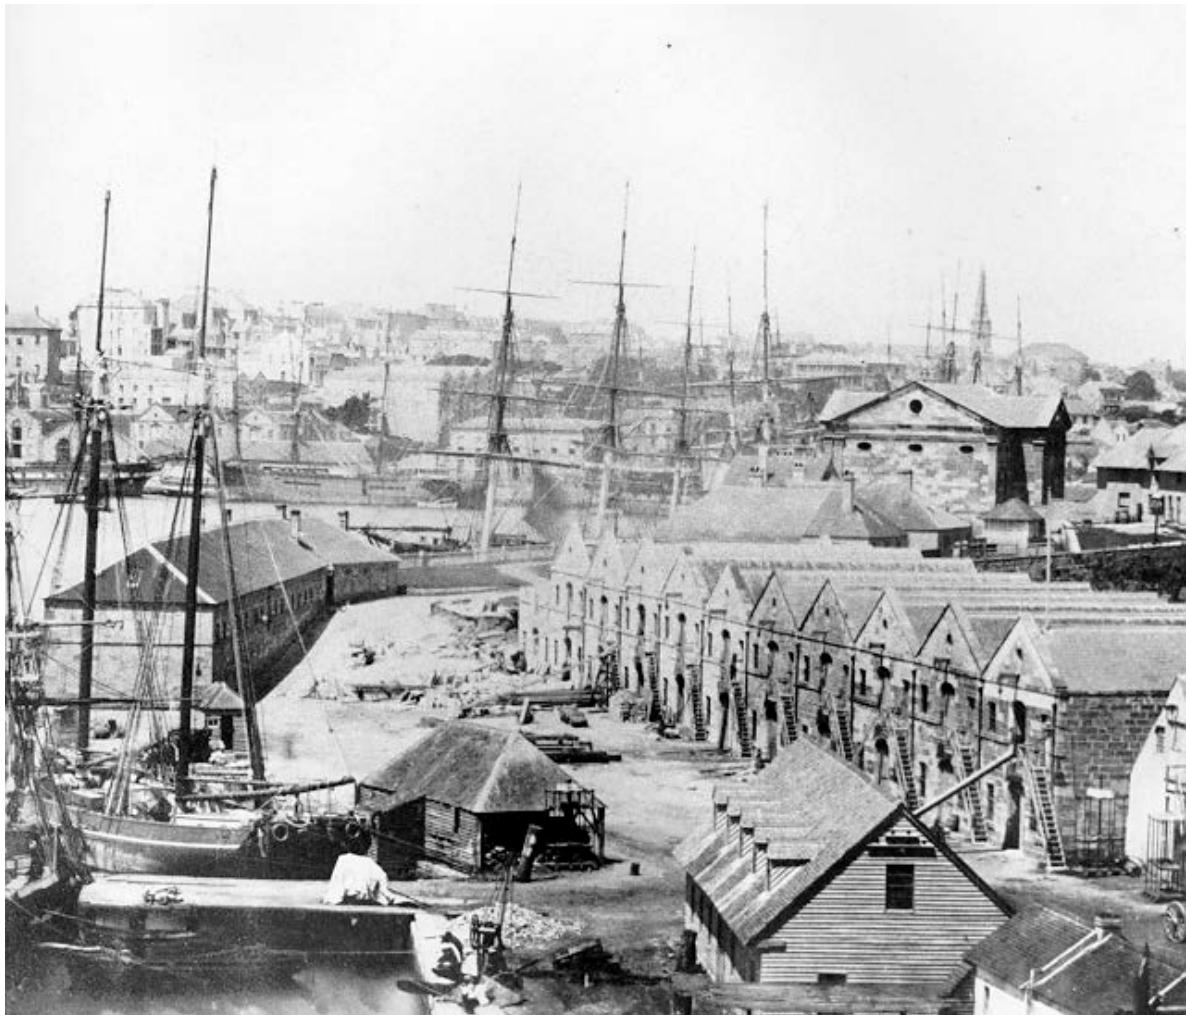
Figure 2.22 Campbell's Stores c1860. Note the staircases leading up to the pedestrian door of the second level of each store and that the southernmost bay is still under construction. This bay was demolished to make way for the infrastructure of the Overseas Passenger Terminal.

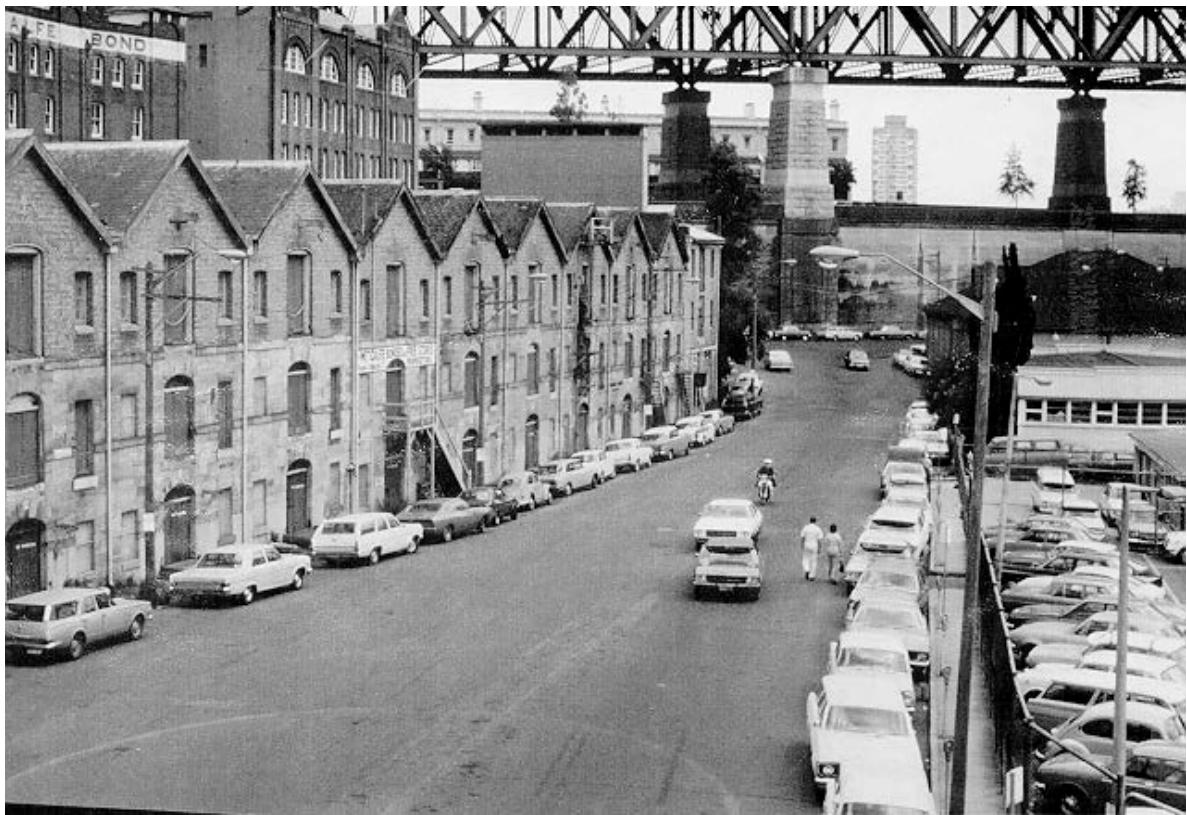
Figure 2.23 Campbell's Store c1970. The stores at this stage were home to Carmels Wine and perhaps a single restaurant. They had suffered from severe rising damp and soft degrade and the staircases were missing off most second levels.

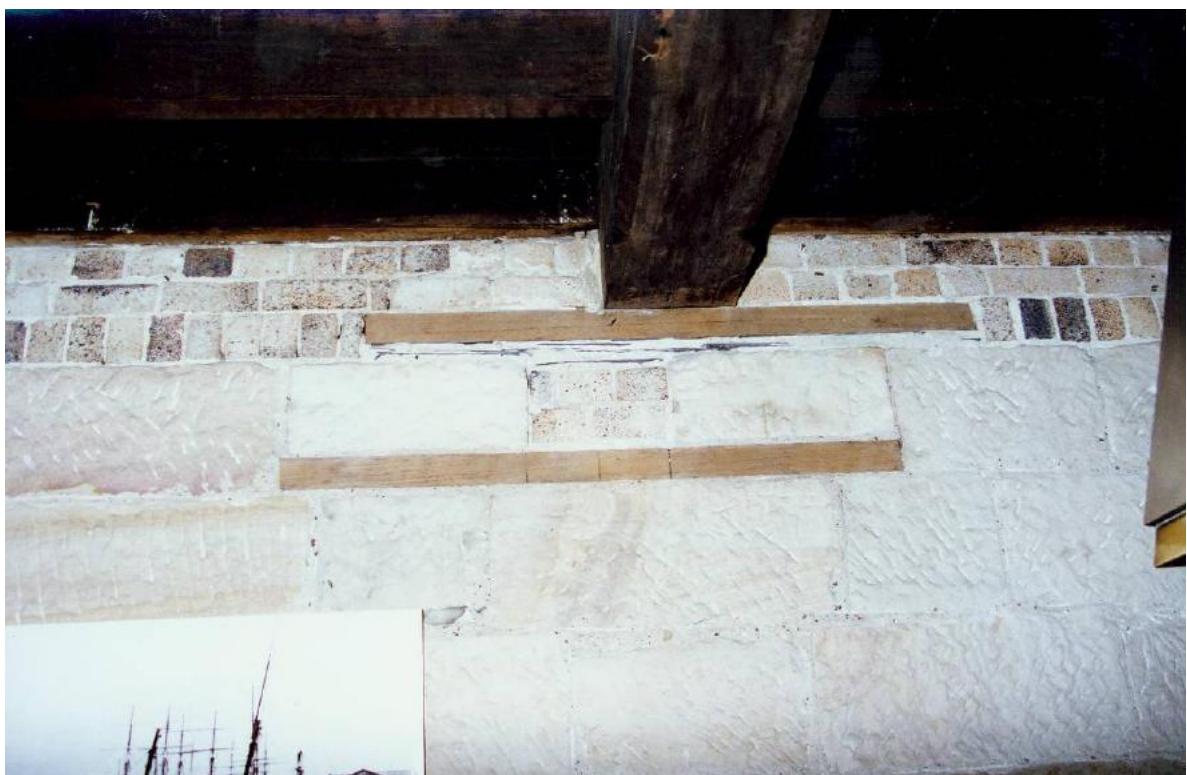
Figure 2.24 The typical arrangement of the pads for the beams. The present pad, which holds the beam to support the floor joists for Level 3, has been packed to raise it to the correct height. The earlier pad shown immediately below, has the three vertical cuts indicating the form and position of the roof truss.

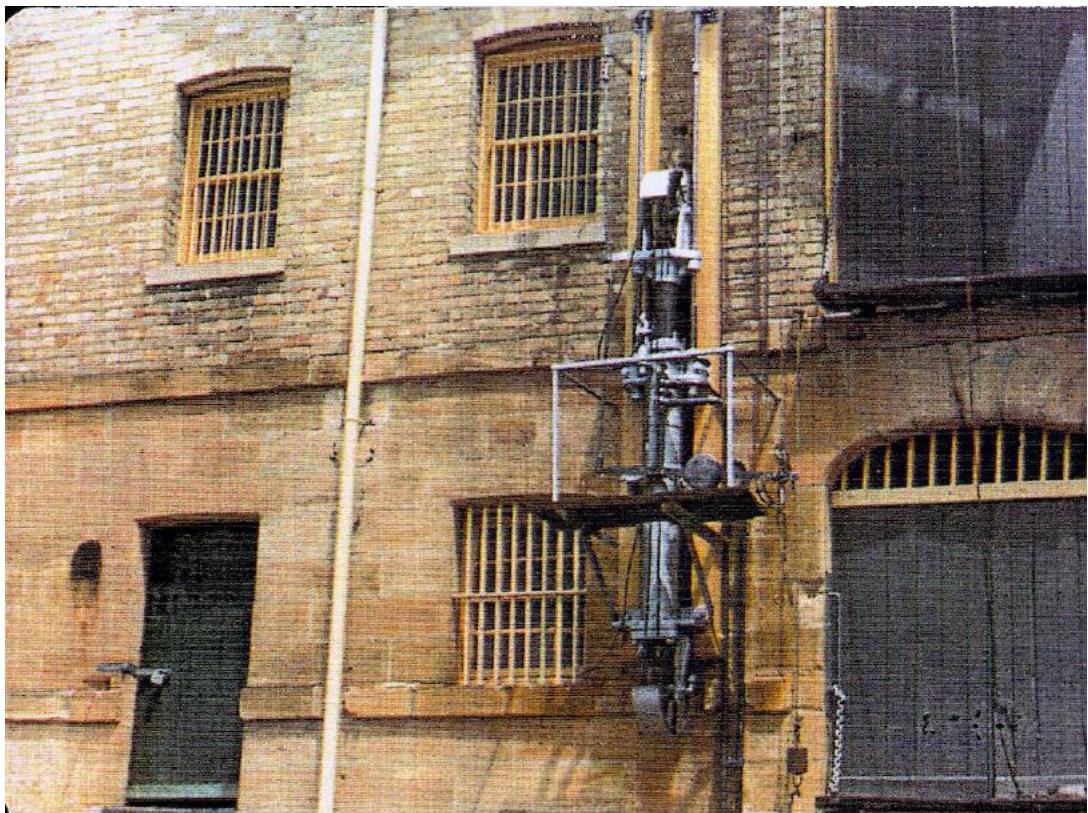
Figure 2.25 The hydraulic hoist outside Bay 1. Note the hoist is complete in almost all details, with the hoist cable, the activating lever and the activating lever cable intact. A similar hoist was outside Bay 8.

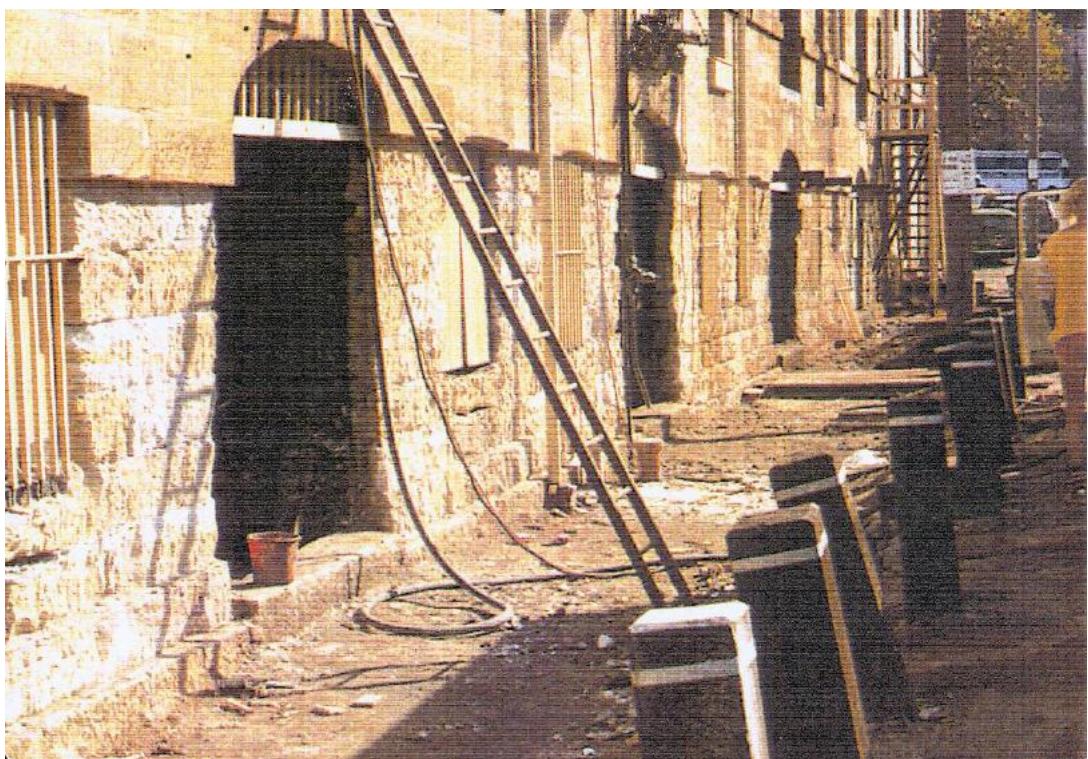
Figure 2.26 The building in June 1977 showing the decayed outer 100mm of stone removed. (Source: CCM105, June 1977)

During the 1970s restoration work, the salt-damaged sandstone of the east facade was removed to a depth of about 100mm using mechanical picks (Figure 2.26). The attack appears to be less obvious at the southern end of the building, although several of the arches over the Level 1 doors were replaced in the same contract.

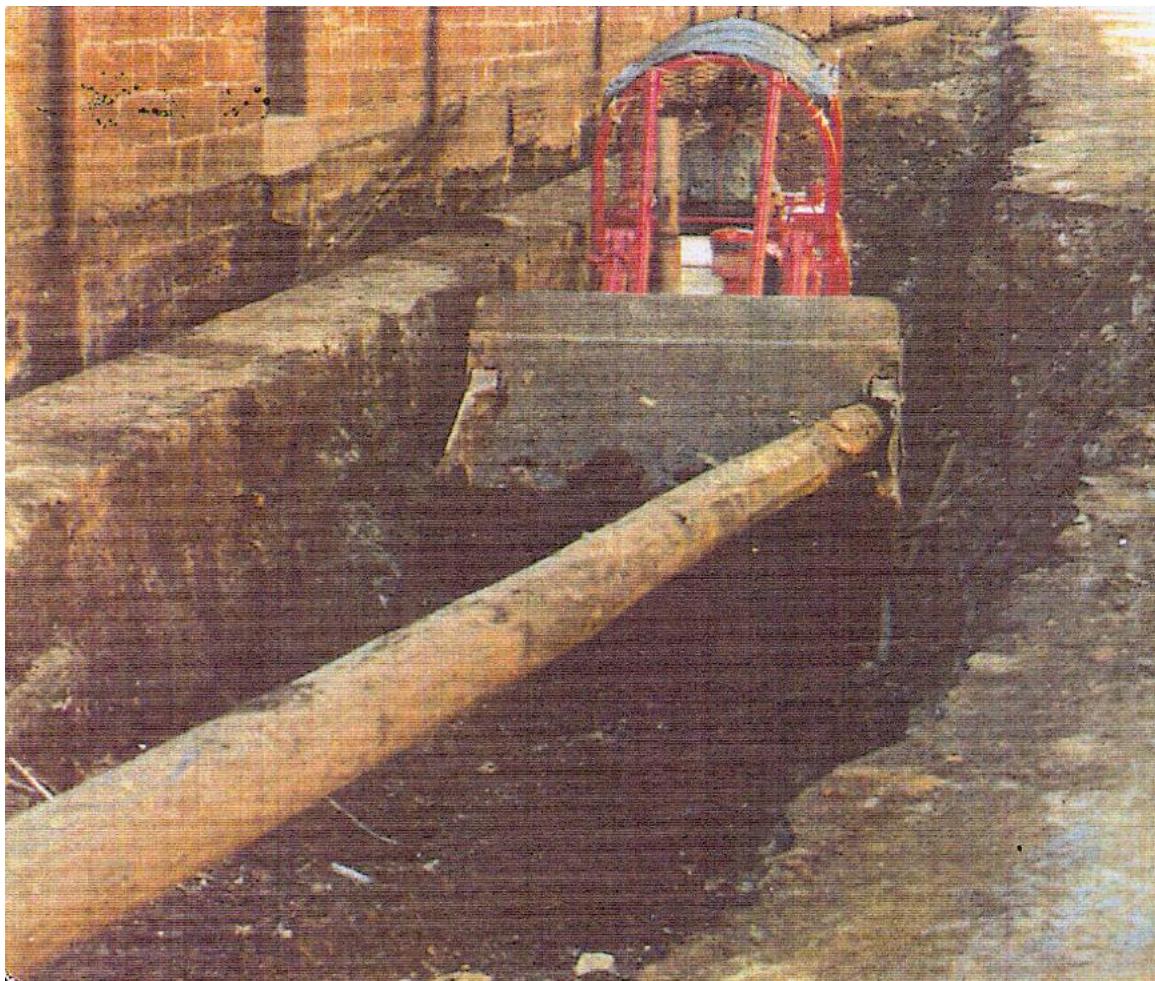
Figure 2.27 The concrete retaining wall about 800mm from the west wall of the building, in 1977.

The west facade of Campbell's Stores fronts Hickson Road. Hickson Road was originally a wide rear laneway and the contemporary road was constructed during the twentieth century. A new concrete retaining wall was built some 600mm to the west of the building (Figure 2.27). This retaining wall held back the fill on which Hickson Road was laid. Photographic evidence¹ indicates that there was a bridge or slab spanning the space between the retaining wall and the building. This prevented fill from falling into the space and coming in contact with the wall. The footpath, which was constructed on this bridging material, however, did contact and mark the wall and is evident in the photographs of the facade.

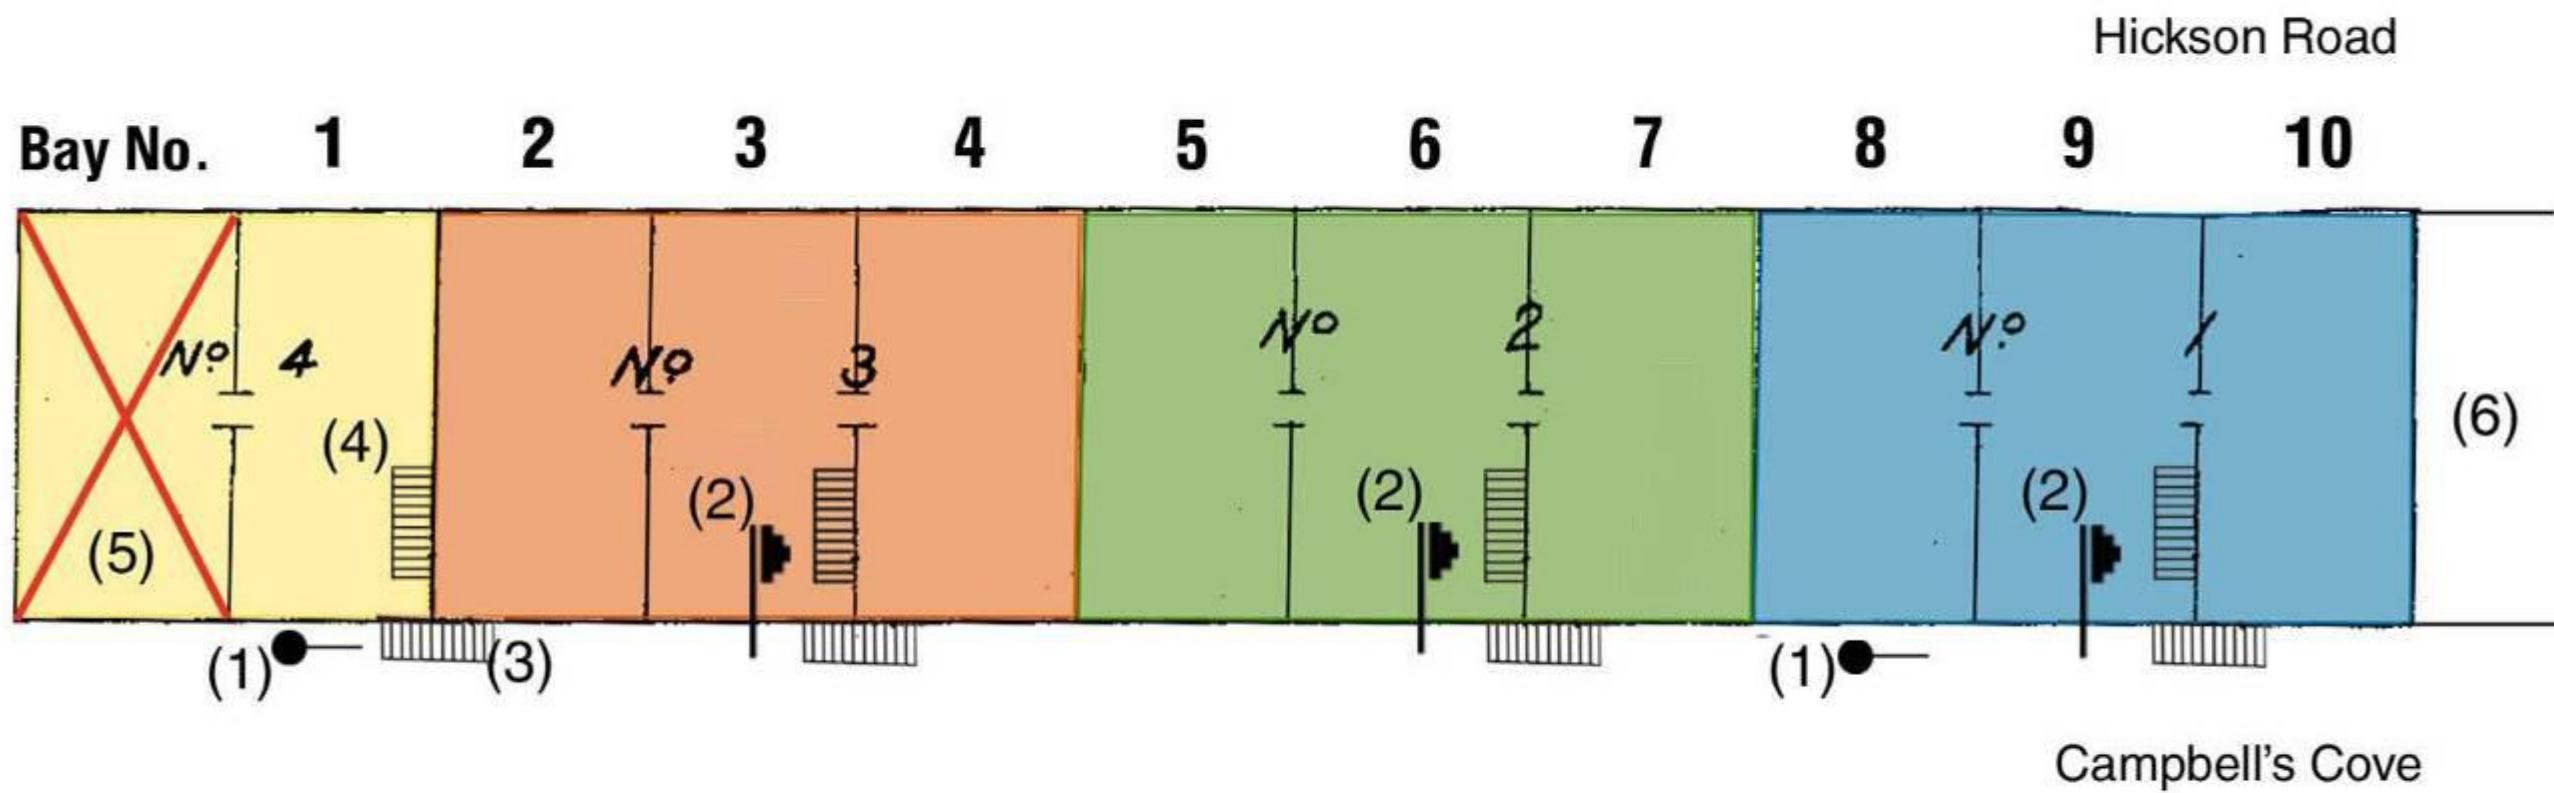
- (1) Hydraulic hoists on building exterior
- (2) Engine driven winches in level 3 interior
- (3) External stairs from ground (level 1) to level 2 (originally one for each bay)
- (4) Internal stairs from level 2 to level 3
- (5) Original Bay demolished in 1958
- (6) Government Printer addition c1890 now bay 11

Figure 3.1 Stores operational units (and possibly lease areas) after the construction of Level 3 and based on the Percy Dove plan of 1887 (see Figure 2.13). Each of the units had at least one engine-powered winch or hydraulic hoist, openings between bays and internal stair access from Level 2 to the top floor, Level 3

The gas engine-driven winch is located in Bay 6 also gave access into Bays 5 and 7. The winch in Bay 9 served Bays 8, 9, and 10. The motor-driven winches are located in Bays 3 and 9. The Bay 3 winch also serves Bays 2 and 4, while the Bay 9 winch serves Bays 8, 9 and 10. This Bay 9 winch served the same bays as the hydraulic hoist mounted outside Bay 8.

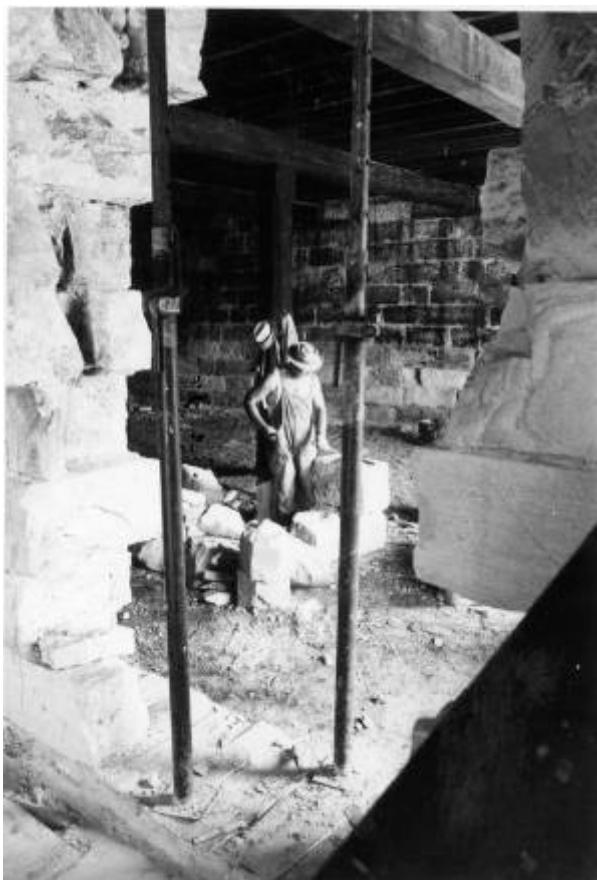
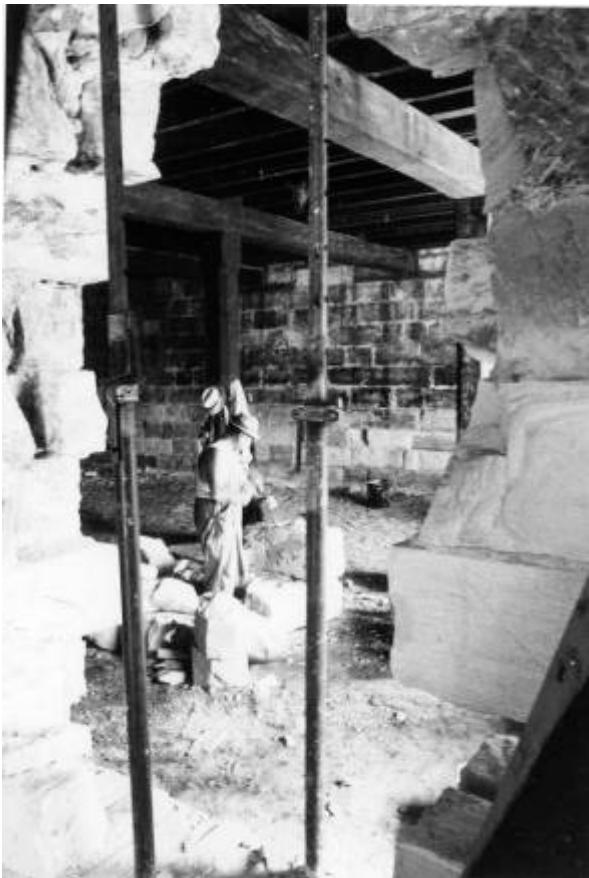
CCM 46-49 and CCM 96

Views of internal restoration work in the stores indicate that if sandstone flagging had once existed on the ground floors of the bays this has probably all been replaced by other surfaces such as concrete. It is thus unlikely that any large areas of earlier underfloor accumulations remain intact below these modern surfaces. Photos of the restoration work also indicate that even if the original flooring had been flagging it has been disturbed by recent activities associated with restoration and maintenance of the building. This is especially the case where recent drains and sewerage services have been laid in the basement and ground floor levels in order to facilitate operation of the various restaurants currently occupying the stores. The possibility (albeit slight) of the original sandstone flagging surviving in some areas below current concrete surfaces should be considered.

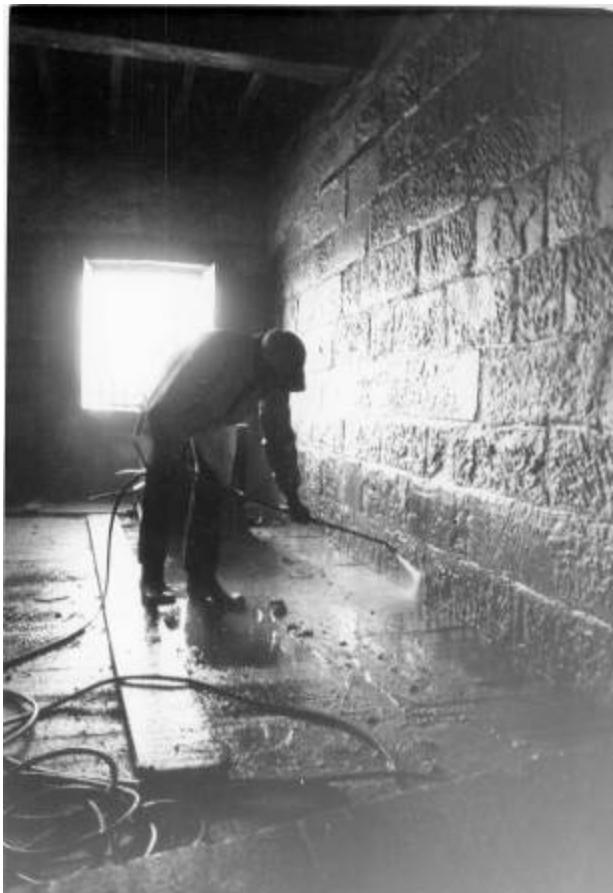
CCM 51 (SHFA)

Photographic evidence indicates that the sandstone walls were water blasted during the 1970s restoration. This process would have effectively removed evidence of plaster, render or paint traces from the stores' earlier occupation period.

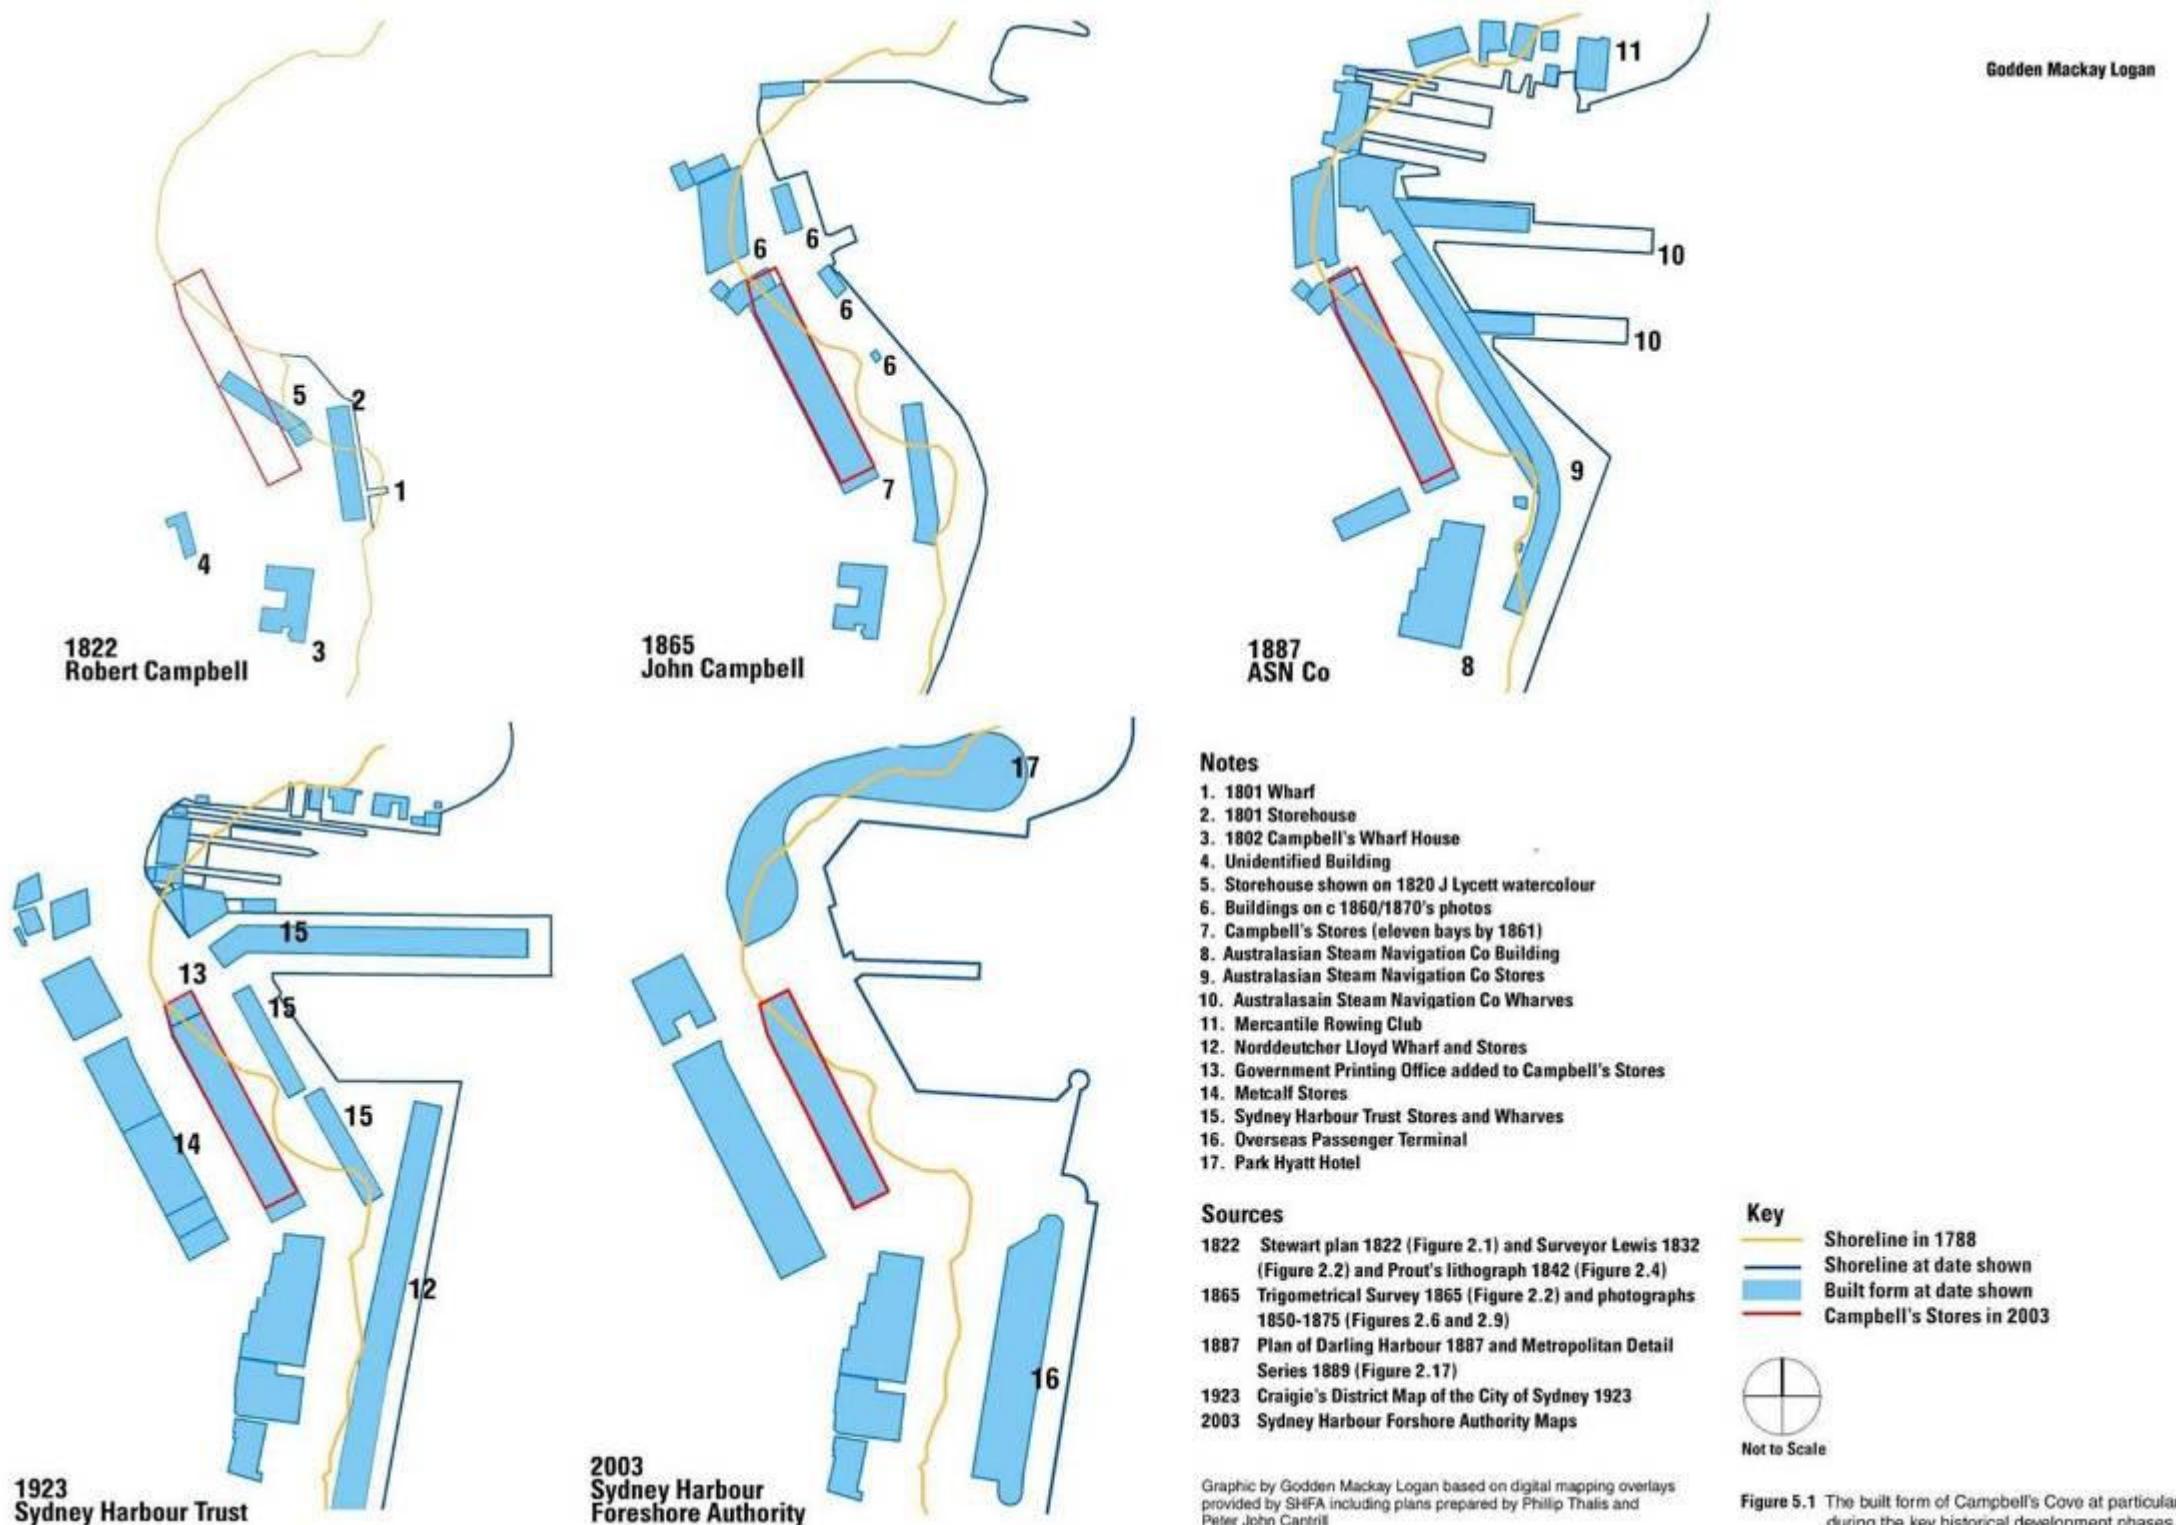
Figure 3.2 The built form of Campbell's Cove at particular dates during the key historical development phases.

Figure 3.2 shows the relationship between goods handling and the lease areas after the third level was constructed.
