Campbell's Stores, The Rocks Conservation Management Plan

Report prepared for the Sydney Harbour Foreshore Authority
July 2014

This Conservation Management Plan (CMP) reviews and updates a 1996 CMP and a 2004 CMP for Campbell's Stores to reflect the changes that have occurred since then to 2010. The CMP has been prepared as a policy document to guide future planning for the site with regard to its heritage value and to provide clarity on future heritage requirements.

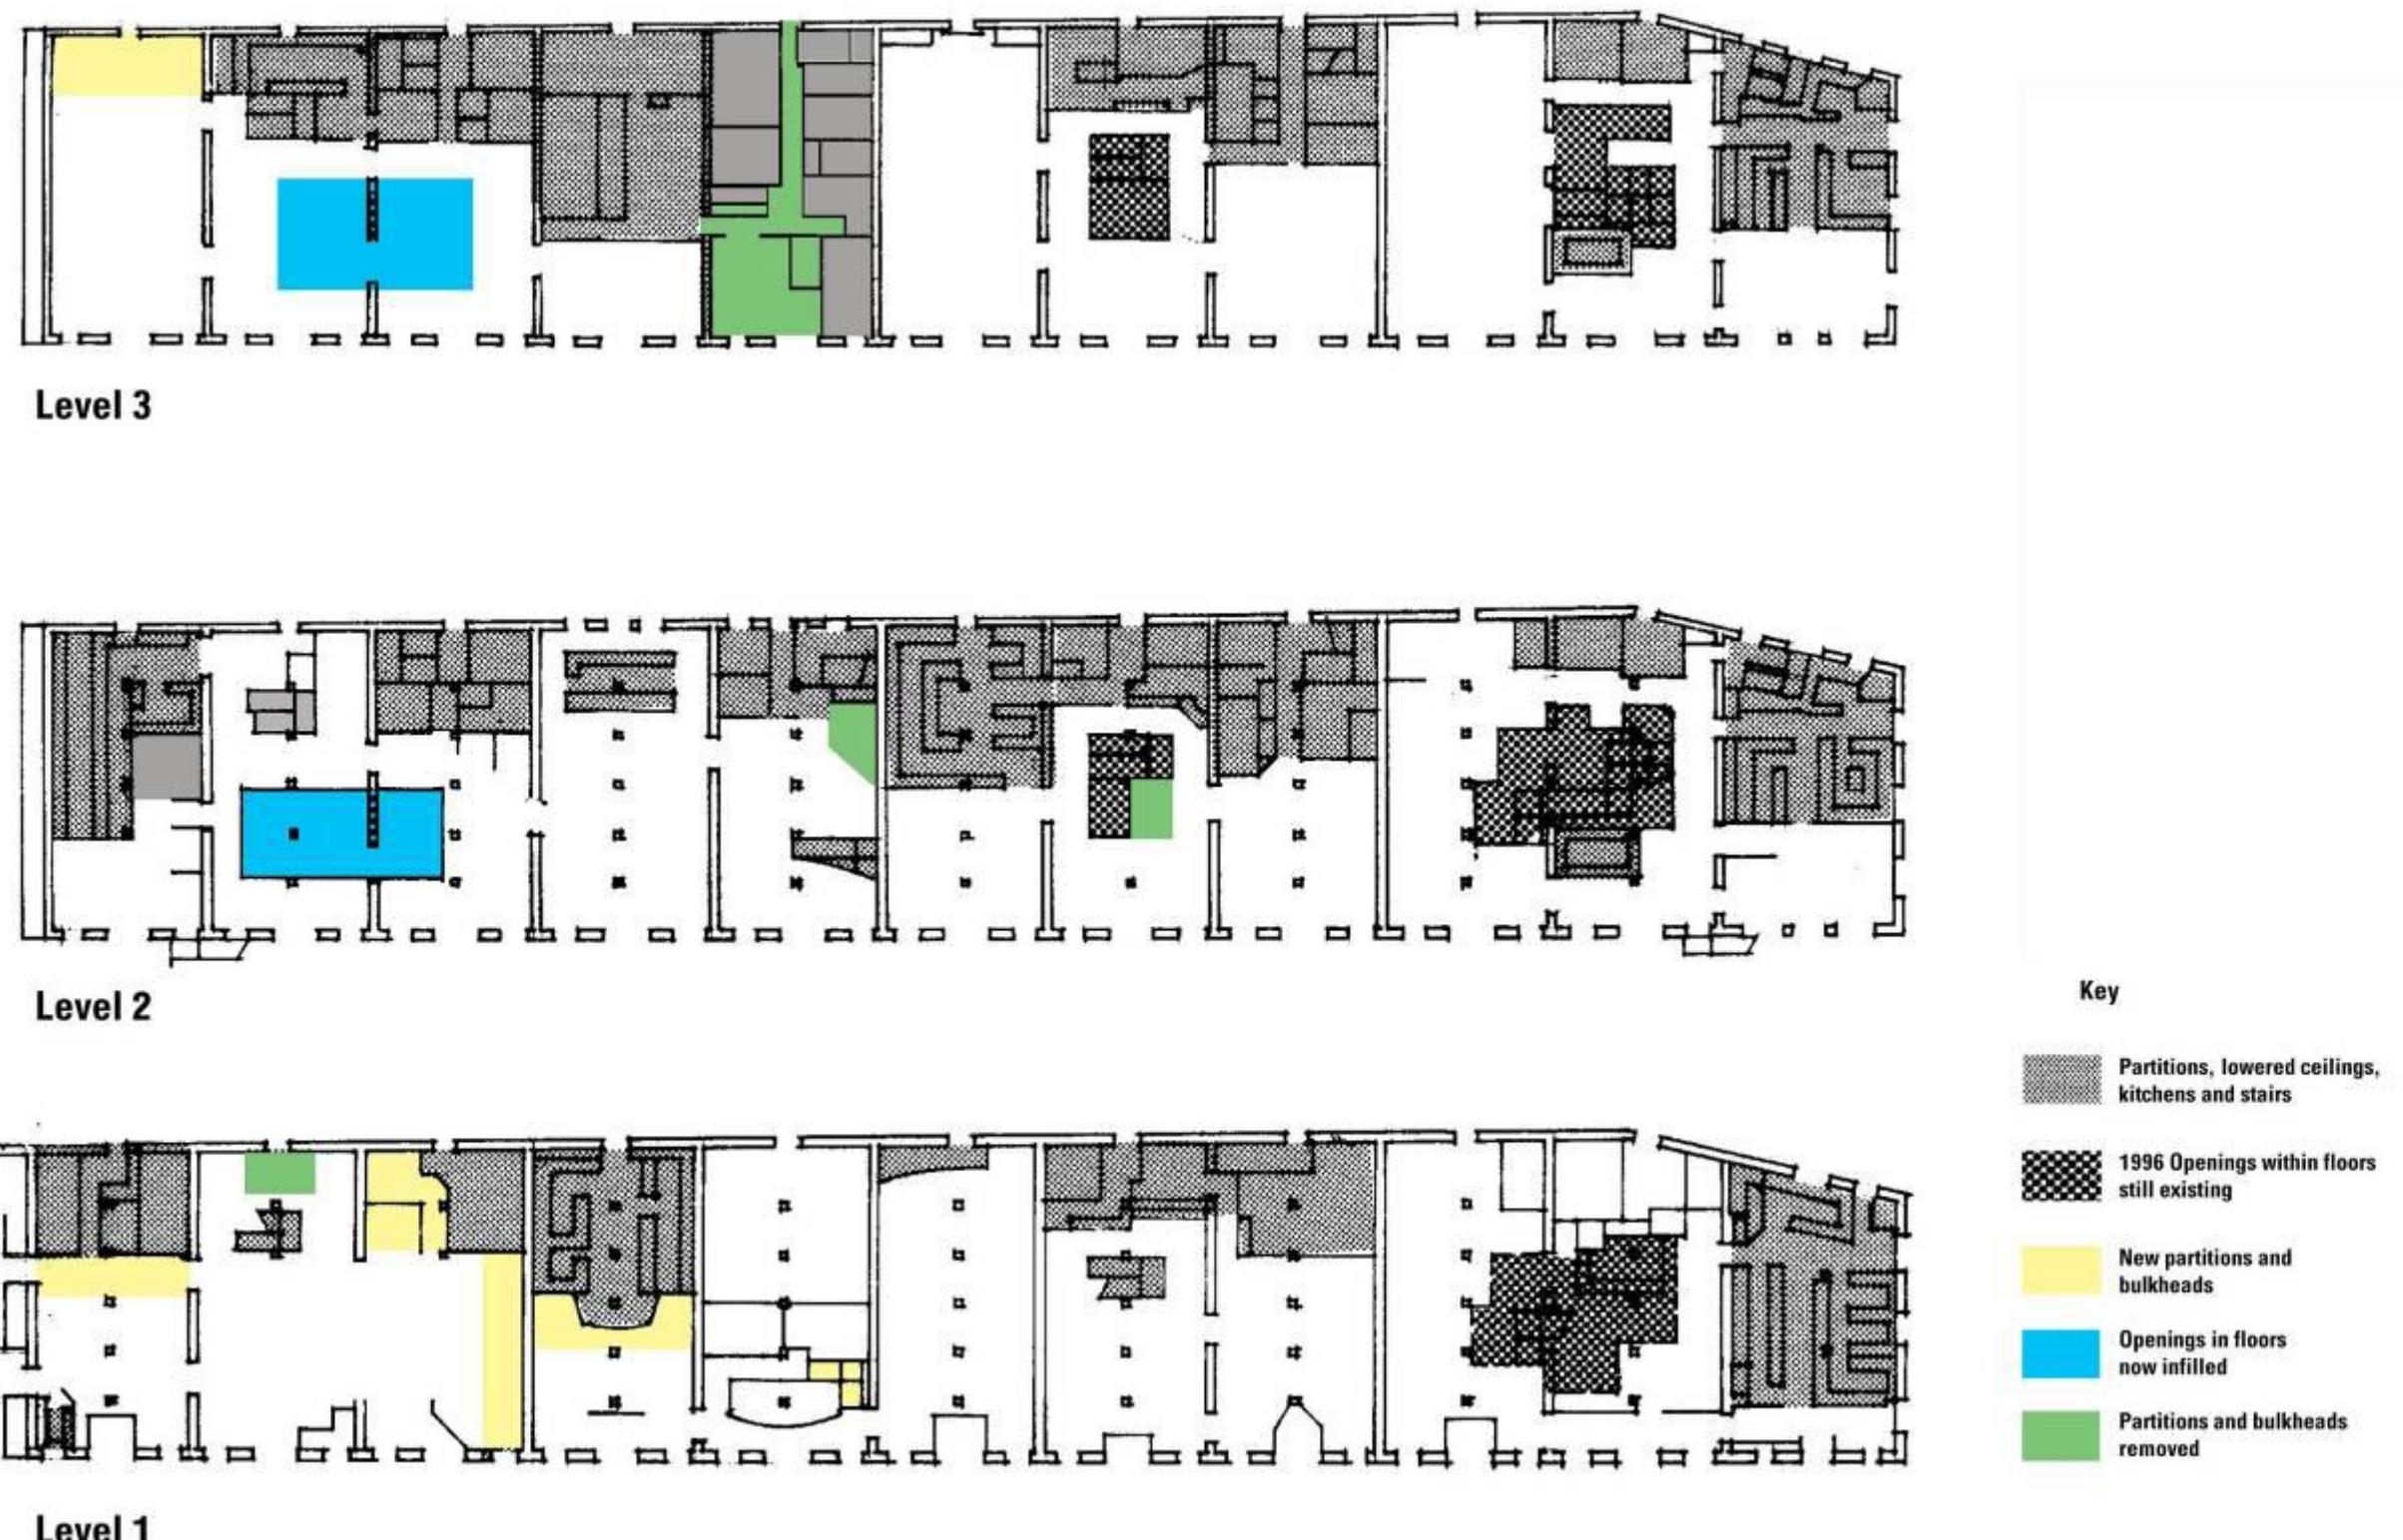
Figure 3.3 Analysis of elements that impact on the original internal spaces, and also showing changes since 1996 (grey tones), April 2003.

Since the 1970s adaptation works a large amount of new fabric has been introduced. Partitions have been constructed for kitchens, amenities, fire stairs and offices. False ceilings and mezzanines for restaurant eating areas have also been inserted. Sections of flooring were removed in a number of areas (in the early 1970s) to create atrium spaces between levels. Numerous door openings have also been made between the spaces. Figure 3.3 is a graphical representation of the impact of these changes on the spaces within Campbell's Stores.

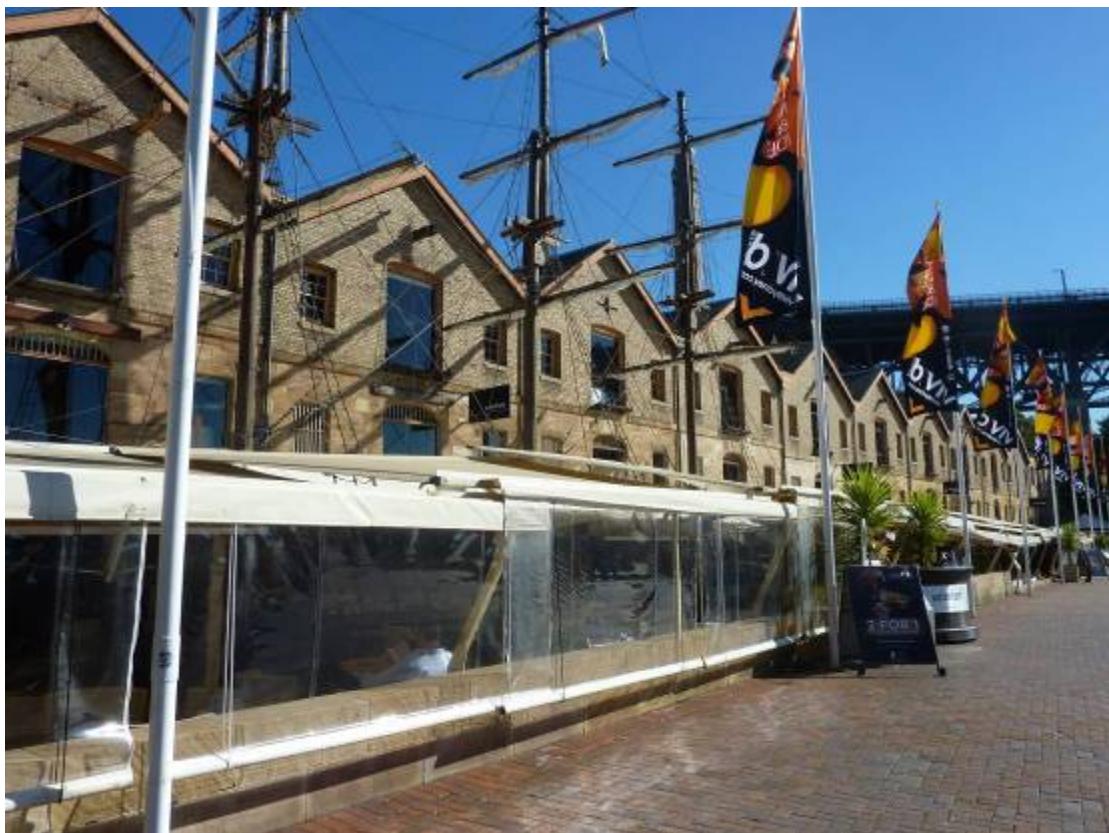
Figure 3.9 The outdoor seating area (2010).

The masts, although a maritime feature, significantly obscure views to and interpretation of Campbell's Stores and the methods used to stabilise them have damaged the fabric of the building (Figure 3.9).

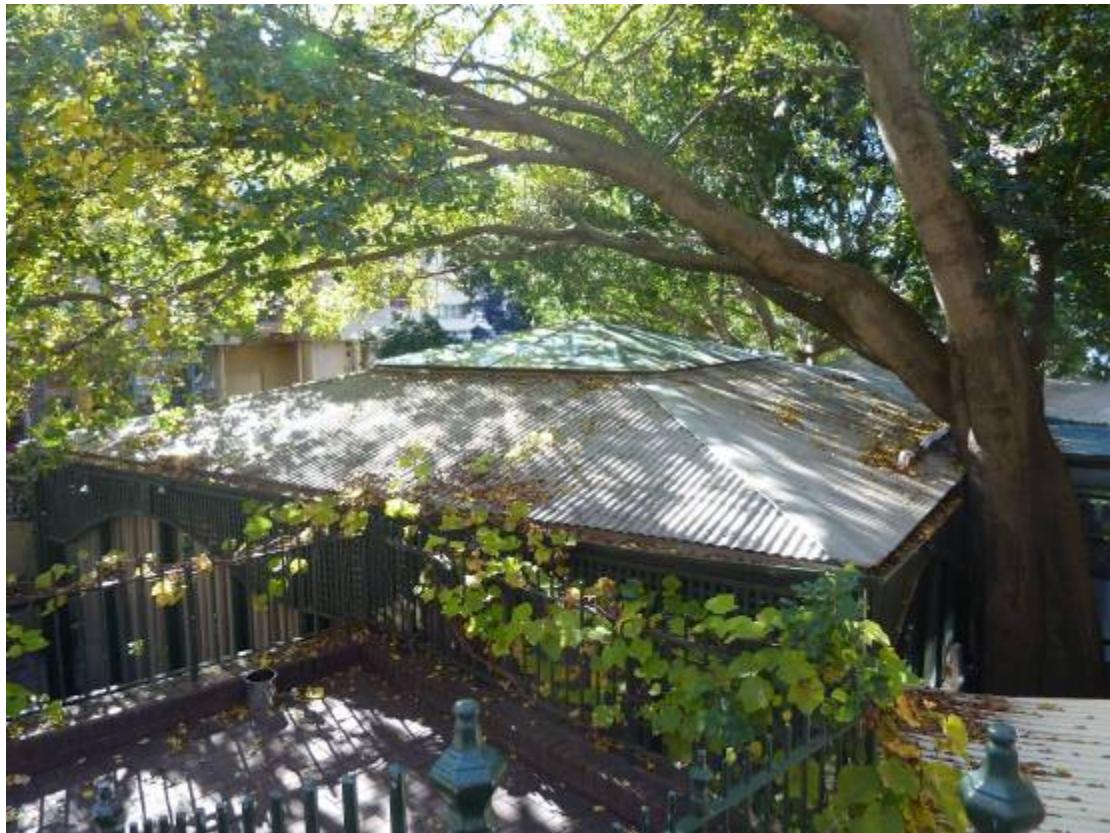
Figure 3.12 The contemporary pavilion (c1990) at the northern end of Campbell's Stores (2010).

The pavilion, located north of the stores, is a square structure measuring about 12m by 12m, which is steel framed and has a corrugated-metal roof (Figure 3.12). All four sides are glazed from floor to ceiling and, on the north and east facades, six of the eight glazed panels slide to the side to allow the dining experience to be almost alfresco. The building has a scalloped decorative lattice panel suspended in front of the glazing on two sides, which acts as a shading device. The pavilion is located adjacent to the newest, and certainly the most altered, of all of the bays of the warehouse.

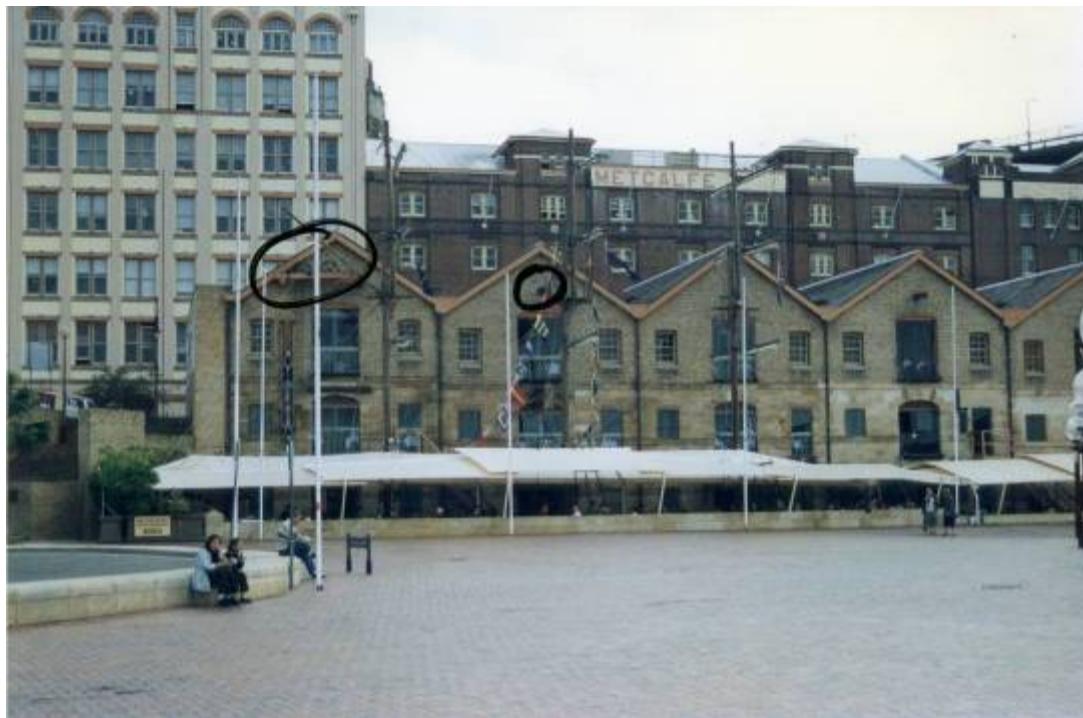
Figure 3.13 The hydraulic hoist, Bay 1 (SHFA c1978).

Two hydraulic hoists were fixed to the front facade of the building, at Bays 1 and 8 (see Figures 3.13 and 3.14). The hoists were driven by the hydraulic rams powered by pressurised water, probably supplied by the Sydney Hydraulic Power Company, which operated from the 1890s until 1970.

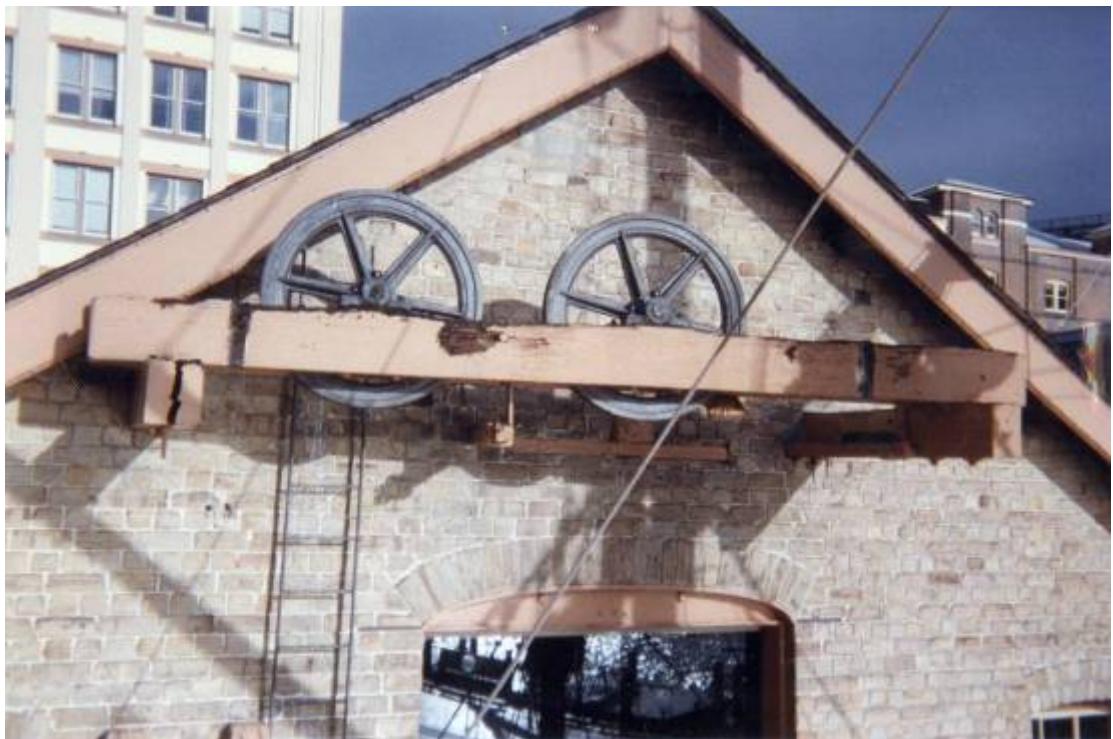
Figure 3.14 Hydraulic hoist, Bay 8 (SHFA c1978).

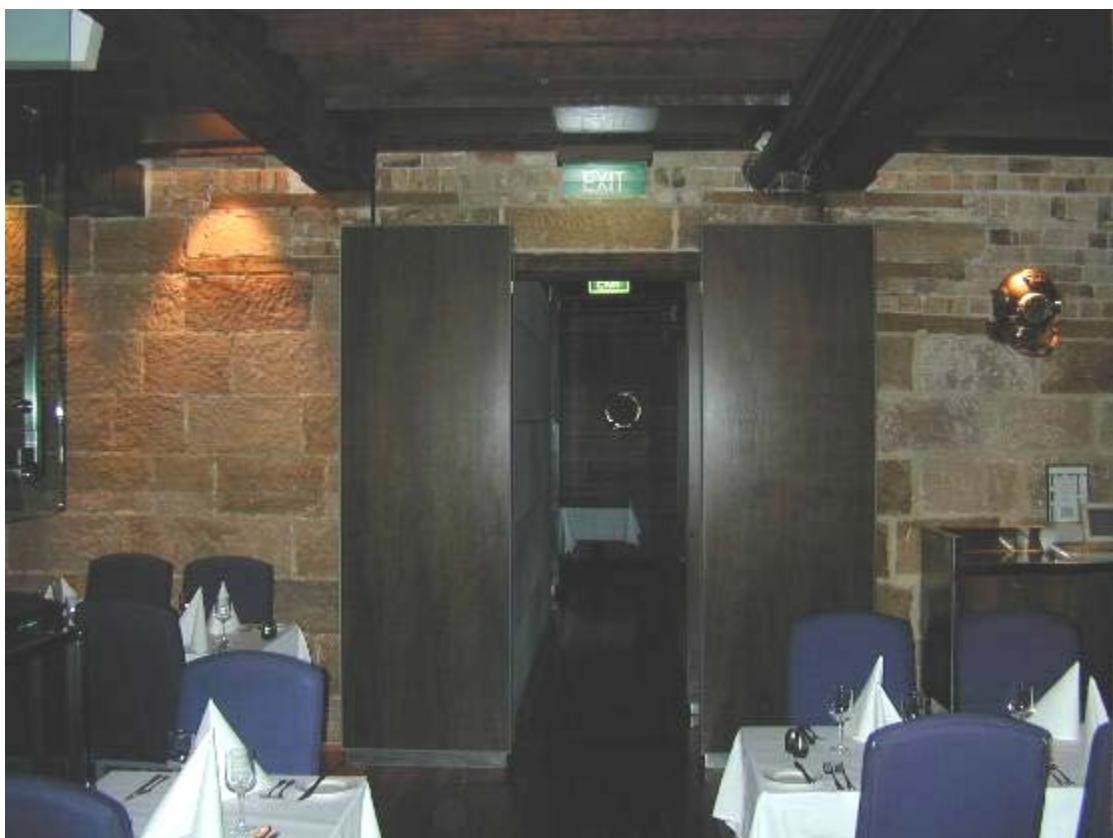
Figure 3.15 The Waterfront Restaurant, Bay 2, Level 2, showing the westernmost doorway in the north wall leading to Bay 3 (2004).

Bay 2, Level 2 is accessed by stairs in sub-bay D and from Bays 1 and 3, Level 2. There are two doorways in the northern wall to Bay 3 (Figure 3.15).

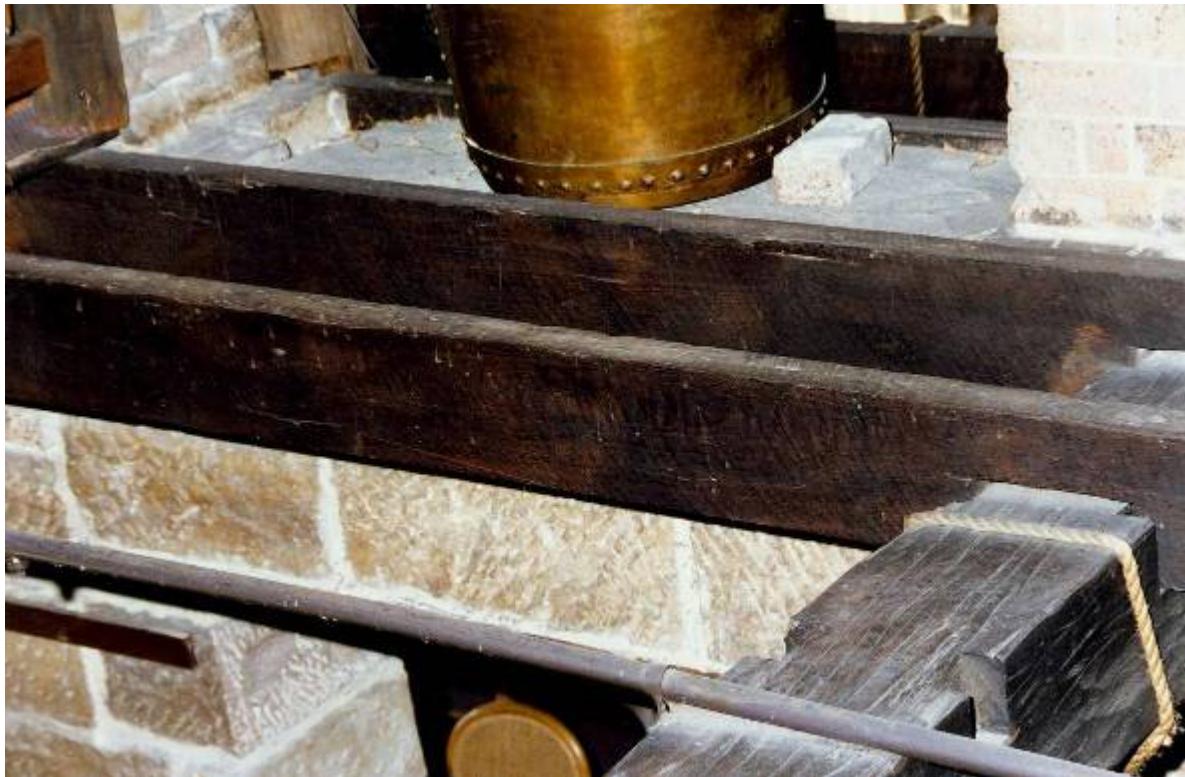
Figure 3.16 Waterfront Restaurant, Bay 3, Level 3, looking down through the void at the longitudinal stone wall. The beam and joist on this level have been machine-sawn (1996).

Bay 3, Level 3: the western end of this bay is partitioned and contains a store, public toilets, bar area and staff stairway connecting to Level 2. The framing of the partition is attached to the fabric of the Bay 4, Level 3 building (Figure 3.16).

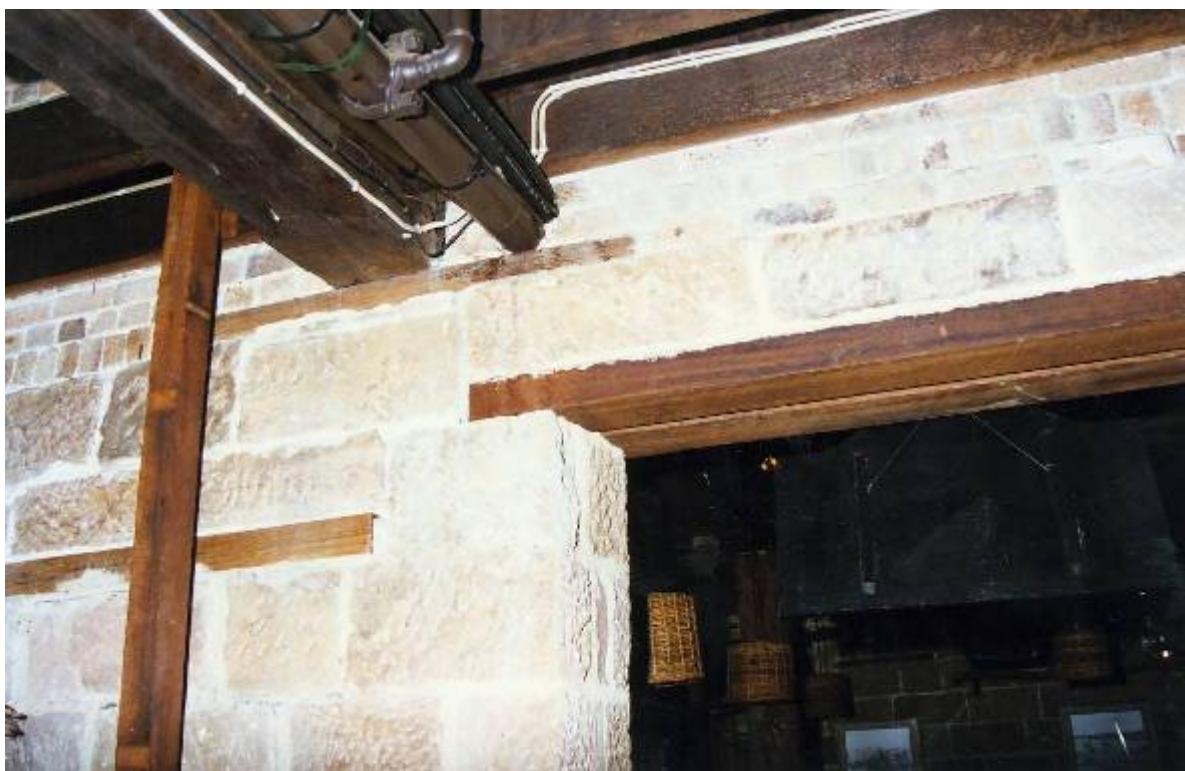
Figure 3.17 Bay 3, Level 2, showing the new opening supported on newly introduced 100mm by 200mm twin lintel boards (1996).

Entry to this bay is via two doorways from Bay 2 (Figure 3.19) and one from Bay 4 (Figure 3.17). It should be noted that on the Devine Erby Mazlin drawings of 1973 the openings in the longitudinal walls are shown to be in sub-bay C and are shown as new fire rated inter-tenancy doors. However, it is not known if the openings existed before 1973 or not. The existing openings in the southern wall of Bay 3, Level 2 are therefore assumed to have been opened c1973.

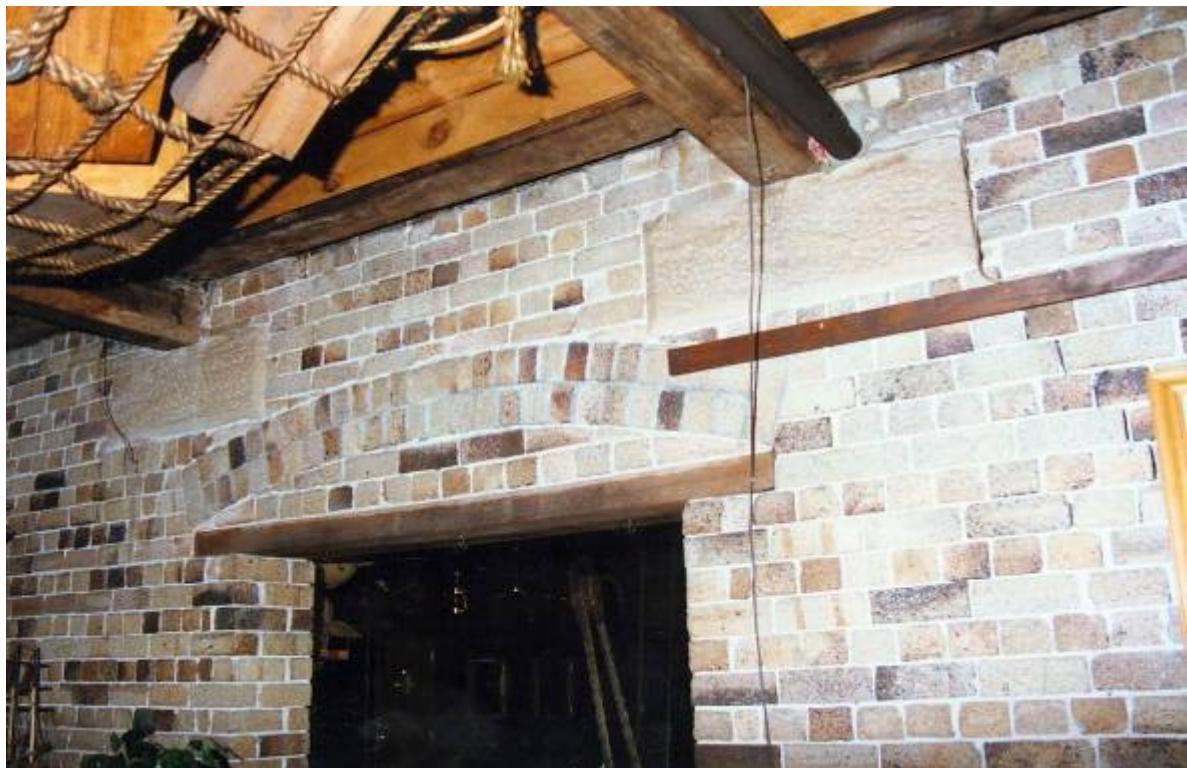
Figure 3.18 Waterfront Restaurant, 1996, Bay 2, Level 3, showing the original doorway connecting Bay 2 with Bay 3. Note the well-formed relieving arch above the lintel and the brick infill between the arch and lintel. The work has been very well executed (1996).

Bay 2, Level 3 has a stairway connecting to Level 2 with partitioned areas taking up much of sub-bays D and E. A new pedestrian door leads through the northern wall to this area. The original opening connecting Bay 2 and Bay 3 is shown in Figure 3.18.

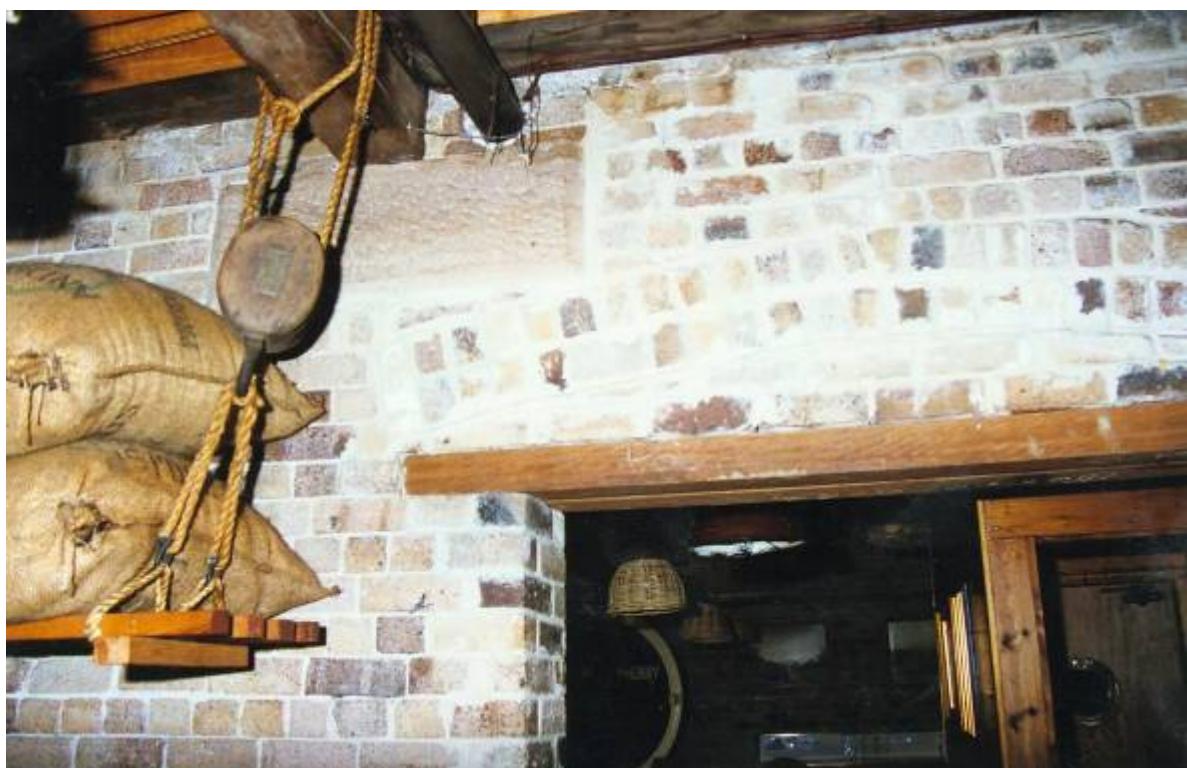
Figure 3.19 Waterfront Restaurant, Bay 3, Level 2. The western doorway leading to Bay 2. The work is meant to be identical with that on the eastern door (Figure 3.10). However, the work is very crudely executed and the pointing is in strongly contrasting mortar (1996).

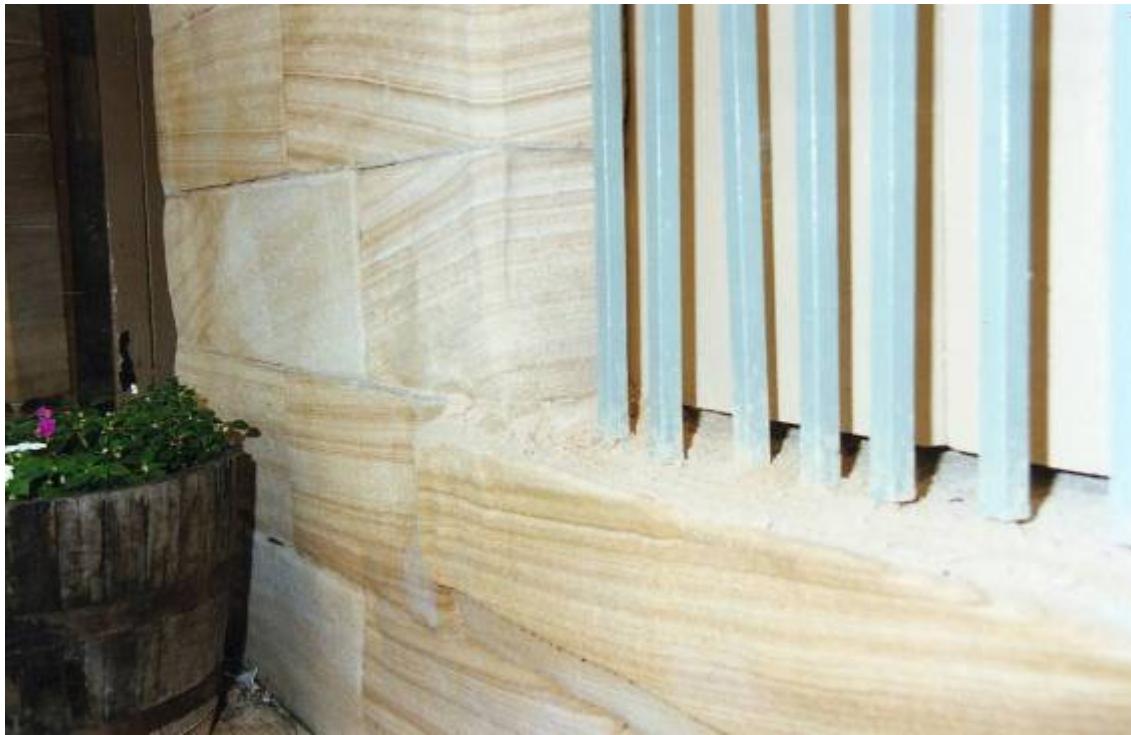
Figure 3.20 Bay 4, window sill and wall. The external wall that was re-skinned in the 1970s is now showing signs of rapid decay (1996).

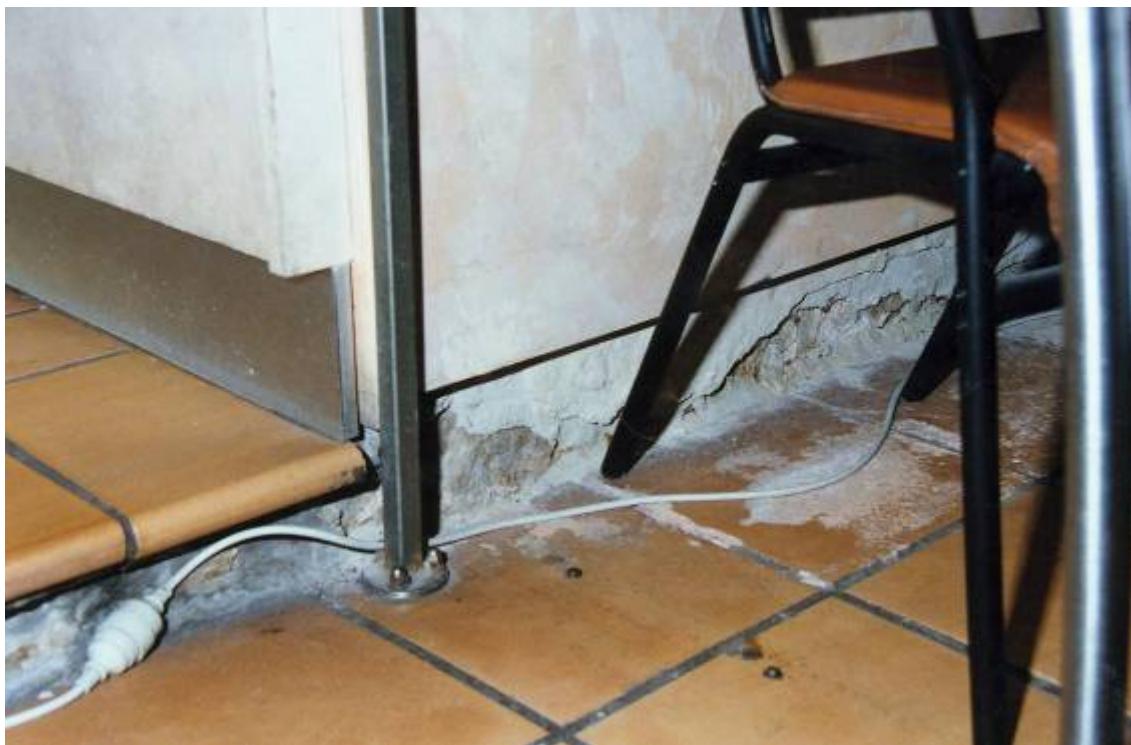
Figure 3.21 Wolfies Restaurant, Bay 6, Level 1. The decay of the sacrificial render faced on the wall has been slowed to a certain extent by the erection of hardboard panelling that can be seen above the shadow line (1996).

This area of the stores has been badly affected by rising damp (Figure 3.21). Internally, plasterboard has been erected to window height in Bay 4, while sacrificial render had been added to

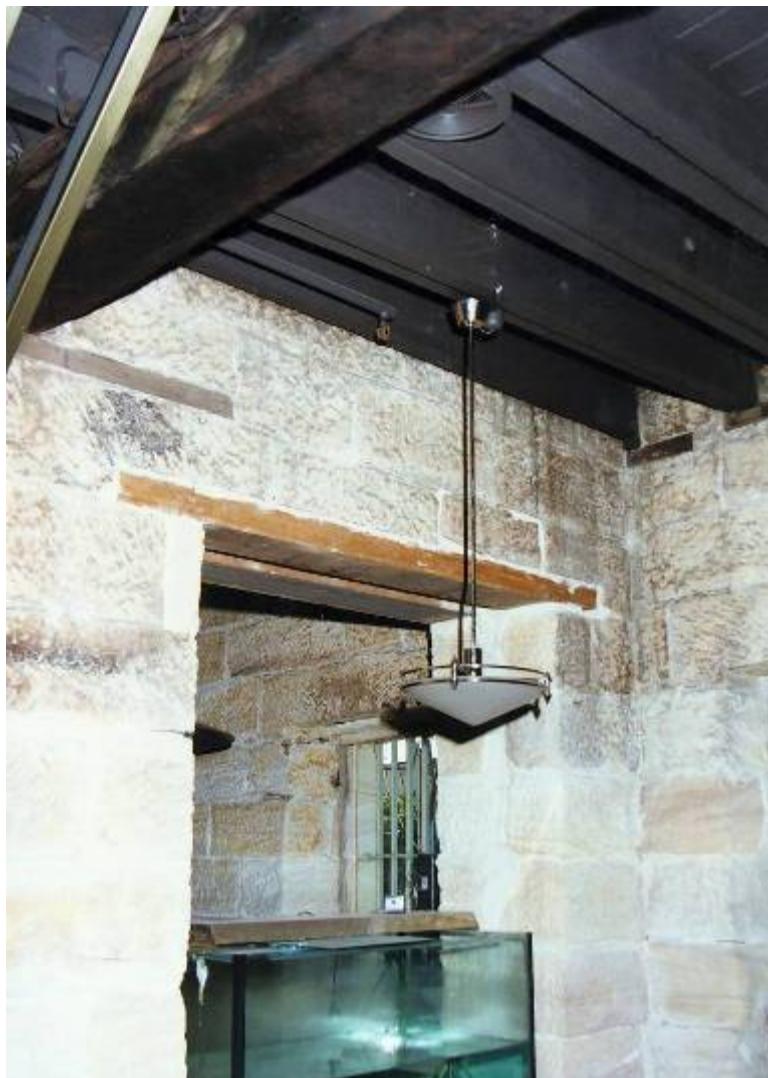
Figure 3.22 Imperial Peking Restaurant, Bay 7, Level 1. The northwestern corner showing the opening between Bay 7 and Bay 8 and the aquarium within the opening (1996).

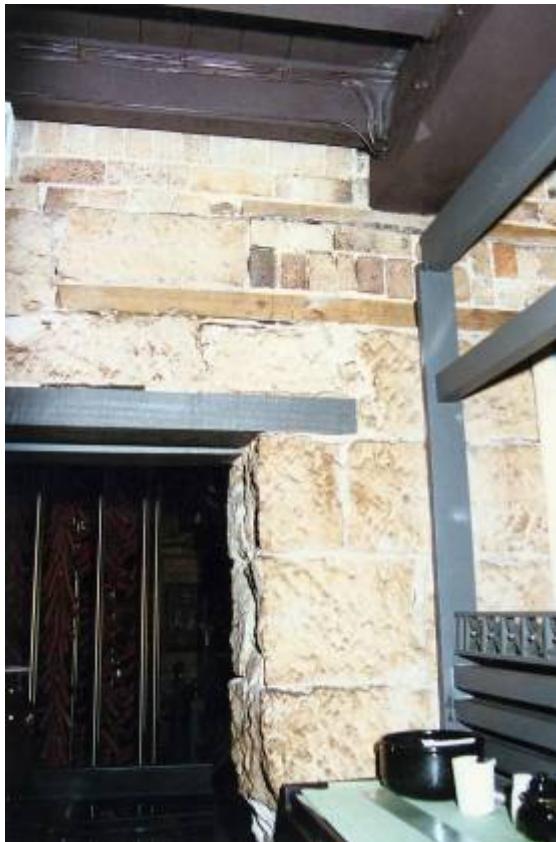
Figure 3.22 Imperial Peking Restaurant, Bay 6, Level 2, with the painted lintel above the doorway and painted beam joists and bottom of the floorboards (1996).

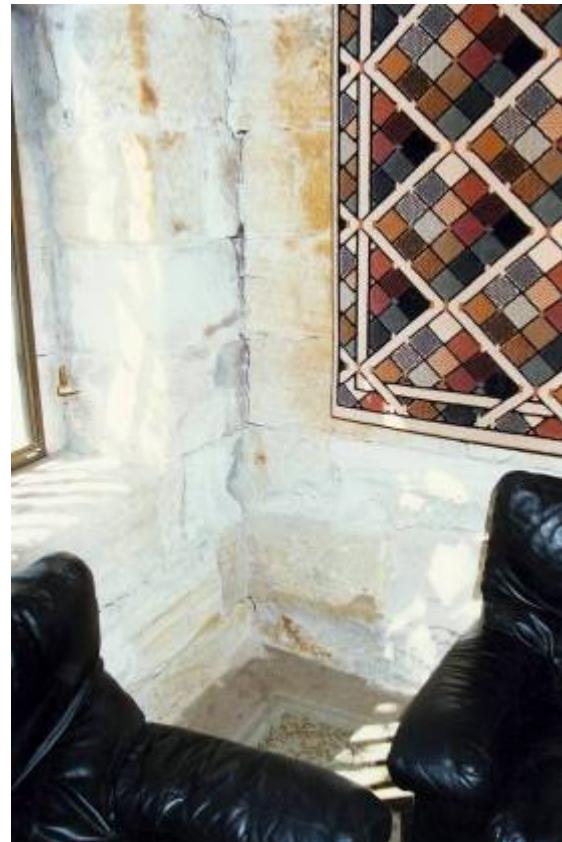
Figure 3.23 Imperial Peking Restaurant, Bay 7, Level 1. Southeast corner showing massive salt decay of sandstone (1996).

Salt attack of the walls in this section of the building is severe (Figures 3.23 and 3.24).

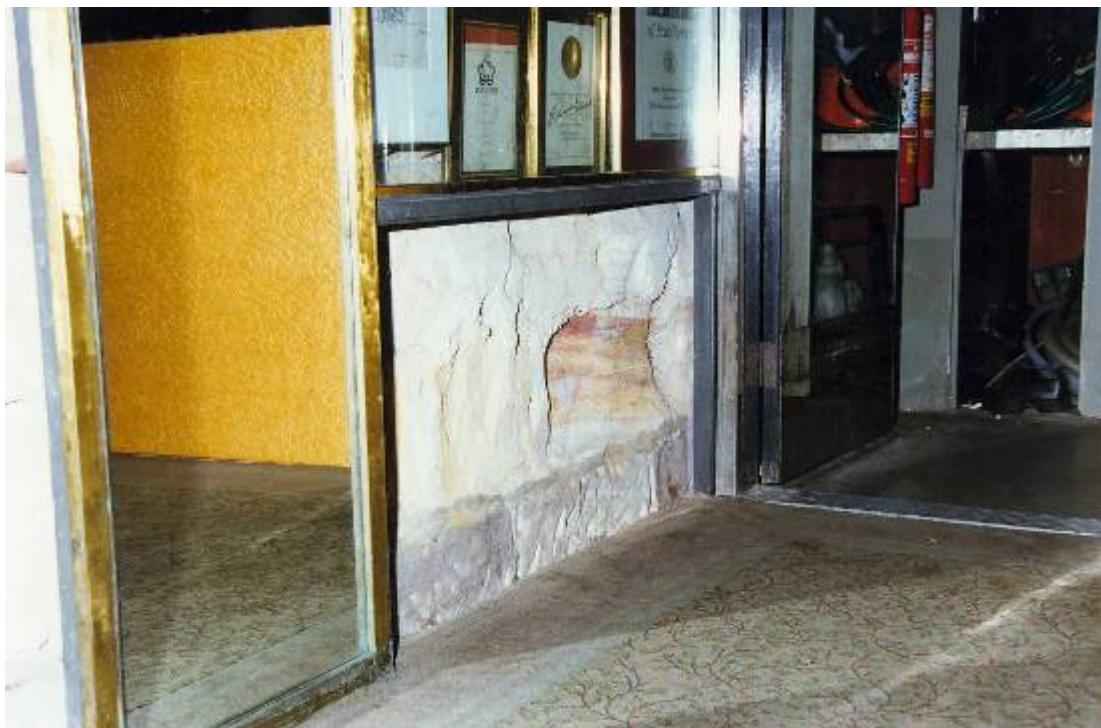
Figure 3.24 Imperial Peking Restaurant, Bay 7, Level 1. The deterioration in the south wall is extremely severe (1996).

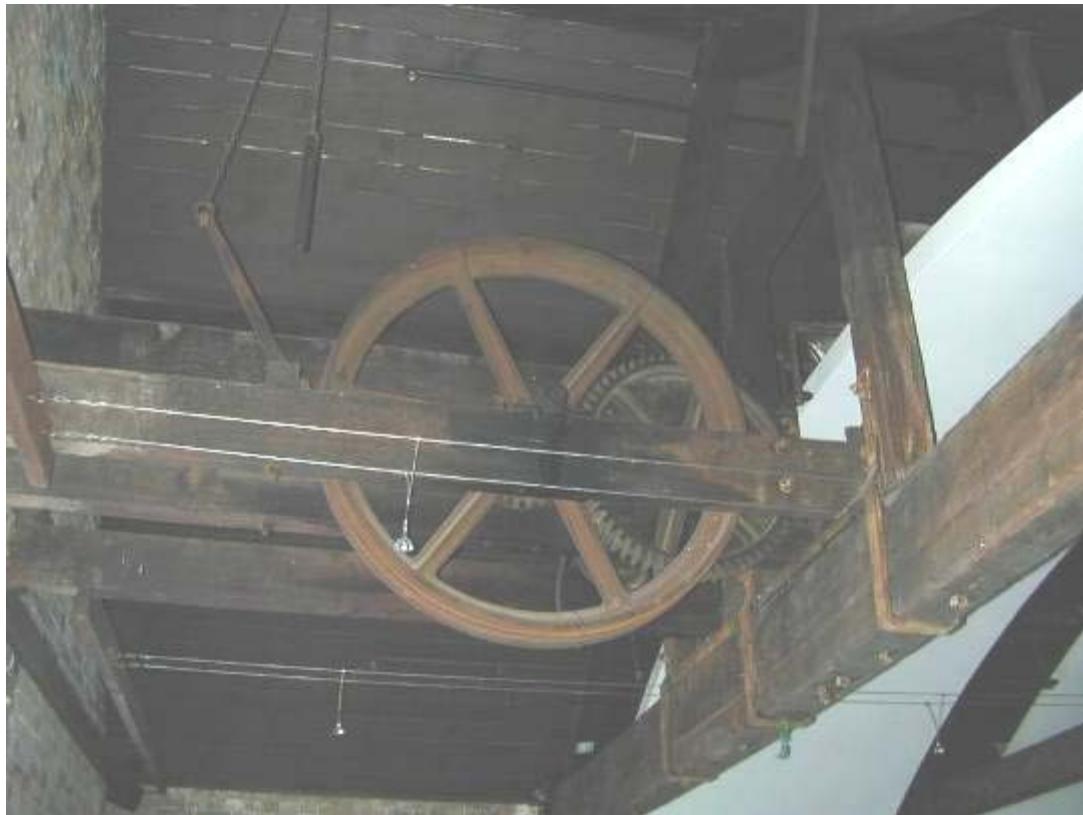
Figure 3.26 Imperial Peking Restaurant, Bay 6, Level 3. The hoist mechanism located on the lower chord of the roof trusses. This winch was operated by engaging the drive wheel of this continually operating machine, and with the use of the brake (2004).

A winch has been installed in the roof space on Level 3 in Bay 6 (Figure 3.26), between the first and second roof truss. The winch utilises the original cat-head beam to carry the winch cable and the cable penetrates the east wall through a small hole, featuring a timber bearing block and metal guide rollers on each side.

The driving wheel, which is a C-Section cast-iron wheel about 800mm diameter, is on a shaft about 3m long (Figure 3.26). The shaft is held by three bearings. The main bearing, adjacent to the driving wheel, is at the southern end. The bearing at the north end, immediately inside, was attached to a triple-V clutch wheel. Adjacent to this was a driven-wheel directly coupled to the shaft of the cast-iron cable drum which is about 500mm in diameter. The cable drum shaft passed through bearings at both ends. The bearing at the south end was fixed while that at the northern end supported a cam. Attached to the end of the shaft bearing was a lever. This lever, when pulled down, lifted the large one-metre driving wheel which was fitted with three grooves that corresponded to the three raised sections of the clutch wheel. By pulling the lever the large wheel was brought into mesh with the clutch wheel, which was constantly in motion, and this gave motion to the cable drum.

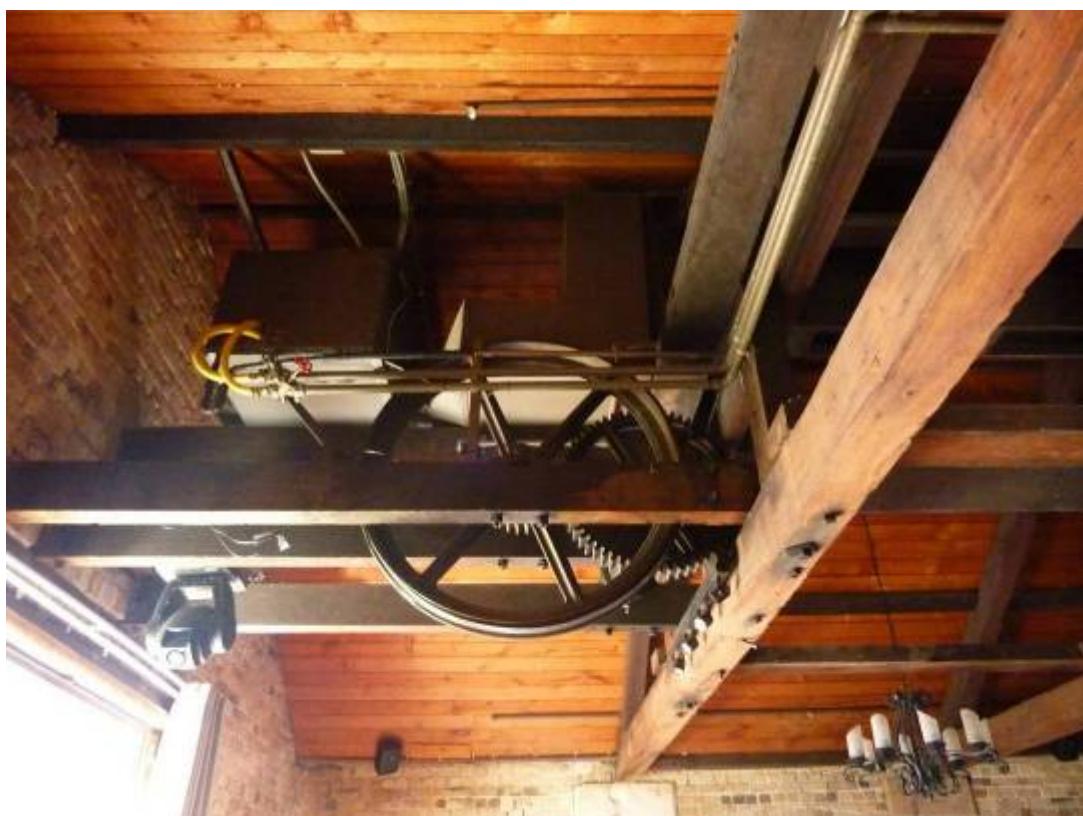
Figure 3.27 Waterfront Restaurant, Level 3, Bay 3. The winch mechanism located on the lower chord of the roof trusses. The brake mechanism is the curved element under the large wheel, connected to a chain with a hanging handle for operating the winch (2004).

In Bay 3, Level 3, there is a winch mounted on a special frame inserted in the roof space between the eastern wall and to the first roof truss (Figures 3.27 and 3.28). The original cat-head portal structure, which is a feature of all of the Level 3 bays, is intact but three additional beams running to the front wall have been added to the portal. These have all been mortised into place. The original cat-head still survives and the winch cable would have led out to the sheave supported at the outer end of the cat-head beam. The bottom chord of the first truss has been strengthened by a section of timber which measures about 225mm by 100mm. This has been attached by a series of nine bolts to the very heavy lower chord of the truss above.

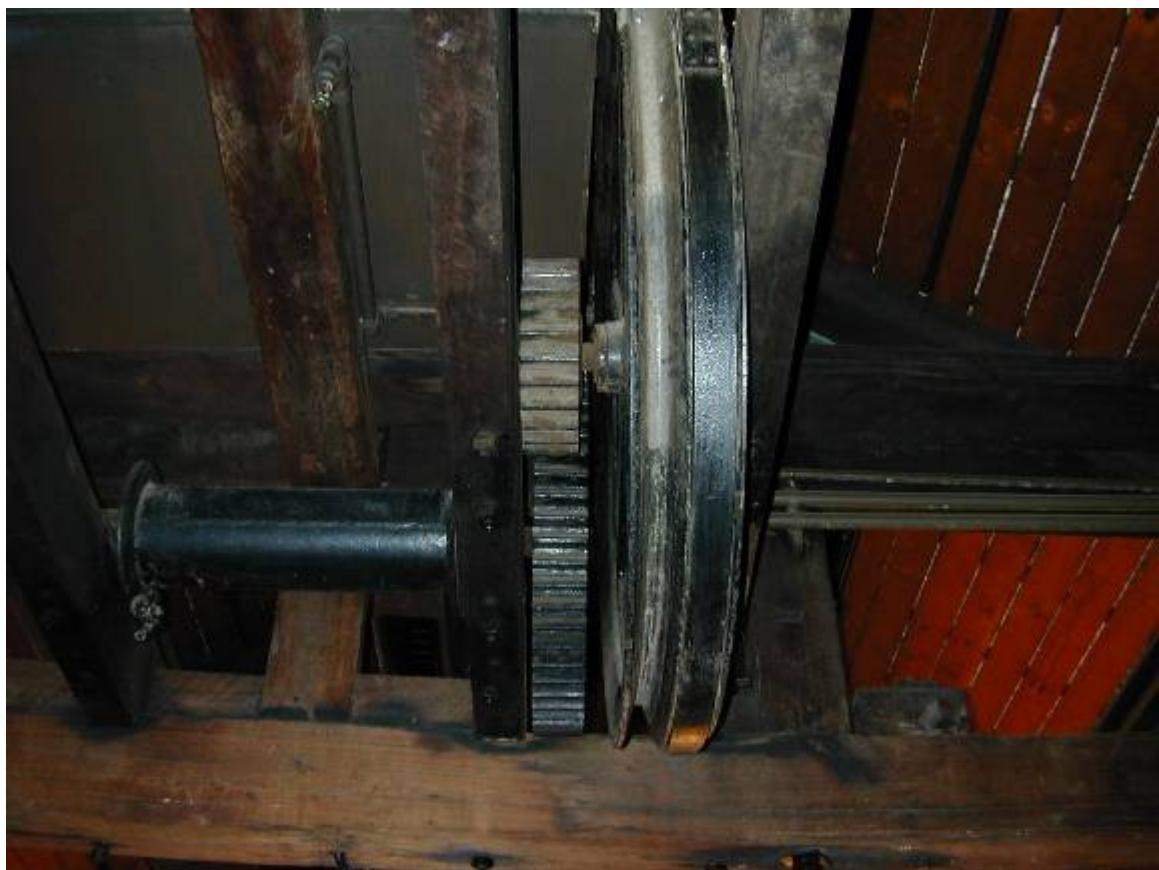
Figure 3.28 Winch in the Waterfront Restaurant, Level 3, Bay 3 (2010).

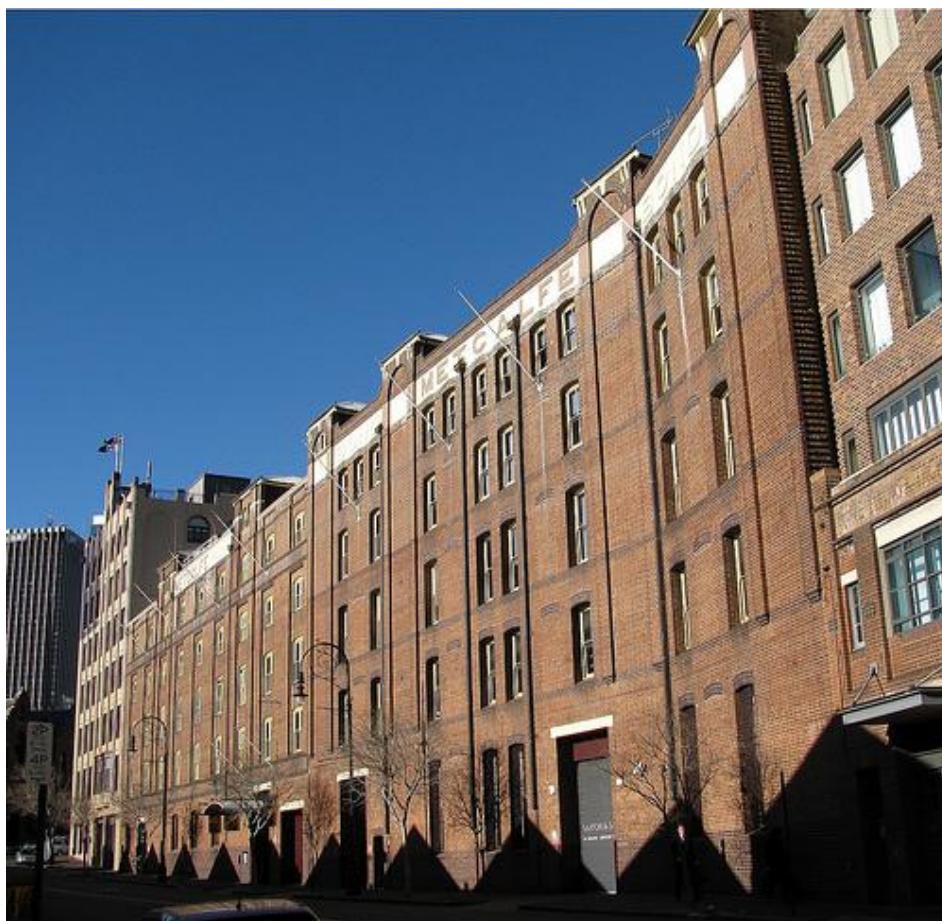
Figure 4.1 Metcalfe Bond Stores (Google Images)

Metcalfe Bond Stores are located at 68–84 George Street, The Rocks, and were constructed between 1912 and 1916, some time after Campbell's Stores.¹ The buildings form a backdrop to Campbell's Stores and are quite prominent on the northern end of George Street. They are larger in scale and while they are similarly constructed of masonry, they differ in appearance and style.

The stores comprise of two adjacent buildings with a post and beam structure and face red brick exterior. The first building constructed in 1912, comprises of seven bays, is three levels high facing George Street, and five levels high facing Hickson Road. It contains a stucco parapet and semi-circular openings on the ground floor. The second building was constructed in 1916 and located to the south. It is similarly three levels facing George Street and five levels facing Hickson Road; however it consists of nine bays with a stepped parapet that divides the facade into three sections. The brickwork is more detailed and all openings are rectangular with two prominent string courses.²

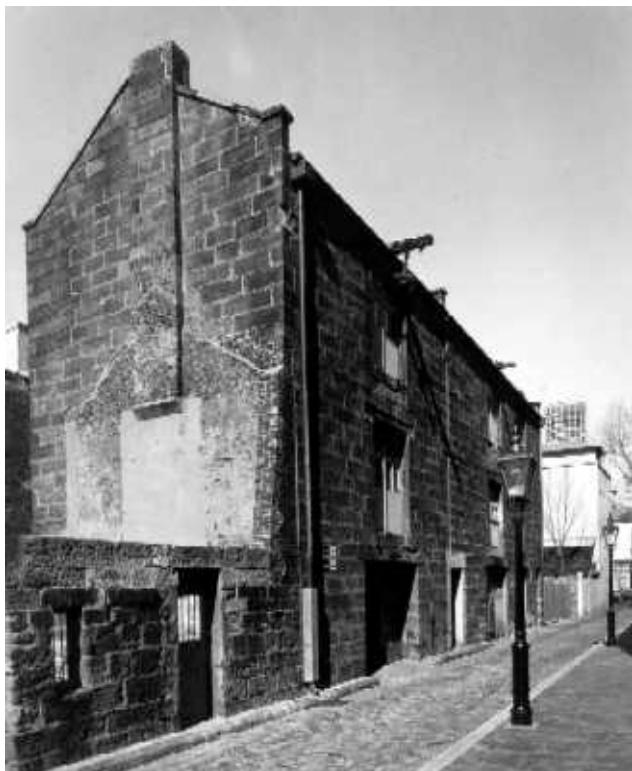
Figure 4.2 Raphael A Mackeller Stores (Google Images)

The Raphael Mackeller Stores, located at 4–6 Kendall Lane, The Rocks, comprise of two narrow stone buildings that are three levels high, with a gable roof. They were constructed between 1853 and 1854, at around the same period as the construction of bays 6–10 (then 1–5) of Campbell's Stores. The Raphael Mackeller Stores are similar in appearance and materiality; however they are considerably smaller in scale. They were built in two stages, the first in 1853 and the second in 1854 evidenced by the continuous vertical joint along the west and east facades. The doors of the six loading bays are framed and braced with hardwood lintels.³
