Campbell's Stores, The Rocks Conservation Management Plan

Report prepared for the Sydney Harbour Foreshore Authority
July 2014

This Conservation Management Plan (CMP) reviews and updates a 1996 CMP and a 2004 CMP for Campbell's Stores to reflect the changes that have occurred since then to 2010. The CMP has been prepared as a policy document to guide future planning for the site with regard to its heritage value and to provide clarity on future heritage requirements.

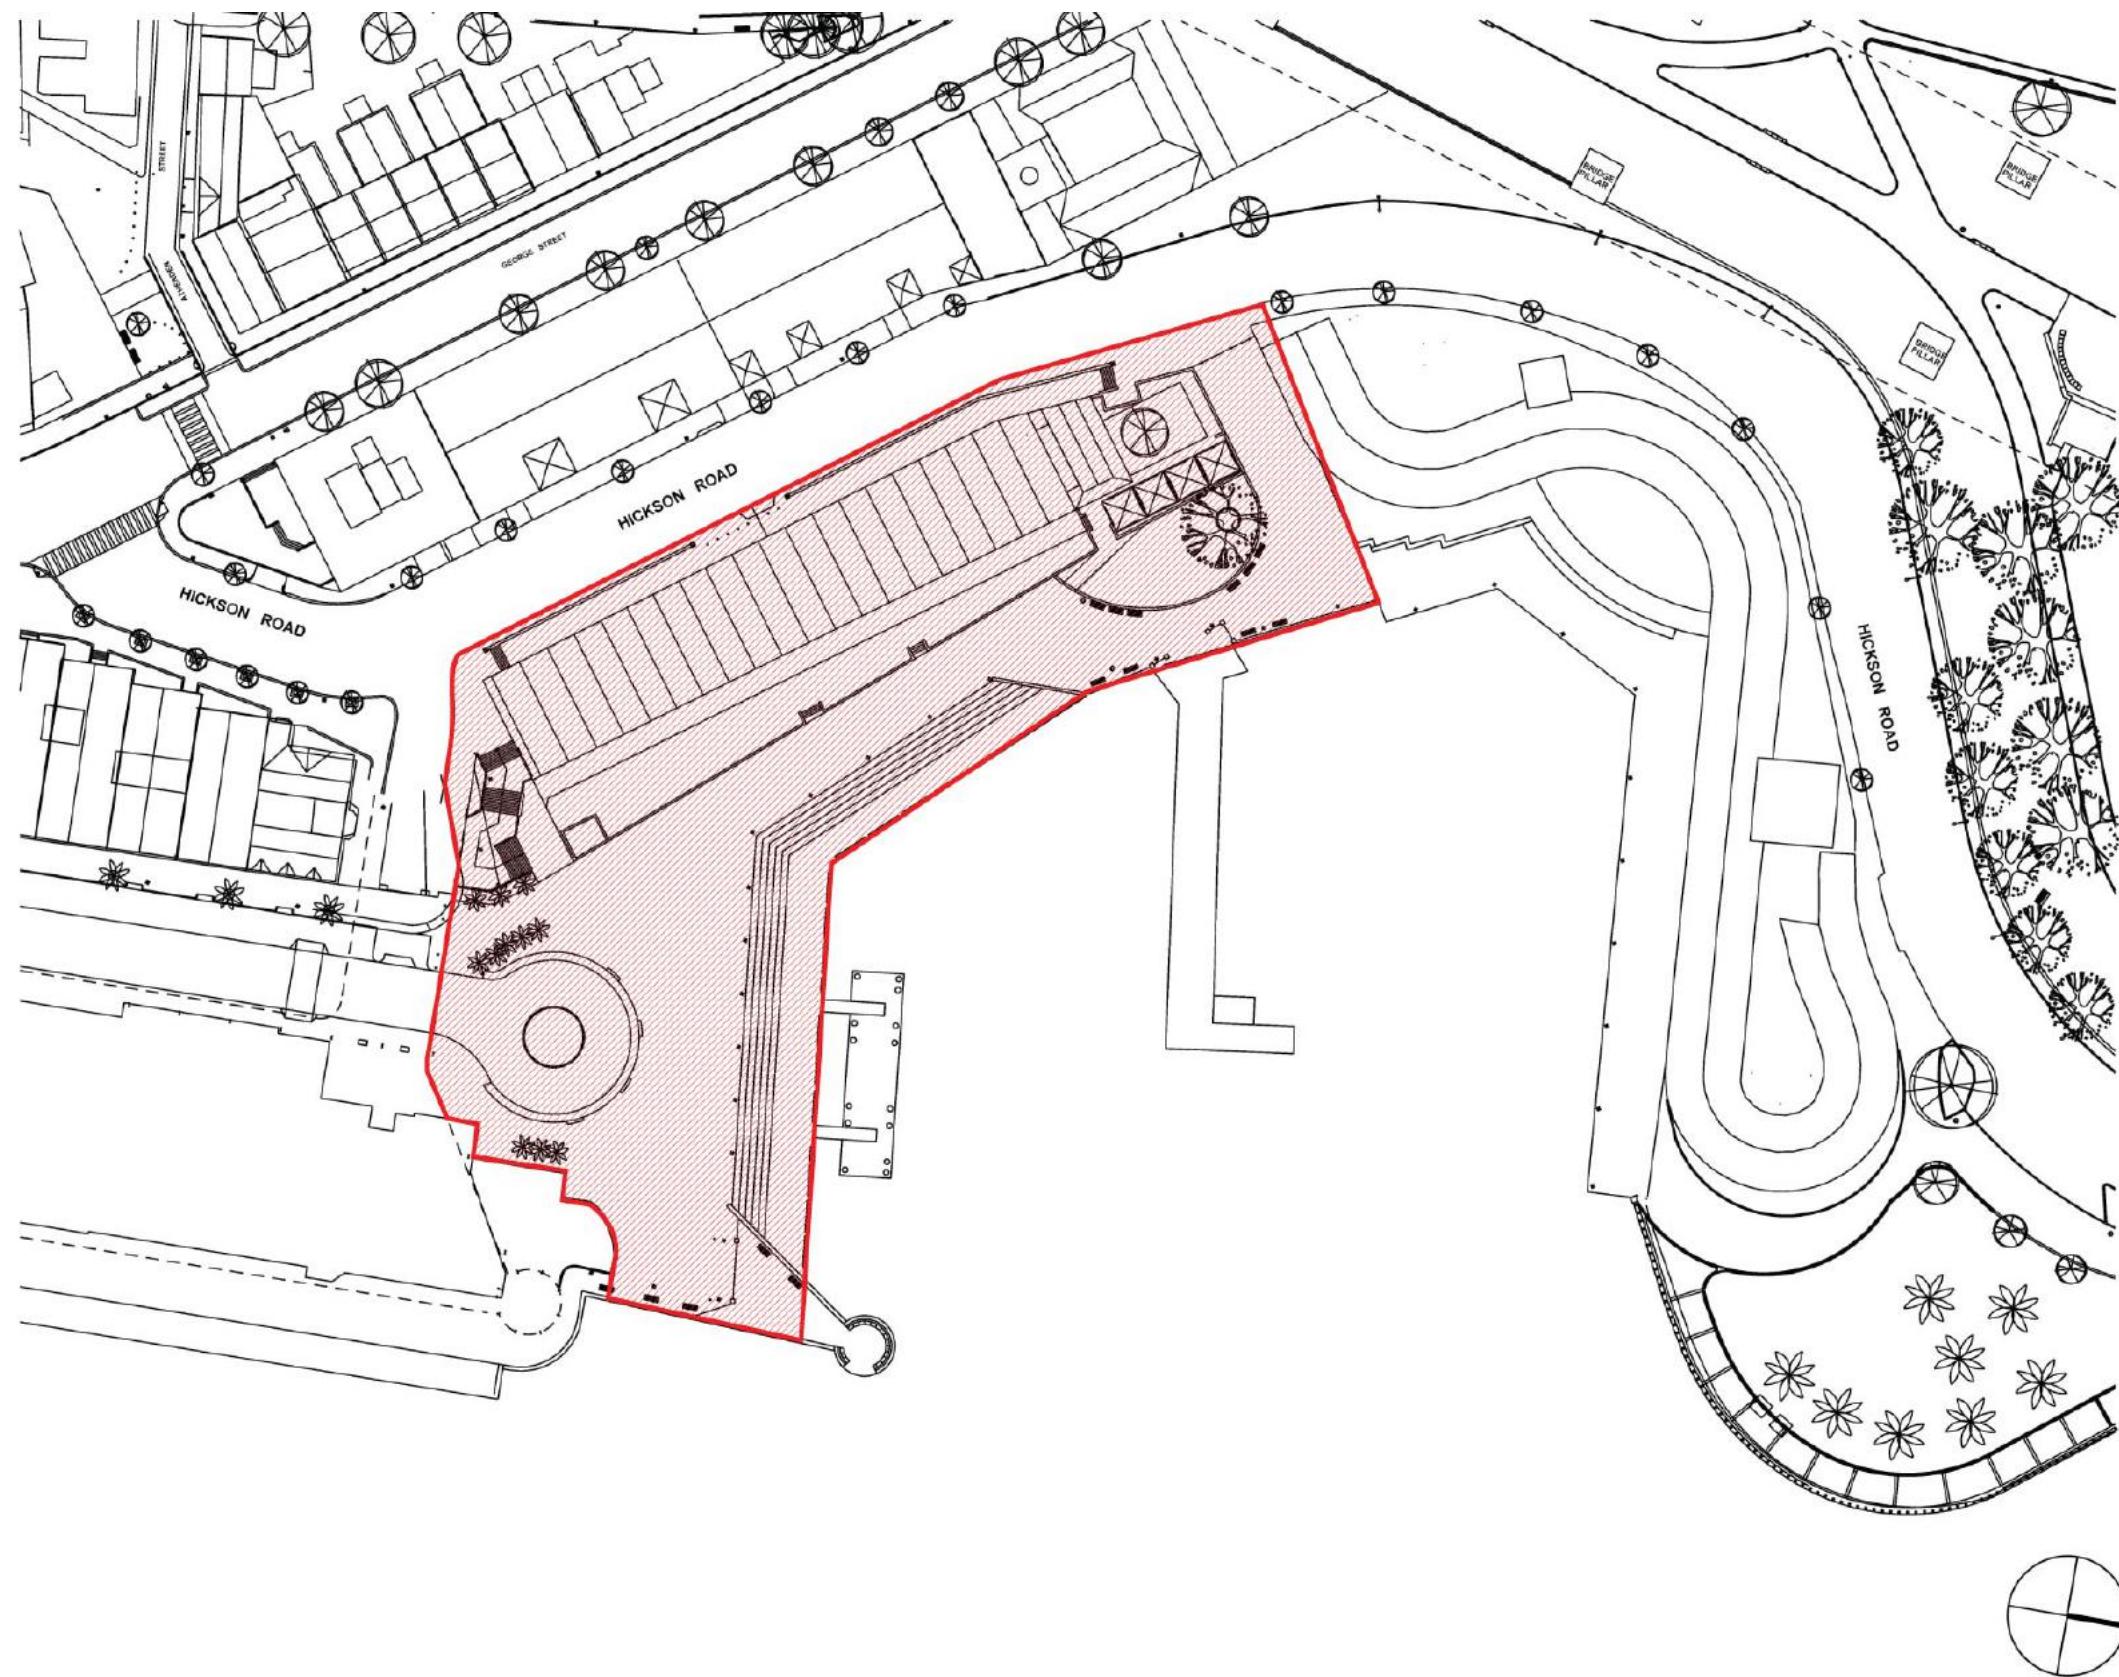
Figure 4.3 Proposed heritage curtilage of Campbell's Stores.

The heritage curtilage is the area required for retention of significant views or for adequate presentation and interpretation of the item. In this case, Hickson Road provides Campbell's Stores enough space so the western façade can be viewed from across the street. To the east, it is the promenade in front of the Campbell's Stores. The proposed heritage curtilage extends from the Overseas Passenger Terminal overpass to the Park Hyatt Hotel (Figure 4.3). Note that the SHR listing does not include a heritage curtilage.

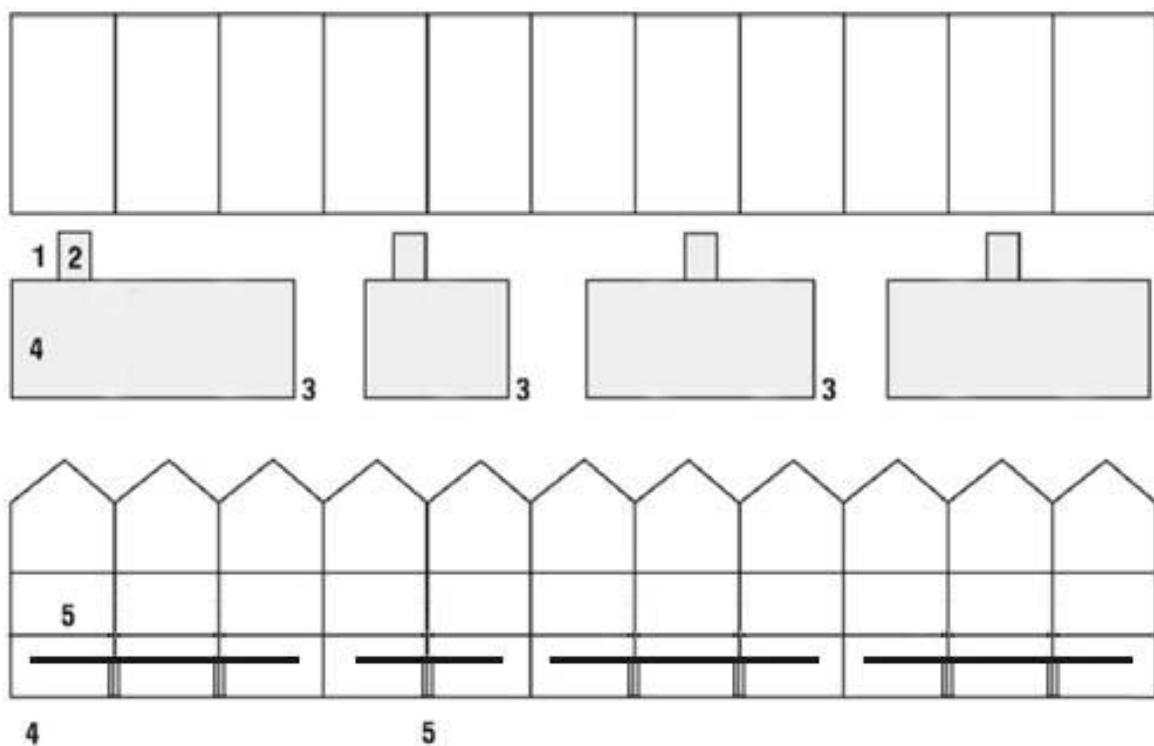
Figure 7.1A Campbell's Stores external forecourt shade canopy design principles.

1. Provide generous gap between canopy & building.
2. Small covers over entries should not be attached to the building.
3. Break canopy into segments to allow views to full building elevations and to differentiate between tenancies.
4. Shade canopies should be low and mono-pitch without facias or valances.
5. Canopy support structure to respond in placement to building rhythm.

- The existing canopy, the non-authentic ship's mast and the glazed pavilion structure in the northern forecourt should be removed. The existing canopy could be replaced with a new canopy that follows the following principles (refer to Figure 7.1):

- the structure of the canopy should also respond to the imagery of maritime activity and machinery that once surrounded Campbell's Stores, in particular the ship and shore jib crane structures, but without being replicas or fake reconstructions (ships' masts are historically inappropriate in this location); and
- while the canopy and its structure should be recessive in colour and materials, the use of carefully controlled elements of colour on the canopy structure such as small banners and flags is appropriate within this former maritime setting.

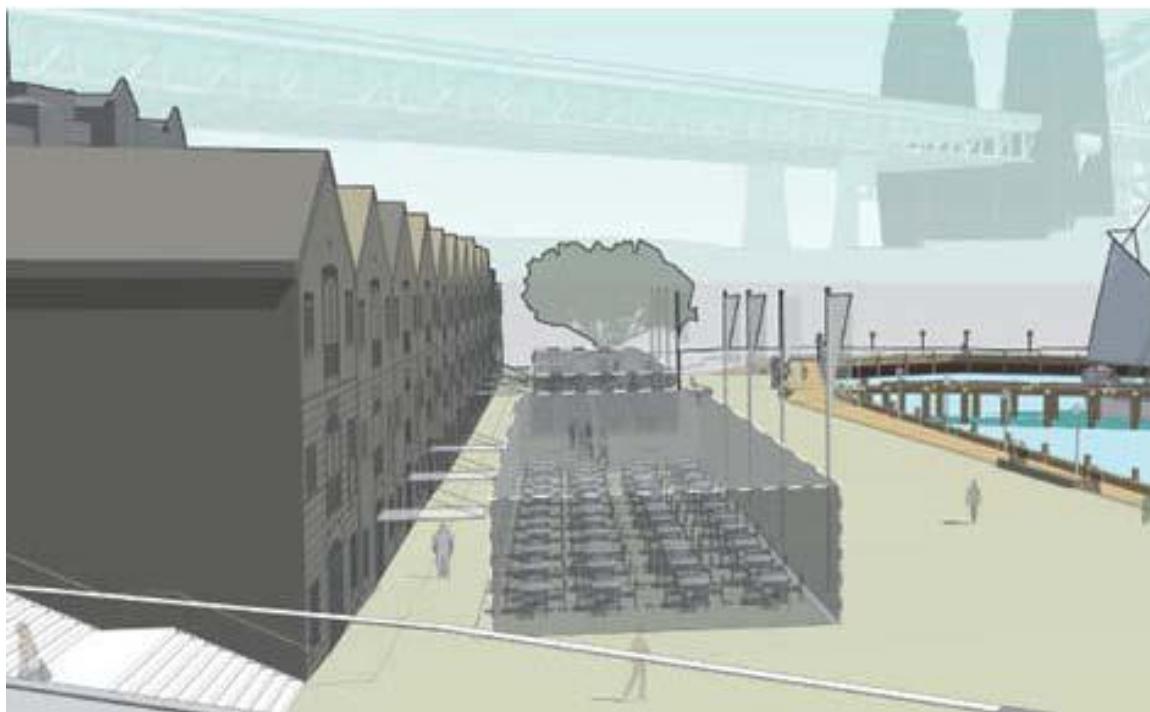
Figure 7.1B Campbell's Stores external forecourt shade canopy design principles.

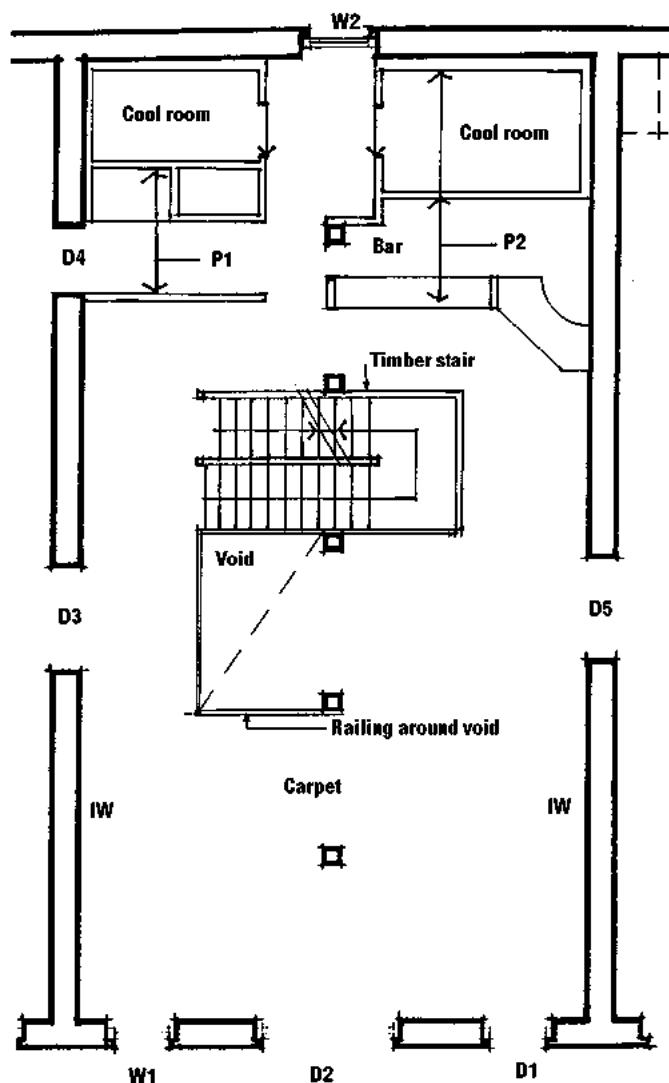
Exceptional
All posts
All beams
All joists
All floorboards
IW Internal sandstone walls
D1, door opening, reveals and gudgeons (door missing)
D2, door opening, reveals, gudgeons, goods apron, chains and handles (doors missing)
W1, window opening, reveals and gudgeons
W2, double-hung sash, window opening, reveals and bars

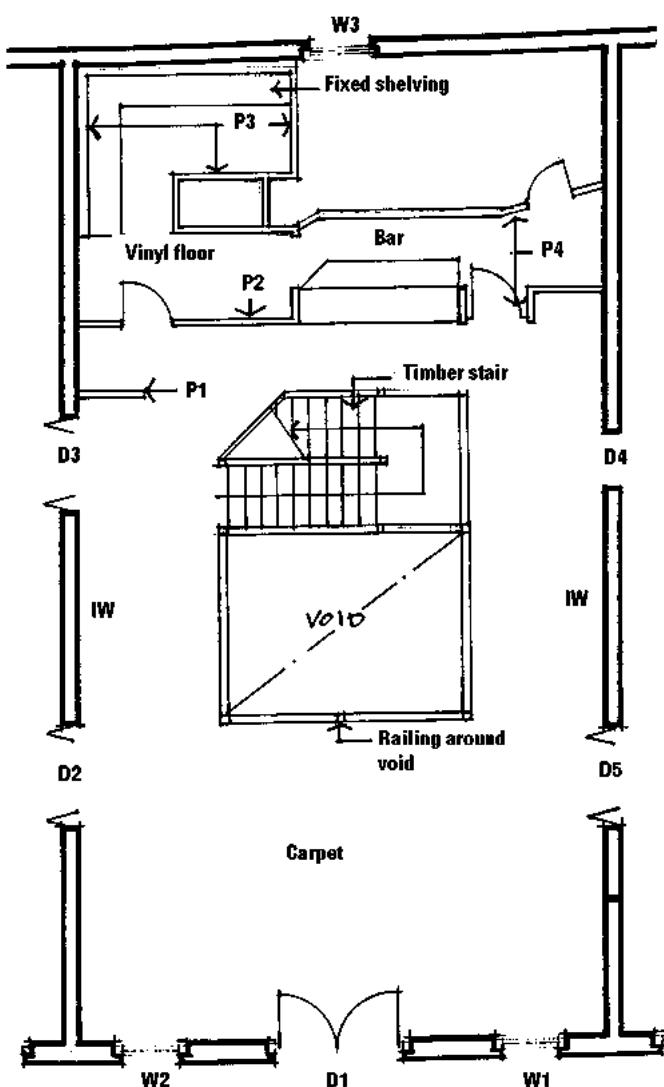
Exceptional
All trusses
All purlin
All floorboards
Cathead beam
Timber ceiling lining
IW Internal brick walls
D1, doors, door opening, reveals, gudgeons, goods apron, chains and handles (doors missing)
Doorway 2
W1, double-hung sash, window opening and reveals
W2, double-hung sash, window opening, reveals and bars
Little
Doorway 3
Doorway 4
Doorway 5
Stair
Straw mat ceiling lining
Intrusive
D1 aluminium sliding window
Void
Railing around void
Fixed shelving
Bar
Partitions (P1–P4)

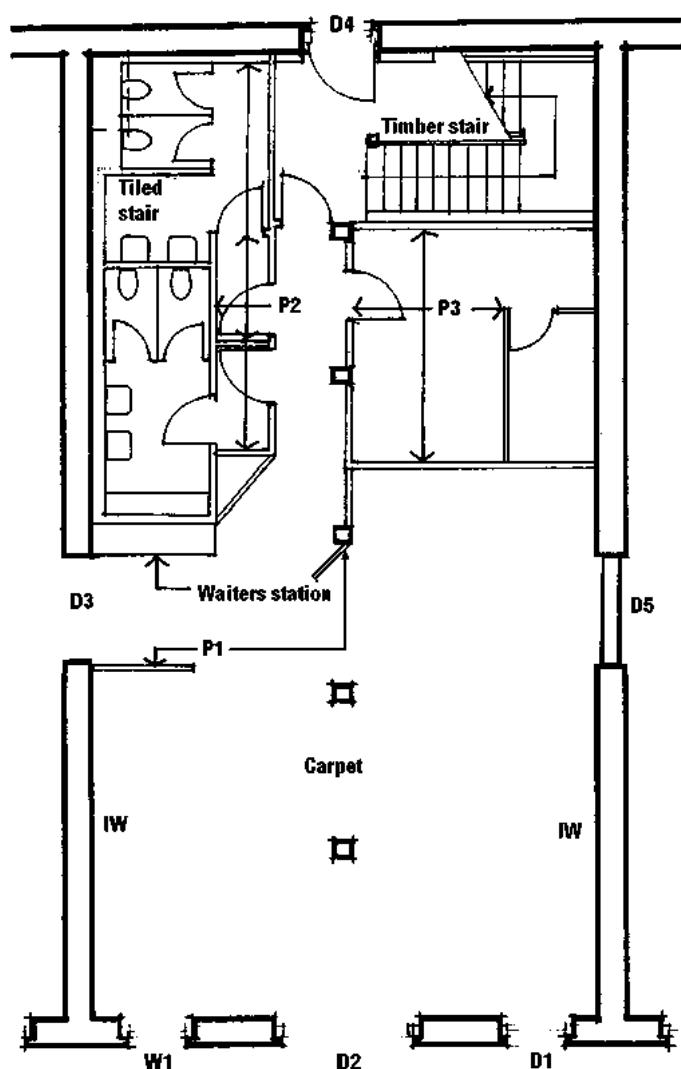
<i>Exceptional Internal</i>
All posts
All beams
All joists
IW Internal sandstone walls
D1, door opening, reveals and gudgeons (door missing)
D2, door opening, reveals and gudgeons (doors missing)
W1, window opening and reveals
<i>External</i>
Hydraulic ram
 <i>High</i>
Doorway 4
 <i>Moderate</i>
Doorway 3
Doorway 5
 <i>Little</i>
Stair
 <i>Intrusive Internal</i>
D1 aluminium double-hung window
D2 aluminium sliding window
W1 single casement
Toilets
Partitions (P1–P3)
Decorative ceiling joists
<i>External</i>
Wooden bracket

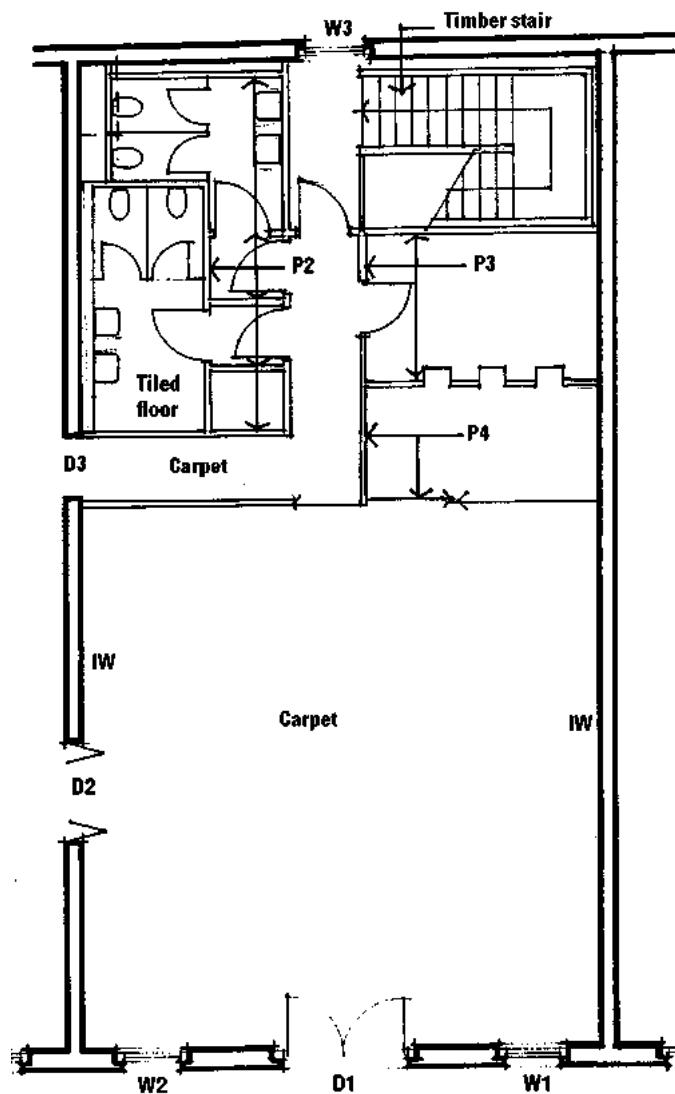
Exceptional
Internal
 All trusses
 All purlins
 All floorboards
 Cathead beam
 Timber ceiling lining
 IW Internal brick walls
 D1, doors, door opening, reveals, gudgeons, goods apron, chains and handles (doors missing)
 W1, double-hung sash, window opening and reveals
 W2, double-hung sash, window opening, reveals and bars
External
 Hydraulic ram

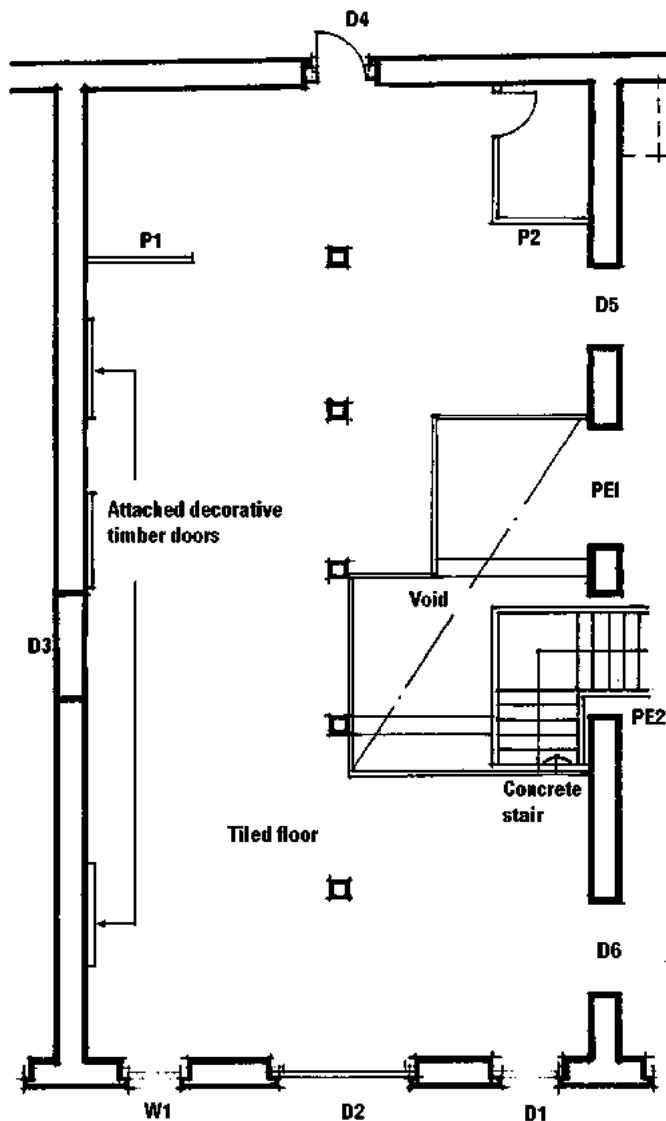
Exceptional
All posts
All beams
All joists

All floorboards (where intact)
IW Internal sandstone walls
D1, doors, door opening, reveals and gudgeons (doors missing)
D2, door opening, reveals, gudgeons, goods apron, chains and handles (doors missing)
W1, window opening, reveals and bars

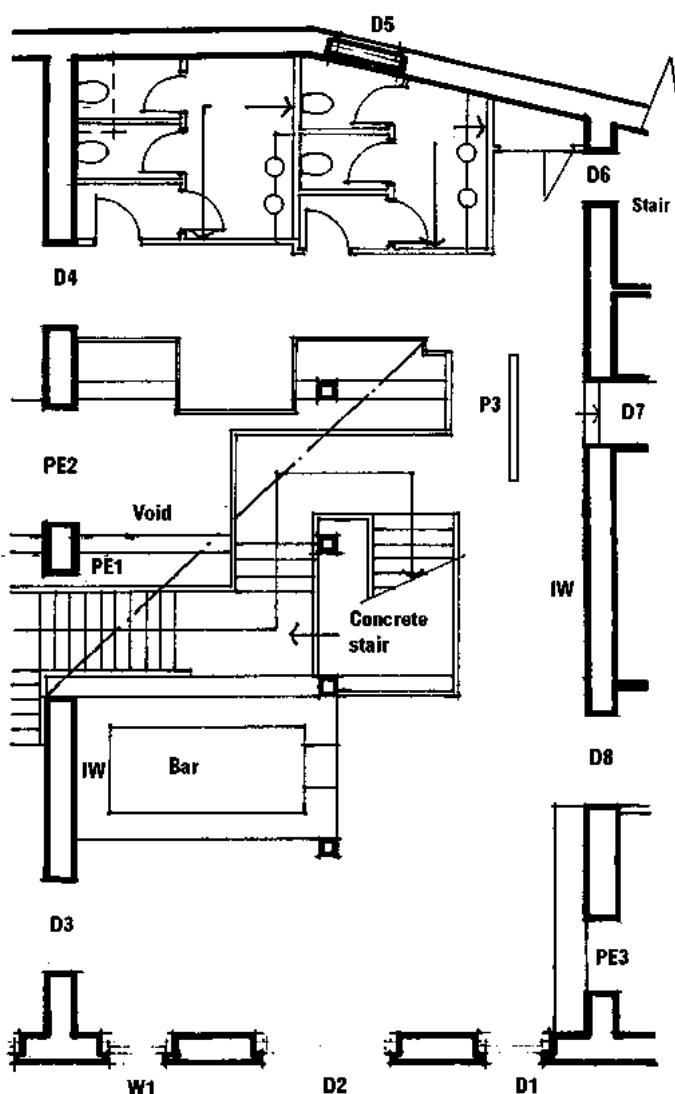
Exceptional
 All posts
 All beams
 All joists
 All floorboards (where intact)
 IW Internal sandstone walls
 D1, door opening, reveals and gudgeons (door missing)
 D2, door opening, reveals, gudgeons, goods apron, chains and handles (doors missing)
 W1, window opening, reveals and bars

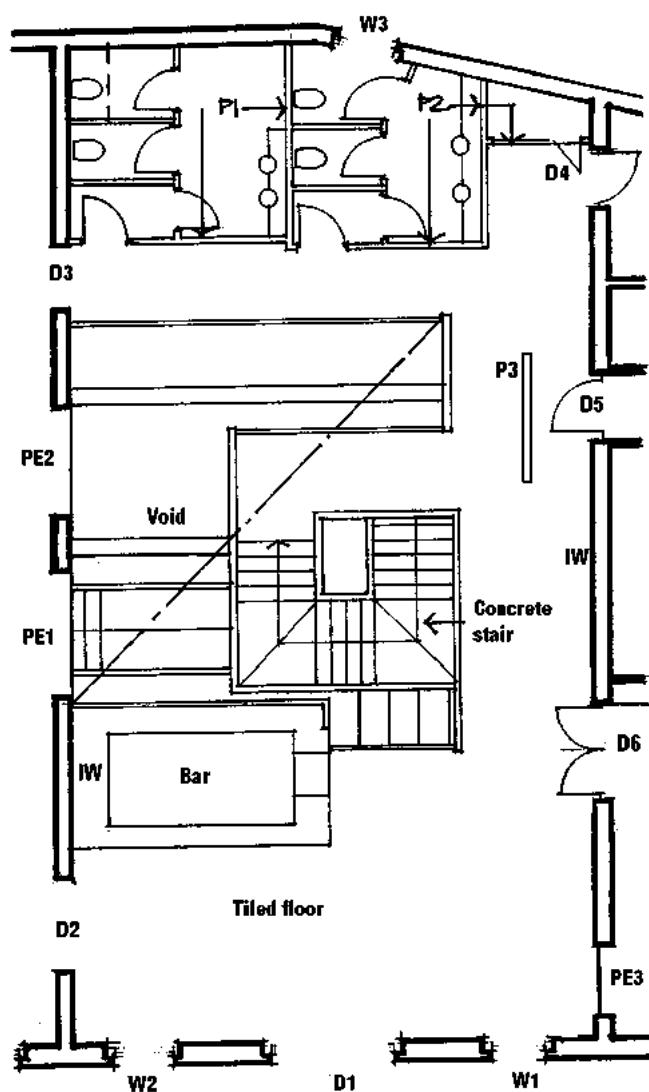
- All trusses
- All purlins
- All floorboards
- Cathead beam
- IW Internal brick walls
- D1, door opening, reveals, gudgeons, goods apron, chains and handles (doors missing)
- W1, double casement, window opening and reveals
- W2, double casement, window opening and reveals
- W3, double-hung sash, window opening, reveals and bars

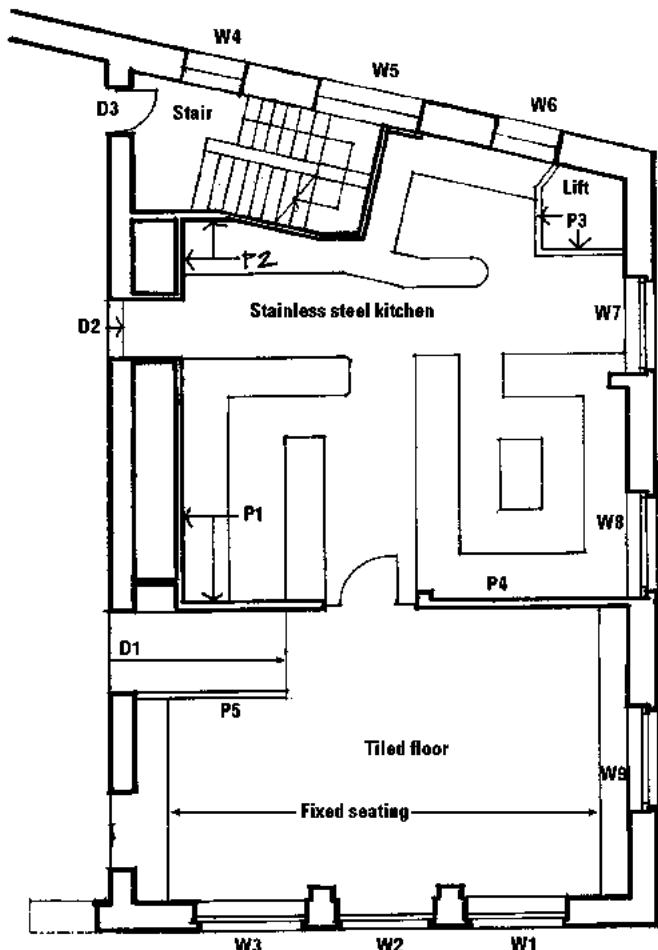
Intact areas of original walls
W2, window opening, reveals, bars, goods
apron, chains and handles
W4, double-hung sash, window opening,
reveals, architraves and bars
W5, double-hung sash, window opening,
reveals, architraves and bars
W6, double-hung sash, window opening,
reveals, architraves and bars

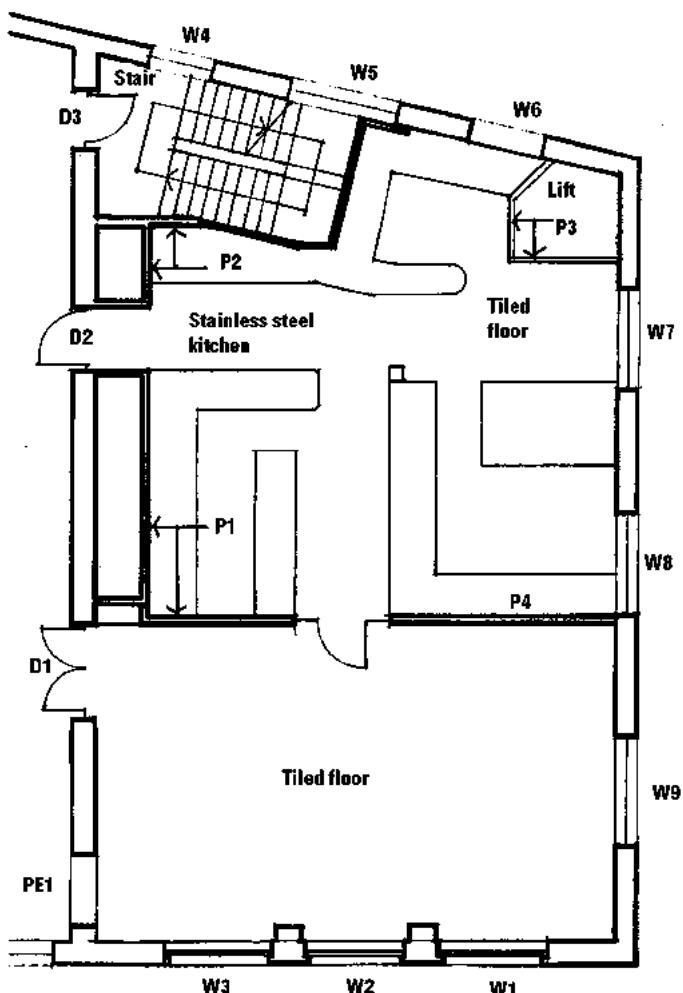
Intact areas of original walls
W2, window opening, reveals, bars, goods apron, chains and handles
W4, double-hung sash, window opening, reveals, architraves and bars
W5, double-hung sash, window opening, reveals, architraves and bars
W6, double-hung sash, window opening, reveals, architraves and bars
