Conservation Management Plan

Sailor's Home (former)

SHR No. 01576

106 – 108 George Street,
The Rocks

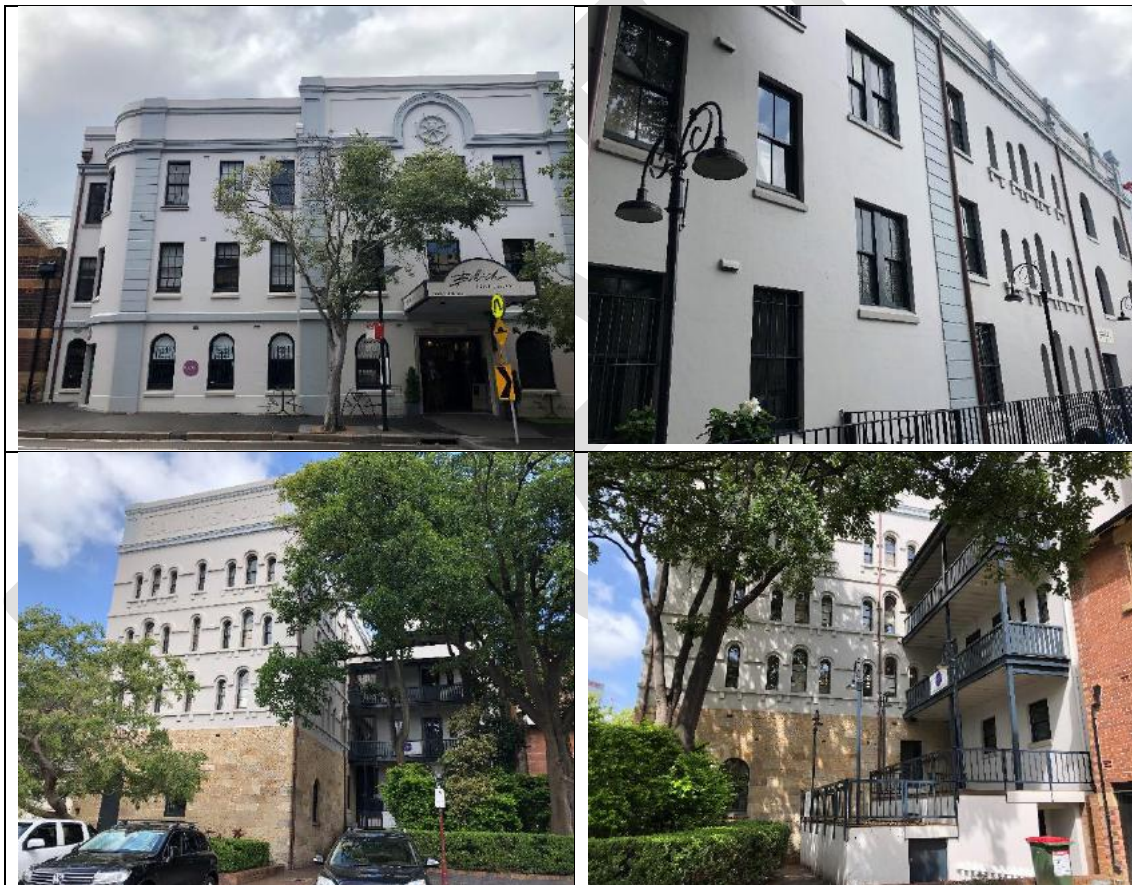
Figure 5: (top to bottom, left to right) west (front) elevation, south (side) elevation, rear (east) elevation and side (north) elevation of the Sailor's Home, The Rocks.

The Sailor's Home (former) is a four storey (three storey plus basement) stone and rendered masonry, U-shaped building, comprising two wings joined along the George Street frontage. Although constructed in two major phases, the two distinct forms are tied together by a high, continuous parapet around most of the perimeter of the building, which conceals the roof. The building presents three storeys to George Street, and four storeys to Circular Quay, due to the fall of the site down to the east towards Circular Quay.

The form of the original 1860s portion of the building is located towards the southeast corner of the site. It is legible along the eastern section of the southern façade, and along the southern portion of the eastern façade. This wing was altered in the 1920s by the addition of a number of regular shaped openings (in contrast to the earlier arched head openings), replacement of the original gabled roof and the addition of the parapet. The 1920s portion of the building is legible along the George Street façade, as well as along the northern façade. Later alterations are also visible, including the 1980s addition of an open balcony along the southern façade of the 1920s wing.

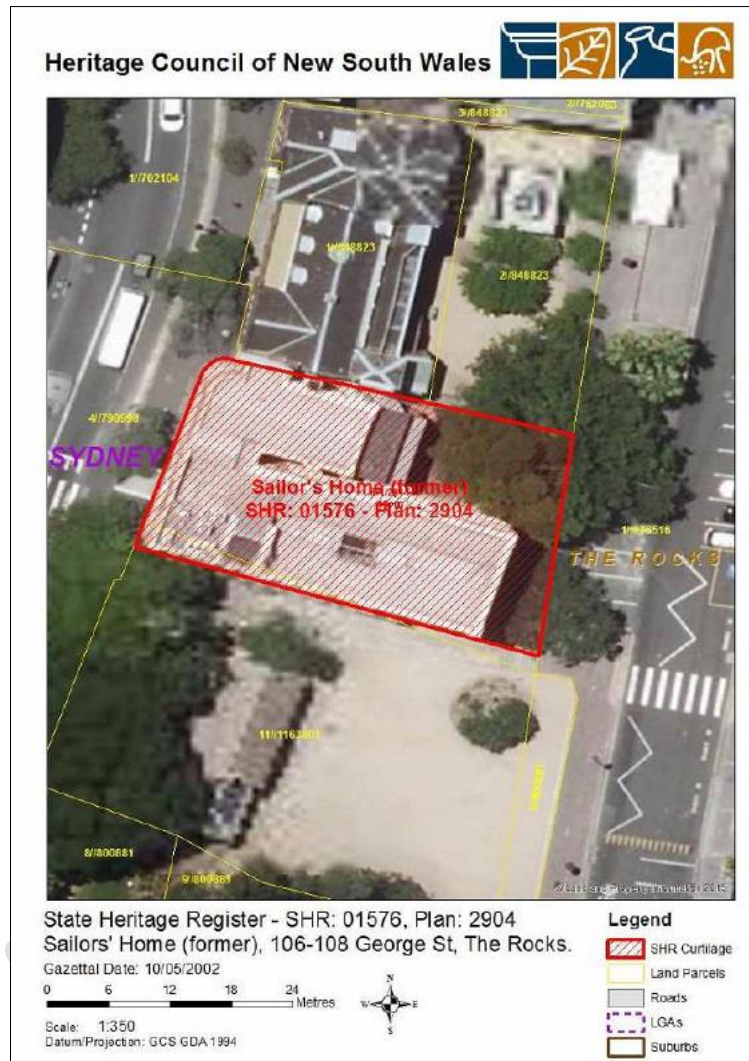
Figure 6: The State Heritage Register listing boundary plan no: for SHR item no: 01576. The SHR boundary is shown in red and includes the current lot boundary (Lot 1 of DP 1007092). (Source: Heritage Council of NSW)

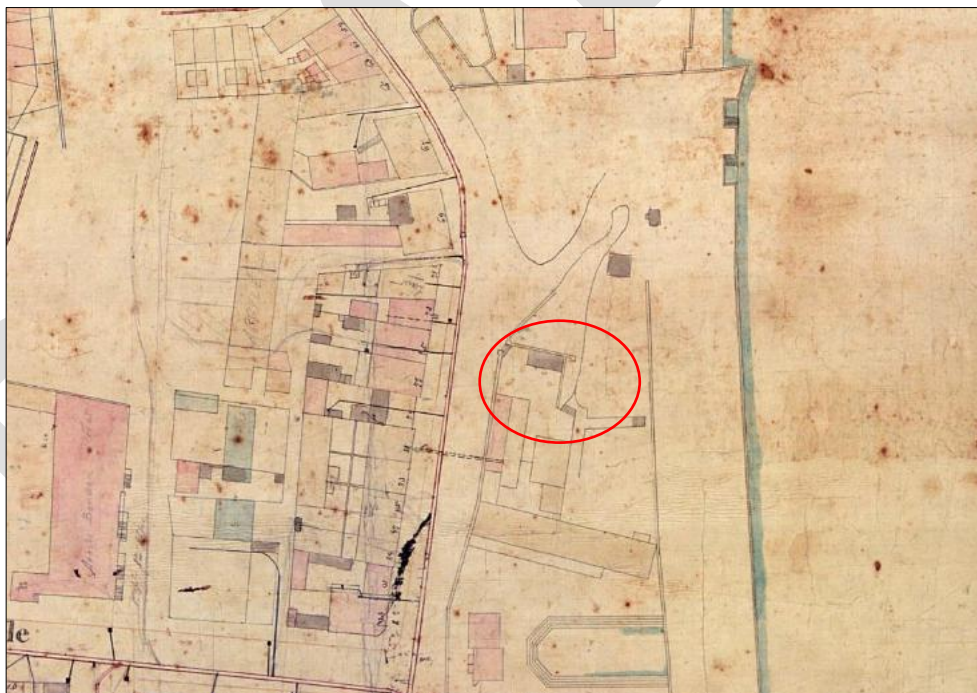
Figure 9: 1865 Trig Survey showing the subject site, extent of reclaimed land and new water line. It is interesting that the Mariner's Church, constructed in 1856-7 is not shown. (Source: City of Sydney Archives, City of Sydney - Trigonometrical Survey, 1855-1865: Block B2-1; cf. Sydney Water Plan Room, 1865 Trig Survey Sheet B2-1 NRS 9929)

In the 1850s, after Sydney had recovered from the depression and was beginning to feel the effects of the gold boom, the Quay was extended again over the Tank Stream around to Campbell's Wharf, located north of the Cadman's Cottage complex and subject site. A Trig Survey Map dated 1865 (Figure 9),²¹ indicates the extent of the reclamation.²²

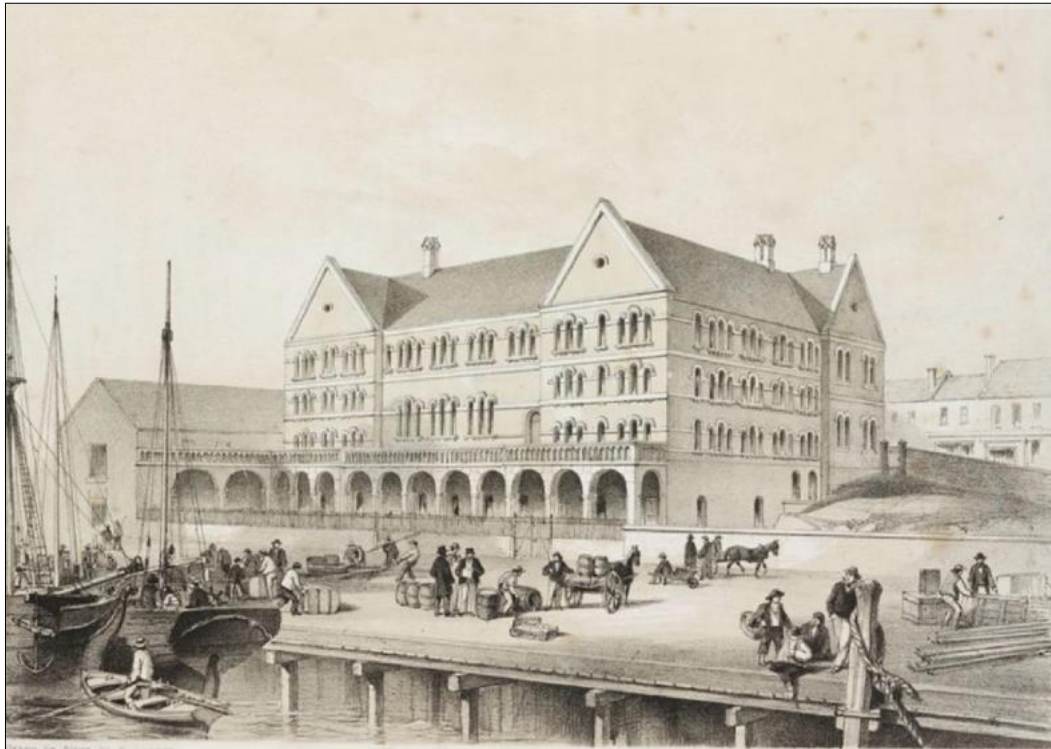
Figure 11: Etching of the proposed Sydney Sailor's Home (former) by Edmund Thomas c.1860 showing Weaver and Kemp's original proposal. (Source: SLNSW, DG SV1A/8; cf. SHFA Archives, GE 01)

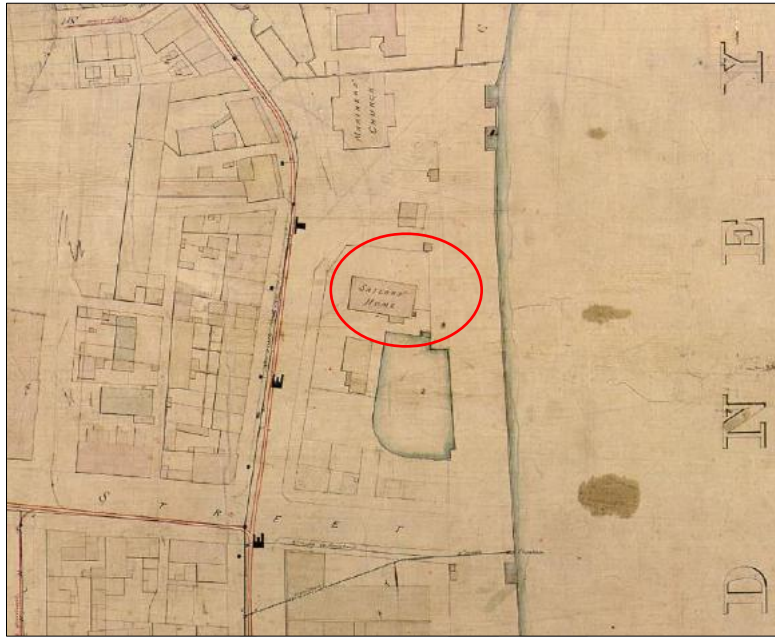
Figure 12: 1865 Trig Survey showing the building and surrounds. The Mariner's Church and Dead House located to its north and Cadman's Cottage to its south. (Source: City of Sydney Archives, City of Sydney - Trigonometrical Survey, 1855-1865: Block B2; cf. Sydney Water Plan Room, 1865 TrigSurvey Sheet B2 NRS 9929)

A Trig Survey, also dating from 1865 (Figure 12),³¹ shows the footprint of the building and its location in relation to George Street and other neighbouring buildings including the Mariners' Church and Dead House, to its north, and Cadman's Cottage to its south. The drawing indicates that there was also some sort of structure attached at the eastern end of the southern façade. Another smaller element is also shown at the south end of the eastern façade.

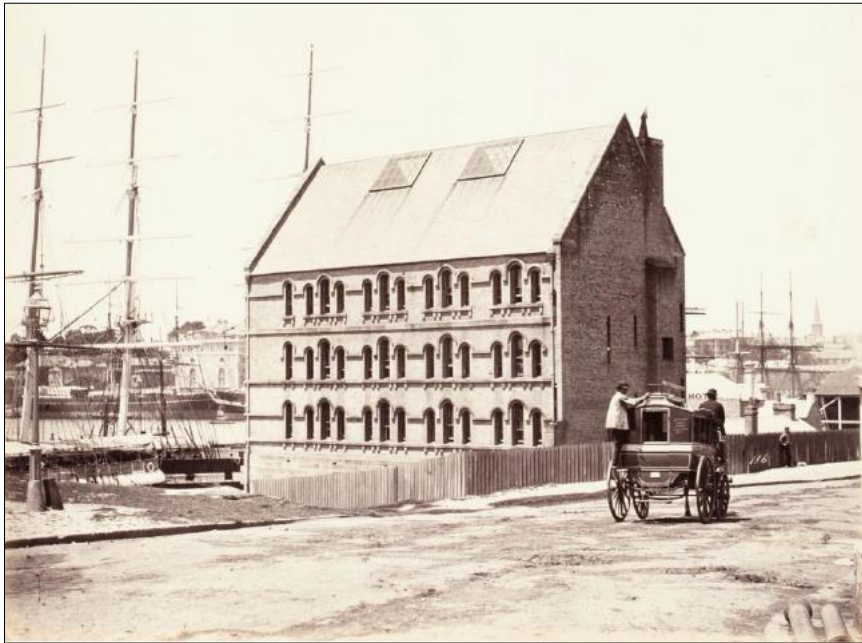
Figure 14: The Sailor's Home (former) as viewed from George Street c. 1872. The unadorned western façade (to George Street) is visible, featuring chimney extending from the gable roof which clearly features large skylights at the apex. (Source: SLNSW, DL PXX 81/44; cf. SHFA Archives, CQW 74)

A photograph of the building dating from c. 1870 (Figure 14) shows the completed wing with steeply pitched, gabled roof and large skylights. The sandstone basement and features of the northern façade, with its series of arched windows and associated trims is clear. The unadorned, simple western façade and chimney appears unfinished in contrast and obviously was intended to be an internal wall.

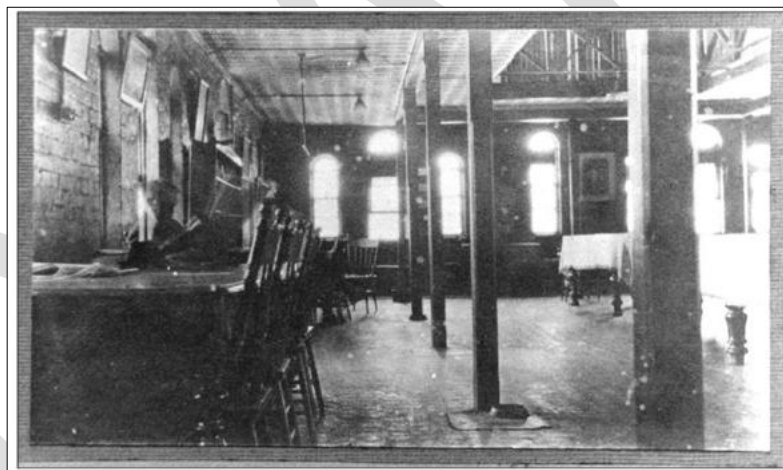
Figure 15: Undated photograph showing the ground floor, "Social Hall". (Source: SHFA Archives CQW 47)

An undated photograph of the "Social Hall" (Figure 15), gives an indication of the layout and finish of the interior. The timber posts that support the upper floor, gallery spaces are visible. It is clear that the interior was generally simply finished with painted brick walls. The photograph also shows what are assumed to be later additions to the interior including pressed metal lining to

the ceilings and surface mounted fixtures and fittings. The void in the first floor level shows the simple timber balustrade to the gallery above.

- at ground floor the original brick wall has been rendered and adorned with simple timber picture rail and skirting board (in contrast to the earlier photograph of the space (Figure 15);

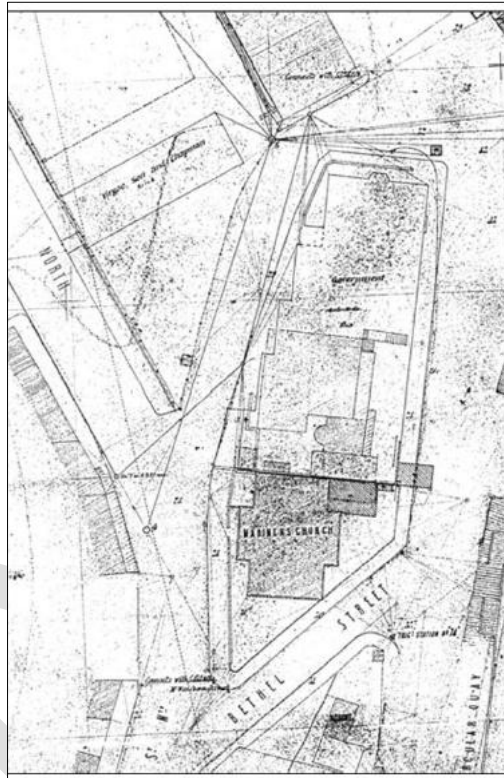
Figure 19: Sydney Water Plan showing the development north of the subject site c. 1880s. (Source: Sydney Water Plan Room, PWD 46 Sheet 3/1544)

Sydney Water plans dating from the 1880s, (Figure 19 & Figure 20, first surveyed in 1881 and revised in 1887 and 1888)³⁵ confirm the location of the original part of the building and site features. The building is set back from the George Street frontage with ample land around its regular footprint, to allow for the anticipated additions. The plans show the surrounding context and development including Bethel Street and the original form of the Mariners' Church north of the subject site.

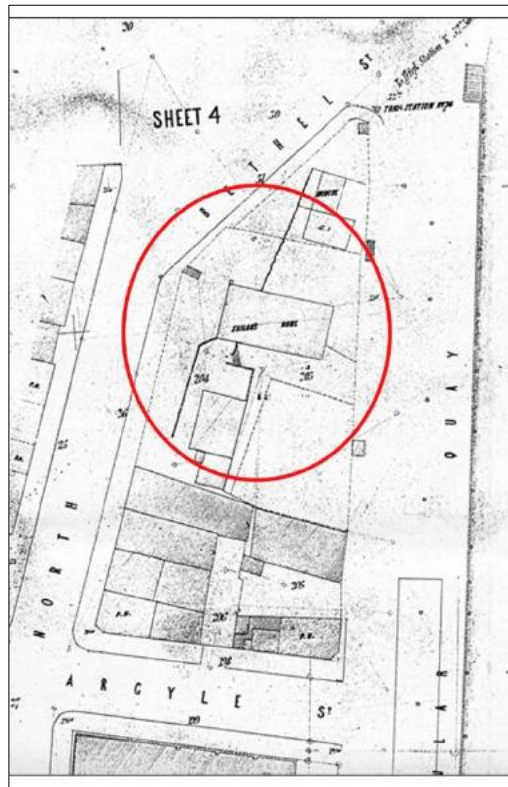
Figure 20: Sydney Water Plan showing the site and associated features including the simple footprint of the Sailor's Home (former), Cadman's Cottage and what appears to be retaining walls and fences. At some stage it would appear that the Morgue building, to the north of the Home, had been extended. (Source: Sydney Water Plan Room, PWD 46 Sheet 4/1554)

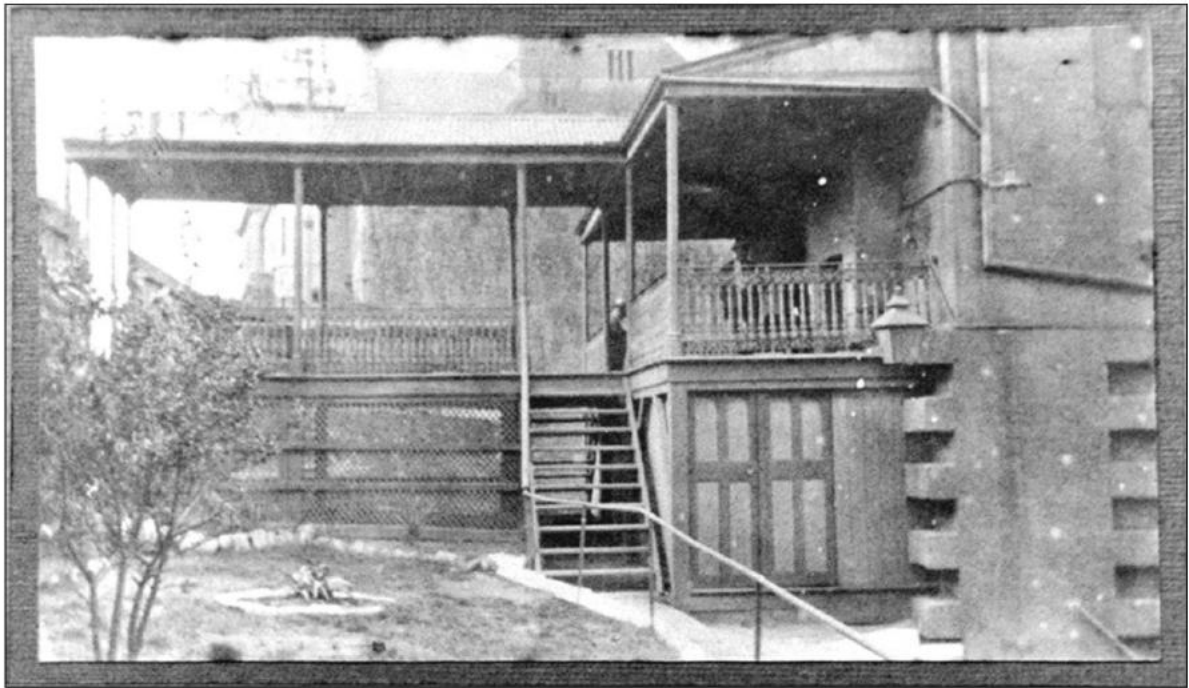
Figure 21: Undated photograph showing the timber framed structure added c. 1882 and “approach from George St North”. Constructed to provide direct access to George Street it also included stairs to access the sides of the building. (Source: SHFA Archives, CQW 46).

direct connection to and from George Street.³⁷ An undated photograph of the building (Figure 21) shows the timber framed structure with corrugated iron roof constructed to the western façade of the building. The structure also included two sets of timber stairs which led down the sides of the building and allowed access to the site and Cadman's Cottage. The photograph also shows the sandstone "keys" and "mortices" left at the south western corner of the building in anticipation of further extensions.

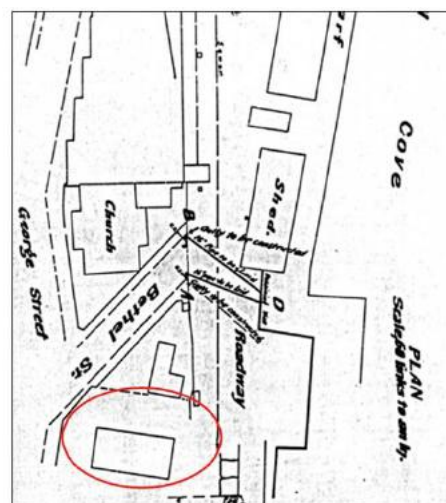
Figure 28: 1901 sewer plan indicating the building footprints on their respective sites. Bethel Street is still shown, later abolished for the construction of the Coroner's Court building in c.1907. (Source: Sydney Water Plan Room, GC/158/1)

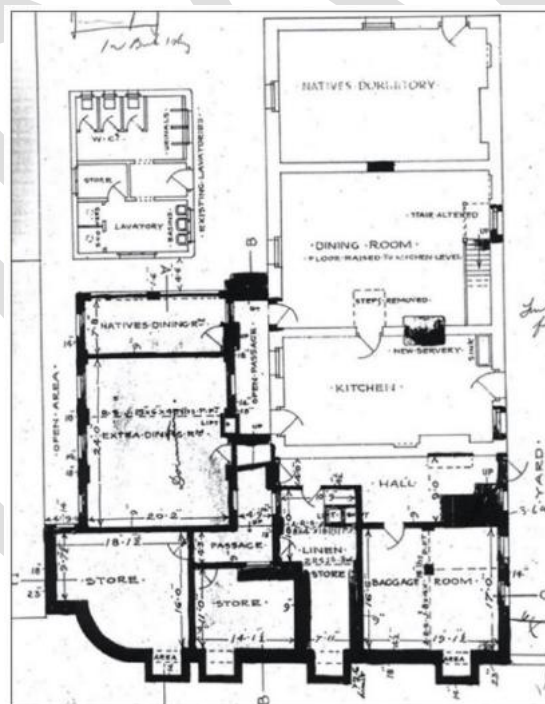
Figure 32: 1925 Basement Plan showing the proposed alterations to the original wing, including the infill of the opening in the wall between the “Natives Dormitory” and “Dining Room”, alteration of the stair on the southern wall and addition of a servery between the “Dining Room” and “Kitchen”. The proposed additions are clearly evident, with notable features including the two “lifts” (dumb waiters) and “shoot”. Note the 1922, existing Lavatory Block. (Source: City of Sydney Archives, 0540/25)

Council records show that a Building Application for a new Lavatory Block was submitted in November 1922.⁴⁷ No drawings of the block have been located, however it would appear that the external washroom was subsequently constructed, in the north eastern section of the site as shown in later drawings (refer Figure 32). Prior to this, amenities were housed in various less substantial outbuildings.⁴⁸

- the infill of a door between the Natives Dormitory and dining room;
- removal of the step between the dining room and kitchen (shown in Figure 22);
- raising of the floor level in the central dining room to the level of the kitchen;
- alteration of the existing stair on the southern wall that provided direct access to the Main Hall on the ground floor;
- work to a window opening in the southern wall in the dining room, adjacent to the stair;
- provision of a new servery in the wall between the kitchen and dining room; and
- addition of a new window in the south western wall of the kitchen.

The incorporation of separate "natives" dining room and dormitory is an indication of the social climate of the day. Segregation of "visiting" sailors, particularly native Pacific Islander sailors is emphasised in the proposed alterations and works at this time (refer Figure 32).

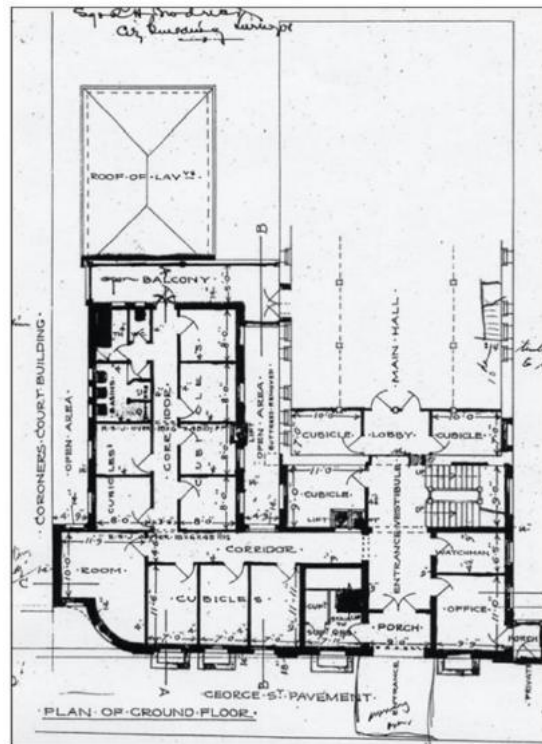
Figure 33: 1925 Ground Floor Plan showing the proposed alterations to the original wing of the building; including the addition of two cubicles and alterations to the lobby, and the proposed addition. Note the “private” porch at bottom right. The hipped roof of the existing, 1922 Lavatory Block is also visible at top left.
(Source: City of Sydney Archives, 0540/25)

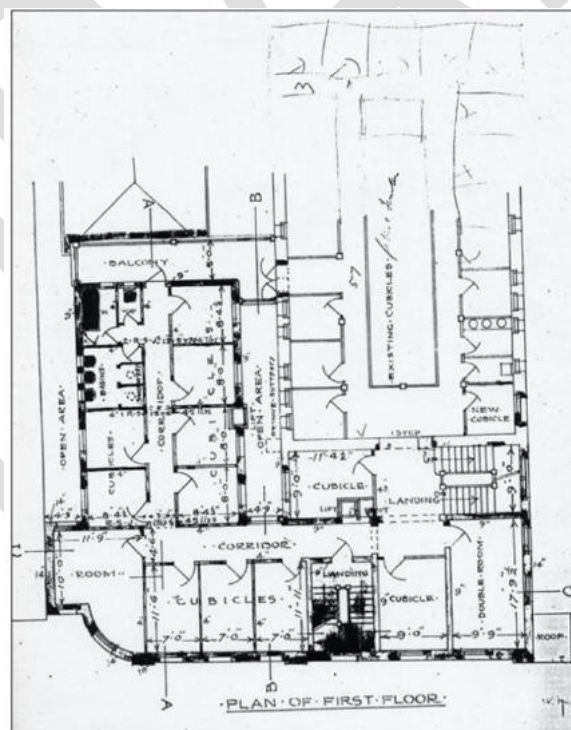
Figure 34: 1925 First Floor plan showing the proposed alterations to the original wing, including the addition of a new cubicle in the southern corner (made possible by the removal of the original accessstair and floor infill) and the northern wing addition featuring open balcony at the eastern end (top left). (Source: City of Sydney Archives, 0540/25)

The second floor plan shows the proposed Superintendent's residence with bedroom, dining and sitting room, bathroom and separate WC, kitchen, work room and small room with “lift and shoot” (dumb waiter and laundry shoot). These actually featured on each of the levels and extended up from the basement linen store. The lightweight, battened partition walls, unlike the levels below, are solid. A central landing and “enclosed balcony” with casement windows overlooking George Street and balcony are shown on the plan (Figure 34) at the eastern end of the addition.

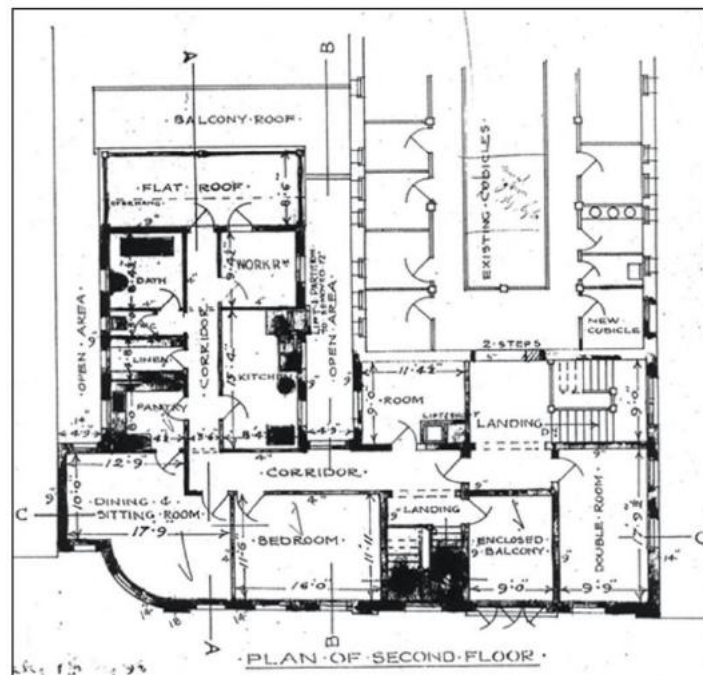
Figure 35: 1925 Second Floor plan showing the proposed alterations to the original wing, including the addition of a new cubicle (made possible by the removal of the original access stair) and proposed northern wing occupied by the Superintendent's quarters. (Source: City of Sydney Archives, 0540/25)

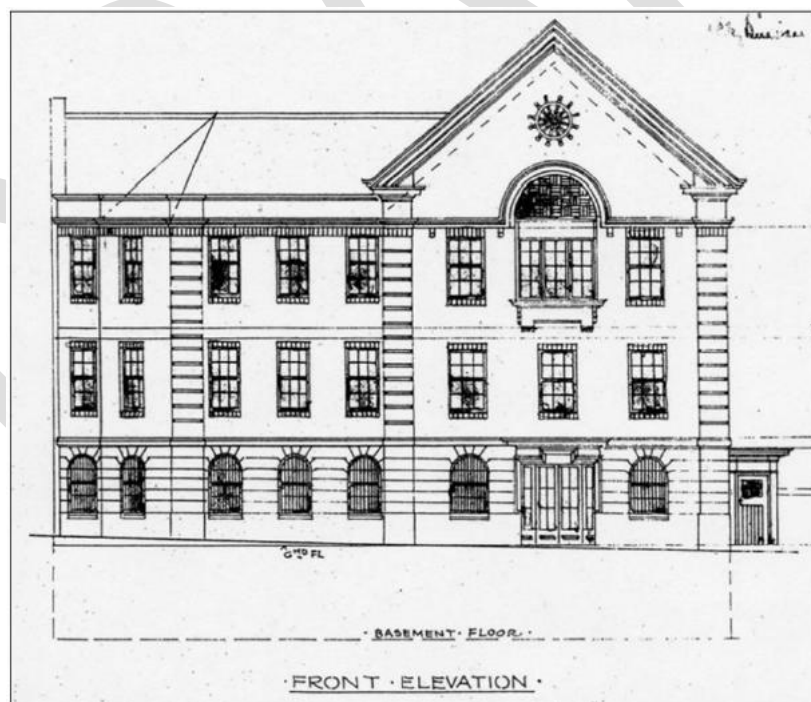
Figure 36: The proposed front elevation of the building prepared by Spain and Cosh in early 1925 with hipped and gabled roof and prominent gabled parapet to the George Street frontage. The separate entry porch is visible at bottom right. (Source: City of Sydney Archives, 0540/25)

In May 1925, Sydney architects Spain and Cosh submitted plans to Sydney City Council proposing extensive alterations and the long anticipated additions to the building.⁴⁹ Approved in July 1925, the drawings, dated May 1925, show the L shaped addition with its Free Classical façade, regular shaped, multipaned timber framed windows, rusticated pilasters and gable roof. The scheme also proposed a prominent gabled parapet to George Street (refer Figure 36).

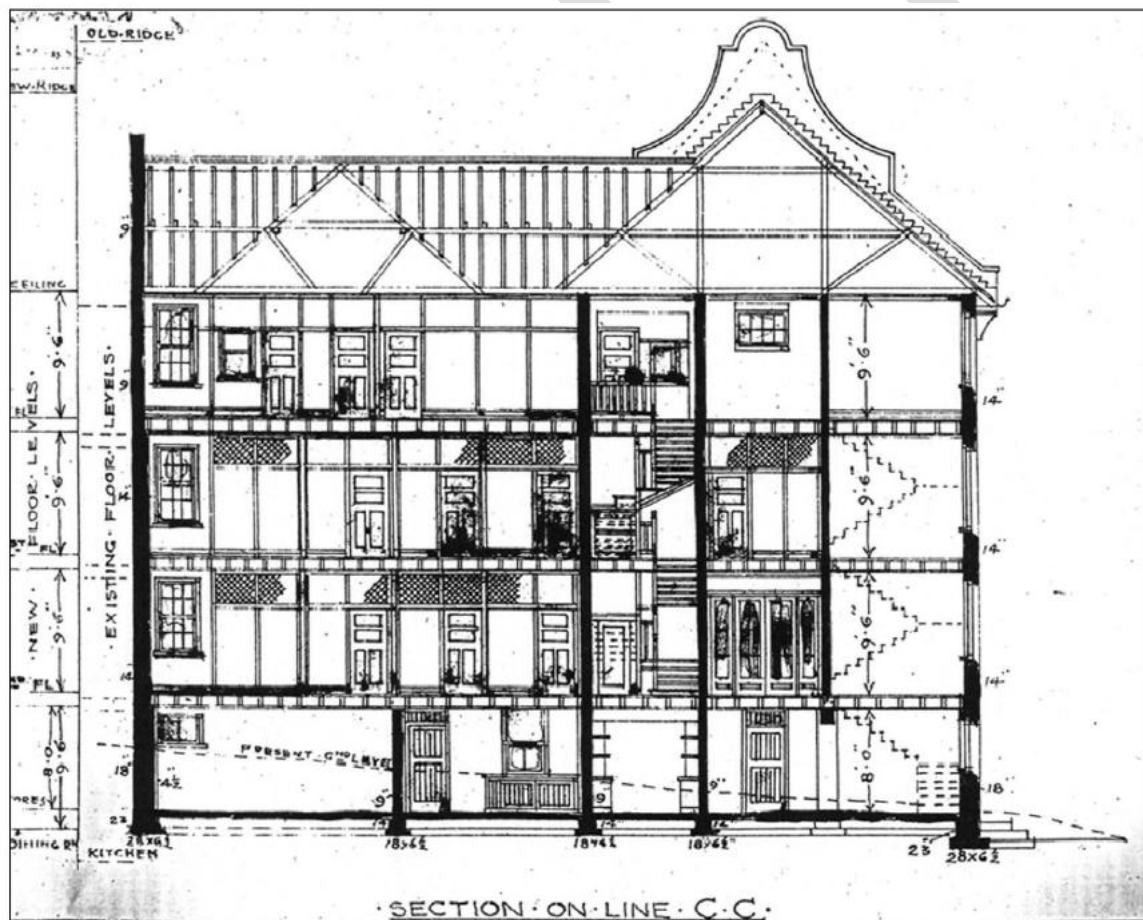
Figure 38: Long Section through the front of the proposed addition which also shows that an Anglo-Dutch inspired parapet, much like the gabled ends of the ASN Building, was considered for the gable end. (Source: City of Sydney Archives, 0540/25)

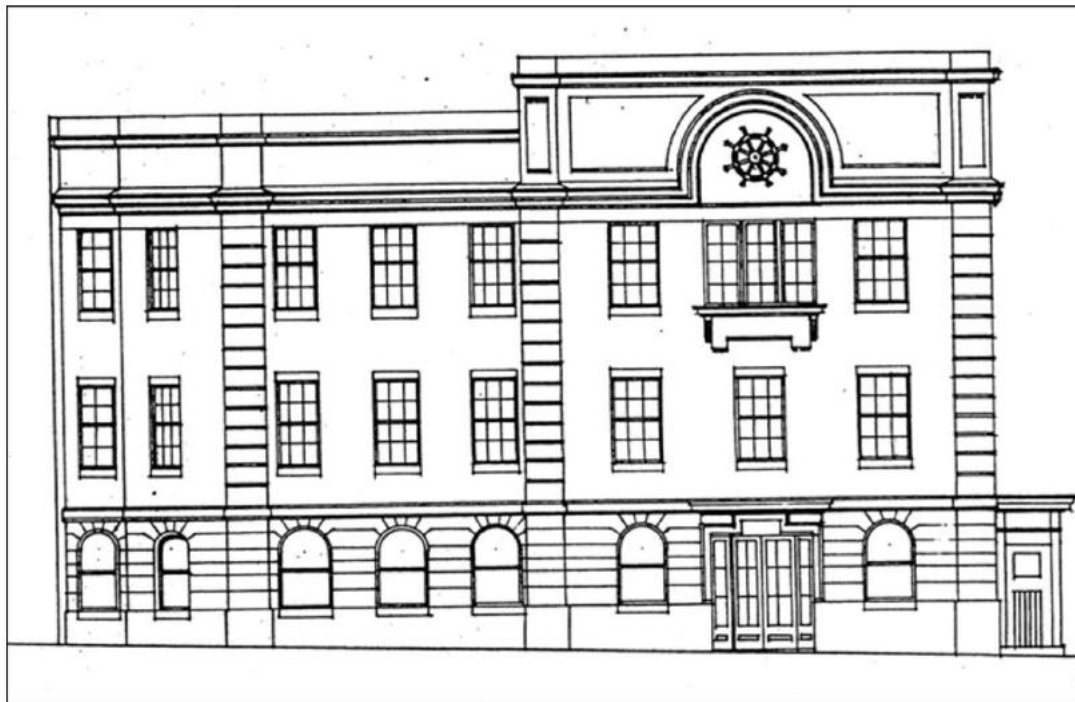
Figure 40: Revised front elevation to George Street, with parapet concealing the roof. The ships wheel motif was proposed for the parapet of the primary bay. (Source: City of Sydney Archives, 0540/25, Sheet No. 5)

In December 1925 the proposed elevations of the building were amended and approved. The drawings⁵⁰ show that the existing and proposed gabled roof was to be replaced with a flat roof, over the two wings of the building. The flat roof was to be supported on regularly spaced trusses and concealed by a high continuous parapet. A ship's wheel motif, dates of the two buildings and "Sailor's Home (former)" are shown on the proposed parapet. An enclosed stair with pitched roof was also proposed to access the flat roof. "Pebbles" is scribbled on the roof plan as is a reference to a skylight (Figure 43).

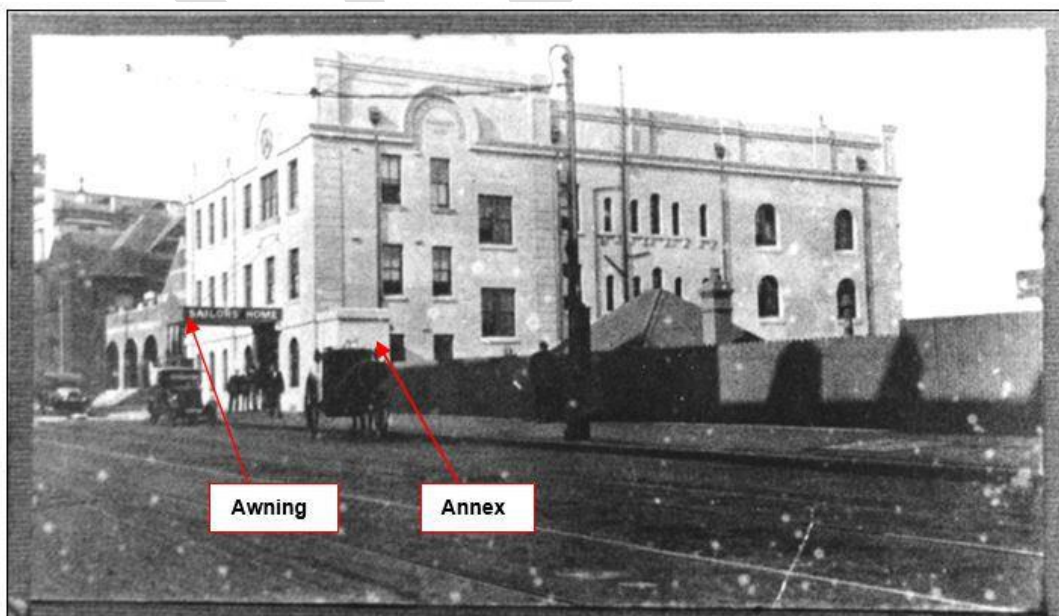
Figure 44: Photograph showing the completed addition and overall form of the building c.1926. The suspended awning to George Street is visible. Note the small annex, entry porch at the south western corner of the building. (Source: SHFA Archives CQW 45)

A photograph of the completed building, dating c. 1926 (Figure 44), shows the overall form of the building with its new, high parapet extending around the perimeter of the building including the original wing of the building. The southern façade of the addition and larger bay to George Street feature arched moulding with relief lettering and ships wheel motif as shown on the drawings. The photograph also shows a small, suspended awning over the George Street entry and southern façade of the building. The southern façade is punctuated by the various openings, including the original, narrow arched windows, later arched openings at the eastern end (at left) and the regular openings of the 1925 addition. A number of service pipes and downpipes are also shown. The small, single storey annex is also visible on the George Street frontage. The simple, parapet structure provided separate, private entry to the ground floor office located in the south western corner of the addition. To facilitate the construction of the continuous parapet, the original, gabled end of the eastern elevation was demolished. The original wing was probably rendered as part of the works.

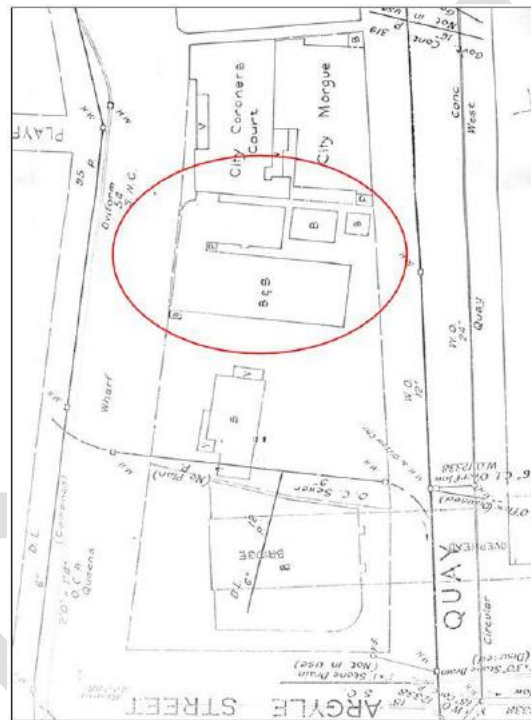
Figure 47: 1962 Sydney Water Plan indicating the size of the Sydney Cover Terminal (at right) and showing the overhead bridge that extended over the Circular Quay West roadway to the area south of Cadman's Cottage. The plan is also interesting in that it shows the footprint of the building and two brick lavatory buildings. (Source: Sydney Water, SRS 3768 Base)

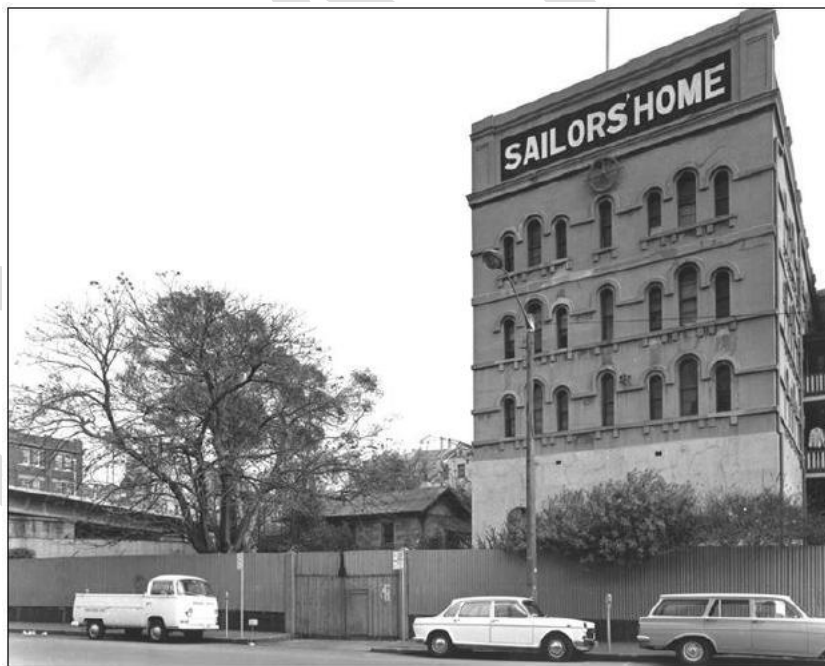
Figure 49: Photograph of part of the eastern façade of the building and Cadman's Cottage site to its immediate south. By this time the basement of the 1860s wing has been rendered. A high fence also remains along the boundary along the Circular Quay West roadway. The photograph also shows plantings around the buildings and the bridge extending from the Sydney Cove Terminal is also partly visible to the south of the site (at left). (Source: SHFA Archives, CQW 20)

A photograph of the eastern façade of the building and Cadman's Cottage site dating from the 1970s (Figure 49), shows that changes had been made to the building by this time. The eastern parapet of the original, 1860s wing of the building proudly bears the word "Sailor's Home (former)", made prominent by contrasting paint colour. The parapet and upper three storeys appears to be painted in one colour with the various rendered mouldings, and string courses creating shadow lines on the facades. A flagpole is fixed to the internal face of the parapet and the facade is also decorated with a ships wheel fixed to the top cornice. The photograph also shows that the sandstone basement of the original wing of the building has also been rendered by this time. It is not clear when these works were carried out and it would appear that the canopy seen in the 1930s photograph (Figure 45) had also been removed. A high fence remains on the site eastern boundary. It is assumed that the two lavatory blocks, that occupied the north eastern section of the site, were removed around this time, when the Sailor's Home (former) vacated the building.

The drawings, dated May 1988, also note that the basement "*sandstone to remain unpainted*" (see Figure 64). This suggests that the render finish to the basement wall, seen in the 1970s photograph (Figure 49), had been removed by this time.

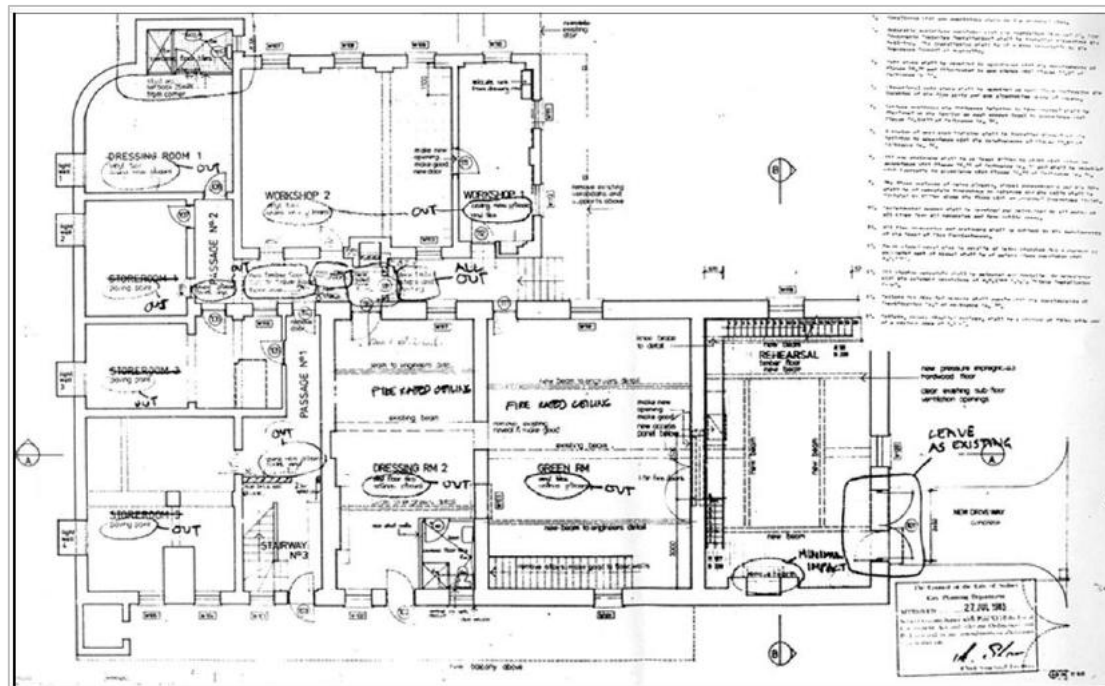
Figure 55: Amended basement plan, approved in 1983, showing the proposed amendments or "omissions". (Source: City of Sydney Archives 539/1/82)

It would appear that these drawings were amended, with amendments approved by Council in July 1983. The proposed uses of the spaces were changed and a number of the proposed works were omitted, with "minimal impact" noted on the drawings. The basement of the original wing of the building, which continued to comprise of three sections was to contain rehearsal room, in the eastern room, Green Room in the central room and Dressing Room 2 in the western room with new ensuite enclosed by lightweight stud wall proposed in the south eastern corner of the room. A Dressing Room was still proposed for the room at the north western corner of the 1920s wing and two workshop spaces are noted for the main area of the northern wing. The omissions included:

- the basement doorway on the eastern façade of the original wing was to remain as existing;
- the hearth in the south eastern section of the basement was to have "minimal impact";
- the floor finishes to the basement were to remain as existing, however fire rated ceilings are noted;
- the ensuite proposed in the northern alcove of the 1920s, northern wing to Dressing Room 1 was to be deleted; and
- Dressing room 2 was relocated with ensuite now proposed for the original wing.

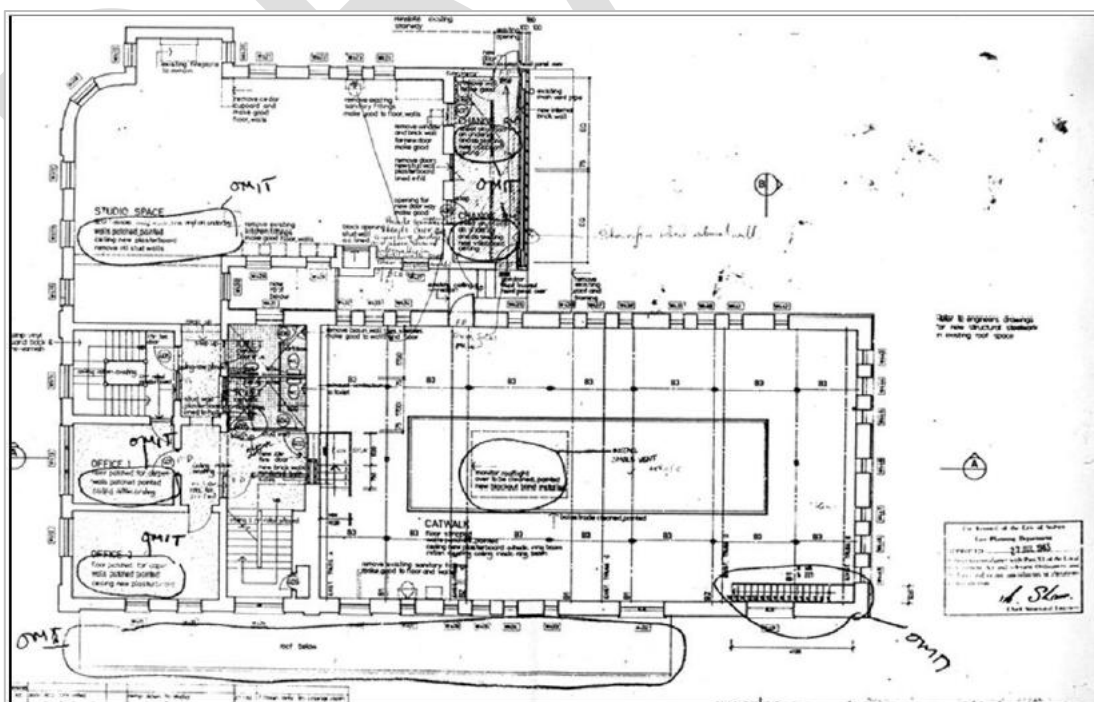
Figure 58: Amended Second Floor plan, approved in 1983, showing the proposed amendments or "omissions".
(Source: City of Sydney Archives 539/1/82)

The first floor amendments included the retention of existing floor and ceiling finishes, with new proposed plasterboard ceilings deleted. This was also repeated on the second floor, in addition to the deletion of a proposed stair in the south eastern corner of the original wing. The amended drawings also show the deletion of air conditioning units and ducting in the original wing of the building, and notes installation of smoke vent to the “rooflight”.

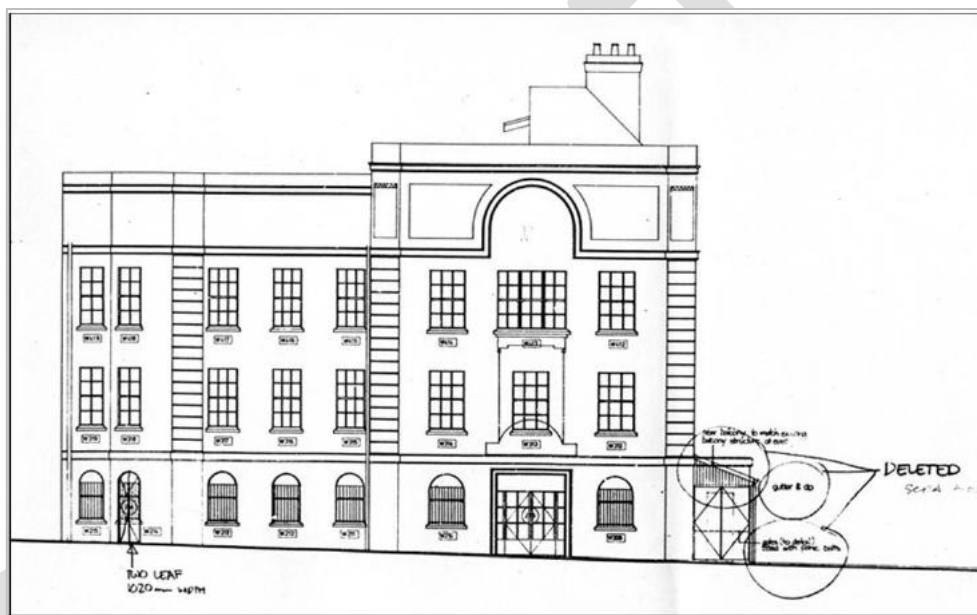
Figure 59: 1982 front, George Street elevation. Note the proposed alteration of the ground floor window to a two leaf door in the north eastern, ground floor façade (bottom left). (Source: City of Sydney Archives 539/1/82)

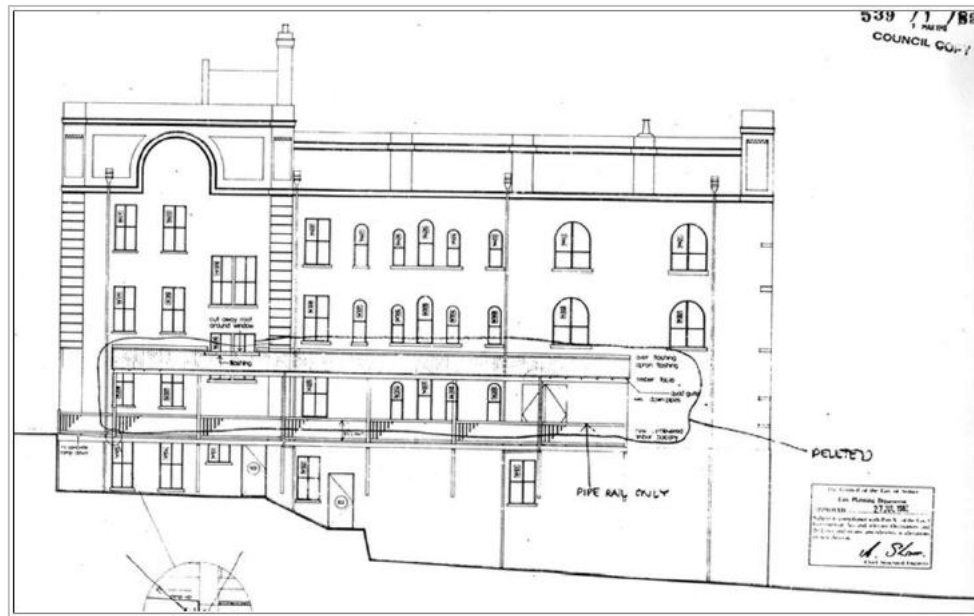
Figure 60: 1982 Southern elevation. The balcony and new doorway were required to provide egress from the theatre auditorium. The roof structure over the balcony was however deleted. (Source: City of Sydney Archives 539/1/82)

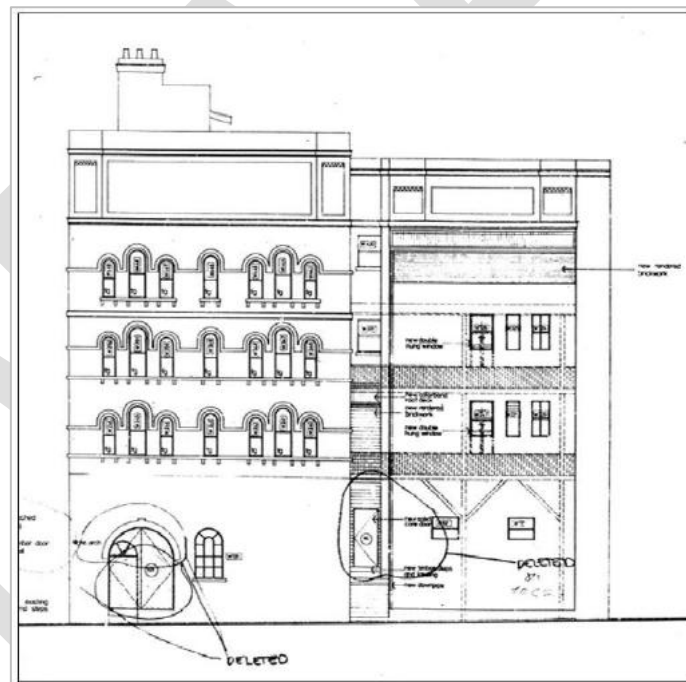
Figure 61: Eastern elevation of the building. The existing basement doorway was retained as existing. (Source: City of Sydney Archives 539/1/82)

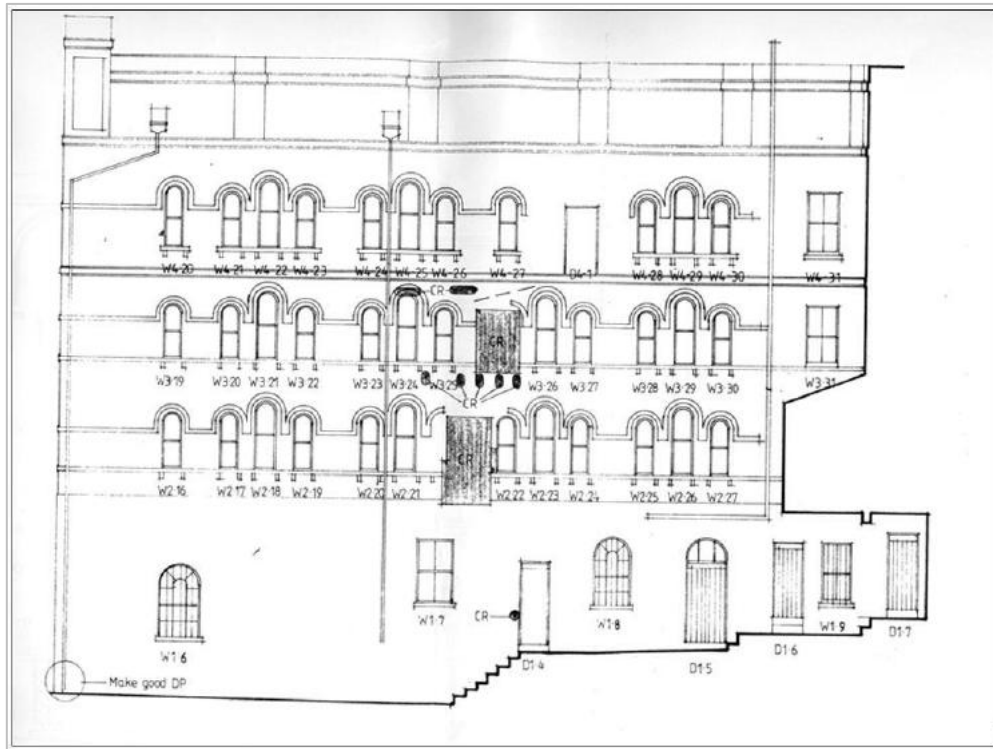
Figure 66: Northern façade of the 1860s wing showing cement render repairs to infilled windows and basement doorway. (Source: SHFA File, No RE 1352.01.01, Drawing No. CP3/27)

In 1988 SCRA issued a Specification for window and render repairs to the building.⁷⁸ Minor cement render repairs were proposed for the south, east and northern elevations of the building. No render repairs were proposed to the George Street, western facade of the building (Figure 64-Figure 67). Works to the timber framed windows included general adjustment of all windows and replacement of sash cords, replacement of stop and parting beads, replacement of sash lifts and fasteners and replacement of glass, as required. The schedule detailed the required works and also documented the complete replacement of window, frame and arch bar of W1-4, the south eastern basement window (Figure 64).

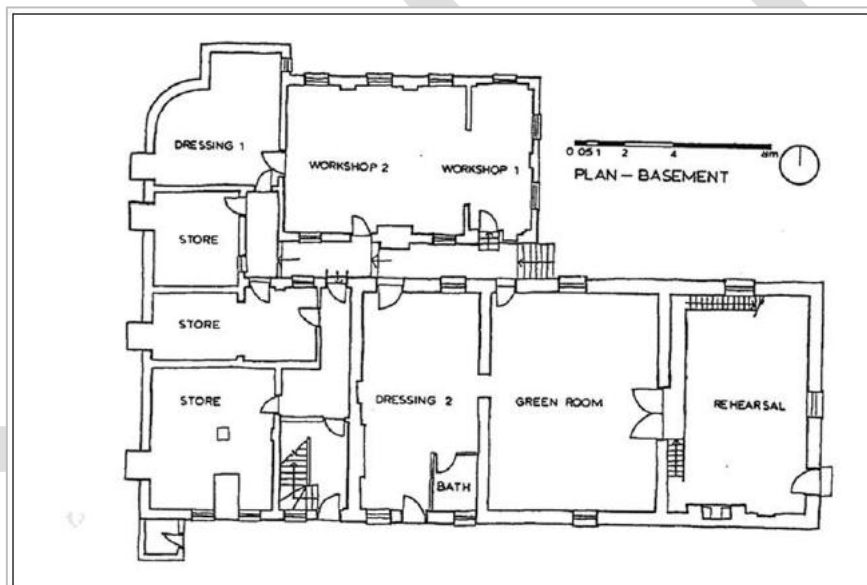
Figure 68: Basement plan, showing the configuration of the building in 1990. (Source: Bligh Robertson Architects, Sydney Sailor's Home (former) (106-8 George Street) Conservation Plan, (Feb 1990))

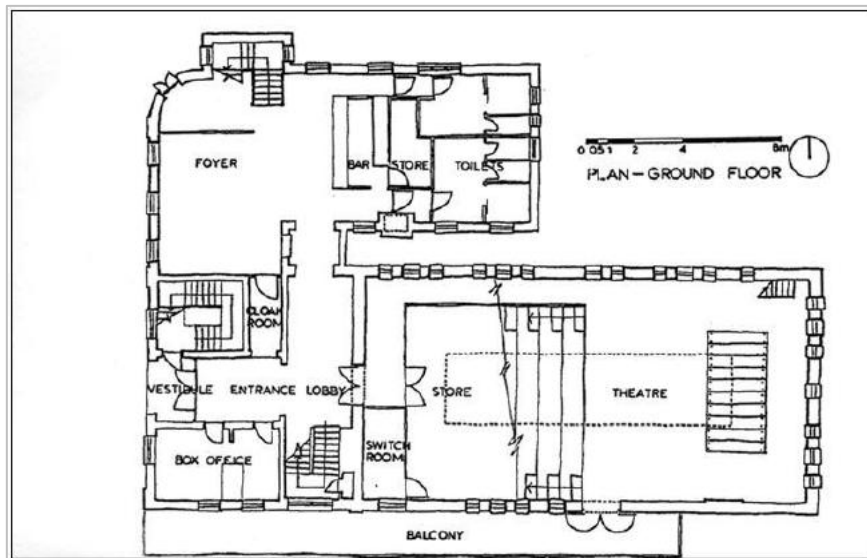
Figure 69: Ground Floor plan, showing the configuration of the building in 1990. (Source: Bligh Robertson Architects, Sydney Sailor's Home (former) (106-8 George Street) Conservation Plan, (Feb 1990))
