Conservation Management Plan

Sailor's Home (former)

SHR No. 01576

106 – 108 George Street,
The Rocks

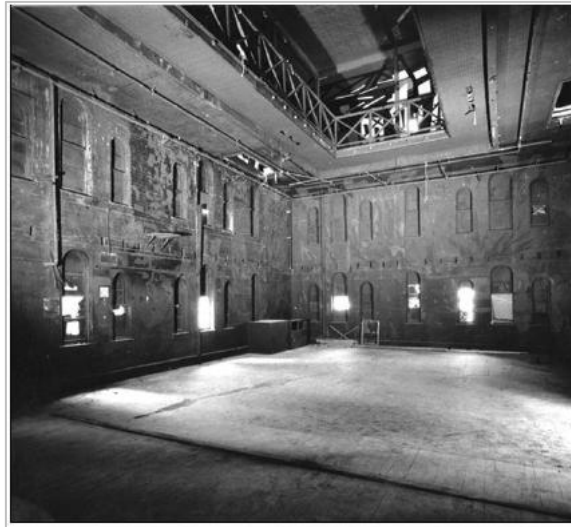
*Figure 72: The ground floor, former Theatre Auditorium looking east after removal of the stage and associated stairs and tiered seating c. early 1990s. Evidence of the first floor gallery and building elements remain.
(Source: SHFA Archives, undated recording by Ross Graphics)*

An addendum to the Specification dated August 1991 outlined the demolition of the tiered seating and platform, removal of applied paint finishes to the masonry wall surface and repairs to the windows. Undated photographs of the ground floor of the original wing and former Theatre Auditorium, assumed to be taken about this time, show the condition of the building elements in this section of the building. Evidence of the former structure was used in the "restoration" of the space and reinstatement of the gallery and associated building elements.

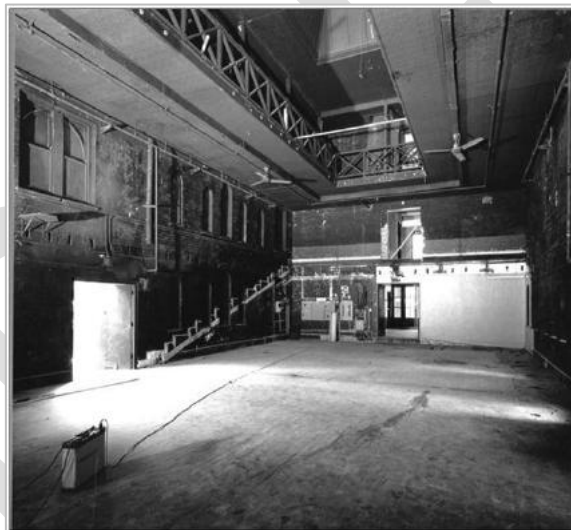
Figure 73: The ground floor, former Theatre Auditorium looking west toward George Street, after removal of the tiered seating c. early 1990s. Note the door opening (at left) made as part of the Marionette Theatre works in the 1980s to allow egress to George Street, via the steel and timber balcony along the southern façade of the building. (Source: SHFA Archives, undated recording by Ross Graphics)

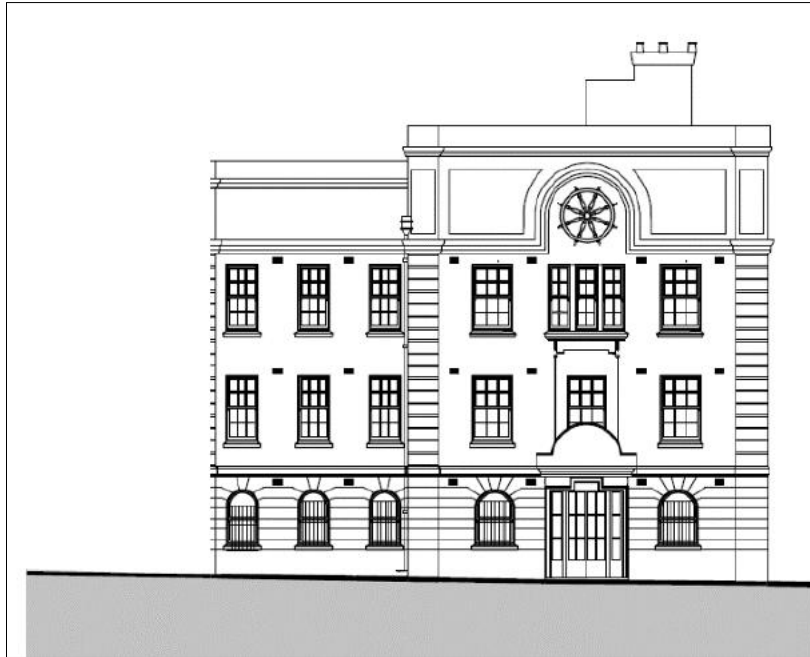
Figure 97: Western (front) Elevation (Source: Planning & Infrastructure Sydney Harbour Foreshore Authority, 2012)

The George Street façade features a distinctive base and middle section, with the ground floor portion of the façade featuring a rendered base/plinth and arched headed multi-paned timber casement windows and two regular shaped door openings. A rendered string course separates the ground from the upper façade which features a number of regular openings with multi-paned, double-hung, timber-framed windows with rendered sills. Many of the window openings, particularly those along the ground level, feature steel security grilles, however, it is not clear when these were added to the building. Four pavement lights are located along the George Street alignment which provide light to the basement level. The wrought iron framed lights are framed by trachyte edging.

Entry into the building along this facade is located directly beneath the pediment detail with timber ships wheel. The entry is defined by a rendered moulding with "106" painted over the centre of the opening. A suspended awning is located above the entry, and is supported by two wrought iron, suspension rods. It features sheet cladding and studded trim to the fascia and what appears to be pressed metal (possibly fibre glass) and open mesh to the soffit. The signage to the awning was added as part of the later fitout for the Billich Gallery in the early 2000s. The pavement to the entry of the building features a bluestone ramp that abuts the original terrazzo flooring.

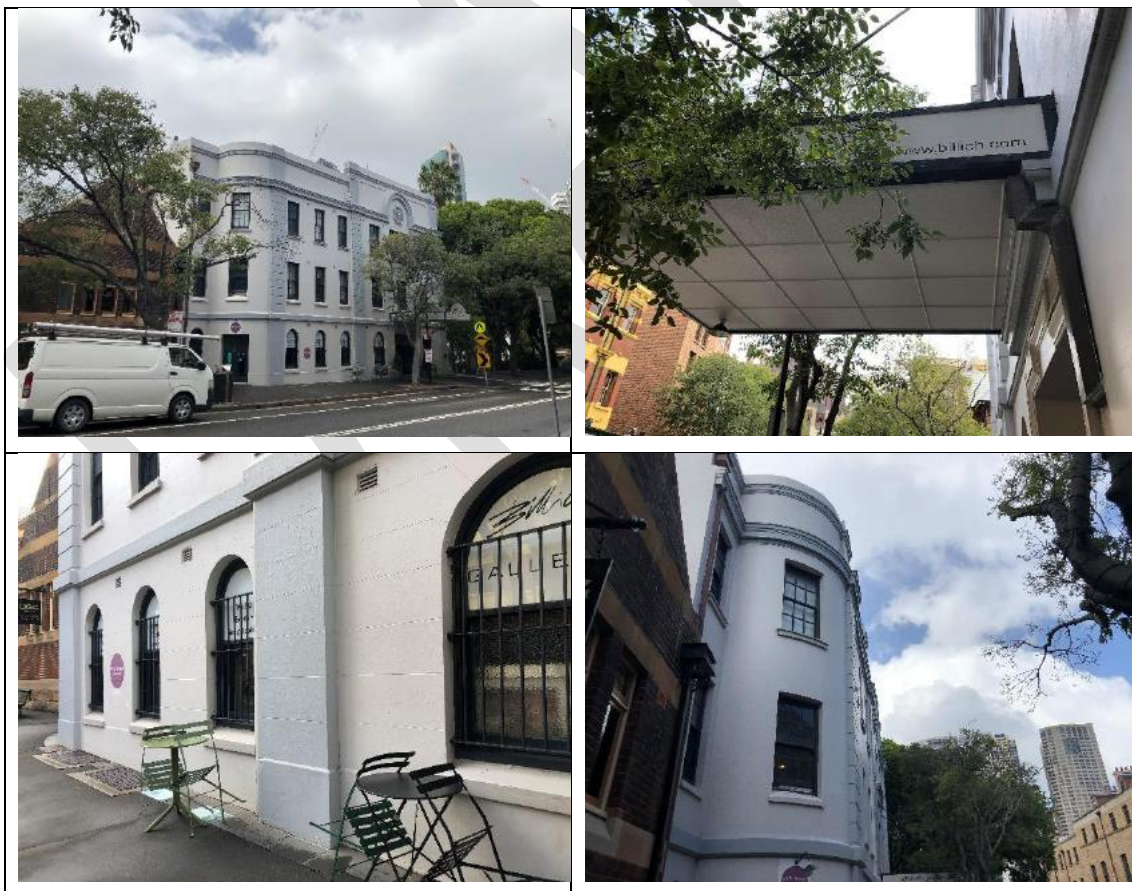
Figure 98: (top to bottom, left to right) (1) View of the front façade looking southeast from George Street; (2) View of the awning over the main, George Street entry; (3) View looking north along the bottom half of the front façade; and (4) View looking south looking up at the junction between the Coroner's Court building.

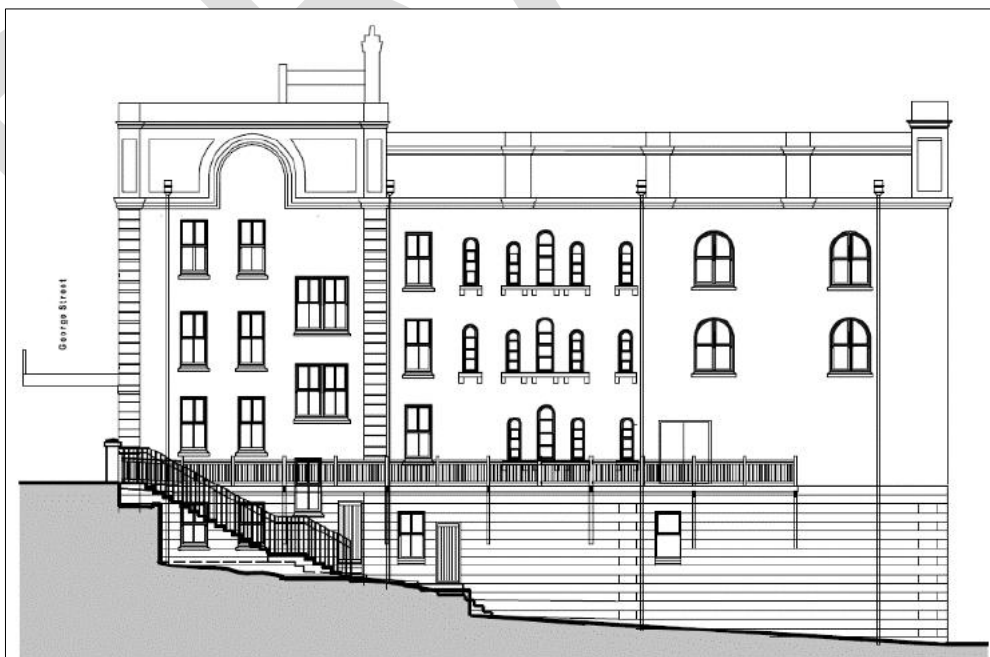
Figure 99: Southern (side) façade (Source: Planning & Infrastructure Sydney Harbour Foreshore Authority, 2012)

The side (southern) façade comprises two distinct sections, defined by the two wings of the building. In particular, the rendered façade of the 1920s addition is clearly visible and is in contrast to the face stonework of the original 1860s wing of the building. The western, 1920s wing located towards the western portion of the façade is bounded by two rusticated pilasters which extend the height of the façade to the parapet. The parapet steps down at the junction between the 1920s addition and original 1860s wing, which sits on a face, sandstone base. The parapet atop the 1860s portion of the building contains, "SAILORS HOME" in large relief lettering.

The southern façade features windows associated with the three phases of the building's development. The western, 1920s portion of the southern façade features regular shaped window openings with double-hung timber-framed windows and rendered sills. The bracketed balcony, added as part of the 1980s works, extends along most of the façade at George Street level and forms a demarcation line between the face stone façade of the basement and rendered planes of the upper façade. The three, regular shaped windows at the junction of the 1860s and 1920s sections were added as part of the 1920s works to the building to provide addition light and ventilation to the new cubicles. The original, 1860s windows towards the eastern portion of the southern façade are smaller, arched headed windows. They feature rendered, bracketed sills and double-hung timber-framed windows. The larger arched headed windows at the very eastern end of the façade were added sometime prior to the 1890s. The basement also features a number of openings. The very eastern end of the southern façade retains an original 'keyed' detail, which suggests that it was left to allow additions to the southern end of the building sometime in the future. Building records indicate that over time most of the windows have been successively repaired and, in some cases, replaced.

The steel and timber bracketed balcony and double doors were added as part of the 1980s works to allow egress from the then Marionette Theatre which occupied the internal spaces of the building. The design of the balcony was to reflect the 1920s details of the existing building. The construction of the balcony and egress also necessitated the removal of the ground floor private porch/annex located at the southwest corner of the building. The location of the former annex is indicated by the patching at the ground floor level of the western portion of the façade. However, the basement annex remains and the floor slab/roof over the basement annex also remains at the southwest corner of the building.

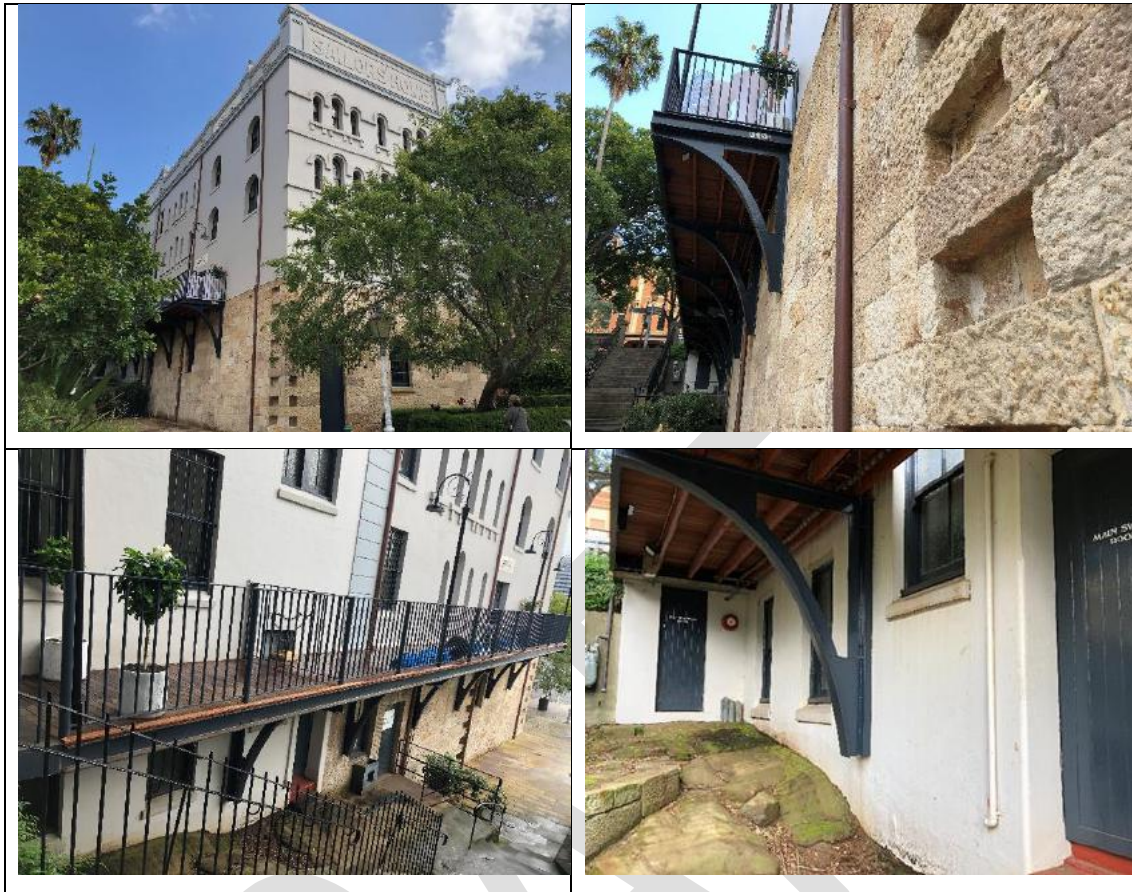
Figure 100: Features of the southern façade.

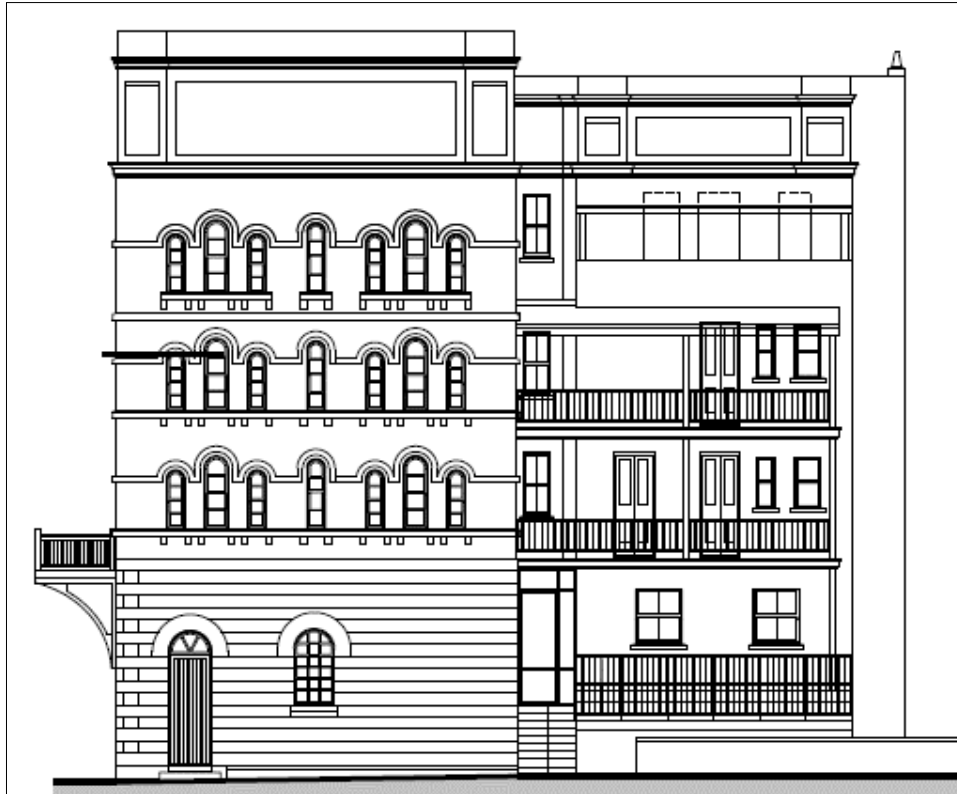
Figure 101: Eastern (rear) façade (Source: Planning & Infrastructure Sydney Harbour Foreshore Authority, 2012)

The timber stair and platform which connect the 1920s portion of the building to Circular Quay were added during the 1990s and provides access to an outdoor deck. The deck features concrete floor slab with timber decking over. It is bounded by simple wrought iron balustrades fixed to the concrete slab and brick base.

A lightwell is located between the two wings of the building. The arched openings of the original 1860s wing are evident and are in contrast to the regular openings of the 1920s wing.

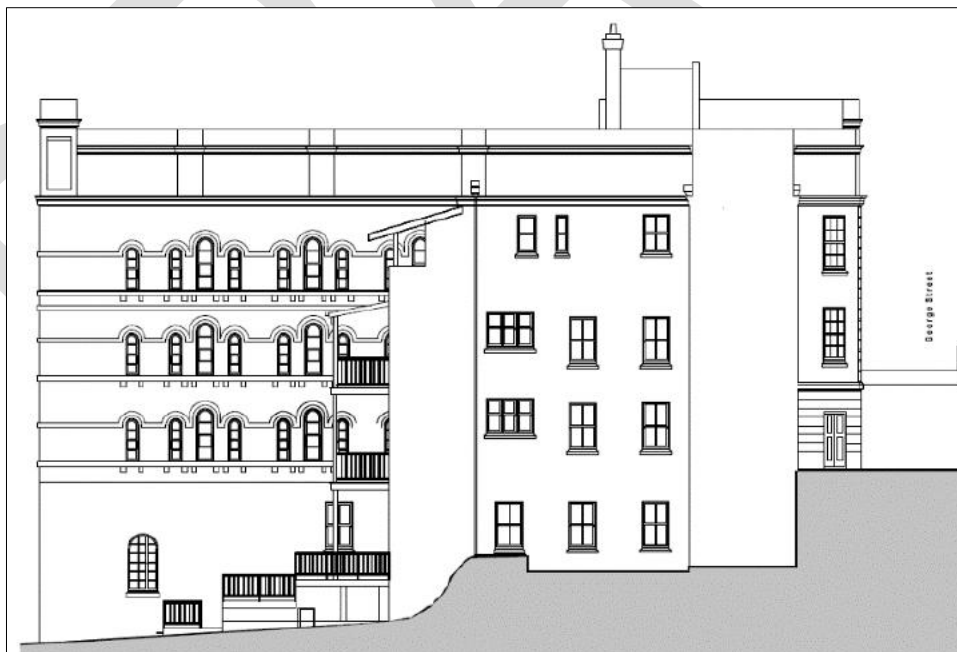
Figure 102: Northern façade (Source: Planning & Infrastructure Sydney Harbour Foreshore Authority, 2012)

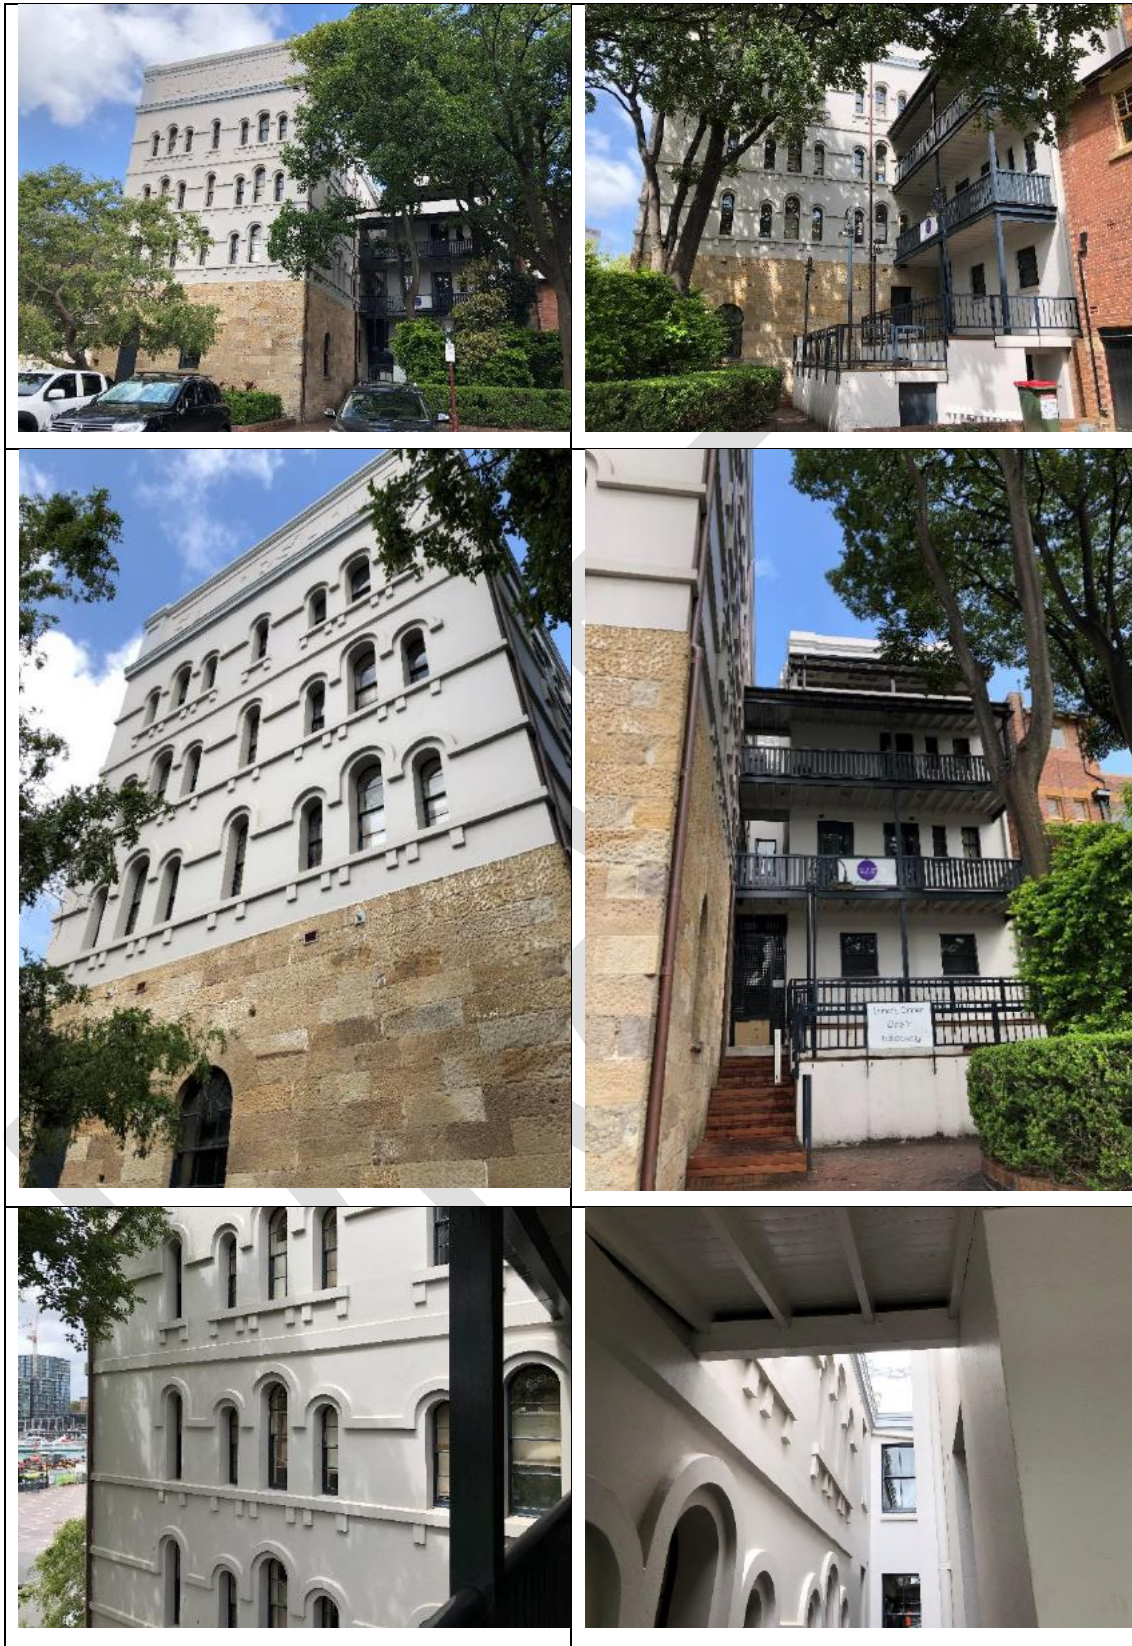
Figure 103: Views of the eastern façade.

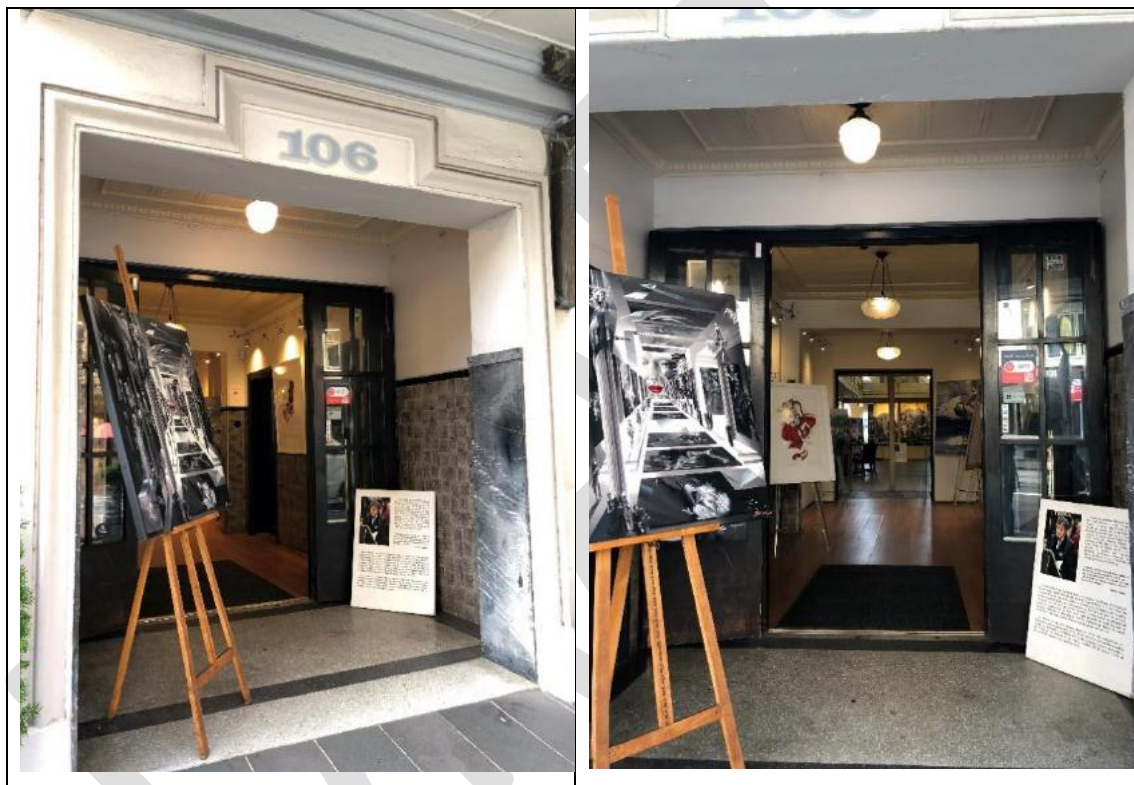
Figure 104: The main entry to the building along George Street.

All four floors of the 1860s wing are currently occupied by the Billich Gallery, including a publicly accessible gallery space. The 1920s entry into the 1860s portion of the building is accessible along George Street. A expandable folding trellis-door encloses the porch space which features original 1920s finishes including terrazzo flooring, ceramic tiles, render finish to the walls, and pressed metal ceiling and cornice. Marble cladding, which is believed to be a later addition, has been fixed to the door reveal to a height to match the ceramic tile and trim. Access to the internal spaces and internal entry vestibule is via a porch space off the George Street alignment, which contains bevelled glass and timber-framed double doors with sidelights.

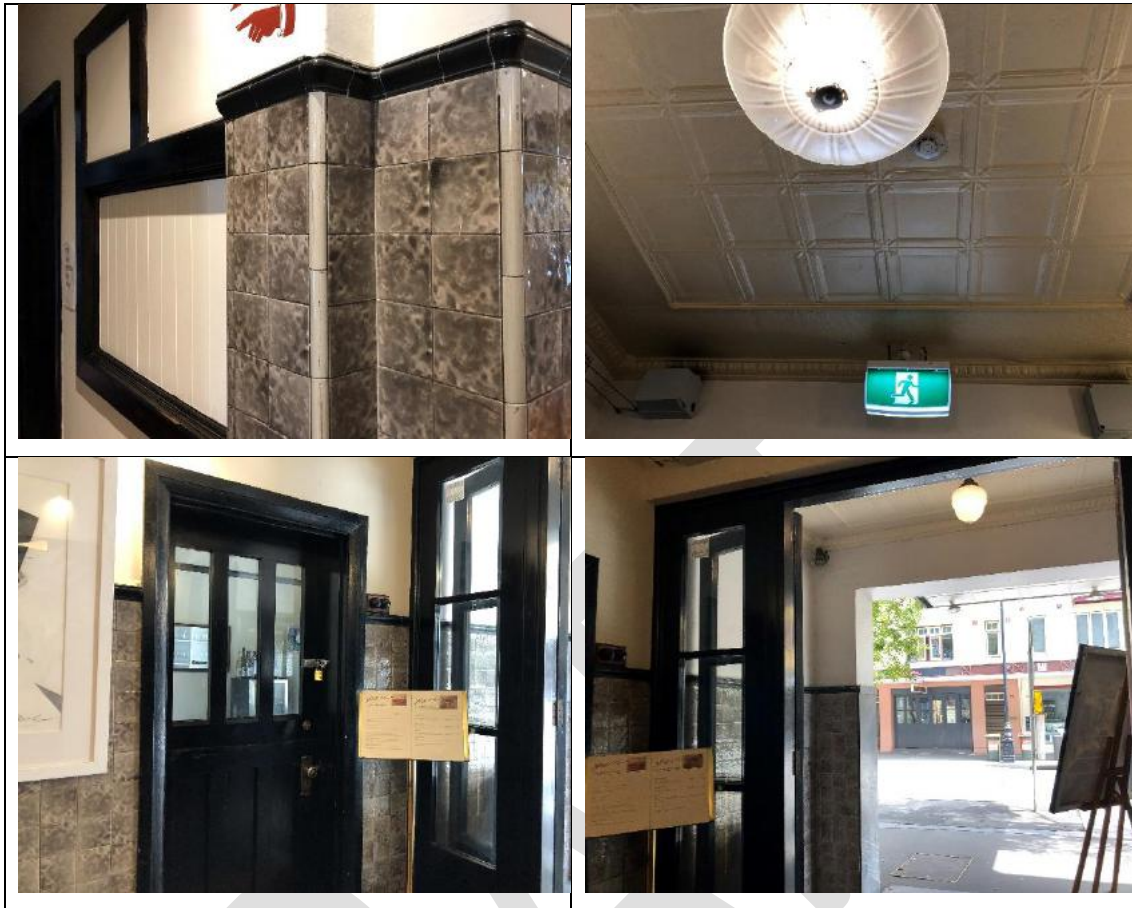
Figure 105: Features of the entry vestibule

The entry vestibule features a timber-panelled and glass door into a separate lobby and a stairwell. (The entry and door originally provided separate access to the Superintendent's Quarters on the second floor). The entry vestibule also contains a passage which extends from the northern side of the vestibule and connects to the 1920s, northern portion of the 1920s wing. The space has been refurbished and is simply finished with vinyl flooring, rendered walls and plasterboard ceiling, all added during the 1990s works to the building. A later lift was also added in the 1990s and is located on the western side of this passage. It features contemporary linings including timber veneer cladding to the walls and timber handrail. The eastern side of the corridor features a small storeroom and former 'cubicle.'

To the south of the entry vestibule is a concrete access stair which was added during the 1920s. It is simply detailed and remains unpainted, featuring a simple pipe rail handrail. It continues up to the roof level and is bounded by rendered walls with a painted dado. The southern wall of the entry vestibule also features two original door openings to former office spaces which feature vinyl flooring and pressed metal ceilings.

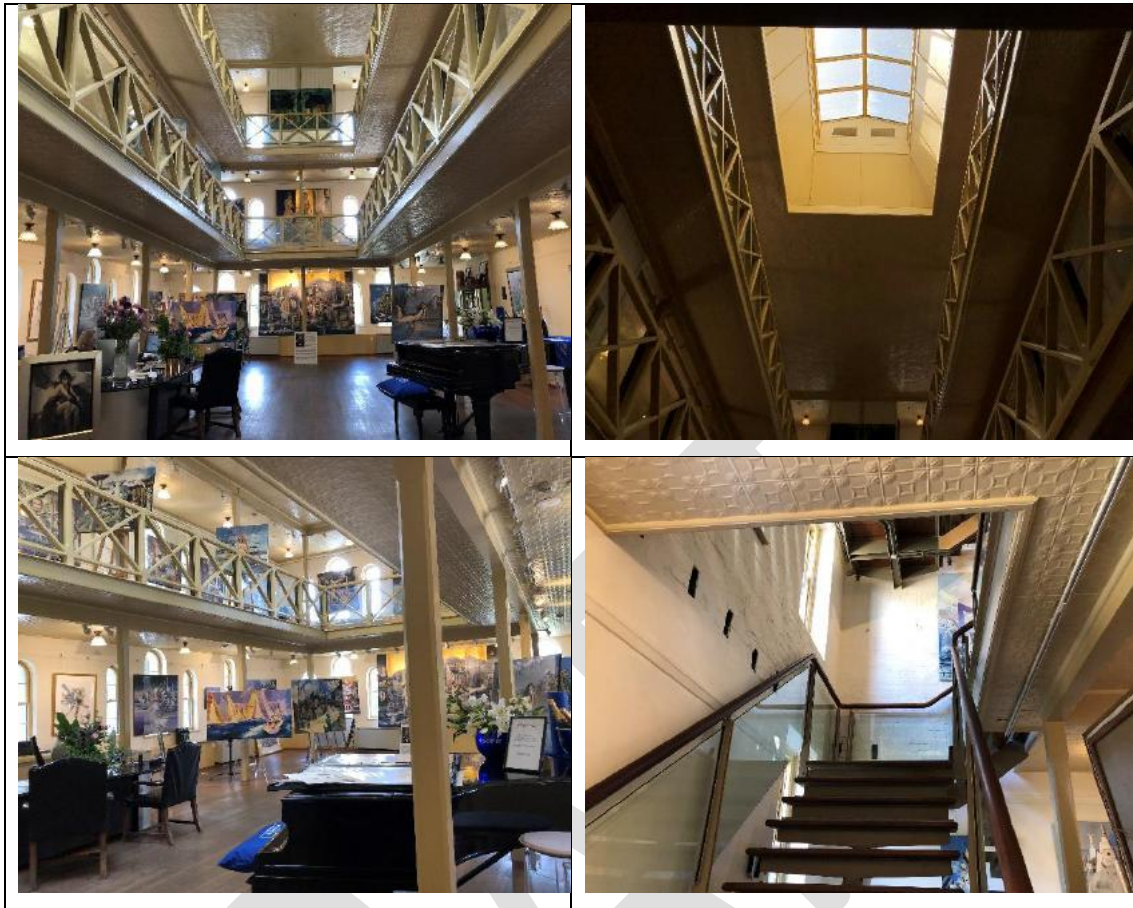
Figure 106: Features of the ground level of the 1860s wing.

An opening connects the entry vestibule to the former 'Main Hall' space which occupies the ground floor of the 1860s wing. It currently contains the publicly accessible art exhibition space for the Billich Gallery. This original 1860s opening was enlarged when the 1920s addition was constructed. The timber post and beam structure and pressed metal ceiling were reconstructed as part of the 1990s conservation works to the building.

The main space contains an atrium which rises to the very top of the 1860s wing. The ground floor level retains timber flooring throughout. However, the 1990s conversion works saw the reconstruction of the first floor mezzanine above, including the reinstatement of the timber post and beam supports and pressed metal ceiling lining with reproduction light fittings to the underside of the mezzanine above. The original perimeter brick walls have been retained, but have been painted.

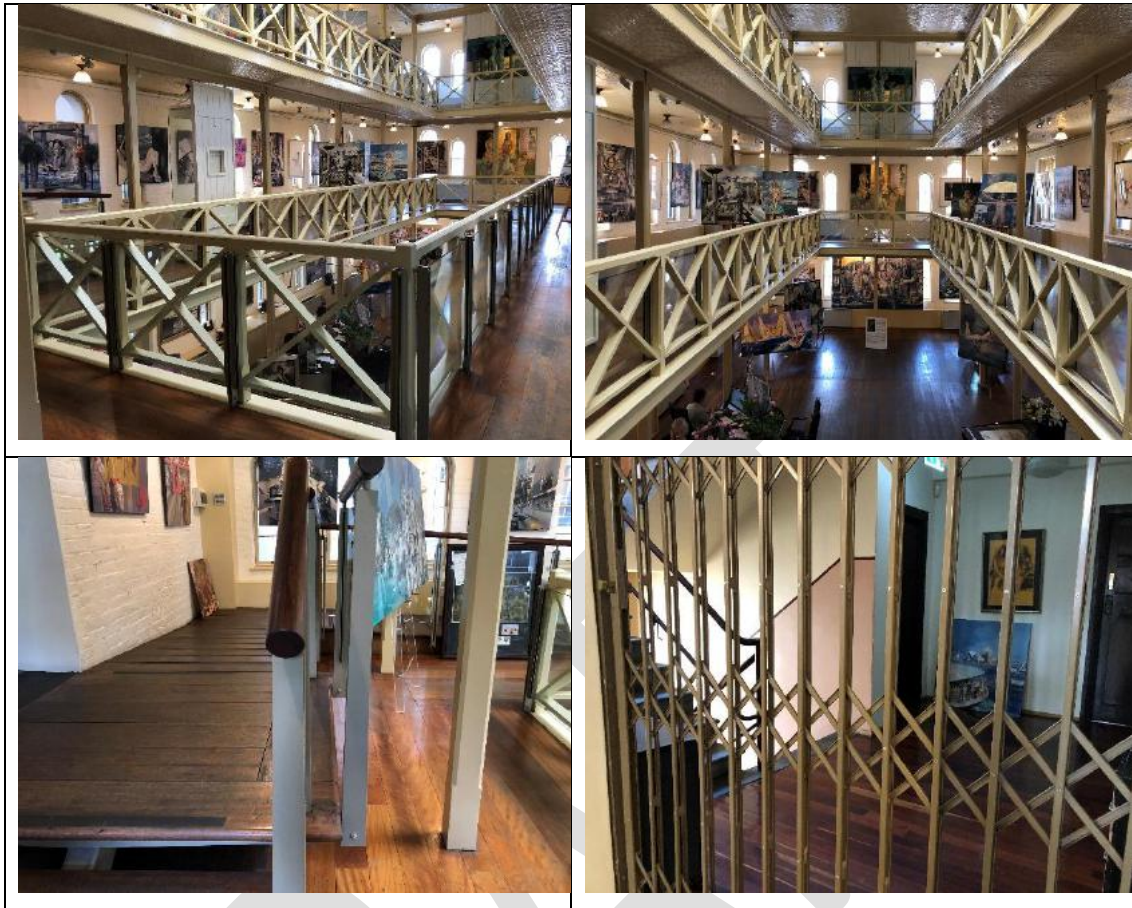
Figure 107: Features of the first level of the 1860s wing.

The upper galleries overlook the ground floor and are bounded by simple timber balustrades, which have been supplemented by later steel and glass balustrades added as part of the 1990s works. These upper galleries are accessed via a later stair located in the southwest corner of the main hall space, which was also added as part of the 1990s works to the building. This stair interprets the location of the original 1860s stair. It is constructed of steel and features open risers with timber treads and glass balustrade with timber handrail. The stairwell features joist holes at the first and second gallery level.

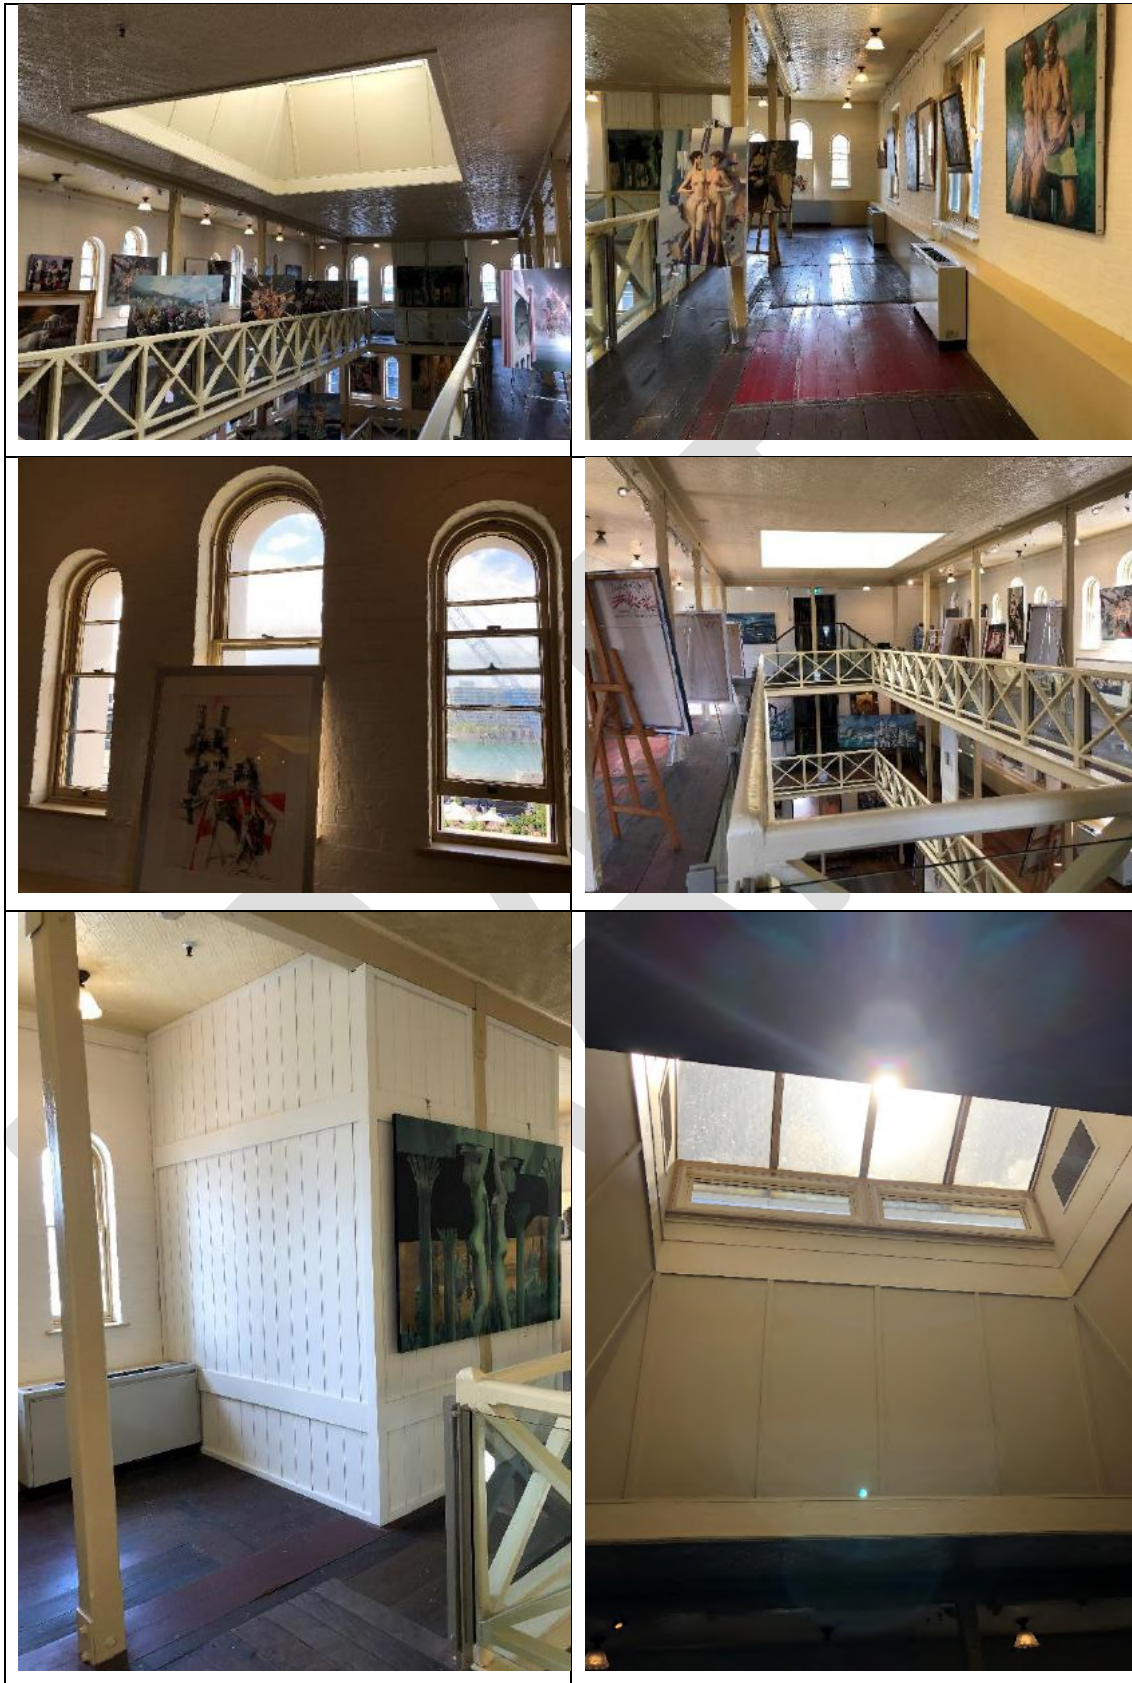
Figure 108: Features of the second level of the 1860s wing.

The second floor mezzanine balcony, (unlike the first floor mezzanine balcony), retains, sections of early timber flooring and original timber joinery and details. Along the eastern wall of the second floor mezzanine balcony space is a small storage space which was added as part of the 1990s works to the building. It interprets the original layout and configuration of 'cubicle' accommodation which would have been located throughout the gallery levels. The early flooring on the second level retains evidence of the size and configuration of the 'cubicle' accommodation. In particular, the flooring indicates that five cubicles would have existed along the eastern wall and eight down each length.

A central clerestory skylight provides natural light to the spaces below. It is believed to have been reconfigured during the 1920s additions to the site. It was refurbished as part of the 1990s works to the building.

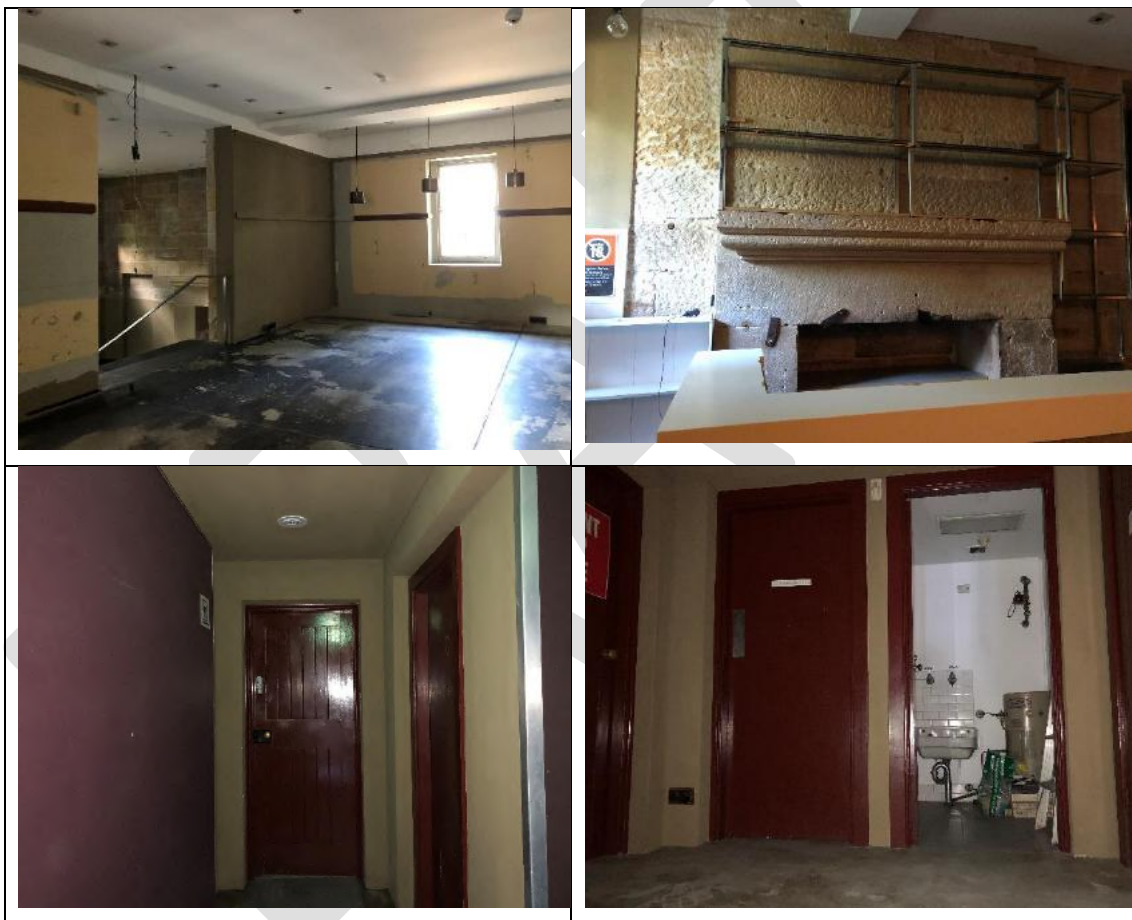
Figure 109: Features of the basement level of the 1860s wing.

The basement level of the original 1860s wing is currently vacant but contains later kitchen and bathroom fitouts associated with the former use of the space as a restaurant. The basement level generally retains evidence of the original three primary spaces and evidence of the various phases of development.

The central room, which is currently vacant, contains a later kitchen and bar fitout with a polished concrete floor, rendered walls and plasterboard ceiling with contemporary and surface mounted services. The floor level of the central basement space was raised as part of the 1920s works. The southern wall also features a separate entry from the sandstone stair and landing south of the building. The opening contains both a timber panelled and a contemporary glass door. This central space retains the original stone hearth and breast along the southwest wall and remnant ceramic wall tiles which relate to its later use as a kitchen. The bar dates from the 1990s fitout.

Passages from the main space lead through to a portion of the 1920s building and contain finishes and fittings, including bathroom fitouts, dating from the 1990s fitout. The sandstone walls and fireplace, are original features which have been retained.

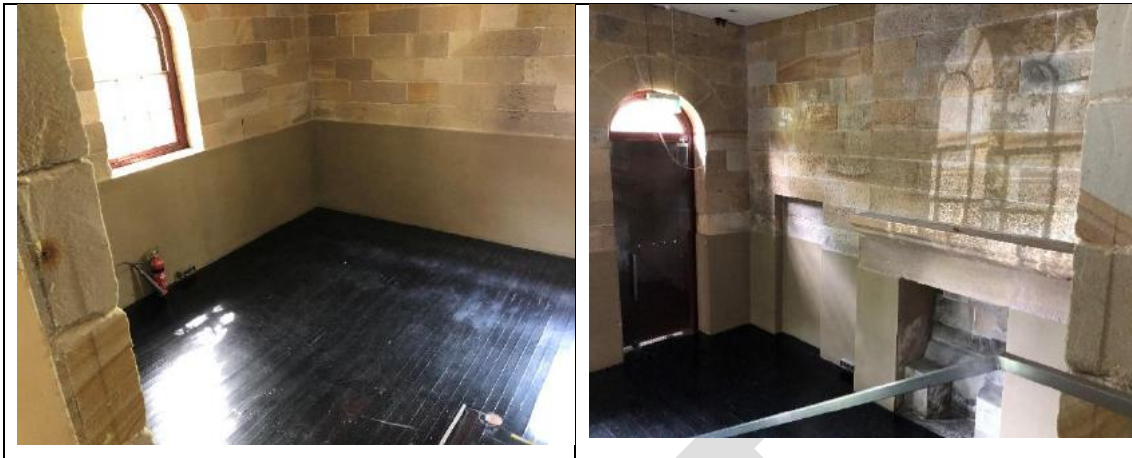
Figure 110: Features of the basement level, former 'Native's Dorm' of the 1860s wing.

The former 'Native's Dorm' is vacant but is believed to have been last used as a restaurant dining area. It is set below the level of the central basement rooms and is accessed via a later stair. This space features polished timber floorboards, face stone walls and plasterboard ceiling. A rendered dado has been added to the base of the wall at a later stage. The southeast section of the basement features a stone hearth and chimney breast and blind recess on the southern wall. An arched door opening featuring a tall, timber panelled door and fanlight is located along the eastern wall.

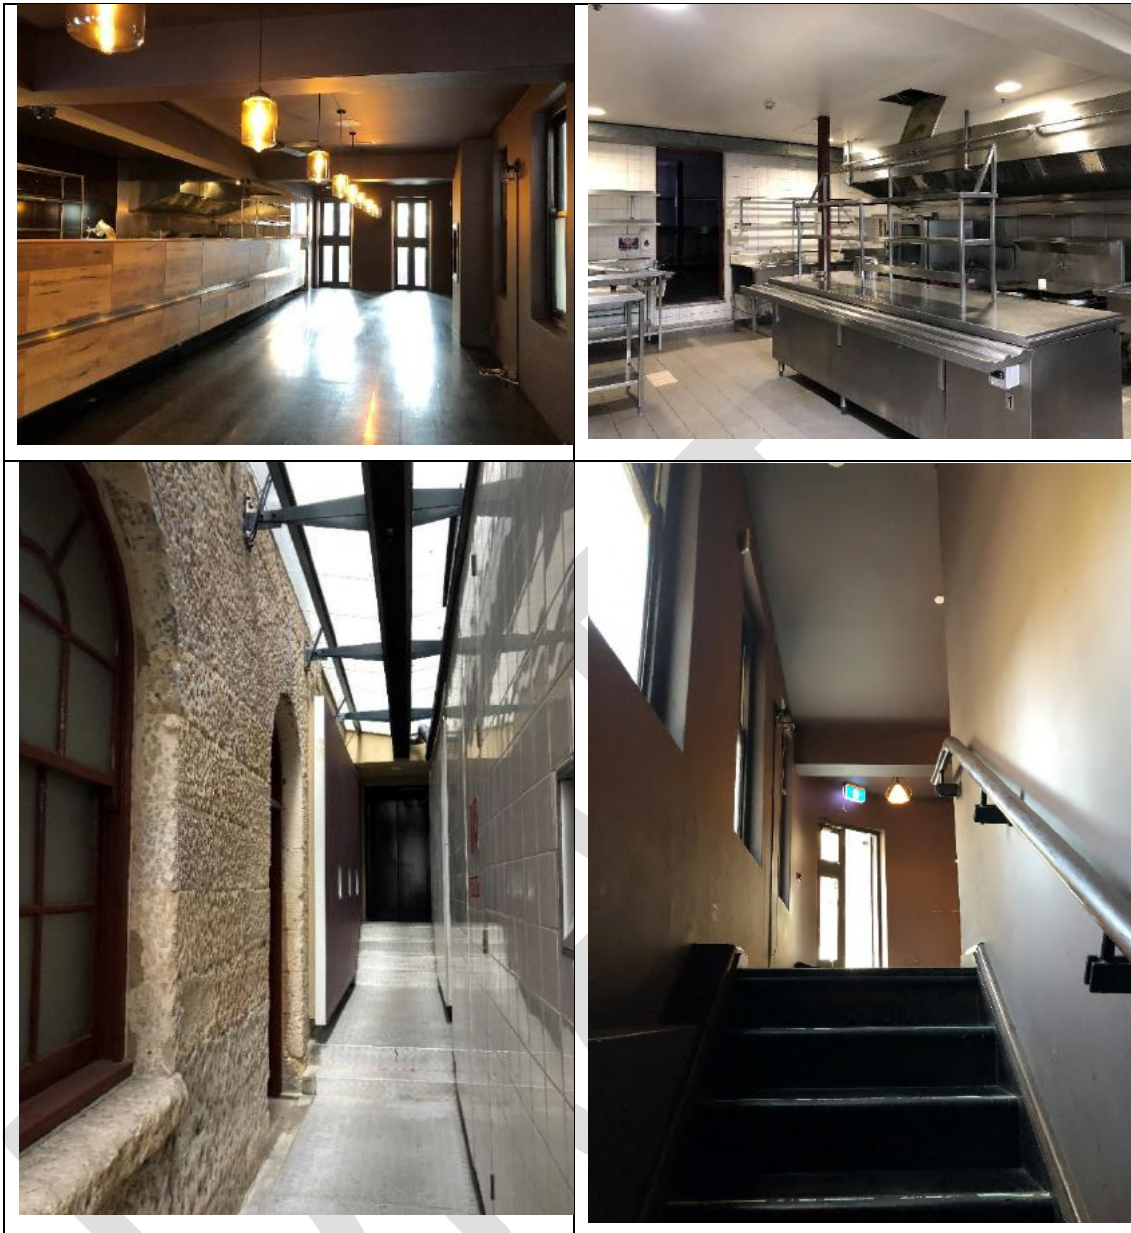
Figure 111: Features of the basement level of the 1920s wing.

A passage containing a steel 'checker plate' floor finish and light well separates the two wings at basement level. The sandstone façade and openings of the original 1860s portion of the building remain. A later steel-framed glass roof connects the original portion of the building to the northern section of the 1920s wing. Another passage runs perpendicular to this space and connects the various storerooms, amenities and office space occupying the western end of the basement level, which contain later finishes and fixtures associated with the 1990s restaurant fitout.

A simple later timber stair and rail wraps around the later lift well and connects the basement level to the ground level of the northern portion of the 1920s wing. The ground level can also be accessed via a door along the curved portion of the George Street façade, close to the northwest corner of the building. The internal ground floor space generally features polished timber floors, rendered walls and plasterboard ceiling. A later kitchen/bar fitout occupies the northern wall and contains later fixtures and fittings. Two pairs of French doors at the eastern end of the space provide access to an outdoor area and timber verandah reinstated as part of the 1990s works to the building.

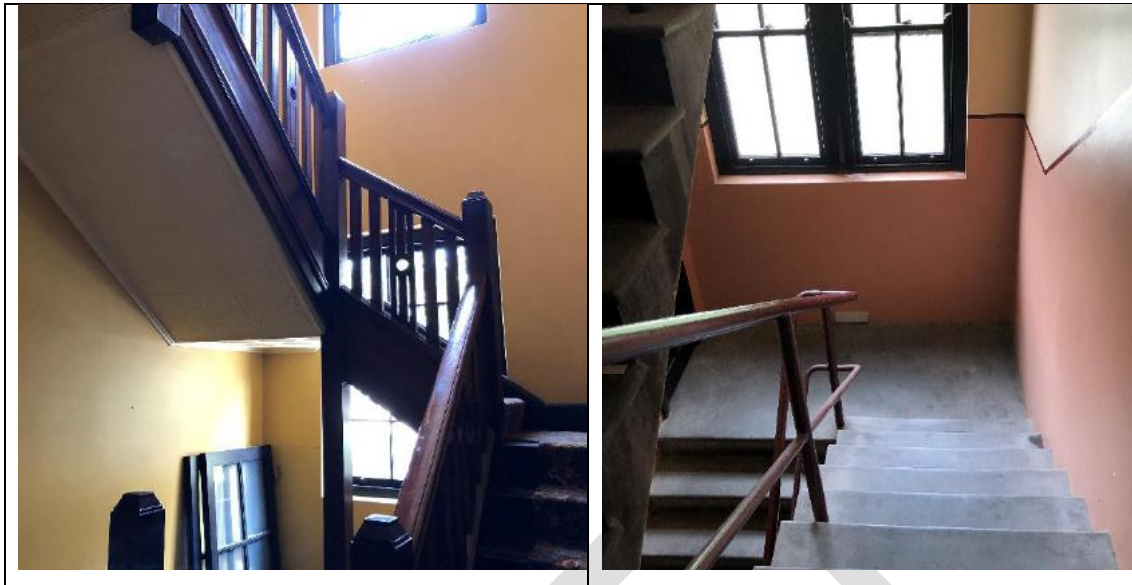
Figure 112: Features of the timber (left) and concrete (right) stairs.

The ground level is connected to the upper floors of the 1926 wing via two stairwells which connect to a shared landing at each of the upper floor levels. The first stairwell is located along the western side of the building. It features a terrazzo floor finish, rendered walls, timber joinery, pressed metal ceilings and a timber stair which features a timber balustrade and newel posts and pressed metal soffit. The second stairwell, primary used as a fire stair, is located along the southern side of the building. It also extends up through to the upper levels of the building, and is in contrast to the more elaborate timber stair, comprising concrete treads and risers.

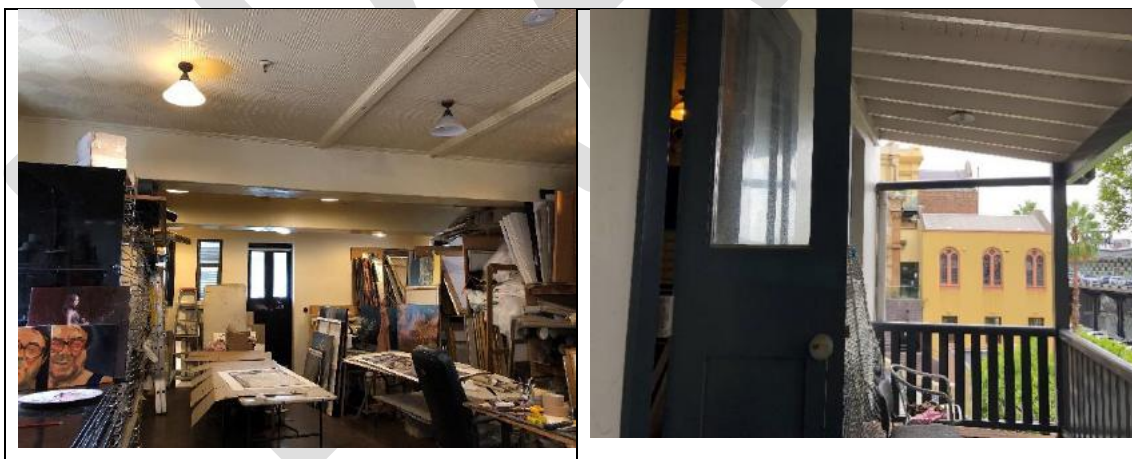
Figure 113: Features of the first floor of the 1920s wing.

The first floor comprises the private spaces, offices and storage areas associated with the Billich Gallery. A former, single cubicle to the north of the stair landing was converted to bathrooms as part of the 1990s works. Another former single cubicle is located west of the first floor landing and is now used as a storage room. It contains an earlier pressed metal ceiling, rendered walls, timber joinery and later carpeted floor. The landing leads through to a passageway which opens onto a large open room along the northern portion of the wing. The space generally features rendered walls, pressed metal ceilings and vinyl floor finish. No original joinery remains in this space, apart from the windows. This space leads through to a timber verandah along the eastern elevation, which was reconstructed as part of the 1990s works. The verandah structure comprises timber framing, timber flooring and a timber balustrade, with boarded soffit to the roof.
