Conservation Management Plan

Sailor's Home (former)

SHR No. 01576

106 – 108 George Street,
The Rocks

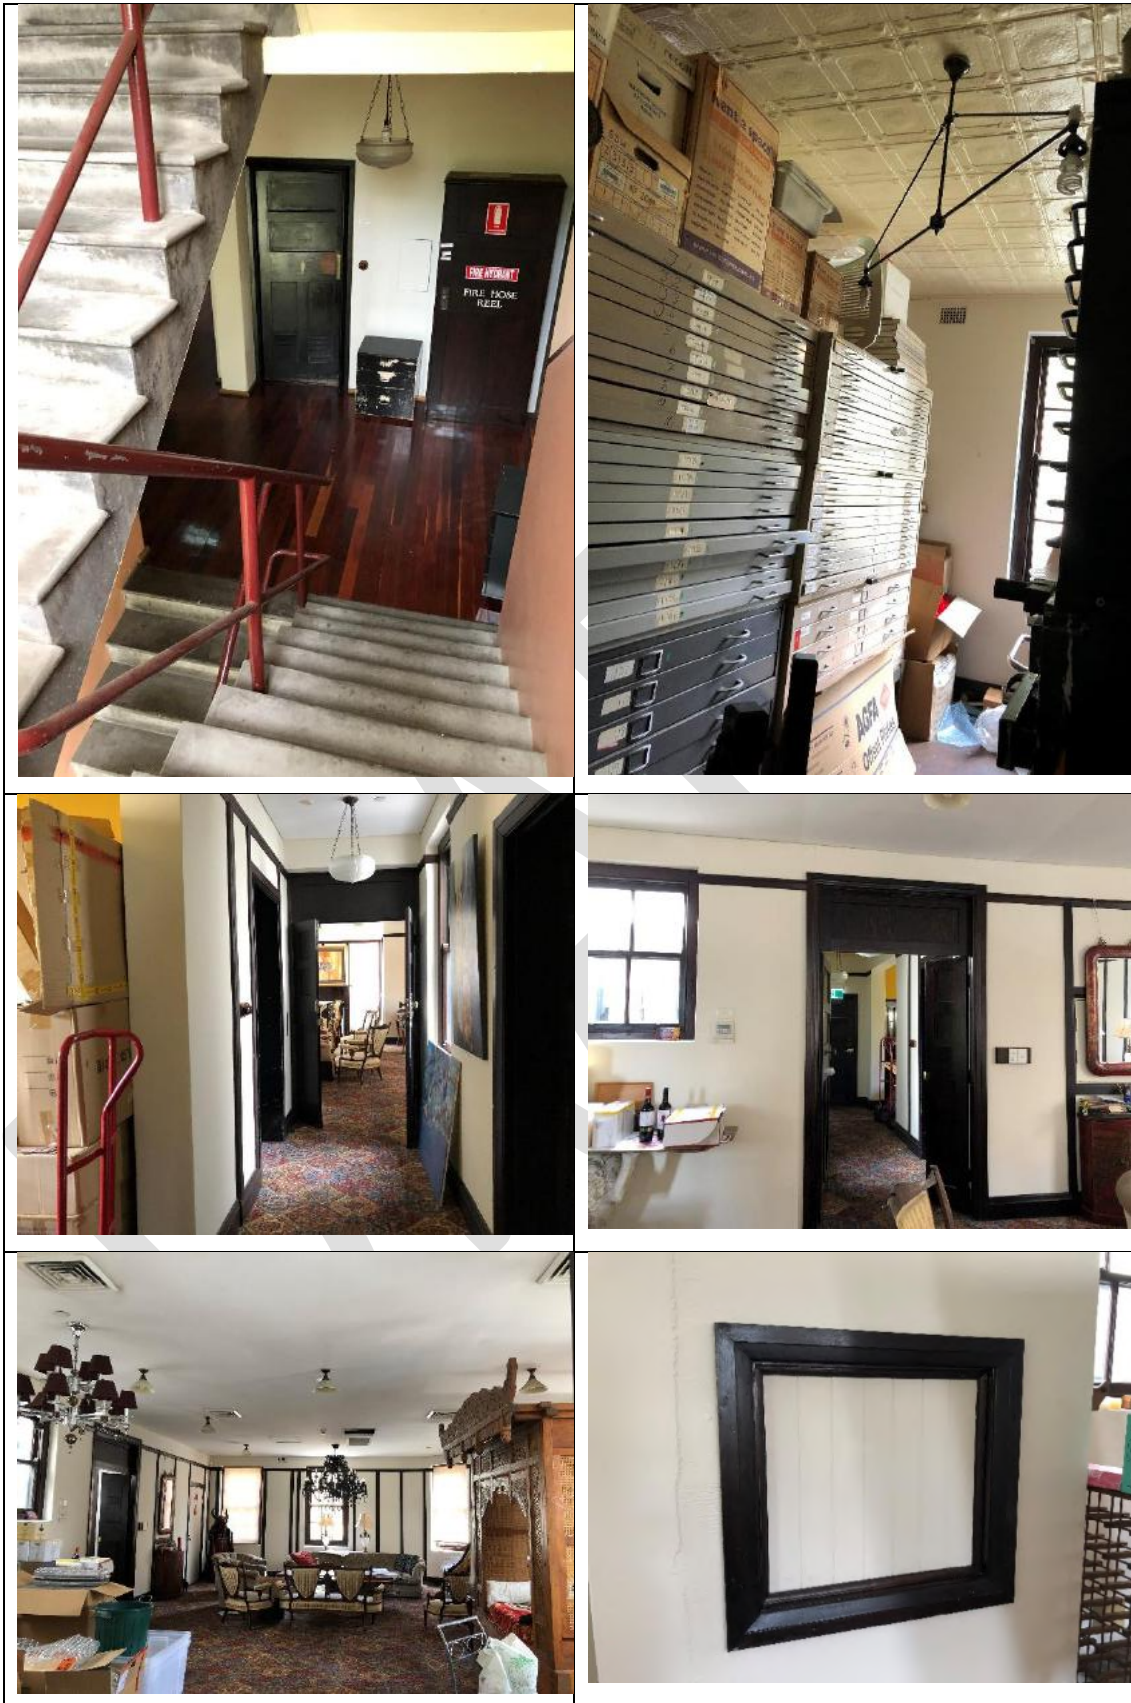
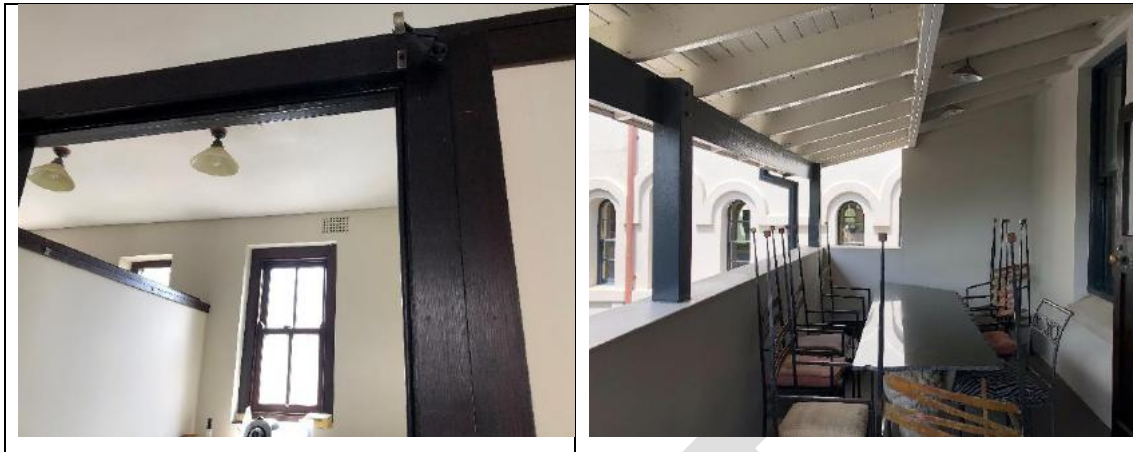
Figure 114: Features of the second floor of the 1920s wing.

The second floor landing features painted concrete and carpeted floor, rendered walls and timber joinery, including skirtings and architraves. A former cubicle located north of the landing has been converted to a male bathroom at a later date, containing contemporary fixtures and fittings. Like the first floor, the main second floor space has also been kept relatively open, apart from a few later partitions. This open space, like the first floor, contains later floor finishes, rendered walls and plasterboard ceiling. A later kitchenette is located towards the northeast corner of the room. The second floor verandah is located at the eastern end of the 1926 wing and features timber floor and a timber framed roof supported by simple timber posts and a solid, rendered balustrade.

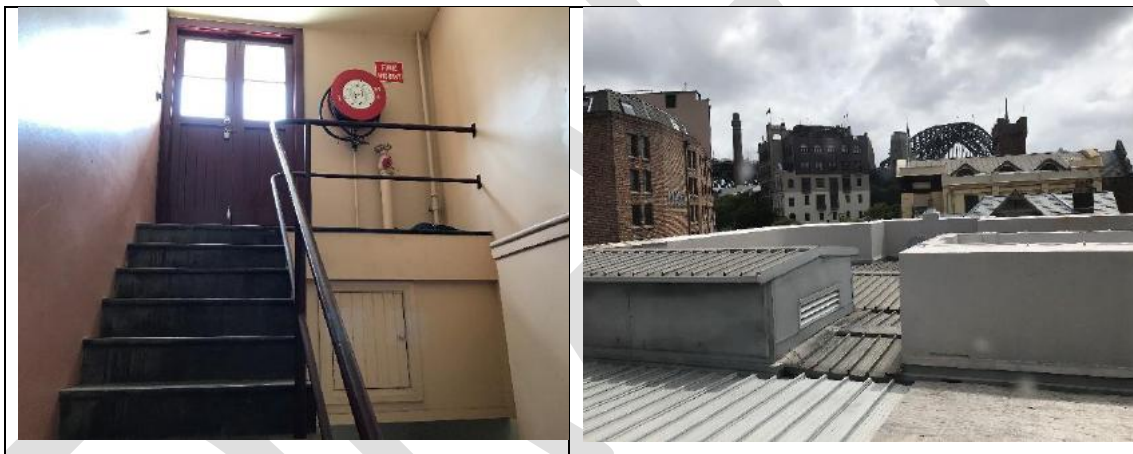
Figure 115: Features of the the roof level.

From the second floor landing, the secondary fire stair extends to the roof level, which can be accessed from the stairwell via a set of timber doors. The roof sheeting was added as part of the 1990s works to the building. The skylight over the 1860s portion of the building is visible from this location. Distant views of the Sydney Harbour Bridge and Sydney Opera House can be seen from this location.

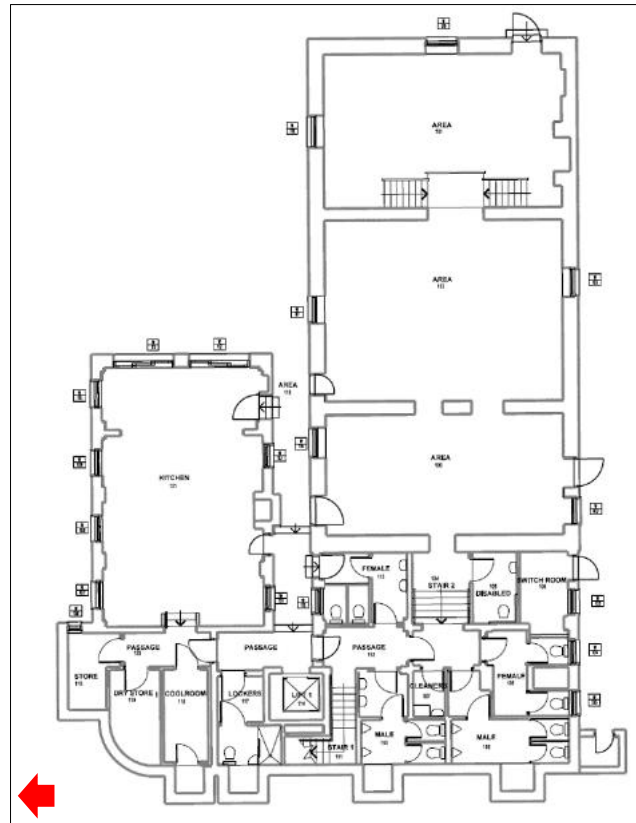
Figure 116: Basement Level Plan (Source: Planning & Infrastructure Sydney Harbour Foreshore Authority, 2012)

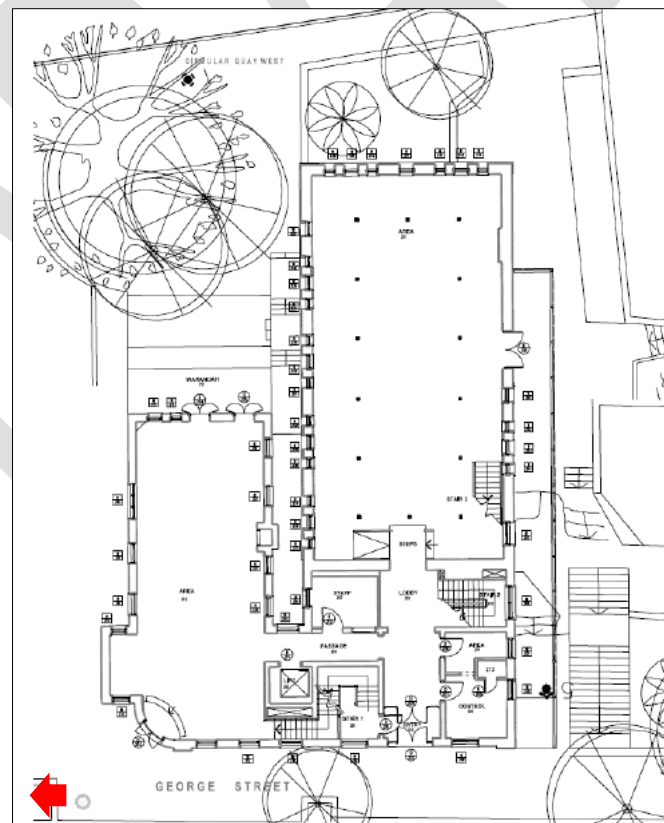
Figure 117: Ground Level Plan (Source: Planning & Infrastructure Sydney Harbour Foreshore Authority, 2012)

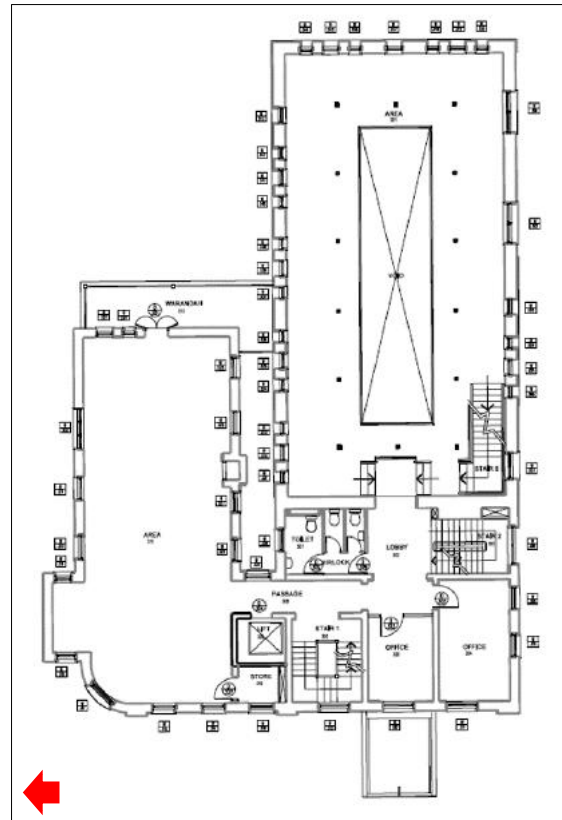
Figure 118: First Level Plan (Source: Planning & Infrastructure Sydney Harbour Foreshore Authority, 2012)

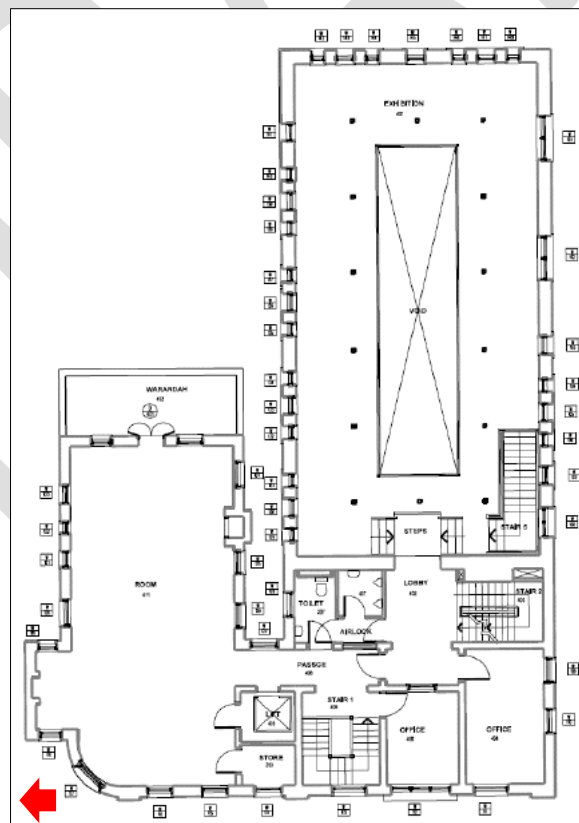
Figure 119: Second Level Plan (Source: Planning & Infrastructure Sydney Harbour Foreshore Authority, 2012)

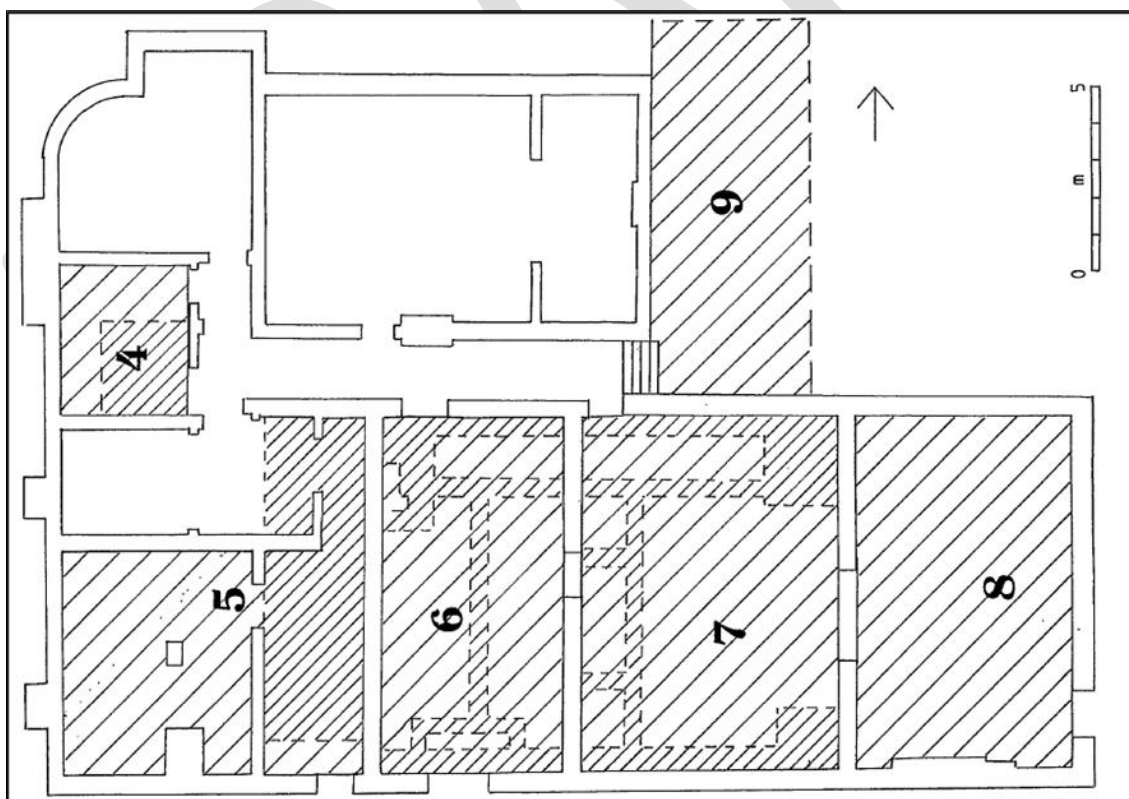
Figure 121: Monitored areas (Godden Mackay Pty Ltd, 1992, p. 34)

Additional monitoring work was undertaken for six more trenches (figure below), labelled as trenches 4-9 (Godden Mackay Pty Ltd 1992, p.17). The results of this found evidence of six phases of development that stretched from pre-1788 – 1991 (the time of the work being completed) (Godden Mackay Pty Ltd 1992, p.35). The first two phases were represented by bedrock and early loam deposit. The third phase was related to the use of the site as a government dockyard (between 1804-1847). The fourth phase was from the Water Police era (1847-1863) and the fourth phase was from the earliest use of the site from the SSH (c.1863-1926). The fifth phase related to the use of the site by the SSH after the significant modifications (1925-1991) and the sixth and final recorded phase was the use of the site as the Marionette theatre, from 1991 onwards.

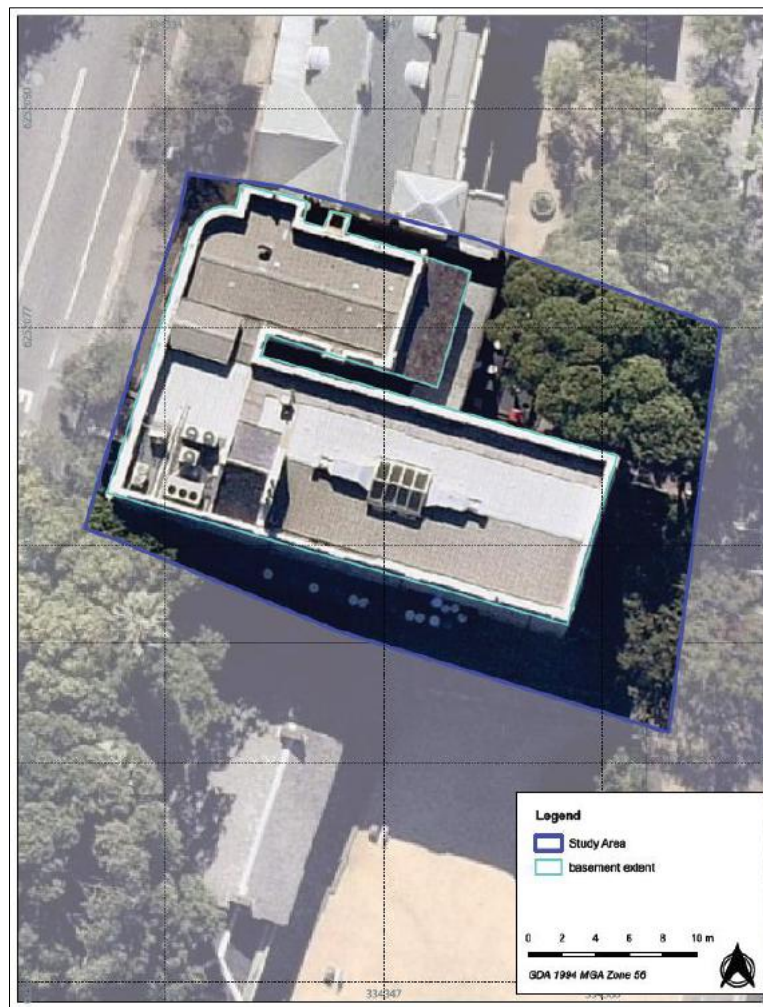
Figure 122: Extent of basement within the study area (Source: Austral Archaeology).

- There is low archaeological potential for the area below the original wing of the Sailor's Home (former) due to the presence of basements and the disturbance that the construction of the building would have caused for the site.

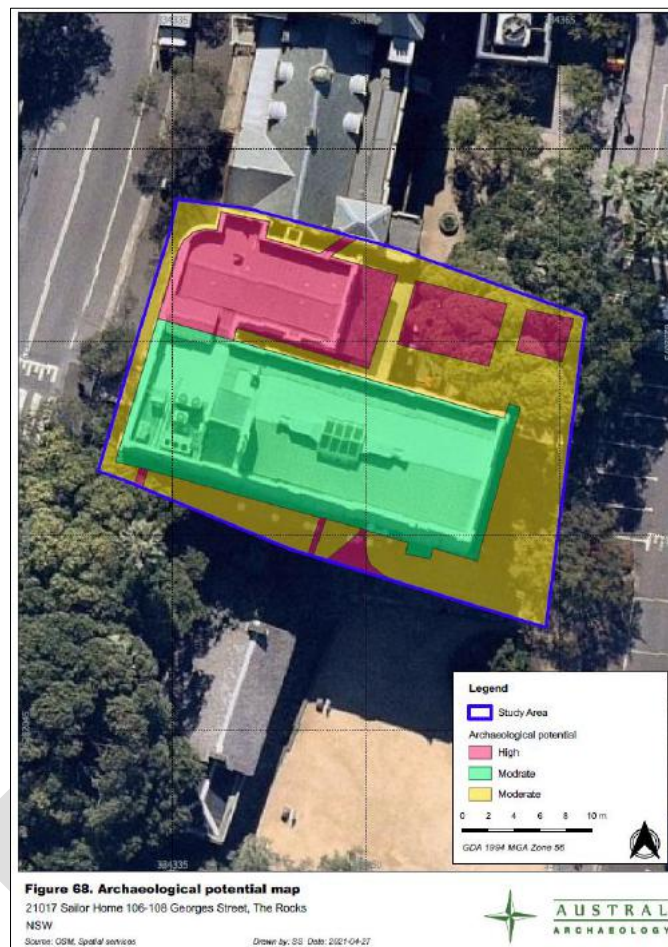
Figure 123: Archaeological potential evident within the study area

- The majority of the site is considered to have at least moderate archaeological potential for deposits of State significance. The site should be subject to further testing and monitored by a qualified archaeologist who meets the Heritage NSW Excavation Director Requirements to disturb relics on an SHR listed site during any ground disturbance following the NSW Heritage Act 1977 archaeological provisions;
- There is a high potential for the remains of the retaining wall of the Water Police compound and the associated wharf to be located on the site.
- There is a high potential for evidence of either of the two 1920s ablutions block to be located on the site. There is moderate potential for deposits and other subsurface features to be located in the area surrounding the site.

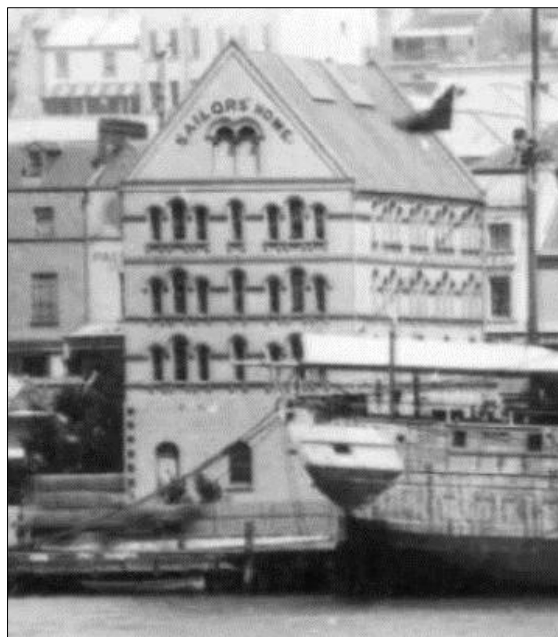
Figure 124: Photograph of the original wing of the Sydney Sailor's Home (former) c. 1892. The original nature and form followed English models. (Source: SHFA CQ23)

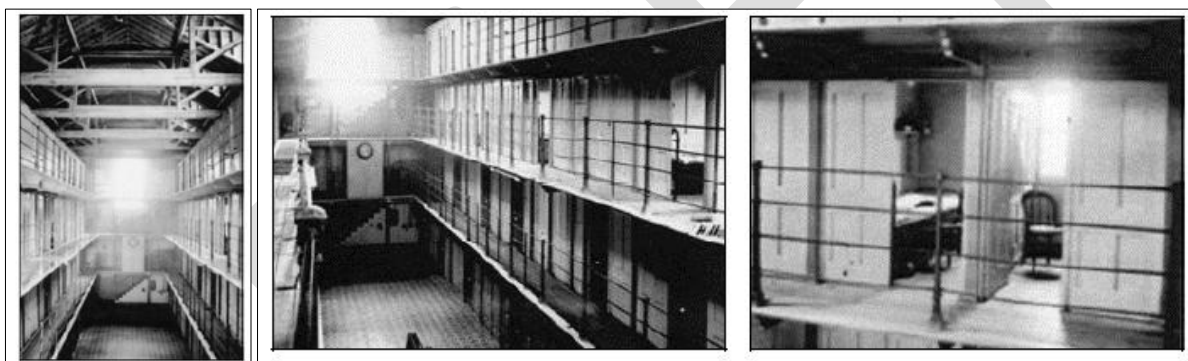
Figure 125: The London Sailor's Home (former) in Wells Street opened in 1835 may have also been a model for the Sydney Sailor's Home. The building interior exhibits the same form with gabled roof and layout with galleries about a central void and a number "berths" or cabins on each floor. (Source: www.portcities.org.uk)

The interior of the London Sailor's Home (former) also comprises of gallery spaces about a central void. Each gallery containing a number of "berths."

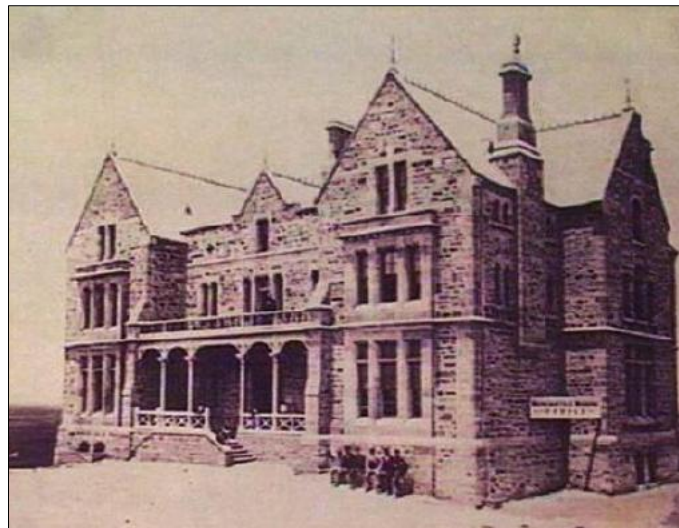
Figure 126: The Prince Alfred Sailor's Home (former), c. 1878 with two gable end wings framing the central bay and storey verandah. (Source: Picture Australia: SLISA: Mortlock Pictorial Collection B 10737)

The most "similar" to the SSH in terms of form was the Home constructed in Port Adelaide. An image of the building dating c.1878, (figure below, assumed to have been taken on completion of the building) shows the building with its prominent gabled roof form. The overall style resembles Kemp's original scheme for the Sydney Home, although is a much smaller in scale. Constructed of stone the building was subsequently altered and possibly enlarged. A photograph taken in October 1932 (shown below), on the eve of its demolition, shows that a roof had been added to the second storey verandah.

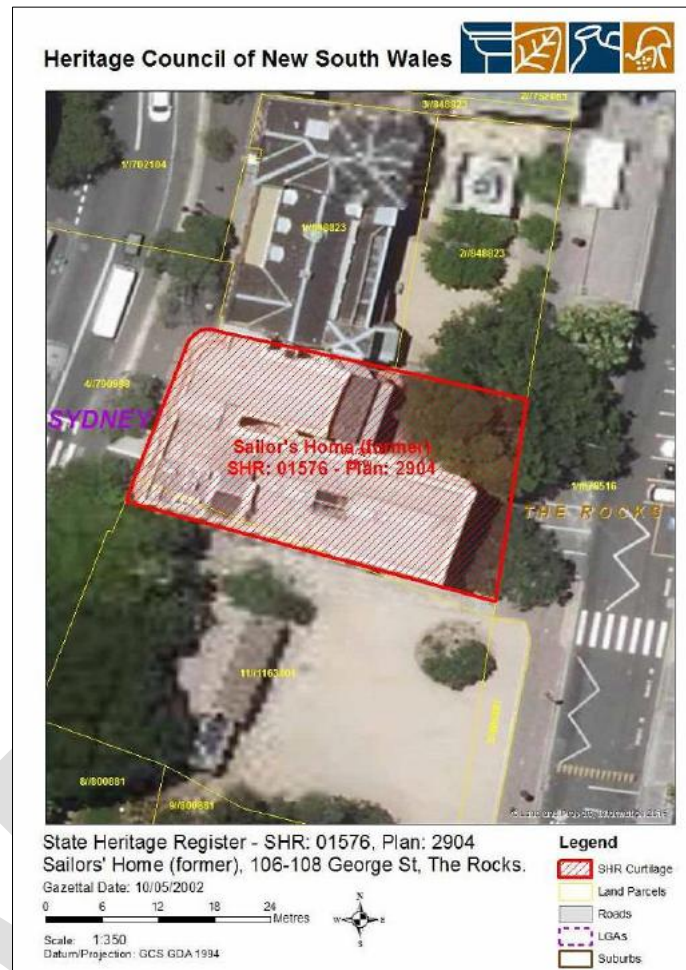
Figure 130: The State Heritage Register listing boundary plan. (Source: Heritage Council of NSW, SHR Plan Number 2904)

The heritage curtilage which applies to the Sailor's Home (former) is its lot boundary curtilage, noting that this is the gazette curtilage and has not been changed as part of the 2021 CMP update.

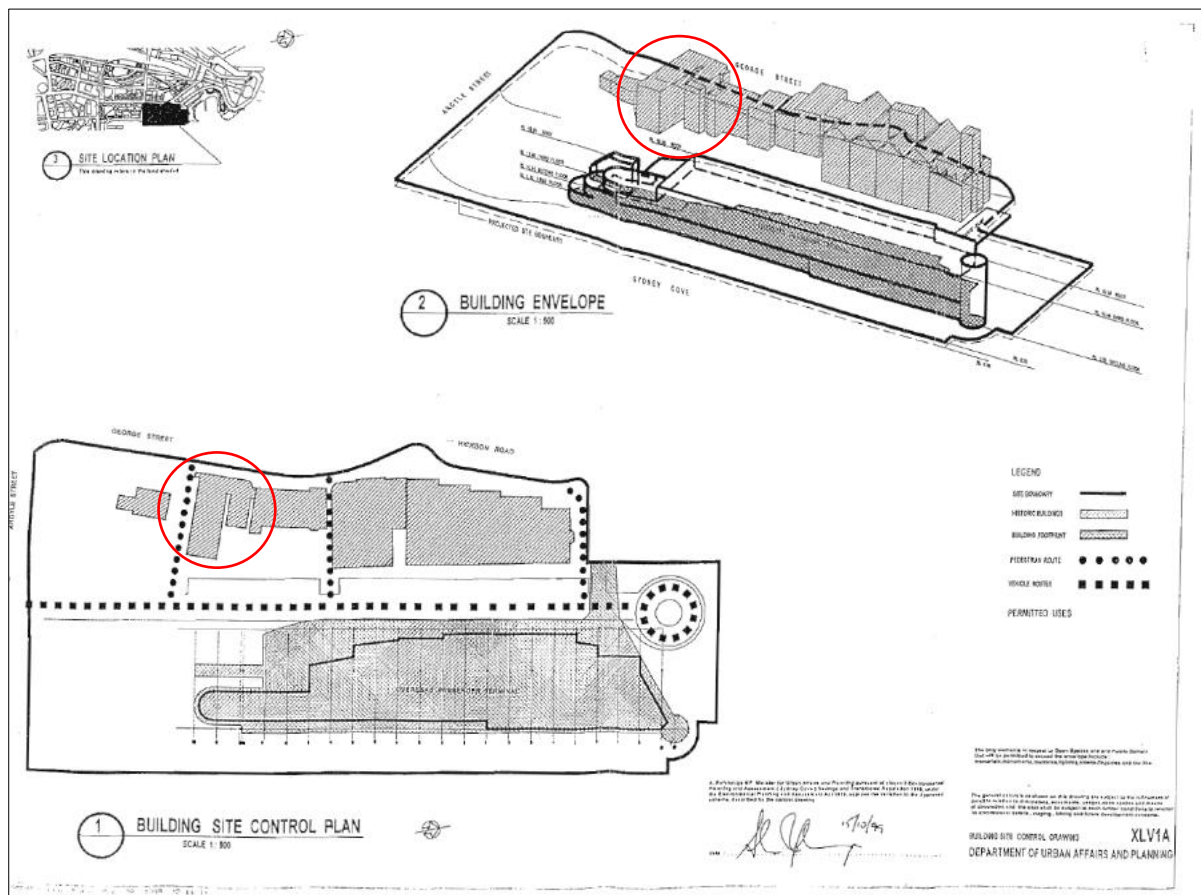
Figure 140: SCRA Building Site Control Drawing 'XLV1A' showing the building envelope circled in red. (Source: City of Sydney)
