73 George Street, The Rocks
Conservation Management Plan

2008

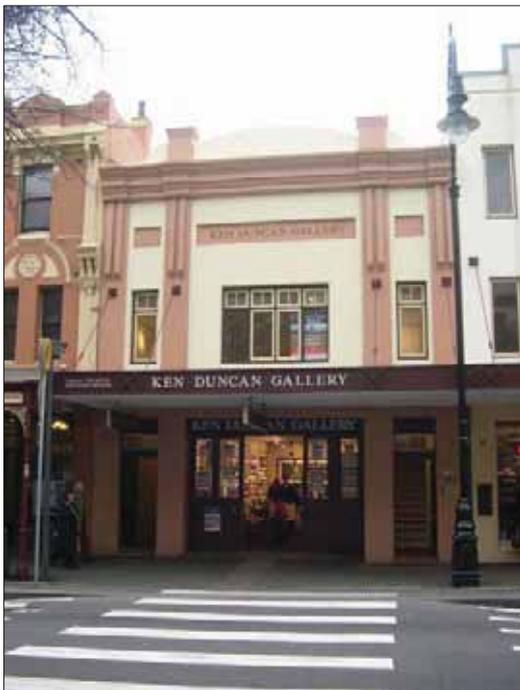
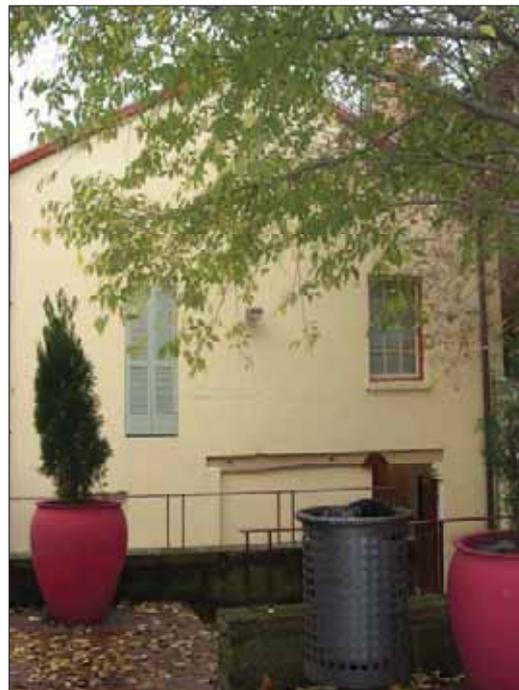
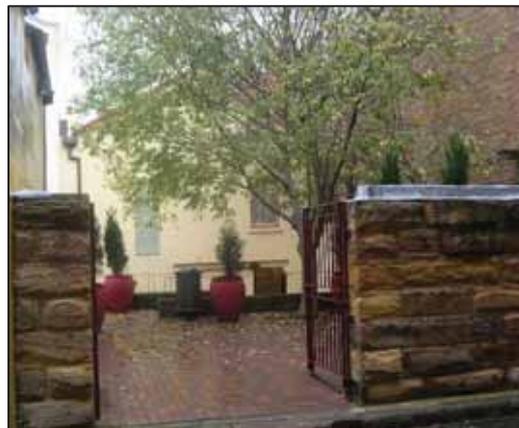
Figure 1-4: Front elevation of Ken Duncan Gallery at 73 George Street (above left); the rear elevation of the Gallery (above right); and the rear view of the site from Kendall Lane (right)

rendered and painted and features three bays articulation both vertically and horizontally. The ground floor and first floor openings are relatively similar in terms of their vertical proportions and symmetry on both sides of the wide central bay. The main gallery is located on the central bay of the ground floor of the shop and accessed via a six-panel folding timber doors. The side bays accessed via eight-pane timber doors with transoms above. The northern bay opens directly to a new stair accessing the upper floor of the Gallery while the southern bay opens to a tiled public access way linking George Street to the rear courtyard and Kendall Lane.

The first floor facade features a four-panel casement window to the central bay and single panel casement windows to the side bays all with multi-pane transoms. The third horizontal bay to the top incorporates simple moulded pilasters emphasising the vertical divisions and extending in wider form and more decorated form to the parapet level. Horizontally placed and recessed business/date plates reflect the proportions of the upper floor windows and the ground floor main central entrance. The central plate depicts the name of the shop 'Ken Duncan Gallery'. A strong moulded cornice dominates the skyline of the building and divides the curvilinear parapet from the main building facade. A suspended awning provides continuity along the footpath.

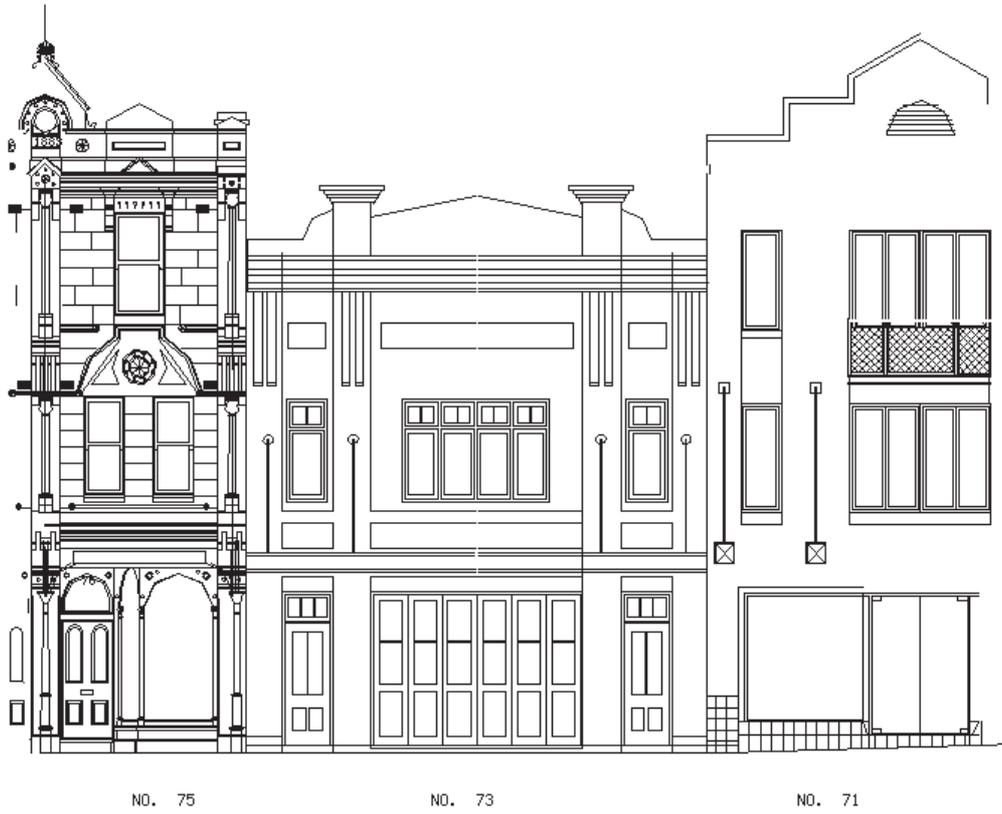
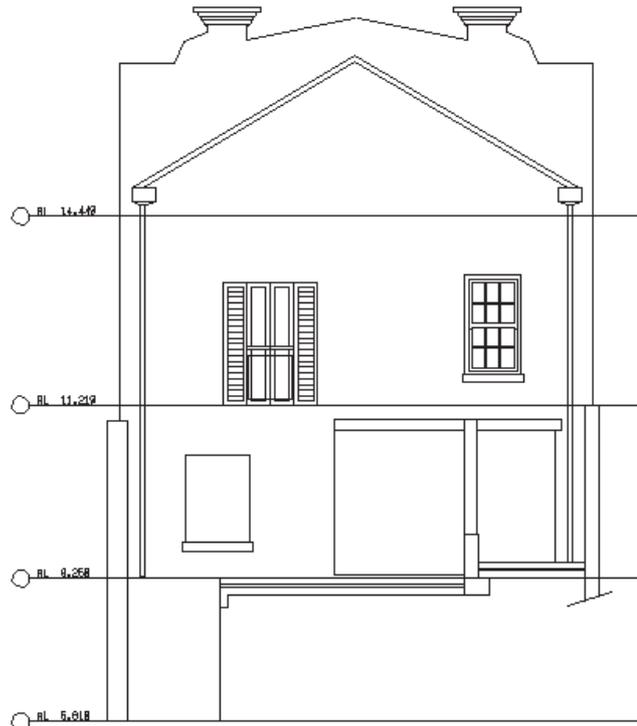
Figure 1-5: Front and rear elevations of 73 George Street, The Rocks
(Source: Sydney Harbour Foreshore Authority, ROX-468-AR-1000, 14.12.2004)

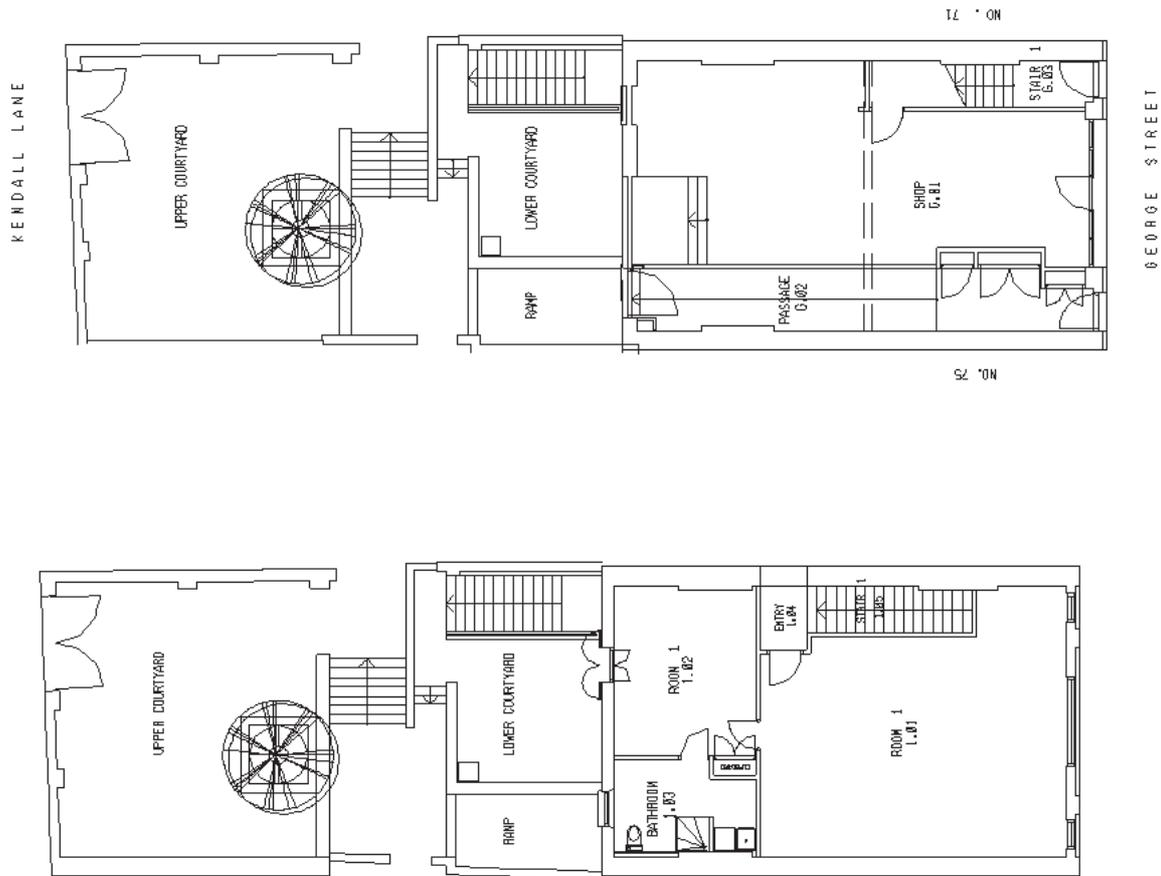
Figure 1-6: Ground and First Floor Plans of 73 George Street, The Rocks
(Source: Sydney Harbour Foreshore Authority, ROX-468-AR-1000, 14.12.2004)

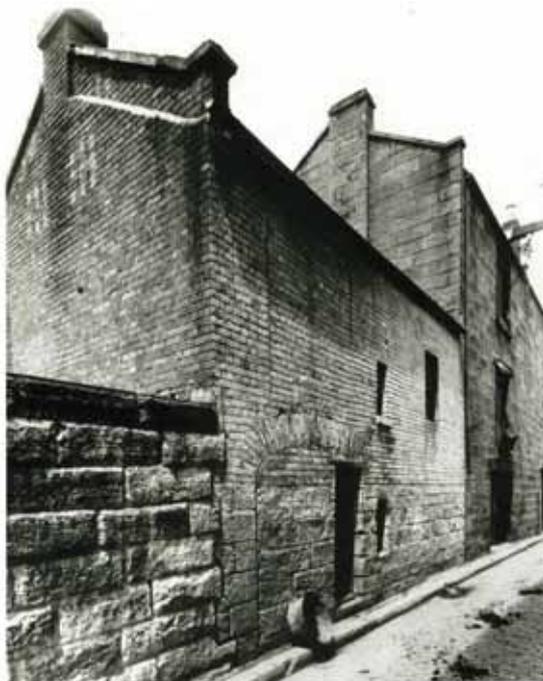
Figure 2-5: View of Kendall Lane, c.1901, showing rear sandstone wall of the subject site at 73 George Street (at the foreground), with Sampson's cottage adjoining the wall and part of Unwin's stores in the background. (Source – The Foreshore Authority, DWX No: 32943, KL3, Samsons Cottage and adjacent warehouse, Kendall Lane, c.1901, SAO COD 121B)

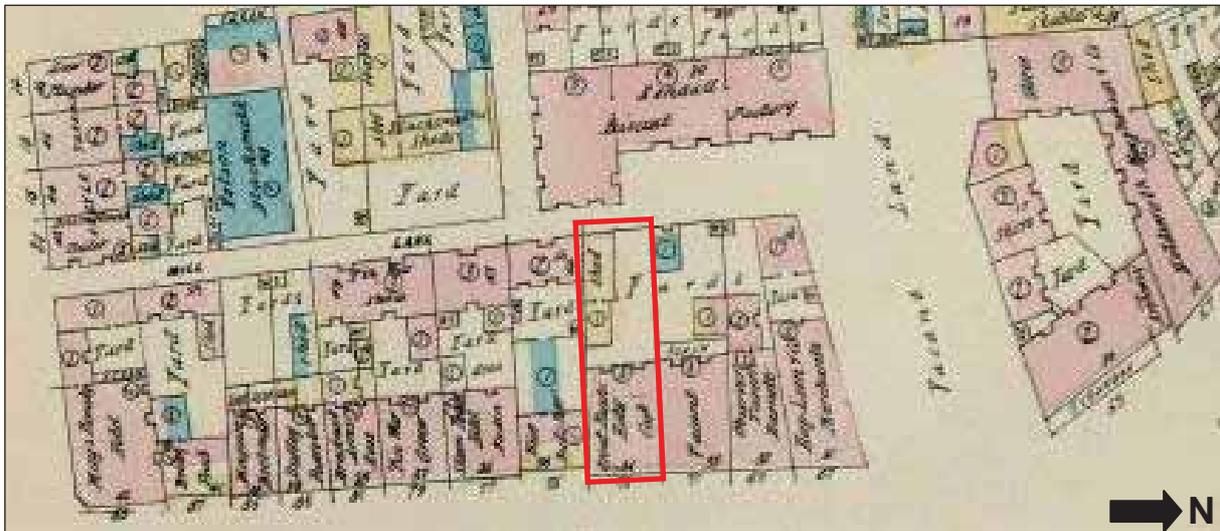
**Figure 2-10: A plan of the buildings in the area, from the survey made by Percy Dove, 1880.
(Source – City of Sydney Council Archives)**

In 1852, Unwin was declared bankrupt and William Nicholson acquired these stores. Nicholson leased them to Berkelman and Bate in 1858, who operated the building as a steam flour mill until c.1860. In 1861, the Steam flour Mill was acquired by Lawrence Kendall who converted the building into "Kendall's Biscuit Factory" (See 1880 plan for location of the factory, Figure 2-10).

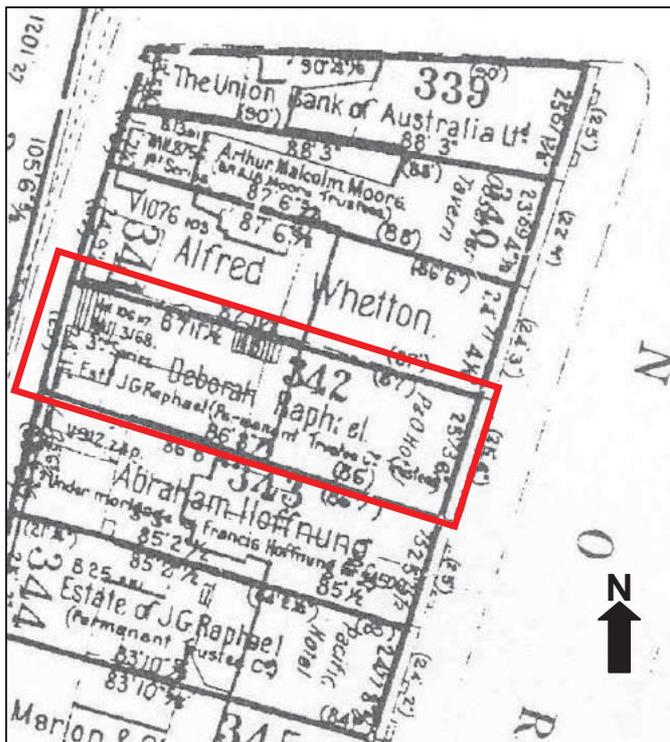
Figure 2-12: Part of the 1901 Resumption plan, with the subject site indicated. Note the layout of the building, with two sets of stairs. Darling Harbour Resumptions, Sections 85, 87, 88 and part 86 City of Sydney. (Source – City of Sydney Council Archives)

The historic curtilage, relevant to the historic theme of *Land Tenure* and *Commerce*, is the same as above. This curtilage is shown in the 1880s survey plan by Percy Dove and 1901 Darling Harbour Resumptions Plan for sections 85, 87, 88 and part 86 of City of Sydney (Figure 2-12).

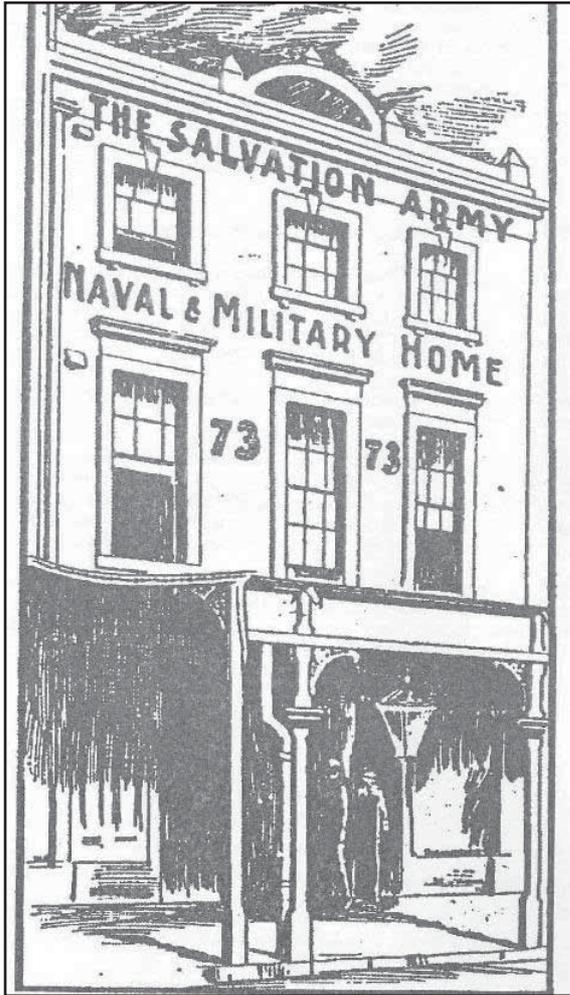
Figure 2-13: The Salvation Army Naval & Military Home, c.1914. Reproduced from the cover of the 1991 Conservation Plan for the subject site by David Sheedy Pty Ltd. This image also shows the original 1842 hotel's facade and footpath awning. (Source ML: *Records of S.A. War*, Melbourne, January 1914)

This information describing the conditions available for servicemen on leave sounds an appropriate description for the existing building and former public hotel at 73 George Street. The cover of the 1991 Conservation Plan for 73 George Street, The Rocks portrayed the building during that phase with a picture from a 1914 history of the Salvation Army. This was the only image documented for this phase.

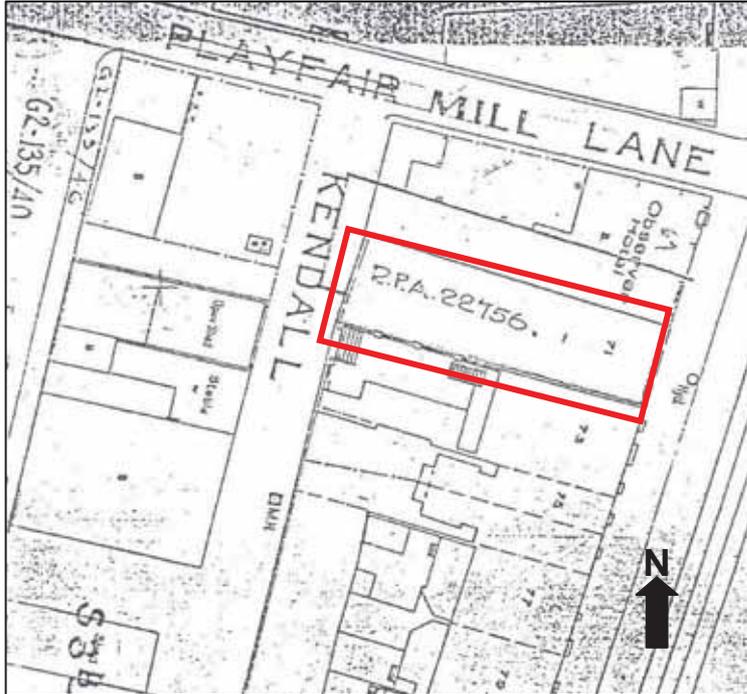
Figure 2-14: A 1923 plan of the area, showing the layout of the building at 73 George Street and the name change from Playfair to Mill Lane to north of the site. Three columns faced George Street and a set of stairs accessed Kendall Lane at the rear. Another set of stairs presumably accessed the first floor area of the building and a yard occupied the southern part of the site. (Source Sydney Cove Authority, map of 1923, reproduced in Robertson & Hindmarsh, 1998)

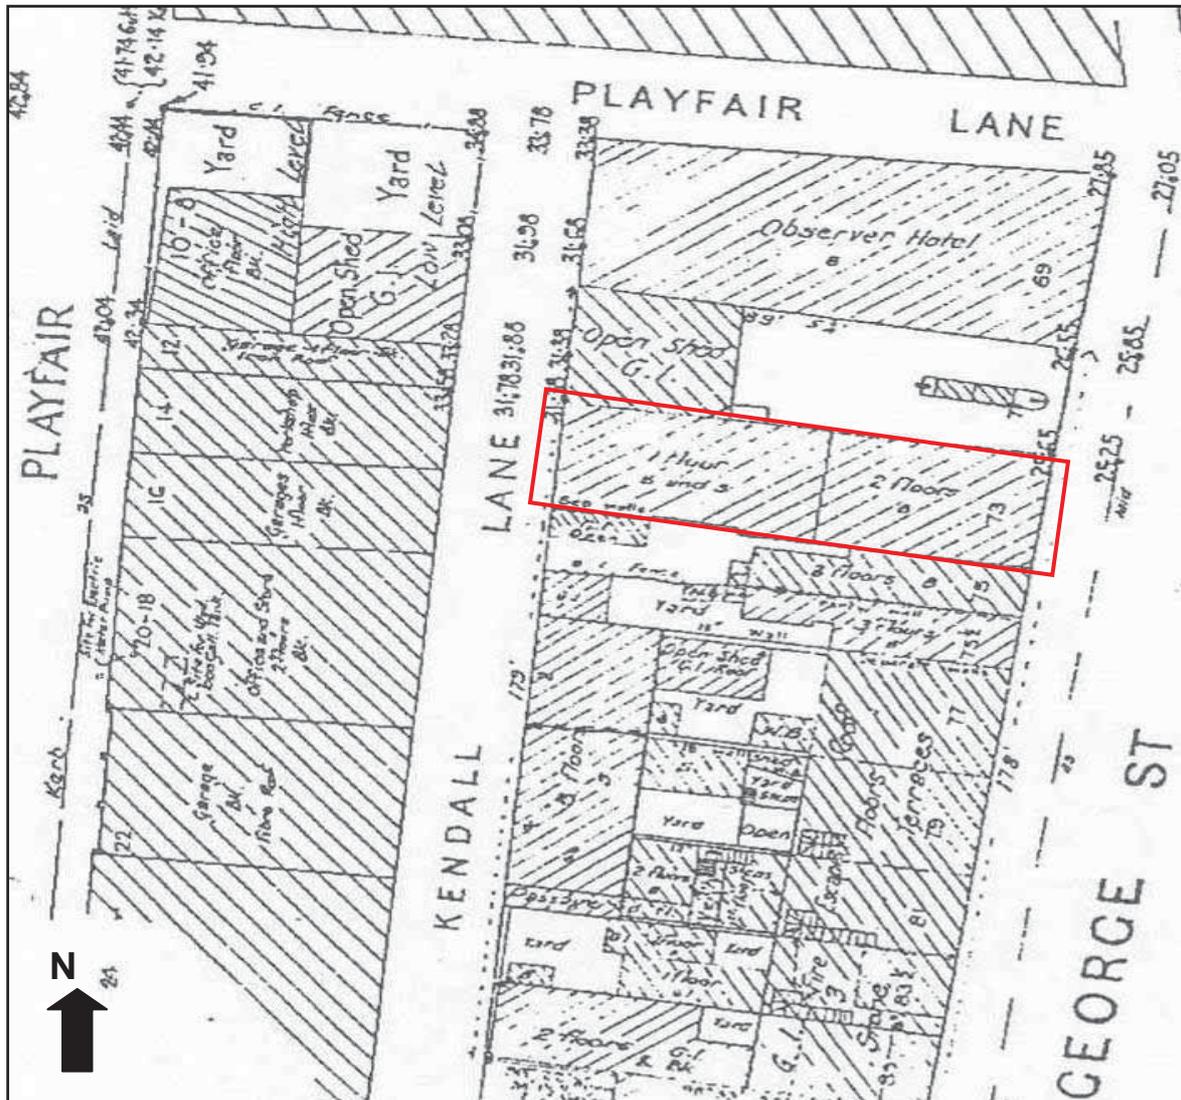
Figure 2-15: Sydney City Council Plan dated 6 January 1930, showing 73 George Street with two storeys at the George Street front and one floor to Kendall Lane. (Source Map HP 161 Sydney Cove Authority reproduced in Robertson & Hindmarsh, 1998)

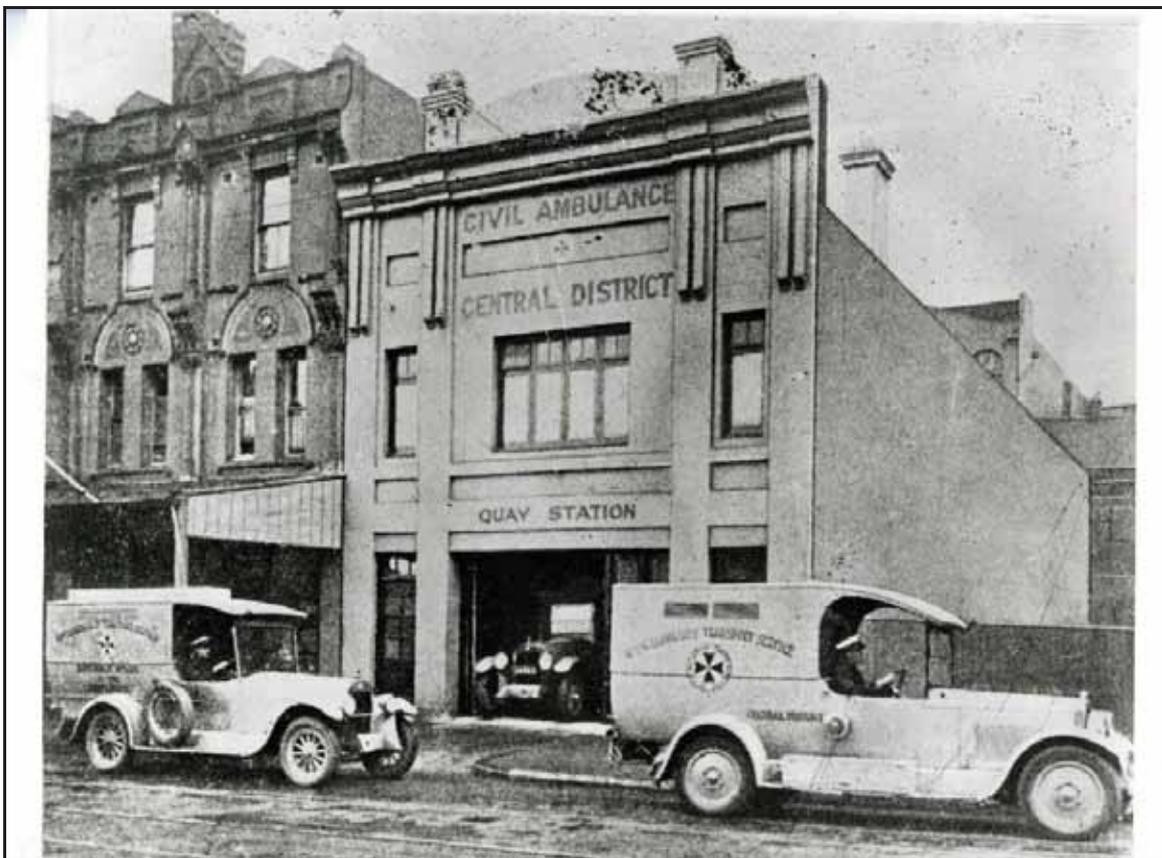
Figure 2-16: The Ambulance Station 73 George Street opened in 1927. (Source DWX No 34087 GE52 - Central District Ambulance Station, 71 George St - c.1930-40s, courtesy The Foreshore Authority)

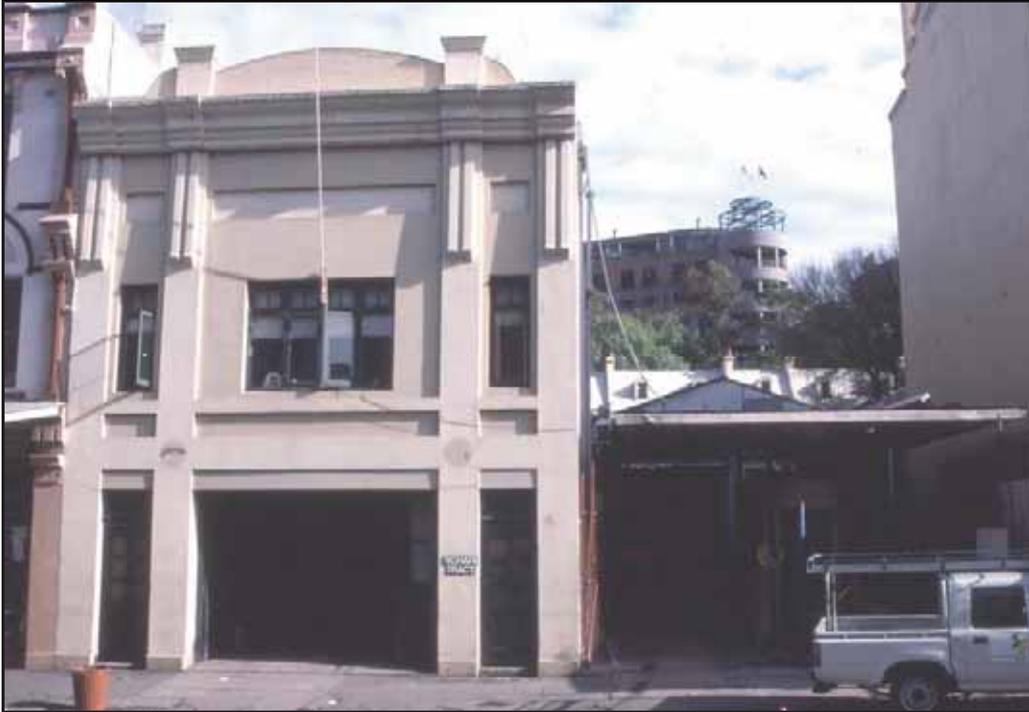
Figure 2-17: c.1992 view of 73 George Street after vacation by the Ambulance Service and the neighbouring former service station at 71 George Street. (Source: The Foreshore Authority)

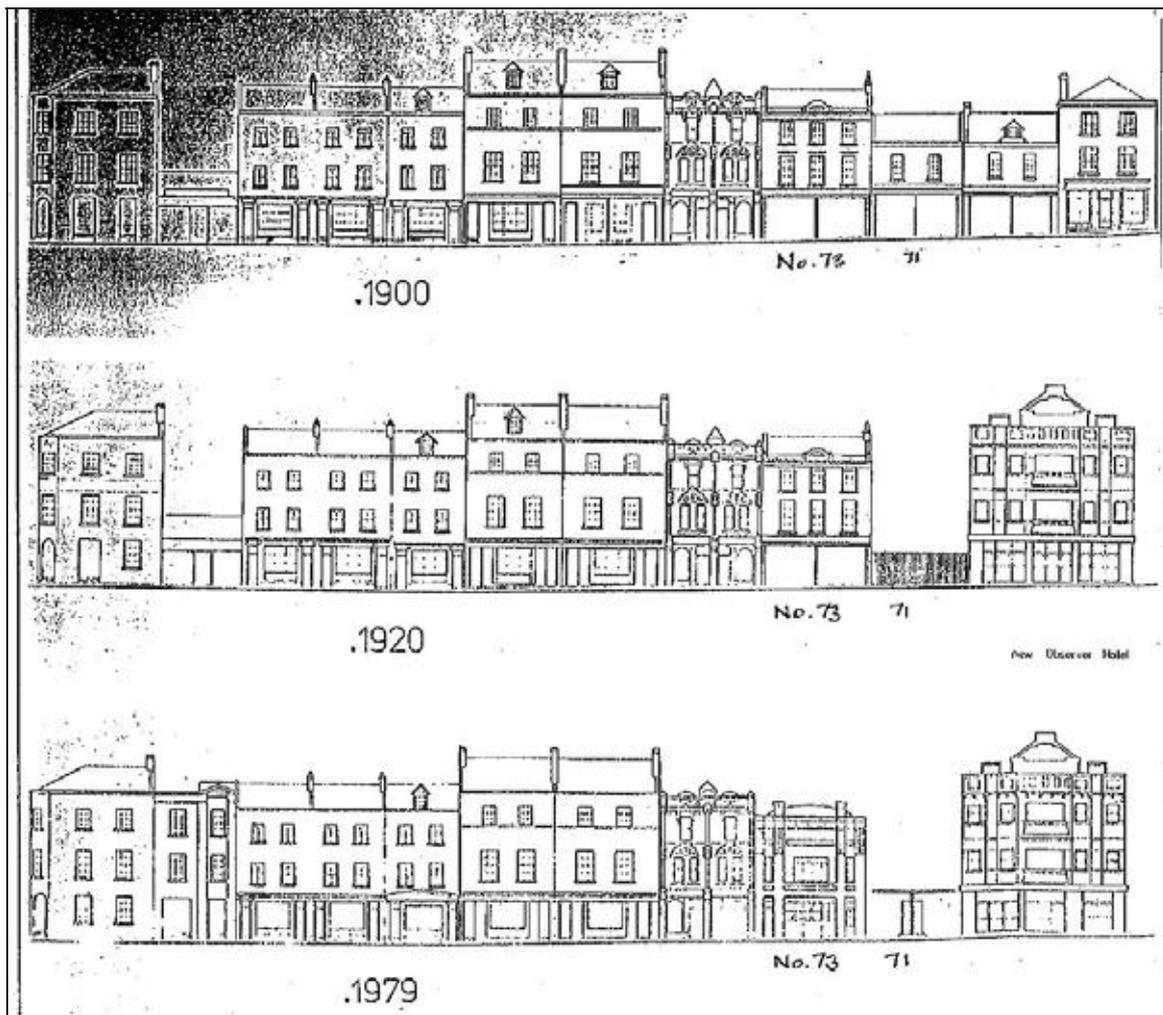
Figure 2-18: George Streetscape showing the evolution of the Ambulance Station site, 73 George Street. (Source: Foreshore Authority, c.1985 Ambulance Station Precinct Plan)

The illustration above has been taken from a 1985 proposal for the site prepared by the Sydney Cove Redevelopment Authority (now Sydney Harbour Foreshore Authority). This drawing best illustrates the changes to the building facade of the 73 George Street site. Unfortunately, historical plans and illustrations of the site were not located other than an 1858 view of the area provided in Figure 2-9. The information available on the building has been obtained from the Sydney Harbour Foreshore Authority resources.

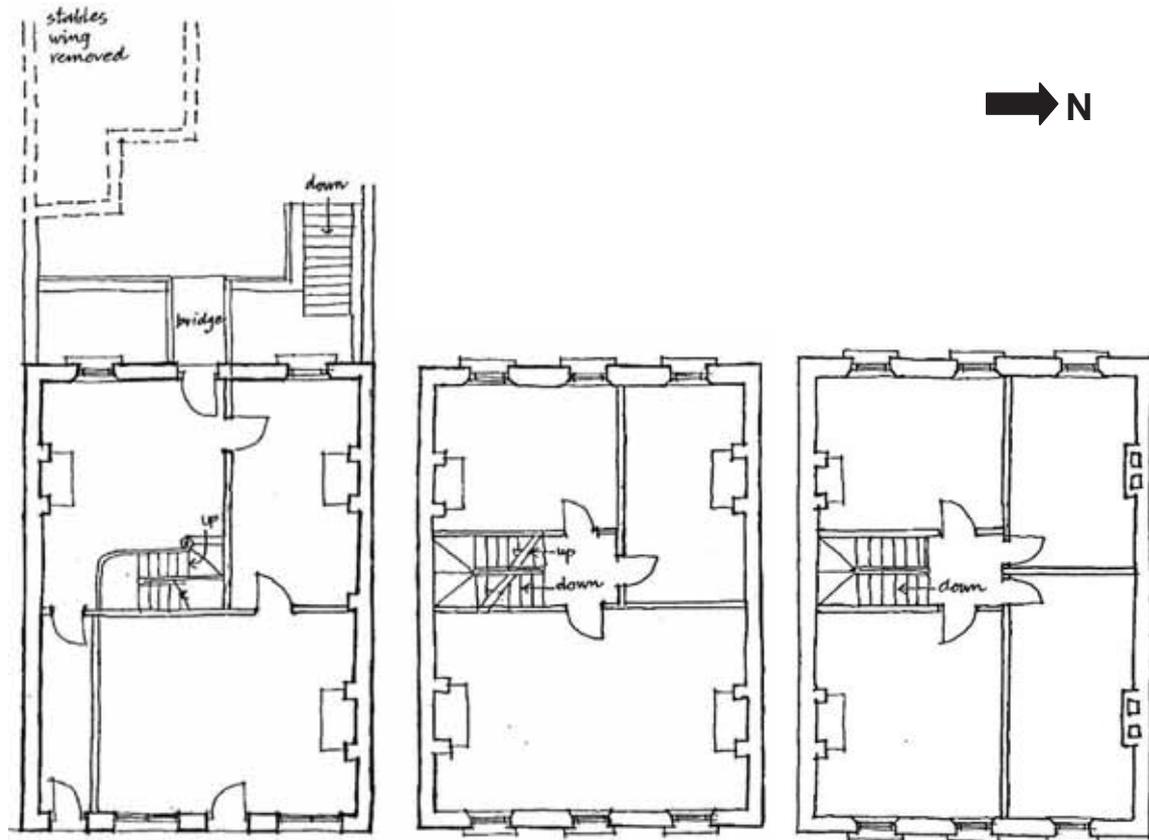
Figure 2-19: Reconstructed drawings showing likely floor layouts of the 1842 Hotel floor plans prepared by David Sheedy in November 1991 as part for the Conservation Plan study for the 73 George Street site. Ground floor plan to second floor plan from left to right.

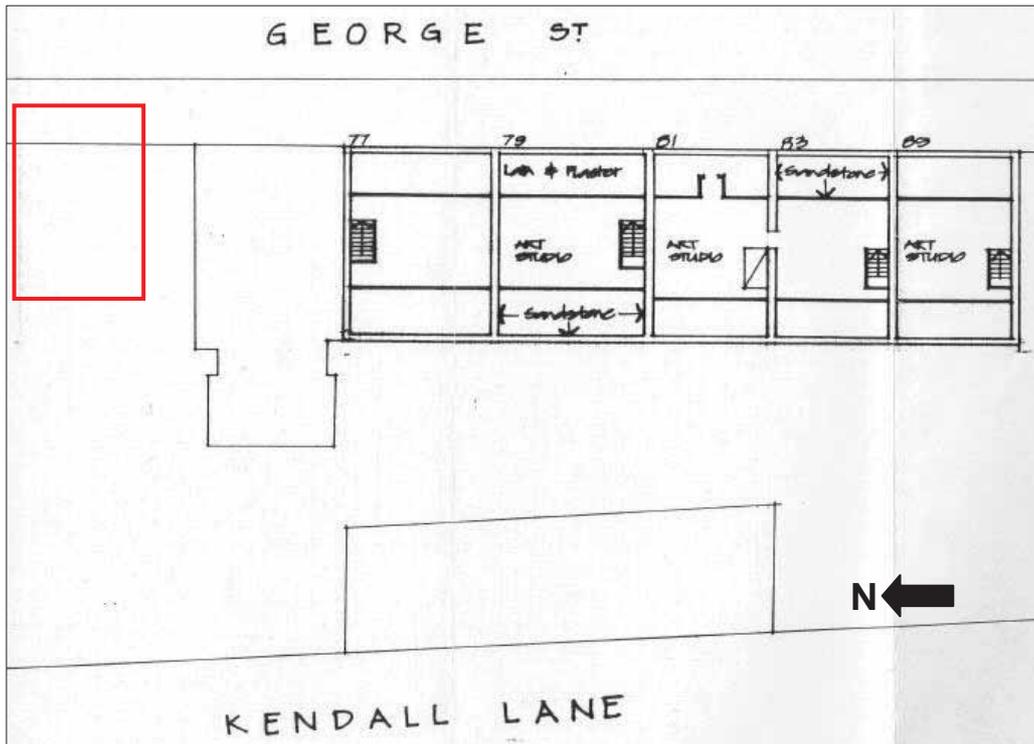
Figure 2-20: The Attic Plan for the Kendall Lane buildings. Note that the subject site is not included, as it didn't have an attic.

The floor plans for the subject site depicted in Figures 2-20 to 2-23 are from a 1972 survey carried out on behalf of the Sydney Cove Redevelopment Authority (now Sydney Harbour Foreshore Authority) when the site was still in operation as an ambulance station.

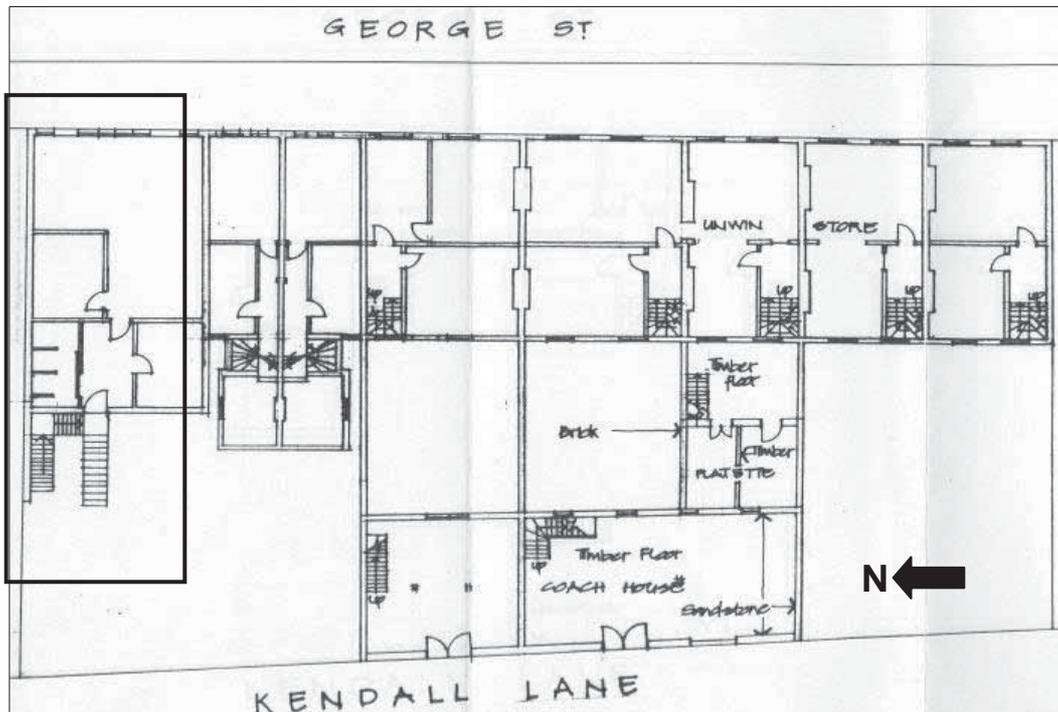
Figure 2-21: The Level One plan with the subject site indicated. Note that two rear staircases are drawn, presumably one is to the cellar, although a cellar plan was not provided in the 1972 survey, see Figure 2-23.

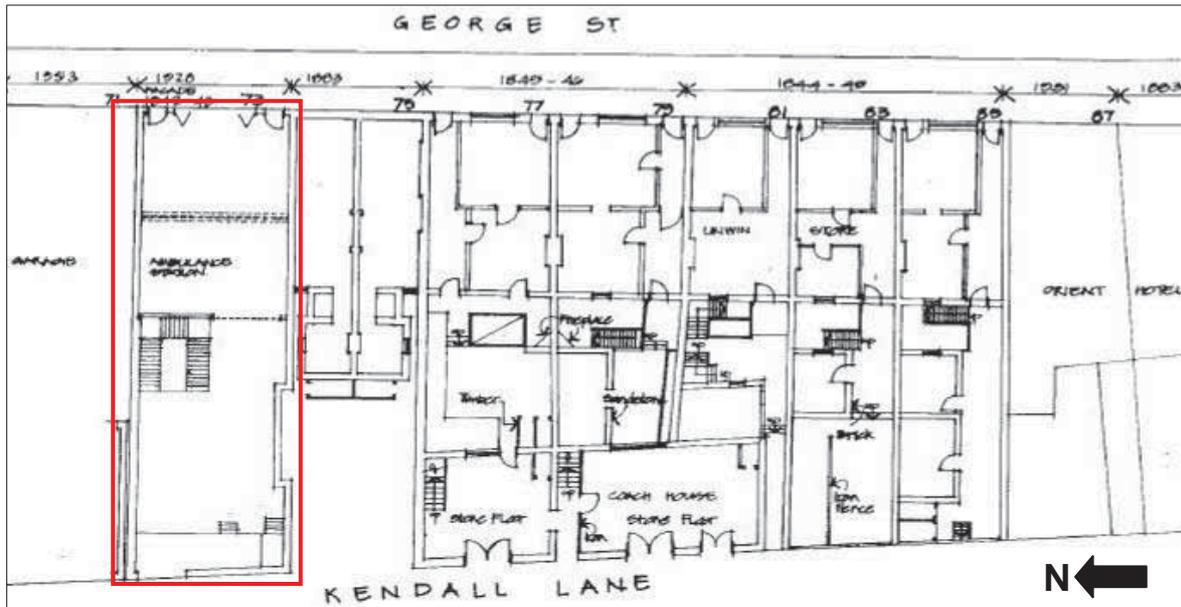
Figure 2-22: 1972 Ground floor plan of the buildings known at this stage as the Kendall Lane Precinct. Note the shared walls and the additional walls in the area of the subject site.

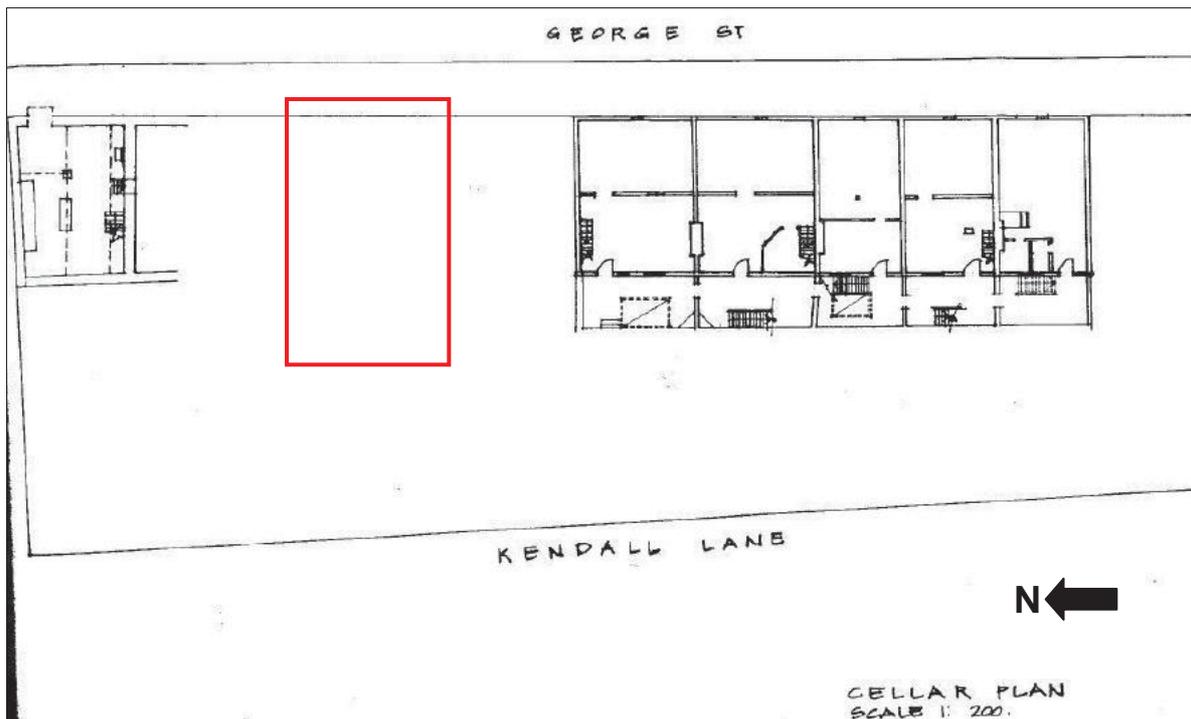
Figure 2-23: 1972 cellar plan of the Kendall Lane Precinct. The subject site indicated however the cellar is not depicted here.

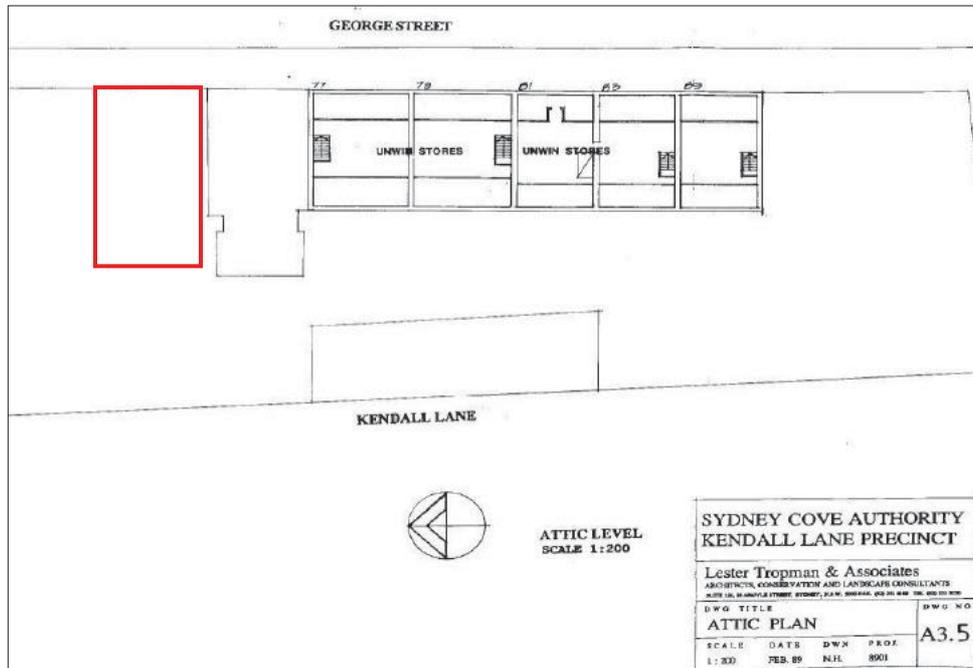
Figure 2-24: 1989 drawing of the attics of the buildings in the Kendall Lane Precinct. The subject site is indicated. Note that the drawings are similar to the 1972 drawings.

The architectural floor plans on the following pages depict the 73 George Street building and its neighbouring buildings to the south and were obtained from the Foreshore Authority from the 1989 survey commissioned to Lester Tropman & Associates as part of the project they were undertaking on the subject site and the next door site at 71 George Street.

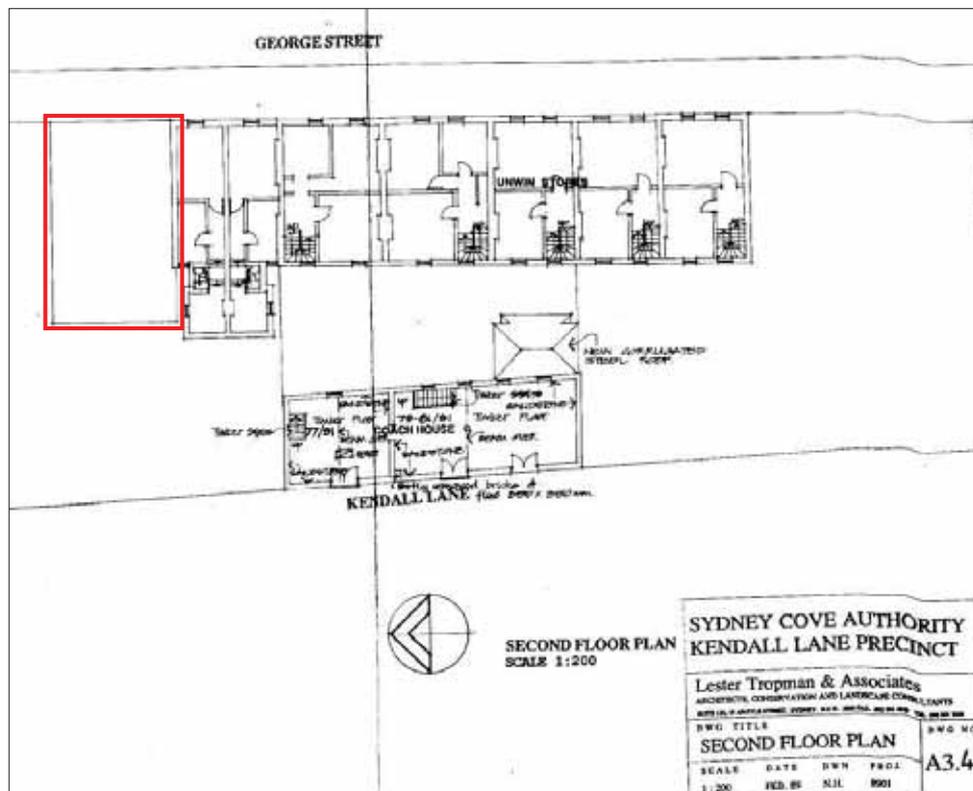
Figure 2-25: Second floor plan from 1989 project. Subject site is indicated.

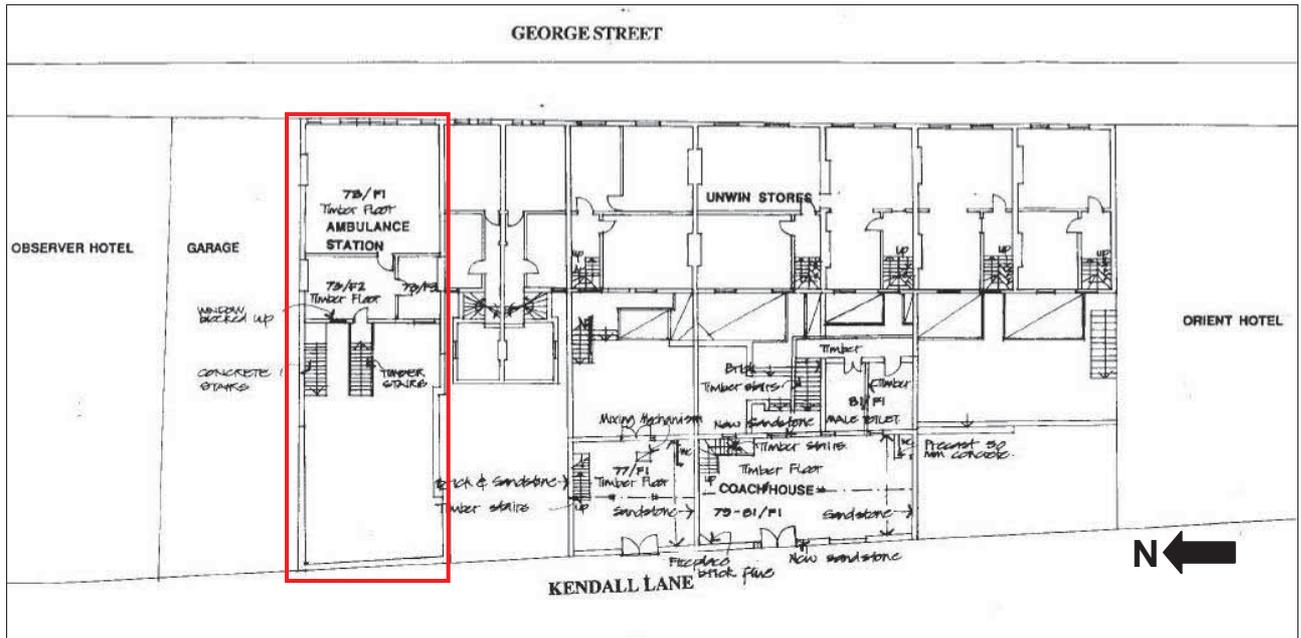
Figure 2-26: 1989 drawing of the first floor of the buildings. The first floor of the then Ambulance Station is similar to the existing layout with the exception of stairwell insertion to the north of the front room and removal of the timber stair to the courtyard. The plan indicates timber floor to the rooms of the Ambulance Station.

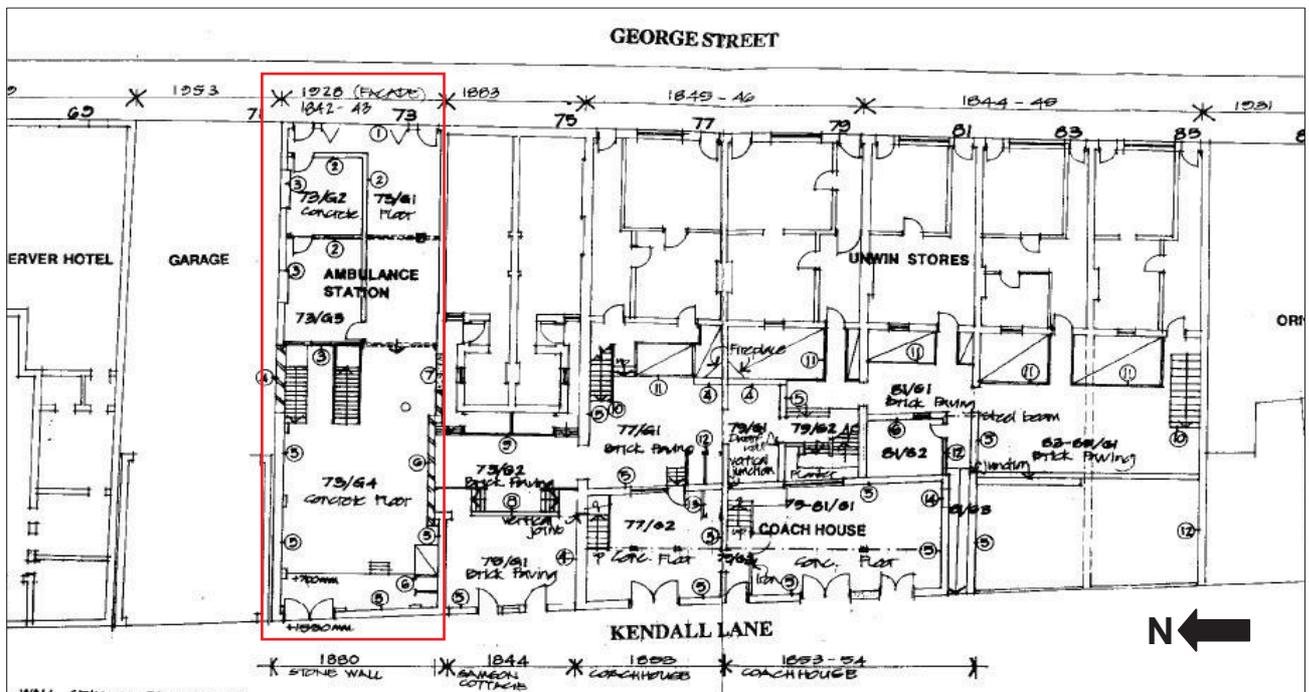
Figure 2-27: Ground floor plan drawn in 1989. The descriptions on the materials referenced by the numbers 1 through 14 depicted on the plan, above. The subject site is indicated and enlarged on the next page with materials as noted and referenced on the drawings.

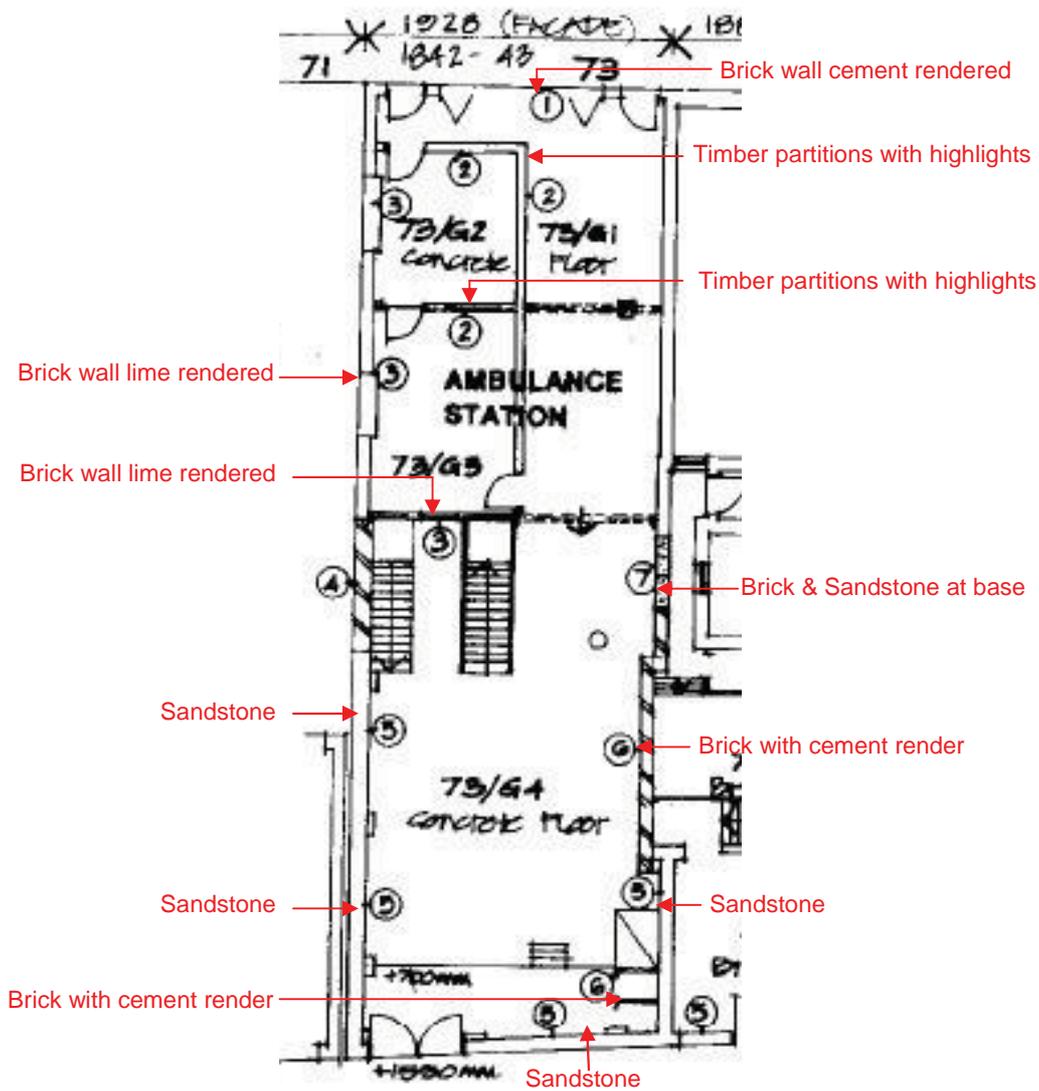
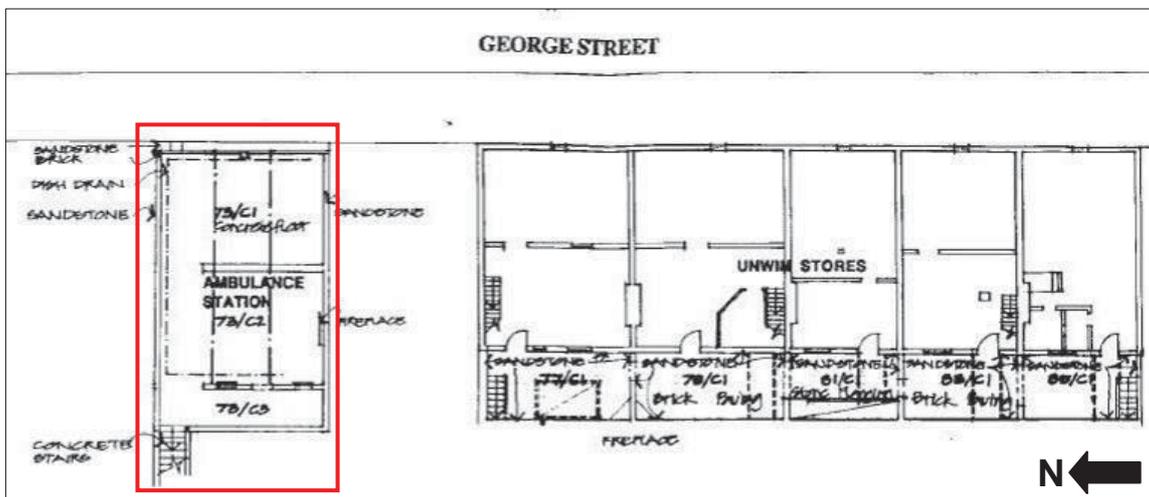
Figure 2-28: 1989 drawing of the cellars of the buildings comprising the Kendall Lane Precinct. The subject site is indicated above and enlarged below. Note that this is the first plan for the cellar located for this Plan. The main change in the basement layout is the insertion of new doors to the spaces indicated as 73/C.2 and 73/C3, and removal of the concrete flooring during contaminated surface removal. Fireplace is no longer visible due to the later structural propping throughout the basement supporting the ground floor concrete flooring and the stormwater/aircondition services. A new brick wall also stands along the northern sandstone wall where the dish drain was located.

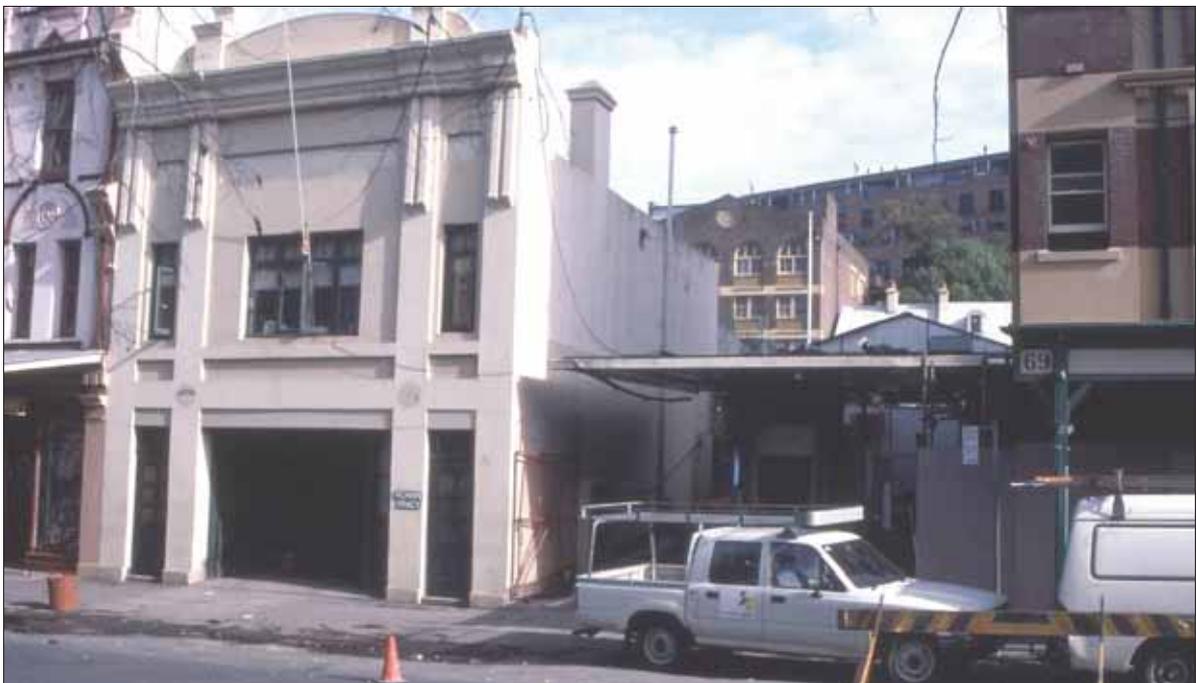
**Figure 2-30: The 73 George Street site after the Ambulance Station had vacated the building.
Note the view through the neighbouring 71 George Street site before its 1992 redevelopment.
(Source: The Authority's Archives)**

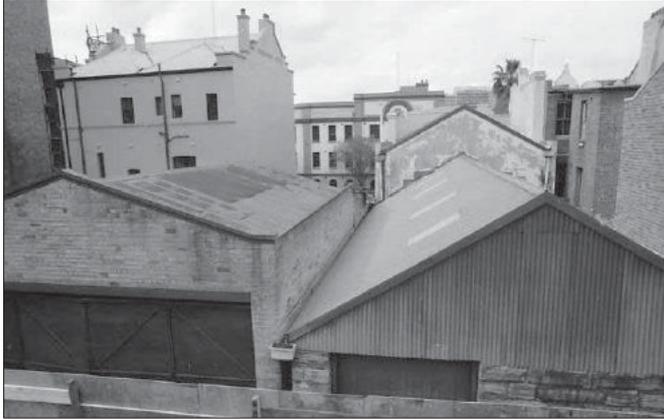
Figure 2-21: c.1992 view of the rear and the roof of the ambulance station at 73 George Street. The enclosed rear is now the terraced open public courtyard.

The following photographs were taken by the Sydney Cove Redevelopment Authority (now the Sydney Harbour Foreshore Authority) c.1990, after the Ambulance Service Station vacated the property and before the 1992 restoration and rebuilding works commenced. The photographs are the only internal documentation of the building during its long history and provide valuable information on how the former public house was adapted for use by the Ambulance Service in c.1927.
