73 George Street, The Rocks
Conservation Management Plan

2008

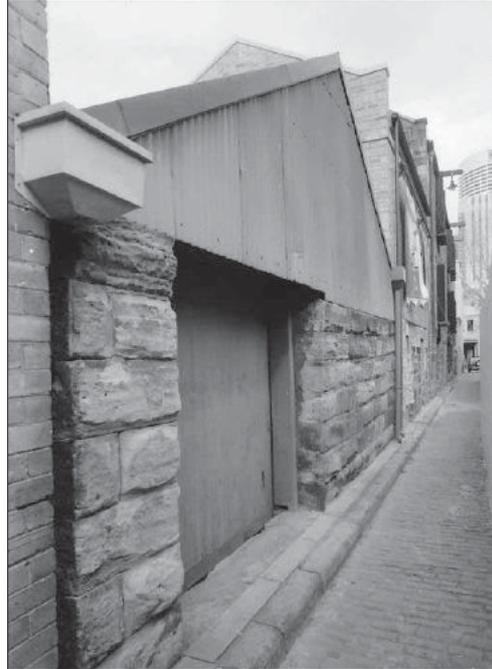
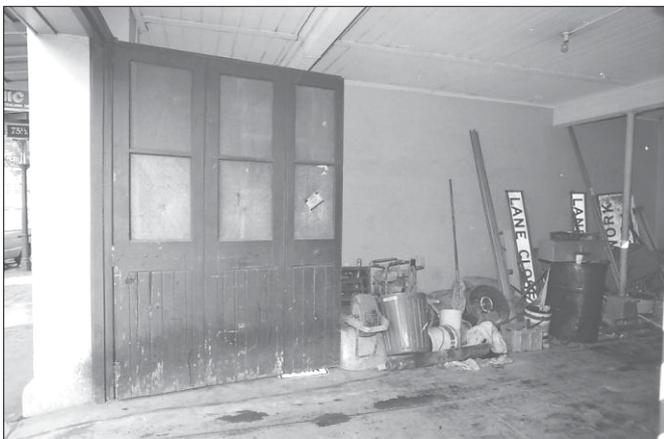
Figure 2-31: The folding doors of the Ambulance Station are now at the subject site George Street entry of the Ken Duncan Gallery.

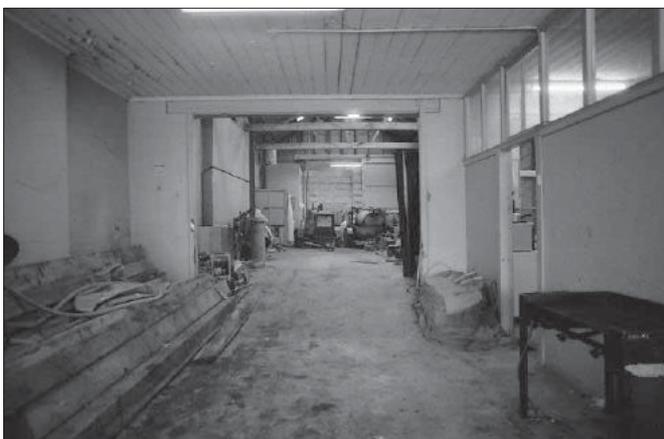
Figure 2-32: The view internally from George Street, note the timber board lined ceiling and timber ceiling beams.

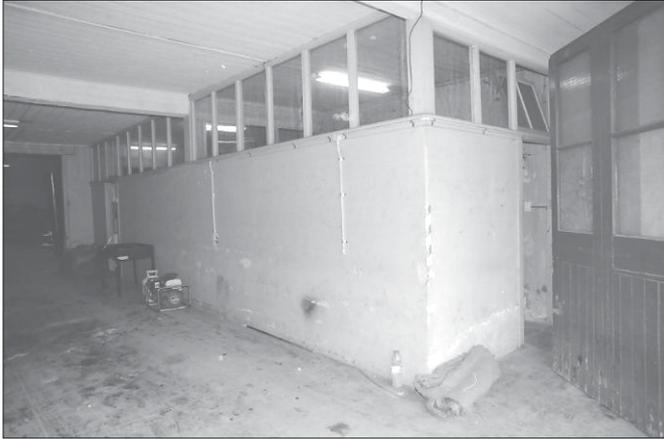
Figure 2-33: The office partition for 2 interconnected rooms inside the George Street entry, on the northern side, where the present staircase to level one is located.

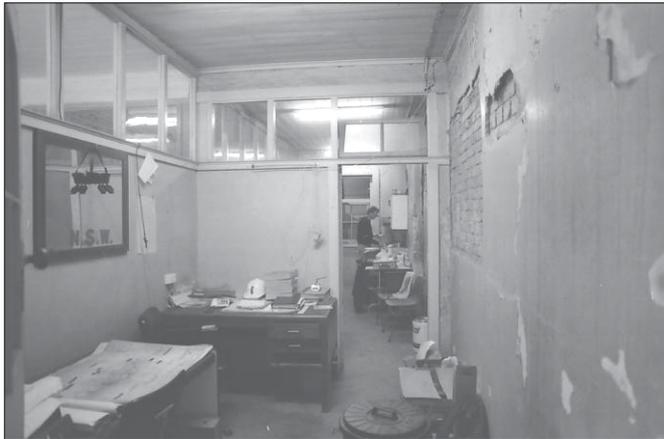
Figure 2-34: Inside the office partitions for 2 rooms on the northern side of the building from the George Street alignment. Note the condition of the walls and brickwork visible.

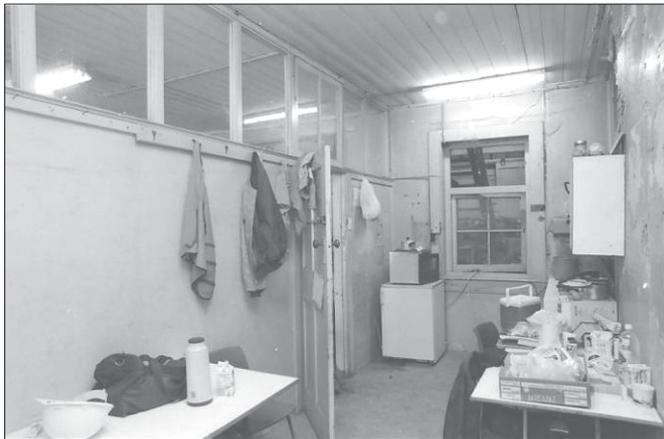
Figure 2-35: Inside room 2 of the office partitions, with window to the rear of the building and site. This window is now bricked-in.

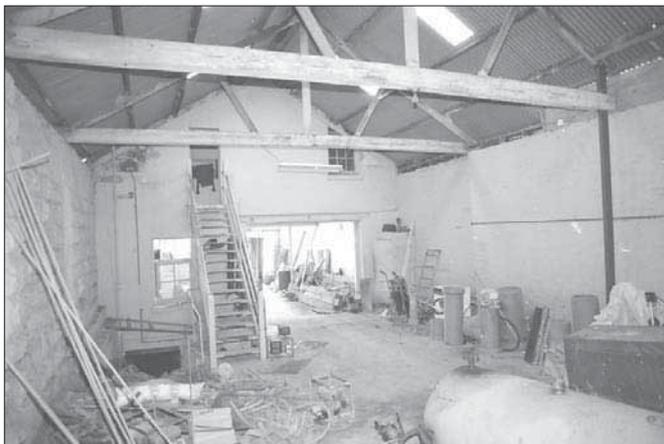
Figure 2-35: View from the then enclosed rear courtyard towards George Street main room where the gallery is located now, showing the offices and the general ambulance room. Note the timber stair to the first floor room. This door is now kept locked. Photo c.1992 after Ambulance Station was vacated and during the alterations.

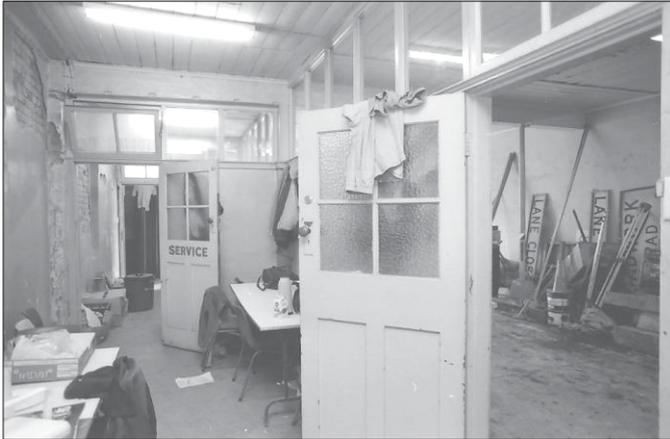
Figure 2-36: View of the offices on the north side of the George Street section taken in c.1992 following the Ambulance Station's move.

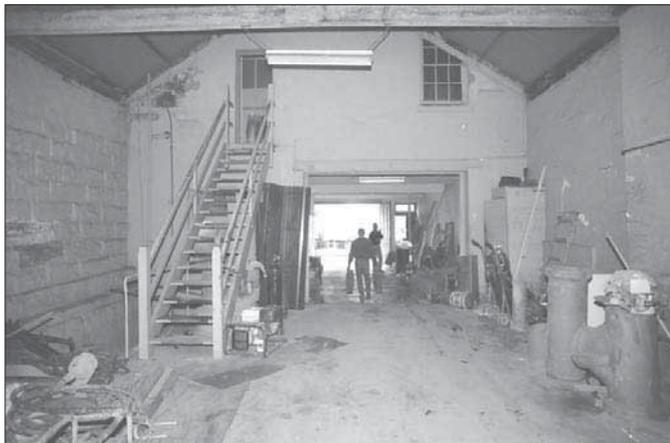
Figure 2-37: View from the Kendall Lane rear of the site showing the building and George Street doors. Photo c.1992 after Ambulance Station was vacated and during the alterations.

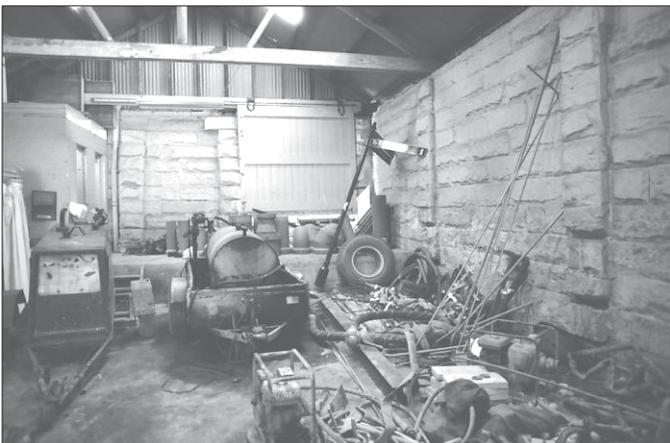
Figure 2-38: View from the rear of the building towards Kendall Lane showing the covered courtyard, WC's and the sandstone boundary wall to north. Photo c.1992 after Ambulance Station was vacated and during the alterations.

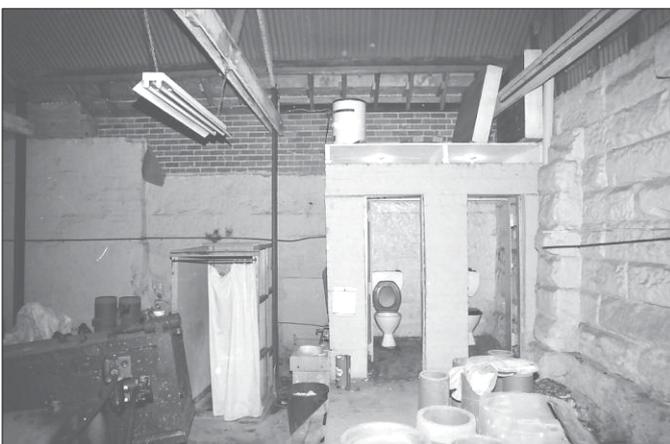
Figure 2-39: View to the south boundary at rear of site, near Kendall Lane. Showing painted sandstone walls and two WC with adjacent shower taken c.1992 after Ambulance Station was vacated and during the alterations. Note the brick infill to the top of sandstone wall on the south boundary behind

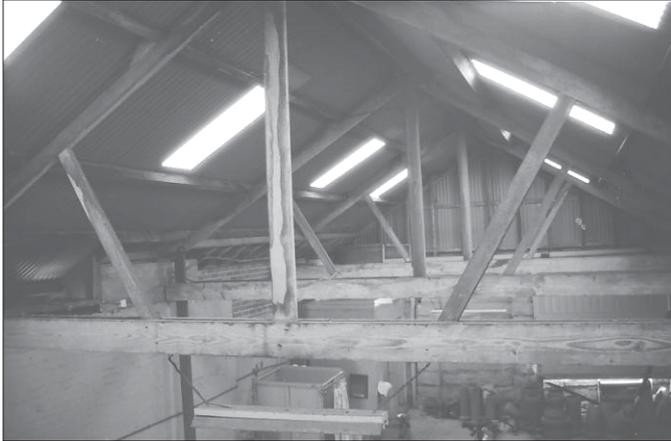
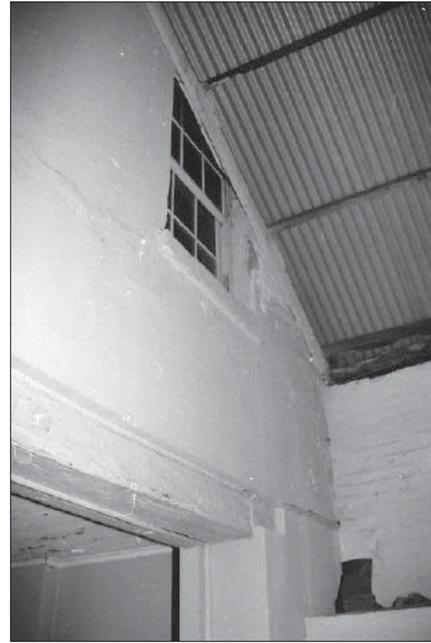
Figure 2-40: Views of the corrugated iron roof over the rear courtyard of the site, extending from first floor of the 73 George Street building with timber trusses and steel support posts.

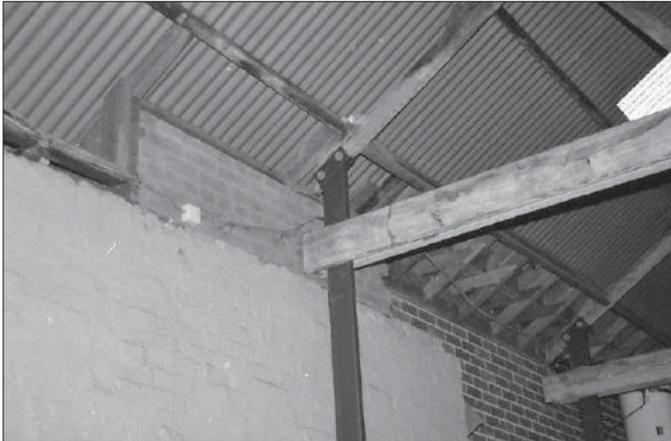
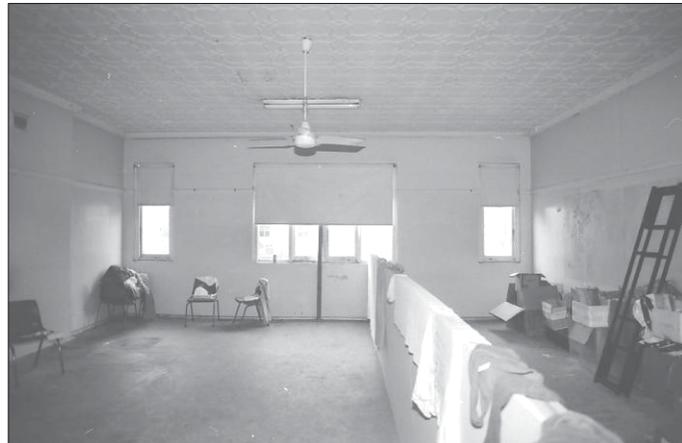
Figure 2-41: First floor main room view towards the George Street elevation of the building. The area on the left of the photo now houses the new stairwell from George Street. The pressed metal ceiling is retained.

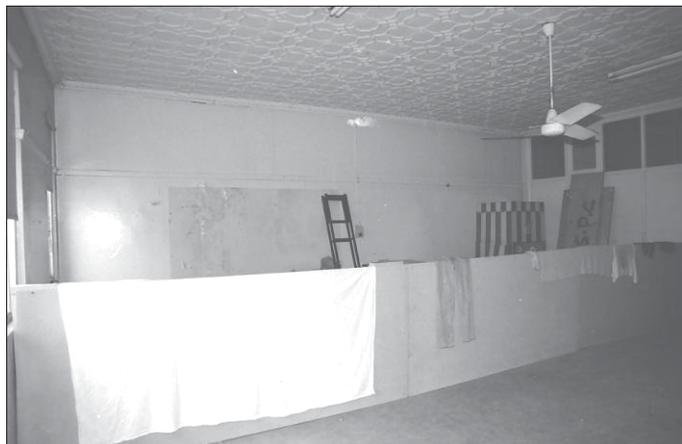
Figure 2-42: First floor main room southern wall view

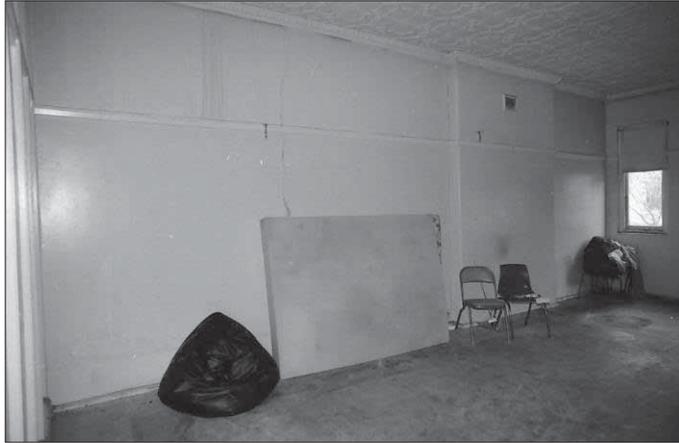
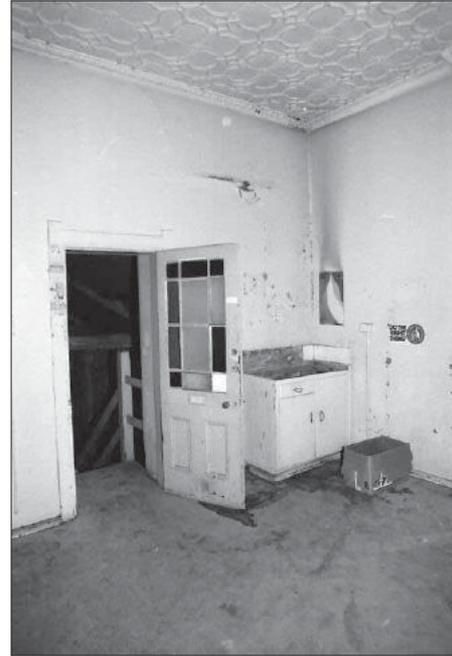
Figure 2-43: Above: First floor main room northern wall where the new stairwell from George Street is located

Right: First floor rear room door opening onto back external timber staircase.

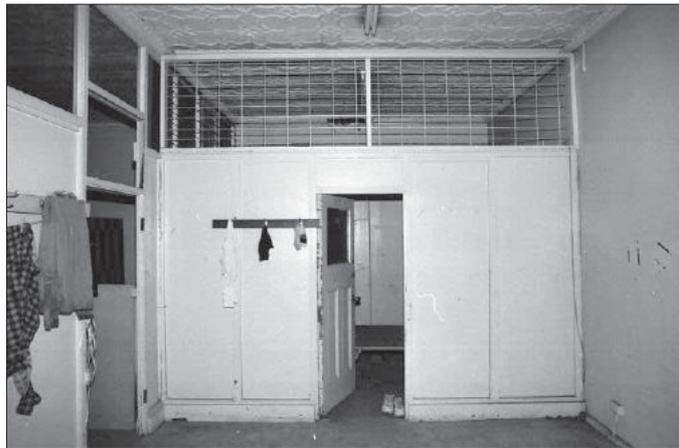
Figure 2-44: First floor partitioning at rear of building on southern side where the current bathroom is

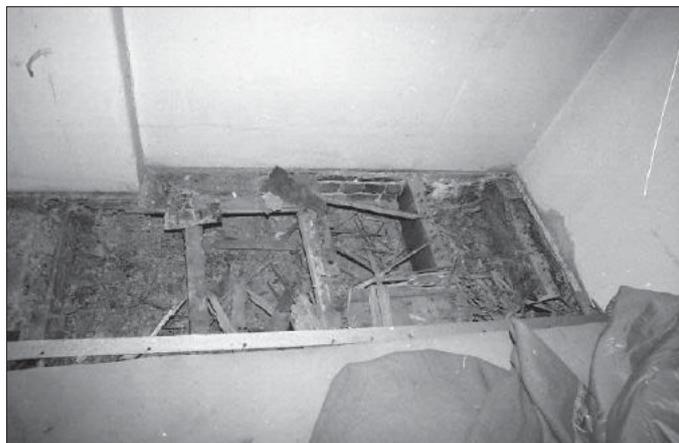
Figure 2-45: First floor main room damaged floor in south-west corner This was also documented in the 1990 report noted in the Ambulance Service records, quoted previously in this section.

By late 1990 an inspection report for the building noted that 'the premises were found to be infested with white ants and the floor boards, particularly on the first floor were unsound and creating an occupational and safety issue.⁴⁹ Accordingly, the building was vacated by the Ambulance Service on 9 November 1990 and the lease relinquished to the Sydney Cove Redevelopment Authority (now the Sydney Harbour Foreshore Authority).⁵⁰

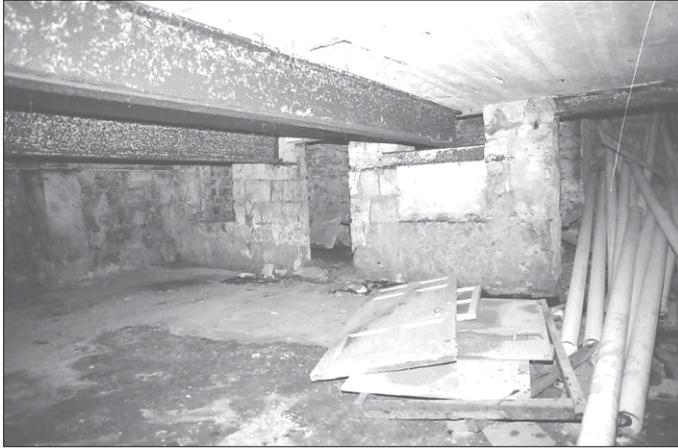
Figure 2-46: Cellar or basement of building. Note the steel support beams and concrete floor above.

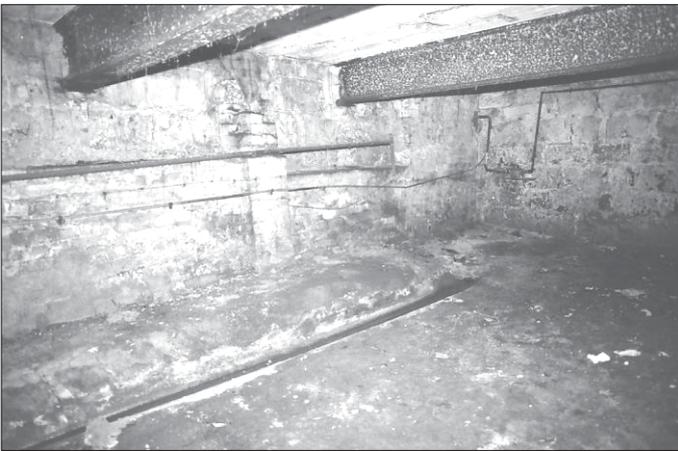
Figure 2-47: Cellar of building, the southern wall with a dishdrain visible in the earthen floor

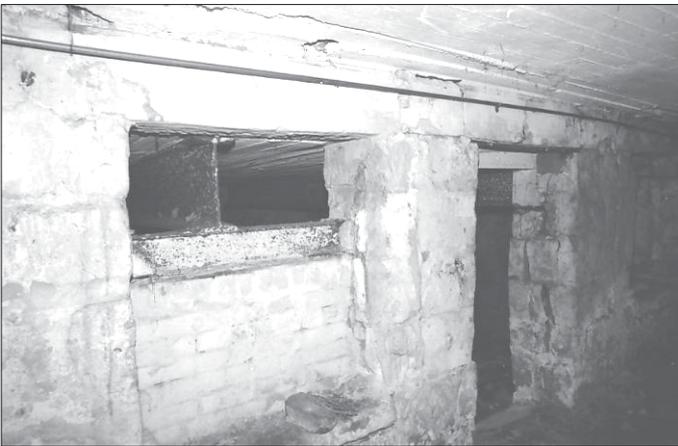
Figure 2-48: Cellar of building, towards the George Street frontage with sandstone foundation piers and a bricked in section in the foreground.

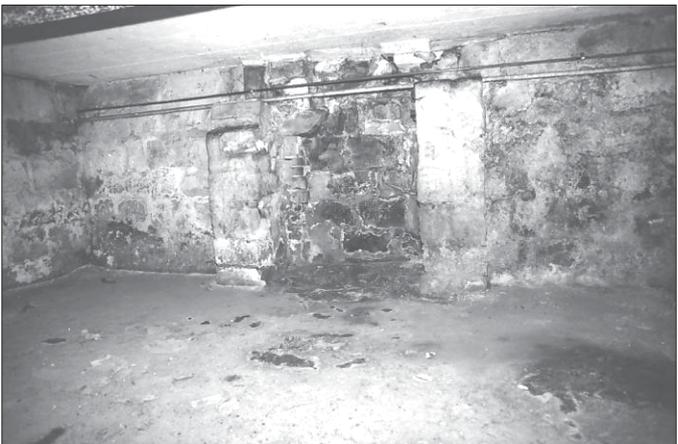
Figure 2-49: Cellar of building, with fireplace area visible on the southern wall

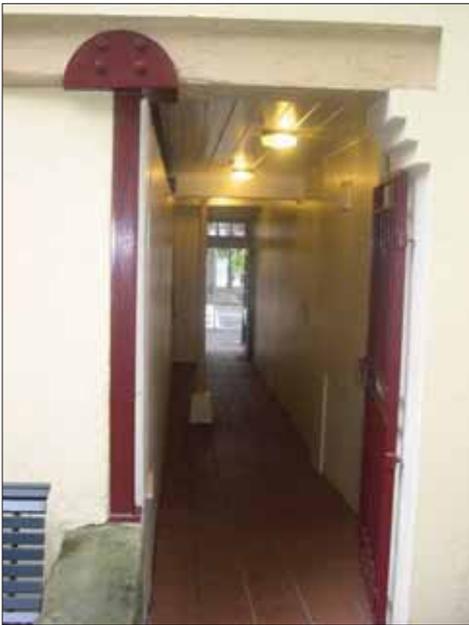
Figure 2-50: The 1992 constructed pedestrian connection through the former Ambulance Station on the southern side. Viewed from the rear of the building towards the George Street doorway taken in June 2008.

This has been achieved by creating a R.O.W (Right of Way) through the Ambulance Station site which links to The Rocks Walk and the Unwin's Courtyards. A public courtyard is created at the rear of the Ambulance Station continuing the sequence of intimate midblock courtyards behind Unwin's Stores. On George Street retail is extended and fills the gap in the streetlevel frontage.

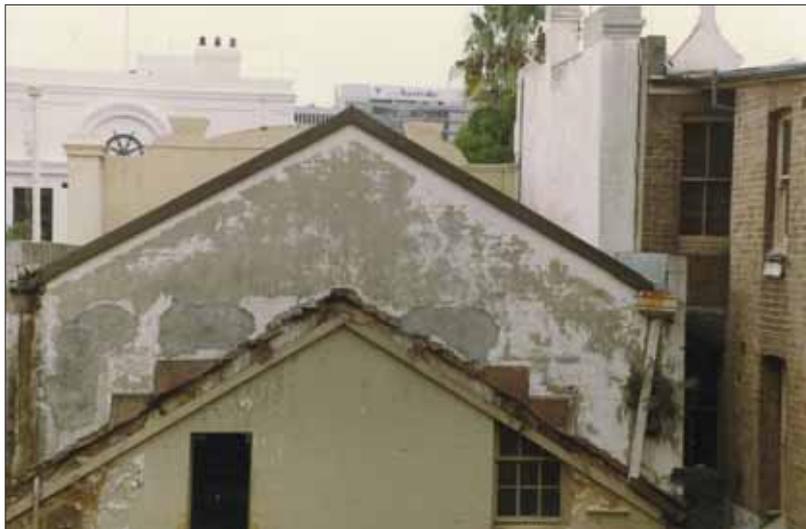
Figure 2-51: The 1992 refit of the subject site from Ambulance Station into Art Gallery, showing changes to the rear elevation following the removal of the roof over the courtyard. The demolition of the service station next door is documented in images from Sydney Harbour Foreshore Authority files, c.1992.

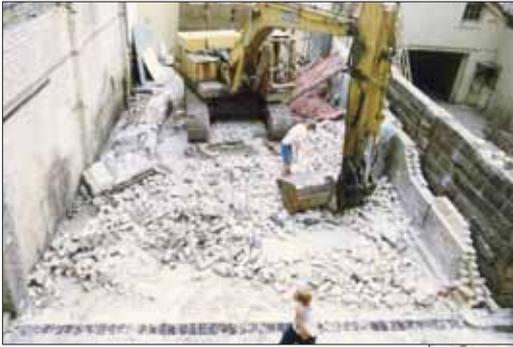
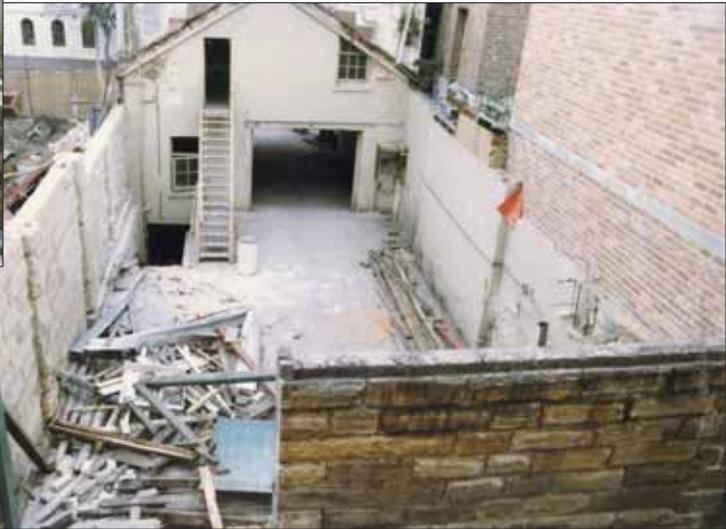
Figure 2-52: The 1992 demolition of the service station at 71 George Street (above), and the alterations to the rear of 73 George Street after the removal of roof over the courtyard

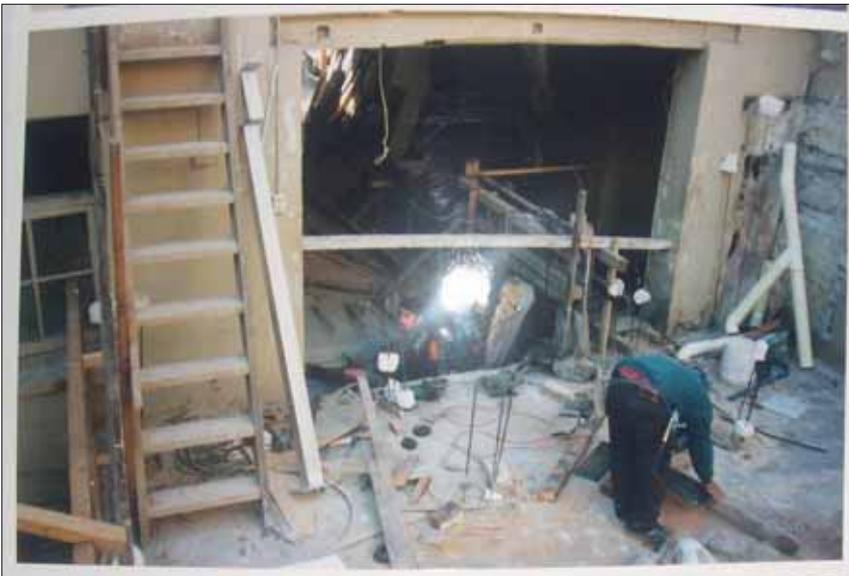
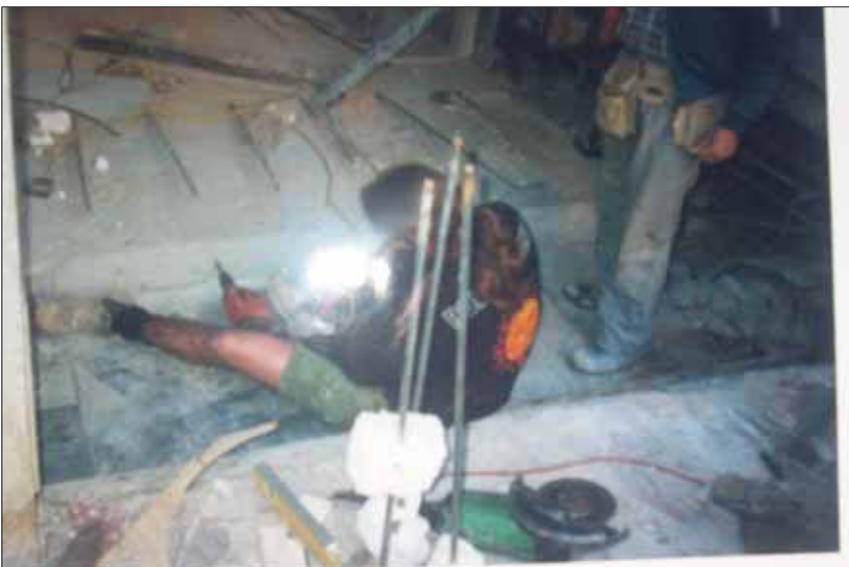
Figure 2-53: A pair of photographs from the Foreshore Authority's Archives, dated 7/9/1994, showing changes to the building including a new concrete slab to the ground floor.

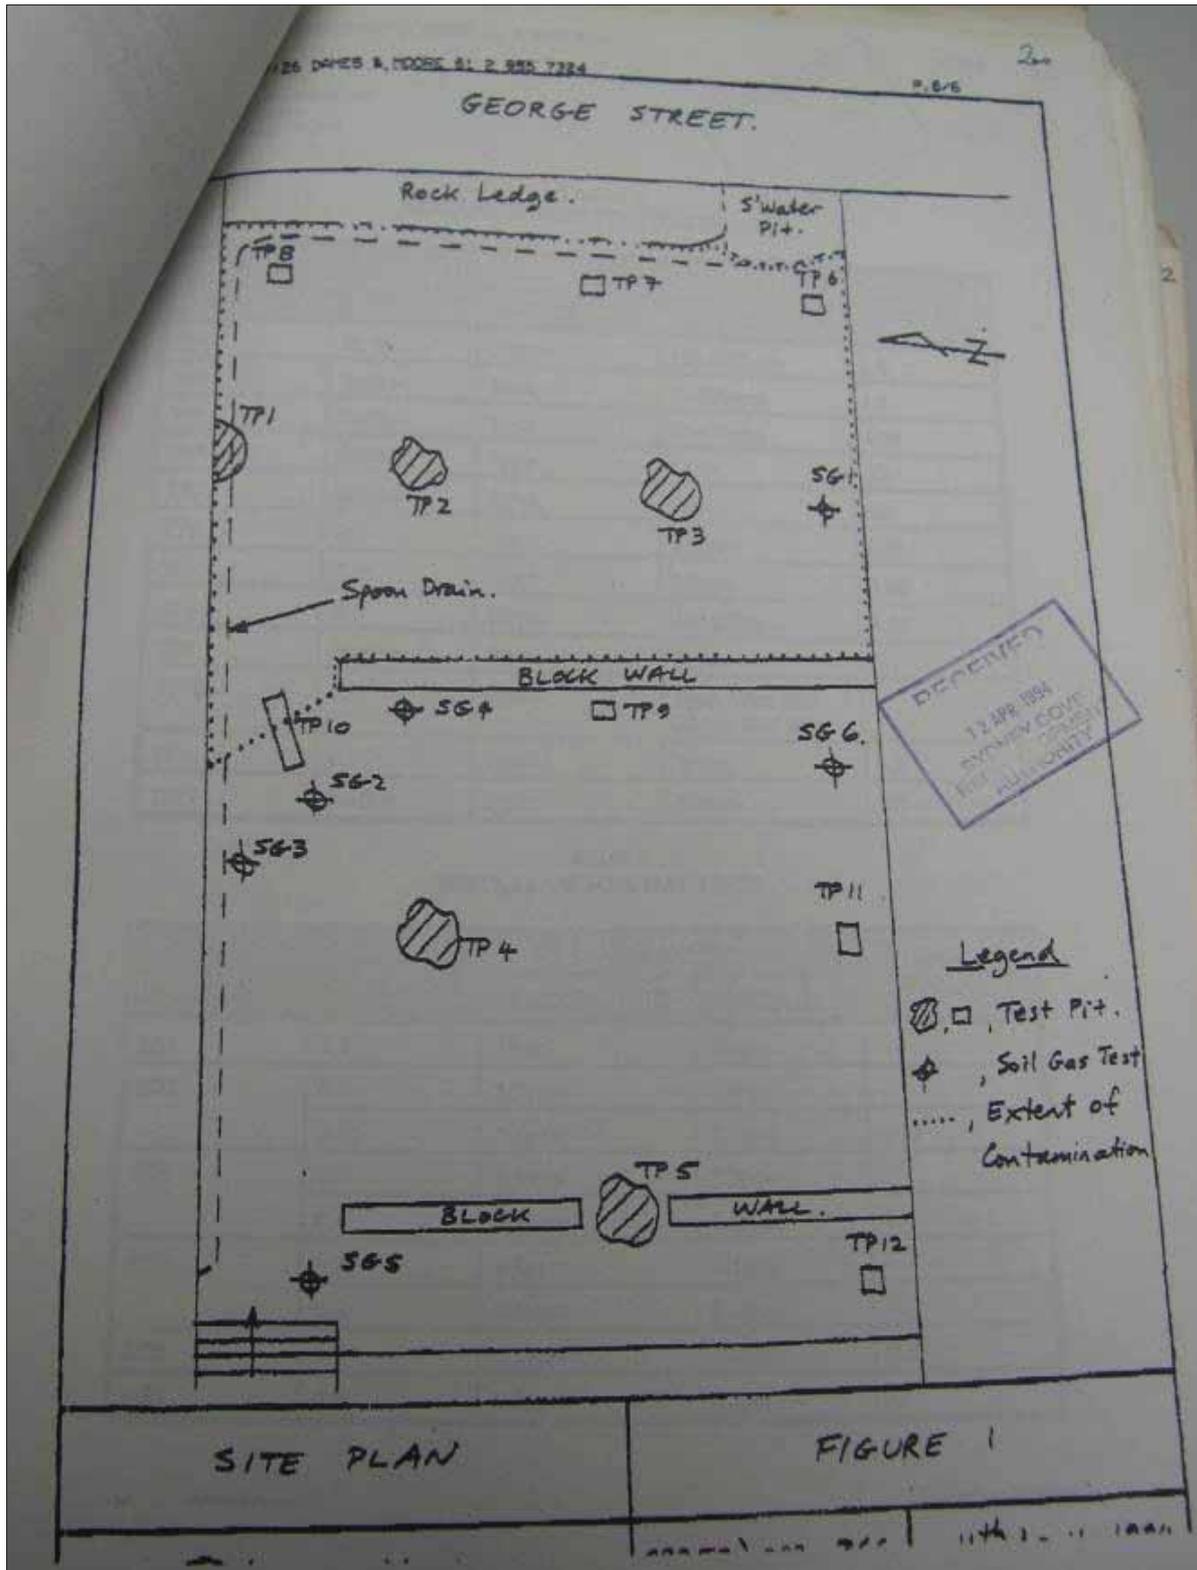
Figure 2-54: A 1991 site plan of the cellar, which shows the original or early foundations and dishdrain along with the pits for soil gas contamination tests, carried out due to the neighbouring service station. The Authority's records show that over 15 tonnes of earth were removed from the 73 George Street cellar due to petrol contamination.

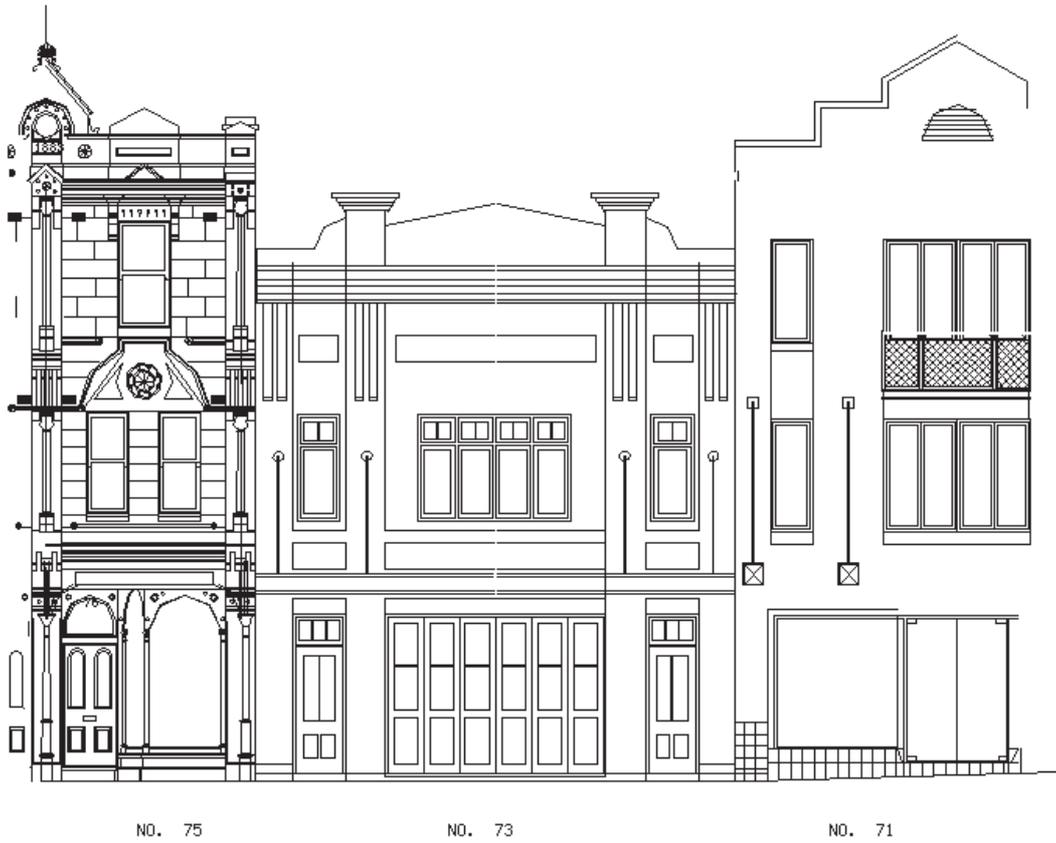
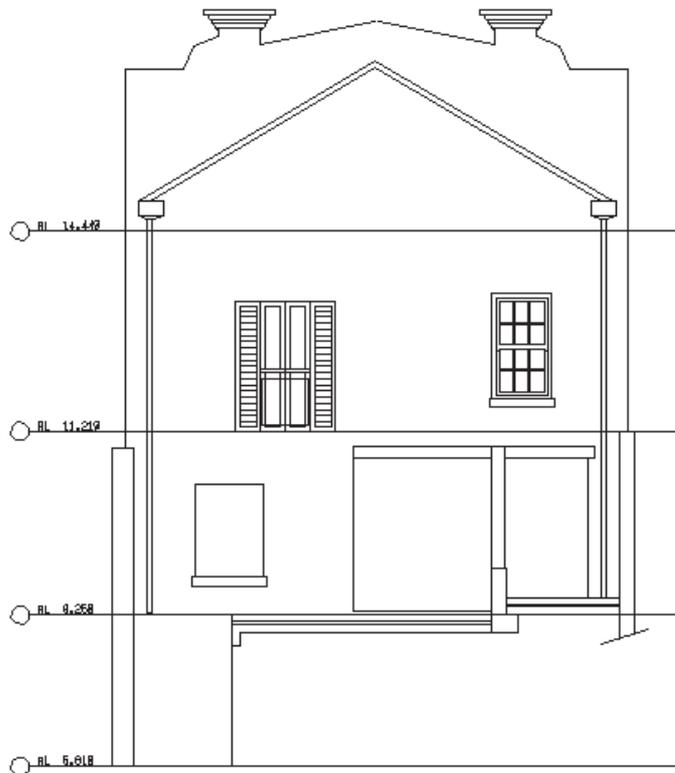
Figure 2-55: Front and rear elevations of the former Ambulance Station in 2004.

The front and rear elevations of the building were changed substantially in the 1927 Ambulance Station fitout. The infill building next door, at 71 George Street was constructed in 1992 and the awnings to both buildings were erected at that time - to match the awnings at the adjacent neighbouring properties to the north and the south, Observer Hotel and former Unwin's Stores. Physical evidence of the original public house remains in some form in the exterior rear yard walls, the cellar and the building's masonry walls. The ambulance station phase has been removed from the current configuration of the building, with the exception of the front doors to George Street and the rear lane access through the sandstone boundary wall.

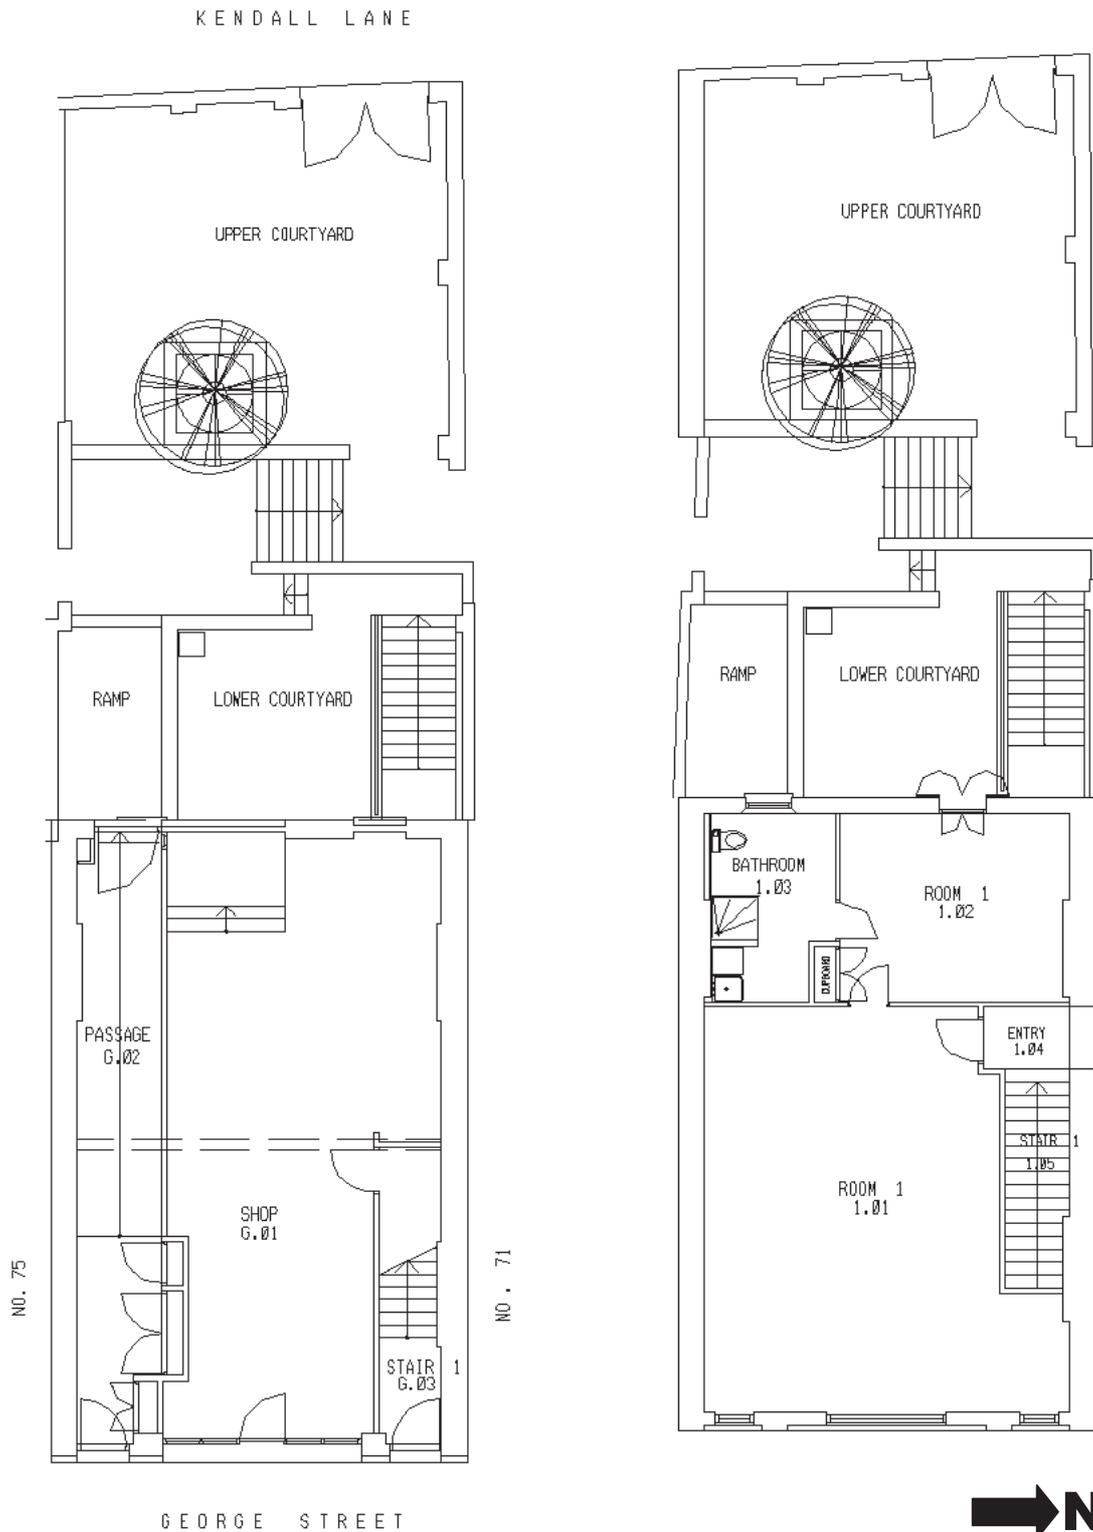
Figure 2-56: Present day floor plans of the former Ambulance Station building

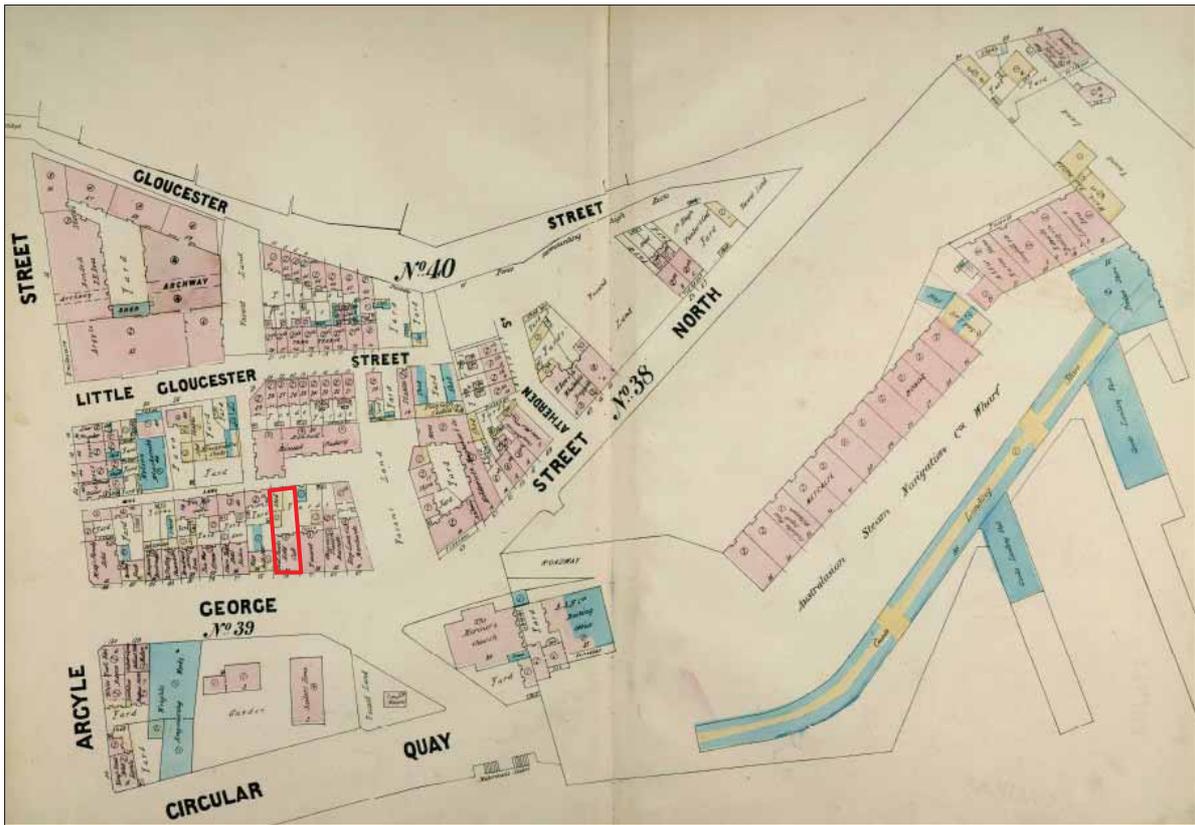
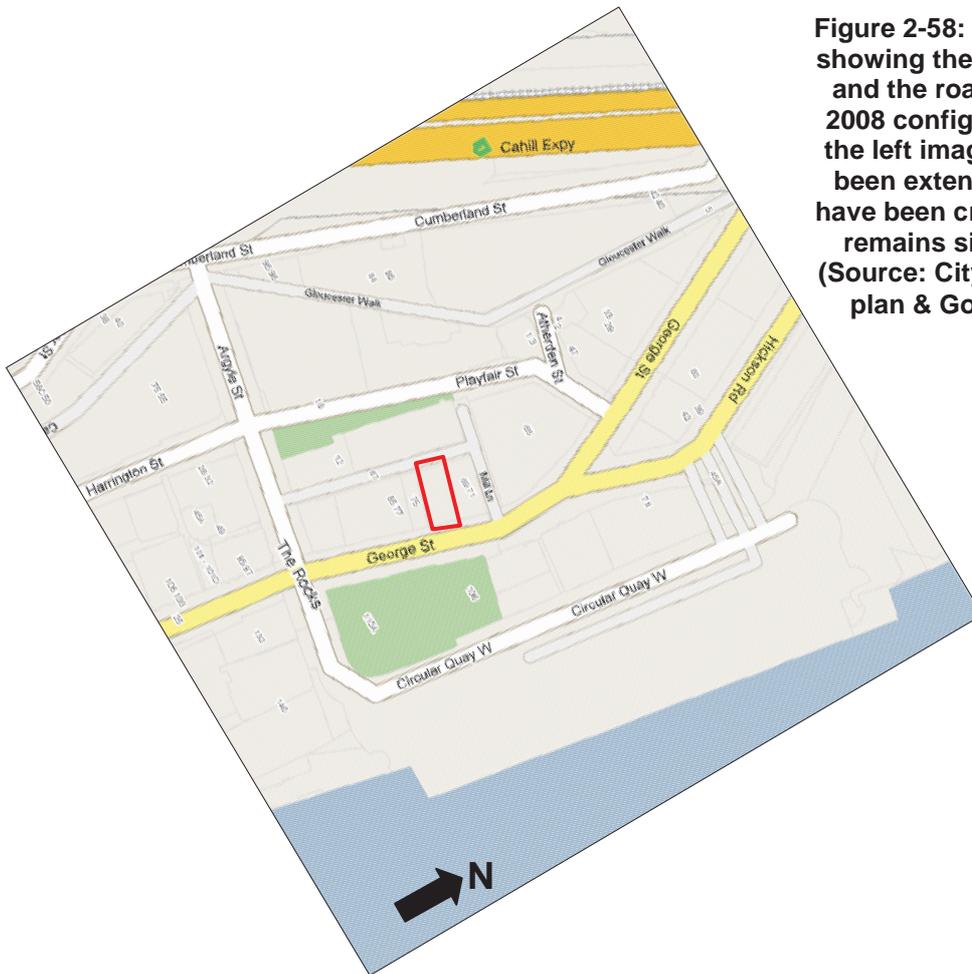
Figure 2-58: An 1880 Dove's survey plan showing the development of the locality and the roadways at the time with the 2008 configuration of the roadways on the left image. Many of the roads have been extended and new lanes/streets have been created but the overall layout remains similar to that in 1880 plan. (Source: City of Sydney Archives 1880s plan & Google maps for 2008 map)

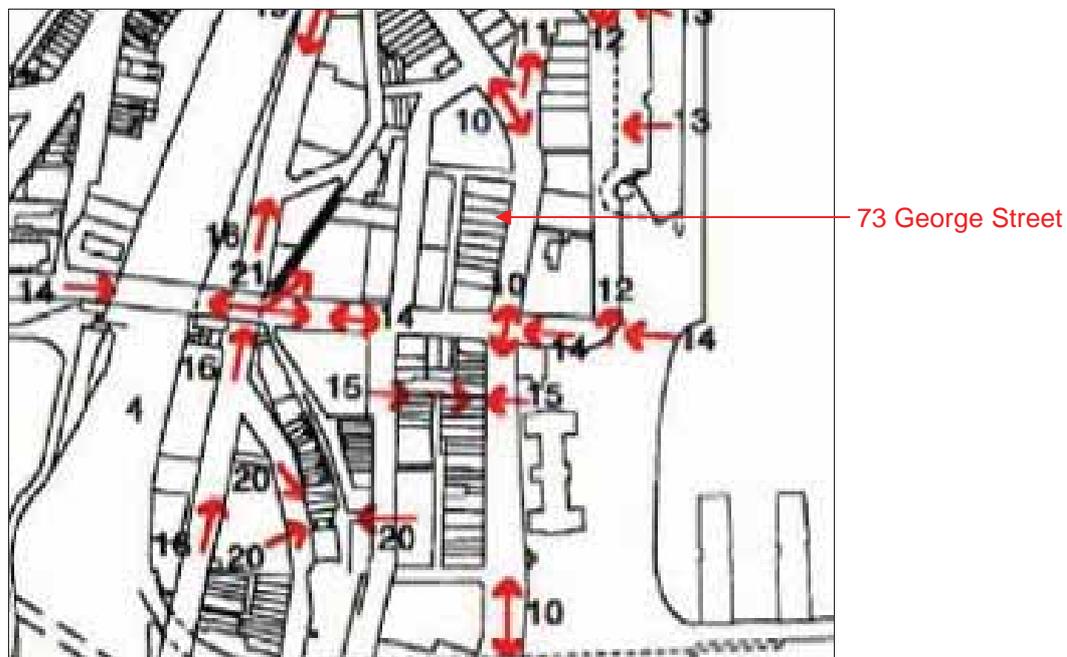
Figure 3-7: Extract from The Rocks Heritage Management Plan, Volume 2, Figure 2.3.3. Views along George Street from Argyle Street and Hickson Road intersections have been indicated as number 10.

Views to and from the shop at street level are available to the north and south along George Street and are the most significant views for the site (Views 2 & 3). The views from Argyle Street and intersection of Hickson Road to north and south along George Street have also been identified as significant views and vistas in The Rocks Heritage Management Plan.

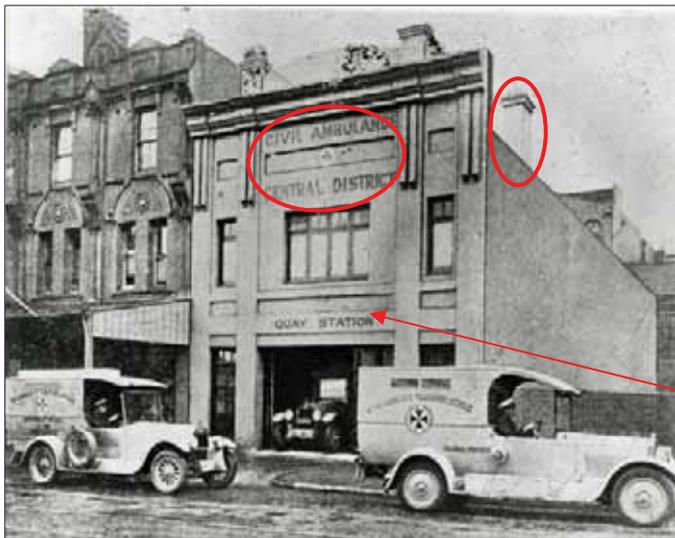
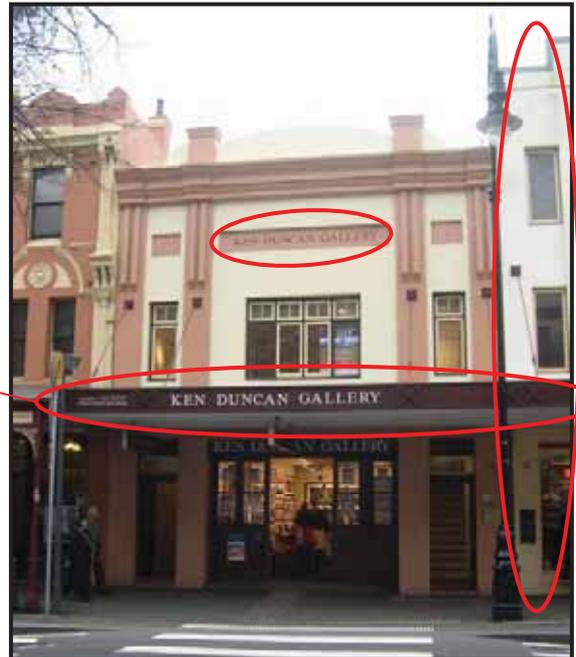
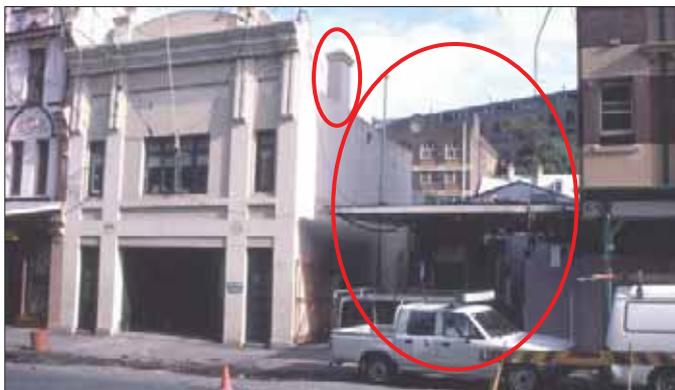
Figure 3-9 Photos of the building in 1927 (above left), in 1991 after the vacation of the ambulance service (left) and present George Street elevation (above), with main changes indicated. Note the original chimney in the 1927 image, which still exists but is obscured from the street due to adjoining infill.

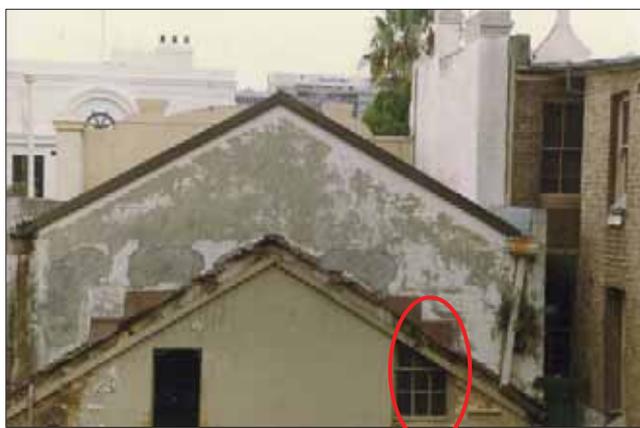
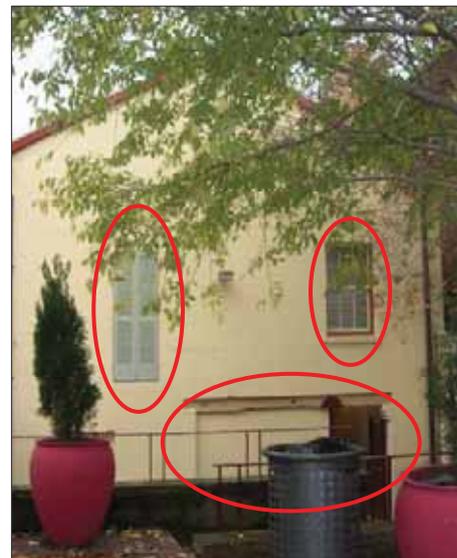
Figure 3-10 – Current view of the rear elevation of the building Kendall Lane (right) and after the removal of the courtyard roof in 1991 (above). See also roof line evidence on the next page.

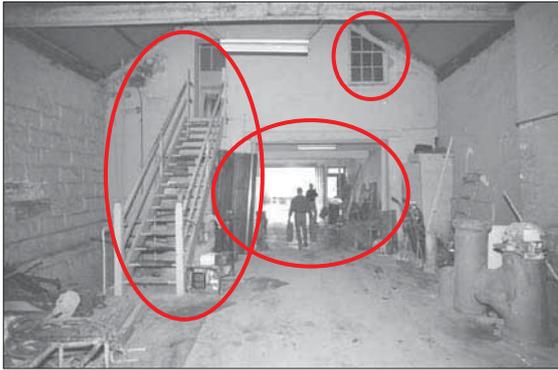
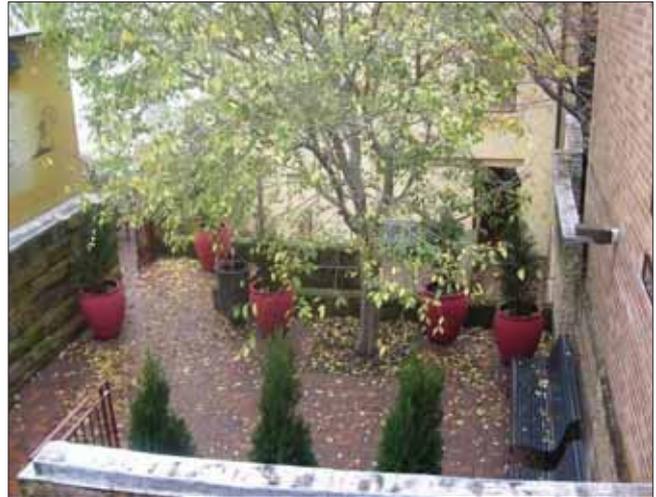
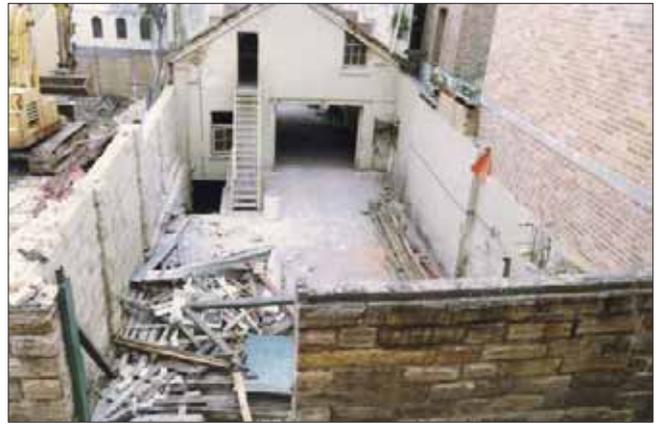
Figure 3-11 (Above), the rear of the building showing the enclosed courtyard and (right) the current layout of the Kendall Lane courtyard and plantings, viewed from a Playfair Street office building. Note the changes to the first floor window, ground floor vehicular opening, removed timber stair and terraced courtyard with brick paving. The courtyard had concrete flooring, now it is brick paving with sandstone retaining walls

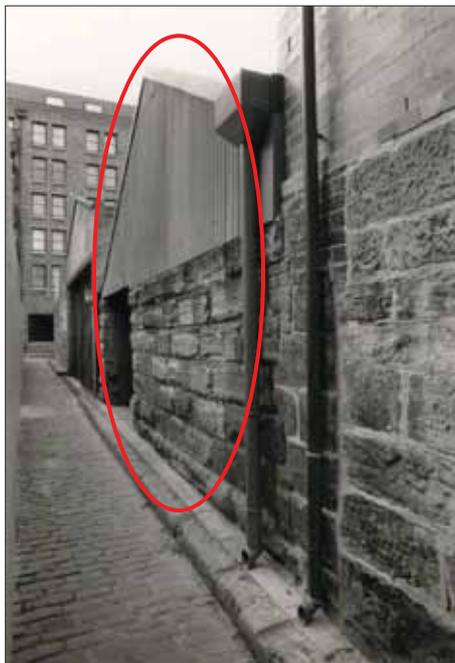
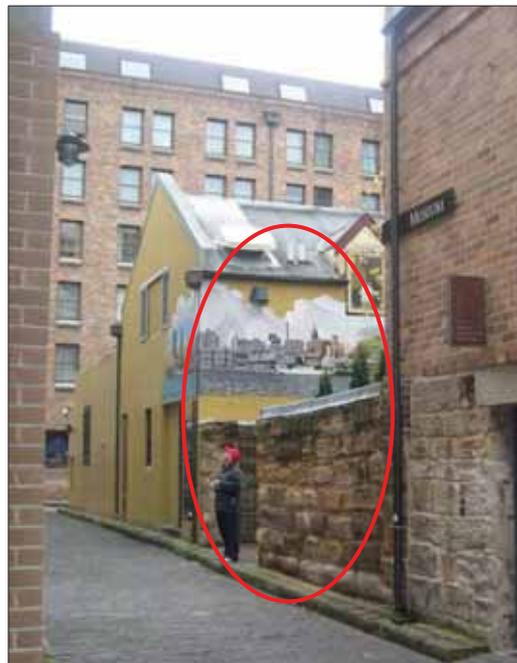
Figure 3-12 – The Kendall Lane streetscape elevation of the subject site in 1991 and 2008. The enclosed courtyard now open to public and accommodates interpretive mural on the wall of neighbouring property with descriptive plaque on the sandstone wall of the subject site.

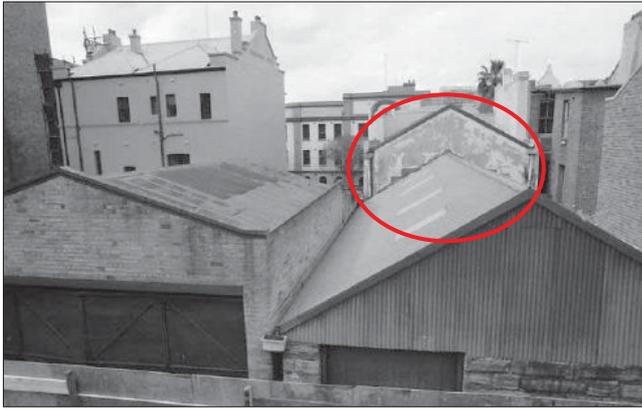
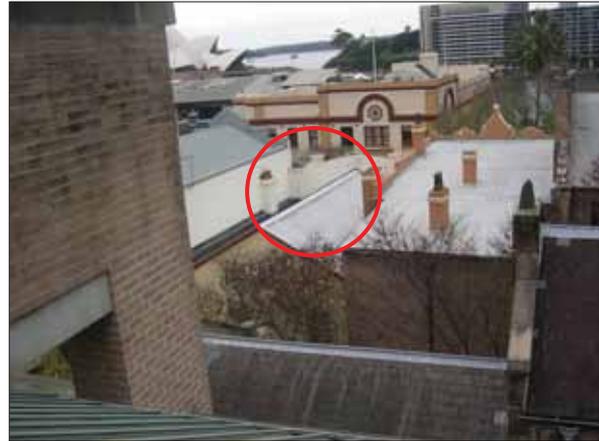
Figure 3-13 – Views of the roofscape in 1991 and 2008 showing the original chimney and exposed rear elevation of the building. Evidence of removed roof line is slightly visible in close inspection as such one can read the fabric if knows about the development history of the site (see below image).
