73 George Street, The Rocks
Conservation Management Plan

2008

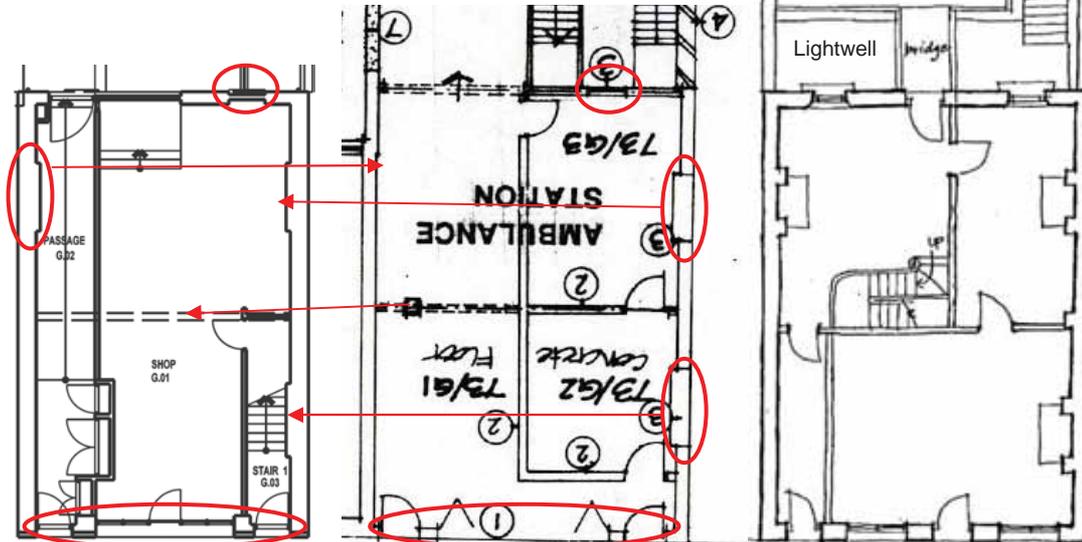
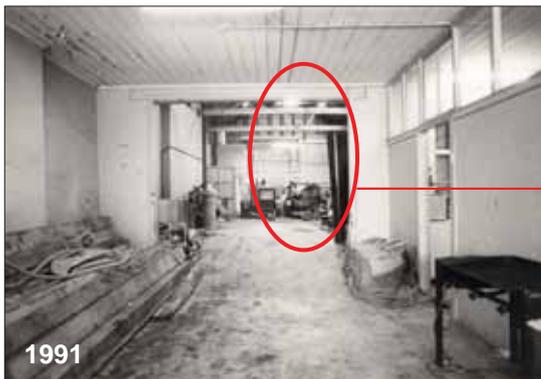
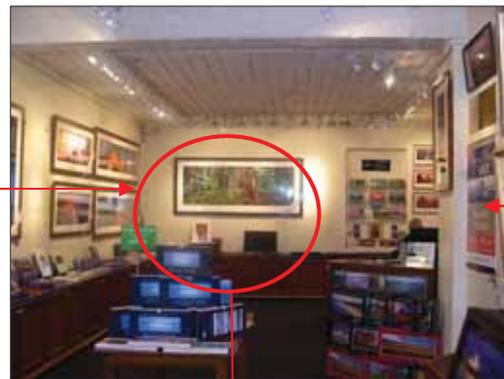
Figure 3-14: Ground floor plans in 2004 and 1989 (below) and likely 1840s layout (right). The overall original external/structural walls remain with only internal modifications to the layout have been made. The steps seen on the top left corner of the 2004 plan no longer exist as the opening to the courtyard has been infilled. Note that all the three original fireplaces have been blocked but remain evident. The lightwell below the bridge seen in the 1840s plan is now part of the basement.

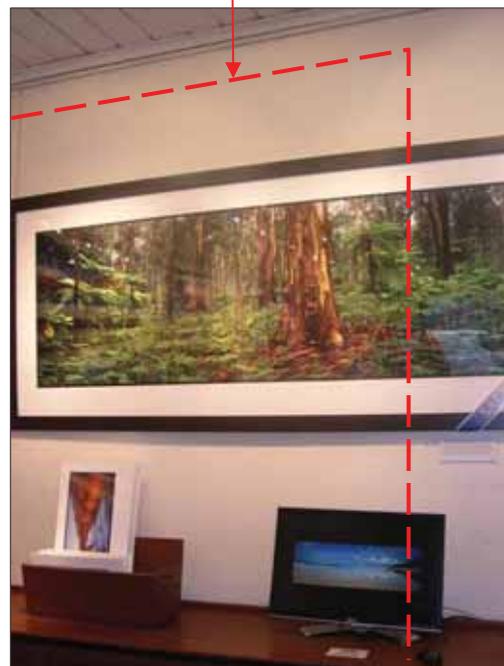
Figure 3-15: Ground floor looking towards the courtyard. The 1991 layout was slightly different in that the then office partition was replaced with a stairwell at further north to allow for the new public way along the southern side. This necessitated the enlargement of the rear vehicular access door towards the south end, which is evident by the new corbelled beam support under the south end of the timber door lintel. The north half of the rear vehicular entry was infilled as it remains within the gallery space of the shop (indicated on the right).

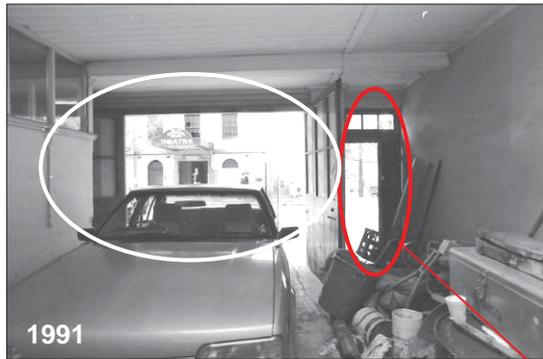
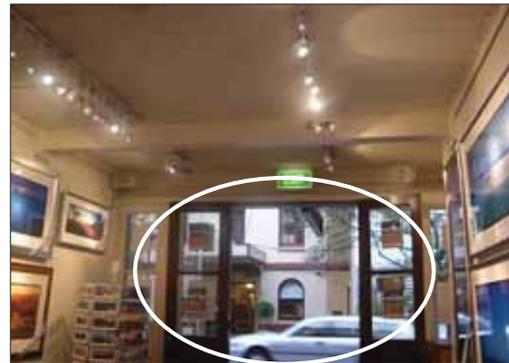
Figure 3-16: Ground floor looking towards George Street entrance. The space width appears to be the same however, as detailed above, the office partition wall was pushed to the north and replaced with a new masonry stairwell for access to the first floor. The door on the south of the main folding door is now separated from the main space in order to create a public access way to Kendall Lane. Note the corbelled beam below the timber lintel of the rear opening indicating slight enlargement to the south end. The steel support on the other side of the opening dates from the 1992 works.

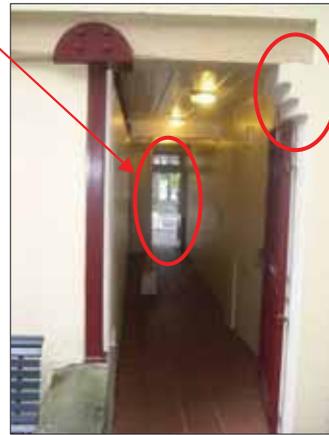
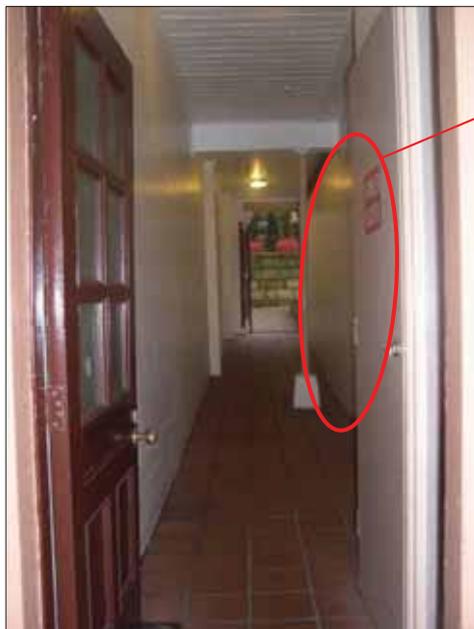
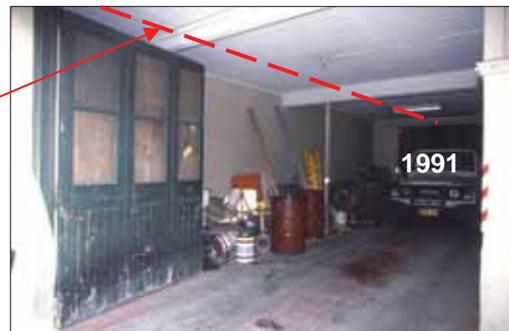
Figure 3-17: Views from the George Street entry showing the new public walkway that was created by separating portion behind the folding doors along southern boundary wall. The visual connection has been provided by three vertical glazing on the new partition. Approximate location of the new partition is indicated. Timber door joinery is retained.

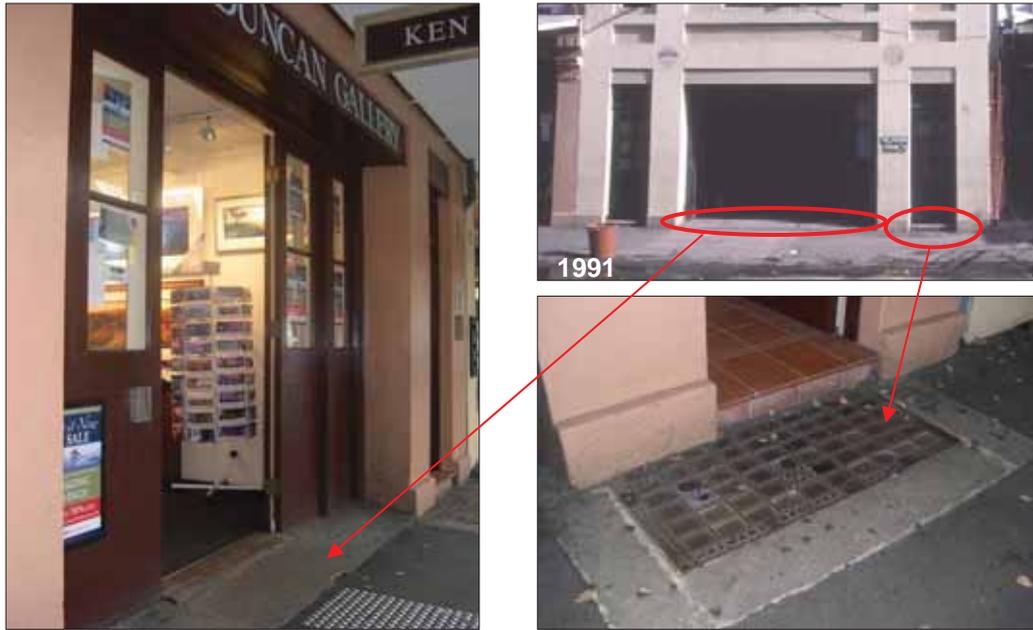
Figure 3-18: The concrete ramp at the threshold of the main entry is associated with the Ambulance Station phase and has been retained. The original pavement light, associated with the original public house use, survives.

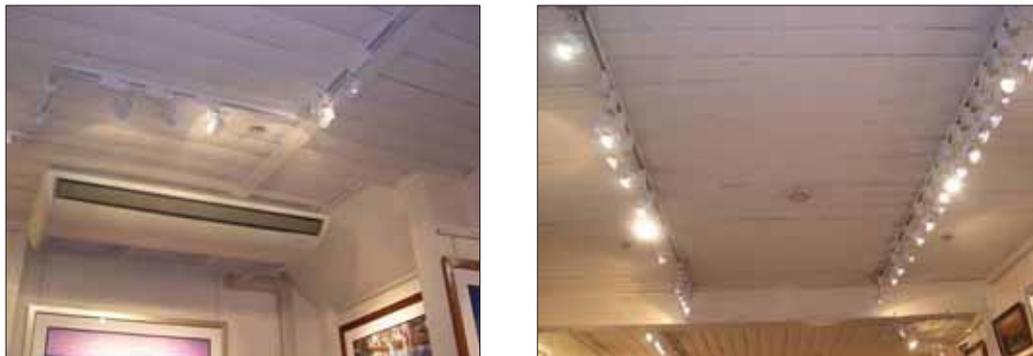
Figure 3-19: Original timber board ceiling linings largely remain with some repair and replacements. Light fittings date from the 1992 or later alterations.

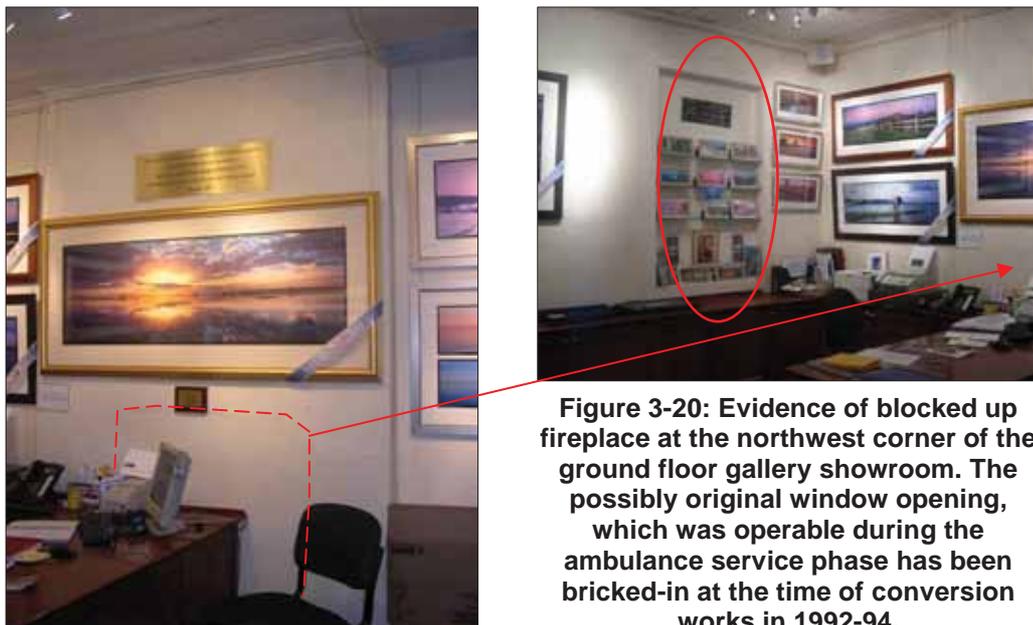
Figure 3-20: Evidence of blocked up fireplace at the northwest corner of the ground floor gallery showroom. The possibly original window opening, which was operable during the ambulance service phase has been bricked-in at the time of conversion works in 1992-94.

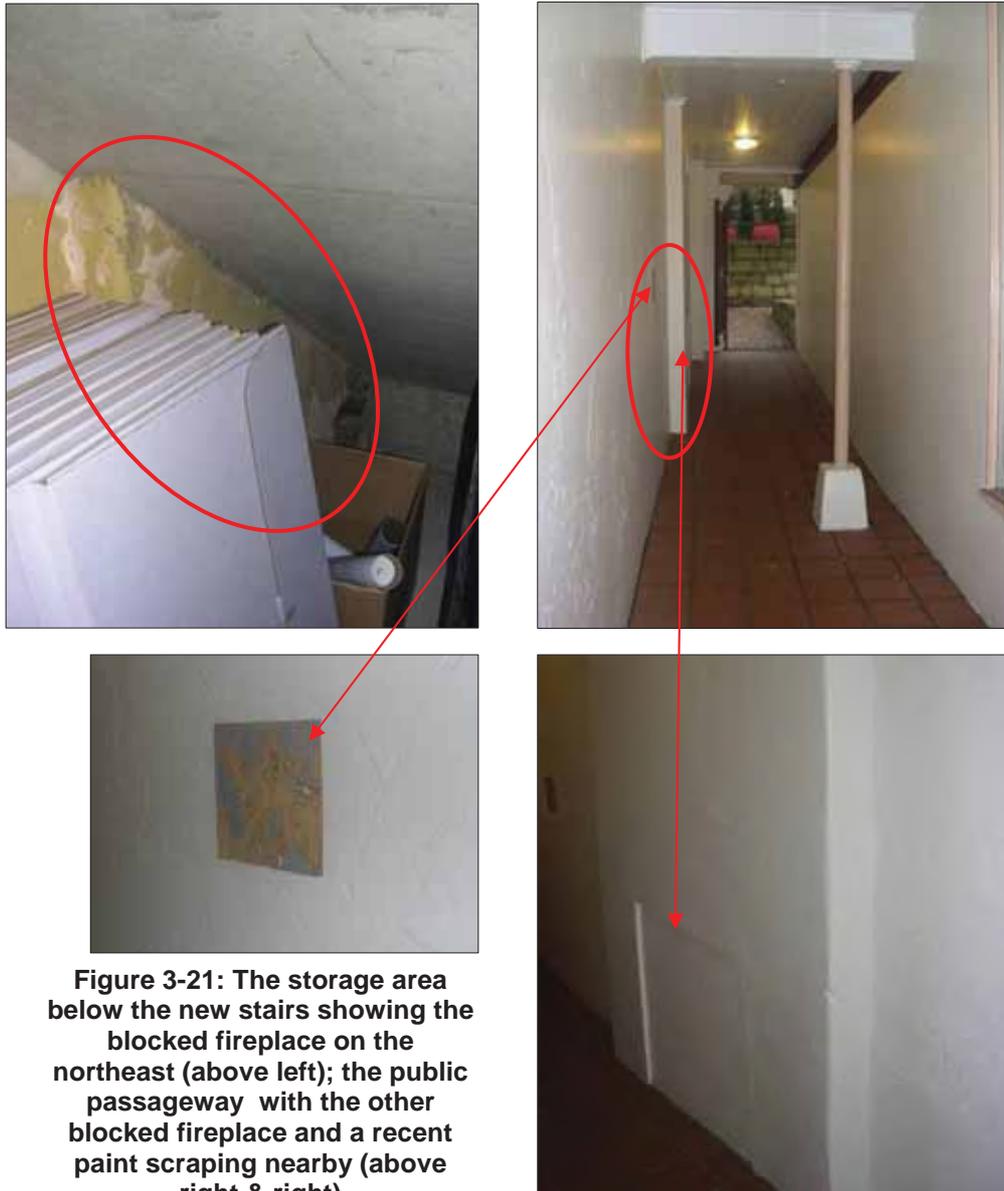
Figure 3-21: The storage area below the new stairs showing the blocked fireplace on the northeast (above left); the public passageway with the other blocked fireplace and a recent paint scraping nearby (above right & right)

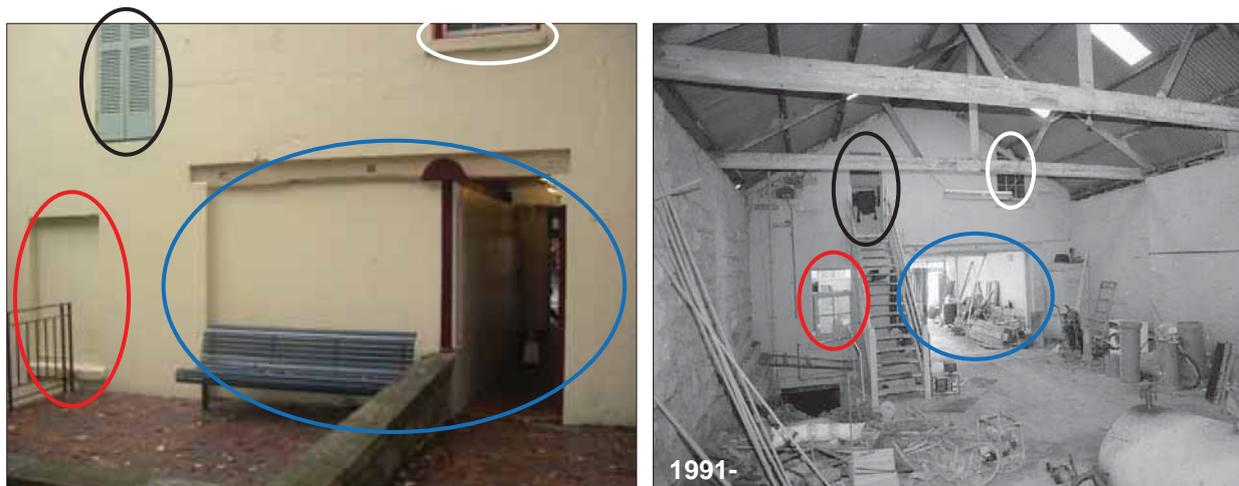
Figure 3-22: Changes to the openings on the rear elevation of the building. Originally, the rear elevation had three narrow window openings to all three levels with the exception of central door opening on the ground floor. It appears that the window openings marked with red and white circles are from that original phase. It is also clearly evident that all openings associated with the Ambulance Station phase although modified remain legible.

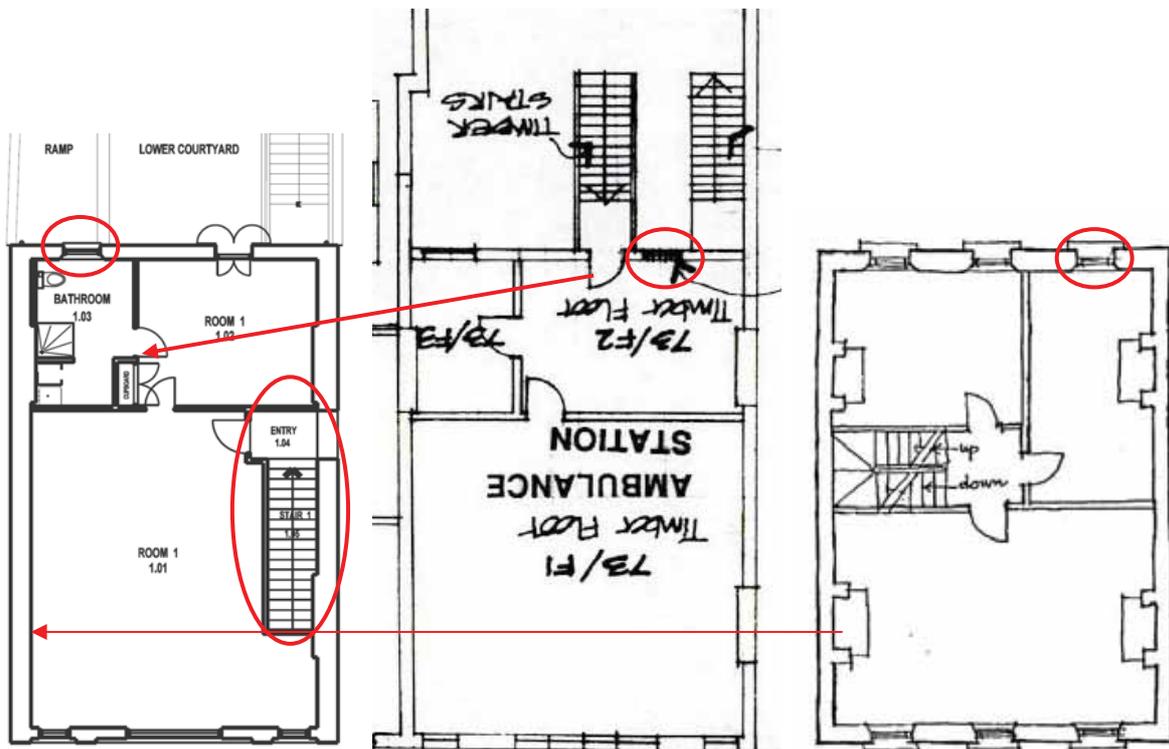
3-23: First floor layouts in present, 1991 and 1840s. Note missing fireplace at the southeast corner of the 1991 and present floor plans. Possible evidence of a slate hearth is observed on ground floor near the door of the public passageway.

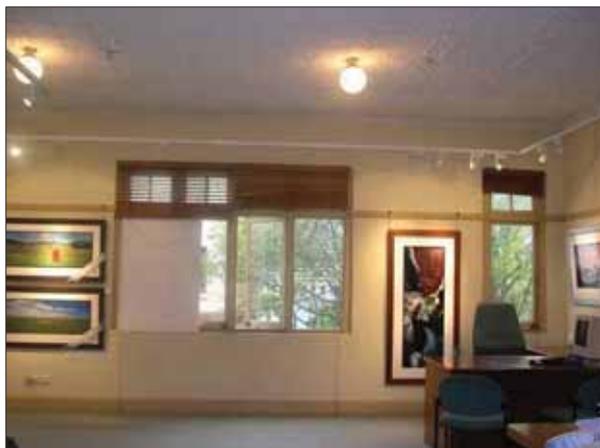
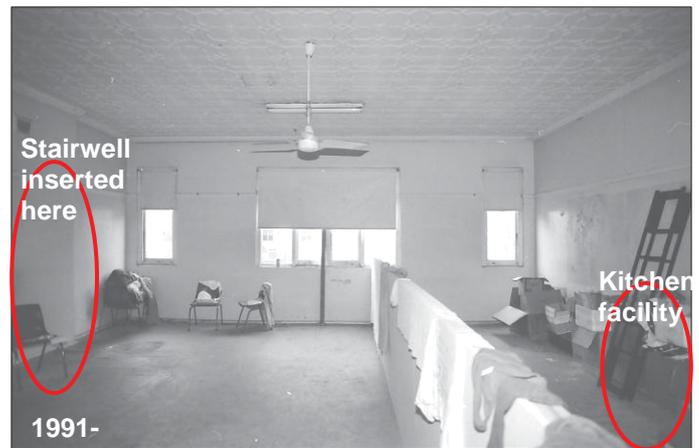
3-24: Front room of the first floor showing 1927 pressed metal ceiling, George Street facade timber casement windows and simple timber picture rails. This room is largely intact exhibiting the 1927 fabric with insertion of a stairwell and kitchen facility at the indicated areas.

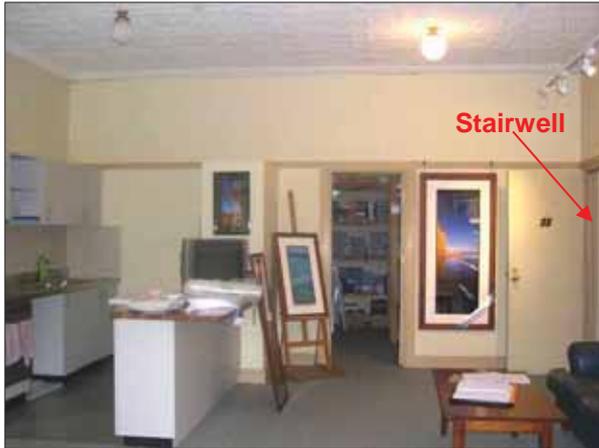
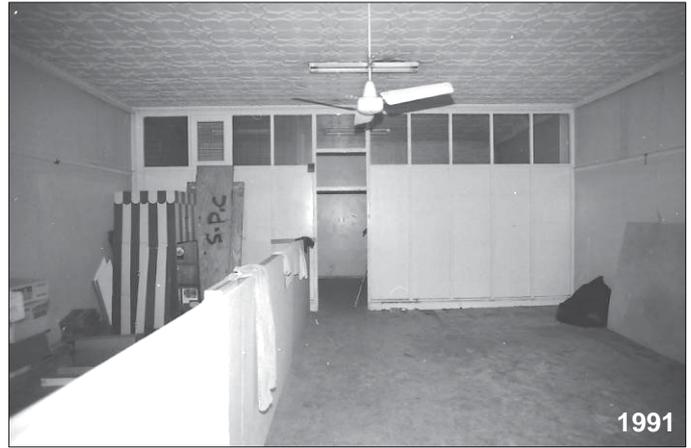
3-25: West wall of the front room on the first floor. Changes include new partition walls, kitchen facility and stairwell. All light fittings and services date to post-1992.

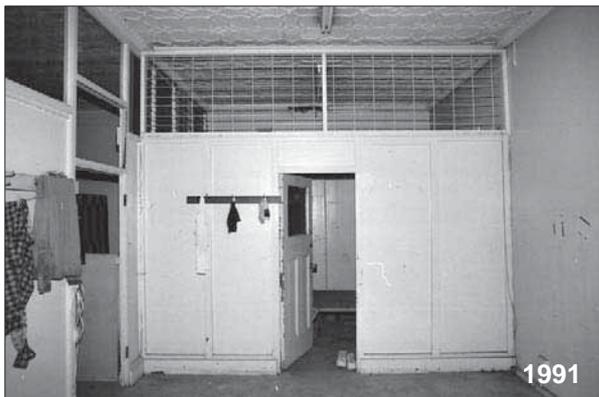
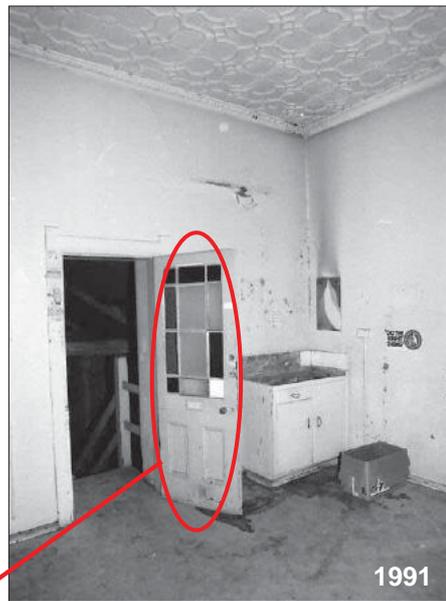
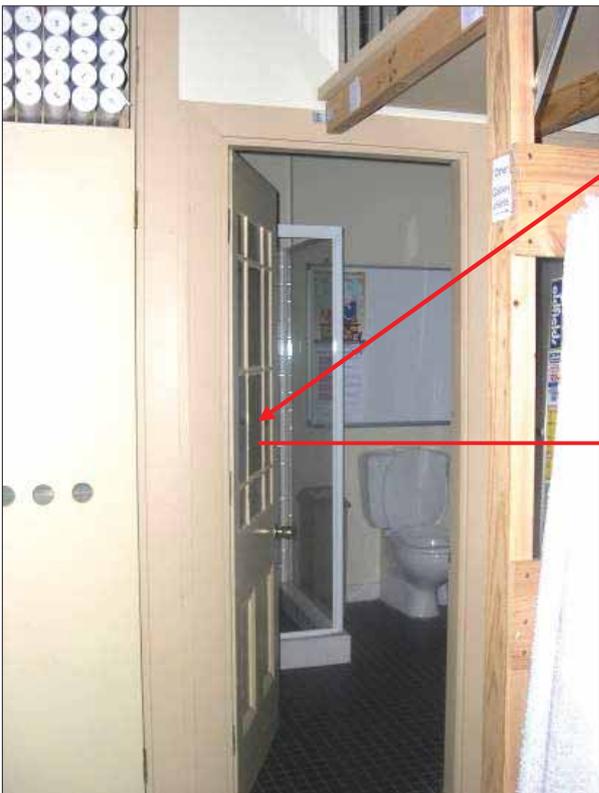
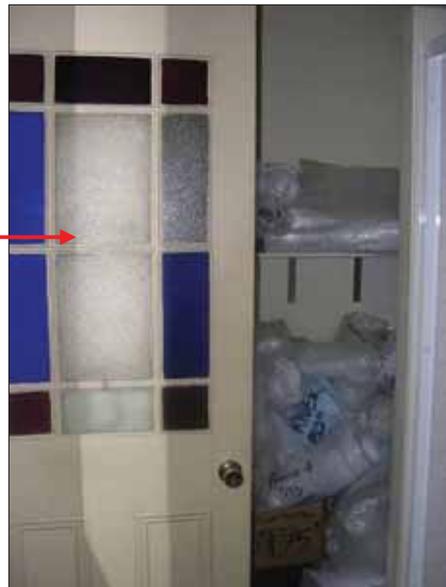
Figure 3-26: Rear room on the first floor showing the new partition wall with a cupboard to the bathroom on the south. The door that was on the rear access is relocated to the bathroom opening. Due to the storage shelves and cupboards clear pictures of the whole room including pressed metal ceiling and blocked fireplace

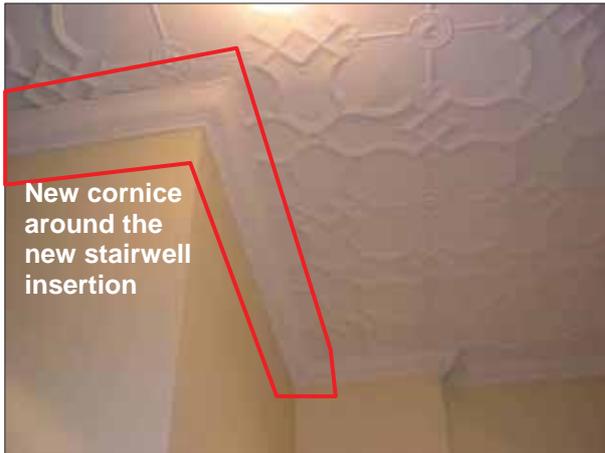
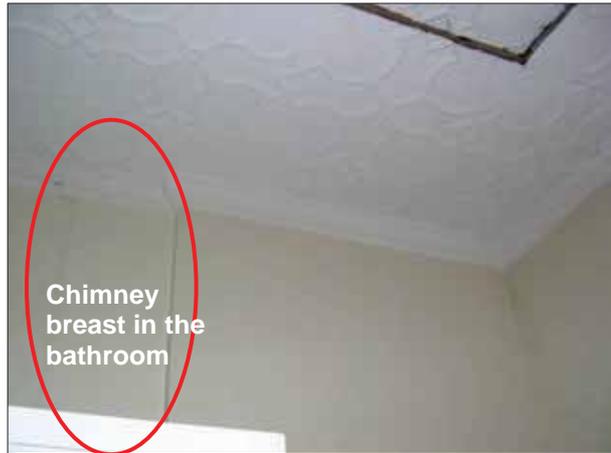
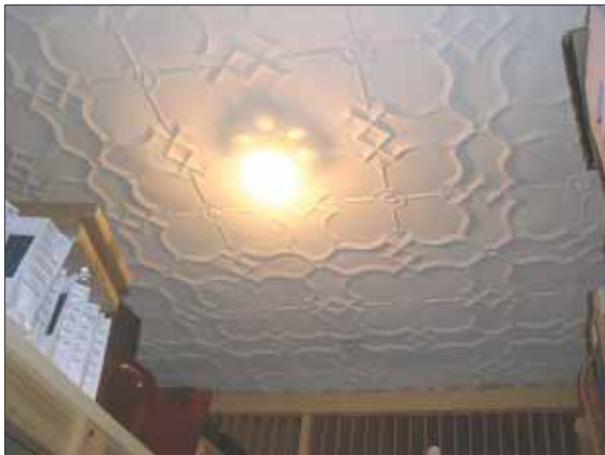
Figure 3-27: 1927 pressed metal ceilings in the front room (above left), bathroom (above) and rear room (left). Note the later plan plaster cornice similar to the original egg & dart cornice around the new stairwell. This is the general approach to new detailing where missing sections reinstated or new sections added.

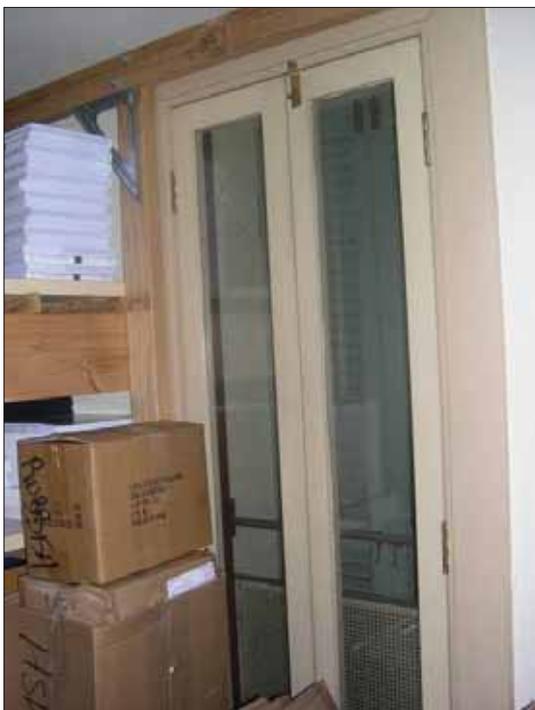
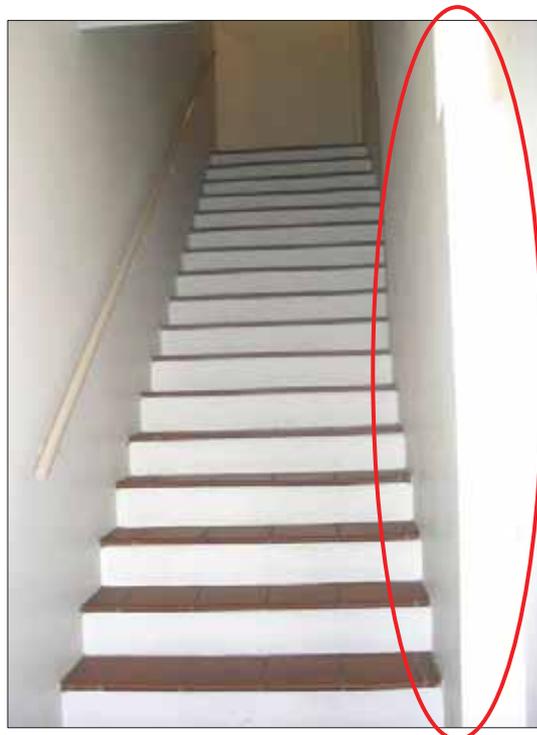
Figure 3-28: New door frame to the former rear access on the first floor (left), and the new stairwell with the blocked off fireplace on the foreground (right).

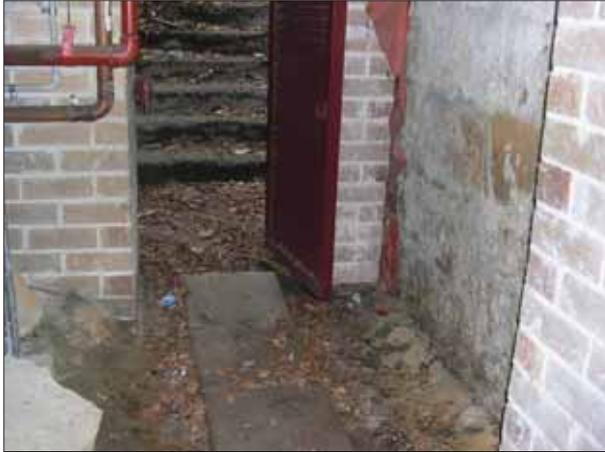
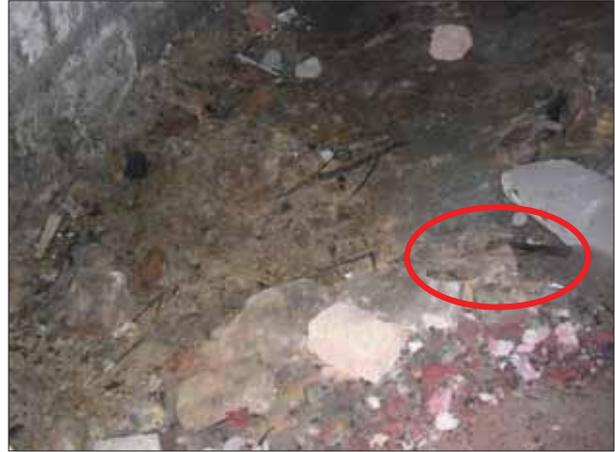
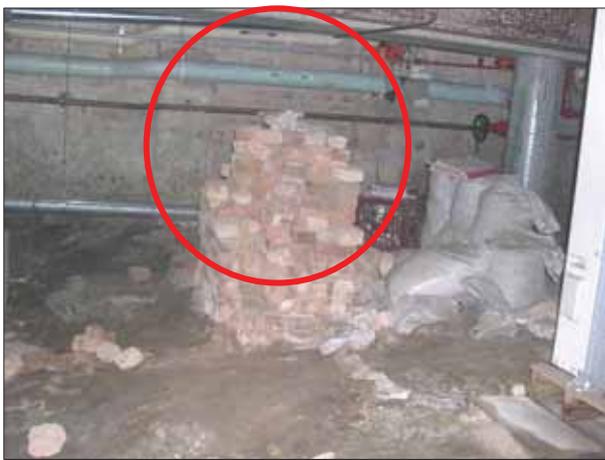
Figure 3-29: Basement entry showing the stonesteps to courtyard (above left); general earth surface and debris containing remnant bones etc (above right); Bricked-in fireplace (left). Note salvaged bricks and remnant materials

- Although the basement has undergone considerable removal of contaminated soil, some contamination material (such as bones) has been sighted during the inspection. The basement also appears to have been used for storage of recycled bricks and other office materials. It is not clear whether the stationary in the basement is used for inspection record purposes or otherwise. Close-up inspection could not be carried out due to uneven surface and dark space conditions. An inspection to clarify potential existence of contaminated soil is recommended within the next 12 months.

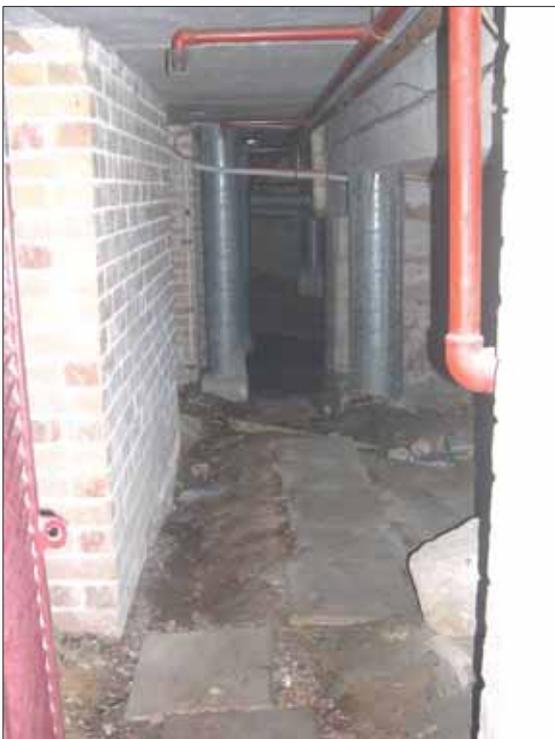
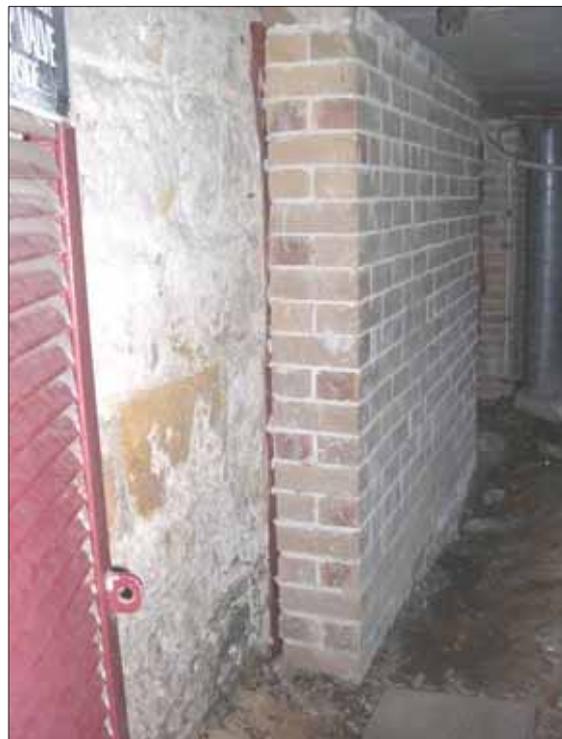
Figure 3-30: General views of the basement level showing C.2 space towards C.1 on the left, and C3 former light well on the right. Note new brick walls, structural steel piers, reinforced concrete ceiling/slab, earth surface and stone walls. Dish drain was removed during contamination works.

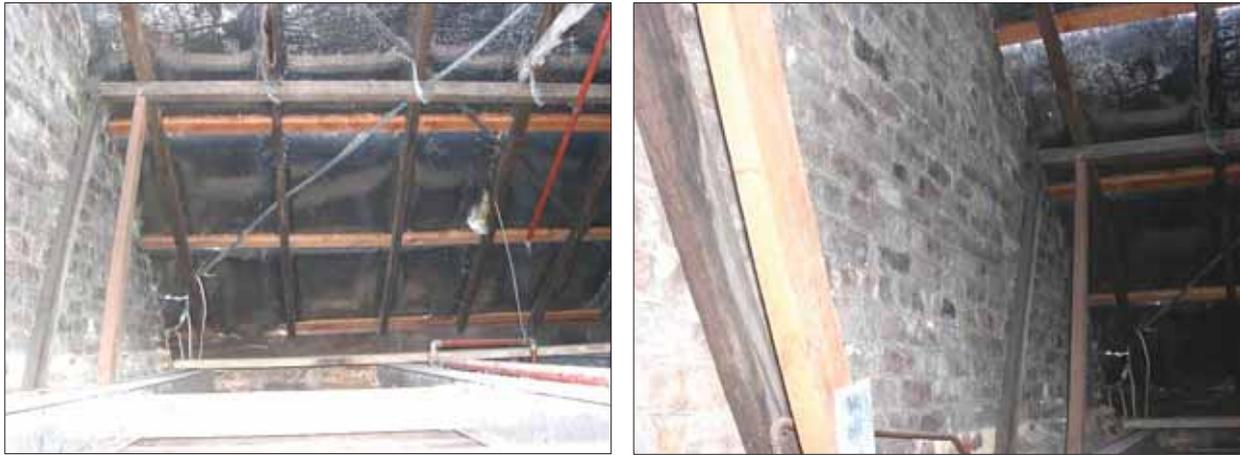
Figure 3-31: Current condition of the roof space showing the original 1842 brick walls at the gable end and the early/original timber structural elements with new supporting elements. Insulation, battens and roofing are new.

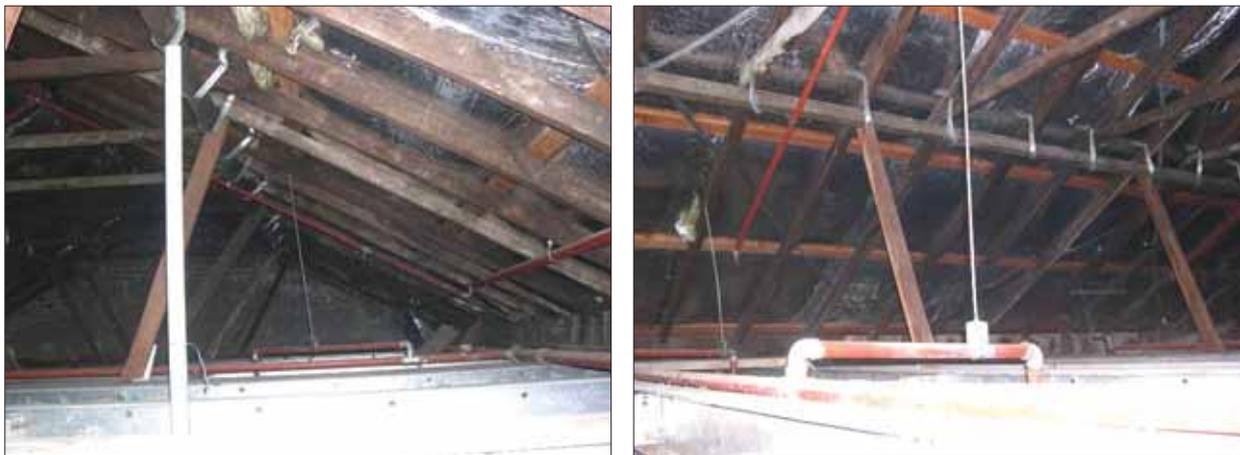
Figure 3-32: Views towards George Street elevation. Brick wall to parapet and new steel beams are visible.

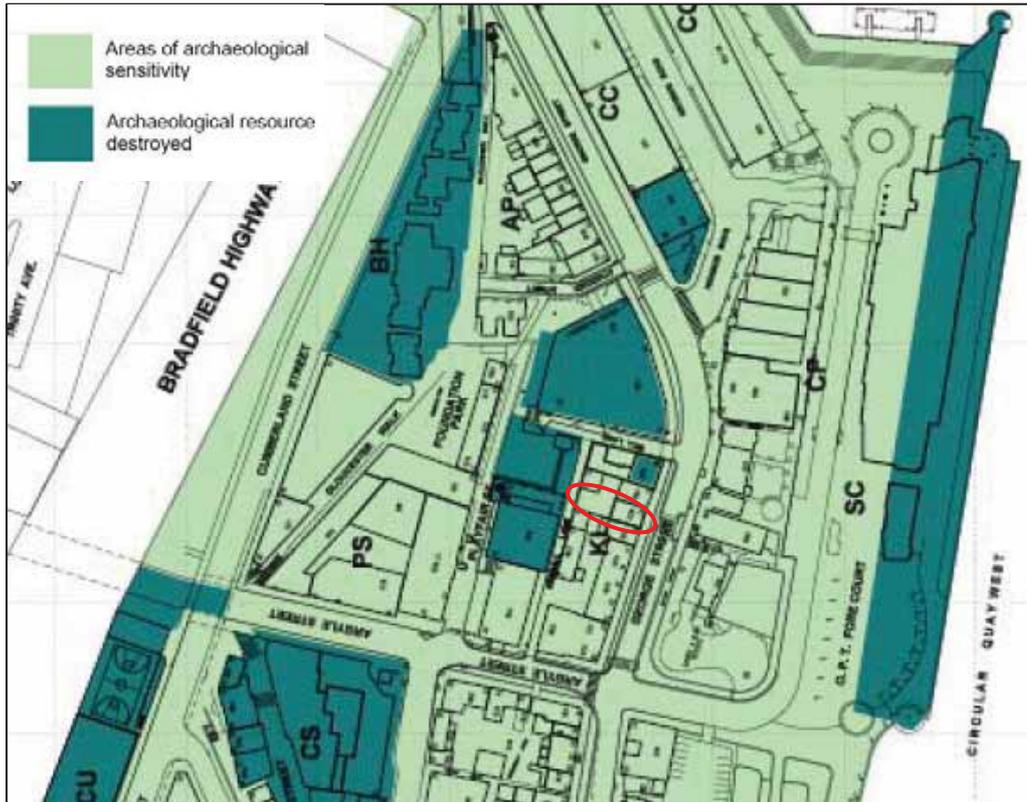
Figure 3-33 - Extract from the Map of Archaeological Resources in The Rocks, Sydney Harbour Foreshore Authority, *The Rocks Heritage Management Plan*, Volume 1, Appendix C, p.67.

Although, as assessed above, the below ground archaeological resources of the site would have been destroyed during the phases of reconstruction on the site, the Map of the Archaeological Resources in The Rocks identifies it as being an area of archaeological sensitivity. Extract of the archaeological map has been provided below.

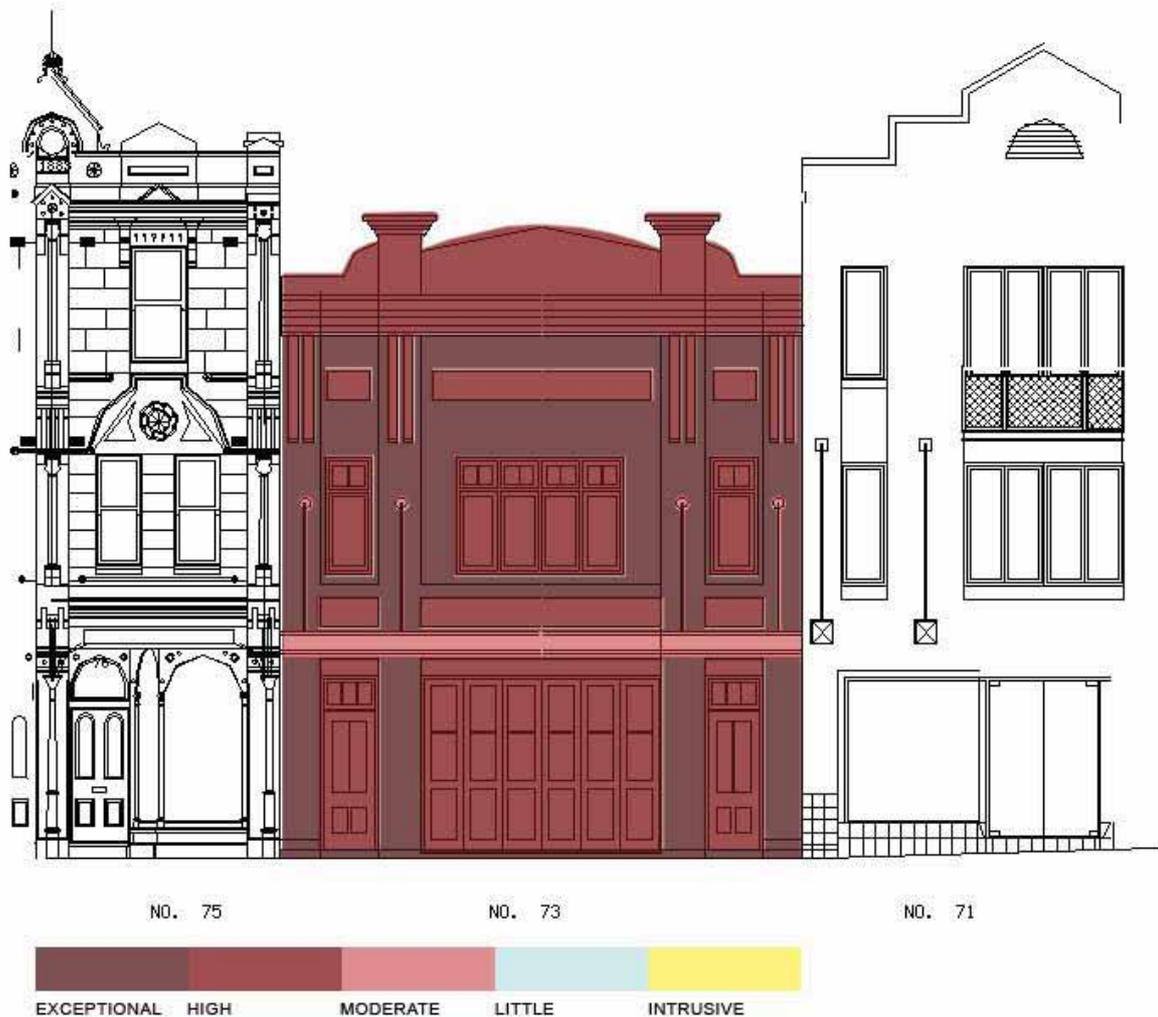
5.1.1 East (George Street) Façade External Elements

George Street Elevation	
Element	Significance
<ul style="list-style-type: none"> – Overall form and scale and walls behind the front facade – Pavement light at the front of the threshold of the north stairwell door 	Exceptional
<ul style="list-style-type: none"> – 1927 facade detailing including arrangement of openings particularly at ground floor level (main vehicular access opening), curved parapet and Art Nouveau style mouldings, sign plates and cornice, timber framed casement windows, timber panelled doors and main timber folding doors to ground floor including transoms, threshold slope at the main entrance 	High
<ul style="list-style-type: none"> – Suspended Awning and its fixing – Colour Scheme 	Moderate
<ul style="list-style-type: none"> – Painted and box business signs, timber threshold to the main entrance 	Little
<ul style="list-style-type: none"> – N/A 	Intrusive

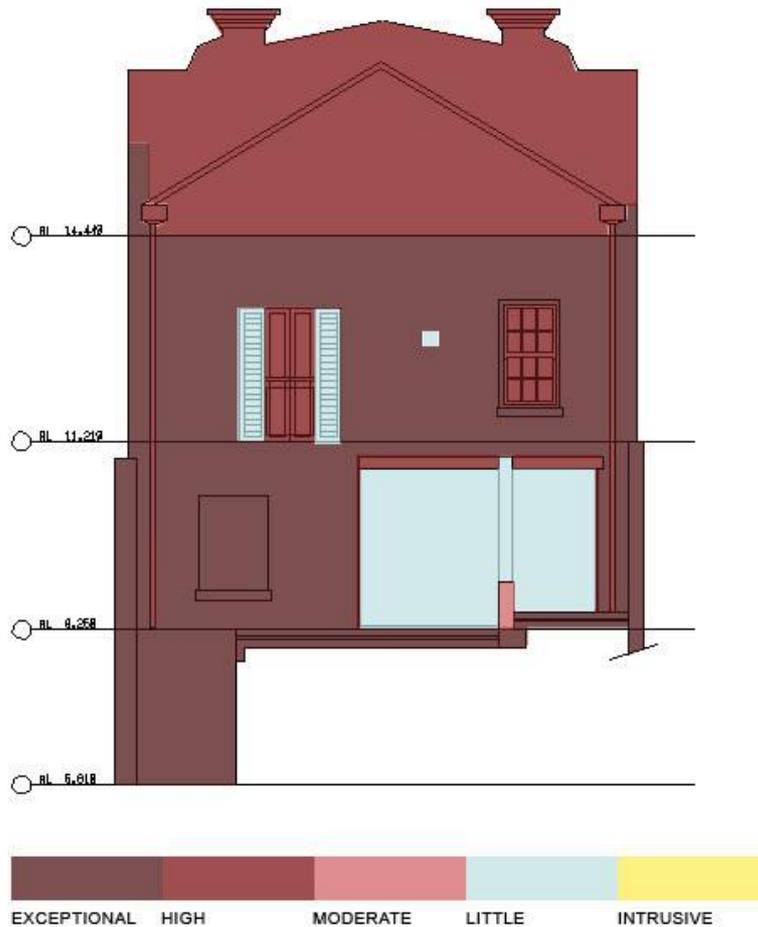
5.1.2 West (Kendall Lane) Façade External Elements

Kendall Lane Elevation	
Element	Significance
<ul style="list-style-type: none"> – Overall form and scale – Brick structural walls – Sandstone and brick boundary walls – Window opening to first floor at south end – Blocked window opening on ground floor at north end – Basement stone steps – Remaining chimney at northeast side 	Exceptional
<ul style="list-style-type: none"> – Overall gabled roof form and original structural timber elements – Parapet wall – First floor door opening only – First floor timber sash window frame – Timber beam above the former vehicular entry – Evidence of removed courtyard roofline – Copper rainwater heads and downpipes (material & form only) 	High

Kendall Lane Elevation	
Element	Significance
– Dwarf stone walls in the courtyard	Moderate
– Corrugated metal roofing (fabric) – Copper rainwater heads and downpipes (fabric only) – First floor door fabric and shutters – Light fitting – Infill, metal support and metal gate to vehicle opening	Little
– N/A	Intrusive

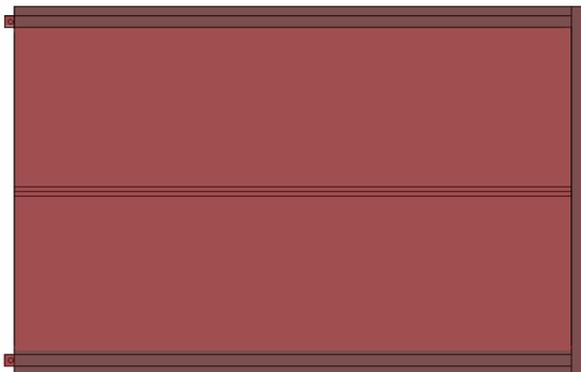
5.1.4 Roof Elements

Roof	
Element	Significance
– Original brick walls are Exceptional	Exceptional
– Overall gabled roof form and original structural timber elements – Parapet wall – Copper rainwater heads and downpipes (material & form only)	High
– N/A	Moderate
– Corrugated metal roofing (fabric) – Copper rainwater heads and downpipes (fabric only)	Little
– N/A	Intrusive

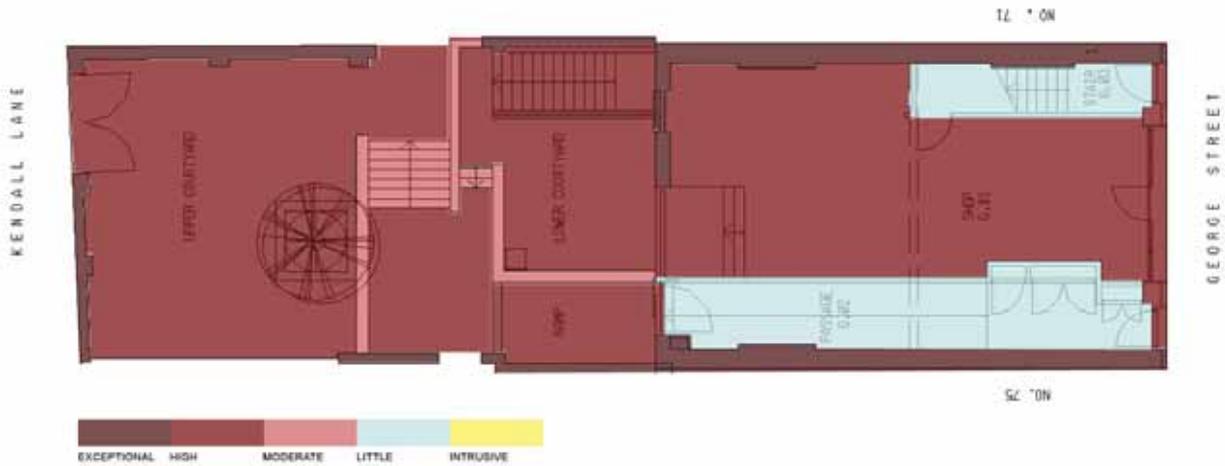
5.1.5 Ground Floor Internal Elements & Courtyard

Ground Floor	
Element	Significance
<ul style="list-style-type: none"> Original 1842 brick walls to north and south boundary, blocked fireplaces and chimney breasts Sandstone and brick boundary walls to courtyard 	Exceptional
<ul style="list-style-type: none"> Overall internal layout and courtyard (form) Stone steps to basement Timber board ceiling lining and timber beams Evidence of blocked openings Front facade door openings and associated fabric Sloping threshold to former vehicle entry (form only) Stone remnant hearth (?) in the passageway behind the door Paint scrape in the passageway 	High
<ul style="list-style-type: none"> Relocated sandstone dwarf walls and steps to courtyard Concrete flooring 	Moderate
<ul style="list-style-type: none"> First floor stair insertion along northern side Public passageway and associated partitions, steel column All light, services and storeroom fittings Carpet flooring Fit-out associated with the gallery use 	Little

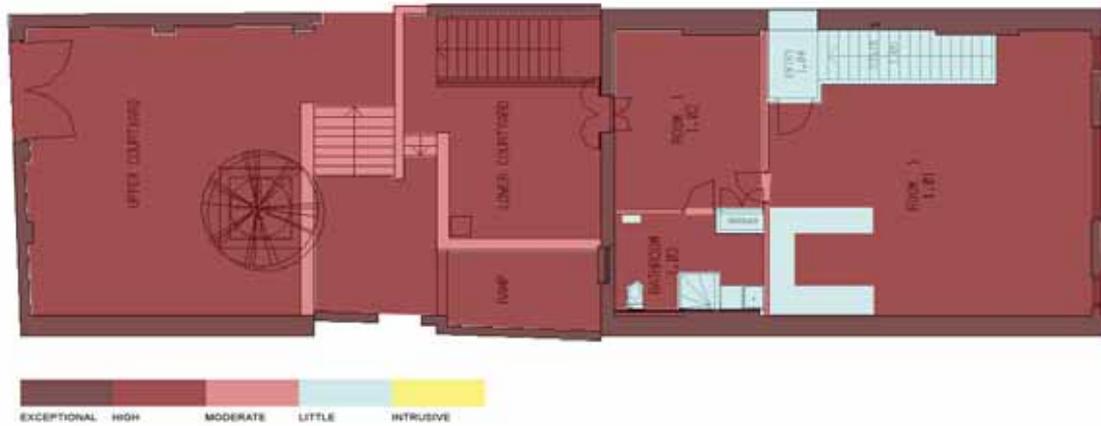
5.1.6 First Floor Internal Elements

First Floor	
Element	Significance
<ul style="list-style-type: none"> Original 1842 brick walls to all elevations, blocked fireplaces and chimney breasts & hearths, window opening to bathroom 	Exceptional
<ul style="list-style-type: none"> Overall floor layout and spatial qualities of front room Timber floor structure and timberboard flooring Pressed metal ceiling throughout and egg & dart cornices Rear door opening (door fabric not included) Panelled timber door with colour glazed panes to bathroom Timber casement windows to front facade (including hardware) & timber sash window frame to bathroom 	High
<ul style="list-style-type: none"> Partition walls between the rooms and bathroom 	Moderate
<ul style="list-style-type: none"> First floor stair insertion along northern side and associated cornices, doors and steps All light, services, kitchen and bathroom fittings Timber skirting Carpet and plastic tile flooring All hardware to doors All blinds and fit-out associated with the gallery use 	Little

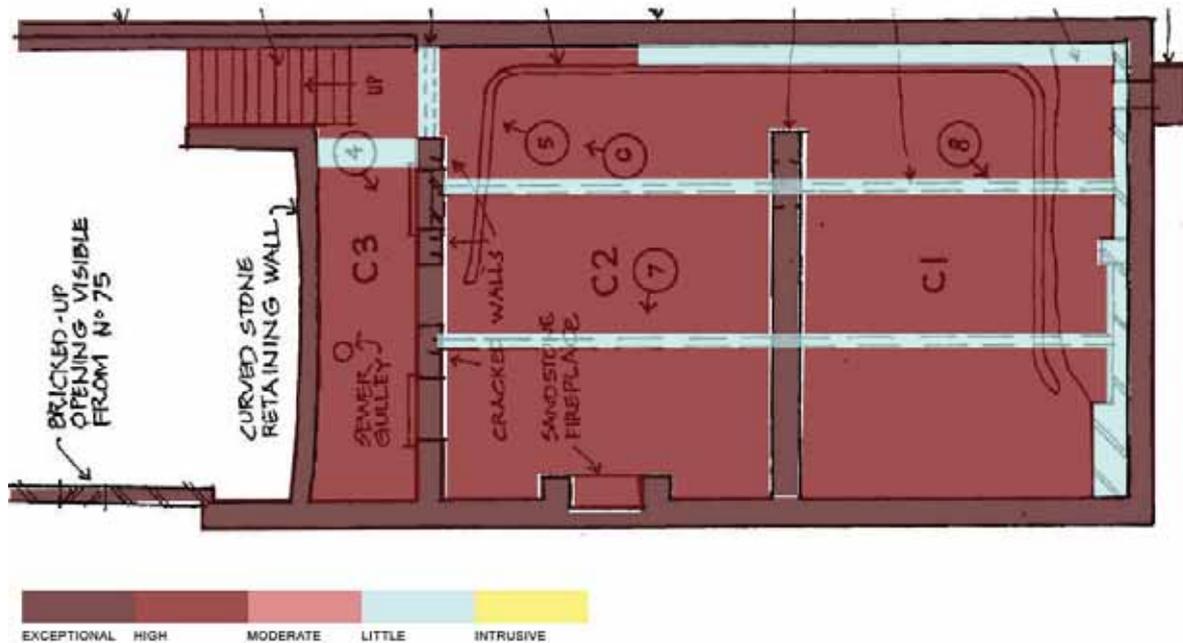
5.1.7 Basement Floor Internal Elements

Basement Floor	
Element	Significance
– Original 1842 stone and brick walls to all boundaries, blocked fireplace and opening associated with pavement light	Exceptional
– Overall floor layout	High
– Remnant brick stock	Moderate
– Concrete ceiling and associated beams and piers – Brick walls to the front of George Street and north boundary retaining walls – Gates to basement – Pipes, cables and equipment/machinery associated with the services	Little
– N/A	Intrusive

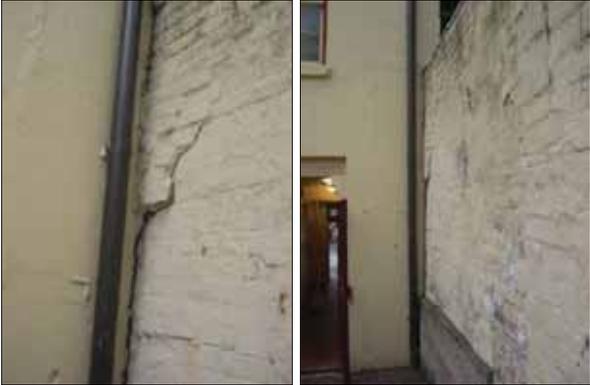
<u>Immediate work (0 – 3 months)</u> - Undertake structural inspection of brick wall adjacent to passageway door for the large crack and movement. Obtain a structural engineer's recommendations for repair and stabilise movement Inspect for cause of rising damp. Undertake necessary actions to halt damp issue
INTERIOR			
Ground Floor			
Walls	Good to Fair	Exceptional to High	<u>Immediate work (0 – 3 months)</u> - Inspect for cause of rising damp on west wall in the Shop. Undertake necessary actions to halt damp issue
Doors	Good	High	- Inspect and repaint as part of ongoing maintenance programme

- The moving boundary brick wall to the south where it adjoins the rear wall of the building near the passageway door. This wall, partially built over a sandstone wall, suffers from rising damp. The rising damp issue is also visible on the other face of the wall from the courtyard of 75 George Street. A structural investigation to identify the cause of the move/large crack and the rising damp is required in short term. The investigation should include the whole associated southern boundary walls both within the building and courtyard.
